## APPENDIX A BAT TECHNICAL APPENDIX

1.1.1 Scottish Hydro Electric Transmission Plc (operating and known as SSEN Transmission) ('the Applicant') submitted a planning application (25/00592/FUL) seeking consent from The Highland Council (THC) for the Bingally 400 / 132 kV Substation project ('the Scheme as Submitted') under the Town and Country Planning (Scotland) Act 1997 (as amended) ('the 1997 Act') in February 2025. A voluntary Environmental Appraisal (EA) was also submitted to support the planning application<sup>1</sup> An Additional Information Report (AIR) has been prepared in response to a number of objections and requests for information by various statutory and non-statutory bodies. The red line boundary of the Scheme as Submitted and the Revised Scheme as presented in **Figure A1 Site Location Plan**, is referred to in this Report as the "Site".

- 1.2.4 This Report is therefore assessing the impact of the Revised Scheme access track which is shown on **Figure A1 Site Location Plan**.

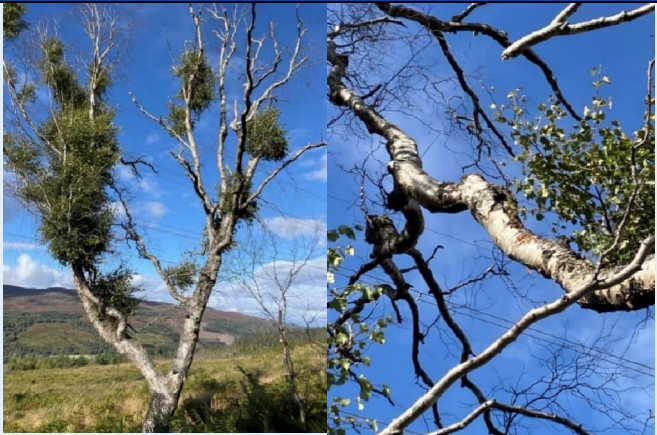
| Reference | Tree Description | PRF Description(s) | | Suitability (GLTA) <sup>6</sup> | Suitability (further inspection) | Photos | Approximate distance from Revised Scheme access track |
|---|---|---|---|---|---|---|---|
| 1 | A mature silver birch on the bank of a watercourse with a DBH of 50 cm. | A | Damage is present at 6 m on the south-east side of a north-west-pointing limb offering a shallow and exposed feature only. | PRF (I) | PRF-I | | Within the track and associated earthworks footprint. |
| | | B | A hollow pruning cut facing south on a south-pointing branch at 10 m provides a 10 cm deep dry cavity. | | | | |
| | | C | Lifted bark roughly 2.5 m off the ground on the east face of the trunk unsuitable as a PRF. | | | | |

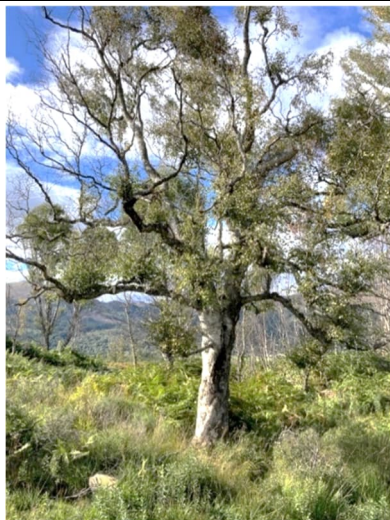
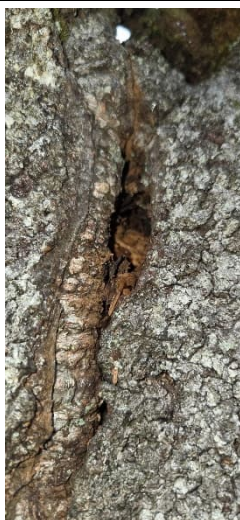
| Reference | Tree Description | PRF Description(s) | Suitability (GLTA)6 | Suitability (further inspection) | Photos | Approximate distance from Revised Scheme access track |
|---|---|---|---|---|---|---|
| 2 | A mature birch with a DBH of approximately 80 cm. | Small cracks and shallow decay features around main trunk and throughout canopy on old tree. | PRF (I) | PRF-I | | 26 m |

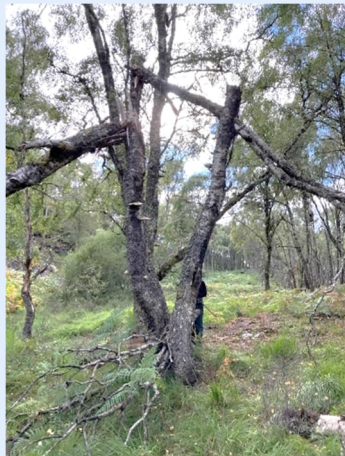
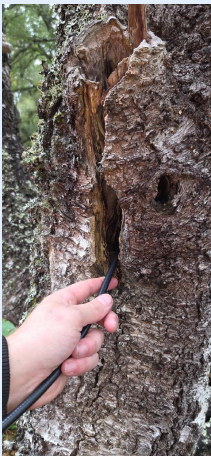
| Reference | Tree Description | PRF Description(s) | Suitability (GLTA)6 | Suitability (further inspection) | Photos | Approximate distance from Revised Scheme access track |
|---|---|---|---|---|---|---|
| 3 | A mature silver birch with partially fallen limbs, with a combined DBH of 70 cm. | Damage at 1.5 m on the northern limb's east-north-east face from a prior lost branch, reveals cluttered splintered bark and leads to a 20 cm deep dry, sheltered cavity up into decayed stem. | PRF (M) | PRF-M | | Within the track and associated earthworks footprint. |

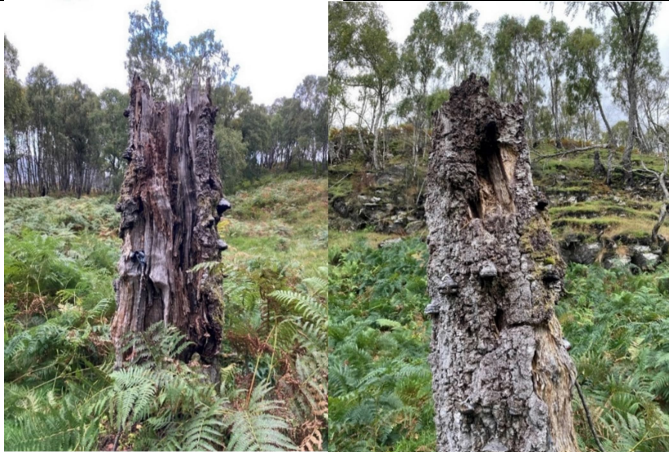
| Reference | Tree Description | PRF Description(s) | | Suitability (GLTA)6 | Suitability (further inspection) | Photos | Approximate distance from Revised Scheme access track |
|---|---|---|---|---|---|---|---|
| 4 | A dead standing birch stump with a DBH of approximately 60 cm. | A very rotten, crumbly old stump that is falling apart with some minor unstable rot holes and flaking bark features. | | PRF (I) | PRF-I | | Within the track and associated earthworks footprint. |

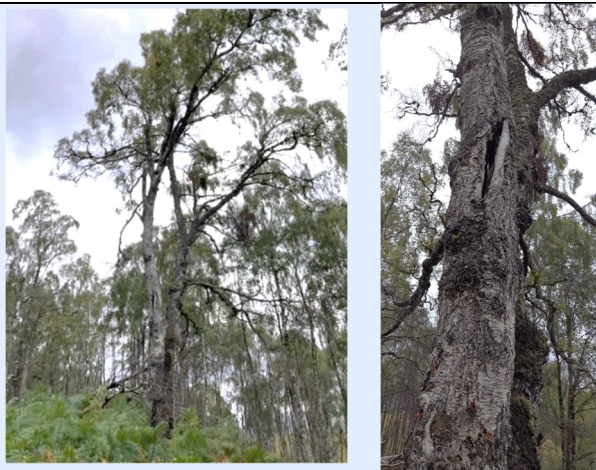
| Reference | Tree Description | PRF Description(s) | | Suitability (GLTA)6 | Suitability (further inspection) | Photos | Approximate distance from Revised Scheme access track |
|---|---|---|---|---|---|---|---|
| 5 | A mature silver birch with a DBH of 45 cm. | A | A tear-out on the east side of a southern limb at 4 m with a visible crack through to the opposite (west) side contains a 10 cm deep upward facing decay pocket. | PRF (M) | PRF M | | 12 m |

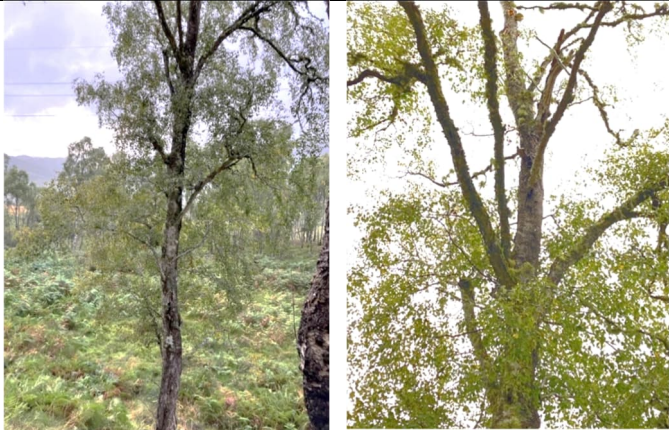
| Reference | Tree Description | PRF Description(s) | | Suitability (GLTA)6 | Suitability (further inspection) | Photos | Approximate distance from Revised Scheme access track |
|---|---|---|---|---|---|---|---|
| 6 | A mature silver birch near the base of a cliff slope, with a DBH of 40 cm. | Lifted bark is visible just below a protruding branch on the south-south-east face at 15 m, offers only a shallow and unsuitable cavity. | | PRF | NONE | | Within the track and associated earthworks footprint. |

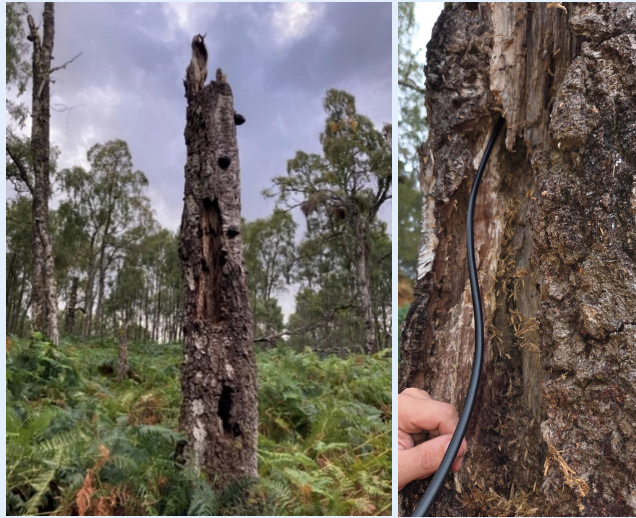
| Reference | Tree Description | PRF Description(s) | | Suitability (GLTA)6 | Suitability (further inspection) | Photos | Approximate distance from Revised Scheme access track |
|---|---|---|---|---|---|---|---|
| 7 | A dead standing birch stump with a DBH of approximately 60cm. | <div>A</div> <div>B</div> | <div>Large rot hole into decayed main stem on east face, 10-20 cm deep, dry and sheltered.</div> <div>Decayed and crumbly top of stump with exposed shallow features.</div> | PRF (M) | PRF-M | | 3 m |

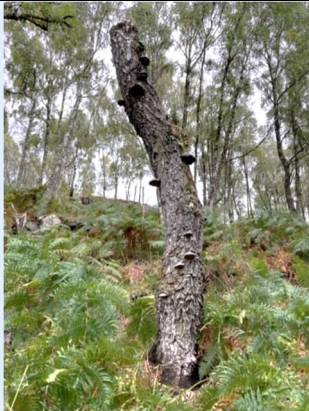
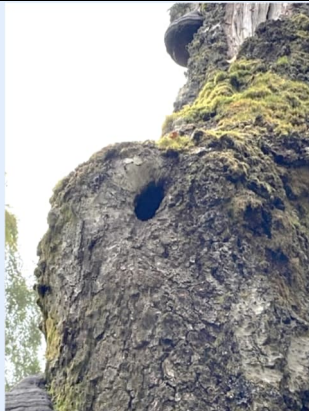
| Reference | Tree Description | PRF Description(s) | | Suitability (GLTA)6 | Suitability (further inspection) | Photos | Approximate distance from Revised Scheme access track |
|---|---|---|---|---|---|---|---|
| 8 | A dead standing mature birch with a DBH of | A | A knothole at 2.5 m on the south face extends straight | PRF (M) | PRF-I | | 16 m |

| Reference | Tree Description | PRF Description(s) | | Suitability (GLTA)6 | Suitability (further inspection) | Photos | Approximate distance from Revised Scheme access track |
|---|---|---|---|---|---|---|---|
| | approximately 40 cm. | | through trunk and is damp. | | | | |
| | | B | Shallow holes and cracks around stump top. | | | | |
| | | B | Decayed and crumbly top of stump with exposed shallow features. | | | | |

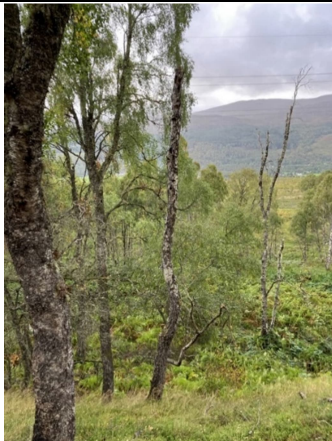
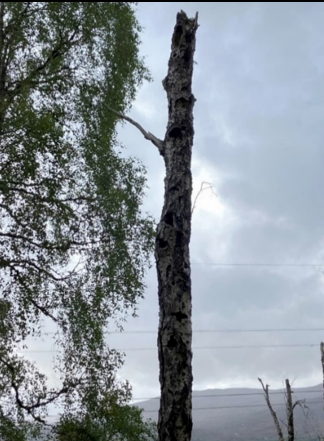
| Reference | Tree Description | PRF Description(s) | | Suitability (GLTA)6 | Suitability (further inspection) | Photos | Approximate distance from Revised Scheme access track |
|---|---|---|---|---|---|---|---|
| 9 | A standing dead birch. | Five woodpecker holes are present on the south-south-east side of the trunk between 7–10 m; all are 4-10 cm deep but a bit exposed and fragile with decay. | | PRF | PRF-I | | 4 m |

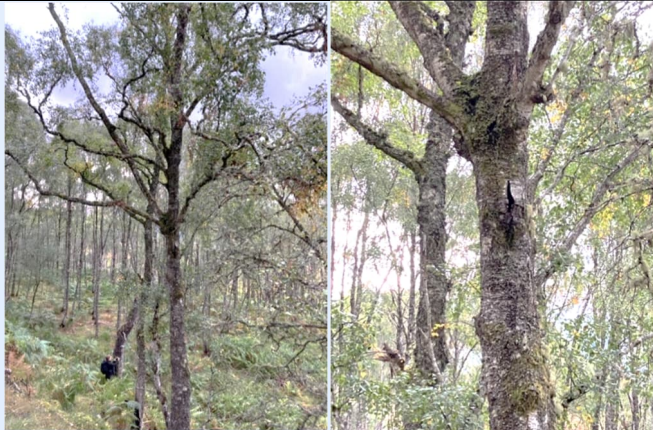
| Reference | Tree Description | PRF Description(s) | Suitability (GLTA)6 | Suitability (further inspection) | Photos | Approximate distance from Revised Scheme access track |
|---|---|---|---|---|---|---|
| 10 | A mature silver birch with minor fire damage at the base and a DBH of 60 cm. | A crack on the east face of the trunk at 9 m contains lifted bark, forming a narrow space that is shallow and exposed; 5 cm deep. | PRF (I) | PRF-I | | 5 m |

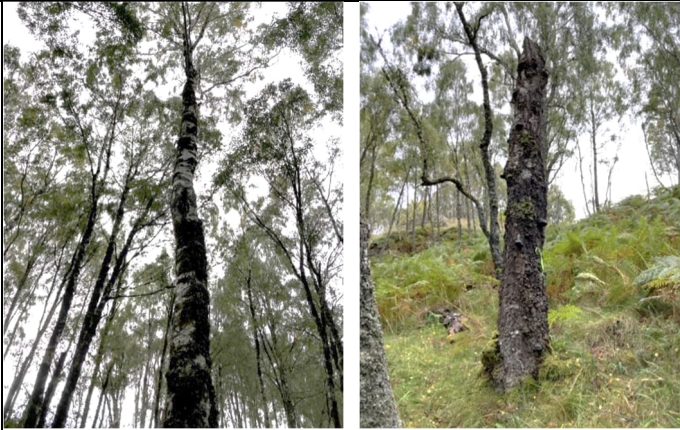
| Reference | Tree Description | PRF Description(s) | Suitability (GLTA)6 | Suitability (further inspection) | Photos | Approximate distance from Revised Scheme access track |
|---|---|---|---|---|---|---|
| 11 | A mature birch with a DBH of approximately 40 cm. | A north-facing knothole at 7 m is shallow and unsuitable. | PRF (I) | NONE | | 24 m |

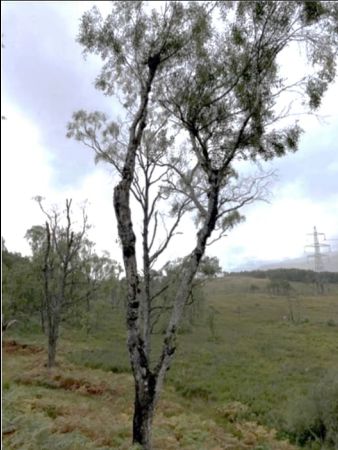
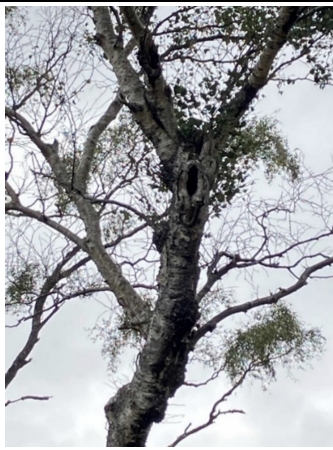
| Reference | Tree Description | PRF Description(s) | | Suitability (GLTA)6 | Suitability (further inspection) | Photos | Approximate distance from Revised Scheme access track |
|---|---|---|---|---|---|---|---|
| 13 | A semi-mature silver birch located on a slope, with a DBH of 25 cm. | A | A tear-out on the north-west limb at 7 m, facing north-east, provides an 8 cm deep semi-sheltered cavity. | PRF | PRF-I | | Within the track and associated earthworks footprint. |
| | | B | A knothole at 5 m on the northwest face has no suitable cavity. | | | | |
| | | B | Lifted bark and decayed wood on the west-north-west face of the south-west trunk near the top conceals a small, shallow, and exposed cavity beneath. | | | | |

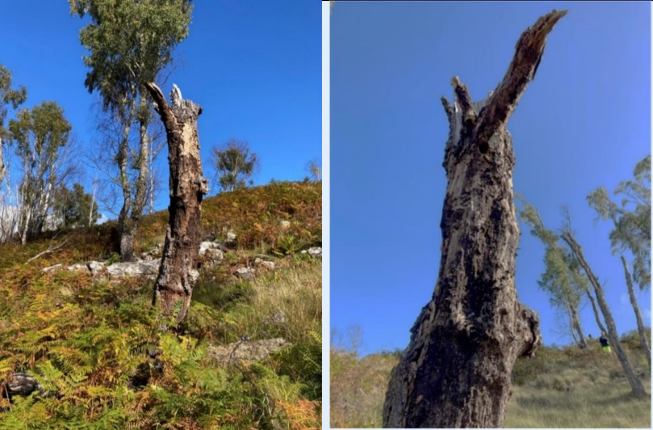
| Reference | Tree Description | PRF Description(s) | | Suitability (GLTA)6 | Suitability (further inspection) | Photos | Approximate distance from Revised Scheme access track |
|---|---|---|---|---|---|---|---|
| 14 | A dead standing birch stump with a base diameter of | A | A large, sheltered woodpecker hole at 4 m on the north-east face is 20 cm deep. | PRF (M) | PRF-I | | Within the track and associated earthworks footprint. |

| Reference | Tree Description | PRF Description(s) | | Suitability (GLTA)6 | Suitability (further inspection) | Photos | Approximate distance from Revised Scheme access track |
|---|---|---|---|---|---|---|---|
| | approximately 50 cm. | B | Woodpecker hole into 10 cm deep cavity. | | | | |
| | | C | Large deep flaking bark features that are falling apart. The whole stump is decayed and unstable. | | | | |

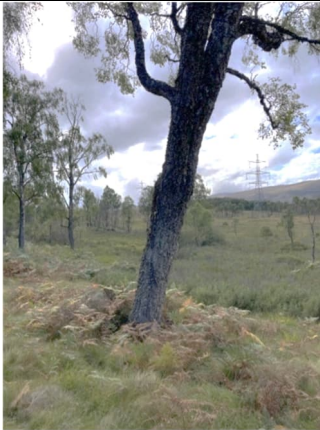
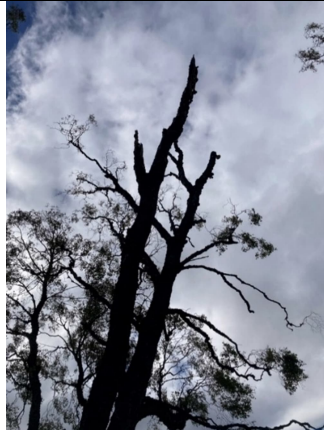
| Reference | Tree Description | PRF Description(s) | Suitability (GLTA)6 | Suitability (further inspection) | Photos | Approximate distance from Revised Scheme access track |
|---|---|---|---|---|---|---|
| 15 | A mature silver birch with a DBH of approximately 60 cm. | Multiple woodpecker holes and rot-pockets on large dead stem that are 8-12 cm deep, dry and sheltered. | PRF (I) | PRF-M | | Within the track and associated earthworks footprint. |

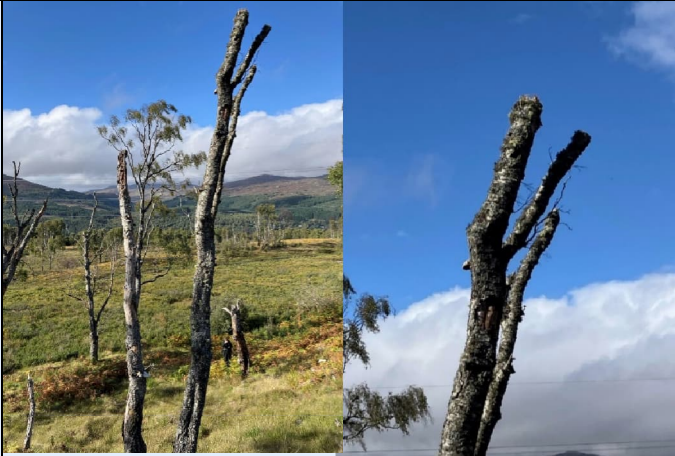
| Reference | Tree Description | PRF Description(s) | | Suitability (GLTA)6 | Suitability (further inspection) | Photos | Approximate distance from Revised Scheme access track |
|---|---|---|---|---|---|---|---|
| 16 | Two adjacent dead standing trees, approximately 8 m and 11 m tall, located near converging streams on a slope. | A | An exposed woodpecker hole on the east-south-east side of the north-east trunk. | PRF (I) | PRF-I | | Within the track and associated earthworks footprint. |
| | | B | Lifted bark and decayed wood on the west-north-west face of the south-west trunk near the top conceals a small, shallow, and exposed cavity beneath. | | | | |

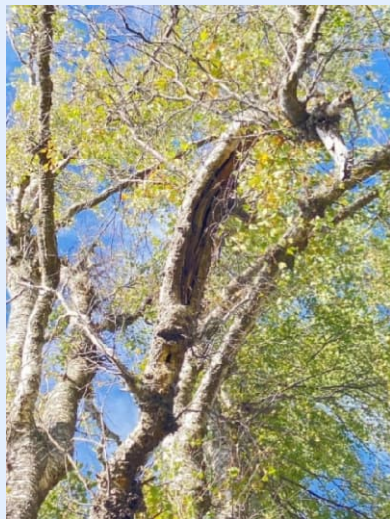
| Reference | Tree Description | PRF Description(s) | | Suitability (GLTA)6 | Suitability (further inspection) | Photos | Approximate distance from Revised Scheme access track |
|---|---|---|---|---|---|---|---|
| 17 | A mature silver birch situated at the top of a slope, with a DBH of 40 cm. | Cracking is present on the underside of a south-east pointing branch at 5 m is too exposed and has no suitable roosting features at present. | | PRF (I) | NONE | | 3 m |

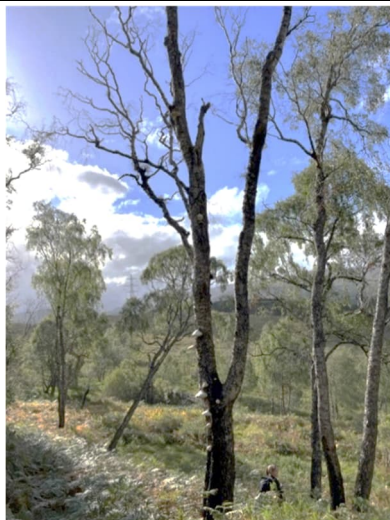
| Reference | Tree Description | PRF Description(s) | | Suitability (GLTA)6 | Suitability (further inspection) | Photos | Approximate distance from Revised Scheme access track |
|---|---|---|---|---|---|---|---|
| 18 | A standing deadwood tree hosting numerous mushrooms along its trunk. | A | A hollow pruning cut is located on the north-east face of the south-east limb at 6 m, appearing to extend downwards, and is unsuitable. | PRF | NONE | | 22 m |
| | | B | An upward-facing tear-out on the northwest limb at 10 m is unsuitable. | | | | |
| | | C | Extensive damage and rotting heartwood on the west face of a south facing branch with no suitable features. | | | | |

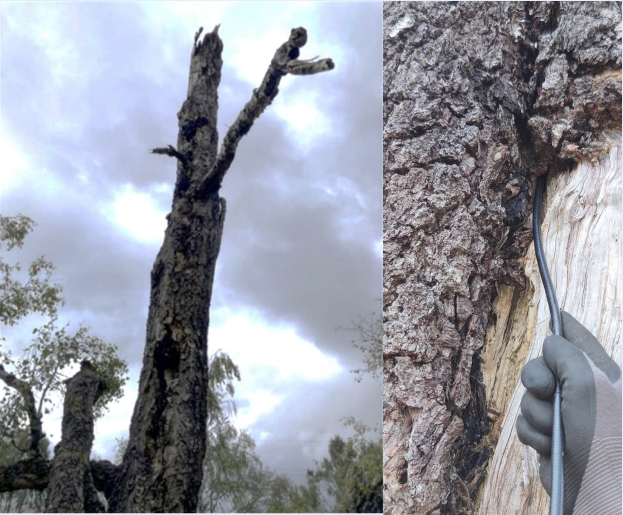
| Reference | Tree Description | PRF Description(s) | | Suitability (GLTA)6 | Suitability (further inspection) | Photos | Approximate distance from Revised Scheme access track |
|---|---|---|---|---|---|---|---|
| 19 | An extremely damaged mature birch with a DBH of approximately 80 cm; appears dead, though minimal growth remains on a low branch. | Extensive damage is present on all sides including an old tear out wound on west side at 50 cm to 2.5 m with wide opening extends into a 40 cm deep, dry, upward rot pocket. Also, multiple large flaking bark features and a 30 cm deep crack on south site at 6 m which is damp and decayed inside. | | PRF (M) | PRF-M | | 2 m |

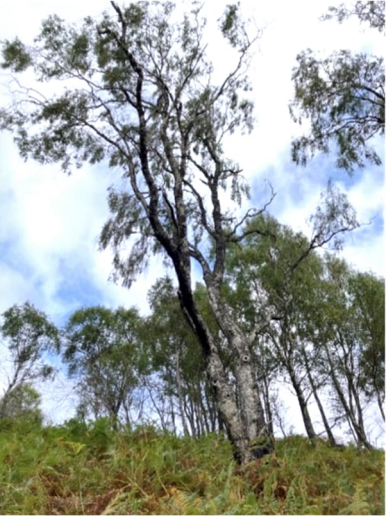
| Reference | Tree Description | PRF Description(s) | | Suitability (GLTA)6 | Suitability (further inspection) | Photos | Approximate distance from Revised Scheme access track |
|---|---|---|---|---|---|---|---|
| 20 | A mature birch growing on the mid-slope, with a combined DBH of 65 cm. | A | A hollow pruning cut is visible on the west-north-west face of the south limb at 2 m but is shallow, exposed, and unsuitable for roosting bats. | PRF | NONE | | 23 m |
| | | B | A tear-out on the north aspect of the south limb at 4 m is shallow, exposed and unsuitable for roosting bats. | | | | |

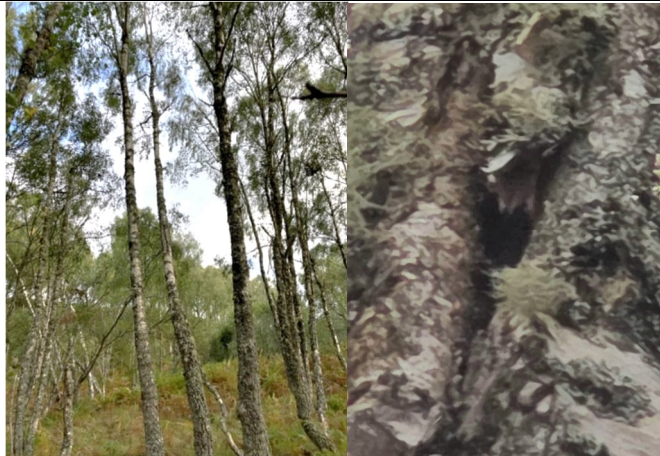
| Reference | Tree Description | PRF Description(s) | Suitability (GLTA)6 | Suitability (further inspection) | Photos | Approximate distance from Revised Scheme access track |
|---|---|---|---|---|---|---|
| 21 | A semi-mature silver birch with a DBH of 25 cm, situated on a slope. | A crack on the north-north-west side of the trunk at 5 m has small upward facing rot pocket that is 6 cm deep. | PRF (I) | PRF-I | | 17 m |
