Chleansaid Wind Farm 132 kV OHL Connection Environmental Appraisal (EA) Report

Appendix 11.1: OHL Woodland Report

November 2024

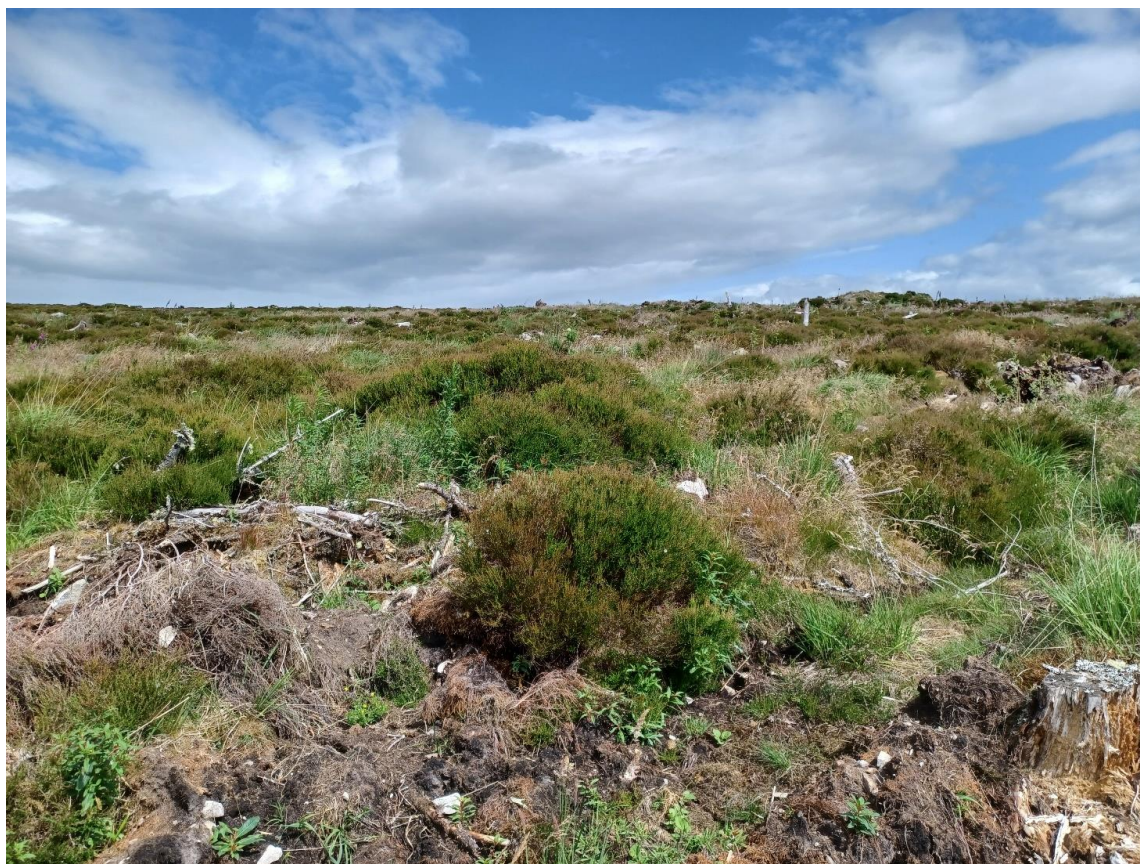
Plate 3.1: Coordinates: 4.4053452 W, 58.0549179 N. North facing.

- 3.1.11 **Plate 3.1** between Poles 1 to 11 show a uniform commercial restock plantation of intimate mix Sitka Spruce and Lodgepole Pine (circa. 0 - 5 years old) with some integrated open ground impacted by the existing OHL operational corridor.

- 3.1.12 A small area 0.89 ha of mixed broadleaf tree species (circa. 0-5 years old) including Holly, Birch, Willow, Alder and Rowan have been restocked in and around the substation area, adjacent to the existing OHL and the planned operational corridor heading north for approximately 240 m. The OC can be narrowed to a width 60m or less where possible for the greater retention of the broadleaf trees. Terrain is gently sloping uphill to the North and east, soils are mostly upland brown earth with some Peaty gleys in the north. There is no harvestable timber present. Young trees and stumps will require to be mulched.

- 3.1.13 DAMS⁴: - 15/16 Sheltered / Moderately exposed, due to age of crop, management felling is not required for this part.

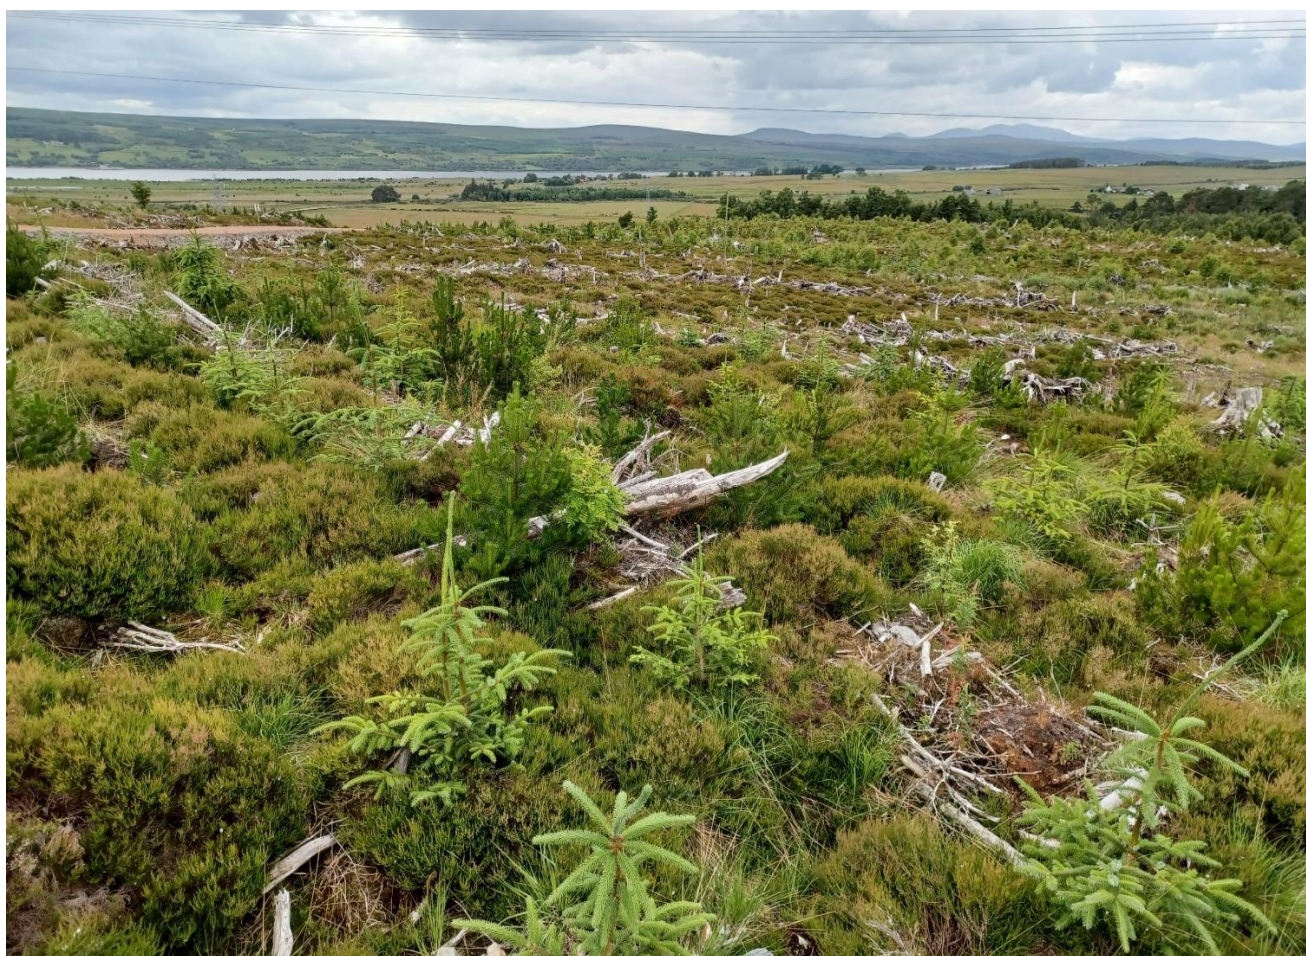
Plate 3.2: Coordinates: 4.4080814 W, 58.0592517 N. southwest facing.

- 3.1.14 **Plate 3.2** between Poles 11 to 16 shows a uniform commercial conifer restocked plantation of an intimate mix of Sitka Spruce and Lodgepole Pine (circa. 0 - 5 years old), this area will be impacted by the Proposed Development OHL operational corridor.
- 3.1.15 Some sporadic small areas of naturally regenerating broadleaf tree species including, Birch and Rowan (circa. 0 - 5 years old) are present within the Proposed Development operational corridor.
- 3.1.16 Terrain is gently undulating north, with some wet juncus boggy areas down towards water course to north. Soils are mostly Peaty podzols and gleys.
- 3.1.17 No harvestable timber present. Young trees and stumps will require to be mulched.
- 3.1.18 DAMS⁴: - 15/16 Sheltered / Moderately exposed.

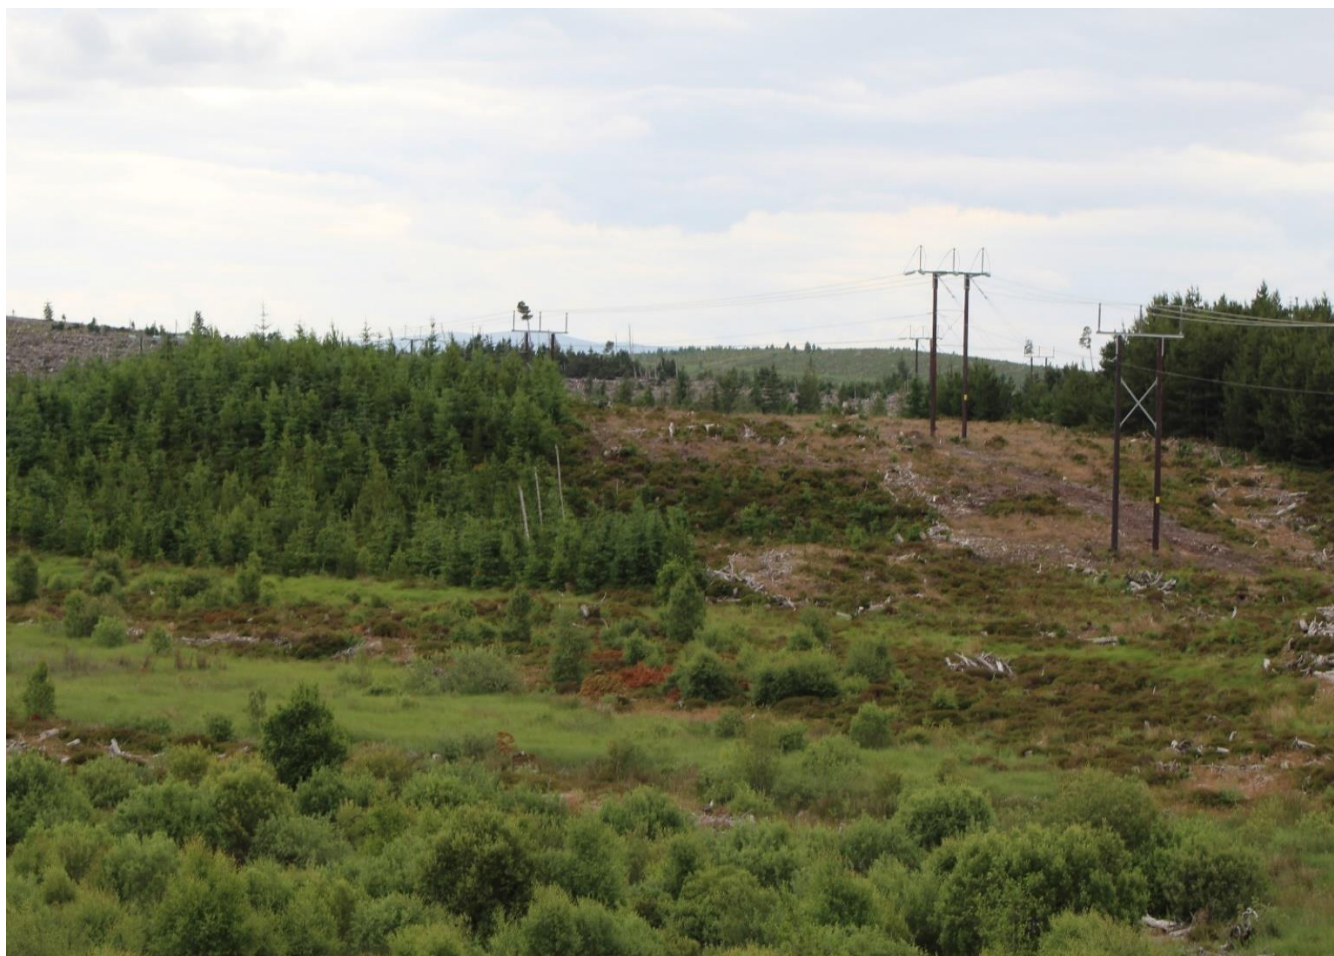
Plate 3.3: Coordinates: 4.4080481 W, 58.00665001 N. south facing.

- 3.1.19 **Plate 3.3** between Poles 16 – 26 shows a small area of uniform commercial restock plantation of Sitka Spruce (circa 0-5 years old). Some sporadically dispersed naturally regenerating mixed broadleaf, including Birch and Willow (circa 0-5 years old) present between Poles 19 – 21. The OC can be narrowed to a width 60 m or less where possible for the greater retention of the broadleaf trees.
- 3.1.20 The terrain is gently undulating, soft / fresh ground conditions for most part. Slight depression leading into riparian zone around the Watercourse where very soft, flushing Peaty surface water gleys, juncus bog and very wet ground conditions are present.

3.1.21 No harvestable timber present. Young trees and stumps will require to be mulched.

3.1.22 DAMS⁴: - 15/16 Sheltered / Moderately exposed.

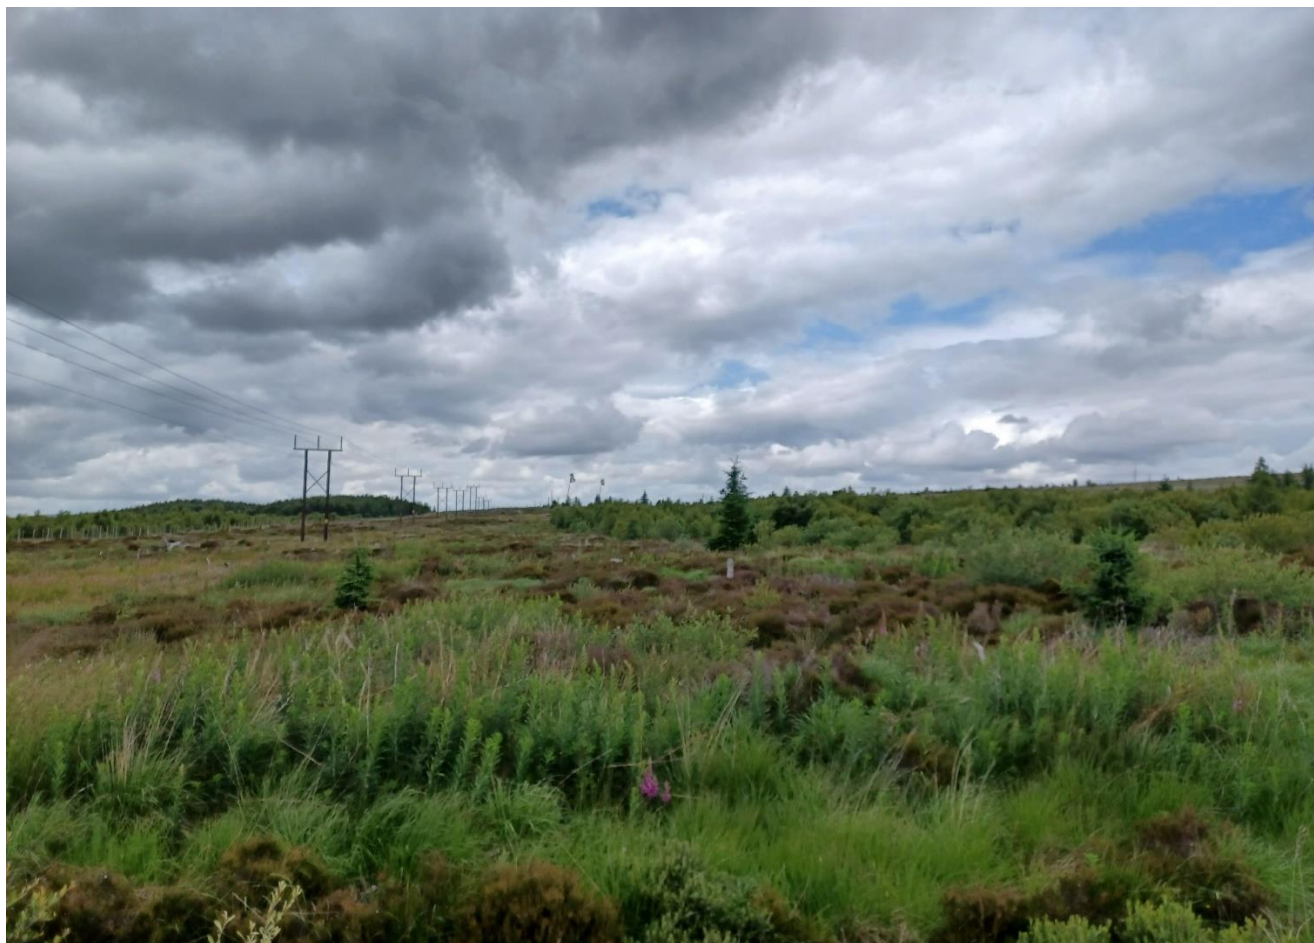
Plate 3.4: Coordinates: 4.4080481 W, 58.00665001 N. north facing.

3.1.23 **Plate 3.4** between Poles 26 and 32 shows a uniform commercial restock of intimate mix Sitka Spruce and Lodgepole Pine (circa. 0-5 years old).

3.1.24 There is an area of open ground and some patchy clusters of mixed broadleaf, species include Birch, Rowan and Willow. The OC can be narrowed to a width 60 m or less where possible for the greater retention of the broadleaf trees.

3.1.25 The terrain is relatively flat, soft fresh / wet ground with a mixture of soil types Peaty podzols up slope and peaty gleys present down slope towards existing OHL.

3.1.26 No harvestable timber present. Young trees and stumps will need to be mulched.

3.1.27 DAMS⁴: - 15/16 Sheltered / Moderately exposed.

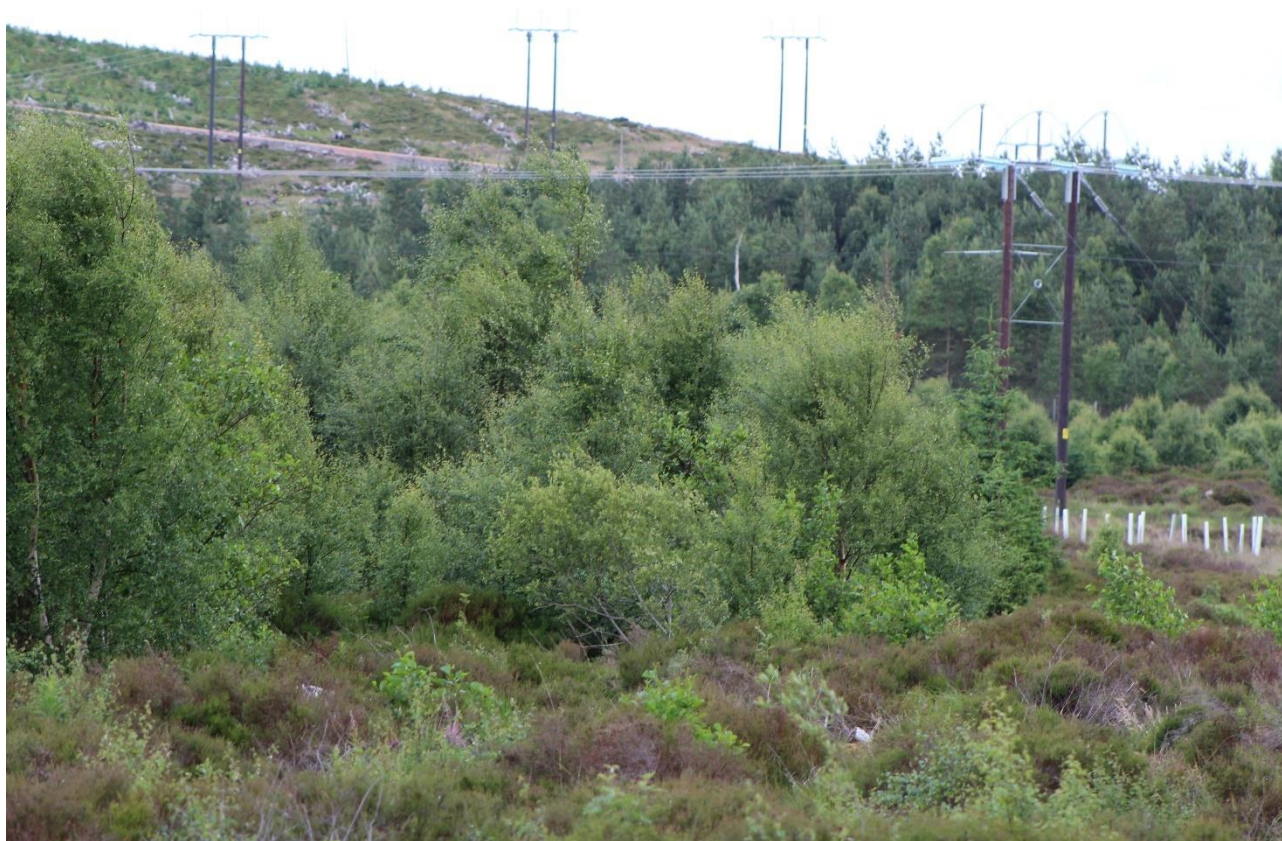
Plate 3.5: Coordinates: 4.4089304 W,58.089757 N. southeast facing.

- 3.1.28 **Plate 3.5** between Poles 32 – 41, shows naturally regenerating young native broadleaved, with a small area of new planting (circa. 5-10 years old). Approx. 0.82Ha, including species such as Birch, Willow and Rowan, that will impact the OHL operational corridor. The OC can be narrowed to a width 60 m or less where possible for the greater retention of the broadleaf trees.
- 3.1.29 Terrain is sloping uphill to the south, soft / wet ground conditions on, Peaty surface water gleys and Peaty podzols as you move up slope.
- 3.1.30 No harvestable timber present. Young trees and stumps will need to be mulched.
- 3.1.31 DAMS⁴: - 15 Sheltered / Moderately exposed.

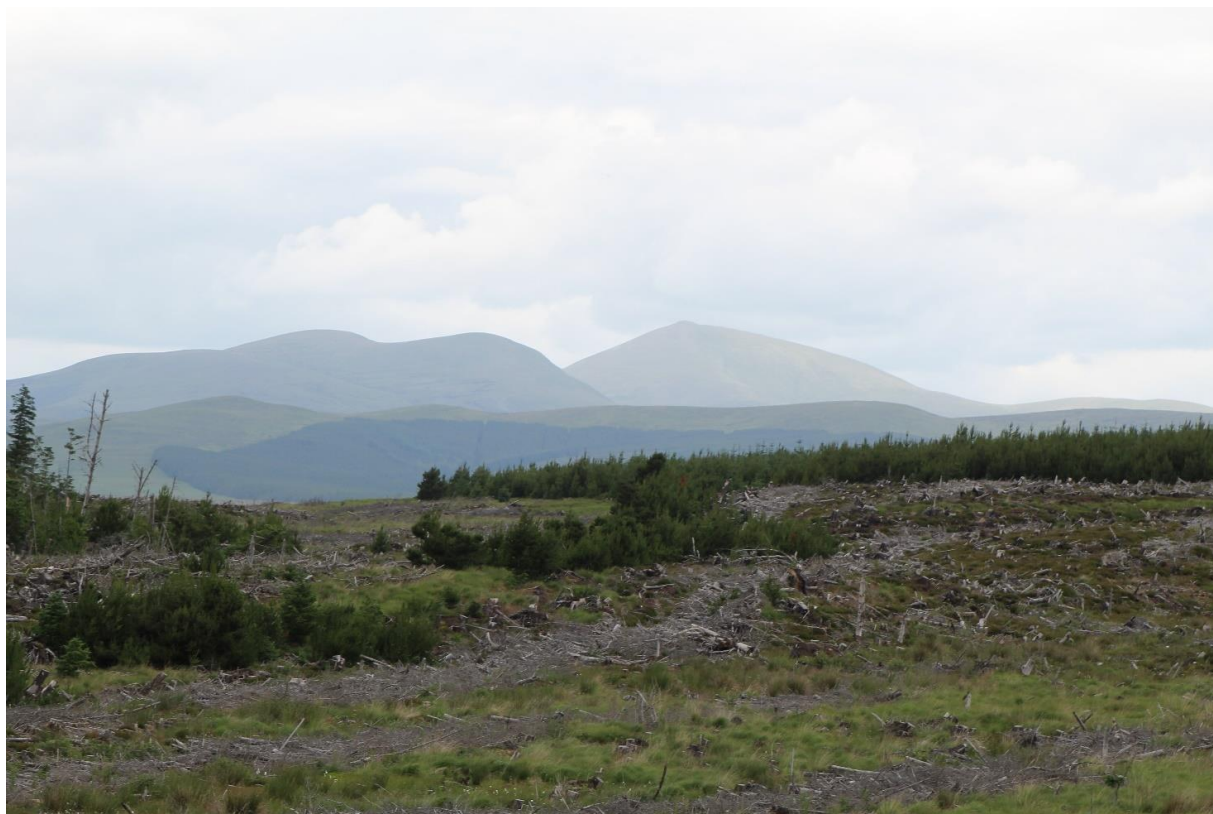
Plate 3.6: Coordinates: 4.4089304 W, 58.089757 N. northeast facing.

- 3.1.32 **Plate 3.6** between Poles 41 – 65 shows an area of clearfelled coniferous woodland. Restocking direction as per the woodland property LMP is to be restocked with coniferous species throughout this part. An area of deadwood has been left that will also be impacted by the OHL operational corridor.

- 3.1.33 The terrain falls into a slight depression at foot of hill rising up gently to the northeast, soft / wet ground conditions are present with Peaty gleys down into valley and Peaty podzol soils moving up slope to east.

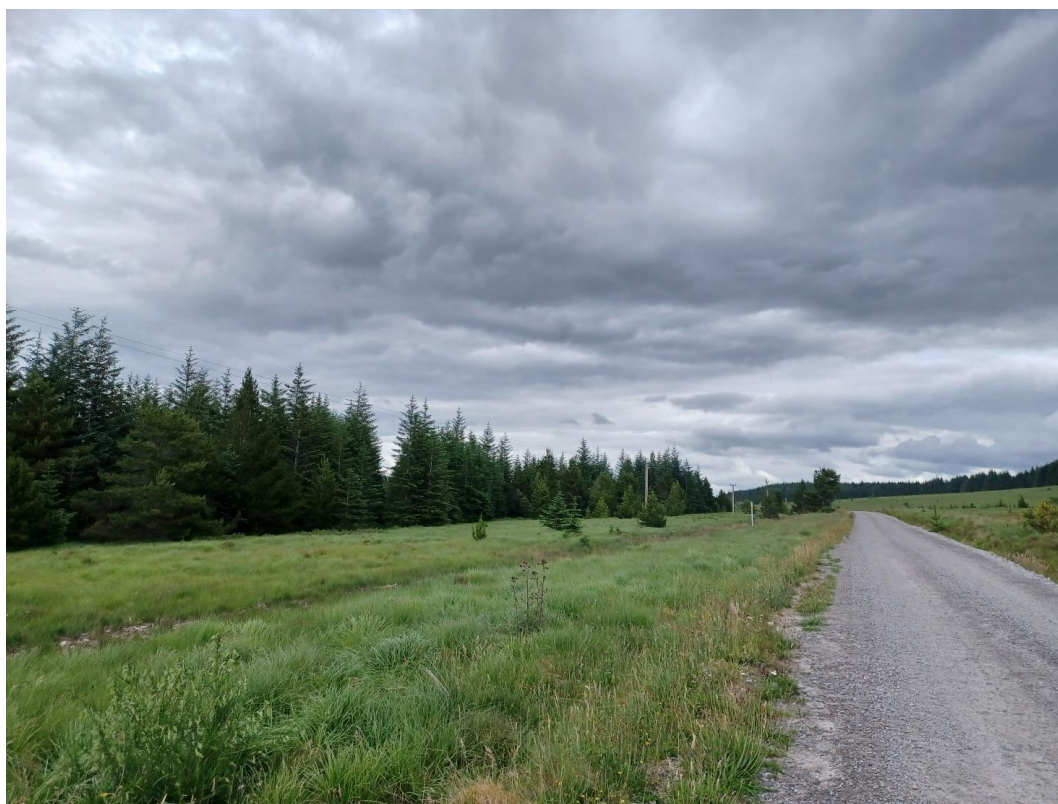
Plate 3.7: Coordinates: 4.4024975 W, 58.0932760 N. east facing.

- 3.1.37 Terrain relatively flat towards forest road gently undulating downhill to north. Soft / wet to very wet ground, evident by juncus Peat bogs through patchy areas. Fresh upland brown earth towards forest road.

- 3.1.38 Timber production limited due to variable sizes in tree crop, small roundwood and biofuel would be the optimal market for this young unthinned crop. Best of timber to the west leading into much poorer check timber to the northeast open and patchy areas. Approx. 150 m³ – 200m³ p/ha.

- 3.1.39 DAMS⁴: - 16 Moderately exposed.

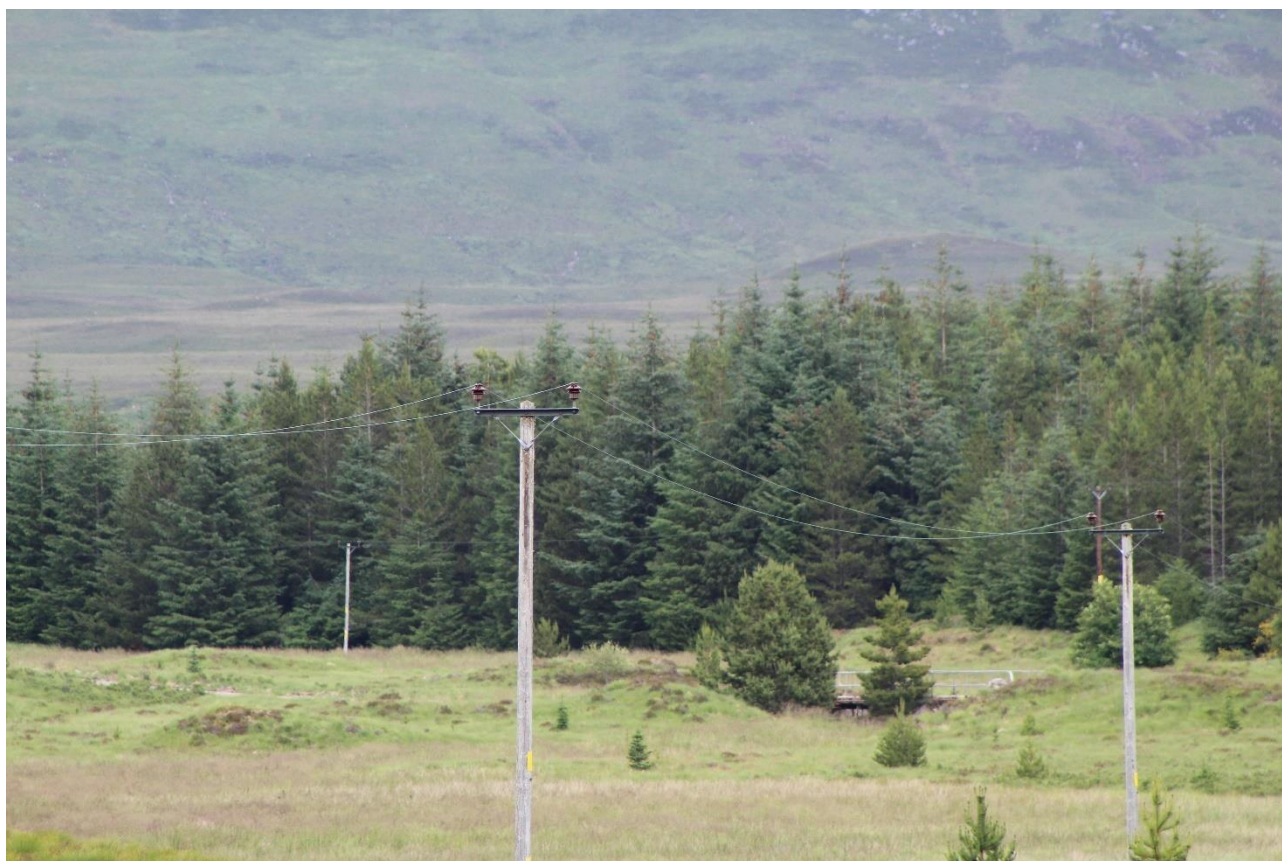
Plate 3.8: Coordinates: 4.3754756 W, 58.0956775 N. southeast facing.

- 3.1.40 **Plate 3.8** between Poles 76 – 93, show open ground down into the valley floor where water course is present. Some sporadic natural regeneration mostly Lodgepole Pine (Circa. 0-5 years old).
- 3.1.41 Terrain relatively flat, gently sloping up hill at forest road to south. Soils predominantly Peat, with some Molinia boggy areas present towards watercourse.
- 3.1.42 No harvestable timber present. Young trees and stumps will need to be mulched.
- 3.1.43 DAMS⁴: - 16 Moderately exposed

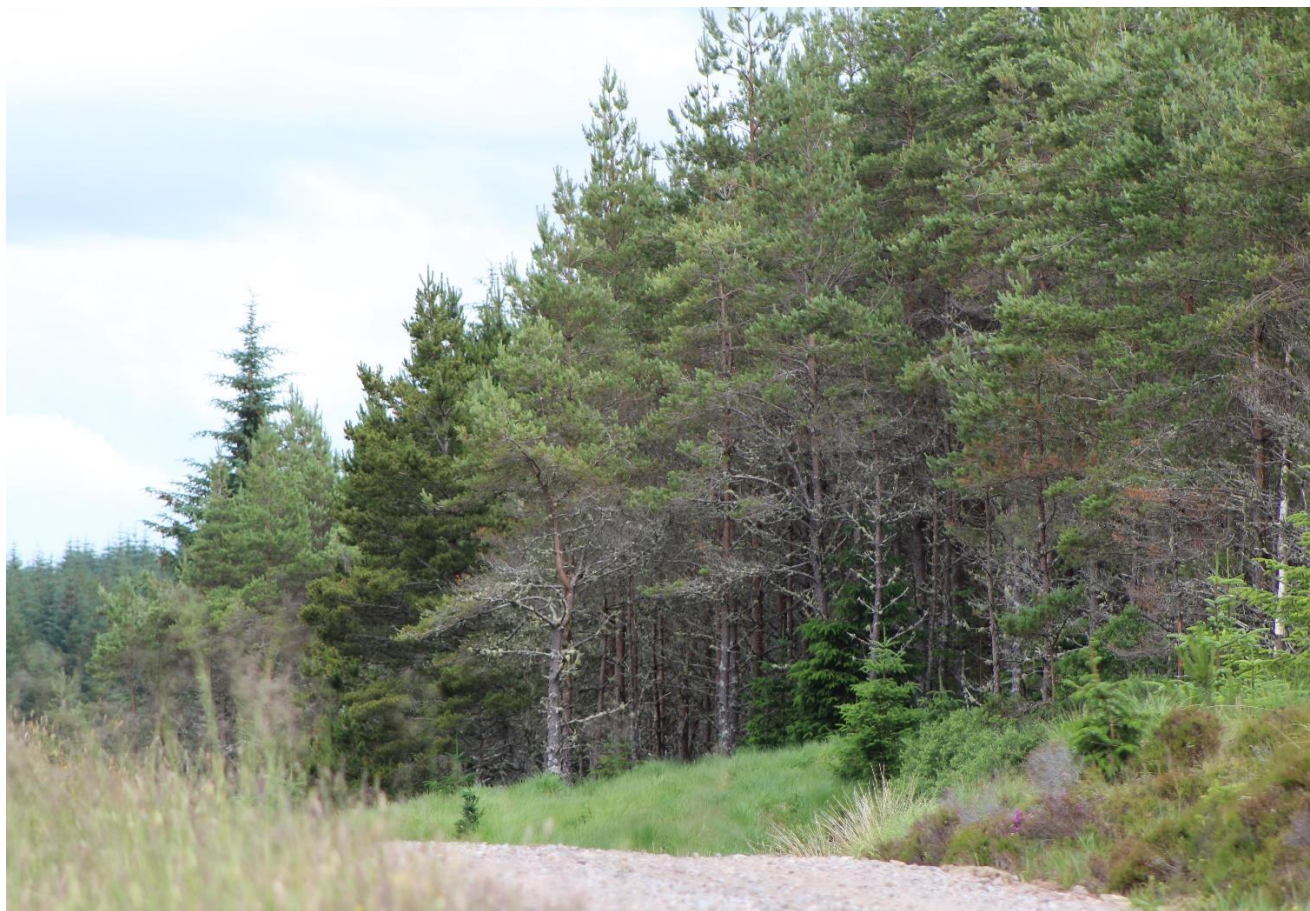
Plate 3.9: Coordinates: 4.3602092 W, 58.0941903 N. east facing.

- 3.1.44 **Plate 3.9** between Poles 93 – 99, show and area of commercially stocked, pole stage reasonable form Scots pine. (circa 15-20 years old) with isolated island of poor form Lodgepole Pine. (circa 10-15 years old) with some check areas.
- 3.1.45 Terrain gently rising to the south, soft / wet ground conditions, soil type Peaty podzols moving into Peaty gleys and Molinia boggy ground to east.
- 3.1.46 Timber production limited due to variable sizes in tree crop, small roundwood and biofuel would be the optimal market for this young unthinned crop. Due to age of crop and unthinned with soft / wet ground, management felling has been designated for this part.
- 3.1.47 DAMS⁴: - 16 Moderately exposed.

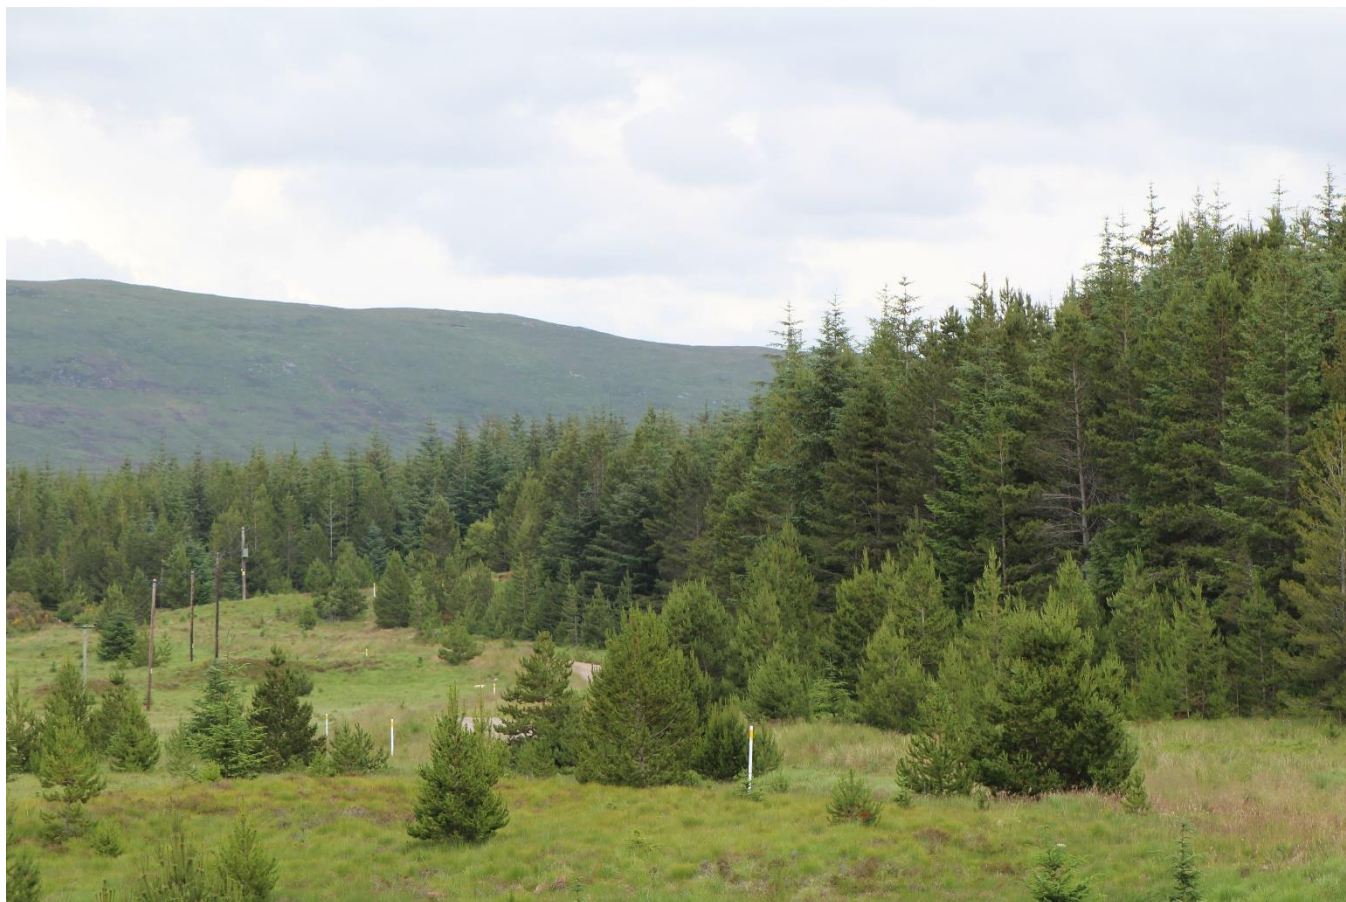
Plate 3.10: Coordinates: 4.3486077 W, 58.0945662 east facing.

- 3.1.48 **Plate 3.10** between Poles 99 -108, show an area of semi-mature unthinned Sitka Spruce generally in good form, with some nearby small islands of Lodgepole Pine in much poorer form and some isolated pockets of check (circa. 20-25 years old). In the surrounding crop there is evidence of windthrow due to the soft wet ground and trees are generally unstable, management felling will be required to take the crop back to a windfirm edge.

- 3.1.49 Terrain is rising gently to the south, soft / wet ground conditions are present. Soil type is predominantly Peaty gleys with some Peaty podzols as you move up slope to the south.

- 3.1.50 Timber production is limited due to variable sizes in tree crop, Small round wood and biofuel would be the optimal market for this young unthinned crop. Due to age of crop and being unthinned with soft wet ground, management felling has been designated for this part.

- 3.1.51 DAMS⁴: - 16 Moderately exposed.

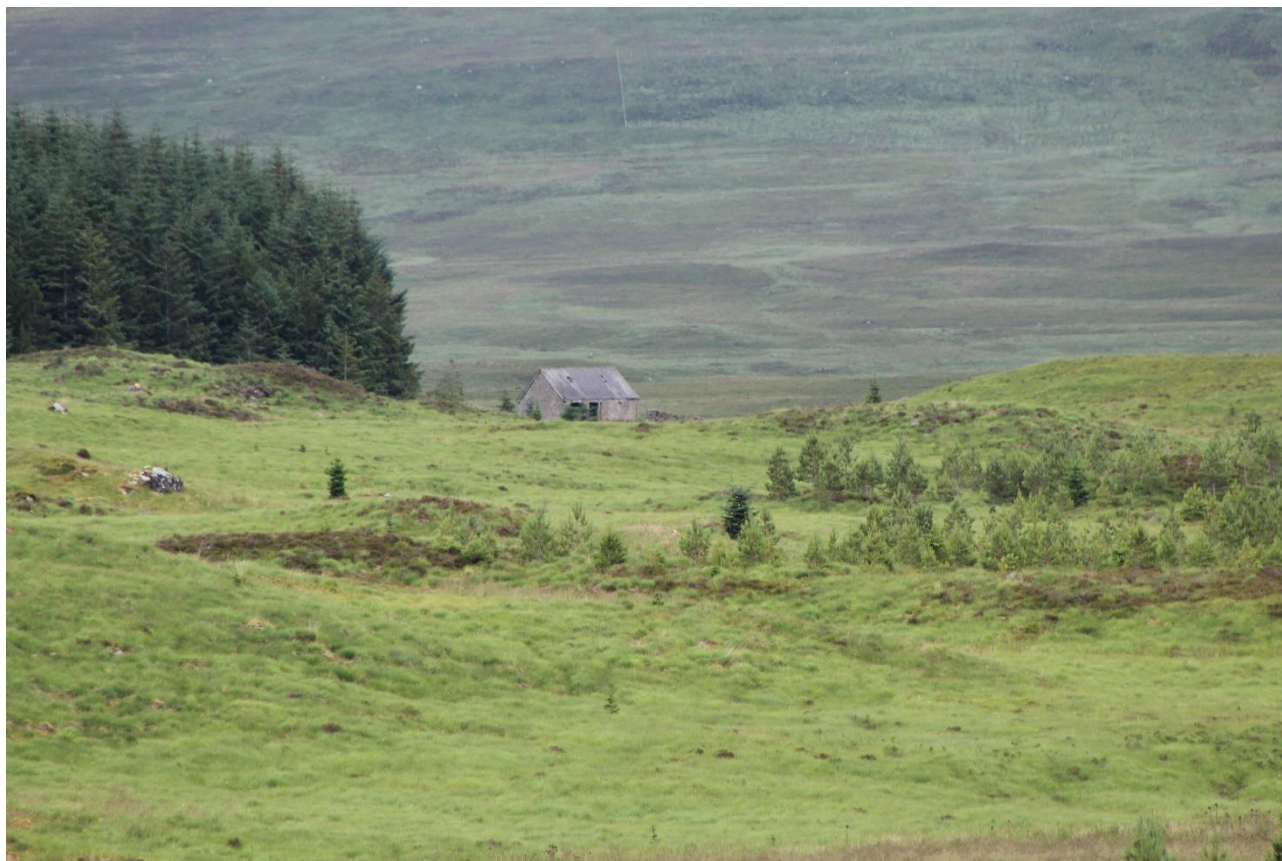
Plate 3.11: Coordinates: 4.3486077 W, 58.0945662 N. northeast facing

- 3.1.52 **Plate 3.11** between Poles 108 – 114, show an area of open ground tailing off into the valley to the woodland property boundary. There is a number of small, isolated pockets of conifer regeneration throughout, predominantly Lodgepole Pine with some Sitka Spruce (circa. 0-5 years old).
- 3.1.53 Terrain falls into a slight depression along the watercourse with soft / wet ground. Soil types are predominantly Peaty gleys, with some Peaty bog areas down into valley indicated by juncus, as you rise up the valley to the south soil profiles turn to Peaty podzols.
- 3.1.54 No harvestable timber. Young trees and stumps will need to be mulched.
- 3.1.55 DAMS⁴: - 16 Moderately exposed. Isolated natural regeneration, no management felling identified for this area.
