Proposed Cable Alignments, Loch na Cathrach, near Inverness Archaeological Walkover Survey Report

AOC Project No: 70706

January 2023

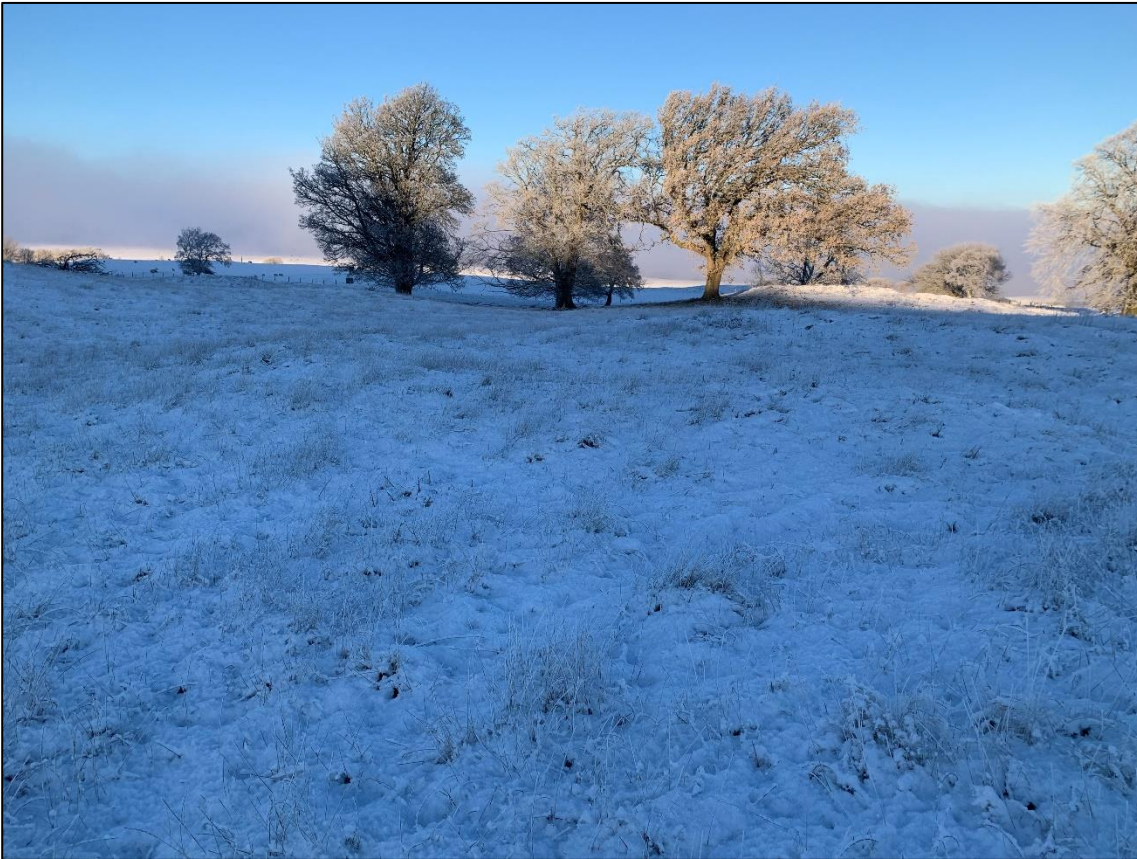
- 5.2.2 **Assets 3 – 5** are located on the west side of the road adjacent to Knocknagael Substation (Plates 1 – 2). They comprise the degraded remains of two prehistoric hut circles and a possible third circular structure. The three structures are defined by low turf banks and measure between 8 m-10 m diameter, with the smaller **Asset 5** measuring 6 m diameter. Another hut circle (**Asset 1**) is located a short distance to the south, just outside the survey boundary on the opposite side of the road (Plate 3). This hut circle has a post-medieval boundary stone (**Asset 2**) standing next to it. A second boundary stone (**Asset 17**) lies to the north near the substation. It is not known if this stone survives as it lies within the substation development area, which was not accessed during survey.

Plate 1: General view across hut circle Assets 3 and 4, facing NW

- For prehistoric hut circles, structures, and cairns, buffer zones of 20 m are recommended. These should be demarcated with high visibility fencing to prevent accidental damage by plant movement through the landscape. (**Assets 3, 4, 8, 10, 11, 13, 36, 51, 52, 58, 60, 68**)

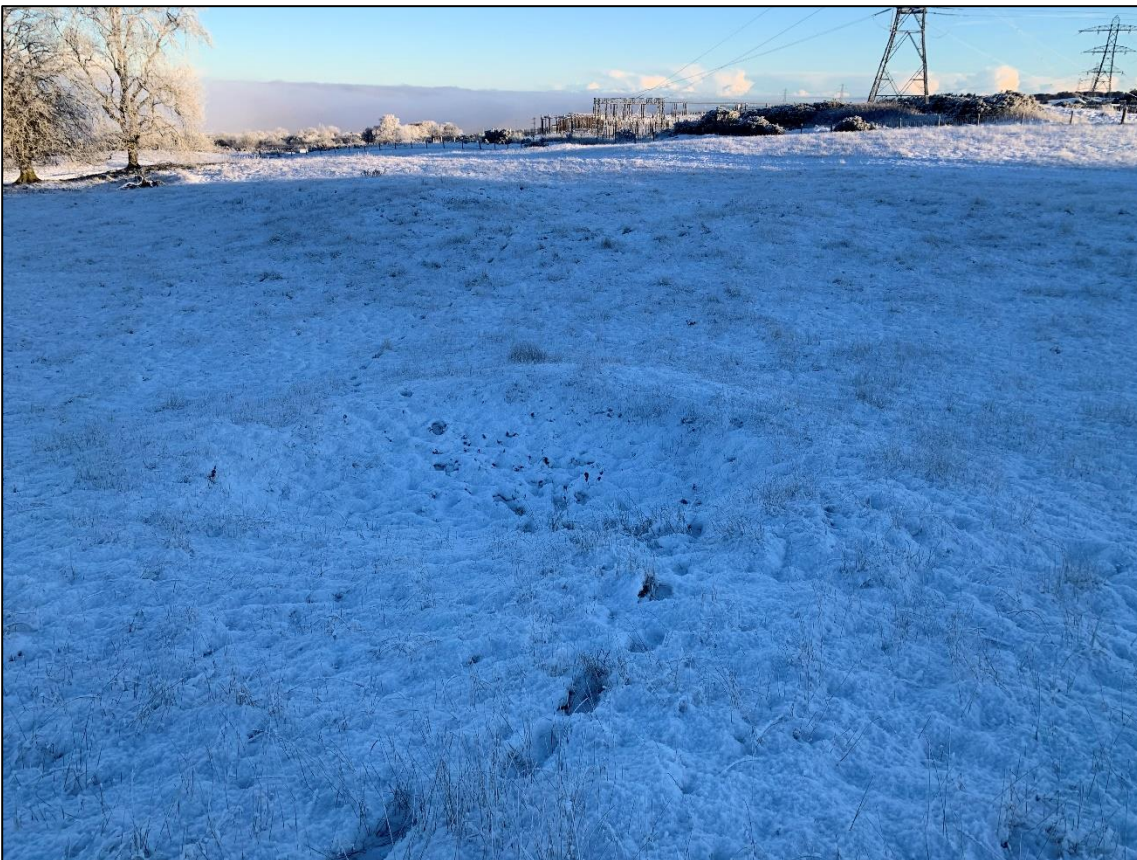
Plate 2: General view of structure Asset 5, facing NE

- 6.2 Based on the current proposed route, there is high potential for direct impacts upon five assets: clearance cairns **Assets 12 and 24**, and hut circles/structures **Assets 5, 14 and 44**. These assets lie either directly on the UGC route or within 10 m of the route. Due to the probable prehistoric origin of these assets their significance is deemed medium. For prehistoric assets, a buffer zone of 20 m is recommended, but in the case of these assets this may not be possible. It is recommended that these assets are demarcated and the UGC route micrositied around the upstanding remains, keeping as large a buffer zone as reasonably possible. Watching brief is also recommended during groundworks in these areas.

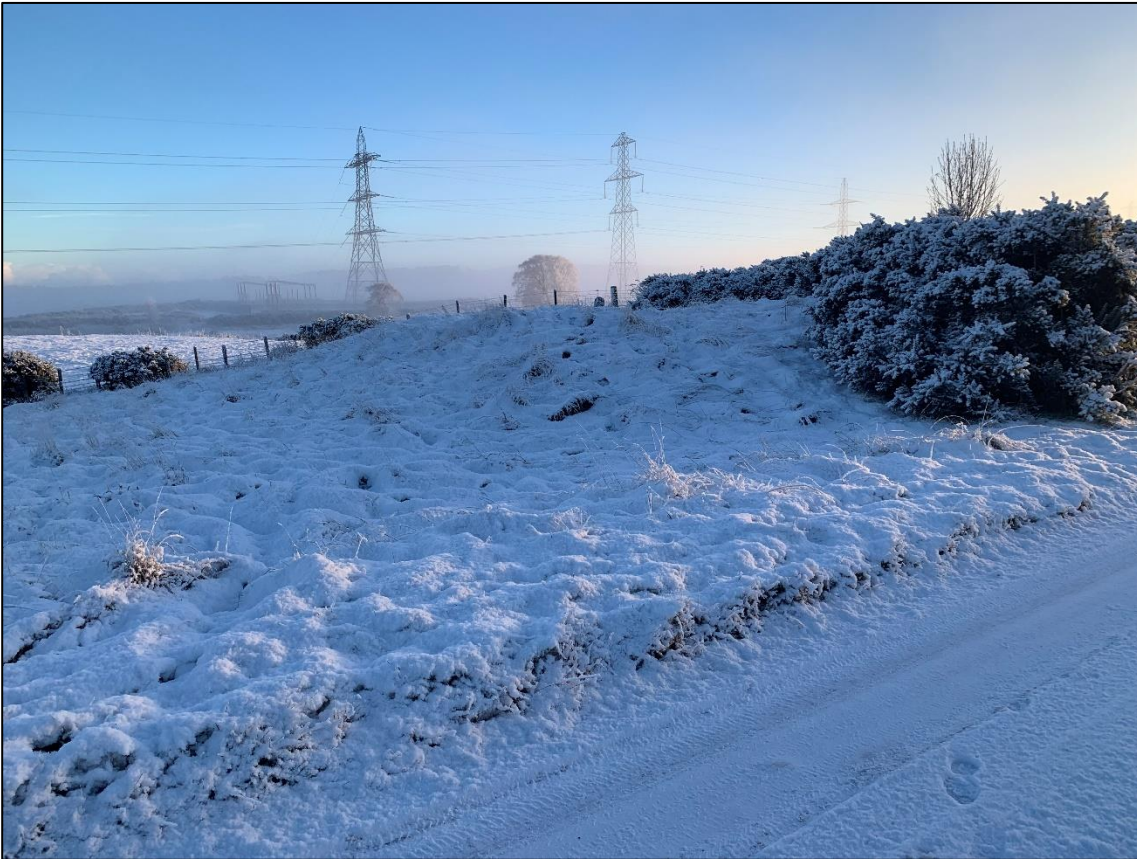
Plate 3: General view of hut circle and boundary stone Assets 1 and 2 (in back), facing NE

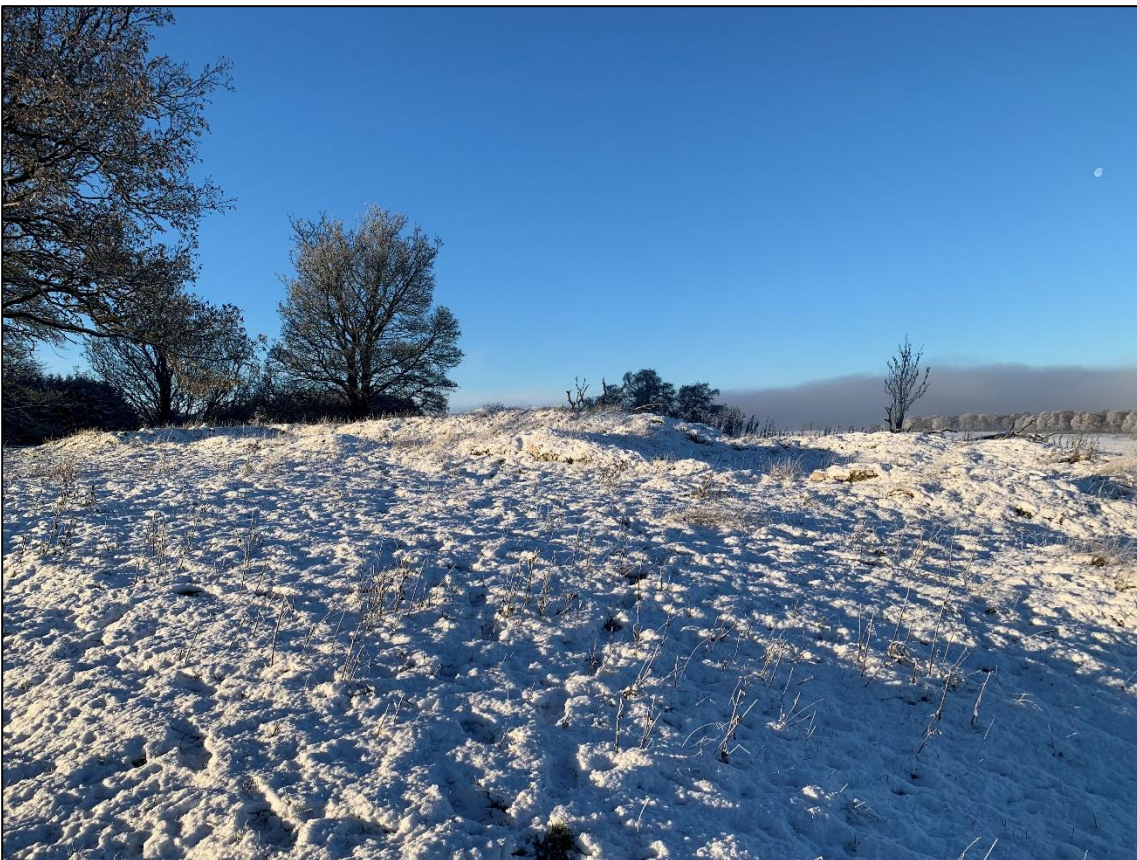
- 5.2.3 Immediately to the north of the prehistoric assets, a group of post-medieval remains were identified within the area between two branches of the survey corridor. **Asset 6** comprises the degraded remains of a post-medieval farmstead, with an adjacent smaller building and an enclosure (**Asset 7**) (Plates 4 – 5). Survey by HAS in 2020 also identified an area of field clearance (**Asset 19**) and three dyke fragments (**Assets 18, 20 and 21**) in the surrounding area.

Plate 4: General view of farmstead Asset 6, facing W

- For post-medieval settlement remains buffer zones of 10 m are recommended. (**Assets 6 and 7**)
 - For dykes and clearance cairns, buffer zones of 5 m are recommended. (**Asset 15-20, 35, 50, 56, 59, 61, 63, 66 and 70**)

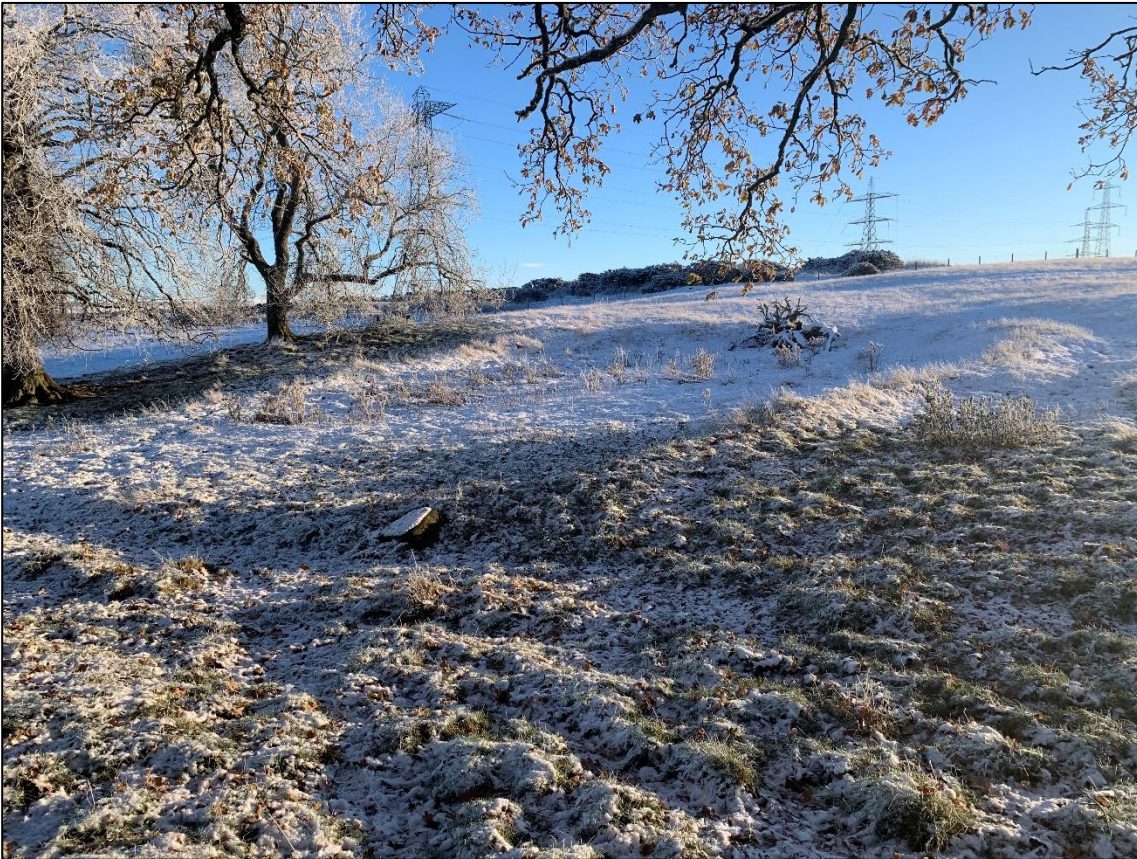
Plate 5: General view of enclosure Asset 7, facing ESE

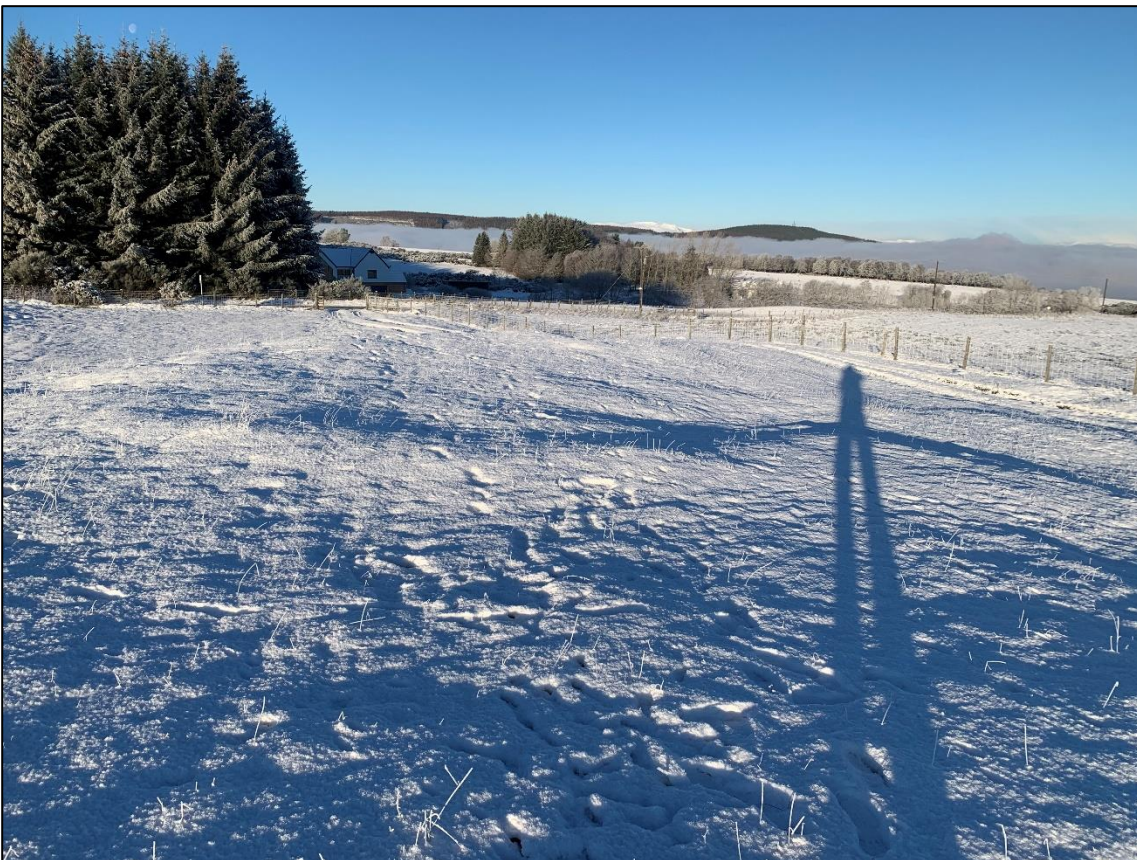
- 5.2.4 **Asset 8** near Achvraid house comprised the possible remains of a very degraded sub-circular structure (Plate 6). Only very low turf banks defined this asset, but it may be the truncated remains of a small structure or hut circle. Two other hut circles (**Assets 22 and 23**) are known from previous survey c.100 m to the east.

Plate 6: General view of possible hut circle Asset 8, facing NNW

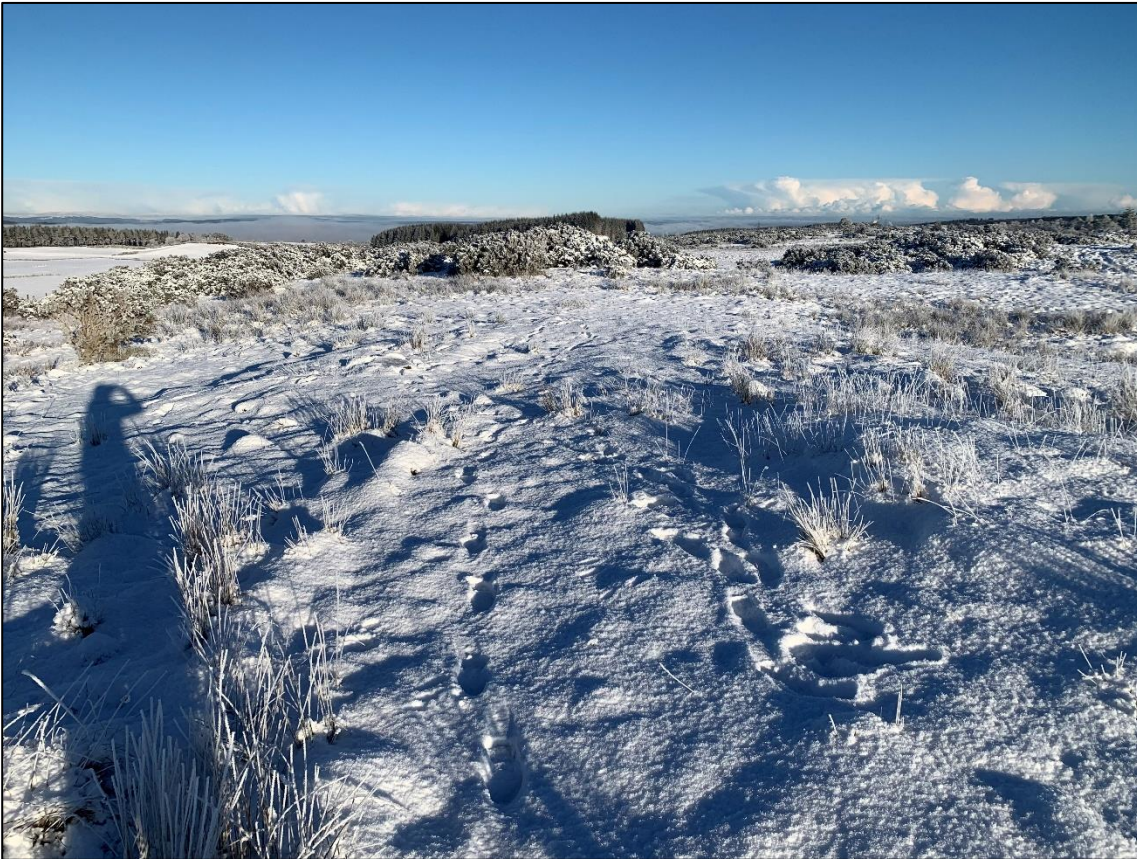
- 5.3.1 At Drumashie, the remains of three possible hut circles were identified within the survey corridor on the east side of the modern road. **Assets 10 and 11** survived as very degraded sub-oval turf banks measuring between 6 m-9 m diameter (Plates 7 – 8). **Asset 36**, which was previously recorded in the HER, could not be located due to dense gorse. These are likely prehistoric features associated with the wider prehistoric settlement described in section 5.2.6.
- 5.3.2 Other assets in this area included a small fragment of dyke (**Asset 35**), a clearance cairn (**Asset 42**) and three quarries (**Assets 9, 37, and 41**) (Plate 9). While the dyke and clearance cairn may be part of the prehistoric field system or a later post-medieval field system, the quarries are probably 19th/20th century and associated with the construction of the modern road.

Plate 7: General view of possible hut circle Asset 10, facing NE

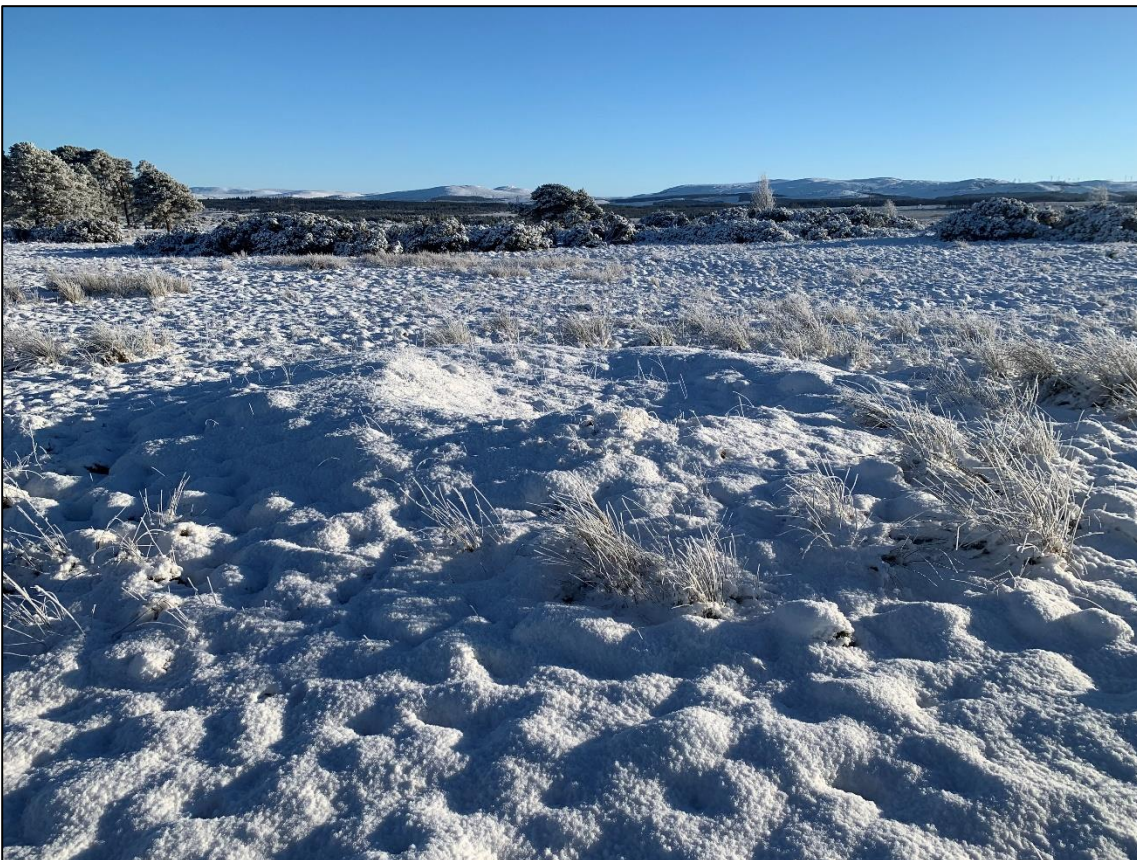
Plate 8: General view of structure Asset 11, facing NNW

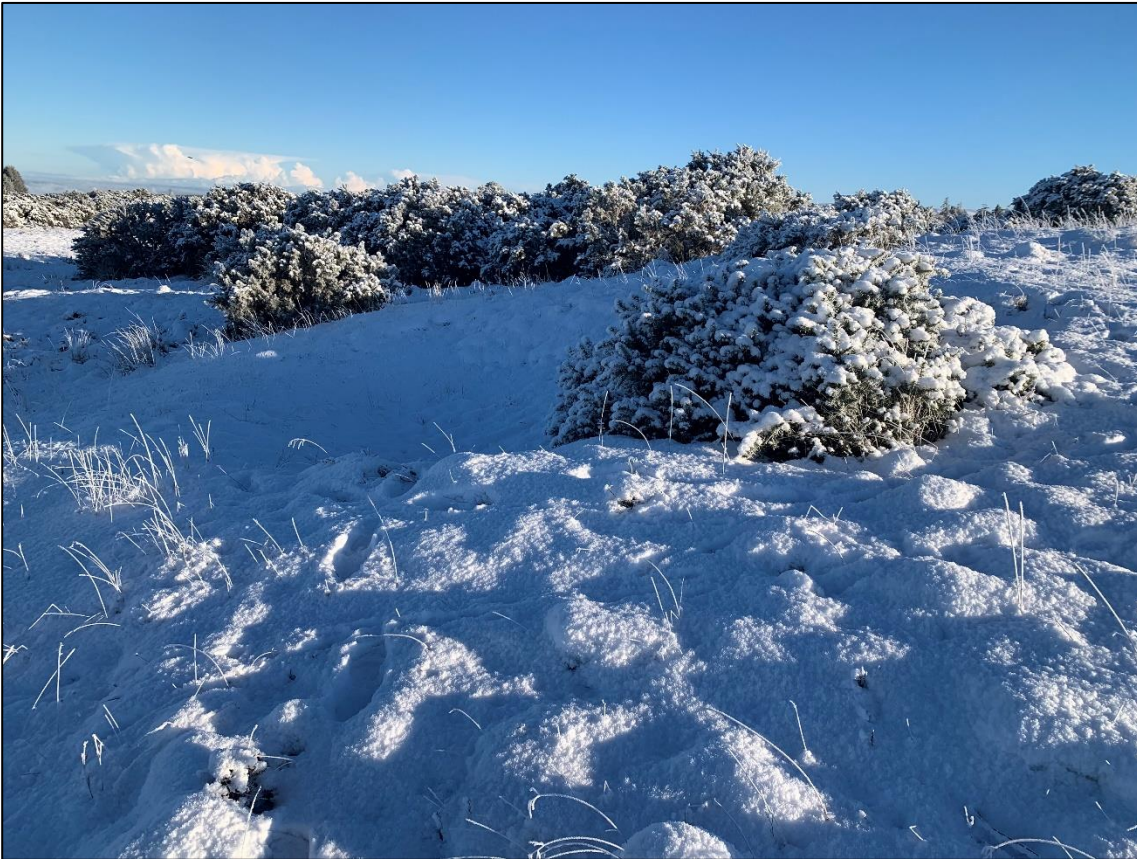
Plate 9: General view of quarry Asset 9, facing NNE

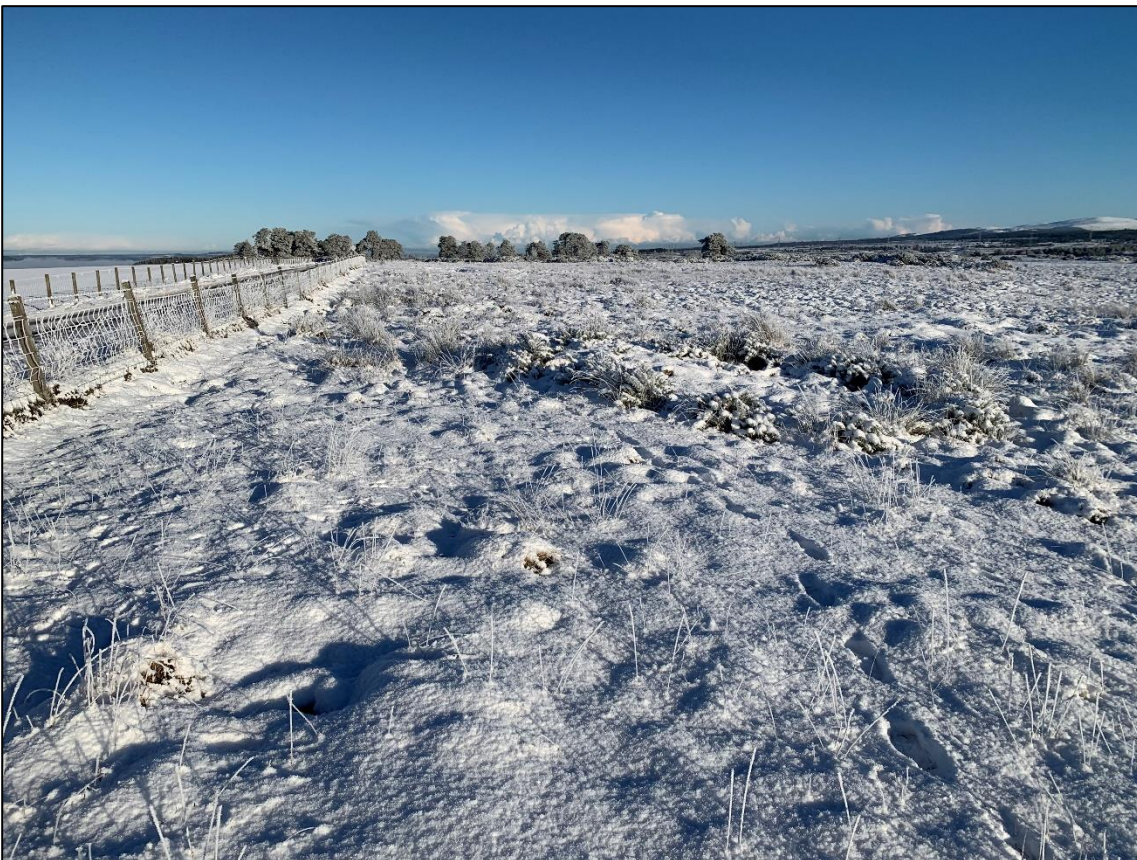
Plate 10: General view of clearance cairn Asset 12, facing NE

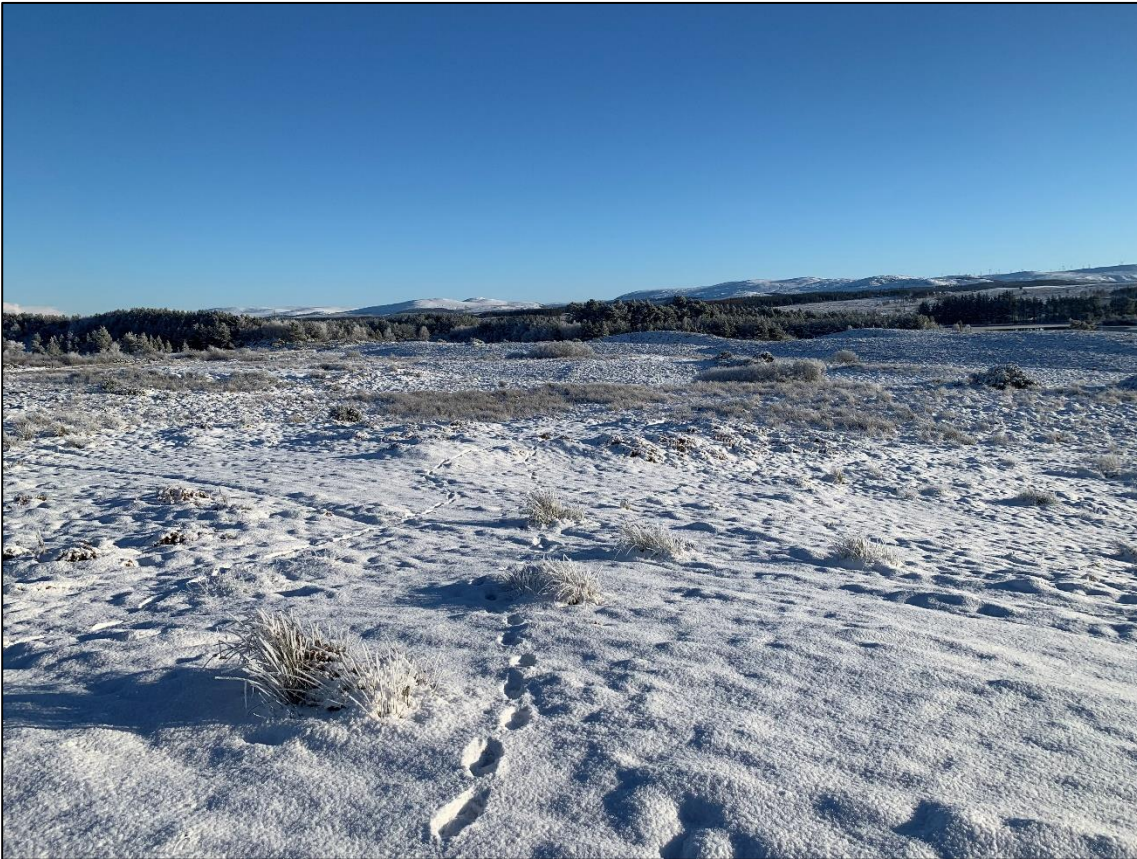
Plate 11: General view of hut circle Asset 13, facing NE

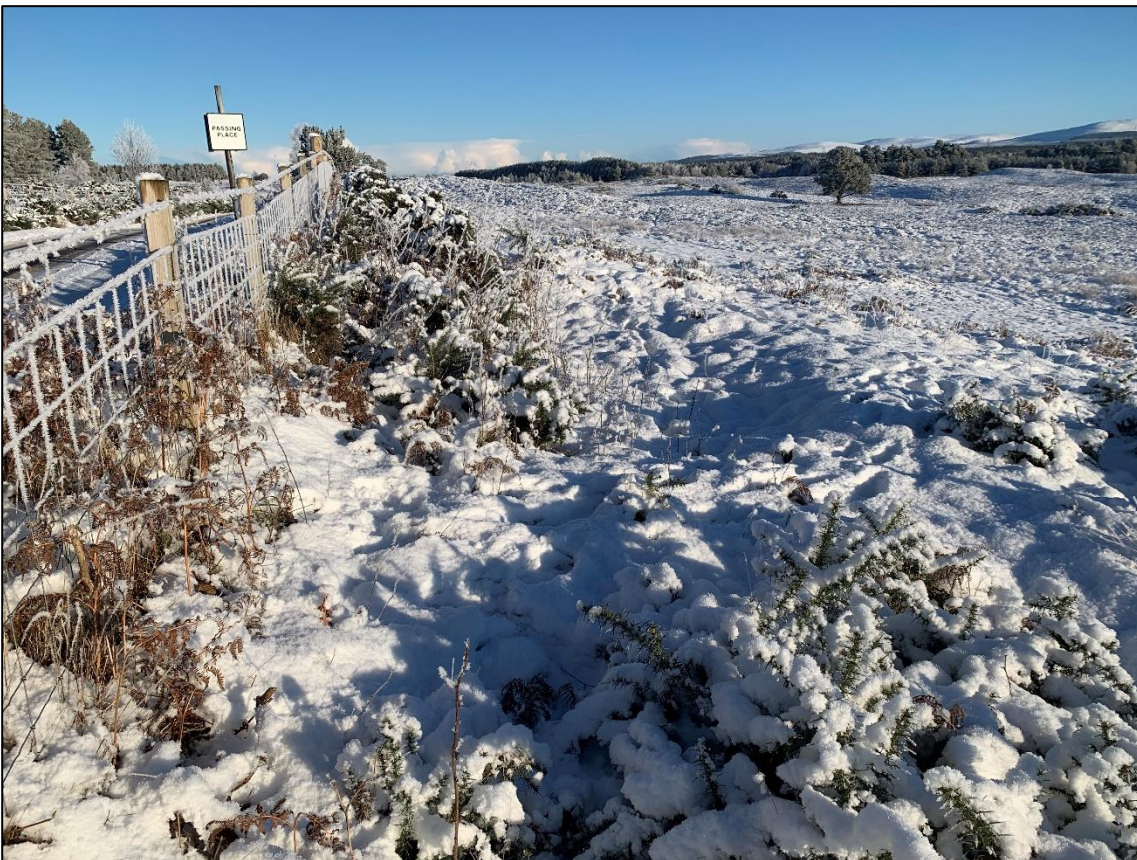
- 5.4.2 **Asset 14** was located immediately next to the road and formed a possible circular bank c.10 m-11 m diameter (Plate 12). Due to the presence of other hut circles in the area, it is possible that this is the remains of another such feature that has been truncated by the modern road. It lies close to a known hut circle (**Asset 60**) which could not be identified during survey due to snow and vegetation cover. On the opposite side of the road from these two assets are the remains of the kerb cairn (**Asset 58**) and several smaller clearance cairns (**Assets 57 and 59**), indicating that this is an area of prehistoric settlement.

Plate 12: General view of possible hut circle Asset 14, facing ENE

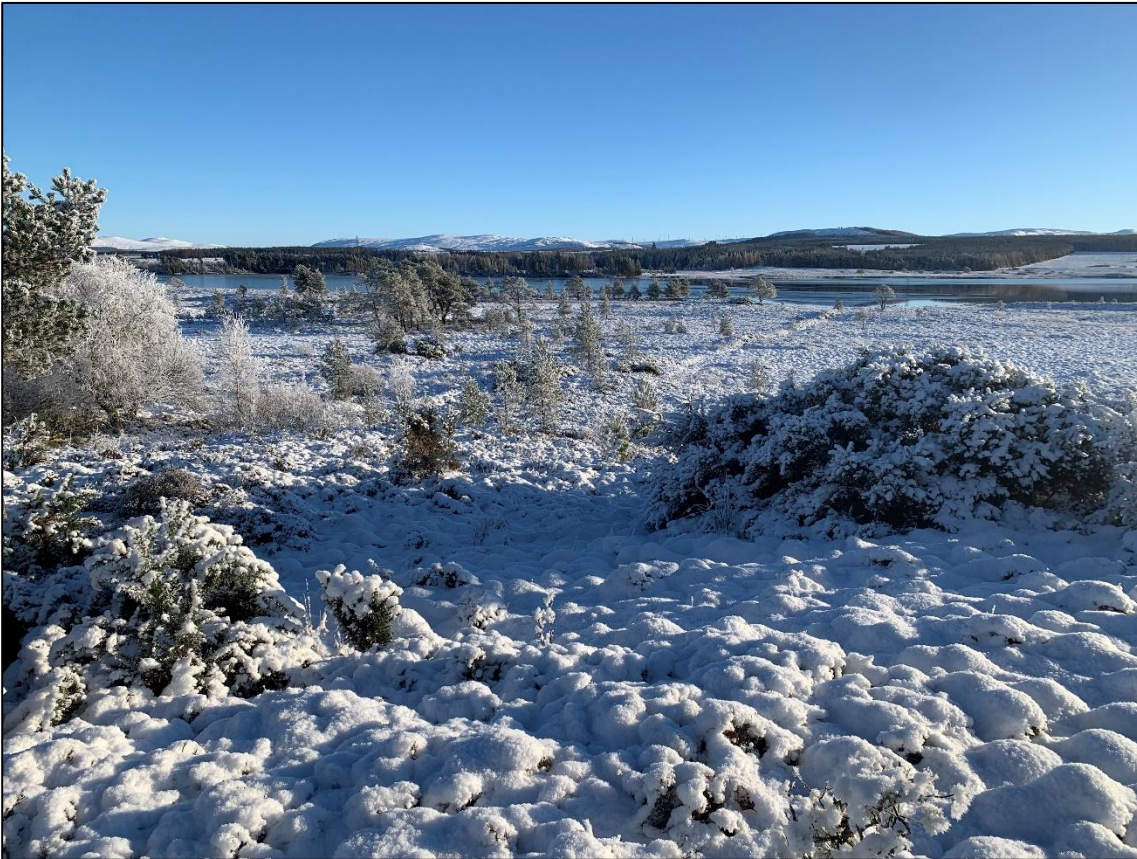
- 5.5.1 Along the southern end of the UGC route next to Loch Ashie, the remains of two drystone dykes (**Assets 15 and 16**) were recorded (Plates 13 – 14). Both dykes had been noted in the previous surveys in the area and continue beyond the survey corridor. They are post-medieval boundary walls.
- 5.5.2 Between the two dykes, several fragments of very degraded turf banks (**Assets 66, 67 and 71**) have been recorded during previous surveys. These are likely to be remains of older, possibly prehistoric field systems, though most were too degraded to identify under the snow cover. A large cairnfield (**Asset 68**) is located on the opposite side of the road, where at least 26 cairns have been recorded, some of which may be burial cairns.
- 5.5.3 Finally, two small roadside quarries (**Assets 69 and 72**) were also noted in this area.

Plate 13: General view of drystone dyke Asset 15, facing SE

- 6.3 There is also the potential for direct impacts upon some portions of low turf banks (**Assets 20, 50, 61, 66**), which are thought to be remnants of past field systems, and on the two post-medieval drystone dykes (**Assets 15 and 16**). These assets are generally extensive in nature and as such, only a small portion of them would be impacted by groundworks. They have low archaeological significance due to their ephemeral nature and in the case of the post-medieval dykes their recent origins. It is recommended that where possible buffer zones of 5 m are maintained along their lengths. Where cable trenches are required to cut through the dykes, it is recommended that sections of the dyke where there is existing tumble or degradation are chosen to cut through. If this is not possible, then a minimum amount of the dyke should be sacrificed for the crossing point. Tracking of vehicles over dykes should also be kept to a minimum.

15	Drumashie	n/a	Wall	Location of a drystone wall recorded by WCAS 2015 and HAS 2020.	NW-SE	Degraded	Post-medieval	262729	835675	5m buffer. If the cable trench must cut the wall, then the section causing the least disturbance should be chosen.

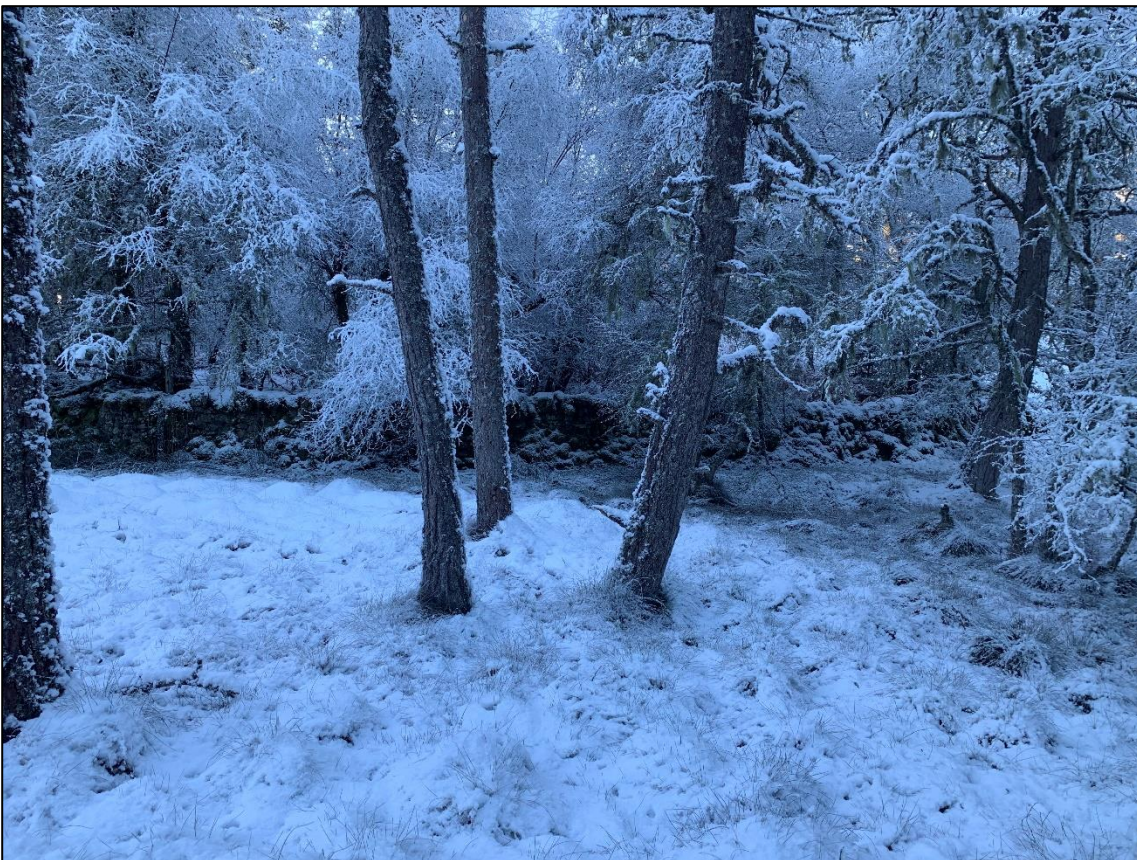
Plate 14: General view of drystone dyke Asset 16, facing SW

Asset No.	Name	HER Reference	Form	Description	Alignment	Condition	Period	Easting	Northing	Mitigation
16	Drumashie	n/a	Wall	Location of a drystone wall recorded by WCAS 2015 and HAS 2020.	Various	Degraded	Post-medieval	262267	835003	5m buffer. If the cable trench must cut the wall, then the section causing the least disturbance should be chosen.
17	Essich	Canmore 370890	Other	Location of a possible boundary stone recorded in the HER. Not identified due to its location within the substation development area. It is not known if it survives.	N/A	N/A	Post-medieval	265111	838992	5m buffer
18	Essich	n/a	Bank	Location of possible old dyke or bank recorded by HAS 2020.	N-S	N/A	Unknown	265013	839057	5m buffer
19	Essich	n/a	Clearance Cairn	Location of an area of field clearance recorded by HAS 2020.	N/A	N/A	Unknown	264980	839028	5m buffer
20	Essich	n/a	Dyke	Location of a possible dyke recorded by HAS 2020.	NW-SE	N/A	Unknown	264867	838922	5m buffer. If the cable trench must cut the wall, then the section causing the least disturbance should be chosen.
