SKYE REINFORCEMENT PROJECT

Appendix V2-6.2: Schedule of Permanent Watercourse Crossings

Prepared for: Scottish & Southern Electricity
Networks Transmission (SSEN Transmission)

SLR Ref: 428.04707.00020
Version No: Final
September 2022

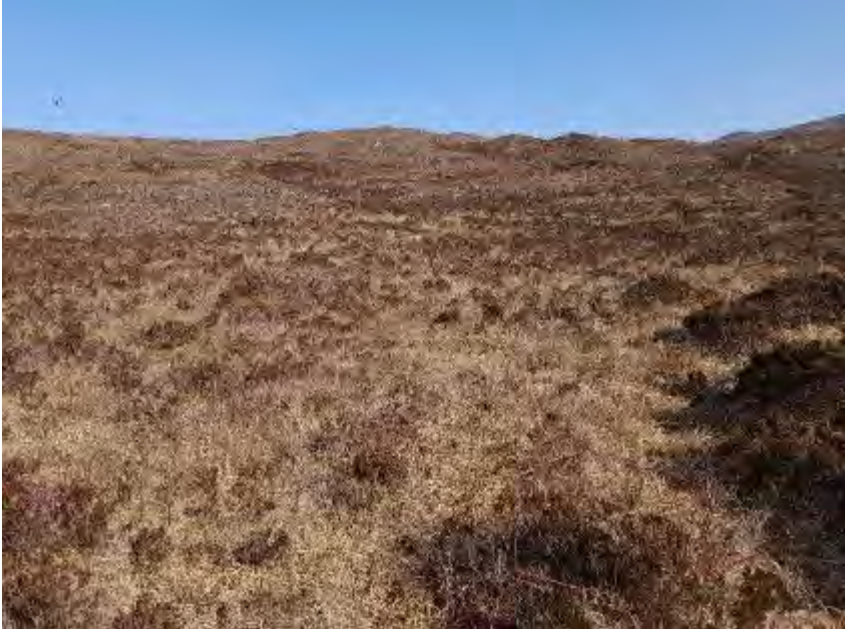
Watercourse Crossing ID	WX2.17
Watercourse Crossing Details	Watercourse Crossing: WX2.17 NGR: NG 56952 27077 Watercourse Width: N/A Watercourse Depth: N/A Notes: no defined channel found and more likely only conveys flows / surface water runoff during periods of high rainfall.
Photograph Looking Upstream

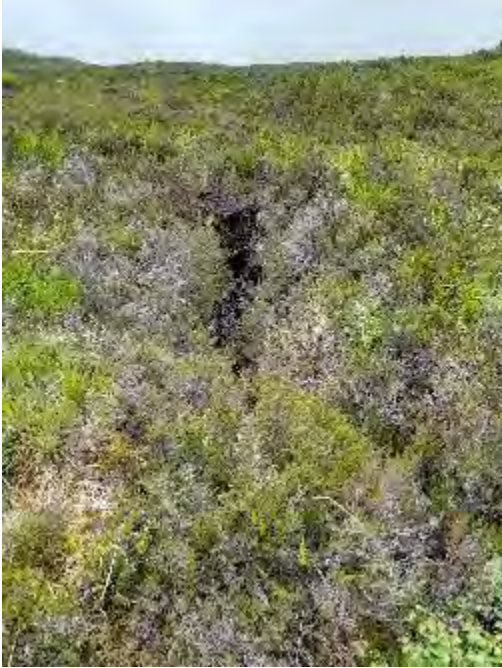
Watercourse Crossing ID	WX3.31	
Watercourse Crossing Details	<p>Watercourse Crossing: WX3.31 NGR: NG 76283 24538 Watercourse Width: 0.3 m Watercourse Depth: 1 m Notes: Channel incised in peat with bedrock noted at the bed of the watercourse.</p>	
Photograph Looking Upstream

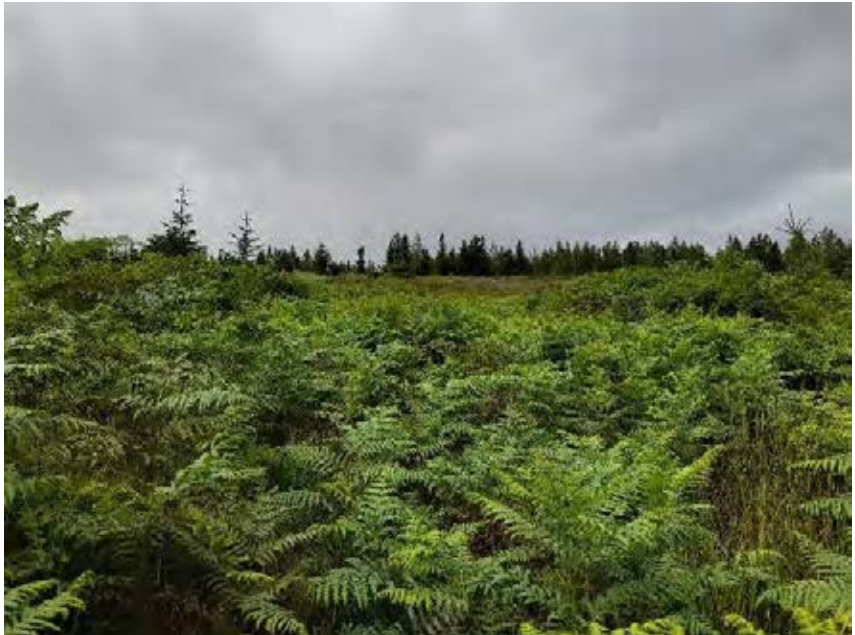
Watercourse Crossing ID	WX4.17
Watercourse Crossing Details	<p>Watercourse Crossing: WX4.17 NGR: NG 81269 22164 Watercourse Width: N/A Watercourse Depth: N/A Notes: No active channel noted at crossing location. The wider channel area extended to approximately 5m wide, with waterlogged soils and bracken. Watercourse becomes more defined downstream of crossing location.</p>
Photograph Looking Upstream

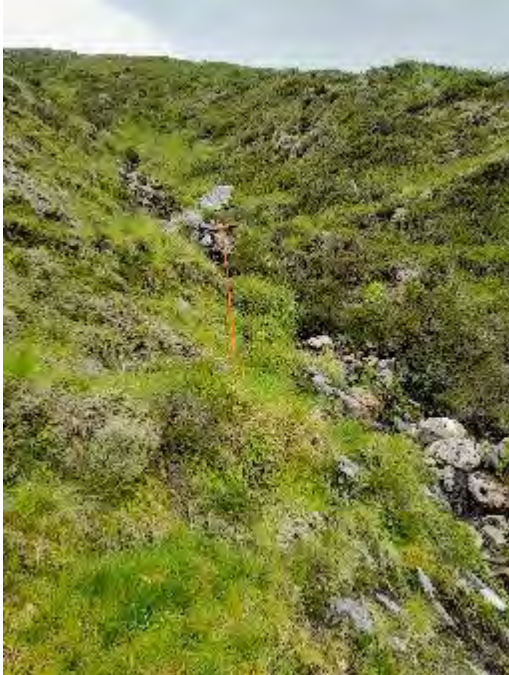
Watercourse Crossing ID	WX4.48
Watercourse Crossing Details	<p>Watercourse Crossing: WX4.48 NGR: NG 87914 12564 Watercourse Width: 1 m Watercourse Depth: 3 m Notes: Steep watercourse in a defined channel with boulders in channel. Recommended to move slightly downstream where slopes are less steep.</p>
Photograph Looking Upstream

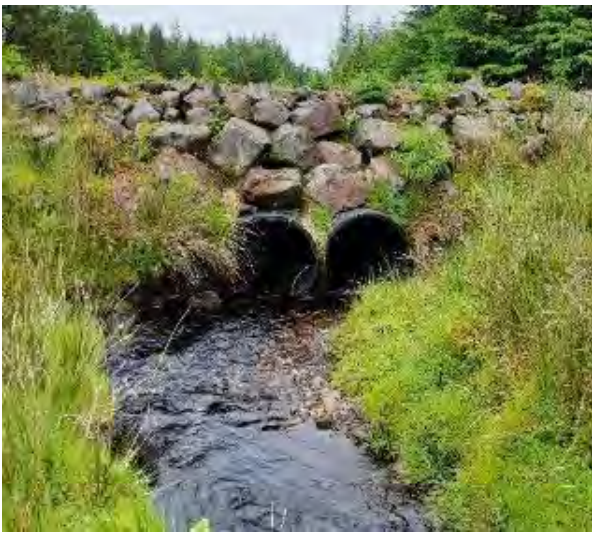
Section 0	
There are no existing crossings on existing tracks to be upgraded in Section 0.	
Section 1	
Watercourse Crossing ID	WX1.2
Watercourse Crossing Details	<p>Watercourse Crossing: WX1.2 NGR: NG 43459 38444 Status: Existing Culvert Diameter: 1m x2 Culvert Construction Type: two twinwall plastic circular Watercourse Width: 2m Watercourse Depth: N/A Notes: Culverts in good condition / no obstruction.</p>
Photograph Looking at Culvert Entrance from Upstream

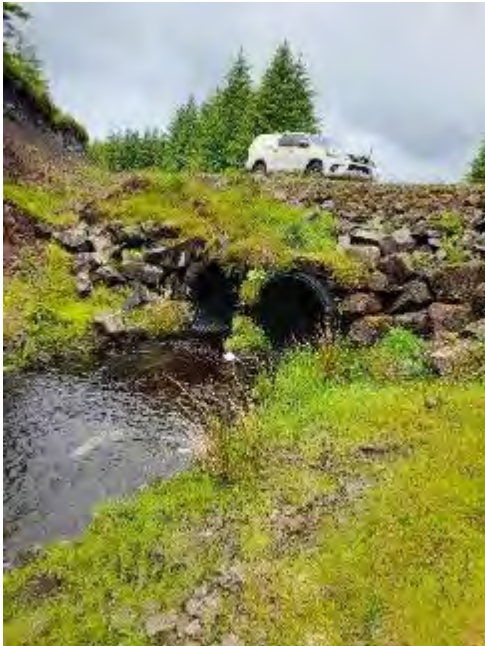
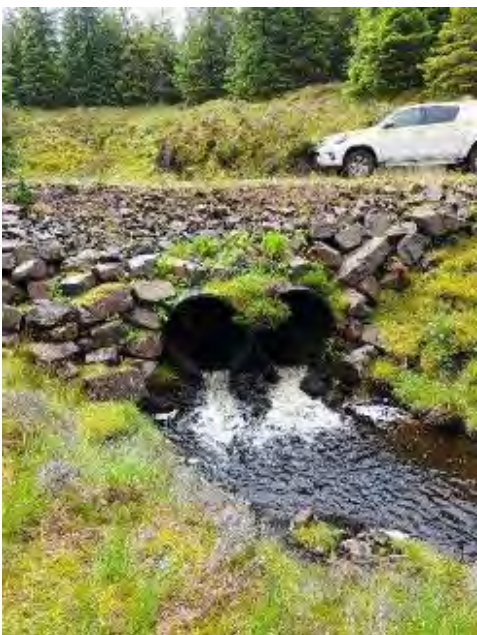
Watercourse Crossing ID	WX1.7	
Watercourse Crossing Details	<p>Watercourse Crossing: WX1.7 NGR: NG 42732 36171 Status: Existing Culvert Diameter: 1.5 m x2 Culvert Construction Type: two twinwall plastic circular Watercourse Width: 3 m Watercourse Depth: N/A Notes: Culverts clear and in good condition.</p>	
Photograph Looking at Culvert Entrance from Upstream

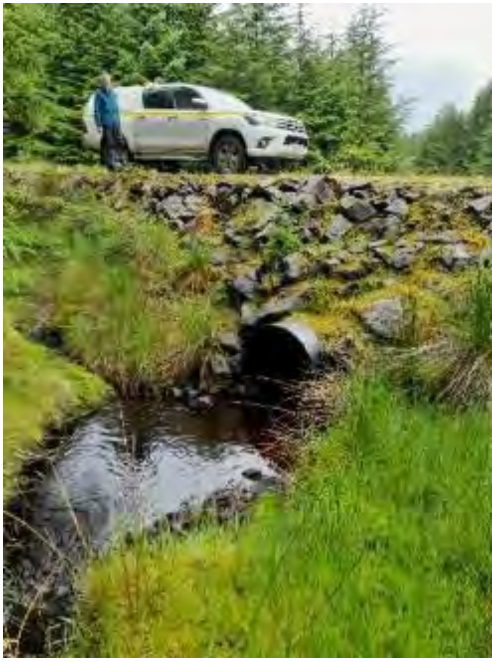
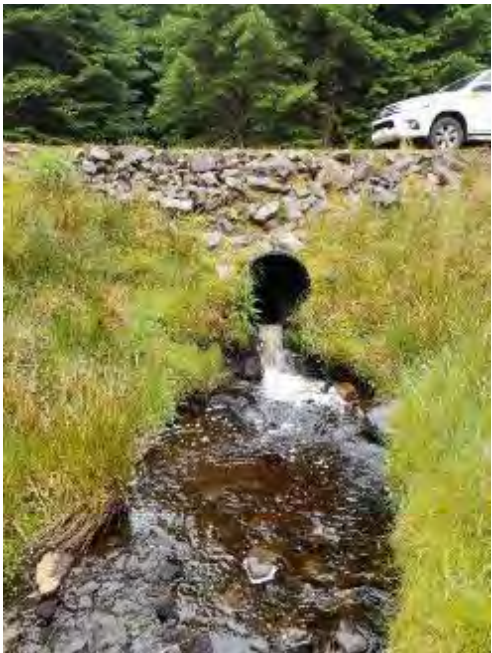
Watercourse Crossing ID	WX1.8	
Watercourse Crossing Details	<p>Watercourse Crossing: WX1.8 NGR: NG 42491 36277 Status: Existing Culvert Diameter: 1 m Culvert Construction Type: twinwall plastic circular Watercourse Width: 2 m Watercourse Depth: N/A Notes: Culvert in good condition, cobbles to boulders noted within channel</p>	
Photograph Looking at Culvert Entrance from Upstream

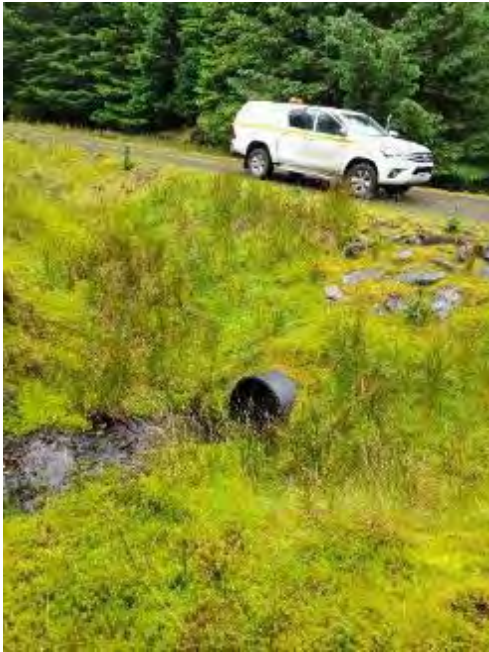
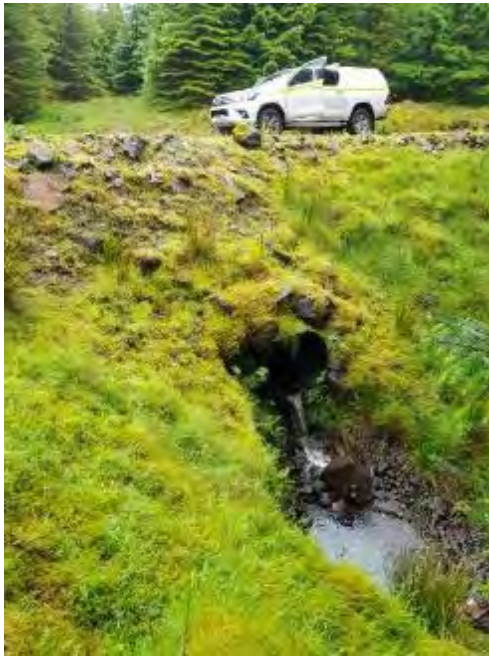
Watercourse Crossing ID	WX1.9
Watercourse Crossing Details	<p>Watercourse Crossing: WX1.9 NGR: NG 42335 36327 Status: Existing Culvert Diameter: 1 m Culvert Construction Type: twinwall plastic circular Watercourse Width: 1.5 m Watercourse Depth: N/A Notes: Culvert in good condition.</p>
Photograph Looking at Culvert Entrance from Upstream

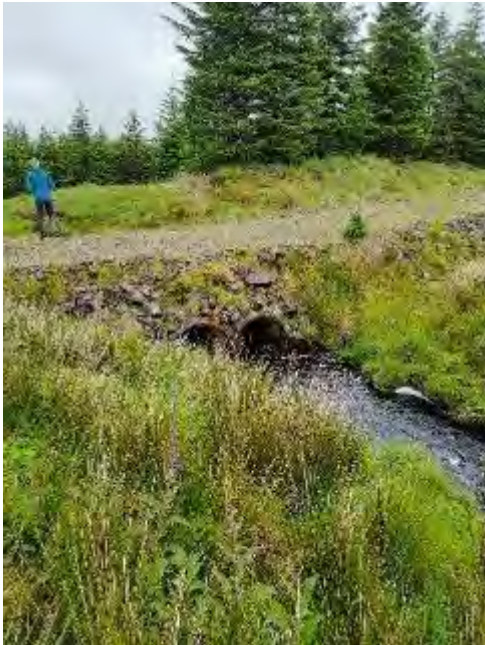
Watercourse Crossing ID	WX1.10
Watercourse Crossing Details	<p>Watercourse Crossing: WX1.10 NGR: NG 42097 36428 Status: Existing Culvert Diameter: 1 m x2 Culvert Construction Type: two concrete circular Watercourse Width: 2.5 m Watercourse Depth: N/A Notes: Culverts in good condition.</p>
Photograph Looking at Culvert Entrance from Upstream

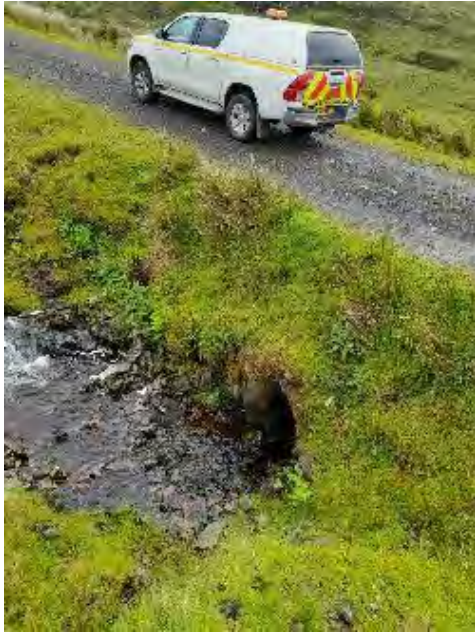
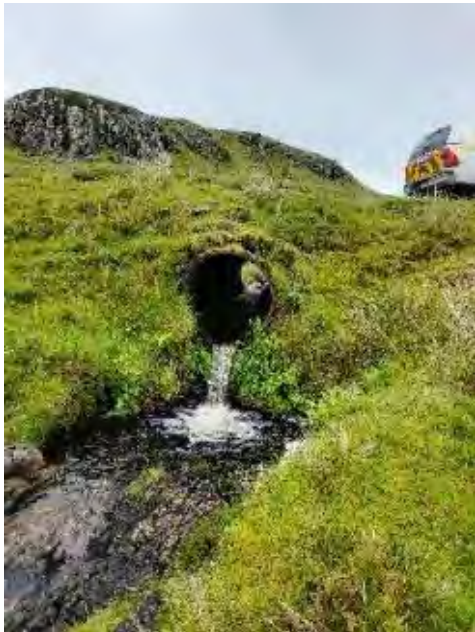
Watercourse Crossing ID	WX1.13	
Watercourse Crossing Details	<p>Watercourse Crossing: WX1.13 NGR: NG 41029 35612 Status: Existing Culvert Diameter: 1 m Culvert Construction Type: concrete circular Watercourse Width: 1.5 m Watercourse Depth: N/A Notes: Culvert in good condition.</p>	
Photograph Looking at Culvert Entrance from Upstream

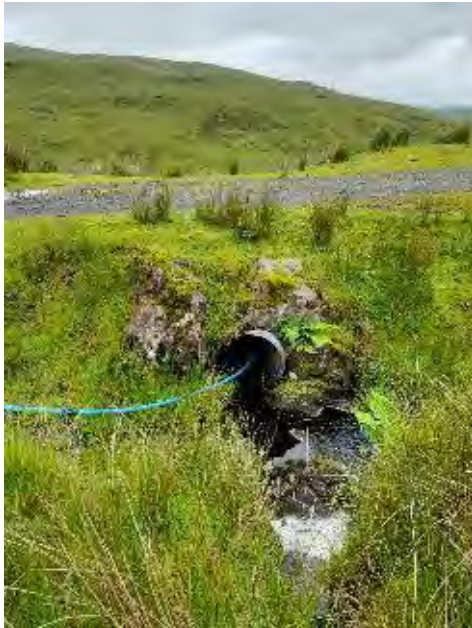
Watercourse Crossing ID	WX1.18	
Watercourse Crossing Details	<p>Watercourse Crossing: WX1.18 NGR: NG 39405 35022 Status: Existing Culvert Diameter: 0.7 m Culvert Construction Type: twinwall plastic circular Watercourse Width: 1 to 1.5 m Watercourse Depth: N/A Notes: Culvert in good condition.</p>	
Photograph Looking at Culvert Entrance from Upstream

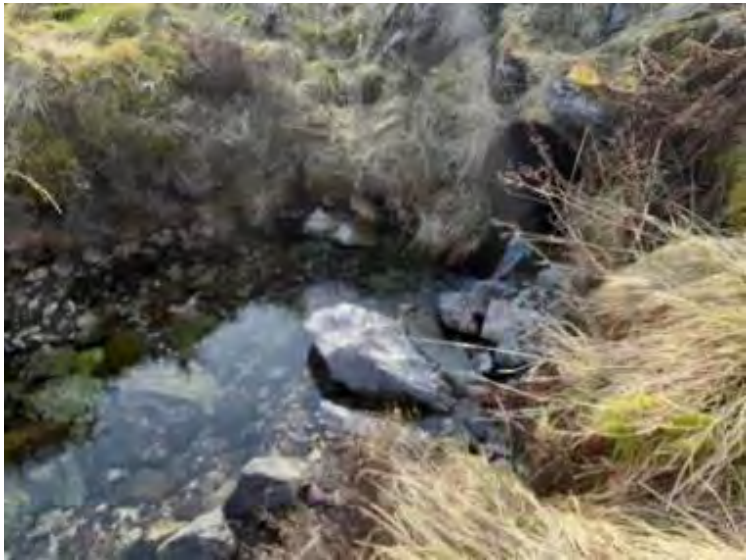
Section 2	
Watercourse Crossing ID	WX2.6
Watercourse Crossing Details	<p>Watercourse Crossing: WX2.6 NGR: NG 62443 24578 Status: Existing Culvert Diameter: 0.5m Culvert Construction Type: corrugated iron pipe Watercourse Width: 1-2m Watercourse Depth: 1m Notes: existing iron culvert has rusted. Evidence of flooding at culvert entrance</p>
Photograph Looking at Culvert Entrance from Upstream

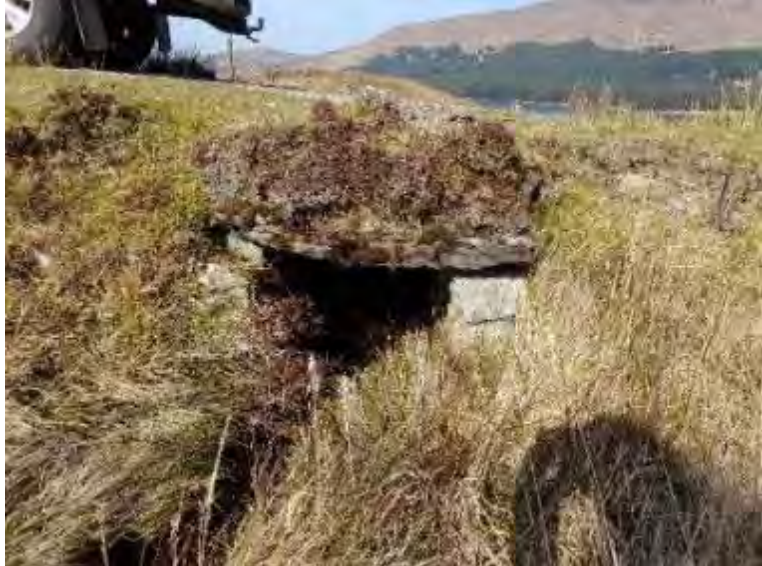
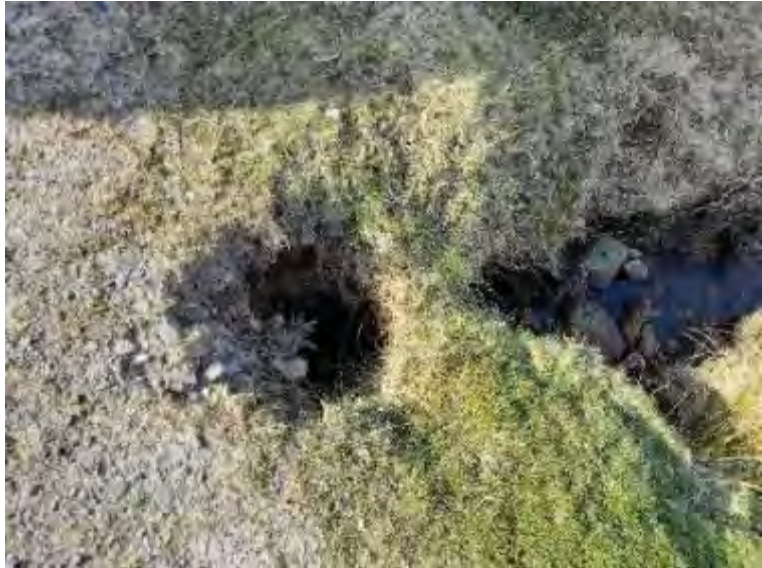
Watercourse Crossing ID	WX2.23
Watercourse Crossing Details	<p>Watercourse Crossing: WX2.23 NGR: NG 59679 26594 Status: Existing Culvert Diameter: 0.5m Culvert Construction Type: stone and concrete Watercourse Width: 0.5-2m Watercourse Depth: 0.1m Notes: existing culvert has a hole on the top towards the downstream end. Boulders and cobbles are deposited throughout the channel and evidence of flooding was noted</p>
Photograph Looking at Culvert Entrance from Upstream

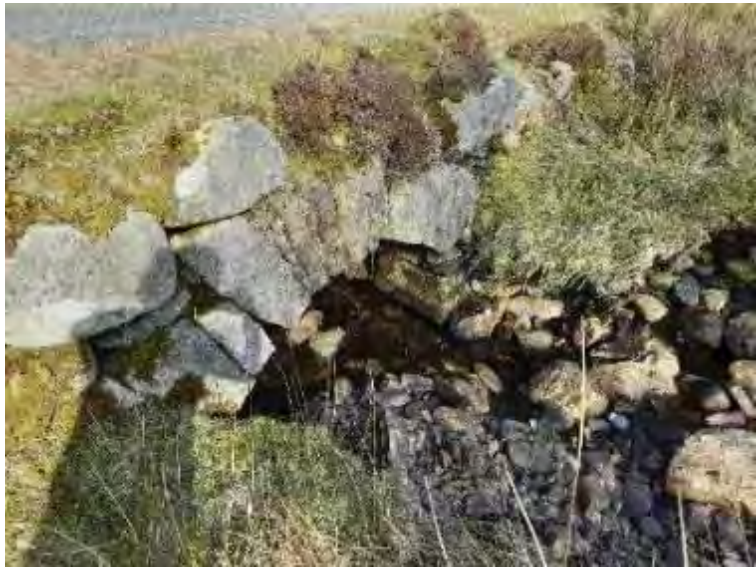
Watercourse Crossing ID	WX2.24
Watercourse Crossing Details	<p>Watercourse Crossing: WX2.24 NGR: NG 59723 26604 Status: Existing Culvert Diameter: 0.4m height, 0.6m wide Culvert Construction Type: stone arch in good condition Watercourse Width: 1.5-2m Watercourse Depth: 1m Notes: channel incised into bedrock with boulders deposited at the reach. Evidence of flooding around the culvert entrance.</p>
Photograph Looking at Culvert Entrance from Upstream

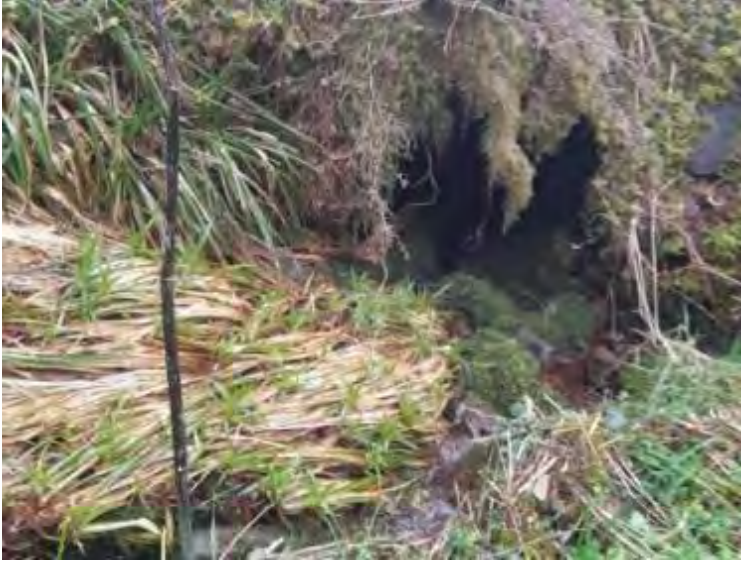
Watercourse Crossing ID	WX3.24
Watercourse Crossing Details	<p>Watercourse Crossing: WX3.24 NGR: NG 78681 21851 Status: Existing Culvert Diameter: 0.3m Culvert Construction Type: circular corrugated metal Watercourse Width: 0.2-0.4m Watercourse Depth: 0.1m Notes: active channel sits within a large channel which is 1.5m deep. Downstream outfall culvert has slightly corroded with moss present along the base.</p>
Photograph Looking at Culvert Entrance from Upstream

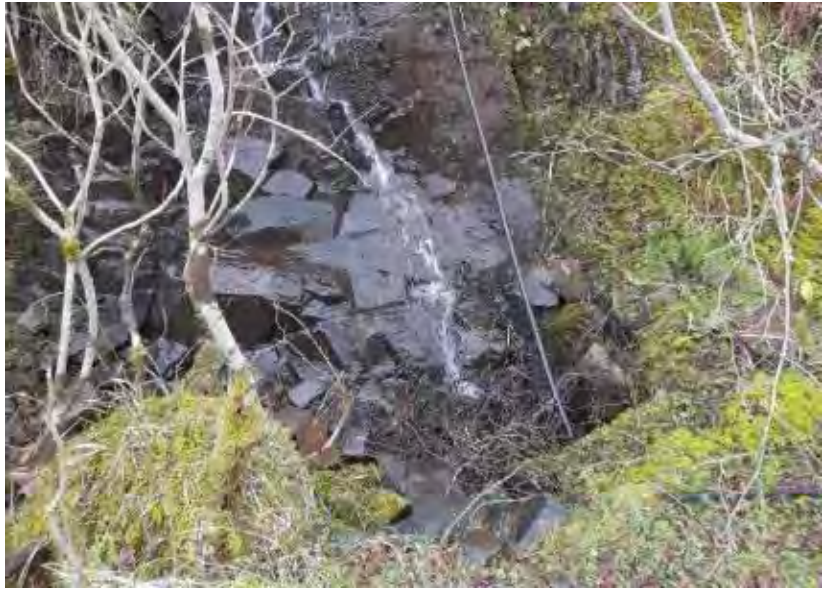
Section 4	
Watercourse Crossing ID	WX4.1
Watercourse Crossing Details	<p>Watercourse Crossing: WX4.1 NGR: NG 79540 21392 Status: Existing Culvert Diameter: 0.3m Culvert Construction Type: open arch culvert Watercourse Width: 0.5 Watercourse Depth: 0.1m Notes: culvert is rusted, dented and partially blocked with debris.</p>
Photograph Looking at Culvert Entrance Upstream

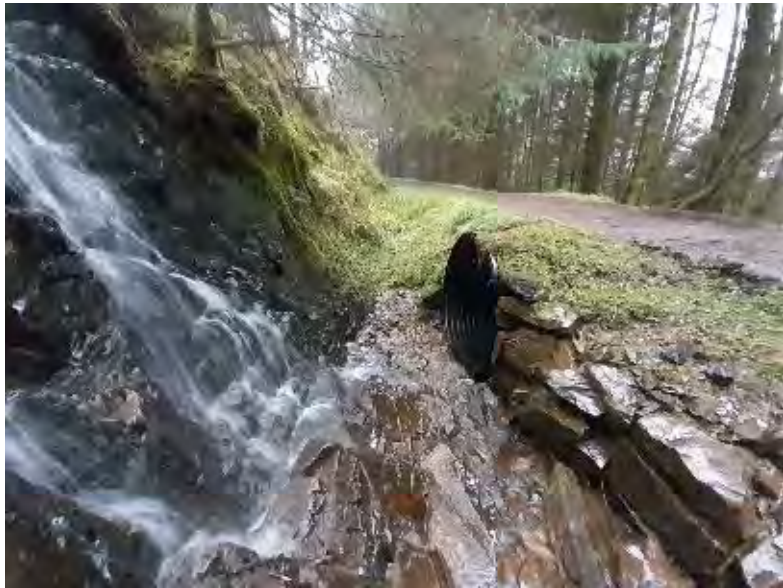
Watercourse Crossing ID	WX4.4
Watercourse Crossing Details	<p>Watercourse Crossing: WX4.4 NGR: NG 79787 22217 Status: Existing Culvert Diameter: 1.5m Culvert Construction Type: circular plastic culvert Watercourse Width: 0.5-1.5m Watercourse Depth: 0.1m Notes: channel is deeper and wider downstream with boulders and cobbles noted, existing culvert appears in good condition</p>
Photograph Looking at Culvert Entrance from Upstream

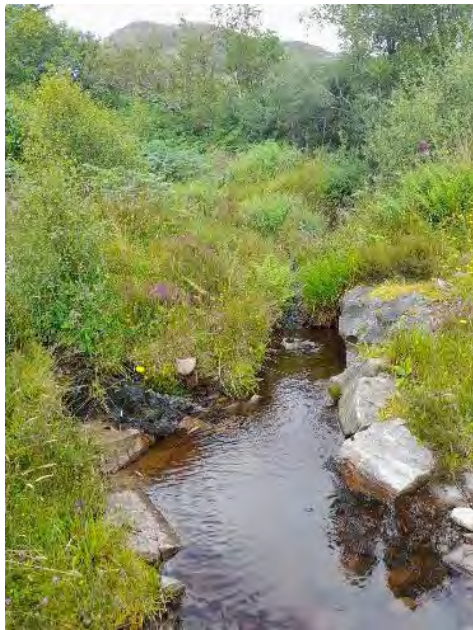
Watercourse Crossing ID	WX4.9
Watercourse Crossing Details	<p>Watercourse Crossing: WX4.9 NGR: NG 81262 21683 Status: Existing Culvert Diameter: N/A Culvert Construction Type: N/A Watercourse Width: 1 m Watercourse Depth: 0.2 m Notes: No formal infrastructure noted.</p>
Photograph Upstream

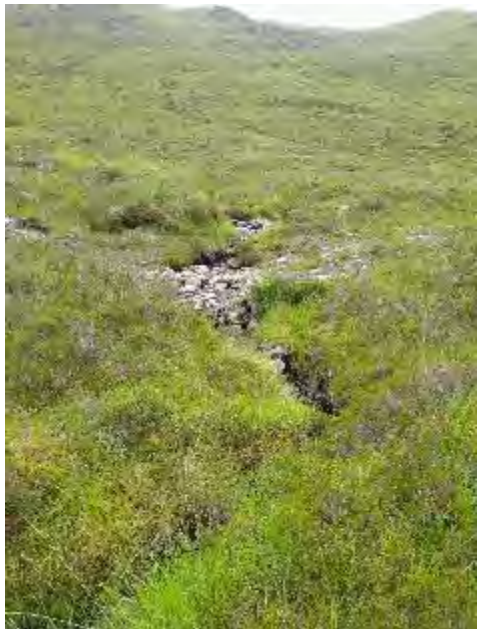
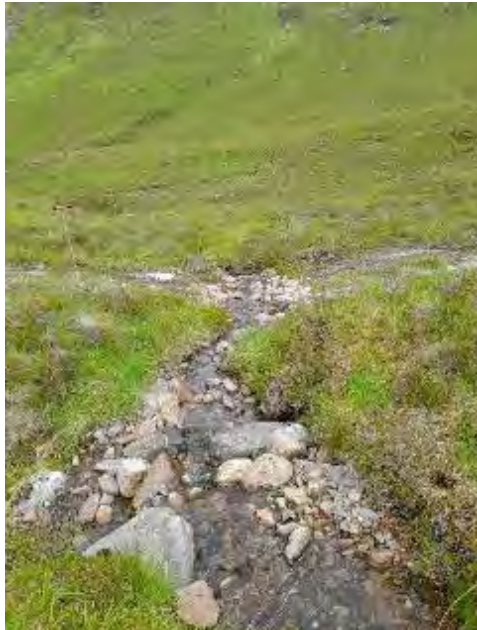
Watercourse Crossing ID	WX4.16	
Watercourse Crossing Details	<p>Watercourse Crossing: WX4.16 NGR: NG 88079 12918 Status: Existing Culvert Diameter: N/A Culvert Construction Type: N/A Watercourse Width: 2 m Watercourse Depth: 0.5 m Notes: Water overflows across track with no formal infrastructure noted</p>	
Photograph Looking Upstream

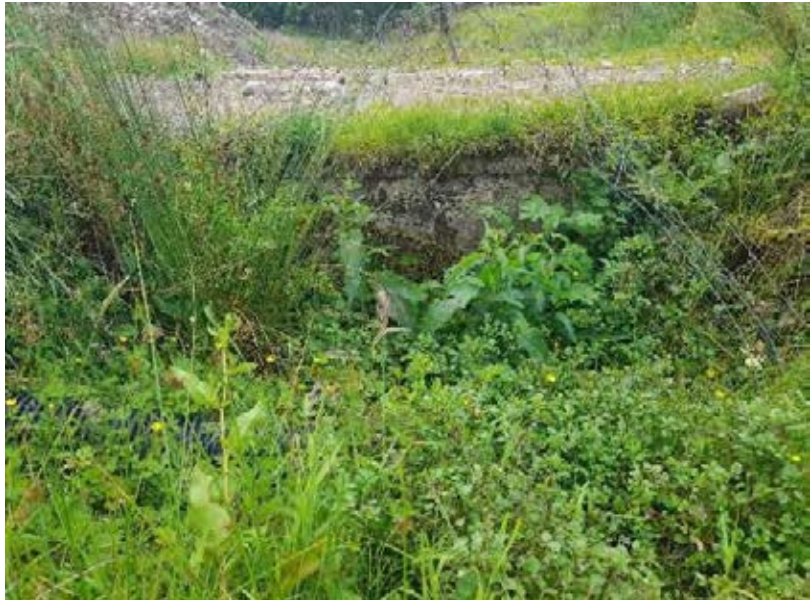
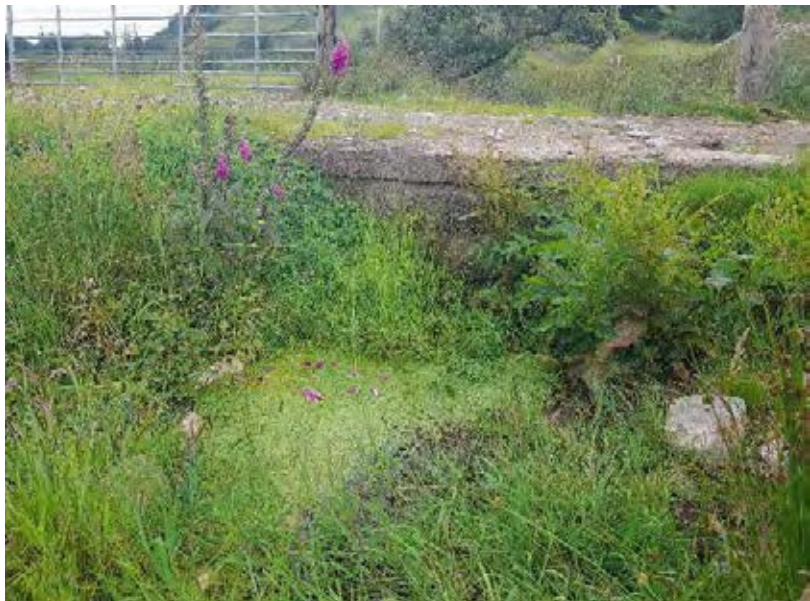
Watercourse Crossing ID	WX4.31
Watercourse Crossing Details	<p>Watercourse Crossing: WX4.31 NGR: NG 83708 19741 Status: Existing Culvert Diameter: 0.2 m Culvert Construction Type: concrete circular Watercourse Width: 0.4 m Watercourse Depth: 0.2 m to 1 m deep Notes: Survey approximately 50 m upstream where track crosses small tributary of the Glenmore River. Culvert is covered by dense vegetation. No track noted at crossing location. Glenmore River is approximately 10 m wide and 0.5 m deep at the crossing location.</p>
<p>Photograph Looking at Culvert Entrance from Upstream</p>

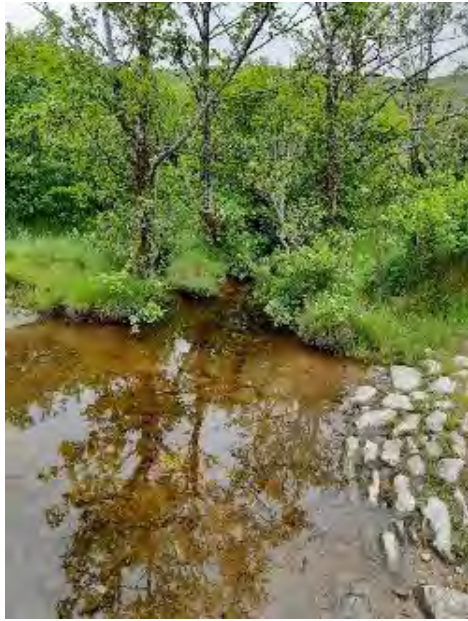
Watercourse Crossing ID	WX4.32
Watercourse Crossing Details	<p>Watercourse Crossing: WX4.32 NGR: NG 85158 16174 Status: Existing Culvert Diameter: N/A Culvert Construction Type: N/A Watercourse Width: 4 m Watercourse Depth: 0.2 m Notes: Wide ford crossing, no formal infrastructure noted</p>
Photograph Looking Upstream

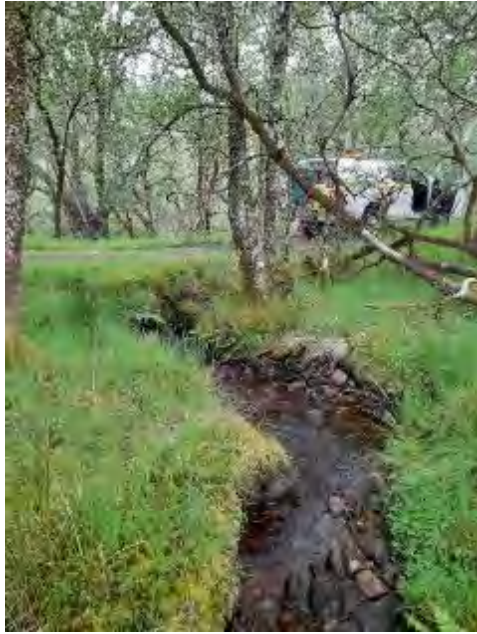
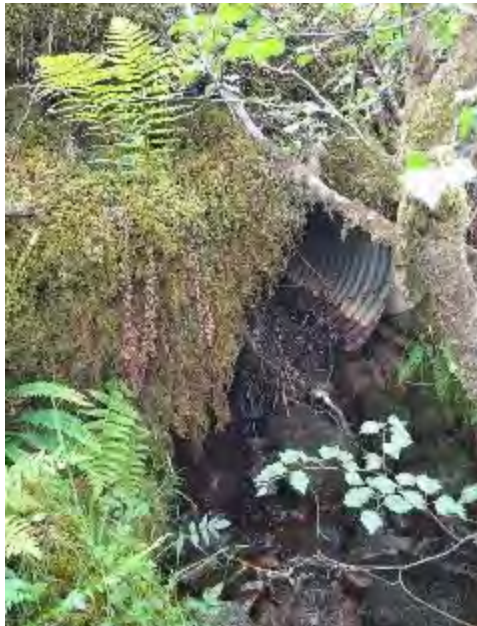
Watercourse Crossing ID	WX4.36	
Watercourse Crossing Details	<p>Watercourse Crossing: WX4.36 NGR: NG 86953 15919 Status: Existing Culvert Diameter: 0.6 m Culvert Construction Type: corrugated metal Watercourse Width: 1 m Watercourse Depth: N/A Notes: Downstream side has partially corroded and culvert appears partially blocked.</p>	
Photograph Looking at Culvert Entrance from Upstream

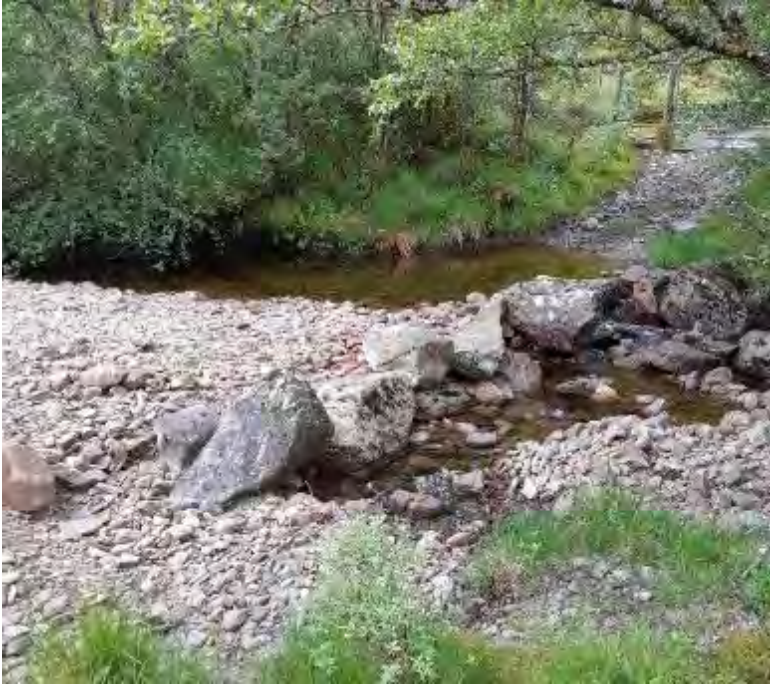
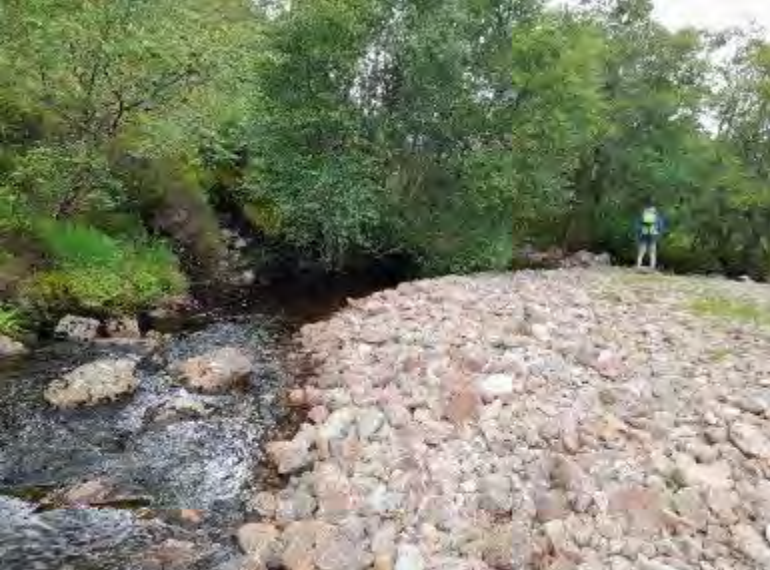
Watercourse Crossing ID	WX4.37
Watercourse Crossing Details	<p>Watercourse Crossing: WX4.37 NGR: NG 87335 15876 Status: Existing Culvert Diameter: N/A Culvert Construction Type: N/A Watercourse Width: 2.5 m Watercourse Depth: 1 m Notes: Large ford crossing with no formal infrastructure noted.</p>
Photograph Looking Upstream

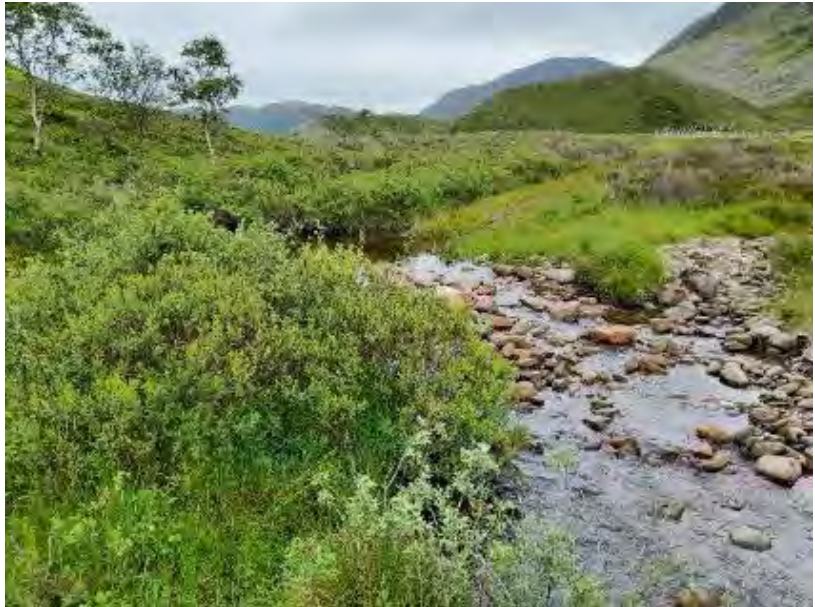
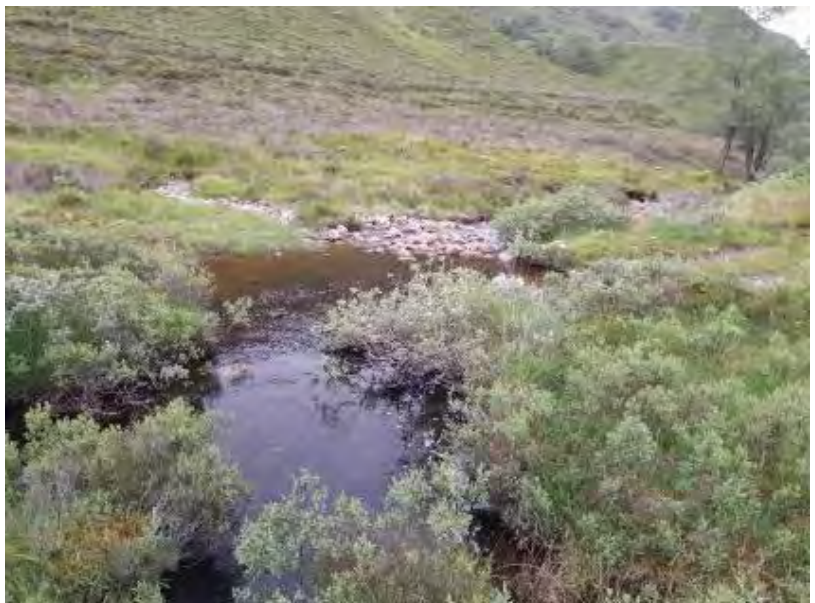
Watercourse Crossing ID	WX4.38
Watercourse Crossing Details	<p>Watercourse Crossing: WX4.38 NGR: NG 87445 15980 Status: Existing Culvert Diameter: N/A Culvert Construction Type: N/A Watercourse Width: 3 m Watercourse Depth: 0.5 m Notes: Wide ford crossing with no formal infrastructure noted.</p>
Photograph Looking Upstream

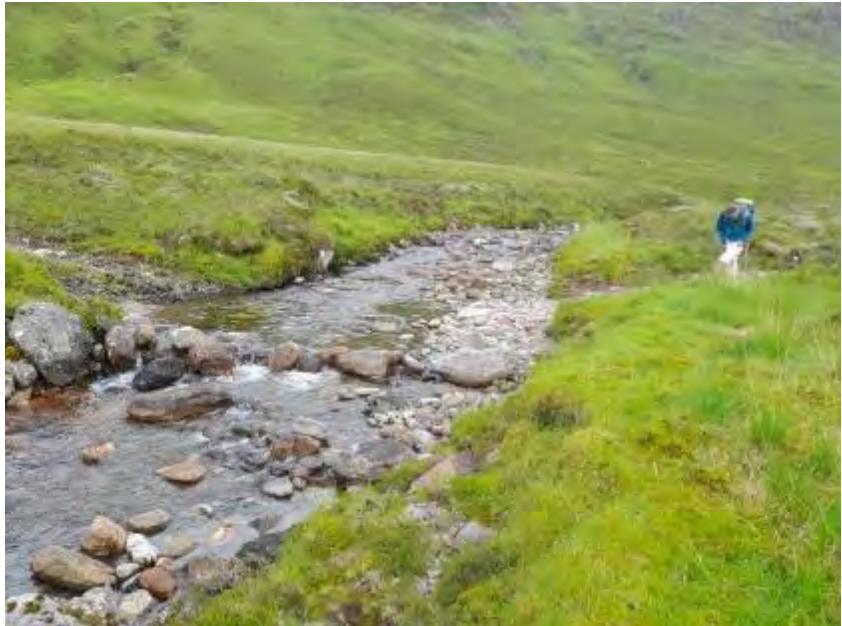
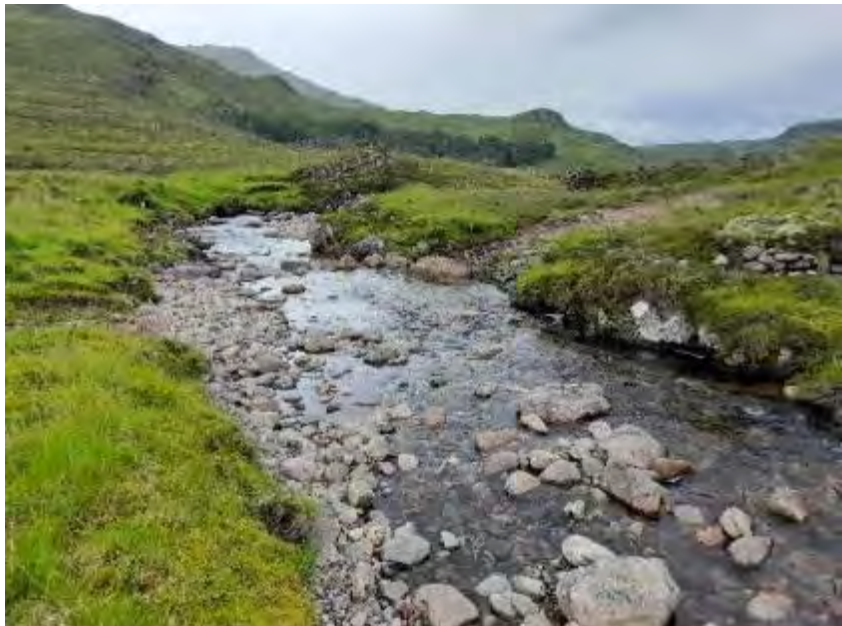
Watercourse Crossing ID	WX4.39
Watercourse Crossing Details	<p>Watercourse Crossing: WX4.39 NGR: NG 87537 14158</p> <p>Status: Existing Culvert Diameter: N/A Culvert Construction Type: N/A Watercourse Width: 4 m Watercourse Depth: 1.5 m Notes: Large ford crossing, with no formal infrastructure noted.</p>
Photograph Looking Upstream

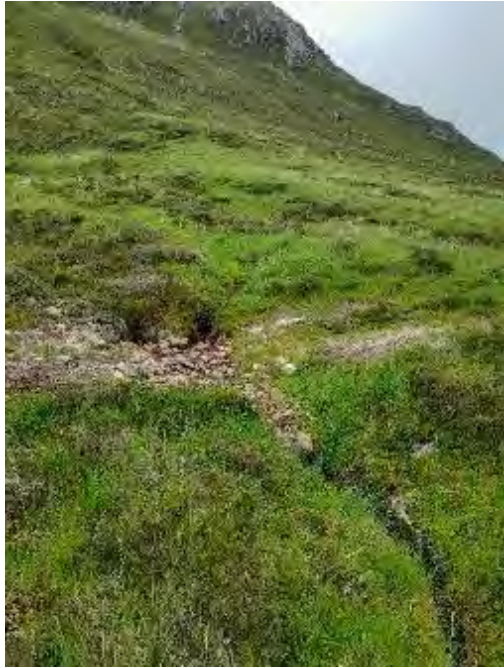
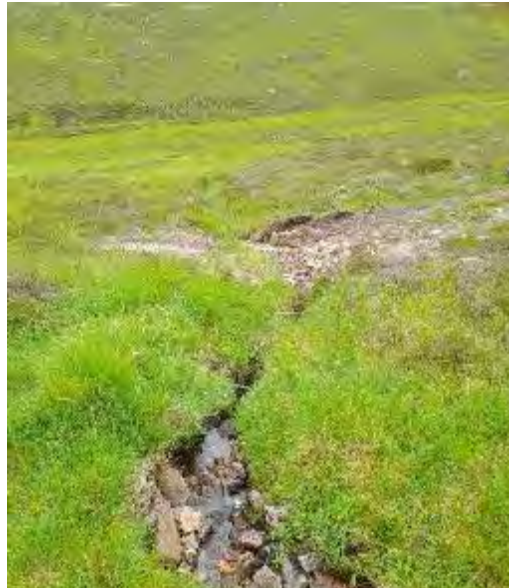
Watercourse Crossing ID	WX4.40
Watercourse Crossing Details	<p>Watercourse Crossing: WX4.40 NGR: NG 87892 13550 Status: Existing Culvert Diameter: N/A Culvert Construction Type: N/A Watercourse Width: 1 m Watercourse Depth: 0.3 Notes: Water flows over track, no formal infrastructure noted. Steep watercourse incised in bedrock</p>
Photograph Looking Upstream

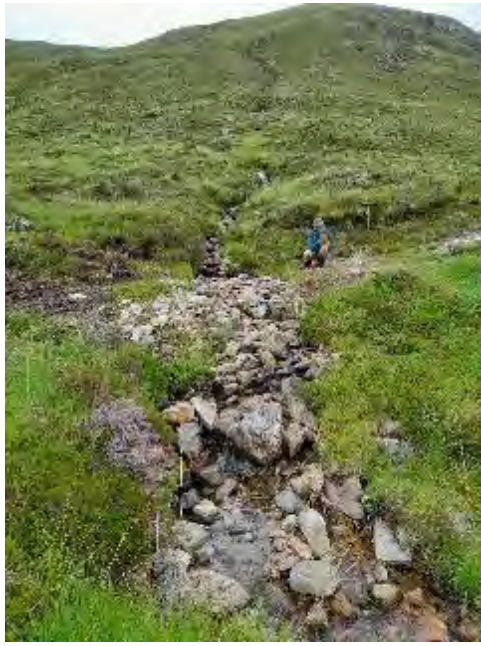
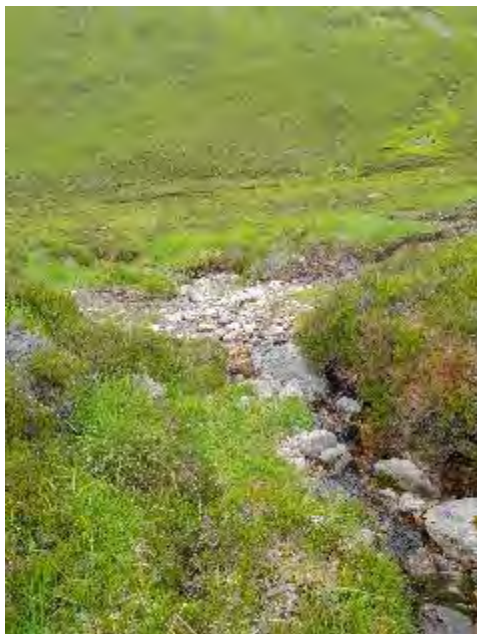
Watercourse Crossing ID	WX4.41	
Watercourse Crossing Details	<p>Watercourse Crossing: WX4.41 NGR: NG 88021 13233 Status: Existing Culvert Diameter: N/A Culvert Construction Type: N/A Watercourse Width: 2 m Watercourse Depth: 0.3 m Notes: Water flows over existing track, no formal infrastructure noted. Steep watercourse and boulders within the channel.</p>	
Photograph Looking Upstream

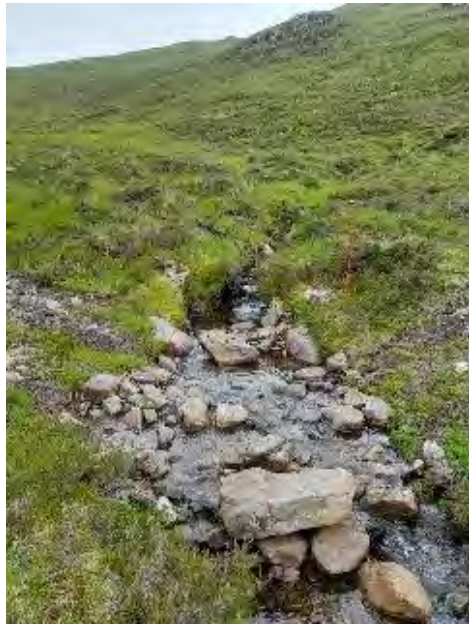
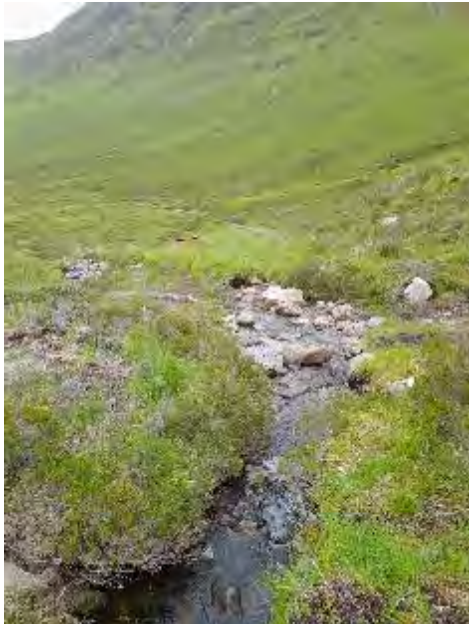
Watercourse Crossing ID	WX4.43	
Watercourse Crossing Details	<p>Watercourse Crossing: WX4.44 NGR: NG 88056 13057 Status: Existing Culvert Diameter: N/A Culvert Construction Type: N/A Watercourse Width: 2 m Watercourse Depth: 0.5 m Notes: Water flows over existing track, no formal infrastructure noted. Steep watercourse and boulders within the channel.</p>	
Photograph Looking Upstream

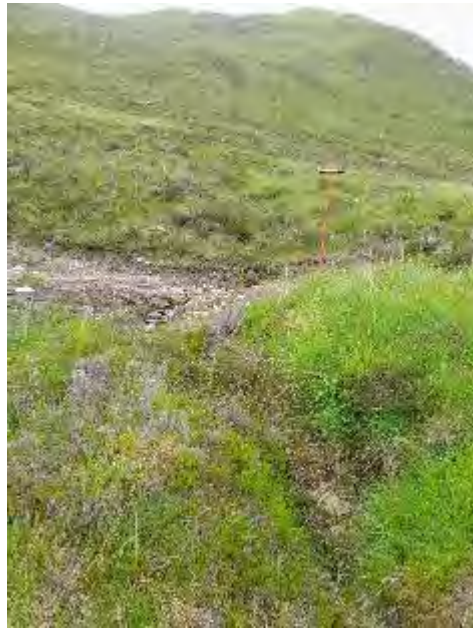
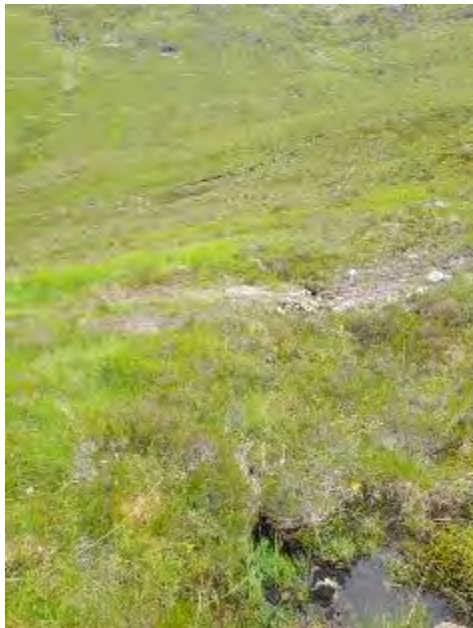
Watercourse Crossing ID	WX4.44	
Watercourse Crossing Details	<p>Watercourse Crossing: WX4.44 NGR: NG 88061 12998 Status: Existing Culvert Diameter: N/A Culvert Construction Type: N/A Watercourse Width: 0.5 m Watercourse Depth: 0.5 m Notes: Water flows over existing track, no formal infrastructure noted. Small reeded watercourse with low flow.</p>	
Photograph Looking Upstream

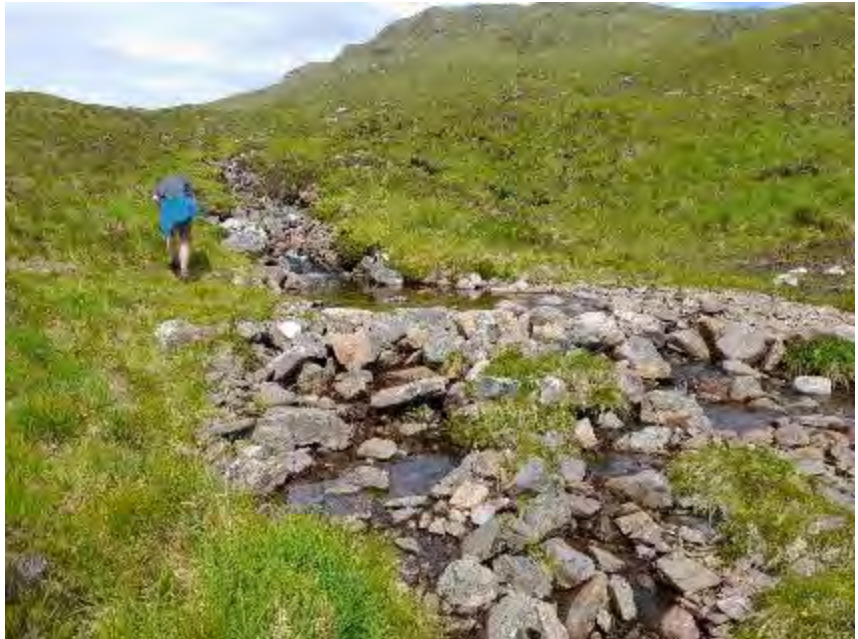
Watercourse Crossing ID	WX4.54
Watercourse Crossing Details	<p>Watercourse Crossing: WX4.54 NGR: NG 89301 11475 Status: Existing Culvert Diameter: N/A Culvert Construction Type: N/A Watercourse Width: 1.7 m Watercourse Depth: 0.8 m Notes: Small ford crossing on bedrock. No formal infrastructure noted.</p>
Photograph Looking Upstream

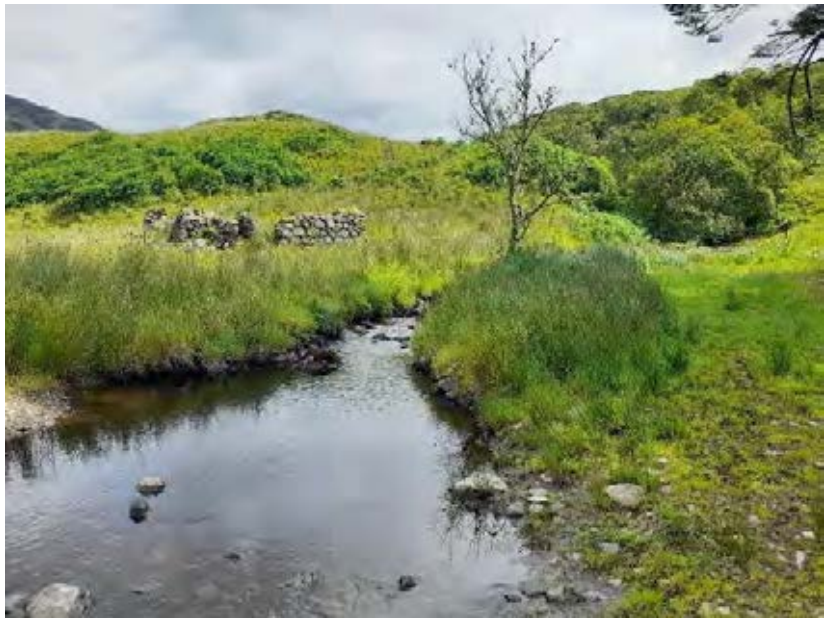
Watercourse Crossing ID	WX4.58
Watercourse Crossing Details	<p>Watercourse Crossing: WX4.58 NGR: NG 84260 19808 Status: Existing Culvert Diameter: N/A Culvert Construction Type: N/A Watercourse Width: 3 m Watercourse Depth: 0.3 m Notes: Ford crossing with no formal infrastructure. Channel noted narrower and slightly deeper both upstream and downstream of crossing location</p>
Photograph Looking Upstream

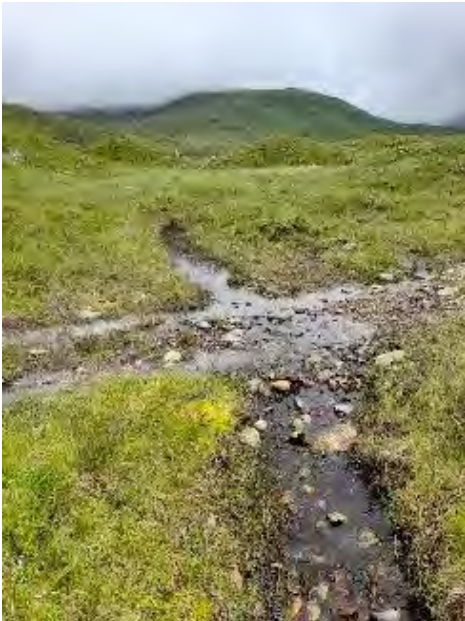
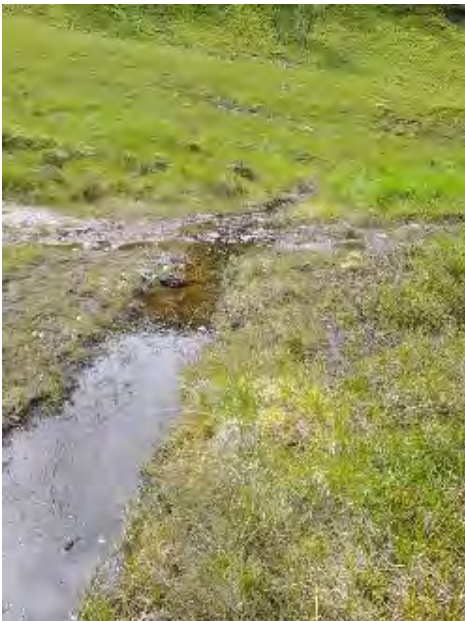
Watercourse Crossing ID	WX4.60
Watercourse Crossing Details	<p>Watercourse Crossing: WX4.60 NGR: NG 91750 09659 Status: Existing Culvert Diameter: N/A Culvert Construction Type: N/A Watercourse Width: 1.5 m Watercourse Depth: 0.2 m Notes: Small ford crossing. No formal infrastructure noted.</p>
Photograph Looking Upstream

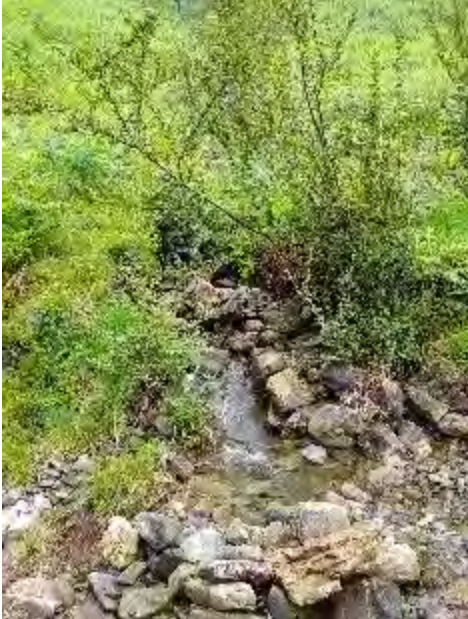
Watercourse Crossing ID	WX4.72	
Watercourse Crossing Details	<p>Watercourse Crossing: WX4.72 NGR: NG 95051 07319 Status: Existing Culvert Diameter: N/A Culvert Construction Type: N/A Watercourse Width: 2.5 m Watercourse Depth: 0.2 m Notes: Water flows over track with no formal infrastructure noted. Most of water is diverted down the track.</p>	
Photograph Looking Upstream

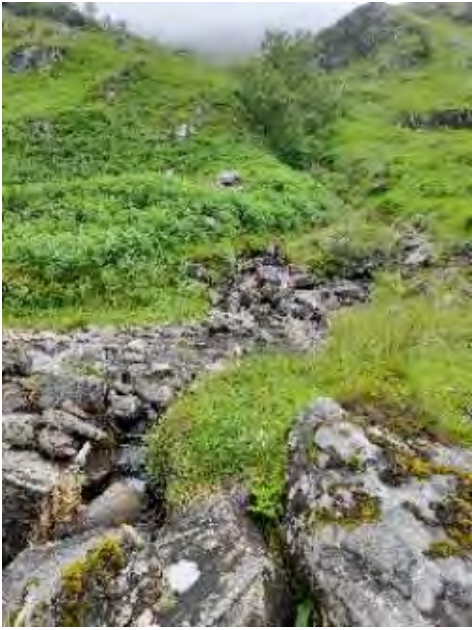
Watercourse Crossing ID	WX4.76	
Watercourse Crossing Details	<p>Watercourse Crossing: WX4.76 NGR: NG 95459 06997 Status: Existing Culvert Diameter: N/A Culvert Construction Type: N/A Watercourse Width: 3 m Watercourse Depth: 0.3 m Notes: Same as WX4.75 as no additional watercourse is not noted.</p>	
Photograph Looking Upstream

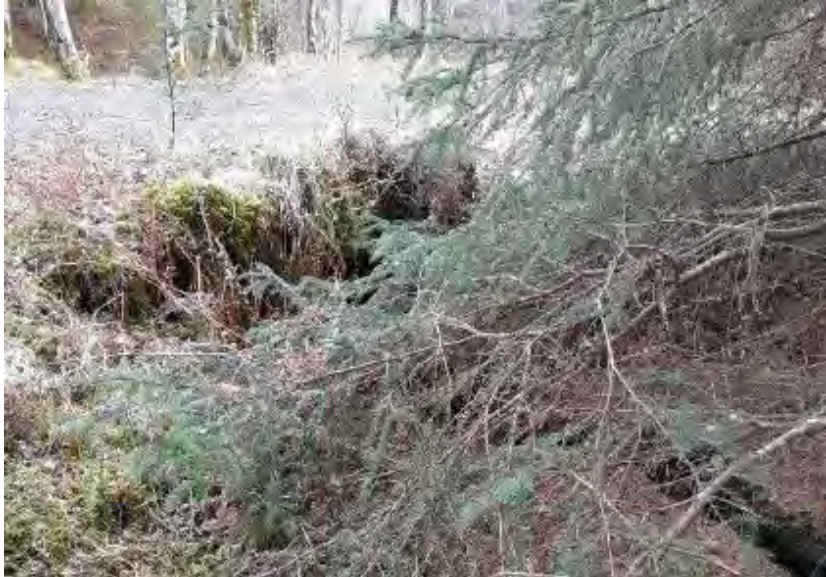
Watercourse Crossing ID	WX5.5
Watercourse Crossing Details	<p>Watercourse Crossing: WX5.5 NGR: NH 28420 02034 Status: Existing Culvert Diameter: 1m Culvert Construction Type: corrugated metal culvert Watercourse Width: 0.3m Watercourse Depth: 0.3m Notes: culvert showing corrosion, existing track is located directly on top with little cover between the road level and culvert soffit, no evidence of flooding, pebbles and cobbles deposited in channel</p>
Photograph Looking at Upstream of Culvert
