SKYE REINFORCEMENT PROJECT

Appendix V2-6.2: Schedule of Permanent Watercourse Crossings

Prepared for: Scottish & Southern Electricity
Networks Transmission (SSEN Transmission)

SLR Ref: 428.04707.00020
Version No: Final
September 2022

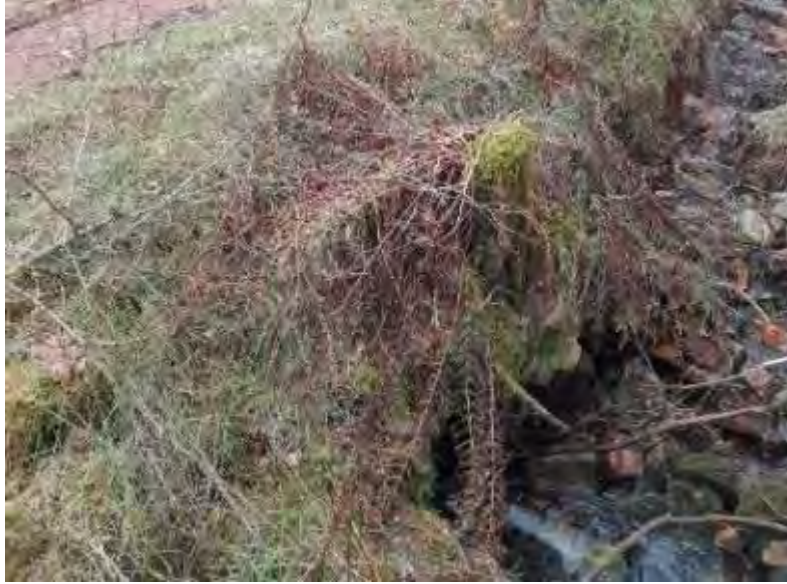
Watercourse Crossing ID	WX5.10
Watercourse Crossing Details	<p>Watercourse Crossing: WX5.10 NGR: NH 19927 02456 Status: Existing Culvert Diameter: 0.6m Culvert Construction Type: circular concrete culvert Watercourse Width: 0.5m Watercourse Depth: 0.2-1m Notes: channel incised into bedrock with boulders deposited in the reach, existing culvert appears in good condition, evidence of flooding adjacent to the channel.</p>
Photograph Looking at Culvert Entrance from Upstream
