SKYE REINFORCEMENT PROJECT

Appendix V6-6.2: Alternative Alignment Schedule of Permanent Watercourse Crossings

Prepared for: Scottish & Southern Electricity
Networks Transmission (SSEN Transmission)

SLR Ref: 428.04707.00020
Version No: Final
September 2022

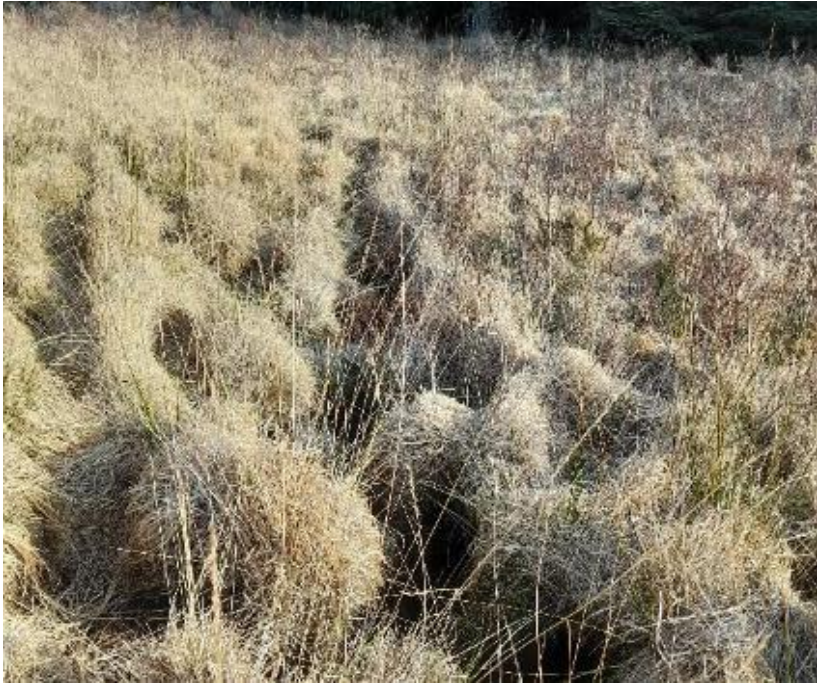
Watercourse Crossing ID	WX1
Watercourse Crossing Details	<p>Watercourse Crossing: WX1 NGR: NG 62868 24055 Watercourse Width: 0.3m Watercourse Depth: 0.3m Notes: Channel incised into peat.</p>
Photograph Looking Upstream

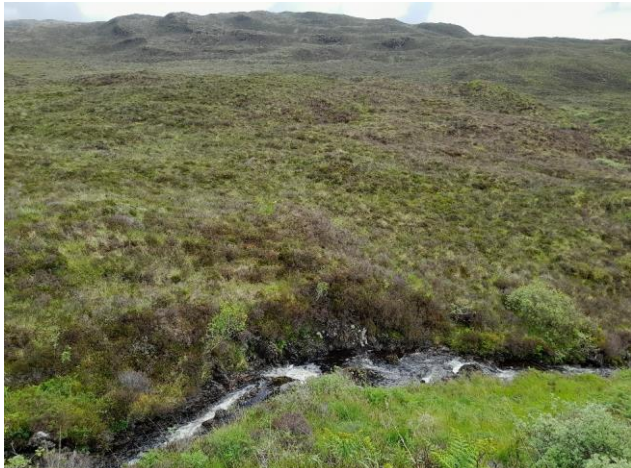
Watercourse Crossing ID	WX3
Watercourse Crossing Details	<p>Watercourse Crossing: WX3 NGR: NG 74238 21002 Watercourse Width: Not recorded Watercourse Depth: Not recorded Notes: Unable to access during survey (as ground conditions were heavily vegetated and safe passage on foot was not possible). Photo of general area of the crossing is shown.</p>
Photograph of General Area

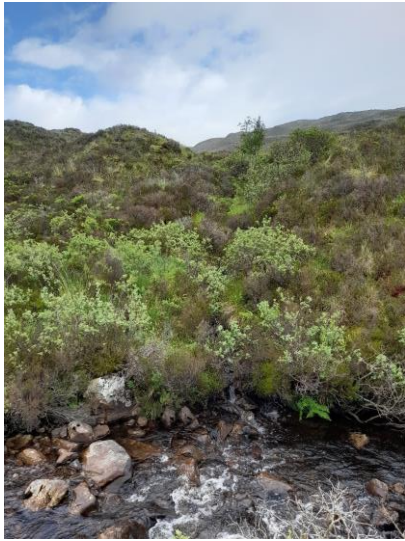
Watercourse Crossing ID	WX4
Watercourse Crossing Details	<p>Watercourse Crossing: WX4 NGR: NG 74472 20915 Watercourse Width: ~0.5 m Watercourse Depth: ~0.3 m Notes: Unable to access (as ground conditions were heavily vegetated and safe passage on foot was not possible), approximate measurements taken from approximately 100 m downstream of watercourse, where it meets Allt Mor watercourse.</p>
Photograph of Watercourse Downstream of the crossing location

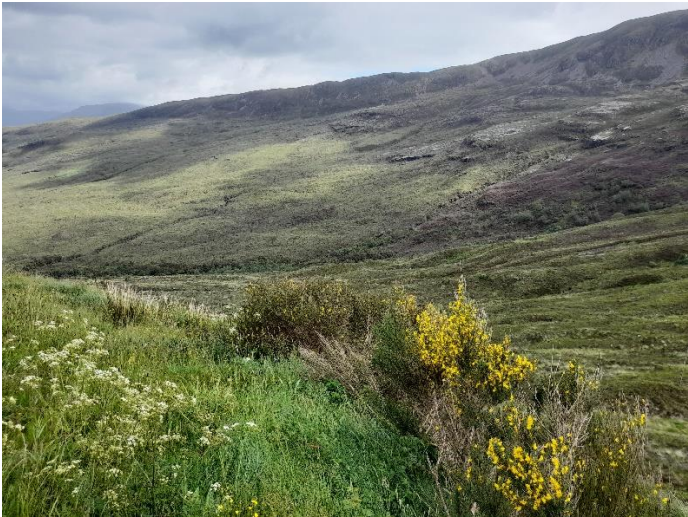
Watercourse Crossing ID	WX5
Watercourse Crossing Details	<p>Watercourse Crossing: WX5 NGR: NG 75434 20417 Watercourse Width: Not recorded Watercourse Depth: Not recorded Notes: Unable to access during survey (as ground conditions were heavily vegetated and safe passage on foot was not possible). Photograph of general area of the crossing is shown below.</p>
Photograph of General Area

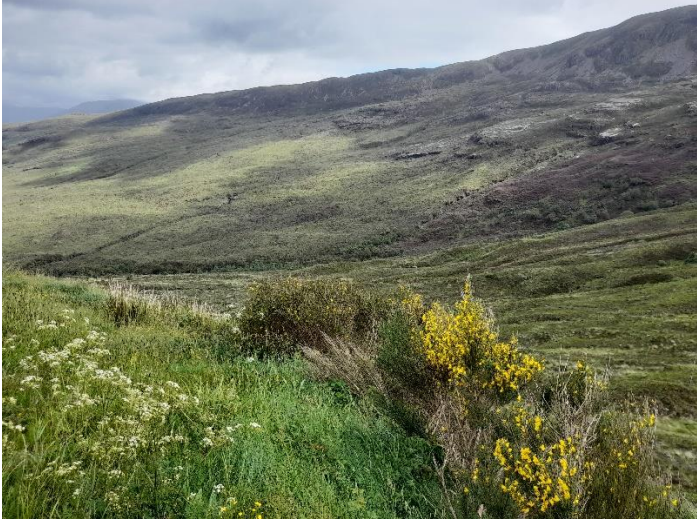
Watercourse Crossing ID	WX6
Watercourse Crossing Details	<p>Watercourse Crossing: WX6 NGR: NG 75479 20339 Watercourse Width: Not recorded Watercourse Depth: Not recorded Notes: Unable to access during survey (as ground conditions were heavily vegetated and safe passage on foot was not possible). Photograph of general area of the crossing is shown below.</p>
Photograph of General Area

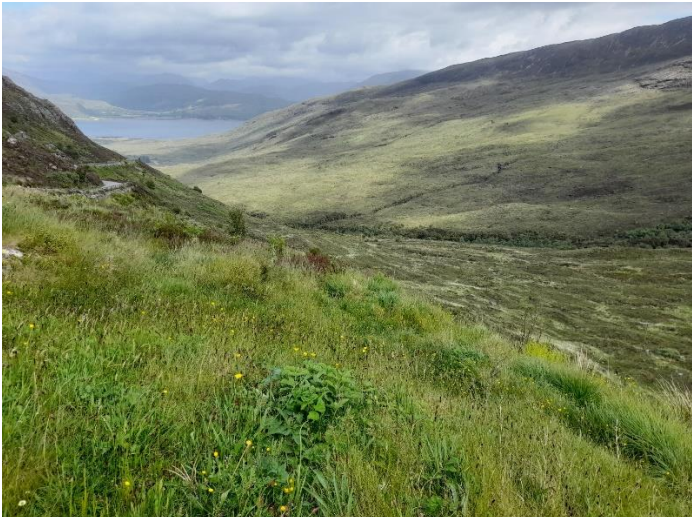
Watercourse Crossing ID	WX7
Watercourse Crossing Details	<p>Watercourse Crossing: WX7 NGR: NG 75525 20345 Watercourse Width: Not recorded Watercourse Depth: Not recorded Notes: Unable to access during survey (as ground conditions were heavily vegetated and safe passage on foot was not possible). Photograph of general area of the crossing is shown below.</p>
Photograph of General Area

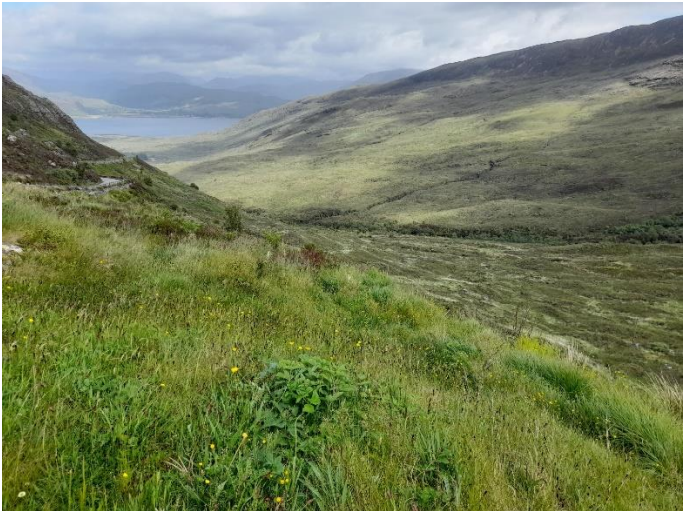
Watercourse Crossing ID	WX8
Watercourse Crossing Details	<p>Watercourse Crossing: WX8 NGR: NG 75521 20425 Watercourse Width: Not recorded Watercourse Depth: Not recorded Notes: Unable to access during survey (as ground conditions were heavily vegetated and safe passage on foot was not possible). Photograph of general area of the crossing is shown below.</p>
Photograph of General Area

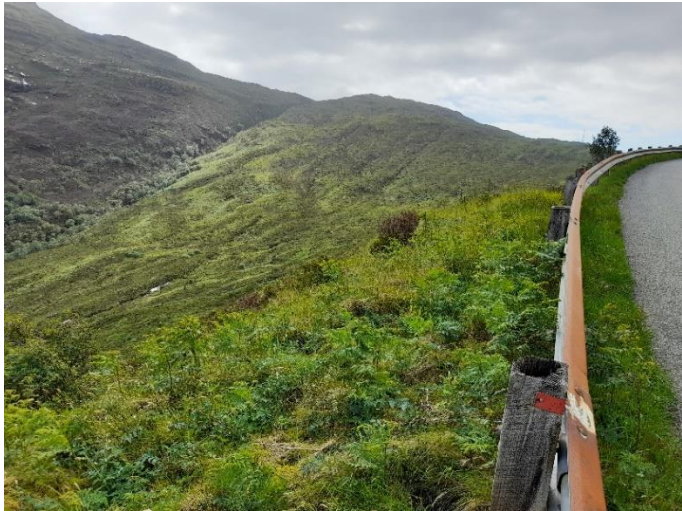
Watercourse Crossing ID	WX9
Watercourse Crossing Details	<p>Watercourse Crossing: WX9 NGR: NG 75795 20548 Watercourse Width: Not recorded Watercourse Depth: Not recorded Notes: Unable to access during survey (as ground conditions were heavily vegetated and safe passage on foot was not possible). Photograph of general area of the crossing is shown below.</p>
Photograph of General Area

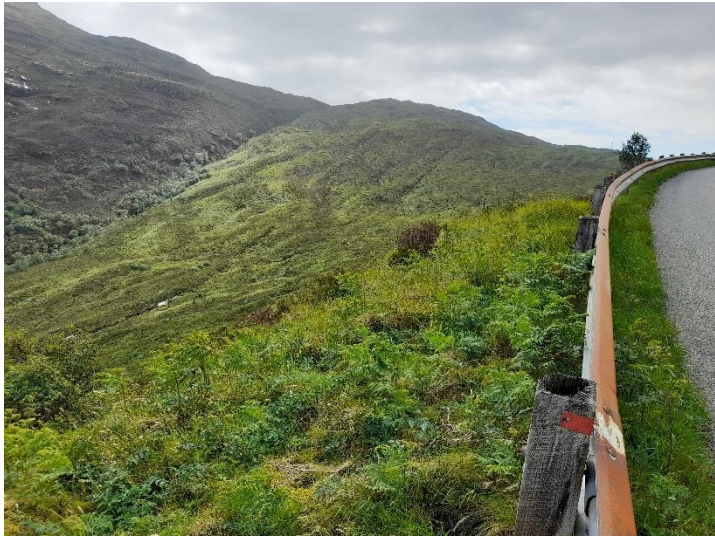
Watercourse Crossing ID	WX10
Watercourse Crossing Details	<p>Watercourse Crossing: WX10 NGR: NG 75827 20506 Watercourse Width: Not recorded Watercourse Depth: Not recorded Notes: Unable to access during survey(as ground conditions were heavily vegetated and safe passage on foot was not possible). Photograph of general area of the crossing is shown below.</p>
Photograph of General Area

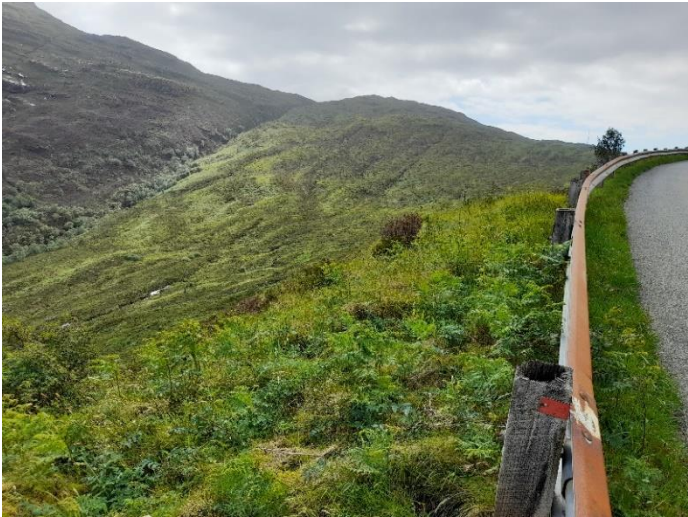
Watercourse Crossing ID	WX11
Watercourse Crossing Details	<p>Watercourse Crossing: WX11 NGR: NG 75867 20470 Watercourse Width: Not recorded Watercourse Depth: Not recorded Notes: Unable to access during survey(as ground conditions were heavily vegetated and safe passage on foot was not possible). Photograph of general area of the crossing is shown below.</p>
Photograph of General Area

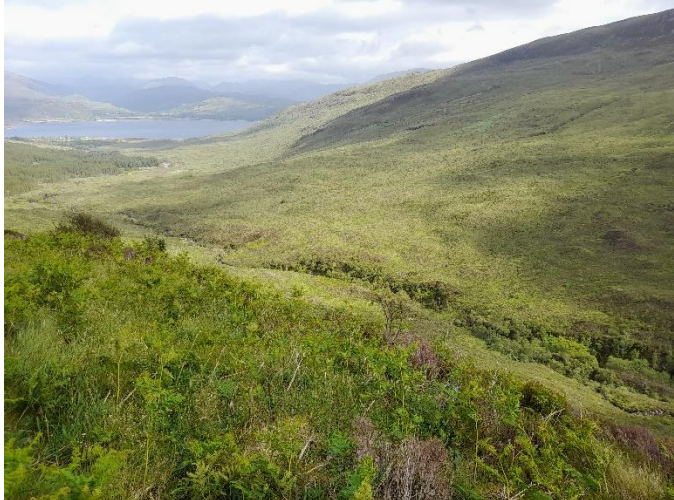
Watercourse Crossing ID	WX12
Watercourse Crossing Details	<p>Watercourse Crossing: WX12 NGR: NG 76655 20577 Watercourse Width: Not recorded Watercourse Depth: Not recorded Notes: Unable to access during survey (as ground conditions were heavily vegetated and safe passage on foot was not possible). Photograph of general area of the crossing is shown below.</p>
Photograph of General Area

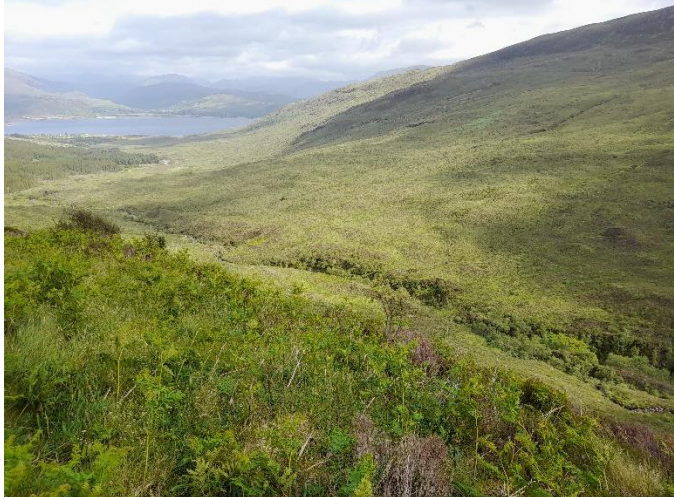
Watercourse Crossing ID	WX13
Watercourse Crossing Details	<p>Watercourse Crossing: WX13 NGR: NG 77295 20317 Watercourse Width: Not recorded Watercourse Depth: Not recorded Notes: Unable to access during survey (as ground conditions were heavily vegetated and safe passage on foot was not possible). Photograph of general area of the crossing is shown below.</p>
Photograph of General Area

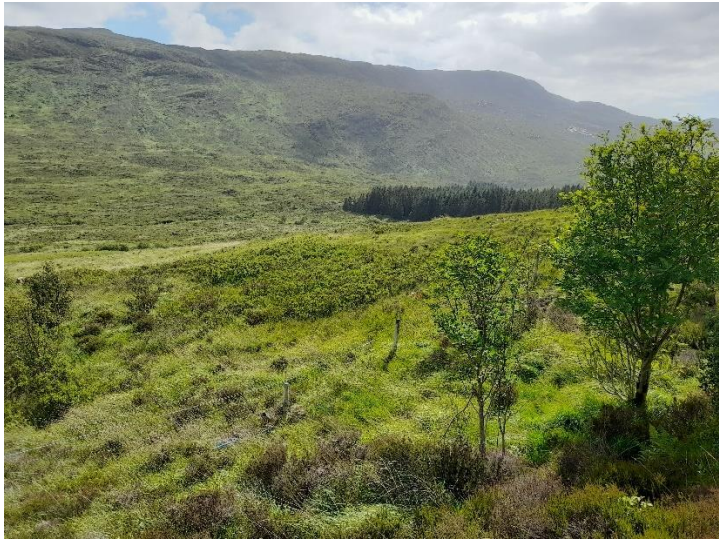
Watercourse Crossing ID	WX14
Watercourse Crossing Details	<p>Watercourse Crossing: WX14 NGR: NG 77763 20421 Watercourse Width: Not recorded Watercourse Depth: Not recorded Notes: Unable to access during survey (as ground conditions were heavily vegetated and safe passage on foot was not possible). Photograph of general area of the crossing is shown below.</p>
Photograph of General Area

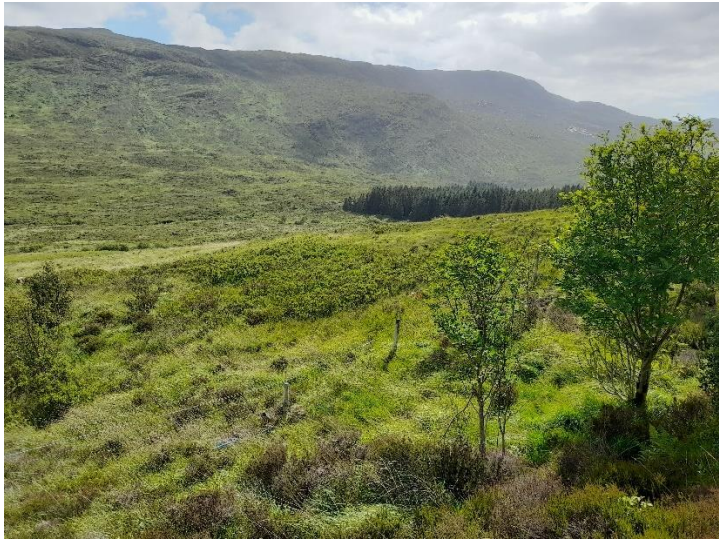
Watercourse Crossing ID	WX15
Watercourse Crossing Details	<p>Watercourse Crossing: WX15 NGR: NG 77819 20474 Watercourse Width: Not recorded Watercourse Depth: Not recorded Notes: Unable to access during survey (as ground conditions were heavily vegetated and safe passage on foot was not possible). Photograph of general area of the crossing is shown below.</p>
Photograph of General Area

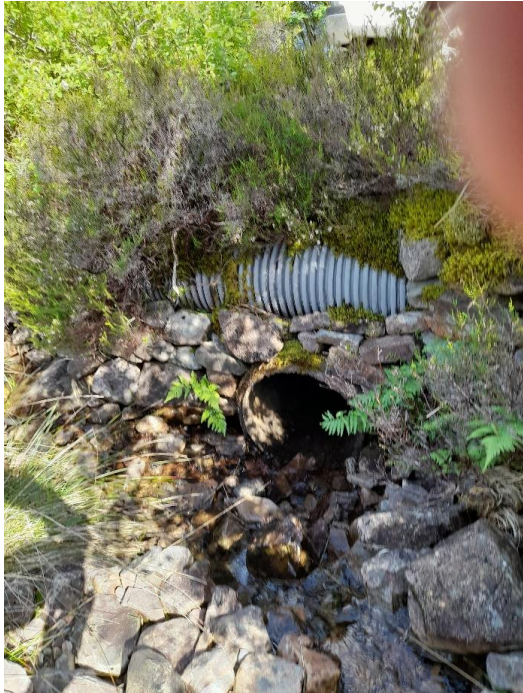
Watercourse Crossing ID	WX16
Watercourse Crossing Details	<p>Watercourse Crossing: WX16 NGR: NG 78581 20927 Watercourse Width: 0.5 m Watercourse Depth: 0.5 m Notes: Watercourse culverted under existing track by a concrete circular culvert which is 0.45 m in diameter. Culvert was clear and no obstruction was noted.</p>
Photograph Looking at Culvert Entrance from Upstream

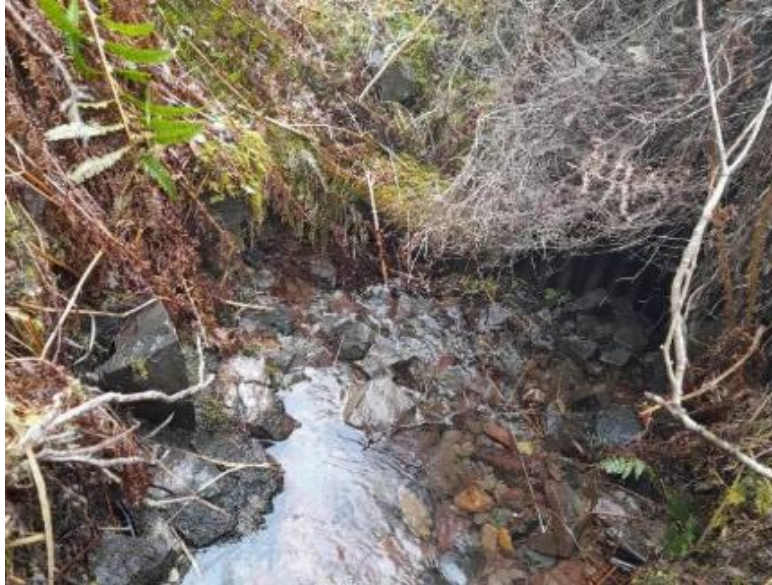
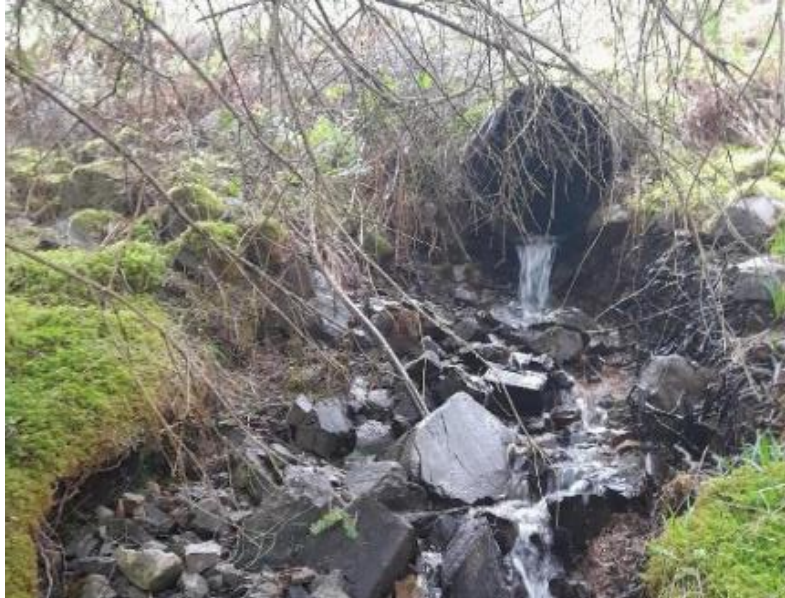
Watercourse Crossing ID	WX17
Watercourse Crossing Details	<p>Watercourse Crossing: WX17 NGR: NG 78677 21465 Status: Existing Culvert Diameter: 0.8m Culvert Construction Type: circular corrugated metal culvert Watercourse Width: 0.4m Watercourse Depth: 0.3-1m Notes: Channel deeper downstream of the culvert which is partially misshapen at the outfall.</p>
Photograph Looking at Culvert Entrance from Upstream

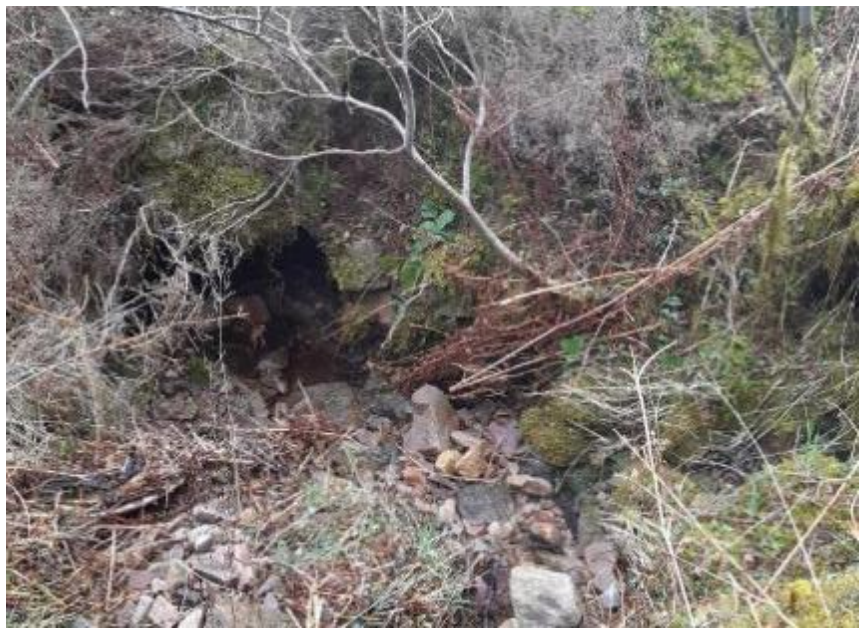
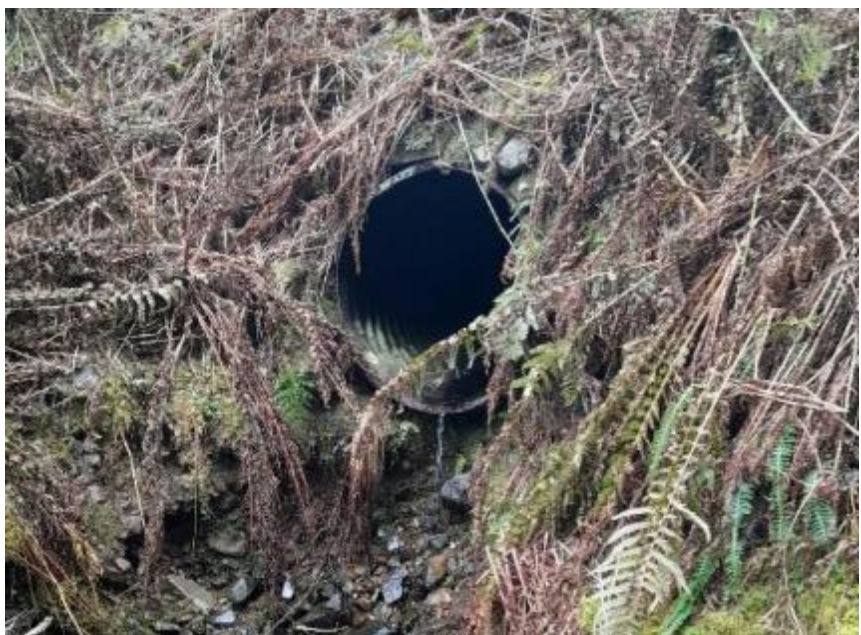
Watercourse Crossing ID	WX18
Watercourse Crossing Details	<p>Watercourse Crossing: WX18 NGR: NG 78665 21765 Status: Existing Culvert Diameter: 0.8m Culvert Construction Type: circular corrugated metal culvert Watercourse Width: 0.3-1.5m Watercourse Depth: 0.1-0.3m Notes: Channel significantly narrower upstream (0.3m) and much wider downstream (1.5m), dry on the date of the survey (March 2022).</p>
Photograph Looking at Culvert Entrance from Upstream

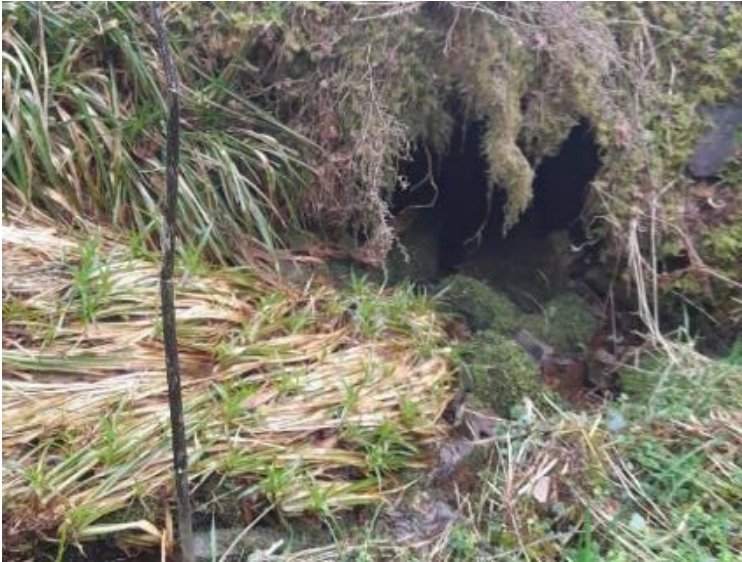
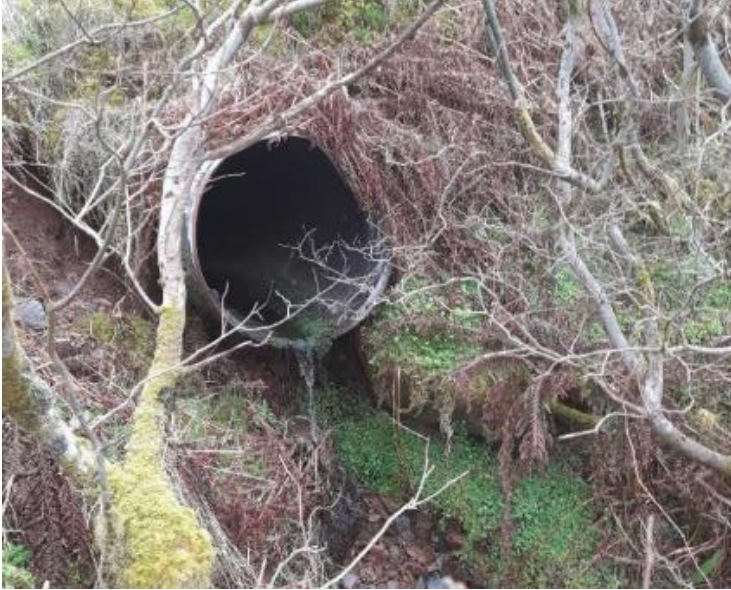
Watercourse Crossing ID	WX19
Watercourse Crossing Details	<p>Watercourse Crossing: WX19 NGR: NG 78681 21851 Status: Existing Culvert Diameter: 0.3m Culvert Construction Type: circular corrugated metal Watercourse Width: 0.2-0.4m Watercourse Depth: 0.1m Notes: Active channel is within a larger channel which is 1.5m deep. Downstream outfall culvert has slightly corroded with moss present along the base.</p>
Photograph Looking at Culvert Entrance from Upstream

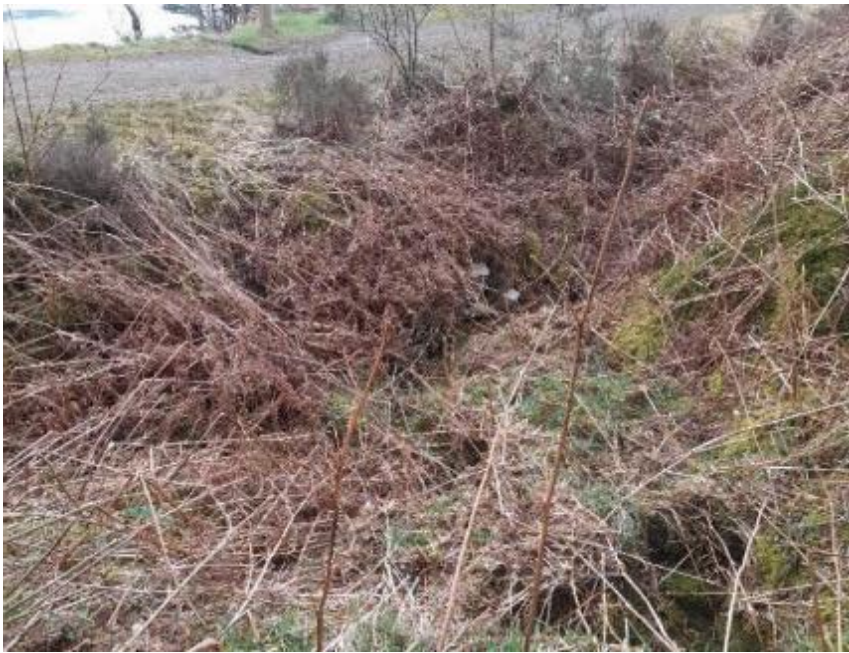
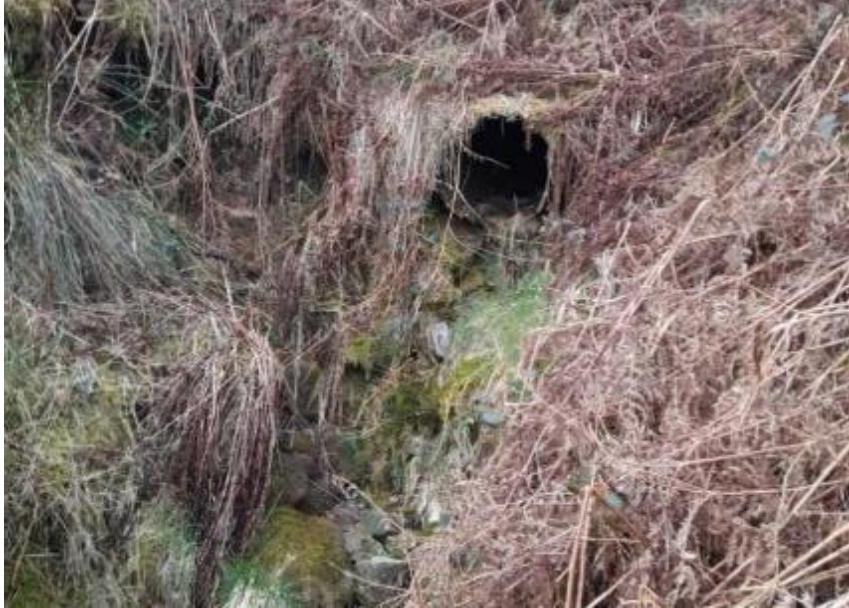
Watercourse Crossing ID		WX20
Watercourse Details	Crossing	<p>Watercourse Crossing: WX20 NGR: NG 78696 21970 Status: Existing Culvert Diameter: 0.3m Culvert Construction Type: circular corrugated metal culvert Watercourse Width: 0.1m Watercourse Depth: 0.1m Notes: Active channel is within larger channel which is up to 1m wide and 1.5m deep. Dry channel during survey (March 2022) with upstream of the culvert heavily reeded/vegetated. Downstream end of culvert is corroded at the base.</p>
Photograph Looking at Culvert Entrance from Upstream

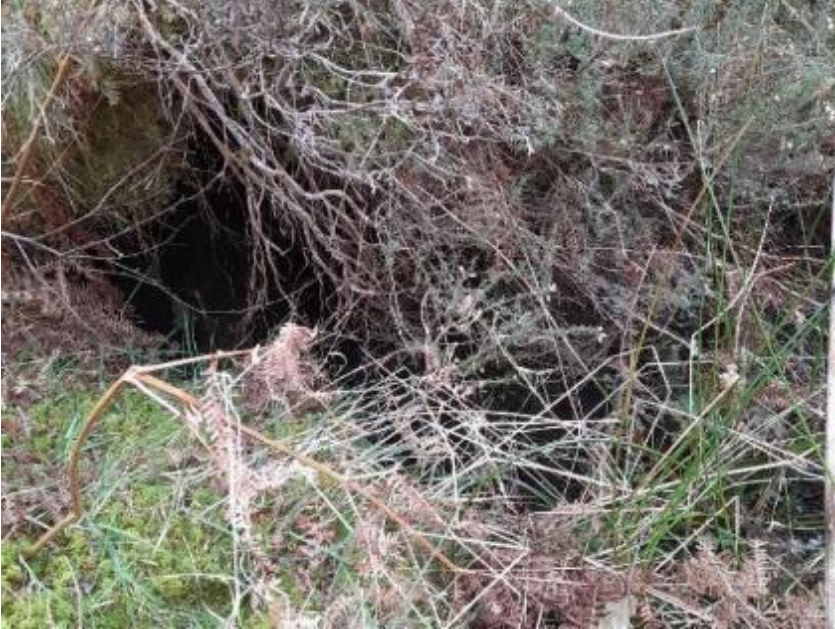
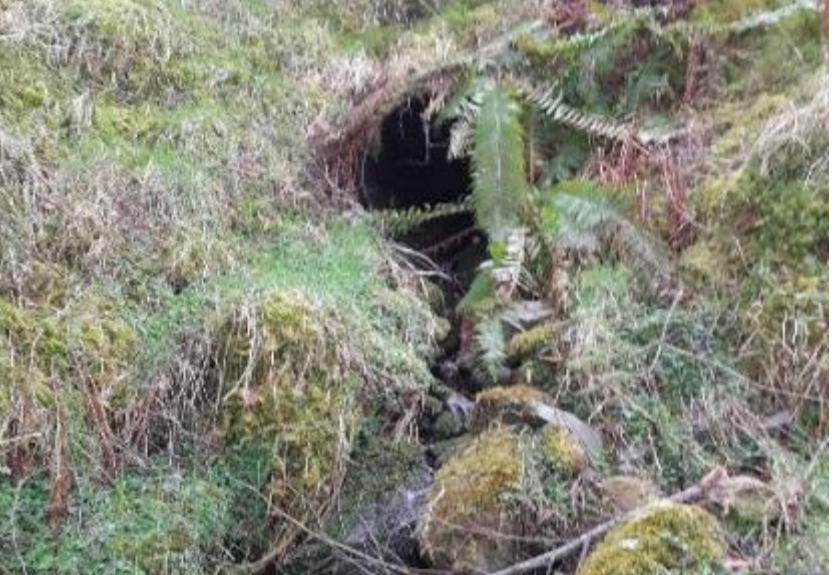
Watercourse Crossing ID	WX21
Watercourse Crossing Details	<p>Watercourse Crossing: WX21 NGR: NG 78690 22071 Status: Existing Culvert Diameter: 0.4m Culvert Construction Type: circular corrugated metal culvert Watercourse Width: 0.2m Watercourse Depth: 0.1m Notes: Active channel is within a wider channel which is 0.7m wide and 0.5m high.</p>
Photograph Looking at Culvert Entrance from Upstream

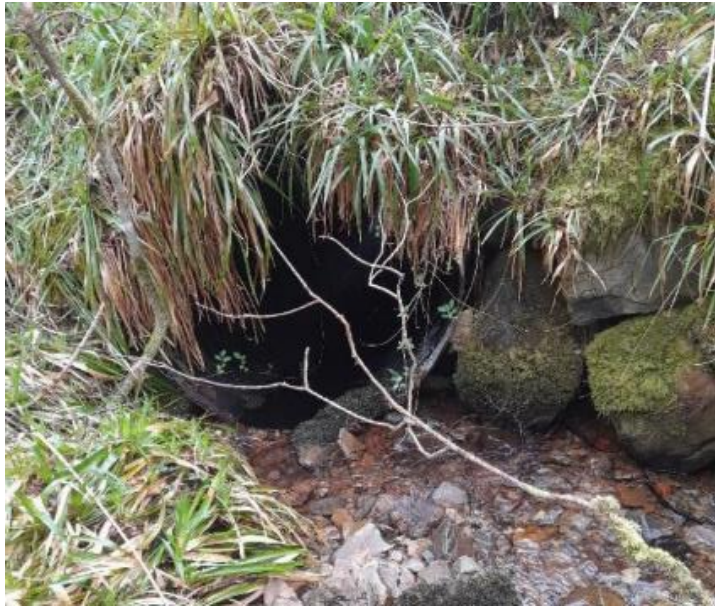
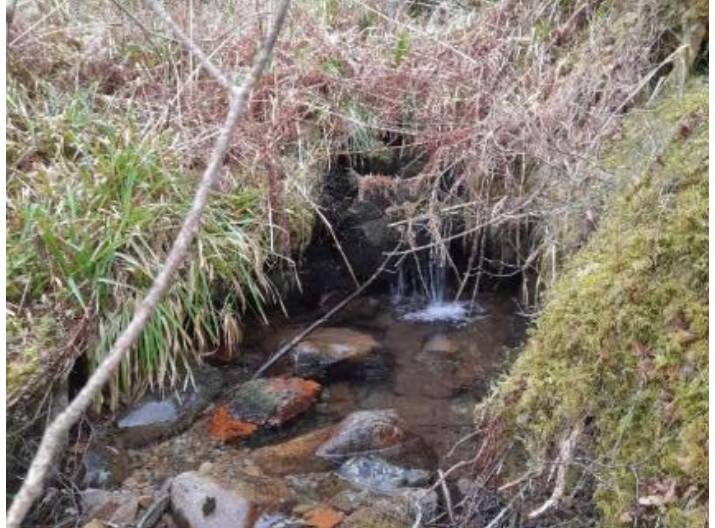
Watercourse Crossing ID	WX22
Watercourse Crossing Details	<p>Watercourse Crossing: WX22 NGR: NG 78657 22171 Status: Existing Culvert Diameter: 1m Culvert Construction Type: circular corrugated metal culvert Watercourse Width: 1-3m Watercourse Depth: 0.3m Notes: Upstream channel is around 1m wide but downstream the cross section is less uniform extending to 1 - 3m width. Active watercourse in a larger 2m deep channel.</p>
Photograph Looking at Culvert Entrance from Upstream

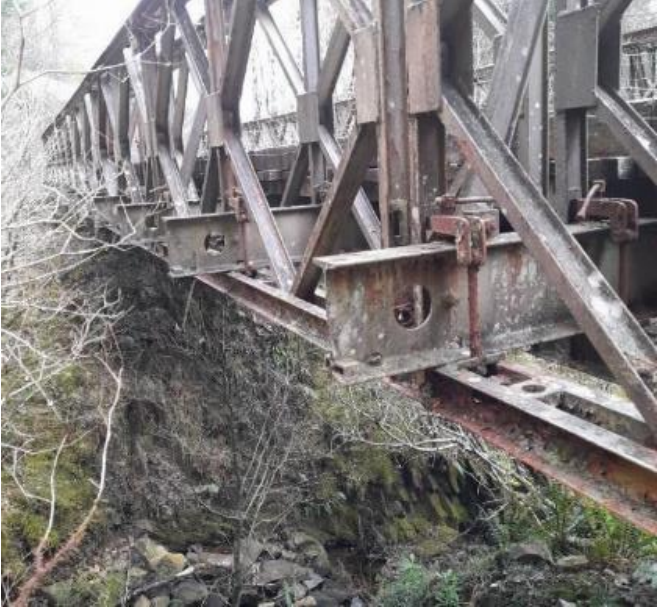
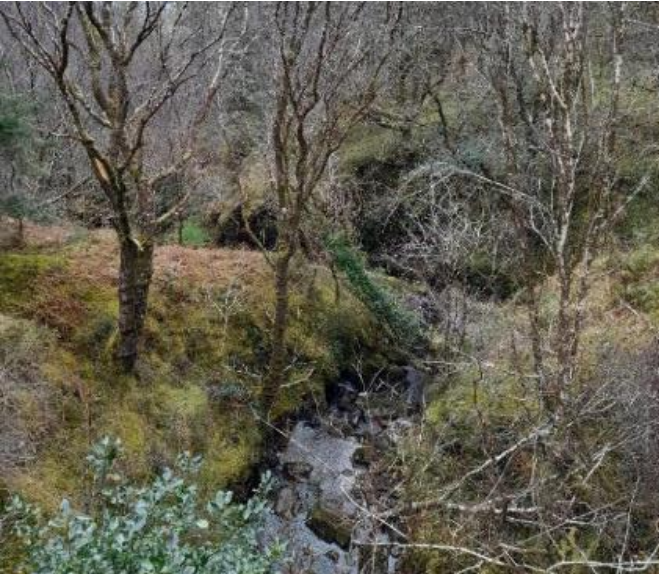
Watercourse Crossing ID	WX24
Watercourse Crossing Details	<p>Watercourse Crossing: WX24 NGR: NG 78665 22360 Status: Existing Bridge Width: 20m Culvert Construction Type: open span bridge with steel frame and wooden slats Watercourse Width: 5m Watercourse Depth: 10-15m Notes: Fast flowing channel incised into bedrock.</p>
Photograph Looking at Bridge from Upstream

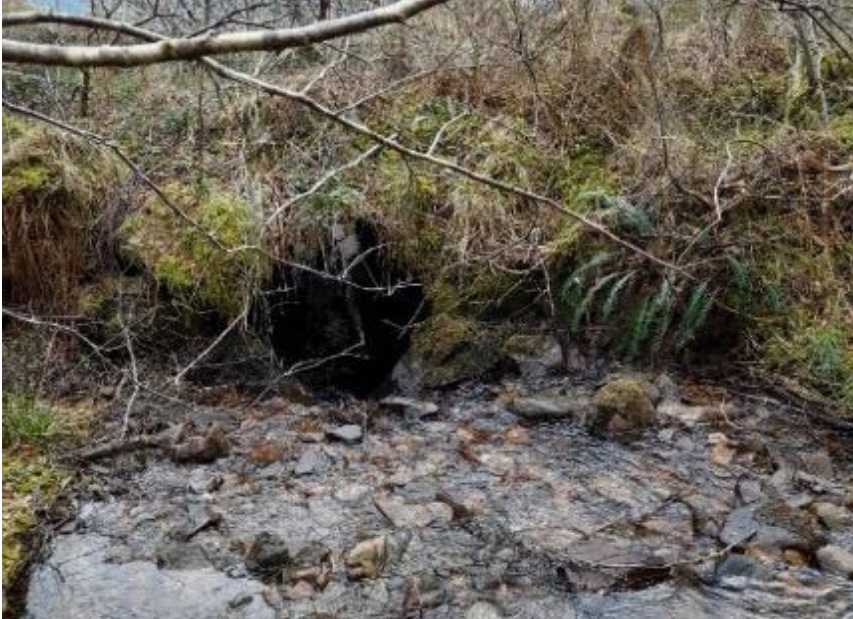
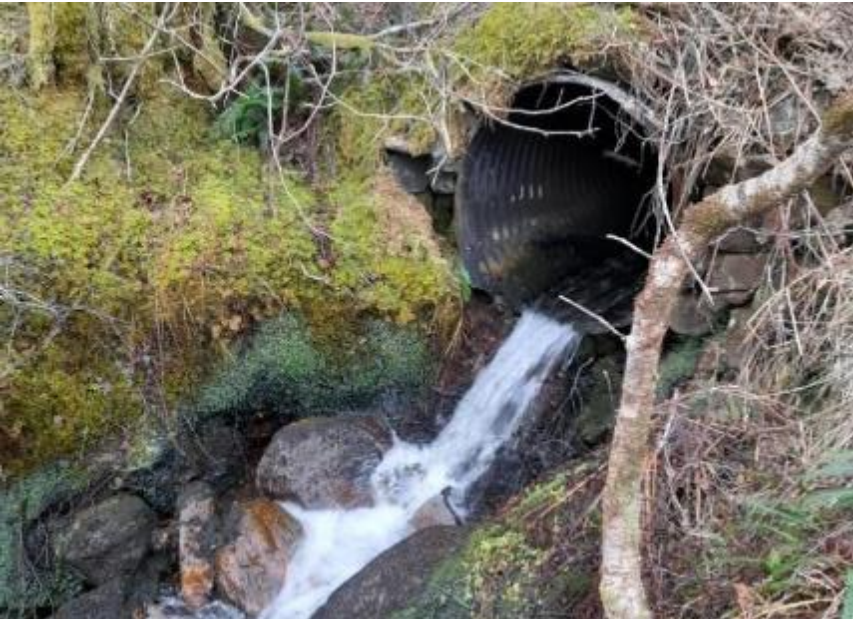
Watercourse Crossing ID	WX25
Watercourse Crossing Details	<p>Watercourse Crossing: WX25 NGR: NG 78778 22514 Status: Existing Culvert Diameter: 0.6m Culvert Construction Type: circular corrugated metal culvert Watercourse Width: 0.5-1.5m Watercourse Depth: 0.4m Notes: Channel becomes more incised into bedrock downstream to form a channel depth of 3m.</p>
Photograph Looking at Culvert Entrance from Upstream

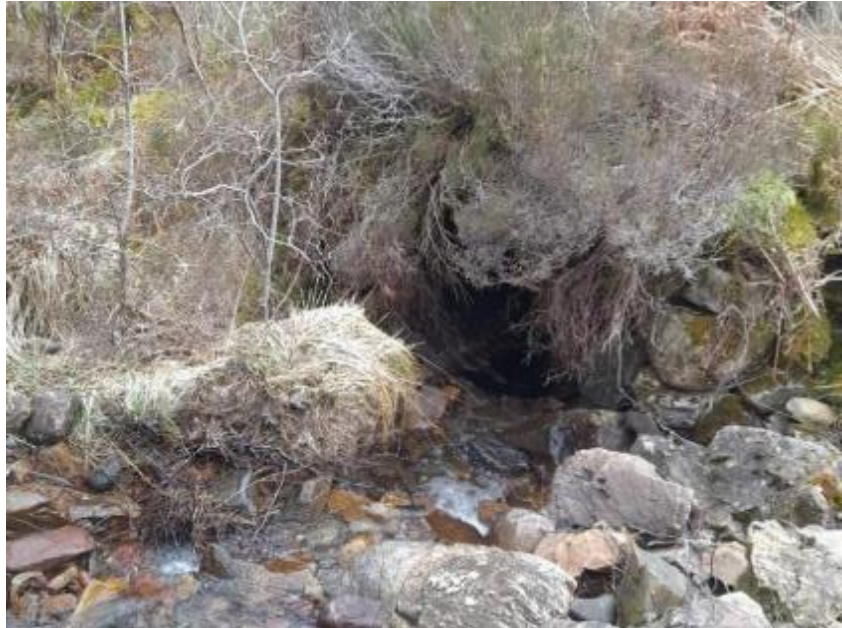
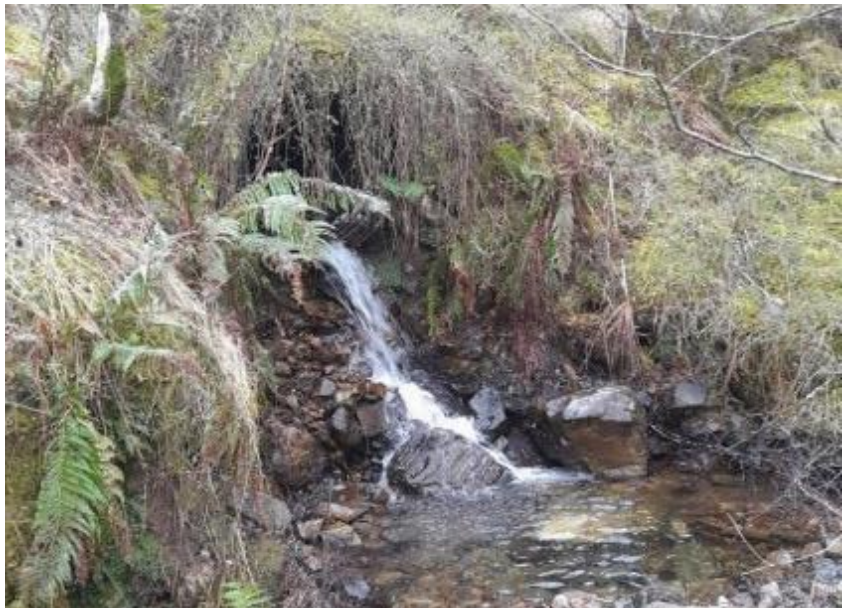
Watercourse Crossing ID	WX26
Watercourse Crossing Details	<p>Watercourse Crossing: WX26 NGR: NG 78860 22636 Status: Existing Culvert Diameter: 1m Culvert Construction Type: circular corrugated metal Watercourse Width: 2-3m Watercourse Depth: 0.3m Notes: Upstream catchment is steep with waterfall.</p>
Photograph Looking at Culvert Entrance from Upstream

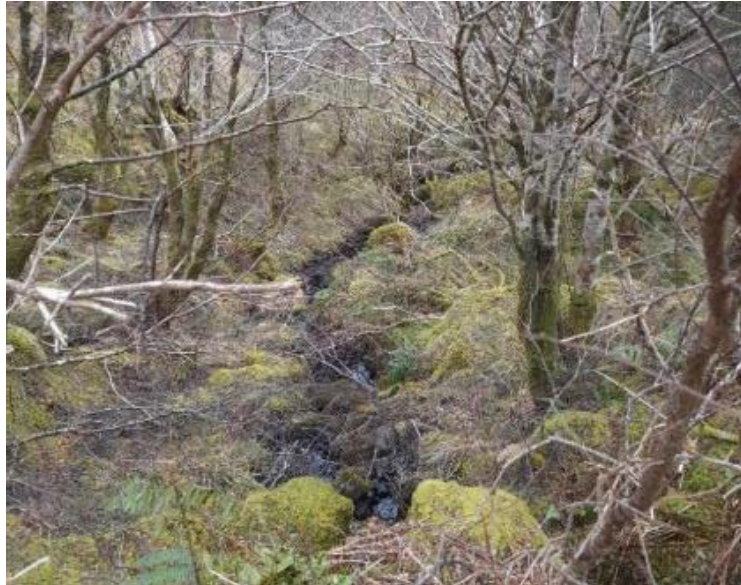
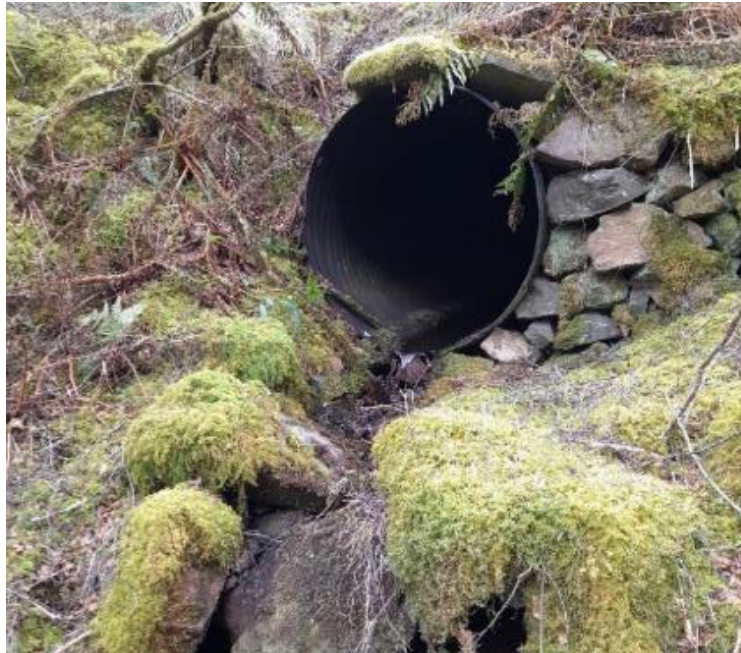
Watercourse Crossing ID	WX27
Watercourse Crossing Details	<p>Watercourse Crossing: WX27 NGR: NG 78874 22689 Status: Existing Culvert Diameter: 1m Culvert Construction Type: circular corrugated metal culvert Watercourse Width: 0.3m Watercourse Depth: 0.1m Notes: Two small channels join upstream of the culvert.</p>
Photograph Looking Upstream from Upstream

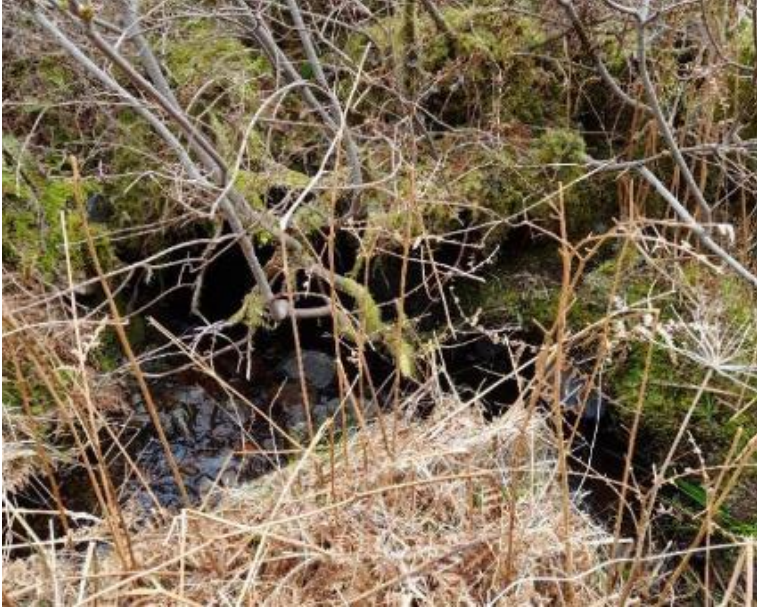
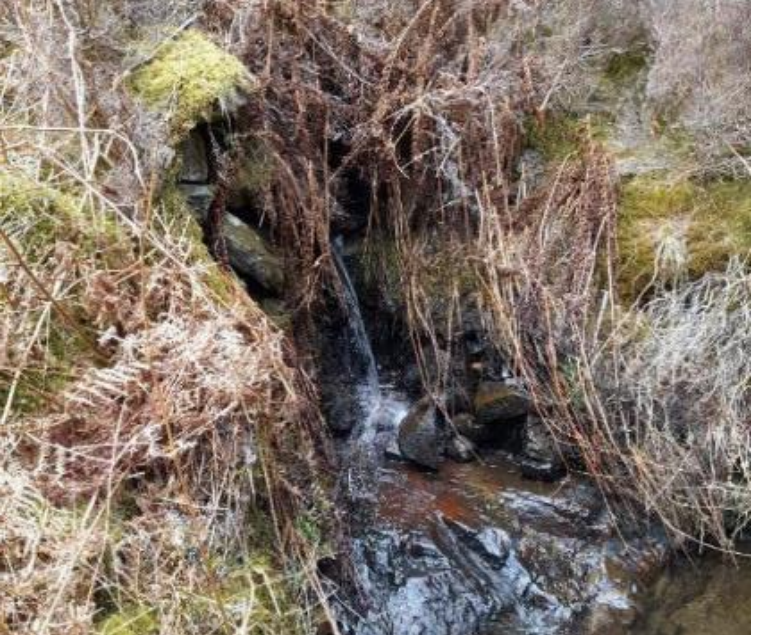
Watercourse Crossing ID	WX28
Watercourse Crossing Details	<p>Watercourse Crossing: WX28 NGR: NG 79031 22919 Status: Existing Culvert Diameter: 0.4m Culvert Construction Type: circular corrugated metal culvert Watercourse Width: 0.1m Watercourse Depth: 0.2m Notes: Two small 0.1m x 0.2m channels join at the crossing, incised into peat/soil.</p>
Photograph Looking at Culvert Entrance from Upstream

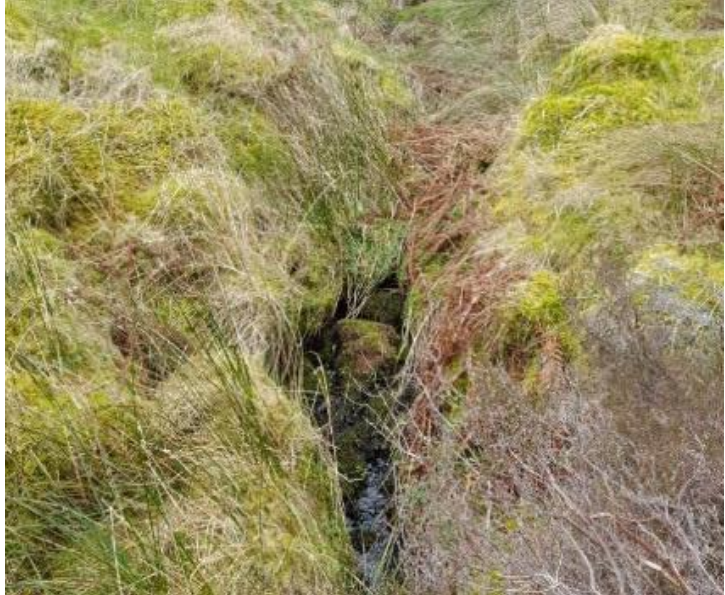
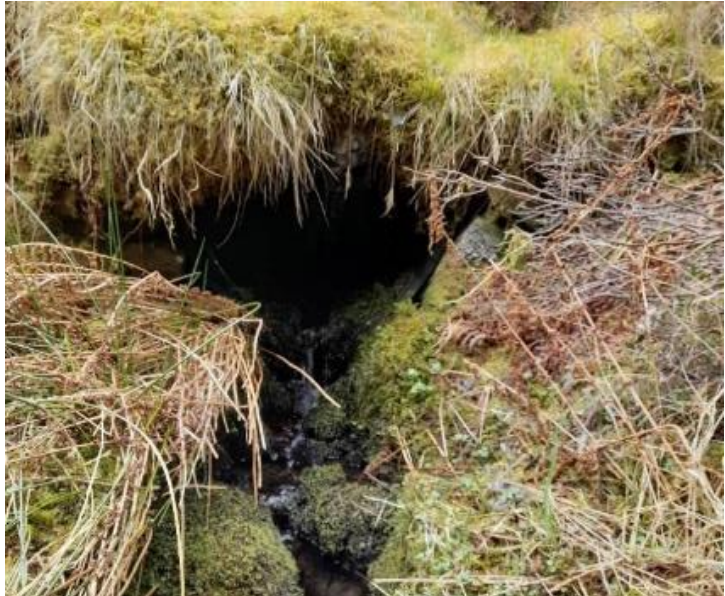
Watercourse Crossing ID	WX29
Watercourse Crossing Details	<p>Watercourse Crossing: WX29 NGR: NG 79156 23144 Status: Existing Culvert Diameter: 0.4m Culvert Construction Type: circular plastic culvert Watercourse Width: 0.2m Watercourse Depth: 0.2m Notes: Channel is incised into peat, culvert is slightly deformed downstream.</p>
Photograph Looking at Culvert Entrance from Upstream
