Strathy South Wind Farm Grid Connection

Volume 4: Appendix V1-9.3: Schedule of Watercourse Crossings

5 February 2025

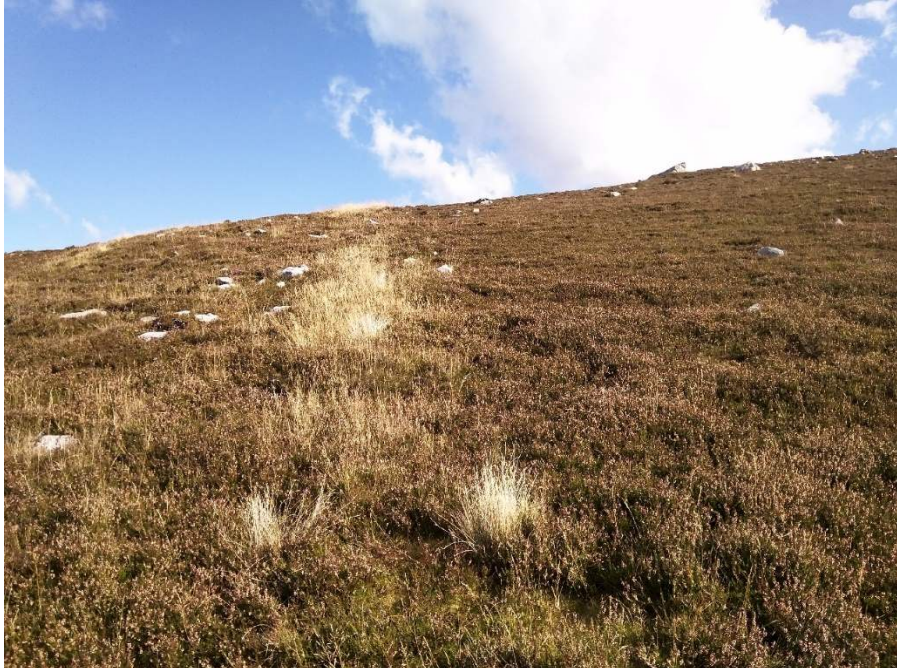
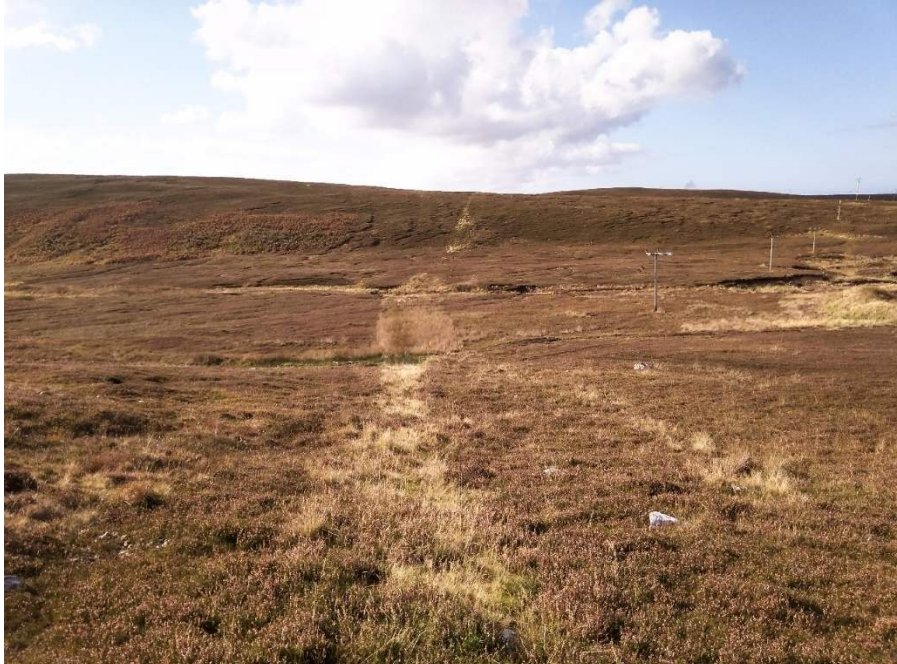
Watercourse Crossing ID	WX05
Watercourse Crossing Details	<p>NGR: NC 87150 64860</p> <p>Status: New Permanent Crossing</p> <p>Watercourse Width: N/A</p> <p>Watercourse Depth: N/A</p> <p>Notes: No watercourse recorded during survey. Change in vegetation is noted to be approximately 1 m wide. Potential buried drain or culvert.</p>
Photograph Looking Upstream

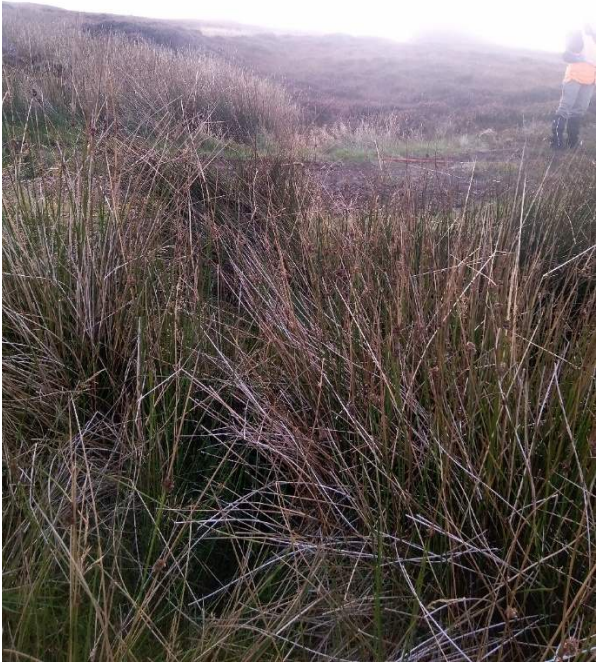
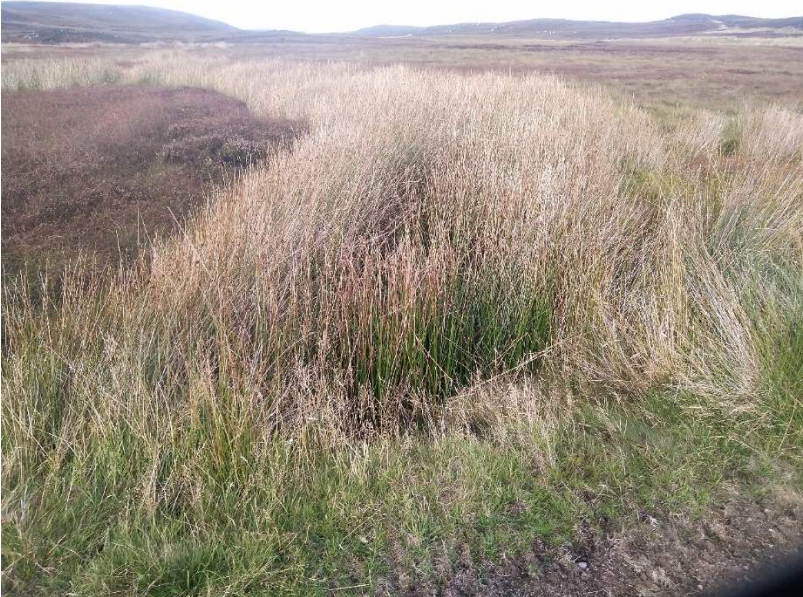
Watercourse Crossing ID	WX06
Watercourse Crossing Details	<p>NGR: NC 87134 63528</p> <p>Status: Existing Crossing</p> <p>Watercourse Width: 1.5 m</p> <p>Watercourse Depth: 0.2 m</p> <p>Notes: Watercourse slightly wider on downstream side of channel compared to upstream. Channel is heavily vegetated. Unable to survey existing culvert due to vegetation.</p>
Photograph Looking Upstream

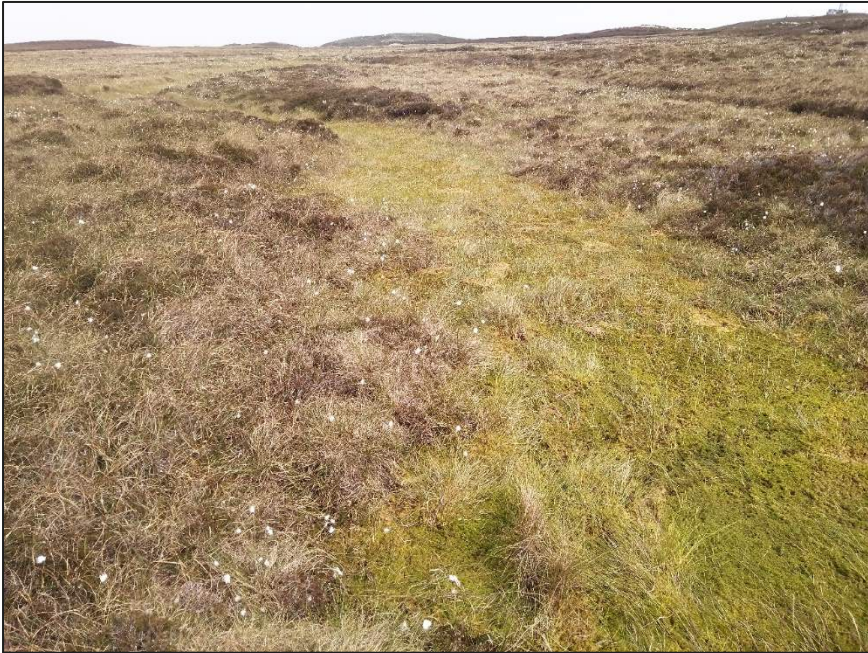
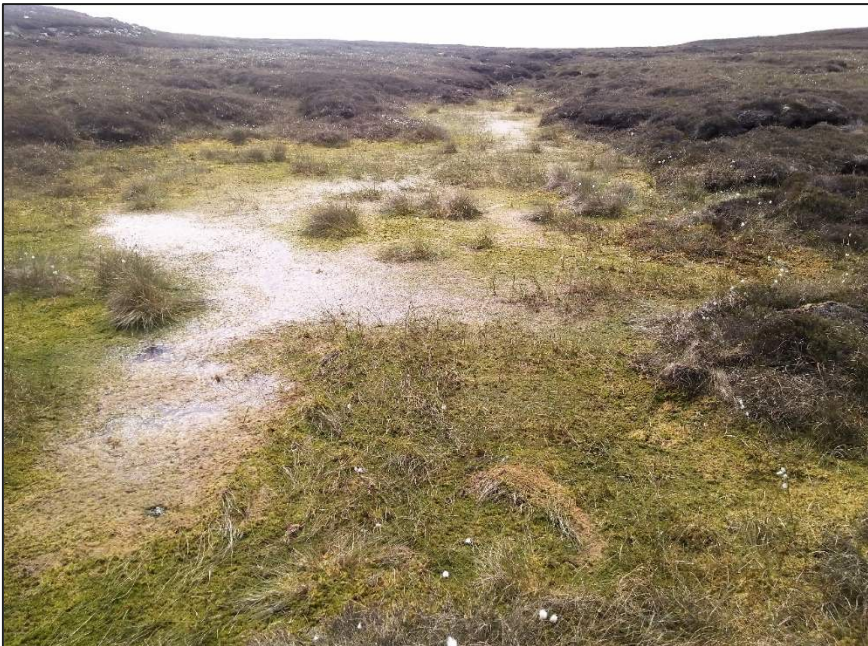
Watercourse Crossing ID	WX07
Watercourse Crossing Details	<p>NGR: NC 87674 63527</p> <p>Status: New Permanent Crossing</p> <p>Watercourse Width: N/A</p> <p>Watercourse Depth: N/A</p> <p>Notes: No active watercourse noted during survey, however, a waterlogged area up to 4m wide and 0.5m deep is recorded.</p>
Photograph Looking Upstream

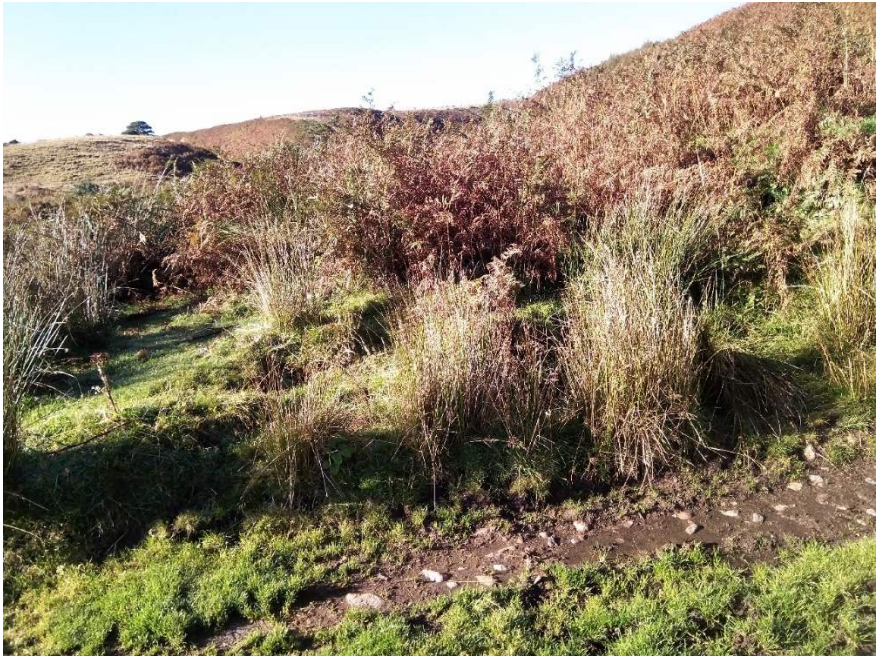
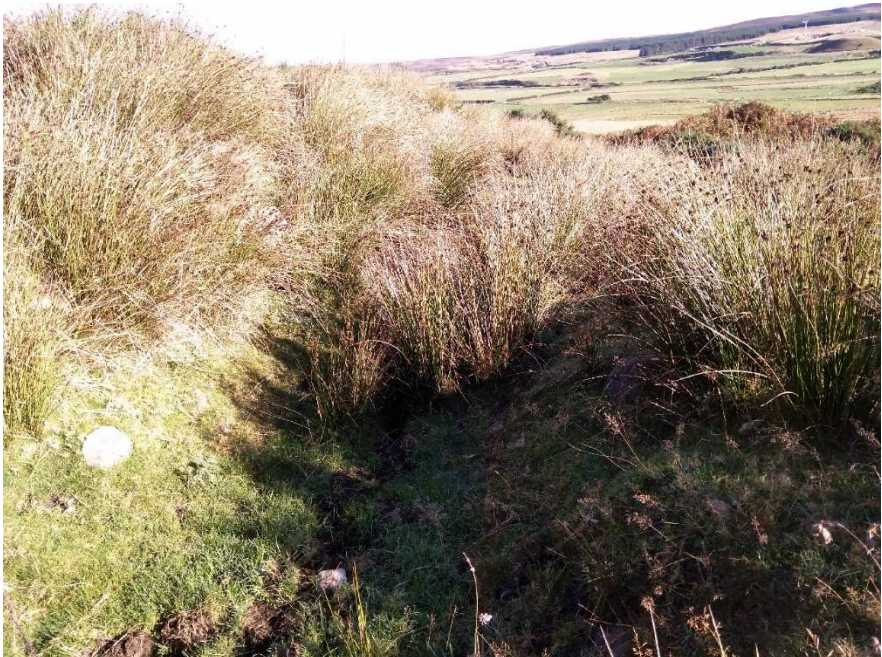
Watercourse Crossing ID	WX08
Watercourse Crossing Details	<p>NGR: NC 88804 61979</p> <p>Status: Existing Crossing</p> <p>Watercourse Width: N/A</p> <p>Watercourse Depth: N/A</p> <p>Notes: Waterlogged area with no active watercourse or flowing water. In a wider channel which is 1.5m wide and 1m deep downstream of crossing. No formal drainage features (culvert etc) noted.</p>
Photograph Looking Upstream

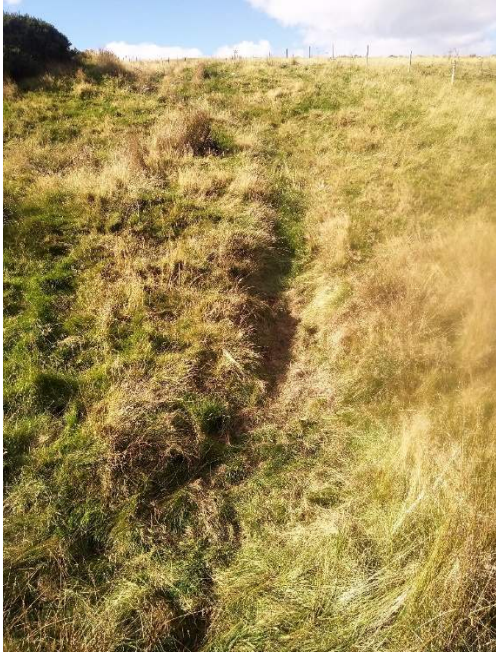
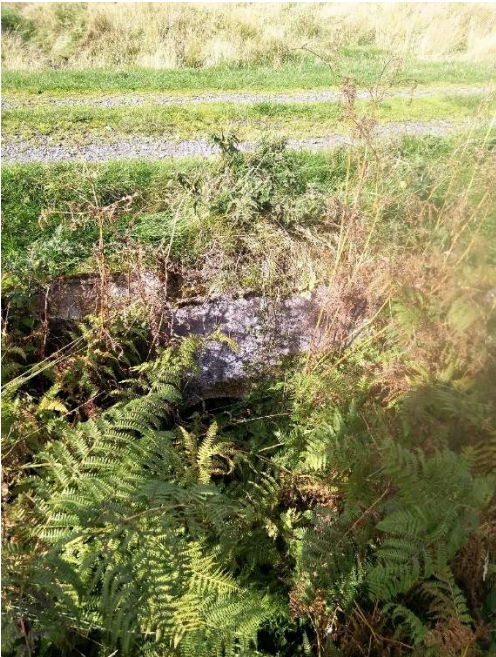
Watercourse Crossing ID	WX11
Watercourse Crossing Details	<p>NGR: NC 88749 61425</p> <p>Status: Existing Crossing</p> <p>Crossing Type: Corrugated metal circular culvert.</p> <p>Crossing Dimensions: 0.5m diameter.</p> <p>Watercourse Width: N/A</p> <p>Watercourse Depth: N/A</p> <p>Notes: No active watercourse recorded during survey. Culvert entrance and exit is heavily vegetated. Culvert is reinforced with stone headwall.</p>
Photograph from Upstream

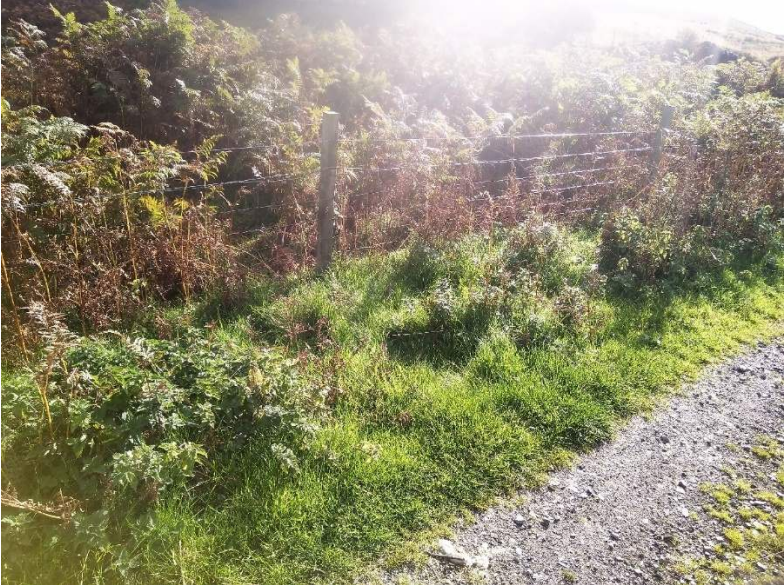
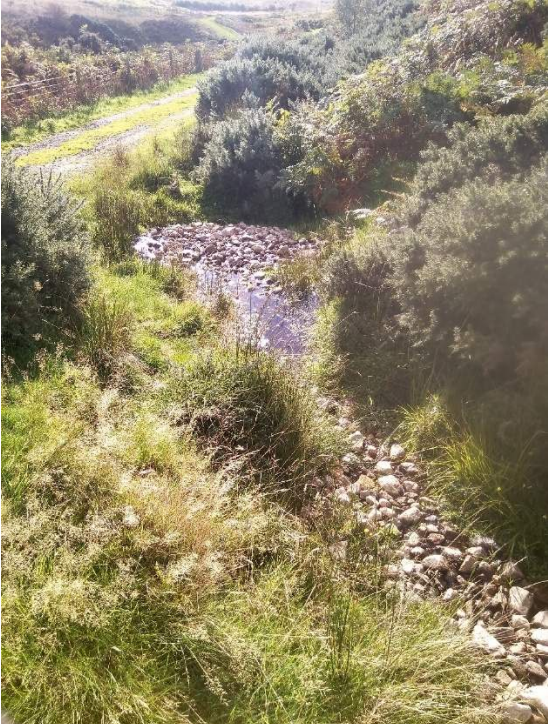
Watercourse Crossing ID	WX12
Watercourse Crossing Details	<p>NGR: NC 88722 61385</p> <p>Status: Existing Crossing</p> <p>Watercourse Width: 0.5m</p> <p>Watercourse Depth: 0.2m</p> <p>Notes: Watercourse is located in a channel which is up to 2m wide downstream of crossing point. No obvious watercourse upstream of the crossing point. No evidence of existing drainage at crossing location (culvert etc), however crossing point and upstream of crossing was overgrown during survey.</p>
Photograph Looking Upstream

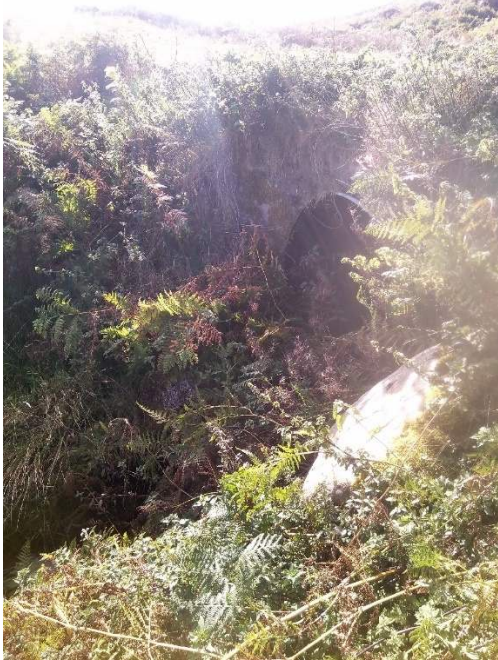
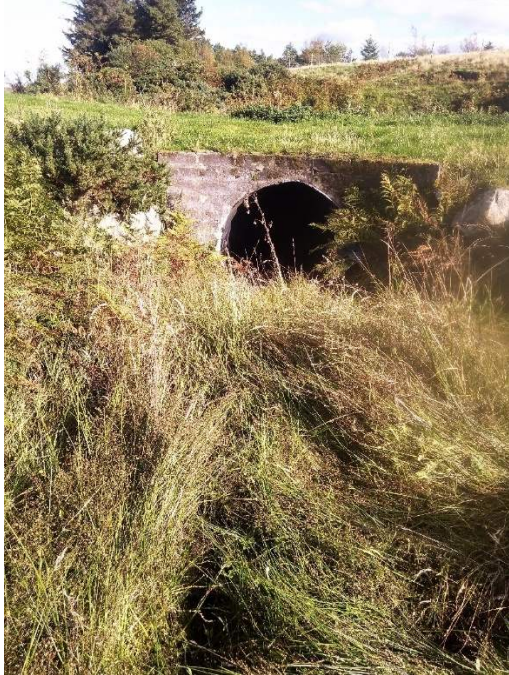
Watercourse Crossing ID	WX13
Watercourse Crossing Details	<p>NGR: NC 88661 61252</p> <p>Status: Existing Crossing</p> <p>Crossing Type: Corrugated metal circular culvert.</p> <p>Crossing Dimensions: 1.7m diameter.</p> <p>Watercourse Width: 1.4m</p> <p>Watercourse Depth: 0.3m</p> <p>Notes: Channel upstream of culvert was overgrown. Culvert reinforced with stone headwall.</p>
Photograph Looking at Culvert Entrance from Upstream

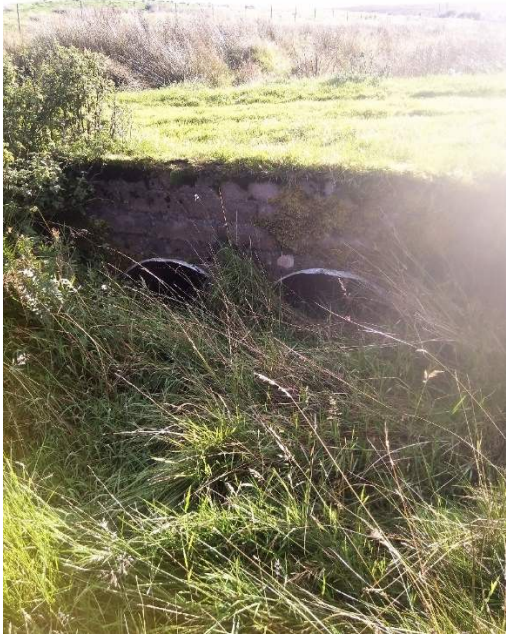
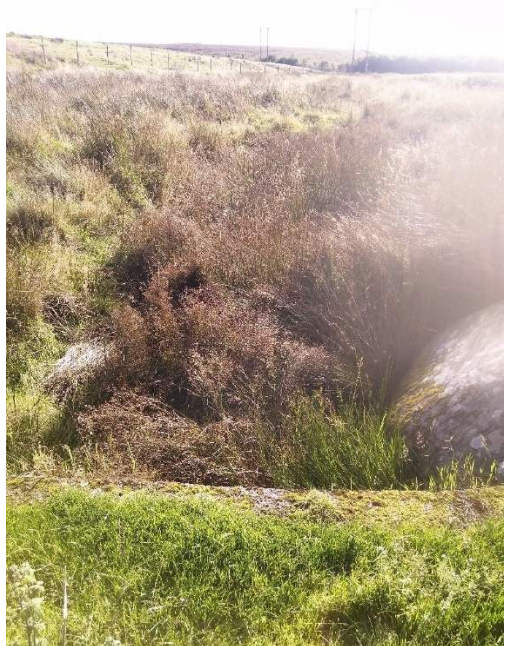
Watercourse Crossing ID	WX14
Watercourse Crossing Details	<p>NGR: NC 88603 61124</p> <p>Status: Existing Crossing</p> <p>Crossing Type: Twin circular culvert.</p> <p>Crossing Dimensions: 0.8m diameter.</p> <p>Watercourse Width: 0.1m</p> <p>Watercourse Depth: 0.2m</p> <p>Notes: Watercourse located in a channel which is up to 2m wide. Culverts reinforced with a stone headwall.</p>
Photograph Looking at Culvert Entrance from Upstream

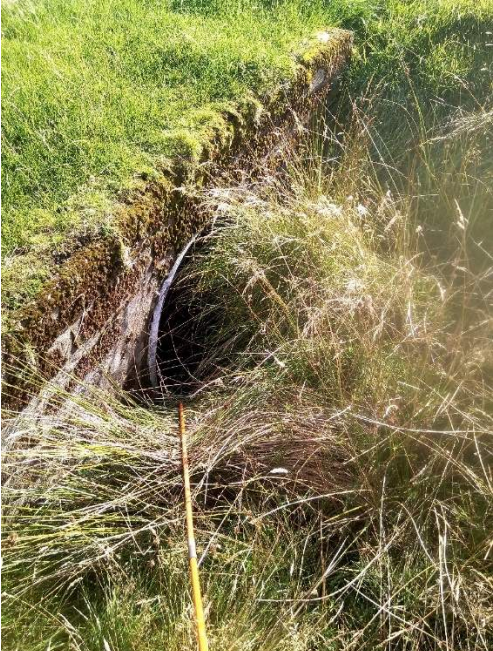
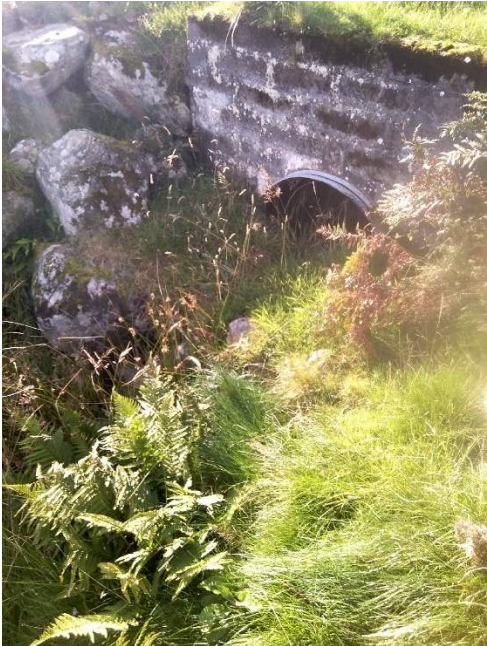
Watercourse Crossing ID	WX15
Watercourse Crossing Details	<p>NGR: NC 88465 60965</p> <p>Status: Existing Crossing</p> <p>Crossing Type: Corrugated circular culvert.</p> <p>Crossing Dimensions: 1m diameter.</p> <p>Watercourse Width: 1.5m</p> <p>Watercourse Depth: 0.3m</p> <p>Notes: None.</p>
Photograph Looking at Culvert Entrance from Upstream

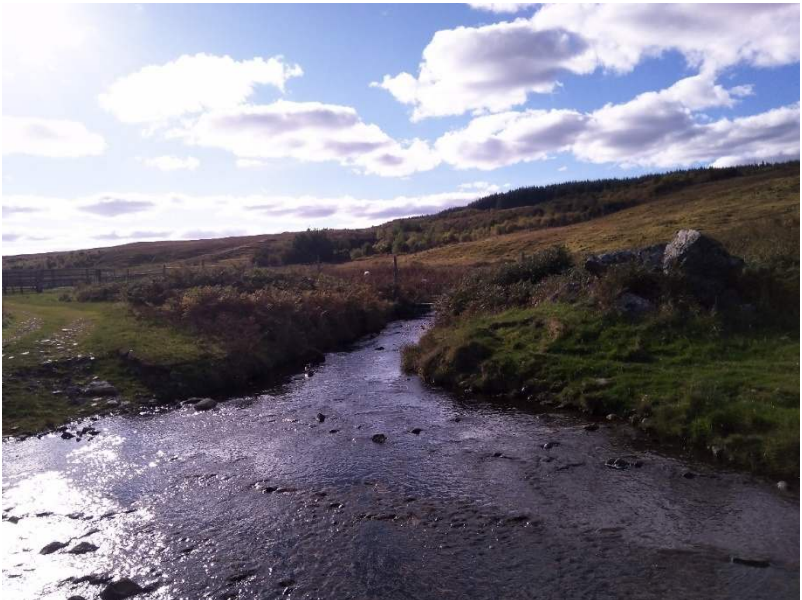
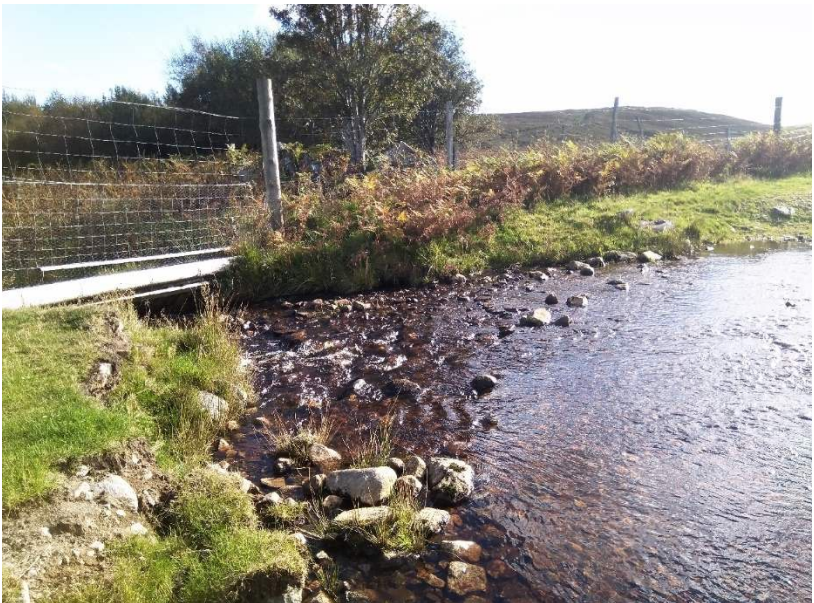
Watercourse Crossing ID	WX16
Watercourse Crossing Details	<p>NGR: NC 88457 60867</p> <p>Status: Existing Crossing</p> <p>Crossing Type: Ford</p> <p>Watercourse Width: 2m</p> <p>Watercourse Depth: 0.4m</p> <p>Notes: Watercourse increases to approximately 6m wide at crossing. Ford crossing is same width of existing track (approximately 3m).</p>
Photograph Looking at Crossing from Upstream

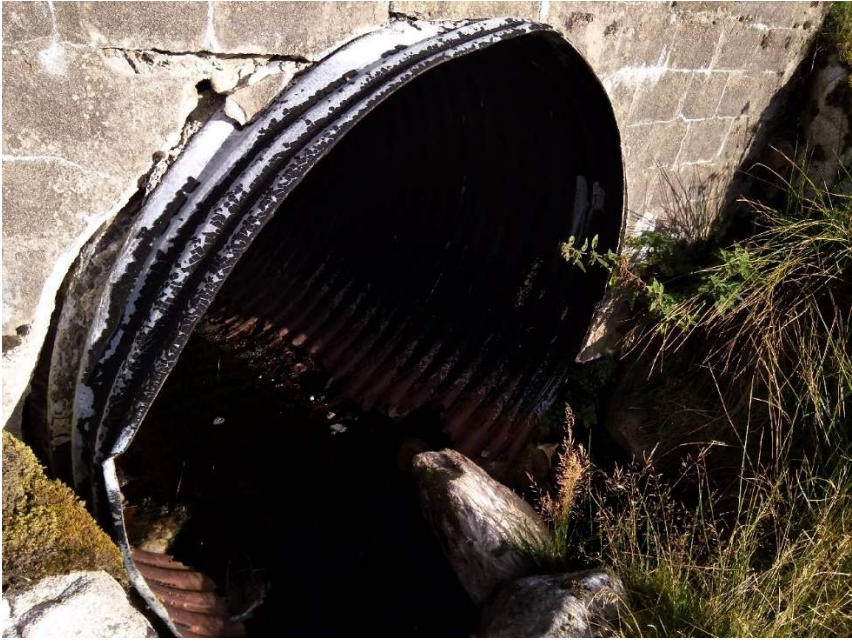
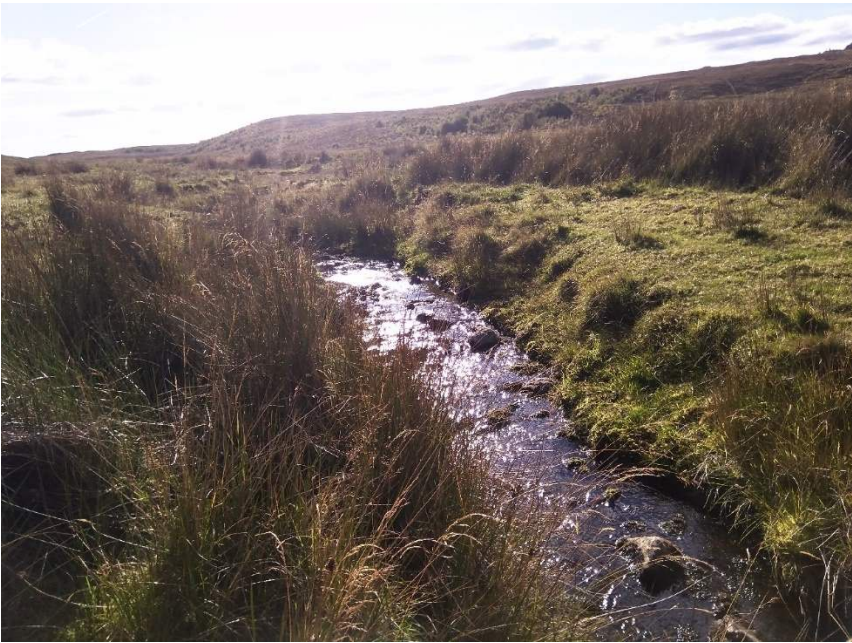
Watercourse Crossing ID	WX17
Watercourse Crossing Details	<p>NGR: NC 88485 60719</p> <p>Status: Existing Crossing</p> <p>Crossing Type: Corrugated circular culvert.</p> <p>Crossing Dimensions: 1.5m diameter.</p> <p>Watercourse Width: 2m</p> <p>Watercourse Depth: 0.4m</p> <p>Notes: Watercourse slightly larger downstream of crossing compared to upstream and located in a channel which is up to 3m wide and 1.5m deep.</p>
Photograph Looking at Culvert Entrance from Upstream

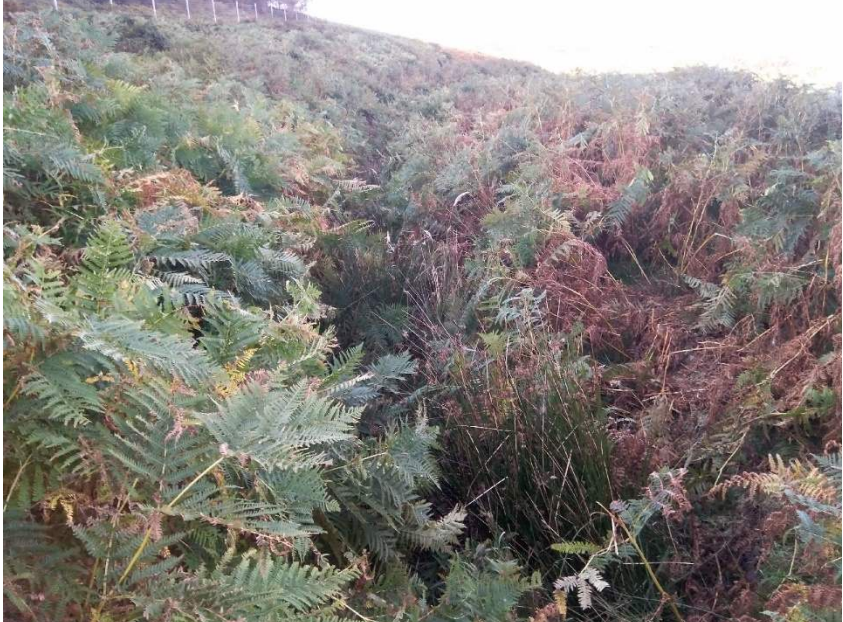
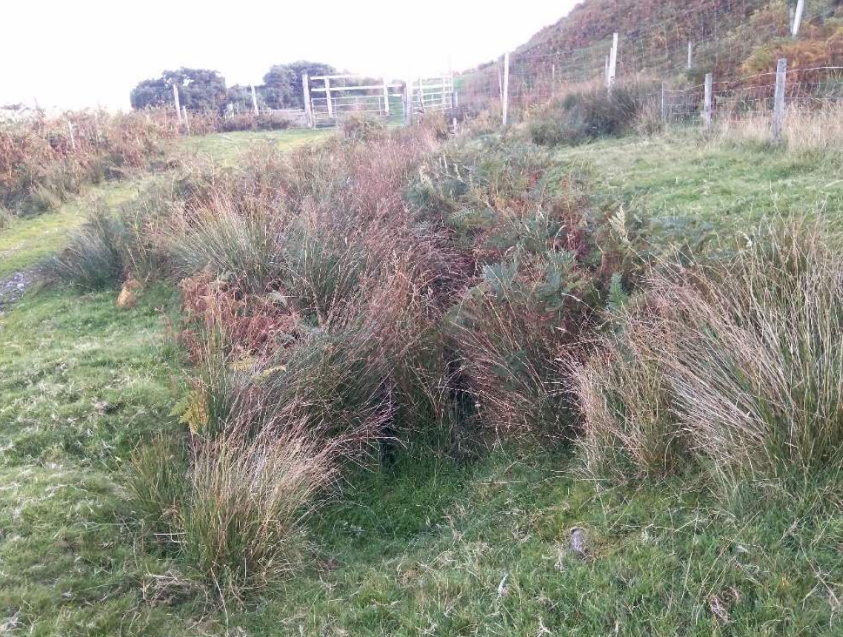
Watercourse Crossing ID	WX19
Watercourse Crossing Details	<p>NGR: NC 89277 60691</p> <p>Status: Existing Crossing</p> <p>Watercourse Width: N/A</p> <p>Watercourse Depth: N/A</p> <p>Notes: Channel very overgrown. Watercourse and existing culvert was inaccessible during the survey. Watercourse located in a channel which is approximately 2m wide and 1.5m deep.</p>
Photograph Looking Upstream

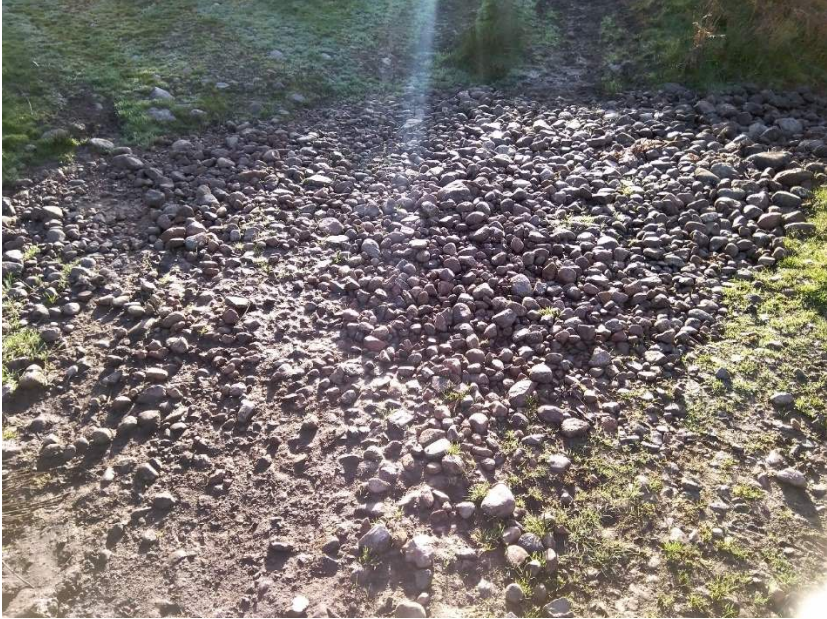
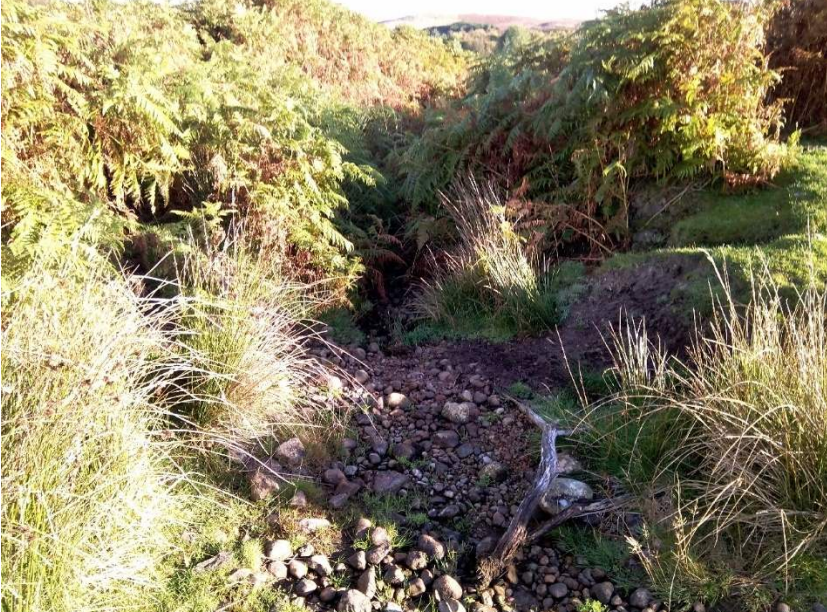
Watercourse Crossing ID	WX20
Watercourse Crossing Details	<p>NGR: NC 89382 60262</p> <p>Status: Existing Crossing</p> <p>Crossing Type: Ford (dry during survey).</p> <p>Watercourse Width: N/A</p> <p>Watercourse Depth: N/A</p> <p>Notes: Stagnant water noted upstream, but no flowing / active watercourse recorded during the survey. Watercourse located in a channel which is up to 1m wide and 0.3m deep.</p>
Photograph Looking at Crossing

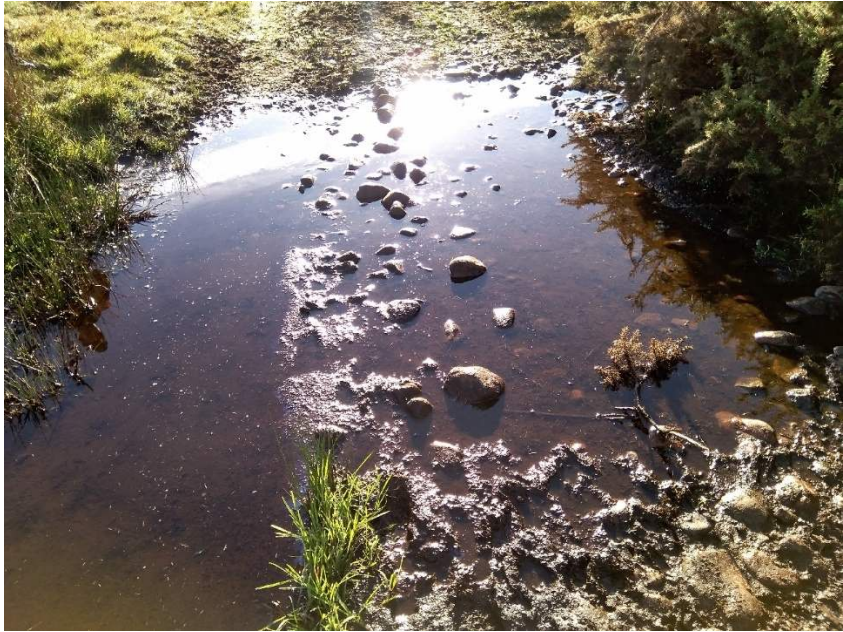
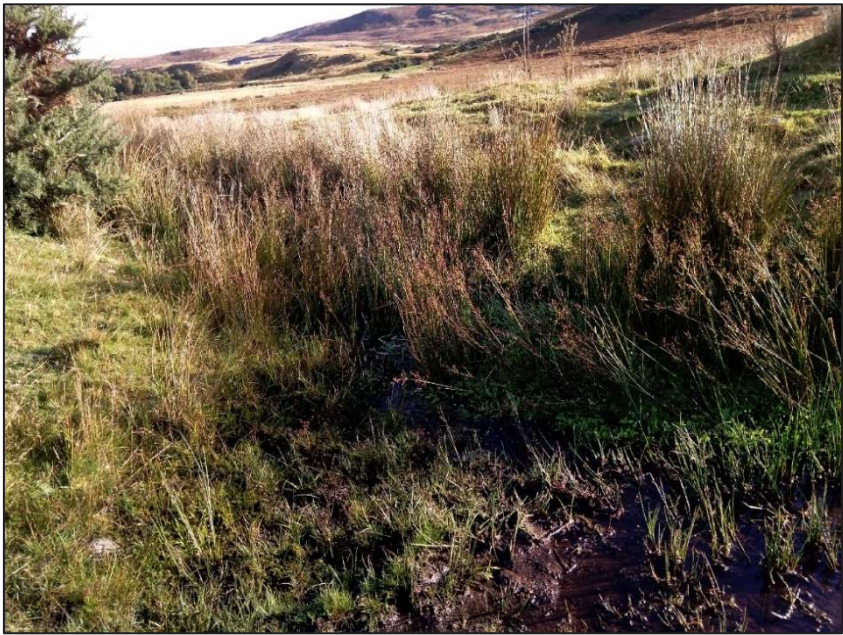
Watercourse Crossing ID	WX21
Watercourse Crossing Details	<p>NGR: NC 89465 60053</p> <p>Status: Existing Crossing</p> <p>Crossing Type: Ford</p> <p>Watercourse Width: 0.2</p> <p>Watercourse Depth: 0.1m</p> <p>Notes: Watercourse located in a channel which up to 2m wide and 0.5m deep. Channel is slightly narrower upstream of crossing point. Downstream of crossing point watercourse channel ill-defined.</p>
Photograph Looking at Crossing
