COIRE GLAS OVERHEAD LINE GRID CONNECTION

Technical Appendix 10.4 Schedule of Permanent Watercourse Crossings

Prepared for: Scottish & Southern Electricity
Networks Transmission (SSEN Transmission)

SLR Ref: 428.04707.00031
Version No: 01
March 2023

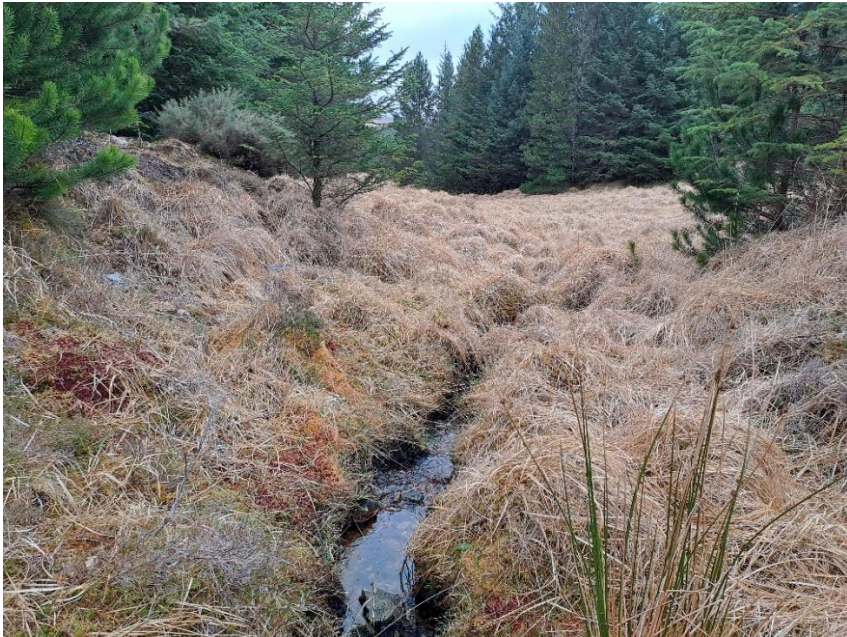
Watercourse Crossing ID	WX09
Watercourse Crossing Details	<p>Watercourse Crossing: WX09 NGR: NH 31205 03289 Status: New Watercourse Width: 0.4 to 1m Watercourse Depth: 0.1m Notes: Small ford crossing associated with an existing small track which has a maximum track width of 1m.</p>
Photograph Looking Upstream

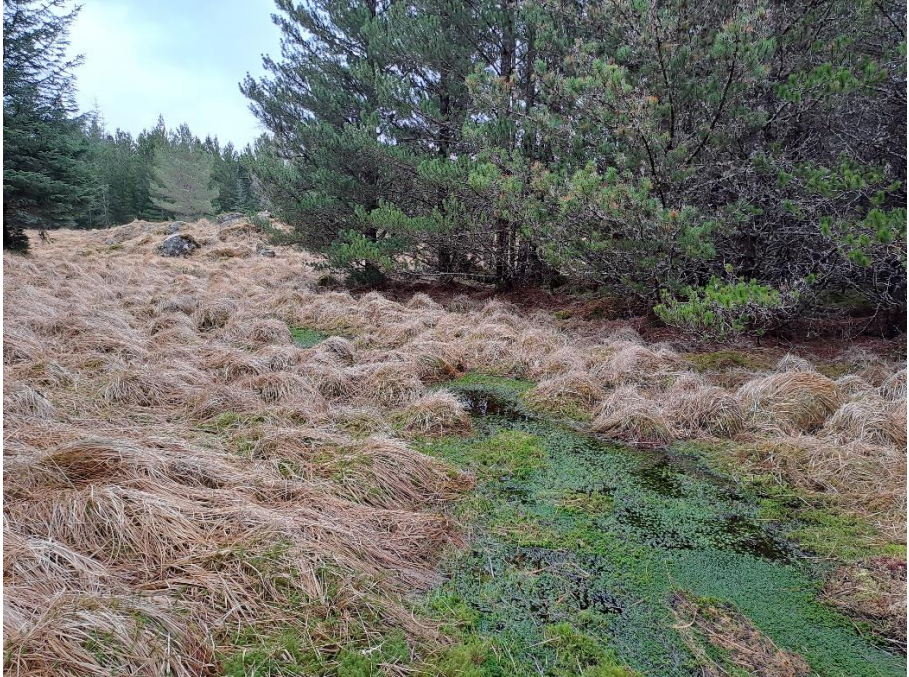
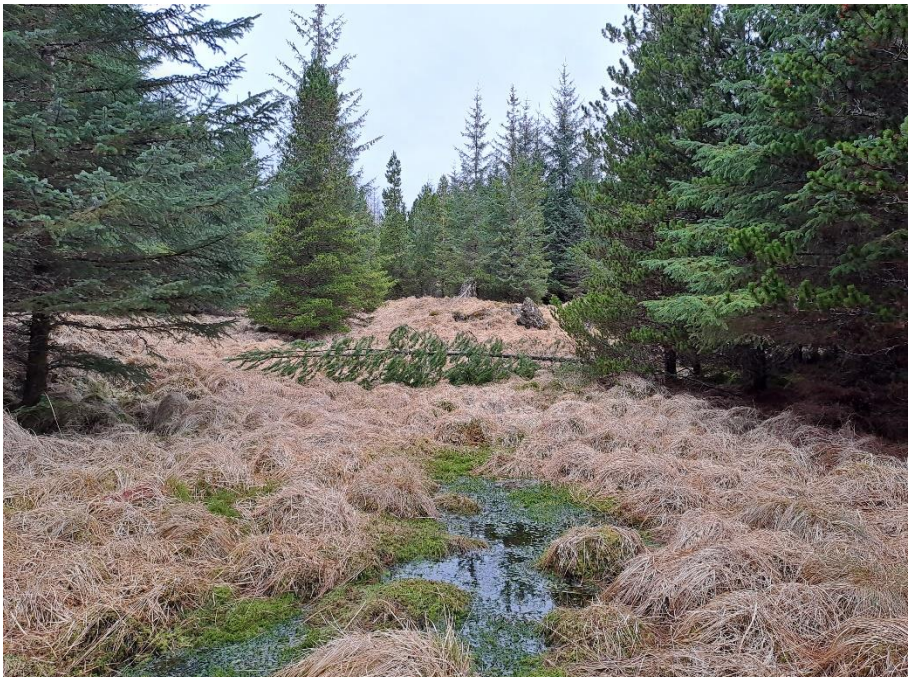
Watercourse Crossing ID	WX13
Watercourse Crossing Details	<p>Watercourse Crossing: WX13 NGR: NH 30579 03222 Status: New Watercourse Width: 2m Watercourse Depth: 0.4m Notes: Minor watercourse with very low flow.</p>
Photograph Looking Upstream

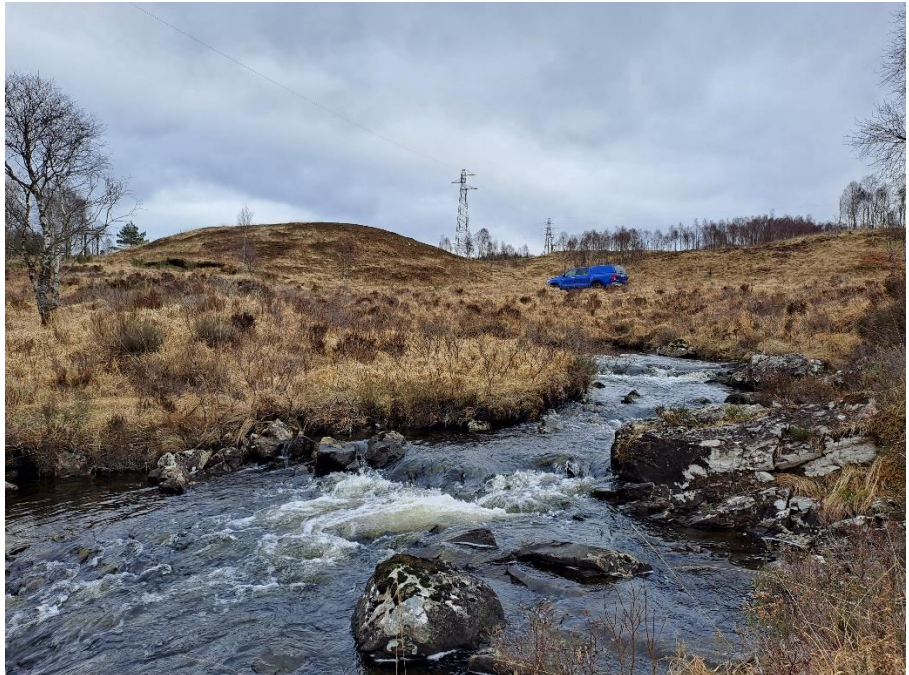
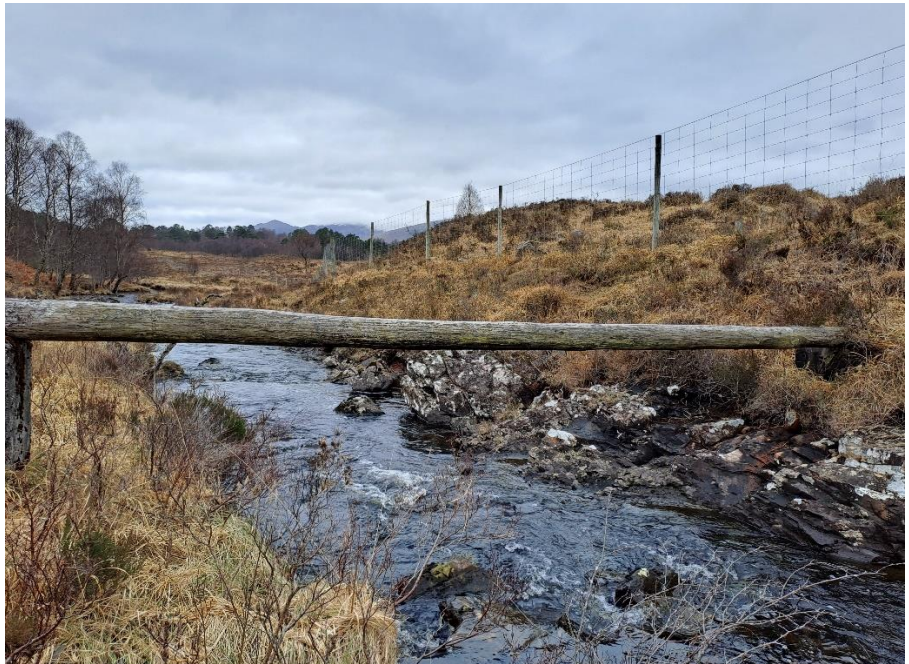
Watercourse Crossing ID	WX14
Watercourse Crossing Details	<p>Watercourse Crossing: WX14 NGR: NH 29478 02512 Status: New Watercourse Width: 1m Watercourse Depth: 0.5m Notes: Watercourse sits in larger channel which has a depth of up to 2m. Right bank is higher than left bank.</p>
Photograph Looking Upstream

A photograph showing a rocky watercourse flowing through a landscape of dry, brownish grass and shrubs. In the background, there are rolling hills, a utility tower, and a blue tarp on the ground under a cloudy sky.
Photograph Looking Downstream

A photograph showing a watercourse flowing downstream. A wooden log bridge crosses the water in the foreground. The banks are covered in dry vegetation, and a wire fence runs along the right bank. The background shows a hazy landscape with hills and a cloudy sky.

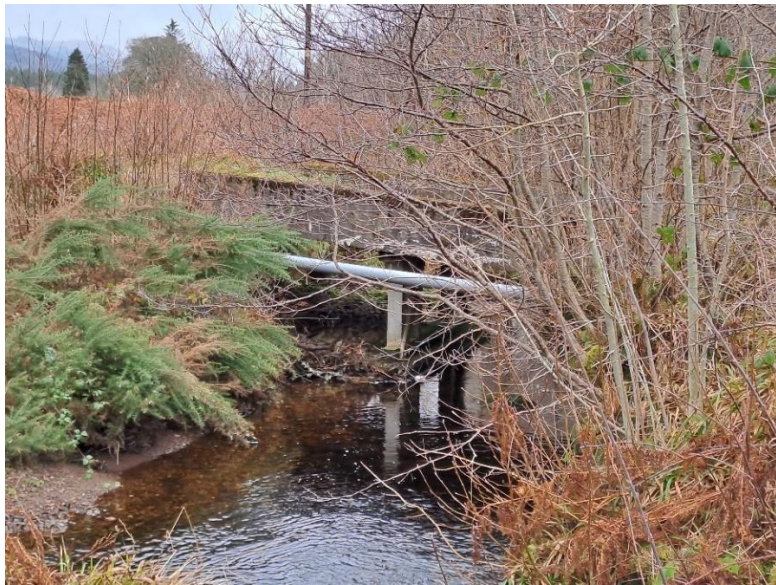
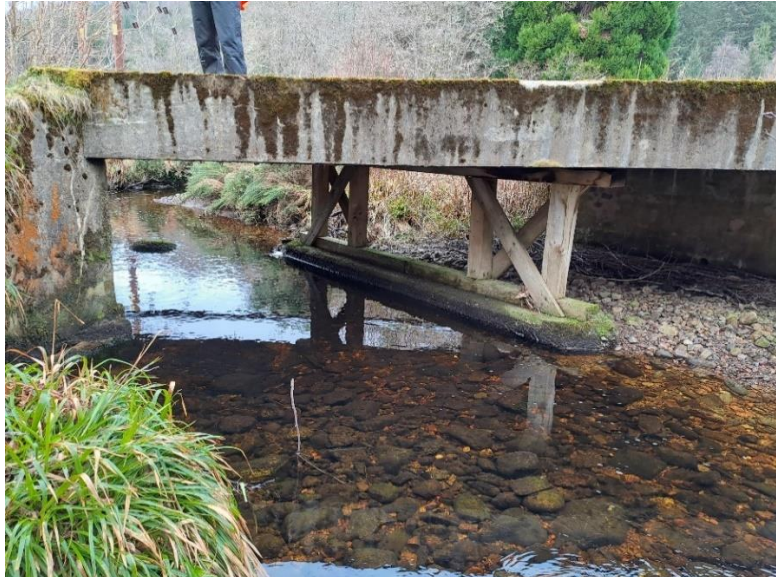
Watercourse Crossing ID	WX01
Watercourse Crossing Details	<p>Watercourse Crossing: WX01 NGR: NH 34816 07356 Status: Existing Bridge Dimensions: 3.5m wide, 7m long, soffit 1.6m above watercourse Culvert Construction Type: Open span concrete bridge Watercourse Width: 2.5m Watercourse Depth: 0.2m Notes: Confluence noted immediately upstream of bridge. No blockage.</p>
Photograph Looking at Culvert Entrance from Upstream

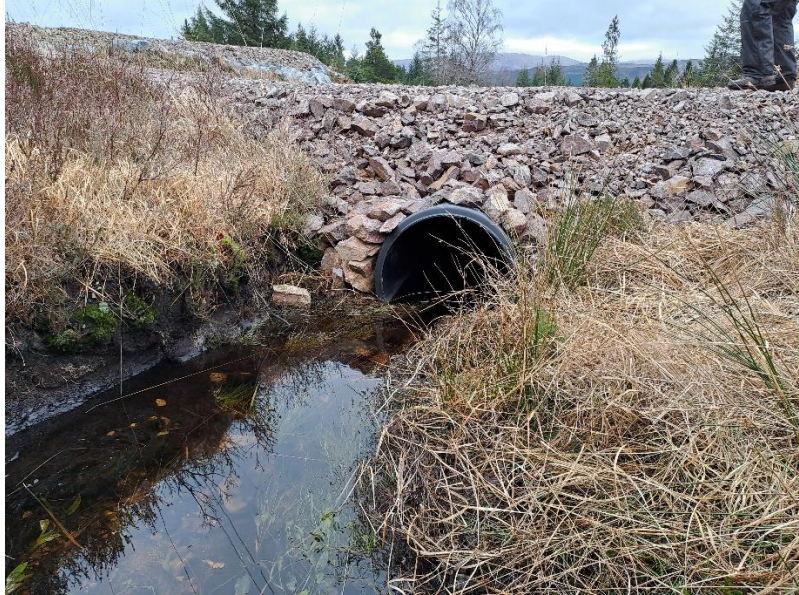
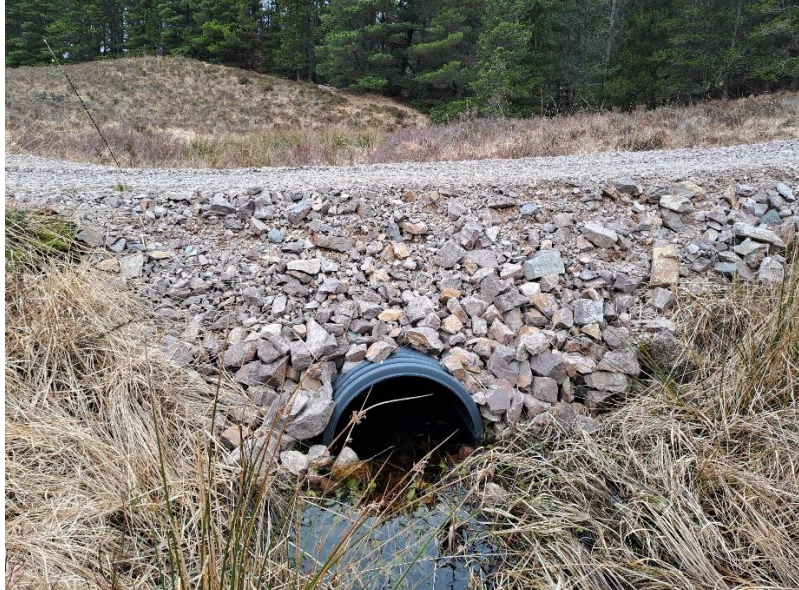
Watercourse Crossing ID	WX02
Watercourse Crossing Details	<p>Watercourse Crossing: WX02 NGR: NH 33114 06159 Status: Existing Culvert Diameter: 0.6m Culvert Construction Type: Circular plastic culvert Watercourse Width: 0.8m Watercourse Depth: 0.2m Notes: Low flow, culvert half submerged. Watercourse is located within 0.6m deep channel incised in peat.</p>
Photograph Looking at Culvert Entrance from Upstream

A photograph showing the upstream entrance of a circular plastic culvert. The culvert is partially submerged in a shallow, peat-lined channel. The surrounding area is covered with dry, yellowish-brown grass and a large pile of grey rocks, likely used for erosion control or as a check dam. The background shows a line of trees under a cloudy sky.
Photograph Looking at Culvert Exit from Downstream

A photograph showing the downstream exit of a circular plastic culvert. The culvert is partially submerged in a shallow, peat-lined channel. The surrounding area is covered with dry, yellowish-brown grass and a large pile of grey rocks, likely used for erosion control or as a check dam. The background shows a line of trees under a cloudy sky.

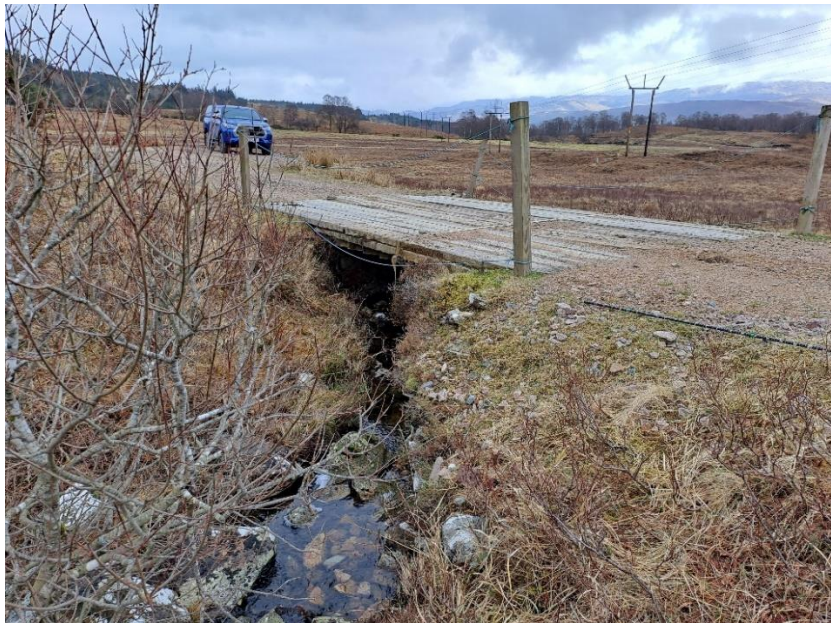
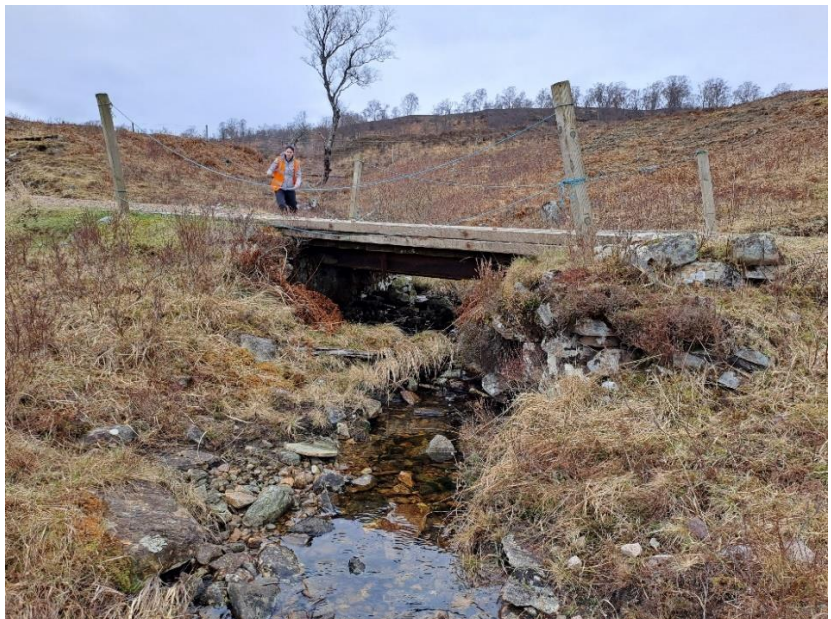
Watercourse Crossing ID	WX05
Watercourse Crossing Details	<p>Watercourse Crossing: WX05 NGR: NH 31094 05340 Status: Existing Bridge Dimensions: 2.5m wide, 4.5m long, soffit 1m above watercourse Culvert Construction Type: Open span wooden bridge Watercourse Width: 1m Watercourse Depth: 0.2m Notes: Small watercourse with cobbles noted within channel.</p>
Photograph Looking at Bridge Entrance from Upstream

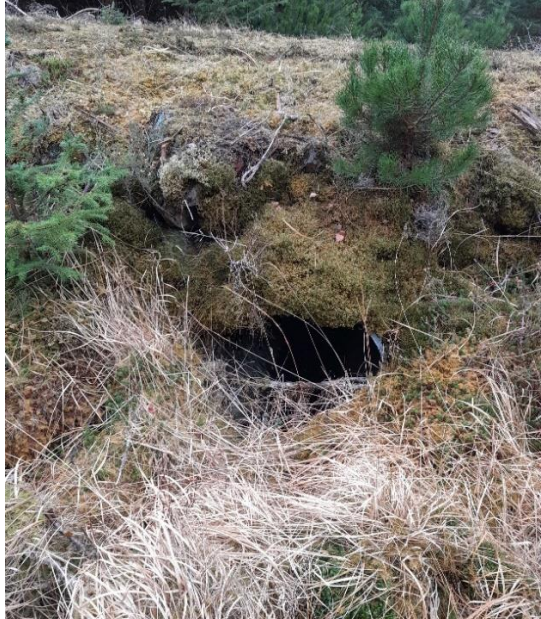
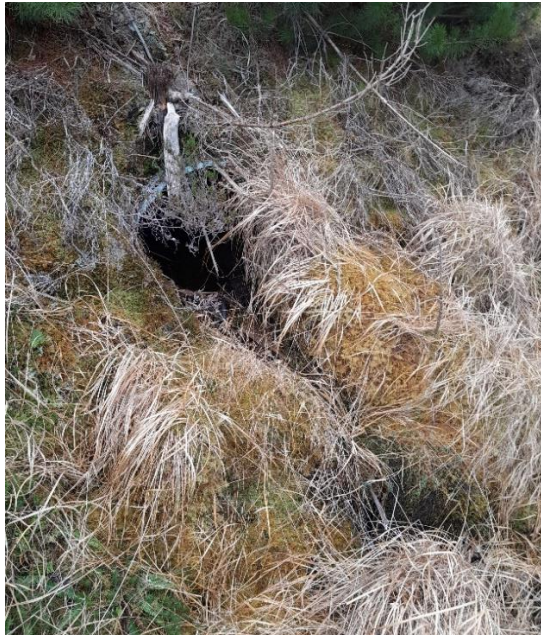
Watercourse Crossing ID	WX10
Watercourse Crossing Details	<p>Watercourse Crossing: WX10 NGR: NH 31358 03246 Status: Existing Culvert Diameter: 0.5m Culvert Construction Type: Circular corrugated metal culvert Watercourse Width: 0.5m Watercourse Depth: 0.2m Notes: Minor watercourse. Heavily vegetated and culvert entrance and exit partially blocked.</p>
Photograph Looking at Culvert Entrance from Upstream

A photograph showing the upstream entrance of a culvert. The culvert is a dark, circular opening partially obscured by dense, dry, yellowish-brown grass and some green ferns. The surrounding area is a grassy slope with some rocks and moss.
Photograph Looking at Culvert Exit from Downstream

A photograph showing the downstream exit of a culvert. The culvert is a dark, circular opening partially obscured by dense, dry, yellowish-brown grass and some green ferns. The surrounding area is a grassy slope with some rocks and moss.

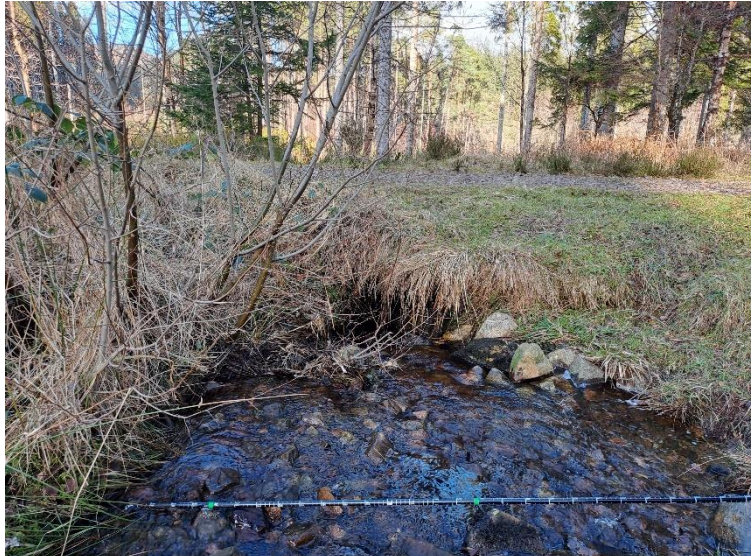
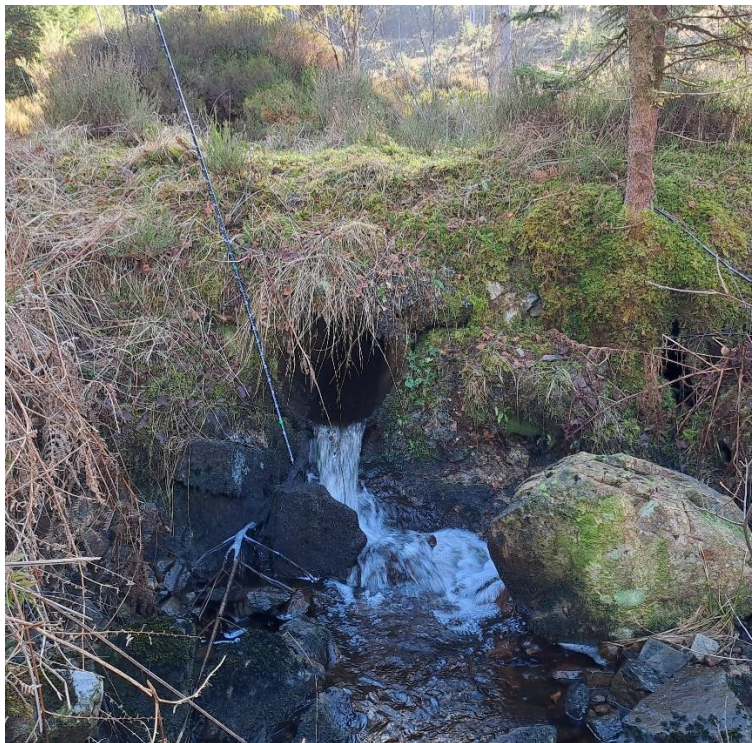
Watercourse Crossing ID	WX16
Watercourse Crossing Details	<p>Watercourse Crossing: WX16 NGR: NH 27749 01522 Status: Existing Culvert Diameter: 0.5m Culvert Construction Type: Circular concrete culvert Watercourse Width: 1.5m Watercourse Depth: 0.1m Notes: Clear / no blockages.</p>
Photograph Looking at Culvert Entrance from Upstream

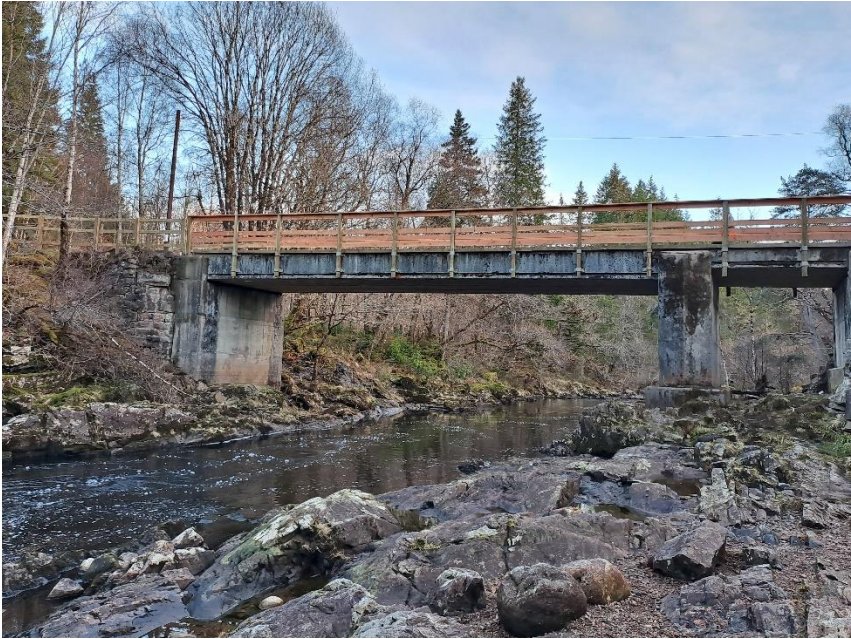
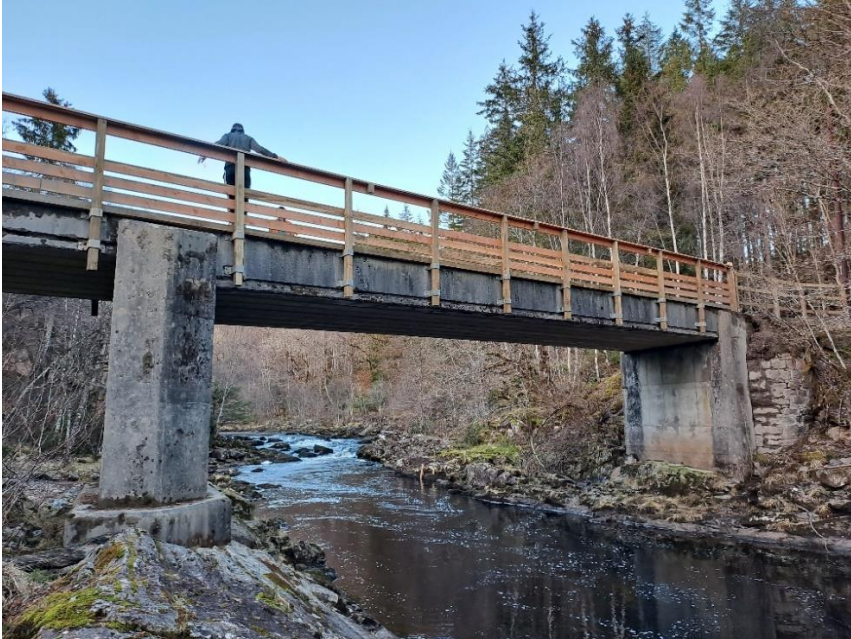
Watercourse Crossing ID	WX17
Watercourse Crossing Details	<p>Watercourse Crossing: WX17 NGR: NH 28364 01350 Status: Existing Bridge Dimensions: 3.5m wide, 20m long, 5m to soffit from watercourse Culvert Construction Type: Open span concrete bridge Watercourse Width: 10m Watercourse Depth: 1.5m Notes: Large open span bridge with no obstructions.</p>
Photograph Looking at Bridge Entrance from Upstream

A photograph taken from an upstream perspective looking towards a concrete bridge. The bridge has two large rectangular concrete piers supporting a dark metal span with wooden railings. The watercourse is rocky with some rapids. The background shows a forest of bare trees and evergreens under a cloudy sky.
Photograph Looking at Bridge Exit from Downstream

A photograph taken from a downstream perspective looking back at the bridge. The bridge structure is similar to the upstream view, showing the concrete piers and metal span with wooden railings. The water is flowing through the bridge opening. The surrounding area is rocky and wooded.

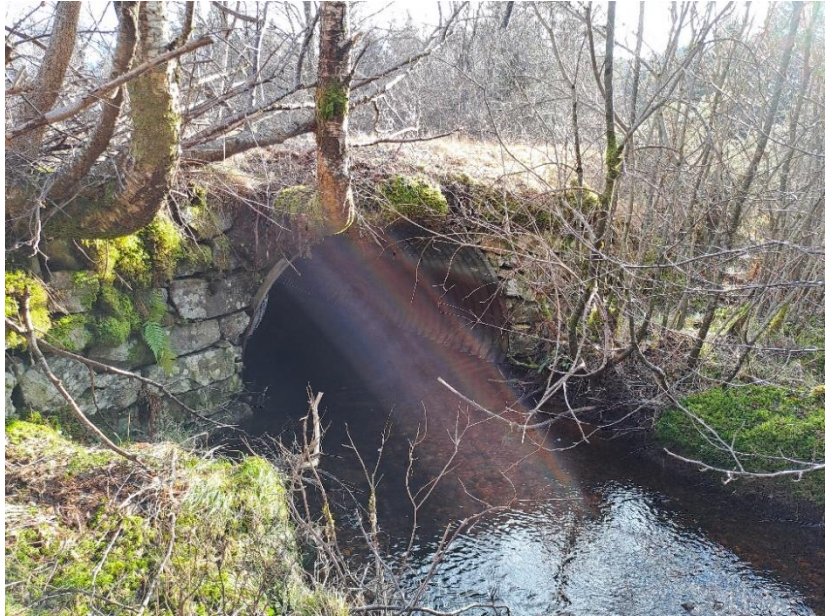
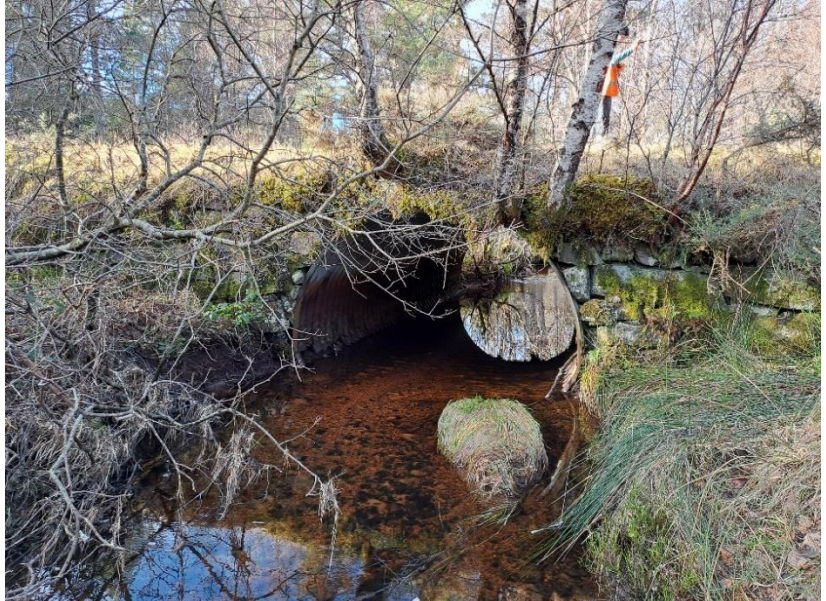
Watercourse Crossing ID	WX18
Watercourse Crossing Details	<p>Watercourse Crossing: WX18 NGR: NH 26400 00478 Status: Existing Culvert Diameter: 2.5m Culvert Construction Type: Circular corrugated metal culvert Watercourse Width: 2.5m Watercourse Depth: 0.2m Notes: Large circular culvert with flattened base. No blockage.</p>
Photograph Looking at Culvert Entrance from Upstream

A photograph showing the upstream entrance of a circular culvert. The culvert is constructed from stone and is partially obscured by moss and bare tree branches. A stream flows through the opening, and the surrounding area is wooded with many bare trees, suggesting a late autumn or winter setting.
Photograph Looking at Culvert Exit from Downstream

A photograph showing the downstream exit of the circular culvert. The culvert is made of corrugated metal and is partially covered by moss and bare tree branches. A stream flows out of the culvert, and the surrounding area is wooded with many bare trees. A person in an orange jacket is visible in the background, standing near the culvert.

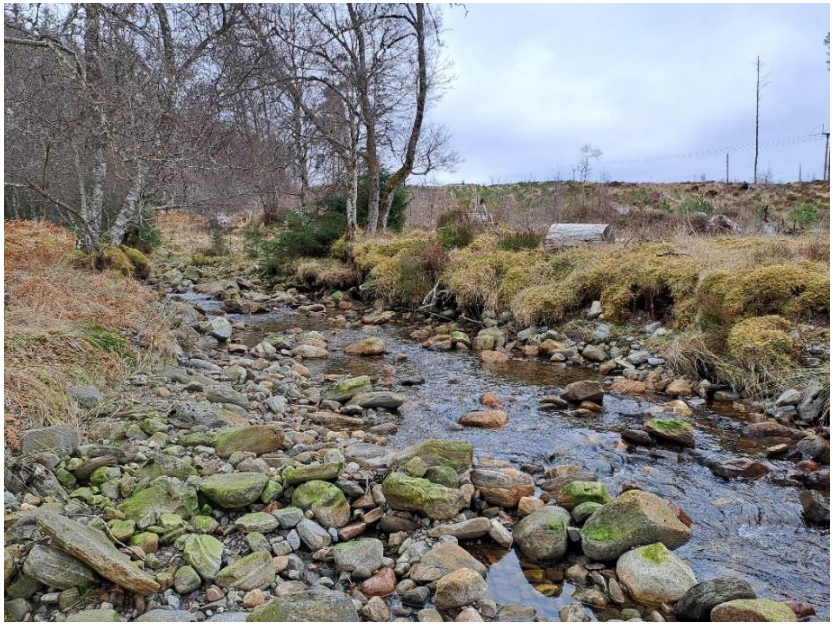
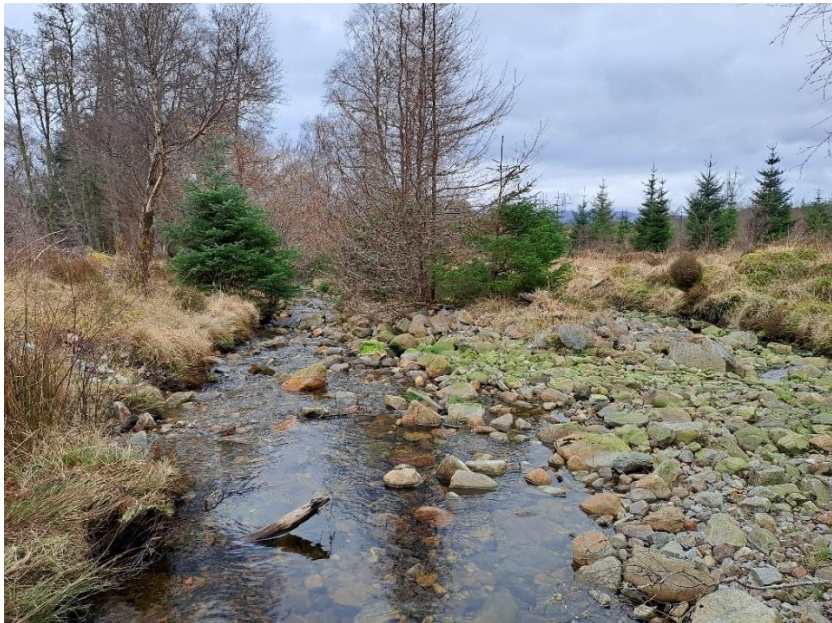
Watercourse Crossing ID	WX03	
Watercourse Crossing Details	<p>Watercourse Crossing: WX03 NGR: NH 31935 05759 Status: New (temporary) Watercourse Width: 2m Watercourse Depth: 0.5m Notes: Watercourse within a channel that is 1-1.5m high and approximately 4m wide.</p>	
Photograph Looking Upstream

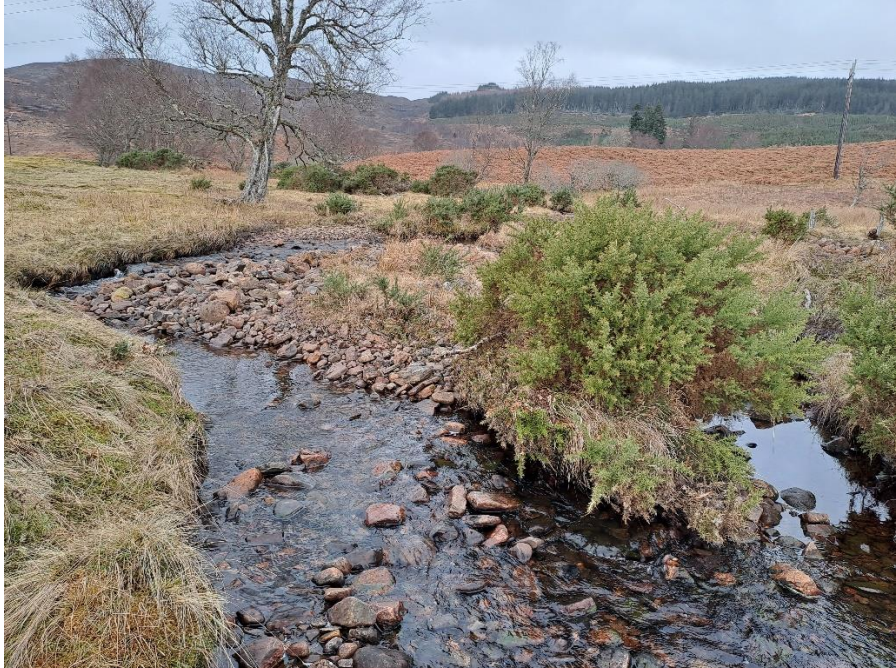
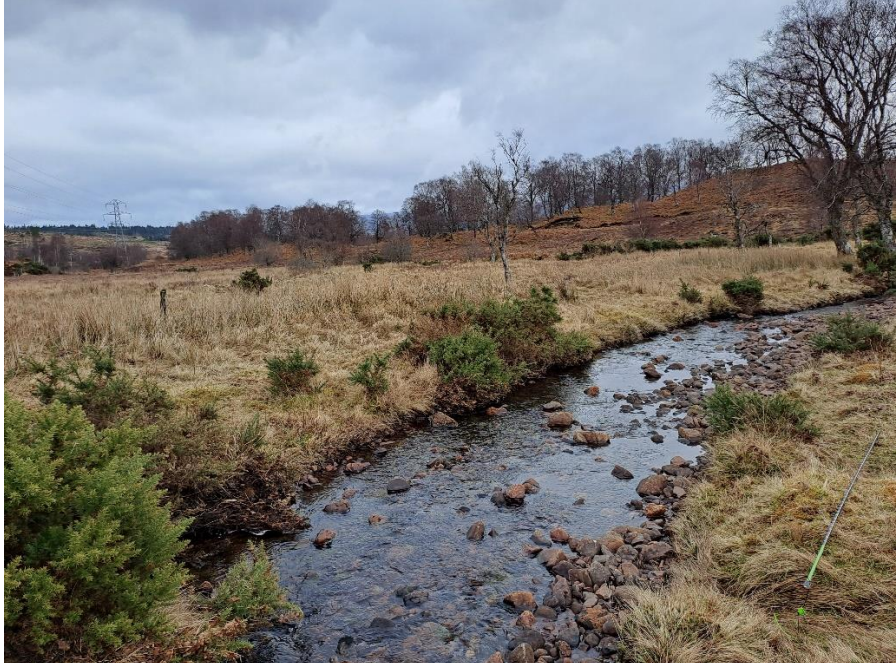
Watercourse Crossing ID	WX04
Watercourse Crossing Details	<p>Watercourse Crossing: WX04 NGR: NH 31485 05375 Status: New (temporary) Watercourse Width: 2.5m Watercourse Depth: 0.1m Notes: None.</p>
Photograph Looking Upstream

A photograph showing a small, rocky watercourse flowing through a grassy field. The water is clear and flows over numerous brown and grey rocks. The banks are covered in dry, yellowish-brown grass and some green shrubs. In the background, there are rolling hills under a cloudy sky.
Photograph Looking Downstream

A photograph showing the same watercourse from a downstream perspective. The water flows over a bed of rocks, surrounded by dry grass and green shrubs. The background shows a landscape with trees and hills under a cloudy sky.
