Melgarve Cluster Project

Appendix 10.3: Schedule of Watercourse Crossings

ASH design+assessment

SLR Consulting Limited

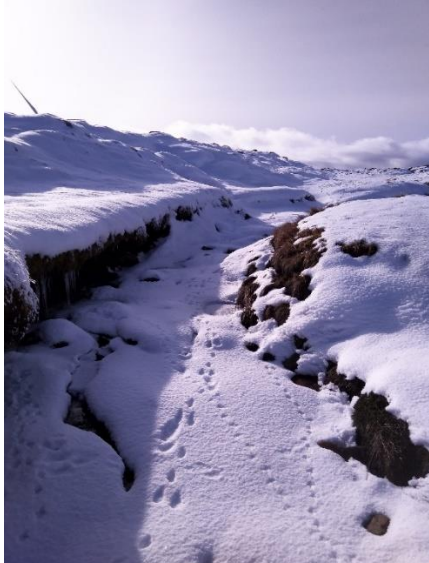
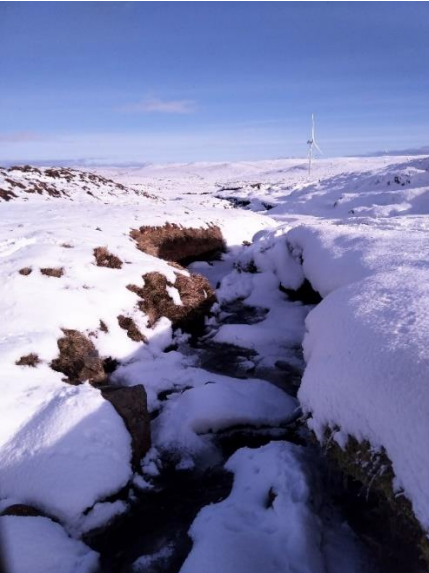
Watercourse Crossing ID	WX01
Watercourse Crossing Details	<p>NGR: NH 50115 05808</p> <p>Status: New Temporary Track Crossing and New Permanent Crossing associated with proposed UGC.</p> <p>Watercourse Width: 2m</p> <p>Watercourse Depth: 0.1m</p> <p>Notes: Surveyed during winter months so water depth may be an underestimate. Incised in peat within a channel approximately 0.5m deep.</p>
Photograph Looking Upstream

<p>A photograph showing a narrow, shallow watercourse cutting through a snow-covered peat bog. The water is dark and still, reflecting the sky. The surrounding peat is covered in a thick layer of snow, with some brown vegetation visible. In the background, a wind turbine is visible on a distant ridge under a clear blue sky.</p>
Photograph Looking Downstream

<p>A photograph showing a similar view of the watercourse from a downstream perspective. The water flows through a narrow channel in the peat, surrounded by snow. The landscape is flat and covered in snow, with a wind turbine visible in the distance under a clear blue sky.</p>

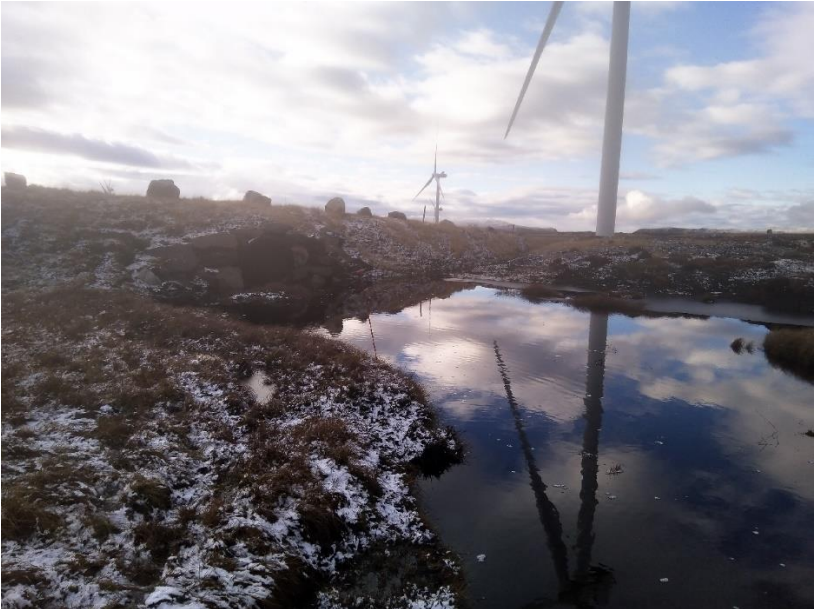
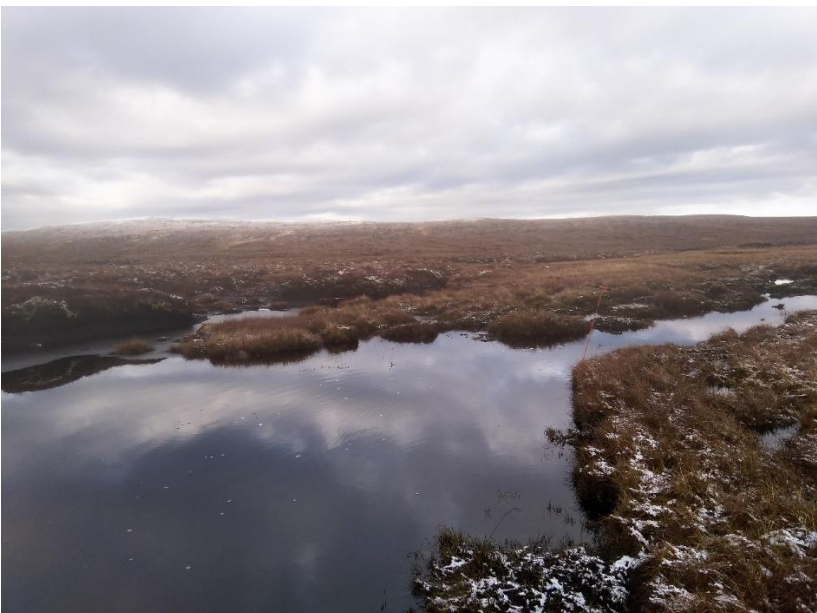
Watercourse Crossing ID	WX02
Watercourse Crossing Details	<p>NGR: NH 49270 05065</p> <p>Status: New Permanent Crossing associated with proposed UGC.</p> <p>Watercourse Width: 10m</p> <p>Watercourse Depth: 0.6m</p> <p>Notes: Approximately 15m downstream of an existing crossing which is 1.5m diameter plastic culvert.</p>
Photograph Looking Upstream

A photograph showing a narrow watercourse flowing through a field of snow-dusted vegetation. In the background, several large wind turbines are visible against a cloudy sky. The water in the stream is dark and reflects the sky and the surrounding landscape.
Photograph Looking Downstream

A wide-angle photograph looking downstream from a watercourse crossing. The water is calm and reflects the overcast sky. The surrounding landscape is a mix of brown, snow-dusted grass and low-lying vegetation. The horizon is flat and distant.

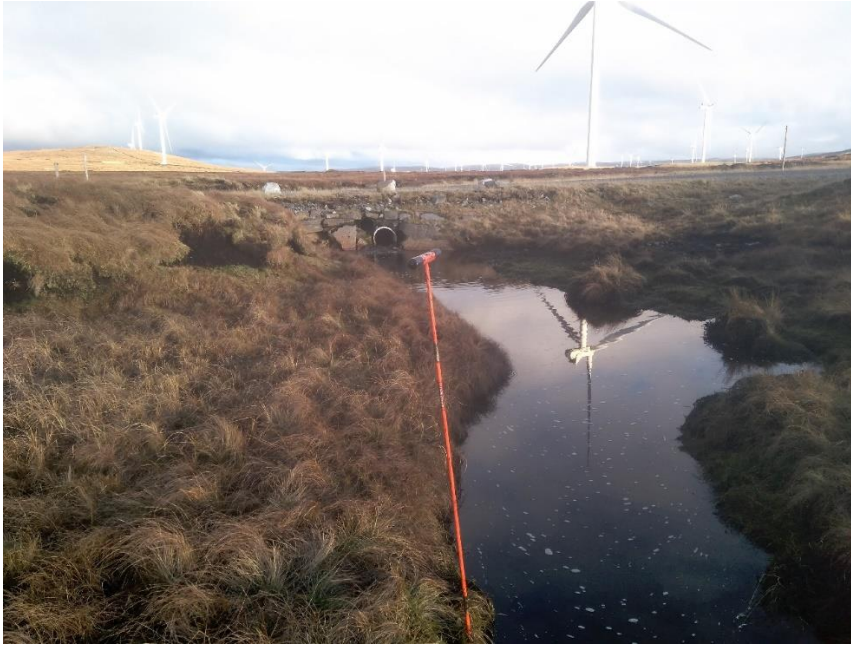
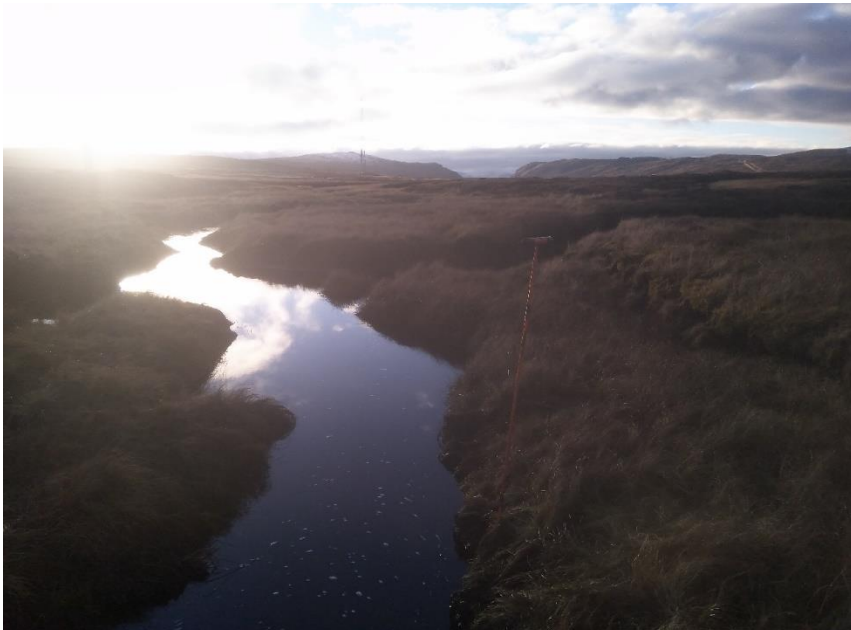
Watercourse Crossing ID	WX03
Watercourse Crossing Details	<p>NGR: NH 48511 04012</p> <p>Status: New Permanent Crossing associated with proposed UGC.</p> <p>Watercourse Width: 2m</p> <p>Watercourse Depth: 0.3m</p> <p>Notes: Approximately 20m downstream of an existing crossing.</p>
Photograph Looking Upstream

A photograph taken from an elevated position looking upstream along a narrow watercourse. The water is dark and reflects the sky. A red surveying pole is visible in the foreground on the right bank. In the background, several white wind turbines are visible on a grassy hill under a cloudy sky.
Photograph Looking Downstream

A photograph taken from an elevated position looking downstream along a watercourse. The water is dark and reflects the sky. A red surveying pole is visible in the foreground on the right bank. The background shows a wide valley with rolling hills and a sunset or sunrise sky with long shadows.

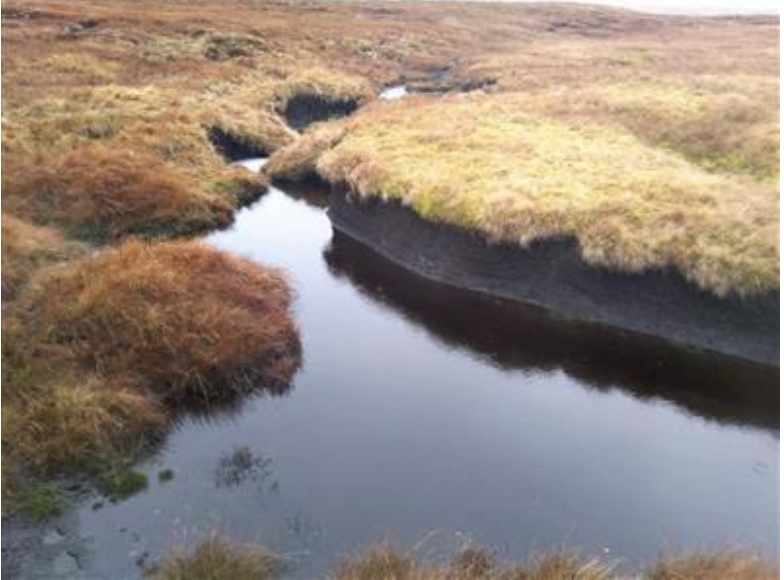
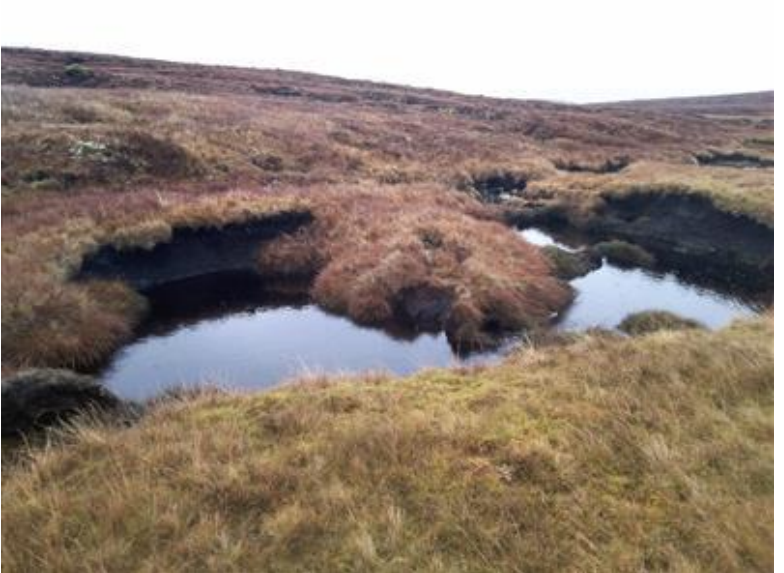
Watercourse Crossing ID	WX04
Watercourse Crossing Details	<p>NGR: NH 47459 02142</p> <p>Status: New Temporary Track Crossing and New Permanent Crossing associated with proposed UGC.</p> <p>Watercourse Width: 4m</p> <p>Watercourse Depth: 2m</p> <p>Notes: Surveyed approximately 15m downstream of the crossing point. Incised in peat.</p>
Photograph Looking Upstream

A photograph showing a narrow, winding watercourse flowing through a peat bog landscape. The water is dark and reflects the surrounding vegetation. The bog is covered in dense, brownish-yellow peat mosses and grasses. The watercourse appears to be incised into the peat.
Photograph Looking Downstream

A photograph showing a wider, more irregularly shaped watercourse in a peat bog landscape. The water is dark and reflects the surrounding vegetation. The bog is covered in dense, brownish-yellow peat mosses and grasses. The watercourse appears to be incised into the peat.

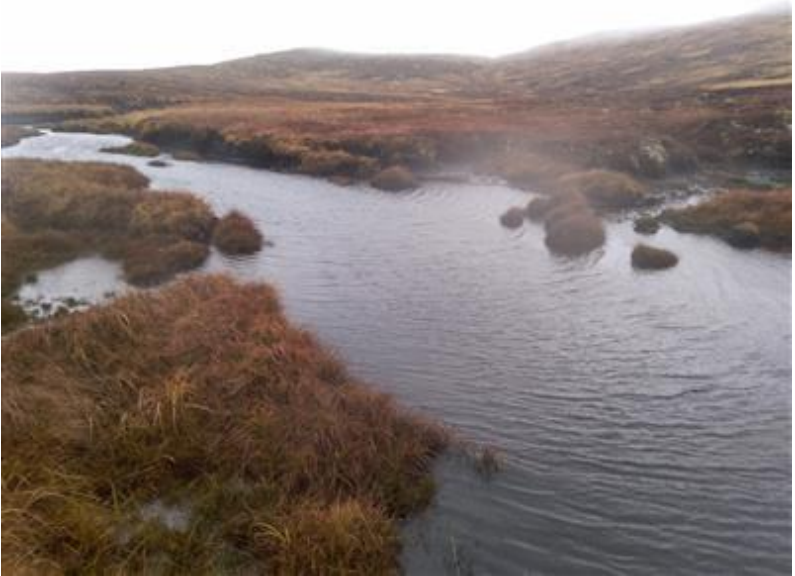
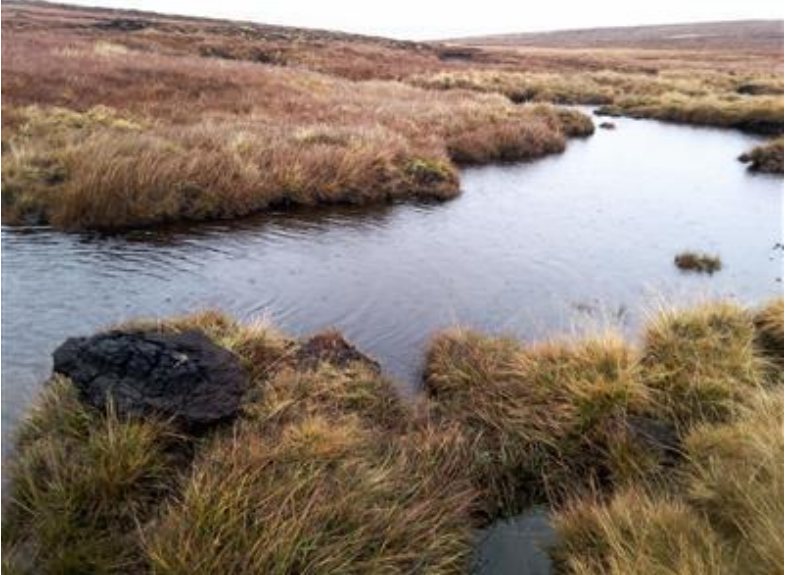
Watercourse Crossing ID	WX05
Watercourse Crossing Details	<p>NGR: NH 48009 01596</p> <p>Status: New Temporary Track Crossing and New Permanent Crossing associated with proposed UGC.</p> <p>Watercourse Width: 8m</p> <p>Watercourse Depth: 1.5m</p> <p>Notes: Surveyed approximately 20m upstream of the crossing point. Incised in peat.</p>
Photograph Looking Upstream

A photograph showing a wide, shallow watercourse flowing through a peat landscape. The water is dark and still, reflecting the overcast sky. The banks are covered in dense, brownish peat vegetation. In the distance, rolling hills are visible under a grey, overcast sky.
Photograph Looking Downstream

A photograph showing a watercourse flowing through a peat landscape, viewed from a different angle than the upstream view. The water is dark and still, reflecting the overcast sky. The banks are covered in dense, brownish peat vegetation. In the foreground, there is a large, dark rock. The watercourse flows towards the right side of the frame.

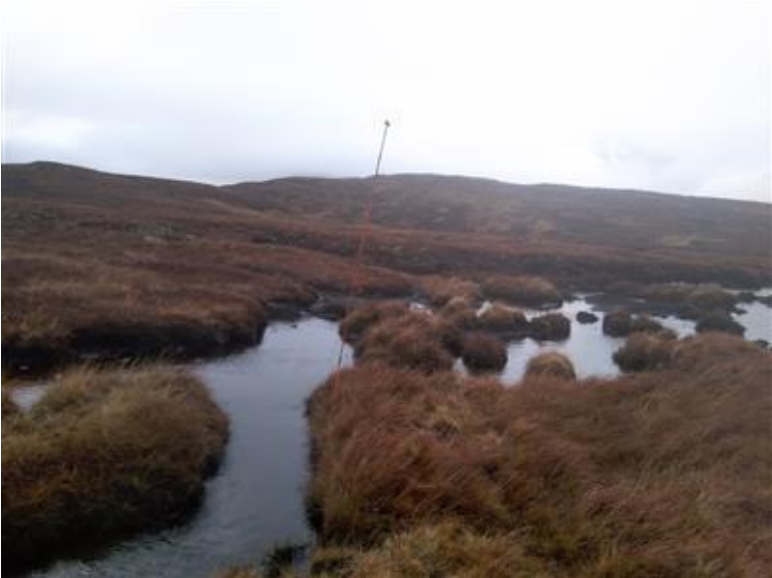
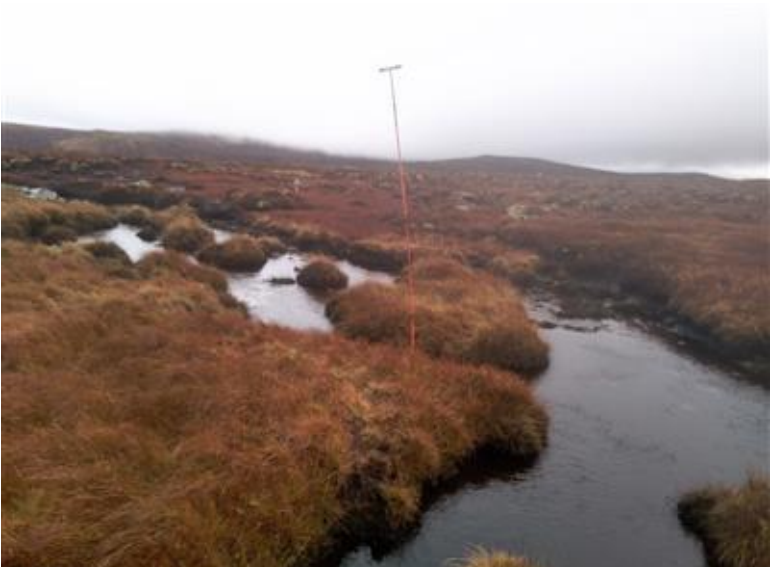
Watercourse Crossing ID	WX06 to WX09
Watercourse Crossing Details	<p>NGR: NH 48435 01529</p> <p>Status: New Temporary Track Crossing, New Permanent Track Crossing and Two New Permanent Crossings associated with proposed UGC.</p> <p>Watercourse Width: 2.5m</p> <p>Watercourse Depth: 0.3m</p> <p>Notes: Incised in peat. Peat hags noted within channel.</p>
Photograph Looking Upstream

A photograph showing a watercourse flowing through a peat bog landscape. The water is dark and narrow, winding through patches of brown peat hags. In the background, there are rolling hills under a cloudy sky. A tall, thin pole is visible in the distance.
Photograph Looking Downstream

A photograph showing a watercourse flowing through a peat bog landscape, viewed from a different angle than the upstream view. The water is dark and narrow, winding through patches of brown peat hags. In the background, there are rolling hills under a cloudy sky. A tall, thin pole is visible in the distance.

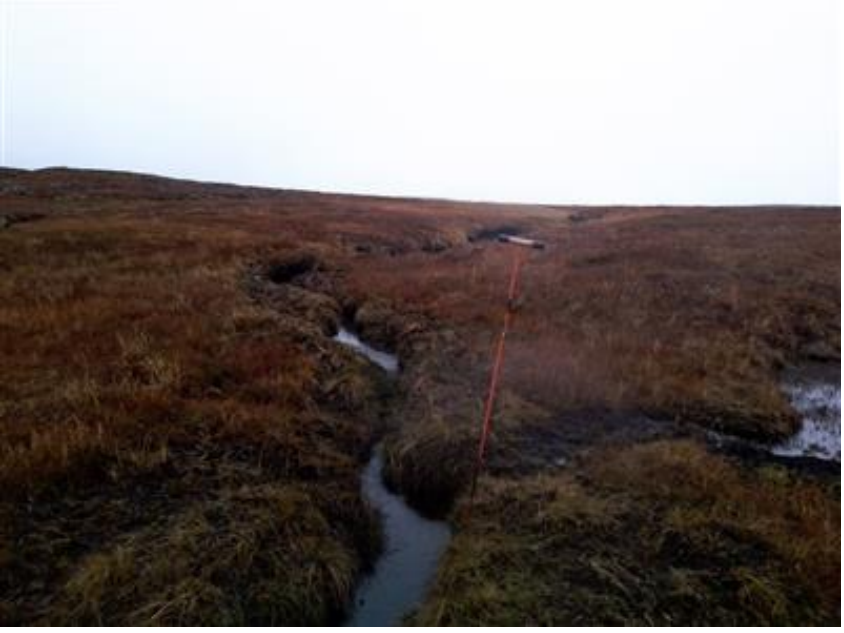
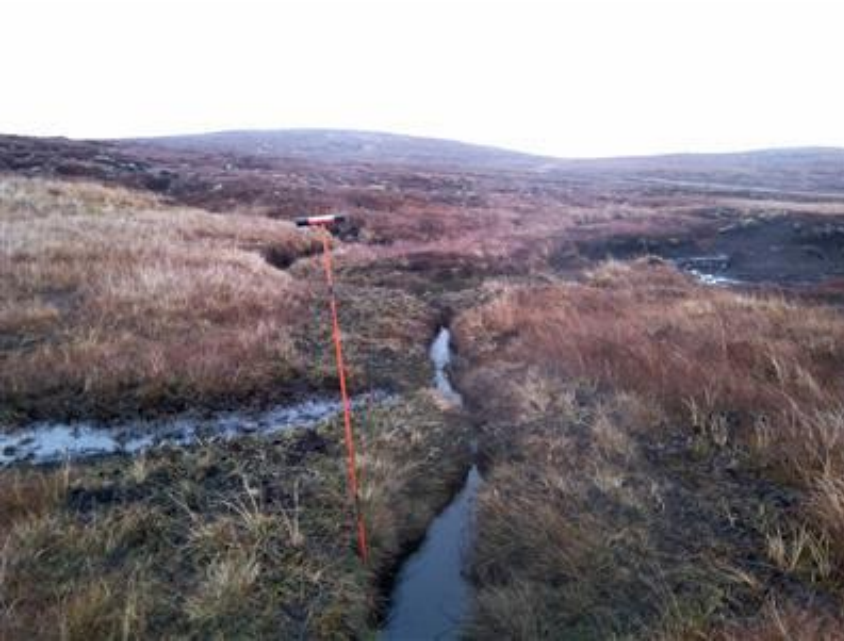
Watercourse Crossing ID	WX10
Watercourse Crossing Details	NGR: NH 48685 01288 Status: New Permanent Track Crossing Watercourse Width: 0.5m Watercourse Depth: 0.2m Notes: Minor watercourse incised in peat and peaty soils.
Photograph Looking Upstream

A photograph showing a narrow, shallow watercourse flowing through a peat bog landscape. The water is dark and still. The surrounding vegetation is brown and peaty. A red surveying pole is visible in the foreground, extending into the water.
Photograph Looking Downstream

A photograph showing a wider view of the watercourse flowing through a peat bog landscape. The water is dark and still. The surrounding vegetation is brown and peaty. A red surveying pole is visible in the foreground, extending into the water.

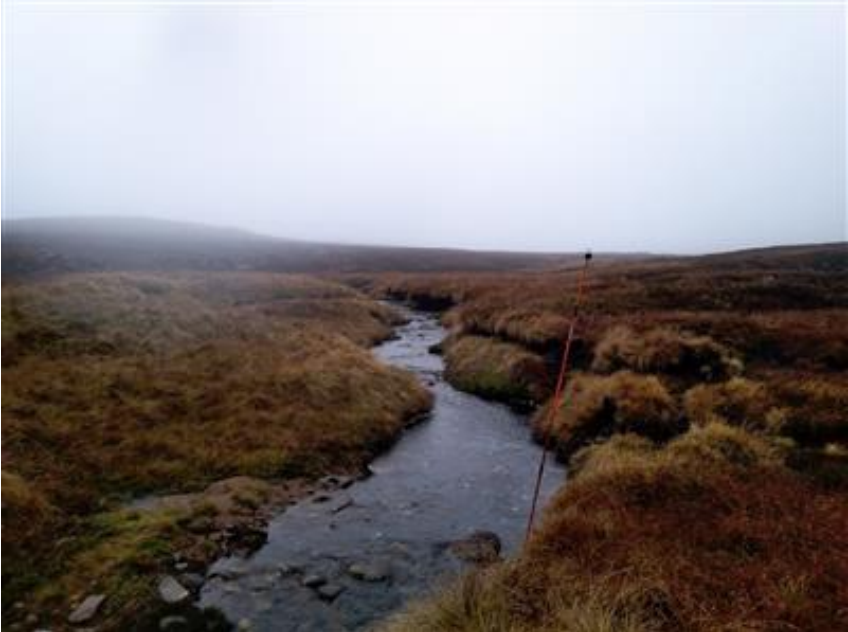
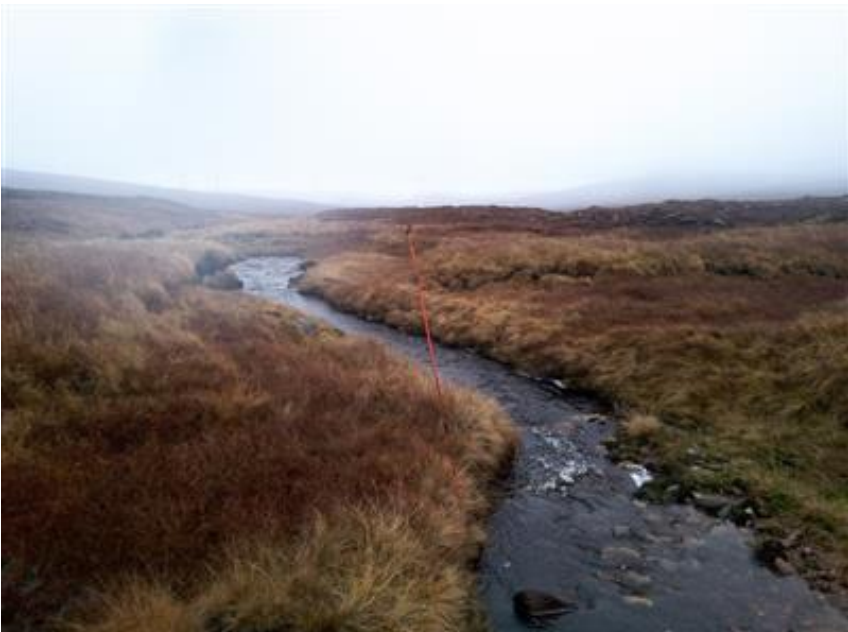
Watercourse Crossing ID	WX11
Watercourse Crossing Details	NGR: NH 48953 01018 Status: New Permanent Track Crossing Watercourse Width: 1.5m Watercourse Depth: 0.3m Notes: Boulders and cobbles noted within the channel bed.
Photograph Looking Upstream

A photograph showing a narrow, shallow watercourse flowing through a landscape of brown, scrubby vegetation. The water is dark and appears to be moving over a rocky or pebbly bed. The sky is overcast and grey.
Photograph Looking Downstream

A photograph showing the same watercourse from a downstream perspective. The water is flowing away from the viewer through the same scrubby landscape. The terrain appears to be a gentle slope.

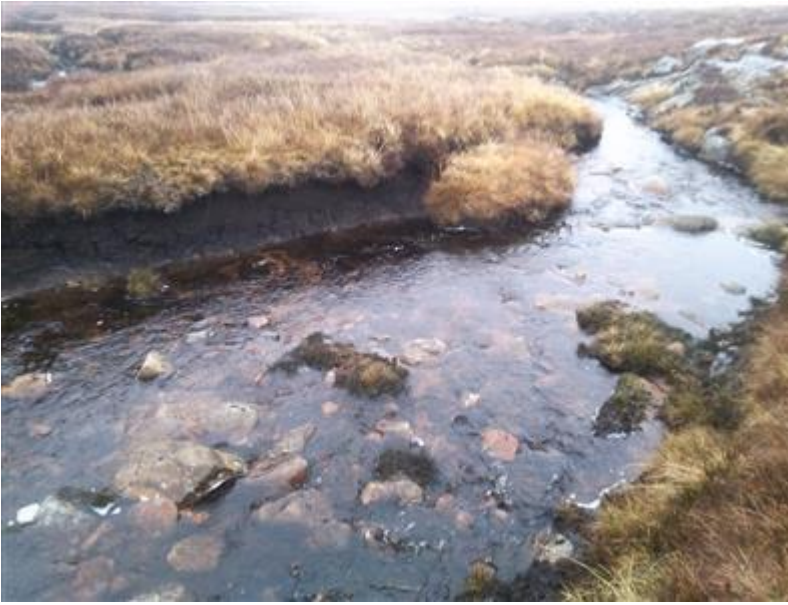
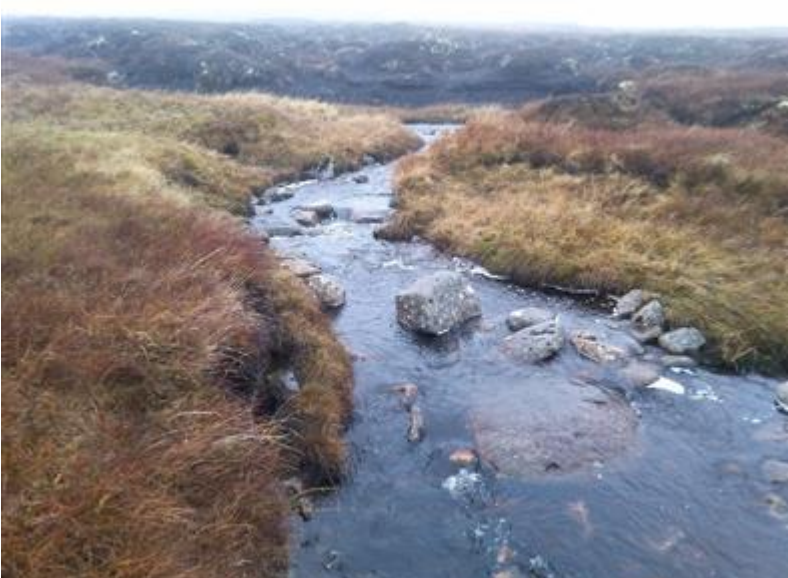
Photograph Looking Downstream

Watercourse Crossing ID	WX12
Watercourse Crossing Details	<p>NGR: NH 49118 00857</p> <p>Status: New Permanent Track Crossing</p> <p>Watercourse Width: 4m</p> <p>Watercourse Depth: 1.2m</p> <p>Notes: Watercourse incised in peat with large boulders noted within the channel.</p>
Photograph Looking Upstream

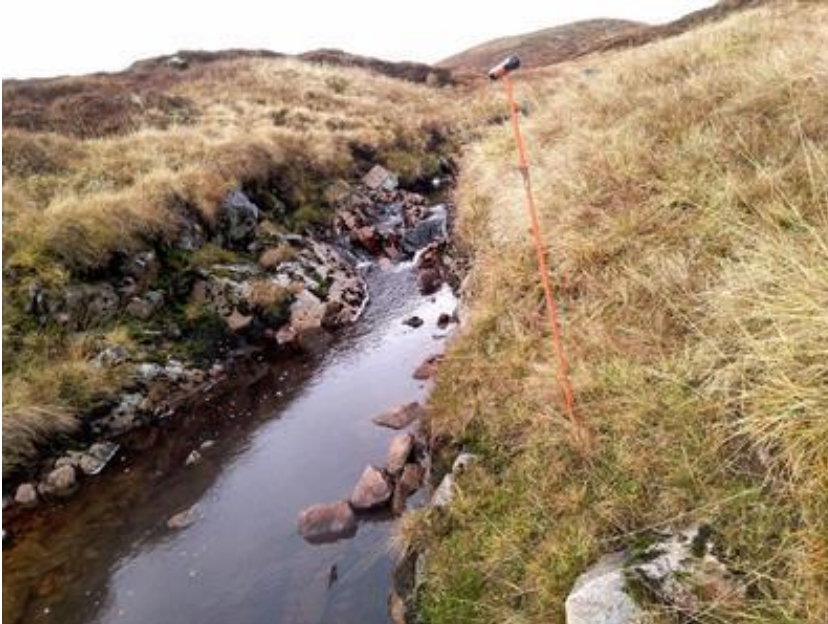
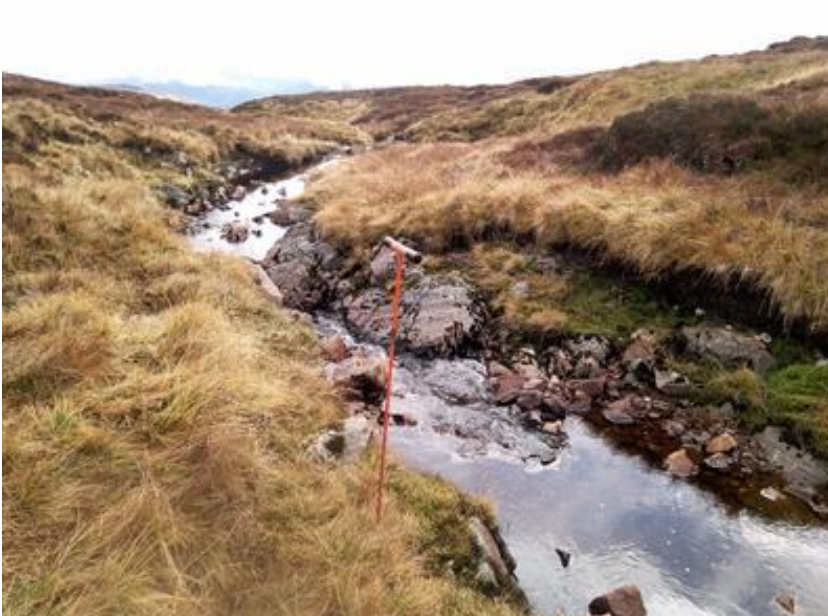
Watercourse Crossing ID	WX13
Watercourse Crossing Details	<p>NGR: NN 50147 99827 Status: New Temporary Track Crossing Watercourse Width: 2m Watercourse Depth: 0.2m Notes: Incised in bedrock with cobbles and boulders noted within the channel.</p>
Photograph Looking Upstream

A photograph showing a narrow, rocky watercourse flowing through a grassy field. The water is dark and reflects the sky. The banks are covered in tall, dry grass and scattered rocks. A red surveying pole is visible on the right bank, extending into the water.
Photograph Looking Downstream

A photograph showing a rocky watercourse flowing through a grassy field, viewed from a downstream perspective. The water is dark and reflects the sky. The banks are covered in tall, dry grass and scattered rocks. A red surveying pole is visible on the left bank, extending into the water.

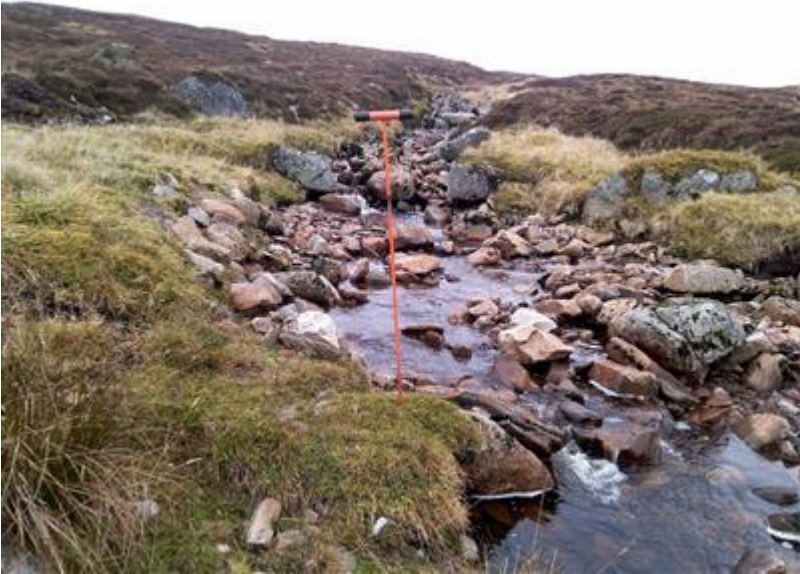
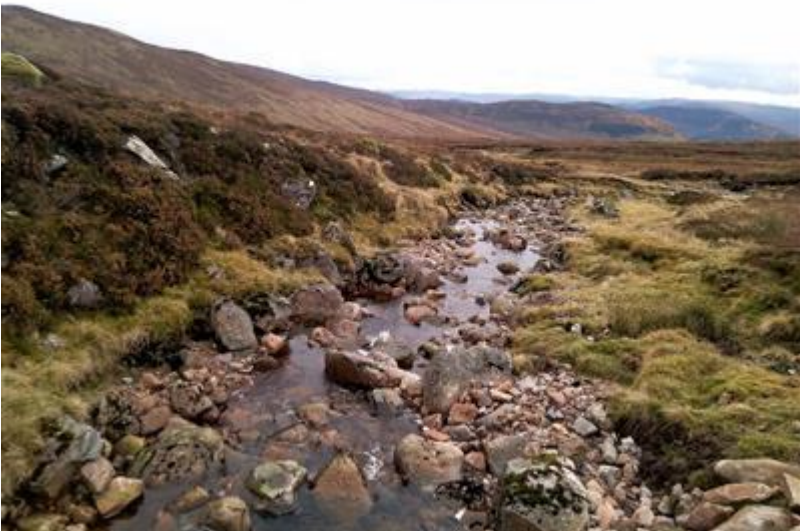
Watercourse Crossing ID	WX14
Watercourse Crossing Details	NGR: NN 50580 98856 Status: New Permanent Track Crossing Watercourse Width: 5 to 6m Watercourse Depth: 0.2m Notes: Rock bed.
Photograph Looking Upstream

A photograph showing a rocky watercourse crossing in a rural landscape. The water is shallow and flows over a bed of large, reddish-brown rocks. A red surveying pole is positioned in the water, likely for measurement. The surrounding area is covered in grass and low-lying vegetation, with hills in the background under a cloudy sky.
Photograph Looking Downstream

A photograph showing a rocky watercourse crossing from a downstream perspective. The water flows over a bed of large, reddish-brown rocks. The surrounding area is covered in grass and low-lying vegetation, with hills in the background under a cloudy sky.

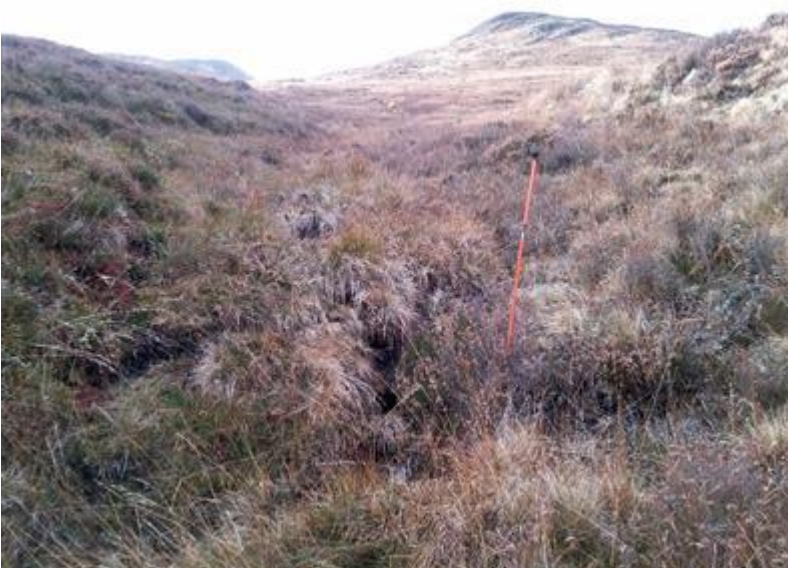
Watercourse Crossing ID	WX16
Watercourse Crossing Details	NGR: NN 51124 97543 Status: New Temporary Track Crossing Watercourse Width: 0.6m Watercourse Depth: 0.2m Notes: Minor watercourse with reeds and peaty soils.
Photograph Looking Upstream

A landscape photograph showing a valley with a watercourse. The terrain is covered in dense, tall grasses and reeds, typical of peaty soils. In the background, there are rolling hills under a clear sky. A red survey pole is visible in the middle ground, marking a point along the watercourse.
Photograph Looking Downstream	  A landscape photograph showing a valley with a watercourse, viewed from a different angle than the upstream view. The terrain is covered in dense, tall grasses and reeds. A red survey pole is visible in the middle ground, marking a point along the watercourse. The background shows rolling hills.

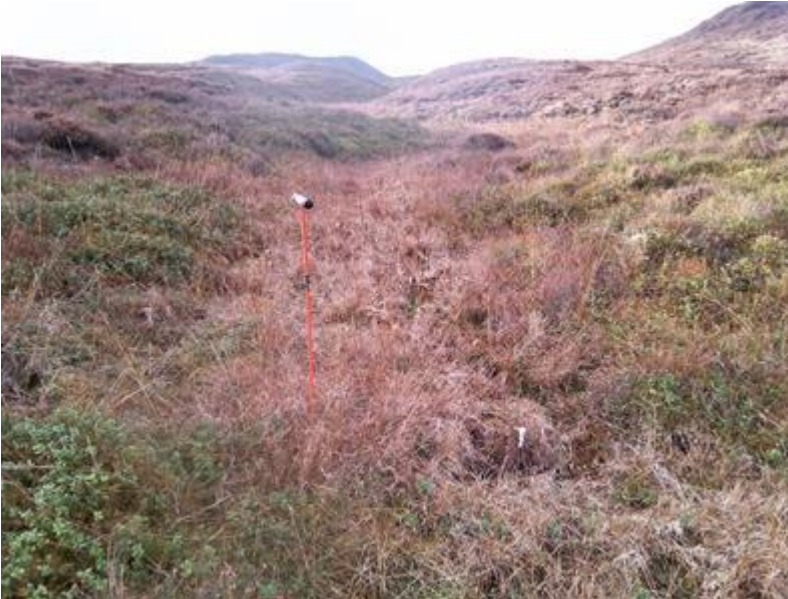
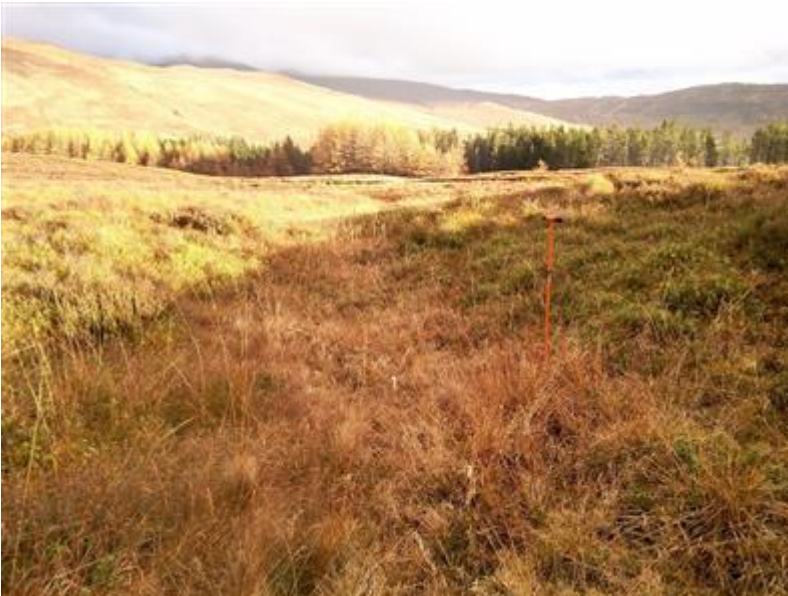
Watercourse Crossing ID	WX17
Watercourse Crossing Details	<p>NGR: NN 51119 97337</p> <p>Status: New Permanent Track Crossing</p> <p>Watercourse Width: N/A</p> <p>Watercourse Depth: N/A</p> <p>Notes: No visible watercourse noted during survey. Wider channel is between 1.5 to 2m wide and 0.3m high with peaty soils and reeds.</p>
Photograph Looking Upstream

<p>A landscape photograph showing a valley with a red survey pole in the foreground. The terrain is covered in dense, brownish vegetation, likely reeds or peaty soils. The background shows rolling hills under a clear sky.</p>
Photograph Looking Downstream

<p>A landscape photograph showing a field with a red survey pole in the foreground. The field is covered in tall, golden-brown grasses. In the background, there is a line of trees and rolling hills under a cloudy sky.</p>
