1. TECHNICAL ANNEX 7.3: PEAT LANDSLIDE HAZARD AND RISK ASSESSMENT

This Technical Annex (TA) presents the Peat Landslide Hazard and Risk Assessment (PLHRA) for the construction and operation of a Tie-In connection to the proposed Creag Dhubh Substation from the existing 132 kV Inveraray to Taynuilt Overhead Line (OHL), as well as the temporary diversion of the existing 132 kV Taynuilt to Inveraray OHL to facilitate its connection to the substation and associated ancillary works. The Proposed Development would be located approximately 2.5 km south west of Cladich, Argyll and Bute (the 'Peat Study Area, 'PSA Site'), as illustrated in **Figure 7.3.1** of this TA.

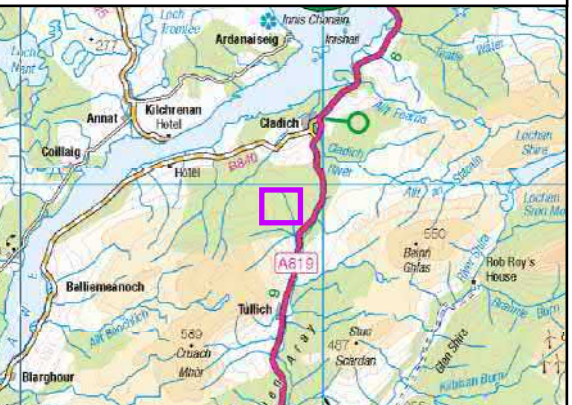
Figure 7.3.2: Peat Landslide Hazard and Risk Assessment:
Proposed Development Layout

- Proposed Creag Dhubh to Dalmally 275kV Connection Towers
- Proposed Creag Dhubh to Dalmally 275kV Connection
- Proposed Creag Dhubh Substation

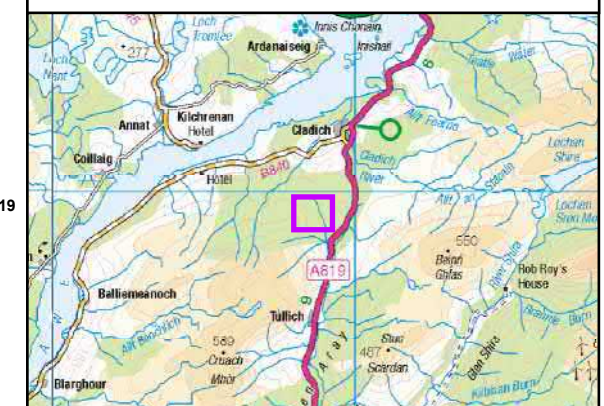
Figure 7.3.6: Peat Landslide Hazard and Risk Assessment:
Bedrock Geology

BGS Bedrock Geology 50k

- Tayvallich Volcanic Formation - Metalava and Metatuff

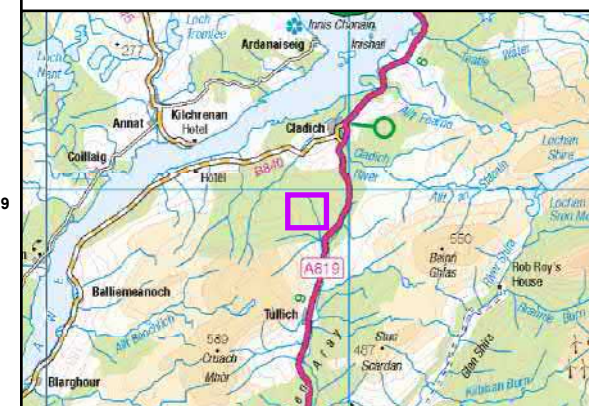
Figure 7.3.7: Peat Landslide Hazard and Risk Assessment:
Superficial Geology

Superficial Geology (BGS 625k)

- Till

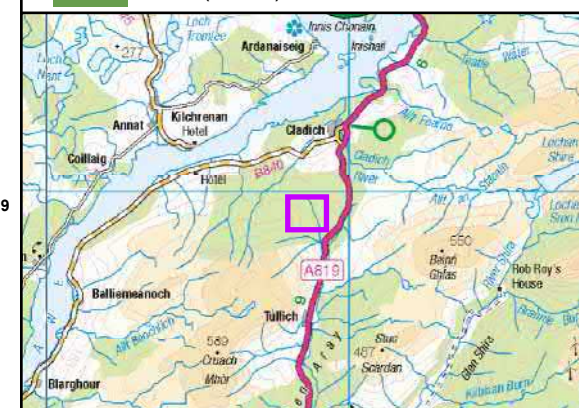
Figure 7.3.9: Peat Landslide Hazard and Risk Assessment:
Factor of Safety

Factor of Safety

- < 1.0 (unstable)
- 1.0 - 1.4 (marginally unstable)
- 1.4 - 2.0 (stable)
- 2.0 - 3.0 (stable)
- > 3.0 (stable)

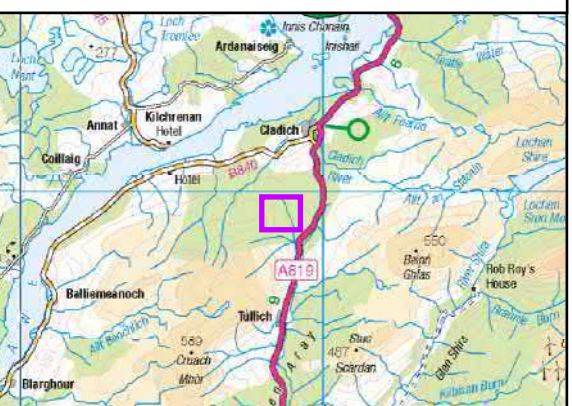
Drainage Scores (D)

- Score 0: No drainage lines
- Score 1: Drain aligned to slope

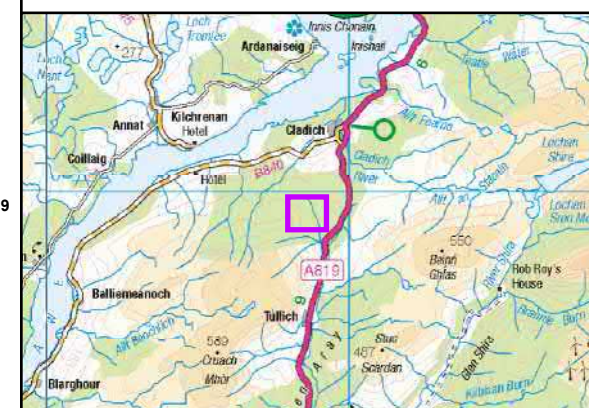
Forestry Scores (F)

- Score 0: Not afforested
- Score 1: Afforested aligned
- Score 2: Deforested aligned

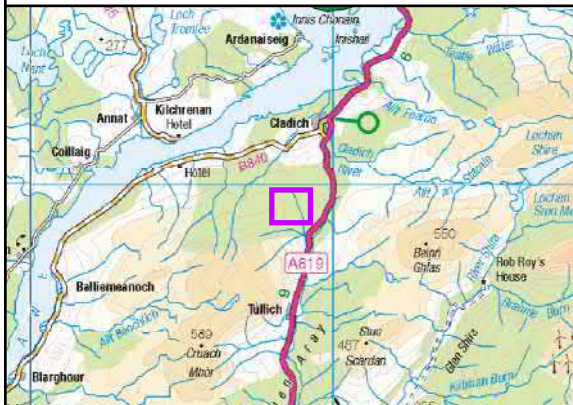
Figure 7.3.11: Peat Landslide Hazard and Risk
Assessment: Peat Slide Likelihood

Summed Score / Likelihood Score

- 2 - 6 (Very Low, 1)
- 7 - 11 (Low, 2)
- 12 - 16 (Moderate, 3)
