**AN SUIDHE SUBSTATION
ENVIRONMENTAL APPRAISAL**

ANNEX O

PEAT LANDSLIDE HAZARD AND RISK ASSESSMENT

JULY 2022

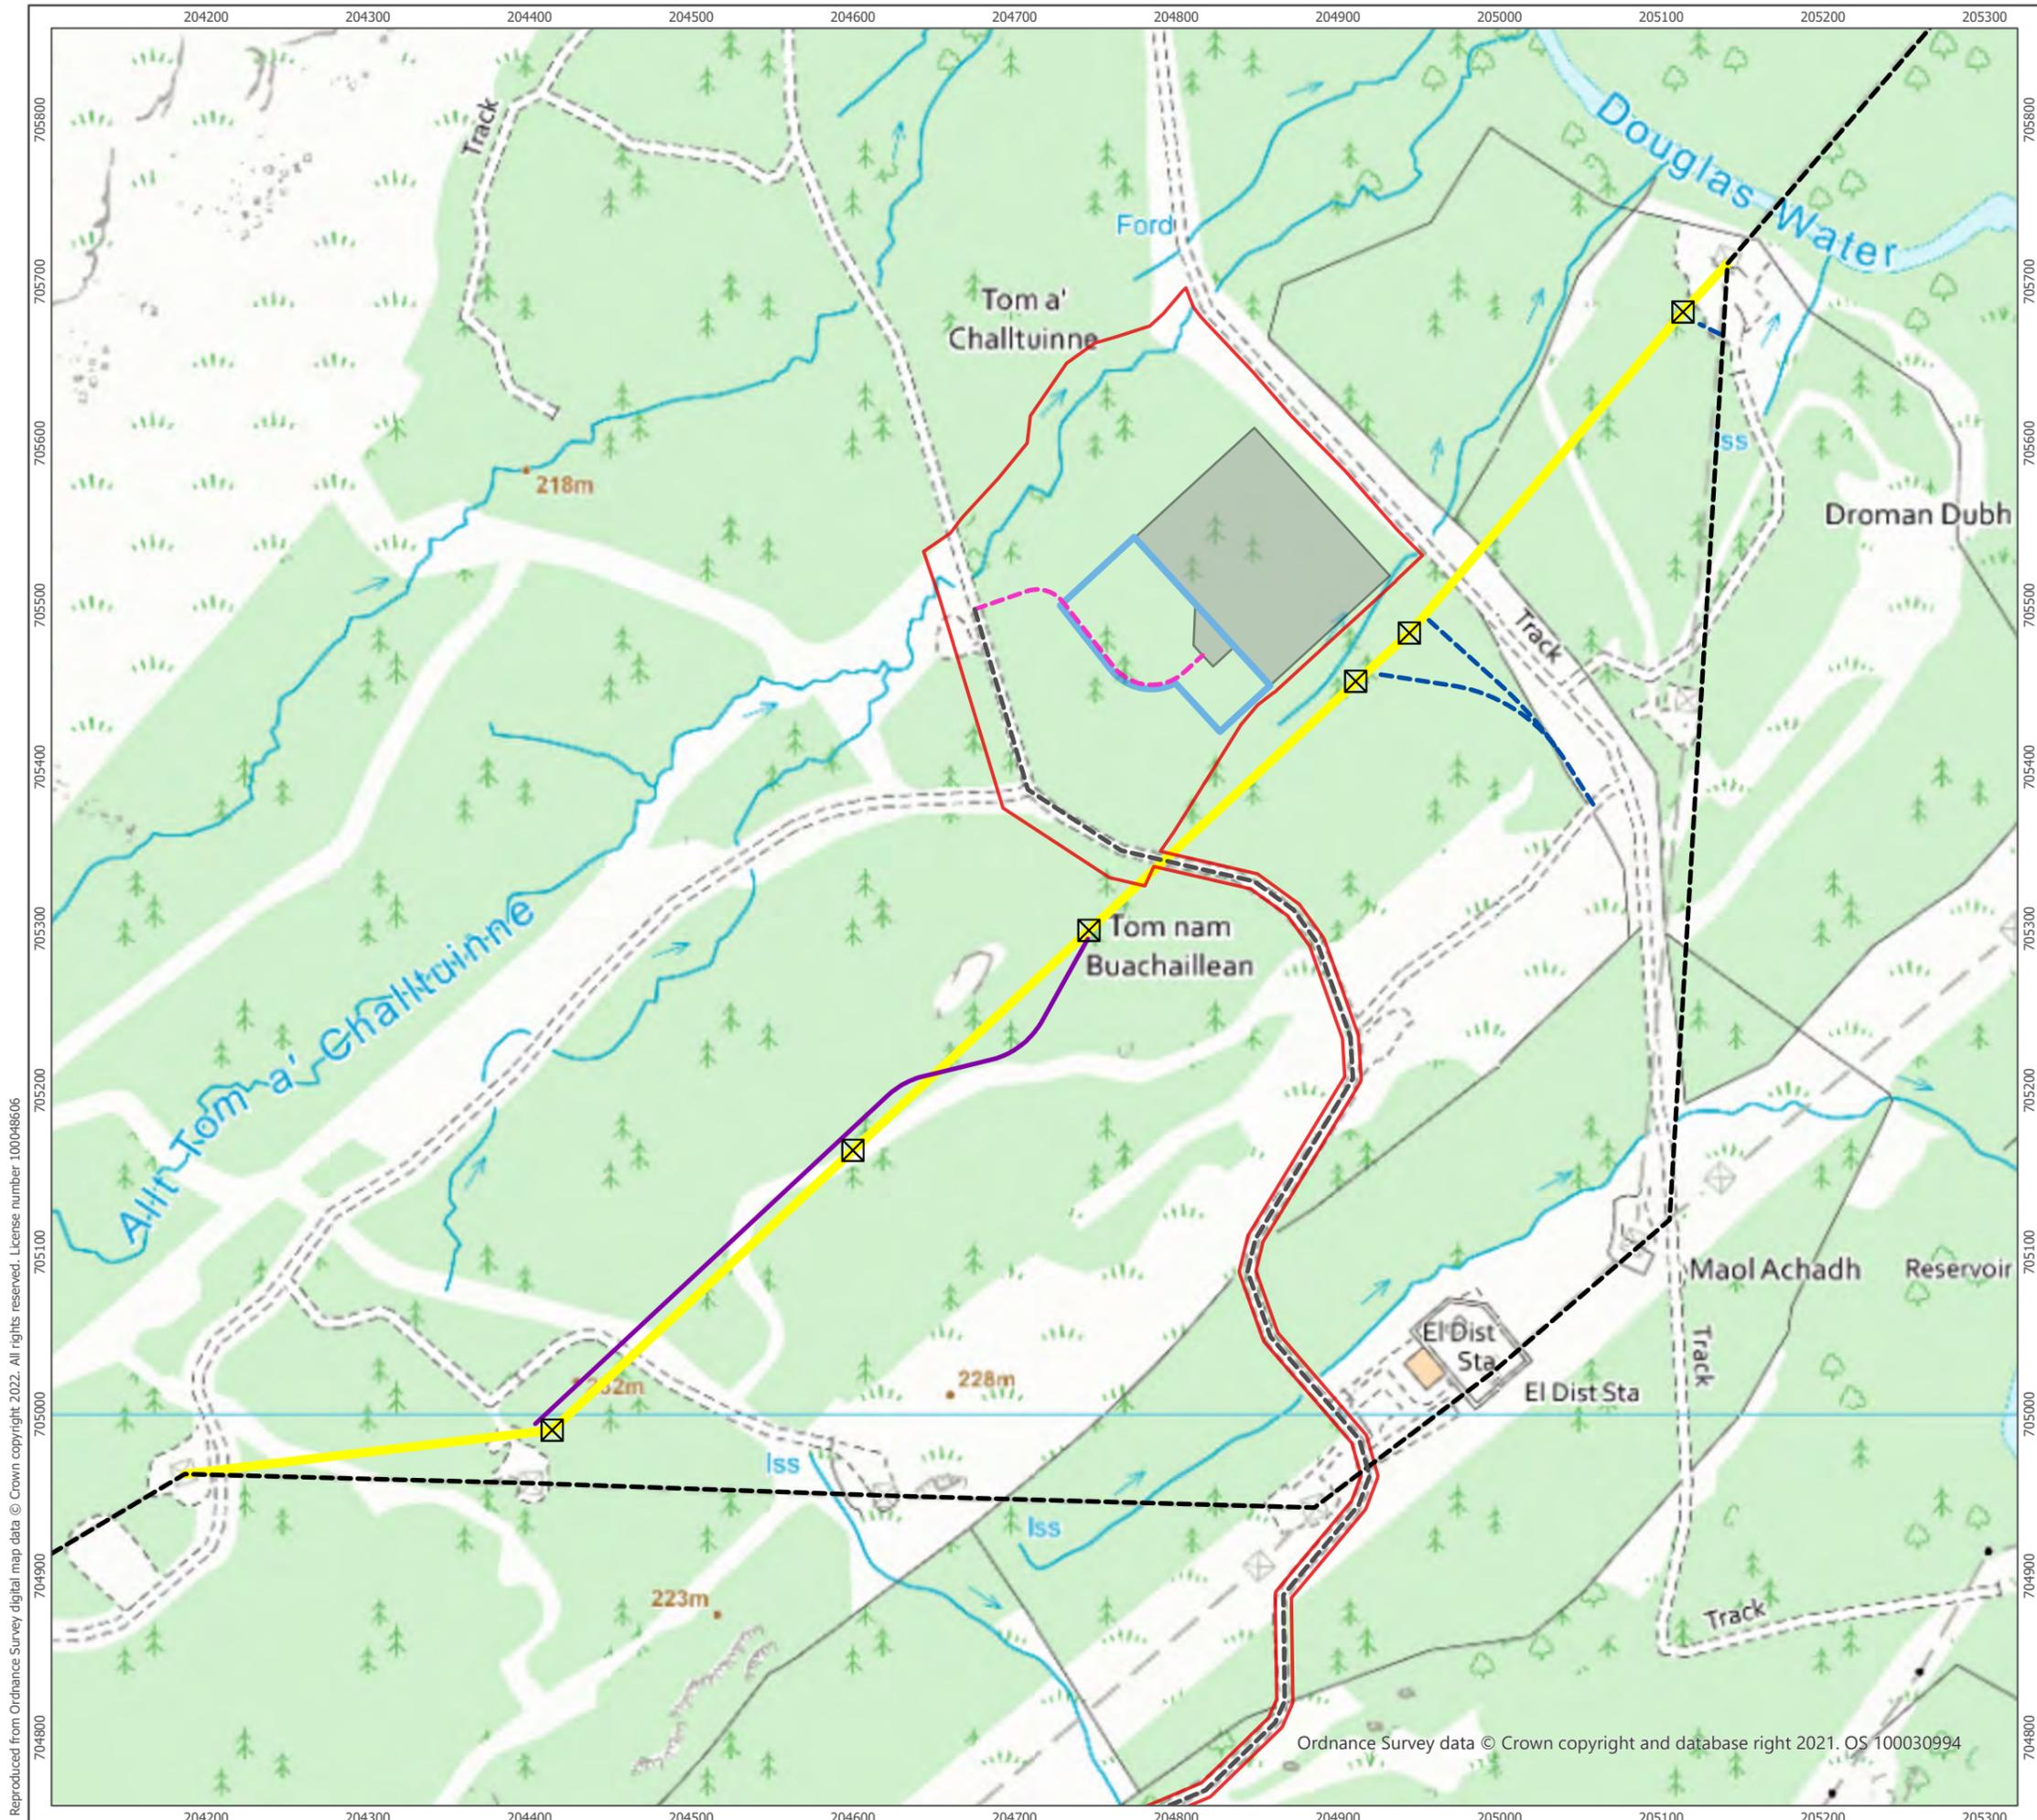
- Existing Inveraray to Crossaig Overhead Line
- Existing Access Track
- Proposed Development**
- ▭ Indicative Town and Country Planning Boundary
- ▭ Proposed Substation Temporary Works Area
- ▭ Proposed Substation Layout
- Proposed Permanent Access Track
- Associated Development**
- Proposed Permanent Access Track
- Proposed Temporary Tracks
- Proposed OHL Alignment
- ⊠ Tower Location

The new substation and accompanying infrastructure aspects (hereby known as the Proposed Development) will be subject to Town and Country Planning, while the OHL Tie-Ins and accompanying towers (hereby known as the Associated Development) will be submitted for Section 37 consent. The Site Layout Plan is shown on **Figure 1** in **Appendix A**.

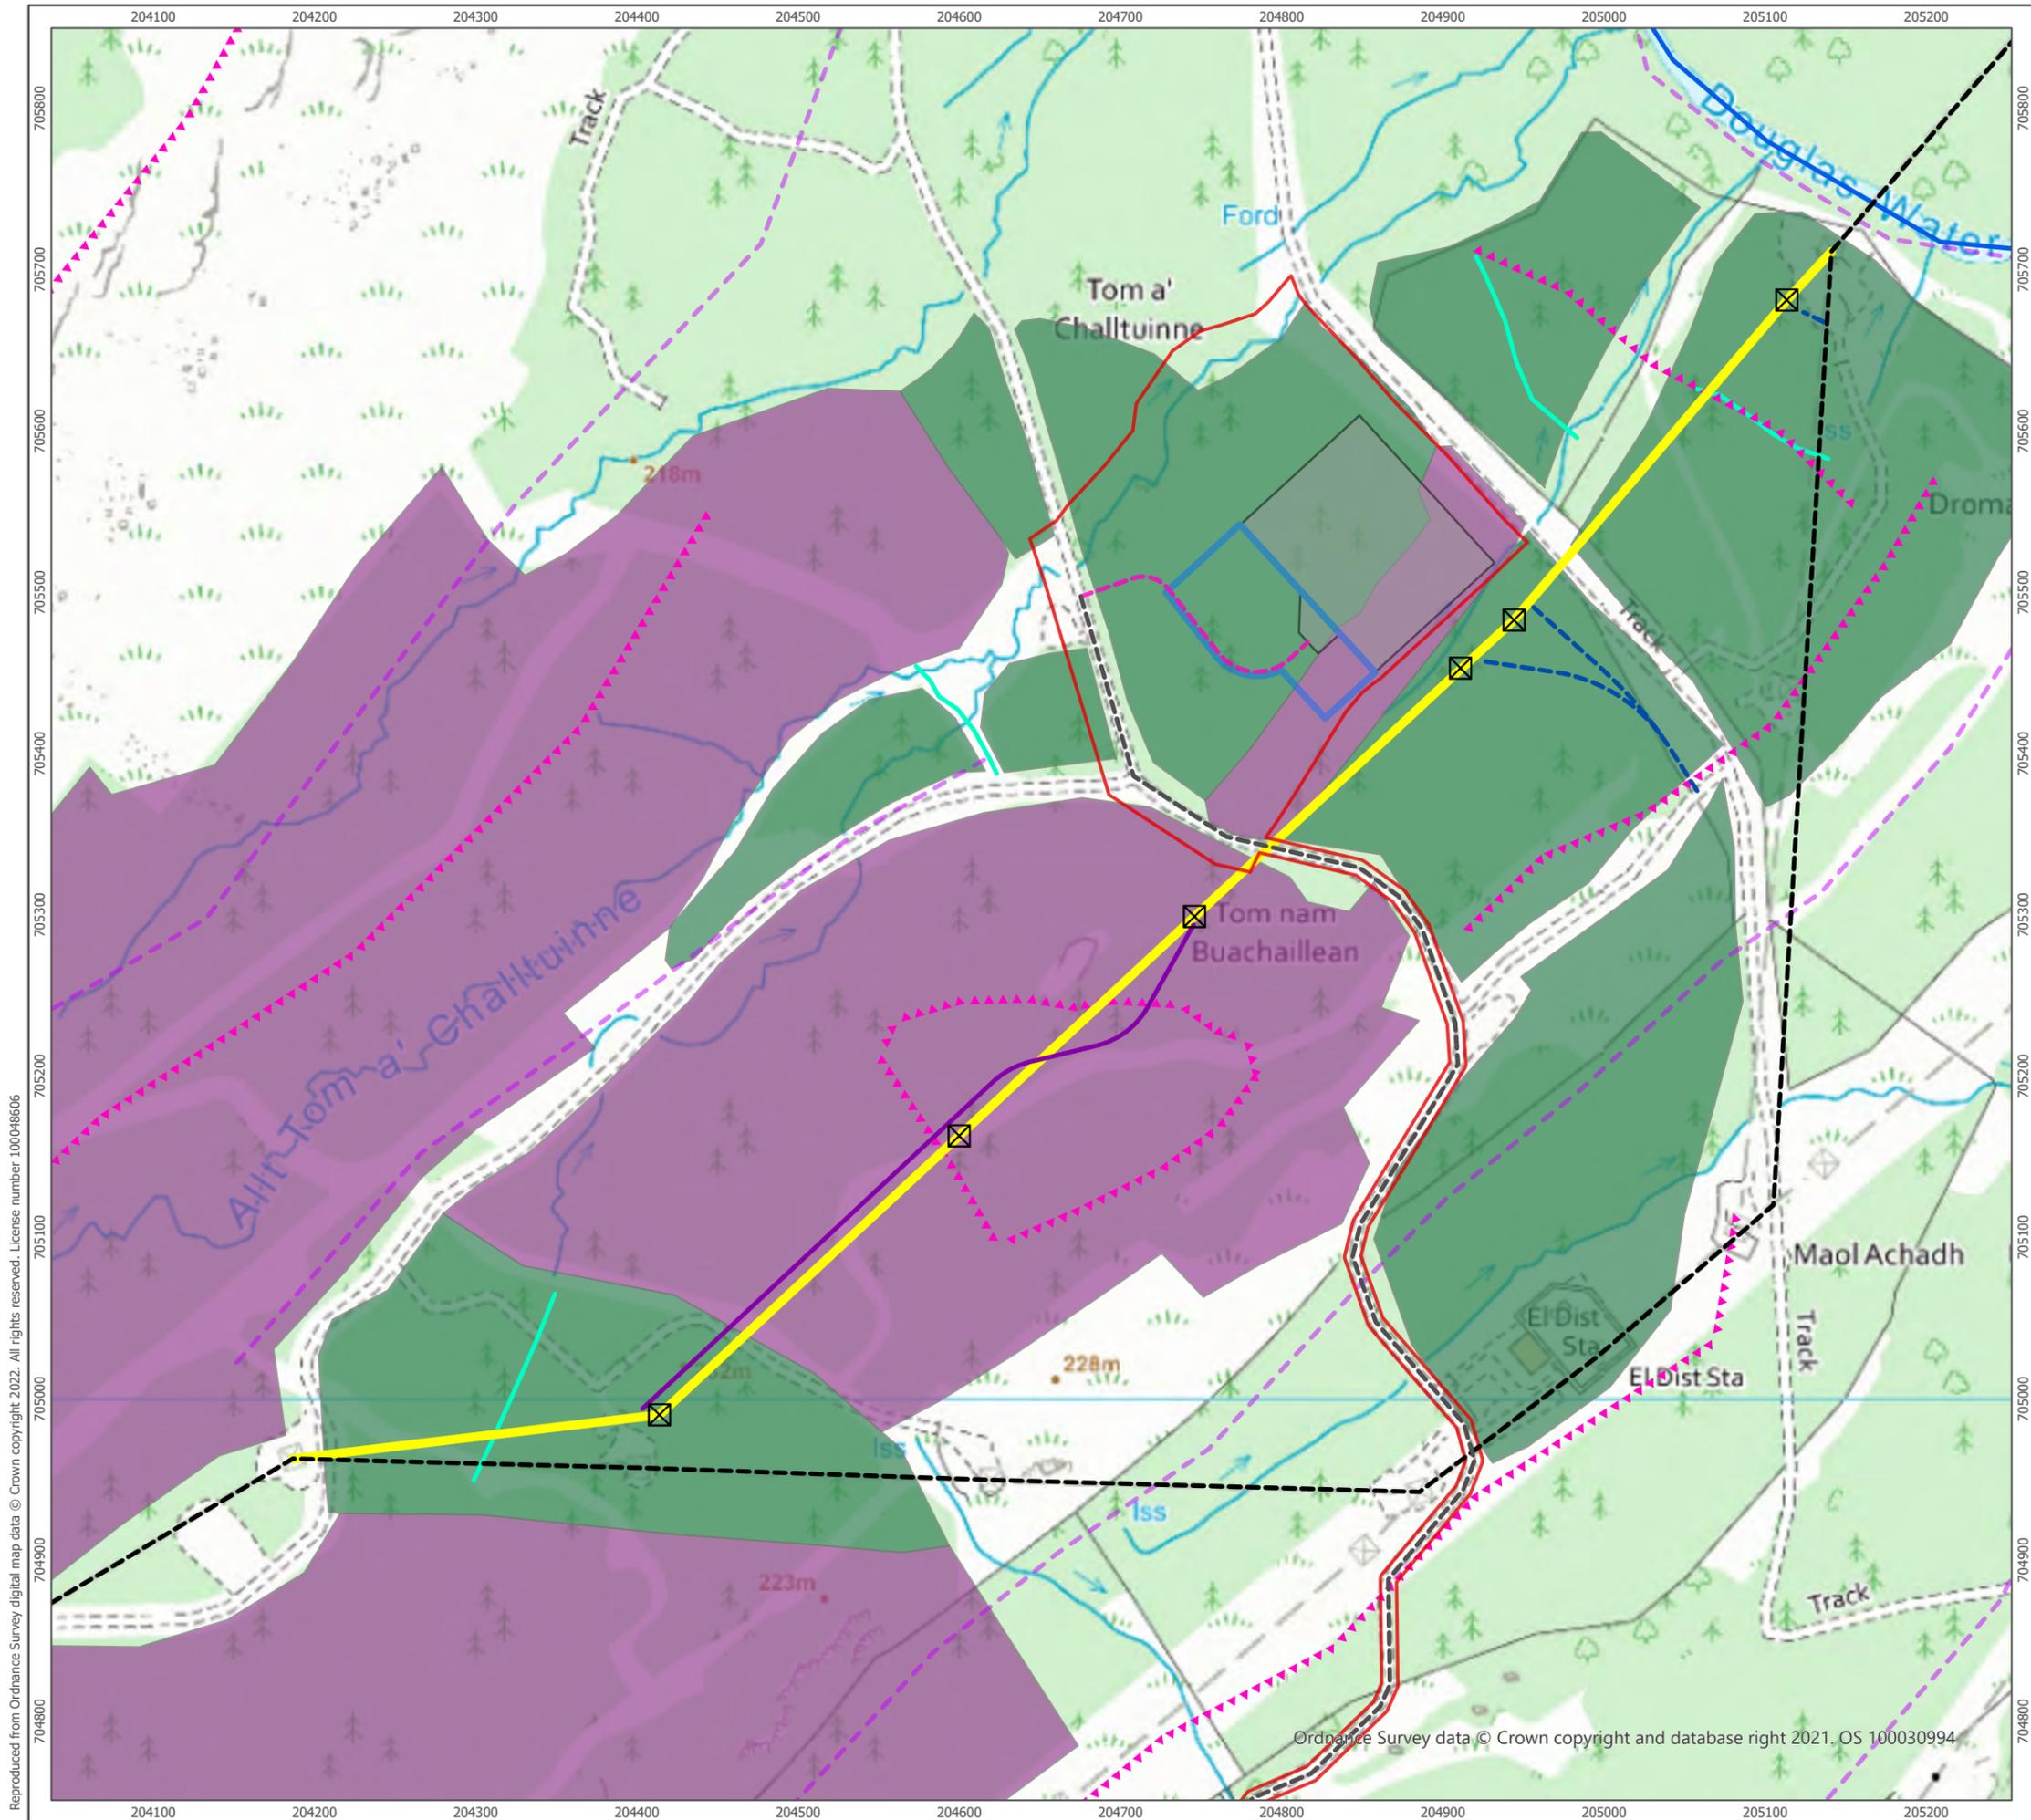
- Existing Access Track
- Existing Inveraray to Crossaig Overhead Line
- Proposed Development**
- ▭ Indicative Town and Country Planning Boundary
- ▭ Proposed Substation Temporary Works Area
- ▭ Proposed Substation Layout
- Proposed Permanent Access Track
- Associated Development**
- Proposed Permanent Access Track
- Proposed Temporary Tracks
- Proposed OHL Alignment
- ⊠ Tower Location
- Geomorphology**
- ▽ Top of Slope
- Bottom of Slope
- Artificial Drainage
- Major Watercourse
- Deforested Area
- Mature Forestry

Vegetation cover and evidence of instability or potential instability were assessed during site surveys and, alongside satellite photography, informed the Geomorphology Map presented in **Figure 4**. This information was also considered during the adoption of hazard zones across the Site, which are presented in **Figure 9**: Hazard Rank Zonation Plan.

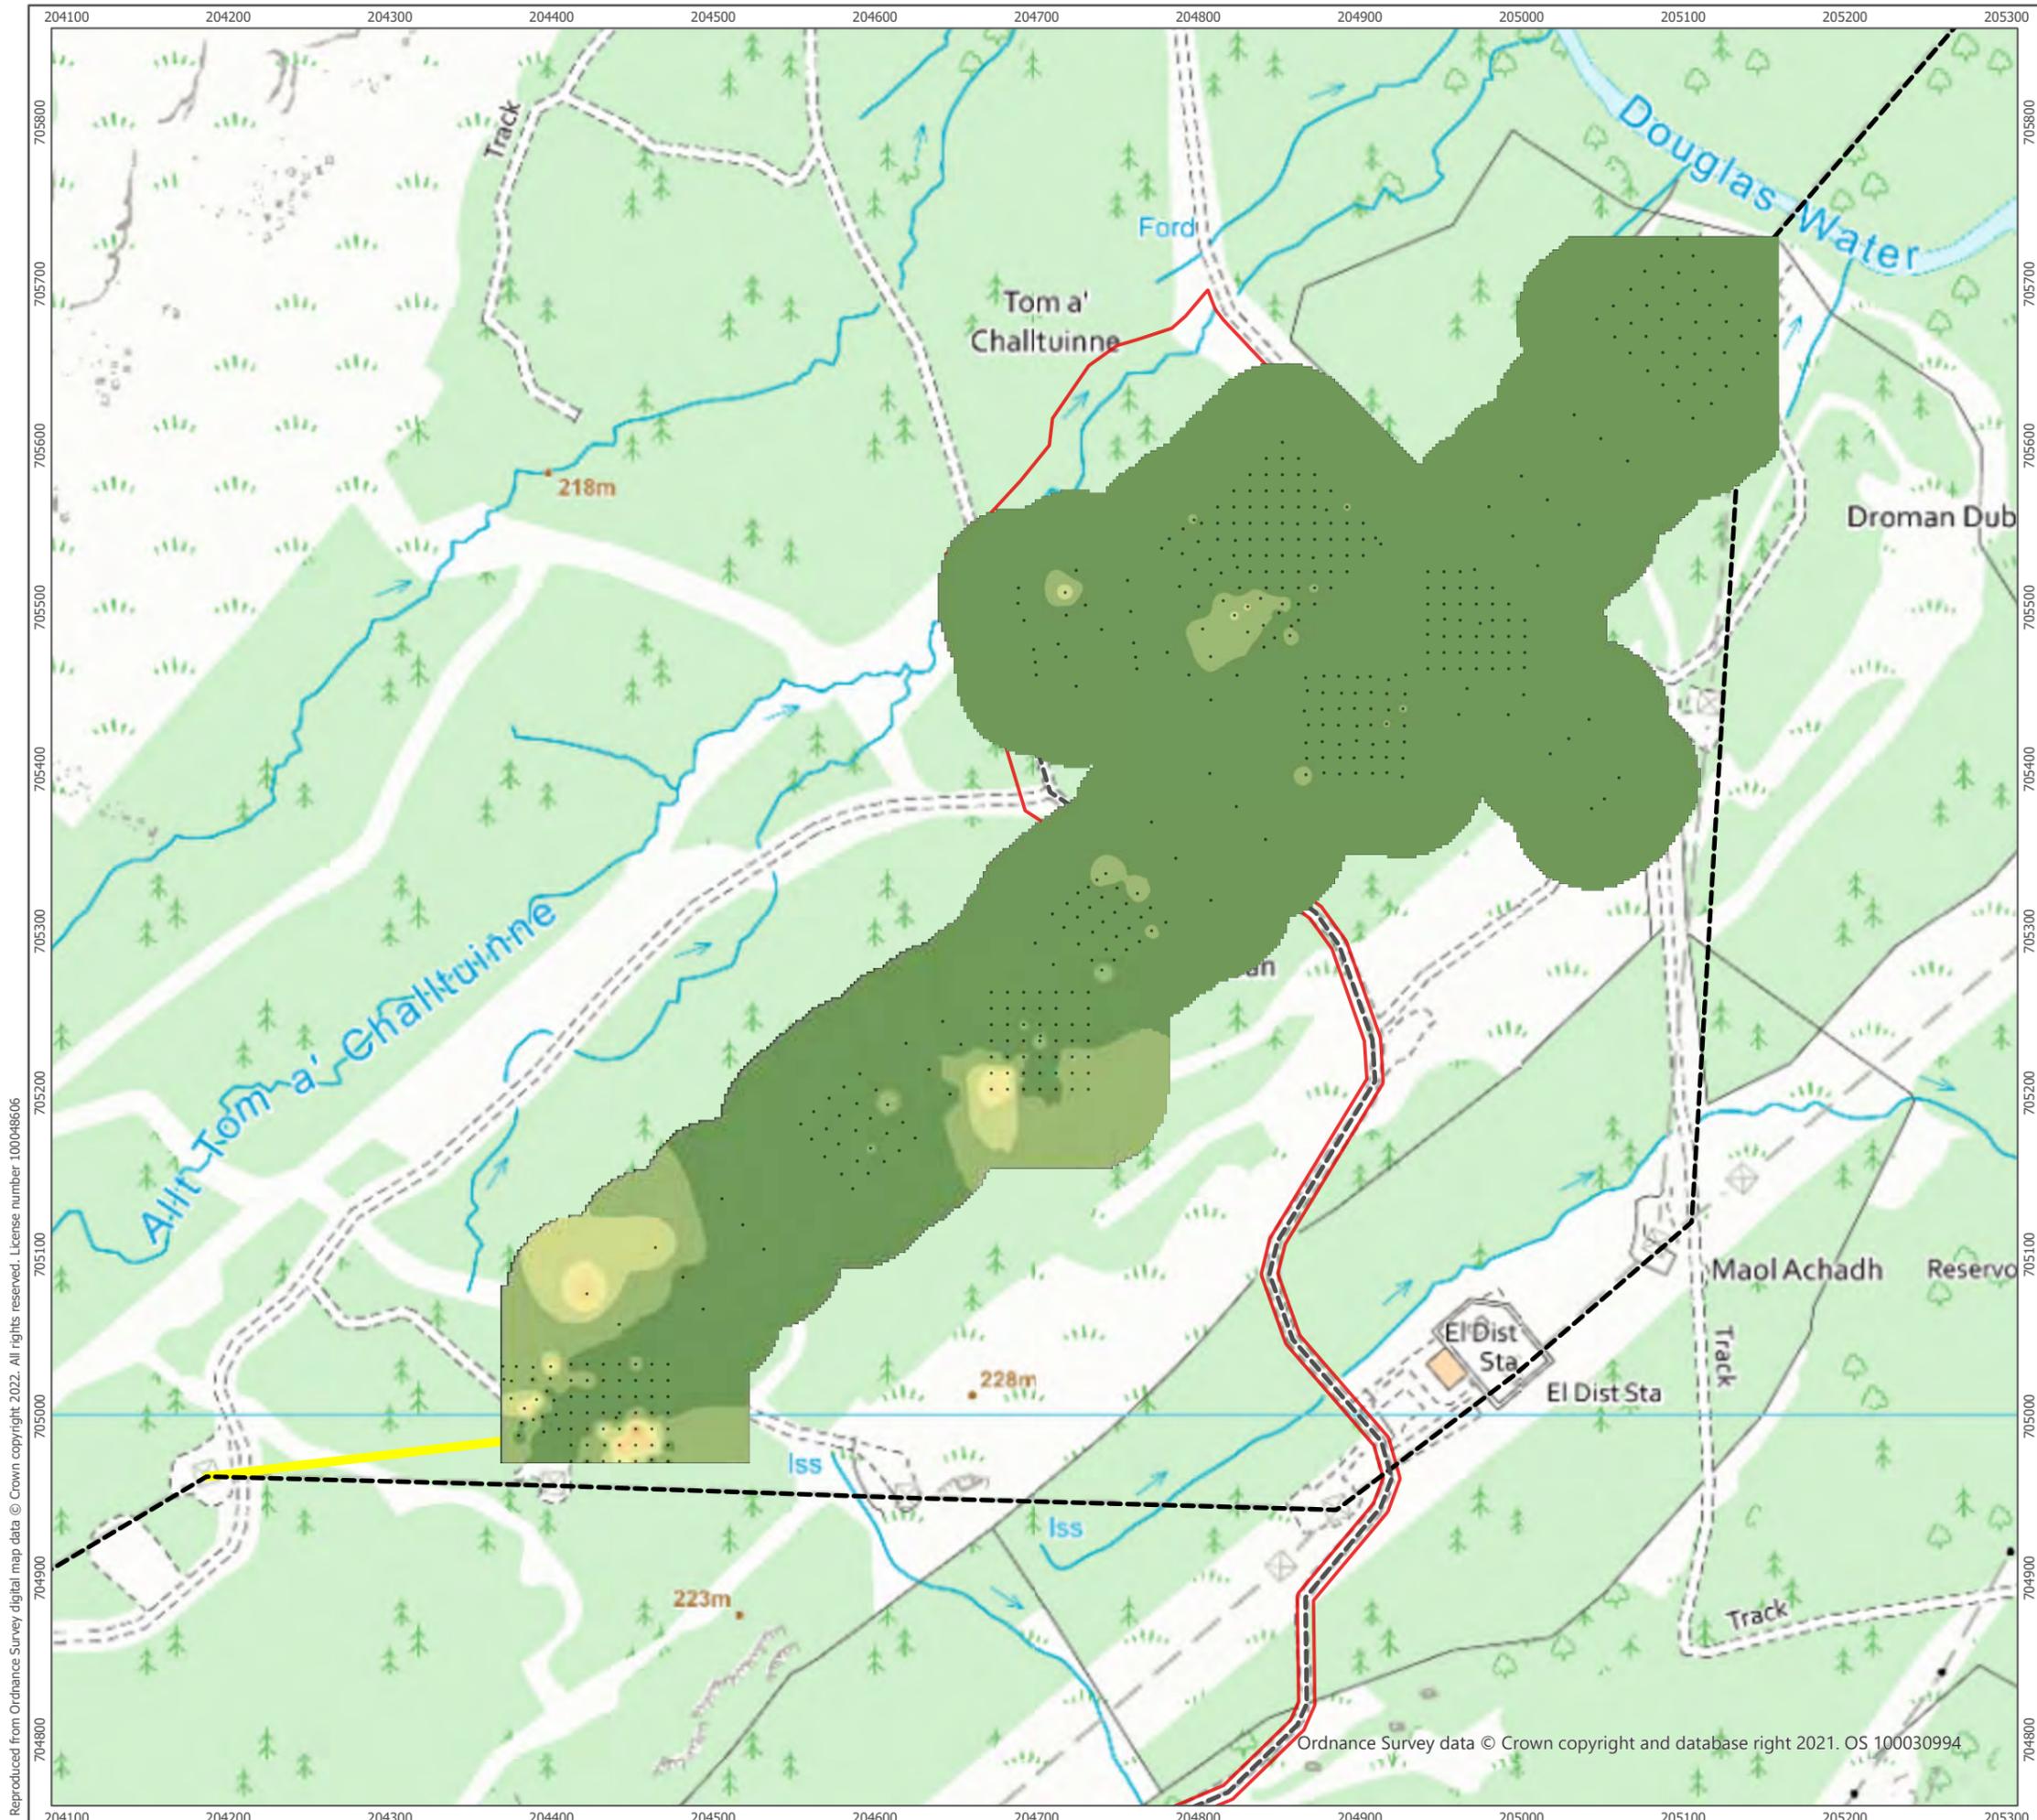
- Existing Access Track
- Existing Inveraray to Crossaig Overhead Line
- Peat Probe Location
- Proposed Development**
- ▭ Indicative Town and Country Planning Boundary
- ▭ Proposed Substation Temporary Works Area
- ▭ Proposed Substation Layout
- Proposed Permanent Access Track
- Associated Development**
- Proposed Permanent Access Track
- Proposed Temporary Tracks
- Proposed OHL Alignment
- ⊠ Tower Location
- Interpolated Peat Depths (m)**
- 0.00 - 0.50
- 0.51 - 1.00
- 1.01 - 1.50
- 1.51 - 2.00
- 2.01 - 2.50
- 2.51 - 3.00
- 3.01 - 3.50
- 3.51 - 4.00

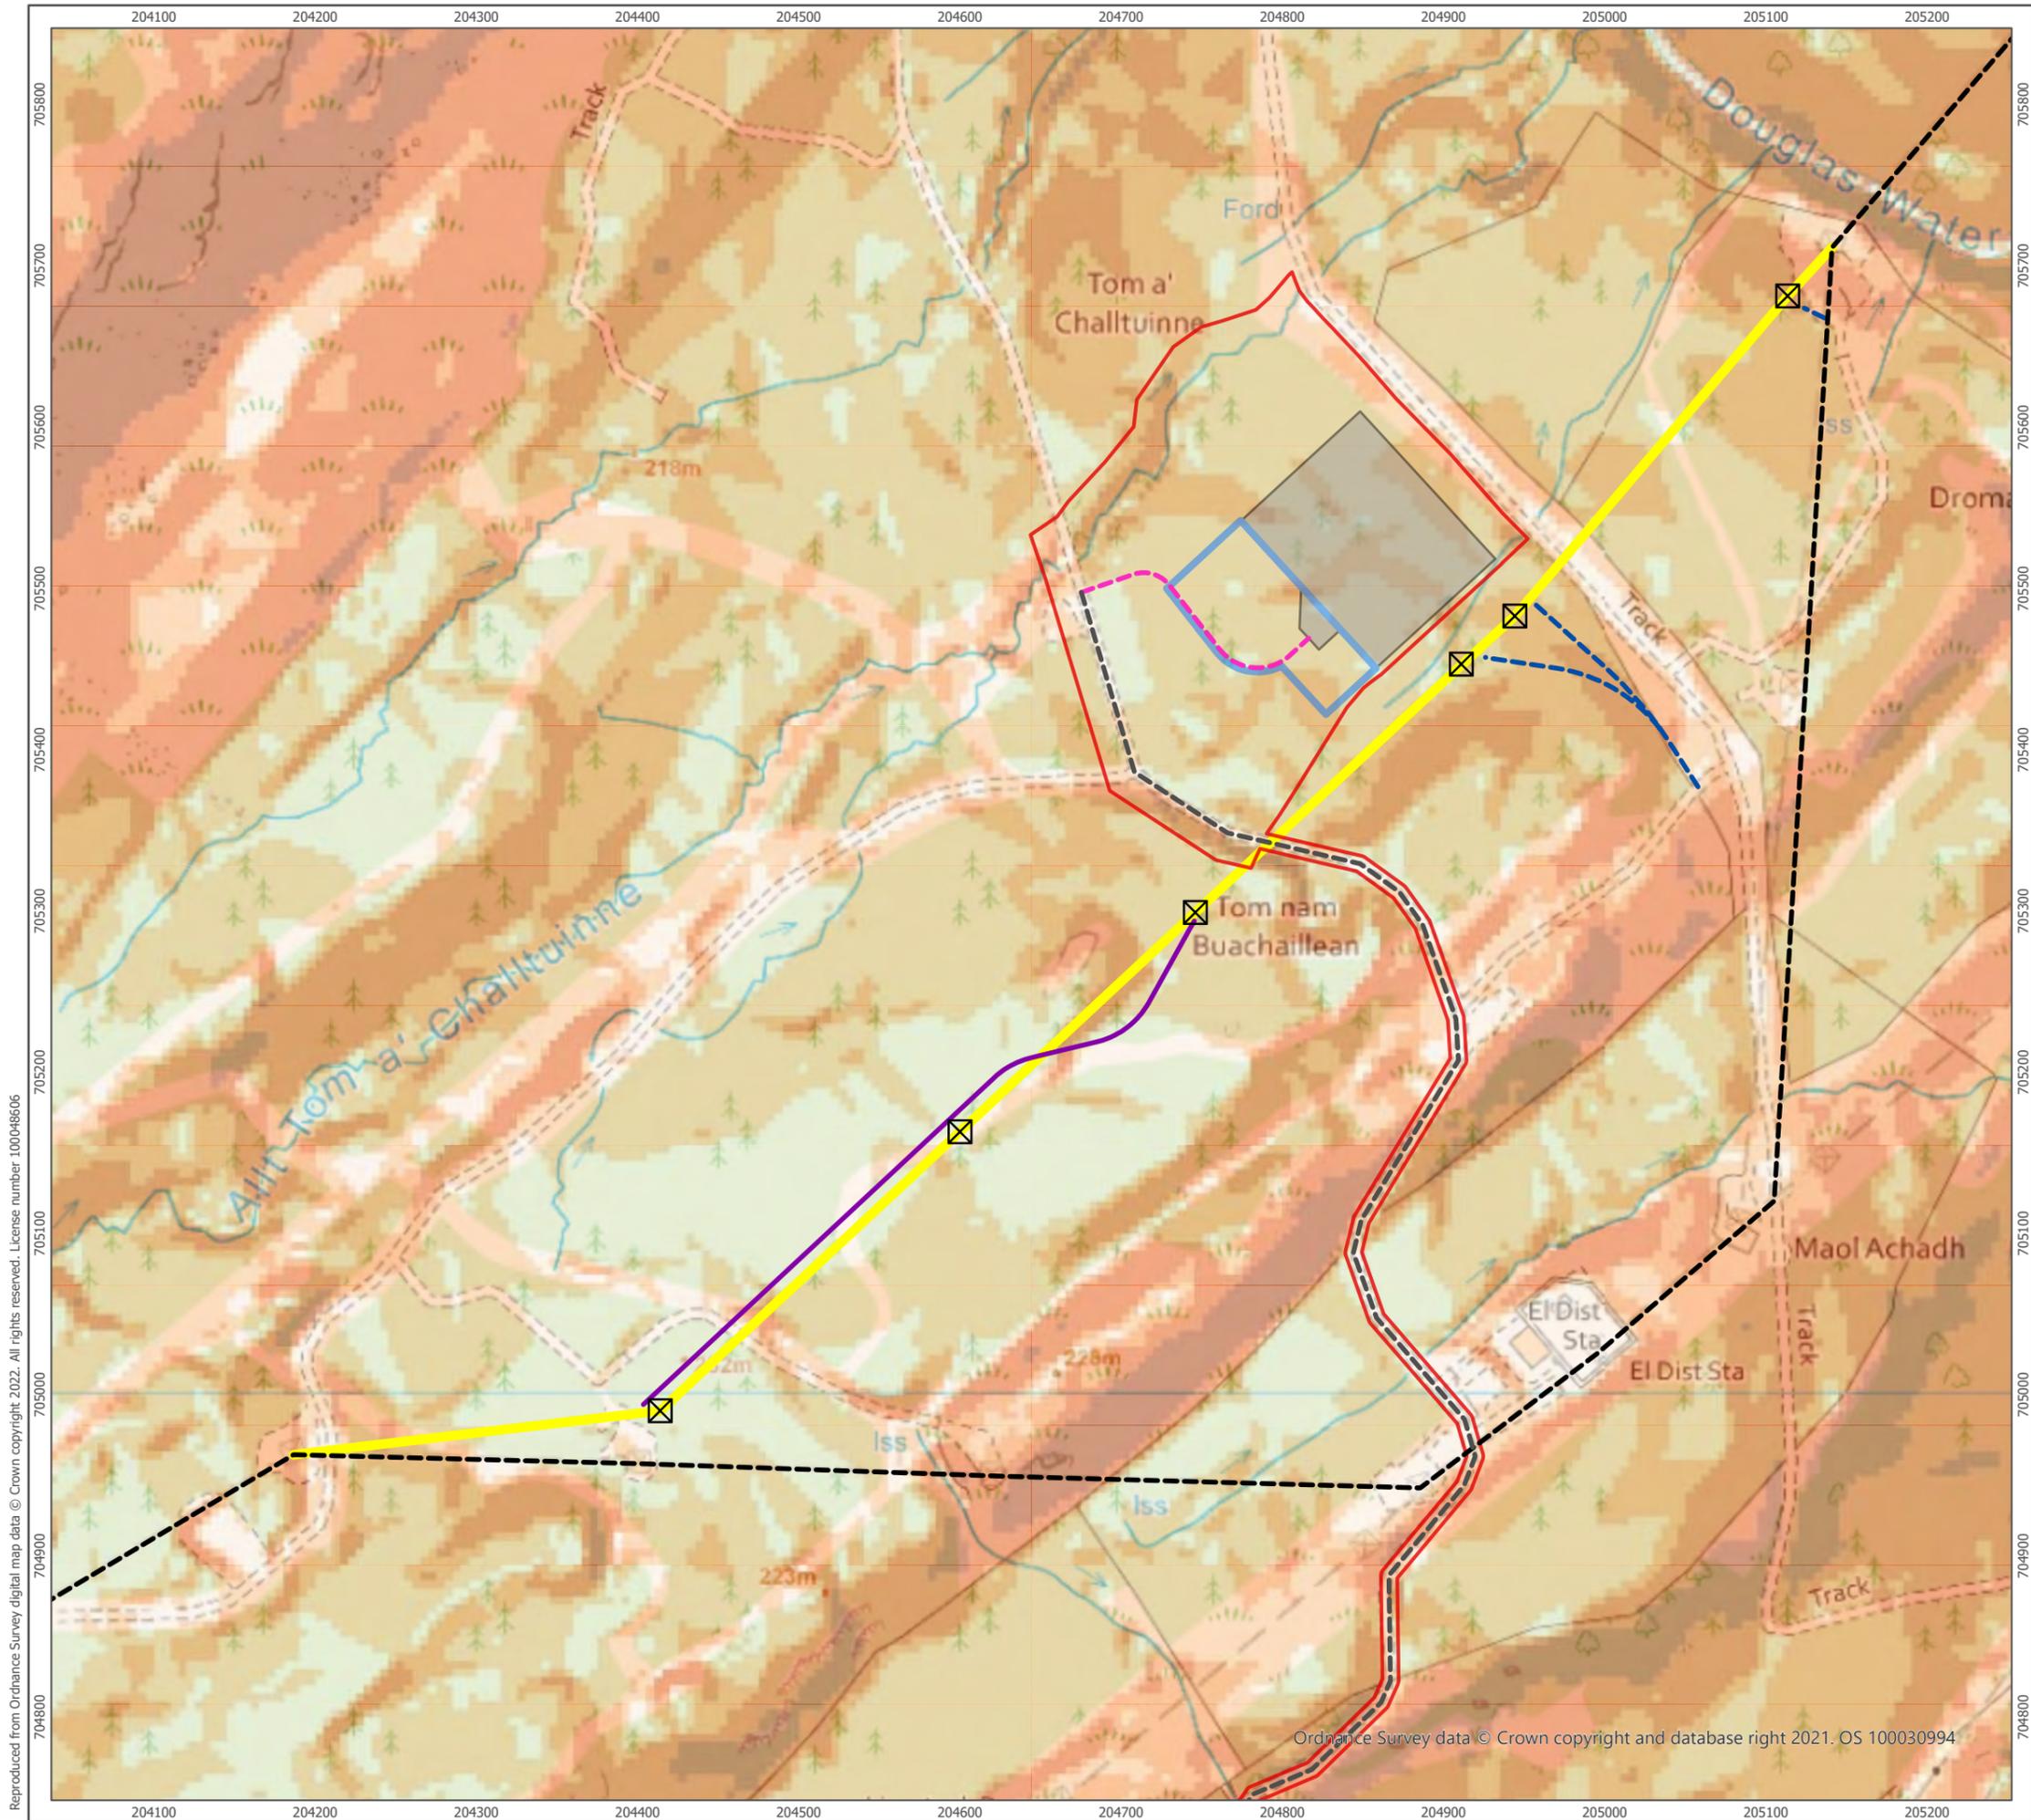
- Existing Access Track
- Existing Inveraray to Crossaig Overhead Line
- Proposed Development**
- Indicative Town and Country Planning Boundary
- Proposed Substation Temporary Works Area
- Proposed Substation Layout
- Proposed Permanent Access Track
- Associated Development**
- Proposed Permanent Access Track
- Proposed Temporary Tracks
- Proposed OHL Alignment
- X Tower Location
- Slope Gradient (degrees)**
- 0 - 5
- 5 - 10
- 10 - 15
- 15 - 30
- 30 +

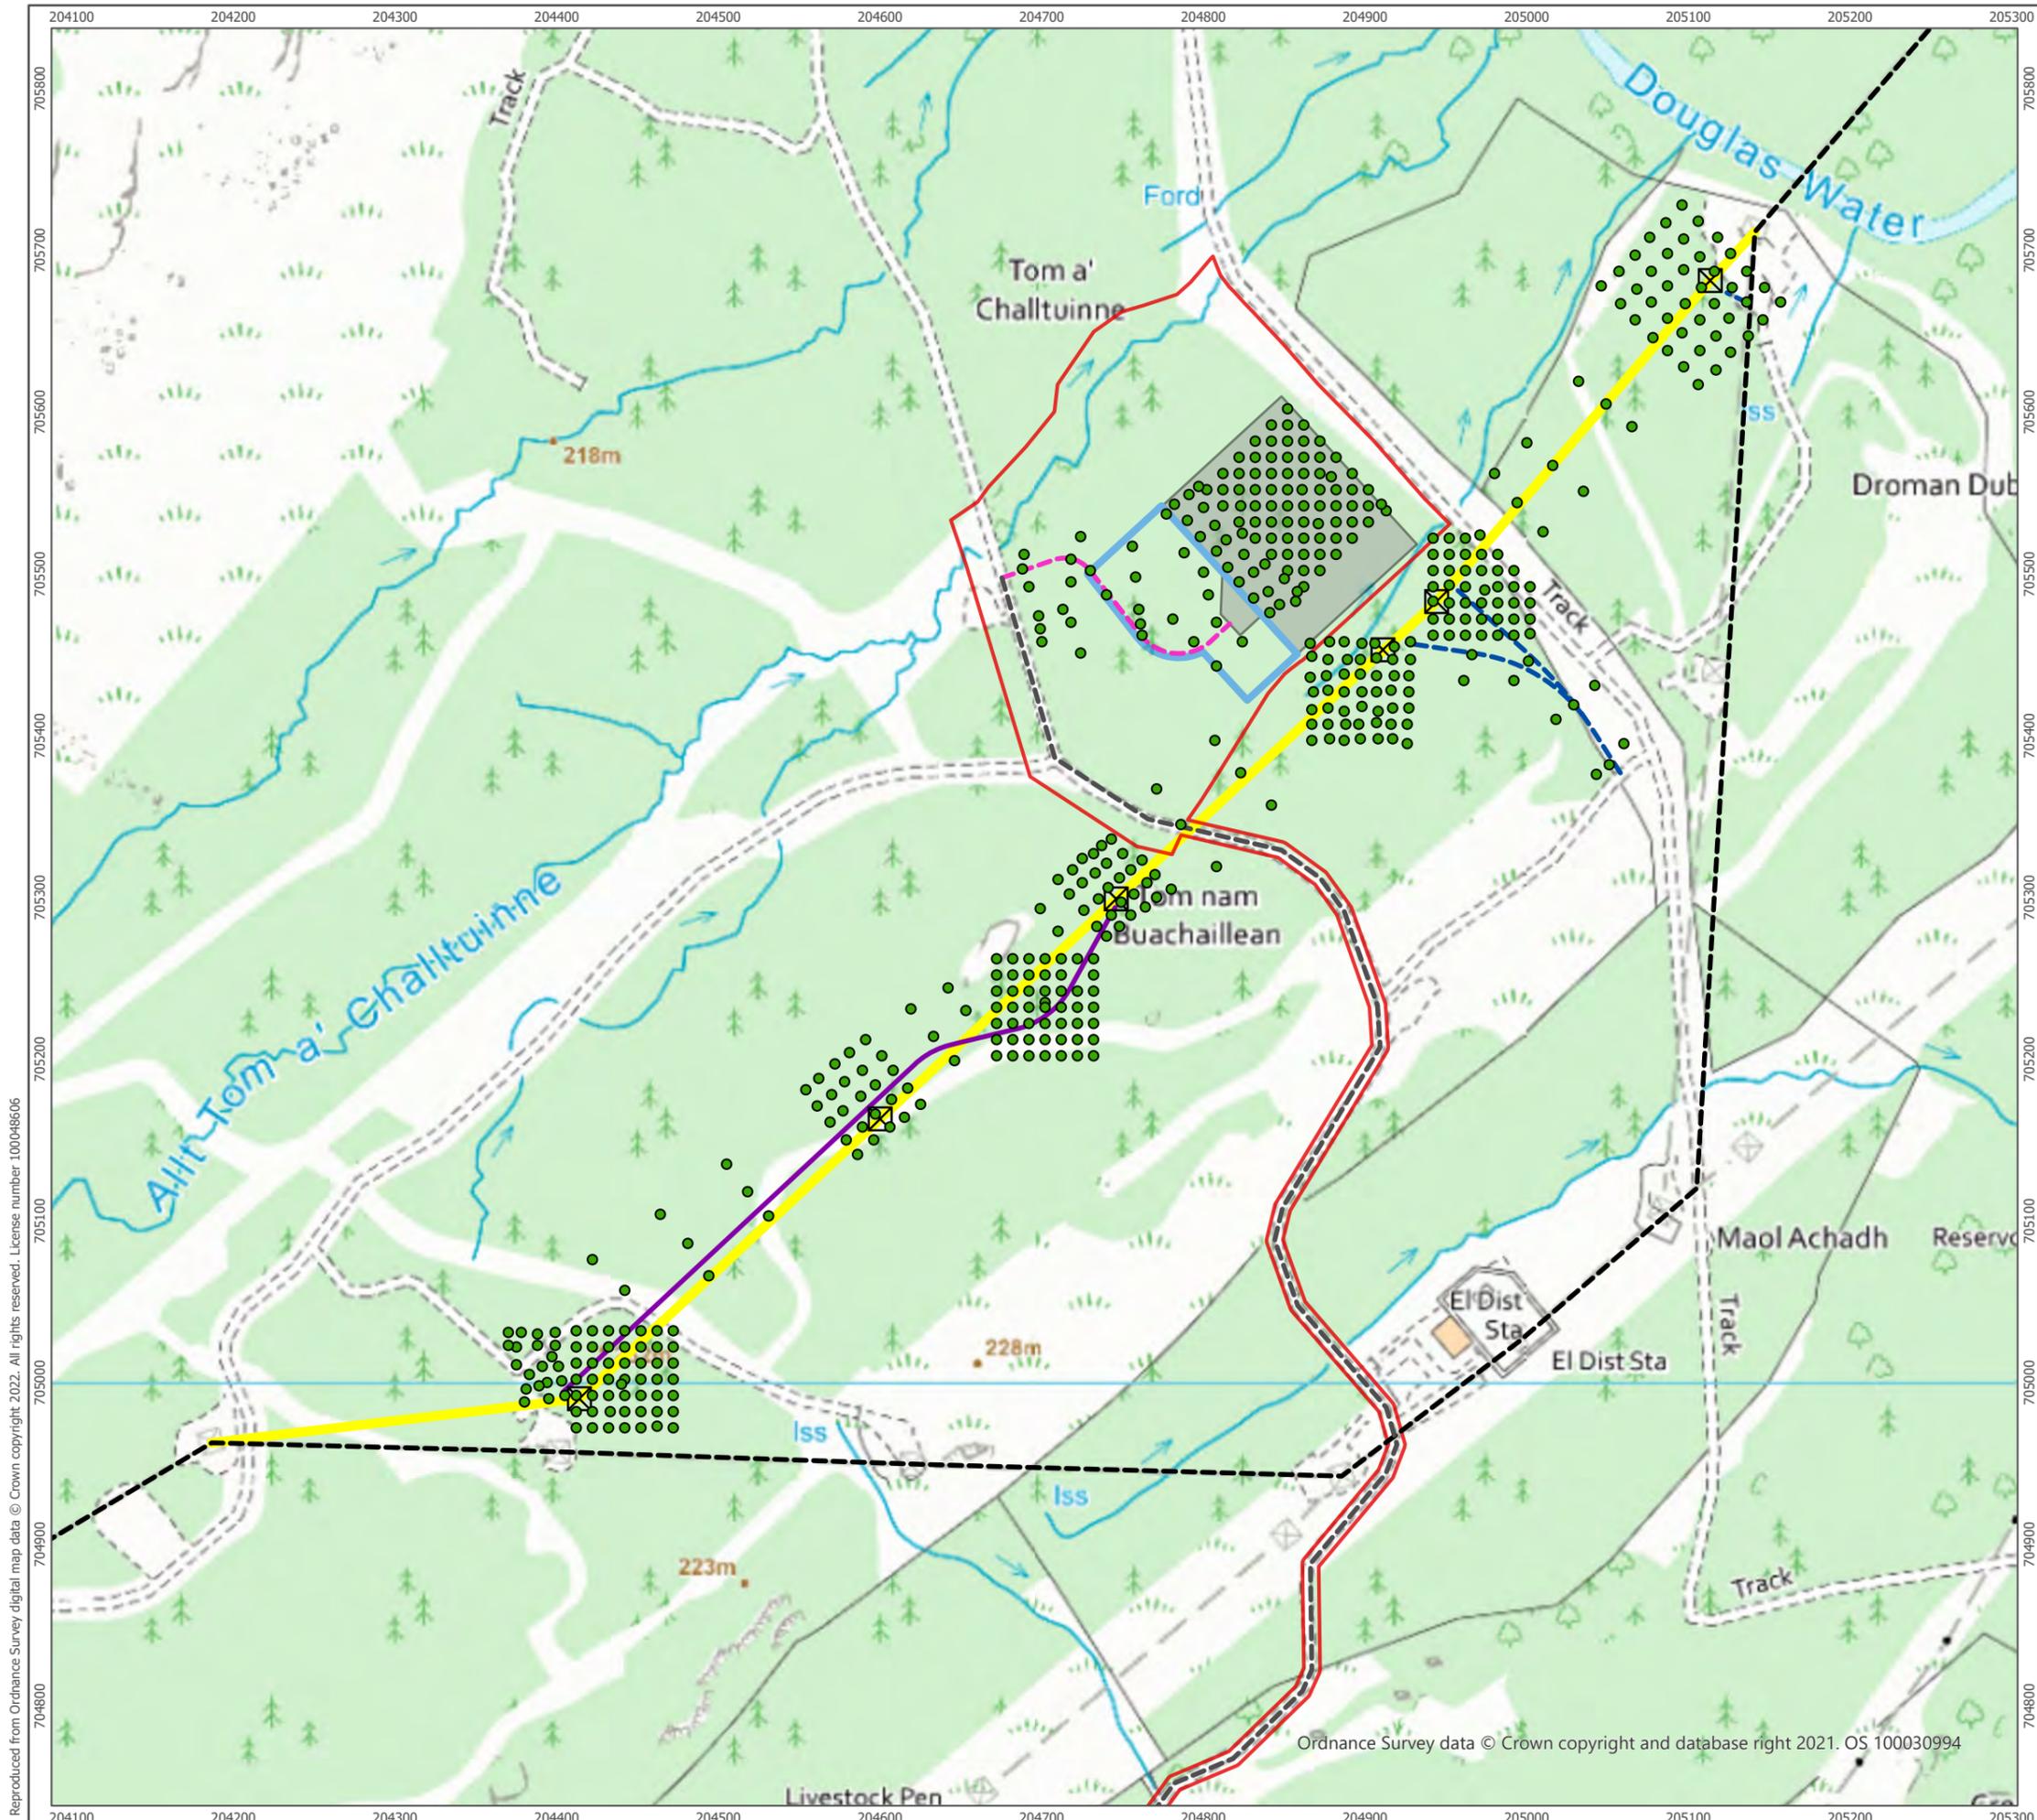
- Existing Access Track
- Existing Inveraray to Crossaig Overhead Line
- Proposed Development**
- Indicative Town and Country Planning Boundary
- Proposed Permanent Access Track
- Proposed Substation Temporary Works Area
- Proposed Substation Layout
- Associated Development**
- Proposed Permanent Access Track
- Proposed Temporary Tracks
- Proposed OHL Alignment
- Tower Location
- Factor of Safety**
- Low Risk

In accordance with the best practice method, F values of <1.0 indicate slopes that would experience failure under the modelled conditions and as such are considered areas of high risk. However, Boylan et al (2008) indicate that a relatively high value of F=1.4 should be used to identify slopes with the potential for instability. Adopting this approach, 'high' risk areas are indicated where F is <1.0, 'medium' risk areas are indicated as 1.01 to 1.50 and >1.5 are 'low' risk.
