**AN SUIDHE SUBSTATION
ENVIRONMENTAL APPRAISAL**

ANNEX O

PEAT LANDSLIDE HAZARD AND RISK ASSESSMENT

JULY 2022

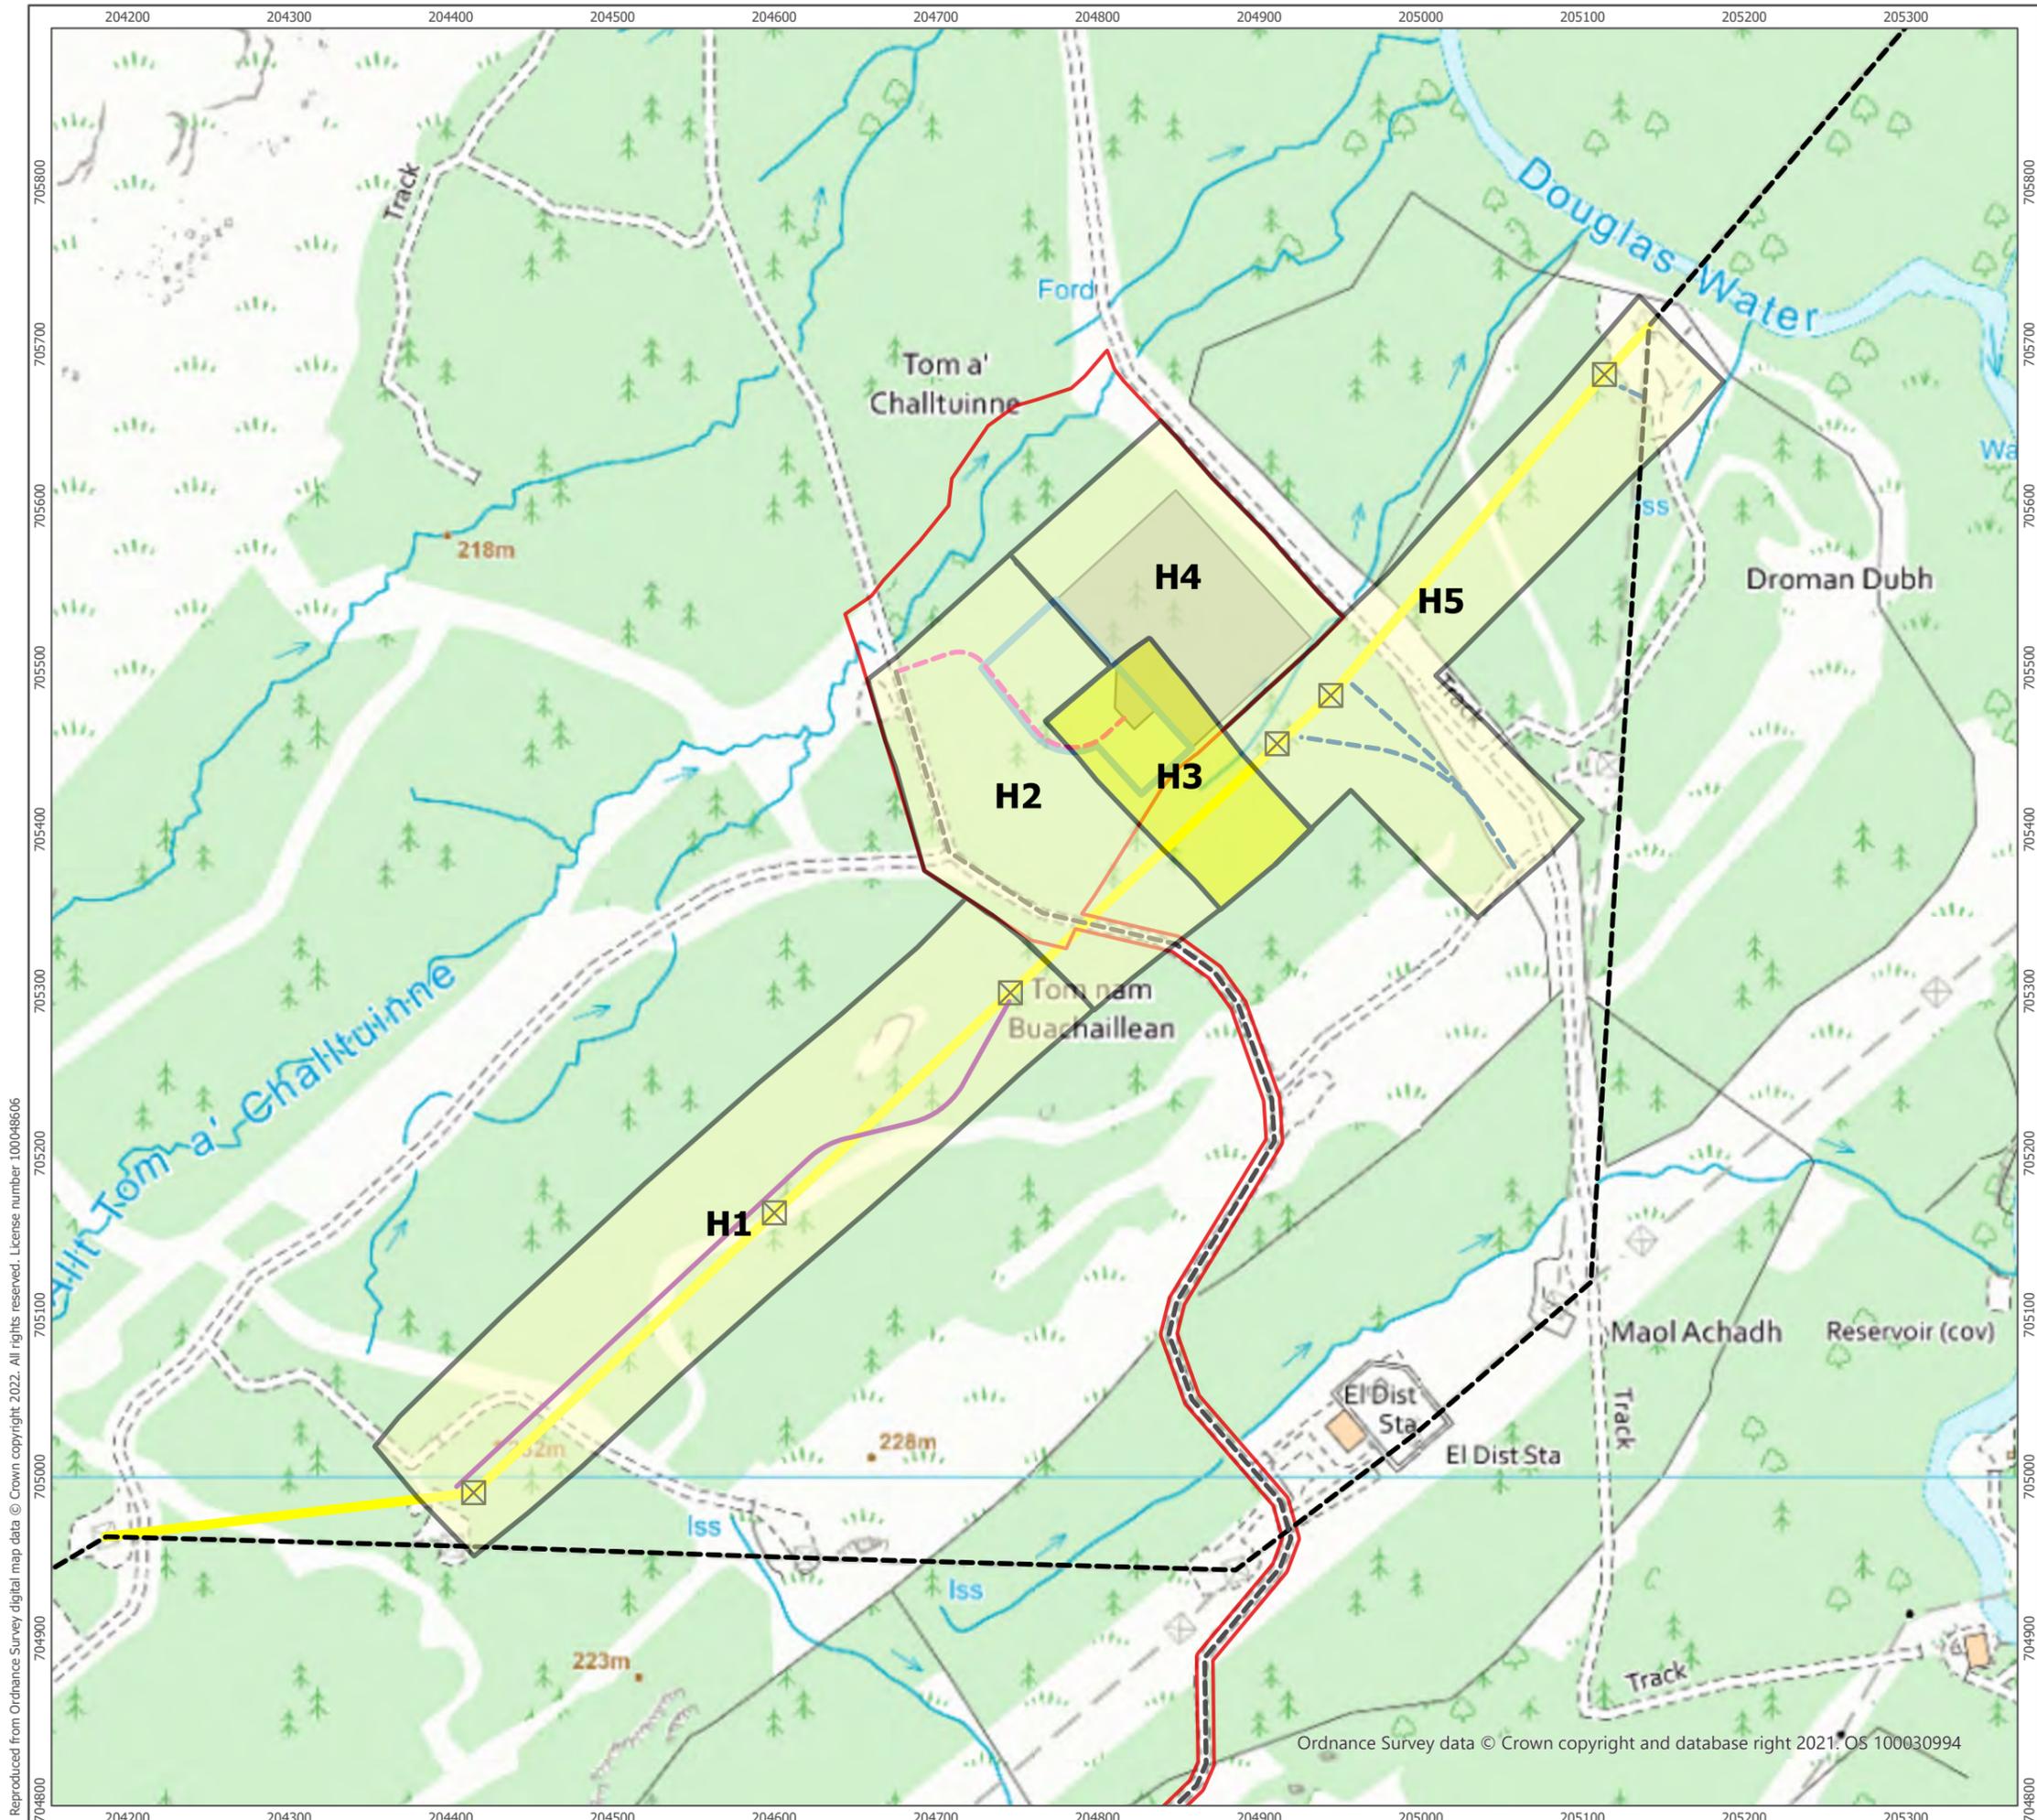
Hazard Rank Zonation Plan
Figure 9

- Existing Access Track
- Existing Inveraray to Crossaig Overhead Line
- Proposed Development**
- Indicative Town and Country Planning Boundary
- Proposed Permanent Access Track
- Proposed Substation Temporary Works Area
- Proposed Substation Layout
- Associated Development**
- Proposed Permanent Access Track
- Proposed Temporary Tracks
- Proposed OHL Alignment
- Tower Location
- Hazard Rank Zonation**
- Negligible
- Low

Vegetation cover and evidence of instability or potential instability were assessed during site surveys and, alongside satellite photography, informed the Geomorphology Map presented in **Figure 4**. This information was also considered during the adoption of hazard zones across the Site, which are presented in **Figure 9**: Hazard Rank Zonation Plan.

Receptor exposure was assessed for each of the five hazard zones using the approach in **Section 5**. A summary of the Hazard Ranking result for each identified area is summarised in **Table 16** and is presented in **Figure 9** - Hazard Ranking Zonation Plan. The zonation is based on a combination of considerations including calculated hazard result, peat depth, topography, receptors and land uses.

The PLHRA has shown the Site to be generally of 'negligible' hazard ranking, with an isolated area of 'low' hazard ranking. These hazard rankings are a result of limited peat cover across much of the site leading to negligible hazard across much of the site and just a localised area of deep peat recorded beneath the proposed substation platform which has informed a Low rank area.

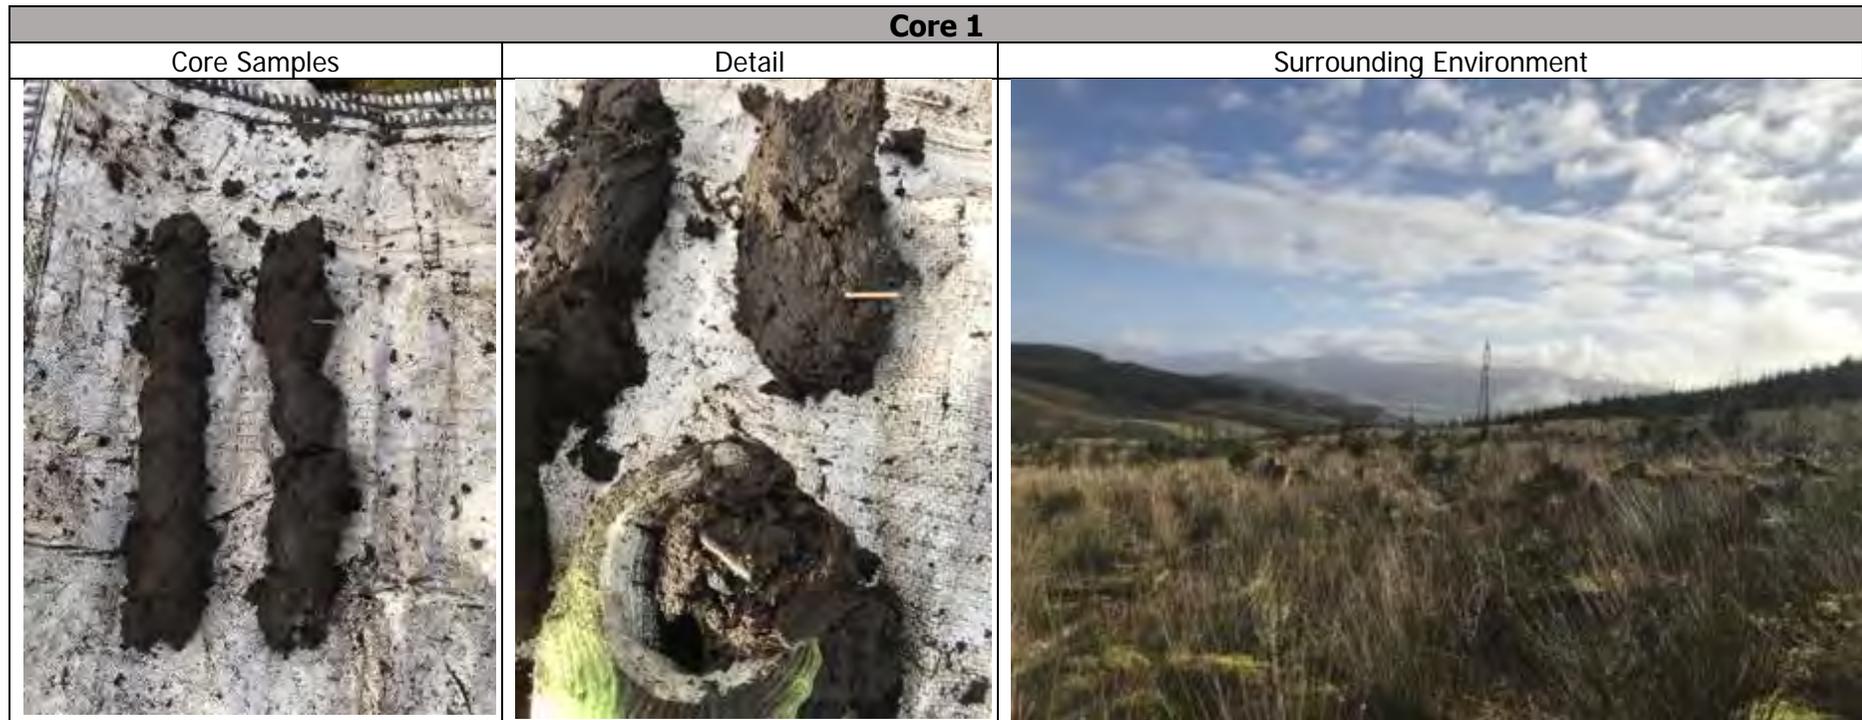
Location	Depth (m)	Firmness of Surface (P)	Von Post (H)	Fine Fibres (F)	Coarse Fibres (R)	Wood Remains (W)	Other Observations (Colour)
E204781, N705476	0.0-0.5	3	6	1	1	2	Dark Brown
	0.5-1.0		8	1	0	1	Dark Brown

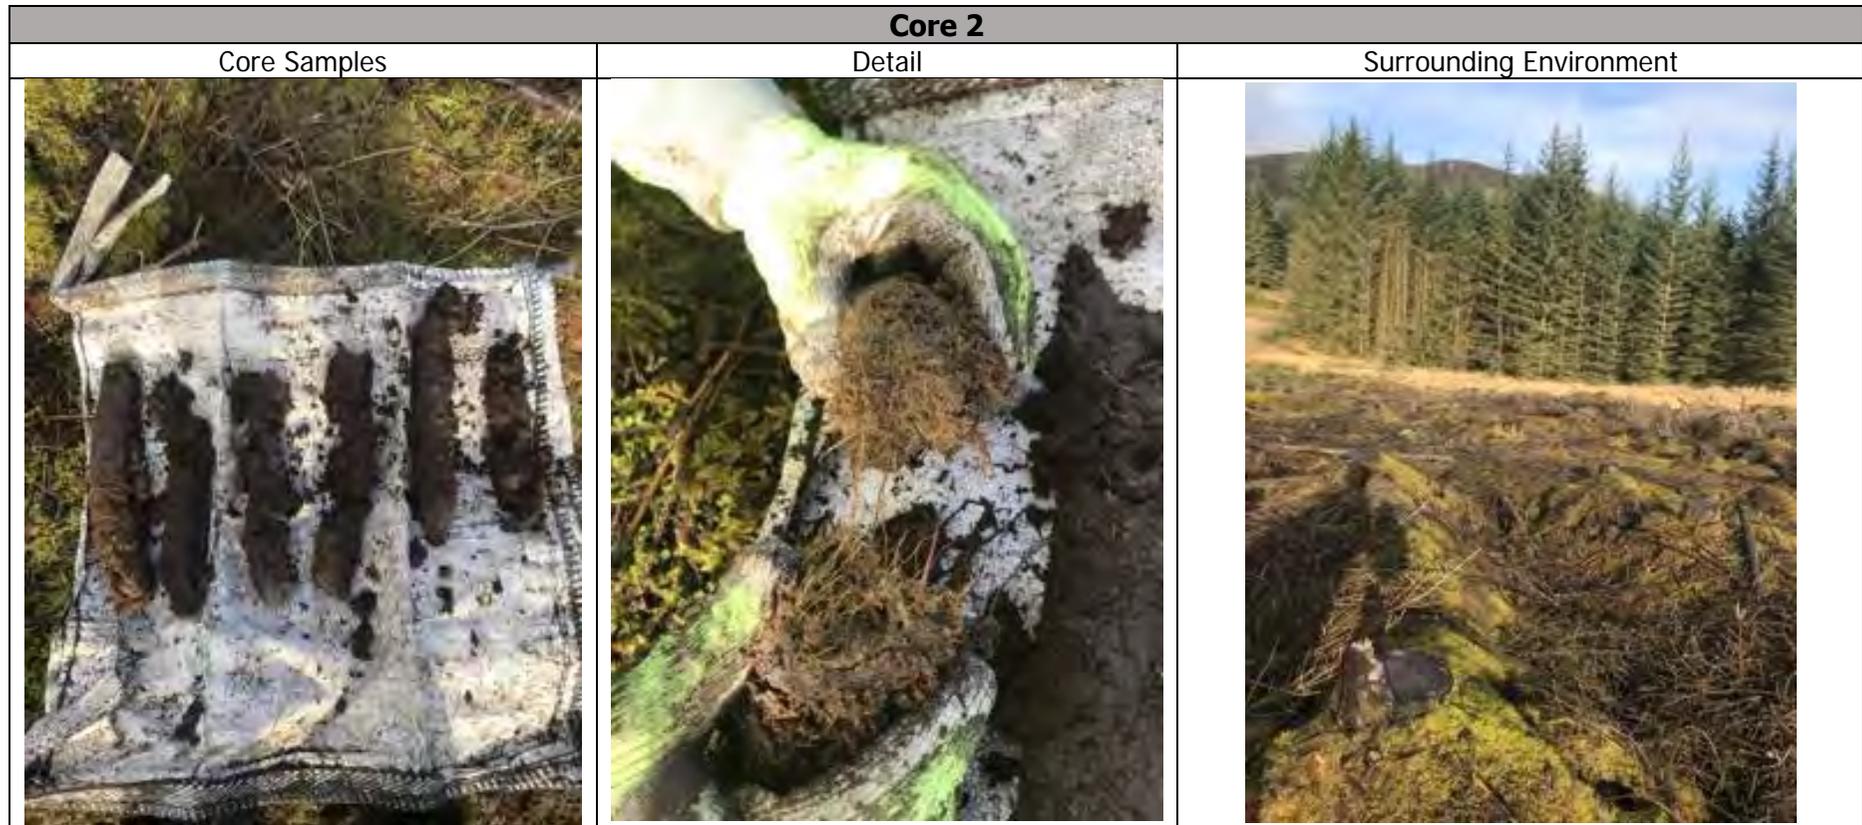
Location	Depth (m)	Firmness of Surface (P)	Von Post (H)	Fine Fibres (F)	Coarse Fibres (R)	Wood Remains (W)	Other Observations (Colour)
	0.0-0.5	2	4	2	3	1	Light Brown
	0.5-1.0		5	1	2	1	Brown
	1.0-1.5		7	1	1	2	Brown
	1.5-2.0		8	1	1	3	Brown
	2.0-2.5		7	0	1	3	Brown
	2.5-3.0		7	0	1	3	Brown
