# Cambushinnie 400 kV Substation Haul Track

Scottish & Southern Electricity Networks (SSEN)  
Transmission

Project number: 60721943

June 2025

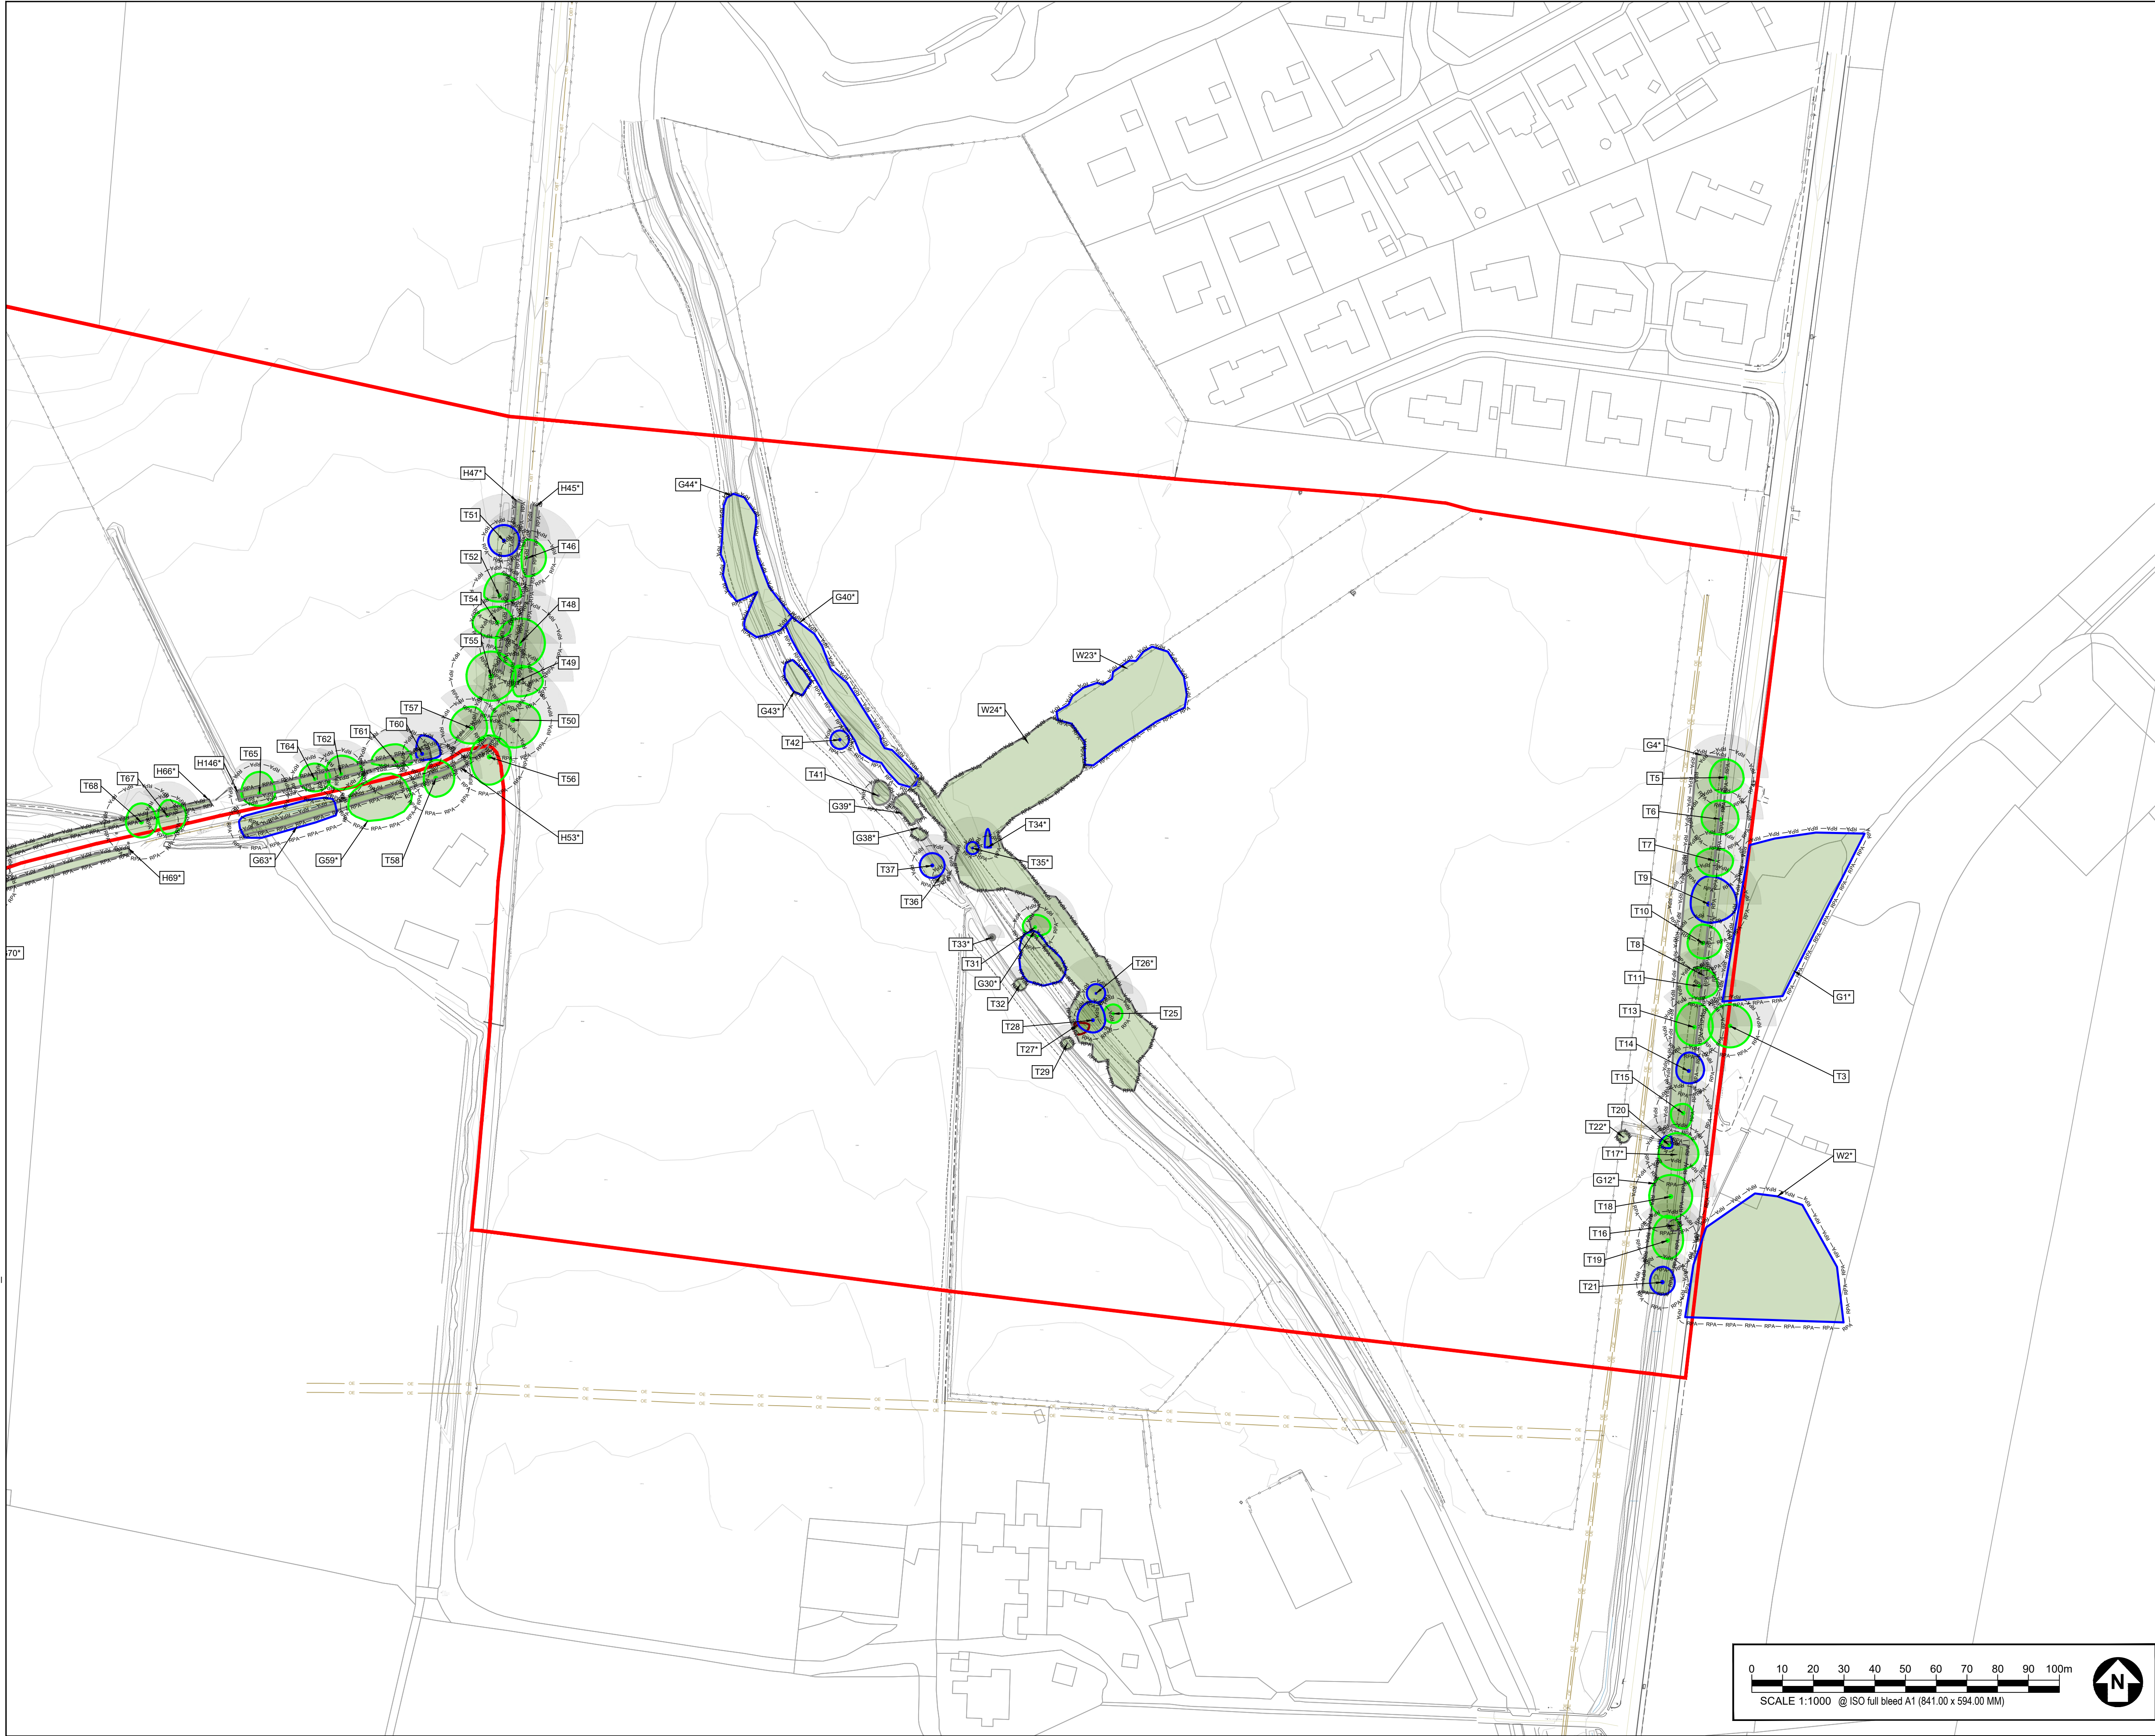
# Appendix A Tree Constraints Plan

- 1.4.7 A Tree Constraints Plan showing the position of trees and the spatial constraints associated with them is included as **Appendix A Tree Constraints Plan** of this report, which corresponds with **Appendix B Tree Survey Schedule**.
- 1.4.8 The tree categorisation process recommended by BS5837:2012 is summarised in the table below and corresponds with the tree canopy outline shown in **Appendix A Tree Constraints Plan** and the information in **Appendix B Tree Survey Schedule**.

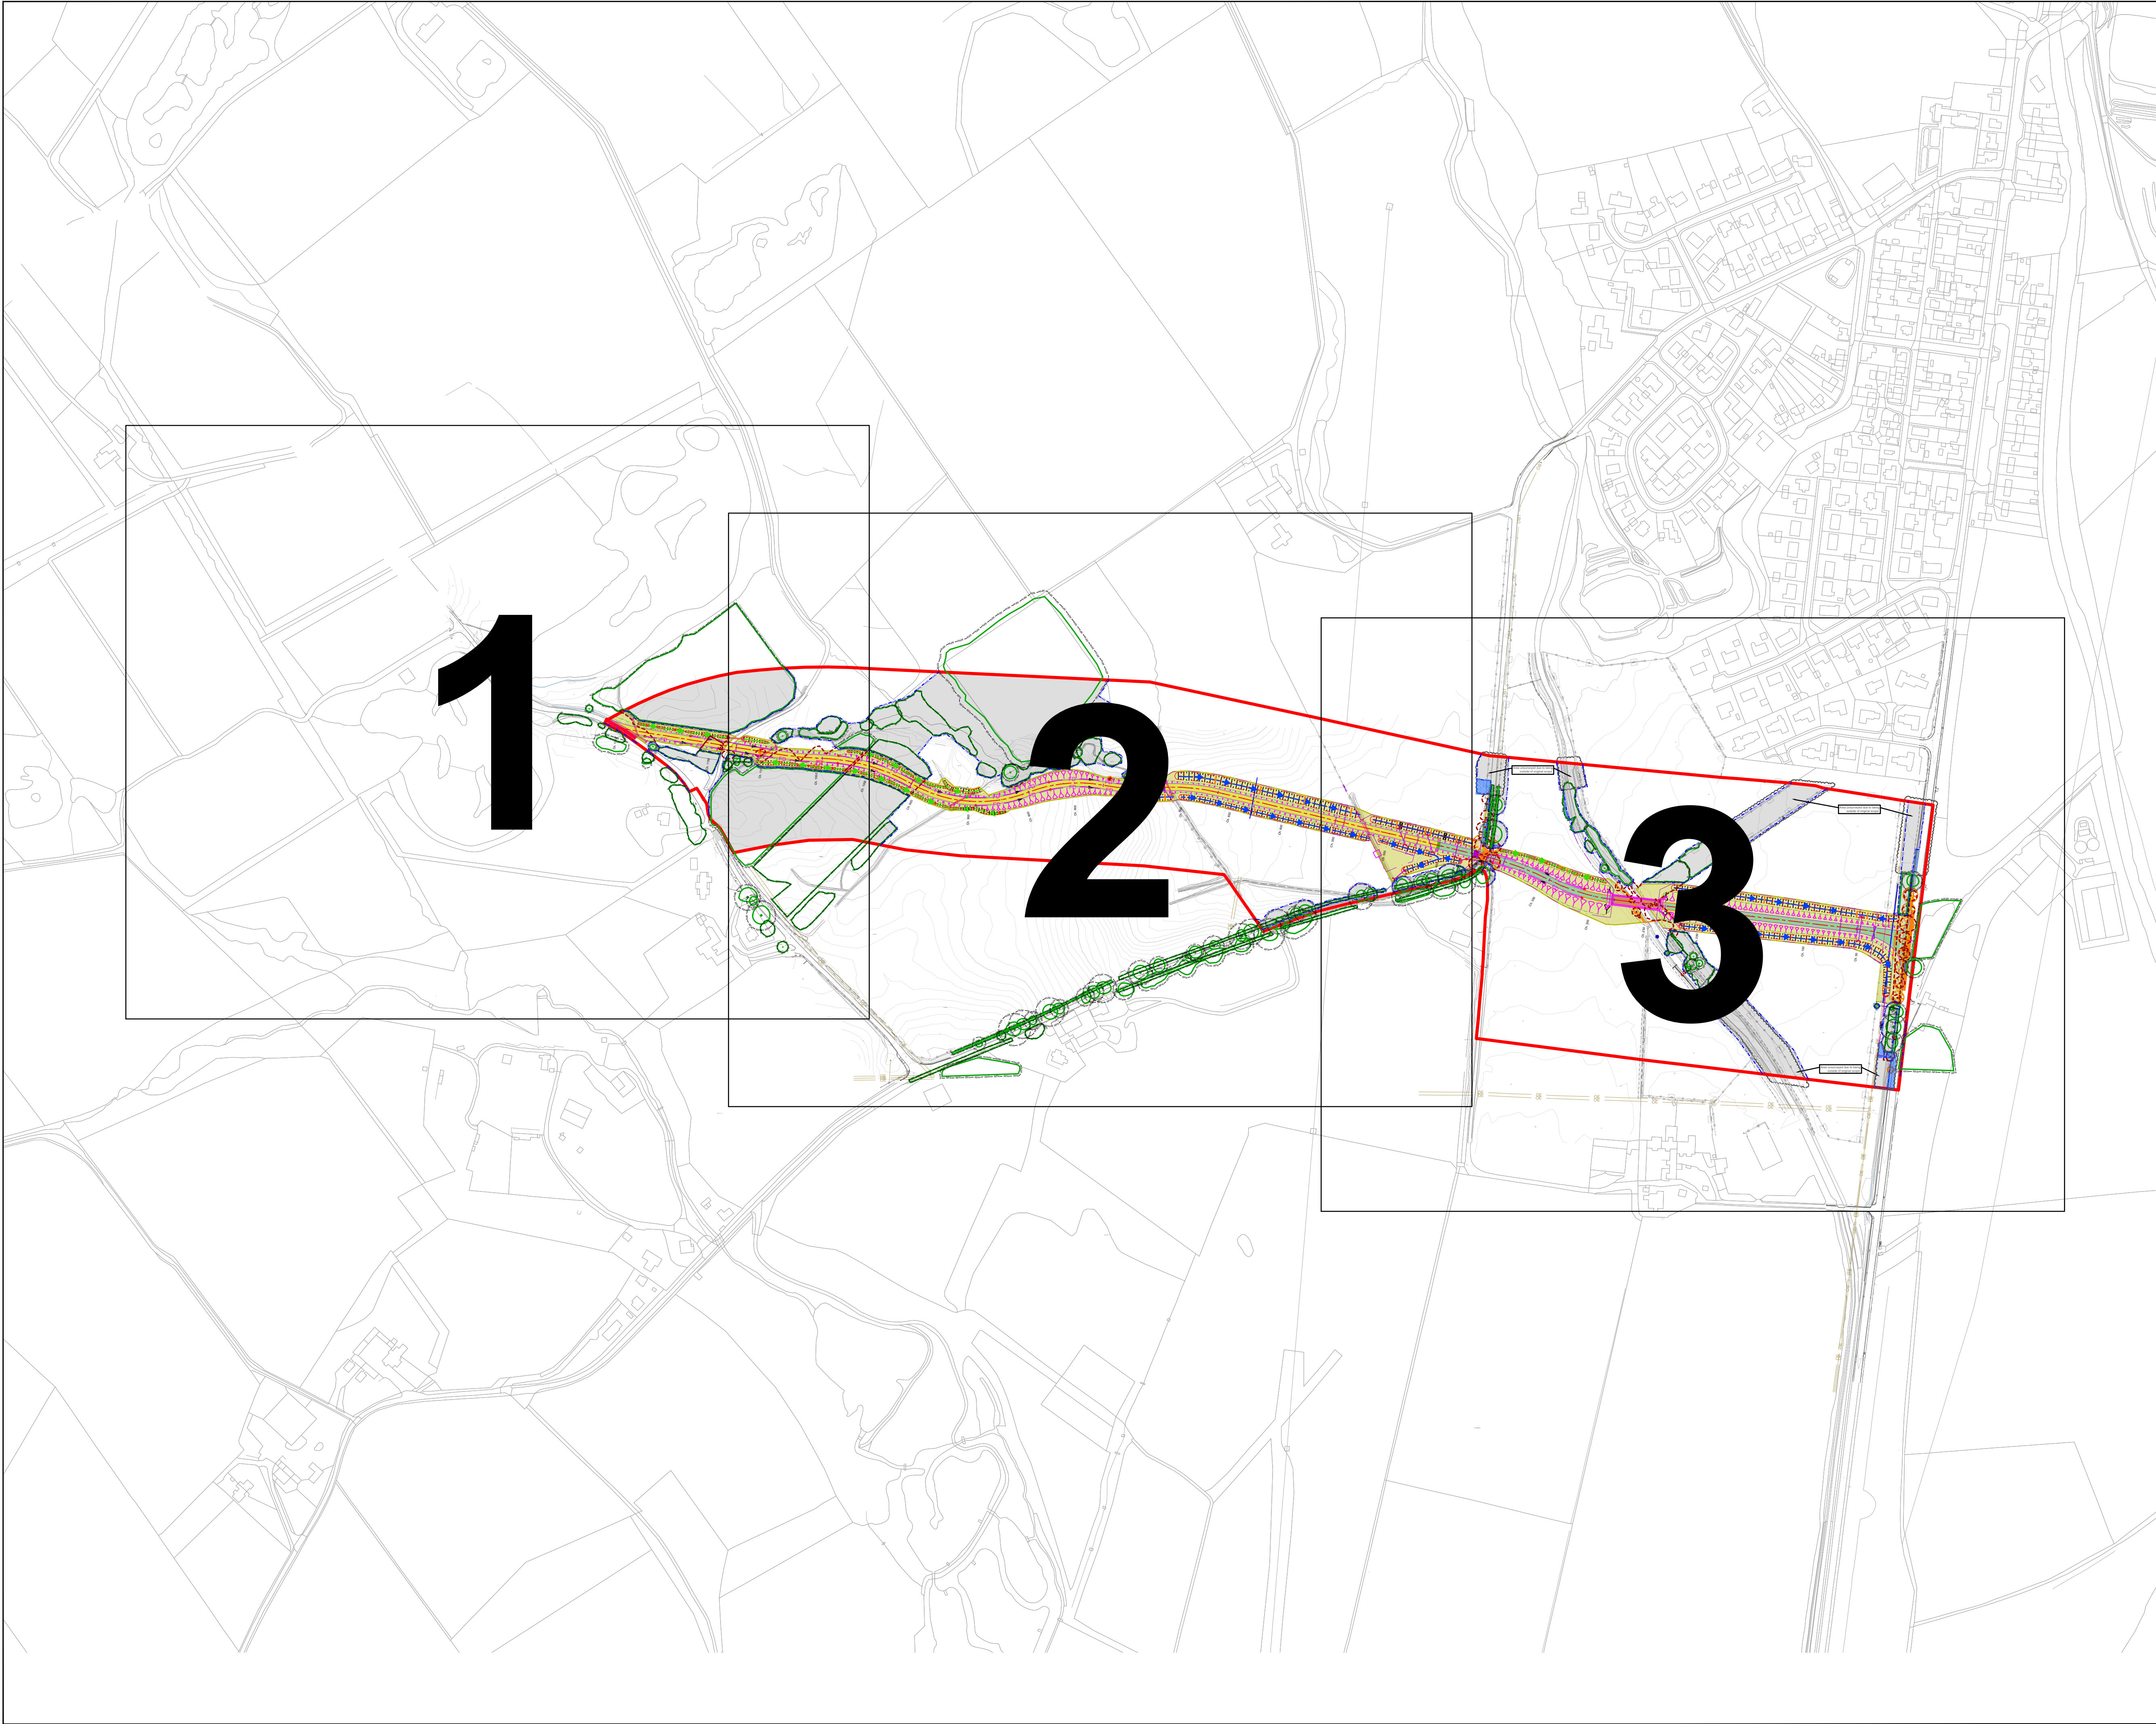
# Appendix C Tree Protection Plan

1.2.7 An Arboricultural Impact Assessment is then developed to identify the likely direct and indirect impacts of the Proposed Development, and a Tree Protection Plan is prepared to identify trees to be removed or retained and to illustrate how retained trees are to be protected. An Arboricultural Method Statement is often required as a condition of planning consent to detail how sensitive operations are to be achieved in proximity to retained trees. These elements are the minimum normally required for a planning application and are intended to ensure both a sustainable and harmonious relationship between trees and new development.
