LT307 – BRACO WEST
SITES 2 & 3

REPORT ON GROUND INVESTIGATION

Contract Number: 26555

Report Type: Factual

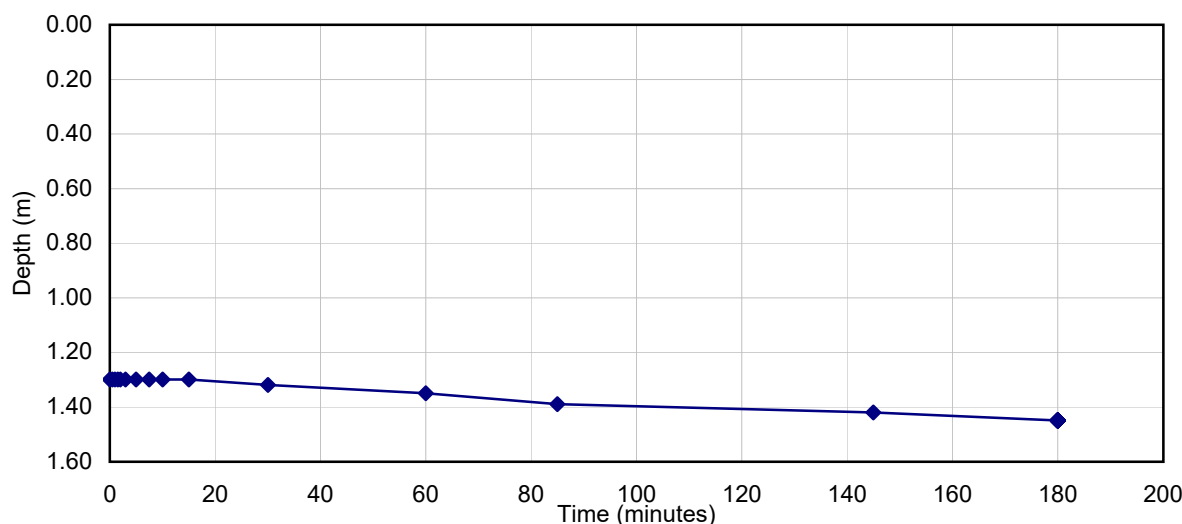
Originator	Checked & Approved	SOAKAWAY BRE 365	
RB	 14/12/2023

Comments
Bedrock at 2.00m. Test terminated due to slow water outflow.

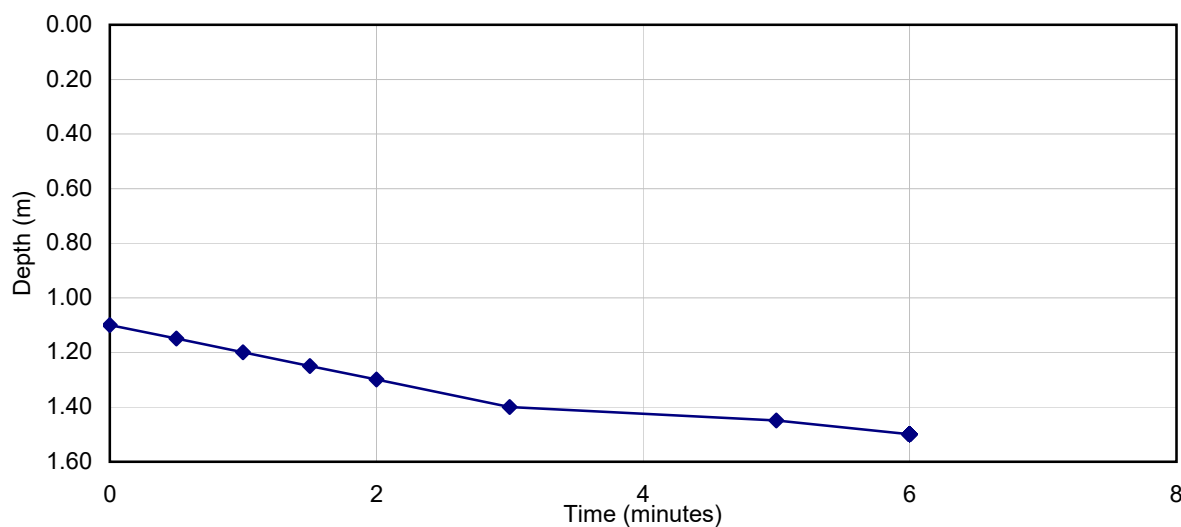
Originator	Checked & Approved	SOAKAWAY BRE 365	
RB	 14/12/2023

Soil Infiltration Rate
1.1E-03 m/s

Comments
Bedrock at 1.50m. Unable to fill pit above 1.10m due to filtration rate.

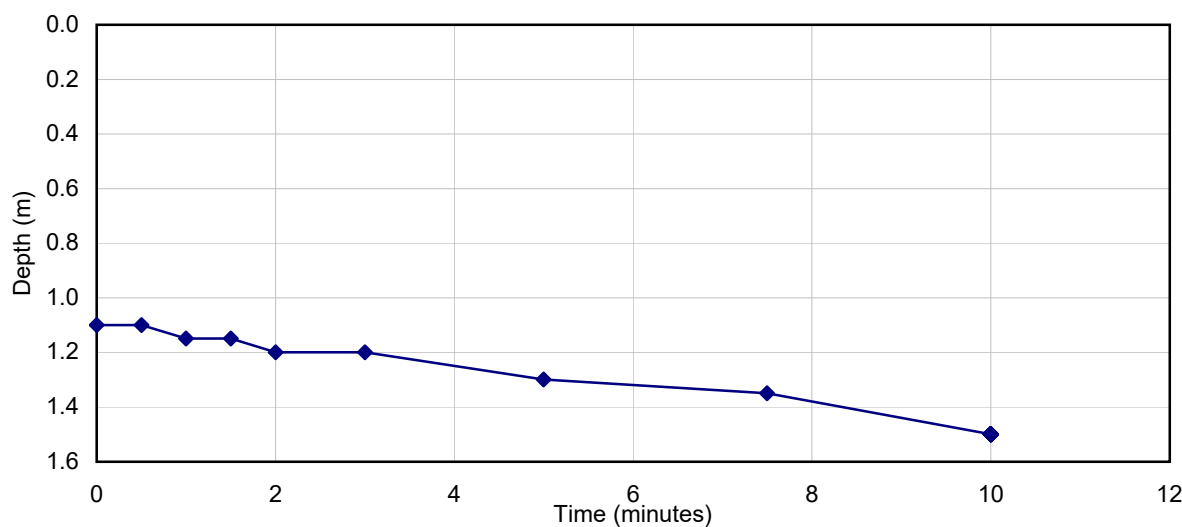
Originator	Checked & Approved	SOAKAWAY BRE 365	
RB	 14/12/2023

Comments
Bedrock at 1.50m. Unable to fill pit above 1.10m due to filtration rate.

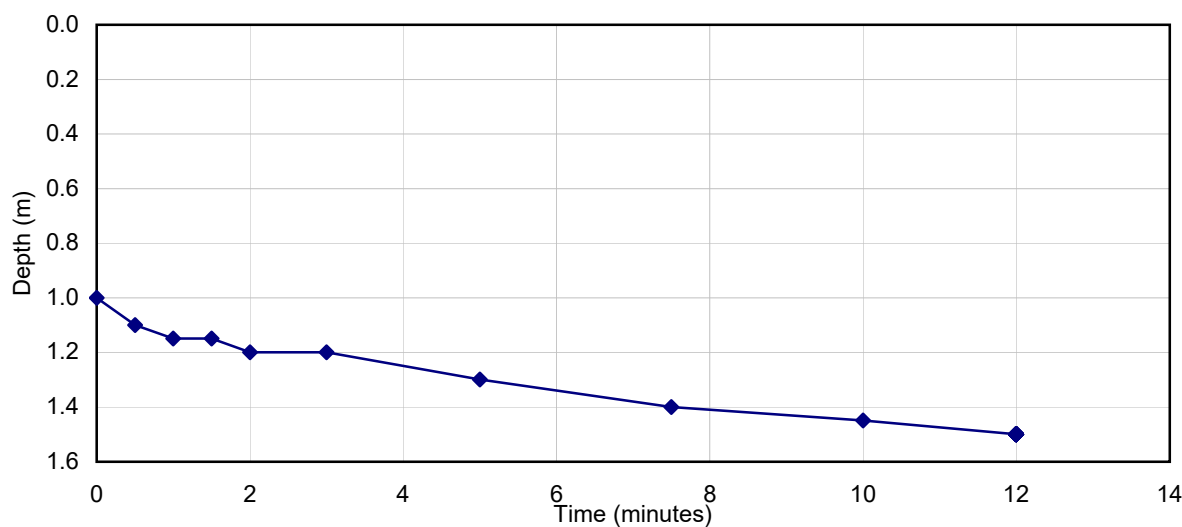
Originator	Checked & Approved	SOAKAWAY BRE 365	
RB	 14/12/2023

Comments
Bedrock at 1.50m.

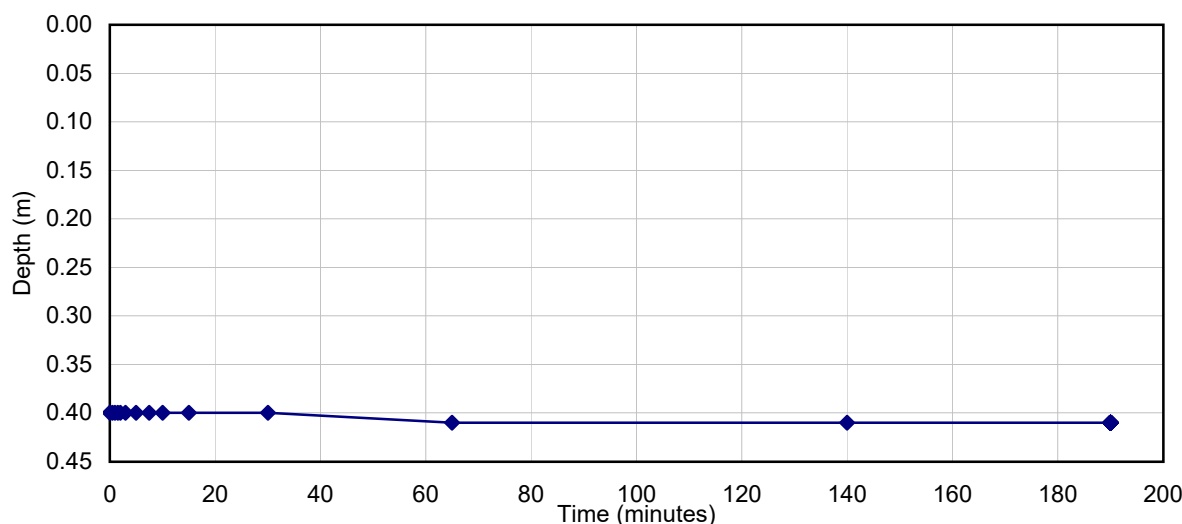
Originator	Checked & Approved	SOAKAWAY BRE 365	
RB	 14/12/2023

Comments
Bedrock at 1.20m. Test terminated due to slow water outflow.

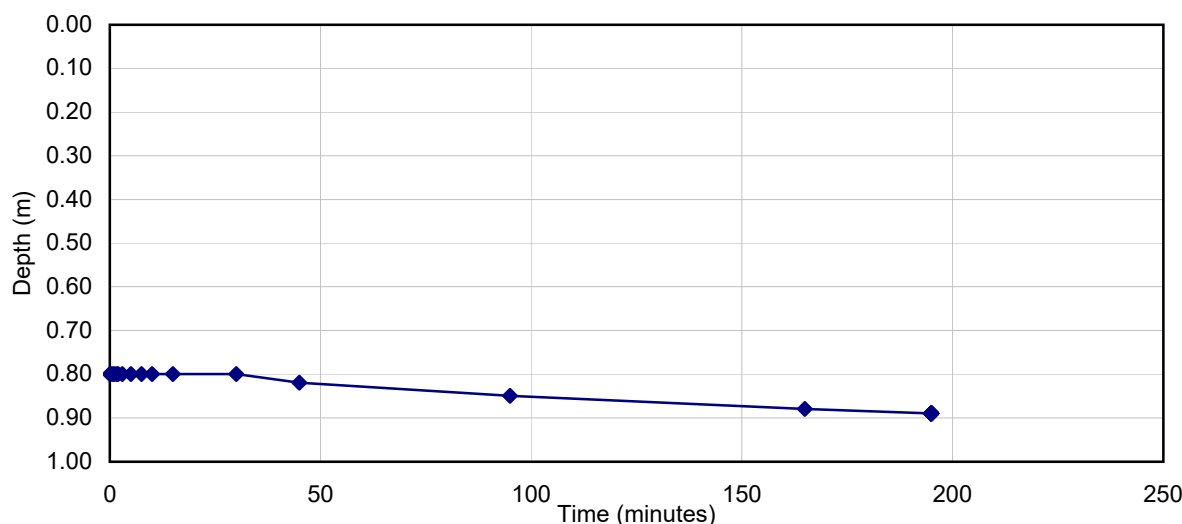
Originator	Checked & Approved	SOAKAWAY BRE 365	
RB	 14/12/2023

Comments
Bedrock at 2.00m. Test terminated due to slow water outflow.

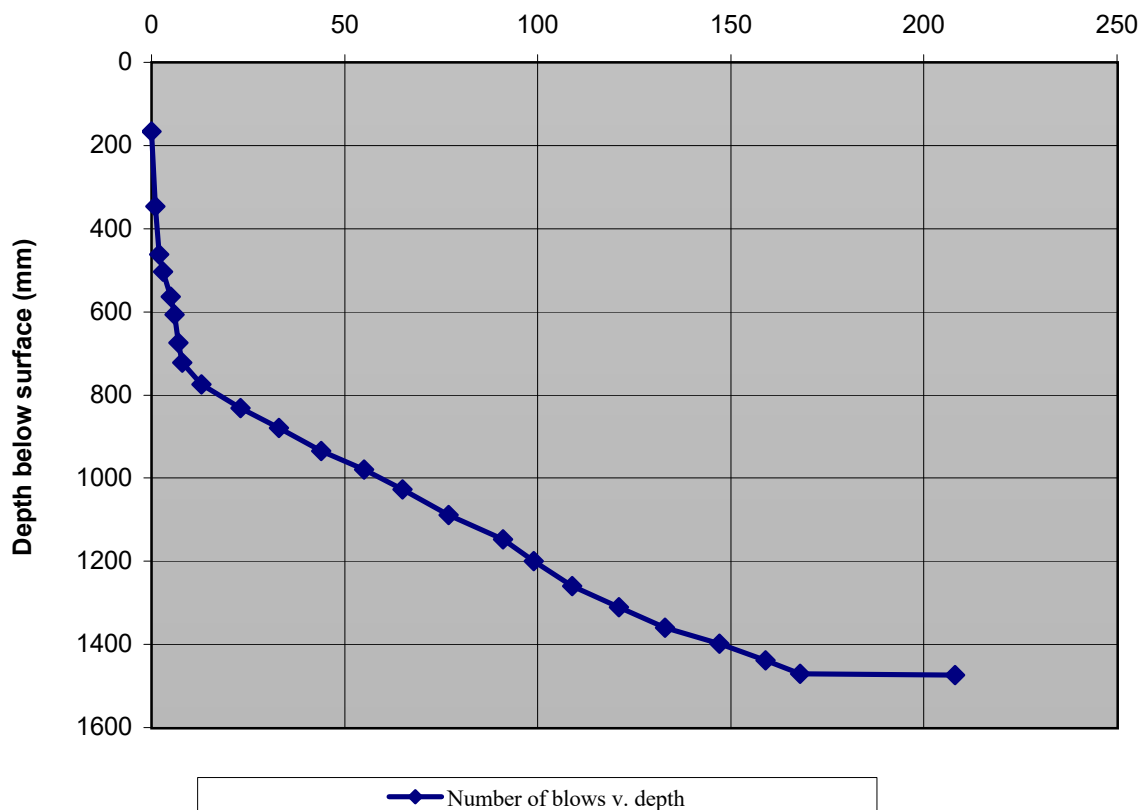
Start Depth (mm)	Finish Depth (mm)	No. of Blows	Blows per Layer	Material	DCP mm/blow	Estimated average CBR over depth range (%)
167	722	8	8	Topsoil	69.38	3
722	1259	109	101	Unknown	5.32	52
1259	1471	168	59	Unknown	3.59	78
1471	1474	208	40	Unknown	0.08	4667

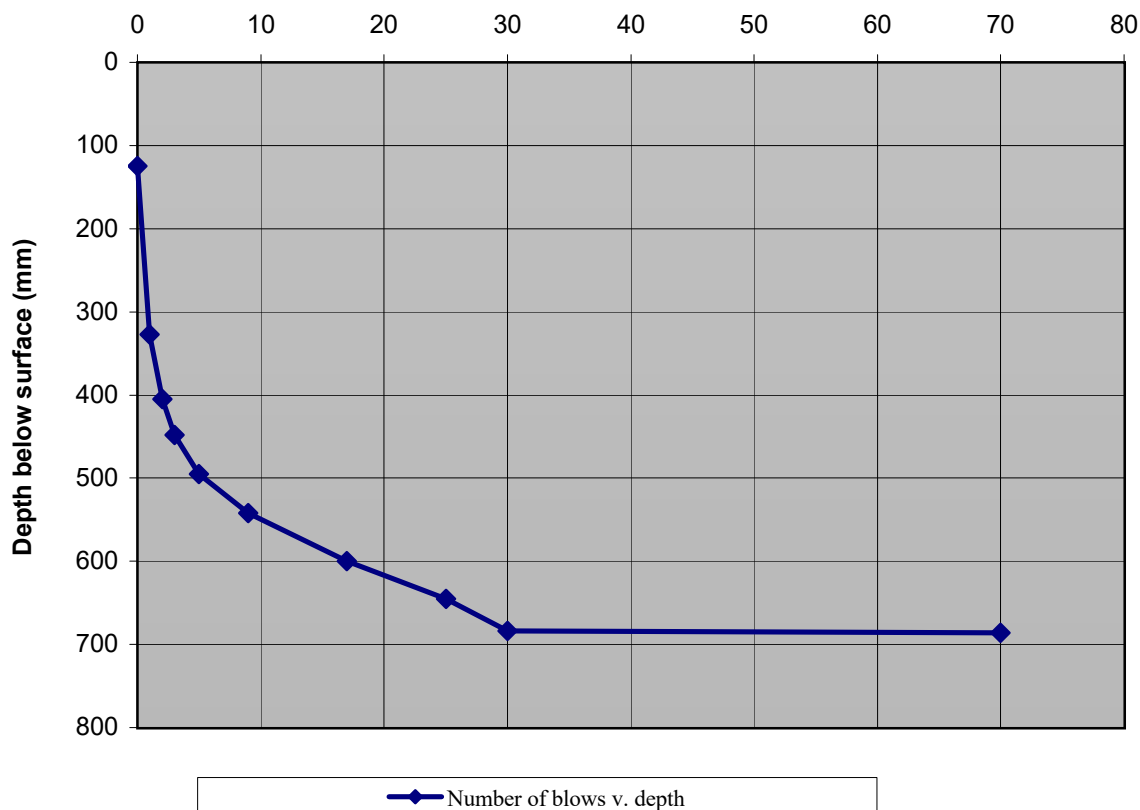
Start Depth (mm)	Finish Depth (mm)	No. of Blows	Blows per Layer	Material	DCP mm/blow	Estimated average CBR over depth range (%)
125	405	2	2	Topsoil	140.00	2
405	495	5	3	Unknown	30.00	8
495	645	25	20	Unknown	7.50	36
645	684	30	5	Unknown	7.80	34
684	686	70	40	Unknown	0.05	7165

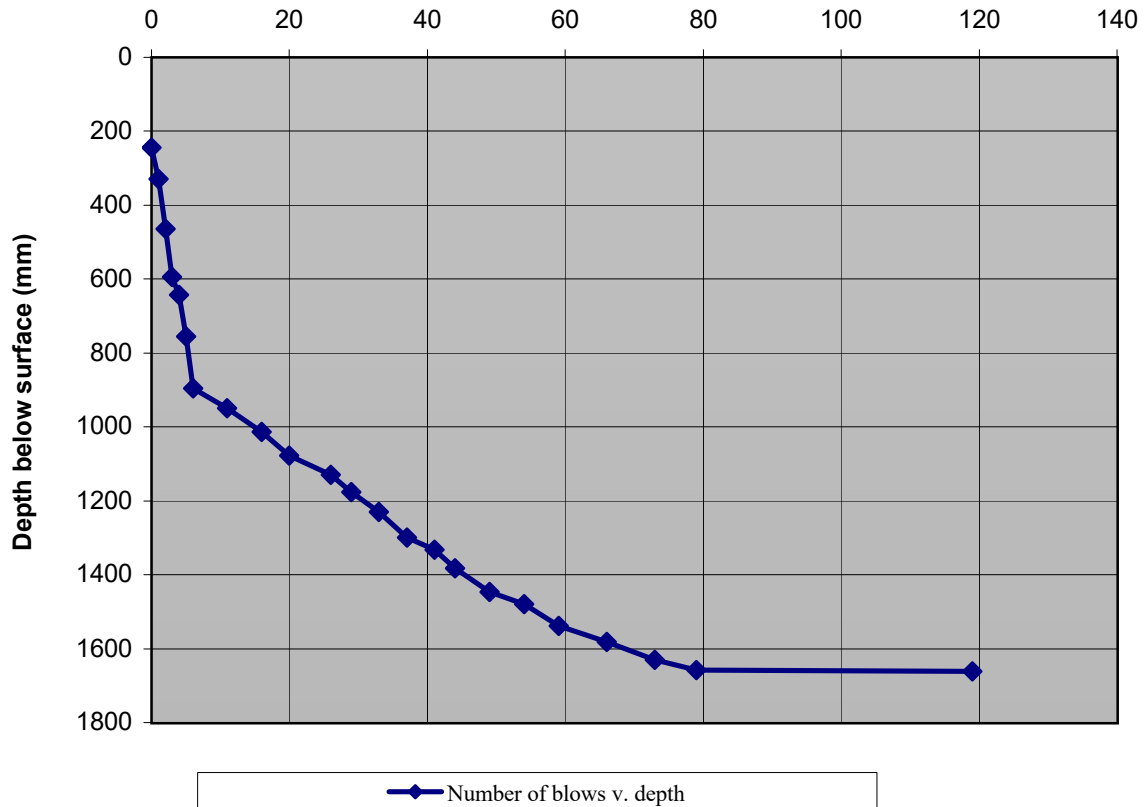
Start Depth (mm)	Finish Depth (mm)	No. of Blows	Blows per Layer	Material	DCP mm/blow	Estimated average CBR over depth range (%)
245	895	6	6	Topsoil	108.33	2
895	1129	26	20	Unknown	11.70	22
1129	1333	41	15	Unknown	13.60	19
1333	1658	79	38	Unknown	8.55	31
1658	1661	119	40	Unknown	0.08	4667

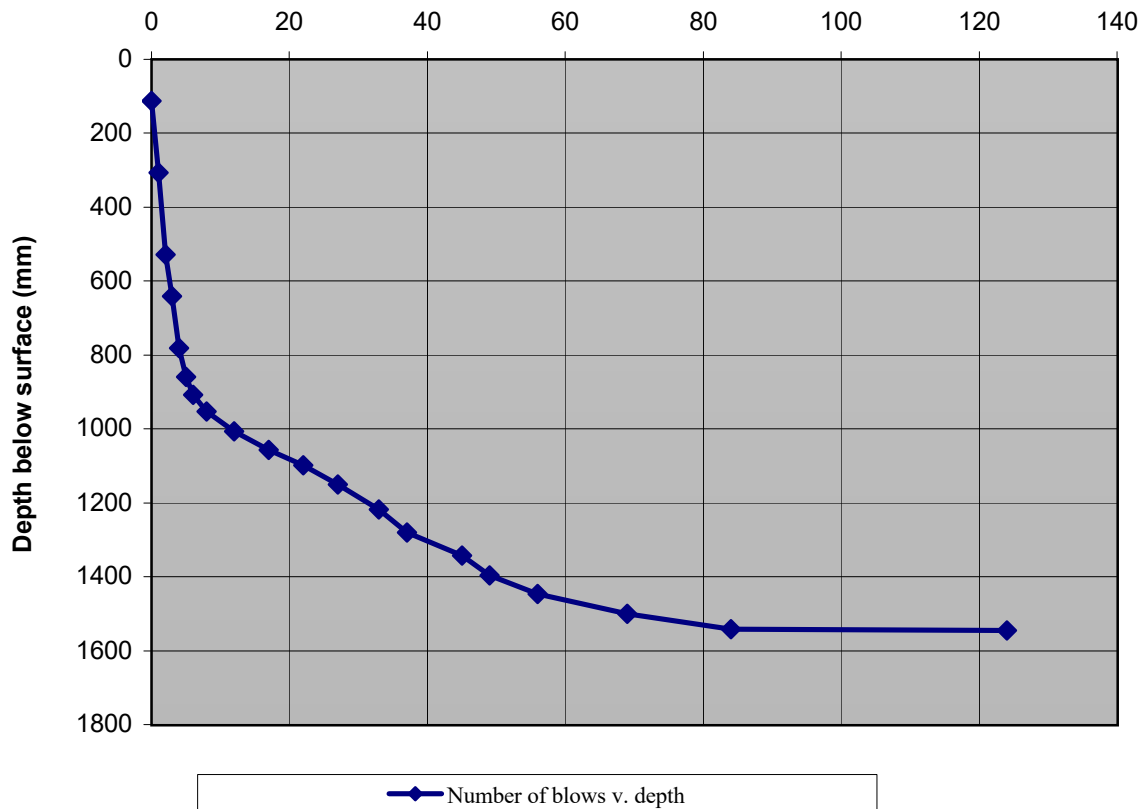
Start Depth (mm)	Finish Depth (mm)	No. of Blows	Blows per Layer	Material	DCP mm/blow	Estimated average CBR over depth range (%)
113	907	6	6	Topsoil	132.33	2
907	1280	37	31	Unknown	12.03	22
1280	1446	56	19	Unknown	8.74	31
1446	1542	84	28	Unknown	3.43	82
1542	1545	124	40	Unknown	0.08	4667

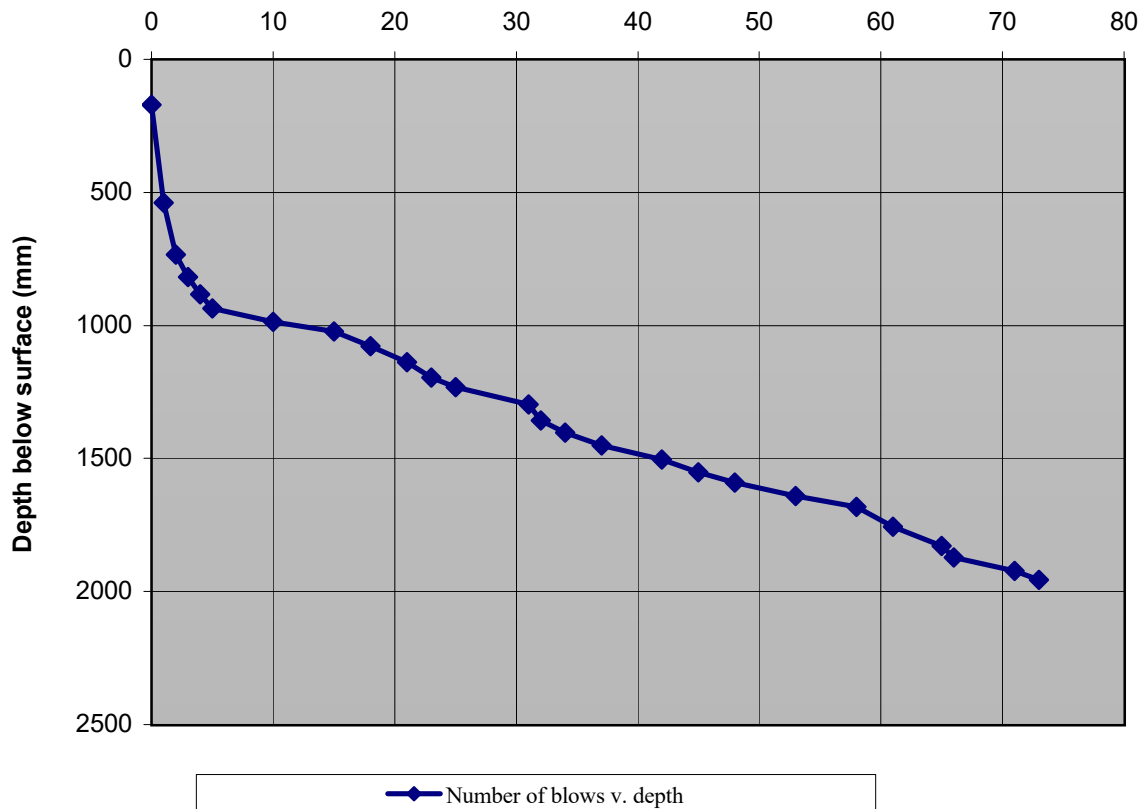
Start Depth (mm)	Finish Depth (mm)	No. of Blows	Blows per Layer	Material	DCP mm/blow	Estimated average CBR over depth range (%)
170	735	2	2	Topsoil	282.50	1
735	937	5	3	Unknown	67.33	4
937	1022	15	10	Unknown	8.50	31
1022	1297	31	16	Unknown	17.19	15
1297	1403	34	3	Unknown	35.33	7
1403	1681	58	24	Unknown	11.58	23
1681	1871	66	8	Unknown	23.75	11
1871	1957	73	7	Unknown	12.29	21

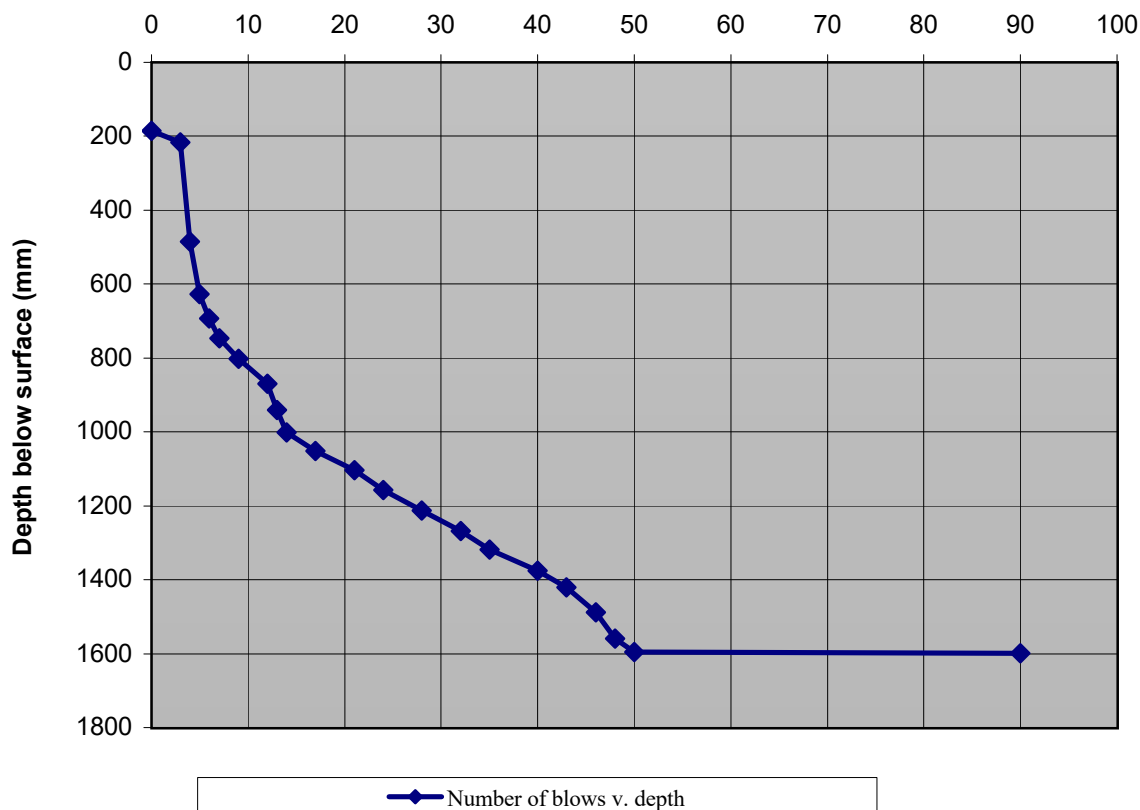
Start Depth (mm)	Finish Depth (mm)	No. of Blows	Blows per Layer	Material	DCP mm/blow	Estimated average CBR over depth range (%)
185	217	3	3	Topsoil	10.67	25
217	693	6	3	Unknown	158.67	1
693	870	12	6	Unknown	29.50	8
870	1001	14	2	Unknown	65.50	4
1001	1489	46	32	Unknown	15.25	17
1489	1596	50	4	Unknown	26.75	9
1596	1599	90	40	Unknown	0.08	4667

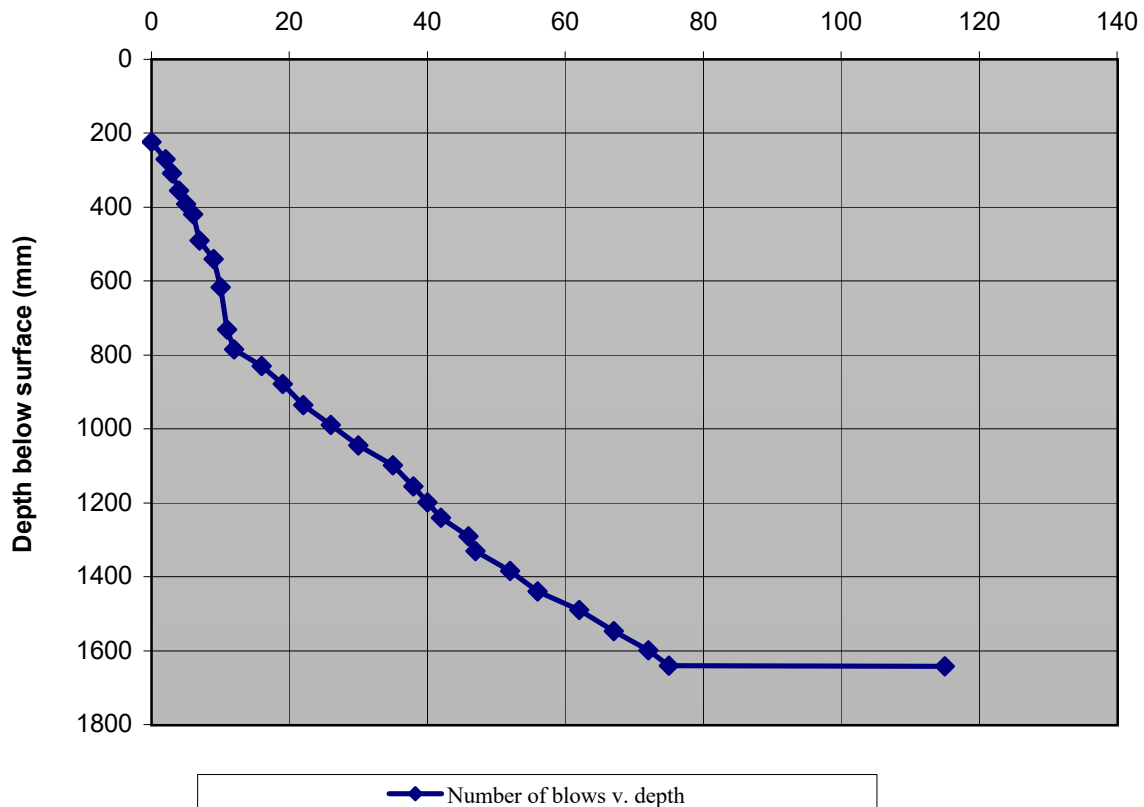
Start Depth (mm)	Finish Depth (mm)	No. of Blows	Blows per Layer	Material	DCP mm/blow	Estimated average CBR over depth range (%)
223	541	9	9	Topsoil	35.33	7
541	784	12	3	Unknown	81.00	3
784	1331	47	35	Unknown	15.63	17
1331	1640	75	28	Unknown	11.04	24
1640	1642	115	40	Unknown	0.05	7165

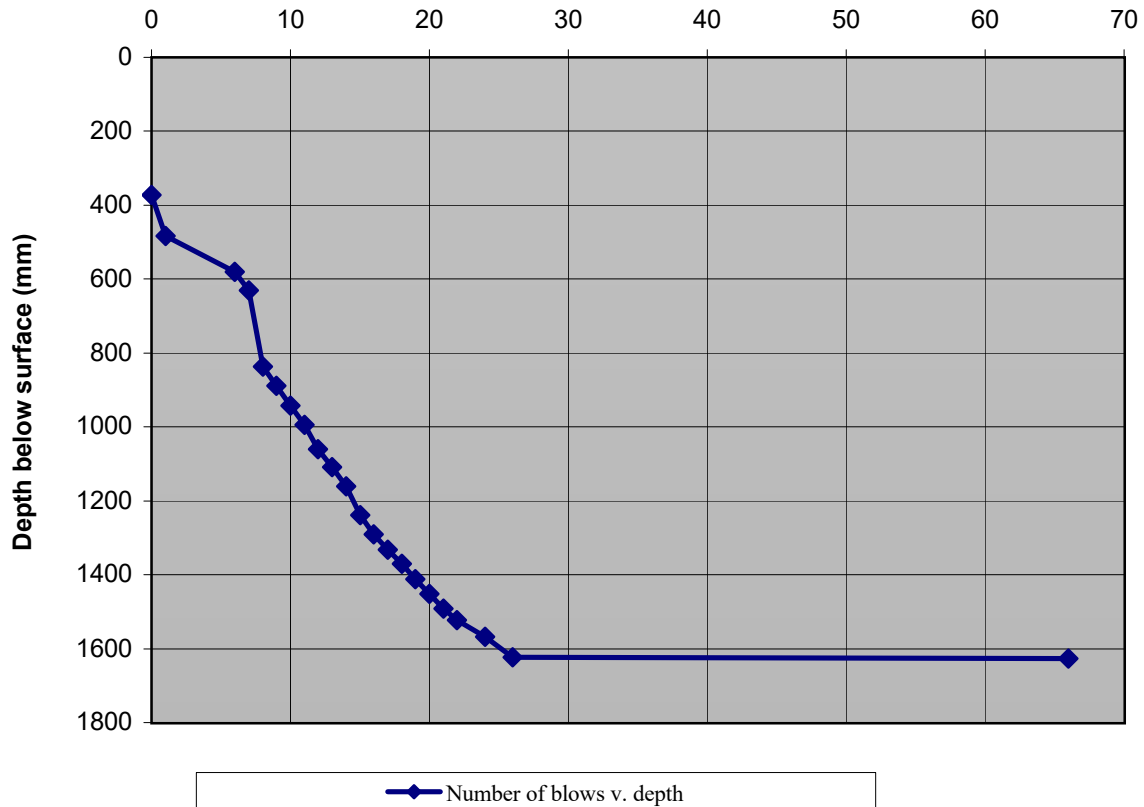
Start Depth (mm)	Finish Depth (mm)	No. of Blows	Blows per Layer	Material	DCP mm/blow	Estimated average CBR over depth range (%)
372	484	1	1	Topsoil	112.00	2
484	580	6	5	Unknown	19.20	13
580	837	8	2	Unknown	128.50	2
837	1160	14	6	Unknown	53.83	4
1160	1523	22	8	Unknown	45.38	5
1523	1623	26	4	Unknown	25.00	10
1623	1626	66	40	Unknown	0.08	4667

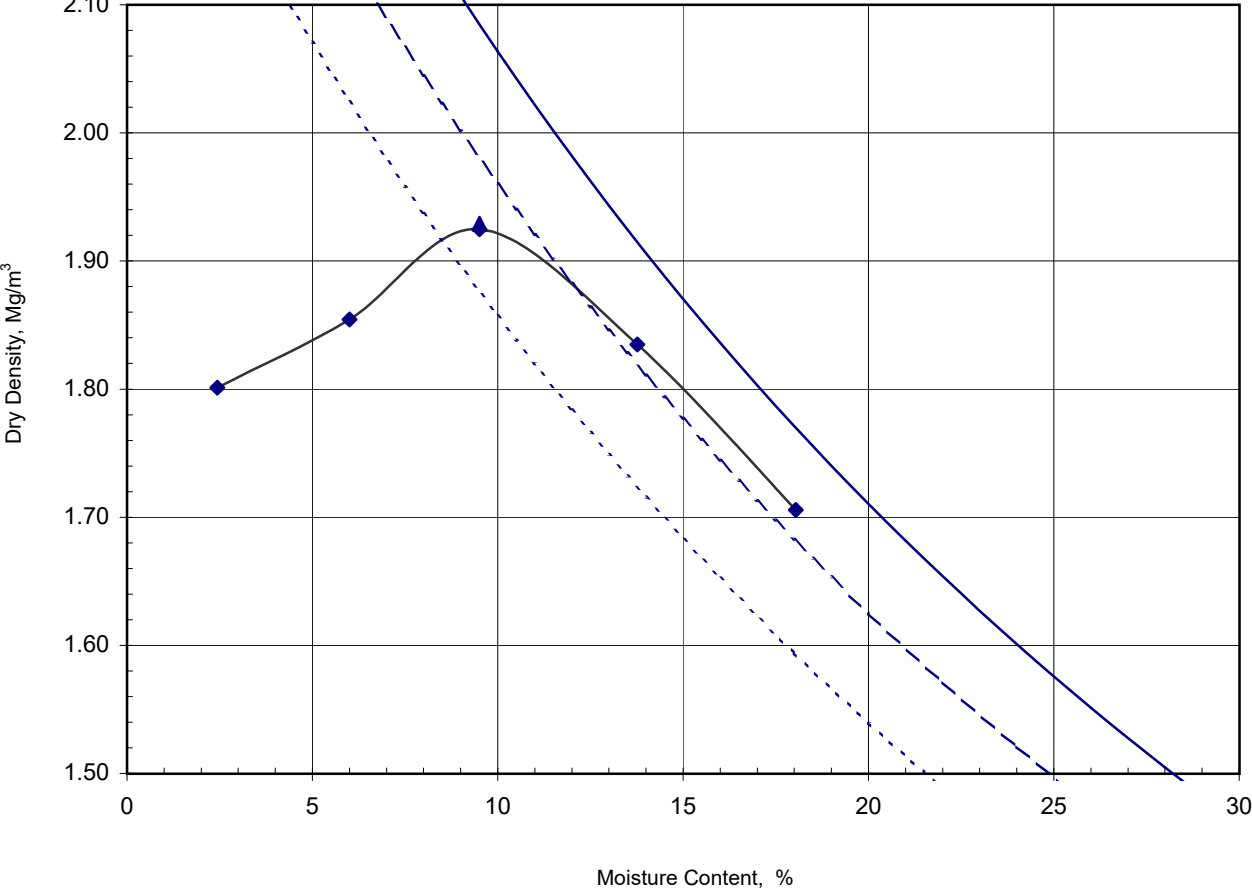
Moisture Content, %	Dry Density, Mg/m³
2.5	1.80
6.0	1.85
9.5	1.93
13.5	1.83
18.0	1.71

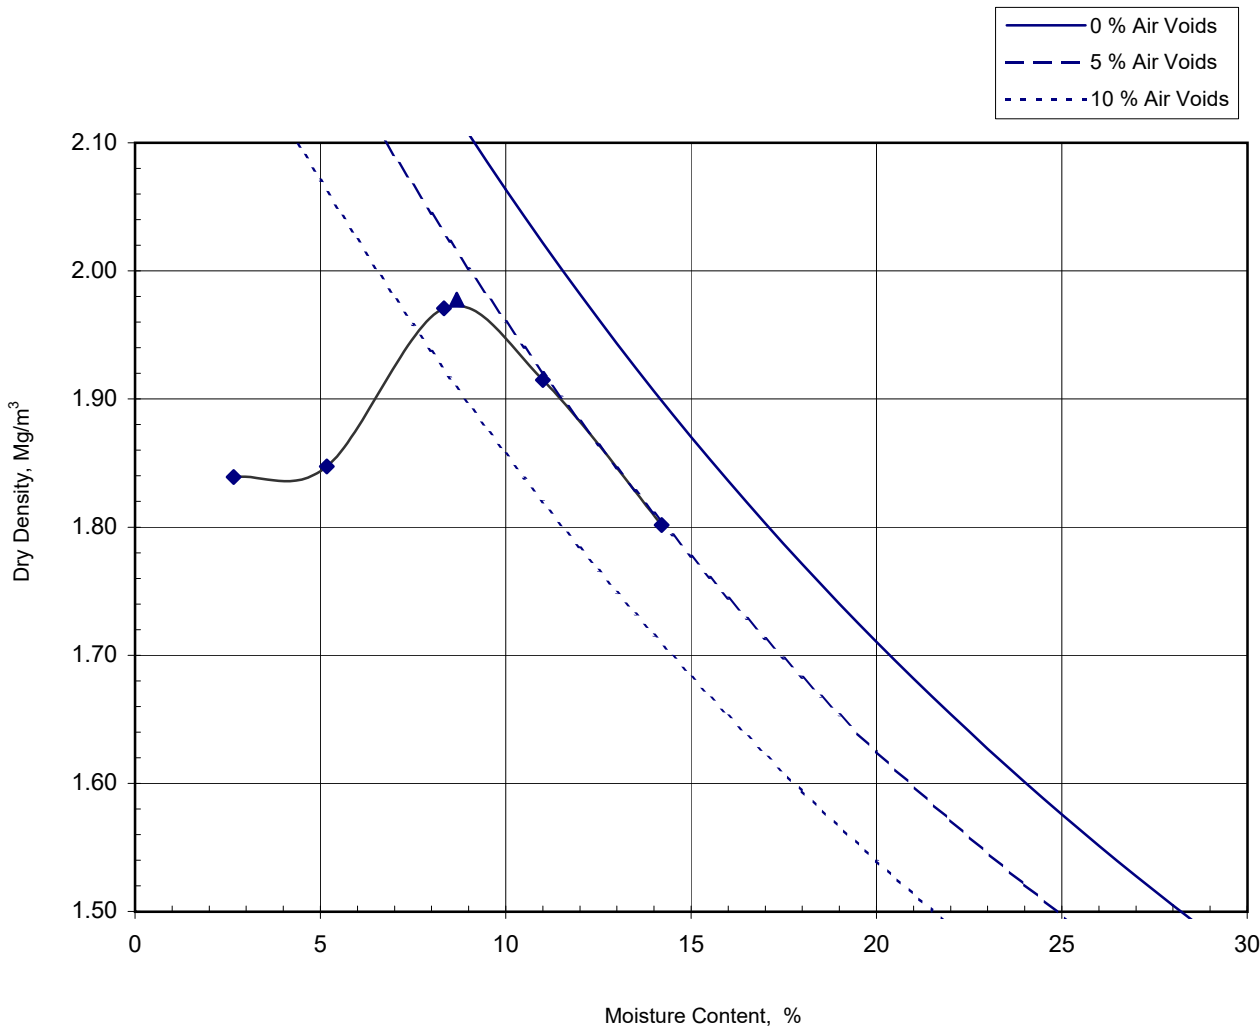
Non Engineering Description	Brown silty SAND and GRAVEL. Gravel is fine to coarse
Preparation	Oven dried
Test Method	4.5kg Rammer for soils with some coarse gravel-size particles
Samples Used	Single
Mass Retained on 37.5 mm Sieve	9
Mass Retained on 20.0 mm Sieve	23
Particle Density - Assumed	2.60
Natural Moisture Content	17
Maximum Dry Density	1.98
Optimum Moisture Content	8.7

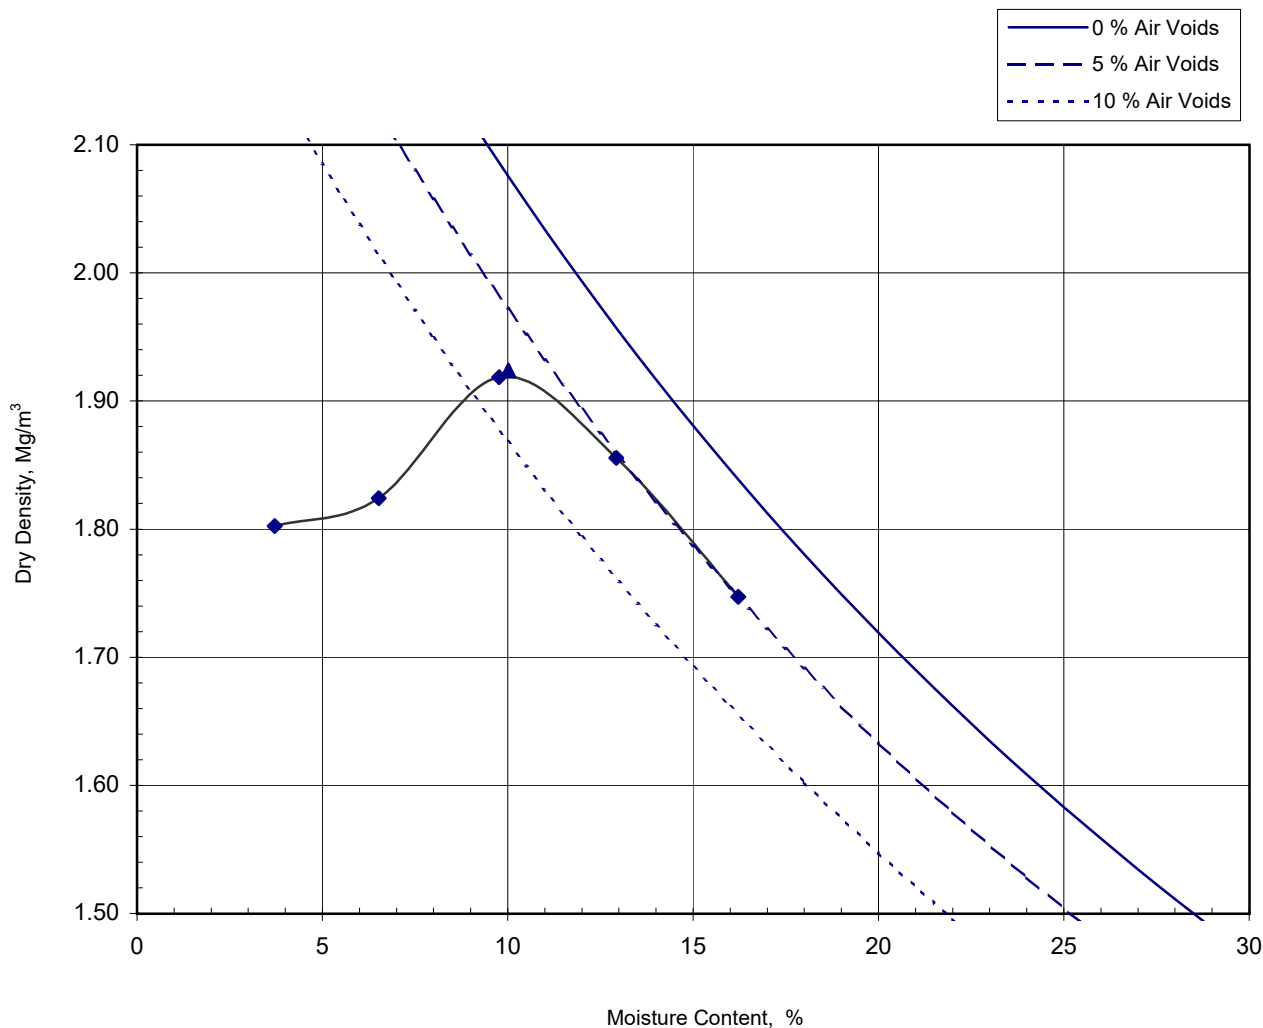
Non Engineering Description	Brown slightly gravelly slightly sandy CLAY. Gravel is fine to coarse
Preparation	Oven dried
Test Method	2.5kg Rammer for soils with some coarse gravel-size particles
Samples Used	Single
Mass Retained on 37.5 mm Sieve	% 3
Mass Retained on 20.0 mm Sieve	% 15
Particle Density - Assumed	Mg/m³ 2.62
Natural Moisture Content	% 16
Maximum Dry Density	Mg/m³ 1.92
Optimum Moisture Content	% 10.0

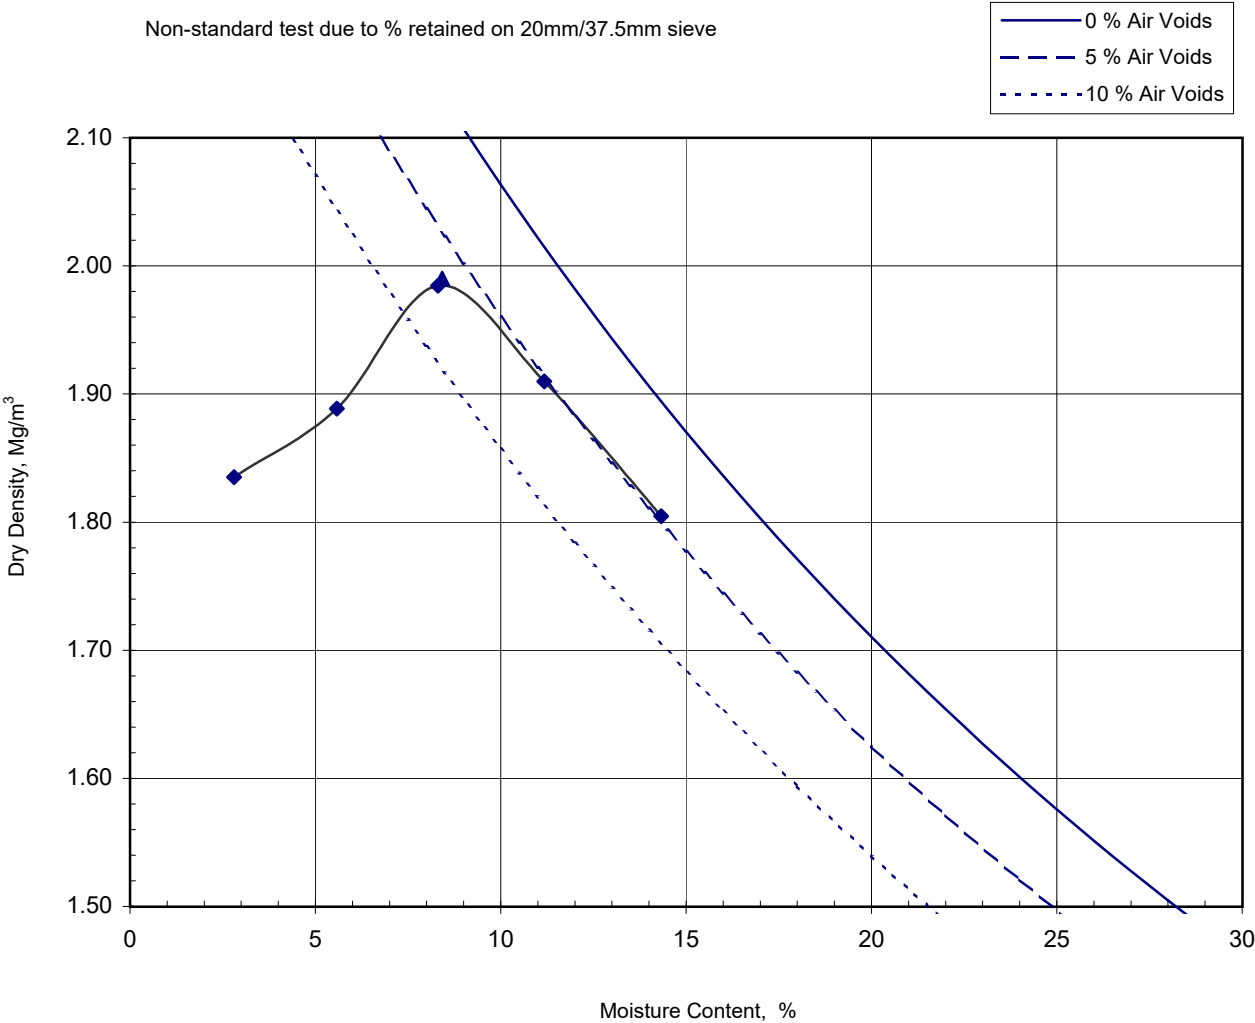
Non Engineering Description	Brown clayey SAND and GRAVEL with cobbles. Gravel is fine to coarse
Preparation	Oven dried
Test Method	4.5kg Rammer for soils with some coarse gravel-size particles
Samples Used	Single
Mass Retained on 37.5 mm Sieve	%28
Mass Retained on 20.0 mm Sieve	%31
Particle Density - Assumed	Mg/m³2.60
Natural Moisture Content	%13
Maximum Dry Density	Mg/m³1.99
Optimum Moisture Content	%8.4

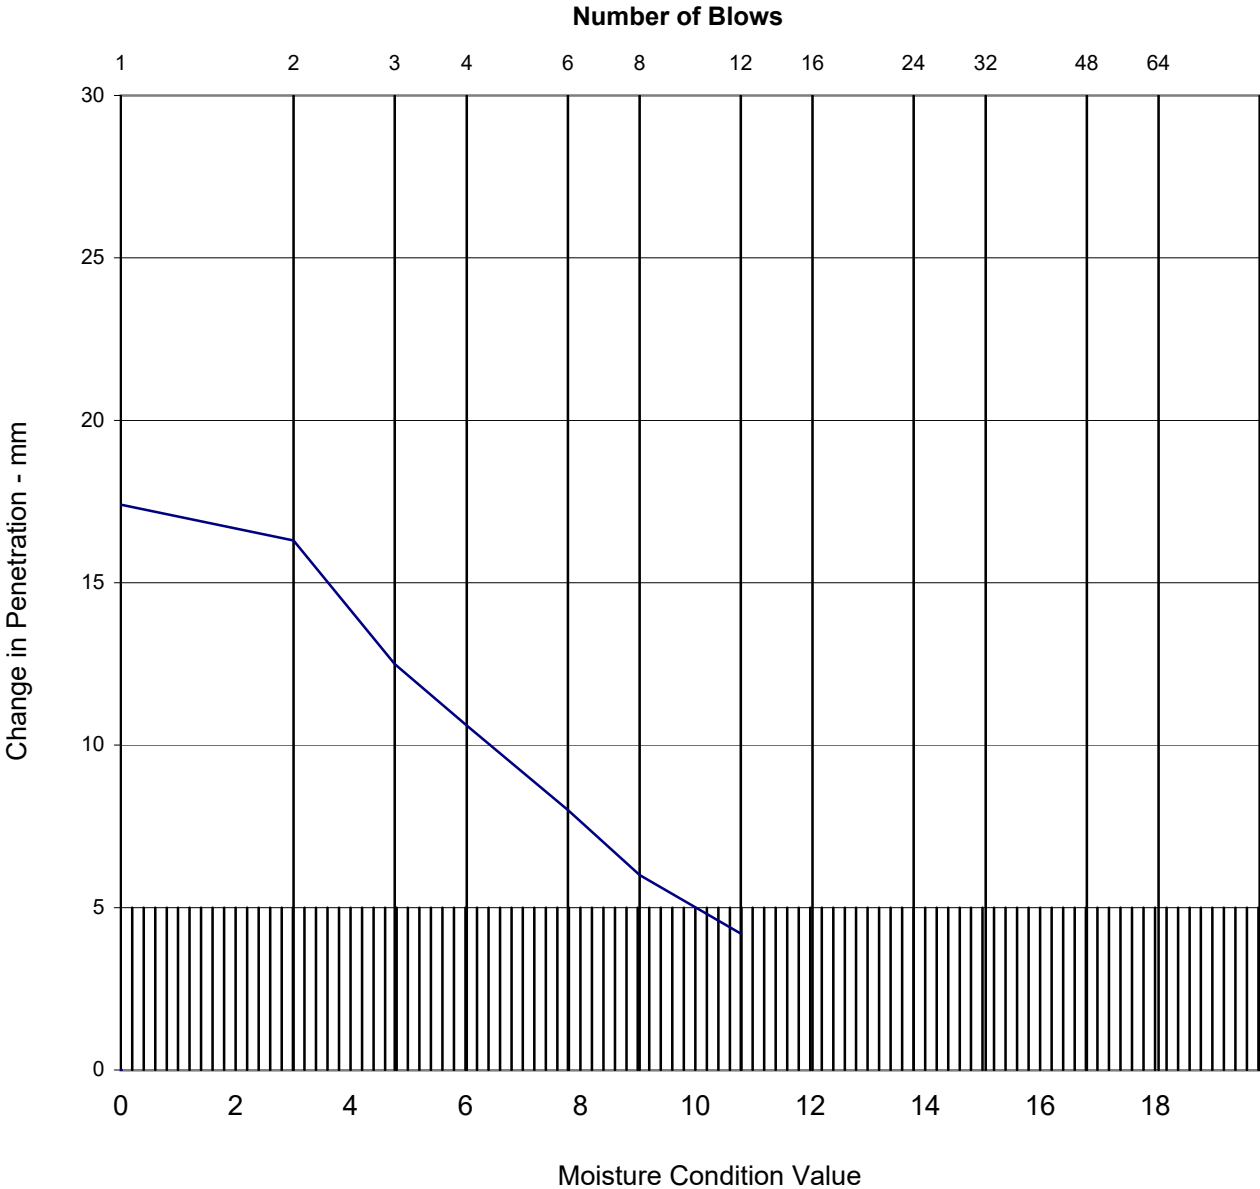
Site	LT520 BRACO WEST SUBSTATION	Contract No	26555
Client	SHE Transmission plc	Hole ID	TP19
Engineer	SSE Perth Inveralmond HSE	Sample Ref	
		Depth (m)	1.10
		Sample Type	B

Non Engineering Description	Brown slightly gravelly slightly sandy CLAY. Gravel is fine to coarse	
Determination No	1	
Moisture Condition Value	8.2	
Moisture Content	%	17
Method of determining MCV	Steepest fit line	
Mass retained on 20mm sieve	%	7.0
Notes

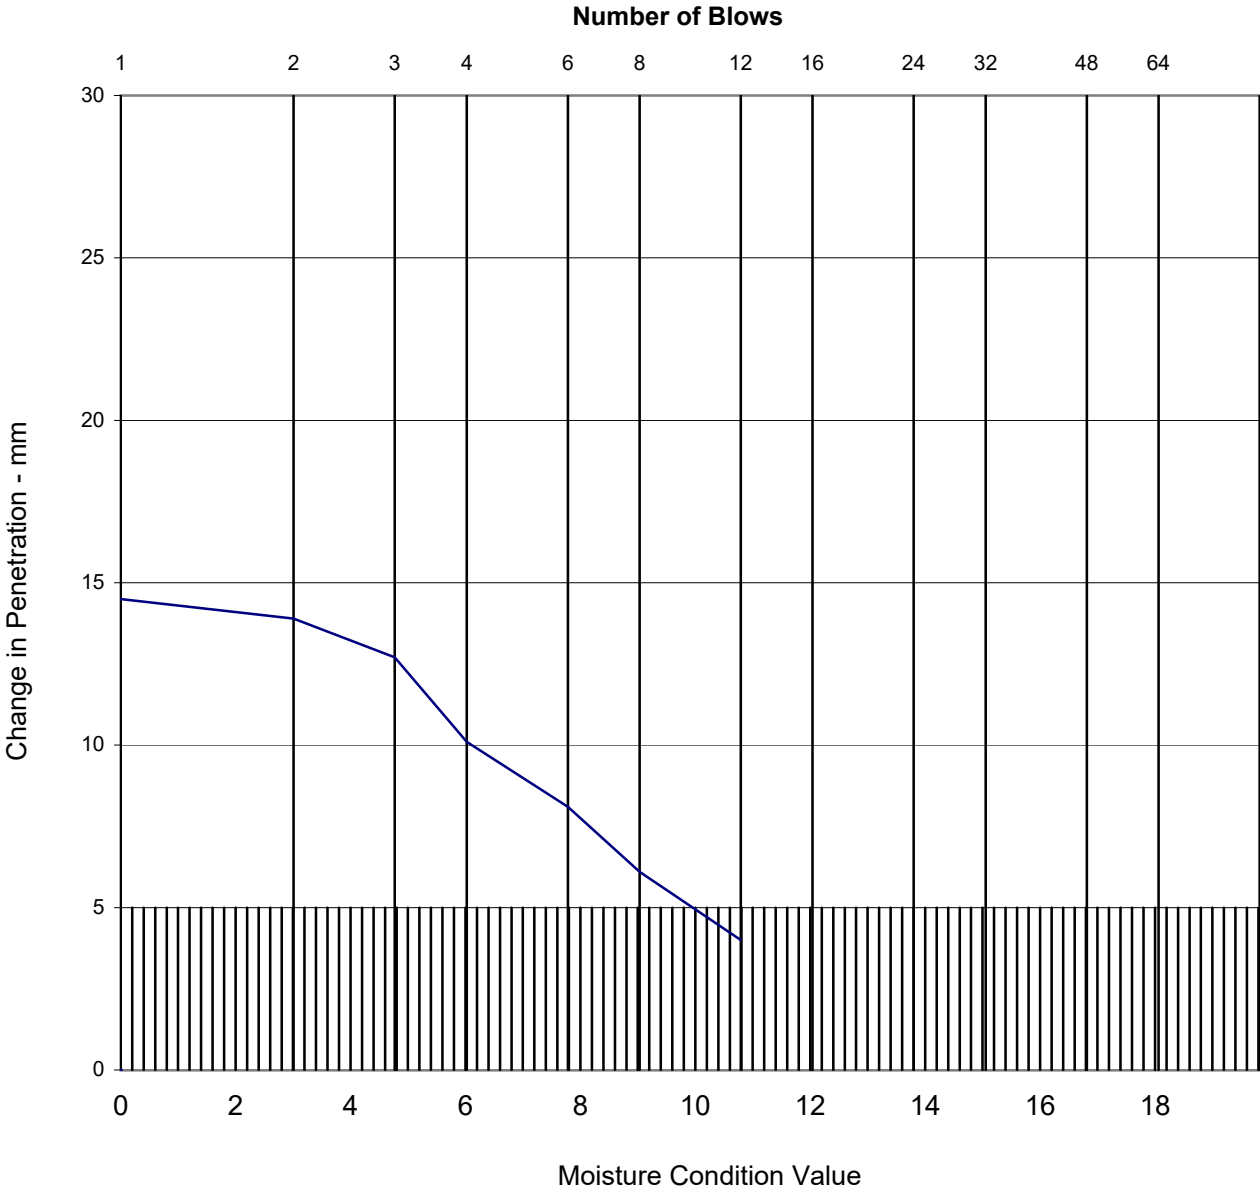
Site	LT520 BRACO WEST SUBSTATION	Contract No	26555
Client	SHE Transmission plc	Hole ID	TP20
Engineer	SSE Perth Inveralmond HSE	Sample Ref	
		Depth (m)	1.40
		Sample Type	B

Non Engineering Description	Brown clayey SAND and GRAVEL with cobbles. Gravel is fine to coarse	
Determination No	1	
Moisture Condition Value	8.5	
Moisture Content	%	18
Method of determining MCV	Steepest fit line	
Mass retained on 20mm sieve	%	33.0
Notes

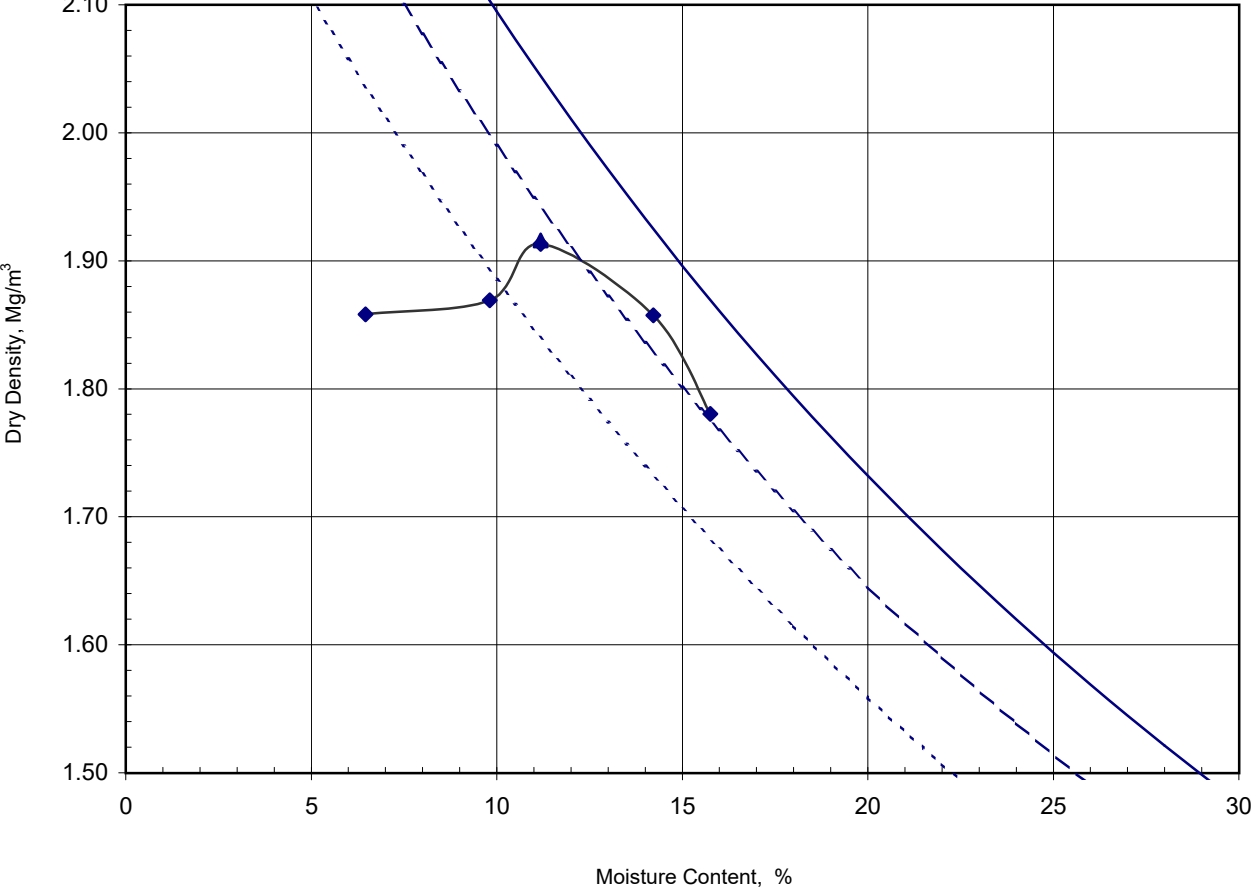
Non Engineering Description	Brown slightly grvaelly slightly sandy clayey SILT. Gravel is fine to coarse
Preparation	Oven dried
Test Method	4.5kg Rammer for soils with some coarse gravel-size particles
Samples Used	Single
Mass Retained on 37.5 mm Sieve	4
Mass Retained on 20.0 mm Sieve	10
Particle Density - Assumed	2.65
Natural Moisture Content	14
Maximum Dry Density	1.92
Optimum Moisture Content	11.2

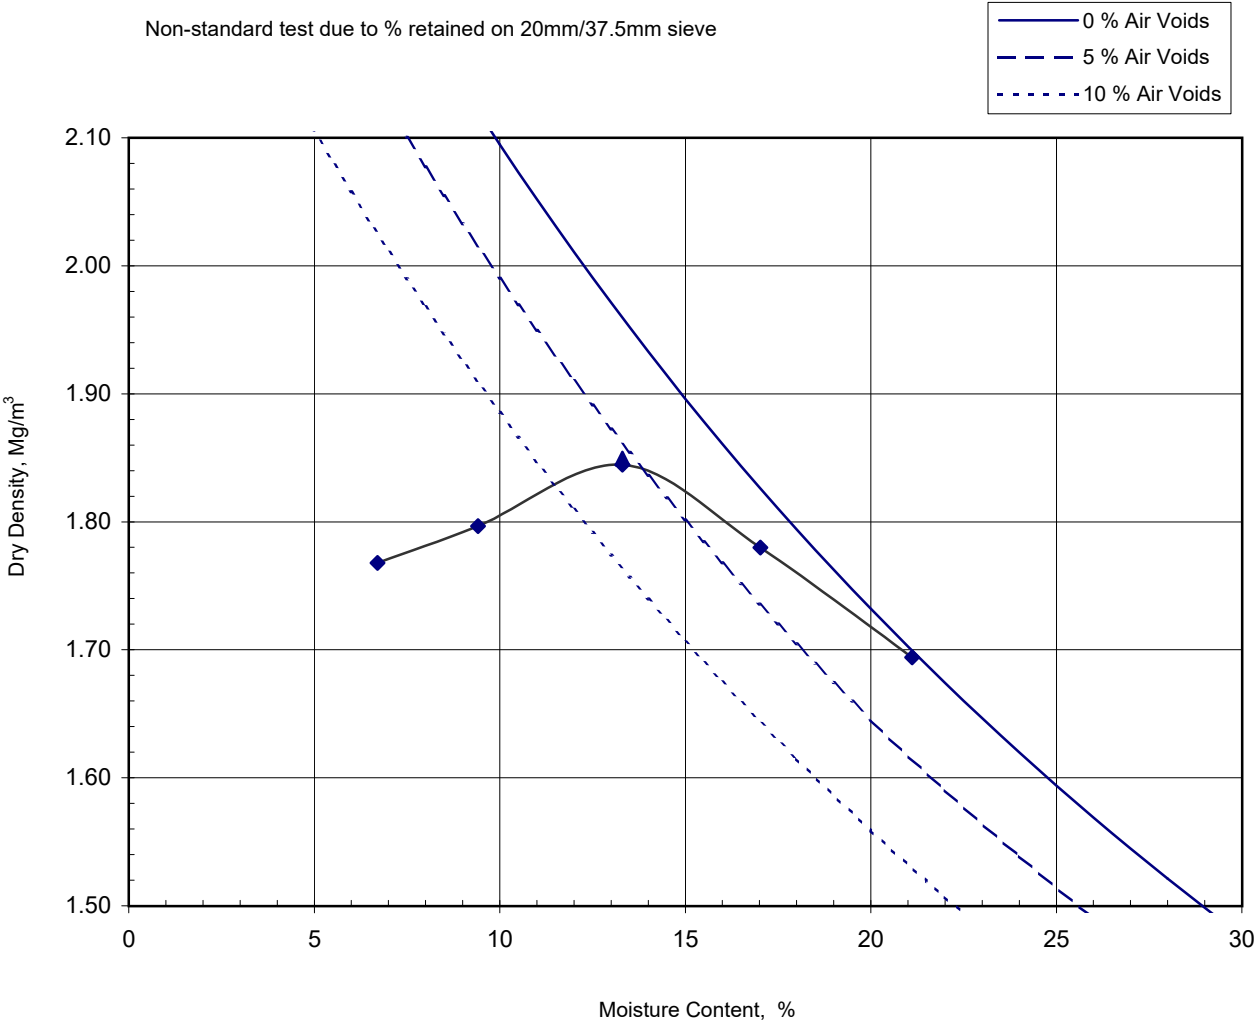
Non Engineering Description	Brown silty SAND and GRAVEL with cobbles. Gravel is fine to coarse
Preparation	Oven dried
Test Method	4.5kg Rammer for soils with some coarse gravel-size particles
Samples Used	Single
Mass Retained on 37.5 mm Sieve	% 19
Mass Retained on 20.0 mm Sieve	% 28
Particle Density - Assumed	Mg/m³ 2.65
Natural Moisture Content	% 17
Maximum Dry Density	Mg/m³ 1.85
Optimum Moisture Content	% 13.3
