LT307 – BRACO WEST
SITES 2 & 3

REPORT ON GROUND INVESTIGATION

Contract Number: 26555

Report Type: Factual

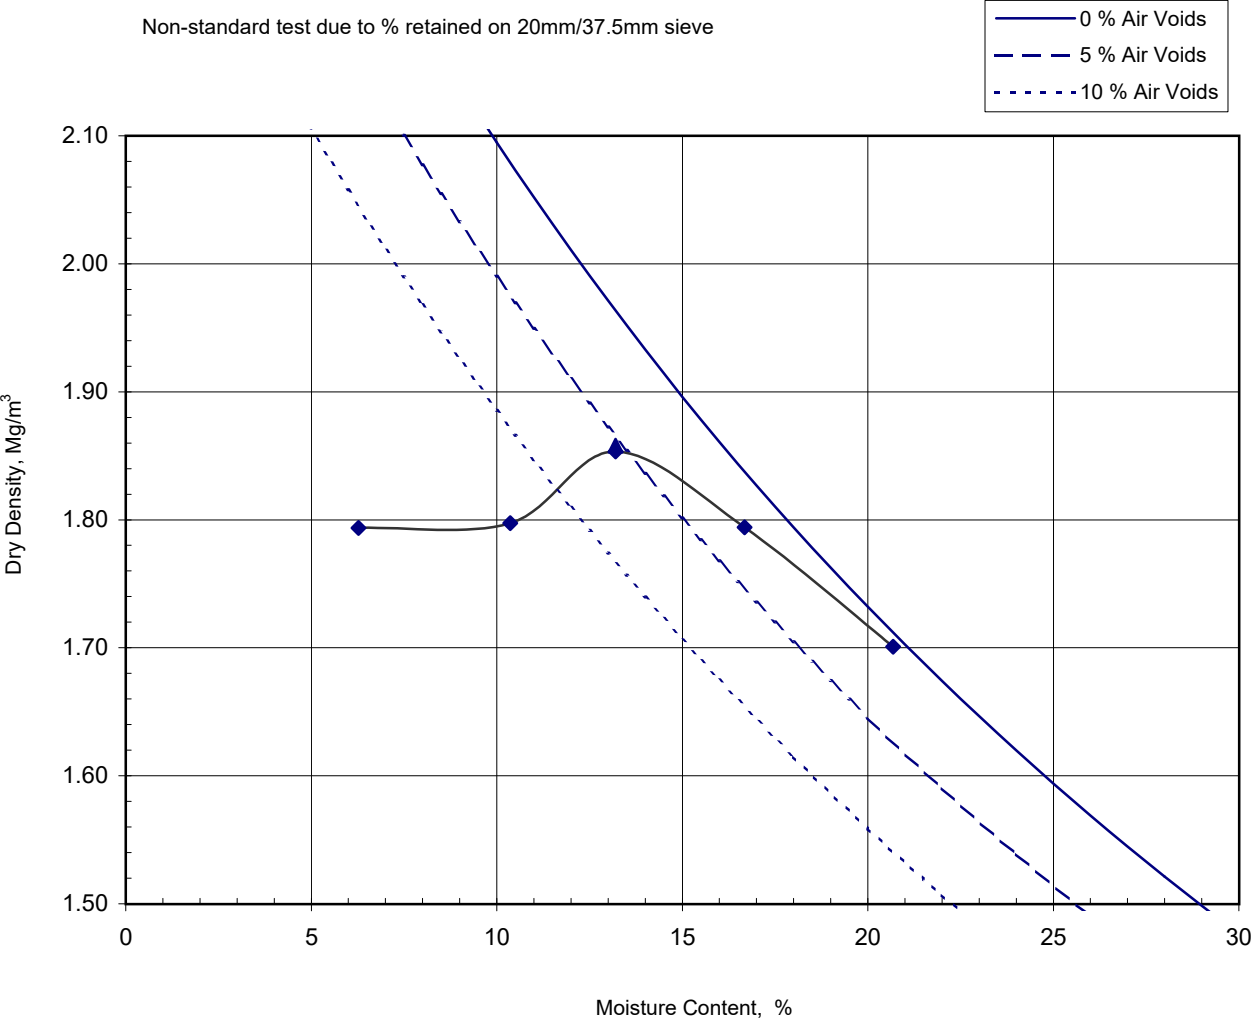
Non-standard test due to % retained on 20mm/37.5mm sieve

Moisture Content (%)	Dry Density (Mg/m³)
6.5	1.79
10.5	1.80
13.2	1.86
16.5	1.79
20.5	1.70

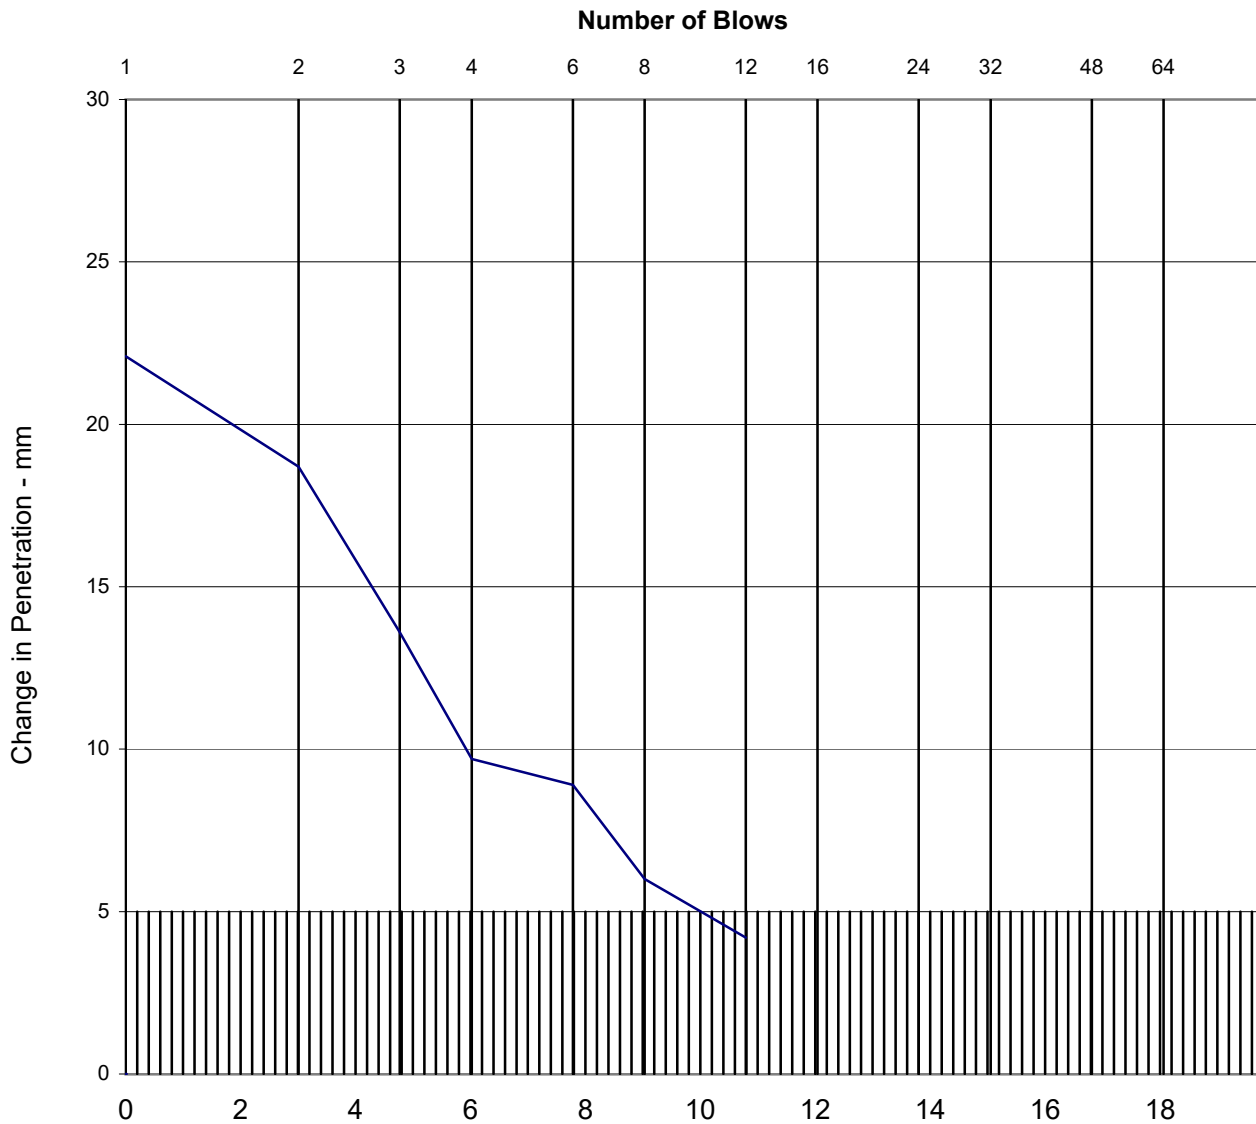
Non Engineering Description	Brown silty SAND and GRAVEL with cobbles. Gravel is fine to coarse
Determination No	1
Moisture Condition Value	7.5
Moisture Content	%16
Method of determining MCV	Steepest fit line
Mass retained on 20mm sieve	%28.0
Notes
