# Preliminary Peat Landslide Hazard and Risk Assessment

**Project Name – Cambushinnie 400kV Substation**

**Project Code – LT520 (60721943)**

**April 2025**

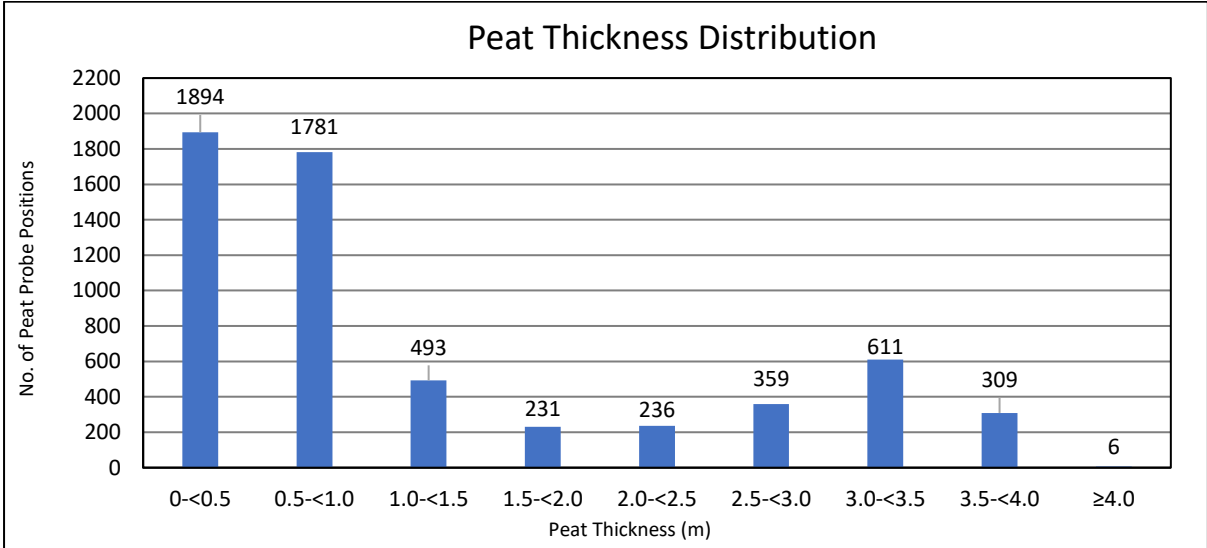
**Plot 1 - Peat Thickness Distribution**

**Plot 1** and **Plot 2** below, present the distribution of peat probes against the thickness range recorded.

When considering both the IGNE and AECOM peat probe surveys undertaken, 2245 of the probes (~37.9% of the 5920 no. total probes) indicate deep peat >1.0m in thickness. Peat deposits between 0.5m and <1.0m thick were recorded in 1781 no. of the probes (~30.1% of the 5920 no. total probes), and peaty soil <0.5m thick were recorded in 1894 no. of the probes (~32.0% of the 5920 no. total probes).

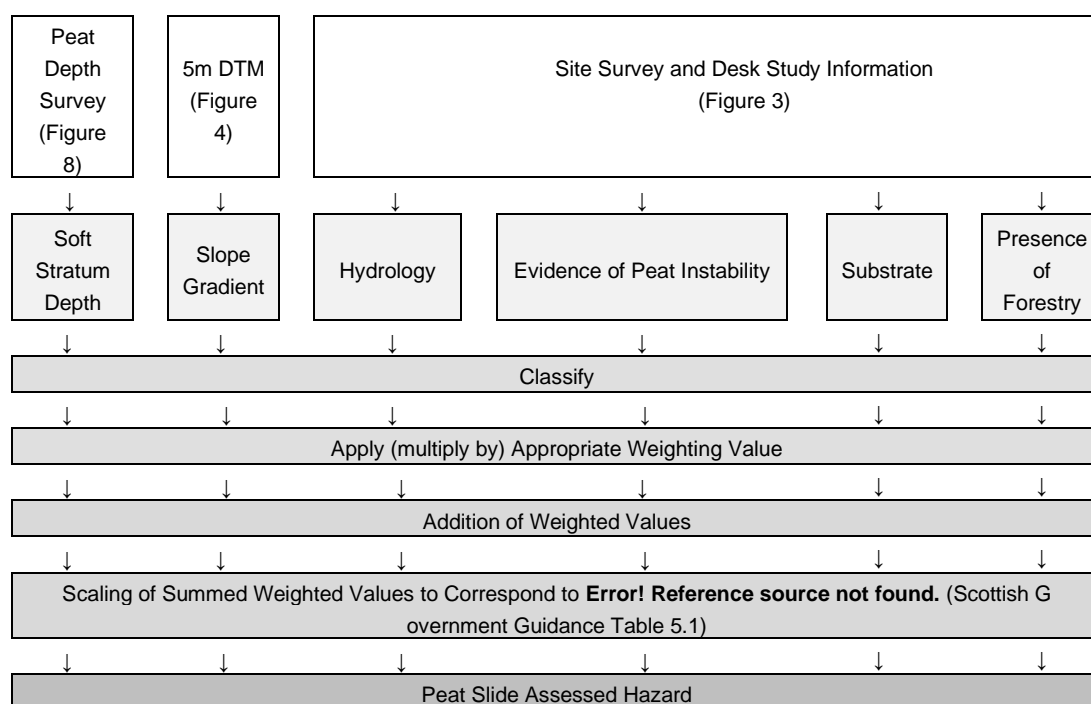
**Insert 6-2 GIS Multi-Criteria Analysis**

Parameter	Ranking Factor	Weighting
Slope Angle	1	6
Signs of Relic Failure	2	6
Peat Thickness	3	4
Substrate	4	3
Forestry	5	3
Hydrology	6	2

To estimate the level of hazard across the Site and produce the Peat Slide Assessed Hazard (PSAH) plan, the classification and weighting was carried out in Geographic Information Systems (GIS) software using a multi-criteria analysis. The process used is illustrated in **Insert 6-2**.

The scaling of the Weighted Totals corresponds to **Table 6-1** (and the Scottish Government Guidance Table 5.1) and is shown in below.

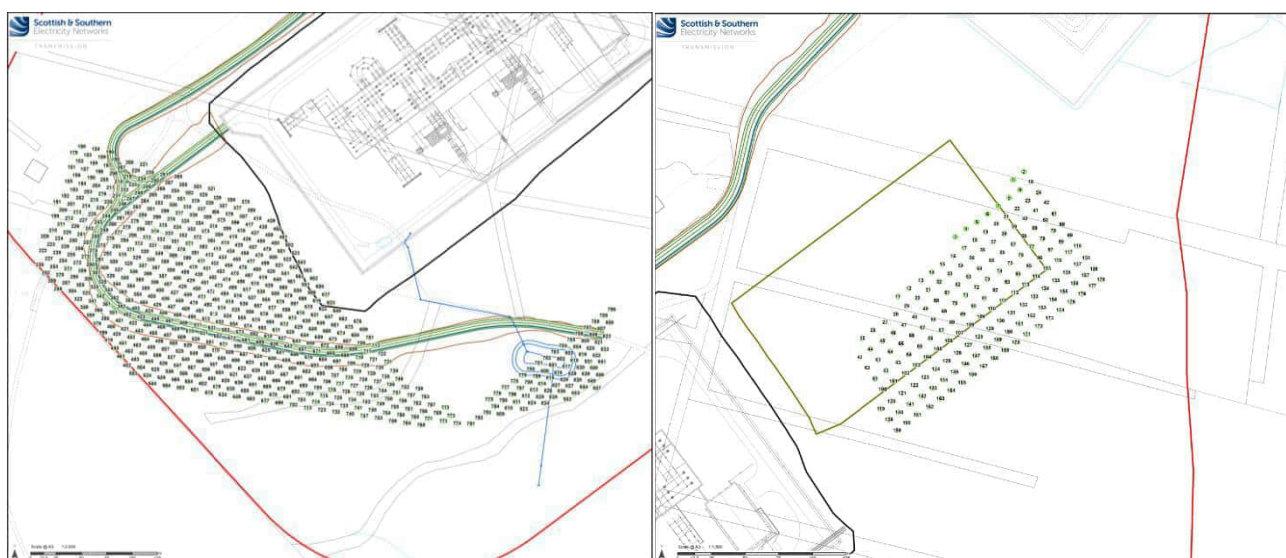
**Insert 1: Peat Probe Locations**

The additional peat probing was carried out by AECOM during March 2024 and was proposed to comprise of 847 probes on a 10m x 10m grid covering areas of the proposed works site which were not investigated as part of the initial peat probing by Igne in late 2023. The peat investigation can be split into two key areas: a small area northeast of the proposed substation and southwest of the existing substation covering areas of the proposed Contractors compound and a large area south and southwest of the proposed substation largely covering the proposed new access track and SuDs network. The smaller compound area comprised 178 probe locations whereas the larger area comprised 669 probe locations. See Insert 1 which shows these two areas.

During the site works, two areas were identified where trees were still present within the site. Within these areas it was not possible to safely undertake all of the probe hole locations. The two areas in question both relate to the larger probing area of the site. Figure 1 within Appendix A shows the areas where probes were cancelled and provides photographs of the condition. The first area indicatively shown by the red block in Figure 1, comprised mature trees which were severely windblown and had either collapsed or partially collapsed. This made the area inaccessible to the peat probing team. The second area indicatively shown by the purple block in Figure 1, comprised dense semi-mature trees where access could not be made easily and safely. Probing in these areas was undertaken where access could be made safely, however, 390 probes were cancelled due to the access and safety concerns. A further 15 probe locations were also cancelled due to the presence of overlying rock fill or gravel track. The peat probe result table in Appendix B provides the results of the probing exercise and where not undertaken, provides reasoning for this.
