# Stage 1 Peat Management Plan

**Project Name – Cambushinnie 400kV Substation**

**Project Code – LT520 (60721943)**

**April 2025**

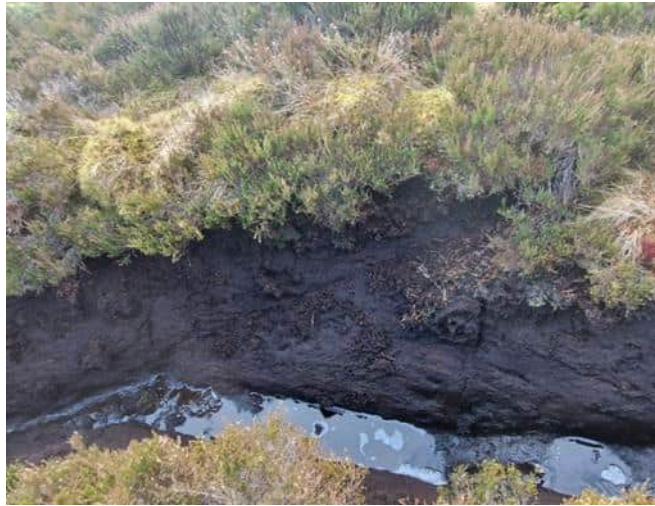
**Insert 2 - Photograph of peat exposure within a drainage ditch in northeast of main works area taken during site reconnaissance in March 2024**

Site reconnaissance during peat probing works in March 2024 and a subsequent site walkover in May 2024 typically agreed with the information obtained through the desk-based research presented above. The main works area was partially occupied by semi-mature conifer plantation trees, with the remainder felled and containing new very young plantation. The surrounding areas to the north, south and west of the main works area are also occupied by semi-mature to mature conifer plantations. Towards the southwestern corner of the main works area windblown trees were noted. Where zones were cleared, felled stumps were still noted to be present with branches and other woodland debris noted on the ground surface. In the zones of the new plantation and semi-mature trees the furrows created as part of the plantation process were noted to be particularly prevalent.

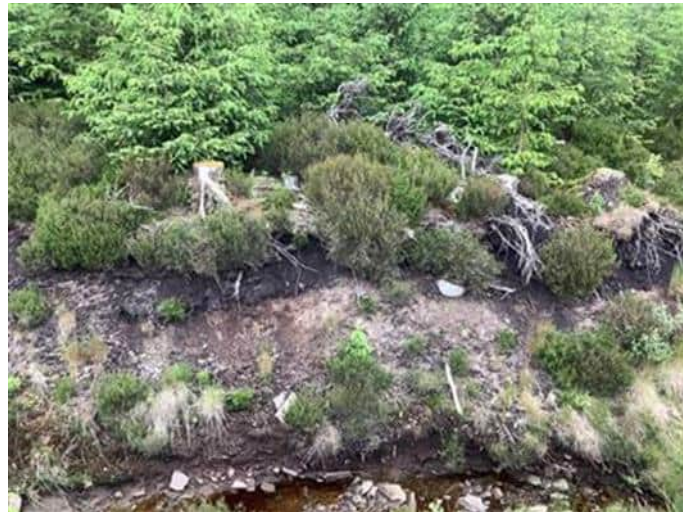
**Insert 3 – Photograph of peat exposure within a drainage ditch in west of main works area (approximate NGR NN 78848 08907) taken during site walkover in May 2024**

Throughout the main works area drainage ditches and channels were frequently noted associated with the forestry land use of the area many of which can be seen from aerial imagery. In some cases, these ditches were approximately 2 m in depth. As a result of the drainage present the underfoot conditions were typically not noted as boggy or saturated, except for a strip following the line of the existing overhead line in the northwest of the main works area. Peat deposits were generally noted in the sidewalls of the ditches observed within the main works area. Towards the north and northwest of the main works area and further north outwith the Site boundary, the sidewalls contained peat across the full depth, (see **Insert 2**) which shows some agreement with the peat probing results in that zone and that deep peat deposits are present (peat probing results discussed in more detail in **Section 3.6**). To the south and west of the main works area, the peat observed in the sidewalls of the drainage ditches was not noted to be as deep, approximately 0.5 m observed overlying mineral soils (see **Insert 3**). Again this shows agreement with the peat probing results.

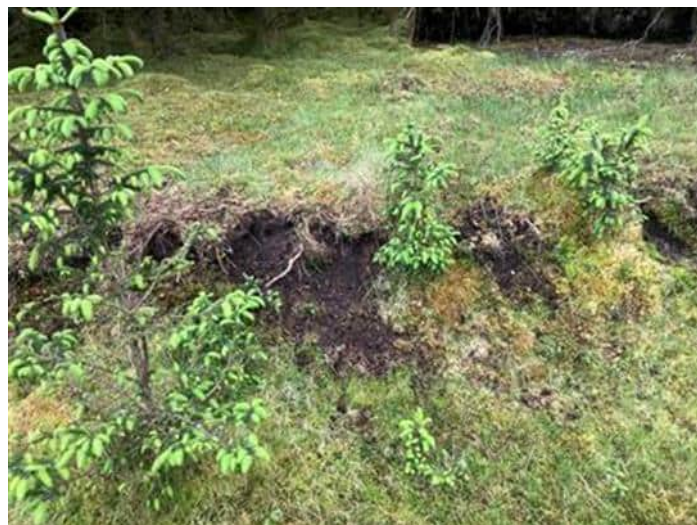
**Insert 4 - Photograph of peat exposure within a ditch adjacent to the south of the existing access track towards its western extent on approach to the existing Braco West Substation (approximate NGR NN79868 09471) taken during site walkover in May 2024**

Observations made along the existing access track did not highlight peat exposure or peat soils within the sidewalls of drainage channels along the majority of the track. The exception to this was towards the western end of the track leading up to the existing Braco West Substation, where peat was noted in the sidewalls of drainage channels (see **Insert 4**). Along the route of the existing access track the surrounding land use was noted as being a combination of agricultural and forestry plantation in various stages of felling/replanting.
