# TECHNICAL NOTE - GEOTECHNICAL SYNOPSIS

<b>DATE:</b>	17 July 2024	<b>CONFIDENTIALITY:</b>	Confidential
<b>SUBJECT:</b>	Cambushinnie 400kV Substation, 70108968		
<b>CLIENT:</b>	Balfour Beatty	<b>AUTHOR:</b>	Sophie Gedge
<b>CHECKED:</b>	Darren Warnock	<b>APPROVED:</b>	Brennig Davis

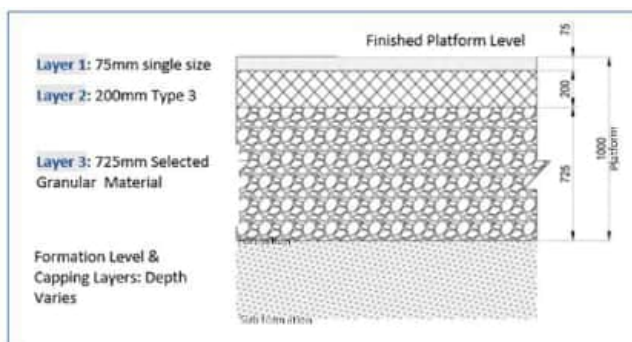
Figure 2 – Substation platform make up (Figure 5.1 of SP-NET-CIV-501 rev 2.0)

The make-up of the platform fill and surfacing shall be in accordance with SSEN Specification for Earthworks (SP-NET-CIV-501, rev 2.0), as shown below as Figure 3.

Based on the generalised ground model for the site and on the assumption that Peat and any soft Glacial Till below the platform is fully excavated and replaced, it is considered that conventional ground bearing shallow foundations are likely to be suitable at the site, bearing within either placed engineered granular fill or the existing firm or stiff Glacial Till, weathered rock or bedrock. The allowable bearing capacity of placed granular fill is anticipated to be 150 kN/m<sup>2</sup>, which is the minimum requirement for the sub-formation as specified within SSEN Specification for Earthworks (SP-NET-CIV-501, rev 2.0)
