Route Feasibility Report

**For the delivery of 261 te Transformer
from Grangemouth to Cambushinnie Substation**

A242494

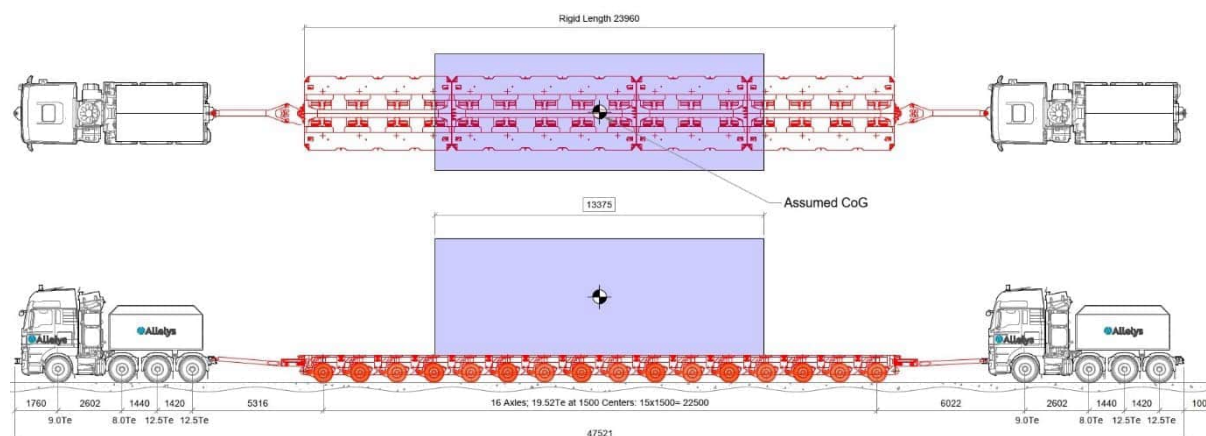
Figure 3 261 te SGT loaded onto 16-axle flat top trailer

7.1.4. This transport arrangement has a gross weight 312.4 te, width 4.7 m, height 5.8 m and axle line load 19.5 te. Therefore, it is to be carried under Special Order legislation. Full technical drawing no. ALL-A242494-TA-02 is included under Appendix A.

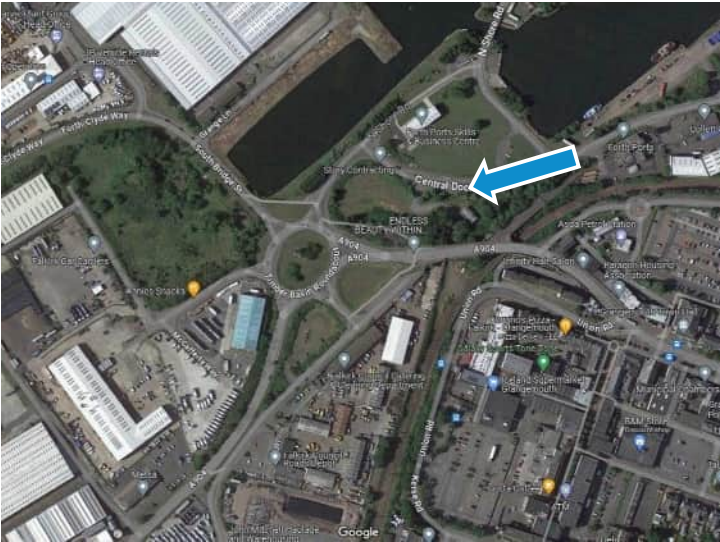
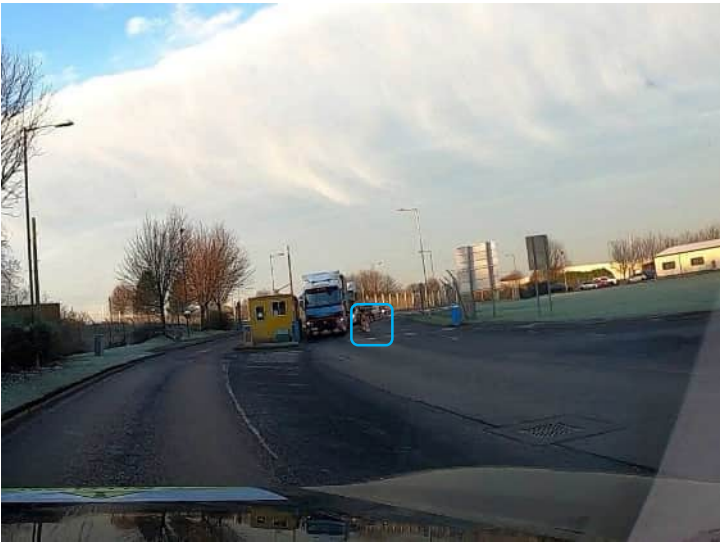
Ref. ALL-A242494-RS-03 <i>Forth Ports (Grangemouth) port security</i>

Direction of Travel Location: Westbound on Central Dock Rd through Forth Ports (Grangemouth) port security	Coordinates: 56.021056, -3.724889
Enabling Works Required: Contraflow manoeuvre Removal of barrier support pole and cones	Enabling Work Grade: Medium Medium
Assessment Works Required: Route survey carried out	Assessment Work Grade: Complete

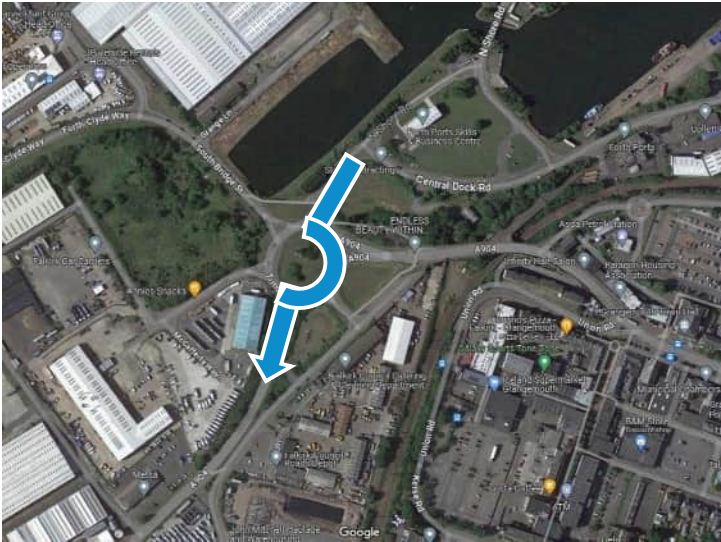
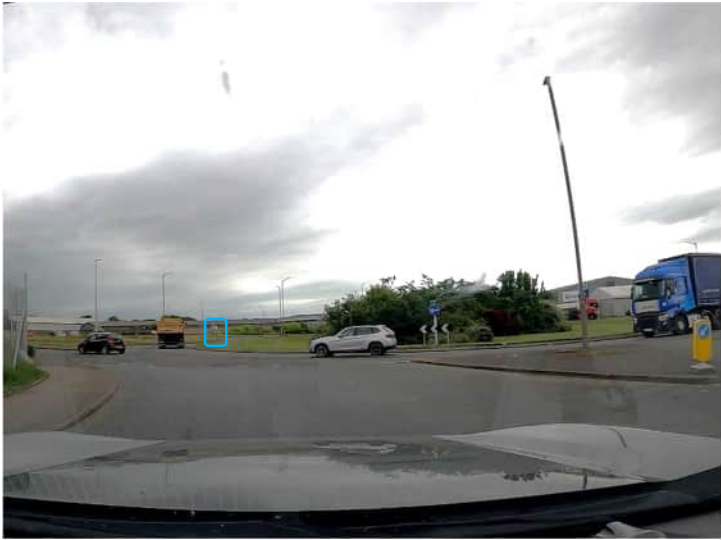
<div>Ref. ALL-A242494-RS-04</div> <div>N Shore Rd/A904 Timber Basin Roundabout</div>

<div>Direction of Travel Location:</div> <div>Straight on at A904 Timber Roundabout from N Shore Rd onto A904</div>	<div>Coordinates:</div> <div>56.020333, -3.727778</div>
<div>Enabling Works Required:</div> <div>Removal of 2 no. illuminated road sign and 2 no. non-illuminated road sign</div>	<div>Enabling Work Grade:</div> <div>Medium</div>
<div>Assessment Works Required:</div> <div>Route survey carried out</div>	<div>Assessment Work Grade:</div> <div>Complete</div>

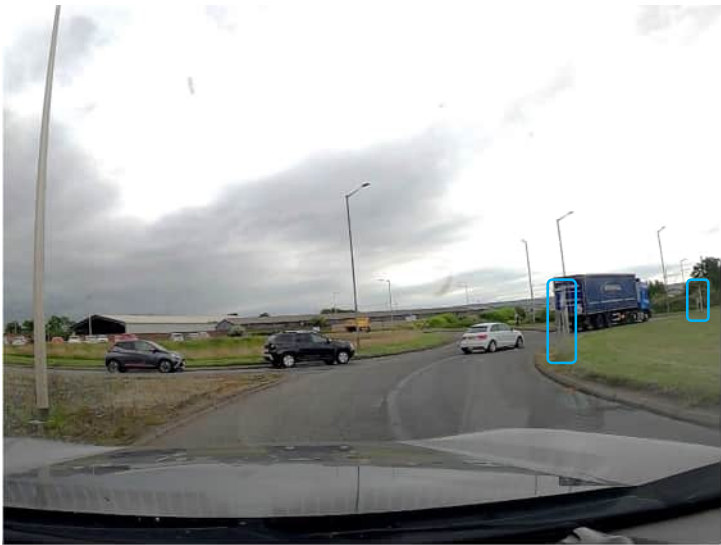
Ref. ALL-A242494-RS-04 cont'd <i>N Shore Rd/A904 Timber Basin Roundabout</i>

Direction of Travel Location: Straight on at A904 Timber Roundabout from N Shore Rd onto A904	Coordinates: 56.020333, -3.727778
Enabling Works Required: Removal of 2 no. illuminated road sign and 2 no. non-illuminated road sign	Enabling Work Grade: Medium
Assessment Works Required: Route survey carried out	Assessment Work Grade: Complete

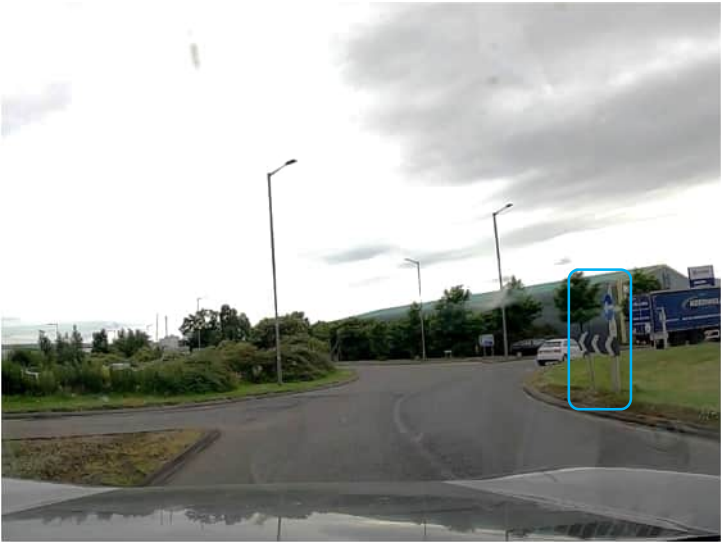
Ref. ALL-A242494-RS-04 cont'd <i>N Shore Rd/A904 Timber Basin Roundabout</i>

Direction of Travel Location: Straight on at A904 Timber Roundabout from N Shore Rd onto A904	Coordinates: 56.020333, -3.727778
Enabling Works Required: Removal of 2 no. illuminated road sign and 2 no. non-illuminated road sign	Enabling Work Grade: Medium
Assessment Works Required: Route survey carried out	Assessment Work Grade: Complete

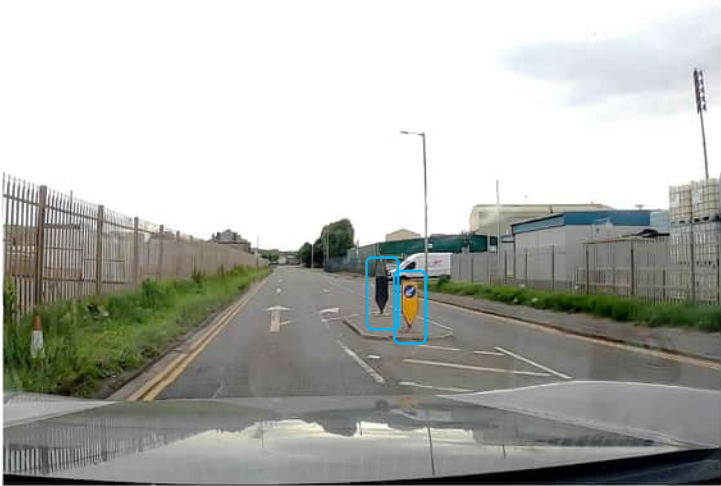
Ref. ALL-A242494-RS-07	
A904 central splitter island no. 1

Direction of Travel Location: Southbound on A904	Coordinates: 56.017250, -3.731472
Enabling Works Required: Removal of 2 no. keep left bollard	Enabling Work Grade: Medium
Assessment Works Required: Route survey carried out	Assessment Work Grade: Complete

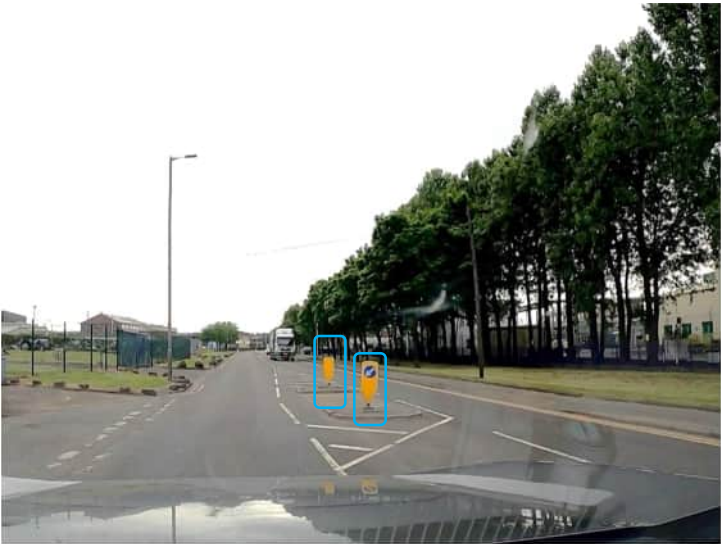
<div>Ref. ALL-A242494-RS-08</div> <div>A904 central splitter island no. 2</div>

<div>Direction of Travel Location:</div> <div>Southbound on A904</div>	<div>Coordinates:</div> <div>56.016056, -3.733722</div>
<div>Enabling Works Required:</div> <div>Removal of 2 no. keep left bollard</div>	<div>Enabling Work Grade:</div> <div>Medium</div>
<div>Assessment Works Required:</div> <div>Route survey carried out</div>	<div>Assessment Work Grade:</div> <div>Complete</div>

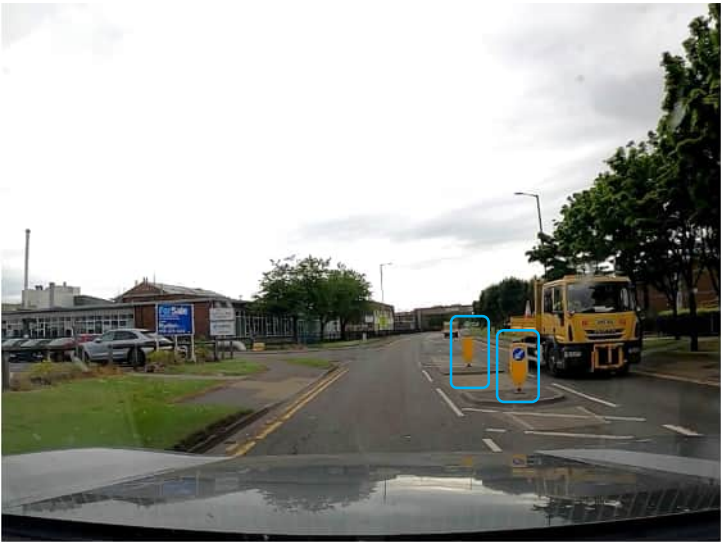
Ref. ALL-A242494-RS-09 <i>A904 central splitter island no. 3</i>

Direction of Travel Location: Southbound on A904	Coordinates: 56.015333, -3.735056
Enabling Works Required: Removal of 2 no. keep left bollard	Enabling Work Grade: Medium
Assessment Works Required: Route survey carried out	Assessment Work Grade: Complete

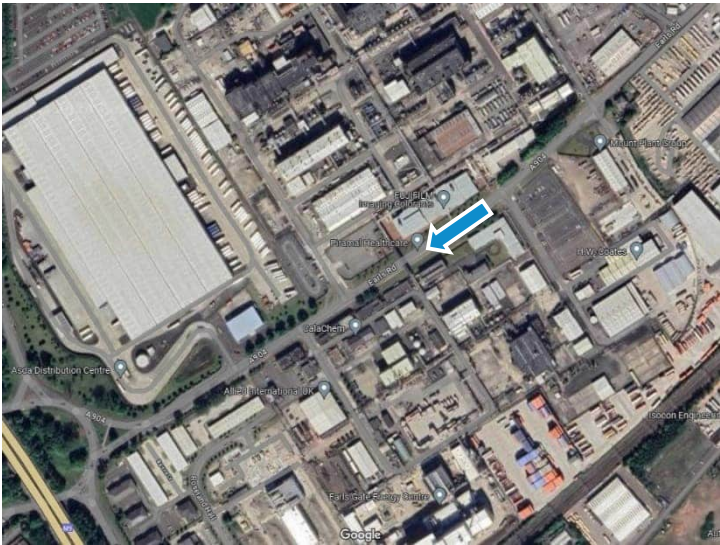
Ref. ALL-A242494-RS-10	
A904 central splitter island no. 4

Direction of Travel Location: Southbound on A904	Coordinates: 56.014639, -3.736667
Enabling Works Required: Removal of 2 no. keep left bollard	Enabling Work Grade: Medium
Assessment Works Required: Route survey carried out	Assessment Work Grade: Complete

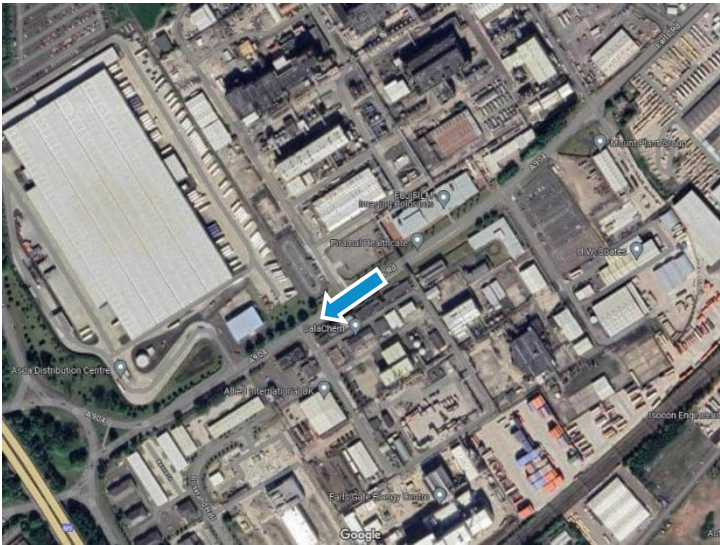
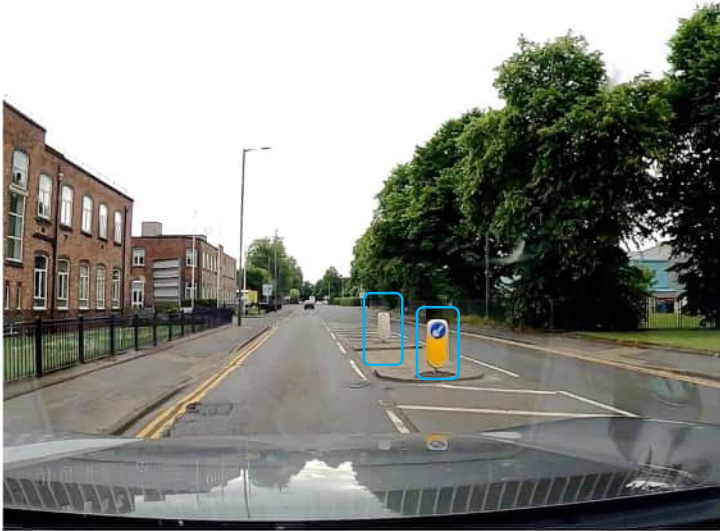
Ref. ALL-A242494-RS-11 <i>A904 central splitter island no. 5</i>

Direction of Travel Location: Southbound on A904	Coordinates: 56.013889, -3.738750
Enabling Works Required: Removal of 2 no. keep left bollard	Enabling Work Grade: Medium
Assessment Works Required: Route survey carried out	Assessment Work Grade: Complete

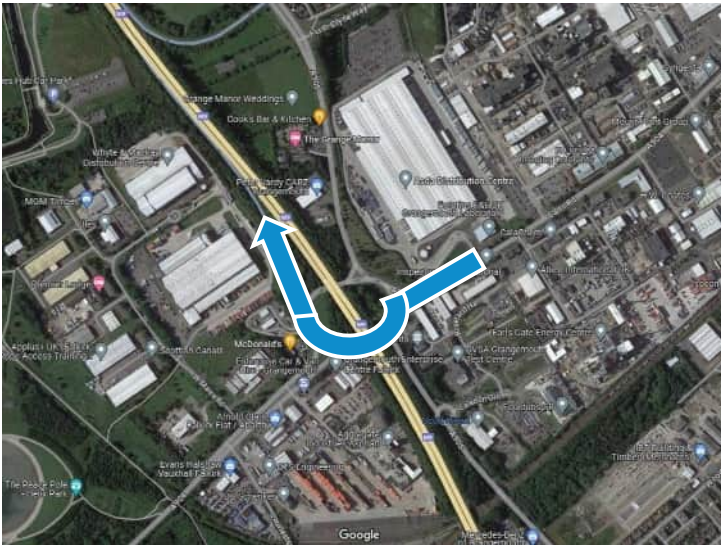
Ref. ALL-A242494-RS-12	
A904 Earl's Gate Roundabout

Direction of Travel Location: RH turn at A904 Earl's Gate Roundabout remaining from A904 onto M9	Coordinates: 56.012306, -3.744722
Enabling Works Required: N/A	Enabling Work Grade: N/A
Assessment Works Required: Route survey carried out - negotiable	Assessment Work Grade: Complete

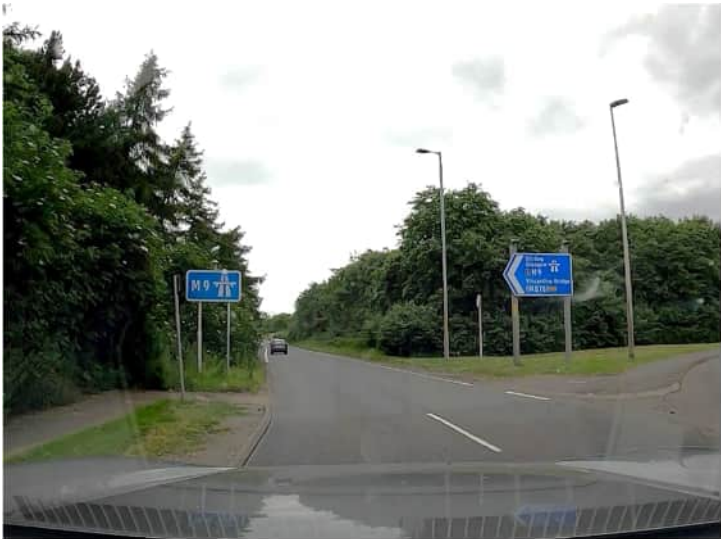
Ref. ALL-A242494-RS-12 cont'd <i>A904 Earl's Gate Roundabout</i>

Direction of Travel Location: RH turn at A904 Earl's Gate Roundabout remaining from A904 onto M9	Coordinates: 56.012306, -3.744722
Enabling Works Required: N/A	Enabling Work Grade: N/A
Assessment Works Required: Route survey carried out - negotiable	Assessment Work Grade: Complete

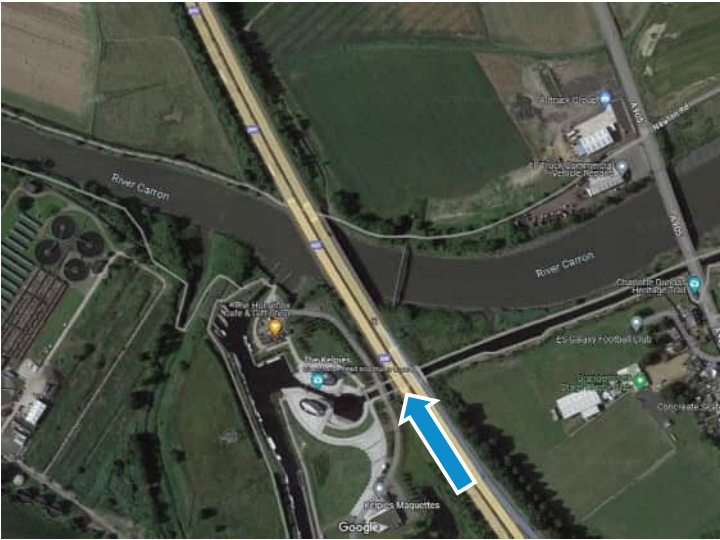
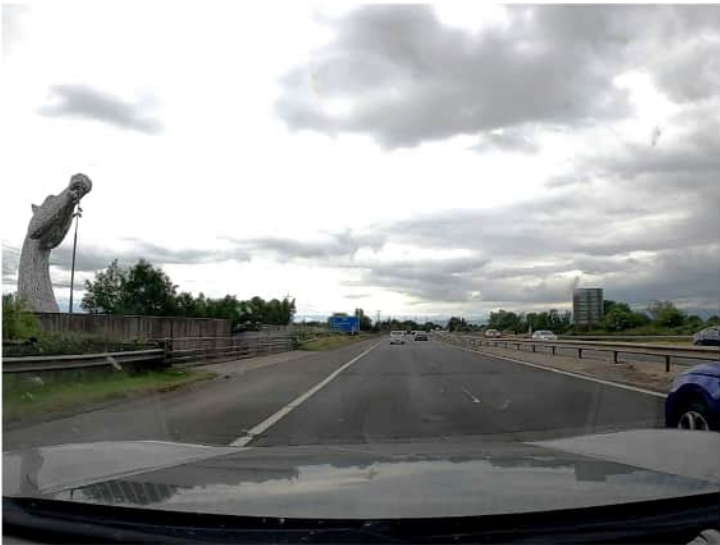
Ref. ALL-A242494-RS-13 <i>M9 6-7 24 Kelpies (Helix) Canal</i>

Direction of Travel Location: Northbound on M9 over structure no. M9 6-7 24 Kelpies (Helix) Canal	Coordinates: 56.019306, -3.754333
Enabling Works Required: Subject to structural assessment	Enabling Work Grade: TBC
Assessment Works Required: Failed Transport Scotland/BEAR (SES) checks Further structural assessment required, suitable for overbridging, if required	Assessment Work Grade: Complete Medium

8.3. Structure no's M9 6-7 24 M9 Kelpies (Helix) Canal, A822/01 Millstone Burn and B8033/03 Bridge of Keir are thought to be suitable for overbridging, however, the remaining structures are unsuitable and therefore pose a high risk to delivery of the SGTs should the results of the assessments be negative.

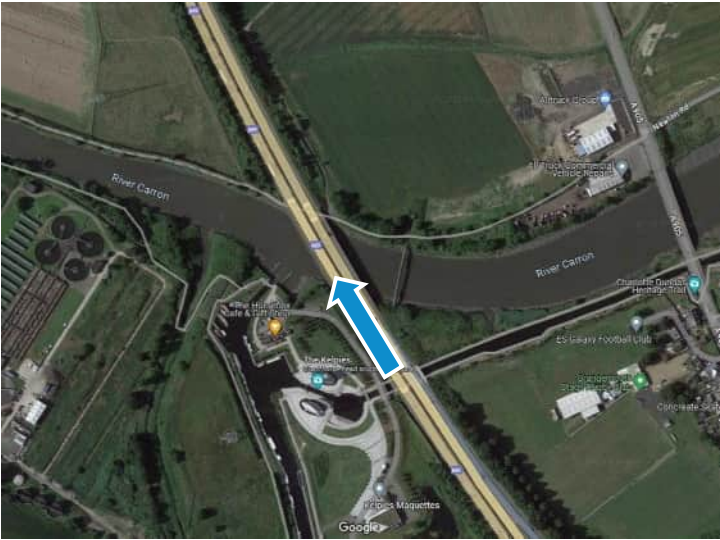
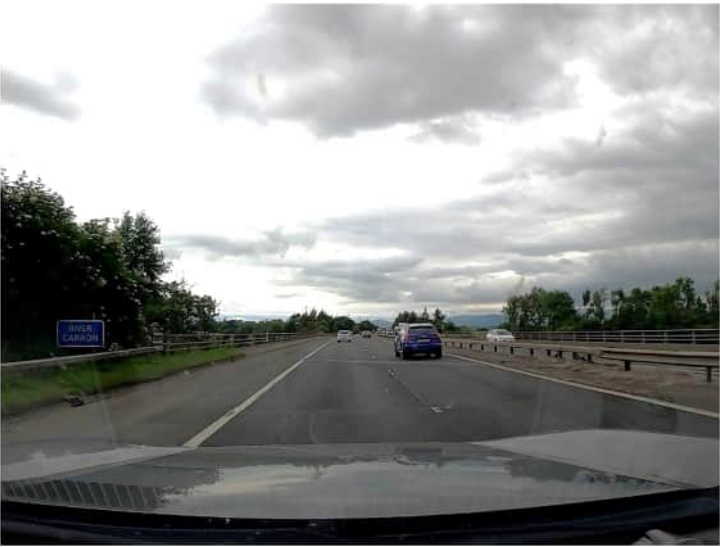
Ref. ALL-A242494-RS-14	
M9 6-7 25 Carron

Direction of Travel Location: Northbound on M9 over structure no. M9 6-7 25 Carron	Coordinates: 56.020628, -3.7557451
Enabling Works Required: Subject to structural assessment	Enabling Work Grade: TBC
Assessment Works Required: Failed Transport Scotland/BEAR (SES) checks Further structural assessment required, unsuitable for overbridging, if required	Assessment Work Grade: Complete High

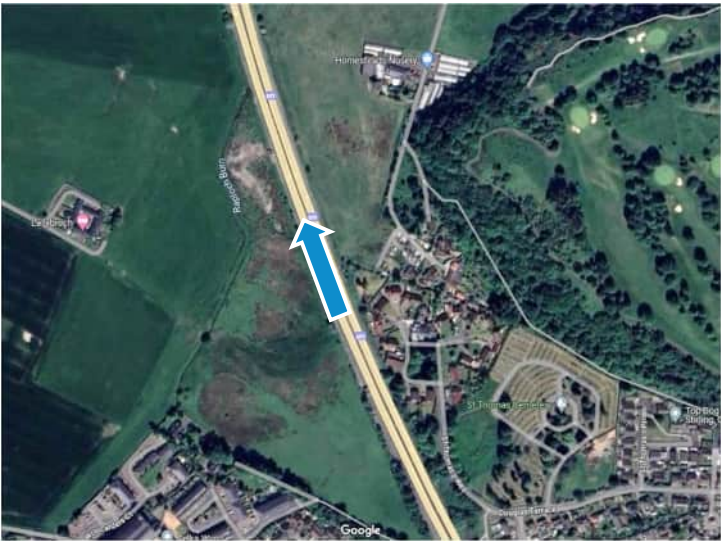
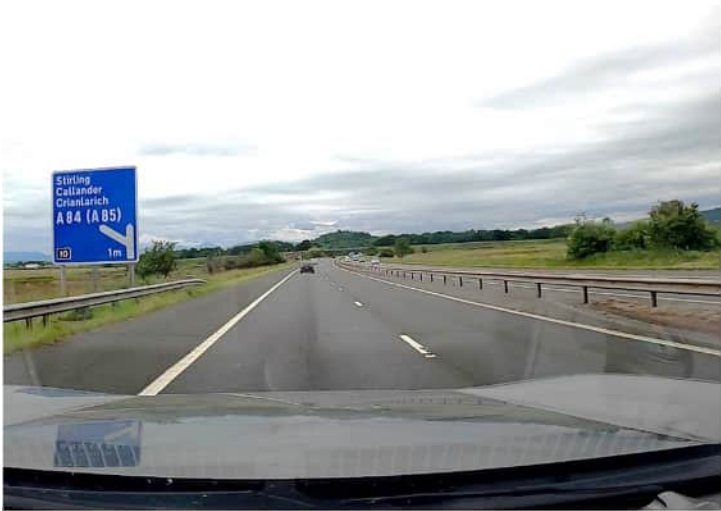
Ref. ALL-A242494-RS-15	
M9 gradient

Direction of Travel Location: Northbound on M9	Coordinates: 56.115639, -3.967306
Enabling Works Required: Additional tractor unit(s) needed to produce necessary braking effort	Enabling Work Grade: Low
Assessment Works Required: Route survey carried out	Assessment Work Grade: Complete

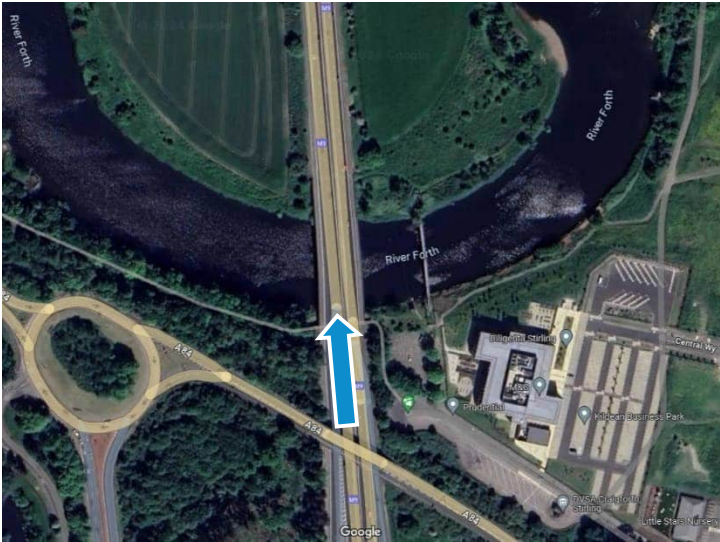
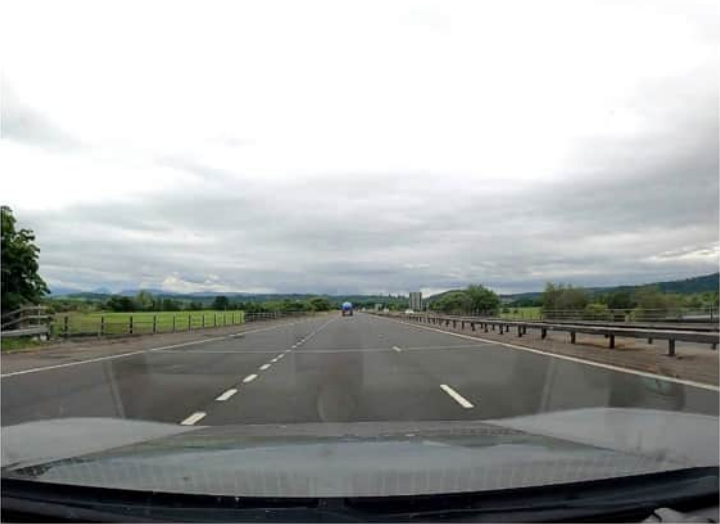
Ref. ALL-A242494-RS-16 <i>M9 10-11 5 Forth</i>

Direction of Travel Location: Northbound on M9 over structure no. M9 10-11 5 Forth	Coordinates: 56.135917, -3.971111
Enabling Works Required: Subject to structural assessment	Enabling Work Grade: TBC
Assessment Works Required: Failed Transport Scotland/BEAR (SES) checks Further structural assessment required, unsuitable for overbridging, if required	Assessment Work Grade: Complete High

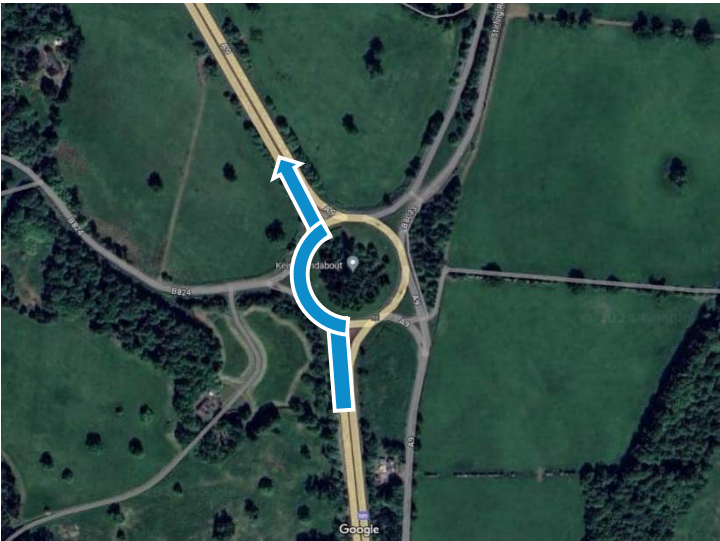
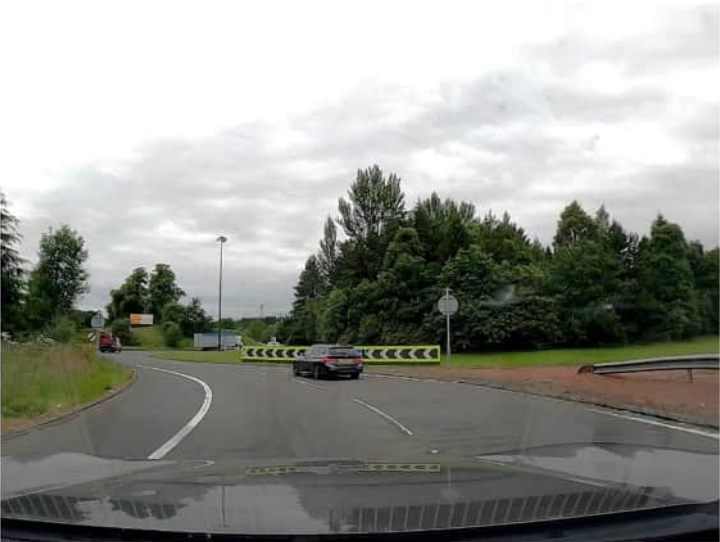
Ref. ALL-A242494-RS-17 <i>M9/A9 Keir Roundabout</i>

Direction of Travel Location: Straight on from M9 onto A9 at Keir Roundabout	Coordinates: 56.170222, -3.970306
Enabling Works Required: N/A	Enabling Work Grade: N/A
Assessment Works Required: Route survey carried out - negotiable	Assessment Work Grade: Complete

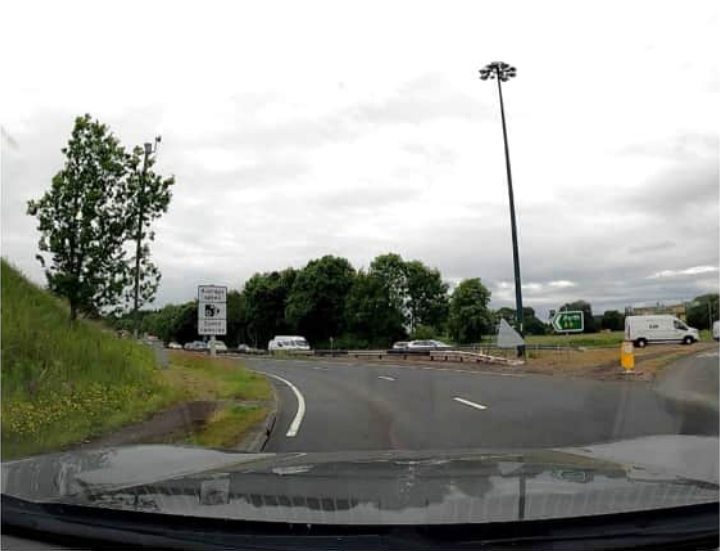
Ref. ALL-A242494-RS-17 cont'd	
M9/A9 Keir Roundabout

Direction of Travel Location: Straight on from M9 onto A9 at Keir Roundabout	Coordinates: 56.170222, -3.970306
Enabling Works Required: N/A	Enabling Work Grade: N/A
Assessment Works Required: Route survey carried out - negotiable	Assessment Work Grade: Complete

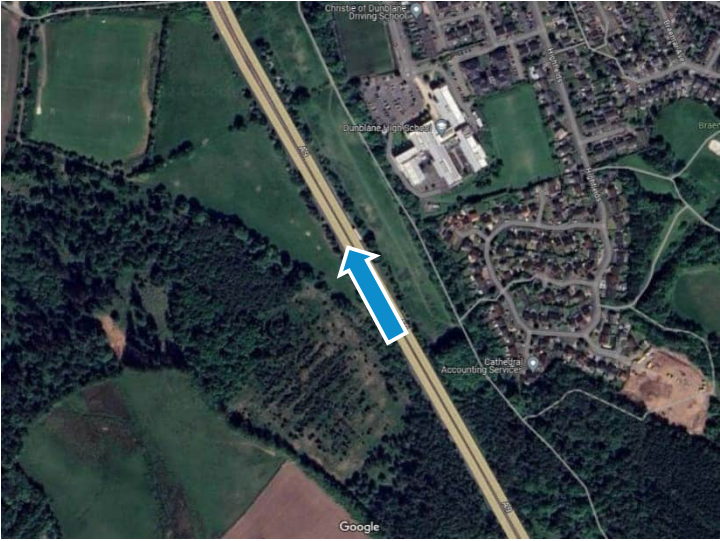
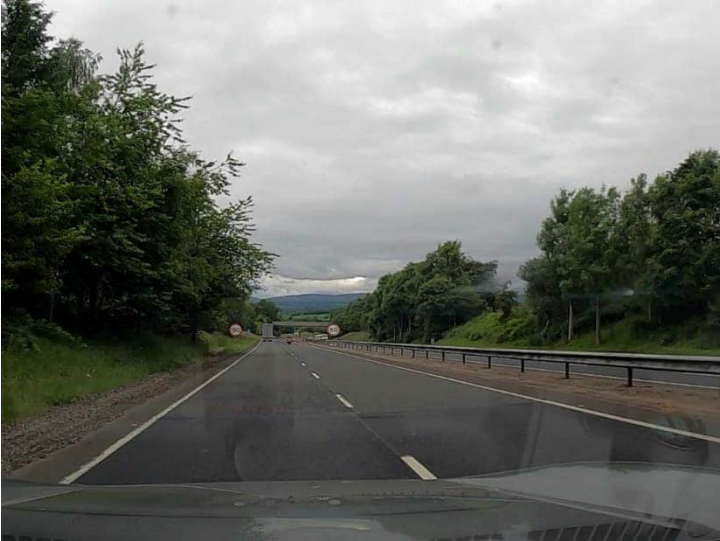
Ref. ALL-A242494-RS-18	
A9 gradient

Direction of Travel Location: Northbound on A9	Coordinates: 56.181611, -3.982194
Enabling Works Required: Additional tractor unit(s) needed to produce necessary braking effort	Enabling Work Grade: Low
Assessment Works Required: Route survey carried out	Assessment Work Grade: Complete

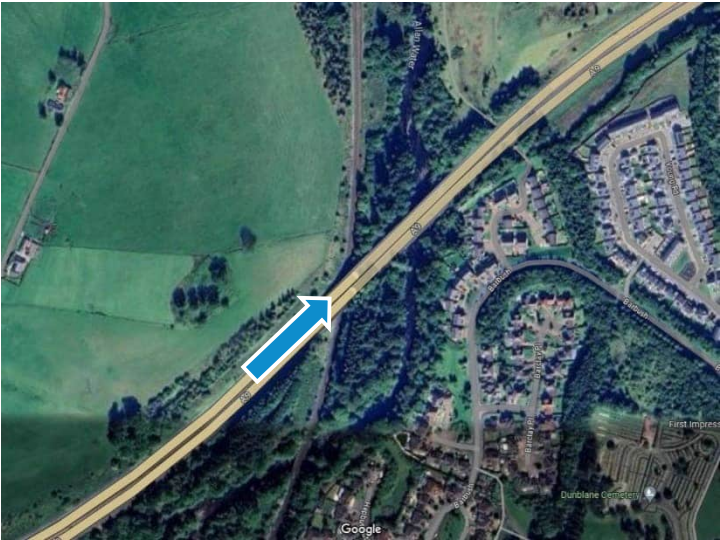
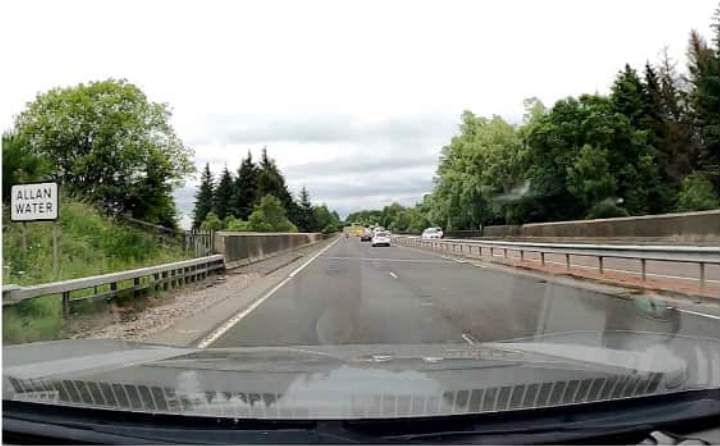
Ref. ALL-A242494-RS-19	
A9 80 Auchinlay Rail

Direction of Travel Location: Northbound on A9 over structure no. A9 80 Auchinlay Rail	Coordinates: 56.200667, -3.962667
Enabling Works Required: Subject to structural assessment	Enabling Work Grade: TBC
Assessment Works Required: Failed Transport Scotland/Amey (NES) checks Further structural assessment required, unsuitable for overbridging, if required	Assessment Work Grade: Complete High

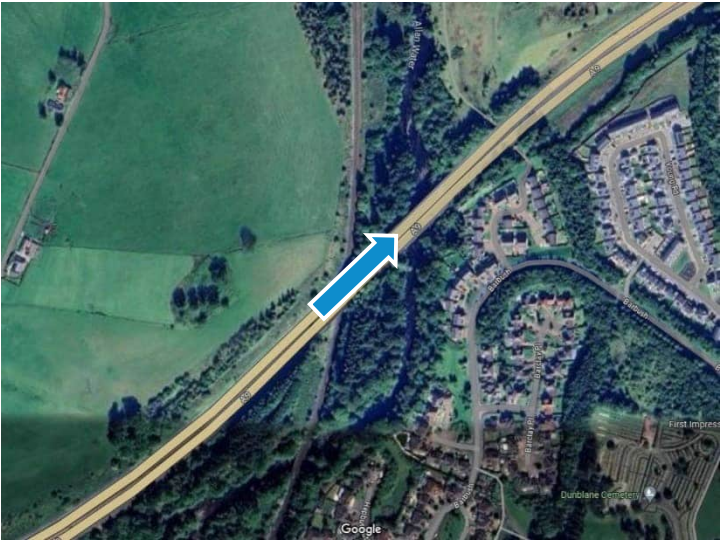
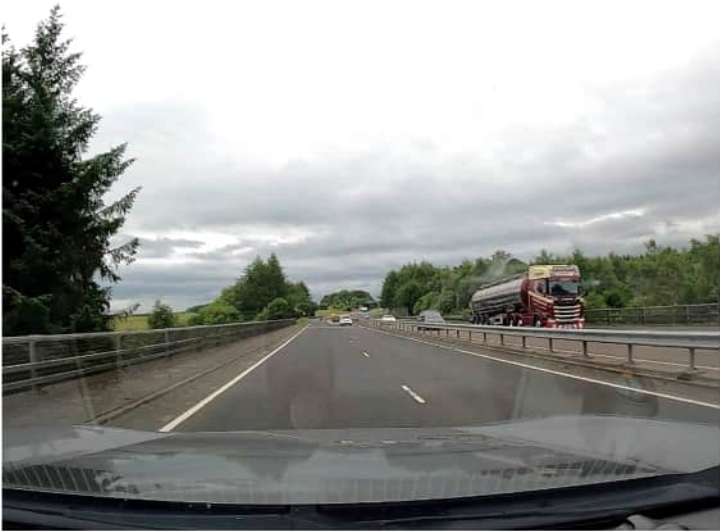
Ref. ALL-A242494-RS-20 <i>A9 90 Allan Water</i>

Direction of Travel Location: Northbound on A9 over structure no. A9 90 Allan Water	Coordinates: 56.201417, -3.961278
Enabling Works Required: Subject to structural assessment	Enabling Work Grade: TBC
Assessment Works Required: Failed Transport Scotland/Amey (NES) checks Further structural assessment required, unsuitable for overbridging, if required	Assessment Work Grade: Complete High

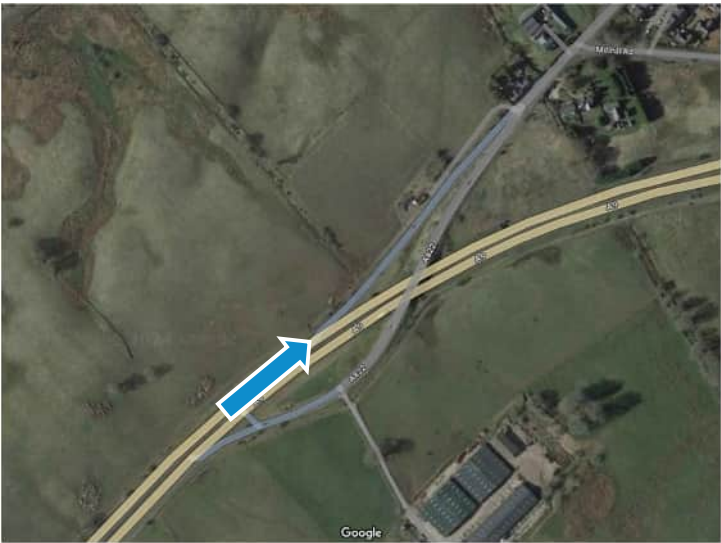
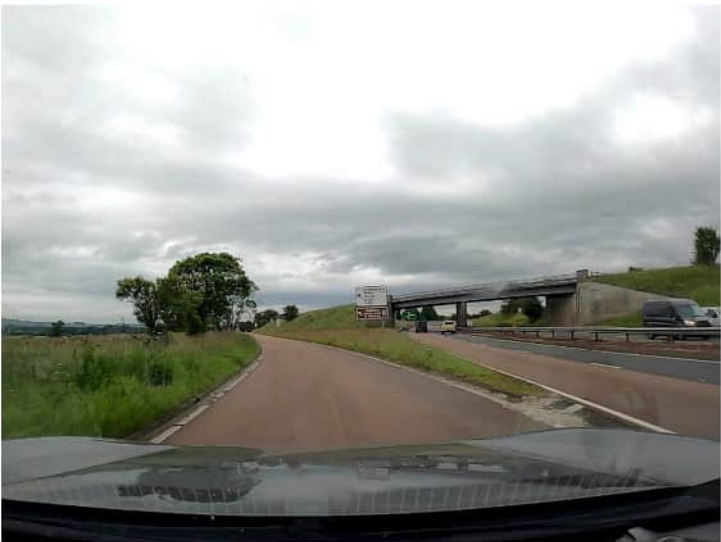
Ref. ALL-A242494-RS-21	
A9/A822 LH turn

Direction of Travel Location: LH turn from A9 onto A822	Coordinates: 56.240083, -3.890611
Enabling Works Required: N/A	Enabling Work Grade: N/A
Assessment Works Required: Route survey carried out - negotiable	Assessment Work Grade: Complete

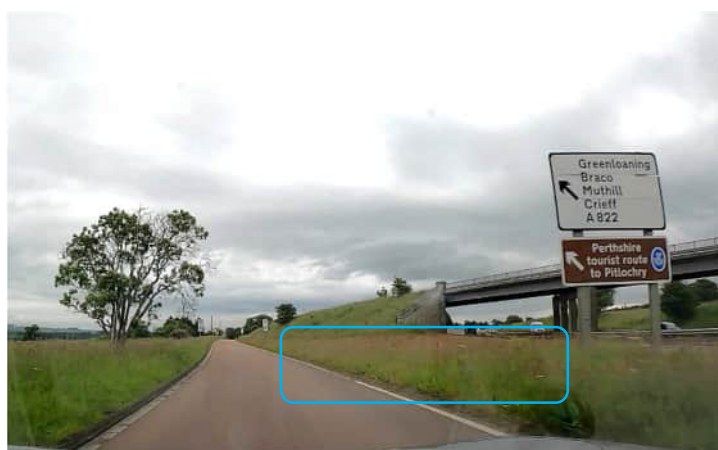
Ref. ALL-A242494-RS-21*A9/A822 slip road trailer interchange location*

**Direction of Travel Location:**

Northbound on A9/A822 slip road

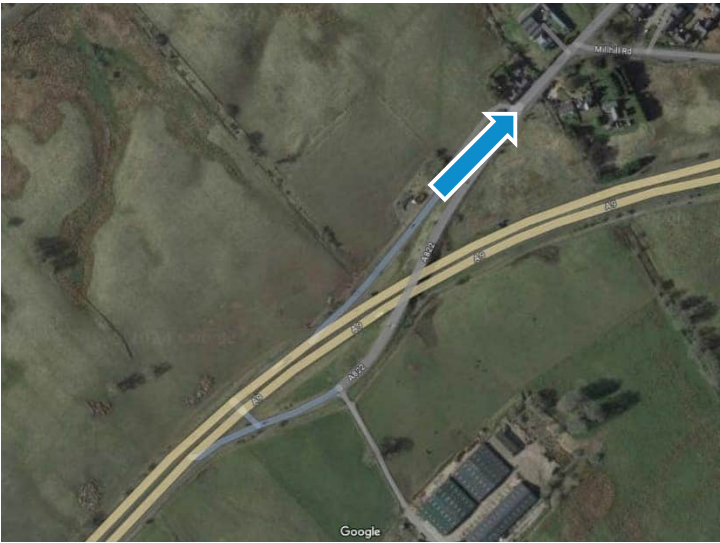
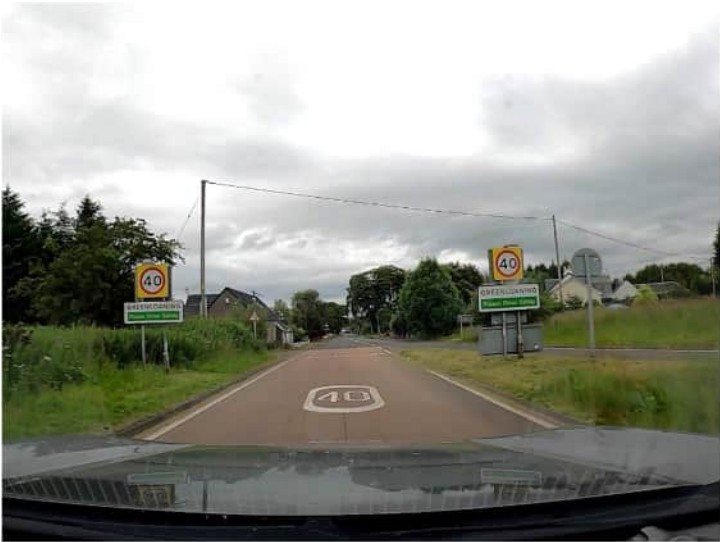
Ref. ALL-A242494-RS-23 <i>A9 slip road/A822 junction (24-axle GFT)</i>

Direction of Travel Location: Straight on from A9 slip road onto A822 northbound	Coordinates: 56.242139, -3.887361
Enabling Works Required: N/A	Enabling Work Grade: N/A
Assessment Works Required: Route survey carried out - negotiable	Assessment Work Grade: Complete

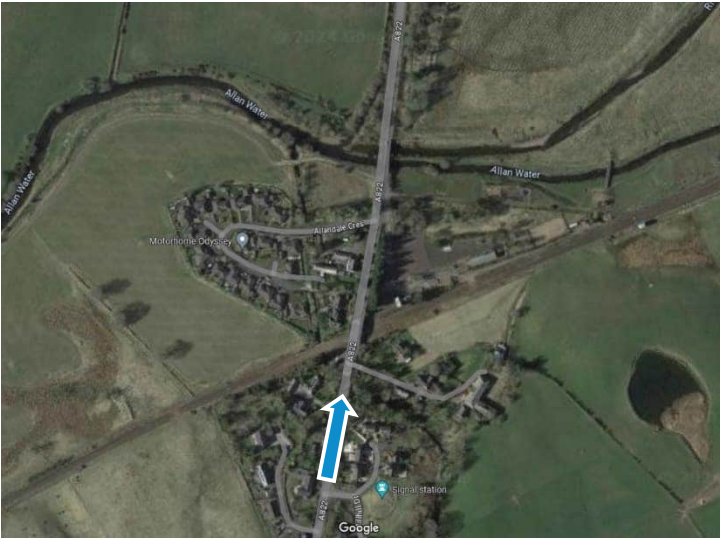
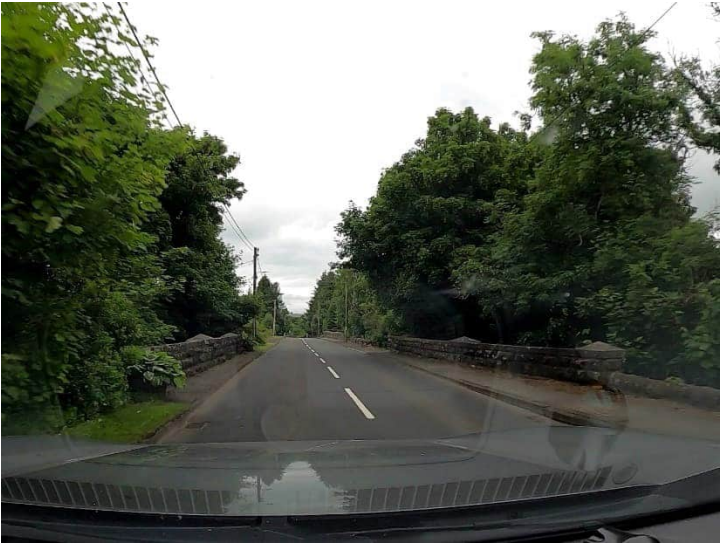
Ref. ALL-A242494-RS-24 <i>A822/01 Millstone Burn (24-axle GFT)</i>

Direction of Travel Location: Northbound on A822 over structure no. A822/01 Millstone Burn	Coordinates: 56.247000, -3.882250
Enabling Works Required: TBC	Enabling Work Grade: TBC
Assessment Works Required: Failed Perth & Kinross Council checks Further structural assessment, suitable for overbridging, if required	Assessment Work Grade: Complete Medium

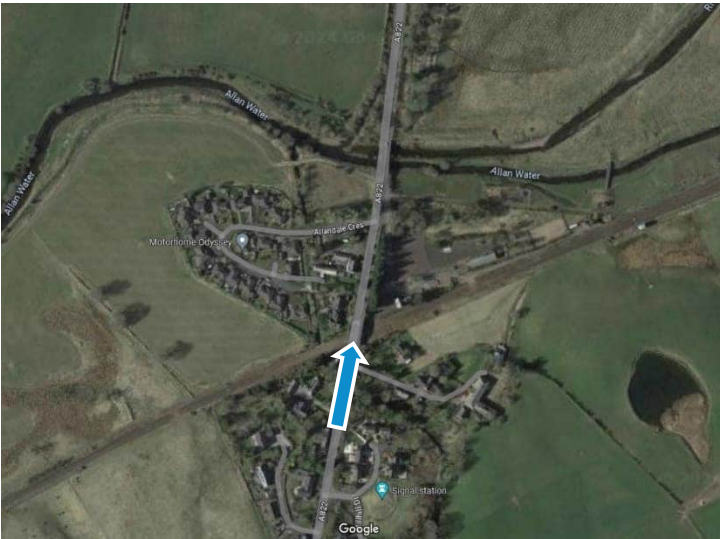
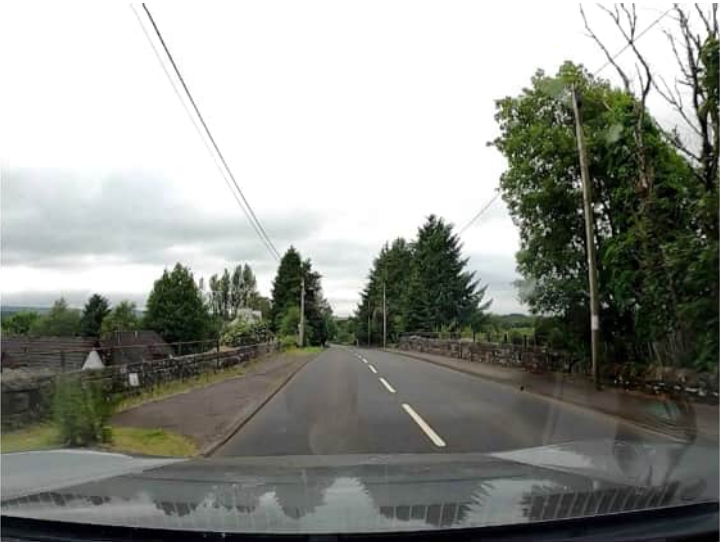
Ref. ALL-A242494-RS-25 SCM4/B/21 A822 Main Road (24-axle GFT)

Direction of Travel Location: Northbound on A822 over structure no. SCM4/B/21 A822 Main Road	Coordinates: 56.247472, -3.882083
Enabling Works Required: N/A	Enabling Work Grade: N/A
Assessment Works Required: Passed Perth & Kinross Council checks	Assessment Work Grade: Complete

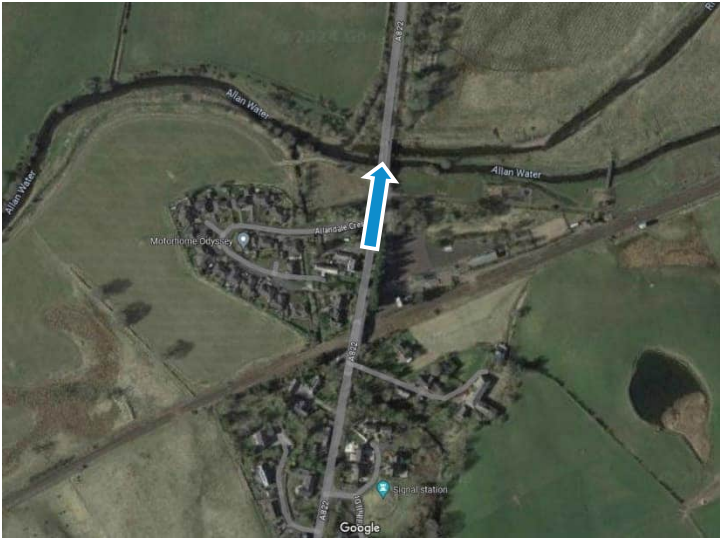
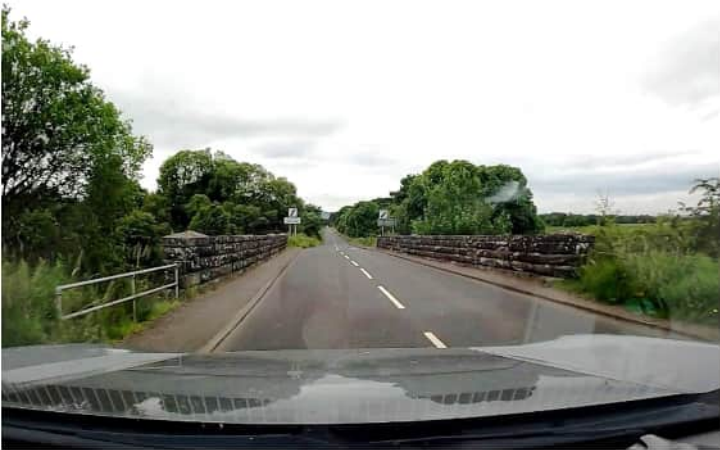
Ref. ALL-A242494-RS-26 <i>A822/03 River Allan (24-axle GFT)</i>

Direction of Travel Location: Northbound on A822 over structure no. A822/03 River Allan	Coordinates: 56.249167, -3.881583
Enabling Works Required: TBC	Enabling Work Grade: TBC
Assessment Works Required: Failed Perth & Kinross Council checks Further structural assessment, suitable for overbridging, if required	Assessment Work Grade: Complete Medium

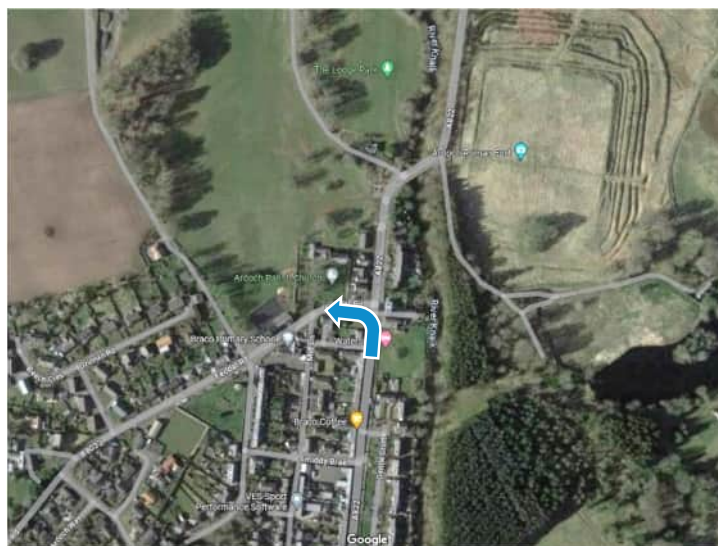
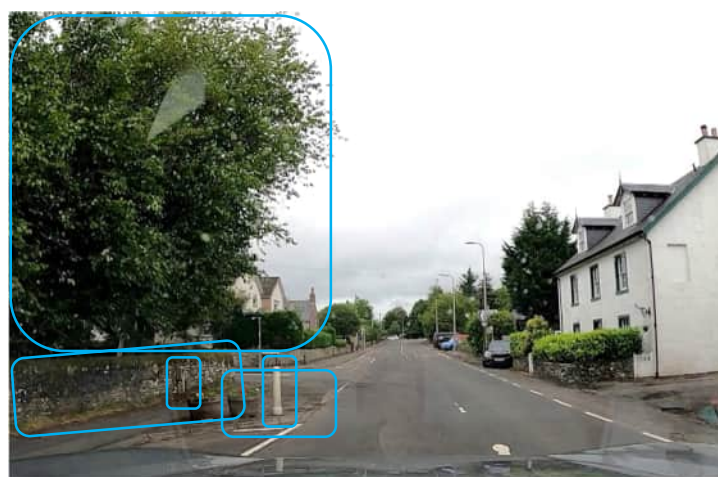
Ref. ALL-A242494-RS-27*A822/B8033 junction (24-axle GFT)*

Swept Path Assessment (SPA) of the A822/B8033 junction in Braco village has been carried out and has found that the junction is not negotiable for the 24-axle GFT due to the need for third-party land uptake and removal of mature trees/hedgerow when both turning left and performing a shunt manoeuvre continuing northbound on the A822 past the junction before turning the tractor units around and turning right onto the B8033 from the A822 southbound. SPA has also been carried out of the 24-axle GFT travelling southbound around an S-bend on the B8033 over structure no. B8033/03 Bridge of Keir and, again, the results show a need for the removal of mature trees in order to facilitate the vehicle. A third SPA has been carried out of the 24-axle GFT travelling southbound on the B8033 around a right-hand bend adjacent to the private property "Loaning View", which also shows a requirement for third-party land uptake and removal of mature trees/hedgerow. Therefore, it is deemed that the section of route through Braco village to the private access track is not negotiable for the 24-axle GFT.

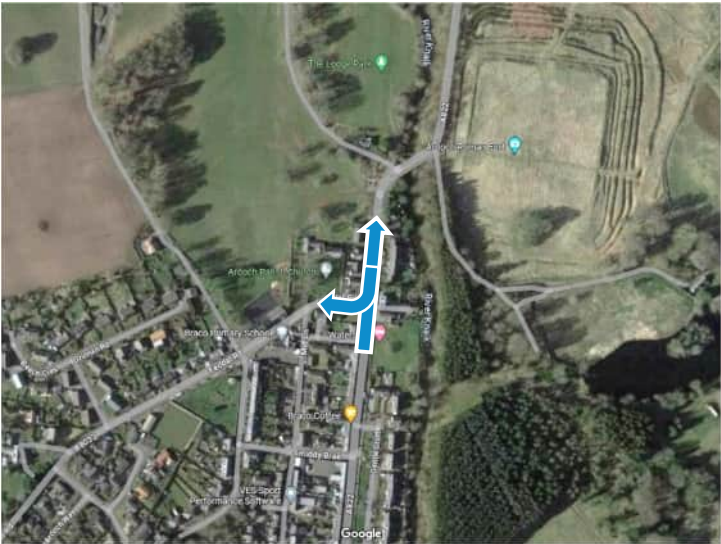
Ref. ALL-A242494-RS-27 cont'd A822/B8033 junction (24-axle GFT)

Direction of Travel Location: Northbound on A822 past B8033 junction	Coordinates: 56.266083, -3.878611
Enabling Works Required: Shunt manoeuvre	Enabling Work Grade: Medium
Assessment Works Required: Route survey carried out SPA carried out, drawing no. ALL-A242494-SPA-01 included in Appendix D	Assessment Work Grade: Complete Complete

- 9.1. Swept Path Assessment (SPA) of the A822/B8033 junction in Braco village has been carried out and has found that the junction is not negotiable for the 24-axle GFT due to the need for third-party land uptake and removal of mature trees/hedgerow when both turning left and performing a shunt manoeuvre continuing northbound on the A822 past the junction before turning the tractor units around and turning right onto the B8033 from the A822 southbound.

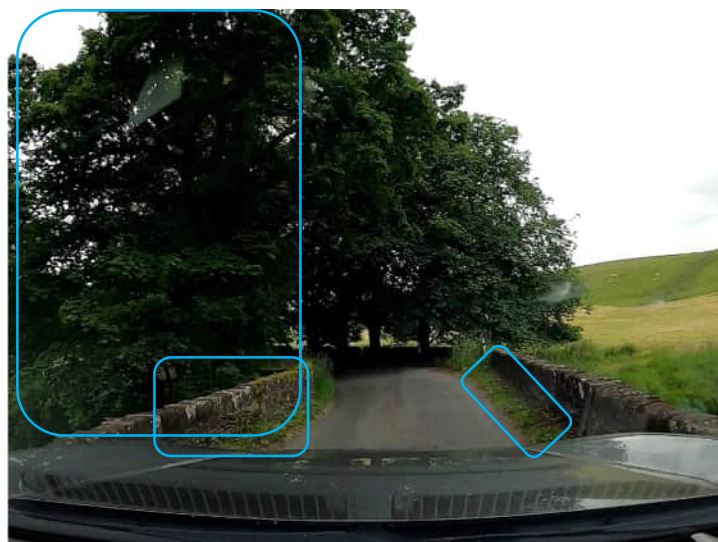
Ref. ALL-A242494-RS-28 cont'd*B8033 Bridge of Keir S-bend (24-axle GFT)*

**Direction of Travel Location:**

Westbound on B8033 over Bridge of Keir

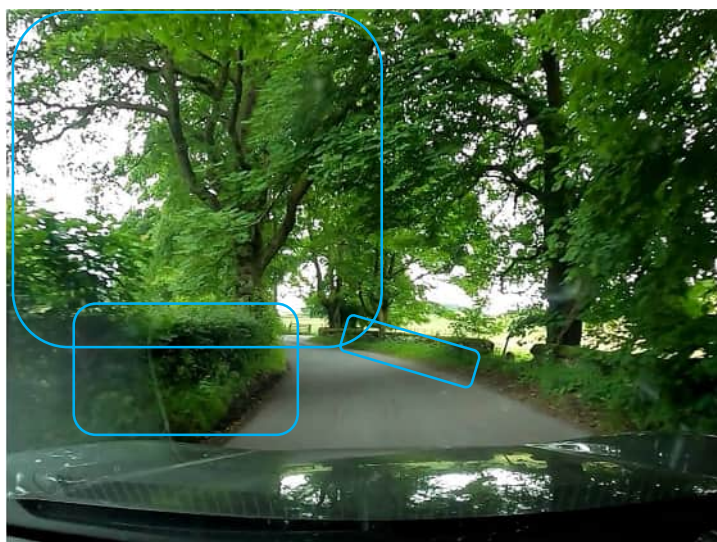
Ref. ALL-A242494-RS-28 cont'd*B8033 Bridge of Keir S-bend (24-axle GFT)*

**Direction of Travel Location:**

Westbound on B8033 over Bridge of Keir

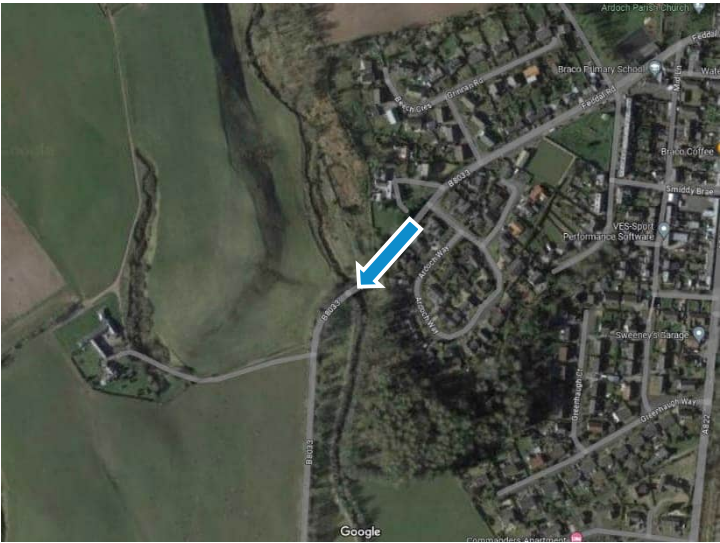
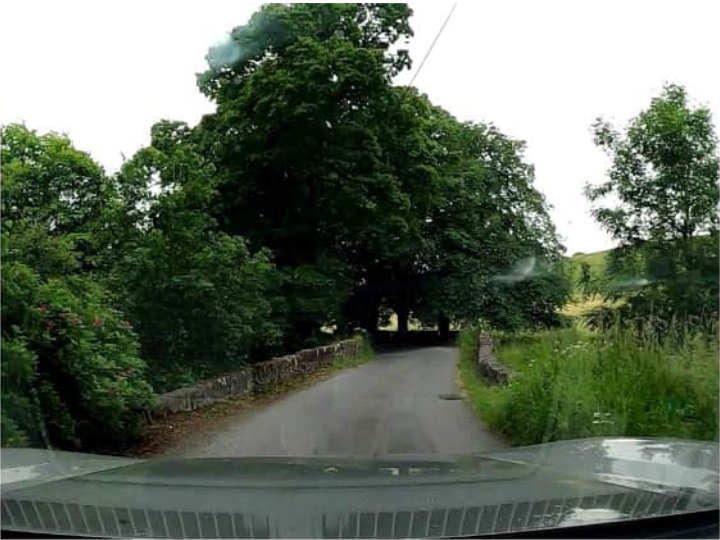
Ref. ALL-A242494-RS-29	
B8033/03 Bridge of Keir (24-axle GFT)

Direction of Travel Location: Westbound on B8033 over structure no. B8033/03 Bridge of Keir	Coordinates: 56.263750, -3.885250
Enabling Works Required: TBC	Enabling Work Grade: TBC
Assessment Works Required: Failed Perth & Kinross Council checks Further structural assessment, unsuitable for overbridging	Assessment Work Grade: Complete High
