Route Feasibility Report

**For the delivery of 261 te Transformer
from Grangemouth to Cambushinnie Substation**

A242494

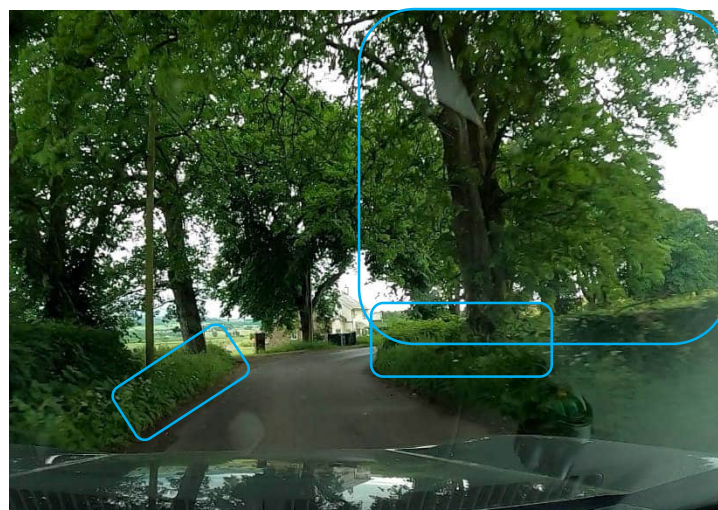
Ref. ALL-A242494-RS-30*B8033 Loaning View RH bend (24-axle GFT)*

**Direction of Travel Location:**

Westbound on B8033 around RH bend at Loaning View

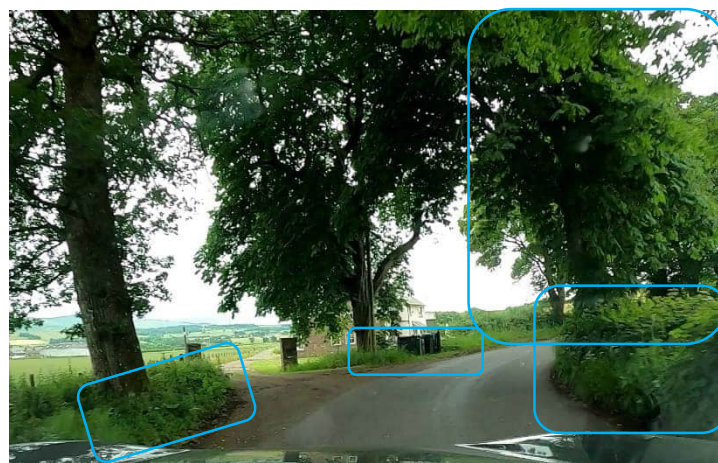
Ref. ALL-A242494-RS-30 cont'd*B8033 Loaning View RH bend (24-axle GFT)*

**Direction of Travel Location:**

Westbound on B8033 around RH bend at Loaning View

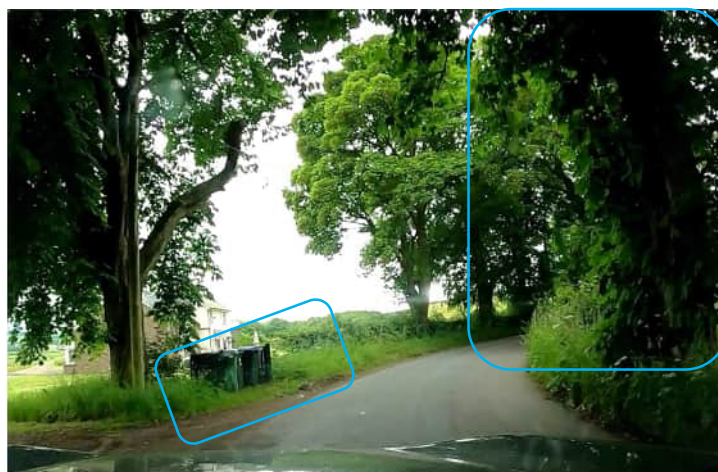
Ref. ALL-A242494-RS-30 cont'd*B8033 Loaning View RH bend (24-axle GFT)*

**Direction of Travel Location:**

Westbound on B8033 around RH bend at Loaning View

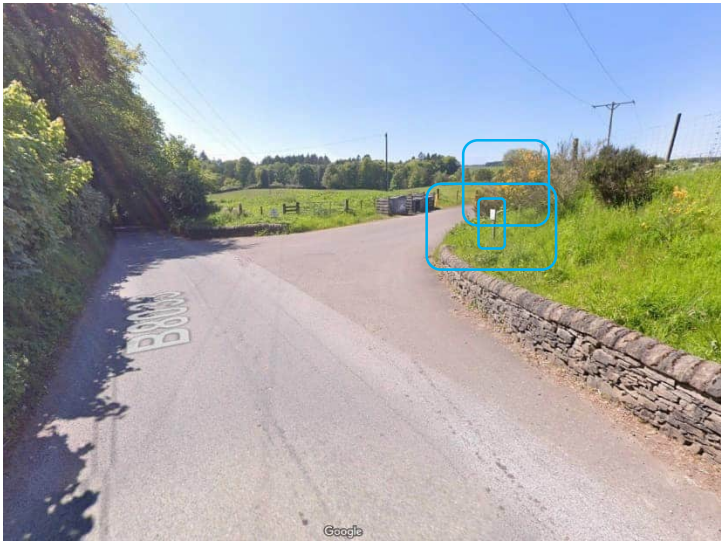
Ref. ALL-A242494-RS-31 <i>B8033/UC road RH turn (24-axle GFT)</i>

Direction of Travel Location: RH turn from B8033 onto UC road	Coordinates: 56.258333, -3.894611
Enabling Works Required: Cut in of bank to inside of turn to accommodate girder frame oversail Vegetation clearance to accommodate oversail Removal of 1 no. non-illuminated road sign	Enabling Work Grade: High High Medium
Assessment Works Required: Route survey carried out	Assessment Work Grade: Complete

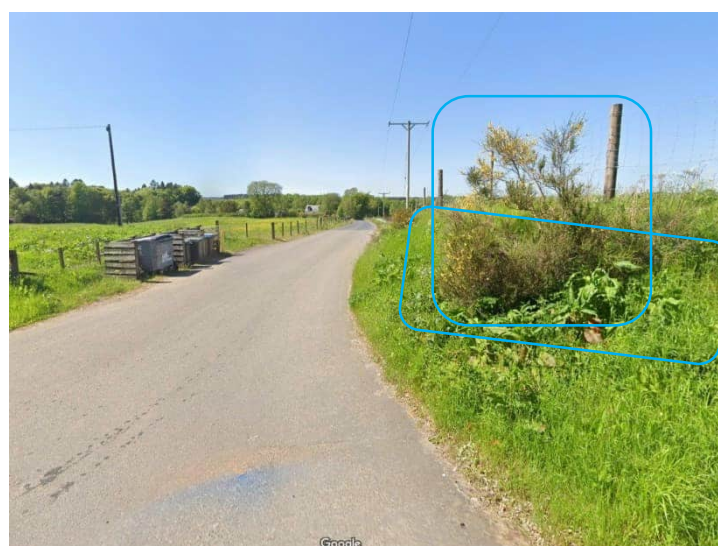
Ref. ALL-A242494-RS-31 cont'd*B8033/UC road RH turn (24-axle GFT)*

**Direction of Travel Location:**

RH turn from B8033 onto UC road

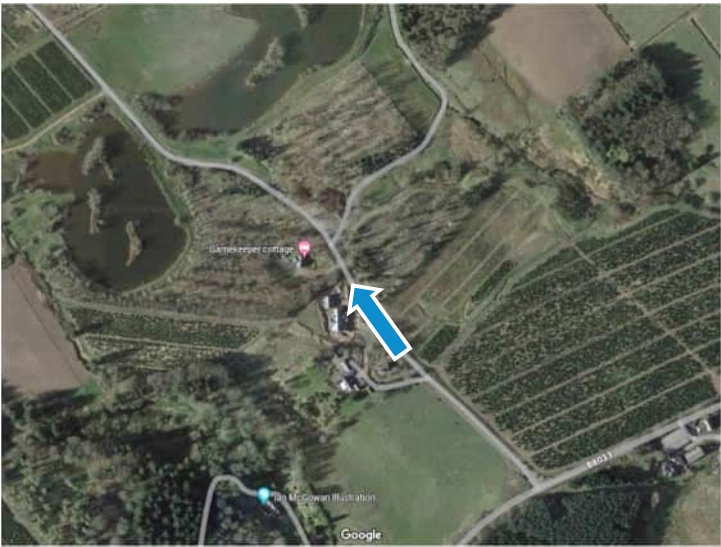
Ref. ALL-A242494-RS-32 <i>Site access track cattle grid no. 1 (24-axle GFT)</i>

Direction of Travel Location: Northbound on site access track over cattle grid no. 1	Coordinates: 56.260250, -3.897778
Enabling Works Required: To be overbridged, span = 10.1 m	Enabling Work Grade: Medium
Assessment Works Required: Route survey carried out	Assessment Work Grade: Complete

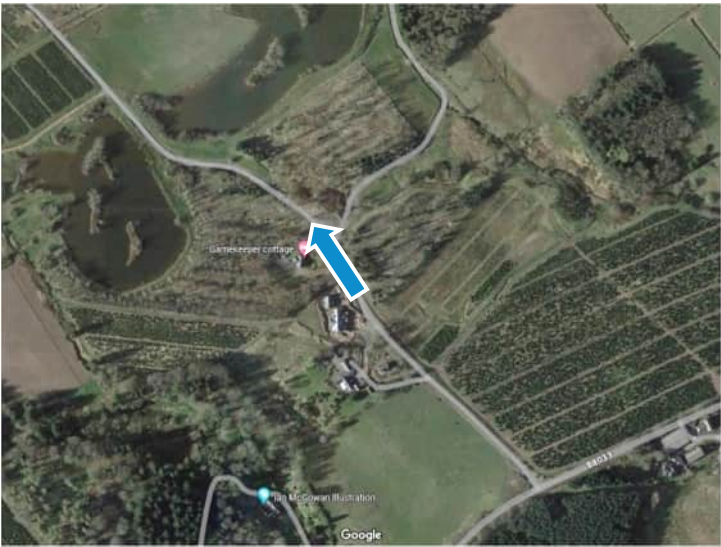
Ref. ALL-A242494-RS-33 Site access track LH turn no. 1 (24-axle GFT)

Direction of Travel Location: LH turn on site access track	Coordinates: 56.260556, -3.898000
Enabling Works Required: N/A	Enabling Work Grade: N/A
Assessment Works Required: Route survey carried out - negotiable	Assessment Work Grade: Complete

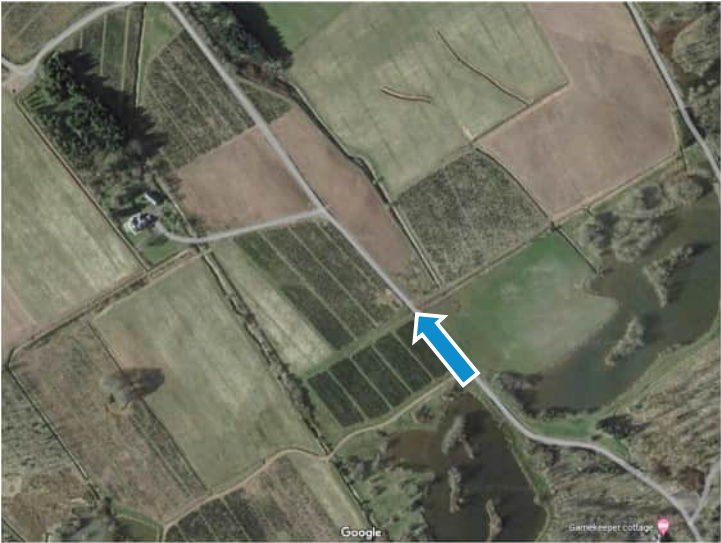
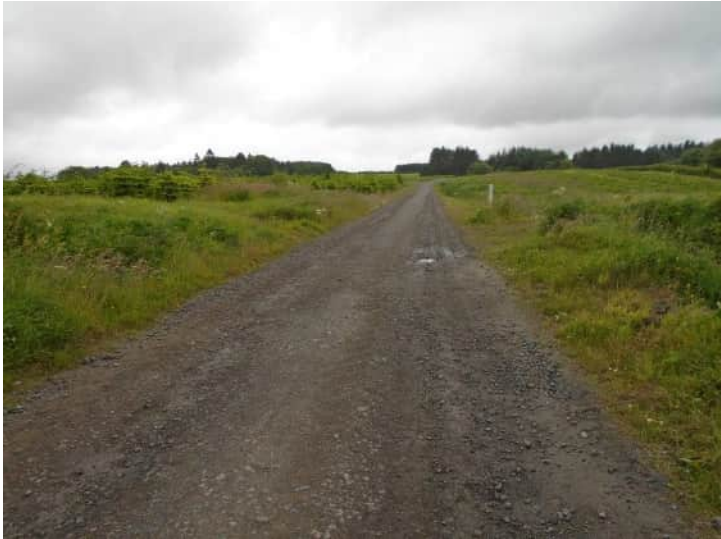
Ref. ALL-A242494-RS-34 <i>Site access track culvert no. 1 (24-axle GFT)</i>

Direction of Travel Location: Northbound on site access track over culvert no. 1	Coordinates: 56.262472, -3.902611
Enabling Works Required: To be overbridged, span = 1.0 m	Enabling Work Grade: Medium
Assessment Works Required: Route survey carried out	Assessment Work Grade: Complete

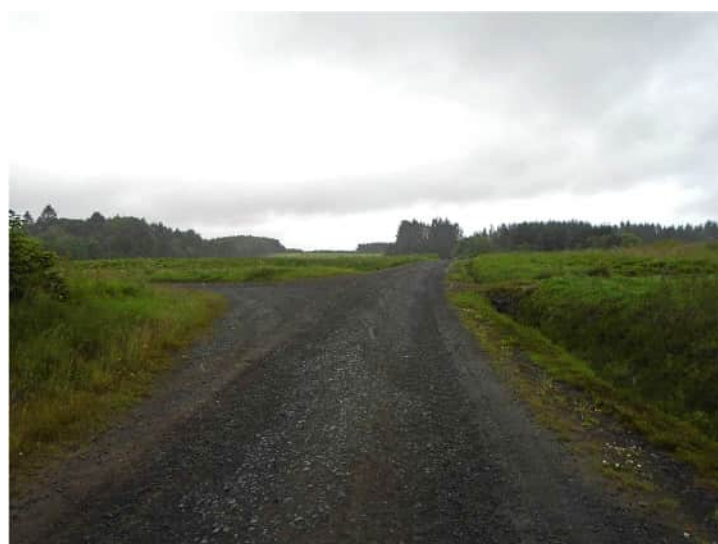
Ref. ALL-A242494-RS-35*Site access track RH turn no. 1 (24-axle GFT)*

**Direction of Travel Location:**

RH turn no site access track

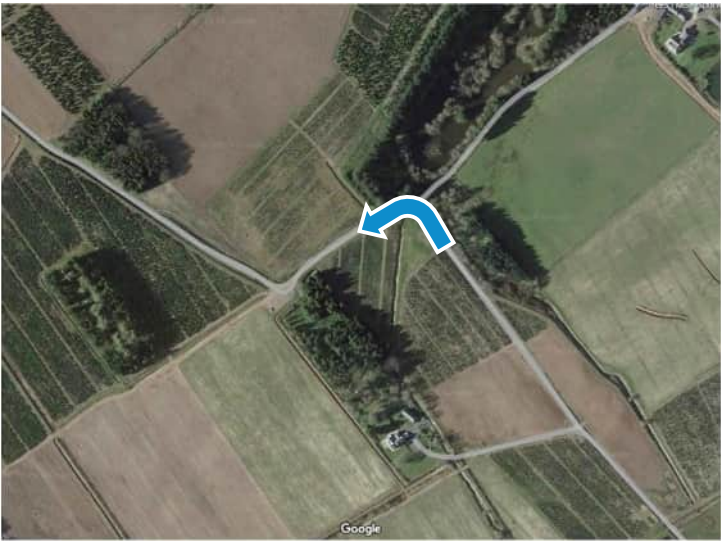
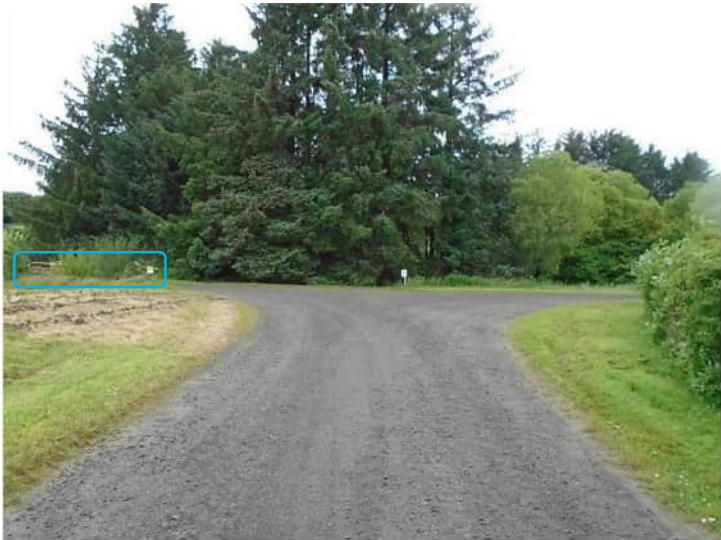
Ref. ALL-A242494-RS-36 <i>Site access track LH turn no. 2 (24-axle GFT)</i>

Direction of Travel Location: LH turn on site access track	Coordinates: 56.265361, -3.906806
Enabling Works Required: Removal of wooden fence line to inside of turn	Enabling Work Grade: Medium
Assessment Works Required: Route survey carried out	Assessment Work Grade: Complete

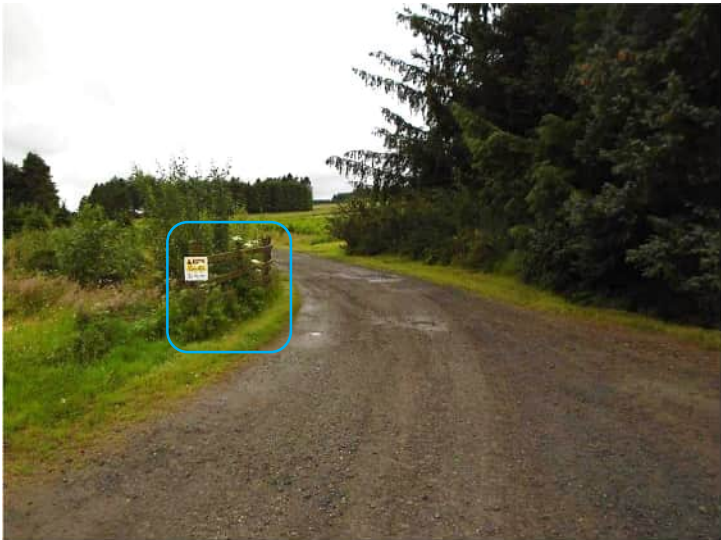
Ref. ALL-A242494-RS-36 cont'd	
Site access track LH turn no. 2 (24-axle GFT)

Direction of Travel Location: LH turn on site access track	Coordinates: 56.265361, -3.906806
Enabling Works Required: Removal of wooden fence line to inside of turn	Enabling Work Grade: Medium
Assessment Works Required: Route survey carried out	Assessment Work Grade: Complete

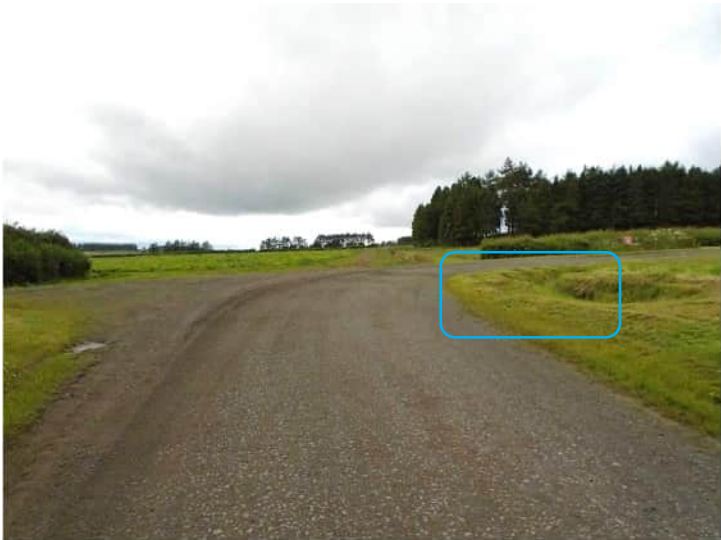
Ref. ALL-A242494-RS-38 <i>Site access track RH turn no. 2 (24-axle GFT)</i>

Direction of Travel Location: RH turn on site access track	Coordinates: 56.264694, -3.909056
Enabling Works Required: Carriageway widening to inside of turn to accommodate vehicle track	Enabling Work Grade: High
Assessment Works Required: Route survey carried out	Assessment Work Grade: Complete

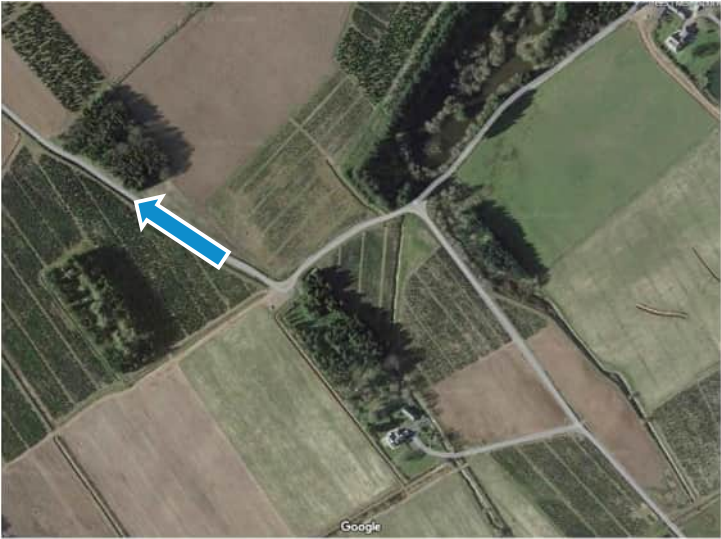
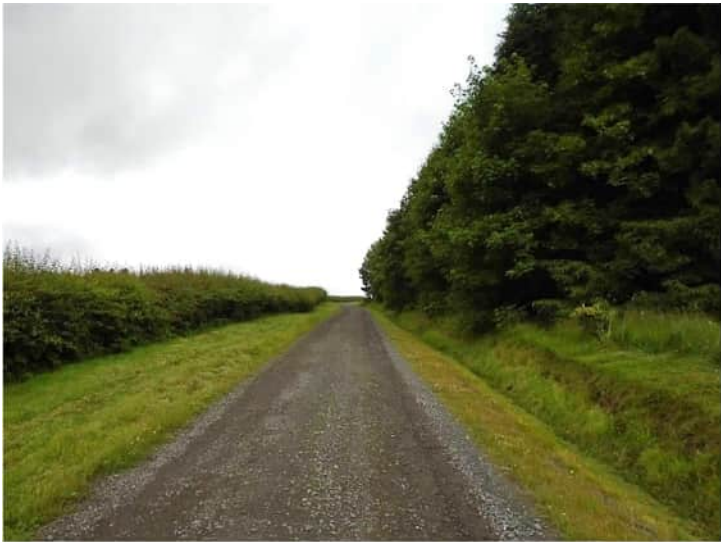
Ref. ALL-A242494-RS-39 <i>Site access track gradient (24-axle GFT)</i>

Direction of Travel Location: Northbound on site access track	Coordinates: 56.265500, -3.911583
Enabling Works Required: Additional tractor unit(s) to provide necessary tractive effort	Enabling Work Grade: Low
Assessment Works Required: Route survey carried out	Assessment Work Grade: Complete

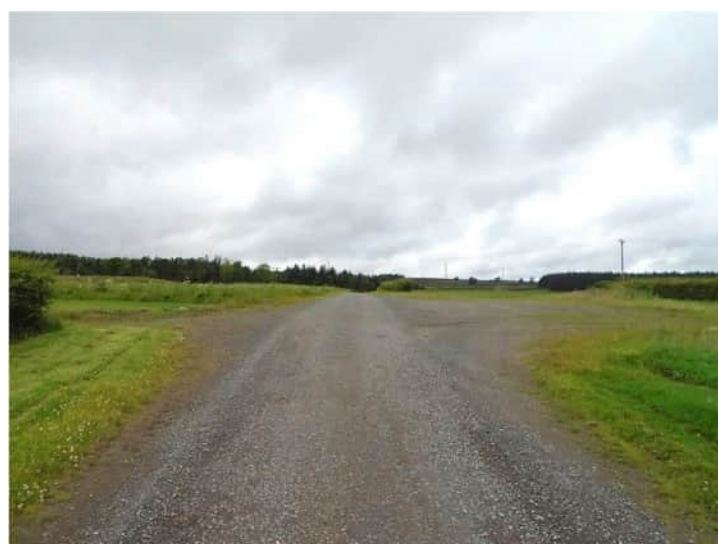
Ref. ALL-A242494-RS-40*Site access track RH turn no. 3 (24-axle GFT)*

**Direction of Travel Location:**

RH turn on site access track

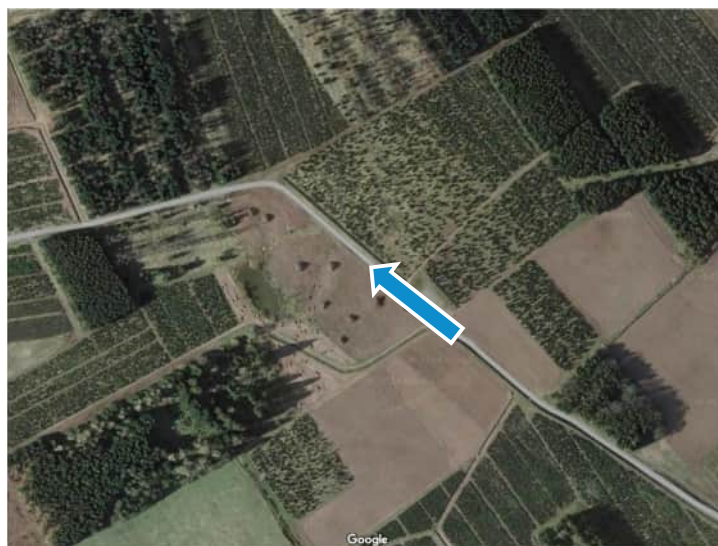
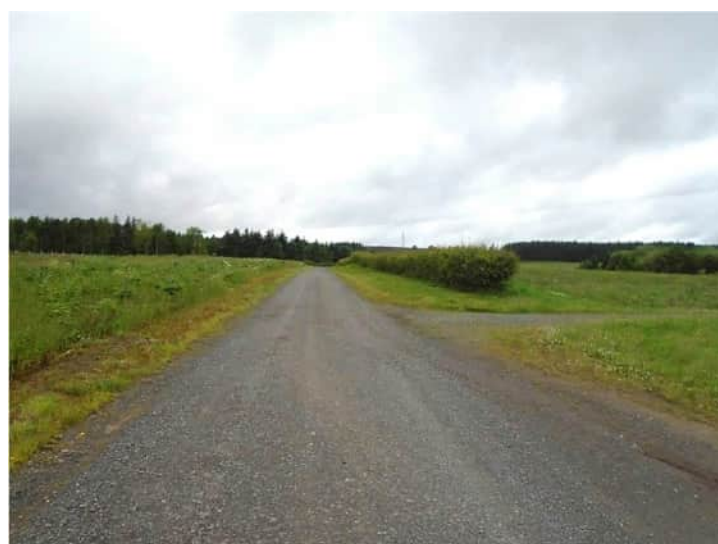
Ref. ALL-A242494-RS-41*Site access track LH turn no. 3 (24-axle GFT)*

**Direction of Travel Location:**

LH turn on site access track

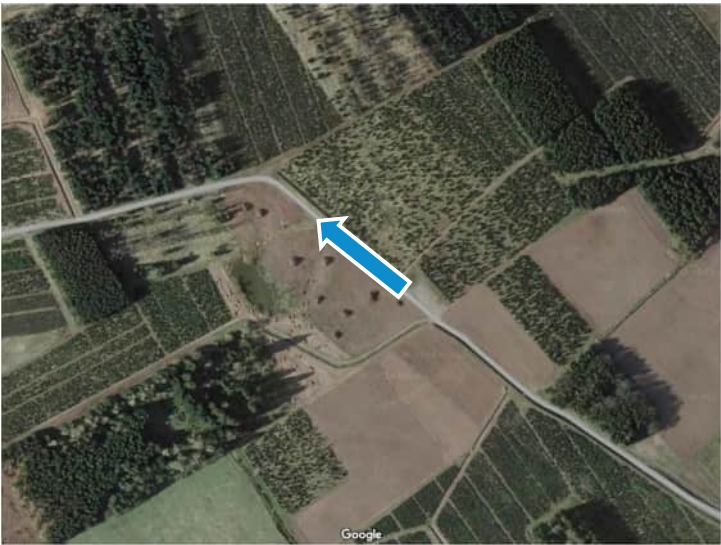
Ref. ALL-A242494-RS-42 <i>Site access track OHL line (24-axle GFT)</i>

Direction of Travel Location: Northbound on site access track	Coordinates: 56.267611, -3.916472
Enabling Works Required: TBC	Enabling Work Grade: TBC
Assessment Works Required: Route survey carried out Confirmation of max. permitted vehicle height required	Assessment Work Grade: Complete Medium

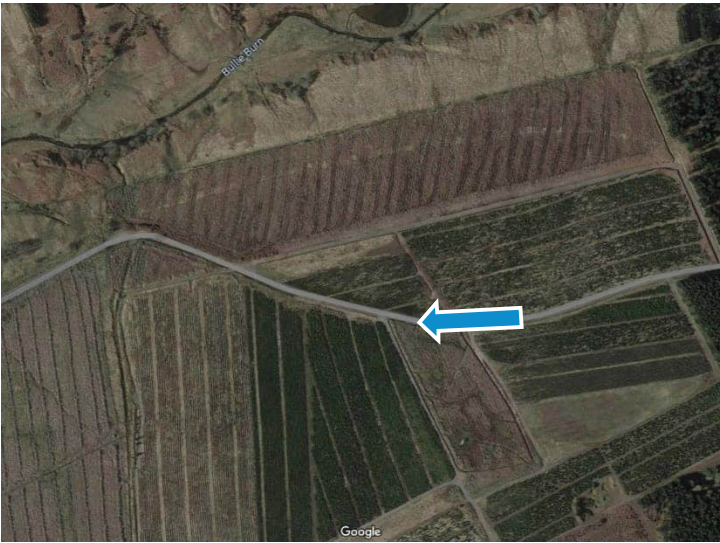
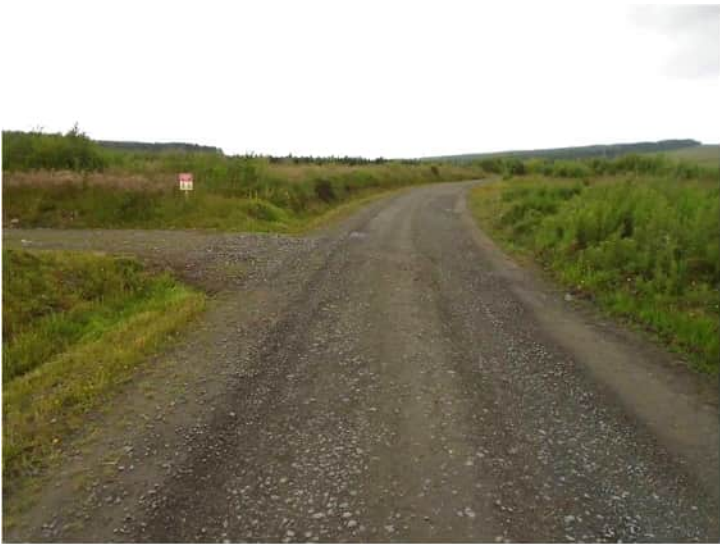
Ref. ALL-A242494-RS-45	
Site access track RH turn no. 5 (24-axle GFT)

Direction of Travel Location: RH turn on Torgoyle OHL track	Coordinates: 56.267056, -3.924667
Enabling Works Required: N/A	Enabling Work Grade: N/A
Assessment Works Required: Route survey carried out - negotiable	Assessment Work Grade: Complete

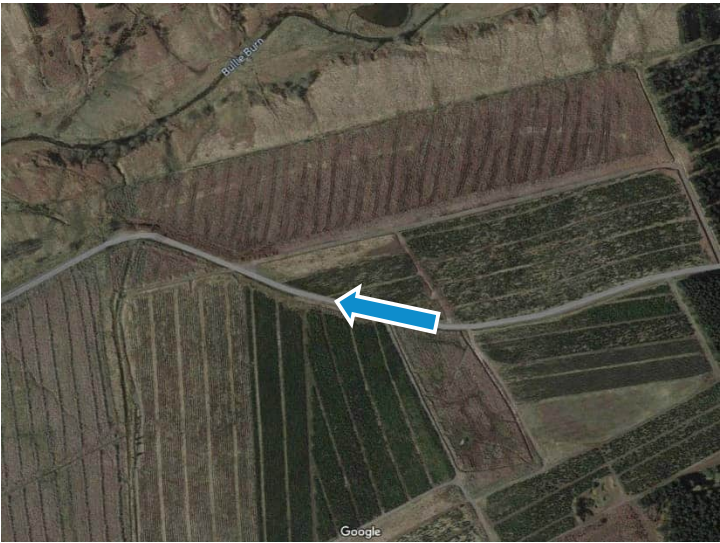
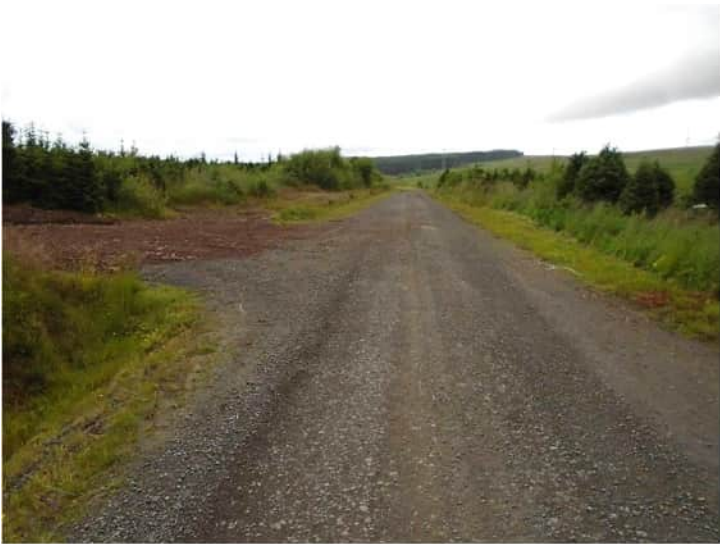
Ref. ALL-A242494-RS-46	
Site access track RH turn no. 6 (24-axle GFT)

Direction of Travel Location: RH turn on Torgoyle OHL track	Coordinates: 56.267167, -3.926083
Enabling Works Required: N/A	Enabling Work Grade: N/A
Assessment Works Required: Route survey carried out - negotiable	Assessment Work Grade: Complete

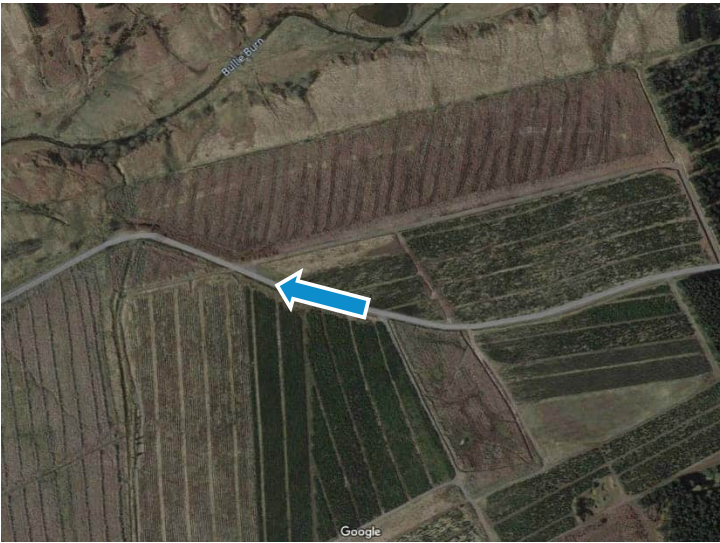
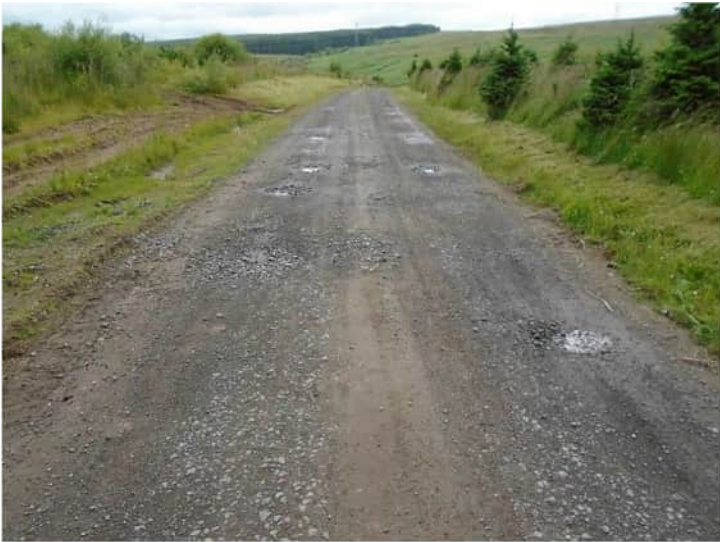
Ref. ALL-A242494-RS-47	
Site access track surface (24-axle GFT)

Direction of Travel Location: Northbound on site access track	Coordinates: 56.267333, -3.927250
Enabling Works Required: Carriageway re-surfacing works	Enabling Work Grade: Medium
Assessment Works Required: Route survey carried out	Assessment Work Grade: Complete

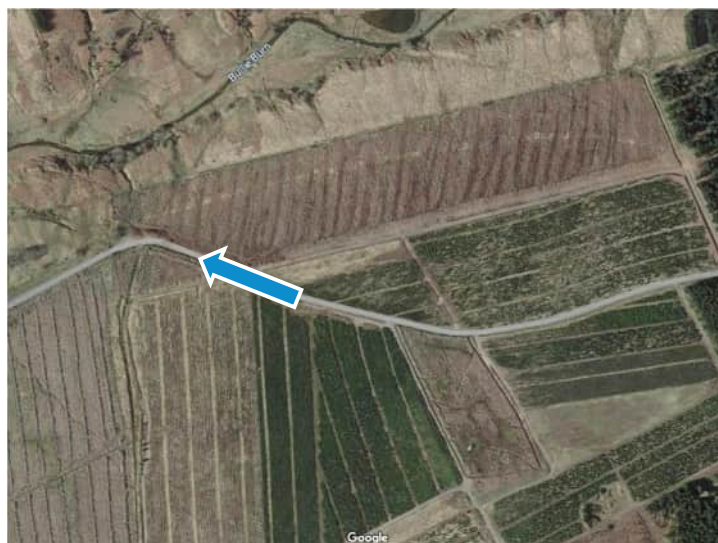
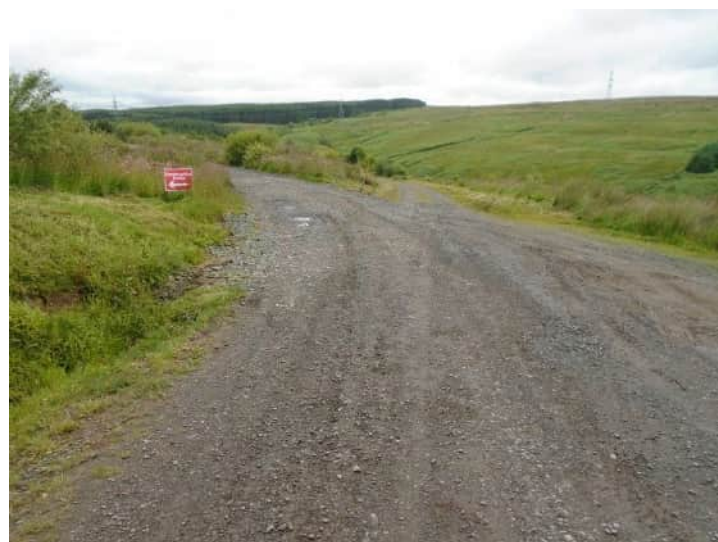
Ref. ALL-A242494-RS-48*Site access track crossroads no. 2 (24-axle GFT)*

Straight on through crossroads on site access track

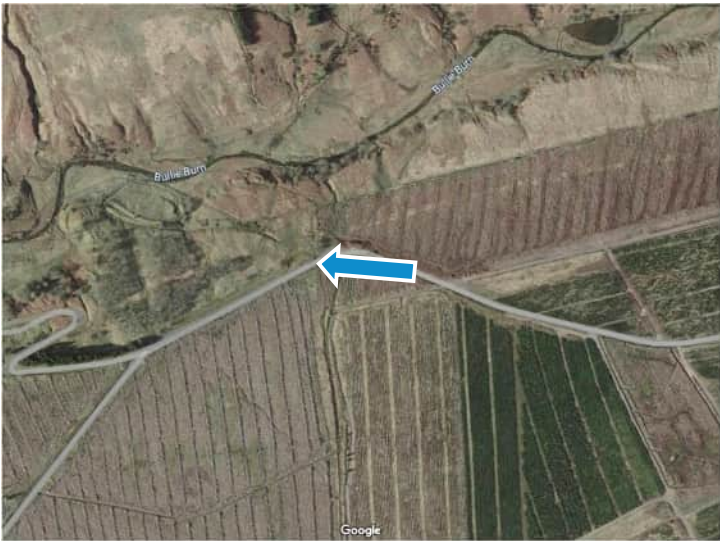
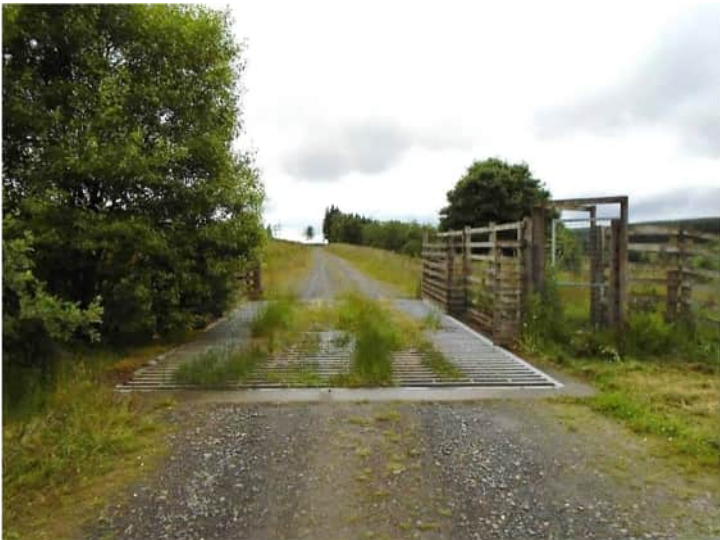
Ref. ALL-A242494-RS-49 <i>Site access track cattle grid no. 2 (24-axle GFT)</i>

Direction of Travel Location: Westbound on site access track	Coordinates: 56.267806, -3.930750
Enabling Works Required: To be overbridged, span = 9.5 m	Enabling Work Grade: Medium
Assessment Works Required: Route survey carried out	Assessment Work Grade: Complete

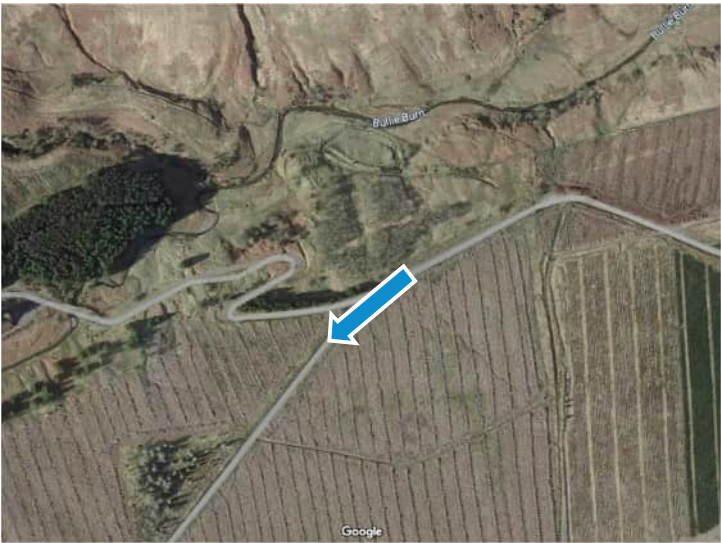
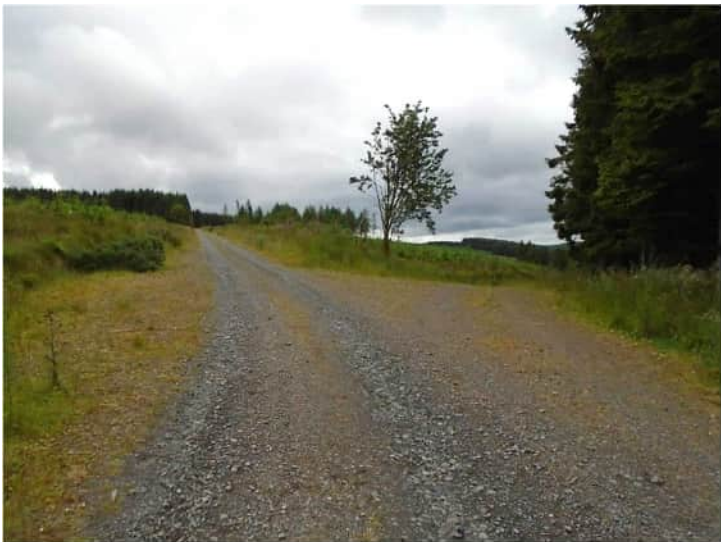
Ref. ALL-A242494-RS-50 Site access track LH turn no. 4 (24-axle GFT)

Direction of Travel Location: LH turn on site access track	Coordinates: 56.266944, -3.933639
Enabling Works Required: N/A	Enabling Work Grade: N/A
Assessment Works Required: Route survey carried out - negotiable	Assessment Work Grade: Complete

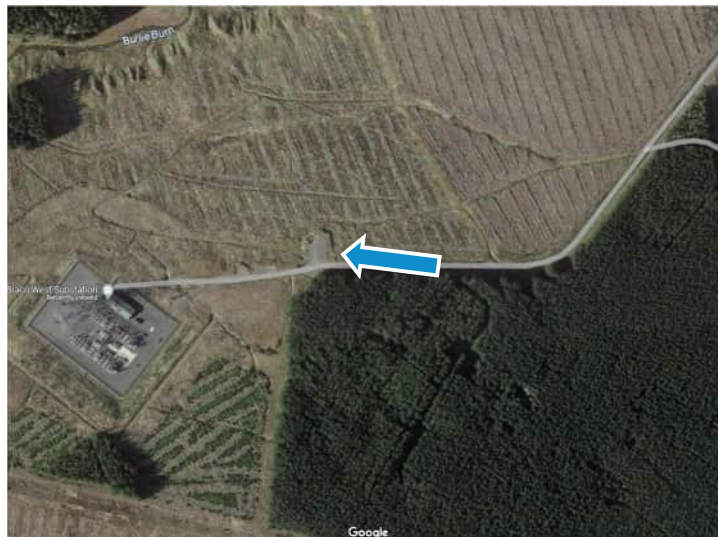
Ref. ALL-A242494-RS-52

Existing Braco Substation access track/proposed Cambushinnie Substation access track RH turn (24-axle GFT)

RH turn from existing site access track onto proposed Cambushinnie Substation access track

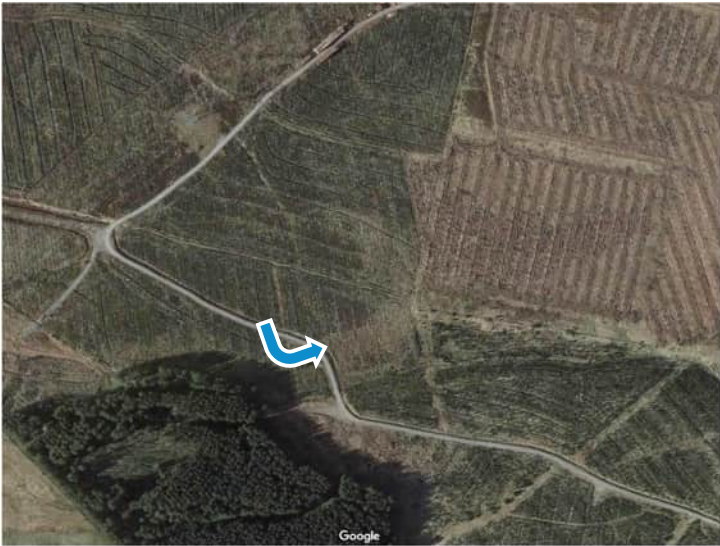
Ref. ALL-A242494-RS-56 <i>Substation site access road LH turn (24-axle GFT)</i>

Direction of Travel Location: LH turn on proposed Cambushinnie Substation site access road	Coordinates: 56.256111, -3.954444
Enabling Works Required: N/A	Enabling Work Grade: N/A
Assessment Works Required: Desktop design check carried out - negotiable	Assessment Work Grade: Complete

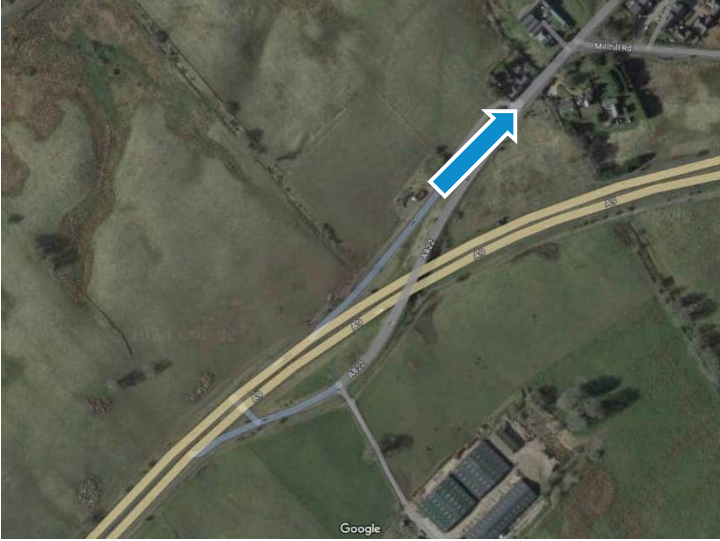
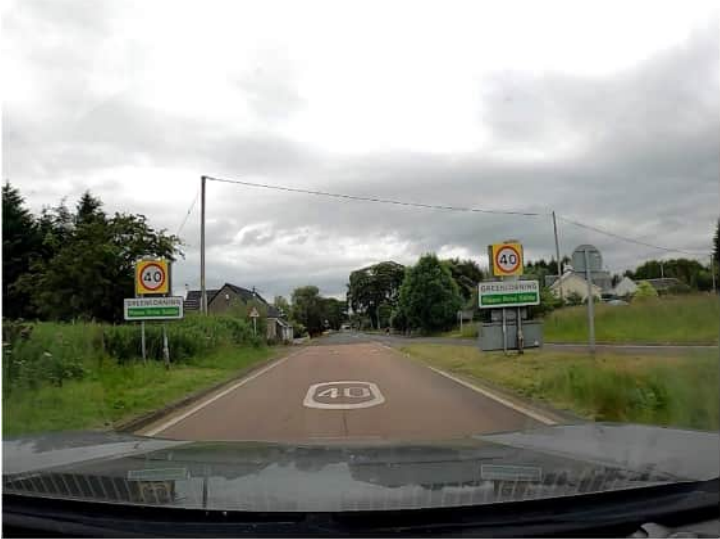
Ref. ALL-A242494-RS-61 <i>A9 slip road/A822 junction (16-axle FT)</i>

Direction of Travel Location: Straight on from A9 slip road onto A822 northbound	Coordinates: 56.242139, -3.887361
Enabling Works Required: N/A	Enabling Work Grade: N/A
Assessment Works Required: Route survey carried out - negotiable	Assessment Work Grade: Complete

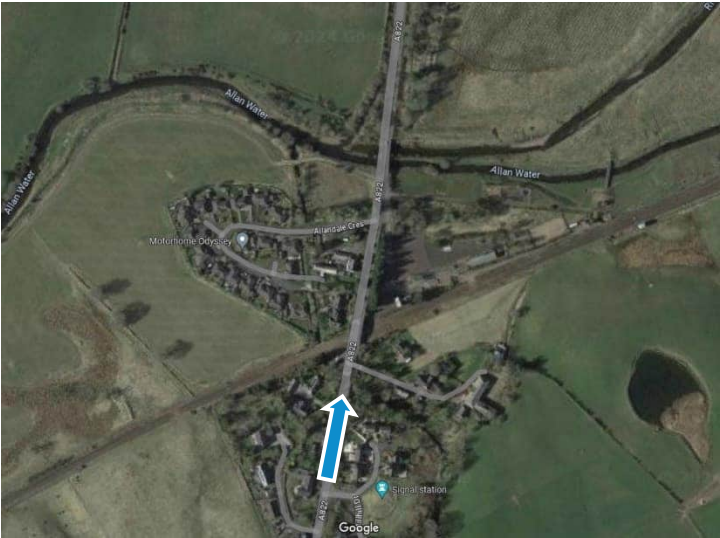
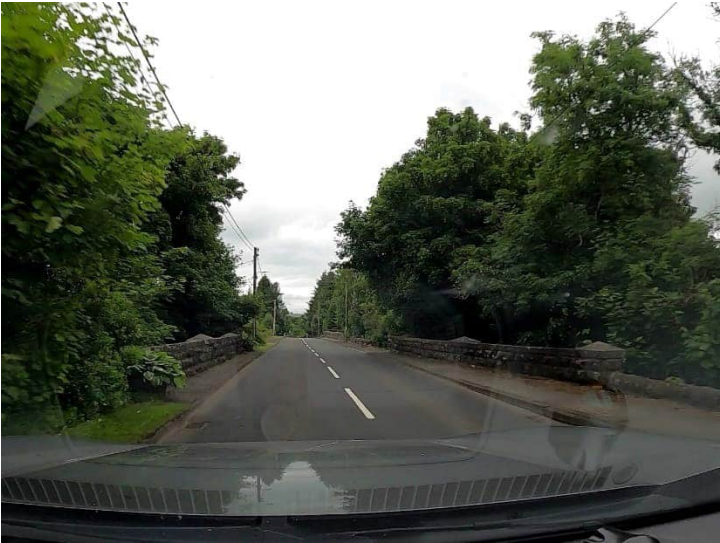
Ref. ALL-A242494-RS-62 <i>A822/01 Millstone Burn (16-axle FT)</i>

Direction of Travel Location: Northbound on A822 over structure no. A822/01 Millstone Burn	Coordinates: 56.247000, -3.882250
Enabling Works Required: TBC	Enabling Work Grade: TBC
Assessment Works Required: Failed Perth & Kinross Council checks Further structural assessment, suitable for overbridging, if required	Assessment Work Grade: Complete Medium

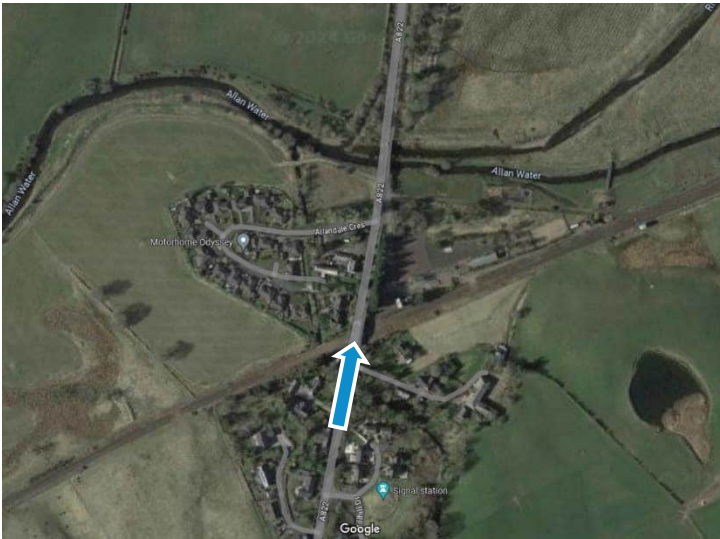
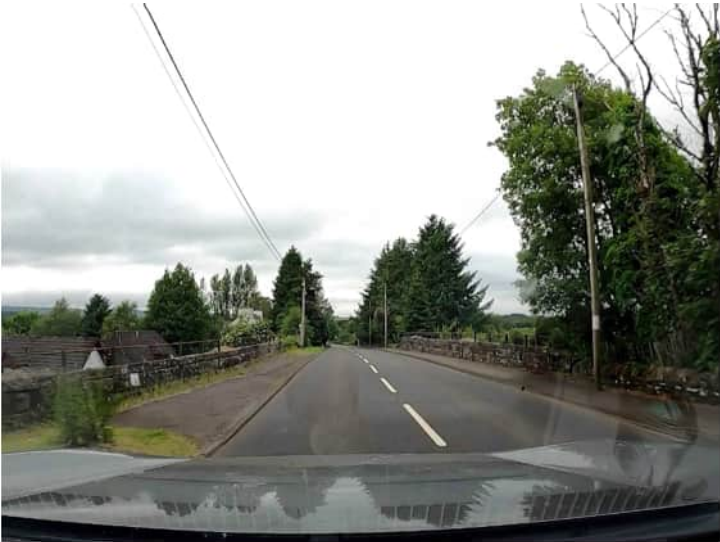
Ref. ALL-A242494-RS-63	
SCM4/B/21 A822 Main Road (16-axle FT)

Direction of Travel Location: Northbound on A822 over structure no. SCM4/B/21 A822 Main Road	Coordinates: 56.247472, -3.882083
Enabling Works Required: N/A	Enabling Work Grade: N/A
Assessment Works Required: Passed Perth & Kinross Council checks	Assessment Work Grade: Complete

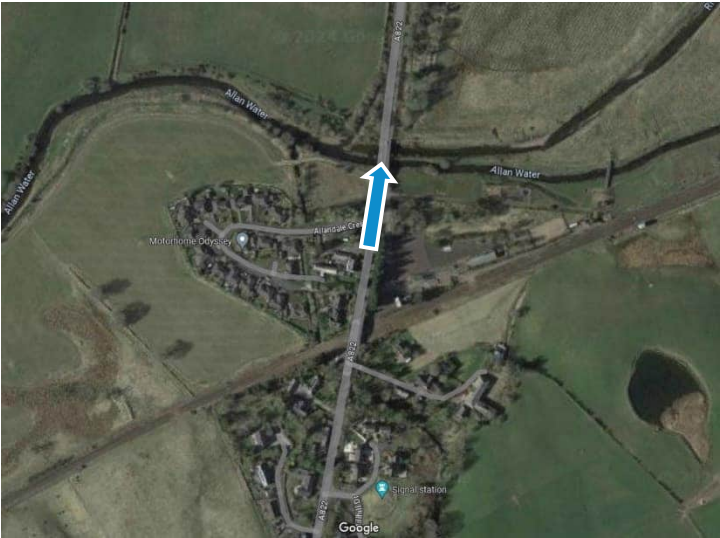
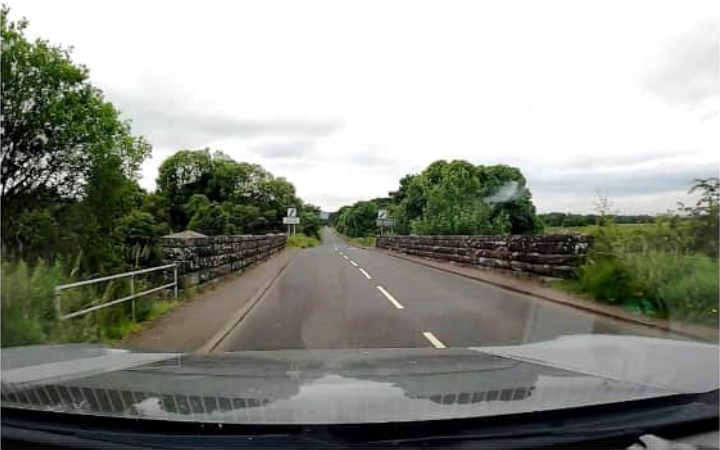
Ref. ALL-A242494-RS-64 <i>A822/03 River Allan (16-axle FT)</i>

Direction of Travel Location: Northbound on A822 over structure no. A822/03 River Allan	Coordinates: 56.249167, -3.881583
Enabling Works Required: TBC	Enabling Work Grade: TBC
Assessment Works Required: Failed Perth & Kinross Council checks Further structural assessment, suitable for overbridging, if required	Assessment Work Grade: Complete Medium

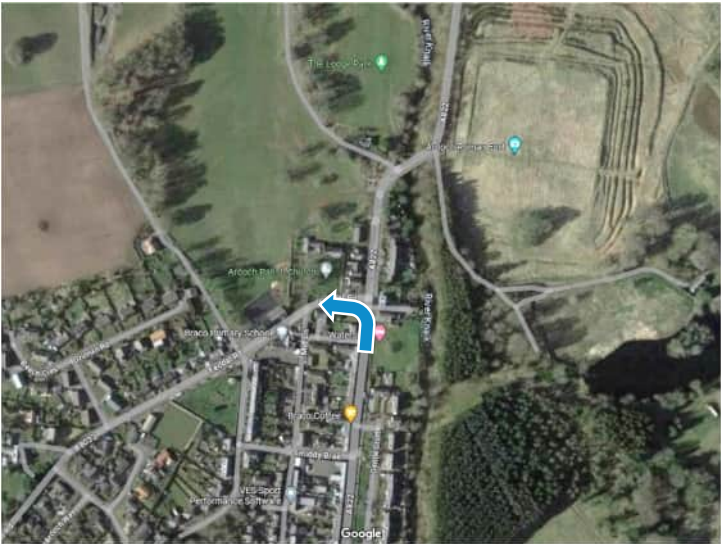
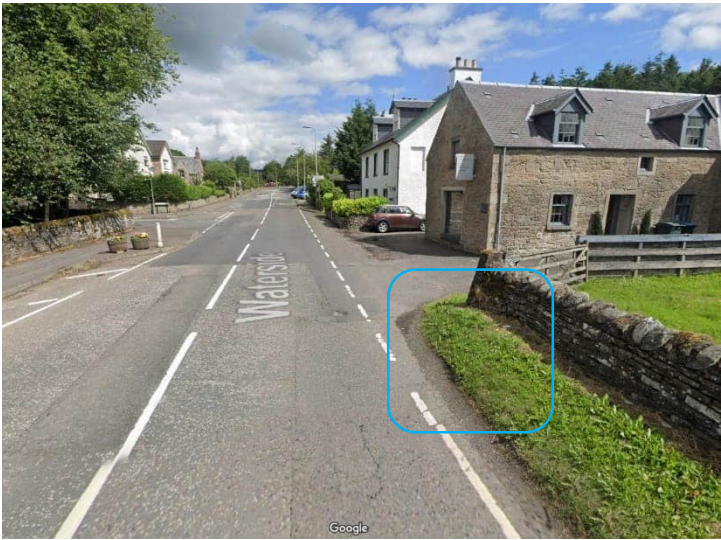
Ref. ALL-A242494-RS-65 <i>A822/B8033 junction (16-axle FT)</i>

Direction of Travel Location: LH turn from A822 onto B8033	Coordinates: 56.266083, -3.878611
Enabling Works Required: Temporary steel plating required to facilitate verge overrun	Enabling Work Grade: Low
Assessment Works Required: Route survey carried out SPA carried out, drawing no. ALL-A242494-SPA-04 included in Appendix D	Assessment Work Grade: Complete Complete

The A822/B8033 junction in Braco is negotiable for the 16-axle flat top trailer with street furniture removals and temporary steel plating of sections of pavement and verge to facilitate vehicle overrun beyond the kerb.

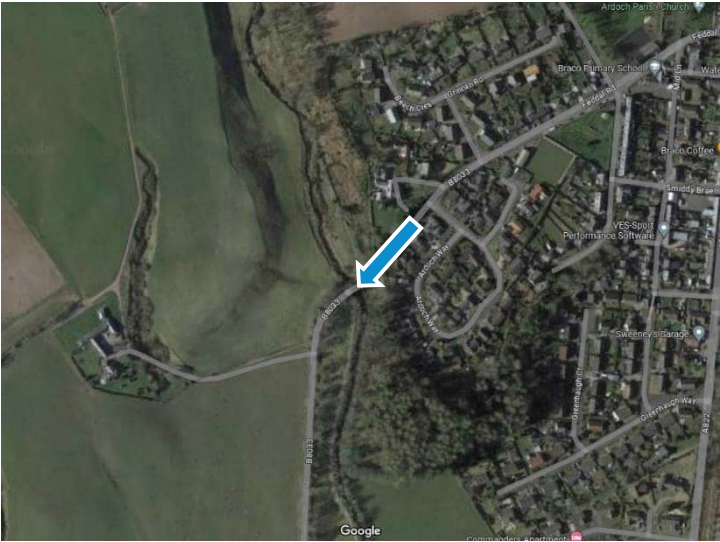
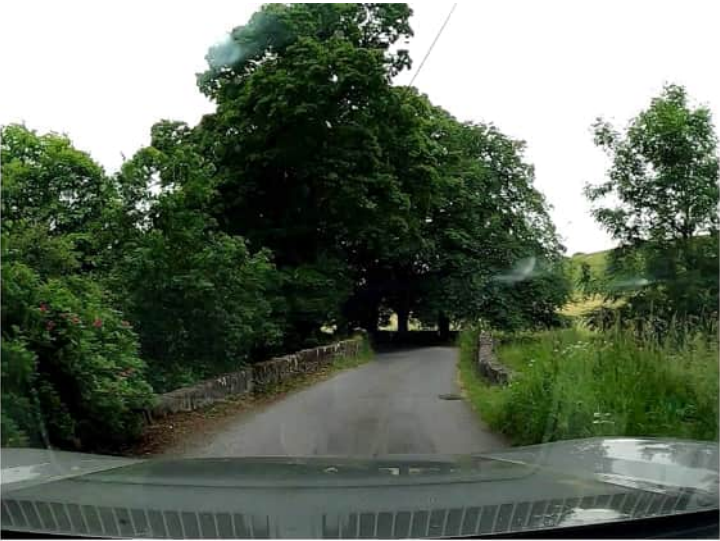
Ref. ALL-A242494-RS-67	
B8033/03 Bridge of Keir (16-axle FT)

Direction of Travel Location: Westbound on B8033 over structure no. B8033/03 Bridge of Keir	Coordinates: 56.263750, -3.885250
Enabling Works Required: TBC	Enabling Work Grade: TBC
Assessment Works Required: Failed Perth & Kinross Council checks Further structural assessment, unsuitable for overbridging, if required	Assessment Work Grade: Complete High

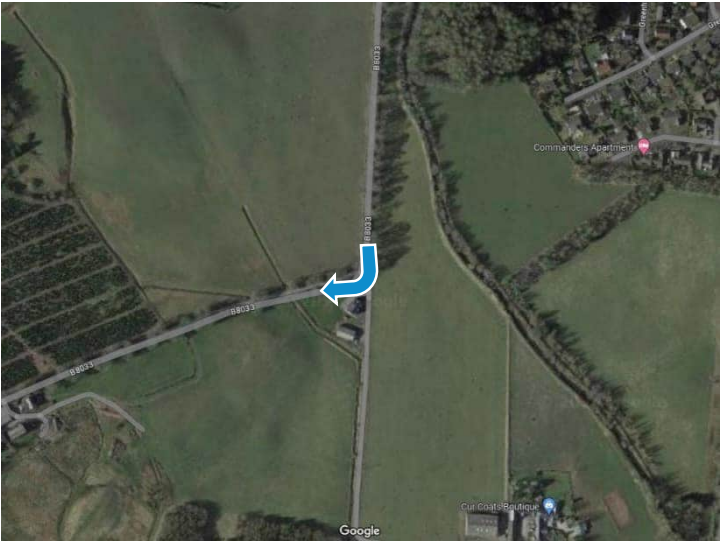
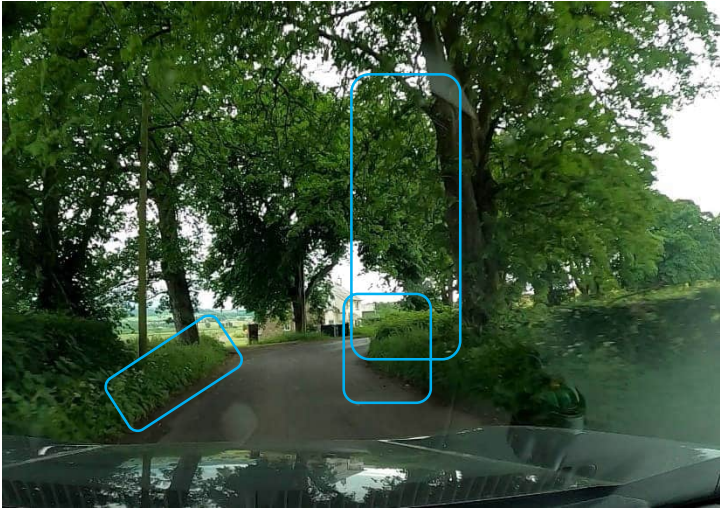
Ref. ALL-A242494-RS-68 <i>B8033 Loaning View RH bend (16-axle FT)</i>

Direction of Travel Location: Westbound on B8033 around RH bend at Loaning View	Coordinates: 56.260139, -3.886278
Enabling Works Required: Removal of 1 no. mature tree Carriageway widening to accommodate overrun beyond kerb	Enabling Work Grade: High High
Assessment Works Required: Route survey carried out SPA carried out, drawing no. ALL-A242494-SPA-07 included in Appendix D	Assessment Work Grade: Complete Complete

The RH bend on the B8033 at Loaning View is negotiable for the 16-axle flat top trailer with the removal of a mature tree to the inside of the turn. Overrun beyond the kerb is also required to both sides of the carriageway throughout the turn with minor carriageway widening works needed to facilitate.

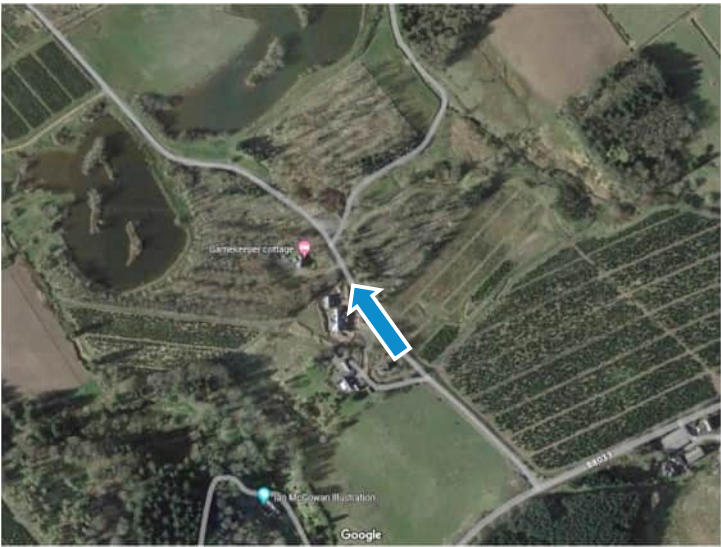
Ref. ALL-A242494-RS-70 <i>Site access track cattle grid no. 1 (16-axle FT)</i>

Direction of Travel Location: Northbound on site access track over cattle grid no. 1	Coordinates: 56.260250, -3.897778
Enabling Works Required: To be overbridged, span = 10.1 m	Enabling Work Grade: Medium
Assessment Works Required: Route survey carried out	Assessment Work Grade: Complete

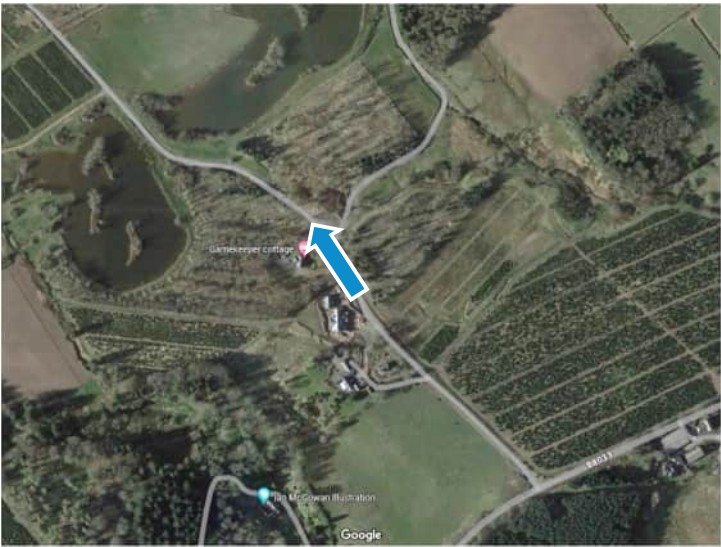
Ref. ALL-A242494-RS-71 Site access track LH turn no. 1 (16-axle FT)

Direction of Travel Location: LH turn on site access track	Coordinates: 56.260556, -3.898000
Enabling Works Required: N/A	Enabling Work Grade: N/A
Assessment Works Required: Route survey carried out - negotiable	Assessment Work Grade: Complete

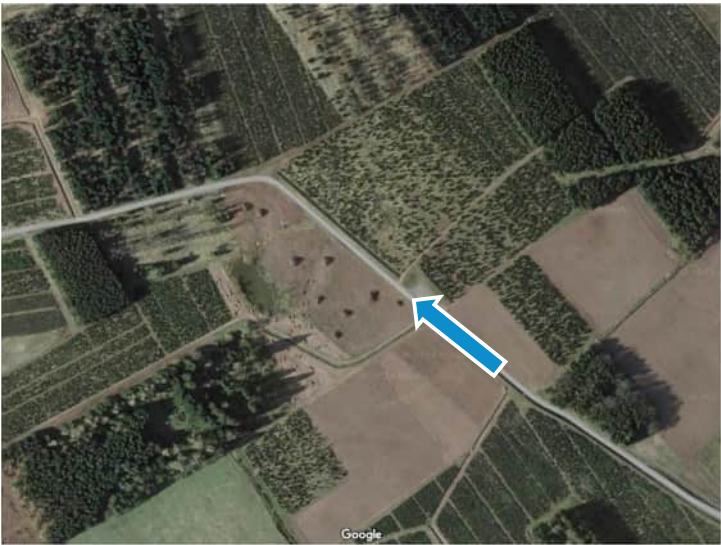
Ref. ALL-A242494-RS-78 <i>Site access track RH turn no. 3 (16-axle FT)</i>

Direction of Travel Location: RH turn on site access track	Coordinates: 56.266722, -3.914639
Enabling Works Required: N/A	Enabling Work Grade: N/A
Assessment Works Required: Route survey carried out - negotiable	Assessment Work Grade: Complete
