Route Feasibility Report

**For the delivery of 261 te Transformer
from Grangemouth to Cambushinnie Substation**

A242494

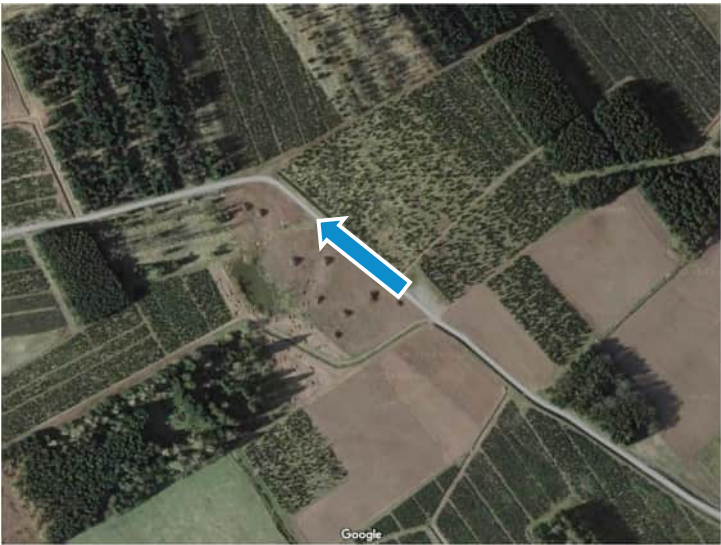
Direction of Travel Location: Northbound on site access track	Coordinates: 56.267611, -3.916472
Enabling Works Required: TBC	Enabling Work Grade: TBC
Assessment Works Required: Route survey carried out Confirmation of max. permitted vehicle height required	Assessment Work Grade: Complete Medium

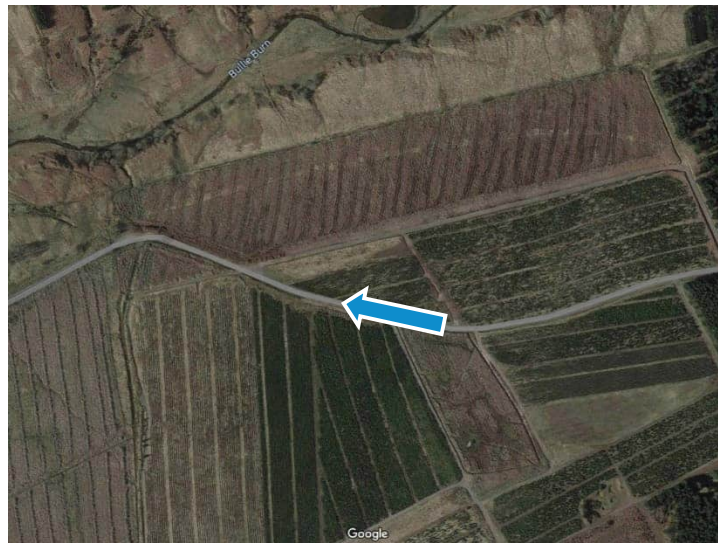
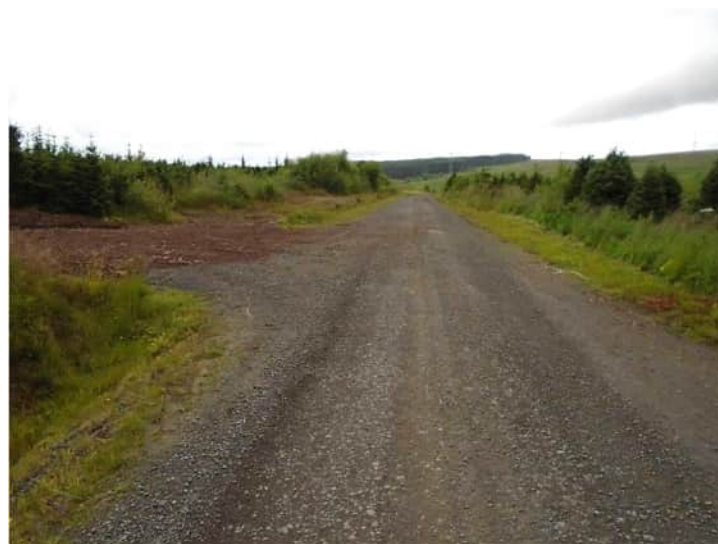
Ref. ALL-A242494-RS-84*Site access track RH turn no. 6 (16-axle FT)*

RH turn on Torgoyle OHL track

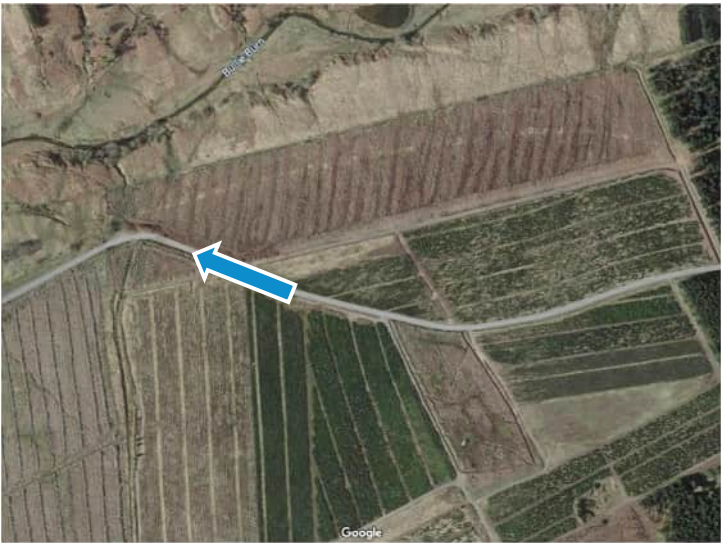
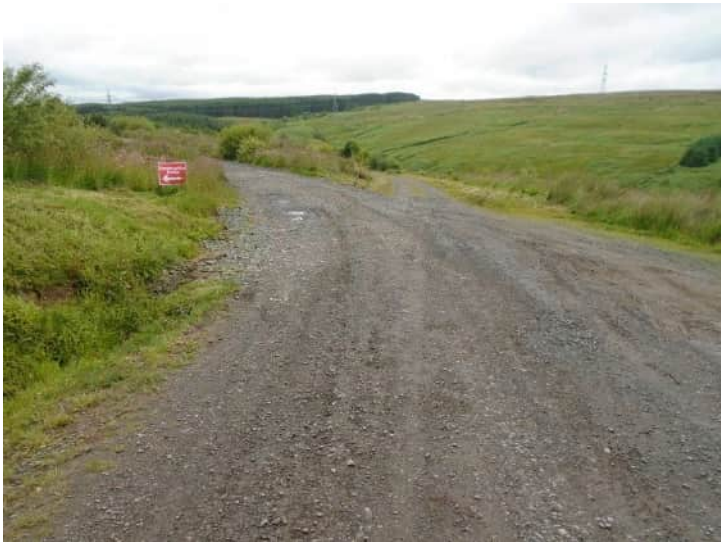
Ref. ALL-A242494-RS-86	
Site access track crossroads no. 2 (16-axle FT)

Direction of Travel Location: Straight on through crossroads on site access track	Coordinates: 56.267611, -3.928528
Enabling Works Required: N/A	Enabling Work Grade: N/A
Assessment Works Required: Route survey carried out - negotiable	Assessment Work Grade: Complete

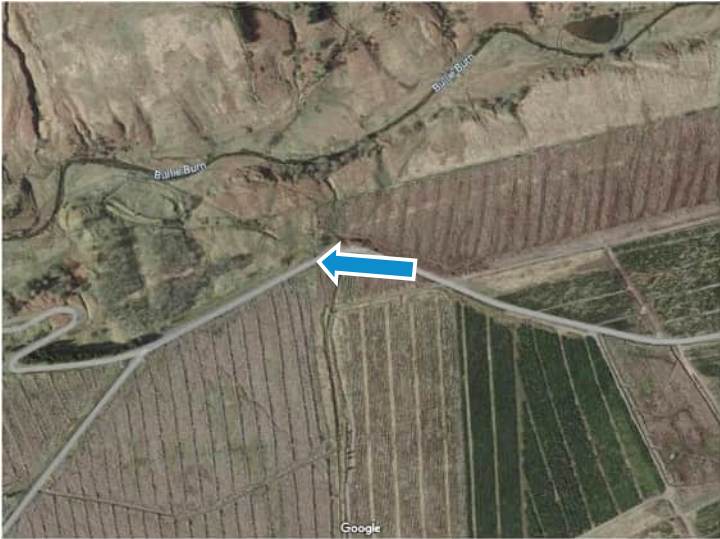
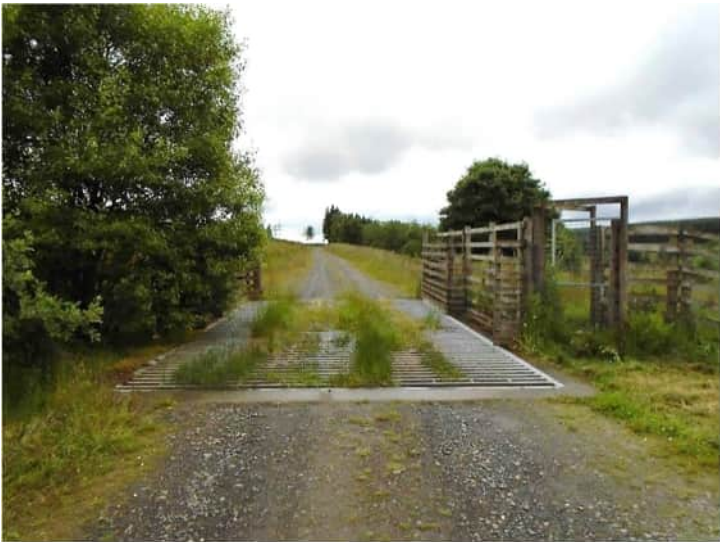
Ref. ALL-A242494-RS-87 <i>Site access track cattle grid no. 2 (16-axle FT)</i>

Direction of Travel Location: Westbound on site access track	Coordinates: 56.267806, -3.930750
Enabling Works Required: To be overbridged, span = 9.5 m	Enabling Work Grade: Medium
Assessment Works Required: Route survey carried out	Assessment Work Grade: Complete

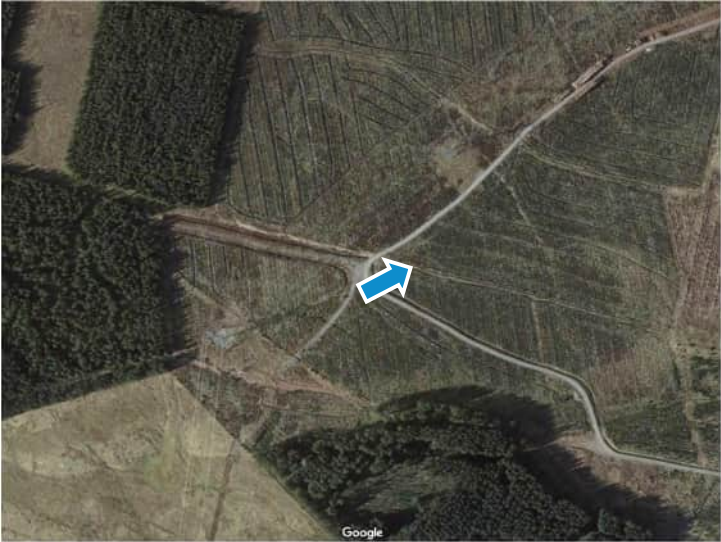
Ref. ALL-A242494-RS-92 <i>Cambushinnie Substation access gate</i>

Direction of Travel Location: Northbound on proposed Cambushinnie Substation access track through access gate	Coordinates: 56.257222, -3.956667
Enabling Works Required: Offside gatepost and adjacent fence line to be demountable	Enabling Work Grade: Medium
Assessment Works Required: Route survey carried out	Assessment Work Grade: Complete

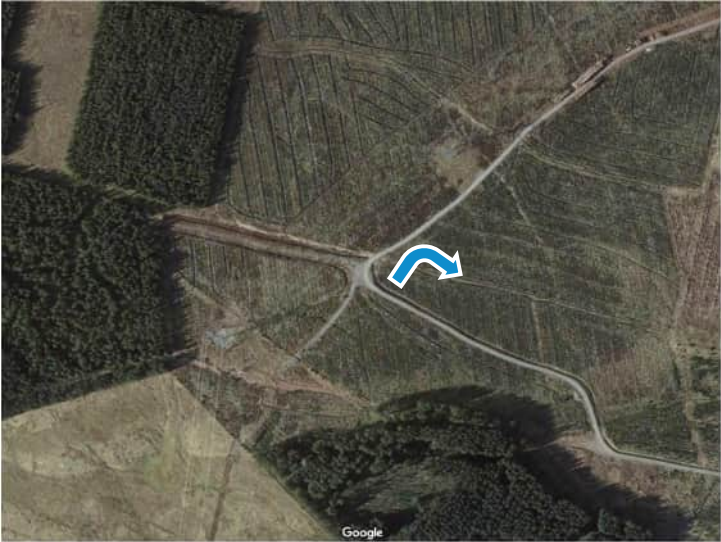
Ref. ALL-A242494-RS-93 <i>Substation site access road RH turn</i>

Direction of Travel Location: RH turn on proposed Cambushinnie Substation site access road	Coordinates: 56.257500, -3.956389
Enabling Works Required: Carriageway widening works to inside of turn	Enabling Work Grade: High
Assessment Works Required: Route survey carried out	Assessment Work Grade: Complete
