**ARGYLL SUBSTATIONS – CRAIG MURRAIL
ENVIRONMENTAL APPRAISAL**

ANNEX P

PEAT LANDSLIDE HAZARD AND RISK ASSESSMENT

JULY 2022

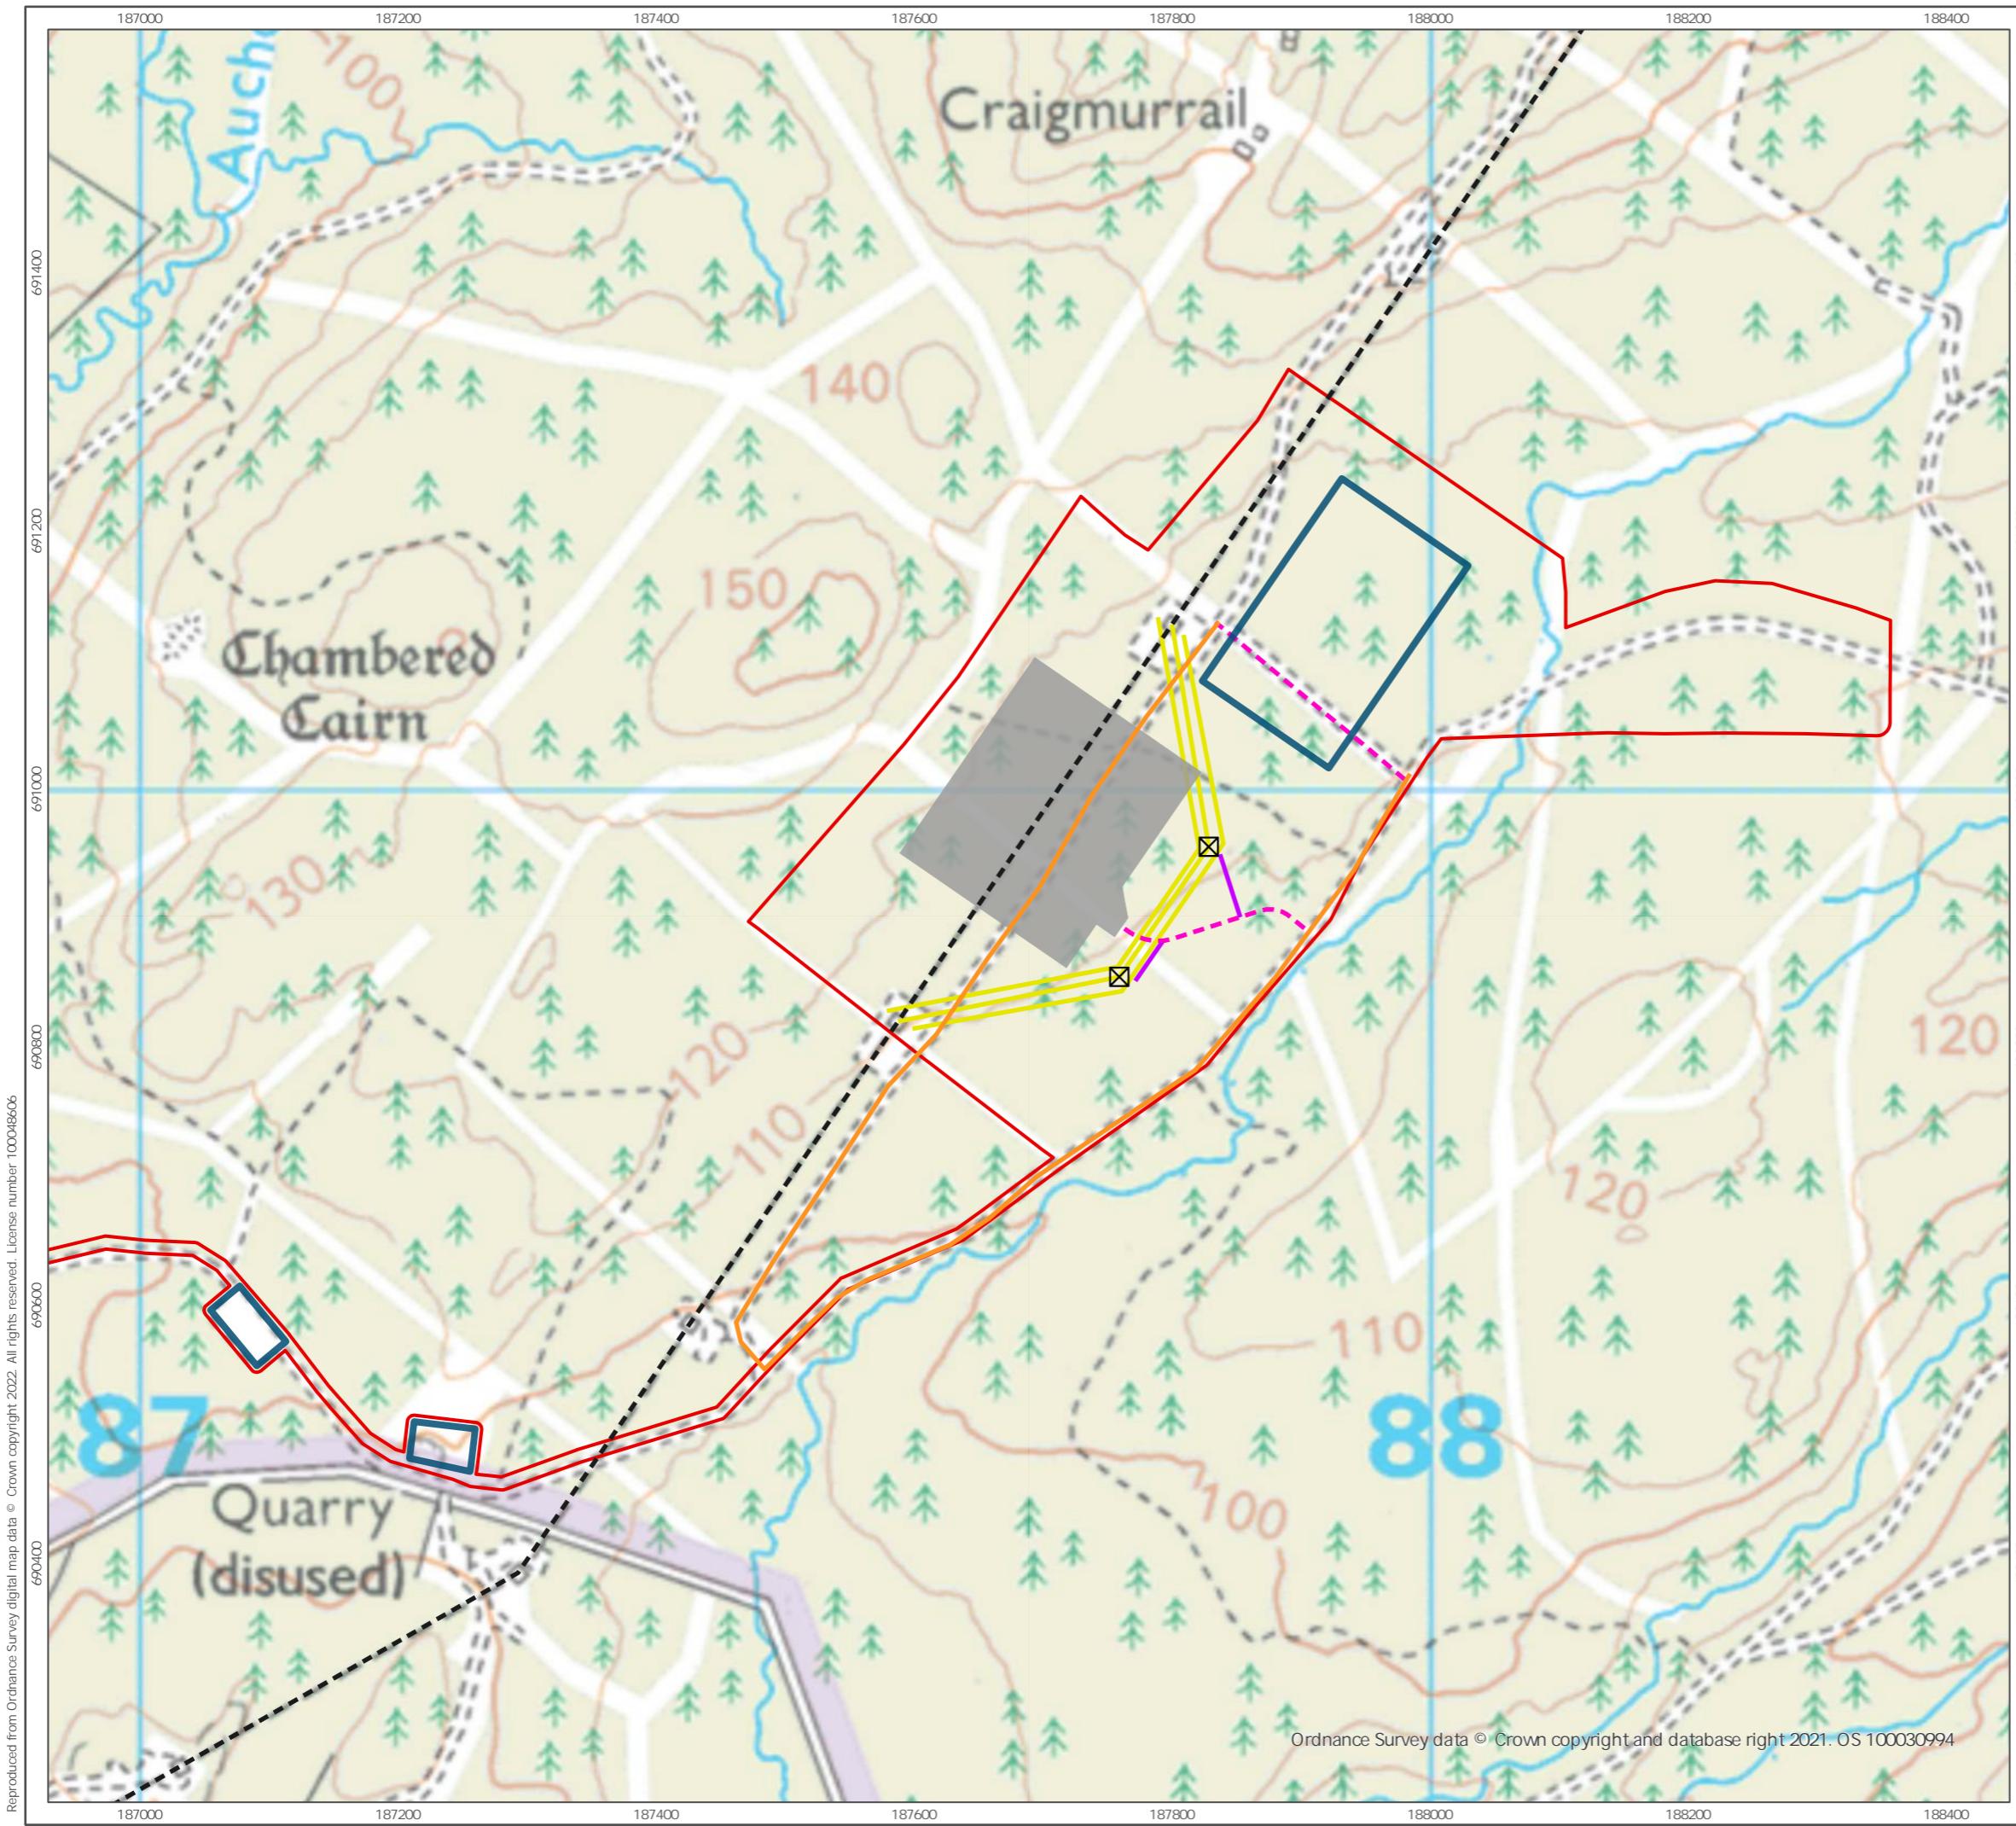
- 1:5,000 Scale @ A3
- Produced By: BM Ref: 4534-REP-015
- Checked By: DB Date: 28/06/2022
- Site Layout Plan Figure 1**
- Craig Murrail Annex N: Peat Slide Risk Assessment**

The new substation and accompanying infrastructure aspects (hereby known as the Proposed Development) will be subject to Town and Country Planning, while the OHL Tie-In, Temporary Diversion accompanying towers and temporary access track (hereby known as the Associated Development) will be submitted for Section 37 consent. The Site Layout Plan is shown on **Figure 1 in Appendix A**.

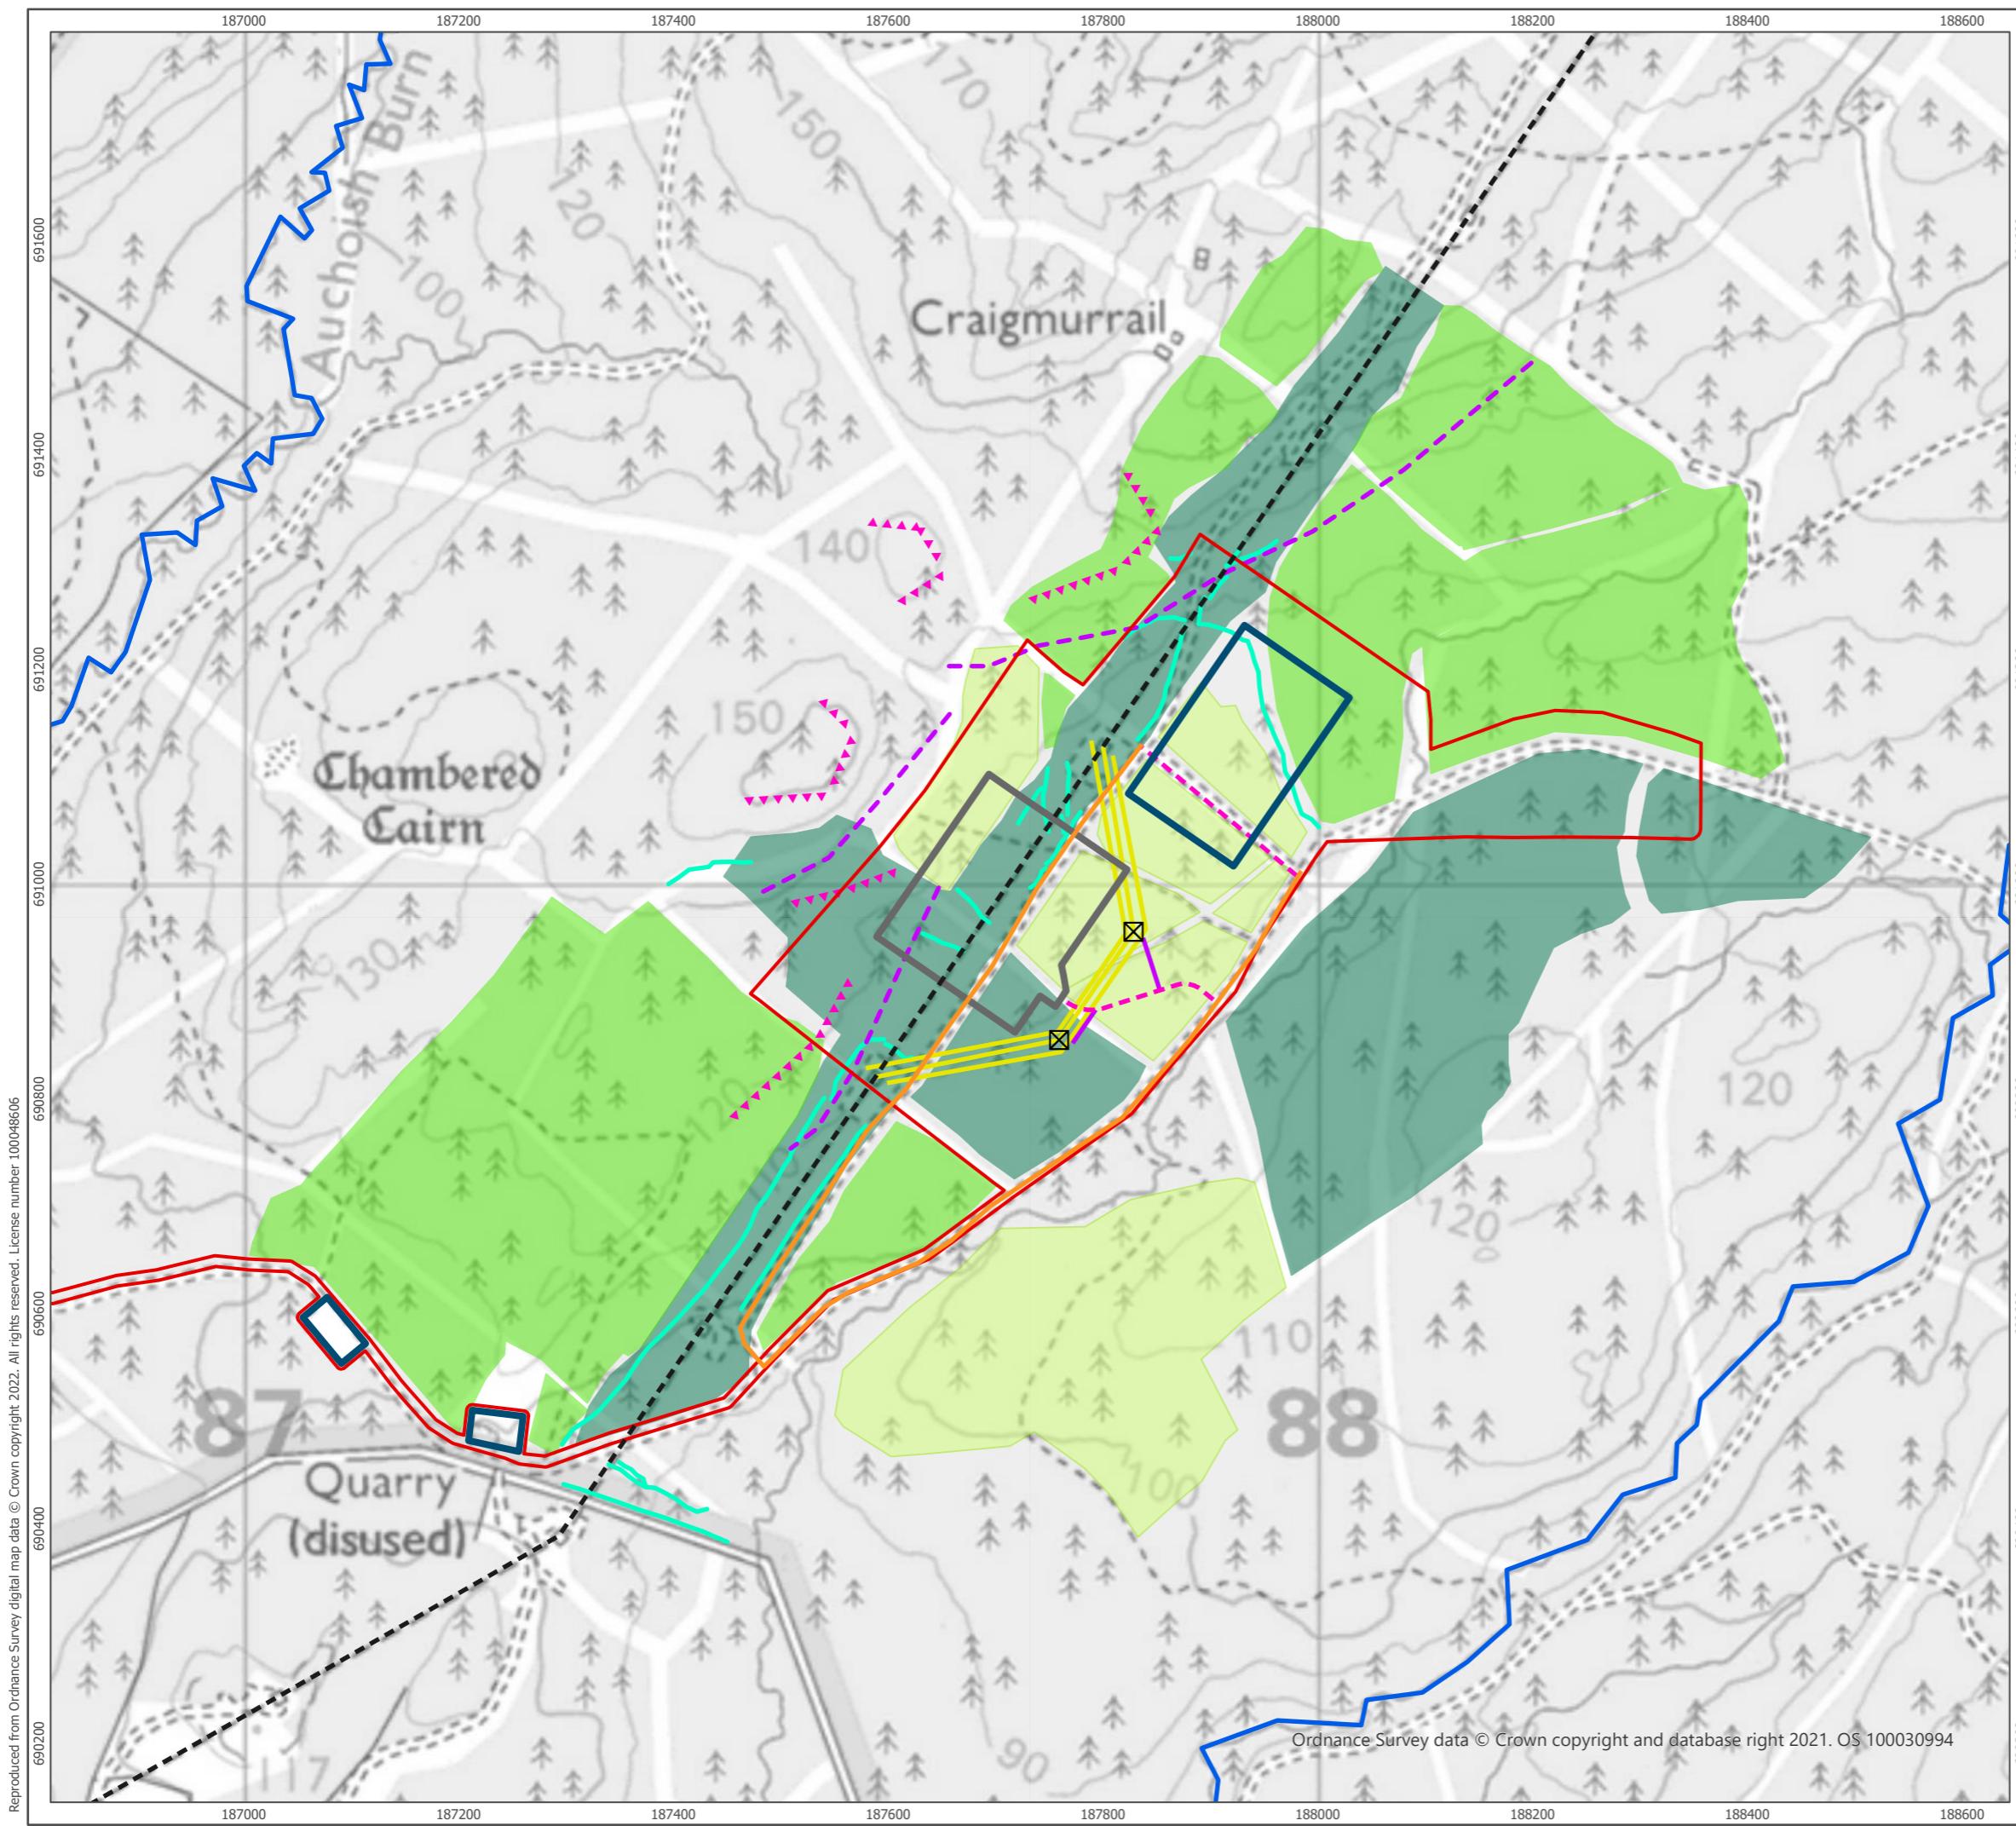
Geomorphology Map
Figure 4

presented in **Figure 4**. This information was also considered during the adoption of hazard zones across the Site, which are presented in **Figure 9**: Hazard Rank Zonation Plan.

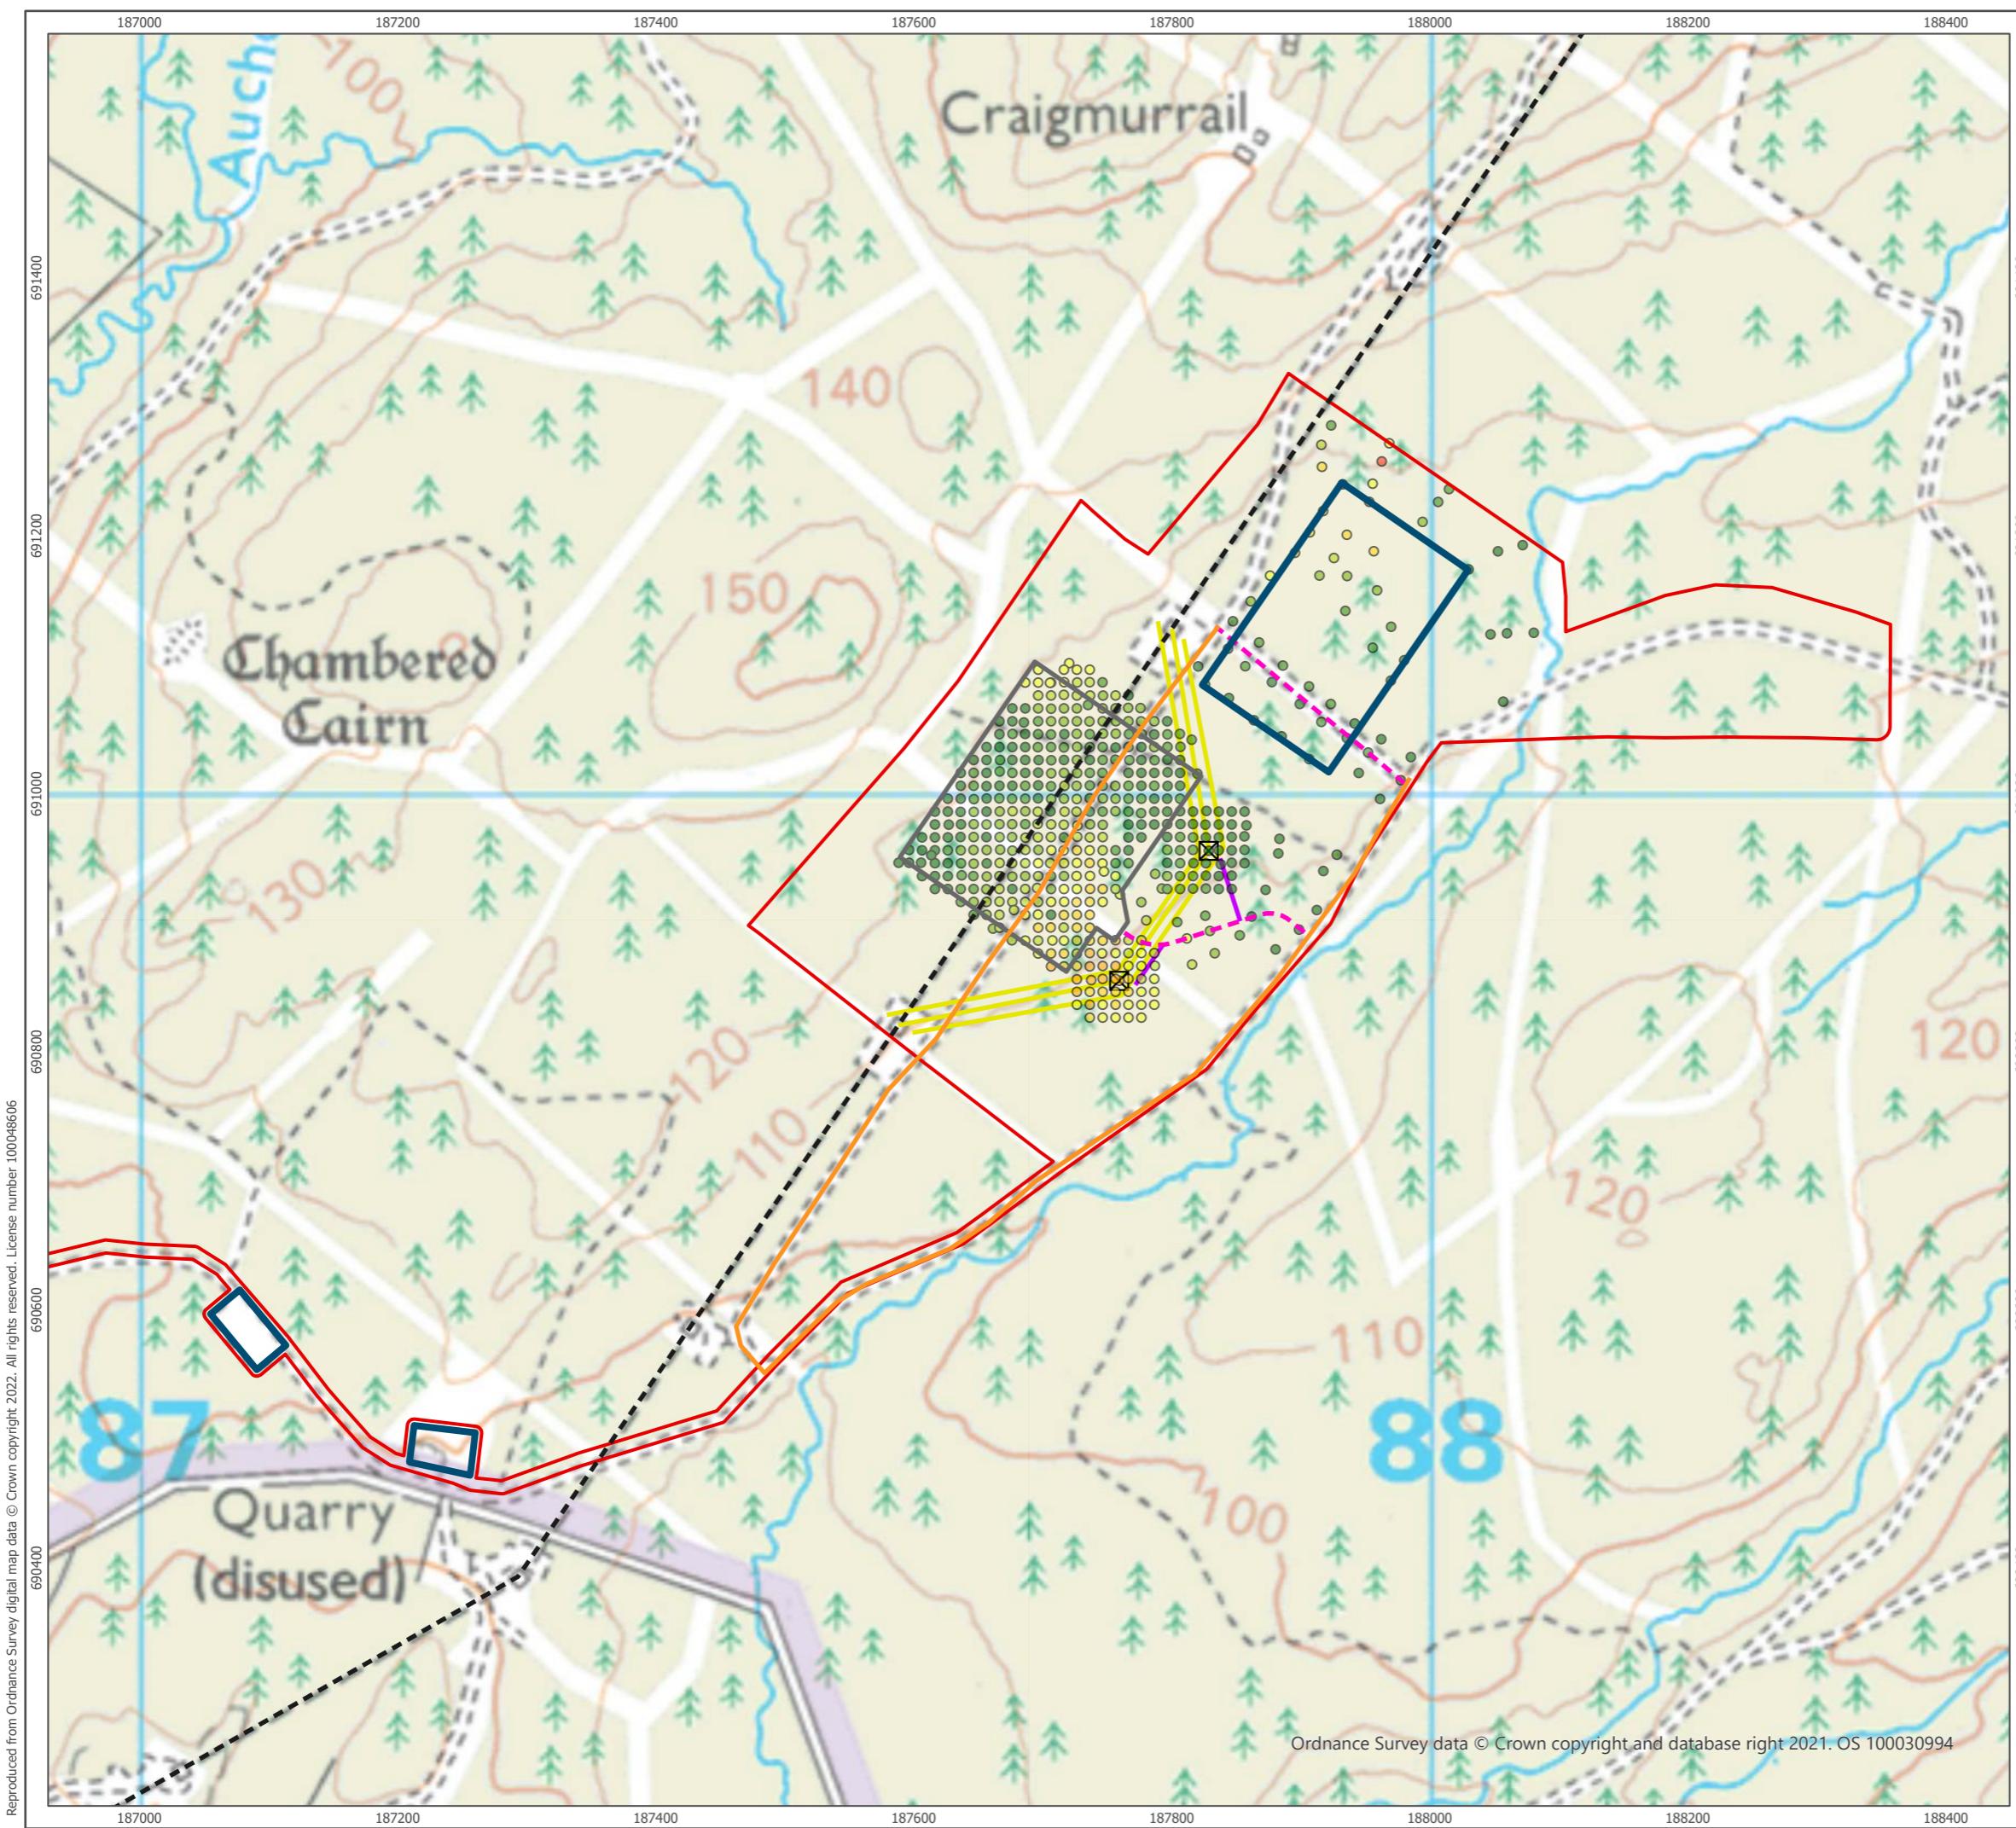
Recorded Peat Depths
Figure 5

The existing peat depths across the Site have been determined through a peat probe survey undertaken as recommended in the NatureScot (formally Scottish Natural Heritage), Scottish Government and James Hutton Institute guidance for investigating peat⁷.

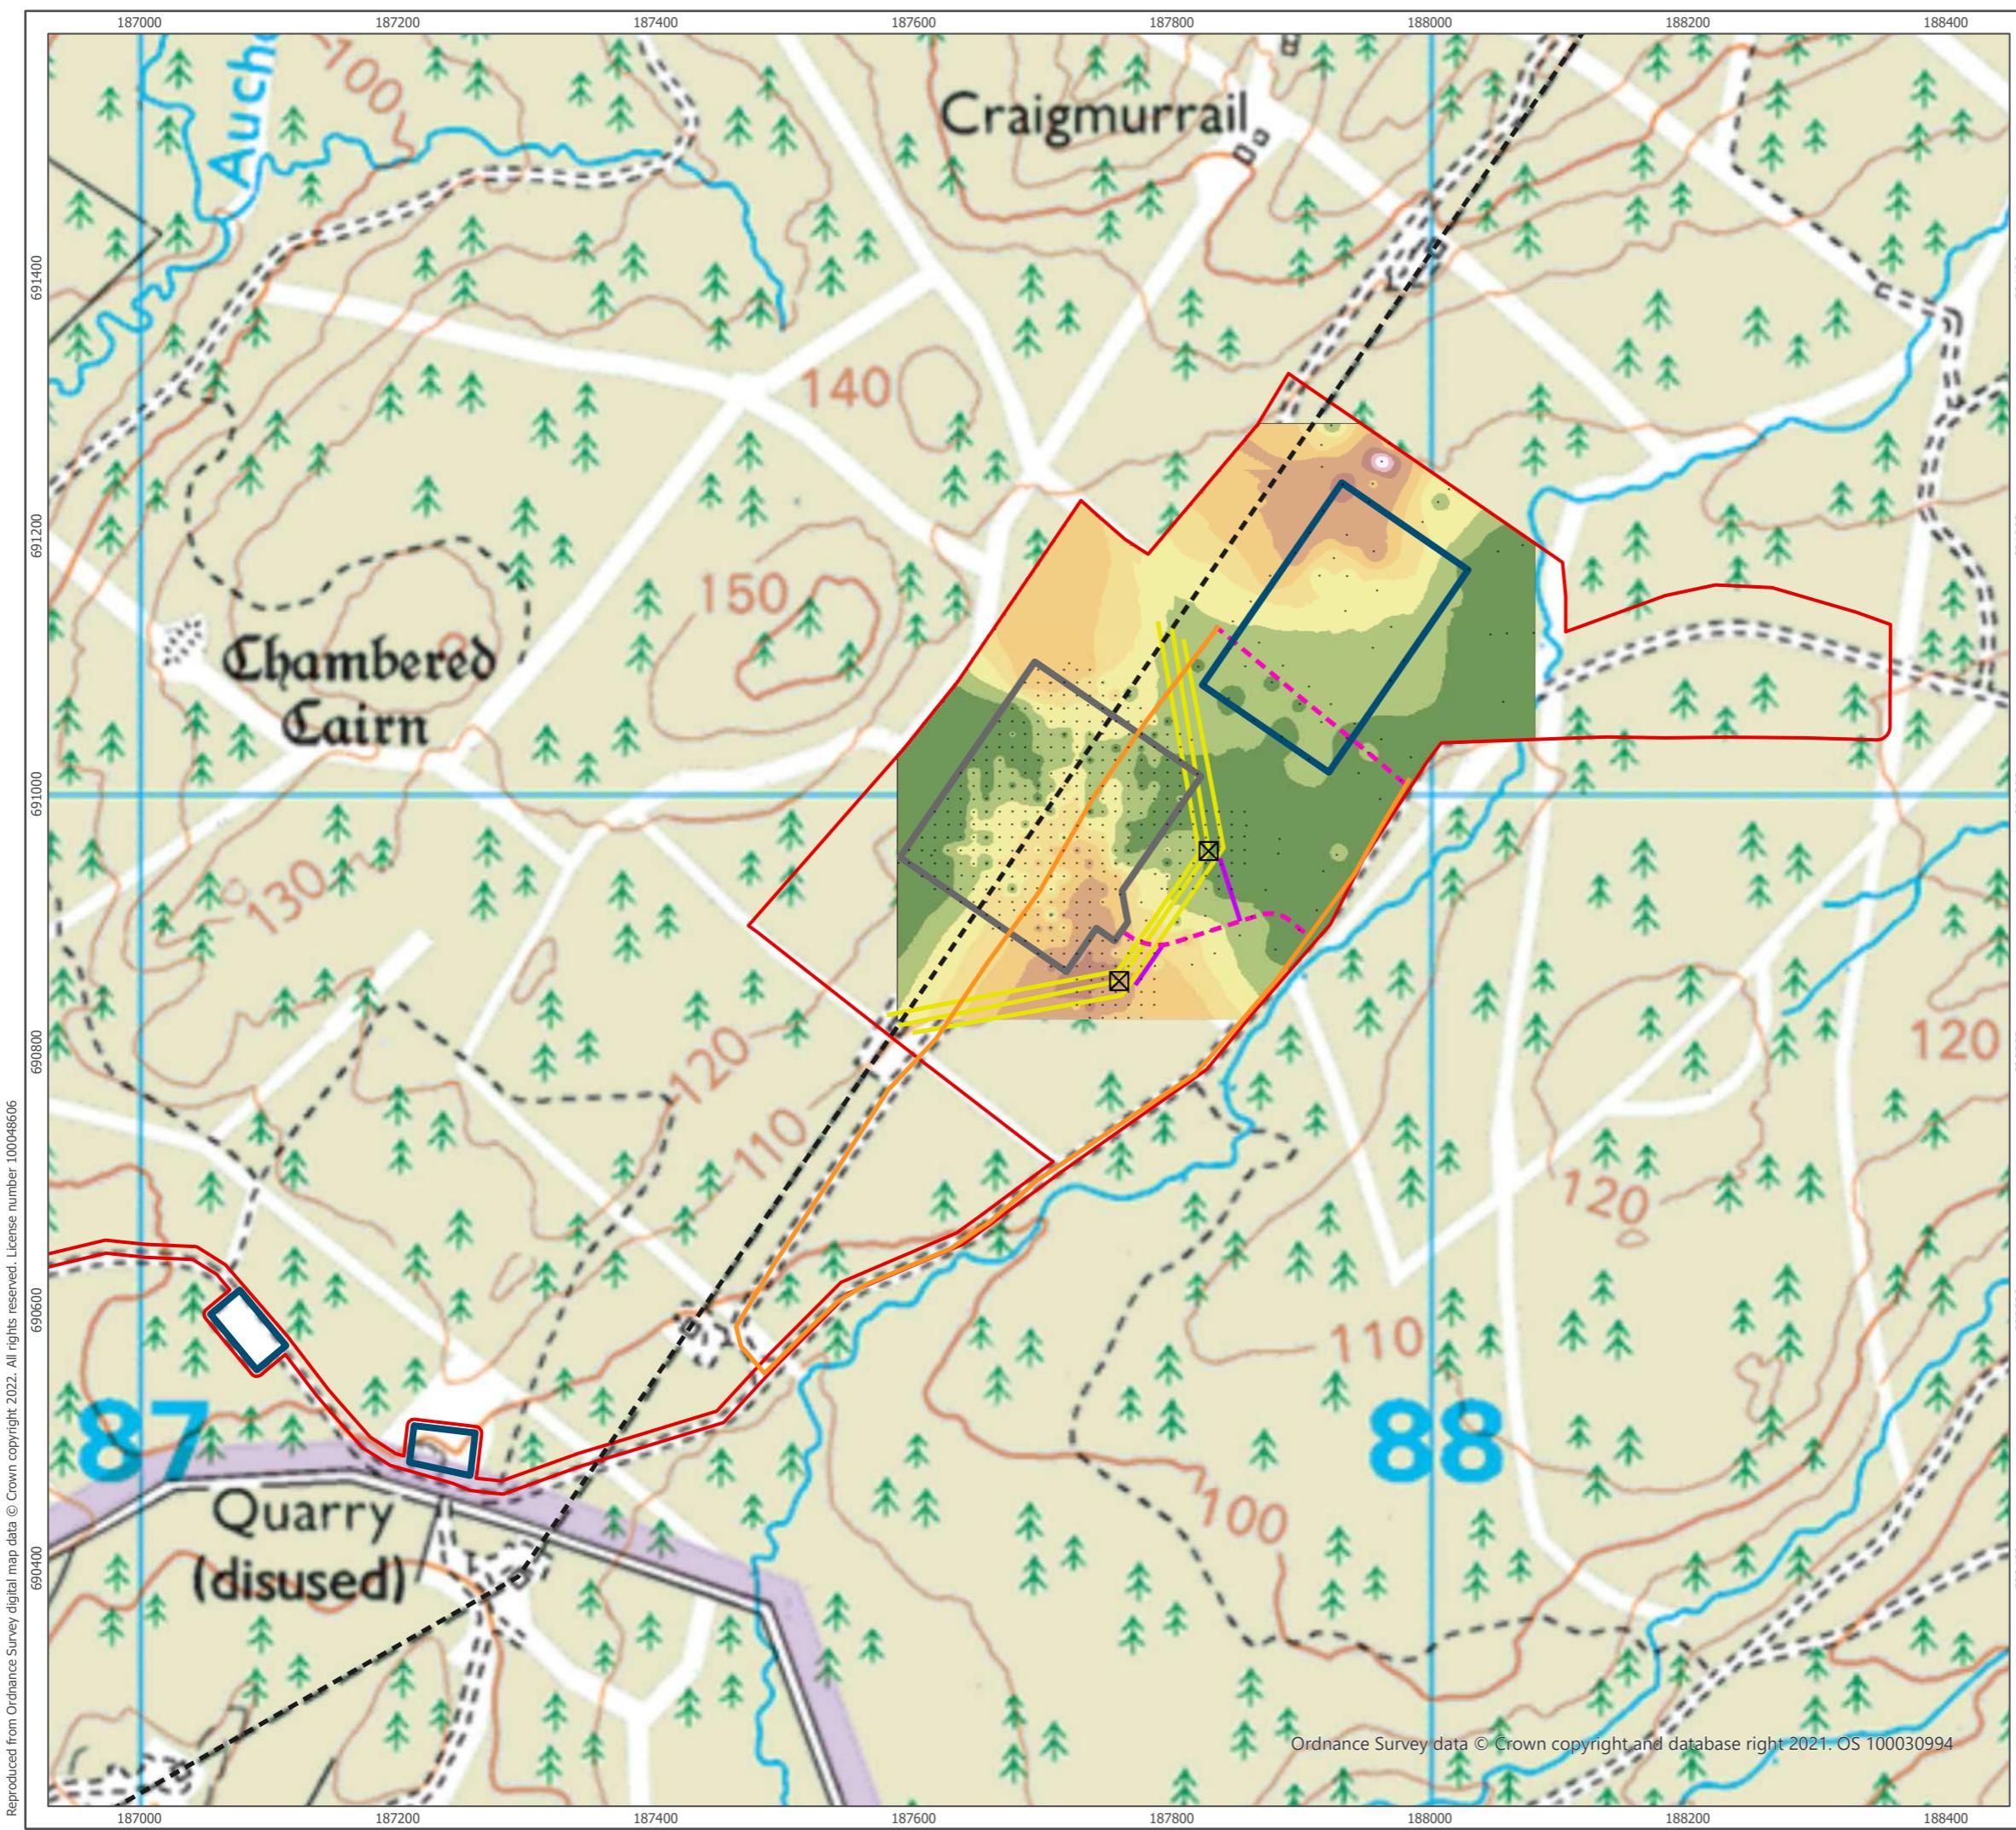
Interpolated Peat Depths
Figure 6

- Peat Probe Location
- Existing Access Tracks
- Existing Inveraray to Crossraig Overhead Line
- Proposed Development
 - Indicative Town and Country Planning Boundary
 - Proposed Substation Temporary Works Area
 - Proposed Substation Layout
 - Proposed Permanent Access Tracks
- Associated Development
 - Proposed Indicative Tower Location
 - New Temporary Tracks
 - Overhead Line

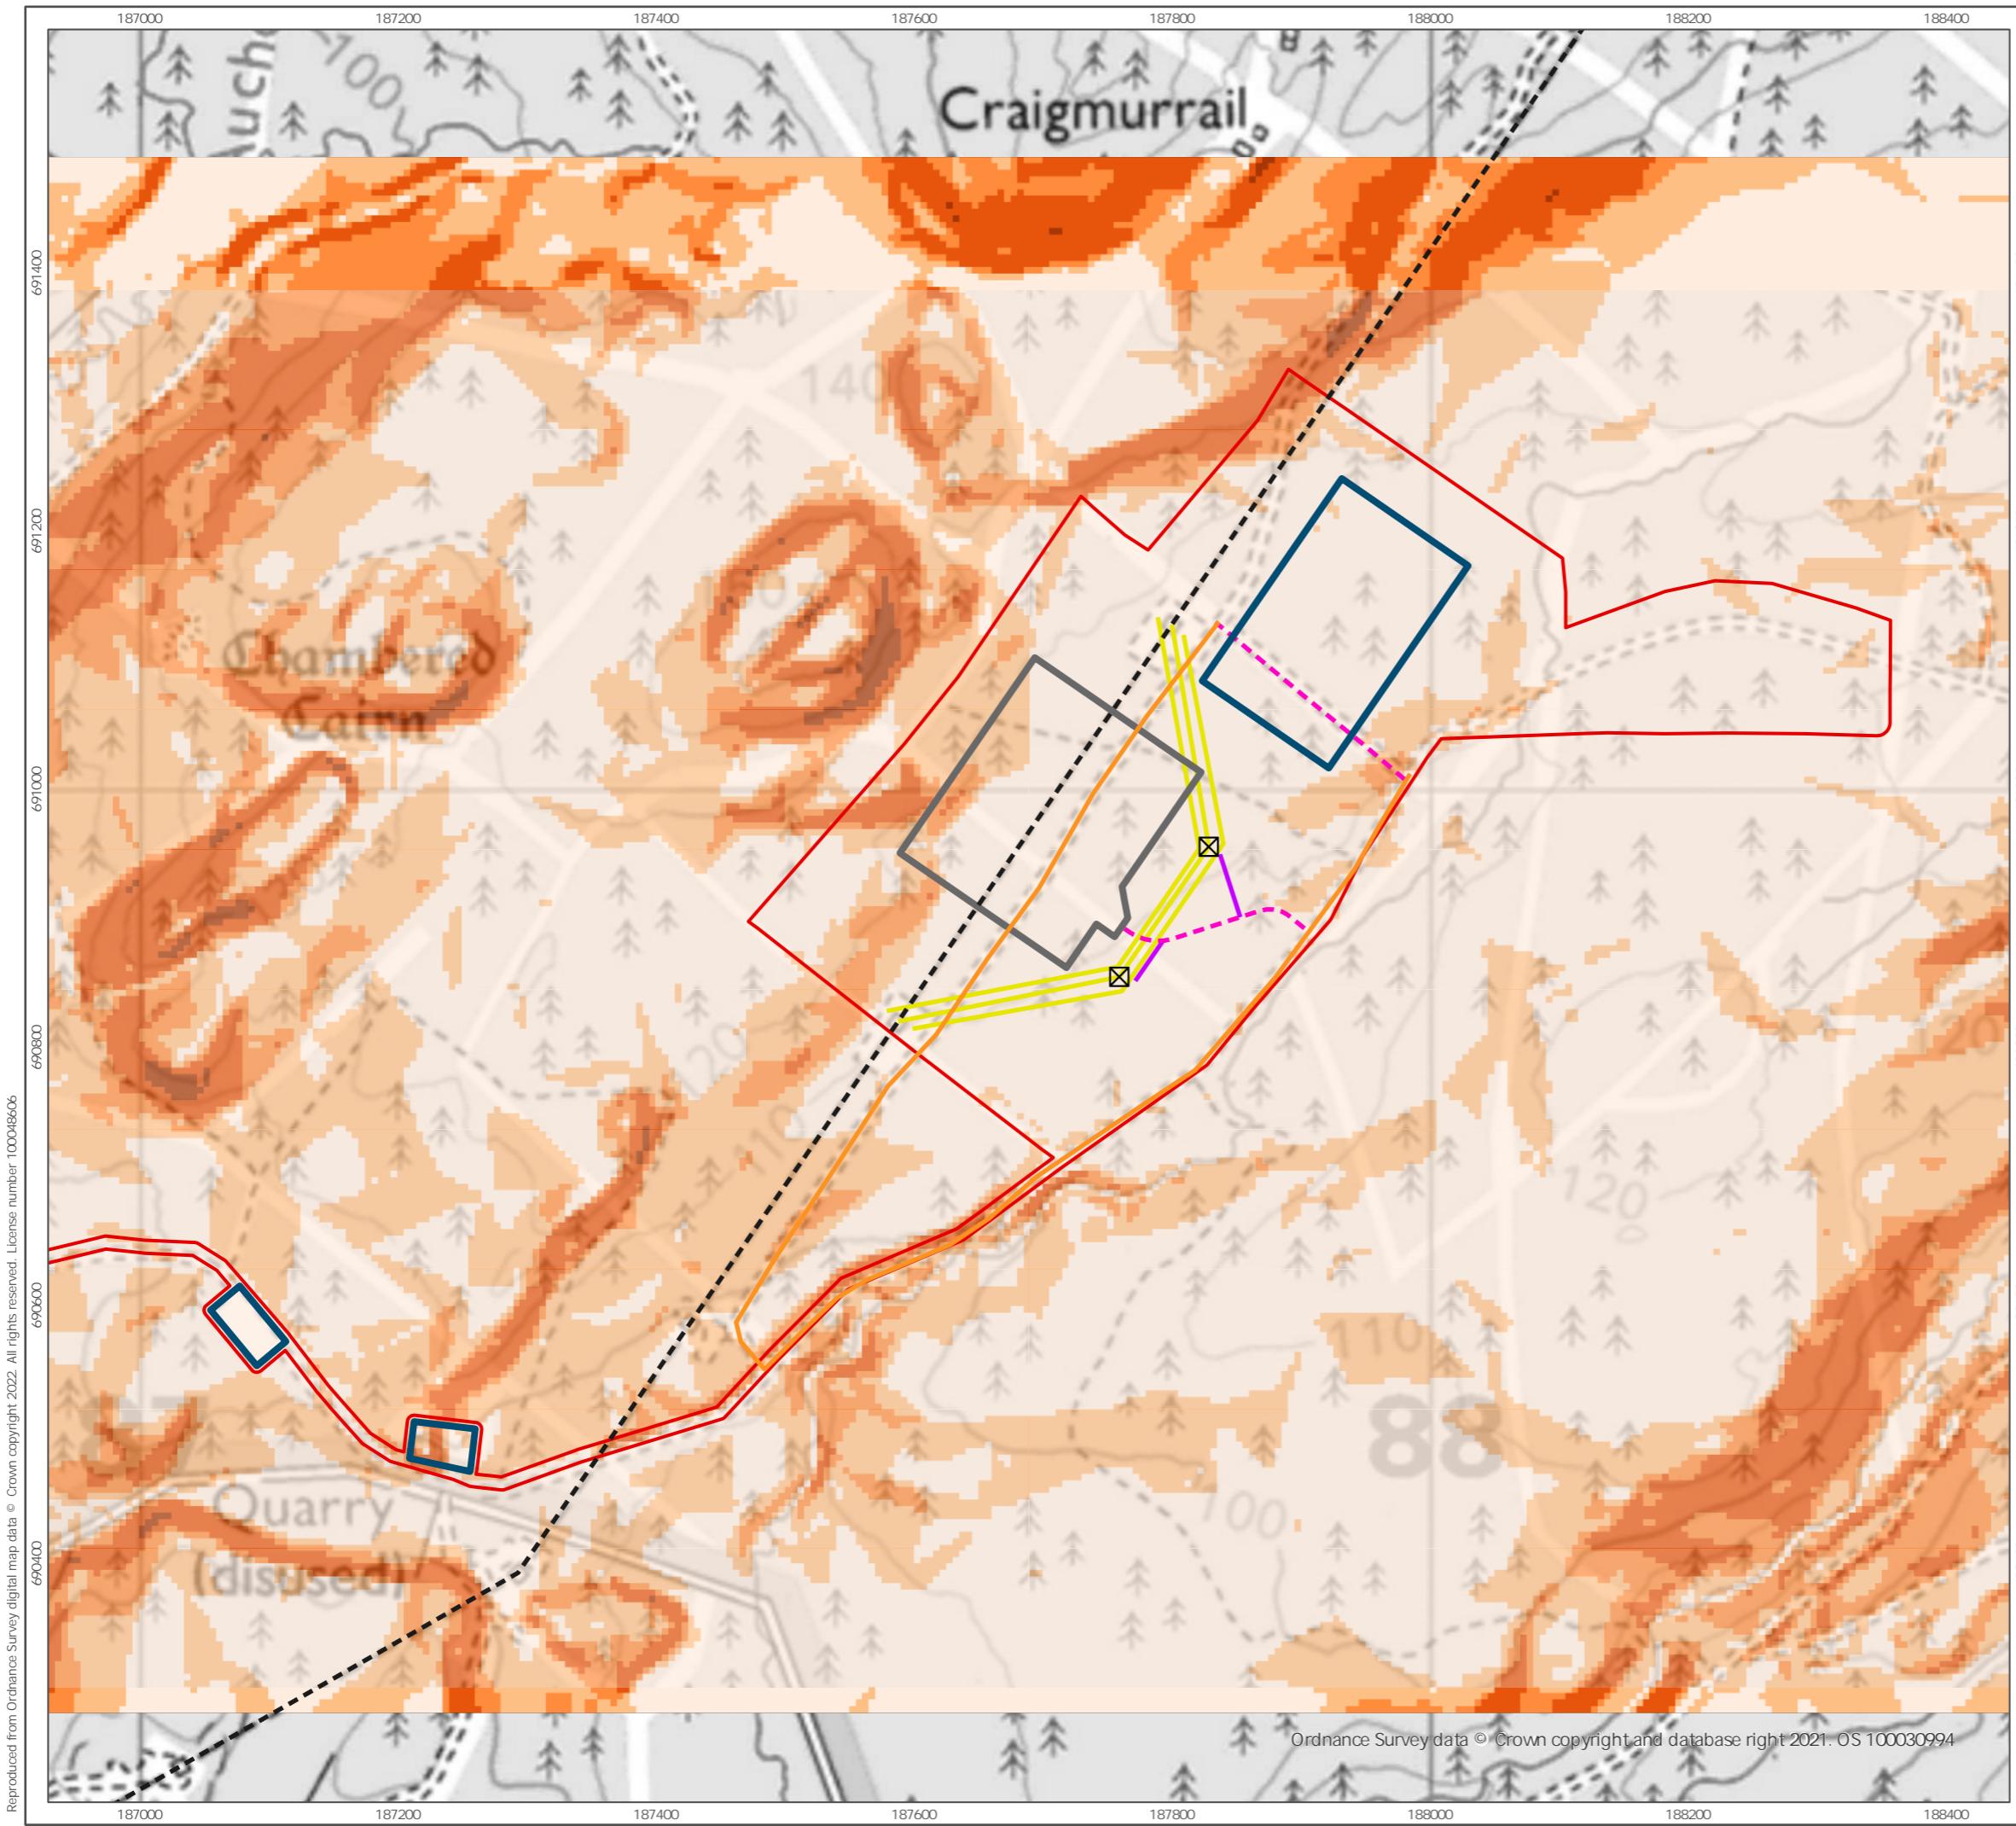
Slope Map
Figure 7

Topographically the Site has a gradual slope throughout from north west to south east; however, no steep gradients were observed during the walkover and the proposed infrastructure is generally located in flatter areas. The elevation of the Site ranges from around 110 metres (m) Above Ordnance Survey Datum in the south east (AOD) to around 150 m AOD in the north western sector of the Site.

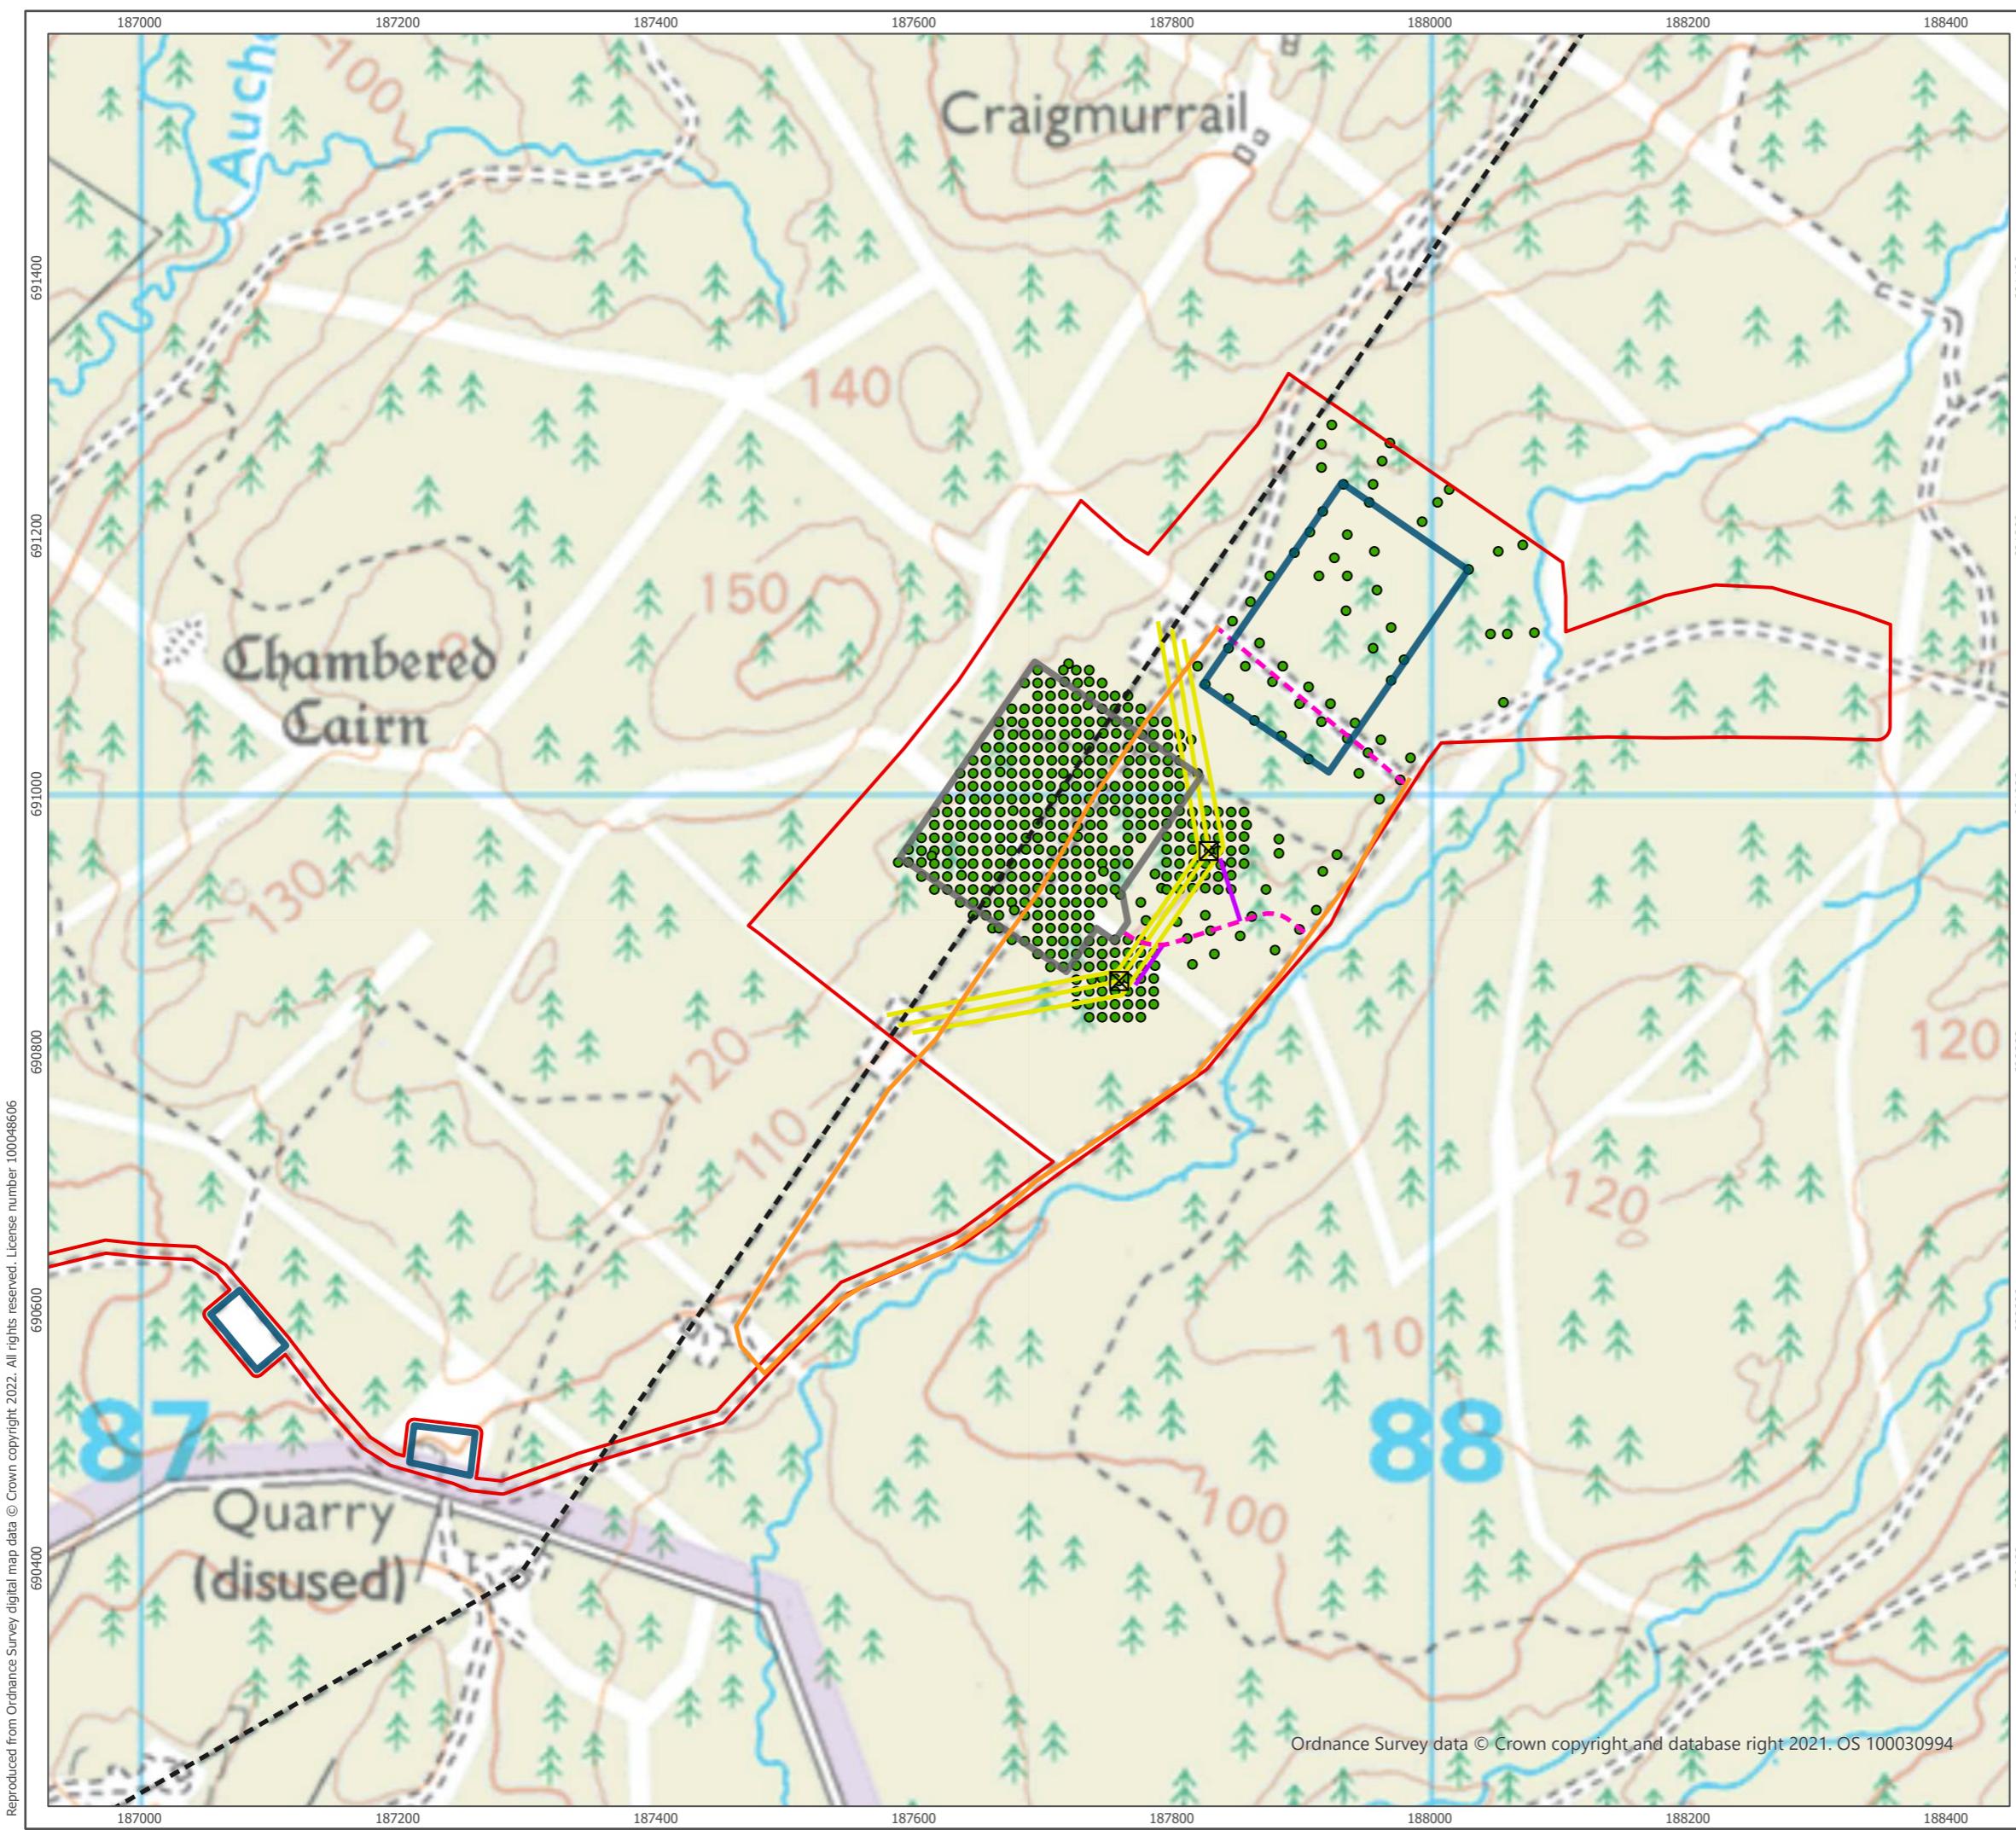
Factor of Safety Plan Figure 8

The results of the Factor of Safety calculations indicated all points on the Site as low risk. This was primarily due to the light undulating topography and generally flat-lying conditions on the Site.

- Existing Access Tracks
- Existing Inveraray to Crossaig Overhead Line
- Proposed Development
 - Indicative Town and Country Planning Boundary
 - Proposed Substation Temporary Works Area
 - Proposed Substation Layout
 - Proposed Permanent Access Tracks
- Associated Development
 - Proposed Indicative Tower Location
 - New Temporary Tracks
 - Overhead Line
- Factor of Safety
 - Low Risk

In accordance with the best practice method, F values of <1.0 indicate slopes that would experience failure under the modelled conditions and as such are considered areas of high risk. However, Boylan et al (2008) indicate that a relatively high value of F=1.4 should be used to identify slopes with the potential for instability. Adopting this approach, high risk areas are indicated where F is <1.0, medium risk areas are indicated as 1.01 to 1.50 and >1.5 are low risk.
