**ARGYLL SUBSTATIONS – CRAIG MURRAIL
ENVIRONMENTAL APPRAISAL**

ANNEX P

PEAT LANDSLIDE HAZARD AND RISK ASSESSMENT

JULY 2022

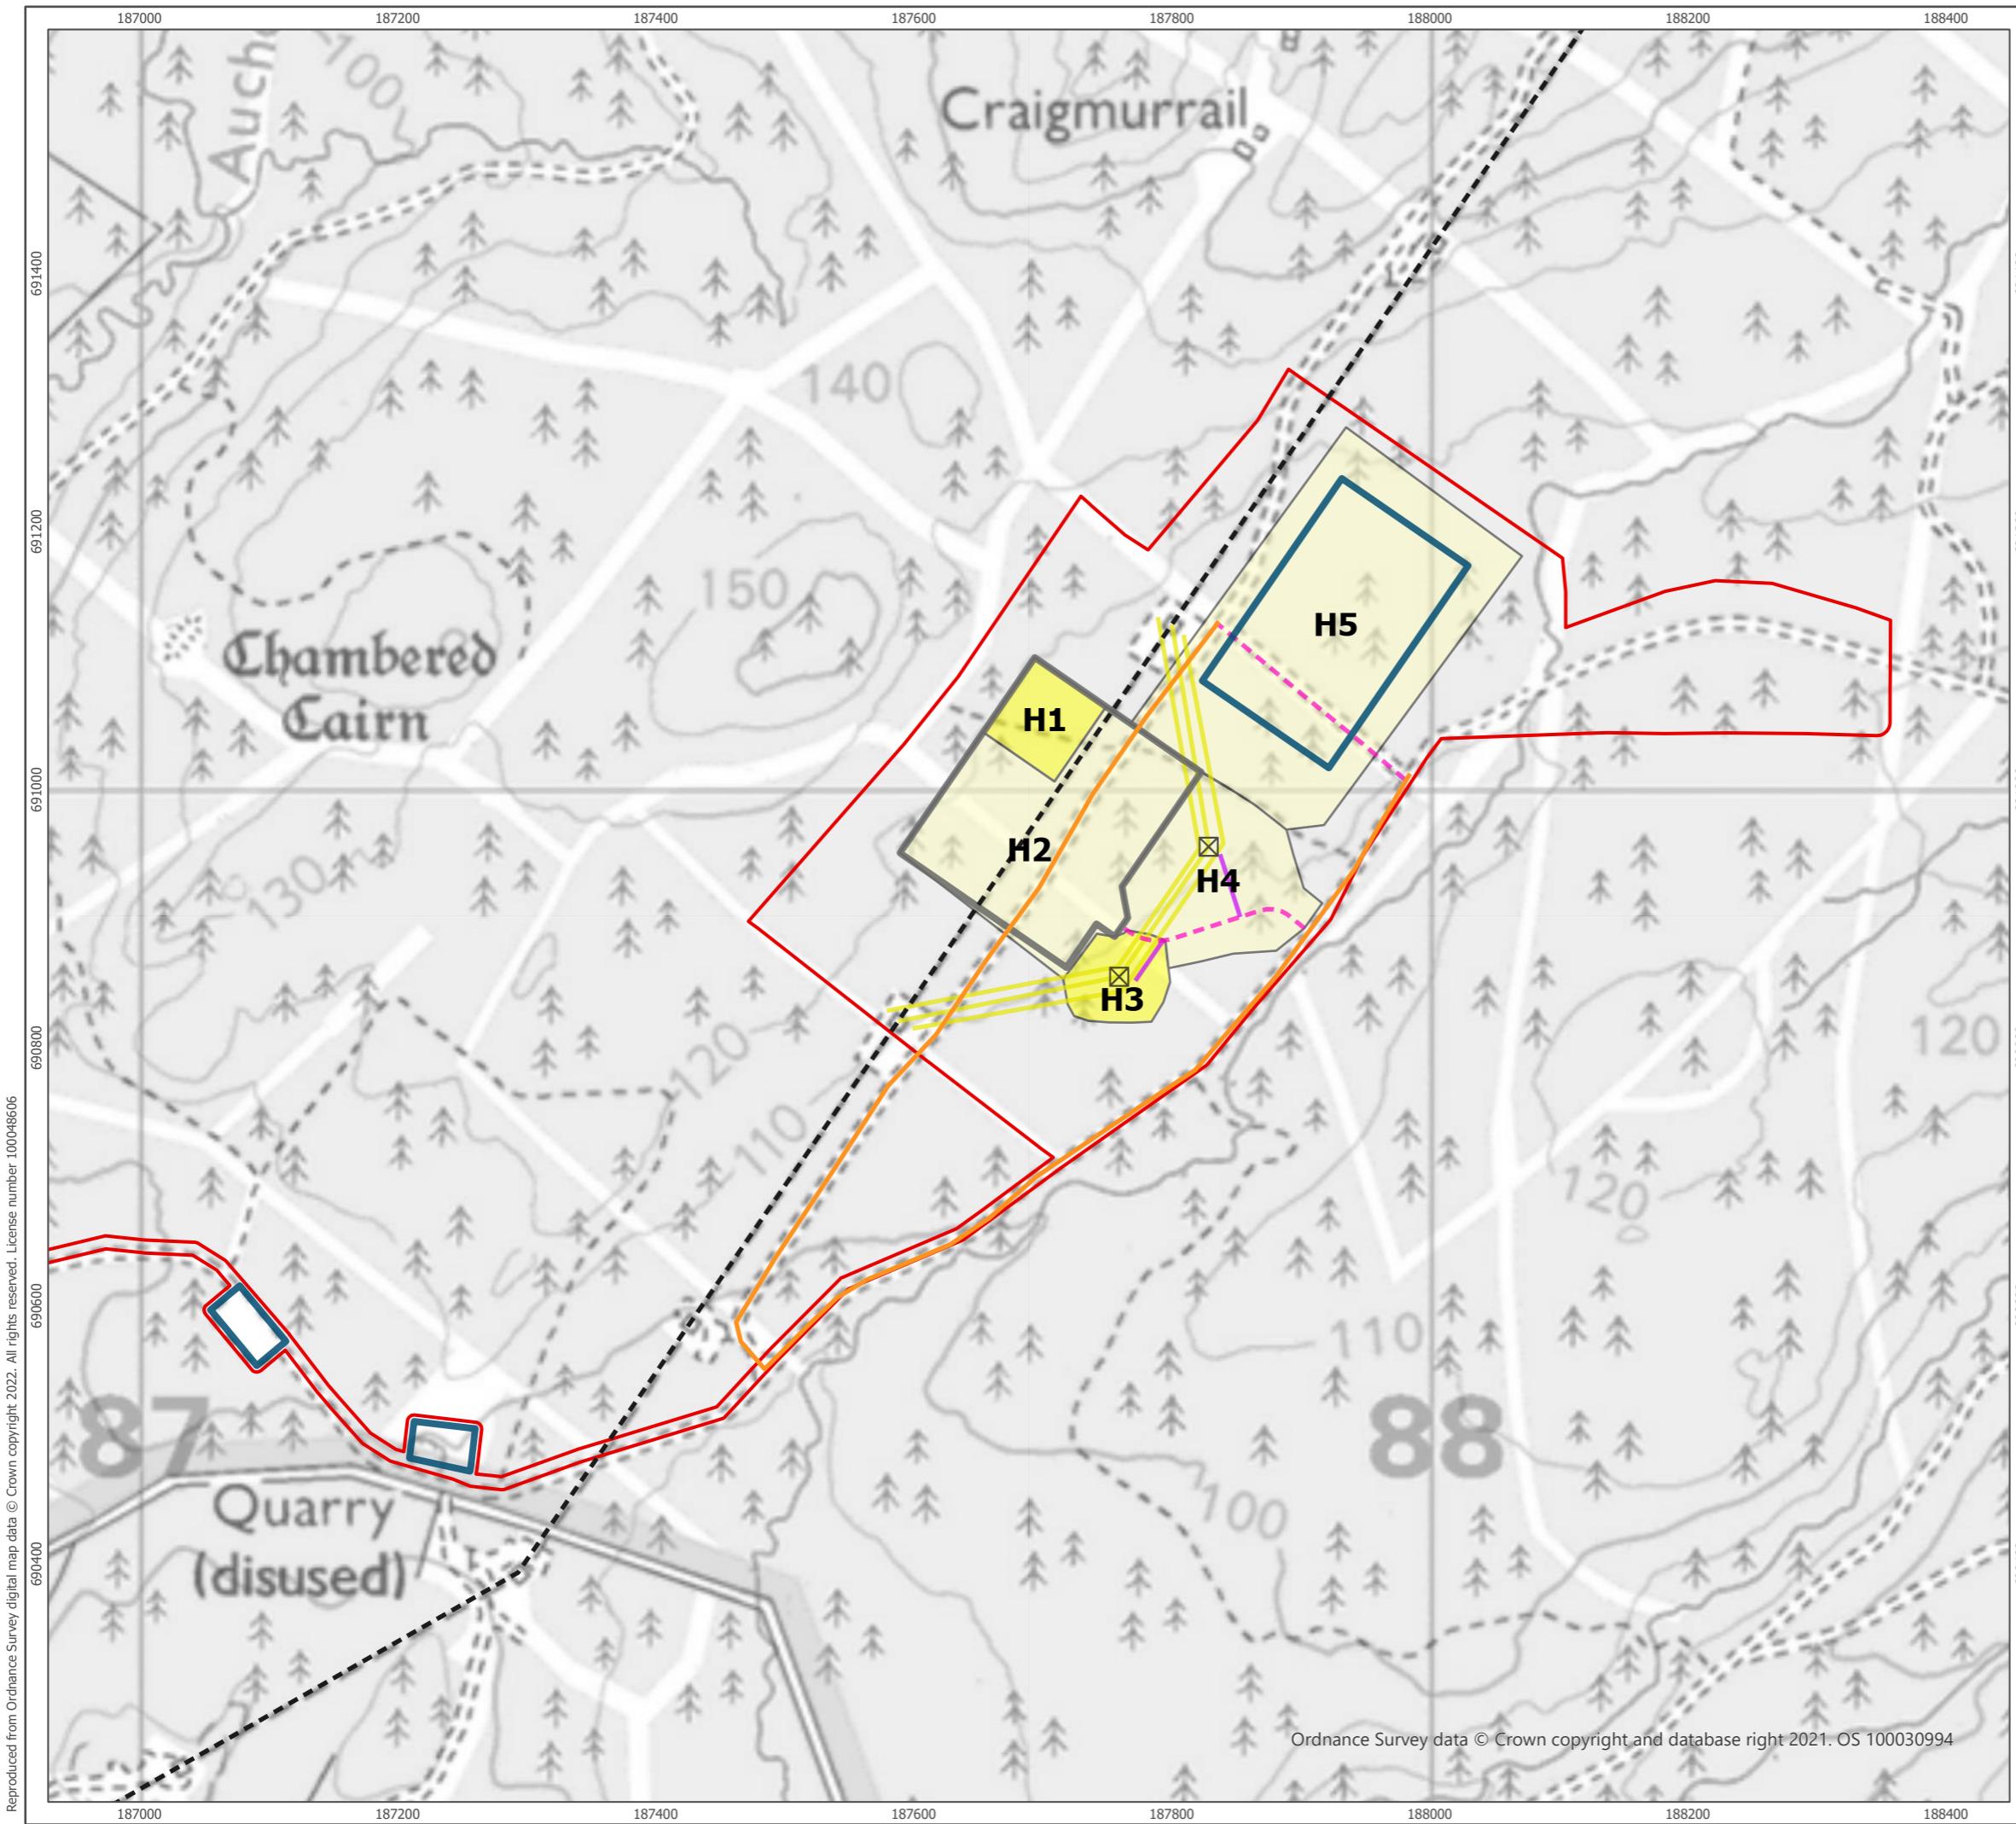
Hazard Rank Zonation Plan Figure 9

Receptor exposure was assessed for each of the five hazard zones using the approach in **Section 5**. A summary of the Hazard Ranking result for each identified area is summarised in **Table 14** and is presented in **Figure 9** - Hazard Ranking Zonation Plan. The zonation is based on a combination of considerations including calculated hazard result, peat depth, topography, receptors and land uses.

- Existing Access Tracks
- Existing Inveraray to Crossaig Overhead Line
- Proposed Development
 - Indicative Town and Country Planning Boundary
 - Proposed Substation Temporary Works Area
 - Proposed Substation Layout
 - Proposed Permanent Access Tracks
- Associated Development
 - Proposed Indicative Tower Location
 - New Temporary Tracks
 - Overhead Line
- Hazard Rank Zonation
 - Negligible
 - Low

The PLHRA has shown the Site to be of 'negligible' and 'low' hazard ranking with no areas of 'medium' or 'high' hazard ranking.

Of the 483 probe points, all were 'negligible' other than nine where 'low' hazard rankings were recorded. No 'medium' or 'high' risk areas have been identified within the Proposed Development or Associated Development and therefore a significant risk of peat slide is not considered to present based on the Hazard Ranking assessment. Nonetheless, a risk from peat slide may still exist and mitigation measures as outlined in **Section 7.3** of this PLHRA should be applied to minimise any risk.

| Hazard Area and Infrastructure | | Unmitigated Hazard | | Mitigated Hazard | |
|---|---|---|--|---|---|
| H1 | Proposed Substation | Low | Location and topography: Zone covering northern quarter of the proposed substation in the western Site area. Hydrology: No watercourses run through this hazard zone Peat Depth: 0.1 m - 2.5 m. Generally, <1.0 m Slope Gradient: 0° to <10° Exposure: Proposed infrastructure | Best practice measures in relation to drainage prior to and during construction will be implemented as outlined in Annex P: Water Construction Environmental Management Plan (WCEMP) and management of peat and peaty soils as outlined in Annex N: Peat Management Plan (PMP) . During construction visual inspections and monitoring in | Negligible |

| Hazard Area and Infrastructure | | Unmitigated Hazard | | Mitigated Hazard | |
|---|--|---|---|--|---|
| H2 | Proposed Substation | Negligible | <p>Location and topography: South western Site area covering remaining three quarters of the Proposed Substation area.</p> <p>Hydrology: No watercourses run through this hazard zone</p> <p>Peat Depth: 0.0 m – 3.1 m. Generally, <2.00 m</p> <p>Slope Gradient: 0° to <30°</p> <p>Exposure: Proposed infrastructure</p> | <p>Best practice measures in relation to drainage prior to and during construction will be implemented as outlined in Annex N: WCEMP and management of peat and peaty soils as outlined in Annex O: PMP.</p> | Negligible |
| H3 | Proposed Temporary Access Track, Pylon 2 | Low | <p>Location and topography: Flat area covering the southern sector of the Site</p> <p>Hydrology: No watercourses run through this hazard zone</p> <p>Peat Depth: 1.80 m – 3.50 m. Generally, <3.00 m</p> <p>Slope Gradient: 0° to <5°</p> <p>Exposure: Proposed infrastructure</p> | <p>Best practice measures in relation to drainage prior to and during construction will be implemented as outlined in Annex O: WCEMP and management of peat and peaty soils as outlined in Annex N: PMP.</p> <p>During construction visual inspections and monitoring in areas with the potential for peat slide risk should take place.</p> | Negligible |

| Hazard Area and Infrastructure | | Unmitigated Hazard | | Mitigated Hazard | |
|---|---|---|---|--|---|
| H5 | Proposed Temporary Works Area and Temporary Track | Negligible | <p>Location and topography: Large area covering the north eastern sector of the Site</p> <p>Hydrology: No watercourses run through this hazard zone</p> <p>Peat Depth: 0.1 m – 4.5 m. Generally, <1.50 m</p> <p>Slope Gradient: 0° to <15°</p> <p>Exposure: Proposed infrastructure</p> | <p>Best practice measures in relation to drainage prior to and during construction will be implemented as outlined in Annex O: WCEMP and management of peat and peaty soils as outlined in Annex N: PMP.</p> | Negligible |

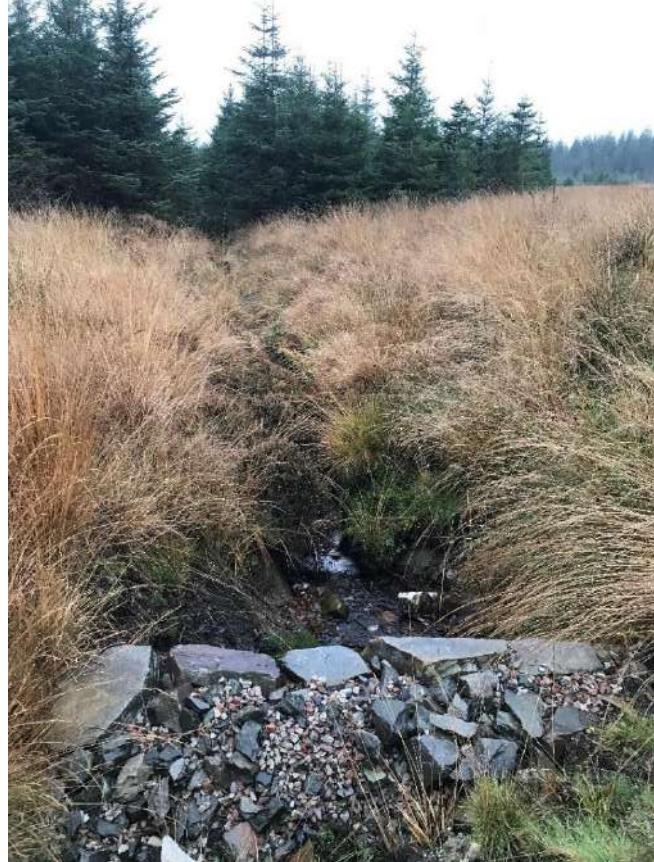
Photograph 5 – Culvert over drainage ditch in central Site area

There are a number of drainage channels associated with the forestry plantation at the Site, including a surface water feature which passes through a culvert beneath a track which dissects the Site from north east to south west; however, there are no recorded watercourses or lochs present within the Site boundary.
