Technical Appendix 9.1: Peat Landslide Hazard Risk Assessment

Glendye Wind Farm Overhead Line Grid Connection

Scottish & Southern Electricity Networks (SSEN) Transmission

19 September 2025

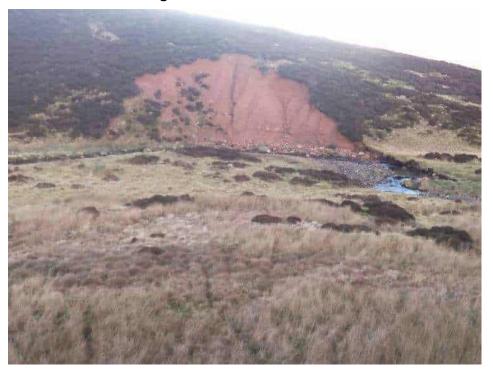
Gulley erosion of mineral soils was noted along watercourses to the south of the Proposed Development. Photo 1, below, details mineral soil erosion located south of Pole 183 at Tough's Market. The instability was likely caused by progressive weathering and erosion of natural fractures within the superficial soils. No peat was observed where gulley erosion along watercourses was observed, only granular superficial soils were noted. The instability has no influence on the Proposed Development but is highlighted as part of the desk based review.

Photo 1: Mineral soil gulley erosion at Tough's Market. Taken from NGR: NO 61357 80192 facing north.

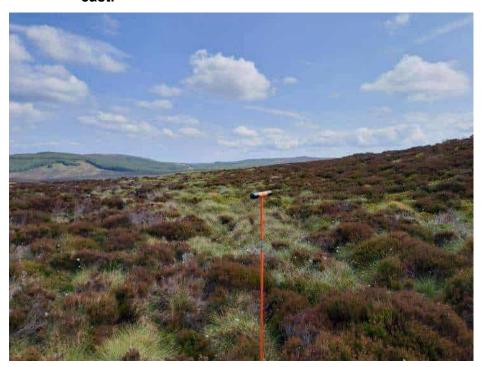
Photo 2: Undulating hillside and forestry to the east of the Proposed Development.

Photo taken from National Grid Reference (NGR): NO 64958 81559 looking east.

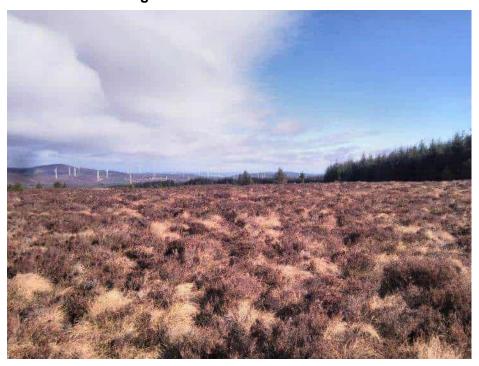
Photo 3: Extensive planation forestry to east of Goyle Hill. Photo taken from NGR: NO 68343 81996 looking north-east.

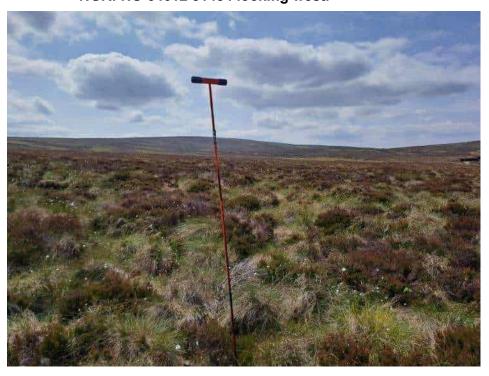
Photo 4: Deep peat of >3 m present within flatter expanse at Pole 149. Taken from NGR: NO 64612 81484 looking west.

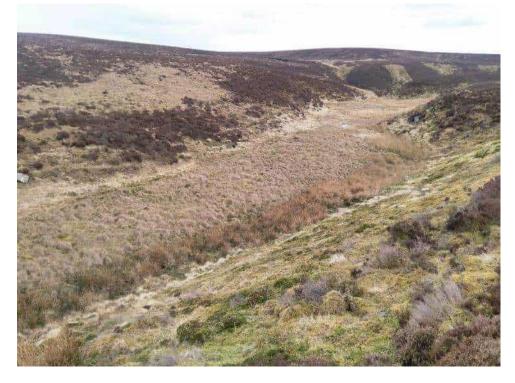
Photo 5: Peat constrained to hollow east of Pole 133. Taken from NGR: NO 66413 81593 looking east.

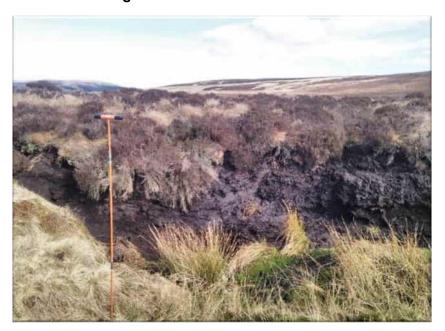
gulleys (as shown below in **Photo 6**). Peat haggs up to 3 m in height were observed with bare substrate at the bases. The central areas of the Proposed Development (east of the B974) also featured extensive erosional features, particularly to the south-west of Goyle Hill where peat haggs at around 1.5 m were recorded. In addition, there are some areas of peatland which have been heavily influenced by wind erosion across higher elevations to the north-west of the Proposed Development at Rough Bank (located within Glendye Wind Farm to the north-west of the Proposed Development). No areas of instability were noted in relation to any erosional features across the Proposed Development.

Photo 6: Peat haggs to the north of Pole 154. Taken from NGR: NO 64239 81218 looking east.

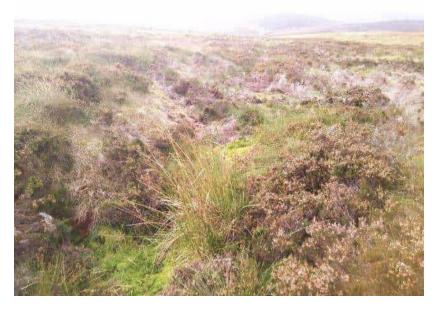
The west of the Proposed Development is extensively drained with dendritic drainage observed trending predominantly east to west, following hill contour orientations. Drainage ditches were recorded up to 1.2 m deep and 1 m wide, with some drainage being blocked with vegetation (see **Photo 7**, below).

Photo 7: Blocked artificial drainage ditch near of Pole 165. Taken from NGR: NO 63265 80773 looking west.

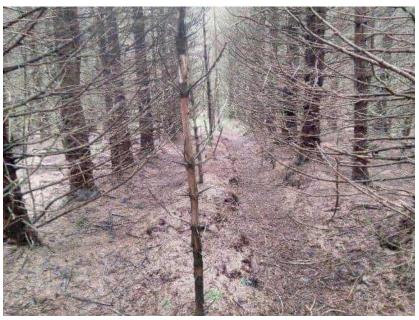
Photo 8: Extensive artificial drainage furrows within Drumtochty Forest. Photo taken from NGR: NO 69039 82075 looking north.

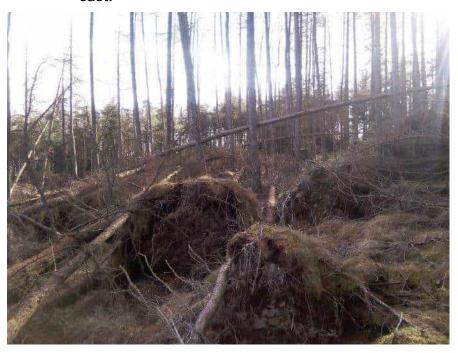
Photo 9: Windblown planation forestry to the south of Bowman's Leap, highlighting shallow mineral soil. Photo taken from NGR: NO 70225 81959 looking northeast.

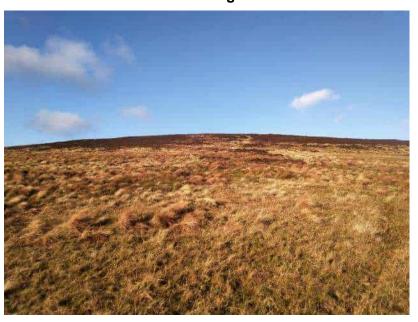
Photo 10: Moderately sloped hillside, looking uphill at Rough Bank. Taken from NGR: NO 60817 80430 facing north-west.

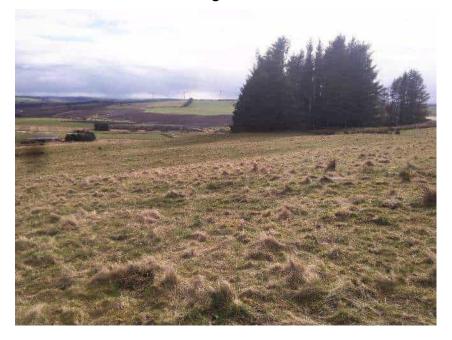
Photo 11: Overview of various agricultural land uses, rough grazing, pasture and crop farming. Looking downhill at the Brae of Glenbervie Taken from NGR: NO 76662 85181 facing south.

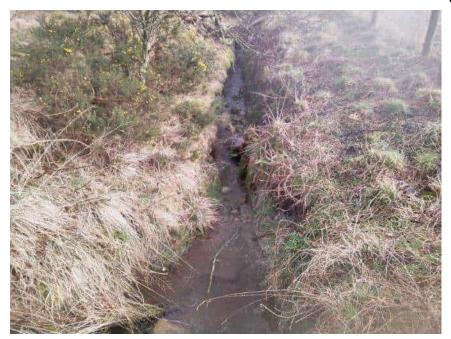
Photo 12: Field drainage associated with improved pasture. Looking east near Brawliemuir. Taken from NGR: NO 75286 83893 facing south.
