# Glendye Wind Farm Overhead Line Grid Connection

## Appendix 9.3 – Peatland Condition Assessment

### SSEN Transmission & ASH Design + Assessment

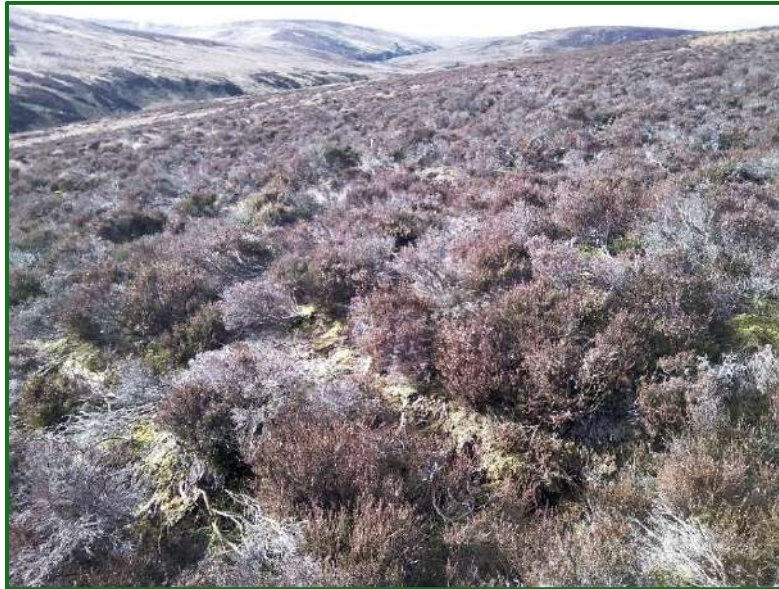
**Photo 4: Example of dominant heather and ericaceous shrub cover with evidence of burning damage to underlying peat, found across the western extent of the Proposed Development.**

Overall, the presence of heather is considered a negative indicator within peat/heath habitat present on the Proposed Development, indicating loss of peatland function and replacement of peat forming species such as *sphagnum spp.*; however the length and maturity of heather growth indicates some areas are subject to lesser amount of grazing due to deer fencing.

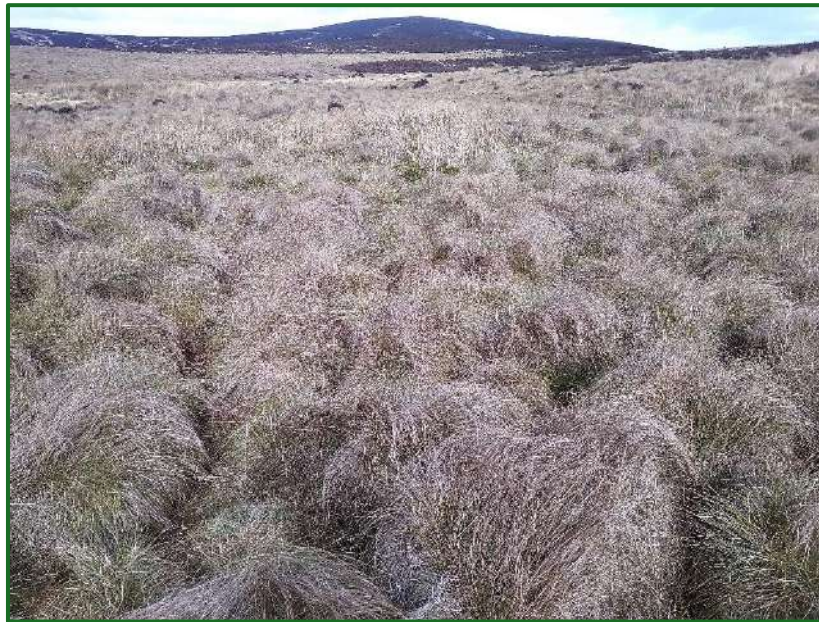
**Photo 5: Example of other cover species, *Juncus sp.* from western extent of the Proposed Development.**

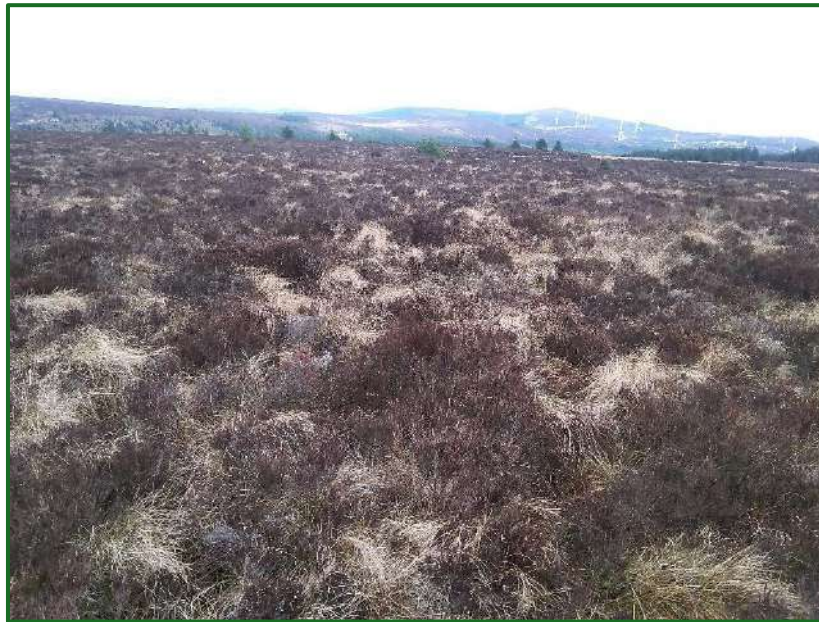
**Photo 6: Conifer colonisation in background of image, location in the central extent of the Proposed Development adjacent to Goyle Hill.**
