# **Volume 5: Appendix 13.1 - Watercourse Crossing and Buffers Assessment**

**February 2026 – Additional Information**

- 1.1.1 This appendix details the assessment undertaken to identify and describe all new and existing watercourse crossings that will be required during the construction of the Kintore to Tealing 400 kV OHL and associated infrastructure (the 'Proposed Development') as described in **Volume 1, Chapter 3: Project Description**. This document should be read in conjunction with **Volume 1, Chapter 3: Project Description** and **Volume 2, Chapter 13: Hydrology, Hydrogeology, Geology and Soils** of the Kintore to Tealing 400 kV OHL Environmental Impact Assessment Report (EIAR).

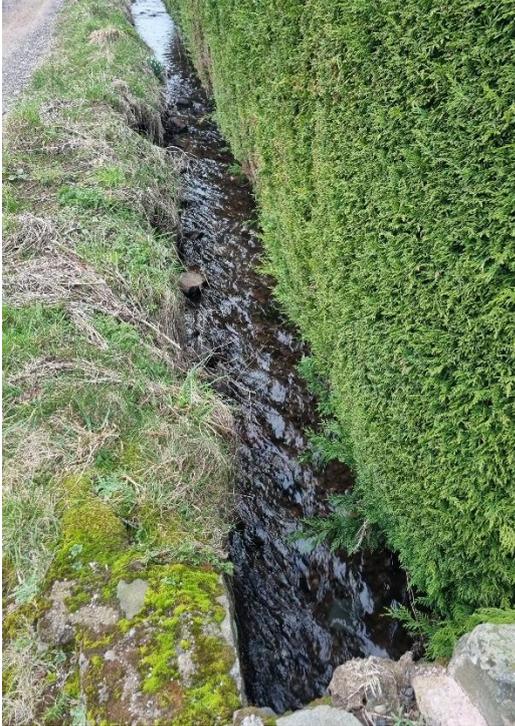
ID – 2 (Existing track crossing)	Unnamed tributary of Tealing Burn
<p><u>Description:</u> Unnamed Tributary of the Tealing Burn flows east in straightened channel adjacent to road and then flows beneath public road in stone arch bridge, which will be used for construction.</p>	
NGR Ref: 339493 738693	
<p>Photo –Unnamed Tributary in straightened channel looking west upstream</p>

Width of watercourse (m)	1.1 m
Bed Sediment	Mix of silt and cobble
Bank Erosion	No
Natural Channel	No
Existing Crossing	Existing bridge with stone arch culvert of unknown dimensions
Proposed Crossing	No upgrade. If engineering assessment determines the crossing to be structurally unsound, a temporary over-bridging solution will be put in place during construction.
Additional Mitigation	None
Catchment (km <sup>2</sup> )	0.43 km <sup>2</sup>
Minor Watercourse	Yes
Main river catchment	Dighty Water
Within catchment of SAC designated river	No

CAR Authorisation Required	No

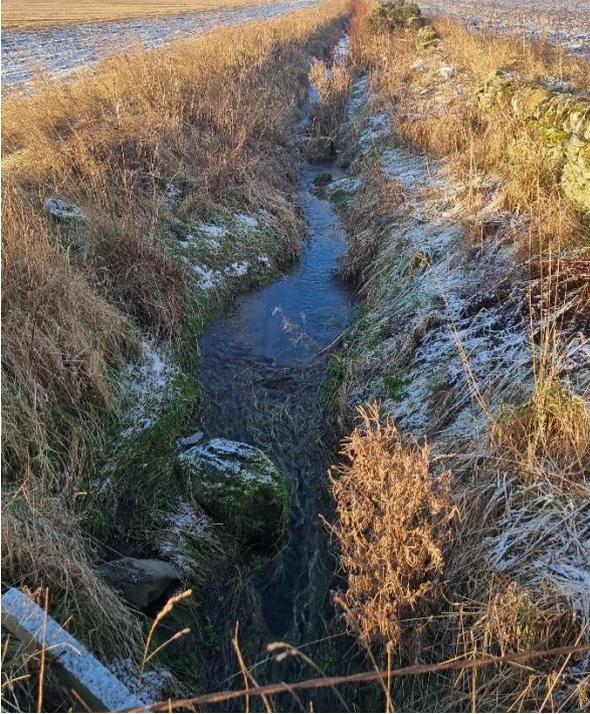
ID – 3 (Existing track crossing)	Unnamed tributary of Tealing Burn
<b>Description:</b> Open straightened channel flows to the east and is culverted beneath existing crossing in a stone box culvert 1m wide.	
NGR Ref: 340188 738640	
Photo – Unnamed Tributary looking west, upstream

Width of watercourse (m)	1.2 m
Bed Sediment	Mix of silt and pebble
Bank Erosion	No
Natural Channel	No
Existing Crossing	Existing bridge with stone box culvert of unknown dimensions
Proposed Crossing	No upgrade. If engineering assessment determines the crossing to be structurally unsound, a temporary over-bridging solution will be put in place during construction.
Additional Mitigation	None
Catchment (km <sup>2</sup> )	0.82 km <sup>2</sup>
Minor Watercourse	No
Main river catchment	Dighty Water
Within catchment of SAC designated river	No
CAR Authorisation Required	No

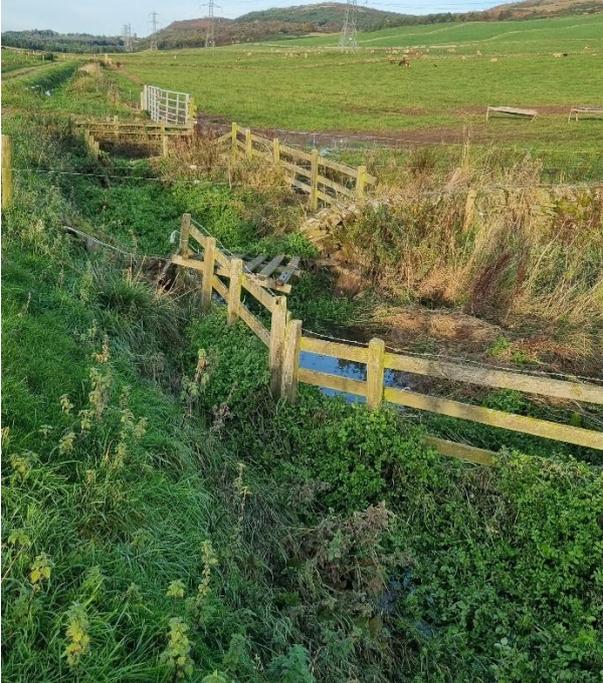
ID – 7 (Proposed track crossing – temporary)	Unnamed tributary of Tealing Burn/ Fithie Burn
<u>Description:</u> Unnamed tributary is heavily modified as straightened here as it flows through vegetated channel to the east.	
NGR Ref: 338208 738852	
Photo – Unnamed tributary looking upstream to the west

Width of watercourse (m)	1.5 m
Bed Sediment	Mix of silt and pebble
Bank Erosion	No
Natural Channel	No
Existing Crossing	None
Proposed Crossing	Single Span Bridge (temporary). The crossing location is rural and a temporary crossing sized to the 1 in 30 year flow is considered suitable for the location, size of watercourse and temporary nature of the track crossing. Designing for a 1 in 200 year flow (plus climate change) could result in oversizing the bridge, requiring widening of the channel at the crossing and the need for raised embankments, which is not appropriate for a temporary crossing in a rural setting. The proposed design will allow the crossing to be removed at the end of the construction period with no legacy effect on the existing channel. In the event of a higher flood event occurring when the temporary crossing is in place, water would overtop the track and return back into the channel downstream of the track. There are no nearby receptors and there is considered to be no increased flood risk to others.

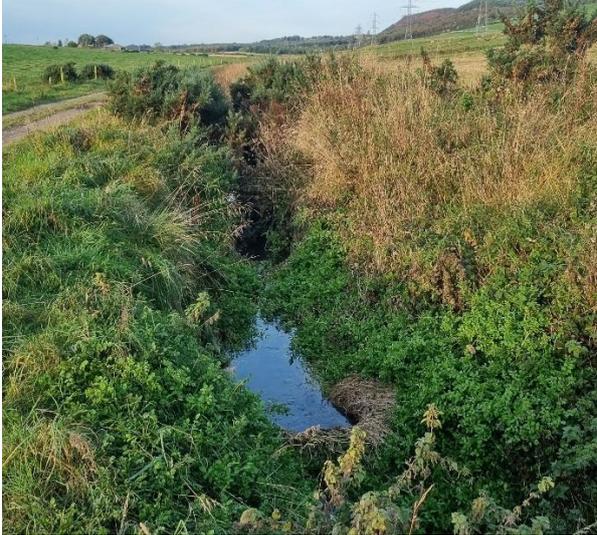
ID – 8 (Existing track crossing)	Unnamed tributary of Tealing Burn/ Fithie Burn
<u>Description:</u> Unnamed tributary is heavily modified as straightened here as it flows through vegetated channel to the east.	
NGR Ref: 338367 738865	
Photo – Unnamed tributary looking downstream

Width of watercourse (m)	1.4 m
Bed Sediment	Mix of silt and pebble
Bank Erosion	No
Natural Channel	No
Existing Crossing	Existing crossing with stone box culvert of unknown dimensions
Proposed Crossing	No upgrade. If engineering assessment determines the crossing to be structurally unsound, a temporary over-bridging solution will be put in place during construction.
Additional Mitigation	None
Catchment (km <sup>2</sup> )	1.15 km <sup>2</sup>
Minor Watercourse	Yes
Main river catchment	Dighty Water
Within catchment of SAC designated river	No
CAR Authorisation Required	No

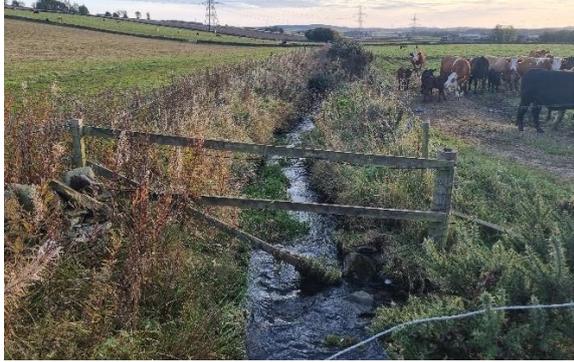
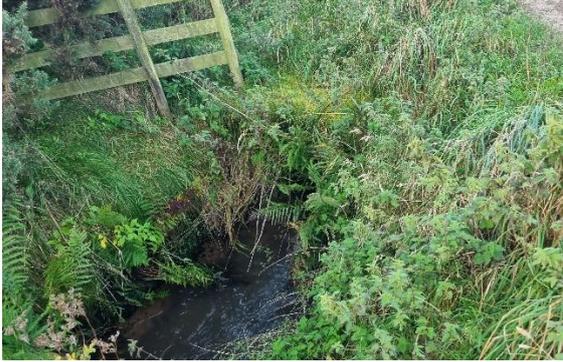
ID – 9 (Existing track crossing)	Unnamed tributary of Tealing Burn/ Fithie Burn
<u>Description:</u> At the crossing location, the watercourse is crossed by an existing farm access track.	
NGR Ref: 338463 738881	
Photo – Unnamed tributary looking downstream	Photo – Unnamed tributary looking upstream at crossing

Width of watercourse (m)	1.5 m
Bed Sediment	Mix of silt and pebble
Bank Erosion	No
Natural Channel	No
Existing Crossing	Existing crossing with stone box culvert of unknown dimensions
Proposed Crossing	No upgrade. If engineering assessment determines the crossing to be structurally unsound, a temporary over-bridging solution will be put in place during construction.
Additional Mitigation	None
Catchment (km <sup>2</sup> )	1.24 km <sup>2</sup>
Minor Watercourse	Yes
Main river catchment	Dighty Water
Within catchment of SAC designated river	No
CAR Authorisation Required	No

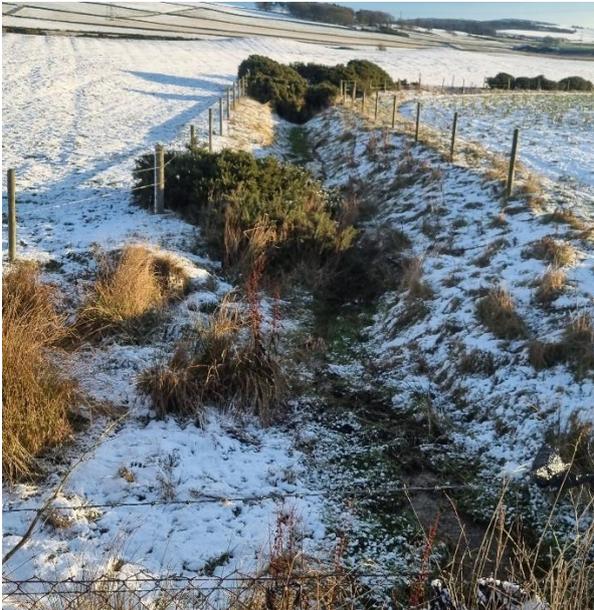
ID – 10 (Existing track crossing)	Unnamed tributary of Tealing Burn
<p><b>Description:</b> Minor watercourse tributary flows east beneath track, vegetated upstream of crossing and less defined, whereas downstream of crossing channel is more open, defined and less vegetated, with steeper and larger banks.</p>	
<p>NGR Ref: 339753 739590</p>	
<p>Photo – Watercourse looking downstream</p>

<p>Width of watercourse (m)</p>	<p>0.5 m</p>
<p>Bed Sediment</p>	<p>Mix of silt and pebble</p>
<p>Bank Erosion</p>	<p>No</p>
<p>Natural Channel</p>	<p>No</p>
<p>Existing Crossing</p>	<p>Existing crossing with stone box culvert of unknown dimensions</p>
<p>Proposed Crossing</p>	<p>No upgrade. If engineering assessment determines the crossing to be structurally unsound, a temporary over-bridging solution will be put in place during construction.</p>
<p>Additional Mitigation</p>	<p>None</p>

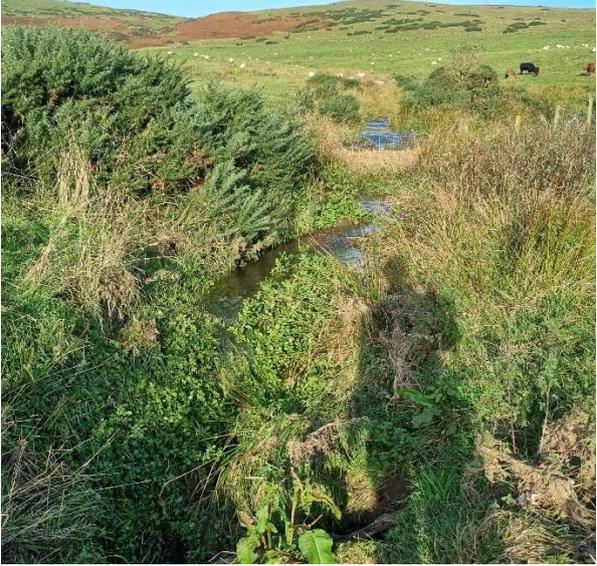
ID – 11 (Existing track crossing)	Tealing Burn
<p><b>Description:</b> Tealing Burn flows to the southeast in fluctuating channel, moving between wider sediment deposition zones and narrower vegetated channel sections. The watercourse is culverted beneath the existing track in a 450 mm arch pipe, watercourse is heavily modified.</p>	
<p>NGR Ref: 339605 740020</p>	
<p>Photo – Tealing Burn</p>

<p>Width of watercourse (m)</p>	<p>2.0 m</p>
<p>Bed Sediment</p>	<p>Silt to Cobble</p>
<p>Bank Erosion</p>	<p>No</p>
<p>Natural Channel</p>	<p>Yes - but heavily modified</p>
<p>Existing Crossing</p>	<p>Existing crossing with broken 450 mm pipe</p>
<p>Proposed Crossing</p>	<p>No upgrade. If engineering assessment determines the crossing to be structurally unsound, a temporary over-bridging solution will be put in place during construction.</p>

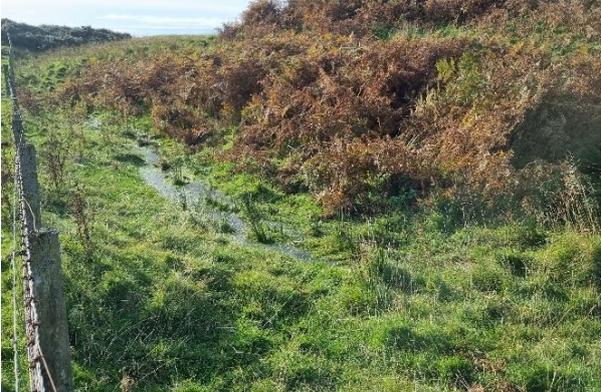
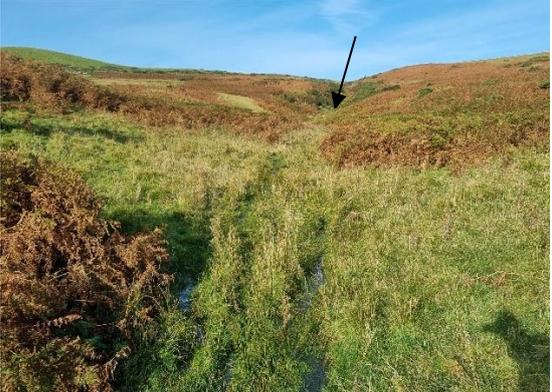
ID – 12 (Proposed track crossing - permanent)	Unnamed Watercourse
<p><b>Watercourse Description:</b> The small watercourse is an upstream tributary of the Tealing Burn. It flows southeast within a ~140 m long culvert under a field at the proposed access track crossing location. The watercourse was dry at the time of the site visit, the culverted section was not visible and the culvert size is unknown. The watercourse is natural and open further upstream then heavily modified and straightened/culverted through grazing land. Approximately 25 m downstream of the track crossing location, the watercourse emerges from the culvert and becomes an open channel again. The proposed new stone permanent track would cross the culverted section of the watercourse at ID12.</p> <p>An alternative crossing location ~200 m upstream of ID12 in the open section of the channel, where the channel is confined in a small valley (as shown on the second photo and in <b>Volume 3, Figure 13.2.1: Hydrology, Flood Risk and Buffers</b>) is proposed as an alternative. The Applicant is currently in discussion with the landowner and, if secured, the upstream crossing is the preferred access which will be taken forward and will require a new single span bridge.</p>

NGR Ref: 339189 740147	
Photo – natural upstream section of watercourse looking downstream	Photo – looking upstream (the arrow shows the approximate location of the alternative crossing location in the open part of the channel)

Width of watercourse/ drain (m)	Estimated ~ 0.6 m
Bed Sediment	Vegetated Channel (upstream). The small watercourse is culverted at crossing location ID12.
Bank Erosion	No
Natural Channel	No – the small channel is within a culvert under the field at the proposed track location. The watercourse is natural ~200 m upstream in the open section at the alternative crossing location (second photo)
Existing Crossing	None – The small watercourse is culverted under the field.
Proposed Crossing	<p>It is not proposed to upgrade to the underground culverted section of the watercourse. However, an engineering assessment of the hydrology/hydraulics and structure of the culverted section of the watercourse will be carried by the Contractor in advance of construction to assess, design and manage the suitability of crossing location ID12. The alternative crossing location (~200 m upstream in the open part of the watercourse) may be considered instead, following the engineering assessment and is currently the preferred option for the permanent track crossing, if landowner permissions can be secured.</p> <p>If the culvert were to block, there is a risk of localised flooding to the proposed permanent track crossing at ID12. If the culvert were to block or not be able to pass flood flows, flood water would flow overland across the new track following the topography and then continue back into the open channel downstream. The crossing location is in the upper reaches of the burn and the contributing catchment is small (0.2 km<sup>2</sup>) so flood flows</p>

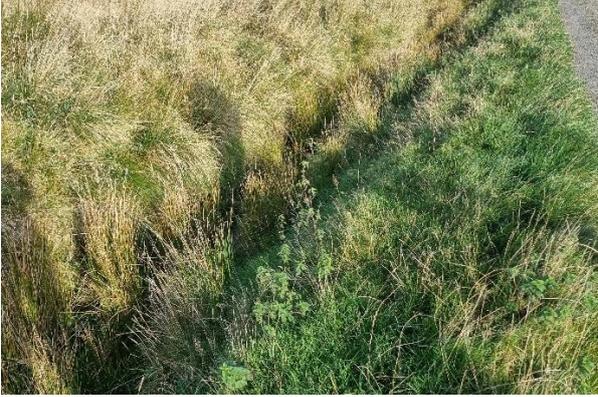
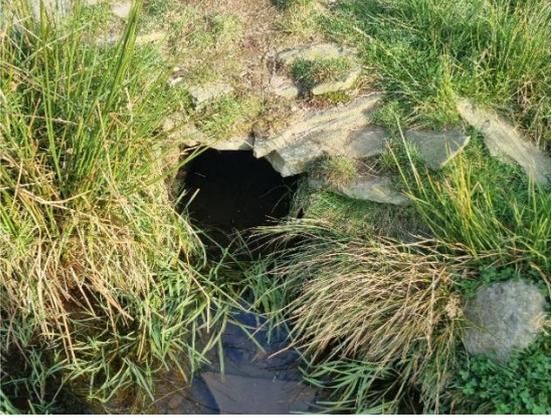
ID – 13 (Proposed track crossing - permanent)	Unnamed Drain
<u>Watercourse Description:</u> Small unnamed drain flowing south adjacent to the main access road. Proposed access crosses drain at the location of a poor quality, stone box culvert.	
NGR Ref: 339501 740317	
Photo – drain looking upstream adjacent to road	Photo – stone box culvert at proposed crossing location

Width of watercourse/ drain (m)	~ 0.5 m
Bed Sediment	Mixed sediment
Bank Erosion	No
Natural Channel	No
Existing Crossing	Existing crossing of the drain using a stone box culvert
Proposed Crossing	Pipe Culvert or Single Span Bridge (permanent)
Additional Mitigation	None
Catchment (km <sup>2</sup> )	0.1 km <sup>2</sup>
Minor Watercourse	Yes
Main river catchment	Dighty Water
Within catchment of SAC designated river	No
CAR Authorisation Required	No

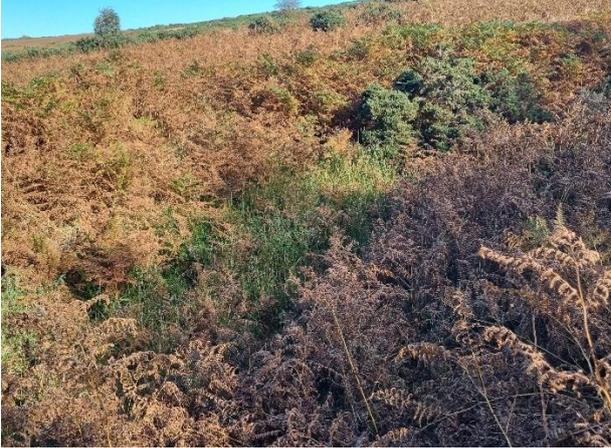
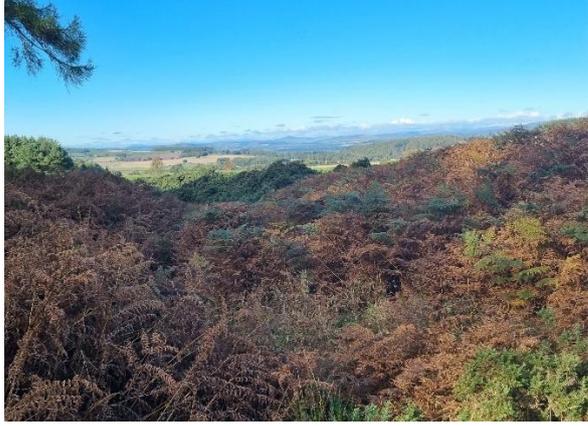
ID – 14 (Proposed track crossing - permanent)	Unnamed Spring fed watercourse
<p><u>Watercourse Description:</u> Small unnamed watercourse tributary to Glen Ogilvie Burn. Watercourse flows downhill to the west and is fed by two springs upslope of the proposed crossing. The watercourse channel is heavily vegetated.</p>	
NGR Ref: 340669 744061	
Photo – Upstream of proposed crossing location, looking upstream	Photo - Looking downstream to crossing location

Width of watercourse/ drain (m)	~ 0.6 m
Bed Sediment	Mixed, heavily vegetated
Bank Erosion	No
Natural Channel	Yes
Existing Crossing	None
Proposed Crossing	Pipe Culvert or Single Span Bridge (permanent)
Additional Mitigation	None
Catchment (km <sup>2</sup> )	0.52 km <sup>2</sup>
Minor Watercourse	No
Main river catchment	Dean Water
Within catchment of SAC designated river	Yes (River Tay SAC)
CAR Authorisation Required	Yes – GBR or Registration

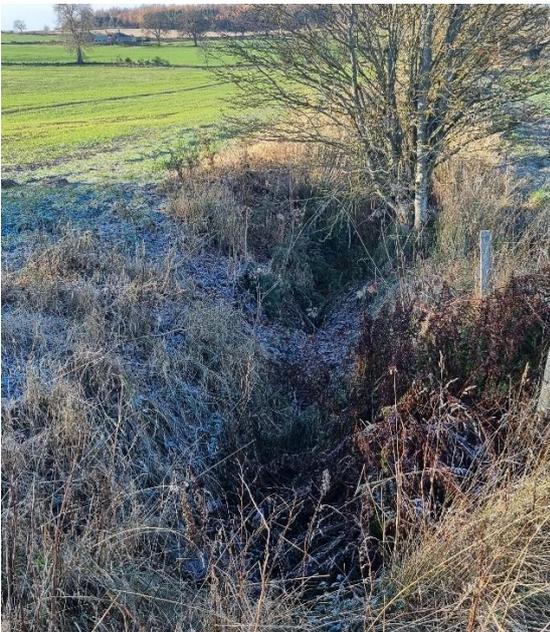
ID – 15 (Proposed track crossing - temporary)	Unnamed drain
<p><u>Watercourse Description:</u> Drain flowing south but was fairly dry when viewed. Drain is vegetated but well-defined in places, there appears to have been construction nearby with a gravel mound which had spilled into part of the drain.</p>	
<p>NGR Ref: 340837 746504</p>	
<p>Photo – Drain viewed looking upstream</p>

<p>Width of watercourse/ drain (m)</p>	<p>0.9 m</p>
<p>Bed Sediment</p>	<p>Pebble cobble</p>
<p>Bank Erosion</p>	<p>No</p>
<p>Natural Channel</p>	<p>No</p>
<p>Existing Crossing</p>	<p>None</p>
<p>Proposed Crossing</p>	<p>Pipe Culvert or Single Span Bridge (temporary). The crossing location is rural and a temporary crossing sized to the 1 in 30 year flow is considered suitable for the location, size of watercourse and temporary nature of the track crossing. Designing for a 1 in 200 year flow (plus climate change) could result in oversizing the crossing, requiring widening of the channel at the crossing and the need for raised embankments, which is not appropriate for a temporary crossing in a rural setting. The proposed design will allow the crossing to be removed at the end of the construction period with no legacy effect on the existing channel.</p> <p>In the event of a higher flood event occurring when the temporary crossing is in place, water would overtop the track and return back into the channel downstream of the track. There are no nearby receptors and there is considered to be no increased flood risk to others.</p>

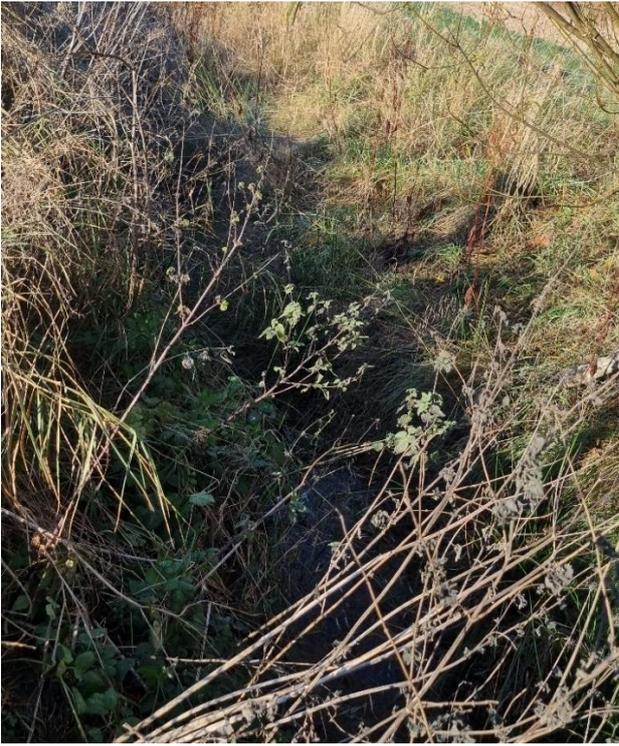
<b>ID – 16</b> <b>(Proposed track crossing - temporary)</b>	<b>Unnamed Drain</b>
<u>Watercourse Description:</u> Unnamed drain flows east towards the Kerbet Water. Channel is wide, deep and well defined, with a large volume of stagnant water, with minimal flow.	
NGR Ref: 341030 746911	
Photo – Drain viewed looking upstream to the west

Width of watercourse/ drain (m)	0.9 m
Bed Sediment	Pebble cobble
Bank Erosion	No
Natural Channel	No
Existing Crossing	None
Proposed Crossing	<p>Pipe Culvert or Single Span Bridge (temporary). The crossing location is rural and a temporary crossing sized to the 1 in 30 year flow is considered suitable for the location, size of drain and temporary nature of the track crossing. Designing for a 1 in 200 year flow (plus climate change) could result in oversizing the crossing, requiring widening of the channel at the crossing and the need for raised embankments, which is not appropriate for a temporary crossing in a rural setting. The proposed design will allow the crossing to be removed at the end of the construction period with no legacy effect on the existing channel.</p> <p>In the event of a higher flood event occurring when the temporary crossing is in place, water would overtop the track and return back into the channel downstream of the track. There are no nearby receptors and there is considered to be no increased flood risk to others.</p>

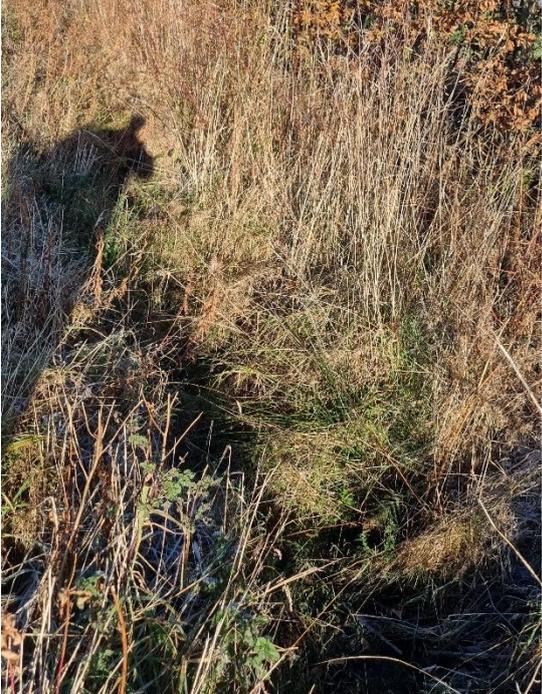
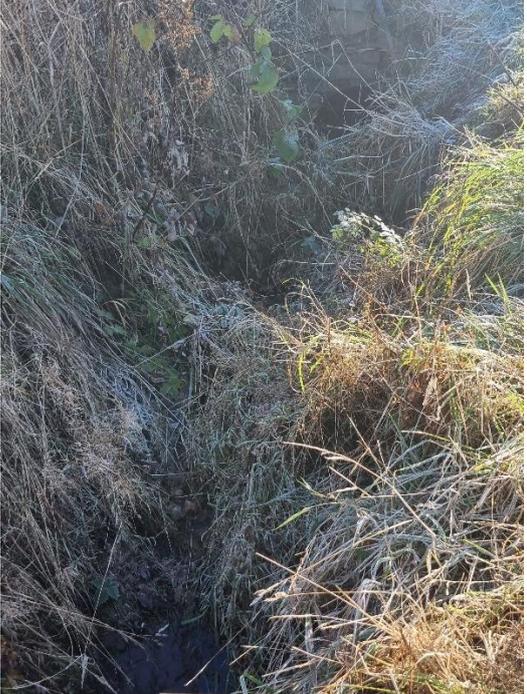
ID – 17 (Existing track crossing)	Unnamed Drain
<p><u>Watercourse Description:</u> Large unnamed drain with existing crossing for field access, drain is largely stagnant with minor flow direction to the north. There is an existing 500 mm culvert to provide farm access at the crossing location.</p>	
NGR Ref: 340989 747525	
Photo – Unnamed drain	Photo – Culvert visible, heavily vegetated channel

Width of watercourse/ drain (m)	0.9 m
Bed Sediment	Pebble, gravel
Bank Erosion	No
Natural Channel	No
Existing Crossing	Existing pipe culvert (500 mm)
Proposed Crossing	No upgrade. If engineering assessment determines the crossing to be structurally unsound, a temporary over-bridging solution will be put in place during construction.
Additional Mitigation	None
Catchment (km <sup>2</sup> )	0.16 km <sup>2</sup>
Minor Watercourse	Yes
Main river catchment	Dean Water
Within catchment of SAC designated river	Yes (River Tay SAC)

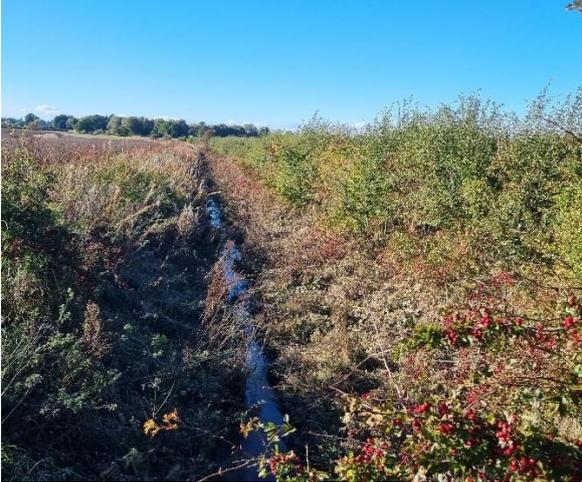
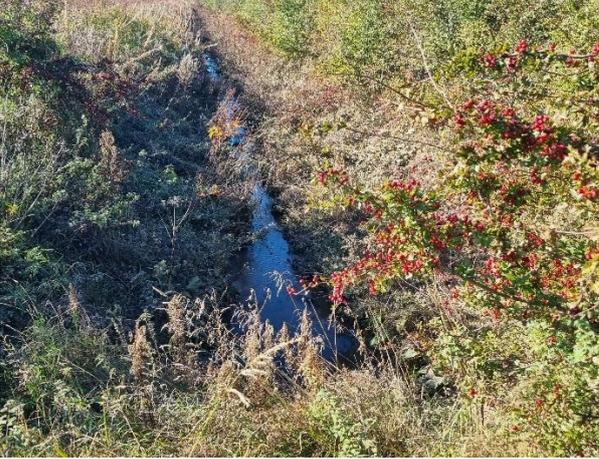
ID – 18 (Existing track crossing)	Unnamed drain tributary to Kerbet Water
<u>Watercourse Description:</u> Large unnamed drain tributary to Kerbet Water flows west. Channel is large and well defined. There is a 500 mm culvert at the existing crossing which provides farm track access across the drain.	
NGR Ref: 341050 748552	
Photo – Drain looking west downstream

Width of watercourse/ drain (m)	1.2 m
Bed Sediment	Gravel, pebble, Cobble
Bank Erosion	No
Natural Channel	No
Existing Crossing	Existing pipe culvert (500 mm)
Proposed Crossing	No upgrade. If engineering assessment determines the crossing to be structurally unsound, a temporary over-bridging solution will be put in place during construction.
Additional Mitigation	None
Catchment (km <sup>2</sup> )	0.65 km <sup>2</sup>
Minor Watercourse	No
Main river catchment	Dean Water
Within catchment of SAC designated river	Yes (River Tay SAC)
CAR Authorisation Required	No

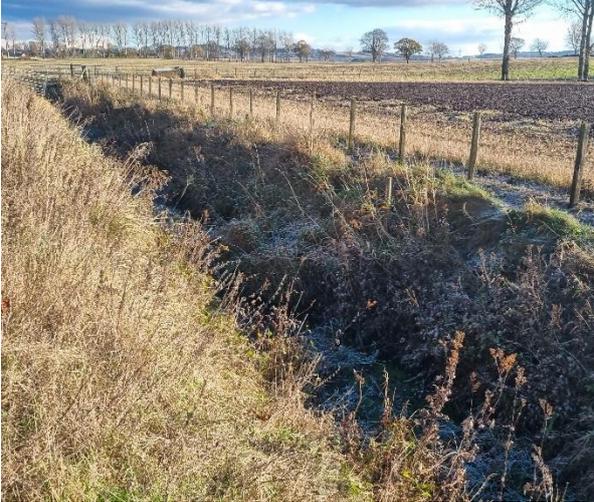
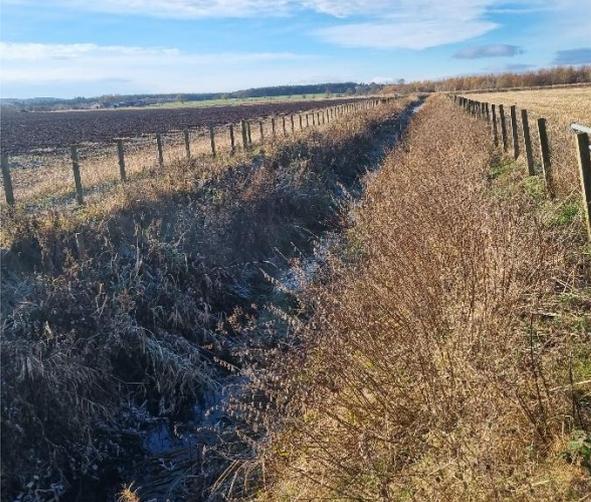
ID – 19 (Proposed track crossing - temporary)	Unnamed Drain
<u>Watercourse Description:</u> Large drain flows west to Gairie Burn and then Dean Water	
NGR Ref: 341045 750045	
Photo – Whiting Burn – upstream of proposed track crossing	Photo – Whiting Burn

Width of watercourse/ drain (m)	1.7 m
Bed Sediment	Silt
Bank Erosion	No
Natural Channel	No
Existing Crossing	None
Proposed Crossing	<p>Pipe Culvert or Single span bridge (temporary). The crossing location is rural and a temporary crossing sized to the 1 in 30 year flow is considered suitable for the location, size of drain and temporary nature of the track crossing. Designing for a 1 in 200 year flow (plus climate change) could result in oversizing the crossing, requiring widening of the channel at the crossing and the need for raised embankments, which is not appropriate for a temporary crossing in a rural setting. The proposed design will allow the crossing to be removed at the end of the construction period with no legacy effect on the existing channel.</p> <p>In the event of a higher flood event occurring when the temporary crossing is in place, water would overtop the track and return back into the channel downstream of the track. There are no nearby receptors and there is considered to be no increased flood risk to others.</p>

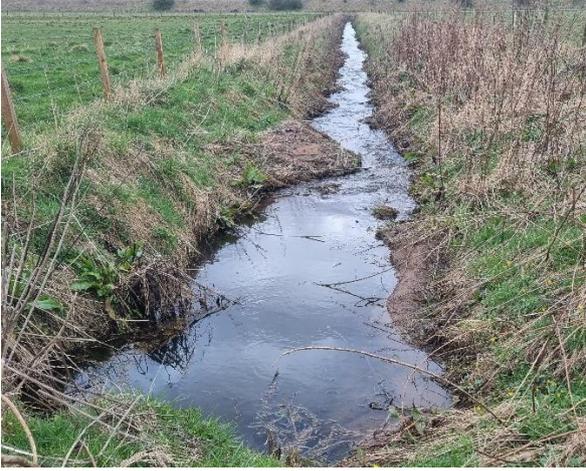
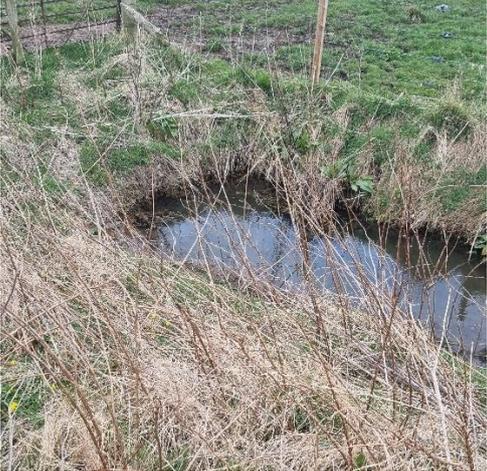
ID – 20 (Proposed track crossing - permanent)	Unnamed Drain
<p><b>Watercourse Description:</b> Proposed crossing in open field over a culverted section of drainage. Drain flows south. Proposed new track crossed over a culverted section of unknown width at time of writing, culvert links to drainage further northeast.</p>	
NGR Ref: 341006 750940	
Photo – Drain viewed looking downstream to the south	Photo – culvert outlet is hidden

Width of watercourse/ drain (m)	1.7 m
Bed Sediment	Silt gravel
Bank Erosion	No
Natural Channel	No
Existing Crossing	Existing culvert, dimensions and structure unknown
Proposed Crossing	No upgrade. If engineering assessment determines the crossing to be structurally unsound, a temporary over-bridging solution will be put in place during construction.
Additional Mitigation	None
Catchment (km <sup>2</sup> )	1.97 km <sup>2</sup>
Minor Watercourse	Yes
Main river catchment	Dean Water

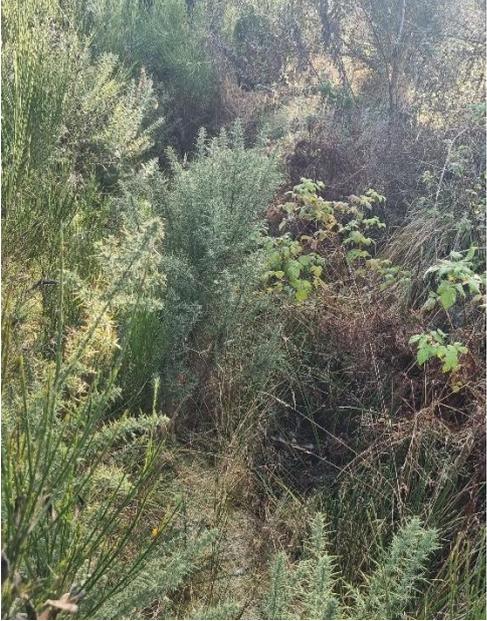
ID – 22 (Existing track crossing)	Unnamed drain
<p><u>Watercourse Description:</u> Unnamed drain flows south in well-defined but heavily vegetated channel, extensive coverage of gorse and other shrubs. There is an existing culvert, but culvert dimensions are unknown at the time of writing. The existing track crossing is in poor condition.</p>	
NGR Ref: 343524 754284	
Photo – Heavily vegetated channel viewed looking south

Width of watercourse/ drain (m)	1.0 m
Bed Sediment	Silt gravel
Bank Erosion	No
Natural Channel	No
Existing Crossing	Existing culvert, dimensions unknown
Proposed Crossing	No upgrade. If engineering assessment determines the crossing to be structurally unsound, a temporary over-bridging solution will be put in place during construction.
Additional Mitigation	None
Catchment (km <sup>2</sup> )	0.12 km <sup>2</sup>
Minor Watercourse	Yes
Main river catchment	River South Esk
Within catchment of SAC designated river	Yes (River Tay SAC)

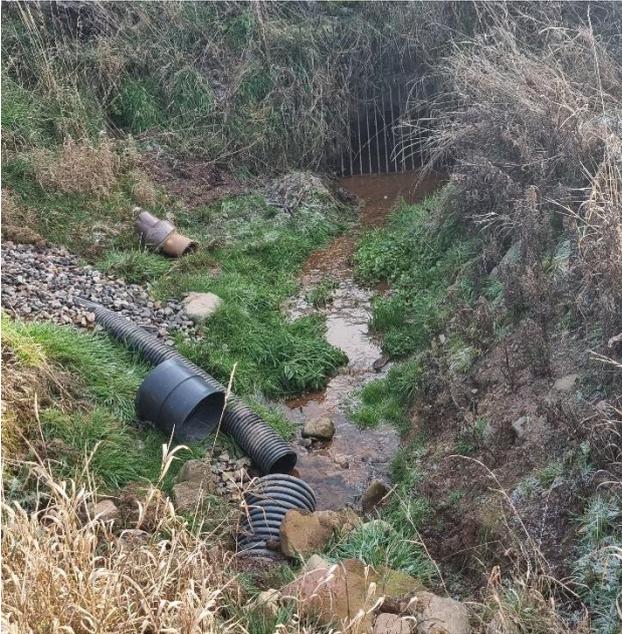
ID – 23 (Proposed track crossing - permanent)	Unnamed Field Drain
<p><b>Watercourse Description:</b> Proposed access track crosses over section of culverted drain, the outlet of which is a 300 mm pipe around 5 m from the proposed track. Although mapped, the drain is not visually obvious in the field at all and is entirely culverted through the field. The drain culvert outlet meets an adjacent open drain which also has a smaller 150 mm culverted field drain within the drainage ditch. These outlets are both drained through a grated culvert to the southeast.</p>	
NGR Ref: 343869 754254	
Photo – Unnamed Drain 300 mm culvert outlet and adjacent drain outlet, with grated culvert draining flows southeast

Width of watercourse/ drain (m)	Estimated ~ 0.5 m
Bed Sediment	Silt gravel pebble
Bank Erosion	No
Natural Channel	No
Existing Crossing	None - although existing field drainage culvert present.
Proposed Crossing	No upgrade. If engineering assessment determines the crossing to be structurally unsound, a temporary over-bridging solution will be put in place during construction.

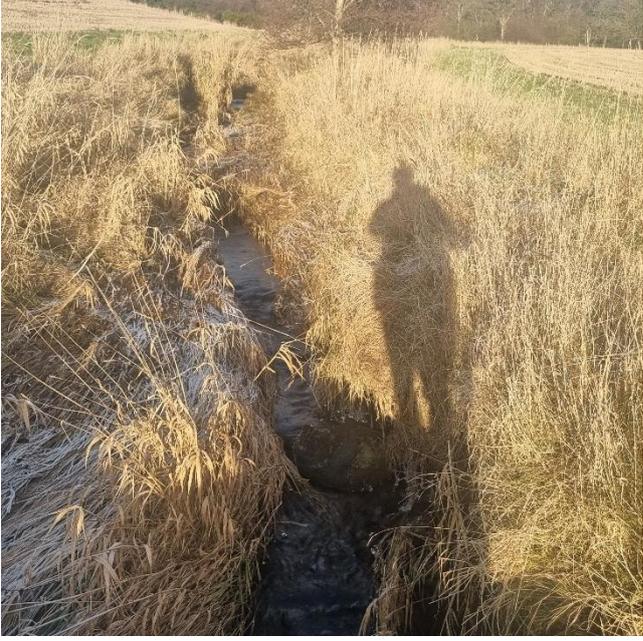
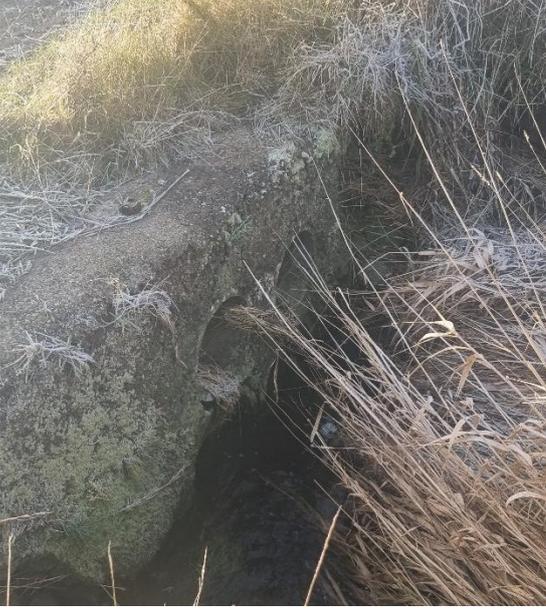
ID – 24 (Existing track crossing)	Tributary to King's Burn
<p><b>Watercourse Description:</b> Existing large crossings over tributary to King's Burn which flows south in small channel. If this existing access route is to be used to access the Proposed Development, there will be an existing culvert and its suitability will be assessed at detailed design stage.</p>	
NGR Ref: 344524 754983	
Photo - Tributary viewed looking upstream to the north	Photo - Several 250mm culverts (4 visible)

Width of watercourse/ drain (m)	0.8 m
Bed Sediment	Silt gravel pebble
Bank Erosion	No
Natural Channel	Yes
Existing Crossing	Existing pipe culverts (4 x 250 mm)
Proposed Crossing	No upgrade. If engineering assessment determines the crossing to be structurally unsound, a temporary over-bridging solution will be put in place during construction.
Additional Mitigation	None
Catchment (km <sup>2</sup> )	1.08 km <sup>2</sup>

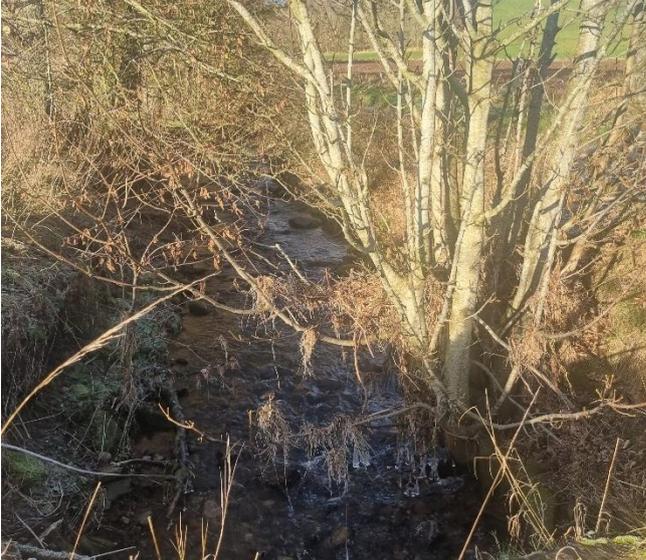
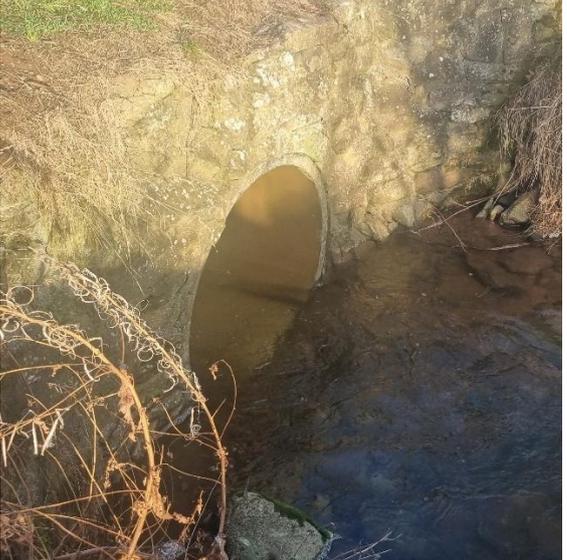
ID – 25 (Existing track crossing)	King's Burn
<p><b>Watercourse Description:</b> Existing track crossing of the upper King's Burn, which flows to the south. There is an existing crossing in place to provide field access with an existing culvert and its suitability will be assessed at detailed design stage.</p>	
NGR Ref: 344690 755000	
Photo – King's Burn viewed looking north upstream	Photo – Culvert outlet

Width of watercourse/ drain (m)	2.2 m
Bed Sediment	Mix silt to cobble
Bank Erosion	Yes
Natural Channel	Yes
Existing Crossing	Existing culvert (750 mm)
Proposed Crossing	No upgrade. If engineering assessment determines the crossing to be structurally unsound, a temporary over-bridging solution will be put in place during construction.
Additional Mitigation	None
Catchment (km <sup>2</sup> )	7.04 km <sup>2</sup>
Minor Watercourse	No
Main river catchment	River South Esk
Within catchment of SAC designated river	Yes (River Tay SAC)

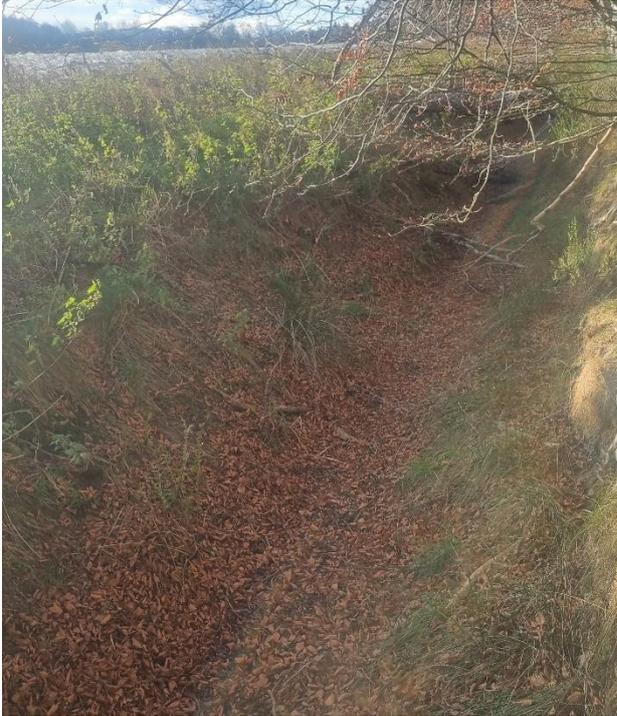
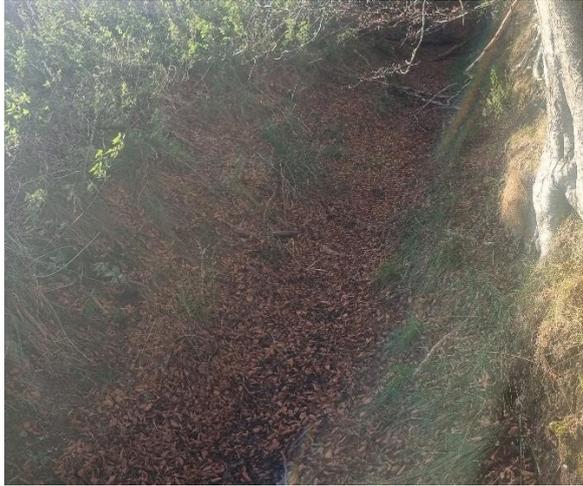
ID – 26 (Proposed track crossing - temporary)	Unnamed drain
<p><b>Watercourse Description:</b> Wide but short, defined drain was entirely dry during survey, but otherwise would drain flows to the east and is a tributary drain to River South Esk. There is no existing crossing over the drain, so would require a new crossing.</p>	
NGR Ref: 345135 756961	
Photo – Dry, unnamed drain viewed looking upstream to the west	Photo – Dry, unnamed drain

Width of watercourse/ drain (m)	1.2 m
Bed Sediment	Silt
Bank Erosion	No
Natural Channel	No
Existing Crossing	None
Proposed Crossing	<p>Pipe Culvert or Single span bridge (temporary). The crossing location is rural and a temporary crossing sized to the 1 in 30 year flow is considered suitable for the location, size of drain and temporary nature of the track crossing. Designing for a 1 in 200 year flow (plus climate change) could result in oversizing the crossing, requiring widening of the channel at the crossing and the need for raised embankments, which is not appropriate for a temporary crossing in a rural setting. The proposed design will allow the crossing to be removed at the end of the construction period with no legacy effect on the existing channel.</p> <p>In the event of a higher flood event occurring when the temporary crossing is in place, water would overtop the track and return back into the channel downstream of the track. There are no nearby receptors and there is considered to be no increased flood risk to others.</p>

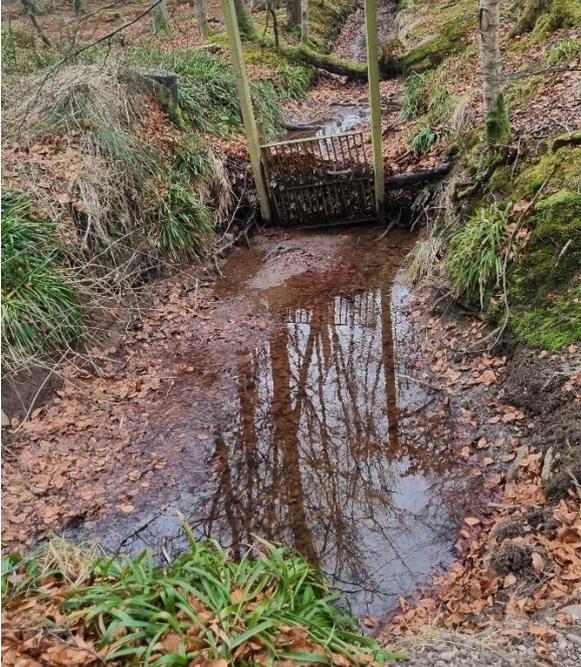
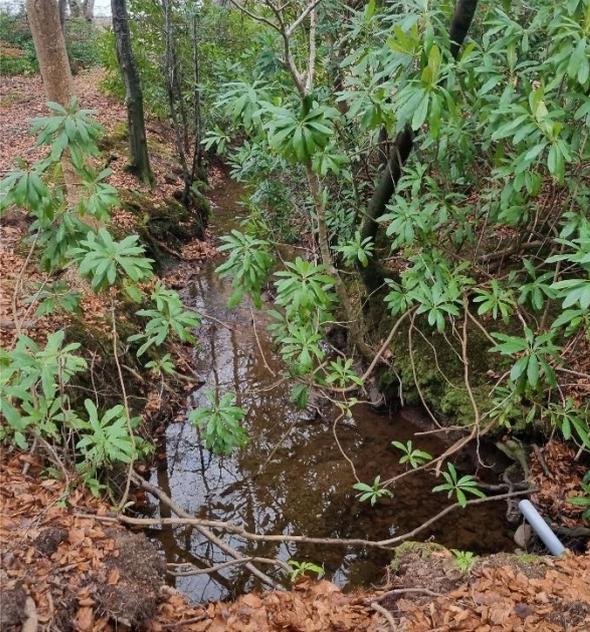
ID – 27 (Existing track crossing)	Unnamed drain
<p><u>Watercourse Description:</u> Drain flows east beneath Inshewan Avenue access road, the drain is very wide with significant water but almost no flow. There are two overflow culverts at 300 mm in diameter with a much smaller pipe.</p>	
NGR Ref: 344533 757317	
Photo – Drain viewed looking west, upstream	Photo – Drain viewed looking east, downstream

Width of watercourse/ drain (m)	2.1 m
Bed Sediment	Silt
Bank Erosion	No
Natural Channel	No
Existing Crossing	Existing pipe culverts (2 x 300 mm)
Proposed Crossing	No upgrade. If engineering assessment determines the crossing to be structurally unsound, a temporary over-bridging solution will be put in place during construction.
Additional Mitigation	None
Catchment (km <sup>2</sup> )	0.29 km <sup>2</sup>
Minor Watercourse	Yes
Main river catchment	River South Esk
Within catchment of SAC designated river	Yes (River Tay SAC)

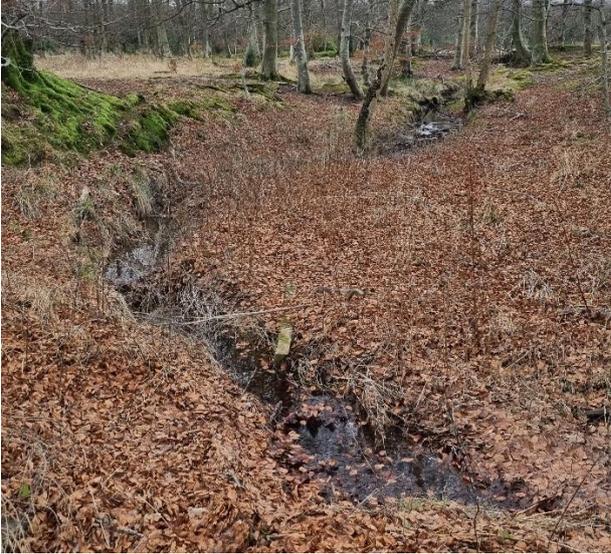
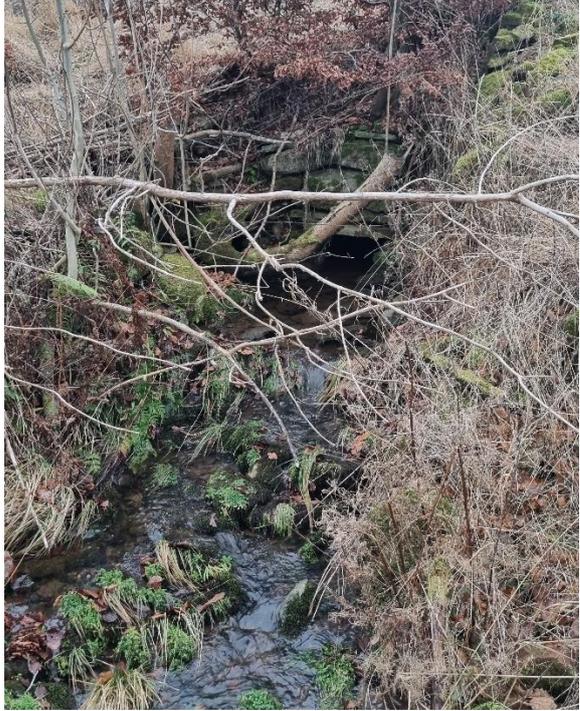
ID – 28 (Existing track crossing)	Unnamed drain
<u>Watercourse Description:</u> Drain flows southeast beneath existing track towards River South Esk.	
NGR Ref: 345061 757237	
Photo – Drain viewed upstream looking northwest, around 70 m upstream of here channel is straightened	Photo – Drain viewed looking downstream to the east

Width of watercourse/ drain (m)	0.8 m
Bed Sediment	Silt
Bank Erosion	No
Natural Channel	Yes but altered
Existing Crossing	Existing crossing with stone box culvert with irregular dimensions.
Proposed Crossing	No upgrade. If engineering assessment determines the crossing to be structurally unsound, a temporary over-bridging solution will be put in place during construction.
Additional Mitigation	None
Catchment (km <sup>2</sup> )	0.83 km <sup>2</sup>
Minor Watercourse	Yes
Main river catchment	River South Esk
Within catchment of SAC designated river	Yes (River Tay SAC)
CAR Authorisation Required	No

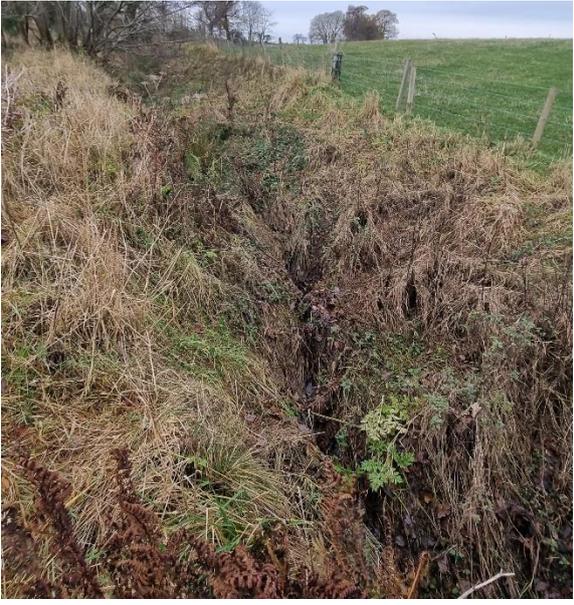
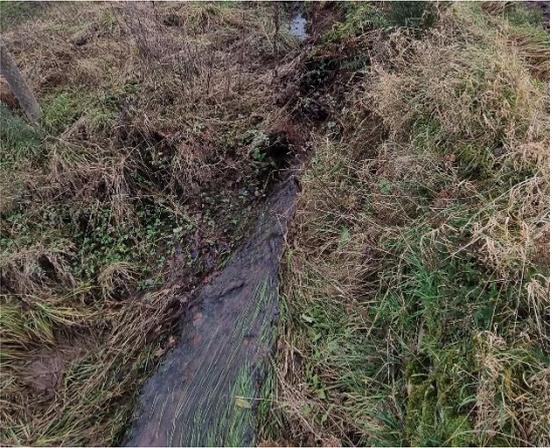
ID – 29 (Existing track crossing)	Unnamed drain
<p><u>Watercourse Description:</u> Narrow but defined drain was entirely dry during one survey and had significant flow during another, drain flows to the east and is a tributary drain to River South Esk. There is an existing field crossing, culvert dimensions unknown</p>	
NGR Ref: 345135 756961	
Photo – Small, vegetated channel looking upstream	Photo – Channel viewed looking downstream

Width of watercourse/ drain (m)	0.7 m
Bed Sediment	Silt
Bank Erosion	No
Natural Channel	Yes
Existing Crossing	Existing crossing with stone box culvert, dimensions unknown
Proposed Crossing	No upgrade. If engineering assessment determines the crossing to be structurally unsound, a temporary over-bridging solution will be put in place during construction.
Additional Mitigation	None
Catchment (km <sup>2</sup> )	0.5 km <sup>2</sup>
Minor Watercourse	Yes
Main river catchment	River South Esk

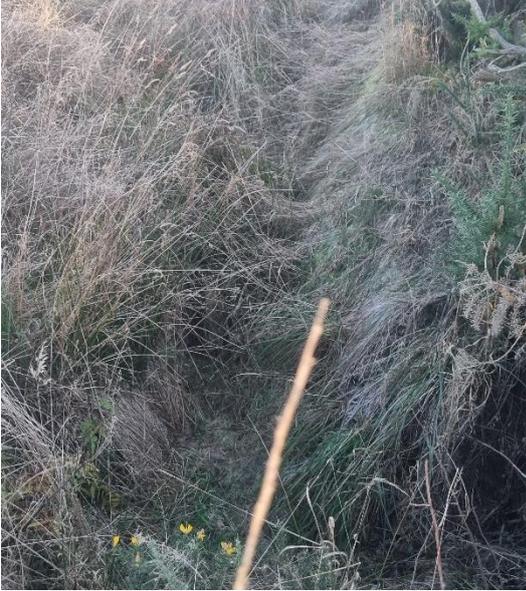
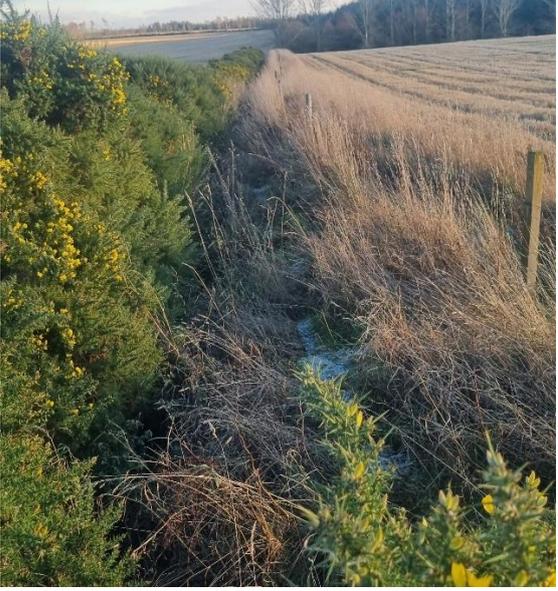
ID – 30 (Proposed track crossing - temporary)	Unnamed drain
<u>Watercourse Description:</u> Heavily vegetated but well-defined drain which is not shown on Ordnance Survey mapping. Connects to adjacent drain which is mapped and flows into Coe Burn.	
NGR Ref: 350938 762097	
Photo – Dry, unnamed drain viewed looking upstream to the east. Not mapped and connects to adjacent mapped drain	Photo – adjacent mapped drain which flows southeast to Coe Burn adjacent to track

Width of watercourse/ drain (m)	0.8 m
Bed Sediment	Silt
Bank Erosion	No
Natural Channel	No
Existing Crossing	None
Proposed Crossing	<p>Pipe Culvert or Single Span Bridge (temporary). The crossing location is rural and a temporary crossing sized to the 1 in 30 year flow is considered suitable for the location, size of drain and temporary nature of the track crossing. Designing for a 1 in 200 year flow (plus climate change) could result in oversizing the crossing, which is not appropriate for a temporary crossing in a rural setting. The proposed design will allow the crossing to be removed at the end of the construction period with no legacy effect on the existing channel.</p> <p>In the event of a higher flood event occurring when the temporary crossing is in place, water would overtop the track and return back into the channel downstream of the track. There are no nearby receptors and there is considered to be no increased flood risk to others.</p>

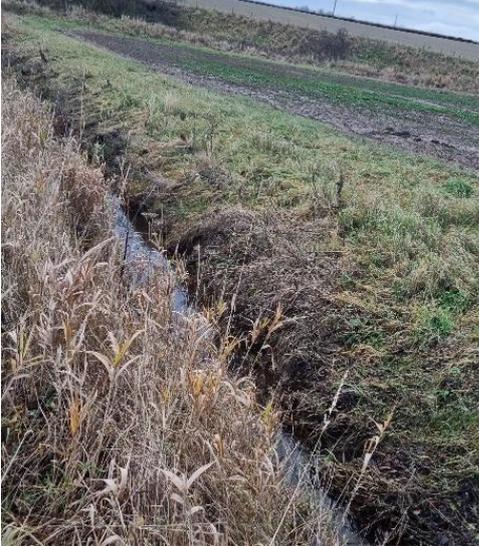
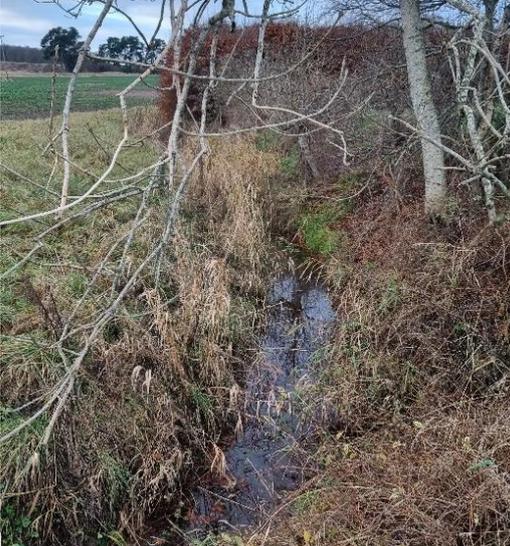
ID – 31 (Proposed track crossing - temporary)	Unnamed drain
<u>Watercourse Description:</u> Heavily vegetated drainage channel, very straight and feeds into Willie Mills Burn further downstream. No existing crossing over the drain.	
NGR Ref: 356045 762860	
Photo – Drain further downstream of crossing	Photo – Drain

Width of watercourse/ drain (m)	0.9 m
Bed Sediment	Silt
Bank Erosion	No
Natural Channel	No
Existing Crossing	None
Proposed Crossing	<p>Single Span Bridge (temporary). The crossing location is rural and a temporary crossing sized to the 1 in 30 year flow is considered suitable for the location, size of drain and temporary nature of the track crossing. Designing for a 1 in 200 year flow (plus climate change) could result in oversizing the bridge, requiring widening of the channel at the crossing and the need for raised embankments, which is not appropriate for a temporary crossing in a rural setting. The proposed design will allow the crossing to be removed at the end of the construction period with no legacy effect on the existing channel.</p> <p>In the event of a higher flood event occurring when the temporary crossing is in place, water would overtop the track and return back into the channel downstream of the track. There are no nearby receptors and there is considered to be no increased flood risk to others.</p>
