# **Volume 5: Appendix 13.1 - Watercourse Crossing and Buffers Assessment**

**February 2026 – Additional Information**

- 1.1.1 This appendix details the assessment undertaken to identify and describe all new and existing watercourse crossings that will be required during the construction of the Kintore to Tealing 400 kV OHL and associated infrastructure (the 'Proposed Development') as described in **Volume 1, Chapter 3: Project Description**. This document should be read in conjunction with **Volume 1, Chapter 3: Project Description** and **Volume 2, Chapter 13: Hydrology, Hydrogeology, Geology and Soils** of the Kintore to Tealing 400 kV OHL Environmental Impact Assessment Report (EIAR).

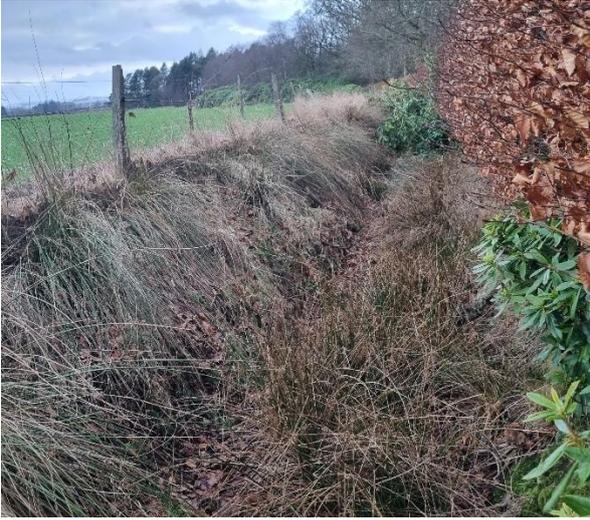
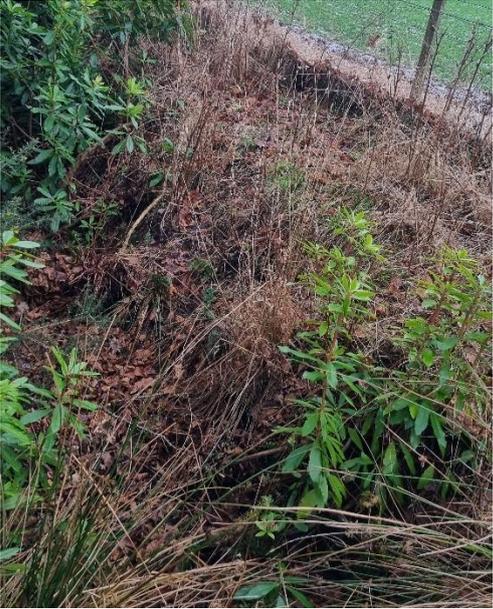
ID – 32 (Proposed track crossing - temporary)	Unnamed drain
<u>Watercourse Description:</u> Minor mapped drain, flows downstream to the southeast, heavily vegetated.	
NGR Ref: 356806 763081	
Photo – Vegetated drain clogged with bull rush, looking southeast	Photo – Drain

Width of watercourse/ drain (m)	0.4 m
Bed Sediment	Silt
Bank Erosion	No
Natural Channel	No
Existing Crossing	None
Proposed Crossing	<p>Pipe Culvert or Single span bridge (temporary). The crossing location is rural and a temporary crossing sized to the 1 in 30 year flow is considered suitable for the location, size of drain and temporary nature of the track crossing. Designing for a 1 in 200 year flow (plus climate change) could result in oversizing the crossing, requiring widening of the channel at the crossing and the need for raised embankments, which is not appropriate for a temporary crossing in a rural setting. The proposed design will allow the crossing to be removed at the end of the construction period with no legacy effect on the existing channel.</p> <p>In the event of a higher flood event occurring when the temporary crossing is in place, water would overtop the track and return back into the channel downstream of the track. There are no nearby receptors and there is considered to be no increased flood risk to others.</p>

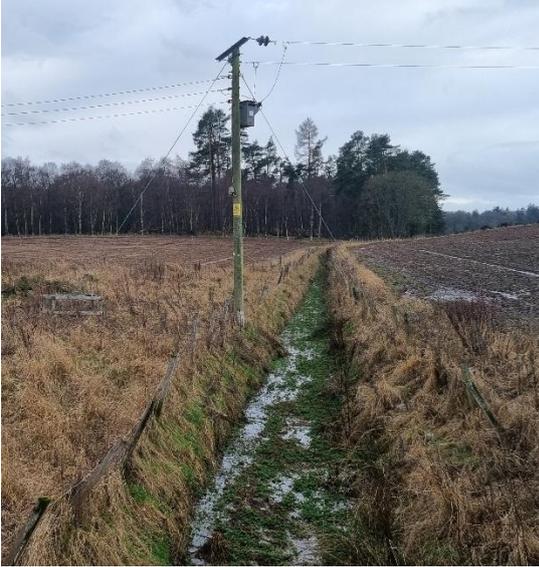
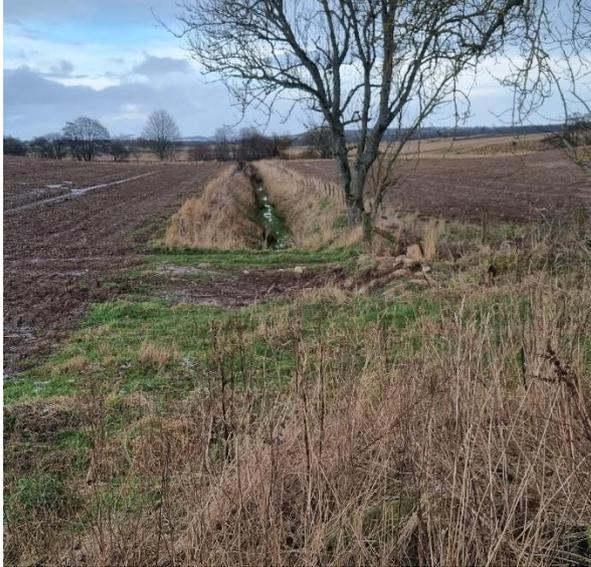
ID – 33 (Existing track crossing)	Unnamed drain tributary to Cruick Water
<u>Watercourse Description:</u> Unnamed drain flows to the east beneath existing crossing in a wide channel. There is a stone box culvert beneath the existing crossing.	
NGR Ref: 357015 763391	
Photo – Drain looking upstream, west	Photo – Drain looking downstream, east

Width of watercourse/ drain (m)	1.1 m
Bed Sediment	Silt
Bank Erosion	No
Natural Channel	No
Existing Crossing	Existing stone box culvert
Proposed Crossing	No upgrade. If engineering assessment determines the crossing to be structurally unsound, a temporary over-bridging solution will be put in place during construction.
Additional Mitigation	None
Catchment (km <sup>2</sup> )	0.12 km <sup>2</sup>
Minor Watercourse	Yes
Main river catchment	River North Esk
Within catchment of SAC designated river	No
CAR Authorisation Required	No

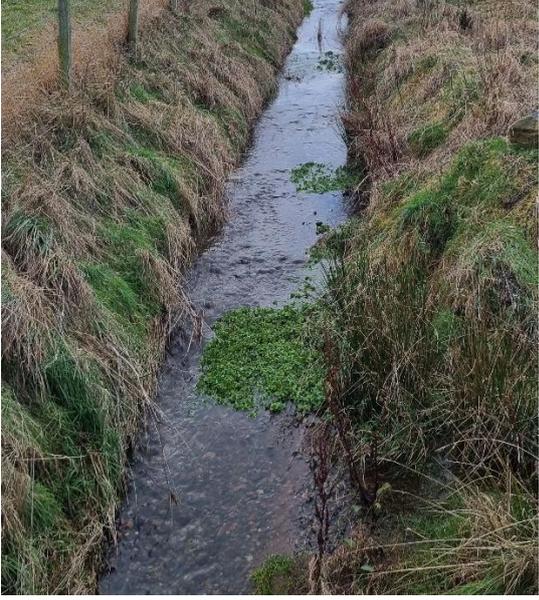
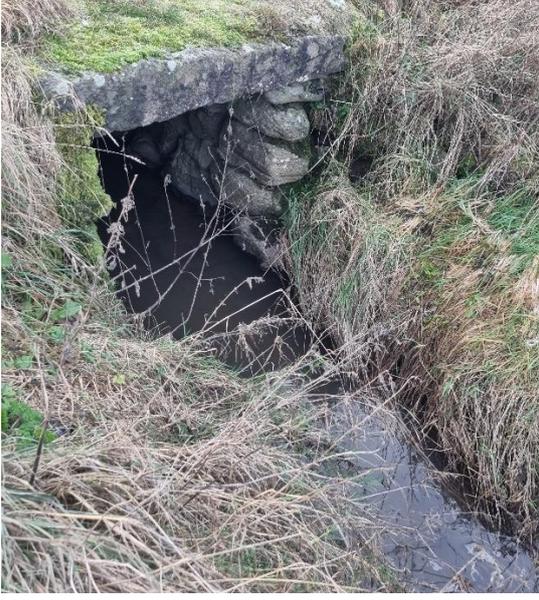
ID – 34 (Existing track crossing)	Unnamed drain tributary to West Water
<u>Watercourse Description:</u> Unnamed drain flows to the east beneath existing crossing with a large, stone box culvert. The drain is large and well-defined.	
NGR Ref: 358777 765481	
Photo – Drain viewed looking upstream	Photo – Box culvert

Width of watercourse/ drain (m)	1.0 m
Bed Sediment	Silt to cobble
Bank Erosion	No
Natural Channel	No
Existing Crossing	Existing stone box culvert
Proposed Crossing	No upgrade. If engineering assessment determines the crossing to be structurally unsound, a temporary over-bridging solution will be put in place during construction.
Additional Mitigation	None
Catchment (km <sup>2</sup> )	0.12 km <sup>2</sup>
Minor Watercourse	No
Main river catchment	River North Esk
Within catchment of SAC designated river	No
CAR Authorisation Required	No

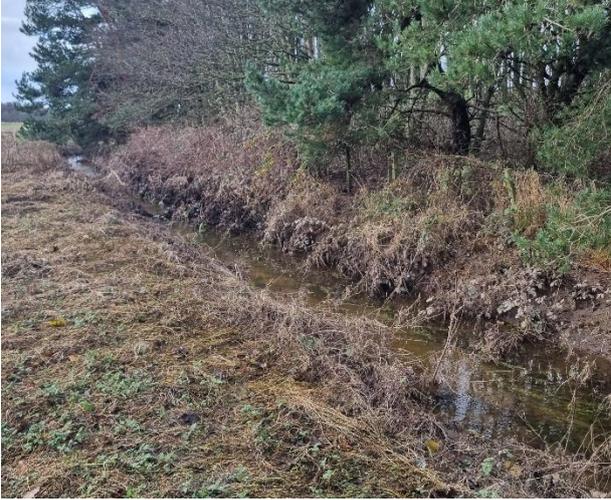
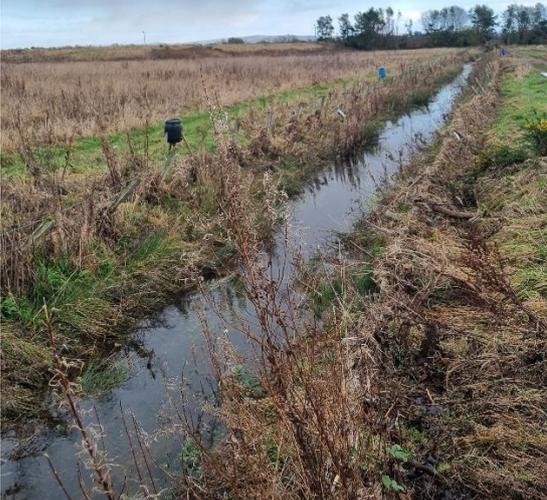
ID – 35 (Existing track crossing)	Whishop Burn
<u>Watercourse Description:</u> Existing crossing and track over Whishop Burn in well-defined channel with a 300 mm culvert beneath the track. Whishop Burn flows to the east.	
NGR Ref: 361393 766403	
Photo – Whishop Burn upstream of crossing	Photo – Whishop Burn downstream of crossing

Width of watercourse/ drain (m)	2.0 m
Bed Sediment	Silt, gravel, pebble
Bank Erosion	No
Natural Channel	Yes
Existing Crossing	Existing crossing (300 mm culvert)
Proposed Crossing	No upgrade. If engineering assessment determines the crossing to be structurally unsound, a temporary over-bridging solution will be put in place during construction.
Additional Mitigation	None
Catchment (km <sup>2</sup> )	3.1 km <sup>2</sup>
Minor Watercourse	No
Main river catchment	River North Esk
Within catchment of SAC designated river	No
CAR Authorisation Required	No

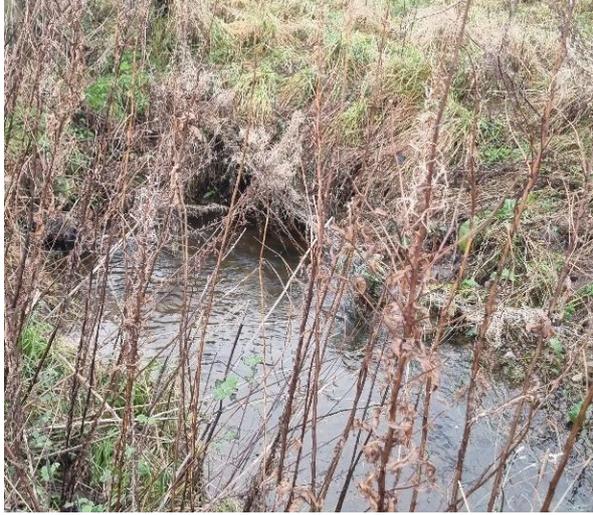
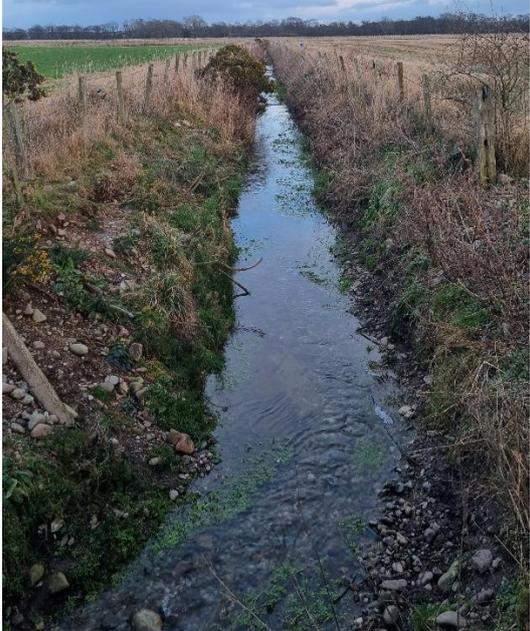
ID – 36 (Proposed track crossing - temporary)	Whishop Burn
<u>Watercourse Description:</u> Proposed crossing over Whishop Burn in well-defined channel which flows to the south.	
NGR Ref: 363988 766380	
Photo – Whishop Burn upstream of crossing	Photo – Whishop Burn upstream of proposed crossing, looking downstream

Width of watercourse/ drain (m)	2.0 m
Bed Sediment	Silt, gravel, pebble
Bank Erosion	No
Natural Channel	Yes
Existing Crossing	None
Proposed Crossing	<p>Single Span Bridge (temporary). The crossing location is rural and a temporary crossing sized to the 1 in 30 year flow is considered suitable for the location, size of watercourse and temporary nature of the track crossing. Designing for a 1 in 200 year flow (plus climate change) could result in oversizing the bridge, requiring widening of the channel at the crossing and the need for raised embankments, which is not appropriate for a temporary crossing in a rural setting. The proposed design will allow the crossing to be removed at the end of the construction period with no legacy effect on the existing channel.</p> <p>In the event of a higher flood event occurring when the temporary crossing is in place, water would overtop the track and return back into the channel downstream of the track. There are no nearby receptors and there is considered to be no increased flood risk to others.</p>

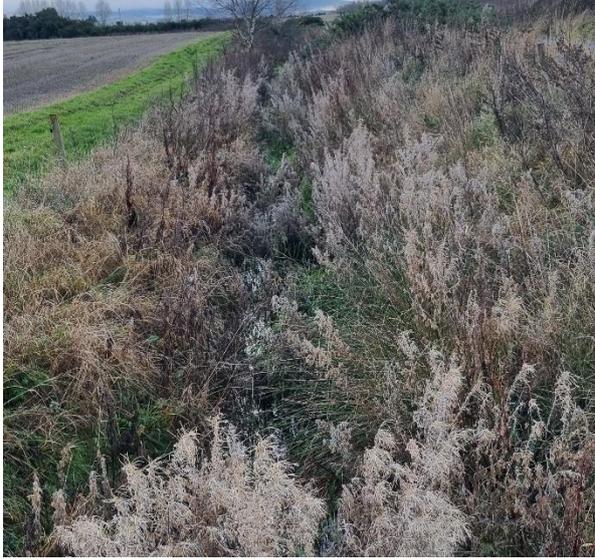
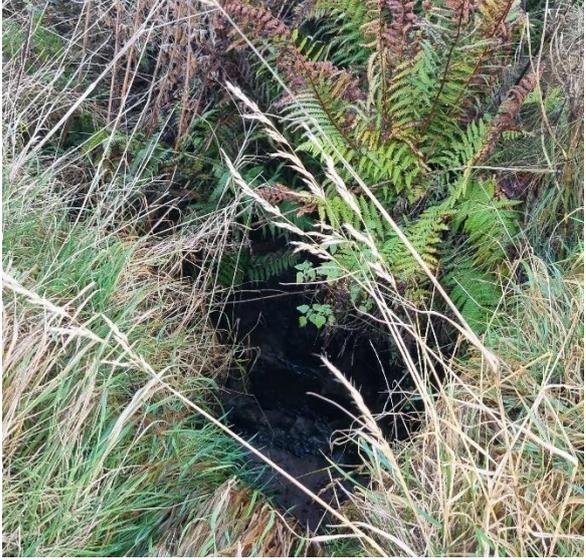
ID – 37 (Proposed track crossing - temporary)	Unnamed drain
<u>Watercourse Description:</u> Heavily vegetated drain, which is a well-defined tributary channel to River North Esk.	
NGR Ref: 362715 767086	
Photo – shows the heavily vegetated drainage channel, approximately 600 m upstream of crossing location	Photo – Heavily vegetated drain, approximately 600 m upstream of crossing location

Width of watercourse/ drain (m)	1.0 m
Bed Sediment	Silt, gravel
Bank Erosion	No
Natural Channel	No
Existing Crossing	None
Proposed Crossing	<p>Pipe Culvert or Single Span Bridge (temporary). The crossing location is rural and a temporary crossing sized to the 1 in 30 year flow is considered suitable for the location, size of watercourse and temporary nature of the track crossing. Designing for a 1 in 200 year flow (plus climate change) could result in oversizing the crossing, requiring widening of the channel at the crossing and the need for raised embankments, which is not appropriate for a temporary crossing in a rural setting. The crossing and temporary track is at the edge of the future flood risk area associated with the River North Esk, so the track (and bridge embankments) will not be raised. The proposed design will allow the crossing to be removed at the end of the construction period with no legacy effect on the existing channel.</p> <p>In the event of a higher flood event occurring when the temporary crossing is in place, water would overtop the track and return back into the channel downstream of the track. There are no nearby receptors and there is considered to be no increased flood risk to others.</p>

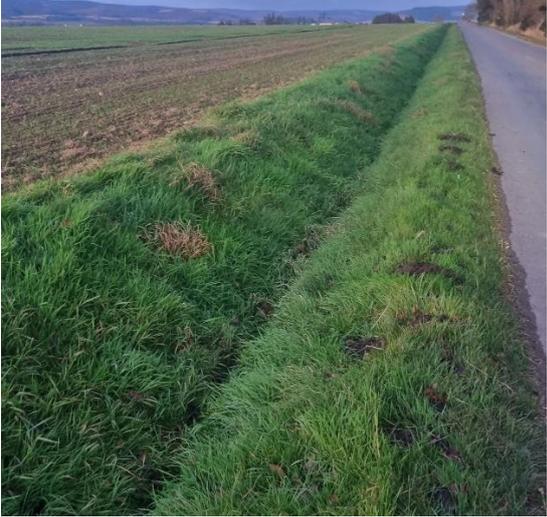
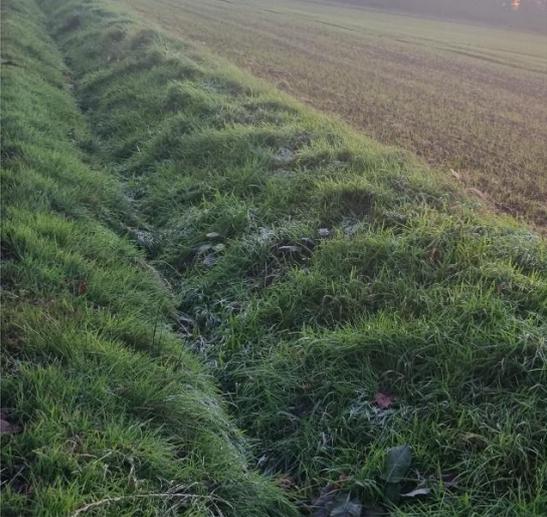
ID – 38 (Proposed track crossing - temporary)	Unnamed drain
<u>Watercourse Description:</u> Small field drain alongside road, well maintained and dry during survey. Very small upstream catchment and not a natural watercourse, just a roadside drain.	
NGR Ref: 364550 768790	
Photo – Looking upslope to northeast	Photo – Looking downslope to southwest

Width of watercourse/ drain (m)	0.3 m
Bed Sediment	Silt
Bank Erosion	No
Natural Channel	No
Existing Crossing	None
Proposed Crossing	<p>Pipe Culvert or Single Span Bridge (temporary). The crossing location is rural and a temporary crossing sized to the 1 in 30 year flow is considered suitable for the location, size of drain and temporary nature of the track crossing. Designing for a 1 in 200 year flow (plus climate change) could result in oversizing the crossing which is not appropriate for a temporary crossing in a rural setting. The catchment area of the drain is small and flood flows in this roadside drain will be low.</p> <p>In the event of a higher flood event occurring when the temporary crossing is in place, water could overtop the existing banks of the drain anyway and it is not considered that the temporary crossing would result in an increased flood risk to other receptors (ie the public road).</p>
