<b>ID – 39</b> <b>(Proposed track crossing - temporary)</b>	<b>Unnamed Drain</b>
<p><u>Watercourse Description:</u> Large field drain, which is a tributary to the Sauchie Burn, flows to the southeast in a straightened drainage channel</p>	
NGR Ref: 365536 770146	
Photo – Drainage channel further upstream	Photo – Drainage channel further upstream

## Section D

## Section E

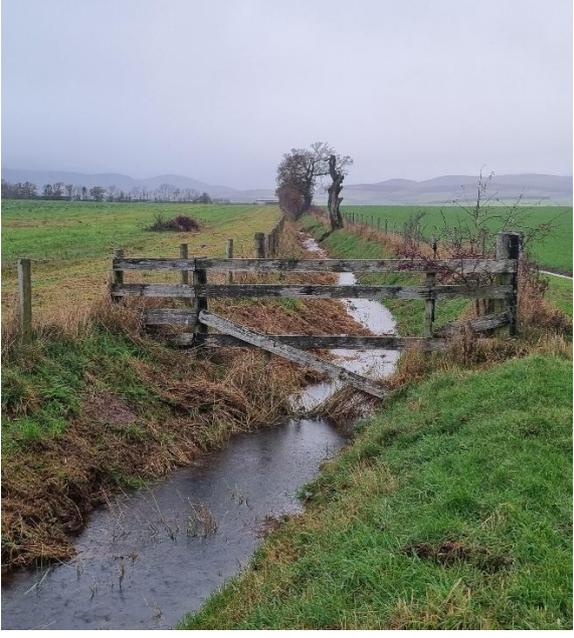
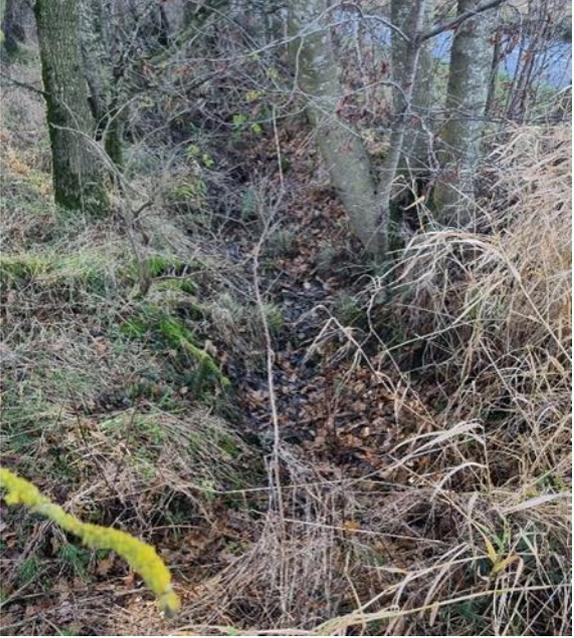
Width of watercourse/ drain (m)	0.6 m
Bed Sediment	Silt
Bank Erosion	No
Natural Channel	No- heavily modified
Existing Crossing	None
Proposed Crossing	<p>Pipe Culvert or Single Span Bridge (temporary). The crossing location is rural and a temporary crossing sized to the 1 in 30 year flow is considered suitable for the location, size of watercourse and temporary nature of the track crossing. Designing for a 1 in 200 year flow (plus climate change) could result in oversizing the crossing, requiring widening of the channel at the crossing and the need for raised embankments, which is not appropriate for a temporary crossing in a rural setting. The proposed design will allow the crossing to be removed at the end of the construction period with no legacy effect on the existing channel.</p> <p>In the event of a higher flood event occurring when the temporary crossing is in place, water would overtop the track and return back into the channel downstream of the track. There are no nearby receptors and there is considered to be no increased flood risk to others.</p>

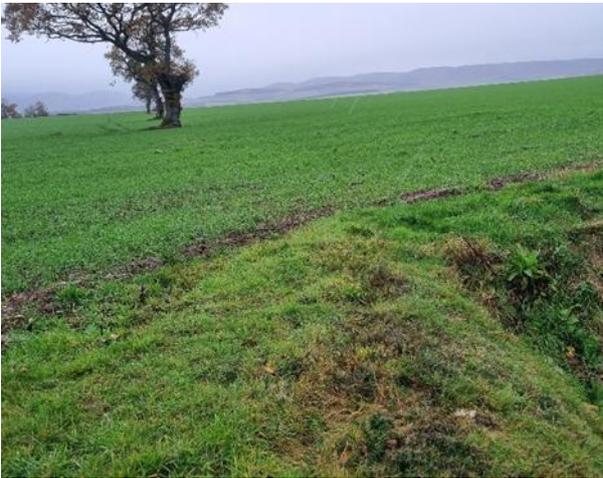
ID – 40 (Proposed track crossing - temporary)	Drainage tributary to Sauchie Burn
<u>Watercourse Description:</u> Large field drain tributary to the Sauchie Burn flows to the southeast in a straightened drainage channel. The channel has since been covered over and culverted within the field	
NGR Ref: 365590 770300	
Photo – drainage channel has been culverted within field along line of trees any shown in photo

Width of watercourse/ drain (m)	1.1 m
Bed Sediment	Silt
Bank Erosion	No
Natural Channel	No
Existing Crossing	None
Proposed Crossing	<p>Pipe Culvert or Single Span Bridge (temporary). The crossing location is rural and a temporary crossing sized to the 1 in 30 year flow is considered suitable for the location, size of drain and temporary nature of the track crossing. Designing for a 1 in 200 year flow (plus climate change) could result in oversizing the bridge, requiring widening of the channel at the crossing and the need for raised embankments, which is not appropriate for a temporary crossing in a rural setting. The proposed design will allow the crossing to be removed at the end of the construction period with no legacy effect on the existing channel.</p> <p>In the event of a higher flood event occurring when the temporary crossing is in place, water would overtop the track and return back into the channel downstream of the track. There are no nearby receptors and there is considered to be no increased flood risk to others.</p>

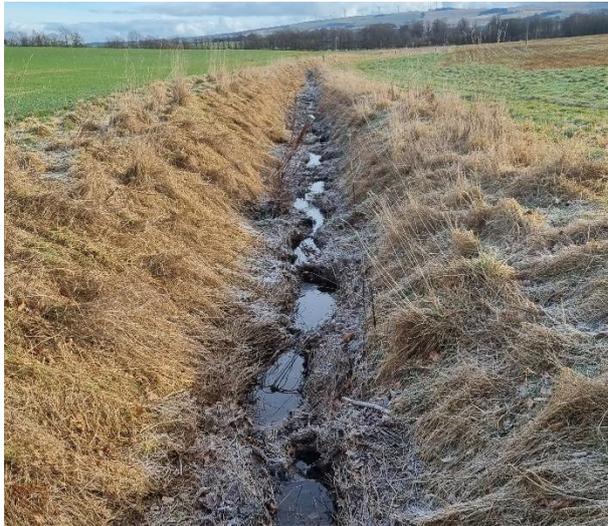
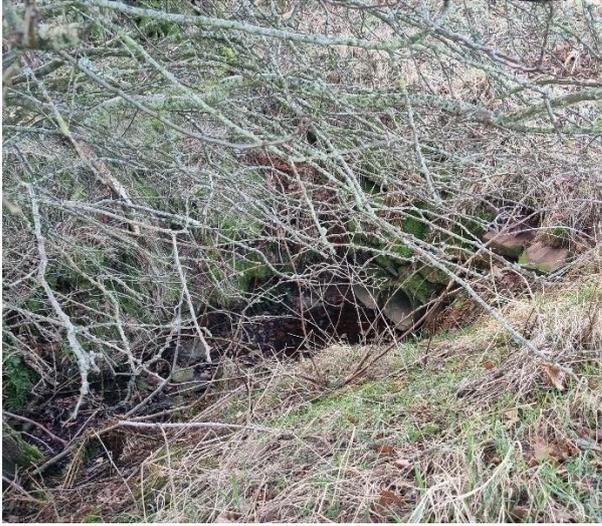
ID – 41 (Existing track crossing)	Unnamed Drain
<p><b>Watercourse Description:</b> Large field drain within agricultural land at Haughhead Farm flows to the east from a field drain outlet. There is an existing field access crossing with two other crossings further upstream. The proposed access track crossing the drain at the location of the existing crossing.</p>	
NGR Ref: 368107 772574	
Photo – Drainage channel, well defined	Photo – Channel field drain culvert outlet further upstream

Width of watercourse/ drain (m)	0.8 m
Bed Sediment	Silt
Bank Erosion	No
Natural Channel	No
Existing Crossing	Existing crossing with stone arch culvert (500 mm wide culvert)
Proposed Crossing	No upgrade. If engineering assessment determines the crossing to be structurally unsound, a temporary over-bridging solution will be put in place during construction.
Additional Mitigation	None
Catchment (km <sup>2</sup> )	0.51 km <sup>2</sup>

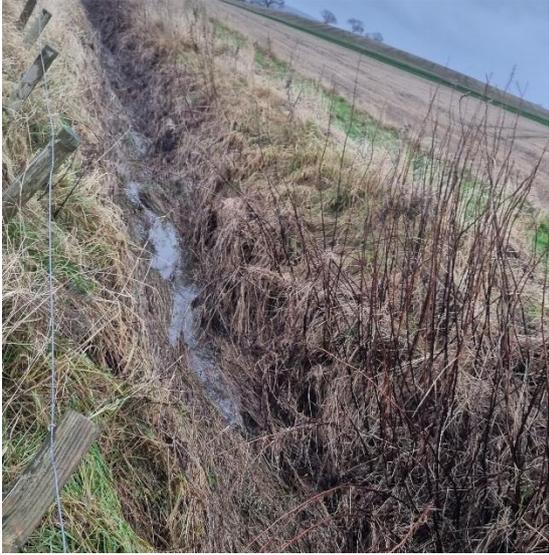
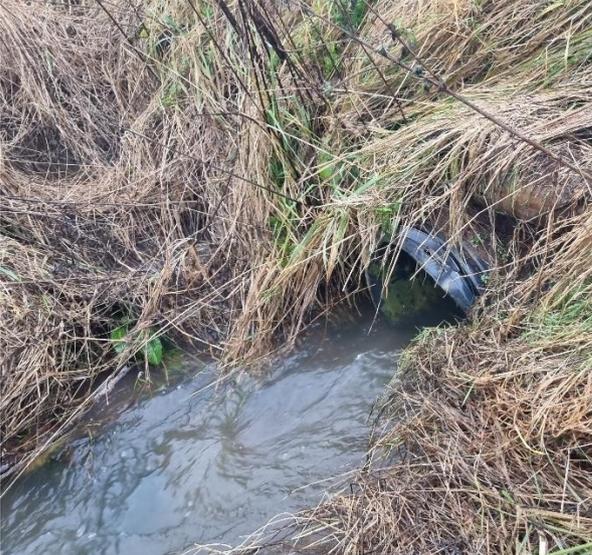
ID – 42 (Existing track crossing)	Unnamed Drain
<u>Watercourse Description:</u> Large field drainage channel flows to the south towards the Ducat Water. The existing track crosses the drainage channel via a 300 mm culvert.	
NGR Ref: 371368 775492	
Photo – Drainage channel alongside road viewed just downstream from crossing	Photo – 300mm culvert

Width of watercourse/ drain (m)	0.7 m
Bed Sediment	Silt
Bank Erosion	No
Natural Channel	No
Existing Crossing	Existing crossing (300 mm culvert)
Proposed Crossing	No upgrade. If engineering assessment determines the crossing to be structurally unsound, a temporary over-bridging solution will be put in place during construction.
Additional Mitigation	None
Catchment (km <sup>2</sup> )	0.58 km <sup>2</sup>
Minor Watercourse	No
Main river catchment	River North Esk
Within catchment of SAC designated river	No
CAR Authorisation Required	No

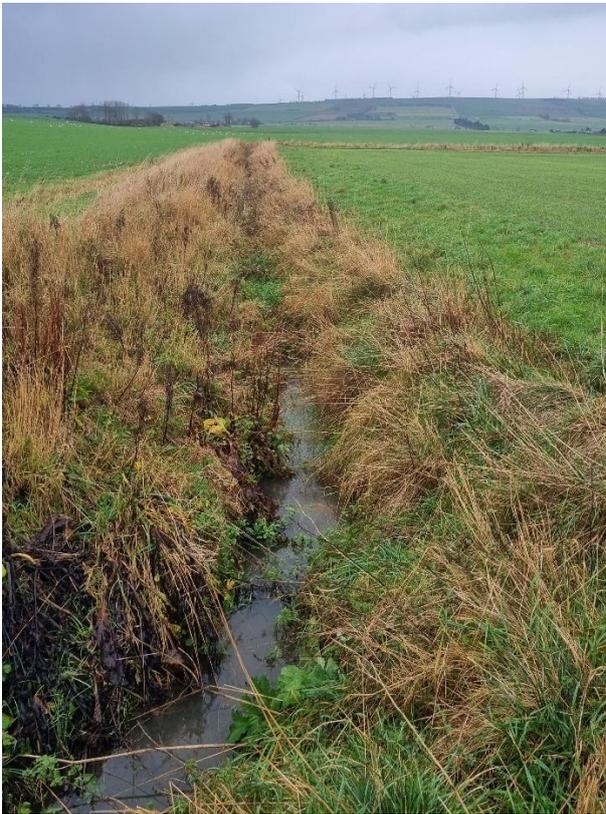
ID – 43 (Proposed track crossing - permanent)	Large Drainage ditch tributary to Luther Water
<u>Watercourse Description:</u> Large drainage ditch tributary flows southeast at proposed crossing location but then turns southwest just metres downstream. Channel is straightened and well-defined.	
NGR Ref: 372673, 775810	
Photo- shows location of proposed crossing, looking downstream, southeast

Width of watercourse/ drain (m)	0.8 m
Bed Sediment	Unknown
Bank Erosion	No
Natural Channel	No
Existing Crossing	None
Proposed Crossing	Pipe Culvert or Single Span Bridge (permanent)
Additional Mitigation	None
Catchment (km <sup>2</sup> )	1.38 km <sup>2</sup>
Minor Watercourse	Yes
Main river catchment	River North Esk
Within catchment of SAC designated river	No
CAR Authorisation Required	No

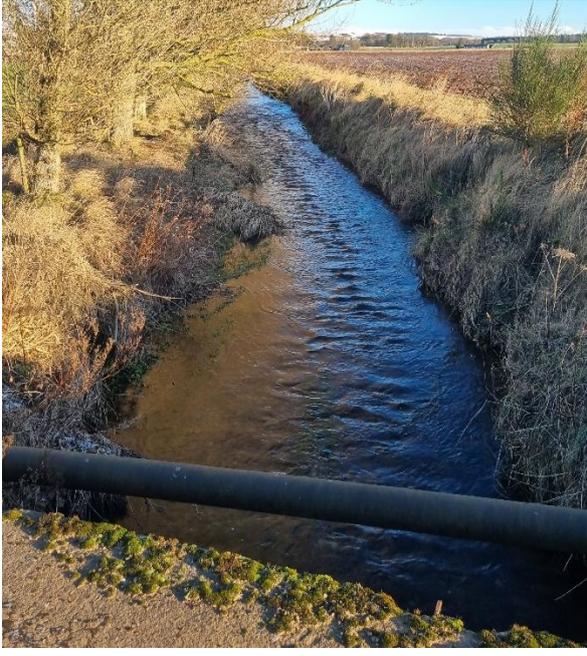
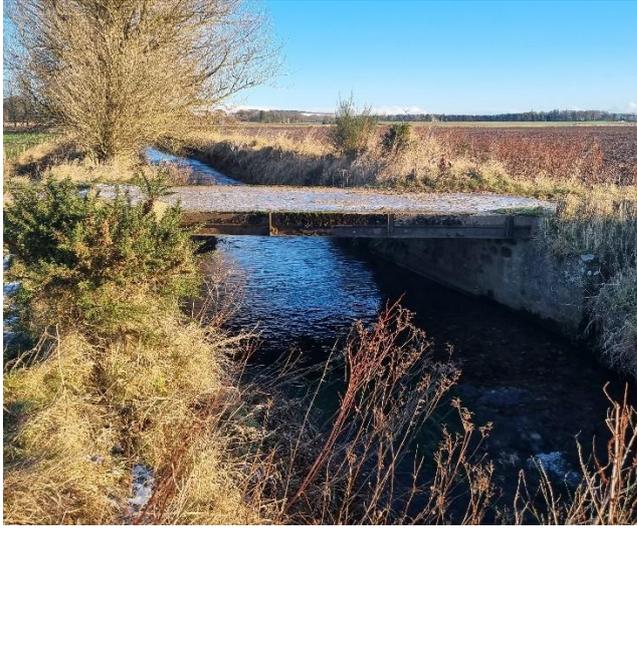
ID – 44 (Existing track crossing)	Luther Water
<p><b>Watercourse Description:</b> Luther Water flows southwest beneath a concrete bridge crossing at this locality. The existing bridge provides field access. The channel is wide with shallow depths, and the watercourse has been heavily modified and straightened. Additionally there is an adjacent ditch which feeds into the Luther Water downstream (ditch has a 1 m culvert).</p>	
NGR Ref: 372643 776149	
Photo – Luther Water looking northeast upstream	Photo – Existing bridge crossing

Width of watercourse/ drain (m)	3.2 m
Bed Sediment	Silt to cobble
Bank Erosion	No
Natural Channel	Natural watercourse, but heavily modified/straightened channel
Existing Crossing	Existing bridge crossing
Proposed Crossing	No upgrade. If engineering assessment determines the crossing to be structurally unsound, a temporary over-bridging solution will be put in place during construction.

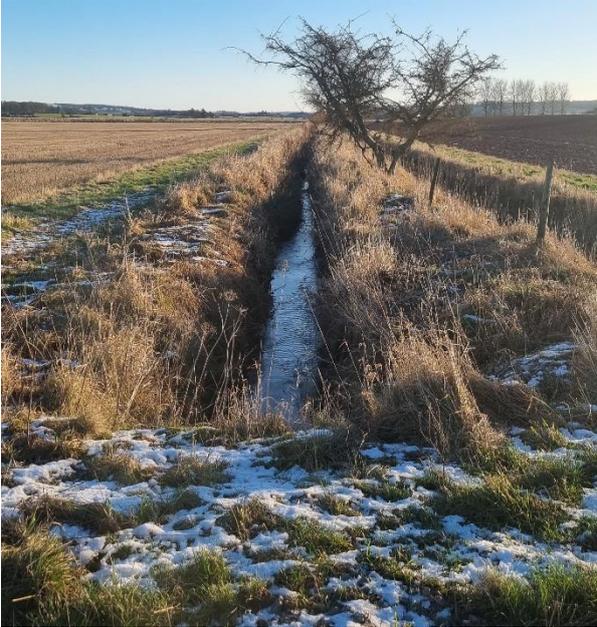
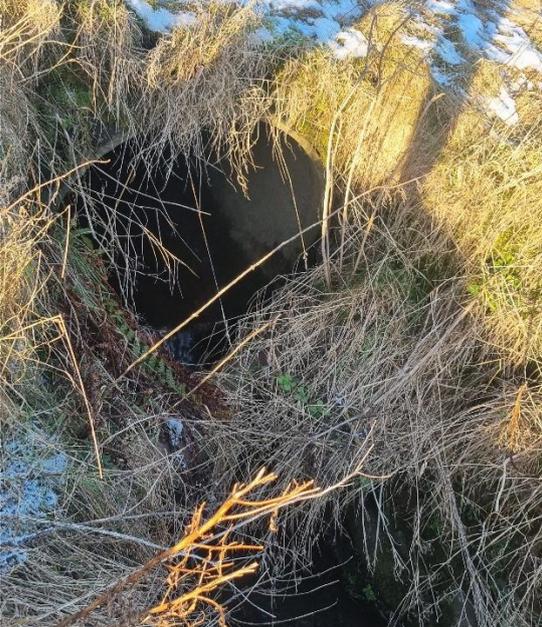
ID – 45 (Existing track crossing)	Scotch Haugh Burn (Luther Water tributary)
<u>Watercourse Description:</u> Scotch Haugh Burn flows southeast in a heavily modified channel that is well-defined and straightened. Watercourse flows beneath existing track crossing in 1000 mm culvert.	
NGR Ref: 372378 776704	
Photo – Drain looking downstream to southeast	Photo – 1000 mm culvert

Width of watercourse/ drain (m)	1.0 m
Bed Sediment	Silt
Bank Erosion	No
Natural Channel	No, artificially straightened
Existing Crossing	Existing bridge crossing
Proposed Crossing	No upgrade. If engineering assessment determines the crossing to be structurally unsound, a temporary over-bridging solution will be put in place during construction.
Additional Mitigation	None
Catchment (km <sup>2</sup> )	4.54 km <sup>2</sup>
Minor Watercourse	No
Main river catchment	River North Esk
Within catchment of SAC designated river	No
CAR Authorisation Required	No

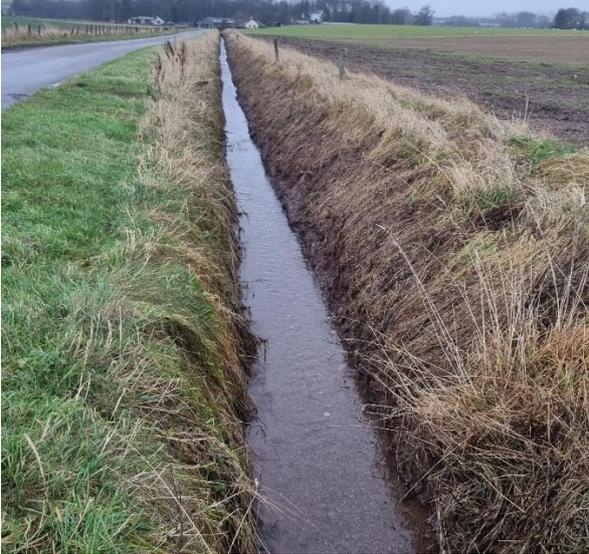
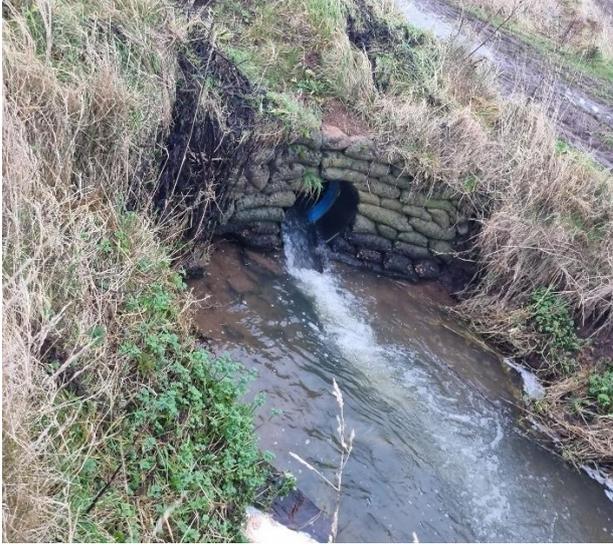
ID – 46 (Proposed track crossing - temporary)	Unnamed Drain
<p><b>Watercourse Description:</b> Large drainage ditch with existing field access crossing just 15 m downstream of proposed temporary track crossing. The drainage ditch flows to the south and at the crossing downstream flows through a 450 mm pipe culvert then is diverted to the east.</p>	
NGR Ref: 373514 776307	
Photo – Drainage channel crossing looking upstream to the north.	Photo – 450 mm pipe culvert outlet, 15 m downstream of proposed temporary track crossing.

Width of watercourse/ drain (m)	0.9 m
Bed Sediment	Silt
Bank Erosion	No
Natural Channel	No
Existing Crossing	None. There is however an existing field access crossing 15 m downstream that could potentially be utilised (with a 450 mm culvert).
Proposed Crossing	<p>Pipe Culvert or Single Span Bridge (temporary). The crossing location is rural and a temporary crossing sized to the 1 in 30 year flow or to maintain the existing capacity of the channel is considered suitable for the location, size of watercourse and temporary nature of the track crossing. Designing for a 1 in 200 year flow (plus climate change) could result in oversizing the crossing, requiring widening of the channel at the crossing and the need for raised embankments, which is not appropriate for a temporary crossing in a rural setting. The crossing and temporary track is within the future flood risk area associated with the Luther Water, so the track (and any bridge embankments) will not be raised.</p> <p>In the event of a higher flow event, it is considered that the existing culvert already restricts flood flows downstream and water could overtop the banks of the drain in the current situation. The temporary crossing will be no smaller than the existing culvert and therefore will not increase flood risk to other receptors.</p>

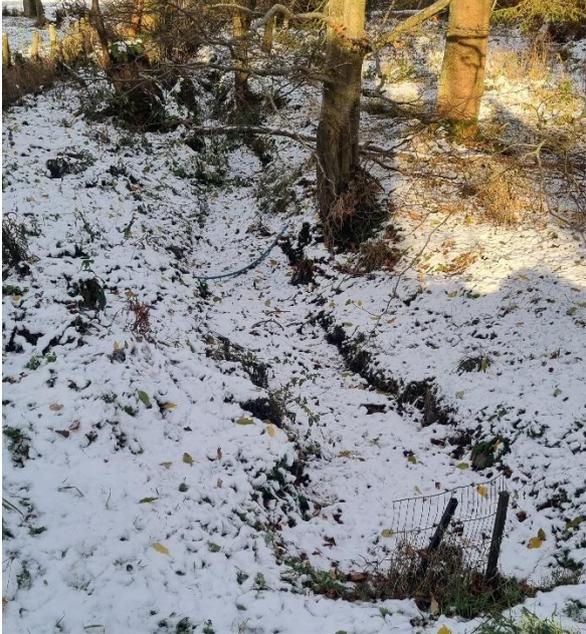
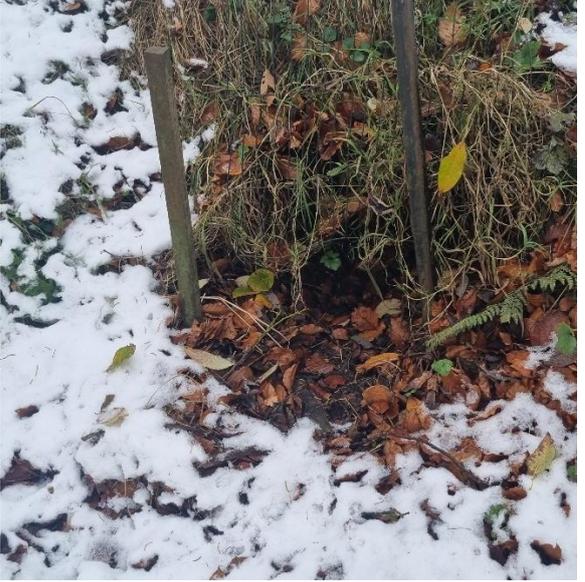
ID – 47 (Existing track crossing)	Unnamed Drain
<u>Watercourse Description:</u> Small drain flowing to the southeast. Dry at time of survey with very blocked small 250 mm culvert.	
NGR Ref: 374250 776929	
Photo – Drainage channel viewed looking north	Photo – Shows vegetated blocked culvert

Width of watercourse/ drain (m)	0.9 m
Bed Sediment	Silt
Bank Erosion	No
Natural Channel	No
Existing Crossing	Existing crossing (250 mm pipe culvert)
Proposed Crossing	No upgrade. If engineering assessment determines the crossing to be structurally unsound, a temporary over-bridging solution will be put in place during construction.
Additional Mitigation	None
Catchment (km <sup>2</sup> )	0.44 km <sup>2</sup>
Minor Watercourse	No
Main river catchment	Bervie Water
Within catchment of SAC designated river	No
CAR Authorisation Required	No

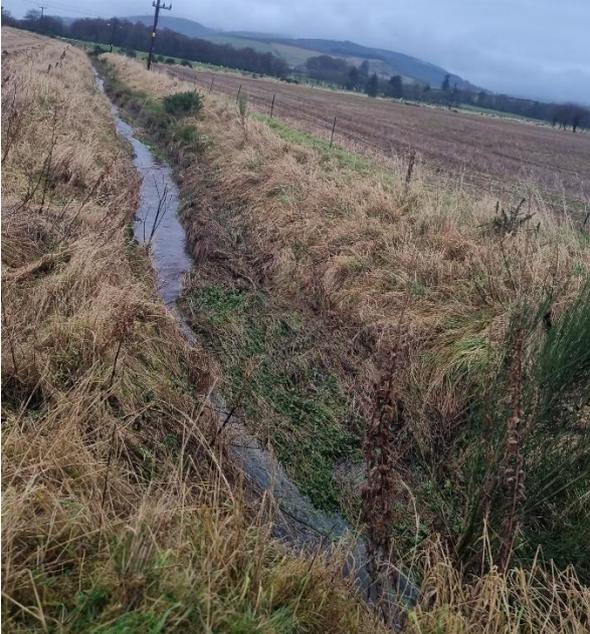
ID – 48 (Existing track crossing)	Mossend Burn
<u>Watercourse Description:</u> Mossend Burn flows east beneath road in large arch culvert. Watercourse has been straightened in this area.	
NGR Ref: 374420 777687	
Photo – Mossend Burn looking west, upstream

Width of watercourse/ drain (m)	1.6 m
Bed Sediment	Mix silt to cobble
Bank Erosion	No
Natural Channel	No
Existing Crossing	Existing Stone Arch bridge crossing
Proposed Crossing	No upgrade. If engineering assessment determines the crossing to be structurally unsound, a temporary over-bridging solution will be put in place during construction.
Additional Mitigation	None
Catchment (km <sup>2</sup> )	1.44 km <sup>2</sup>
Minor Watercourse	No
Main river catchment	Bervie Water
Within catchment of SAC designated river	No
CAR Authorisation Required	No

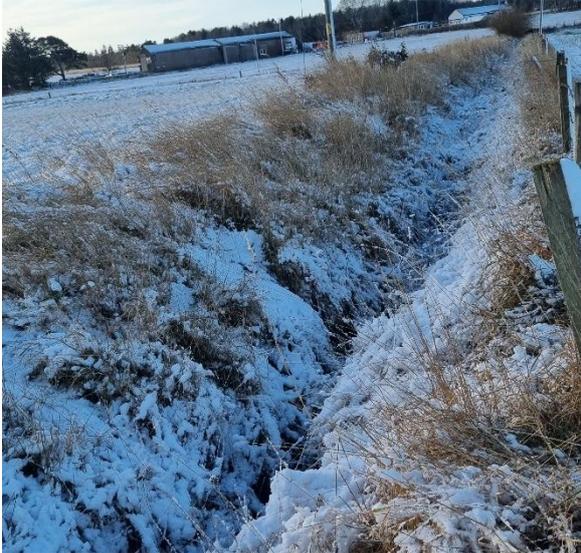
ID – 49 (Existing track crossing)	Mossend Burn
<u>Watercourse Description:</u> Mossend Burn flows west beneath existing in culvert of unknown dimensions.	
NGR Ref: 374716 777667	
Photo – Mossend Burn looking west, upstream

Width of watercourse/ drain (m)	0.7 m
Bed Sediment	Mix silt to cobble
Bank Erosion	No
Natural Channel	No
Existing Crossing	Existing crossing (Culvert dimensions and condition unknown)
Proposed Crossing	No upgrade. If engineering assessment determines the crossing to be structurally unsound, a temporary over-bridging solution will be put in place during construction.
Additional Mitigation	None
Catchment (km <sup>2</sup> )	1.41 km <sup>2</sup>
Minor Watercourse	Yes
Main river catchment	Bervie Water
Within catchment of SAC designated river	No
CAR Authorisation Required	No

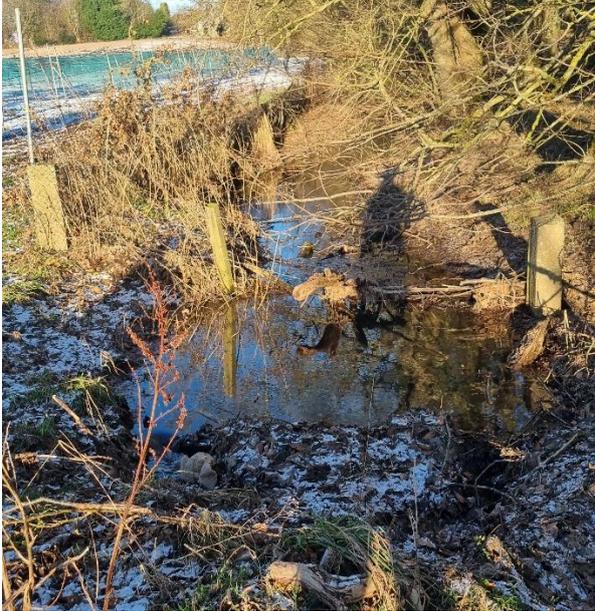
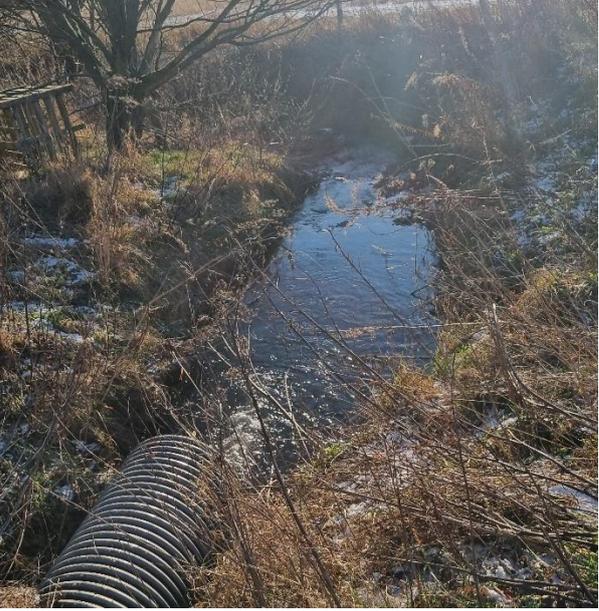
ID – 50 (Existing track crossing)	Nursery Burn
<u>Watercourse Description:</u> Nursery Burn flows south beneath the existing track in a 600 mm pipe culvert.	
NGR Ref: 374688 777954	
Photo – Nursery Burn looking upstream to the north	Photo – looking downstream

Width of watercourse/ drain (m)	1.4 m
Bed Sediment	Gravel to cobble
Bank Erosion	No
Natural Channel	Yes
Existing Crossing	Existing crossing (600 mm pipe culvert)
Proposed Crossing	No upgrade. If engineering assessment determines the crossing to be structurally unsound, a temporary over-bridging solution will be put in place during construction.
Additional Mitigation	None
Catchment (km <sup>2</sup> )	1.40 km <sup>2</sup>
Minor Watercourse	No
Main river catchment	Bervie Water
Within catchment of SAC designated river	No
CAR Authorisation Required	No

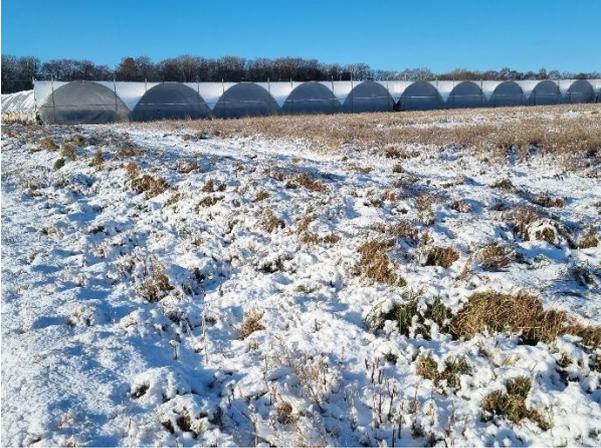
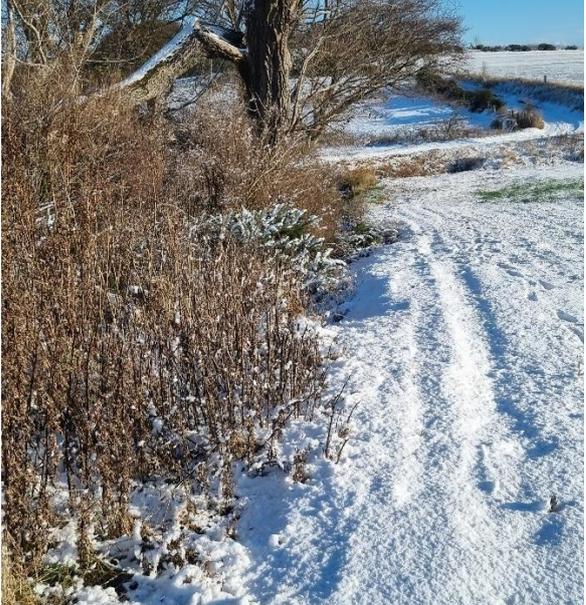
ID – 51 (Proposed track crossing - temporary)	Unnamed Drain
<p><u>Watercourse Description:</u> Minor unnamed drain flows downslope to the east; channel is very unstructured and shallow further west and much deeper and better defined in the east.</p>	
NGR Ref: 374874 778225	
Photo – Shallow poorly defined drain section further west	Photo – Deeper section of channel further east is heavily vegetated

Width of watercourse/ drain (m)	0.3 m
Bed Sediment	Silt
Bank Erosion	No
Natural Channel	No
Existing Crossing	None
Proposed Crossing	<p>Pipe Culvert or Single Span Bridge (temporary). The crossing location is rural and a temporary crossing sized to the 1 in 30 year flow is considered suitable for the location, size of drain and temporary nature of the track crossing. Designing for a 1 in 200 year flow (plus climate change) could result in oversizing the crossing which is not appropriate for a temporary crossing in a rural setting. The catchment area of the drain is small and flood flows in this drain will be low</p> <p>In the event of a higher flood event occurring when the temporary crossing is in place, water would overtop the track and return back into the channel downstream of the track. There are no nearby receptors and there is considered to be no increased flood risk to others.</p>

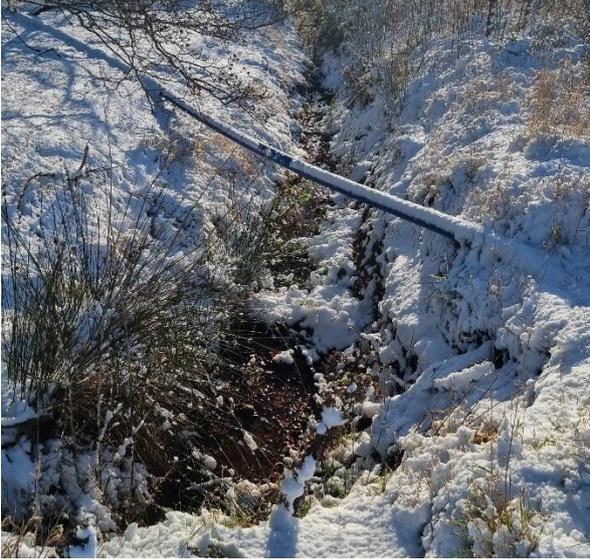
ID – 52 (Existing track crossing)	Unnamed Drain
<u>Watercourse Description:</u> Drainage channel is not mapped but is wide and well defined here with an existing culvert at the track crossing. The channel flows to the south draining commercial agricultural area.	
NGR Ref: 374867 778281	
Photo – Drainage channel at crossing looking south	Photo – Drainage channel viewed looking north

Width of watercourse/ drain (m)	0.9 m
Bed Sediment	Mix silt to pebble
Bank Erosion	No
Natural Channel	No
Existing Crossing	Existing crossing (stone box culvert 600 mm wide by 300 mm high)
Proposed Crossing	No upgrade. If engineering assessment determines the crossing to be structurally unsound, a temporary over-bridging solution will be put in place during construction.
Additional Mitigation	None
Catchment (km <sup>2</sup> )	0.02 km <sup>2</sup>
Minor Watercourse	Yes
Main river catchment	Bervie Water
Within catchment of SAC designated river	No

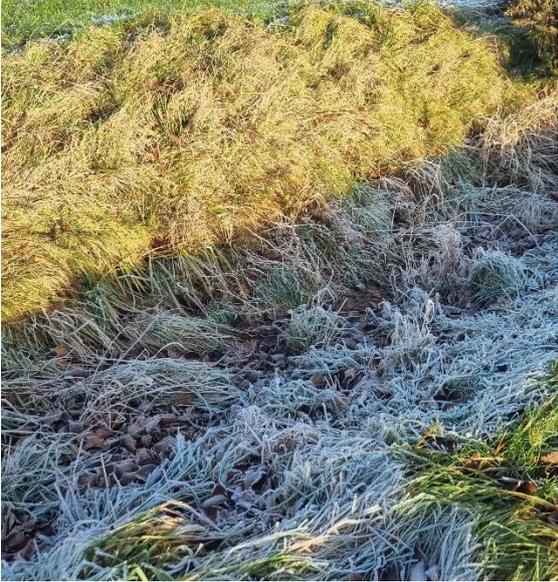
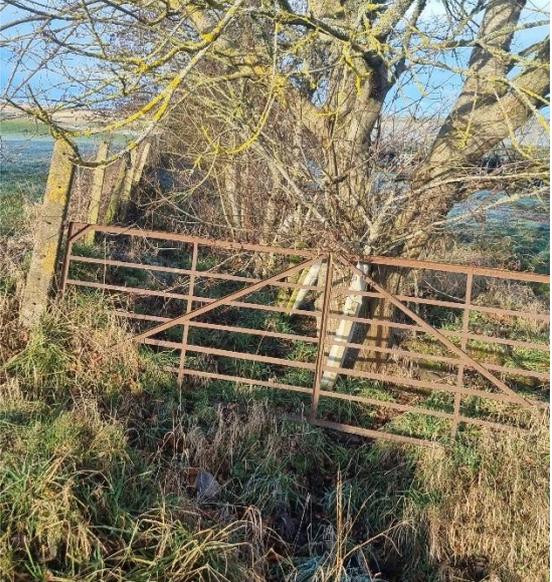
ID – 53 (Proposed track crossing - temporary)	Unnamed Drain
<u>Watercourse Description:</u> Drainage ditch flows to the west. Vegetated channel and highly modified, straightened drainage ditch draining commercial agricultural area. No water/ flow at the time of survey.	
NGR Ref: 374905 779347	
Photo – Drainage ditch, barely any flow and vegetated	Photo – Drain further downstream

Width of watercourse/ drain (m)	0.5 m
Bed Sediment	Silt
Bank Erosion	No
Natural Channel	No
Existing Crossing	None
Proposed Crossing	<p>Pipe Culvert or Single Span Bridge (temporary). The crossing location is rural and a temporary crossing sized to the 1 in 30 year flow is considered suitable for the location, size of drain and temporary nature of the track crossing. Designing for a 1 in 200 year flow (plus climate change) could result in oversizing the crossing, requiring widening of the channel at the crossing and the need for raised embankments, which is not appropriate for a temporary crossing in a rural setting.</p> <p>In the event of a higher flood event occurring when the temporary crossing is in place, water would overtop the track and return back into the channel downstream of the track. There are no nearby receptors and there is considered to be no increased flood risk to others.</p>

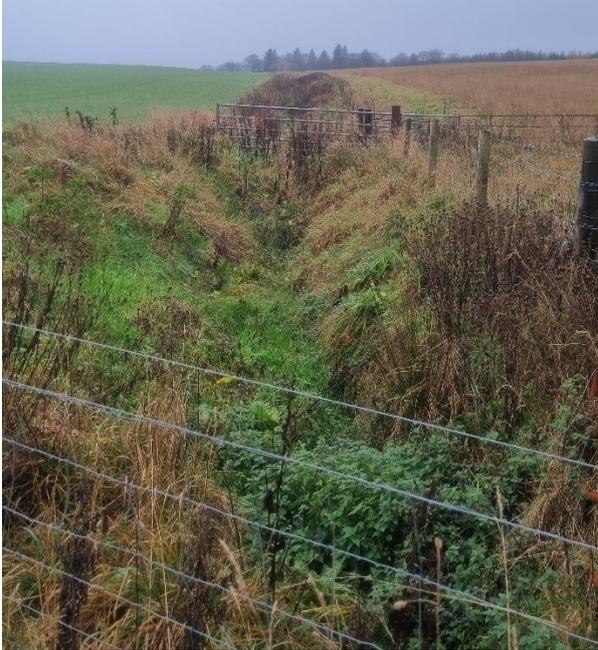
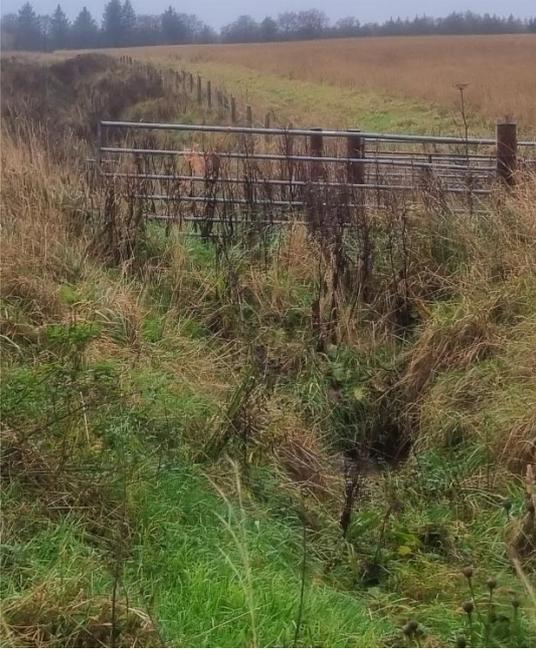
ID – 54 (Proposed track crossing - temporary)	Unnamed Drain
<u>Watercourse Description:</u> Drainage channel flows to the east from field drain outlet.	
NGR Ref: 374443 780365	
Photo – View of watercourse crossing looking upstream

Width of watercourse/ drain (m)	0.5 m
Bed Sediment	Silt
Bank Erosion	No
Natural Channel	No
Existing Crossing	Informal, not a functional existing crossing
Proposed Crossing	<p>Pipe Culvert or Single Span Bridge (temporary). The crossing location is rural and a temporary crossing sized to the 1 in 30 year flow is considered suitable for the location, size of watercourse and temporary nature of the track crossing. Designing for a 1 in 200 year flow (plus climate change) could result in oversizing the bridge, requiring widening of the channel at the crossing and the need for raised embankments, which is not appropriate for a temporary crossing in a rural setting. The proposed design will allow the crossing to be removed at the end of the construction period with no legacy effect on the existing channel.</p> <p>In the event of a higher flood event occurring when the temporary crossing is in place, water would overtop the track and return back into the channel downstream of the track. There are no nearby receptors and there is considered to be no increased flood risk to others.</p>

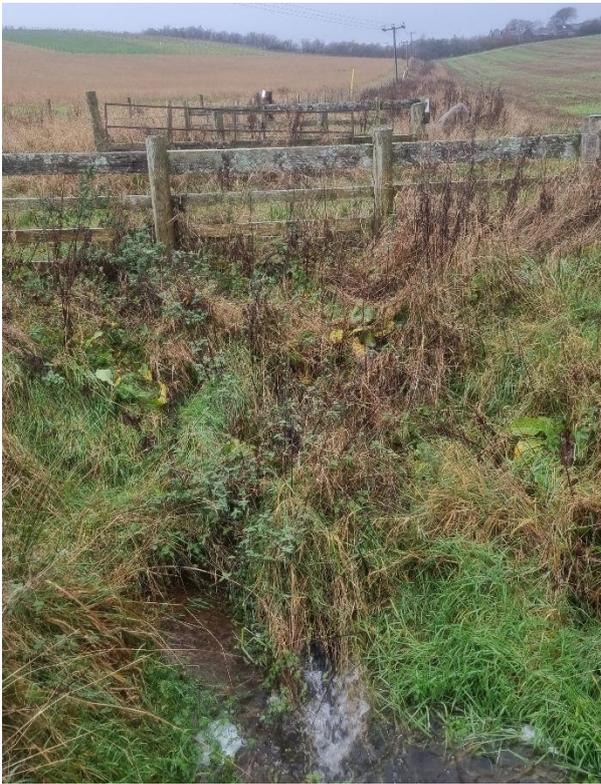
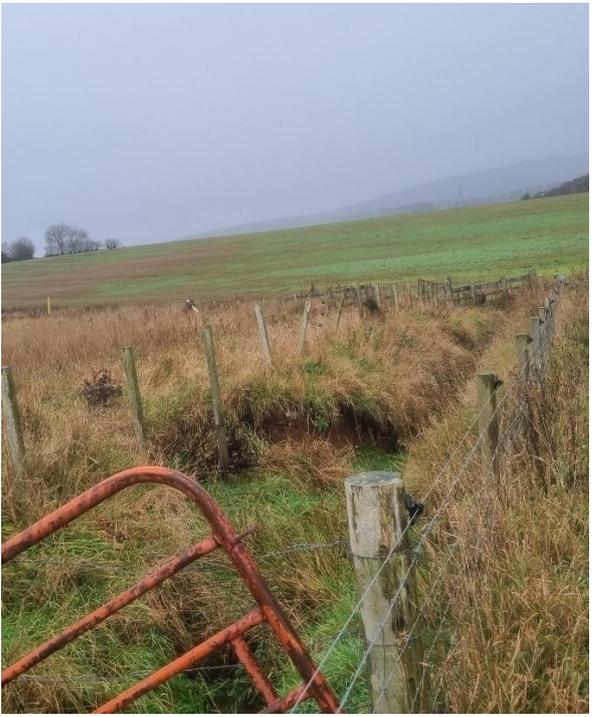
ID – 55 (Existing track crossing)	Unnamed Drain
<u>Watercourse Description:</u> Drain flows east towards the Bervie Water. There is an existing agricultural track crossing with a culvert of unknown dimensions and condition.	
NGR Ref: 374959 780655	
View of drain looking upstream, culvert outlet flow visible at bottom of photo	Drainage ditch tributary confluence and existing crossing visible, viewed looking north, downstream

Width of watercourse/ drain (m)	0.8 m
Bed Sediment	Mix silt to pebble
Bank Erosion	No
Natural Channel	No
Existing Crossing	Existing field crossing, culvert unknown dimensions
Proposed Crossing	No upgrade. If engineering assessment determines the crossing to be structurally unsound, a temporary over-bridging solution will be put in place during construction.
Additional Mitigation	None
Catchment (km <sup>2</sup> )	2 km <sup>2</sup>
Minor Watercourse	Yes
Main river catchment	Bervie Water

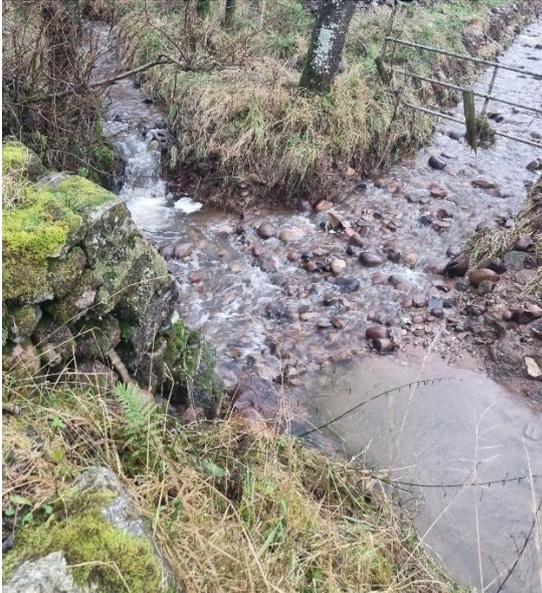
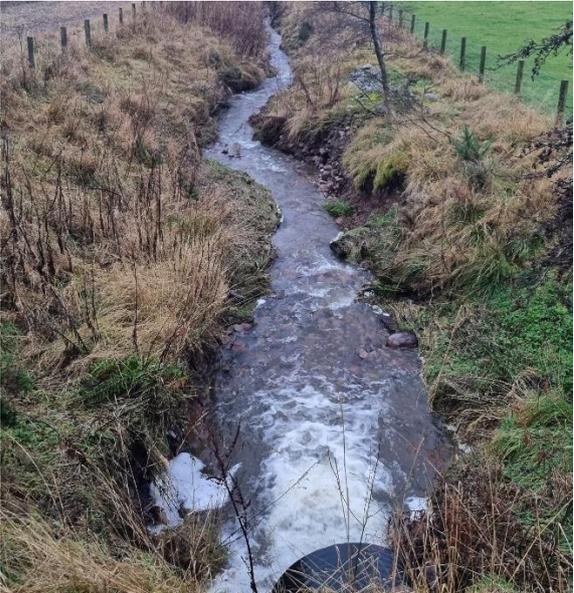
ID – 56 (Existing track crossing)	Pilketty Burn
<u>Watercourse Description:</u> Three drains converge and are culverted beneath the existing road crossing forming the headwaters of the Pilketty Burn which flows south from the crossing.	
NGR Ref: 376125 782033	
Photo – Views convergence of 3 watercourse feeding into culvert inlet	Photo – Culvert (crossing) outlet looking southeast downstream along Pilketty Burn

Width of watercourse/ drain (m)	1.6 m
Bed Sediment	Mix silt to cobble
Bank Erosion	No
Natural Channel	No
Existing Crossing	Existing crossing (stone arch with hidden 500 mm pipe)
Proposed Crossing	No upgrade. If engineering assessment determines the crossing to be structurally unsound, a temporary over-bridging solution will be put in place during construction.
Additional Mitigation	None
Catchment (km <sup>2</sup> )	0.78 km <sup>2</sup>
Minor Watercourse	No
Main river catchment	Bervie Water

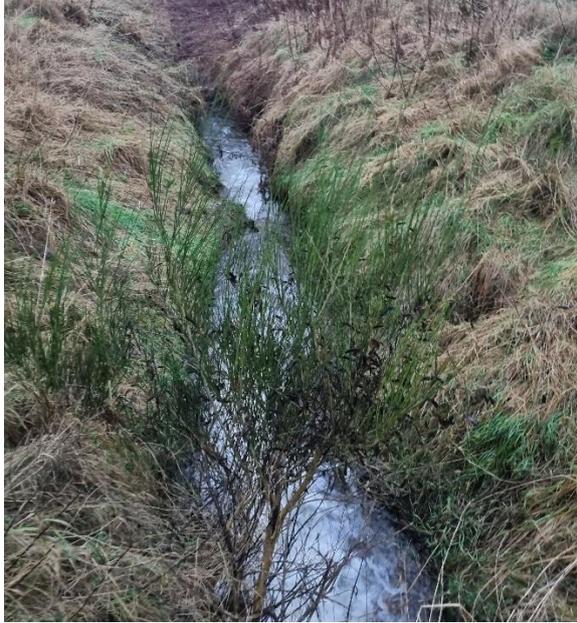
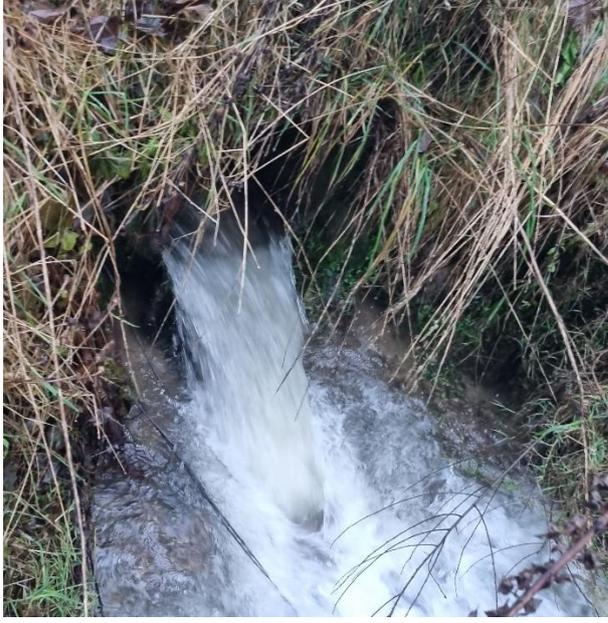
ID – 57 (Existing track crossing)	Killer Burn
<u>Watercourse Description:</u> The watercourse flows to the east, one of several headwater tributary branches of the Killer Burn which converge nearby downstream, beneath an existing track crossing.	
NGR Ref: 377233 784216	
Photo – Shows Killer Burn flowing east	Photo – Culvert outlet of tributary to Killer Burn

Width of watercourse/ drain (m)	0.9 m
Bed Sediment	Mix silt to pebble
Bank Erosion	No
Natural Channel	No - heavily modified
Existing Crossing	Existing track crossing with 450 mm pipe culvert
Proposed Crossing	No upgrade. If engineering assessment determines the crossing to be structurally unsound, a temporary over-bridging solution will be put in place during construction.
Additional Mitigation	None
Catchment (km <sup>2</sup> )	0.32 km <sup>2</sup>
Minor Watercourse	Yes
Main river catchment	Carron Water
Within catchment of SAC designated river	No

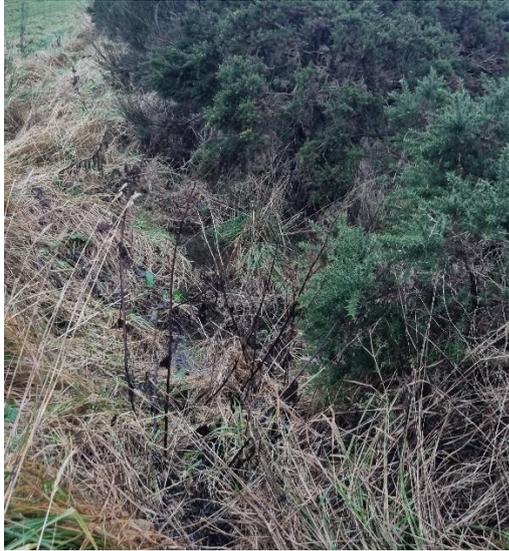
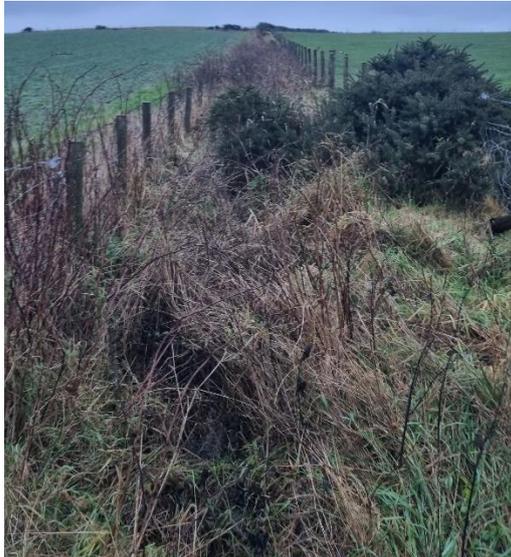
ID – 58 (Proposed track crossing - temporary)	Unnamed Drain
<u>Watercourse Description:</u> The unnamed drain flows west and is a tributary of the Killer Burn. The drain channel is heavily vegetated at the proposed temporary track crossing location.	
NGR Ref: 378441 784227	
Photo – Very vegetated drainage channel, looking downstream to the west	Photo – Drainage channel, looking upstream to the east

Width of watercourse/ drain (m)	0.4 m
Bed Sediment	Silt
Bank Erosion	Yes
Natural Channel	No
Existing Crossing	None
Proposed Crossing	<p>Pipe Culvert or Single Span Bridge (temporary). The crossing location is rural and a temporary crossing sized to the 1 in 30 year flow is considered suitable for the location, size of drain and temporary nature of the track crossing. Designing for a 1 in 200 year flow (plus climate change) could result in oversizing the crossing, requiring widening of the channel at the crossing and the need for raised embankments, which is not appropriate for a temporary crossing in a rural setting.</p> <p>In the event of a higher flood event occurring when the temporary crossing is in place, water would overtop the track and return back into the channel downstream of the track. There are no nearby receptors and there is considered to be no increased flood risk to others.</p>

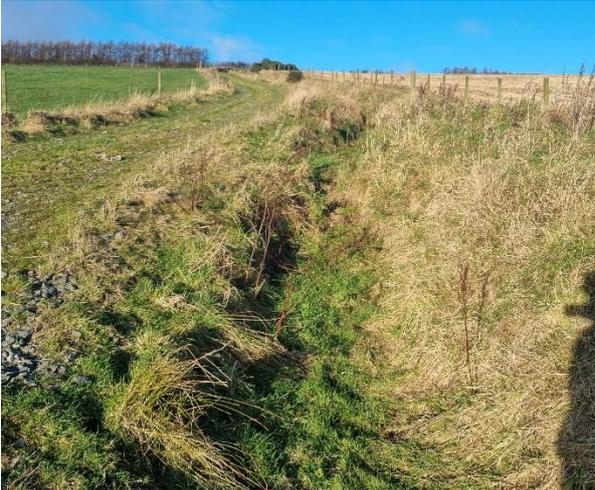
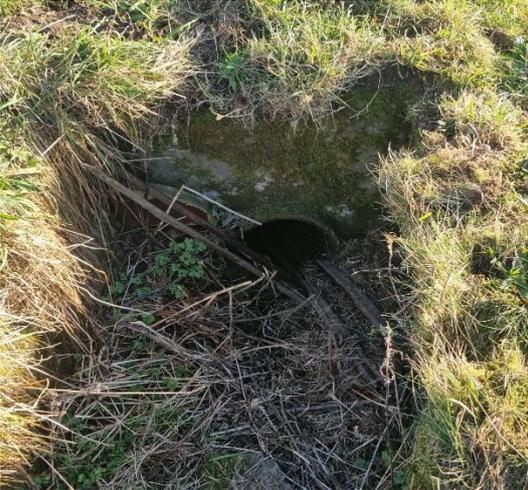
ID – 59 (Proposed track crossing - temporary)	Unnamed Drain
<p><u>Watercourse Description:</u> The unnamed drain flows south in well-defined drainage channel and is culverted in a 300 mm pipe for around 300 m to the southeast just downstream of the proposed crossing location. Drain was dry at time of survey.</p>	
NGR Ref: 378441 784227	
Photo – Drainage ditch at point of proposed crossing, dry at time of survey	Photo – Culvert inlet just downstream of proposed crossing

Width of watercourse/ drain (m)	1.1 m
Bed Sediment	Silt
Bank Erosion	Yes
Natural Channel	No
Existing Crossing	None, 300 mm pipe culvert just downstream of proposed crossing
Proposed Crossing	<p>Pipe Culvert or Single Span Bridge (temporary). The drain enters an existing culvert just at/downstream of the proposed crossing location, which may already restrict flood flows downstream. The crossing location is rural and a temporary crossing sized to the 1 in 30 year flow or to maintain the existing capacity of the channel is considered suitable for the location, size of watercourse and temporary nature of the track crossing.</p> <p>In the event of a higher flow event occurring when the temporary crossing is in place, it is considered that the existing culvert will already restrict flood flows downstream. The temporary crossing will be no smaller than the existing culvert and therefore will not increase flood risk. There are no nearby receptors and it is considered that the temporary crossing will not increase flood risk to other receptors.</p>

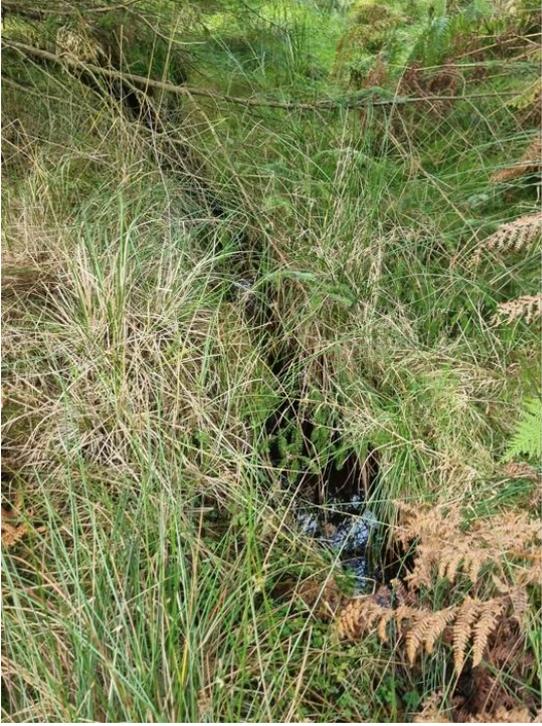
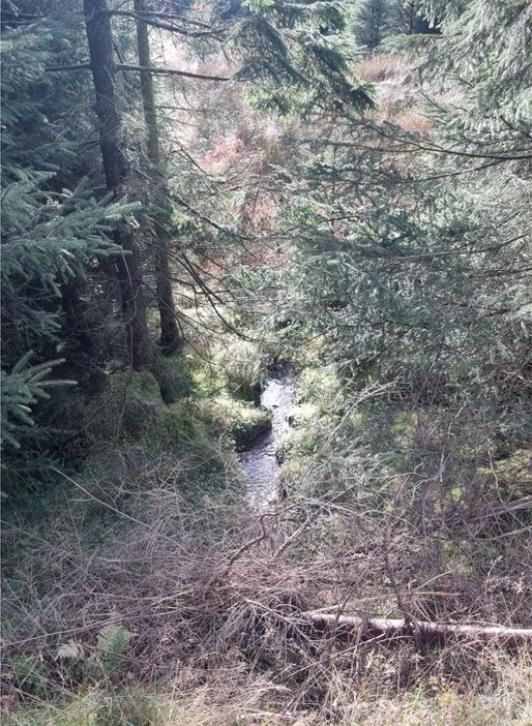
ID – 60 (Existing track crossing)	Whiting Burn
<u>Watercourse Description:</u> Whiting Burn flows beneath existing track bridge via a 300 mm pipe culvert crossing to the south.	
NGR Ref: 378532 786105	
Photo – Whiting Burn – upstream of track crossing	Photo – Whiting Burn – from track

Width of watercourse/ drain (m)	0.4 m
Bed Sediment	Silt
Bank Erosion	No
Natural Channel	Yes
Existing Crossing	Existing 300 mm pipe culvert
Proposed Crossing	No upgrade. If engineering assessment determines the crossing to be structurally unsound, a temporary over-bridging solution will be put in place during construction.
Additional Mitigation	None
Catchment (km <sup>2</sup> )	0.41 km <sup>2</sup>
Minor Watercourse	Yes
Main river catchment	Carron Water
Within catchment of SAC designated river	No
CAR Authorisation Required	No

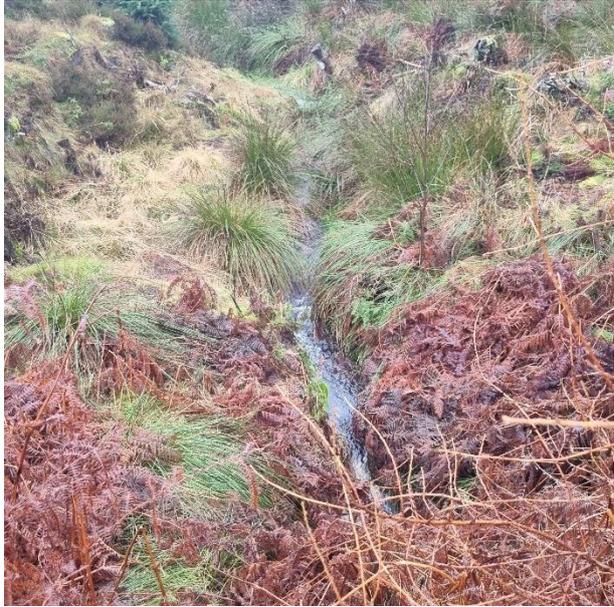
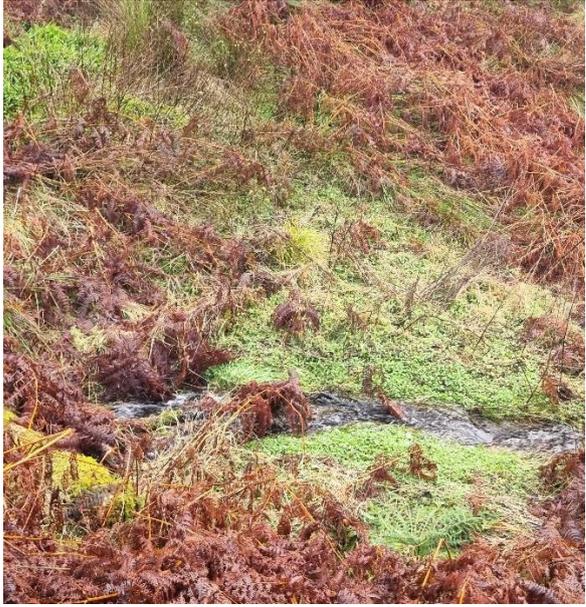
ID – 61 (Existing track crossing)	Burn of Elfhill
<p><b>Watercourse Description:</b> Burn of Elfhill flows beneath existing track crossing to the south. There is an existing culvert, but culvert dimensions are unknown at the time of writing. This crossing is on the Burn of Elfhill and is approximately 300 m downstream from crossing 60.</p>	
NGR Ref: 379197 785944	
Photo – Burn of Elfhill viewed looking upstream (north)	Photo – Culvert outlet on downstream side of existing crossing

Width of watercourse/ drain (m)	0.4 m
Bed Sediment	Unknown – likely mixed/pebble
Bank Erosion	No
Natural Channel	Yes
Existing Crossing	Existing culvert (dimensions unknown)
Proposed Crossing	No upgrade. If engineering assessment determines the crossing to be structurally unsound, a temporary over-bridging solution will be put in place during construction.
Additional Mitigation	None
Catchment (km <sup>2</sup> )	0.60 km <sup>2</sup>

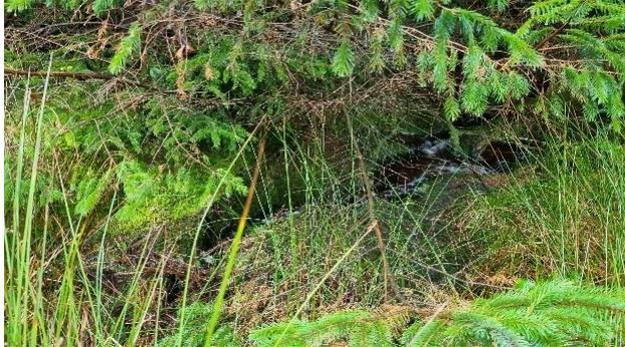
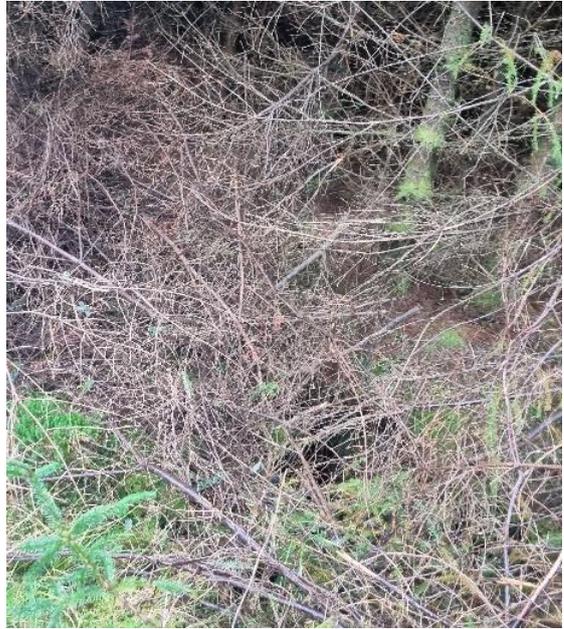
ID – 62 (Existing track crossing)	Burn of Elfhill
<u>Watercourse Description:</u> Burn of Elfhill flows beneath existing track crossing to the south, culvert dimensions unknown.	
NGR Ref: 379042 786220	
Photo – upstream side of Burn of Elfhill in forestry	Photo – Downstream side of Burn of Elfhill

Width of watercourse/ drain (m)	0.4 m
Bed Sediment	Pebble
Bank Erosion	No
Natural Channel	Yes
Existing Crossing	Existing culvert (dimensions unknown)
Proposed Crossing	No upgrade. If engineering assessment determines the crossing to be structurally unsound, a temporary over-bridging solution will be put in place during construction.
Additional Mitigation	None
Catchment (km <sup>2</sup> )	0.36 km <sup>2</sup>
Minor Watercourse	Yes
Main river catchment	Carron Water
Within catchment of SAC designated river	No
CAR Authorisation Required	No
