<b>ID – 39</b> <b>(Proposed track crossing - temporary)</b>	<b>Unnamed Drain</b>
<p><u>Watercourse Description:</u> Large field drain, which is a tributary to the Sauchie Burn, flows to the southeast in a straightened drainage channel</p>	
NGR Ref: 365536 770146	
Photo – Drainage channel further upstream	Photo – Drainage channel further upstream

## Section D

## Section E

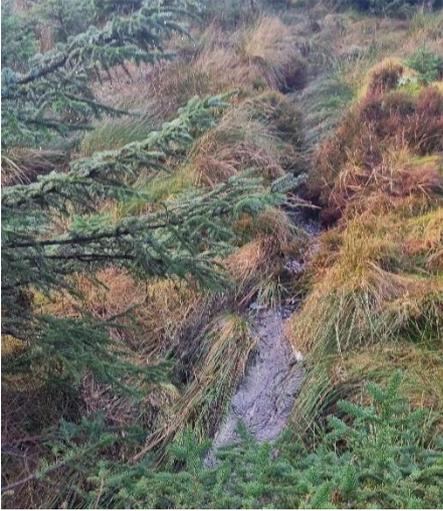
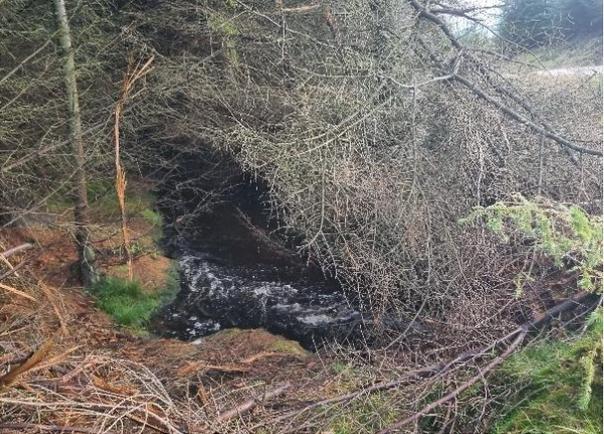
ID – 63 (Existing track crossing)	Burn of Day
<u>Watercourse Description:</u> Burn of Day flows beneath existing track crossing to the east, culvert dimensions unknown.	
NGR Ref: 379998 786787	
Photo – Burn of Day looking upstream	Photo – Burn of Day looking downstream

Width of watercourse/ drain (m)	0.6 m
Bed Sediment	Pebble
Bank Erosion	No
Natural Channel	Yes
Existing Crossing	Existing culvert (dimensions unknown)
Proposed Crossing	No upgrade. If engineering assessment determines the crossing to be structurally unsound, a temporary over-bridging solution will be put in place during construction.
Additional Mitigation	None
Catchment (km <sup>2</sup> )	0.8 km <sup>2</sup>
Minor Watercourse	No
Main river catchment	Cowie Water
Within catchment of SAC designated river	No
CAR Authorisation Required	No

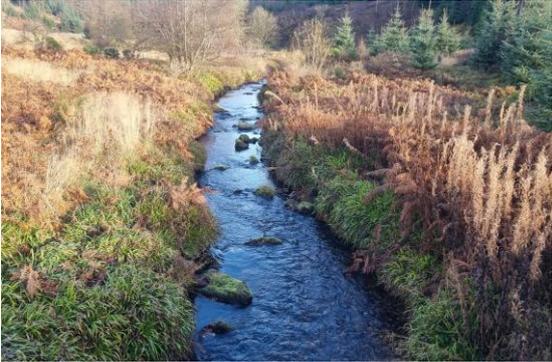
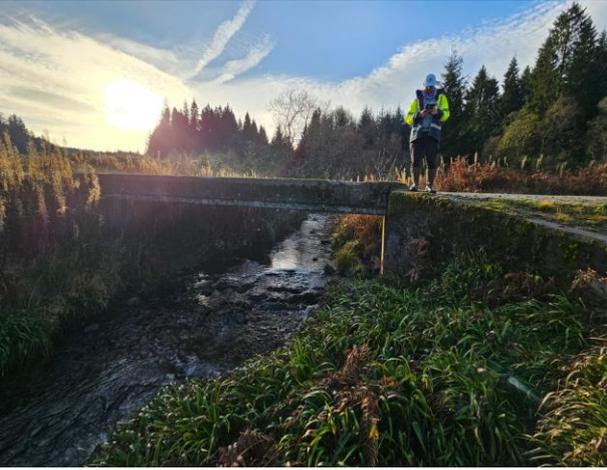
ID – 64 (Existing track crossing)	Cowie Water
<p><u>Watercourse Description:</u> Cowie Water flows beneath existing single span bridge crossing. SEPA future flood mapping indicates that the 200 year + climate change floodplain at the crossing location is approximately 70 m wide, indicating that some of the nearby tracks will have some floodwater during extreme events.</p>	
<p>NGR Ref: 376448 787359</p>	
<p>Photo – Cowie Water – looking upstream from bridge crossing</p>	<p>Photo – Cowie Water – bridge - looking downstream</p>

<p>Width of watercourse/ drain (m)</p>	<p>2.9 m            Bridge deck is 2.2 m high above channel bed and 6 m wide</p>
<p>Bed Sediment</p>	<p>Cobble, boulder</p>
<p>Bank Erosion</p>	<p>No</p>
<p>Natural Channel</p>	<p>Yes</p>
<p>Existing Crossing</p>	<p>Single span bridge</p>
<p>Proposed Crossing</p>	<p>An overbridging system is proposed at this crossing to allow passing of abnormal loads during the construction phase. This is a temporary 'overbridge' which will sit on the deck of the existing bridge/track. There will be no work in the watercourse and no impact to the bed and bank.</p>

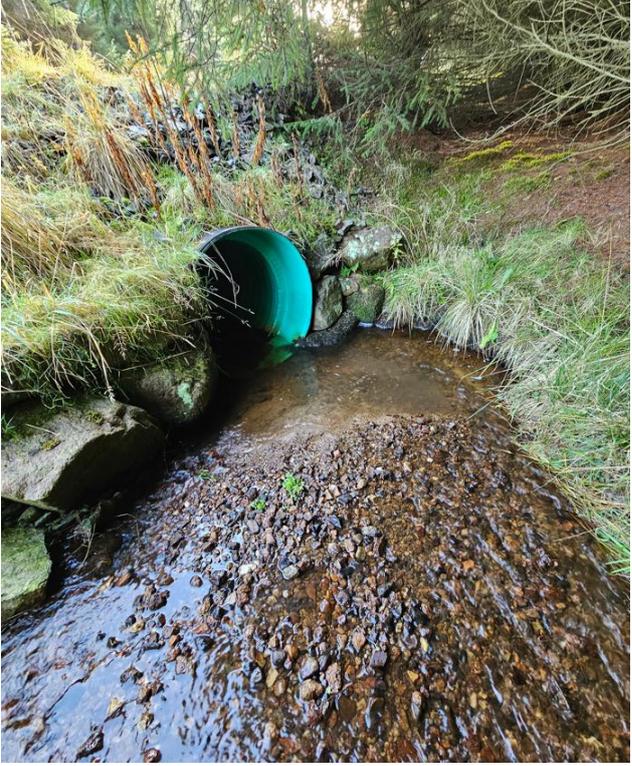
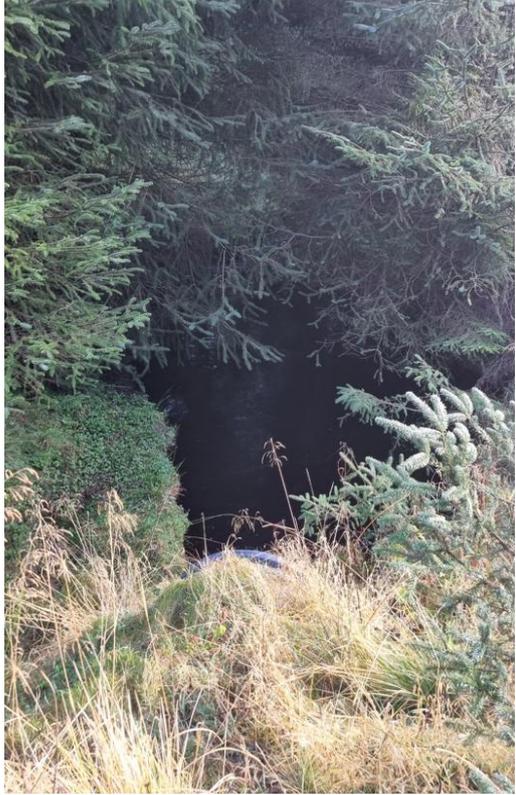
ID – 65 (Existing track crossing)	West Dumer Burn
<u>Watercourse Description:</u> West Dumer Burn flows beneath existing track via a 1000 mm diameter culvert.	
NGR Ref: 376548 787859	
Photo – West Dumer Burn - upstream of the track	West Dumer Burn - downstream of the track

Width of watercourse/ drain (m)	1.3 m
Bed Sediment	Pebble, gravel
Bank Erosion	No
Natural Channel	Yes
Existing Crossing	Existing crossing with 1000 mm pipe culvert
Proposed Crossing	No upgrade. If engineering assessment determines the crossing to be structurally unsound, a temporary over-bridging solution will be put in place during construction.
Additional Mitigation	None
Catchment (km <sup>2</sup> )	1.35 km <sup>2</sup>
Minor Watercourse	No
Main river catchment	Cowie Water
Within catchment of SAC designated river	No
CAR Authorisation Required	No

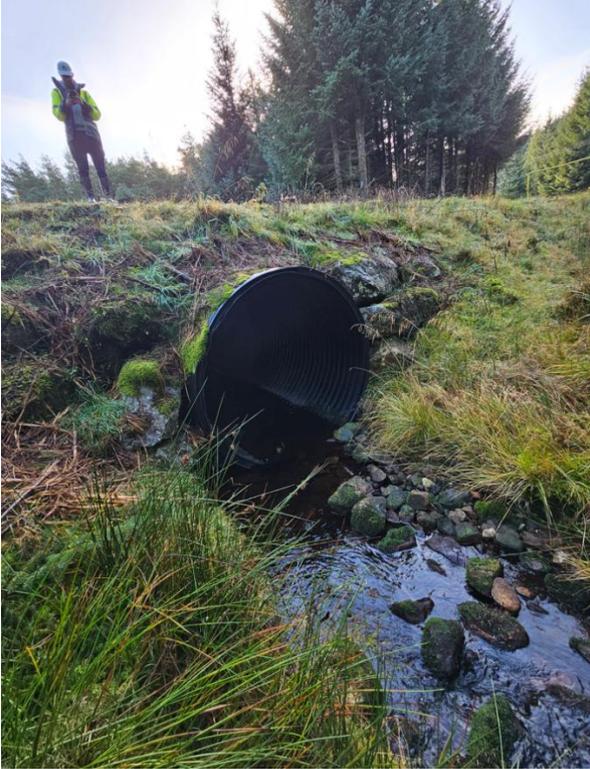
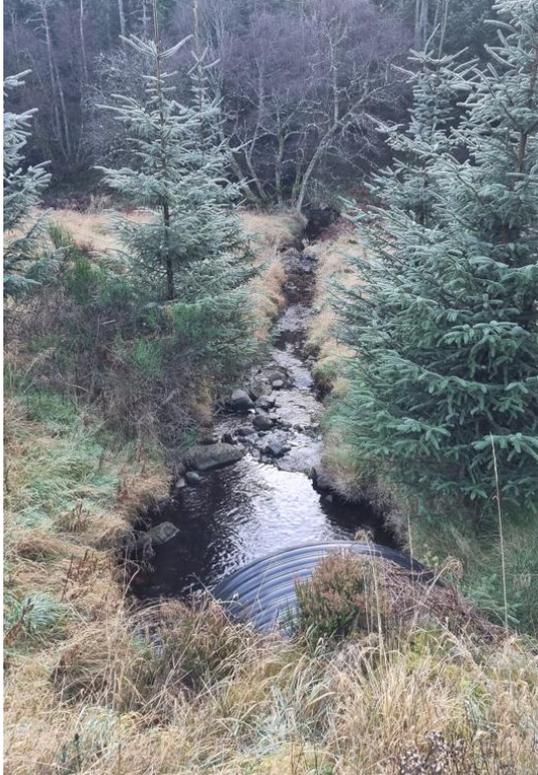
ID – 66 (Existing track crossing)	East Dumer Burn
<u>Watercourse Description:</u> East Dumer Burn flows beneath existing track through a 2000 mm diameter culvert.	
NGR Ref: 376585 787919	
Photo – East Dumer Burn – upstream of the track	East Dumer Burn – downstream of the track

Width of watercourse/ drain (m)	1.7 m
Bed Sediment	Gravel, cobble and boulder
Bank Erosion	No
Natural Channel	Yes
Existing Crossing	Existing crossing with 2000 mm pipe culvert
Proposed Crossing	No upgrade. If engineering assessment determines the crossing to be structurally unsound, a temporary over-bridging solution will be put in place during construction.
Additional Mitigation	None
Catchment (km <sup>2</sup> )	1.77 km <sup>2</sup>
Minor Watercourse	No
Main river catchment	Cowie Water
Within catchment of SAC designated river	No
CAR Authorisation Required	No

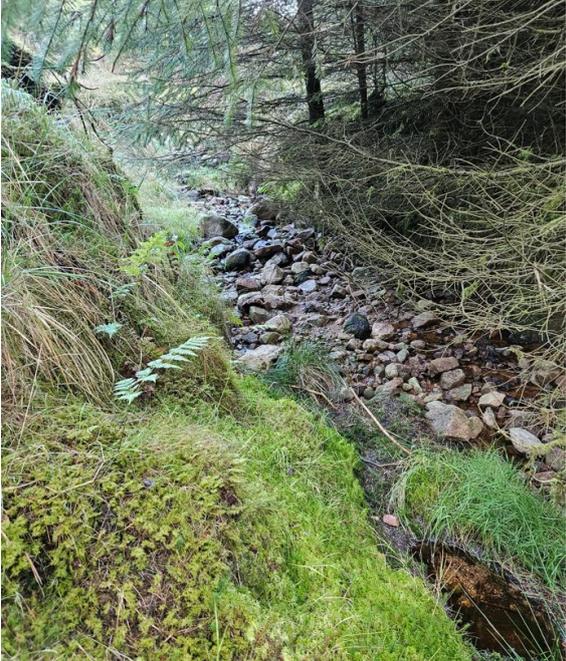
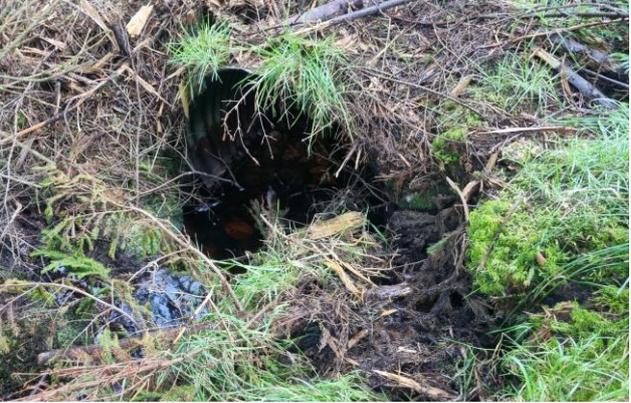
ID – 67 (Existing track crossing)	Irish Burn
<b>Watercourse Description:</b> Irish Burn flows beneath existing track, as a natural gravel and cobble bed channel with 1000 mm diameter culvert under the track.	
NGR Ref: 377110 788249	
Photo – Irish burn (upstream of track)	Photo – Irish burn (culvert - downstream of track)

Width of watercourse/ drain (m)	1.3 m
Bed Sediment	Gravel, cobble, boulder
Bank Erosion	No
Natural Channel	Yes
Existing Crossing	Existing crossing with 1000 mm pipe culvert
Proposed Crossing	No upgrade. If engineering assessment determines the crossing to be structurally unsound, a temporary over-bridging solution will be put in place during construction.
Additional Mitigation	None
Catchment (km <sup>2</sup> )	0.53 km <sup>2</sup>
Minor Watercourse	No
Main river catchment	Cowie Water
Within catchment of SAC designated river	No
CAR Authorisation Required	No

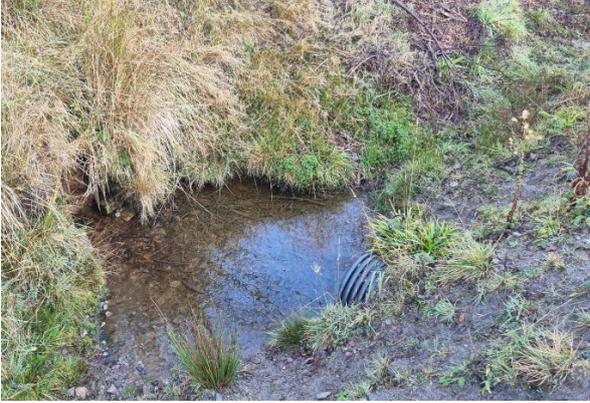
ID – 68 (Existing track crossing)	Unnamed Drain
<u>Watercourse Description:</u> Small unnamed forestry drain which flows beneath existing track in a 500 mm diameter culvert.	
NGR Ref: 378211 788385	
Photo – upstream of track

Width of watercourse/ drain (m)	~ 0.3 m
Bed Sediment	Mixed
Bank Erosion	No
Natural Channel	No
Existing Crossing	Existing crossing with 500 mm pipe culvert
Proposed Crossing	No upgrade. If engineering assessment determines the crossing to be structurally unsound, a temporary over-bridging solution will be put in place during construction.
Additional Mitigation	None
Catchment (km <sup>2</sup> )	0.05 km <sup>2</sup>
Minor Watercourse	Yes
Main river catchment	Cowie Water
Within catchment of SAC designated river	No
CAR Authorisation Required	No

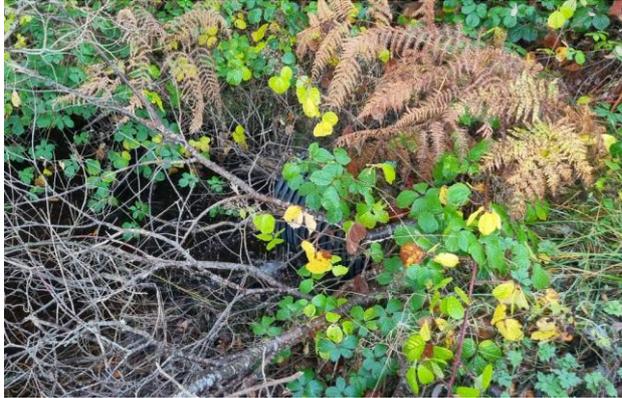
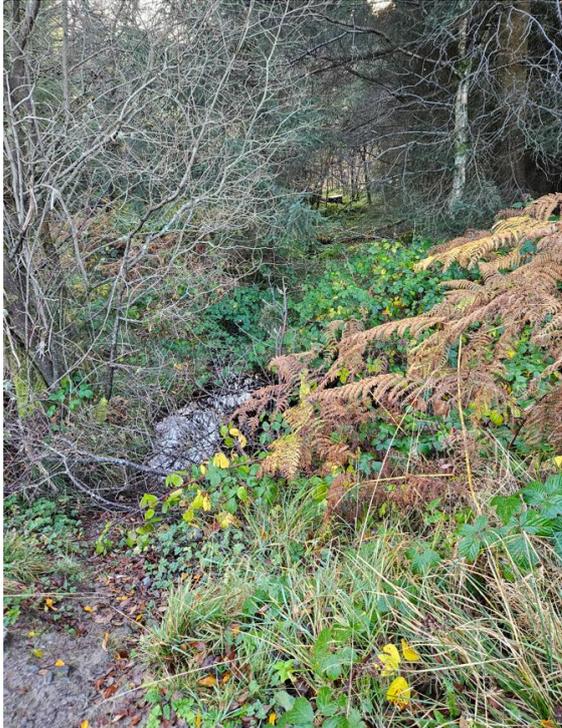
ID – 69 (Existing track crossing)	Unnamed Watercourse
<p><b>Watercourse Description:</b> Small unnamed burn flows beneath existing track to the south and is culverted under the track. A Private Water Supply (PWS) offtake and tank was observed approximately 30 m downstream of the existing track crossing. It is assumed that this is the PWS for the Tillybreak property.</p>	
NGR Ref: 378268 788409	
Photo – watercourse / culvert looking upstream from track	Photo – watercourse looking downstream from track

Width of watercourse/ drain (m)	~ 0.2 – 0.4 m
Bed Sediment	Mixed sediment
Bank Erosion	No
Natural Channel	Yes
Existing Crossing	Existing crossing with 400 mm pipe culvert
Proposed Crossing	No upgrade. If engineering assessment determines the crossing to be structurally unsound, a temporary over-bridging solution will be put in place during construction.
Additional Mitigation	None
Catchment (km <sup>2</sup> )	0.14 km <sup>2</sup>

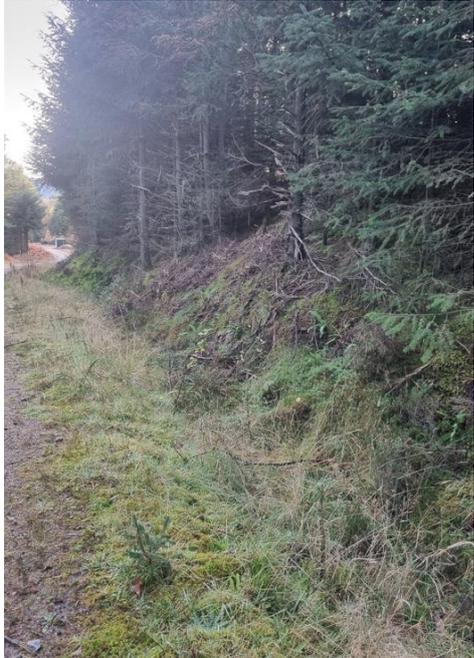
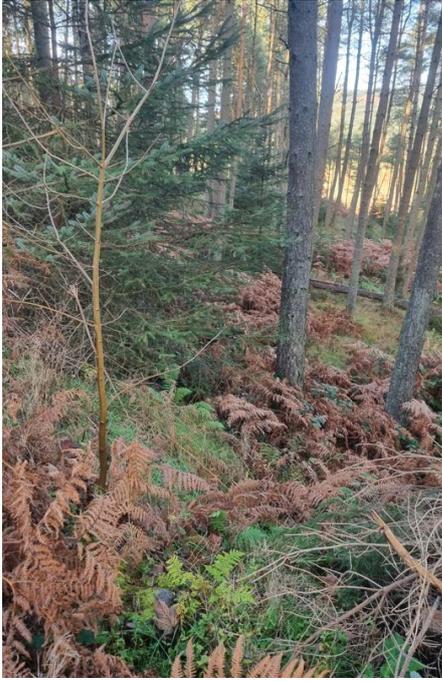
ID – 70 (Existing track crossing)	Unnamed Drain
<p><b>Watercourse Description:</b> The small drain flows southeast and is culverted beneath the existing access track. The drain was dry at the time of the site visit and the culvert was not visible. The drain was clearly heavily modified by forestry.</p>	
NGR Ref: 378602 789396	
Photo – dry drain upstream of track	Photo – dry drain downstream of track

Width of watercourse / drain (m)	Estimated ~ 0.9 m
Bed Sediment	Vegetated Channel (no flow at time of site visit)
Bank Erosion	No
Natural Channel	No
Existing Crossing	Existing crossing with culvert of unknown dimensions
Proposed Crossing	No upgrade. If engineering assessment determines the crossing to be structurally unsound, a temporary over-bridging solution will be put in place during construction.
Additional Mitigation	None
Catchment (km <sup>2</sup> )	0.1 km <sup>2</sup>
Minor Watercourse	Yes

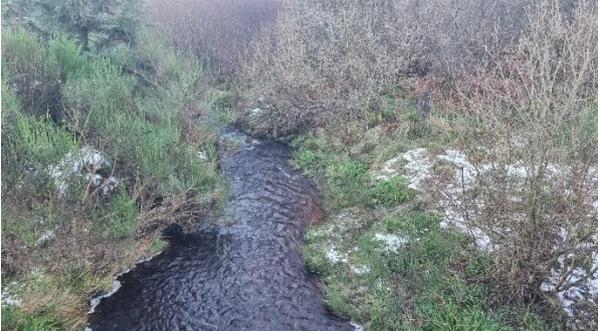
ID – 71 (Existing track crossing)	Black Burn
<p><b>Description:</b> At the crossing location, the Black Burn is crossed by an existing large bridge crossing in a ~ 2.4 m wide channel. Black Burn flows southeast.</p>	
NGR Ref: 378949 789314	
<p>Photo – Black Burn looking downstream</p>

Width of watercourse (m)	2.4 m
Bed Sediment	Mix of pebble and cobble
Bank Erosion	Yes some bank erosion observed near crossing
Natural Channel	Yes
Existing Crossing	Existing Bridge
Proposed Crossing	No upgrade. If engineering assessment determines the crossing to be structurally unsound, a temporary over-bridging solution will be put in place during construction.
Additional Mitigation	None
Catchment (km <sup>2</sup> )	7.85 km <sup>2</sup>
Minor Watercourse	No
Main river catchment	Cowie Water
Within catchment of SAC designated river	No
CAR Authorisation Required	No

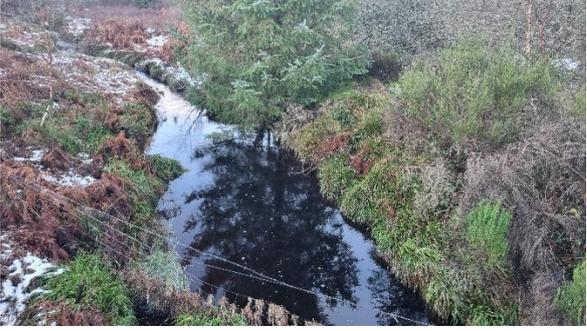
<p>Photo – Black Burn looking upstream from crossing</p>

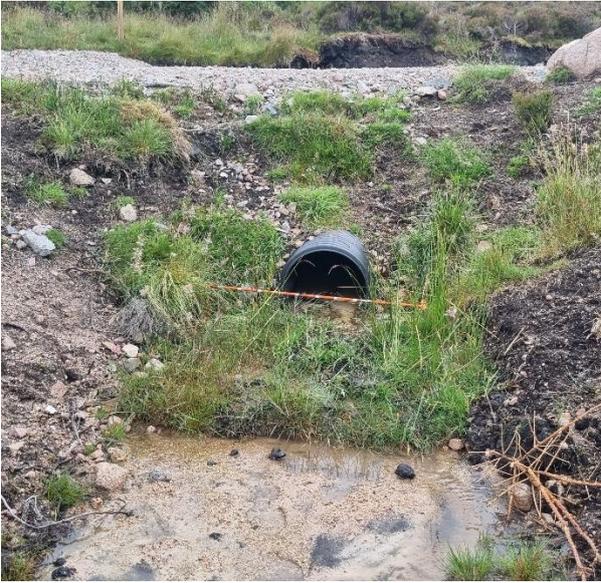
ID – 72 (Existing track crossing)	Unnamed Drain
<p><b>Description:</b> Minor watercourse flows from peat layer overlying clay/rock layer in narrow channel to the west, crosses beneath existing track in 450 mm culvert and spreads into wider channel.</p>	
<p>NGR Ref: 378949 790449</p>	
<p>Photo – Culvert outlet (450 mm)</p>

<p>Width of watercourse (m)</p>	<p>0.3 m</p>
<p>Bed Sediment</p>	<p>Mix of silt to cobble</p>
<p>Bank Erosion</p>	<p>Yes some minor erosion</p>
<p>Natural Channel</p>	<p>Yes - modified</p>
<p>Existing Crossing</p>	<p>Existing Crossing with 450 mm pipe culvert</p>
<p>Proposed Crossing</p>	<p>No upgrade. If engineering assessment determines the crossing to be structurally unsound, a temporary over-bridging solution will be put in place during construction.</p>
<p>Additional Mitigation</p>	<p>None</p>

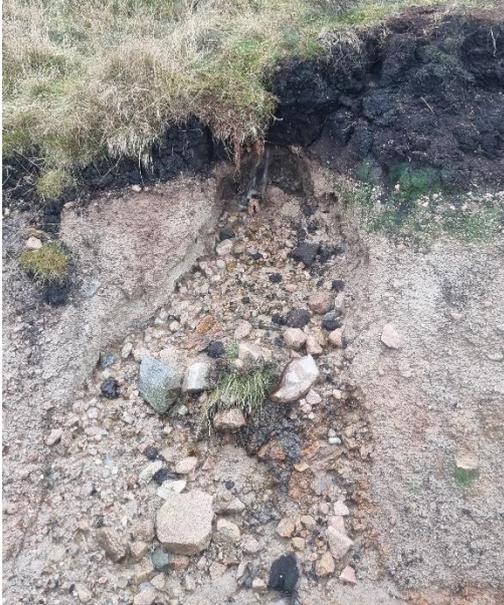
<p>Photo – watercourse upstream of crossing, with peat layer overlying clay/rock</p>
