**Volume 5: Appendix 11.3 – Protected Species
Survey Report**

1.1.1 This appendix presents information relevant to the Kintore to Tealing 400 kV Overhead Line (OHL) Connection. It should be read in conjunction with **Volume 1, Chapter 3: Project Description** of the Environmental Impact Assessment (EIA) for full details of the Proposed Development, and **Volume 2, Chapter 11: Ecology** for an assessment of the effects of the Proposed Development upon Ecology.

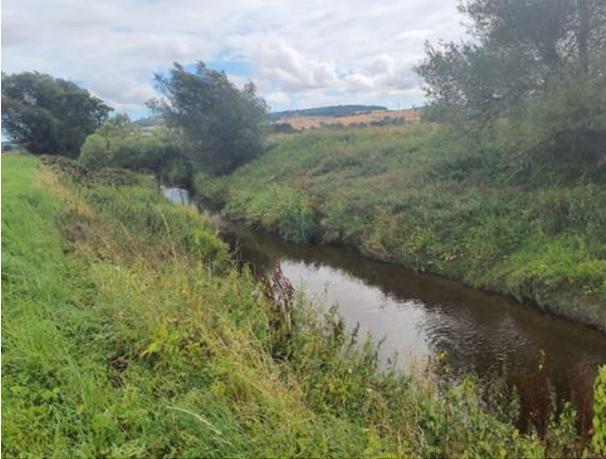
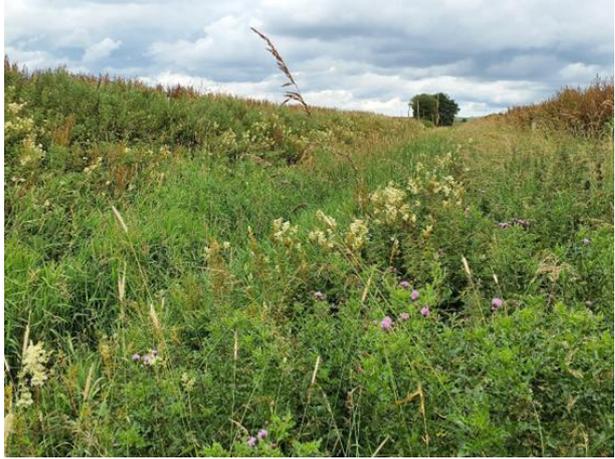
<p>Photo reference: 11.3.1 Kerbet Water with sub-optimal habitat for otter, but unsuitable for beaver and water vole.</p>	<p>Photo reference 11.3.2 Field drain connected to the Kerbet Water with unsuitable habitat for otter, beaver and water vole.</p>

NO 40966 48117	Between S168 and S167	Kerbet Water	<p>The watercourse is typically 2-7 m wide within the ESA, ranges from 0.2 m to 1 m in depth approximately and had a mixture of silt, fine sand, pebble and cobble substrate. It's flow rate was slow to moderate. This watercourse is channelised with dense vegetation overhanging with scattered riparian trees. It has been subject to drainage and run off from the surrounding agricultural land along with a section of erosion being noted. This watercourse is connected to the Dean Water and subsequently the Loch of Forfar. The surrounding terrestrial habitat is dominated by agricultural land used for cereal crops with broadleaved woodland to the</p>	Intersects the whole LOD, extending from west to southeast.	Photo reference: 11.3.1

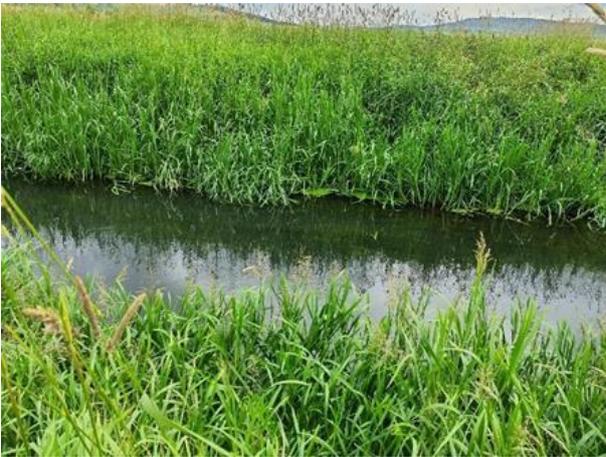
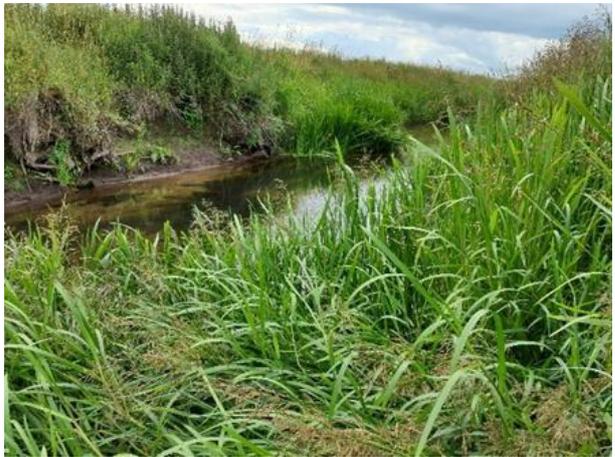
<p>Photo reference: 11.3.3 Dean Water with sub-optimal habitat for otter, but unsuitable for beaver and water vole.</p>	<p>Photo reference: 11.3.4 Another image of Dean Water to show the river bank from a different angle.</p>

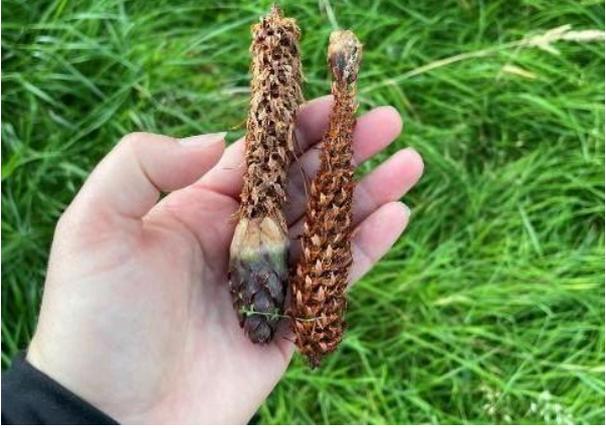
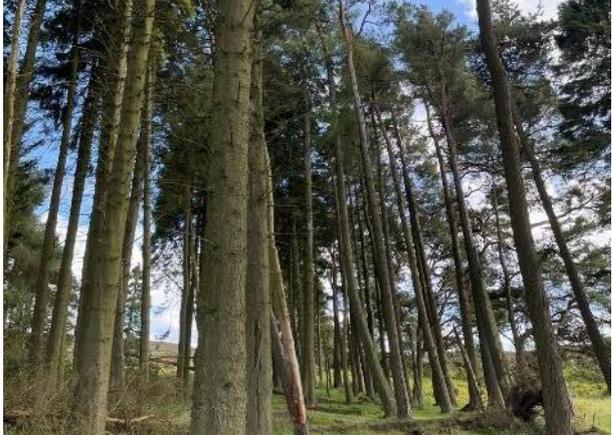
<p>Photo reference: 11.3.5 Red squirrel feeding remains found in coniferous woodland south of Hayston Hill.</p>	<p>Photo reference: 11.3.6 Coniferous woodland south of Hayston Hill. Suitable red squirrel and pine marten habitat.</p>

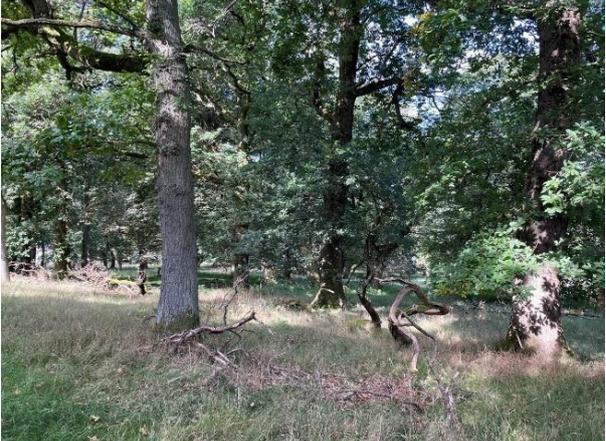
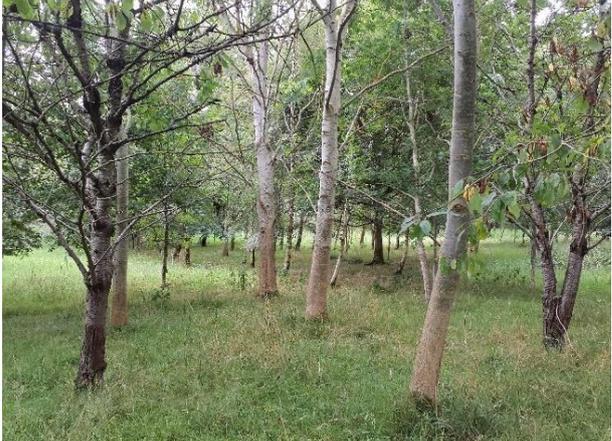
<p>Photo reference: 11.3.7 Broadleaved woodland northwest of Hayston Hill. Sub-optimal red squirrel and pine marten habitat.</p>	<p>Photo reference: 11.3.8 Broadleaved woodland northwest of Douglastown with suitable red squirrel and unsuitable pine marten habitat.</p>

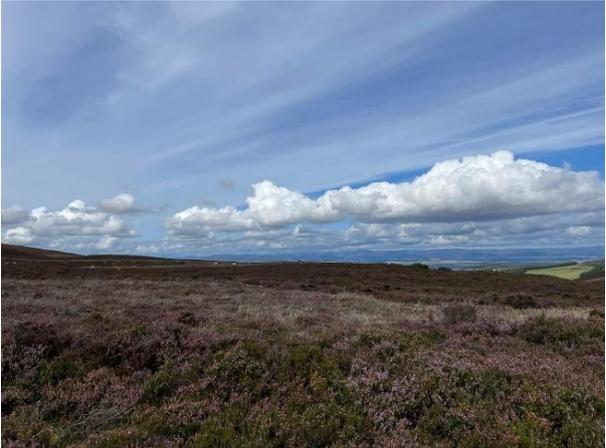
<p data-bbox="204 750 810 819">Photo reference: 11.3.9 Potential mountain hare habitat northwest of Petterden.</p>

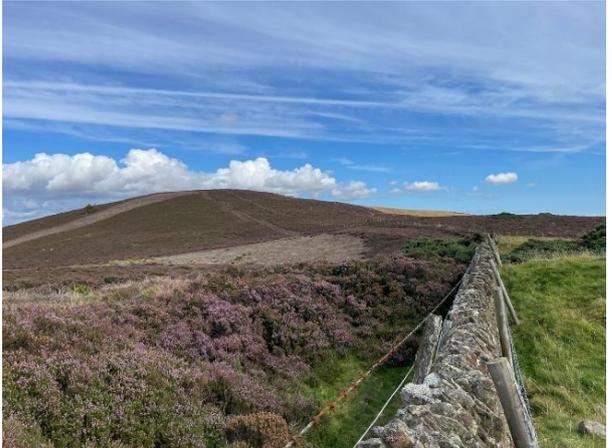
<p data-bbox="829 750 1441 819">Photo reference: 11.3.10 Potential mountain hare habitat northwest of Petterden.</p>

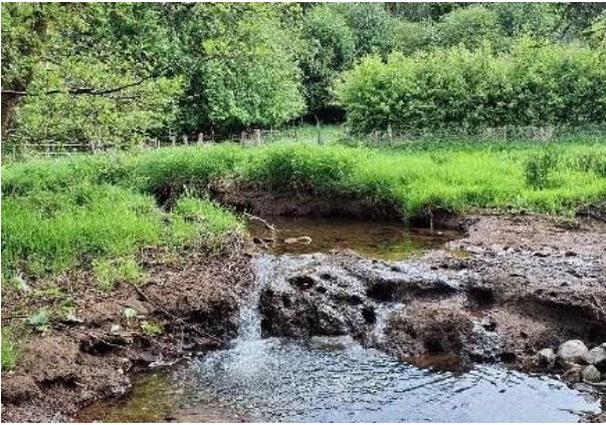
<p data-bbox="204 1534 810 1624">Photo reference: 11.3.11 King's Burn with sub-optimal otter and beaver habitat but unsuitable water vole habitat.</p>

NO 44509 55229	Between S147 and S146	King's Burn	<p>The watercourse is between approximately 0.5 to 2 m wide and ranges from 0.1 to 0.3 m in depth. It has a slow flow with a mixture of silt, coarse sand, cobble, gravel and pebble. There was a high presence of algae and silt within the watercourse. This watercourse is subject to agricultural run-off and erosion. It has a strip of dense vegetation with scattered trees along its banks. This watercourse connects to the Lemno Burn and then the River South Esk, northwest of Burnside the Meadows.</p> <p>This watercourse is surrounded by a mixed of agricultural land to the south which then leads into a mix of broadleaved woodland in the north, consisting of birch, rowan (<i>Sorbus aucuparia</i>), oak, Scots pine (<i>Pinus sylvestris</i>), Sitka spruce (<i>Picea sitchensis</i>) and alder which then leads into hawthorn, alder, sycamore and wild cherry (<i>Prunus avium</i>) woodland. There also are sections of other neutral grassland in the north. The surrounding land dominated by mixed agricultural land.</p> <p>No evidence of protected species was identified during the field surveys.</p> <p>This watercourse is sub- optimal for otter as it has vegetation overhangs on its bank sides which could provide suitable resting places. It has good connectivity to optimal watercourses such as the River South Esk. However, it could be affected by agricultural runoff and dredging which in turn could reduce the foraging resources available.</p>	Intersects the whole LOD, extending from northwest to southeast.	Photo reference: 11.3.11

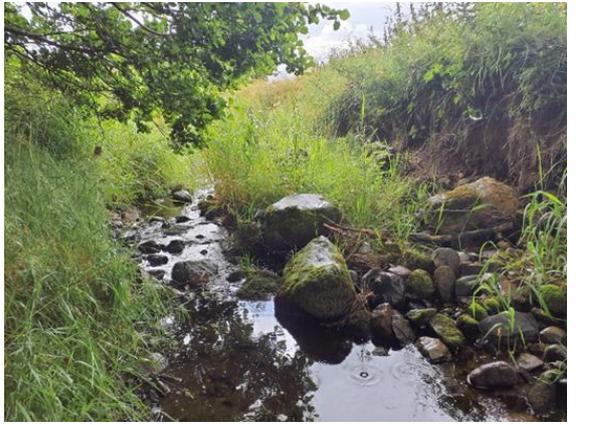
<p data-bbox="829 1534 1441 1624">Photo reference: 11.3.12 King's Burn Tributary with sub-optimal otter and beaver habitat but unsuitable water vole habitat.</p>

NO 44527 54908	Between S147 and S146	Kings Burn Tributary	<p>This watercourse is between approximately 0.3 m and 1 m wide with a depth of 0.1 m. It has a slow flow with a mixture of silt, coarse sand, cobble, gravel and pebble. There was a high presence of algae and silt within the watercourse. This watercourse is also affected by agricultural run-off. It has a strip of dense vegetation with scattered trees along its banks. This watercourse connects to the Lemmo Burn and then the River South Esk, northwest of Burnside the Meadows.</p> <p>This watercourse is surrounded by a mix of agricultural land to the south which then leads into a mix of broadleaved woodland in the north, consisting of birch (<i>Betula</i> spp.), oak (<i>Quercus</i> spp.), sycamore (<i>Acer pseudoplatanus</i>), hawthorn (<i>Crataegus monogyna</i>), horse chestnut (<i>Aesculus hippocastanum</i>) with rare willow (<i>Salix</i> spp.) and alder (<i>Alnus glutinosa</i>). The surrounding land dominated by mixed agricultural land.</p> <p>No evidence of protected species was identified during the field surveys.</p>	Intersects the whole LOD, extending from northwest to southeast.	Photo reference: 11.3.12

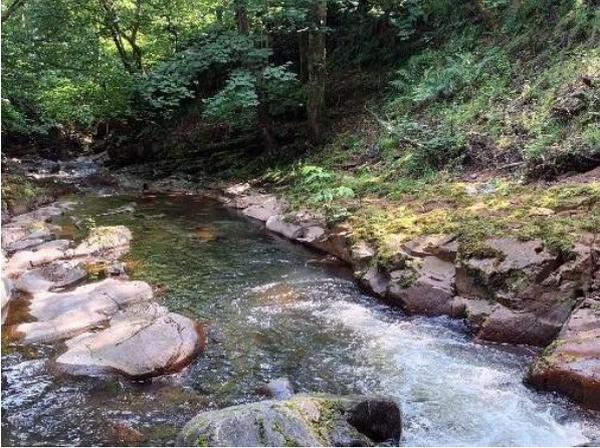
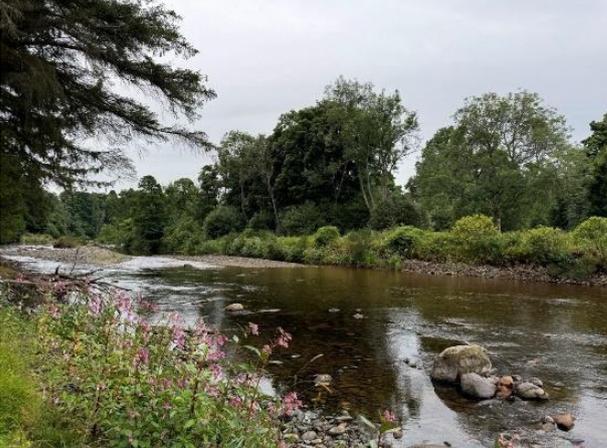
<p>Photo reference: 11.3.13 Noran Water is an optimal habitat for otters; it is however sub-optimal for beavers and unsuitable for water voles.</p>	<p>Photo reference: 11.3.14 River South Esk with optimal otter habitat but unsuitable beaver and water vole habitat.</p>

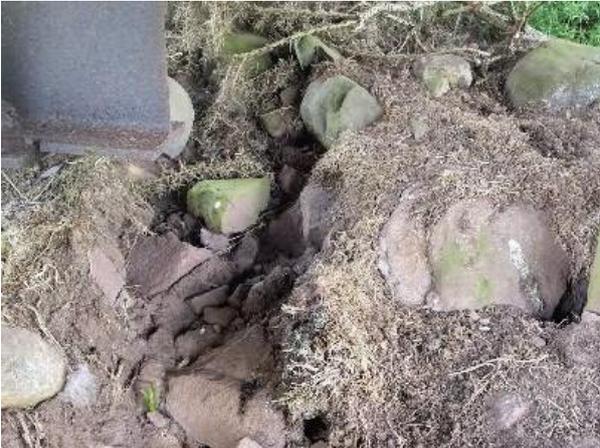
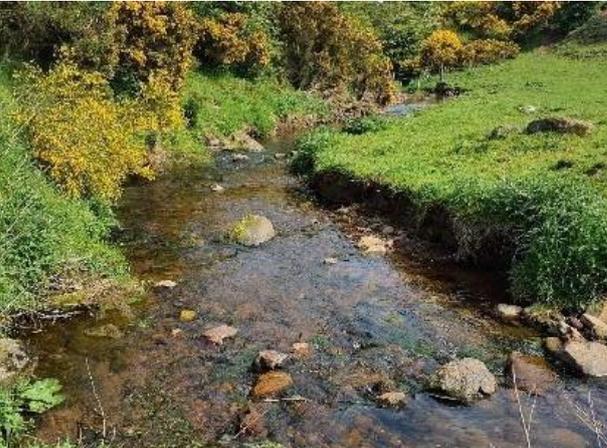
<p>Photo reference: 11.3.15 Otter sprint site found under bridge on the banks of Bog Burn.</p>	<p>Photo reference: 11.3.16 Bog Burn, a watercourse optimal for otters, but unsuitable for water voles and beavers.</p>

NO 46708 58537	Between S136 and S135	Bog Burn	<p>This watercourse has a rocky substrate with dense overhanging vegetation in some areas. It also has several larger boulders in the water. This watercourse is connected to the River South Esk, northwest of Tannadice village.</p> <p>The surrounding habitat on either side of the watercourse is dense gorse scrub which transitions into hawthorn scrub with scattered mature ash trees.</p> <p>Evidence of otter was found at the time of survey in the form of 11 spraints varying in age. No other evidence of protected species was identified during the field surveys.</p> <p>This watercourse provides optimal habitat for otters as it over 1 m wide and is connected to the River South Esk which is optimal for otters. This watercourse has rocky banksides with dense overhanging vegetation and scrub which offers potential resting up sites.</p> <p>This watercourse has unsuitable habitat potential for beaver due to the lack of substantial scrub and woodland around its edges. This reduced the foraging and construction materials available and in turn reduced its suitability to support beavers. This watercourse was surrounded by extensive agricultural land which increases the likelihood of agricultural runoff entering the watercourse, reducing the water quality. The few, isolated stands of woodland and scrub within the wider landscape are not well connected, meaning beaver would have to travel across large, open agricultural fields to forage which reduces the</p>	Intersects the whole LOD, extending from west to east.	Photo reference: 11.3.15 and 11.3.16

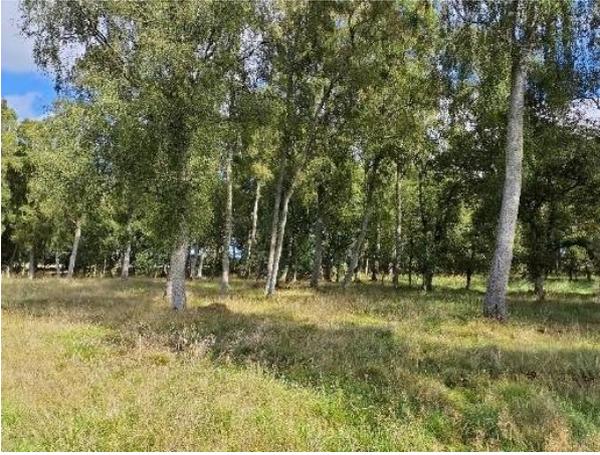
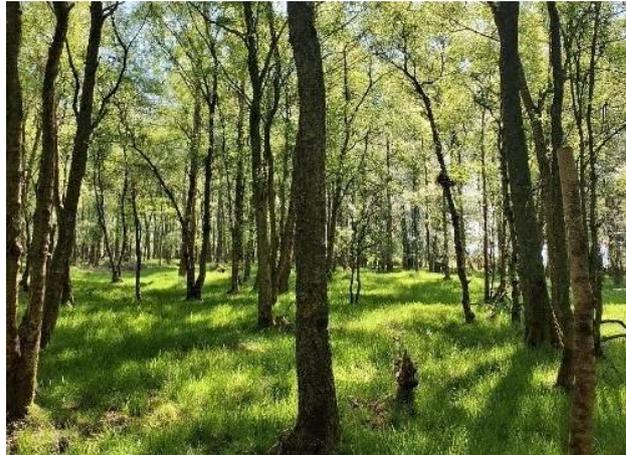
<p>Photo reference: 11.3.17 Lochty Wood with sub-optimal red squirrel and pine marten habitat.</p>	<p>Photo reference: 11.3.18 Forestmuir Wood with sub-optimal red squirrel and pine marten habitat.</p>

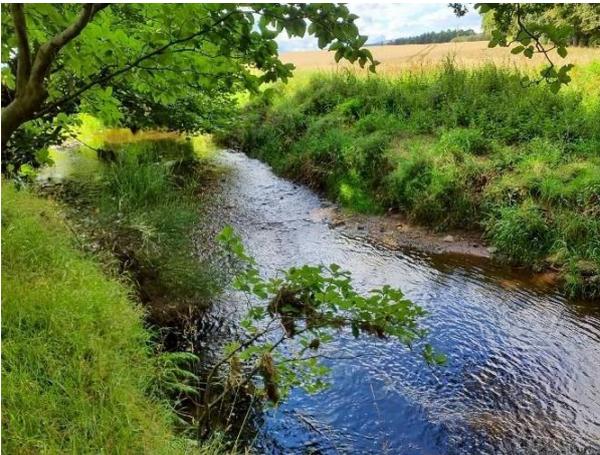
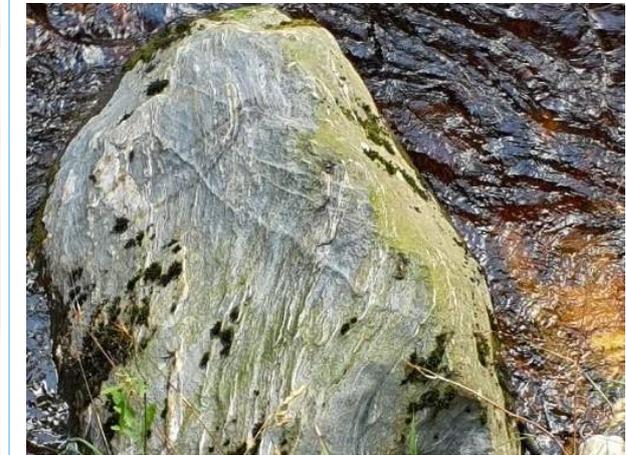
<p>Photo reference: 11.3.19 Cruick Water with optimal otter habitat but not suitable for beaver and water vole.</p>	<p>Photo reference: 11.3.20 Otter spraint recorded on a large boulder in the West Water.</p>

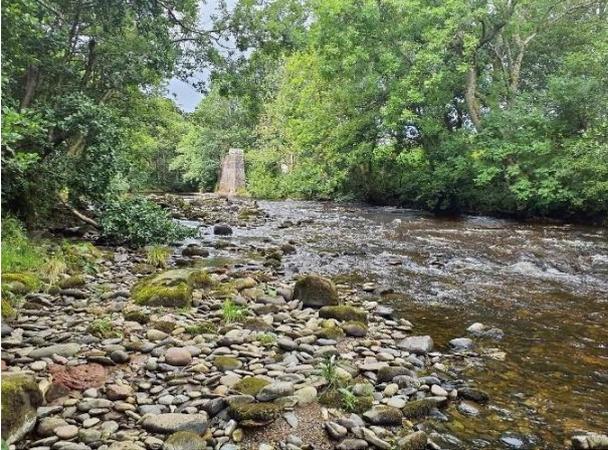
<p>Photo reference: 11.3.21 West Water with optimal otter habitat, but unsuitable for beaver and water vole.</p>

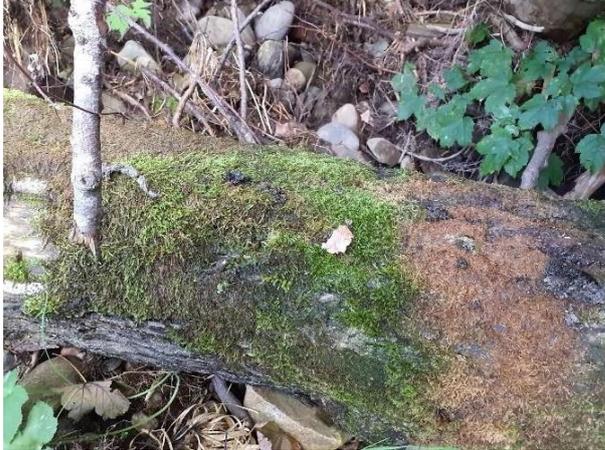
<p>Photo reference: 11.3.22 Otter spraint recorded on the banks of River North Esk.</p>

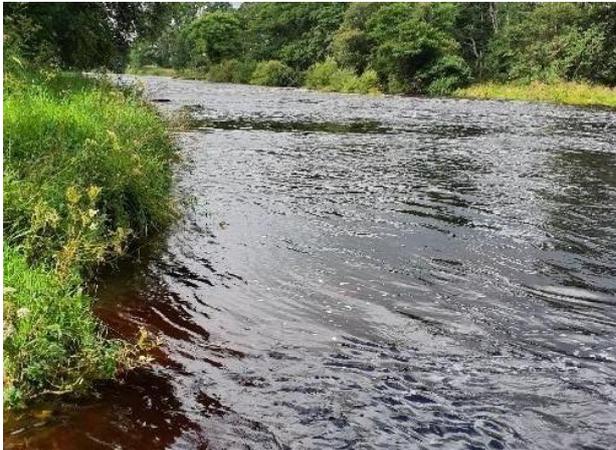
<p>Photo reference: 11.3.23 River North Esk with optimal otter habitat, but unsuitable habitat for beaver and water vole.</p>

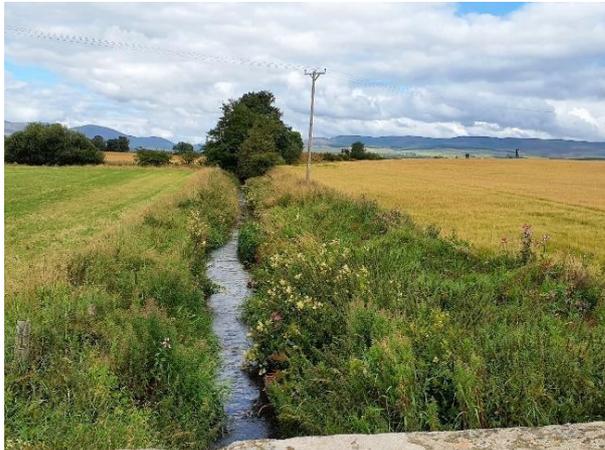
<p>Photo reference: 11.3.24 Black Burn with sub-optimal otter habitat but unsuitable beaver and water vole habitat.</p>

NO 64063 67826	Between S77 and S76	Black Burn	<p>This watercourse is narrow being less than 1.5 m wide with dense vegetation on either bank side in the north and becomes channelised to the south. It also has Himalayan Balsam present on its banksides. This watercourse is connected to the River South Esk and is located southeast of the former Edzell RAF.</p> <p>This watercourse is surrounded by a patch of mixed woodland with conifers and birch to the southeast and otherwise it is bounded by agricultural land.</p> <p>No evidence of protected species was identified during the field surveys.</p> <p>This watercourse provides sub-optimal habitat for otters as it over 1 m wide and is connected to the River South Esk which is optimal for otters. This watercourse has rocky banksides with dense overhanging vegetation and scrub which offers potential resting up sites.</p> <p>This watercourse has unsuitable habitat potential for beaver due to the lack of substantial scrub and woodland around its edges. This reduced the foraging and construction materials available and in turn reduced its suitability to support beavers. This watercourse was surrounded by extensive agricultural land which increases the likelihood of agricultural runoff entering the watercourse, reducing the water quality. The few, isolated stands of woodland and scrub within the wider landscape are not well connected, meaning beaver would have to travel across large, open agricultural fields to forage which reduces the watercourse's suitability for beaver. Overall, therefore this watercourse is considered to be unsuitable for beaver.</p> <p>This watercourse has unsuitable habitat potential for water vole due to the lack of rush vegetation present on its bank sides, reducing the favoured foraging resources available. The banksides are rocky reducing the likelihood of water voles being able to burrow and shelter here. This watercourse is also lined with trees in the south, which could reduce the</p>	Intersects the whole LOD, from northwest to southeast.	Photo reference: 11.3.2 4

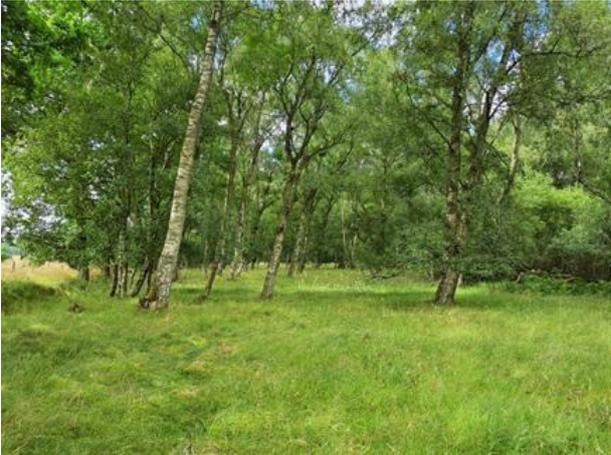
<p>Photo reference: 11.3.25 Little Brechin Wood with sub-optimal red squirrel and pine marten habitat.</p>

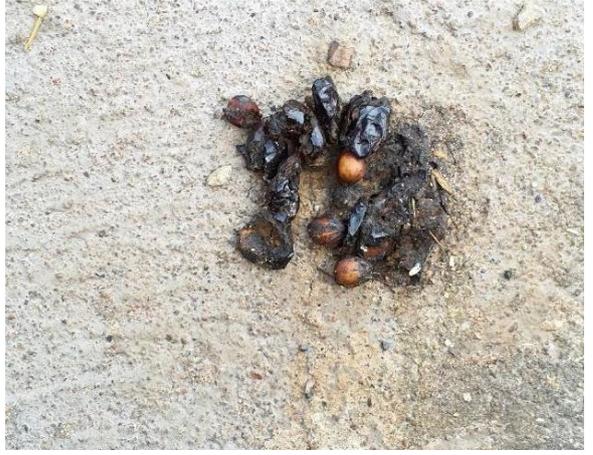
<p>Photo reference: 11.3.26 Pine marten scat found near to a bridge over West Water.</p>

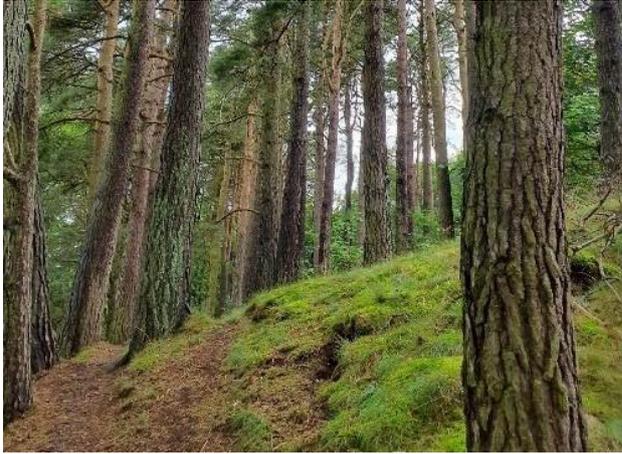
<p>Photo reference: 11.3.27 Inverury Wood with suitable red squirrel and pine marten habitat.</p>

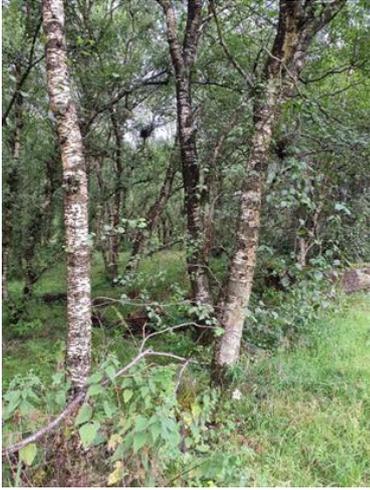
<p>Photo reference: 11.3.28 Clearly Wood mixed woodland with suitable red squirrel and pine marten habitat.</p>

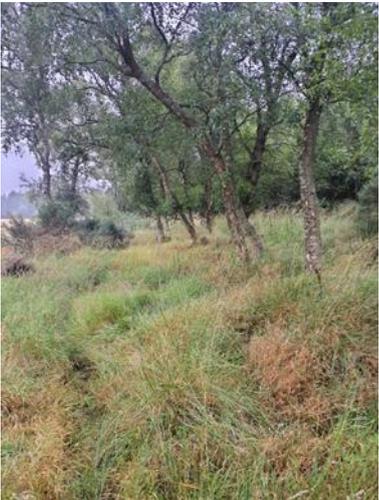
<p>Photo reference: 11.3.29 Lady Jane’s Plantation with suitable red squirrel and pine marten habitat.</p>

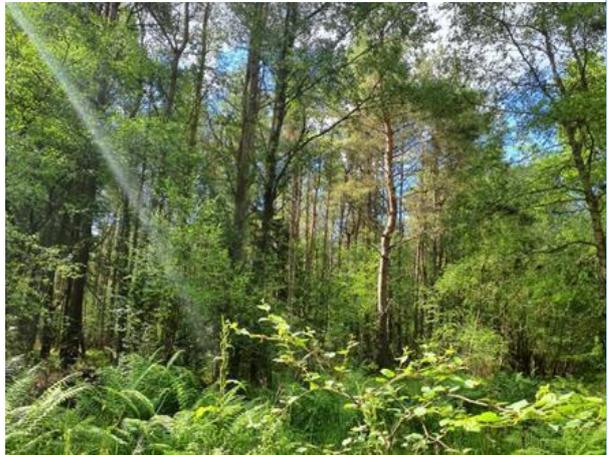
<p>Photo reference: 11.3.30 Greenbottom Wood mixed woodland with sub-optimal red squirrel and pine marten habitat.</p>

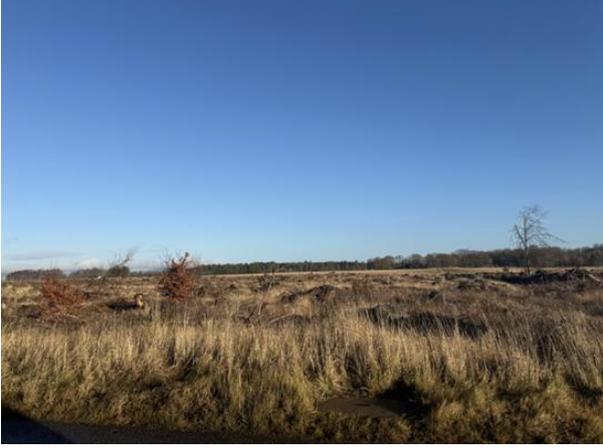
<p>Photo reference: 11.3.31 Capo Plantation with unsuitable habitat suitability for both pine marten and red squirrel.</p>

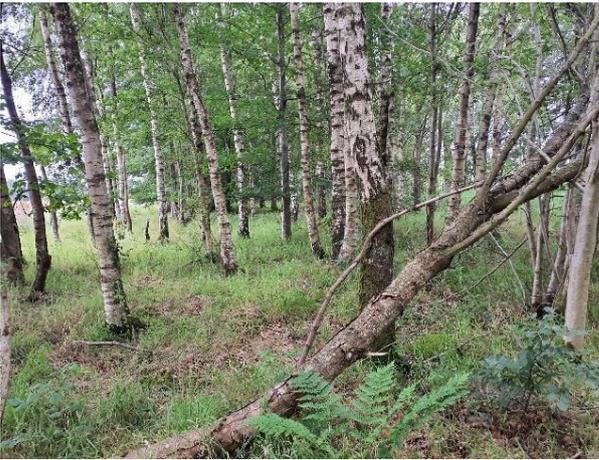
<p>Photo reference: 11.3.32 Narrow mixed broadleaf plantation, north of Cowieshill Cottage which provides sub-optimal habitat for both pine marten and red squirrel.</p>

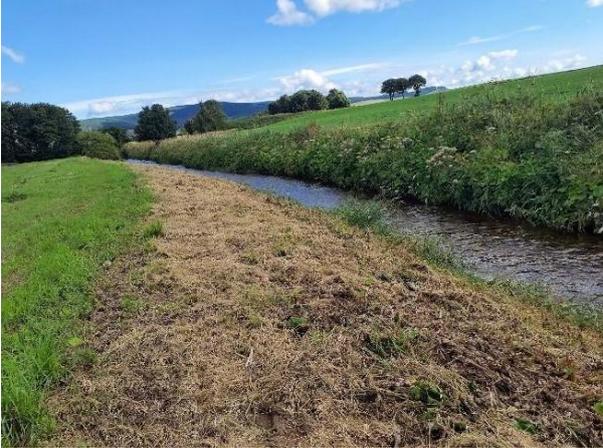
<p>Photo reference: 11.3.33 Black Burn, with sub-optimal otter habitat but no suitable beaver and water vole habitat.</p>

Grid reference	Tower Number	Watercourse Name	Description of Survey Results	Location	
NO 68572 72800	S57 and S56	Black Burn	<p>This watercourse is very channelised and surrounded by agricultural land. It is approximately 2 m wide and less than 0.5 m deep. It has dense vegetation on the north bank with mown vegetation to the south. It has a stoney substrate. This watercourse is connected to the River North Esk and is located northwest of Haughhead Farm.</p> <p>This watercourse flows through agricultural land.</p> <p>No evidence of protected species was identified during the field surveys.</p> <p>The landowner reported to have seen otter using the watercourse.</p> <p>This watercourse is sub-optimal for otter as it is greater than 0.5 m wide and has connectivity to the River North Esk which is optimal for otter. This watercourse has dense grassy vegetation on its banksides which offer resting up opportunities.</p> <p>This watercourse has unsuitable habitat potential for beaver due to the lack of substantial scrub and woodland around its edges. This reduced the foraging and construction materials</p>	Intersects the whole LOD, from north to south.	Photo reference: 11.3.33

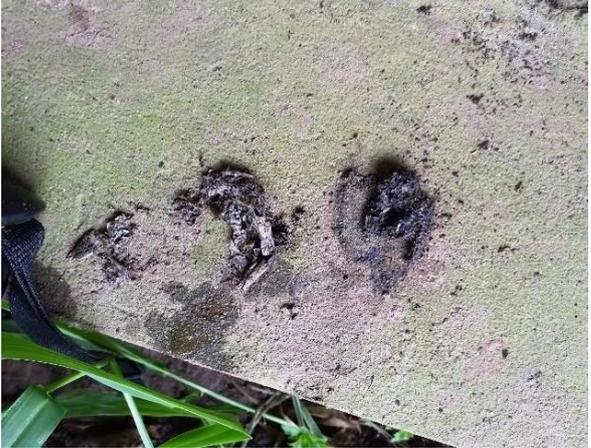
<p>Photo reference: 11.3.34 Otter spraint recorded under bridge on the banks of Luther Water.</p>

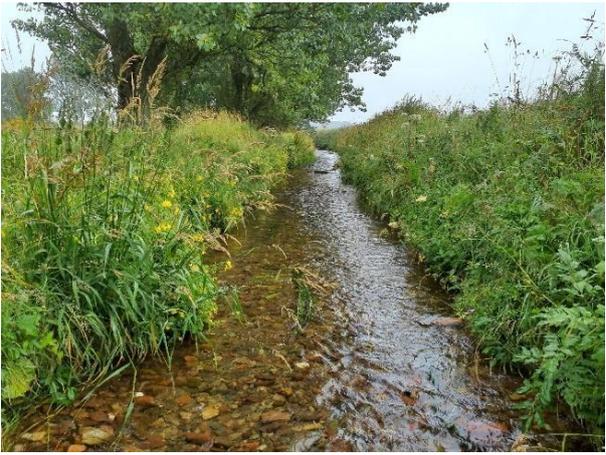
<p>Photo reference: 11.3.35 Luther Water, with sub-optimal otter and unsuitable beaver and water vole habitat.</p>

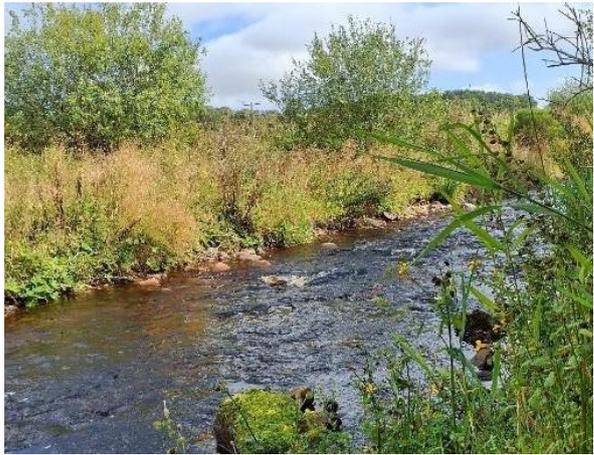
<p>Photo reference: 11.3.36 Bervie Water, with optimal otter habitat but no suitable water vole or beaver habitat.</p>

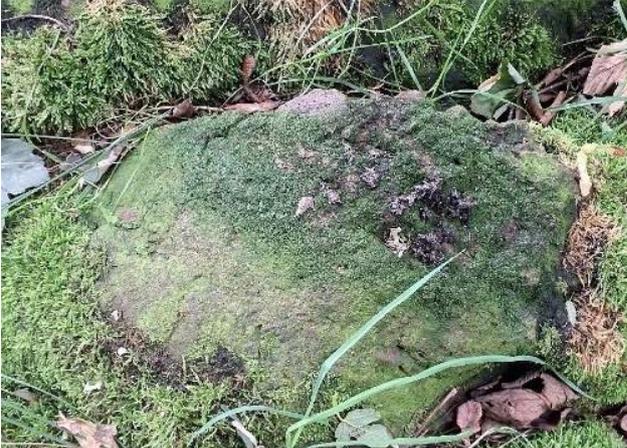
<p>Photo reference: 11.3.37 Otter spraint recorded on banks of Bervie Water.</p>

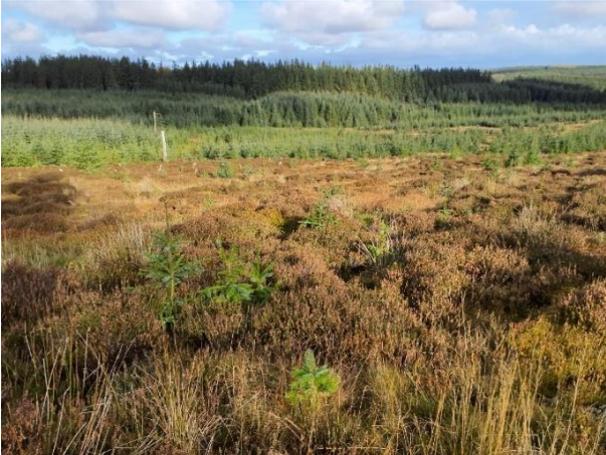
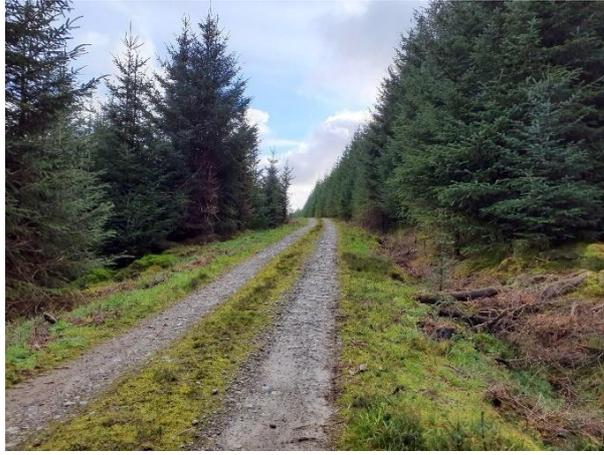
<p>Photo reference: 11.3.39 Fetteresso Forest, an optimal red squirrel and pine marten habitat.</p>	<p>Photo reference: 11.3.40 Fetteresso Forest, an optimal red squirrel and pine marten habitat.</p>

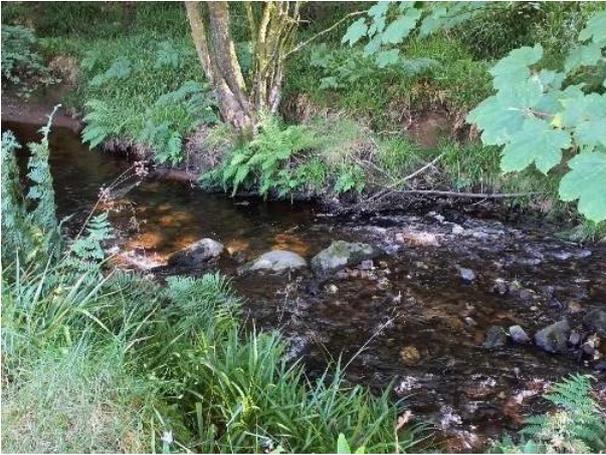
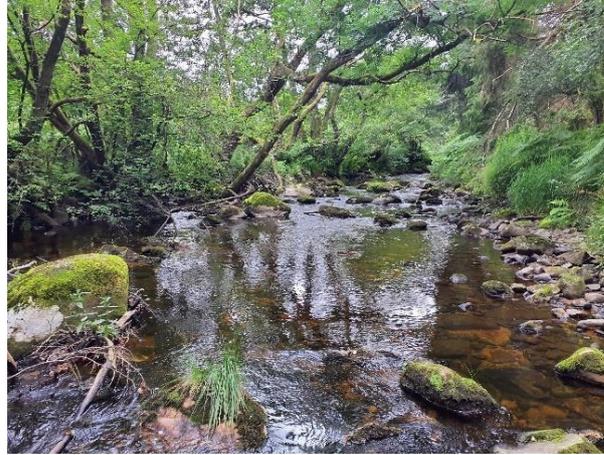
<p>Photo reference: 11.3.41 Cowie Water, with optimal otter habitat, suitable beaver habitat but unsuitable for water voles.</p>	<p>Photo reference: 11.3.42 Burn of Sheeoch, with optimal otter and beaver habitat but no suitable water vole habitat.</p>

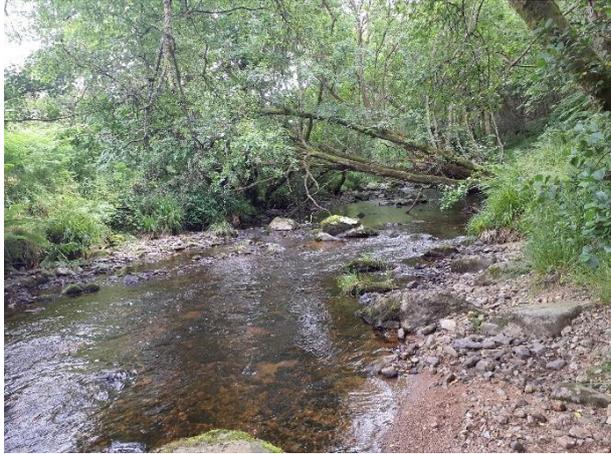
<p>Photo reference: 11.3.43 Another image of Burn of Sheeoch, sandy banks and fallen trees visible.</p>

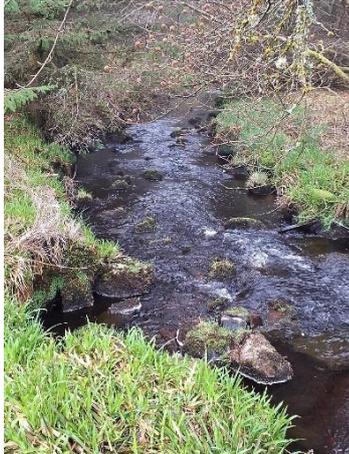
<p>Photo reference: 11.3.44 Black Burn which offer sub-optimal habitat for otters, suitable habitat for beavers and unsuitable habit for water vole.</p>

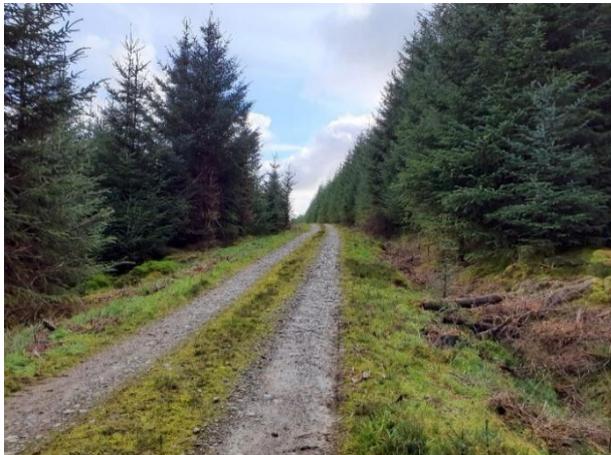
<p>Photo reference: 11.3.45 Fetteresso Forest with optimal pine marten and red squirrel habitat.</p>

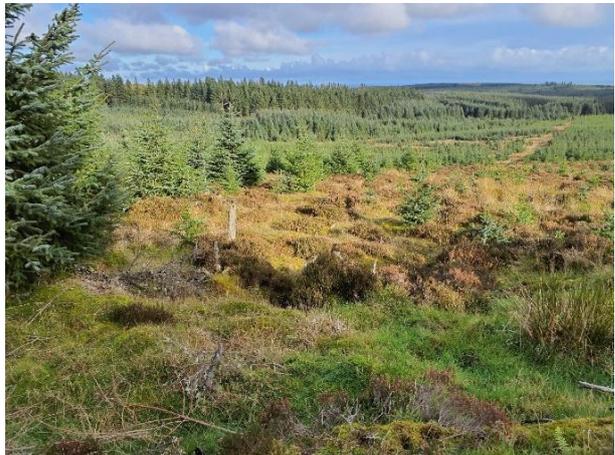
<p>Photo reference: 11.3.46 Fetteresso Forest, an optimal pine marten and red squirrel habitat.</p>

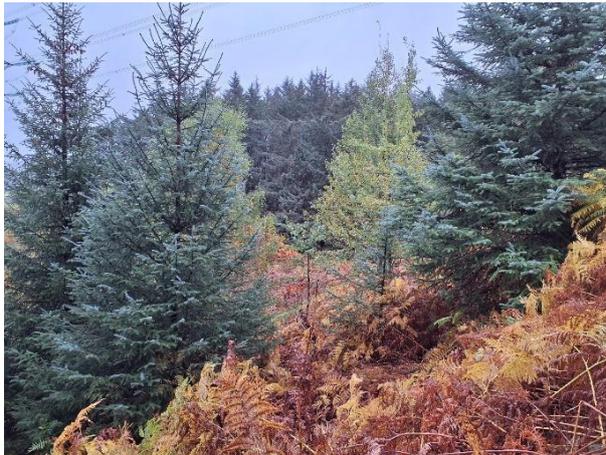
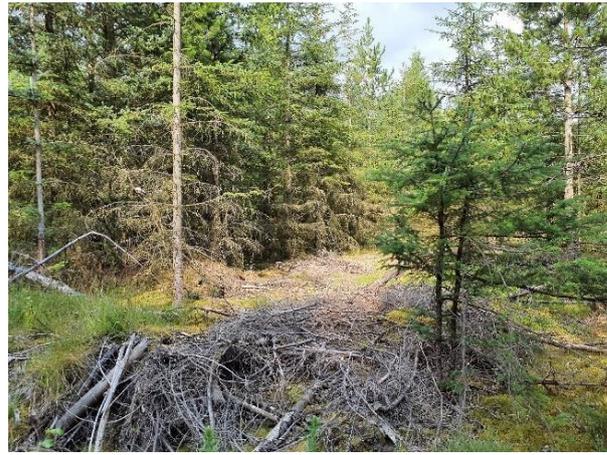
<p>Photo reference: 11.3.47 Durriss Forest with optimal pine marten and red squirrel habitat.</p>	<p>Photo reference: 11.3.48 Free Church Wood with sub-optimal pine marten and red squirrel habitat.</p>

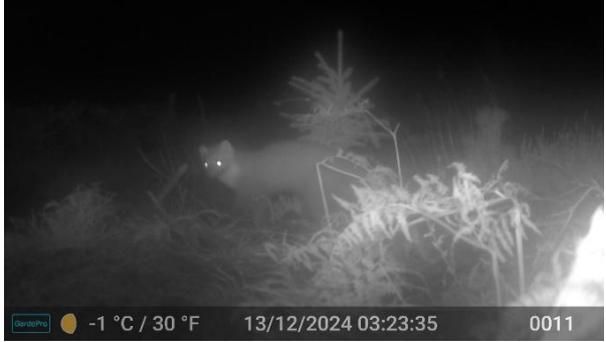
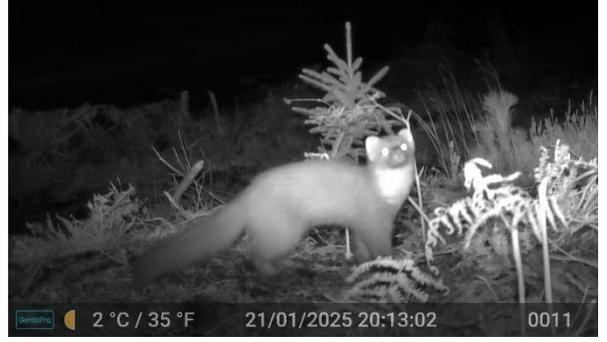
<p>Photo reference: 11.3.49 Pine marten recorded on camera trap in Durriss Forest.</p>	<p>Photo reference: 11.3.50 Pine marten recorded on camera trap in Durriss Forest.</p>

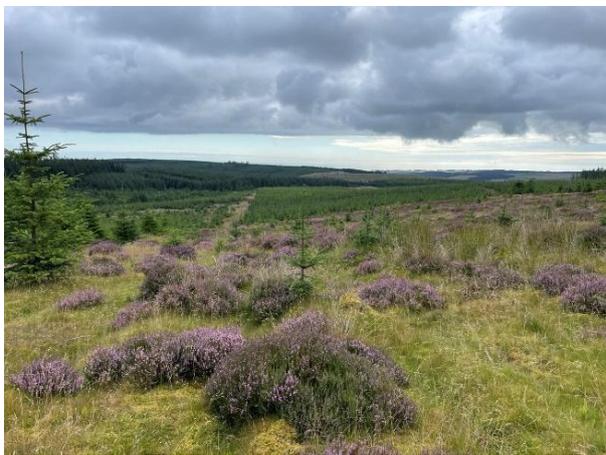
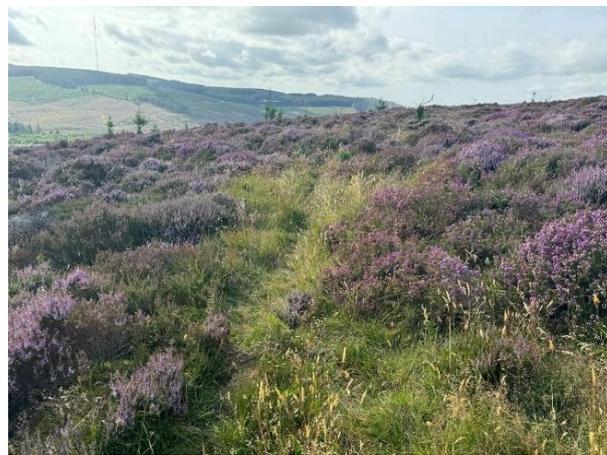
<p>Photo reference: 11.3.51 Fetteresso Forest with potential mountain hare habitat.</p>	<p>Photo reference: 11.3.52 Potential mountain hare habitat north of Fetteresso Forest.</p>

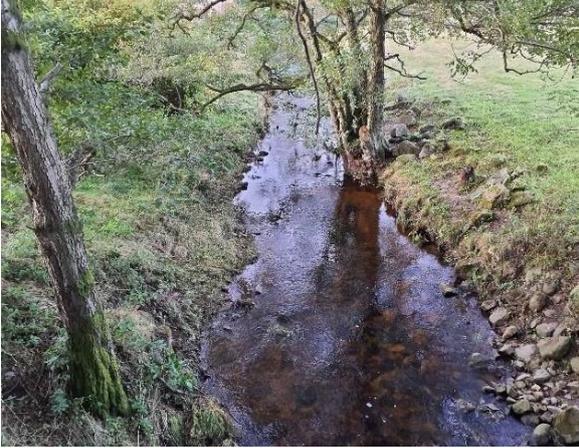
<p>Photo reference: 11.3.53 Gormack Burn with sub-optimal otter habitat but no suitable water vole or beaver habitat.</p>

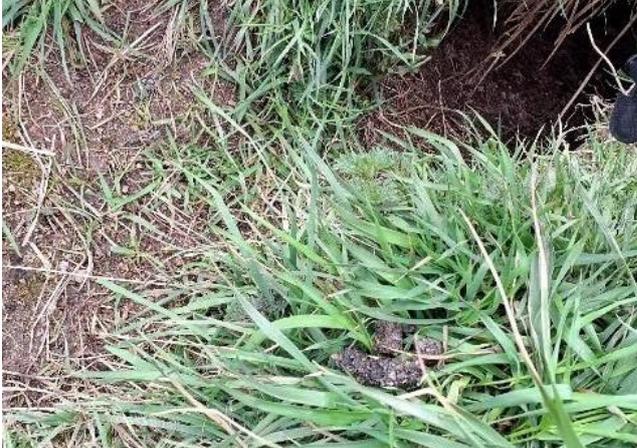
<p>Photo reference: 11.3.54 Otter spraint found on the banks of Corskie Burn.</p>

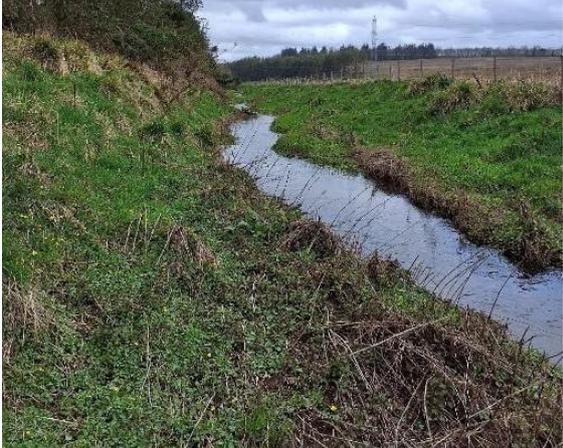
<p>Photo reference: 11.3.55 Corskie Burn with suitable otter habitat but no suitable beaver or water vole habitat.</p>

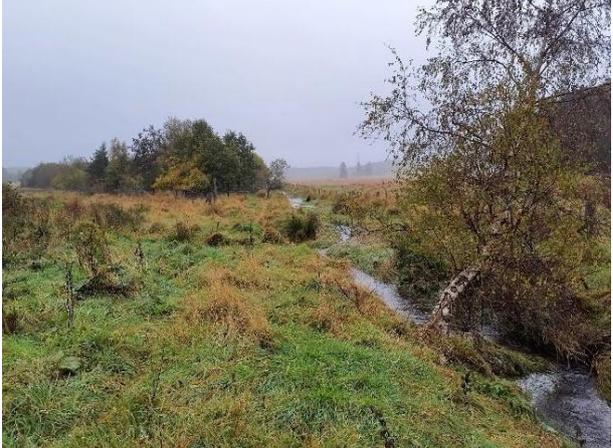
<p>Photo reference: 11.3.56 Bogendinny Burn with suitable habitat for otter but no suitable habitat for beaver and water vole.</p>

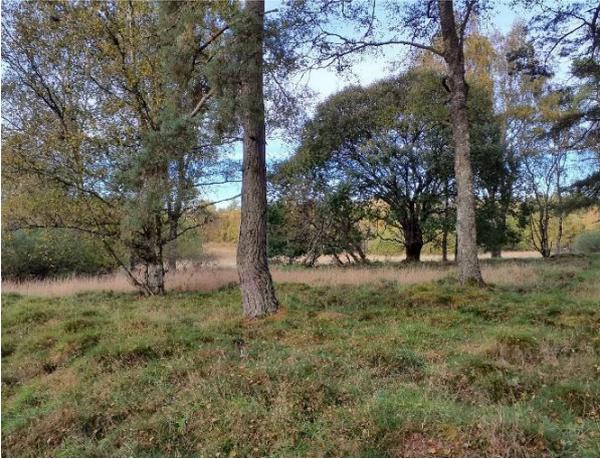
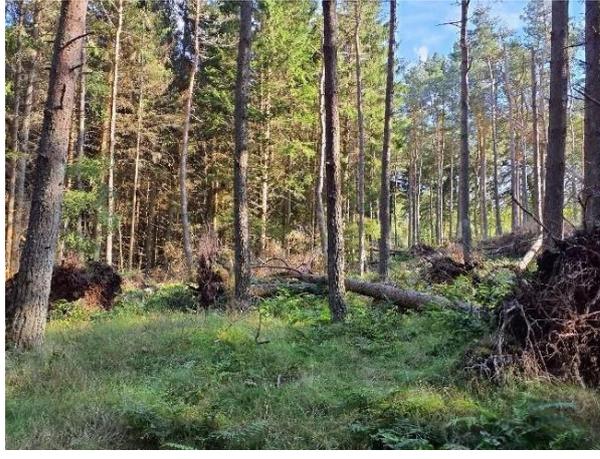
<p>Photo reference: 11.3.57 Backstrip woodland which provides sub-optimal habitat suitability for both red squirrel and pine marten.</p>	<p>Photo reference: 11.3.58 Tillybrig Wood with sub-optimal red squirrel and pine marten habitat.</p>

Grid Reference	Tower Number	Woodland Name	Description of Survey Results	Location	Photo reference
NJ 74053 09380	Between N19 and N17	Tillbrig Wood	<p>Mature coniferous woodland plantation dominated by Sitka spruce and Scots pine, north of New Wester Echt.</p> <p>This woodland in the south of the A944 has good connectivity south to Scaur woodland and southwest to Craig-na-laoigh Woodland, Barmekin Wood woodlands in the wider landscape through green corridors. However north of the A944 the connectivity is low due to mixed agricultural land and the Corskie Burn.</p> <p>No evidence of pine marten was recorded during the surveys.</p> <p>Evidence was recorded to red squirrel during the surveys in the form of several areas with feeding remains found.</p> <p>Overall, this woodland is considered to provide sub-optimal habitat suitability for pine marten and red squirrel due to the presence of mature food plants and good connectivity between this woodland and others close by offering a range of age structures for foraging and sheltering opportunities.</p>	Intersect half of the LOD and extends northwest.	Photo reference: 11.3.58
