Volume 5: Appendix 13.1 – Watercourse Crossing and Buffers Assessment

1 INTRODUCTION

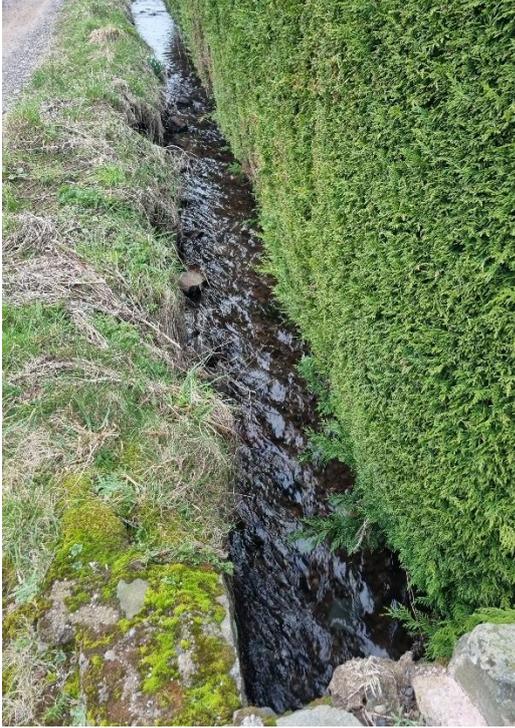
ID – 2 (Existing track crossing)	Unnamed tributary of Tealing Burn
<p><u>Description:</u> Unnamed Tributary of the Tealing Burn flows east in straightened channel adjacent to road and then flows beneath public road in stone arch bridge, which will be used for construction.</p>	
NGR Ref: 339493 738693	
<p>Photo –Unnamed Tributary in straightened channel looking west upstream</p>

Width of watercourse (m)	1.1 m
Bed Sediment	Mix of silt and cobble
Bank Erosion	No
Natural Channel	No
Existing Crossing	Existing bridge with stone arch culvert of unknown dimensions
Proposed Crossing	No upgrade. If engineering assessment determines the crossing to be structurally unsound, a temporary over-bridging solution will be put in place during construction.
Additional Mitigation	None
Catchment (km ²)	0.43 km ²
Minor Watercourse	Yes
Main river catchment	Dighty Water
Within catchment of SAC designated river	No
CAR Authorisation Required	No

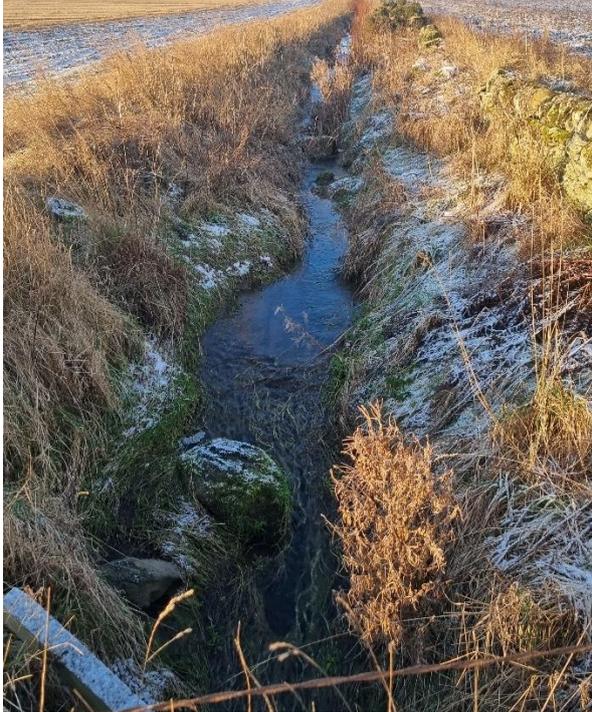
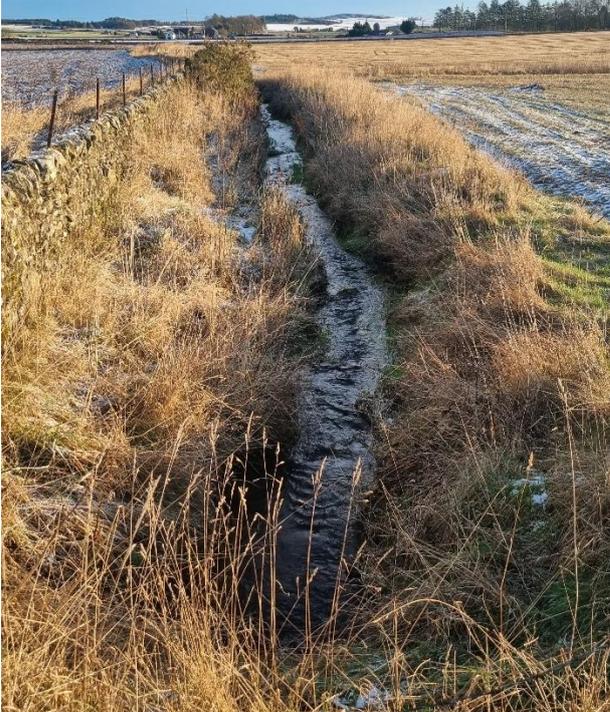
ID – 3 (Existing track crossing)	Unnamed tributary of Tealing Burn
<p>Description: Open straightened channel flows to the east and is culverted beneath existing crossing in a stone box culvert 1m wide.</p>	
<p>NGR Ref: 340188 738640</p>	
<p>Photo – Unnamed Tributary looking west, upstream</p>

<p>Photo – Unnamed tributary looking east</p>

<p>Width of watercourse (m)</p>	<p>1.2 m</p>
<p>Bed Sediment</p>	<p>Mix of silt and pebble</p>
<p>Bank Erosion</p>	<p>No</p>
<p>Natural Channel</p>	<p>No</p>
<p>Existing Crossing</p>	<p>Existing bridge with stone box culvert of unknown dimensions</p>
<p>Proposed Crossing</p>	<p>No upgrade. If engineering assessment determines the crossing to be structurally unsound, a temporary over-bridging solution will be put in place during construction.</p>
<p>Additional Mitigation</p>	<p>None</p>
<p>Catchment (km²)</p>	<p>0.82 km²</p>
<p>Minor Watercourse</p>	<p>No</p>
<p>Main river catchment</p>	<p>Dighty Water</p>

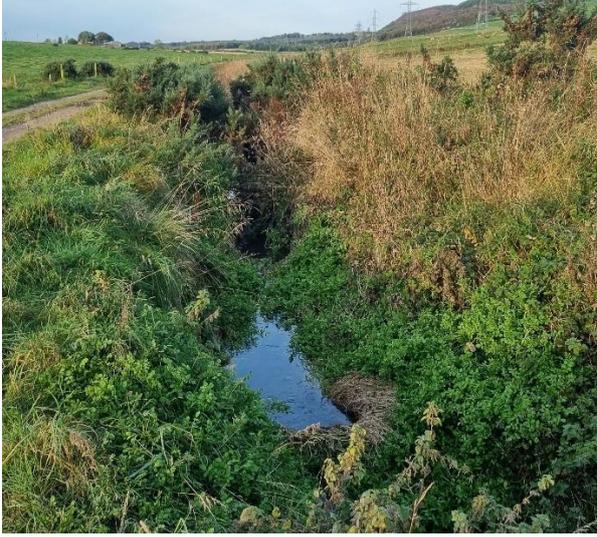
ID – 8 (Existing track crossing)	Unnamed tributary of Tealing Burn/ Fithie Burn
<u>Description:</u> Unnamed tributary is heavily modified as straightened here as it flows through vegetated channel to the east.	
NGR Ref: 338367 738865	
Photo – Unnamed tributary looking downstream

Width of watercourse (m)	1.4 m
Bed Sediment	Mix of silt and pebble
Bank Erosion	No
Natural Channel	No
Existing Crossing	Existing crossing with stone box culvert of unknown dimensions
Proposed Crossing	No upgrade. If engineering assessment determines the crossing to be structurally unsound, a temporary over-bridging solution will be put in place during construction.
Additional Mitigation	None
Catchment (km ²)	1.15 km ²
Minor Watercourse	Yes
Main river catchment	Dighty Water
Within catchment of SAC designated river	No
CAR Authorisation Required	No

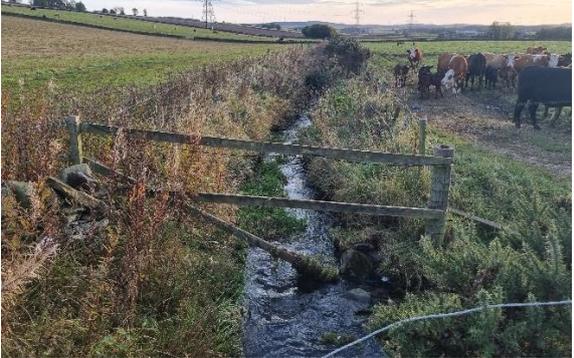
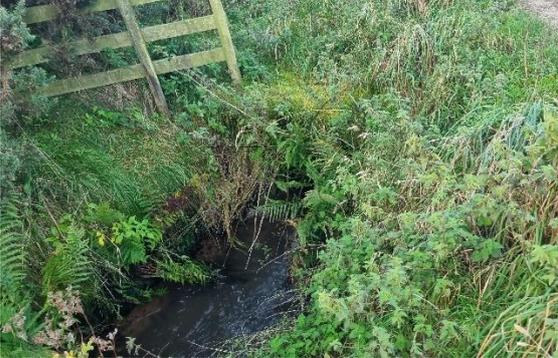
ID – 9 (Existing track crossing)	Unnamed tributary of Tealing Burn/ Fithie Burn
<u>Description:</u> At the crossing location, the watercourse is crossed by an existing farm access track.	
NGR Ref: 338463 738881	
Photo – Unnamed tributary looking downstream

Photo – Unnamed tributary looking upstream at crossing

Width of watercourse (m)	1.5 m
Bed Sediment	Mix of silt and pebble
Bank Erosion	No
Natural Channel	No
Existing Crossing	Existing crossing with stone box culvert of unknown dimensions
Proposed Crossing	No upgrade. If engineering assessment determines the crossing to be structurally unsound, a temporary over-bridging solution will be put in place during construction.
Additional Mitigation	None
Catchment (km ²)	1.24 km ²
Minor Watercourse	Yes
Main river catchment	Dighty Water
Within catchment of SAC designated river	No
CAR Authorisation Required	No

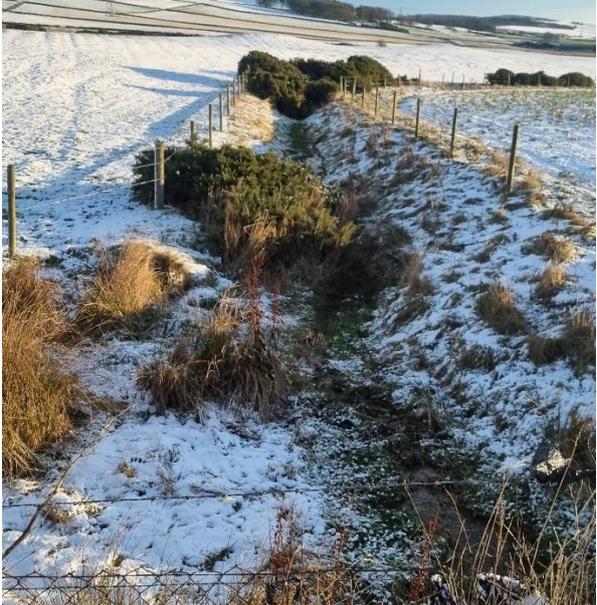
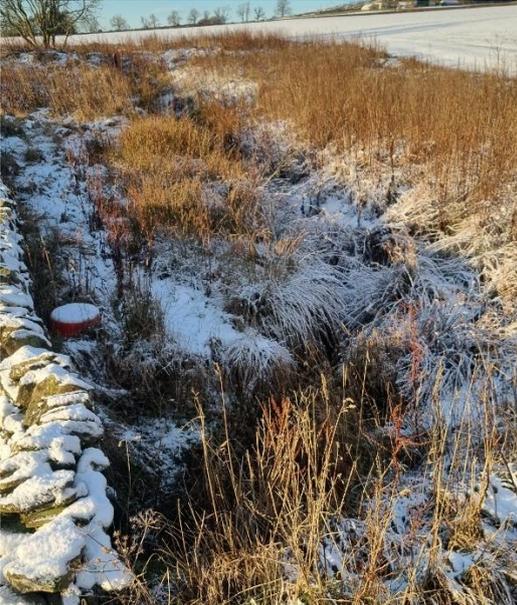
ID – 10 (Existing track crossing)	Unnamed tributary of Tealing Burn
<p>Description: Minor watercourse tributary flows east beneath track, vegetated upstream of crossing and less defined, whereas downstream of crossing channel is more open, defined and less vegetated, with steeper and larger banks.</p>	
<p>NGR Ref: 339753 739590</p>	
<p>Photo – Watercourse looking downstream</p>

<p>Photo – looking upstream</p>

<p>Width of watercourse (m)</p>	<p>0.5 m</p>
<p>Bed Sediment</p>	<p>Mix of silt and pebble</p>
<p>Bank Erosion</p>	<p>No</p>
<p>Natural Channel</p>	<p>No</p>
<p>Existing Crossing</p>	<p>Existing crossing with stone box culvert of unknown dimensions</p>
<p>Proposed Crossing</p>	<p>No upgrade. If engineering assessment determines the crossing to be structurally unsound, a temporary over-bridging solution will be put in place during construction.</p>
<p>Additional Mitigation</p>	<p>None</p>

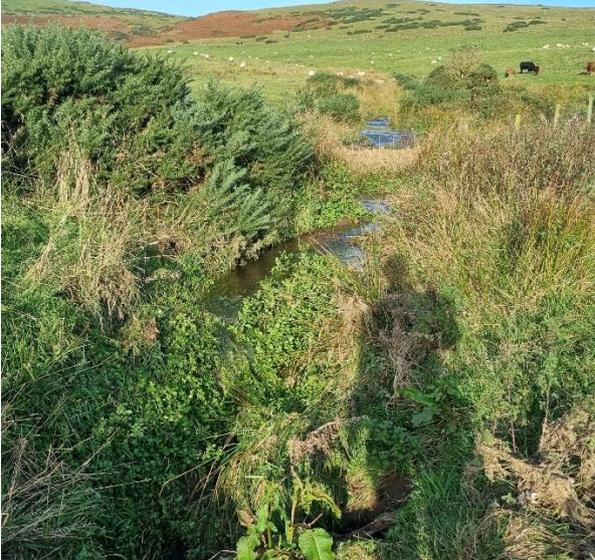
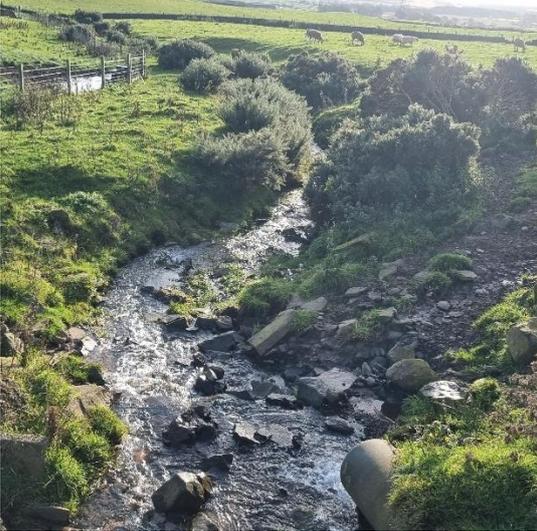
ID – 11 (Existing track crossing)	Tealing Burn
<p>Description: Tealing Burn flows to the southeast in fluctuating channel, moving between wider sediment deposition zones and narrower vegetated channel sections. The watercourse is culverted beneath the existing track in a 450 mm arch pipe, watercourse is heavily modified.</p>	
NGR Ref: 339605 740020	
<p>Photo – Tealing Burn</p>

<p>Photo – Tealing Burn looking downstream from crossing</p>

Width of watercourse (m)	2.0 m
Bed Sediment	Silt to Cobble
Bank Erosion	No
Natural Channel	Yes - but heavily modified
Existing Crossing	Existing crossing with broken 450 mm pipe
Proposed Crossing	No upgrade. If engineering assessment determines the crossing to be structurally unsound, a temporary over-bridging solution will be put in place during construction.
Additional Mitigation	None
Catchment (km ²)	0.82 km ²
Minor Watercourse	No
Main river catchment	Dighty Water

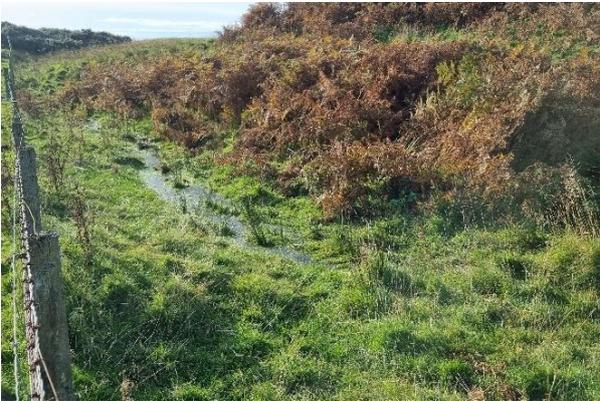
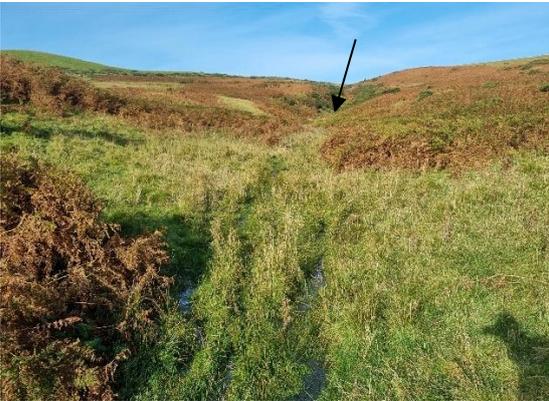
ID – 12 (Proposed track crossing - permanent)	Unnamed Watercourse
<p>Watercourse Description: The small watercourse is an upstream tributary of the Tealing Burn. It flows southeast within a ~140 m long culvert under a field at the proposed access track crossing location. The watercourse was dry at the time of the site visit, the culverted section was not visible and the culvert size is unknown. The watercourse is natural and open further upstream then heavily modified and straightened/culverted through grazing land. Approximately 25 m downstream of the track crossing location, the watercourse emerges from the culvert and becomes an open channel again. The proposed new stone permanent track would cross the culverted section of the watercourse at ID12.</p> <p>An alternative crossing location ~200 m upstream of ID12 in the open section of the channel, where the channel is confined in a small valley (as shown on the second photo and in Volume 3, Figure 13.2.1: Hydrology, Flood Risk and Buffers) is proposed as an alternative. The Applicant is currently in discussion with the landowner and, if secured, the upstream crossing is the preferred access which will be taken forward and will require a new single span bridge.</p>

NGR Ref: 339189 740147	
Photo – natural upstream section of watercourse looking downstream	Photo – looking upstream (the arrow shows the approximate location of the alternative crossing location in the open part of the channel)

Width of watercourse/ drain (m)	Estimated ~ 0.6 m
Bed Sediment	Vegetated Channel (upstream). The small watercourse is culverted at crossing location ID12.
Bank Erosion	No
Natural Channel	No – the small channel is within a culvert under the field at the proposed track location. The watercourse is natural ~200 m upstream in the open section at the alternative crossing location (second photo)
Existing Crossing	None – The small watercourse is culverted under the field.
Proposed Crossing	<p>It is not proposed to upgrade to the underground culverted section of the watercourse. However, an engineering assessment of the hydrology/hydraulics and structure of the culverted section of the watercourse will be carried by the Contractor in advance of construction to assess, design and manage the suitability of crossing location ID12. The alternative crossing location (~200 m upstream in the open part of the watercourse) may be considered instead, following the engineering assessment and is currently the preferred option for the permanent track crossing, if landowner permissions can be secured.</p> <p>If the culvert were to block, there is a risk of localised flooding to the proposed permanent track crossing at ID12. If the culvert were to block or not be able to pass flood flows, flood water would flow overland across the new track following the topography and then continue back into the open channel downstream. The crossing location is in the upper reaches of the burn and the contributing catchment is small (0.2 km²) so flood flows will be low. The flow pathways</p>

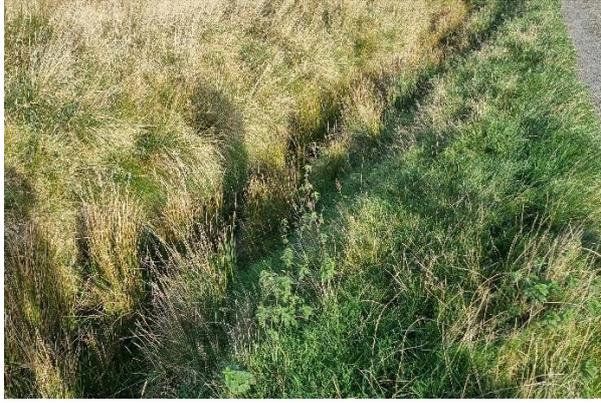
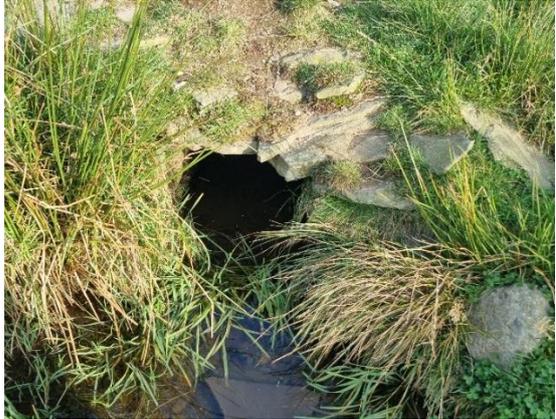
ID – 13 (Proposed track crossing - permanent)	Unnamed Drain
Watercourse Description: Small unnamed drain flowing south adjacent to the main access road. Proposed access crosses drain at the location of a poor quality, stone box culvert.	
NGR Ref: 339501 740317	
Photo – drain looking upstream adjacent to road	Photo – stone box culvert at proposed crossing location

Width of watercourse/ drain (m)	~ 0.5 m
Bed Sediment	Mixed sediment
Bank Erosion	No
Natural Channel	No
Existing Crossing	Existing crossing of the drain using a stone box culvert
Proposed Crossing	Pipe Culvert or Single Span Bridge (permanent)
Additional Mitigation	None
Catchment (km ²)	0.1 km ²
Minor Watercourse	Yes
Main river catchment	Dighty Water
Within catchment of SAC designated river	No
CAR Authorisation Required	No

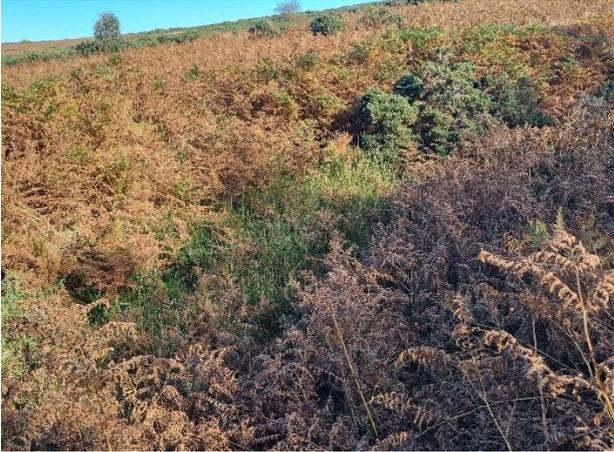
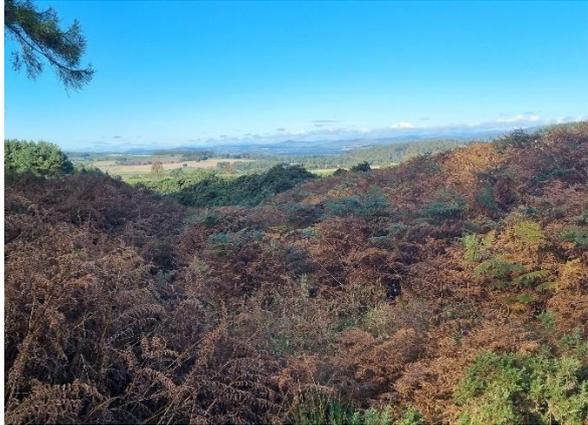
ID – 14 (Proposed track crossing - permanent)	Unnamed Spring fed watercourse
<u>Watercourse Description:</u> Small unnamed watercourse tributary to Glen Ogilvie Burn. Watercourse flows downhill to the west and is fed by two springs upslope of the proposed crossing. The watercourse channel is heavily vegetated.	
NGR Ref: 340669 744061	
Photo – Upstream of proposed crossing location, looking upstream	Photo - Looking downstream to crossing location

Width of watercourse/ drain (m)	~ 0.6 m
Bed Sediment	Mixed, heavily vegetated
Bank Erosion	No
Natural Channel	Yes
Existing Crossing	None
Proposed Crossing	Pipe Culvert or Single Span Bridge (permanent)
Additional Mitigation	None
Catchment (km ²)	0.52 km ²
Minor Watercourse	No
Main river catchment	Dean Water
Within catchment of SAC designated river	Yes (River Tay SAC)
CAR Authorisation Required	Yes – GBR or Registration

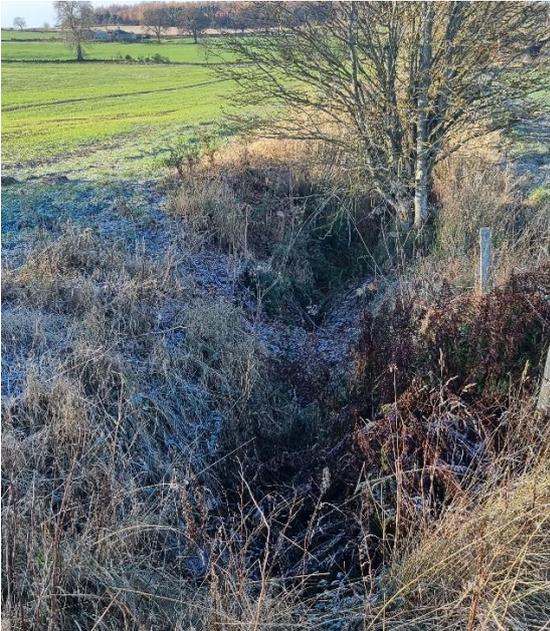
ID – 15 (Proposed track crossing - temporary)	Unnamed drain
Watercourse Description: Drain flowing south but was fairly dry when viewed. Drain is vegetated but well-defined in places, there appears to have been construction nearby with a gravel mound which had spilled into part of the drain.	
NGR Ref: 340837 746504	
Photo – Drain viewed looking upstream

Width of watercourse/ drain (m)	0.9 m
Bed Sediment	Pebble cobble
Bank Erosion	No
Natural Channel	No
Existing Crossing	None
Proposed Crossing	<p>Pipe Culvert or Single Span Bridge (temporary). The crossing location is rural and a temporary crossing sized to the 1 in 30 year flow is considered suitable for the location, size of watercourse and temporary nature of the track crossing. Designing for a 1 in 200 year flow (plus climate change) could result in oversizing the crossing, requiring widening of the channel at the crossing and the need for raised embankments, which is not appropriate for a temporary crossing in a rural setting. The proposed design will allow the crossing to be removed at the end of the construction period with no legacy effect on the existing channel.</p> <p>In the event of a higher flood event occurring when the temporary crossing is in place, water would overtop the track and return back into the channel downstream of the track. There are no nearby receptors and there is considered to be no increased flood risk to others.</p>

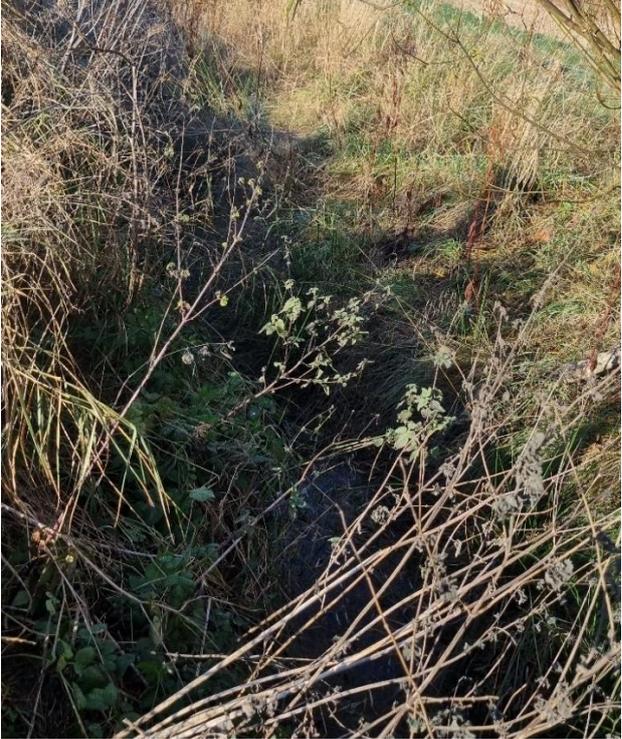
ID – 16 (Proposed track crossing - temporary)	Unnamed Drain
<u>Watercourse Description:</u> Unnamed drain flows east towards the Kerbet Water. Channel is wide, deep and well defined, with a large volume of stagnant water, with minimal flow.	
NGR Ref: 341030 746911	
Photo – Drain viewed looking upstream to the west

Width of watercourse/ drain (m)	0.9 m
Bed Sediment	Pebble cobble
Bank Erosion	No
Natural Channel	No
Existing Crossing	None
Proposed Crossing	<p>Pipe Culvert or Single Span Bridge (temporary). The crossing location is rural and a temporary crossing sized to the 1 in 30 year flow is considered suitable for the location, size of drain and temporary nature of the track crossing. Designing for a 1 in 200 year flow (plus climate change) could result in oversizing the crossing, requiring widening of the channel at the crossing and the need for raised embankments, which is not appropriate for a temporary crossing in a rural setting. The proposed design will allow the crossing to be removed at the end of the construction period with no legacy effect on the existing channel.</p> <p>In the event of a higher flood event occurring when the temporary crossing is in place, water would overtop the track and return back into the channel downstream of the track. There are no nearby receptors and there is considered to be no increased flood risk to others.</p>

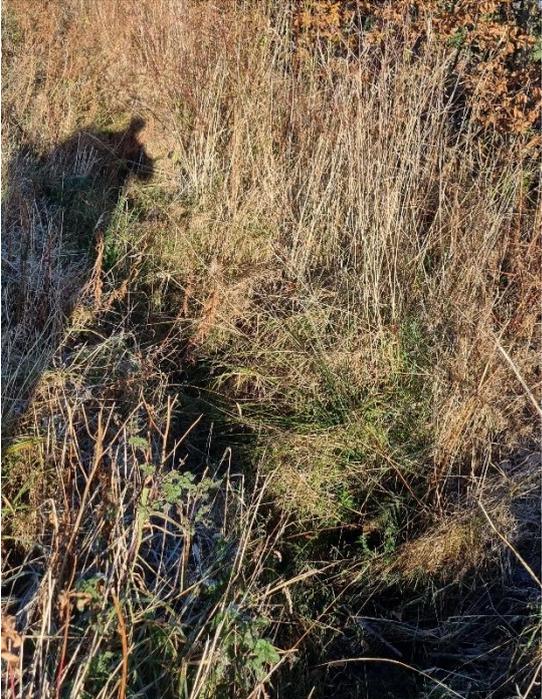
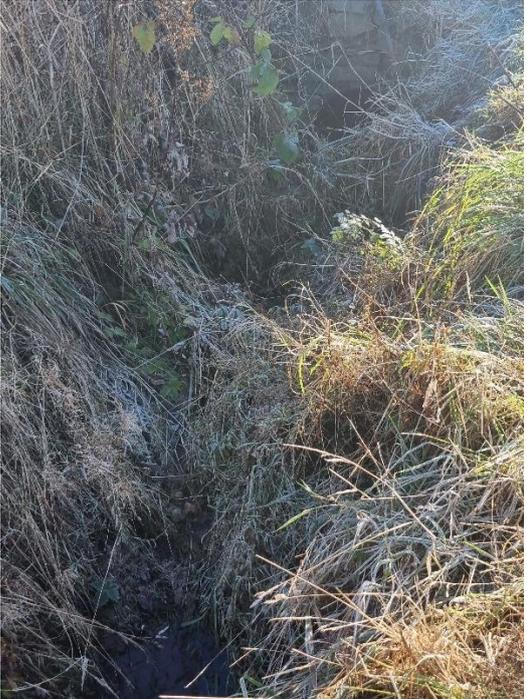
ID – 17 (Existing track crossing)	Unnamed Drain
Watercourse Description: Large unnamed drain with existing crossing for field access, drain is largely stagnant with minor flow direction to the north. There is an existing 500 mm culvert to provide farm access at the crossing location.	
NGR Ref: 340989 747525	
Photo – Unnamed drain	Photo – Culvert visible, heavily vegetated channel

Width of watercourse/ drain (m)	0.9 m
Bed Sediment	Pebble, gravel
Bank Erosion	No
Natural Channel	No
Existing Crossing	Existing pipe culvert (500 mm)
Proposed Crossing	No upgrade. If engineering assessment determines the crossing to be structurally unsound, a temporary over-bridging solution will be put in place during construction.
Additional Mitigation	None
Catchment (km ²)	0.16 km ²
Minor Watercourse	Yes
Main river catchment	Dean Water
Within catchment of SAC designated river	Yes (River Tay SAC)
CAR Authorisation Required	No

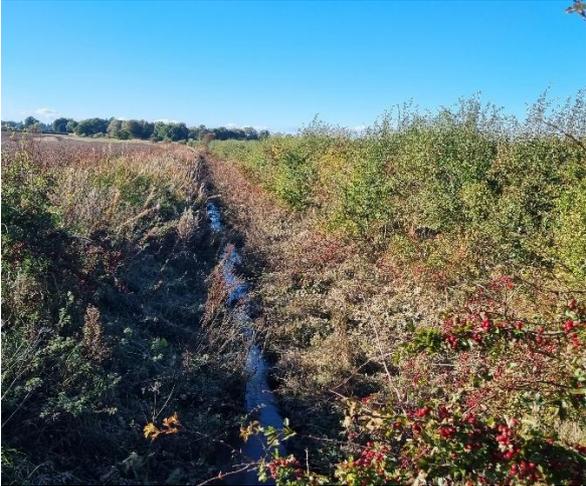
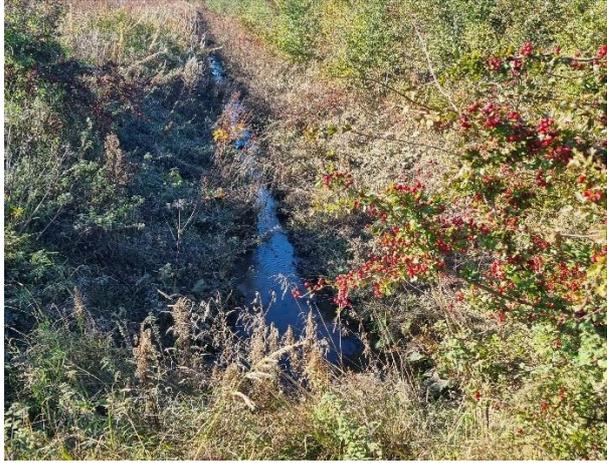
ID – 18 (Existing track crossing)	Unnamed drain tributary to Kerbet Water
<p>Watercourse Description: Large unnamed drain tributary to Kerbet Water flows west. Channel is large and well defined. There is a 500 mm culvert at the existing crossing which provides farm track access across the drain.</p>	
NGR Ref: 341050 748552	
Photo – Drain looking west downstream

Width of watercourse/ drain (m)	1.2 m
Bed Sediment	Gravel, pebble, Cobble
Bank Erosion	No
Natural Channel	No
Existing Crossing	Existing pipe culvert (500 mm)
Proposed Crossing	No upgrade. If engineering assessment determines the crossing to be structurally unsound, a temporary over-bridging solution will be put in place during construction.
Additional Mitigation	None
Catchment (km ²)	0.65 km ²
Minor Watercourse	No
Main river catchment	Dean Water
Within catchment of SAC designated river	Yes (River Tay SAC)
CAR Authorisation Required	No

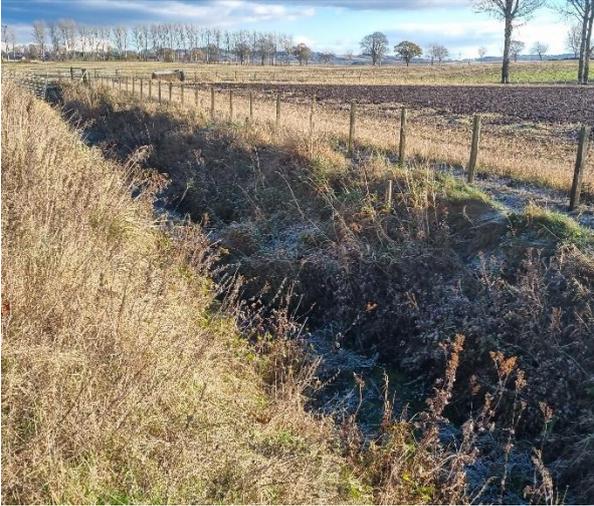
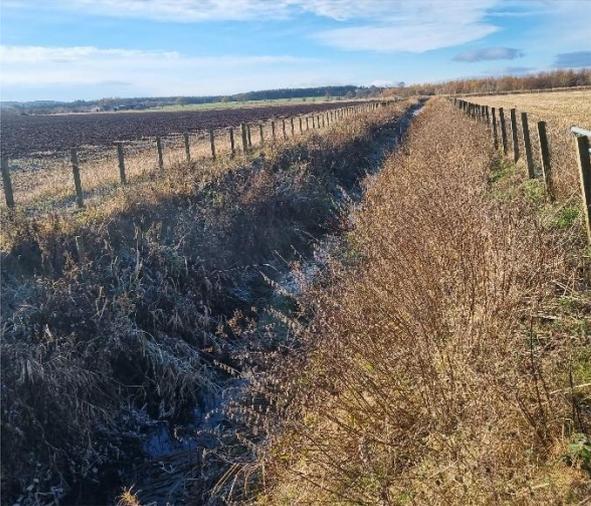
ID – 19 (Proposed track crossing - temporary)	Unnamed Drain
<u>Watercourse Description:</u> Large drain flows west to Gairie Burn and then Dean Water	
NGR Ref: 341045 750045	
Photo – Whiting Burn – upstream of proposed track crossing	Photo – Whiting Burn

Width of watercourse/ drain (m)	1.7 m
Bed Sediment	Silt
Bank Erosion	No
Natural Channel	No
Existing Crossing	None
Proposed Crossing	<p>Pipe Culvert or Single span bridge (temporary). The crossing location is rural and a temporary crossing sized to the 1 in 30 year flow is considered suitable for the location, size of drain and temporary nature of the track crossing. Designing for a 1 in 200 year flow (plus climate change) could result in oversizing the crossing, requiring widening of the channel at the crossing and the need for raised embankments, which is not appropriate for a temporary crossing in a rural setting. The proposed design will allow the crossing to be removed at the end of the construction period with no legacy effect on the existing channel.</p> <p>In the event of a higher flood event occurring when the temporary crossing is in place, water would overtop the track and return back into the channel downstream of the track. There are no nearby receptors and there is considered to be no increased flood risk to others.</p>

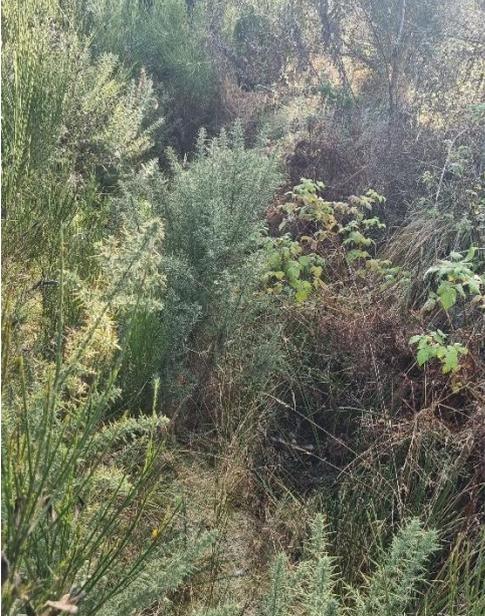
ID – 22 (Existing track crossing)	Unnamed drain
<p>Watercourse Description: Unnamed drain flows south in well-defined but heavily vegetated channel, extensive coverage of gorse and other shrubs. There is an existing culvert, but culvert dimensions are unknown at the time of writing. The existing track crossing is in poor condition.</p>	
NGR Ref: 343524 754284	
<p>Photo – Heavily vegetated channel viewed looking south</p>

Width of watercourse/ drain (m)	1.0 m
Bed Sediment	Silt gravel
Bank Erosion	No
Natural Channel	No
Existing Crossing	Existing culvert, dimensions unknown
Proposed Crossing	No upgrade. If engineering assessment determines the crossing to be structurally unsound, a temporary over-bridging solution will be put in place during construction.
Additional Mitigation	None
Catchment (km ²)	0.12 km ²
Minor Watercourse	Yes
Main river catchment	River South Esk
Within catchment of SAC designated river	Yes (River Tay SAC)

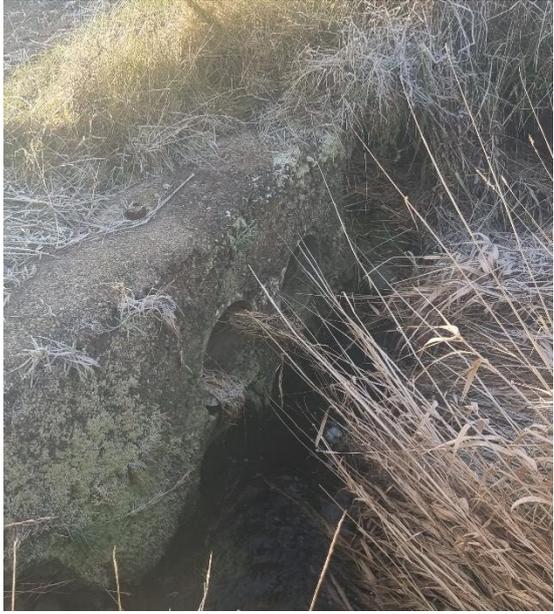
ID – 24 (Existing track crossing)	Tributary to King’s Burn
<p>Watercourse Description: Existing large crossings over tributary to King’s Burn which flows south in small channel. If this existing access route is to be used to access the Proposed Development, there will be an existing culvert and its suitability will be assessed at detailed design stage.</p>	
NGR Ref: 344524 754983	
Photo - Tributary viewed looking upstream to the north	Photo - Several 250mm culverts (4 visible)

Width of watercourse/ drain (m)	0.8 m
Bed Sediment	Silt gravel pebble
Bank Erosion	No
Natural Channel	Yes
Existing Crossing	Existing pipe culverts (4 x 250 mm)
Proposed Crossing	No upgrade. If engineering assessment determines the crossing to be structurally unsound, a temporary over-bridging solution will be put in place during construction.
Additional Mitigation	None
Catchment (km ²)	1.08 km ²
Minor Watercourse	No
Main river catchment	River South Esk

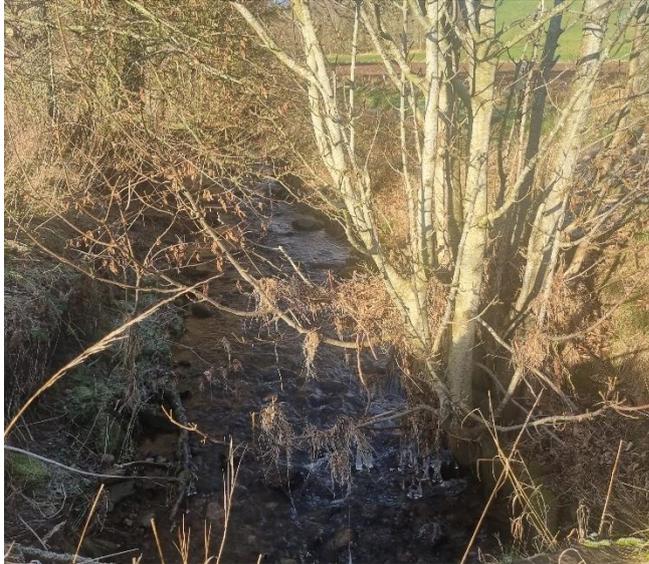
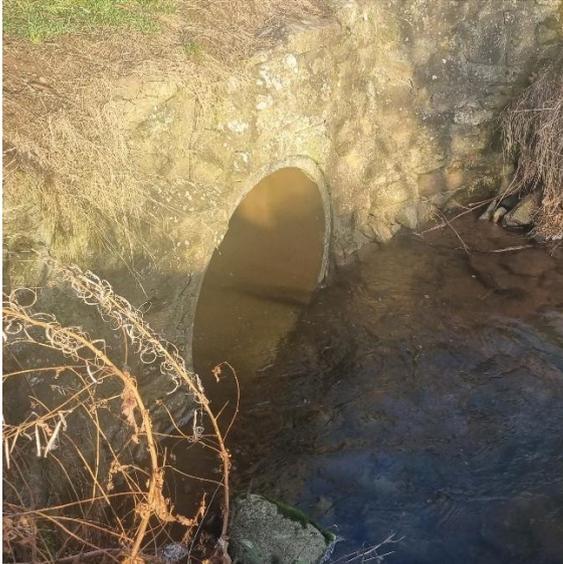
ID – 25 (Existing track crossing)	King's Burn
Watercourse Description: Existing track crossing of the upper King's Burn, which flows to the south. There is an existing crossing in place to provide field access with an existing culvert and its suitability will be assessed at detailed design stage.	
NGR Ref: 344690 755000	
Photo – King's Burn viewed looking north upstream	Photo – Culvert outlet

Width of watercourse/ drain (m)	2.2 m
Bed Sediment	Mix silt to cobble
Bank Erosion	Yes
Natural Channel	Yes
Existing Crossing	Existing culvert (750 mm)
Proposed Crossing	No upgrade. If engineering assessment determines the crossing to be structurally unsound, a temporary over-bridging solution will be put in place during construction.
Additional Mitigation	None
Catchment (km ²)	7.04 km ²
Minor Watercourse	No
Main river catchment	River South Esk
Within catchment of SAC designated river	Yes (River Tay SAC)
CAR Authorisation Required	No

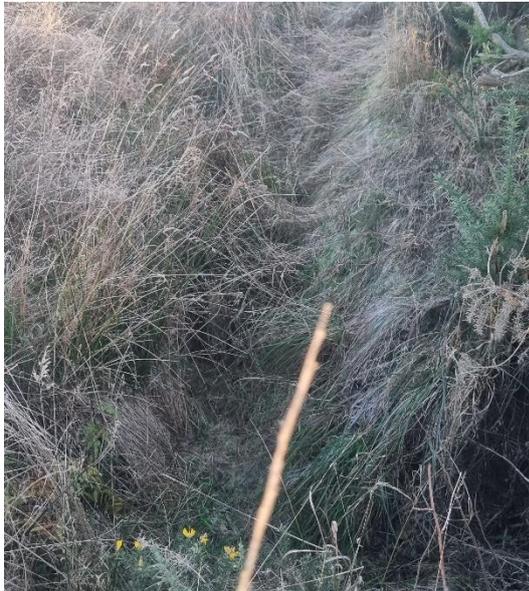
ID – 30 (Proposed track crossing - temporary)	Unnamed drain
<p>Watercourse Description: Heavily vegetated but well-defined drain which is not shown on Ordnance Survey mapping. Connects to adjacent drain which is mapped and flows into Coe Burn.</p>	
NGR Ref: 350938 762097	
Photo – Dry, unnamed drain viewed looking upstream to the east. Not mapped and connects to adjacent mapped drain	Photo – adjacent mapped drain which flows southeast to Coe Burn adjacent to track

Width of watercourse/ drain (m)	0.8 m
Bed Sediment	Silt
Bank Erosion	No
Natural Channel	No
Existing Crossing	None
Proposed Crossing	<p>Pipe Culvert or Single Span Bridge (temporary). The crossing location is rural and a temporary crossing sized to the 1 in 30 year flow is considered suitable for the location, size of drain and temporary nature of the track crossing. Designing for a 1 in 200 year flow (plus climate change) could result in oversizing the crossing, which is not appropriate for a temporary crossing in a rural setting. The proposed design will allow the crossing to be removed at the end of the construction period with no legacy effect on the existing channel.</p> <p>In the event of a higher flood event occurring when the temporary crossing is in place, water would overtop the track and return back into the channel downstream of the track. There are no nearby receptors and there is considered to be no increased flood risk to others.</p>

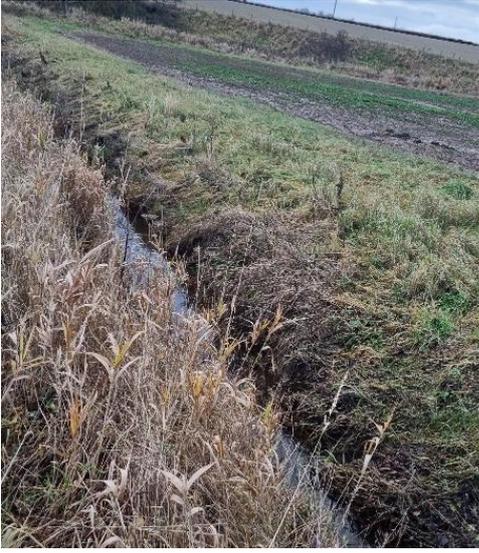
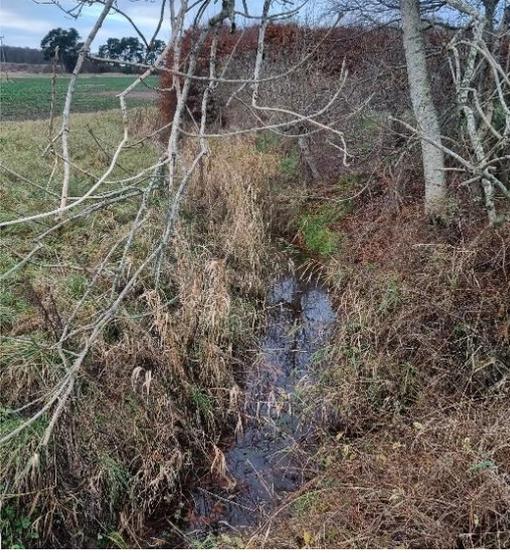
ID – 31 (Proposed track crossing - temporary)	Unnamed drain
<u>Watercourse Description:</u> Heavily vegetated drainage channel, very straight and feeds into Willie Mills Burn further downstream. No existing crossing over the drain.	
NGR Ref: 356045 762860	
Photo – Drain further downstream of crossing	Photo – Drain

Width of watercourse/ drain (m)	0.9 m
Bed Sediment	Silt
Bank Erosion	No
Natural Channel	No
Existing Crossing	None
Proposed Crossing	<p>Single Span Bridge (temporary). The crossing location is rural and a temporary crossing sized to the 1 in 30 year flow is considered suitable for the location, size of drain and temporary nature of the track crossing. Designing for a 1 in 200 year flow (plus climate change) could result in oversizing the bridge, requiring widening of the channel at the crossing and the need for raised embankments, which is not appropriate for a temporary crossing in a rural setting. The proposed design will allow the crossing to be removed at the end of the construction period with no legacy effect on the existing channel.</p> <p>In the event of a higher flood event occurring when the temporary crossing is in place, water would overtop the track and return back into the channel downstream of the track. There are no nearby receptors and there is considered to be no increased flood risk to others.</p>

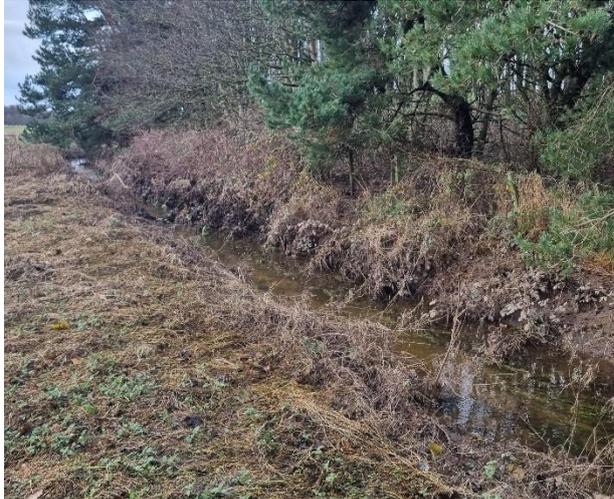
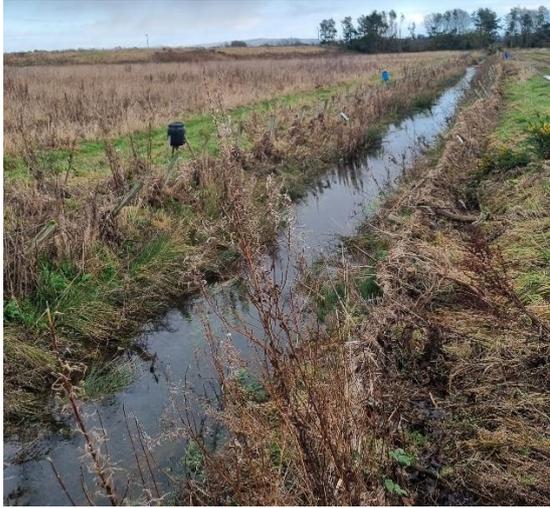
ID – 35 (Existing track crossing)	Whishop Burn
Watercourse Description: Existing crossing and track over Whishop Burn in well-defined channel with a 300 mm culvert beneath the track. Whishop Burn flows to the east.	
NGR Ref: 361393 766403	
Photo – Whishop Burn upstream of crossing	Photo – Whishop Burn downstream of crossing

Width of watercourse/ drain (m)	2.0 m
Bed Sediment	Silt, gravel, pebble
Bank Erosion	No
Natural Channel	Yes
Existing Crossing	Existing crossing (300 mm culvert)
Proposed Crossing	No upgrade. If engineering assessment determines the crossing to be structurally unsound, a temporary over-bridging solution will be put in place during construction.
Additional Mitigation	None
Catchment (km ²)	3.1 km ²
Minor Watercourse	No
Main river catchment	River North Esk
Within catchment of SAC designated river	No
CAR Authorisation Required	No

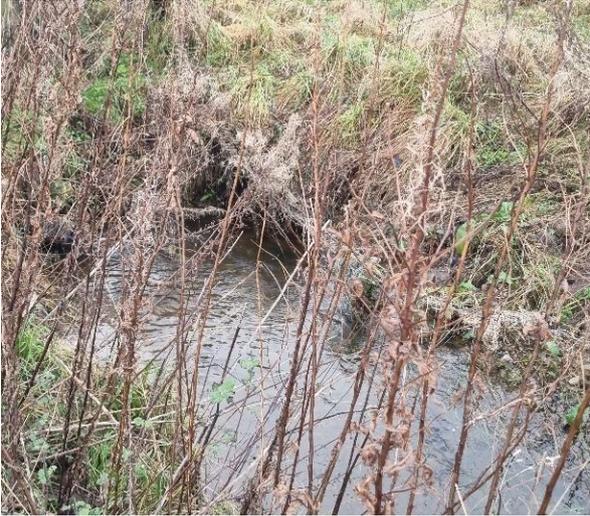
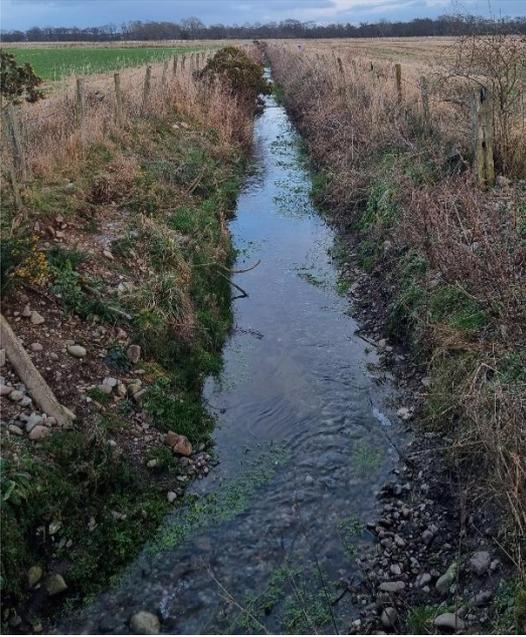
ID – 36 (Proposed track crossing - temporary)	Whishop Burn
<u>Watercourse Description:</u> Proposed crossing over Whishop Burn in well-defined channel which flows to the south.	
NGR Ref: 363988 766380	
Photo – Whishop Burn upstream of crossing	Photo – Whishop Burn upstream of proposed crossing, looking downstream

Width of watercourse/ drain (m)	2.0 m
Bed Sediment	Silt, gravel, pebble
Bank Erosion	No
Natural Channel	Yes
Existing Crossing	None
Proposed Crossing	<p>Single Span Bridge (temporary). The crossing location is rural and a temporary crossing sized to the 1 in 30 year flow is considered suitable for the location, size of watercourse and temporary nature of the track crossing. Designing for a 1 in 200 year flow (plus climate change) could result in oversizing the bridge, requiring widening of the channel at the crossing and the need for raised embankments, which is not appropriate for a temporary crossing in a rural setting. The proposed design will allow the crossing to be removed at the end of the construction period with no legacy effect on the existing channel.</p> <p>In the event of a higher flood event occurring when the temporary crossing is in place, water would overtop the track and return back into the channel downstream of the track. There are no nearby receptors and there is considered to be no increased flood risk to others.</p>
