Volume 5: Appendix 13.6 – Peat Landslide Hazard Risk Assessment (PLHRA)

- 1.1.2 The Proposed Development comprises six sections (A to F) from a new proposed 400 kV substation known as Emmock, near Tealing in the south, to the existing Kintore Substation in the north. The Proposed Development is approximately 105.2 km in length, comprising double circuit 400 kV OHL supported by a combination of suspension and tension towers with associated temporary workings to enable construction and access. Permanent realignment of existing OHLs, a crossing of an existing OHL and temporary OHL diversions are also required. A broad overview of the route is shown on the left panel of **Plate 13.6.1: Proposed Location of Kintore to Tealing 400 kV OHL (left) and the PLHRA Study Area (right)**.

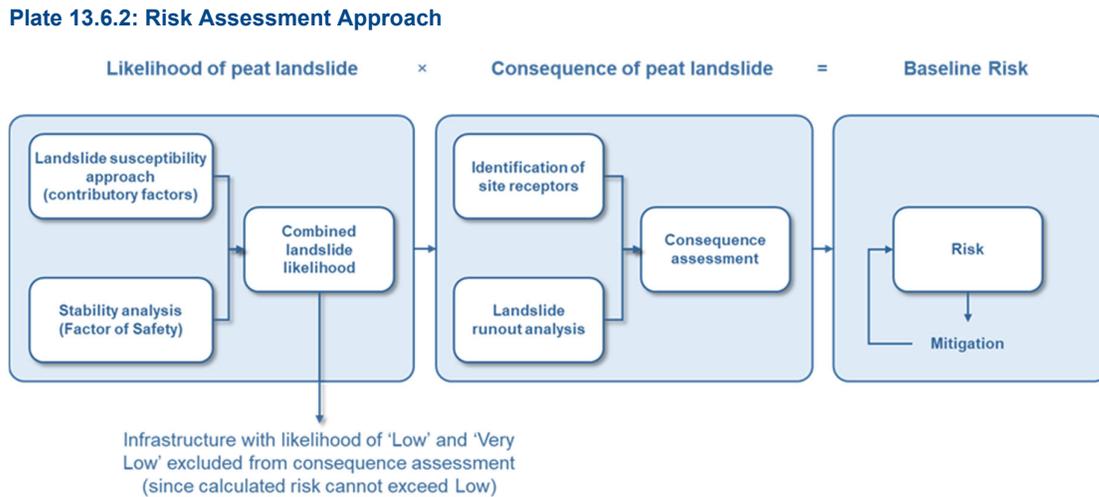
1.4.3 To reflect these limitations, both approaches are adopted and outputs from each approach integrated in the assessment of landslide likelihood. **Plate 13.6.2: Risk Assessment Approach** shows the approach:

1.4.1 This report approaches assessment of peat instability through both a qualitative contributory factor-based approach and via more conventional stability analysis (through limit equilibrium or Factor of Safety (FoS) analysis). The advantage of the former is that many observed relationships between reported peat landslides and ground conditions can be considered together where a FoS is limited to consideration of a limited number of geotechnical parameters. The disadvantage is that the outputs of such an approach are better at illustrating relative variability in landslide susceptibility across a site rather than absolute likelihood.

1.4.2 The advantage of the FoS approach is that clear thresholds between stability and instability can be defined and modelled numerically, however, in reality, there is considerable uncertainty in input parameters and it is a generally held view that the geomechanical basis for stability analysis in peat is limited given the nature of peat as an organic, rather than mineral soil.

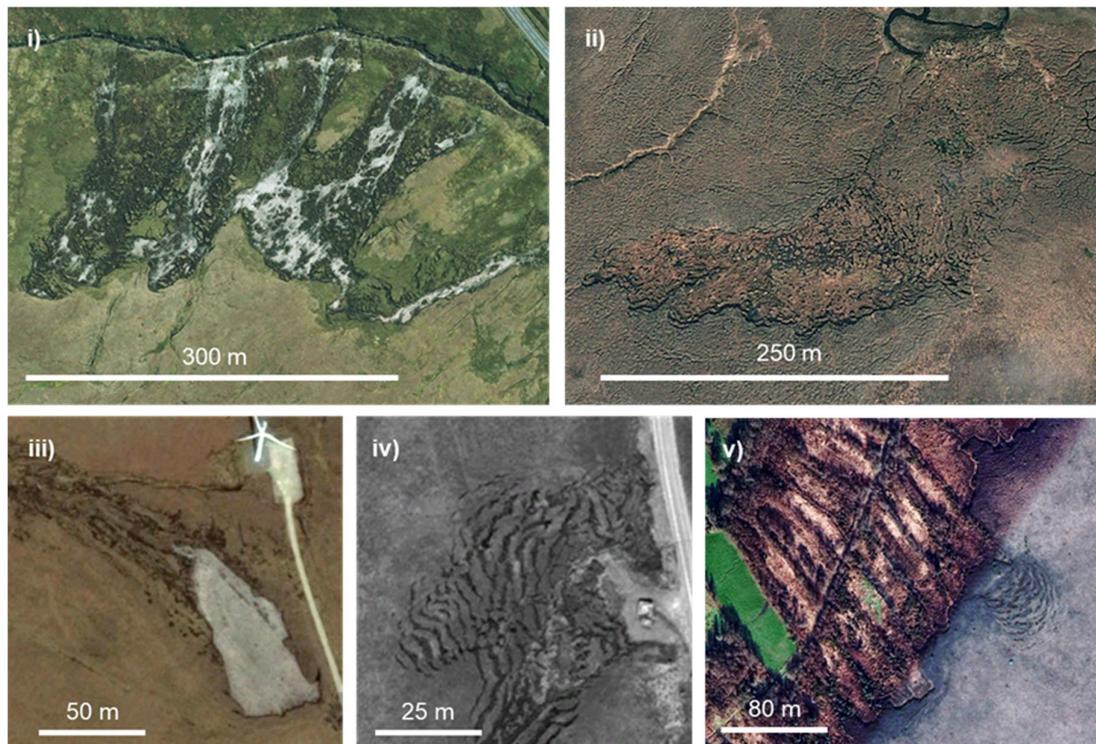
- 2.1.6 Since then, a number of peat landslide events have occurred both naturally and in association with wind farms (eg **Plate 13.6.3: Characteristic Peat Landslide Types in UK and Irish Peat Uplands**: Top row - natural failures: i) multiple peat slides with displaced slabs and exposed substrate, ii) retrogressive bog burst with peat retained within the failed area; Bottom row - failures possibly induced by human activity: iii) peat slide adjacent to turbine foundation, iv) spreading around foundation, v) spreading upslope of cutting). In the case of wind farm sites, these have rarely been reported, however landslide scars of varying age are visible in association with wind farm infrastructure on Corry Mountain, Co. Leitrim, at Sonnagh Old Wind Farm, Co. Galway (near Derrybrien; Cullen, 2011)⁷, and at Corkey Wind Farm, Co. Antrim. In December 2016, a plant operator was killed during excavation works in peat at the

- 2.2.3 For the purposes of this assessment, landslide classification is simplified and split into three main types, typical examples of which are shown in **Plate 13.6.3: Characteristic Peat Landslide Types in UK and Irish Peat Uplands:** Top row - natural failures: i) multiple peat slides with displaced slabs and exposed substrate, ii) retrogressive bog burst with peat retained within the failed area; Bottom row - failures possibly induced by human activity: iii) peat slide adjacent to turbine foundation, iv) spreading around foundation, v) spreading upslope of cutting. Dimensions, slope angles and peat depths are drawn from charts presented in Evans and Warburton (2007)². The term "peat slide" is used to refer to large-scale (typically less than 10,000 of cubic metres) landslides in which failure initiates as large rafts of material which subsequently break down into smaller blocks and slurry. Peat slides occur 'top-down' from the point of initiation on a slope in thinner peats (between 0.5 m and 1.5 m) and on moderate slope angles (typically 5°-15°, see **Plate 13.6.4: Reported slope angles and peat depths associated with peat slides and bog bursts (from literature review of locations, depths and slope angles, after Mills, 2002)**¹⁶).

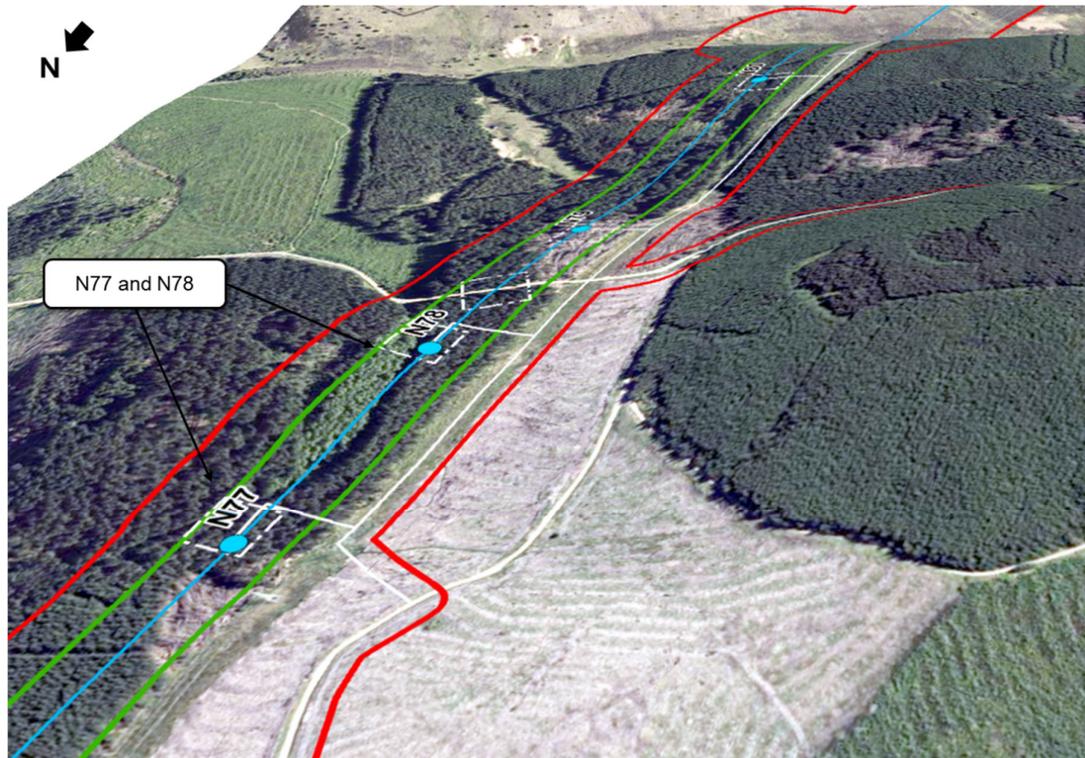
Plate 13.6.5: Ground Conditions in the Vicinity of Towers N77 and N78

- 3.1.1 The route for the OHL between Towers N77 and N78 passes an unnamed hillside of low relief (276 m above ordnance datum (AOD), **Annex 1, Figure A13.6.1: Site Characteristics**) situated between Cairn-mon-earn (378 m AOD c. 1 km to the west) and Strathgyle (297 m AOD, c. 1 km to the east). Towers N77 and N78 sit at approximately 257 m and 266 m elevation respectively (**Annex 1, Figure A13.6.1: Site Characteristics, 'Elevation' panel**). The general ground conditions are shown on **Plate 13.6.5: Ground Conditions in the Vicinity of Towers N77 and N78** below.

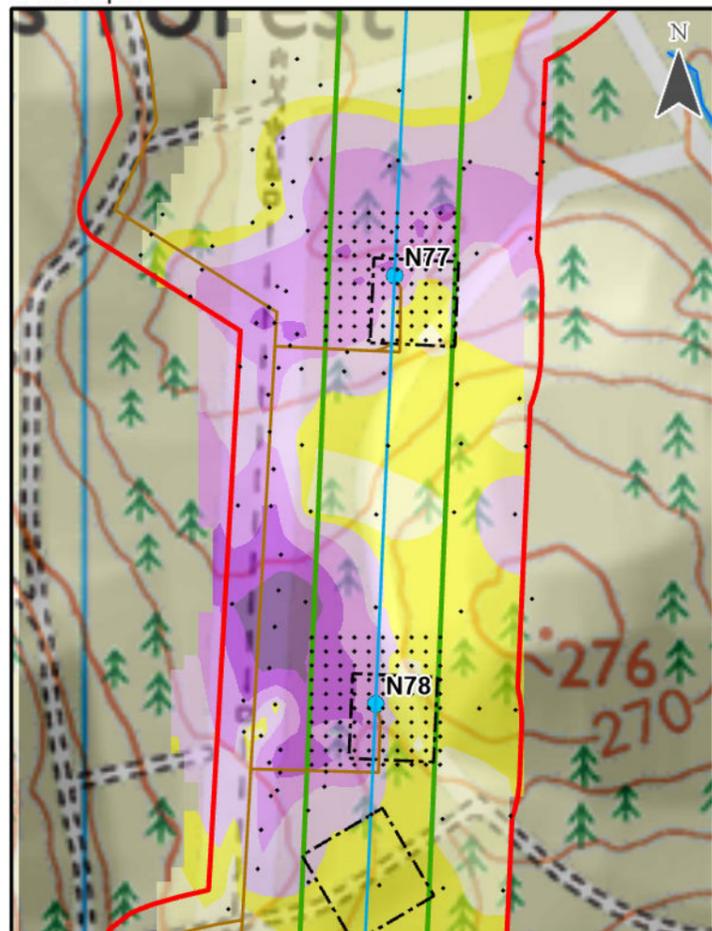
Peat Depth

3.5.3 The peat depth model is shown on **Annex 1, Figure A13.6.1: Site Characteristics**, 'Peat Depth' panel with probing locations superimposed. The tower working area for N77 is located at the periphery of a deep peat deposit, while N78 overlaps an area that deepens to the west. The peat at N77 varies between approximately 0.25 m and 2.1 m and the peat at N78 varies between 0.25 m (soil) and 2.0 m (peat). Given the relatively shallow depths, peat slides are modelled as the mode of failure within this PLHRA (see section 2.3).

- peat is generally thin to absent over much of this section of the OHL;
- locally, immediately to the north and partially overlapping the N77 working area, peat reaches up to 2.0 m in depth within a topographic hollow facing east towards Strans Burn;
- a second isolated pocket of peat is present to the west of the unnamed summit adjacent to Tower N78 – peat is up to 2.0 m in depth at the margin of the tower and working area; and
- Towers N79 to N82 are not located in peat.

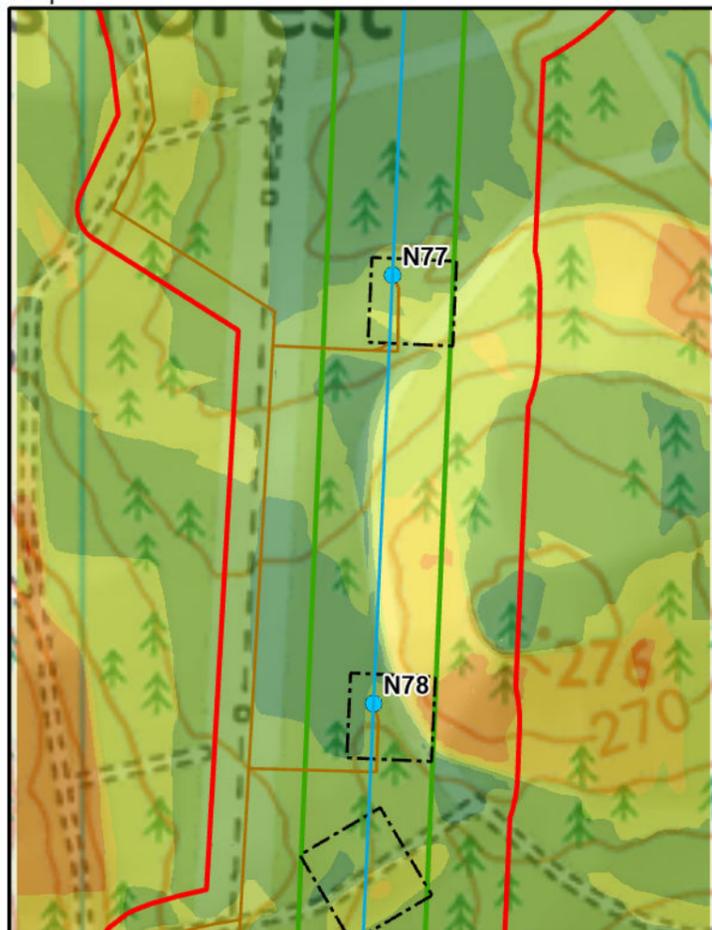
Slope

- 3.1.2 A 5m digital terrain model (DTM) was used to identify slopes within the Site (**Annex 1, Figure A13.6.1: Site Characteristics, 'Slope' panel**). Slopes are generally gentle ($< 5^\circ$) within the Site, locally steeper (up to 15°) on the eastern side of the Limit of Deviation on the sideslopes of a localised unnamed summit.

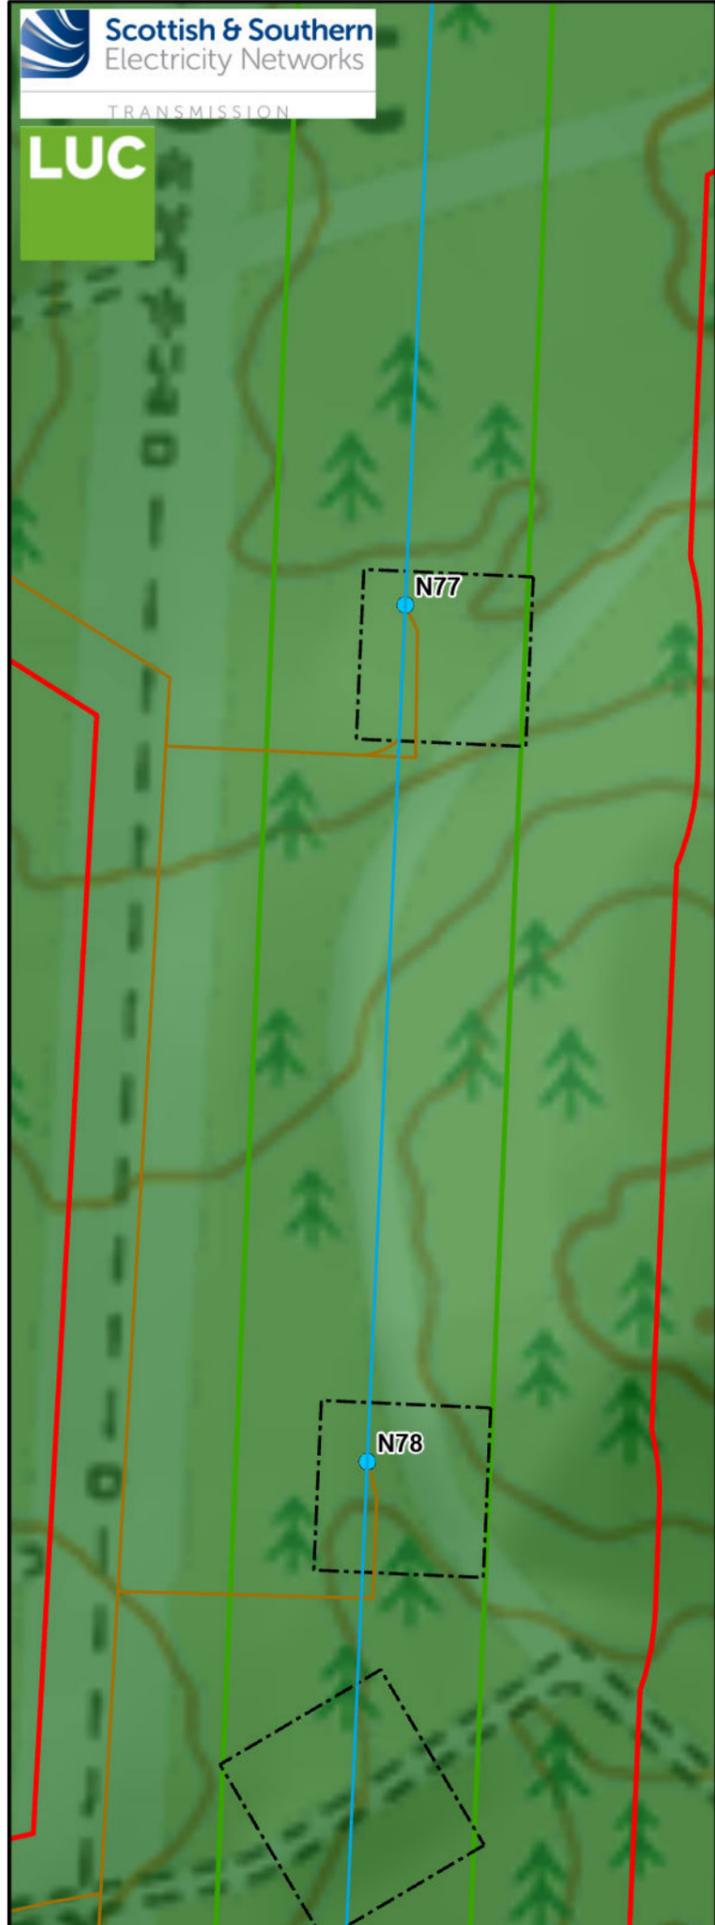
Factor of Safety - Best Estimate

- 4.3.26 There are no areas identified with 'High' or 'Very High' landslide susceptibility. When compared with the stability analysis approach (the left panel of **Annex 1, Figure A13.6.2: PLHRA Results**, 'Factor of Safety – Best Estimate' panel), the outputs of the landslide susceptibility approach indicate more of the study area to be at a slightly lower stability under natural conditions.

4.2.4 Where the driving forces exceed the shear strength (ie where the bottom half of the equation is larger than the top), F is < 1, indicating instability. A factor of safety between 1 and 1.4 is normally taken in engineering to indicate marginal stability (providing an allowance for variability in the strength of the soil, depth to failure, etc). Slopes with a factor of safety greater than 1.4 are generally considered to be stable.

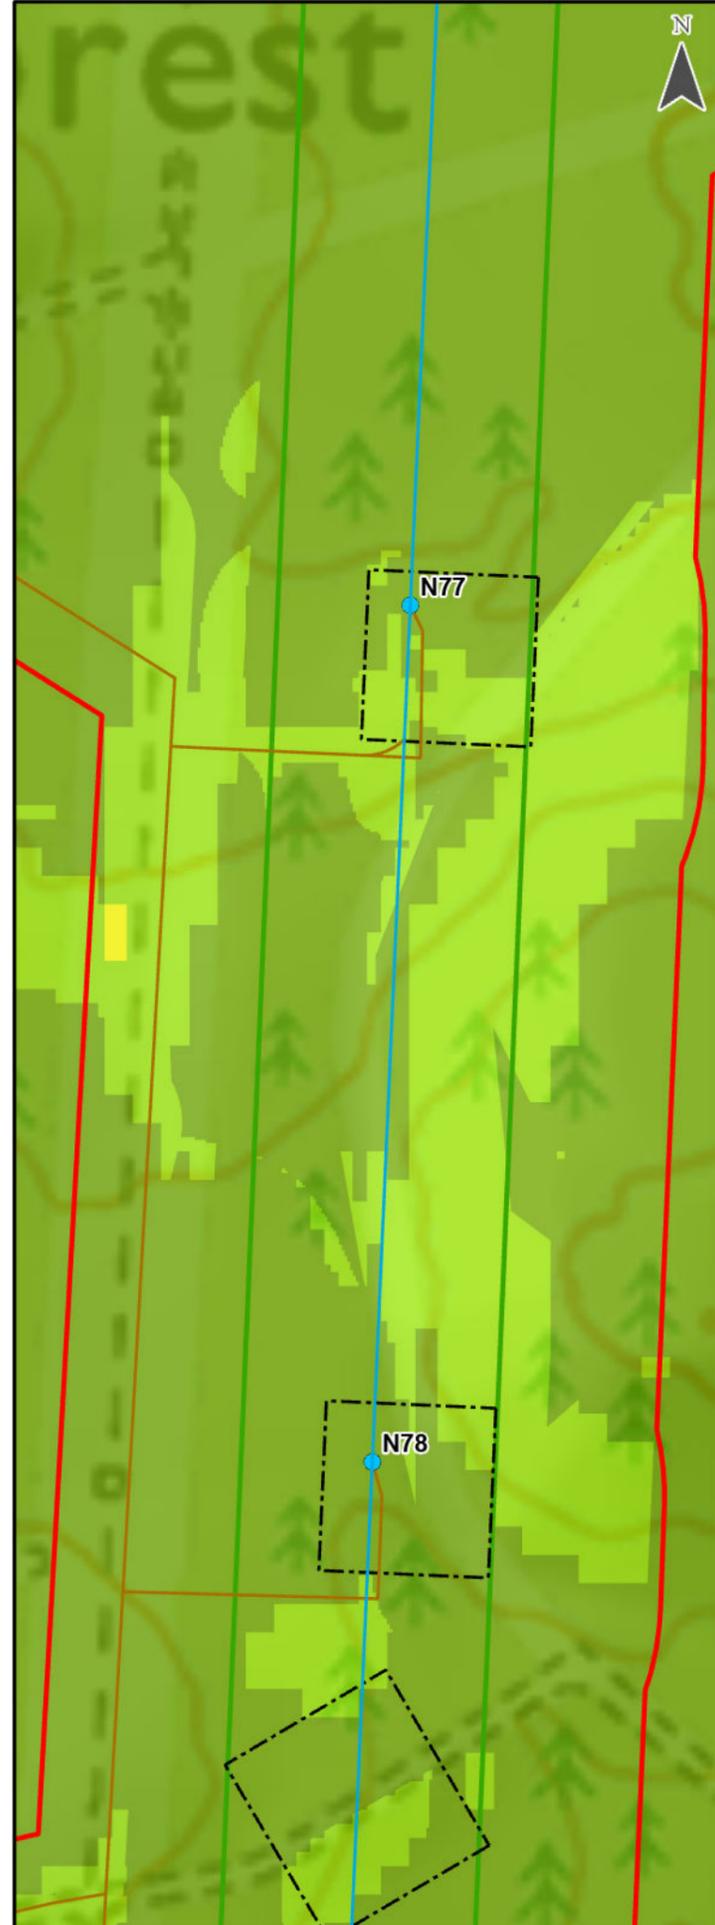
Peat Landslide Likelihood

- 4.3.24 The right panel of **Annex 1, Figure A13.6.2: PLHRA Results**, 'Peat Landslide Likelihood' panel, shows the outputs of the landslide susceptibility (likelihood) approach for peat slides. The results indicate that the majority of the study area has a 'Very Low' or 'Low' likelihood with only one facet being of a 'Moderate' likelihood of a peat slide under natural conditions. This applies to the construction and working areas of both towers, and to the intervening section of land over which the access track is proposed.
