**Netherton Hub 400 kV OHL Connection to  
New Deer and Peterhead: Tie-In  
Environmental Appraisal Report  
Appendix 7.2A - Protected Species  
Addendum**

**August 2026**

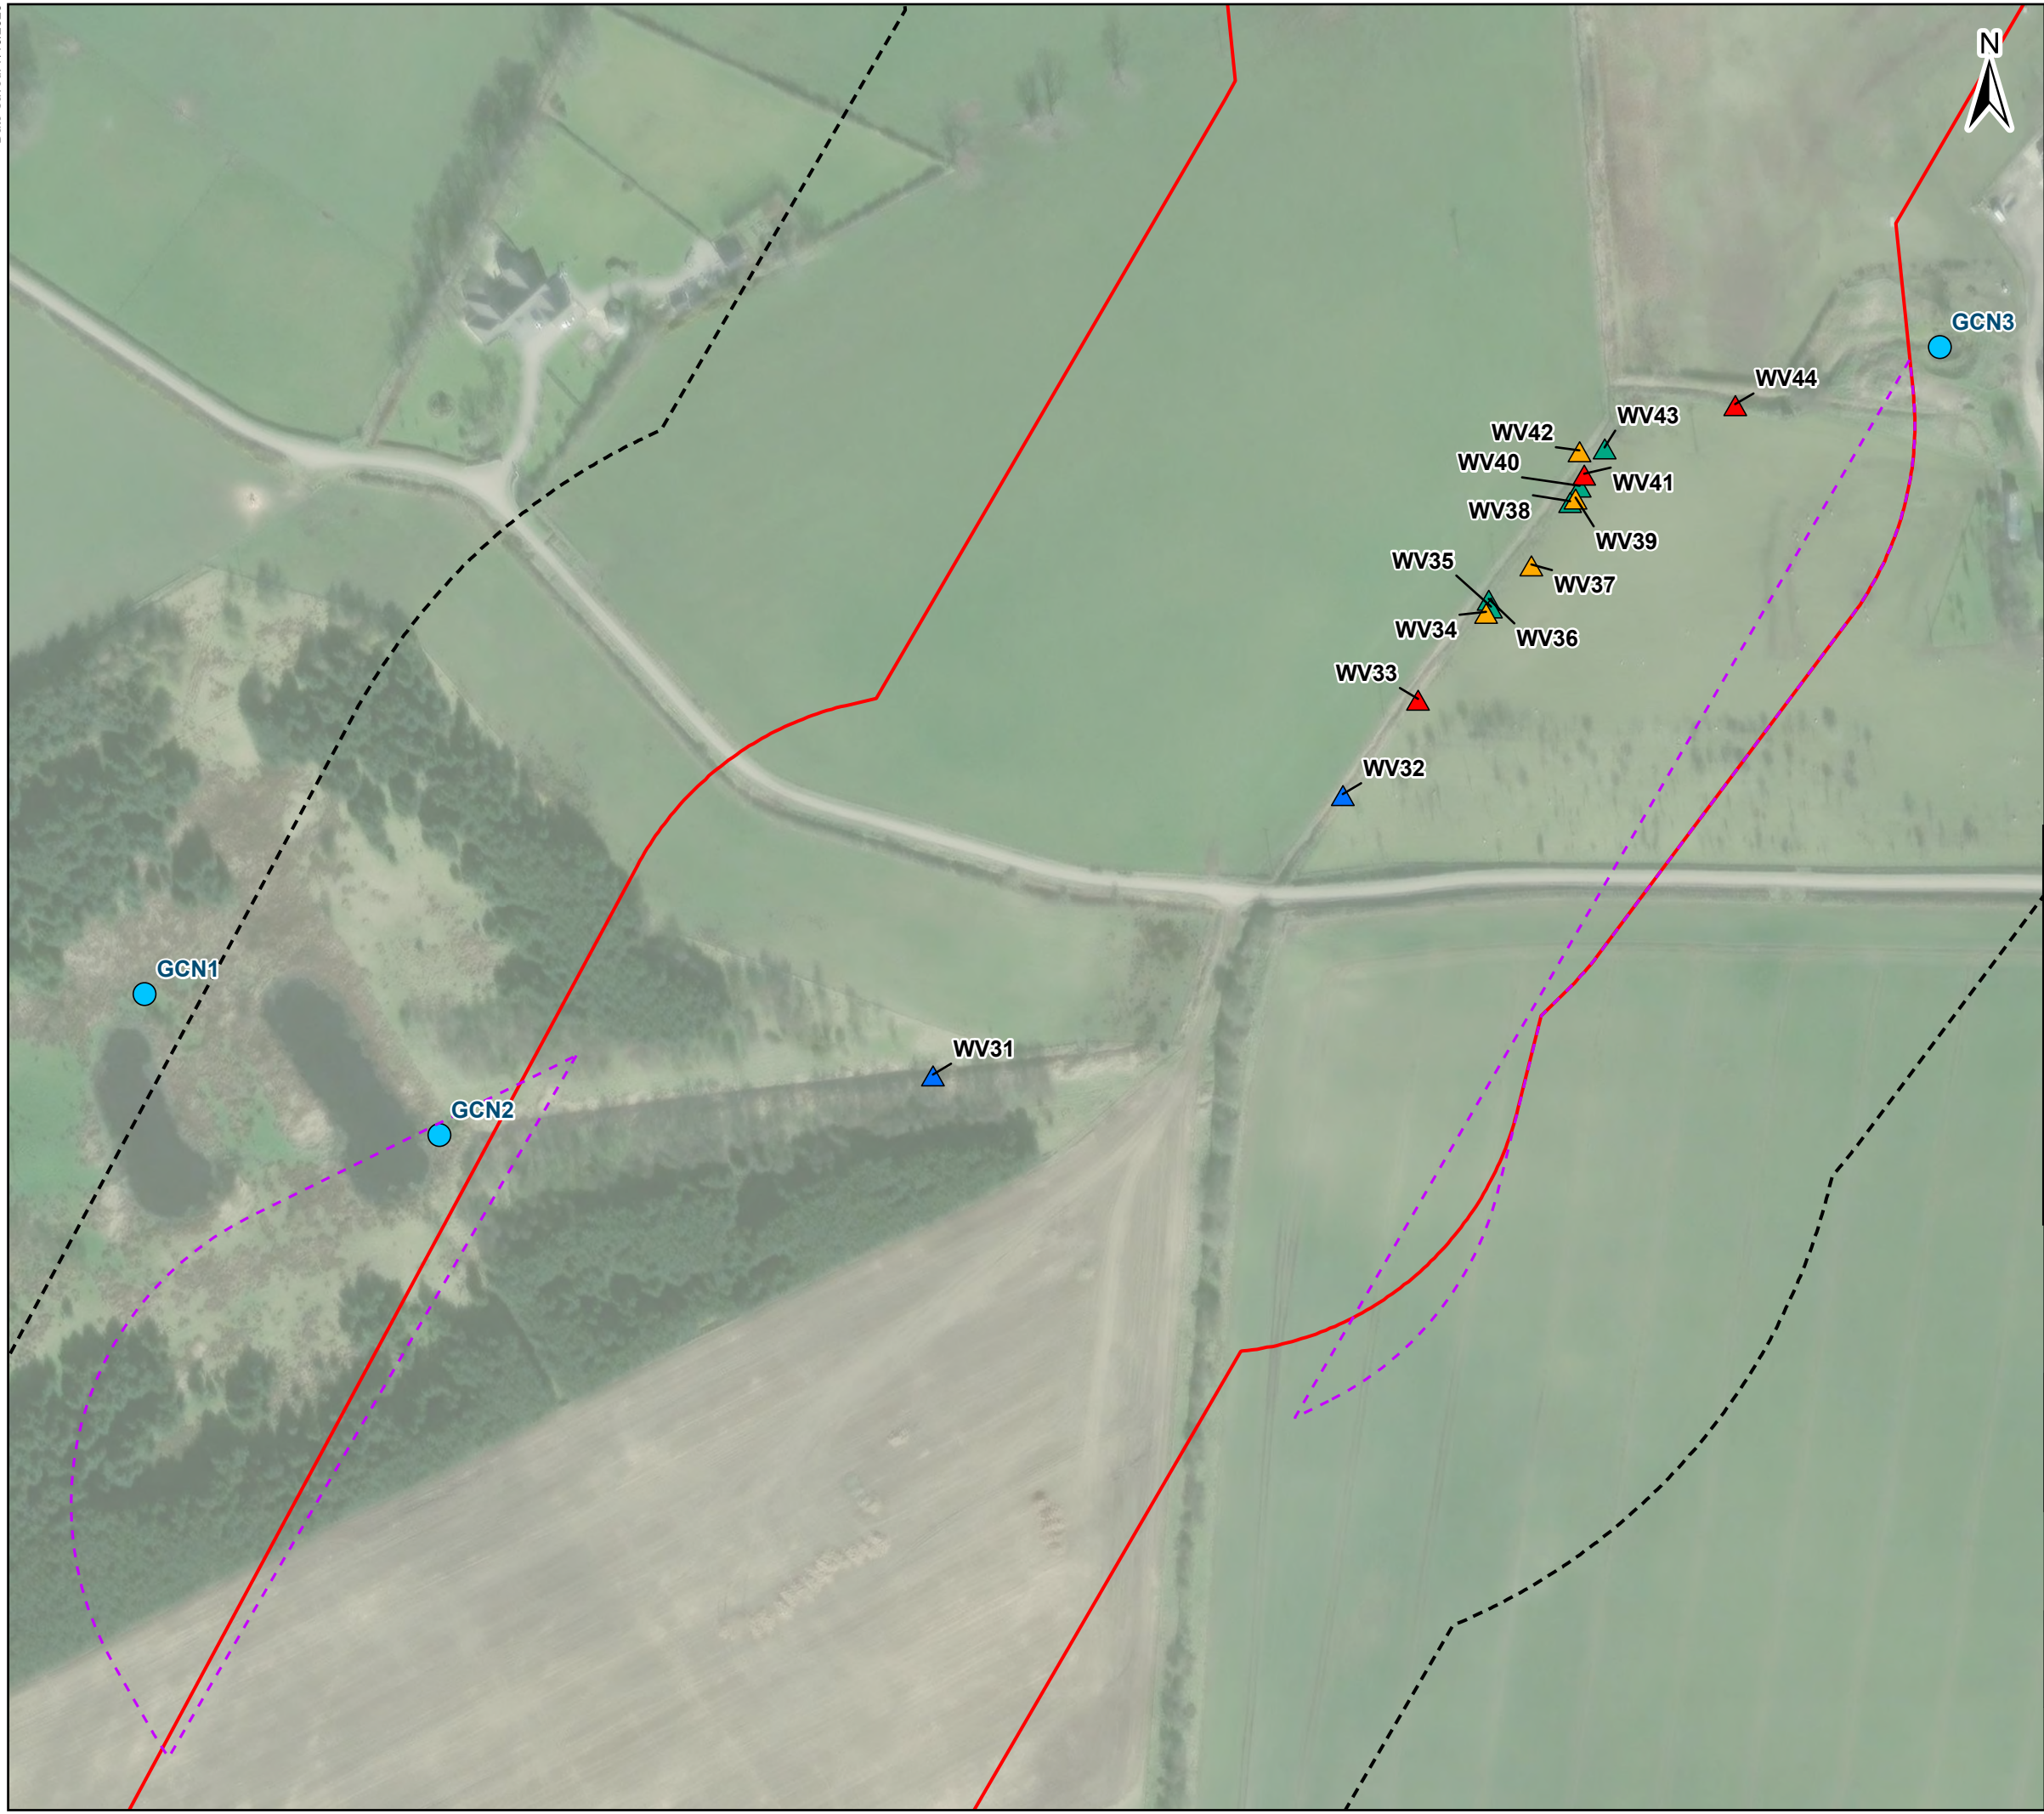
Title  
Figure 7A.1 – Survey Areas and Access Constraints

- Site
- Water Vole Survey Area
- Associated Infrastructure Survey Area
- Access Constraints
- HSI Pond

2.1.11 A second water vole survey within the water vole active season was completed between 2 - 5 June 2026. This covered watercourses and burns (minor watercourses) within the Site and 100 m buffer (hereafter "Water Vole Survey Area") where the previous survey identified suitable habitat and where access was possible. The Water Vole Survey Area is shown in **Annex A: Figure 7A.1 – Survey Areas and Access Constraints**.

Site boundary, and access constraints have been presented on **Annex A – Figure 7A.1: Survey Areas and Access Constraints**.

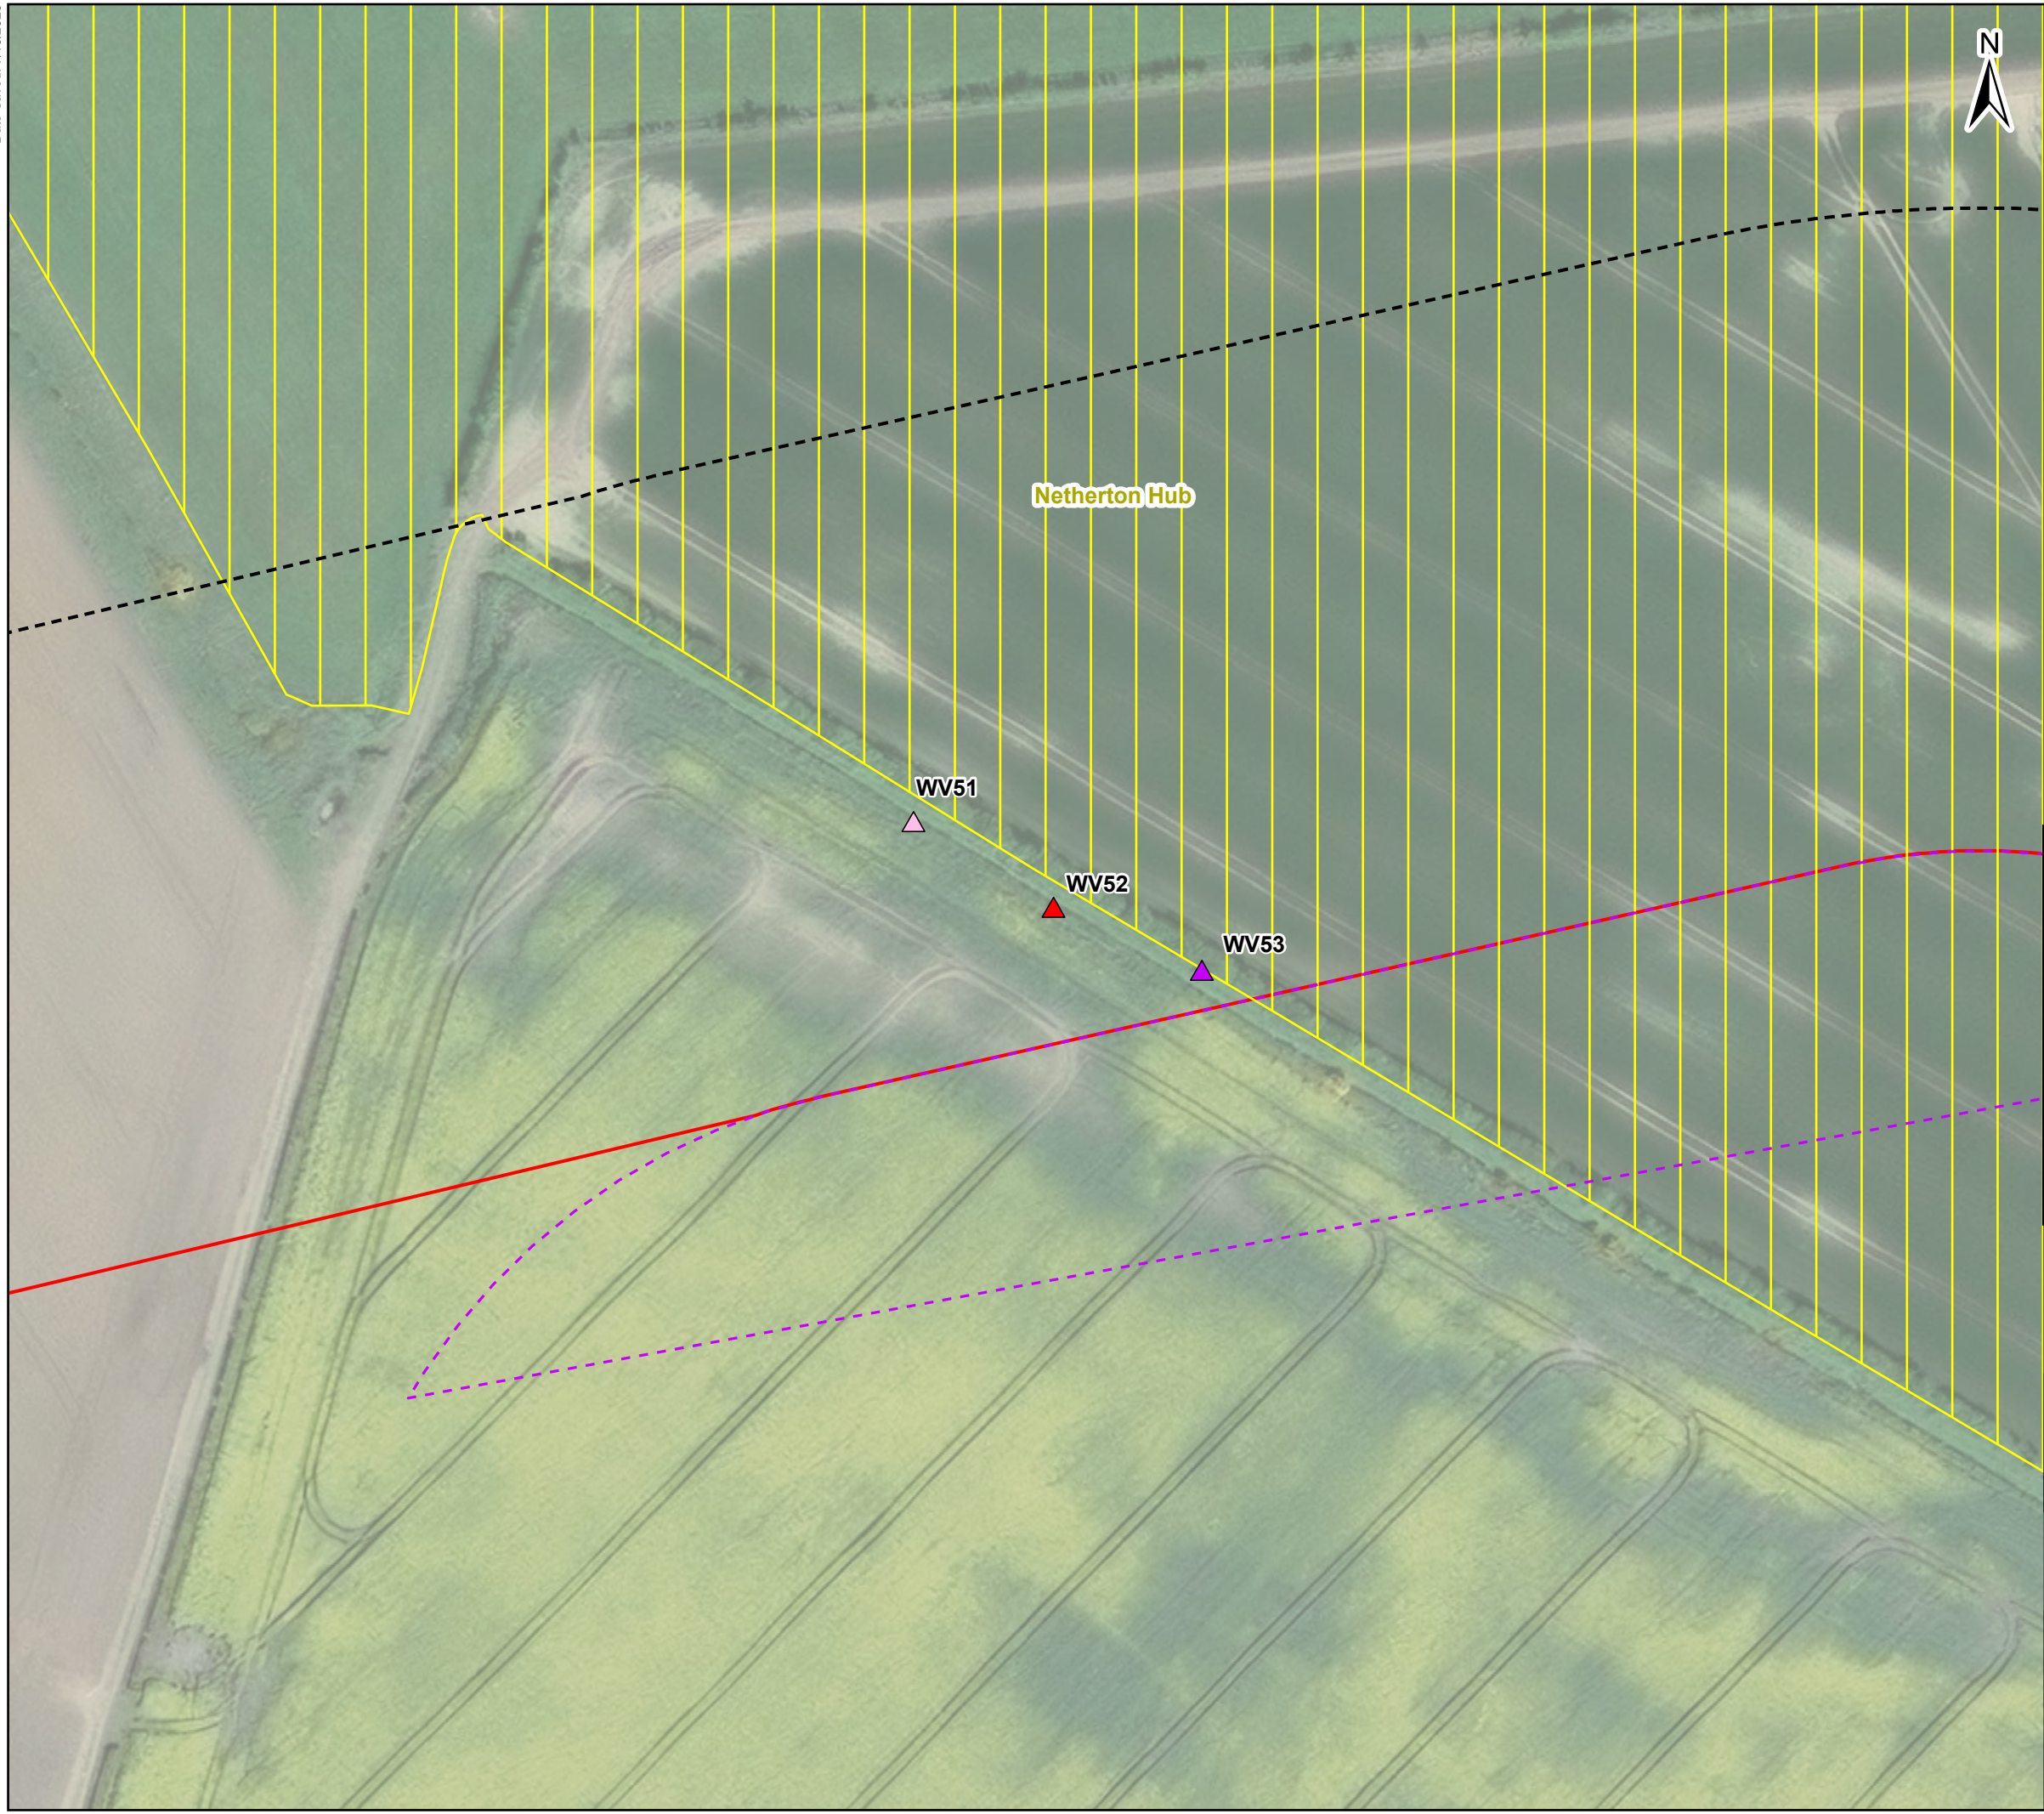
Title 7A.2 - Additional Survey Results 2026  
Page 2 of 6

- Key**
- Site
  - Water Vole Survey Area
  - Associated Infrastructure Survey Area
  - Access Constraints
  - HSI Pond
- Water Vole Survey Results**
- Burrows: Species Unknown
  - Droppings : Confirmed Water Vole
  - Droppings
  - Feeding Remains
  - Potential Water Vole Burrow
  - Suitable Habitat
- Bat DBW GTLA Survey**
- PRF-M

- 3.2.1 Evidence of water vole was recorded within the Water Vole Survey Area, included potential burrows (referred to as **WV34, WV37, WV39, WV42 and WV46 – WV48, Annex B: Table B-2**) recorded along a slow flowing modified ditch, downstream to the Burn of Ludquham (see **Annex A: Figure 7A.2: Additional Survey Results 2026**). In the same location several feeding signs – presumed to be water vole - were recorded (**WV33 and WV44**).

- 3.3.1 The pond scoring 'Poor' (**GCN3**) in the HSI was discounted from eDNA survey and is not considered further in this report. The remaining five waterbodies were accessible and contained sufficient water for GCN eDNA surveys to be completed. The location of these is shown in **Annex A: Figure 7A.2: Additional Survey Results 2026** and below provides a summary of the latest previous HSI results and eDNA results for each waterbody. The eDNA laboratory result reports are included in **Annex C**.

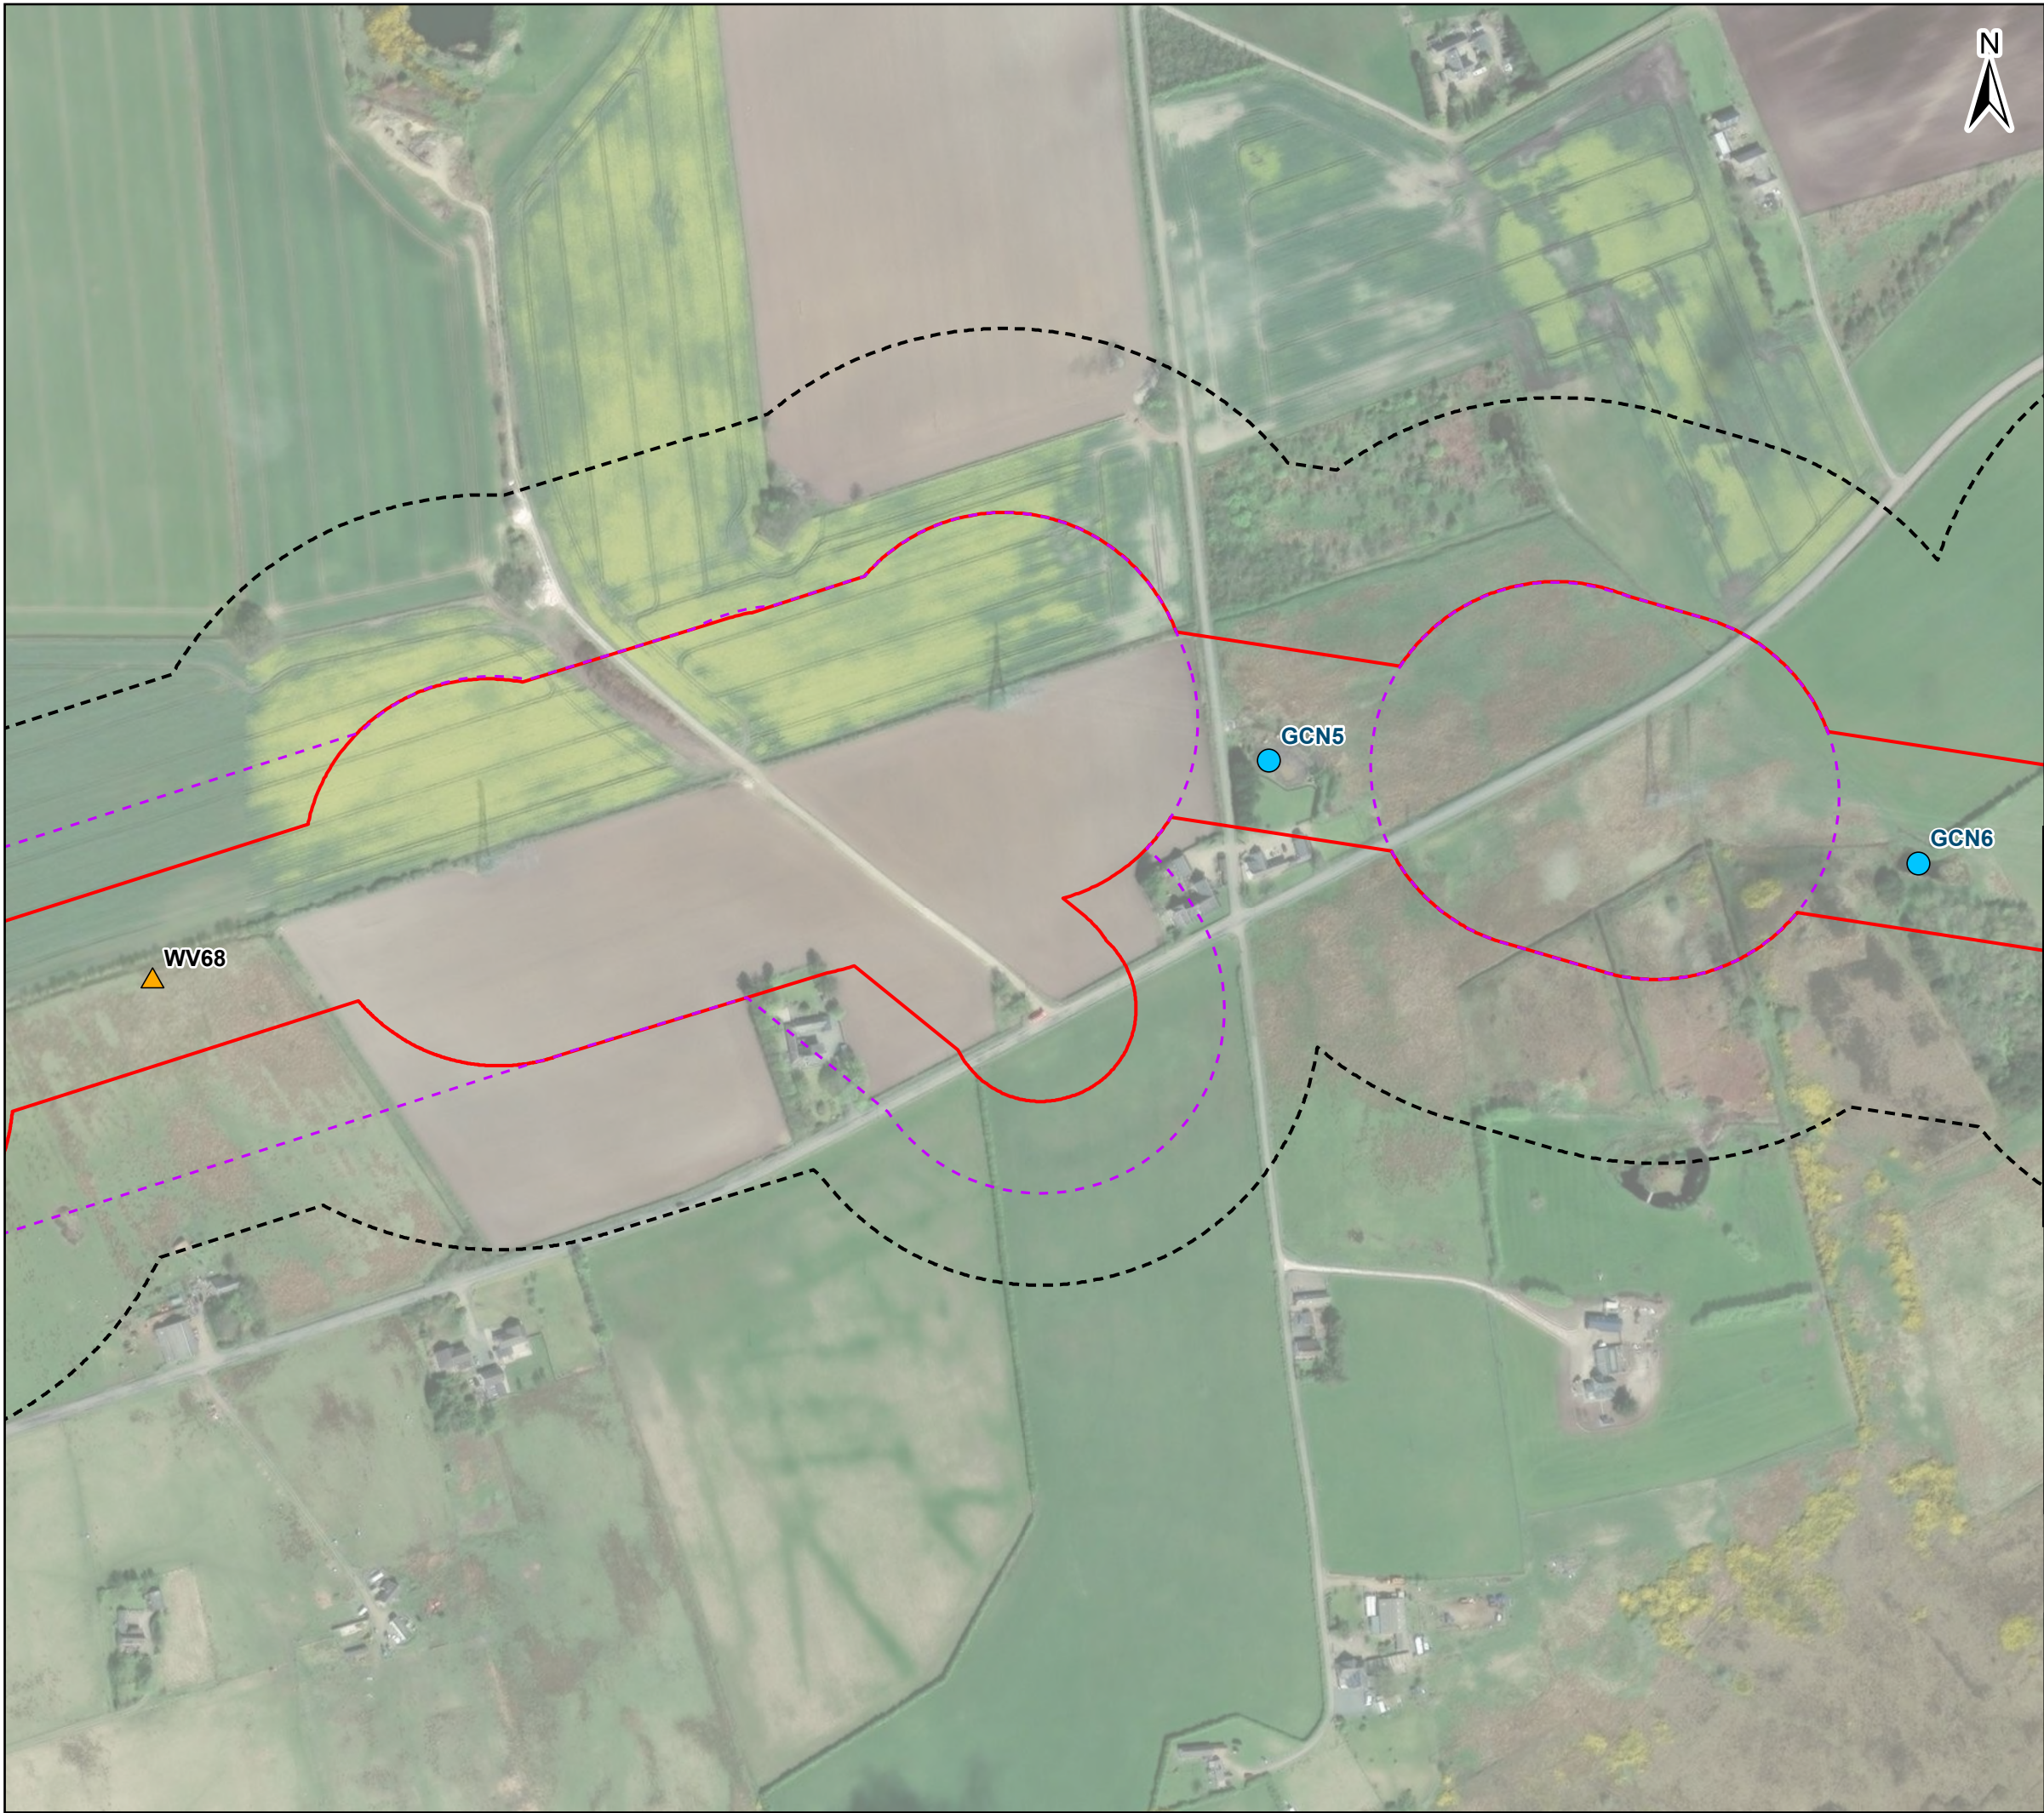
Title: 7A.2 - Additional Survey Results 2026  
Page 5 of 6

- Key**
- Site
  - Water Vole Survey Area
  - Associated Infrastructure Survey Area
  - Access Constraints
  - HSI Pond
- Water Vole Survey Results**
- Burrows: Species Unknown
  - Droppings : Confirmed Water Vole
  - Droppings
  - Feeding Remains
  - Potential Water Vole Burrow
  - Suitable Habitat
- Bat DBW GTLA Survey**
- PRF-M

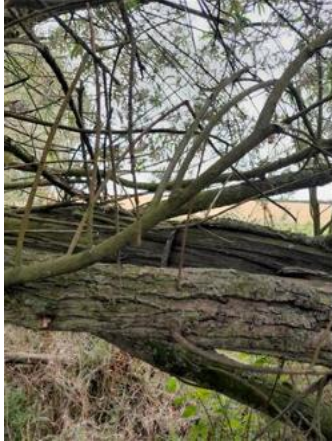
| Tree Ref | Tree Species | Features | PRF Inspection Categorisation | First PRF Inspection Results | Second PRF Inspection Results | Third PRF Inspection Results | Photo |
|---|---|---|---|---|---|---|---|
| T6 | White willow ( <i>Salix alba</i> ) | Hazard beam at 2.5 m with twisted and flaking bark (PRF-M). Second hazard beam on lower limbs at 1 m (PRF-I). | PRF-M | Fully inspected 19 August 2025. No field signs. | Second inspection 15 September 2025. No field signs. | Third inspection 4 June 2026. PRF-M hazard beam fully inspected - no field signs. Additional, new twisted hazard beam at top of canopy inspected (PRF-I) – no field signs. | |

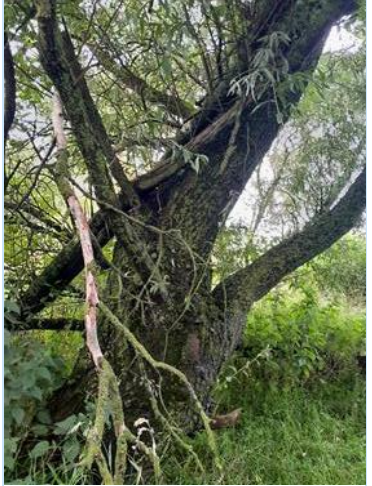
| Tree Ref | Tree Species | Features | PRF Inspection Categorisation | First PRF Inspection Results | Second PRF Inspection Results | Third PRF Inspection Results | Photo |
|---|---|---|---|---|---|---|---|
| T15 | White willow | Willow with hazard beam at 2 m. Freshly formed in recent storm. | PRF-M | Fully inspected 19 August 2025. No field signs. | Second inspection 15 September 2025. No field signs. | Third inspection 4 June 2026. No field signs. | |

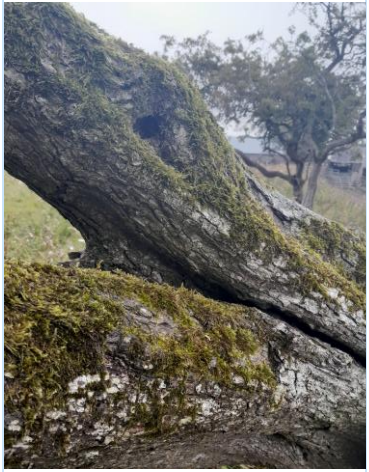
| Tree Ref | Tree Species | Features | PRF Inspection Categorisation | First PRF Inspection Results | Second PRF Inspection Results | Third PRF Inspection Results | Photo |
|---|---|---|---|---|---|---|---|
| T35 | Hawthorn | Twin leaders with gap at Union extending 20 cm back. | PRF-M | Fully inspected 19 August 2025. No field signs. | Second inspection 16 September 2025. No field signs | N/A – no access | |

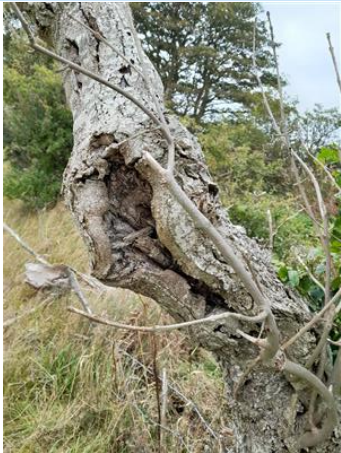
| Tree Ref | Tree Species | Features | PRF Inspection Categorisation | First PRF Inspection Results | Second PRF Inspection Results | Third PRF Inspection Results | Photo |
|---|---|---|---|---|---|---|---|
| T48 | Ash | Desiccation throughout main stem with rot and knot hole on eastern aspect extending into large chamber (PRF-M). Remaining knothole and desiccation (PRF-I). | PRF-M | Fully inspected 20 August 2025. No field signs. | Second inspection 16 September 2025. No field signs. | Final inspection 4 June 2026. No field signs. Active bird's nest present therefore features could not be fully inspected. | |

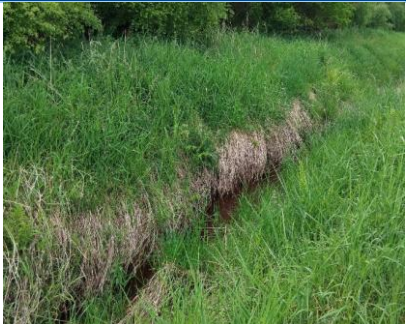
| Ref. | Location - in the Site or wider Survey Area | Species | Field sign | Comment | Example Photo |
|---|---|---|---|---|---|
| WV31 | Site | Water Vole | Suitable habitat | Slow flowing ditch with bank densely covered by common reed, thistle and rush species. Some of the watercourse channel not accessible due to steep banks and ditch soft-bottomed No field signs. | |

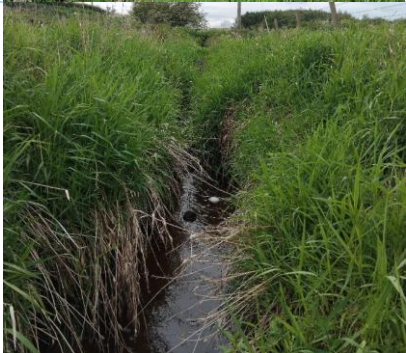
| Ref. | Location - in the Site or wider Survey Area | Species | Field sign | Comment | Example Photo |
|---|---|---|---|---|---|
| WV32 | Site | Water Vole | Suitable habitat | Hard-bottomed ditch with slow flow, with densely covered bank vegetation dominated by common reed. | |

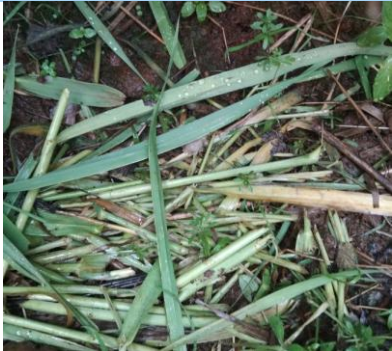
| Ref. | Location - in the Site or wider Survey Area | Species | Field sign | Comment | Example Photo |
|---|---|---|---|---|---|
| WV33 | Site | Water vole | Potential water vole feeding remains | Potential water vole feeding remains within 20 cm of water on the south-east bank of a slow flowing ditch, under overhanging bank/vegetation. Vegetation cut at 45-degree angles. | |

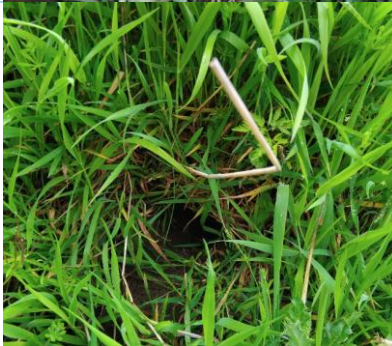
| Ref. | Location - in the Site or wider Survey Area | Species | Field sign | Comment | Example Photo |
|---|---|---|---|---|---|
| WV34 | Site | Water vole | Potential water vole burrow | Potential water vole burrow identified on the south-east bank of slow flowing ditch. Inner tunnel approx. 7 cm wide. | |

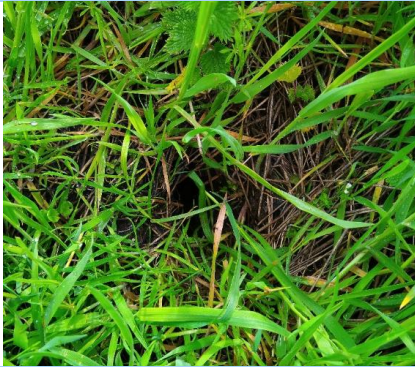
| Ref. | Location - in the Site or wider Survey Area | Species | Field sign | Comment | Example Photo |
|---|---|---|---|---|---|
| WV35 | Site | Water vole | Burrow – species unknown | Single entrance identified on south-east bank of slow flowing ditch. Likely too small for water vole. | |

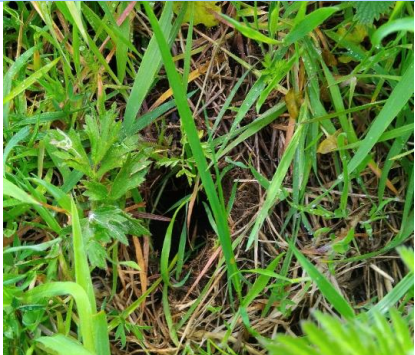
| Ref. | Location - in the Site or wider Survey Area | Species | Field sign | Comment | Example Photo |
|---|---|---|---|---|---|
| WV36 | Site | Water vole | Burrow – species unknown | Single entrance identified on south-east bank of slow flowing ditch. Likely too small for water vole. | |

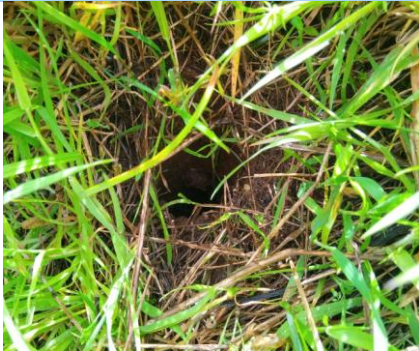
| Ref. | Location - in the Site or wider Survey Area | Species | Field sign | Comment | Example Photo |
|---|---|---|---|---|---|
| WV37 | Site | Water vole | Potential water vole burrow | Potential water vole burrow identified on the south-east bank of slow flowing ditch. Tunnel approx. 10 cm wide. | |

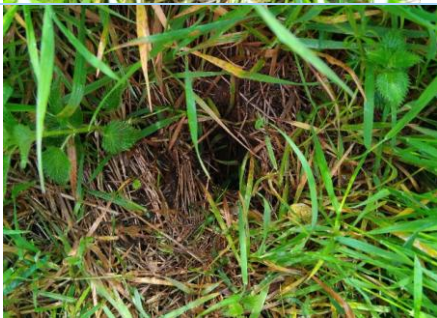
| Ref. | Location - in the Site or wider Survey Area | Species | Field sign | Comment | Example Photo |
|---|---|---|---|---|---|
| WV38 | Site | Water vole | Burrow – species unknown | Single entrance identified on south-east bank of slow flowing ditch. Likely too small for water vole. | |

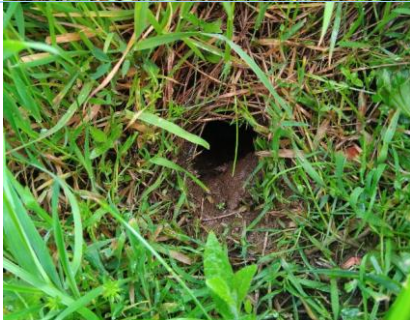
| Ref. | Location - in the Site or wider Survey Area | Species | Field sign | Comment | Example Photo |
|---|---|---|---|---|---|
| WV39 | Site | Water vole | Potential water vole burrow | Potential water vole burrow identified on the south-east bank of slow flowing ditch. Tunnel approx. 10 cm wide. | |

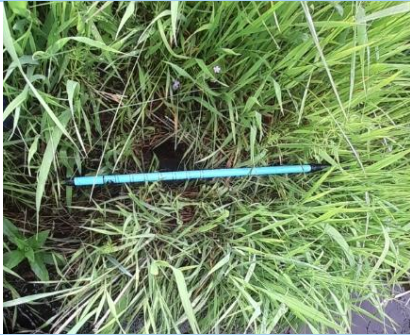
| Ref. | Location - in the Site or wider Survey Area | Species | Field sign | Comment | Example Photo |
|---|---|---|---|---|---|
| WV40 | Site | Water vole | Burrow – species unknown | Bank vole burrow identified on north-west bank with flat chewed vegetation surrounding burrow and within. Burrow is 10 cm wide. | |

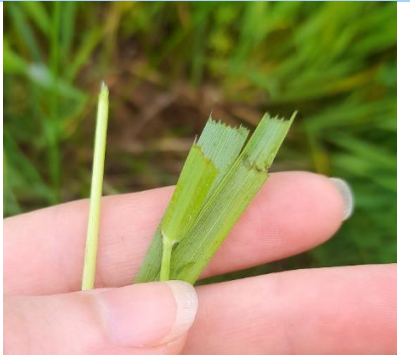
| Ref. | Location - in the Site or wider Survey Area | Species | Field sign | Comment | Example Photo |
|---|---|---|---|---|---|
| WV41 | Site | Water vole | Potential water vole feeding remains | Potential water vole feeding remains identified on south-east bank of slow flowing ditch. Chewed vegetation with a mix of flat and 45-degree edges. | |

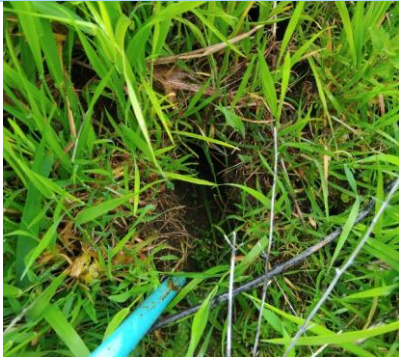
| Ref. | Location - in the Site or wider Survey Area | Species | Field sign | Comment | Example Photo |
|---|---|---|---|---|---|
| WV42 | Site | Water vole | Potential water vole burrow | Potential water vole burrows identified on south-east bank of slow flowing ditch. Four entrances approx.15 cm wide. | |

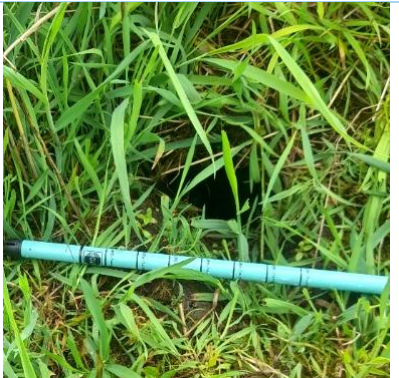
| Ref. | Location - in the Site or wider Survey Area | Species | Field sign | Comment | Example Photo |
|---|---|---|---|---|---|
| WV43 | Site | Water vole | Burrow – species unknown | Small burrow identified on north-west bank of slow flowing ditch, suspected of bank vole but potentially large enough for water vole. | |

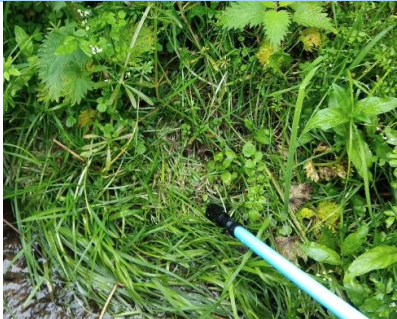
| Ref. | Location - in the Site or wider Survey Area | Species | Field sign | Comment | Example Photo |
|---|---|---|---|---|---|
| WV44 | Site | Water vole | Potential water vole feeding remains | Area of flattened vegetation with feeding remains on edge of water. | |

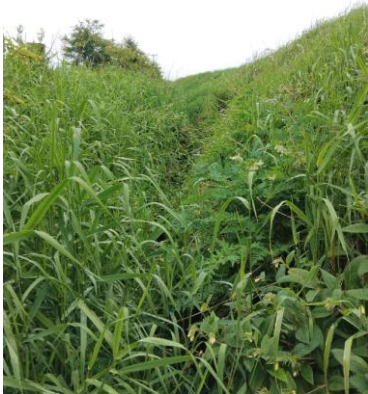
| Ref. | Location - in the Site or wider Survey Area | Species | Field sign | Comment | Example Photo |
|---|---|---|---|---|---|
| WV45 | Site | Water vole | Suitable habitat | Hard-bottomed ditch with slow flow, with densely covered bank vegetation dominated by common reed. | |

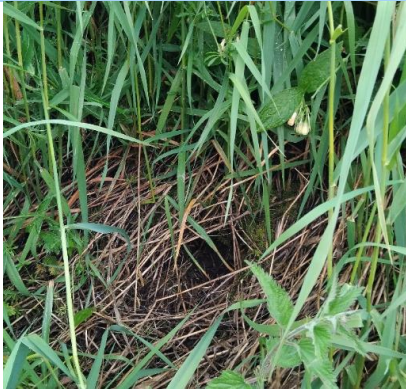
| Ref. | Location - in the Site or wider Survey Area | Species | Field sign | Comment | Example Photo |
|---|---|---|---|---|---|
| WV46 | Site | Water vole | Potential water vole burrow | Potential water vole burrow identified on north-east bank of slow flowing ditch. Approx 20 cm wide opening. | |

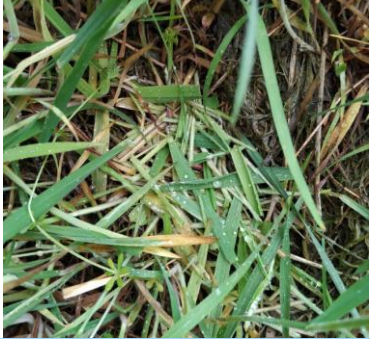
| Ref. | Location - in the Site or wider Survey Area | Species | Field sign | Comment | Example Photo |
|---|---|---|---|---|---|
| WV47 | Site | Water vole | Potential water vole feeding remains | Flattened vegetation and potential water vole feeding remains near edge of water. | |

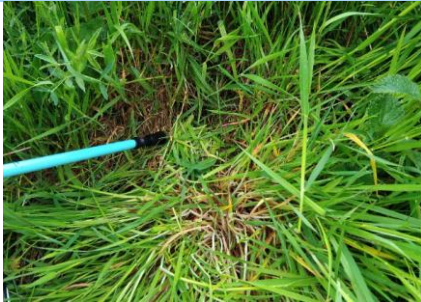
| Ref. | Location - in the Site or wider Survey Area | Species | Field sign | Comment | Example Photo |
|---|---|---|---|---|---|
| WV48 | Site | Water vole | Potential water vole feeding remains | Flattened vegetation and potential water vole feeding remains near edge of water. Vegetation with mix of 45-degree angles and flat chewed edges. | |

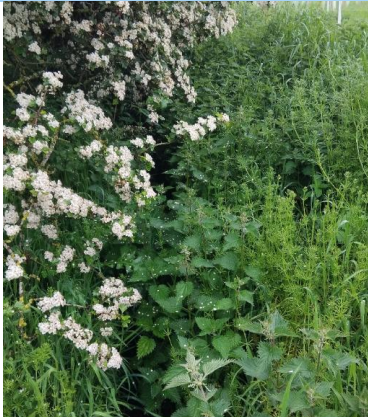
| Ref. | Location - in the Site or wider Survey Area | Species | Field sign | Comment | Example Photo |
|---|---|---|---|---|---|
| WV49 | Site | Water vole | Suitable habitat | Slow flowing ditch with bankside vegetation comprising of grass. Sheltered areas suitable for water vole. | |

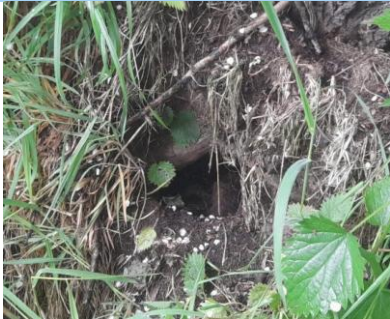
| Ref. | Location - in the Site or wider Survey Area | Species | Field sign | Comment | Example Photo |
|---|---|---|---|---|---|
| WV50 | Site | Water vole | Burrow – species unknown | One burrow where previous one found during 2025 surveys. Potentially brown rat. Appears to have collapsed. | |

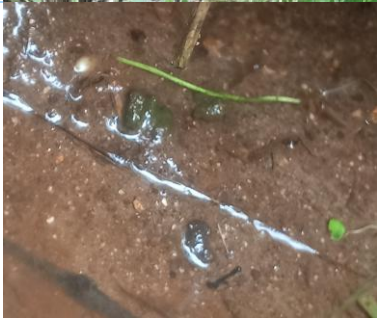
| Ref. | Location - in the Site or wider Survey Area | Species | Field sign | Comment | Example Photo |
|---|---|---|---|---|---|
| WV51 | Water Vole Survey Area | Water vole | Droppings | Confirmed water vole droppings on raised section of mud within ditch. DNA sample returned positive result for water vole. | |

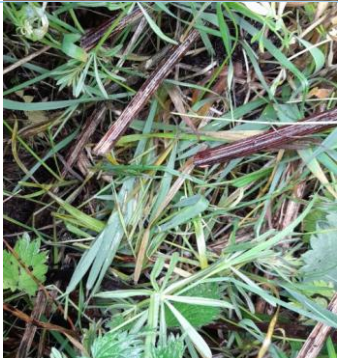
| Ref. | Location - in the Site or wider Survey Area | Species | Field sign | Comment | Example Photo |
|---|---|---|---|---|---|
| WV52 | Water Vole Survey Area | Water vole | Potential water vole feeding remains | Potential water vole feeding station with cut vegetation located 1 m from water edge. | |

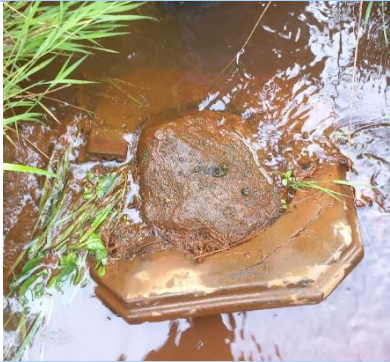
| Ref. | Location - in the Site or wider Survey Area | Species | Field sign | Comment | Example Photo |
|---|---|---|---|---|---|
| WV55 | Site | Water vole | Droppings | Confirmed water vole droppings on prominent rock in slow flowing ditch. DNA sample returned positive result for water vole. | |

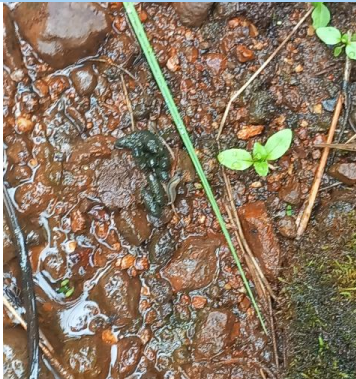
| Ref. | Location - in the Site or wider Survey Area | Species | Field sign | Comment | Example Photo |
|---|---|---|---|---|---|
| WV56 | Site | Water vole | Droppings | Potential water vole droppings on water edge of slowing flowing ditch. | |

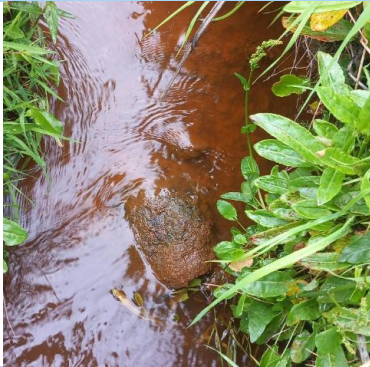
| Ref. | Location - in the Site or wider Survey Area | Species | Field sign | Comment | Example Photo |
|---|---|---|---|---|---|
| WV57 | Site | Water vole | Droppings | Potential water vole droppings on prominent rock in slow flowing ditch. | |

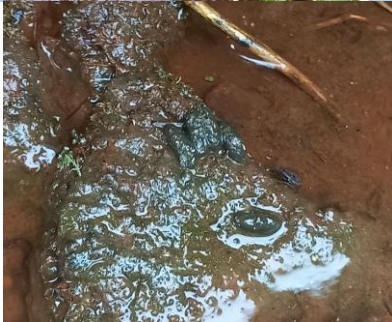
| Ref. | Location - in the Site or wider Survey Area | Species | Field sign | Comment | Example Photo |
|---|---|---|---|---|---|
| WV58 | Site | Water vole | Droppings | Multiple potential water vole droppings on prominent rock in slow flowing ditch. Sample subject to DNA test but species was not identifiable. | |

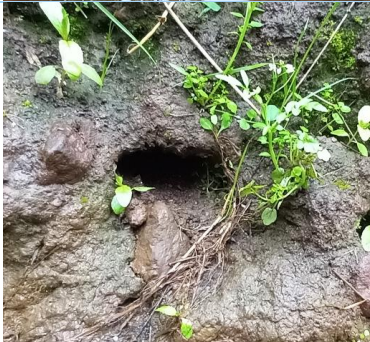
| Ref. | Location - in the Site or wider Survey Area | Species | Field sign | Comment | Example Photo |
|---|---|---|---|---|---|
| WV59 | Site | Water vole | Potential water vole burrow | Potential water vole burrow on south-east bank of slow flowing ditch. | |

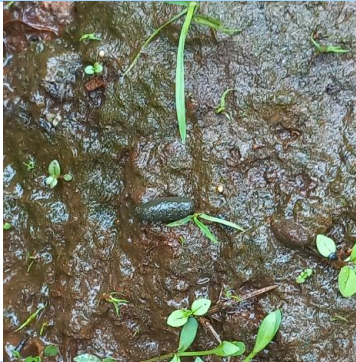
| Ref. | Location - in the Site or wider Survey Area | Species | Field sign | Comment | Example Photo |
|---|---|---|---|---|---|
| WV60 | Site | Water vole | Droppings | Potential water vole droppings on prominent rock in slow flowing ditch. Sample subject to DNA test but species was not identifiable. | |

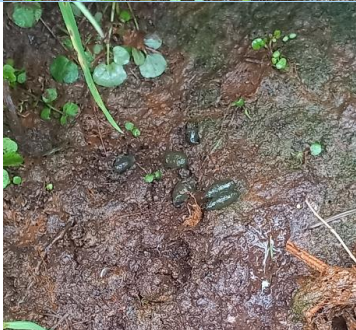
| Ref. | Location - in the Site or wider Survey Area | Species | Field sign | Comment | Example Photo |
|---|---|---|---|---|---|
| WV61 | Site | Water vole | Droppings | Multiple potential water vole droppings on raised section of earth in slow flowing ditch. | |

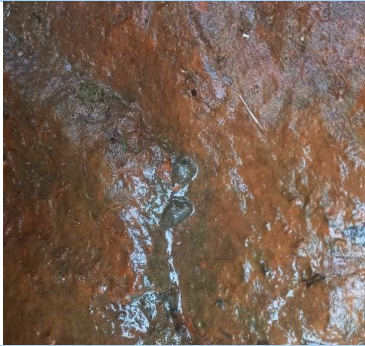
| Ref. | Location - in the Site or wider Survey Area | Species | Field sign | Comment | Example Photo |
|---|---|---|---|---|---|
| WV62 | Site | Water vole | Droppings | Potential water vole droppings on prominent rock in slow flowing ditch. Sample subject to DNA test but species was not identifiable. | |

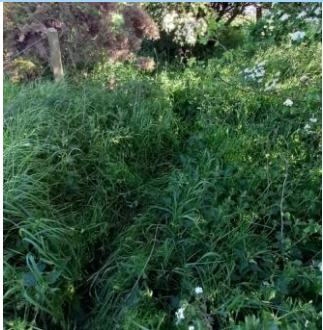
| Ref. | Location - in the Site or wider Survey Area | Species | Field sign | Comment | Example Photo |
|---|---|---|---|---|---|
| WV63 | Site | Water vole | Suitable habitat | Dry ditch with steep banks and banks vegetated with abundant grasses. Considered 'suitable but poor' habitat for water vole. | |

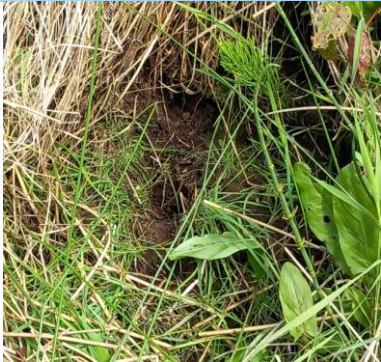
| Ref. | Location - in the Site or wider Survey Area | Species | Field sign | Comment | Example Photo |
|---|---|---|---|---|---|
| WV64 | Site | Water vole | Potential water vole burrow | Two potential water vole burrows at toe of ditch bank. Ditch almost completely dry at time of survey. No field signs. | |

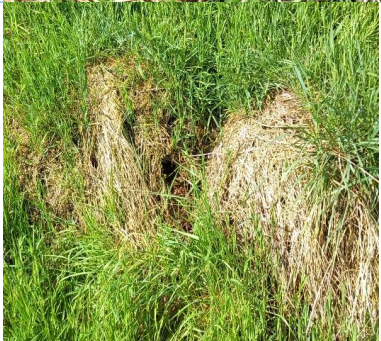
| Ref. | Location - in the Site or wider Survey Area | Species | Field sign | Comment | Example Photo |
|---|---|---|---|---|---|
| WV65 | Water Vole Survey Area | Water Vole | Suitable habitat | Dry ditch with steep banks and banks vegetated with abundant grasses. Considered 'suitable but poor' habitat for water vole. Potential water vole tunnels through thick bankside vegetation. | |

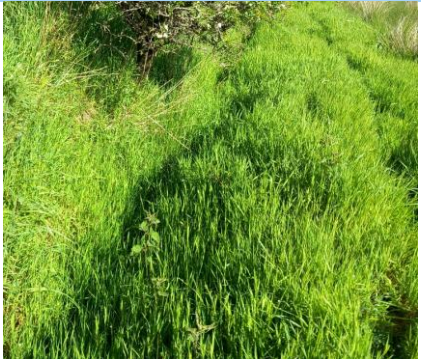
| Ref. | Location - in the Site or wider Survey Area | Species | Field sign | Comment | Example Photo |
|---|---|---|---|---|---|
| WV66 | Water Vole Survey Area | Water vole | Suitable habitat | Dry ditch with steep banks and banks vegetated with abundant grasses. Considered 'suitable but poor' habitat for water vole. | |

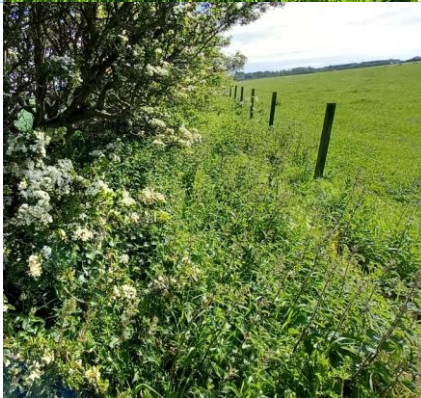
| Ref. | Location - in the Site or wider Survey Area | Species | Field sign | Comment | Example Photo |
|---|---|---|---|---|---|
| WV67 | Water Vole Survey Area | Water vole | Suitable habitat | Dry ditch with steep banks and banks vegetated with abundant grasses. Considered 'suitable but poor' habitat for water vole. Overgrown vegetation prevented survey for majority of this ditch. | |

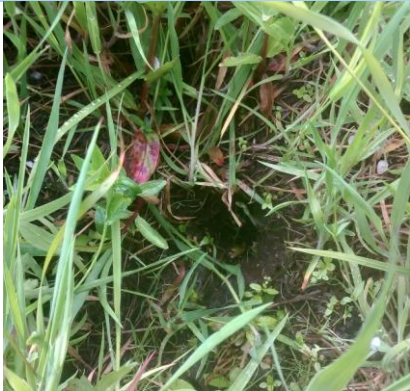
| Ref. | Location - in the Site or wider Survey Area | Species | Field sign | Comment | Example Photo |
|---|---|---|---|---|---|
| WV68 | Site | Water vole | Potential water vole burrow | Multiple potential water vole burrows on south bank of ditch. | |
