# **Netherton Hub 400 kV OHL Connection to New Deer and Peterhead: Tie-In**

## **Environmental Appraisal Report**

### **Volume 3 Appendix 7.2 - Protected Species**

#### **Baseline**

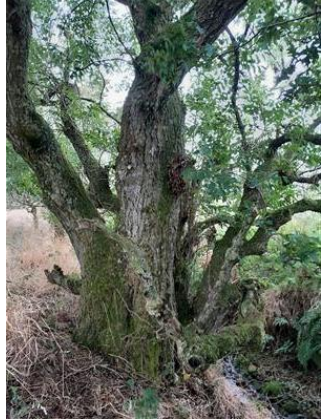
| Tree Ref | Tree Species | Features | PRF Inspection Categorisation | First PRF Inspection Results | Second PRF Inspection Results (PRF-M only) | Photo (PRF-M and PRF-I only) |
|---|---|---|---|---|---|---|
| T1 | Ash ( <i>Fraxinus excelsior</i> ) | Butt rot at base of ash which extends inwards. Some suitably for individual bat to roost within inner chamber. | PRF-I | No field signs | N/A | |

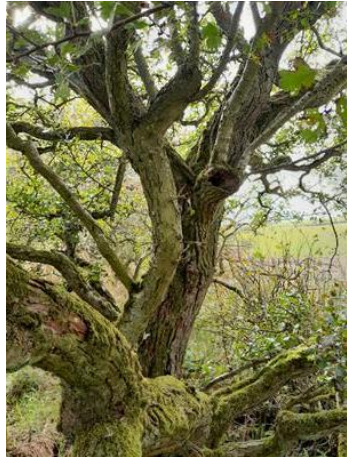
| Tree Ref | Tree Species | Features | PRF Inspection Categorisation | First PRF Inspection Results | Second PRF Inspection Results (PRF-M only) | Photo (PRF-M and PRF-I only) |
|---|---|---|---|---|---|---|
| T2 | Hawthorn ( <i>Crataegus monogyna</i> ) | Pruning cut with decay at 1.5 m east. | PRF-I | No field signs | N/A | |

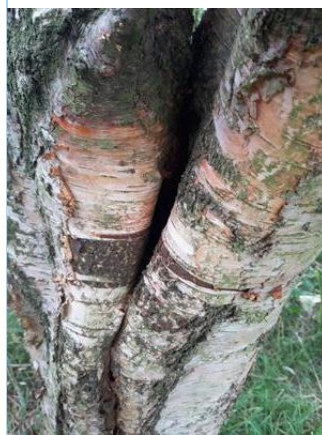
| Tree Ref | Tree Species | Features | PRF Inspection Categorisation | First PRF Inspection Results | Second PRF Inspection Results (PRF-M only) | Photo (PRF-M and PRF-I only) |
|---|---|---|---|---|---|---|
| T5 | Silver birch | Wound where twin leaders have met which extends 10 cm downwards. | PRF-I | No field signs | N/A | |

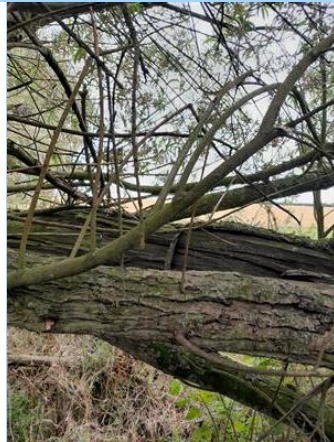
| Tree Ref | Tree Species | Features | PRF Inspection Categorisation | First PRF Inspection Results | Second PRF Inspection Results (PRF-M only) | Photo (PRF-M and PRF-I only) |
|---|---|---|---|---|---|---|
| T6 | White willow ( <i>Salix alba</i> ) | Hazard beam at 2.5 m with twisted and flaking bark (PRF-M). Second hazard beam on lower limbs at 1 m (PRF-I). | PRF-M | Fully inspected 19 August 2025. No field signs. | Second inspection 15 September 2025. No field signs. | |

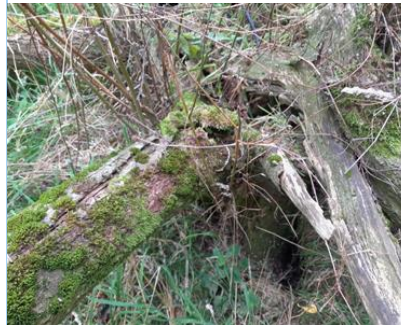
| Tree Ref | Tree Species | Features | PRF Inspection Categorisation | First PRF Inspection Results | Second PRF Inspection Results (PRF-M only) | Photo (PRF-M and PRF-I only) |
|---|---|---|---|---|---|---|
| T7 | White willow | Transverse snap at 0.5 m with small gaps. | PRF-I | No field signs | N/A | |

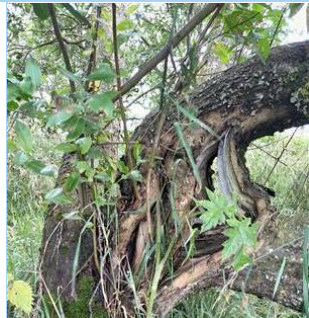
| Tree Ref | Tree Species | Features | PRF Inspection Categorisation | First PRF Inspection Results | Second PRF Inspection Results (PRF-M only) | Photo (PRF-M and PRF-I only) |
|---|---|---|---|---|---|---|
| T8 | Willow sp. ( <i>Salix</i> sp.) | Bay willow with hazard beam on second stem 0.5 m east. | PRF-I | Fully inspected 19 August 2025.<br>No field signs. | N/A | |

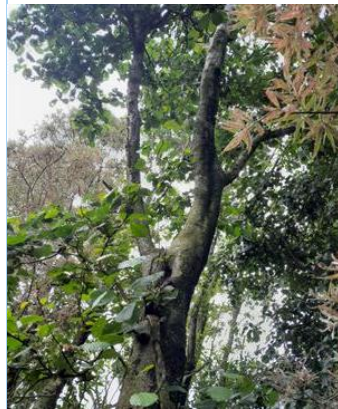
| Tree Ref | Tree Species | Features | PRF Inspection Categorisation | First PRF Inspection Results | Second PRF Inspection Results (PRF-M only) | Photo (PRF-M and PRF-I only) |
|---|---|---|---|---|---|---|
| T9 | Alder ( <i>Alnus glutinosa</i> ) | Knothole at 0.5 m east. | PRF-I | Fully inspected 19 August 2025.<br>No field signs. | N/A | |

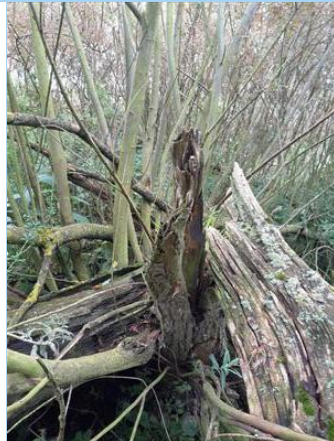
| Tree Ref | Tree Species | Features | PRF Inspection Categorisation | First PRF Inspection Results | Second PRF Inspection Results (PRF-M only) | Photo (PRF-M and PRF-I only) |
|---|---|---|---|---|---|---|
| T10 | Willow sp. | Willow with complete transverse snap on main stem. | PRF-I | Fully inspected 19 August 2025.<br>No field signs. | N/A | |

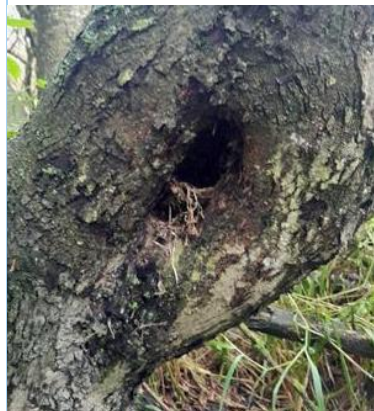
| Tree Ref | Tree Species | Features | PRF Inspection Categorisation | First PRF Inspection Results | Second PRF Inspection Results (PRF-M only) | Photo (PRF-M and PRF-I only) |
|---|---|---|---|---|---|---|
| T13 | Alder | Knot hole at 30 cm with disused nest. | PRF-I | Fully inspected 19 August 2025.<br>No field signs. | N/A | |

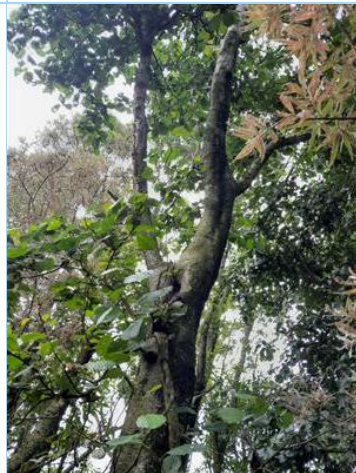
| Tree Ref | Tree Species | Features | PRF Inspection Categorisation | First PRF Inspection Results | Second PRF Inspection Results (PRF-M only) | Photo (PRF-M and PRF-I only) |
|---|---|---|---|---|---|---|
| T14 | Alder | Knothole at 2 m north. | PRF-I | Fully inspected 19 August 2025.<br>No field signs. | N/A | |

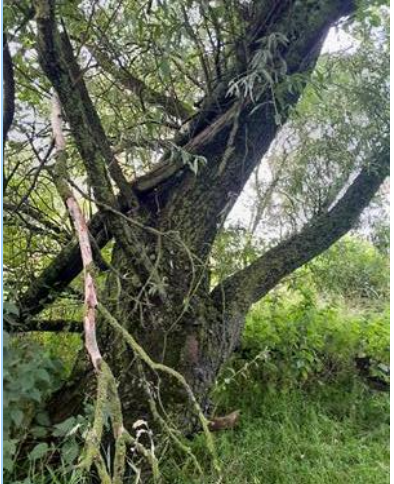
| Tree Ref | Tree Species | Features | PRF Inspection Categorisation | First PRF Inspection Results | Second PRF Inspection Results (PRF-M only) | Photo (PRF-M and PRF-I only) |
|---|---|---|---|---|---|---|
| T15 | White willow | Willow with hazard beam at 2 m. Freshly formed in recent storm. | PRF-M | Fully inspected 19 August 2025.<br>No field signs. | Second inspection 15 September 2025.<br>No field signs. | |

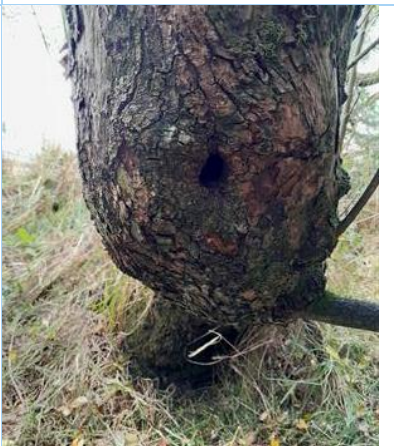
| Tree Ref | Tree Species | Features | PRF Inspection Categorisation | First PRF Inspection Results | Second PRF Inspection Results (PRF-M only) | Photo (PRF-M and PRF-I only) |
|---|---|---|---|---|---|---|
| T16 | Willow sp. | Knothole at 0.5 m south extending upwards but narrows. | PRF-I | Fully inspected 19 August 2025.<br>No field signs | N/A | |

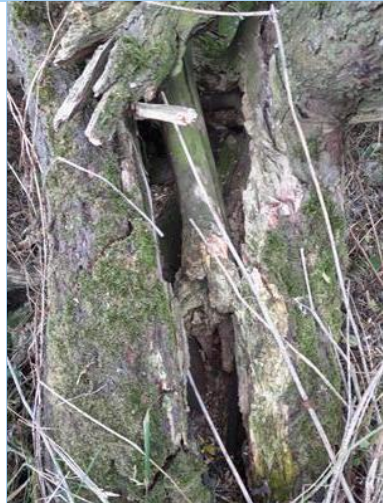
| Tree Ref | Tree Species | Features | PRF Inspection Categorisation | First PRF Inspection Results | Second PRF Inspection Results (PRF-M only) | Photo (PRF-M and PRF-I only) |
|---|---|---|---|---|---|---|
| T17 | Willow sp. | Willow with hazard beam at 0.5 m. | PRF-I | Fully inspected 19 August 2025.<br>No field signs. | N/A | |

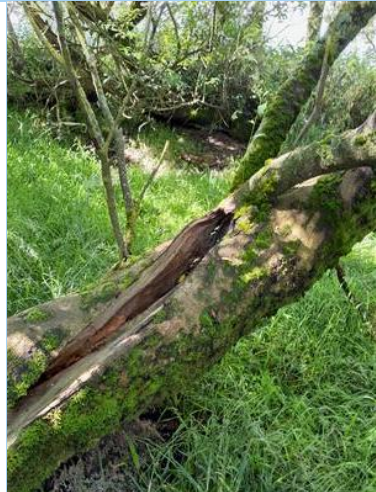
| Tree Ref | Tree Species | Features | PRF Inspection Categorisation | First PRF Inspection Results | Second PRF Inspection Results (PRF-M only) | Photo (PRF-M and PRF-I only) |
|---|---|---|---|---|---|---|
| T19 | Willow sp. | Hazard beam at 0.5 m.. | PRF-I | Fully inspected 19 August 2025.<br>No field signs. | | |

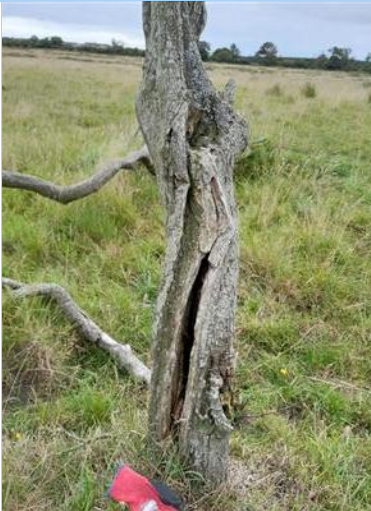
| Tree Ref | Tree Species | Features | PRF Inspection Categorisation | First PRF Inspection Results | Second PRF Inspection Results (PRF-M only) | Photo (PRF-M and PRF-I only) |
|---|---|---|---|---|---|---|
| T24 | Hawthorn | Hawthorn with fluting at 0.5 m. extends 10 cm into gap. | PRF-I | Fully inspected 20 August 2025.<br>No field signs | N/A | |

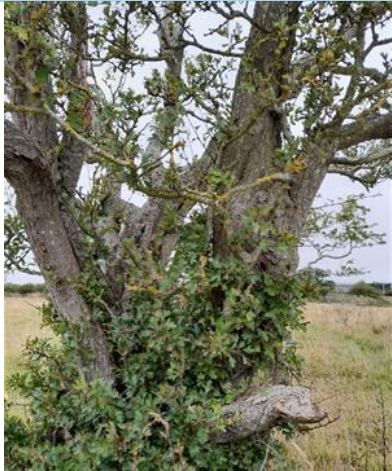
| Tree Ref | Tree Species | Features | PRF Inspection Categorisation | First PRF Inspection Results | Second PRF Inspection Results (PRF-M only) | Photo (PRF-M and PRF-I only) |
|---|---|---|---|---|---|---|
| T26 | Hawthorn | Hawthorn with crack and decay from 1 m – 2 m south. | PRF-I | Fully inspected 20 August 2025.<br>No field signs. | Second inspection 16 September 2025.<br>No field signs.<br>Reclassified as 'PRF-I'. | |

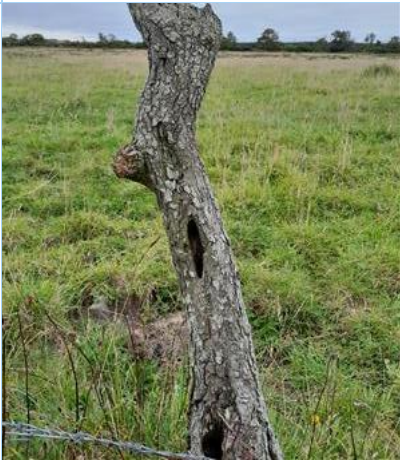
| Tree Ref | Tree Species | Features | PRF Inspection Categorisation | First PRF Inspection Results | Second PRF Inspection Results (PRF-M only) | Photo (PRF-M and PRF-I only) |
|---|---|---|---|---|---|---|
| T27 | Hawthorn | Hawthorn with knothole at 30 cm which extends 10 cm into gap. | PRF-I | Fully inspected 20 August 2025.<br>No field signs. | N/A | |

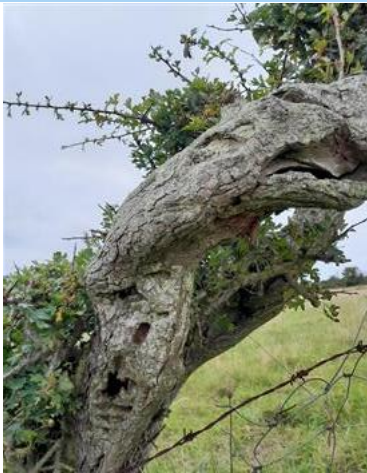
| Tree Ref | Tree Species | Features | PRF Inspection Categorisation | First PRF Inspection Results | Second PRF Inspection Results (PRF-M only) | Photo (PRF-M and PRF-I only) |
|---|---|---|---|---|---|---|
| T28 | Sycamore | Hawthorn with decay hollow at 0.2 m, extends 10 cm upwards into gap. Further substance crack at 30 cm. | PRF-I | Fully inspected 20 August 2025.<br>No field signs. | N/A | |

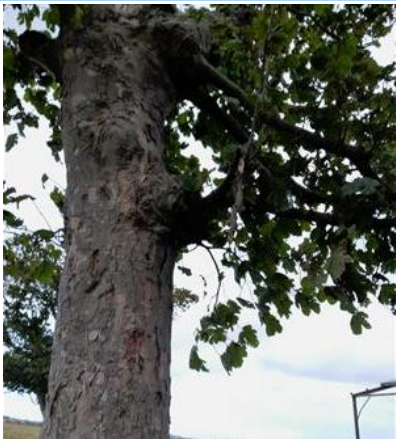
| Tree Ref | Tree Species | Features | PRF Inspection Categorisation | First PRF Inspection Results | Second PRF Inspection Results (PRF-M only) | Photo (PRF-M and PRF-I only) |
|---|---|---|---|---|---|---|
| T29 | Sycamore | Decay hollow at 2 m west and tear out at 2.5 m north. | PRF-I | Fully inspected 19 August 2025.<br>No field signs. | N/A | |

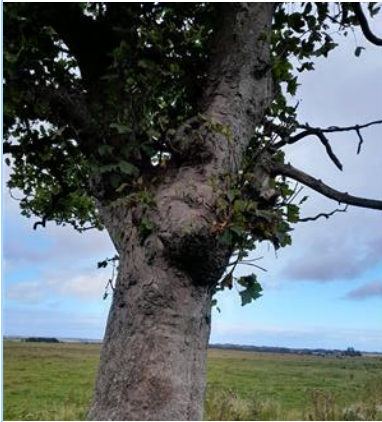
| Tree Ref | Tree Species | Features | PRF Inspection Categorisation | First PRF Inspection Results | Second PRF Inspection Results (PRF-M only) | Photo (PRF-M and PRF-I only) |
|---|---|---|---|---|---|---|
| T30 | Sycamore | Knothole at 2 m north (PRF-I). Decay hollow at 2 m south (PRF-I). Remaining features superficial. | PRF-I | Fully inspected 19 August 2025. No field signs. | N/A | |

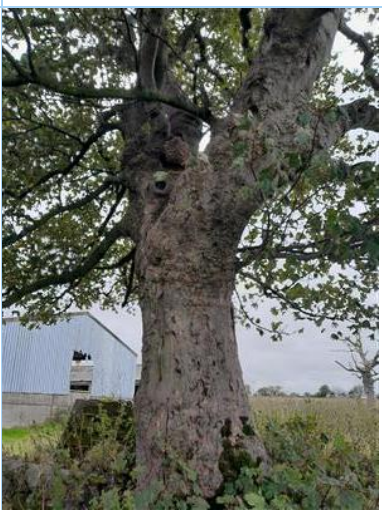
| Tree Ref | Tree Species | Features | PRF Inspection Categorisation | First PRF Inspection Results | Second PRF Inspection Results (PRF-M only) | Photo (PRF-M and PRF-I only) |
|---|---|---|---|---|---|---|
| T31 | Sycamore | Knothole with decay 3 m north. Knothole 2 m east. | PRF-I | Fully inspected 19 August 2025. No field signs. | N/A | |

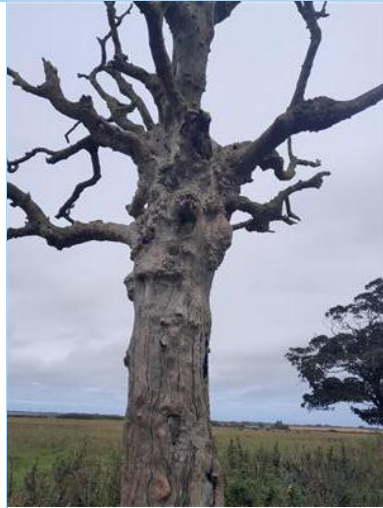
| Tree Ref | Tree Species | Features | PRF Inspection Categorisation | First PRF Inspection Results | Second PRF Inspection Results (PRF-M only) | Photo (PRF-M and PRF-I only) |
|---|---|---|---|---|---|---|
| T32 | Ash | Desiccation and some superficial knotholes. Decay hollow at 2 m south. | PRF-I | Fully inspected 19 August 2025. No field signs. | N/A | |

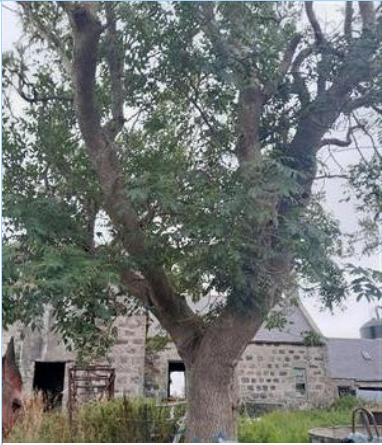
| Tree Ref | Tree Species | Features | PRF Inspection Categorisation | First PRF Inspection Results | Second PRF Inspection Results (PRF-M only) | Photo (PRF-M and PRF-I only) |
|---|---|---|---|---|---|---|
| T34 | Ash | Decay hollow, pruning cut and knothole (PRF-I). Knothole with further decay at 4 m and knothole at 5 m north (both PRF-M). | PRF-M | Fully inspected 19 August 2025.<br>No field signs. | Second inspection 17 September 2025.<br>No field signs. | |

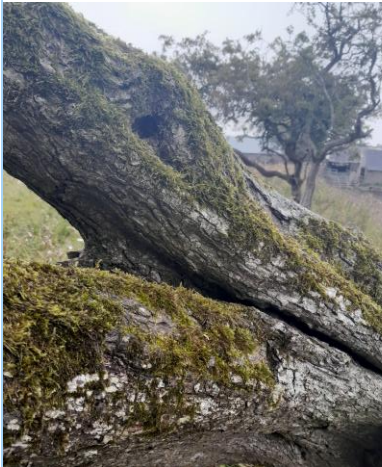
| Tree Ref | Tree Species | Features | PRF Inspection Categorisation | First PRF Inspection Results | Second PRF Inspection Results (PRF-M only) | Photo (PRF-M and PRF-I only) |
|---|---|---|---|---|---|---|
| T35 | Hawthorn | Twin leaders with gap at Union extending 20 cm back. | PRF-M | Fully inspected 19 August 2025.<br>No field signs. | Second inspection 16 September 2025.<br>No field signs | |

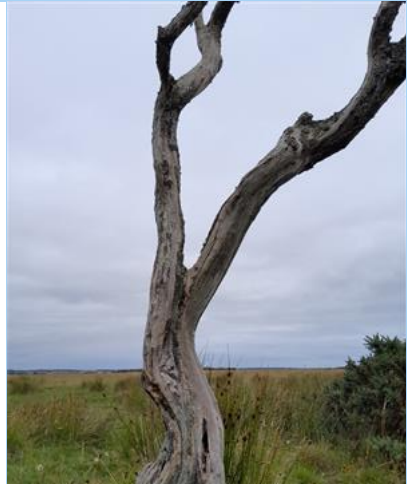
| Tree Ref | Tree Species | Features | PRF Inspection Categorisation | First PRF Inspection Results | Second PRF Inspection Results (PRF-M only) | Photo (PRF-M and PRF-I only) |
|---|---|---|---|---|---|---|
| T36 | Hawthorn | Hawthorn with decay at 0.2 m. extends 10 cm upwards into gap. | PRF-I | Fully inspected 20 August 2025.<br>No field signs. | N/A | |

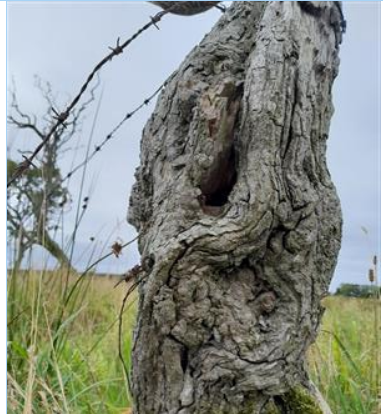
| Tree Ref | Tree Species | Features | PRF Inspection Categorisation | First PRF Inspection Results | Second PRF Inspection Results (PRF-M only) | Photo (PRF-M and PRF-I only) |
|---|---|---|---|---|---|---|
| T37 | Hawthorn | Hawthorn with knothole at 10 cm. extends 5 cm into gap. | PRF-I | Fully inspected 20 August 2025.<br>No field signs. | N/A | |

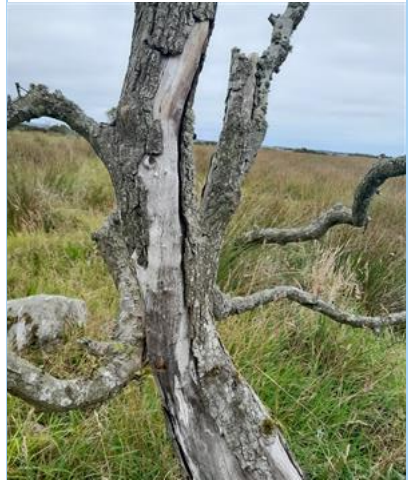
| Tree Ref | Tree Species | Features | PRF Inspection Categorisation | First PRF Inspection Results | Second PRF Inspection Results (PRF-M only) | Photo (PRF-M and PRF-I only) |
|---|---|---|---|---|---|---|
| T38 | Hawthorn | Hawthorn with lifting bark throughout. | PRF-I | Fully inspected 20 August 2025.<br>No field signs. | N/A | |

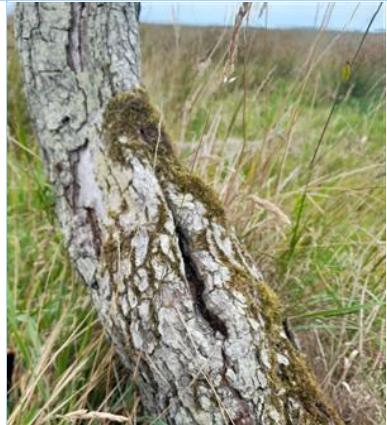
| Tree Ref | Tree Species | Features | PRF Inspection Categorisation | First PRF Inspection Results | Second PRF Inspection Results (PRF-M only) | Photo (PRF-M and PRF-I only) |
|---|---|---|---|---|---|---|
| T39 | Hawthorn | Hawthorn with fluting at 20 cm. | PRF-I | Fully inspected 20 August 2025.<br>No field signs. | Second inspection 16 September 2025.<br>No field signs.<br>Reclassified as 'PRF-I'. | |

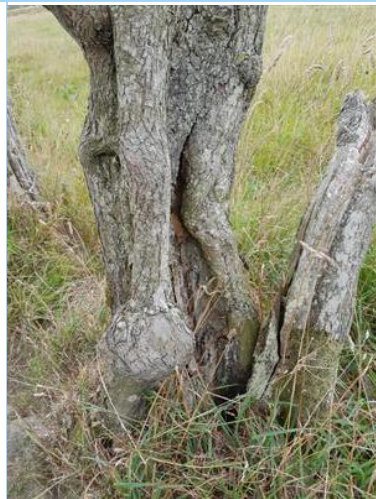
| Tree Ref | Tree Species | Features | PRF Inspection Categorisation | First PRF Inspection Results | Second PRF Inspection Results (PRF-M only) | Photo (PRF-M and PRF-I only) |
|---|---|---|---|---|---|---|
| T40 | Hawthorn | Hawthorn with fluting at 30 cm. extends 10 cm into gap. | PRF-I | Fully inspected 20 August 2025.<br>No field signs. | N/A | |

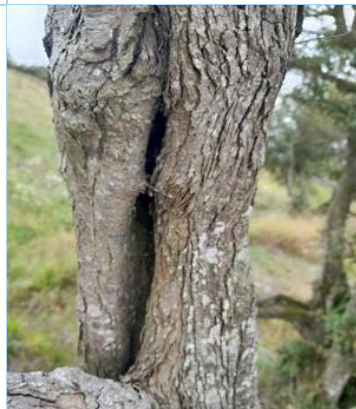
| Tree Ref | Tree Species | Features | PRF Inspection Categorisation | First PRF Inspection Results | Second PRF Inspection Results (PRF-M only) | Photo (PRF-M and PRF-I only) |
|---|---|---|---|---|---|---|
| T41 | Hawthorn | Hawthorn with fluting at 1.5 m extending downwards where two stems meet. | PRF-I | Fully inspected 20 August 2025.<br>No field signs. | N/A | |

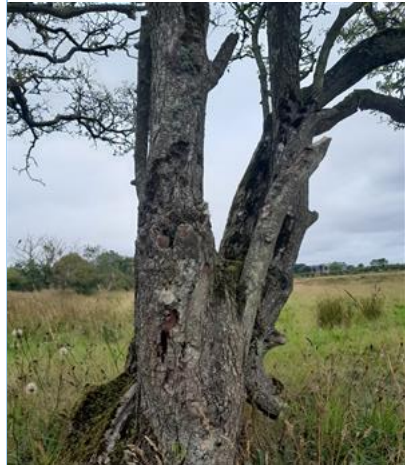
| Tree Ref | Tree Species | Features | PRF Inspection Categorisation | First PRF Inspection Results | Second PRF Inspection Results (PRF-M only) | Photo (PRF-M and PRF-I only) |
|---|---|---|---|---|---|---|
| T42 | Hawthorn | Hawthorn with decay hollow 0.5 m east extending upwards. | PRF-I | Fully inspected 20 August 2025.<br>No field signs. | N/A | |

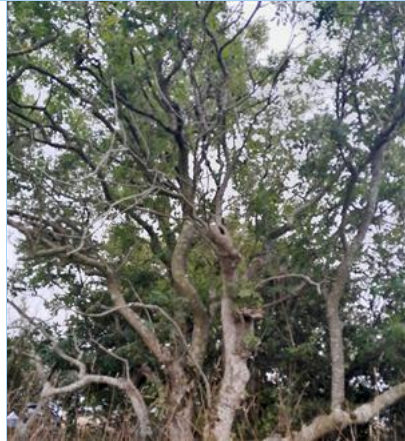
| Tree Ref | Tree Species | Features | PRF Inspection Categorisation | First PRF Inspection Results | Second PRF Inspection Results (PRF-M only) | Photo (PRF-M and PRF-I only) |
|---|---|---|---|---|---|---|
| T43 | Ash | Ash with knot hole 2 m north. | PRF-I | Fully inspected 20 August 2025.<br>No field signs. | N/A | |

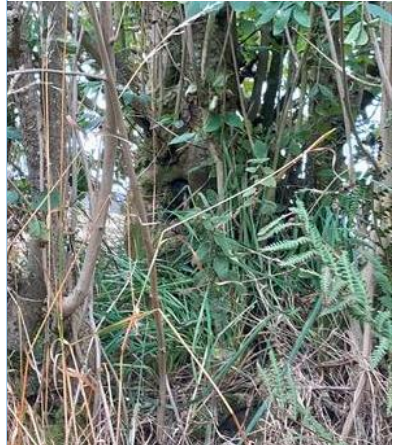
| Tree Ref | Tree Species | Features | PRF Inspection Categorisation | First PRF Inspection Results | Second PRF Inspection Results (PRF-M only) | Photo (PRF-M and PRF-I only) |
|---|---|---|---|---|---|---|
| T44 | Ash | Ash with basal cavity at 10 cm with rot that extends downwards by 10 cm. quite cluttered at entrance with vegetation. | PRF-I | Fully inspected 20 August 2025.<br>No field signs. | N/A | |

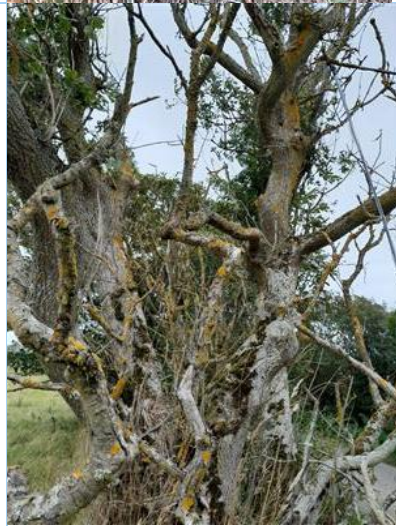
| Tree Ref | Tree Species | Features | PRF Inspection Categorisation | First PRF Inspection Results | Second PRF Inspection Results (PRF-M only) | Photo (PRF-M and PRF-I only) |
|---|---|---|---|---|---|---|
| T45 | Ash | Knotholes throughout from 2-6 m, tear out at 5 m, tree dead. | PRF-I | Fully inspected 20 August 2025.<br>No field signs. | N/A | |

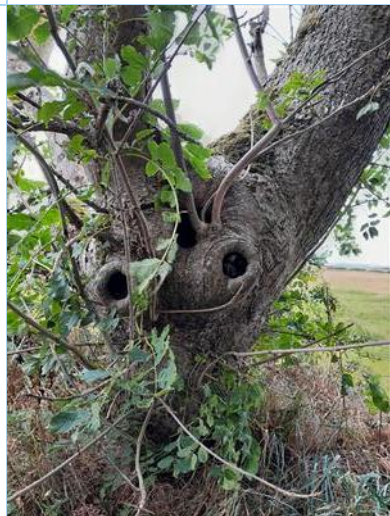
| Tree Ref | Tree Species | Features | PRF Inspection Categorisation | First PRF Inspection Results | Second PRF Inspection Results (PRF-M only) | Photo (PRF-M and PRF-I only) |
|---|---|---|---|---|---|---|
| T47 | Ash | Ash with three knotholes at multiple aspects, 0.5 m. One knothole has large entrance and extends 15 cm into a wide chamber. | PRF-I | Fully inspected 20 August 2025. No field signs. | N/A | |

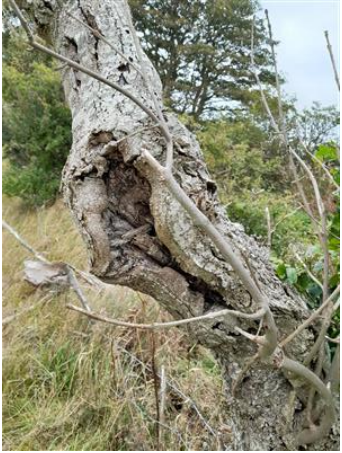
| Tree Ref | Tree Species | Features | PRF Inspection Categorisation | First PRF Inspection Results | Second PRF Inspection Results (PRF-M only) | Photo (PRF-M and PRF-I only) |
|---|---|---|---|---|---|---|
| T48 | Ash | Desiccation throughout main stem with rot and knot hole on eastern aspect extending into large chamber (PRF-M). Remaining knothole and desiccation (PRF-I). | PRF-M | Fully inspected 20 August 2025. No field signs. | Second inspection 16 September 2025. No field signs. | |

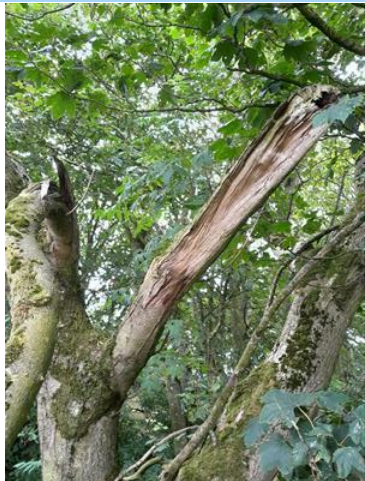
| Tree Ref | Tree Species | Features | PRF Inspection Categorisation | First PRF Inspection Results | Second PRF Inspection Results (PRF-M only) | Photo (PRF-M and PRF-I only) |
|---|---|---|---|---|---|---|
| T51 | Ash | Substance crack at 1 m. Transverse snap at 2 m east and partial transverse snap at 1.7 m north west. | PRF-I | Inspected 20 August 2025. No field signs. | N/A | |

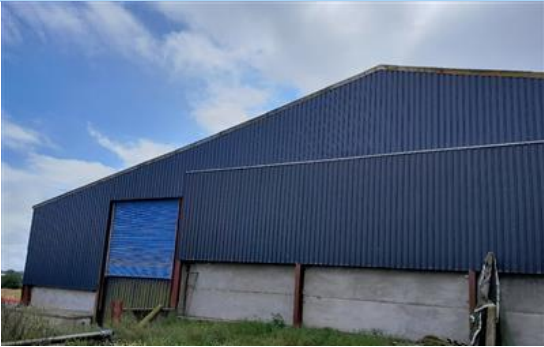
| Structure/<br>Building<br>Reference | Structure/<br>Building<br>Type | Features | Comment | Photo |
|---|---|---|---|---|
| <b>S1</b> | Corrugated iron shed | Corrugated iron and concrete farming shed with gaps between beams and ample cracks in concrete sheets. Did not assess internally. High levels of industrial noise and vibration due to industrial operations. | Moderate suitability for roosting bats in Summer (active season) and low suitability in Winter (hibernation season). | |

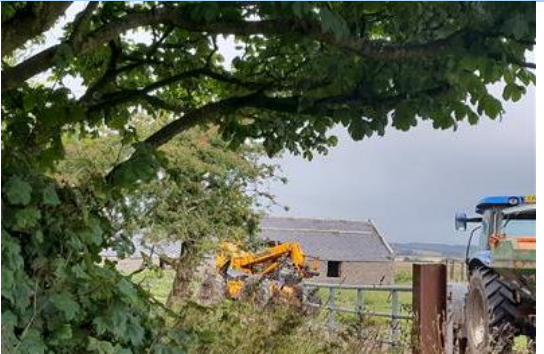
| Structure/<br>Building<br>Reference | Structure/<br>Building<br>Type | Features | Comment | Photo |
|---|---|---|---|---|
| <b>S2</b> | Collection of abandoned residential and farm buildings | Buildings within the footprint of Netherton Hub project. | Moderate suitability for roosting bats in Summer (active season) and moderate suitability in Winter (hibernation season). | |

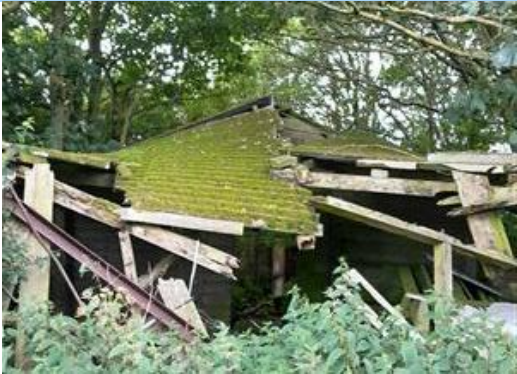
| Structure/<br>Building<br>Reference | Structure/<br>Building<br>Type | Features | Comment | Photo |
|---|---|---|---|---|
| <b>S3</b> | Collapsed wooden shed | Collapsed shed with corrugated iron sheeting. Walls comprised of wooden slats with small, isolated gaps between supporting wooden beams and iron sheeting. Overall gaps appear exposed and offer limited shelter. Not investigated in full due to scrap material and asbestos risk. Assumed low precautionarily. | Low suitability for roosting bats in Summer (active season). | |

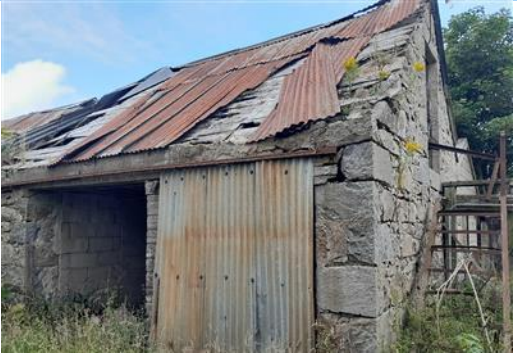
| Structure/<br>Building<br>Reference | Structure/<br>Building<br>Type | Features | Comment | Photo |
|---|---|---|---|---|
| <b>S4</b> | Dilapidated stone outbuilding | Stone outbuilding with pitched roof constructed of wooden beams and corrugated iron sheeting.<br><br>Gaps where mortar has crumbled away in brickwork. Gaps in chimney breast structure. Direct access to loft where roof panels have rotted away. | Moderate suitability for roosting bats in Summer (active season) and moderate suitability in Winter (hibernation season). | |

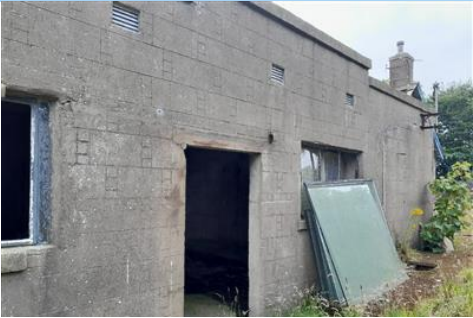
| Structure/<br>Building<br>Reference | Structure/<br>Building<br>Type | Features | Comment | Photo |
|---|---|---|---|---|
| <b>S5</b> | Dilapidated<br>farm building | Gaps where mortar has crumbled away on corners. Direct access into building where roof panels have collapsed. No windows or doors. | Moderate suitability for roosting bats in Summer (active season) and moderate suitability in Winter (hibernation season). | |

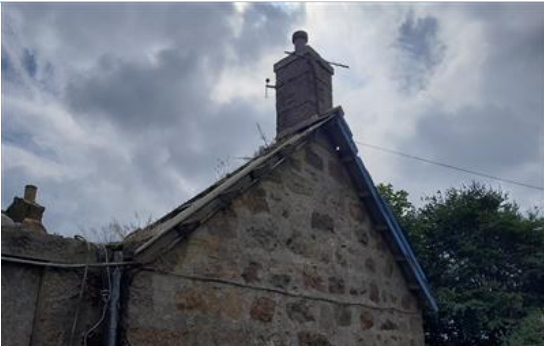
| Structure/<br>Building<br>Reference | Structure/<br>Building<br>Type | Features | Comment | Photo |
|---|---|---|---|---|
| <b>S6</b> | Dilapidated<br>farm building | Gaps where felt roof has come away leading to soffit box, small areas where mortar has crumbled away in brickwork. Gaps in chimney breast structure. Direct access to internal space where roof panels has collapsed. | Moderate suitability for roosting bats in Summer (active season) and moderate suitability in Winter (hibernation season). | |

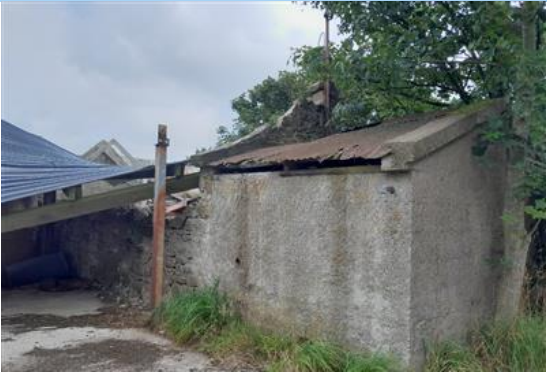
| Structure/<br>Building<br>Reference | Structure/<br>Building<br>Type | Features | Comment | Photo |
|---|---|---|---|---|
| <b>S7</b> | Dilapidated<br>stone<br>outbuilding | Gaps where mortar has crumbled away in brickwork. Roof collapsed in remainder of building | Moderate suitability for roosting bats in Summer (active season) and moderate suitability in Winter (hibernation season). | |

- 3.2.9 Furthermore, an additional area of five separate dilapidated farm buildings and outbuildings was identified within the Site (referred to as **S3 – S7**). These buildings were found to be in a state of disrepair and offered suitable features for roosting bats within both the active and hibernation season. No further surveys were conducted within structures located within the Site.

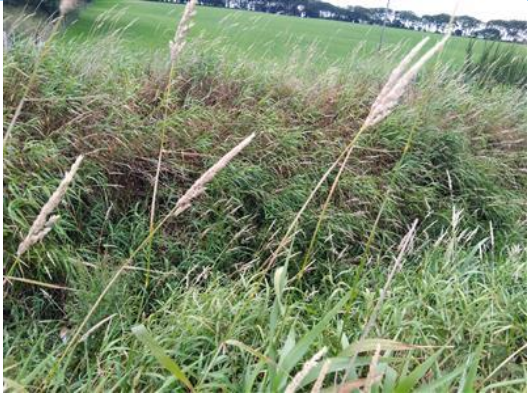
| Ref. | Location - in the Site or wider Survey Area | Species | Field sign | Comment | Example Photo |
|---|---|---|---|---|---|
| <b>O1</b> | ~110 m north of Site boundary | Otter | Suitable habitat | Ditch with slow flowing water, 20 cm in depth. Waterbody surrounded by dense vegetation. Suitable habitat for otter to commute and potentially rest. Vegetation too dense to survey in full. | |

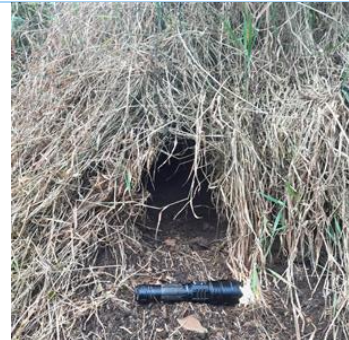
| Ref. | Location - in the Site or wider Survey Area | Species | Field sign | Comment | Example Photo |
|---|---|---|---|---|---|
| <b>O2</b> | ~70 m south of Site boundary, within Associated Infrastructure boundary | Otter | Potential resting site | Tunnel into bank of ditch. Approximately 30 cm wide and extends 1.5 m upwards into bank under mature hawthorn root system. No field signs. Located within the boundary of Netherton Hub project and as such, no further assessment was undertaken. | |

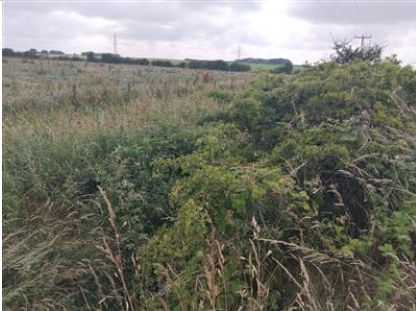
| Ref. | Location - in the Site or wider Survey Area | Species | Field sign | Comment | Example Photo |
|---|---|---|---|---|---|
| <b>O3</b> | Site | Otter | Suitable habitat | Potential for otter to commute and rest among hawthorn hedge and bank. Water levels less than 10 cm in depth. | |

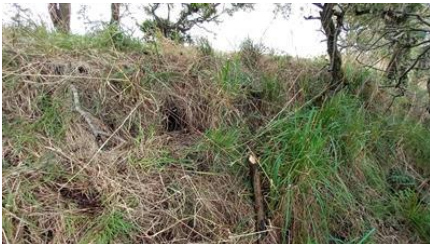
| Ref. | Location - in the Site or wider Survey Area | Species | Field sign | Comment | Example Photo |
|---|---|---|---|---|---|
| <b>O4</b> | ~ 25 m from Site boundary | Otter | Potential resting site | Mammal excavation potentially suitable as a resting site, comprising of a single circular entrance approx. 40 cm wide into bank. Suitable for otter, with spraint (O5) recorded within 10 m of entrance.<br><br>Subject to a suite of camera trapping (CT03). No evidence of this species was returned during the period of assessment. | |

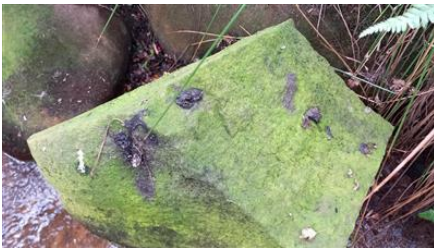
| Ref. | Location - in the Site or wider Survey Area | Species | Field sign | Comment | Example Photo |
|---|---|---|---|---|---|
| <b>O5</b> | ~ 25 m from Site boundary | Otter | Spraint | Multiple otter spraints on large boulder in watercourse. Dry and intact. | |

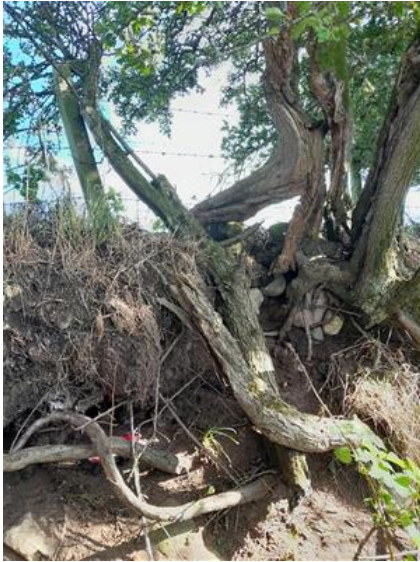
| Ref. | Location - in the Site or wider Survey Area | Species | Field sign | Comment | Example Photo |
|---|---|---|---|---|---|
| <b>O6</b> | ~ 25 m from Site boundary | Otter | Potential resting site | <p>Dry cavity under root plate of hawthorn. Extends beyond reach into a 40 cm circular tunnel system. Dry and sheltered adjacent to secluded watercourse. Suitable for otter, however no field signs.</p> <p>Subject to a suite of camera trapping (CT05). No evidence of this species was returned during the period of assessment.</p> | |

- 3.3.5 The final potential resting opportunity (holt-type structure) (**O6**) was recorded along a small burn which joins the Burn of Ludquham downstream. This feature consisted of a tunnel system under a hawthorn root plate. No positive evidence of otter was recorded during the 6-week camera trap monitoring undertaken at the three identified features, and as such are no longer considered potential resting sites.

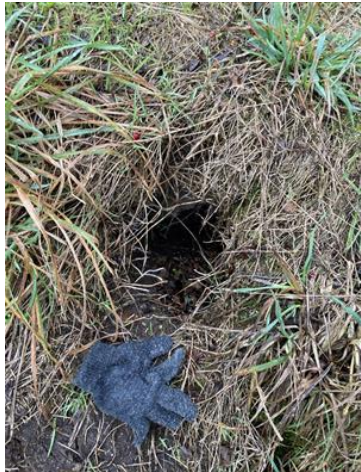
| Ref. | Location - in the Site or wider Survey Area | Species | Field sign | Comment | Example Photo |
|---|---|---|---|---|---|
| <b>O7</b> | Outside of Site, within Associated Infrastructure | Otter | Potential resting site | <p>Burrow approximately 40 cm wide along bank of slow flowing ditch, extends out of sight. No field signs.</p> <p>Subject to a suite of camera trapping (CT07). No evidence of this species was returned during the period of assessment.</p> | |

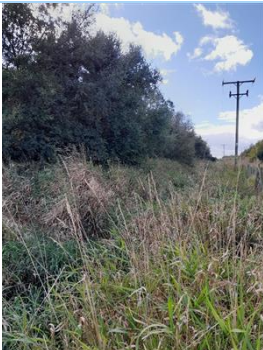
| Ref. | Location - in the Site or wider Survey Area | Species | Field sign | Comment | Example Photo |
|---|---|---|---|---|---|
| <b>WV2</b> | <b>Site</b> | Water vole | Suitable habitat | Slow flowing ditch with bank densely covered by common reed, thistle and rush species. Some of the watercourse not visible for survey due to dense vegetation. No field signs. | |

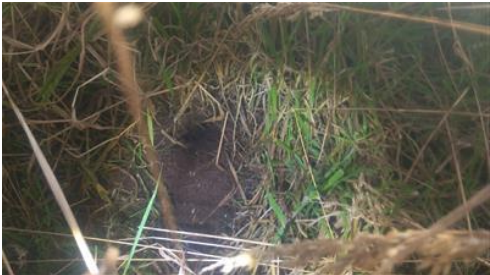
| Ref. | Location - in the Site or wider Survey Area | Species | Field sign | Comment | Example Photo |
|---|---|---|---|---|---|
| <b>WV6</b> | <b>Site</b> | Water vole | Potential water vole burrow | A potential water vole burrow located on the south east bank of a slow-flowing ditch. | |

- 3.4.2 No commercially available records of water vole were identified on NBN Atlas within 2 km of the Site.
- 3.4.3 Evidence of water vole recorded within the Water Vole Survey Area, included potential burrows (referred to as **WV4 - WV6** and **WV8 – WV10**, **Annex B: Table B-3**) recorded along a slow flowing modified ditch, downstream to the Burn of Ludquham (see **Annex A Figure 7.2.3: Protected Species Survey Results**). In the same location ample droppings – presumed to be water vole - were recorded (**WV7**), along with anecdotal evidence from the landowner of water vole presence.

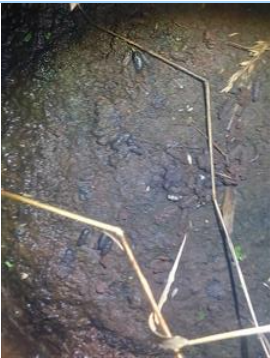
| Ref. | Location - in the Site or wider Survey Area | Species | Field sign | Comment | Example Photo |
|---|---|---|---|---|---|
| <b>WV7</b> | <b>Site</b> | Water vole | Potential droppings | Potential water vole droppings on raised earth patch within ditch. | |

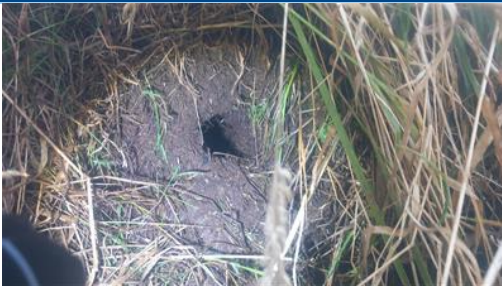
| Ref. | Location - in the Site or wider Survey Area | Species | Field sign | Comment | Example Photo |
|---|---|---|---|---|---|
| <b>WV10</b> | | Water vole | Potential water vole burrow | Potential water vole burrow identified on the south east bank of slow flowing ditch. Located within 20 cm of water, inner tunnel approx. 7 cm wide. | |

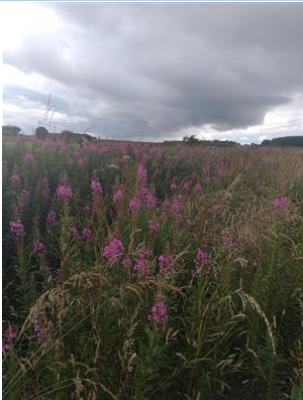
| Ref. | Location - in the Site or wider Survey Area | Species | Field sign | Comment | Example Photo |
|---|---|---|---|---|---|
| <b>WV14</b> | <b>Site</b> | Water vole | Potential droppings | Slow flowing ditch with bankside vegetation comprising of common reed, rosebay willowherb, and false oat grass. Moderate sloping earthen banks with ample small pools and sheltered channel areas. Potential water vole droppings noted. | |

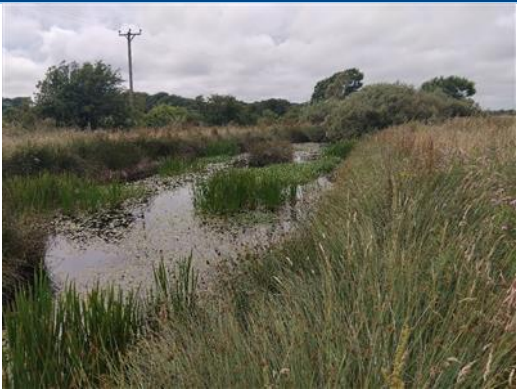
| Ref. | Location - in the Site or wider Survey Area | Species | Field sign | Comment | Example Photo |
|---|---|---|---|---|---|
| WV19 | Site | Water vole | Suitable habitat | Drainage pond located between crop field. Unable to fully due to health and safety reasons. Small island in pond. Rush and grass vegetation, with earthen banks. Suitable for water vole. No field signs. | |

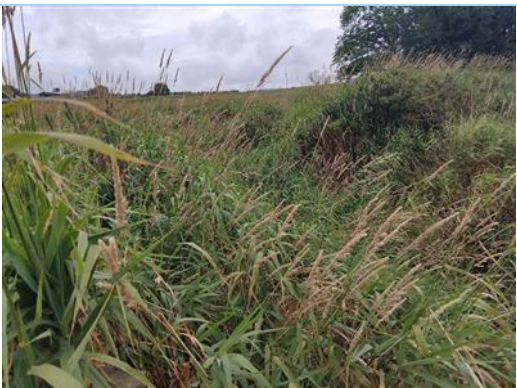
| Ref. | Location - in the Site or wider Survey Area | Species | Field sign | Comment | Example Photo |
|---|---|---|---|---|---|
| WV20 | Outside of Site but within Associated Infrastructure | Water vole | Suitable habitat | Ditch between arable fields. Very dense vegetation on edge of banks and along channel. Unable to survey due to health and safety reasons. Appears to contain suitable banks to support water vole burrows. Where accessible for survey, no field signs. | |

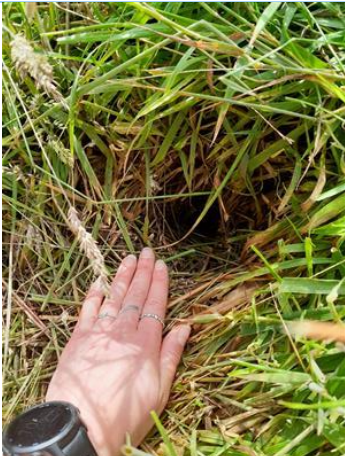
| Ref. | Location - in the Site or wider Survey Area | Species | Field sign | Comment | Example Photo |
|---|---|---|---|---|---|
| <b>WV23</b> | <b>Site</b> | Water vole | Potential water vole burrow | Sluggish watercourse with grassy banks which transitions into an area shaded by gorse. On banks and adjacent to waterline multiple burrows which range in diameter from 3 cm to 5 cm. Potential droppings recorded. | |

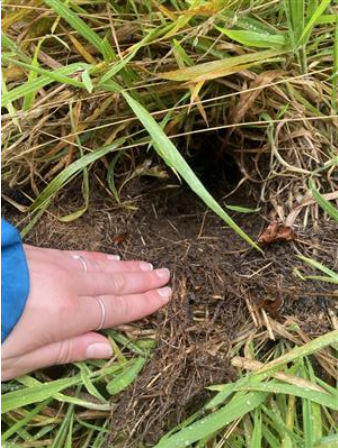
| Ref. | Location - in the Site or wider Survey Area | Species | Field sign | Comment | Example Photo |
|---|---|---|---|---|---|
| <b>WV27</b> | ~150 m west of Site | Water vole | Burrow – species unknown | Further network of burrows paths and some small droppings on dry embankment. Likely too small to be attributed to water vole. | |

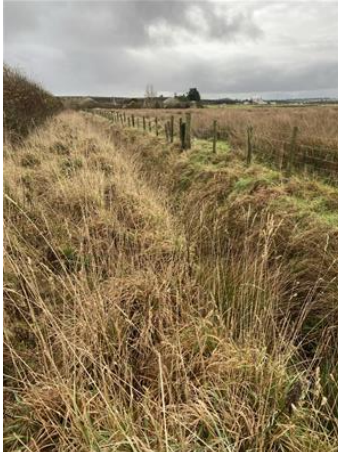
| Ref. | Location - in the Site or wider Survey Area | Species | Field sign | Comment | Example Photo |
|---|---|---|---|---|---|
| <b>WV29</b> | Outside of Site, within Associated Infrastructure | Water vole | Burrow – species unknown | Ditch embankment containing 4 cm in diameter burrows. Ditch with suitability for water vole. No further field signs, however, surveys conducted outwith optimal water vole survey season. | |

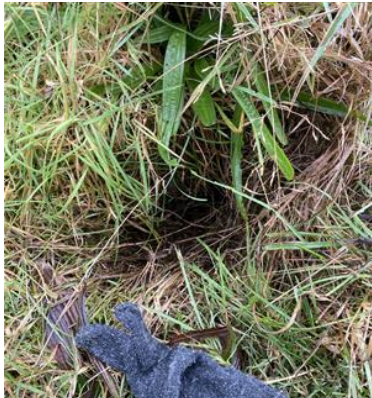
| Ref. | Location - in the Site or wider Survey Area | Species | Field sign | Comment | Example Photo |
|---|---|---|---|---|---|
| <b>WV30</b> | Outside of Site, within Associated Infrastructure | Water vole | Burrow – species unknown | 4 cm in diameter burrows on ditch embankment. Ditch with suitability for water vole. No further field signs, however, surveys conducted outwith optimal water vole survey season. | |

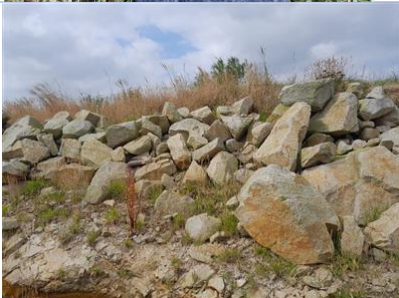
| Ref. | Location - in the Site or wider Survey Area | Species | Field sign | Comment | Example Photo |
|---|---|---|---|---|---|
| <b>PM1</b> | <b>Site</b> | Pine Marten | Resting opportunity | Area of rubble and boulders with gaps and crevices suitable for pine marten. No field signs. | |

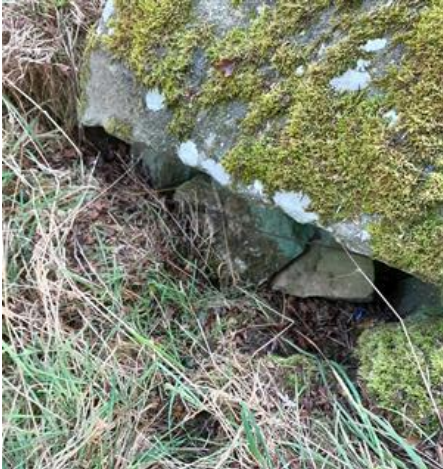
| Ref. | Location - in the Site or wider Survey Area | Species | Field sign | Comment | Example Photo |
|---|---|---|---|---|---|
| PM3 | Site | Pine Marten | Resting opportunity | Dry cavity under collection of boulders, suitable for pine marten resting. No field signs. | |

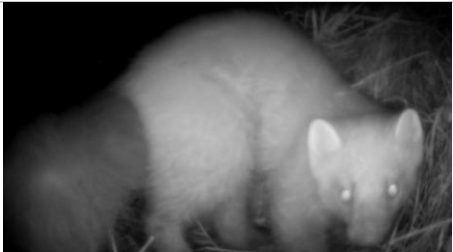
| Ref. | Location - in the Site or wider Survey Area | Species | Field sign | Comment | Example Photo |
|---|---|---|---|---|---|
| PM4 | | Pine Marten | Individual sighting | Individual sighting of pine marten during camera trapping (CT03). | |

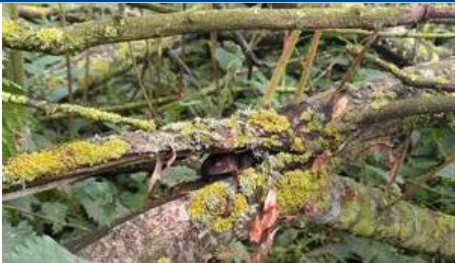
| Ref. | Location - in the Site or wider Survey Area | Species | Field sign | Comment | Example Photo |
|---|---|---|---|---|---|
| <b>TN1 &amp; TN2</b> | <b>Site</b> | Toad | Individual sighting | Sighting of toad within ash tree on two separate occasions. Within 20m of pond habitat. | |
