**Fanellan Hub 400 kV Substation and
Converter Station
Environmental Impact Assessment Report
Volume 4 | Technical Appendices**

**Appendix 11.3 – Archaeological Watching Brief
Data Structure Report
February 2025**

Archaeological Watching Brief Data Structure Report

AOC Project Number: 70733

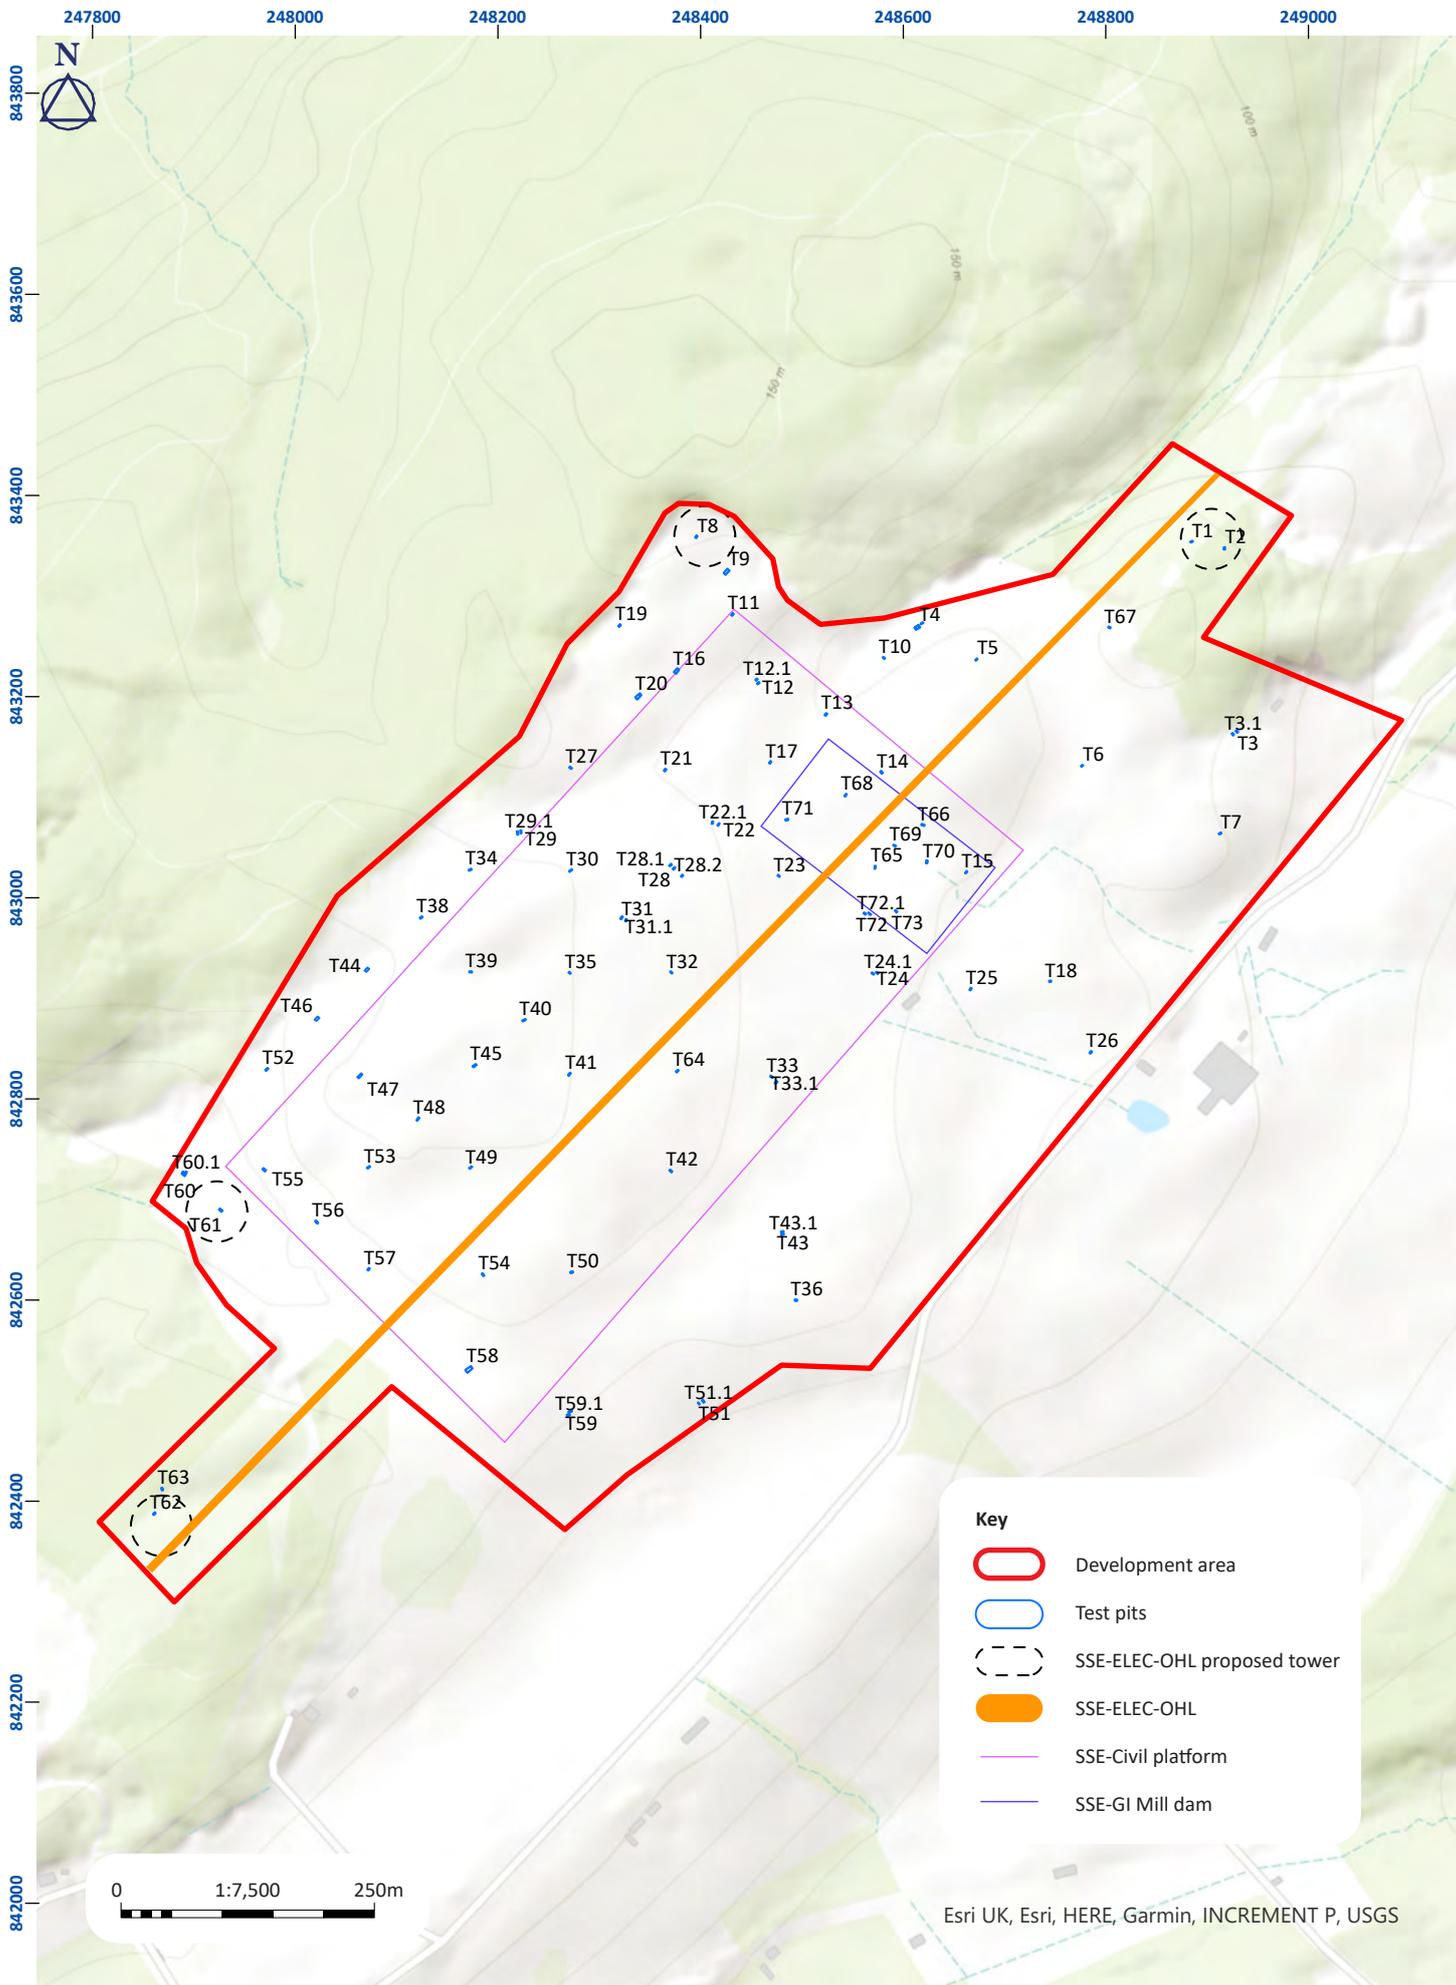
Figure 2: Watching Brief areas

- 4.1 The archaeological watching brief was undertaken during geotechnical investigations as part of the groundworks for the proposed development (**Figure 2**). The archaeologist directed the mechanical excavator, that was fitted with a straight-edged bucket. Excavations ceased at the required geotechnical investigation level or the first archaeological horizon, whichever was encountered first.

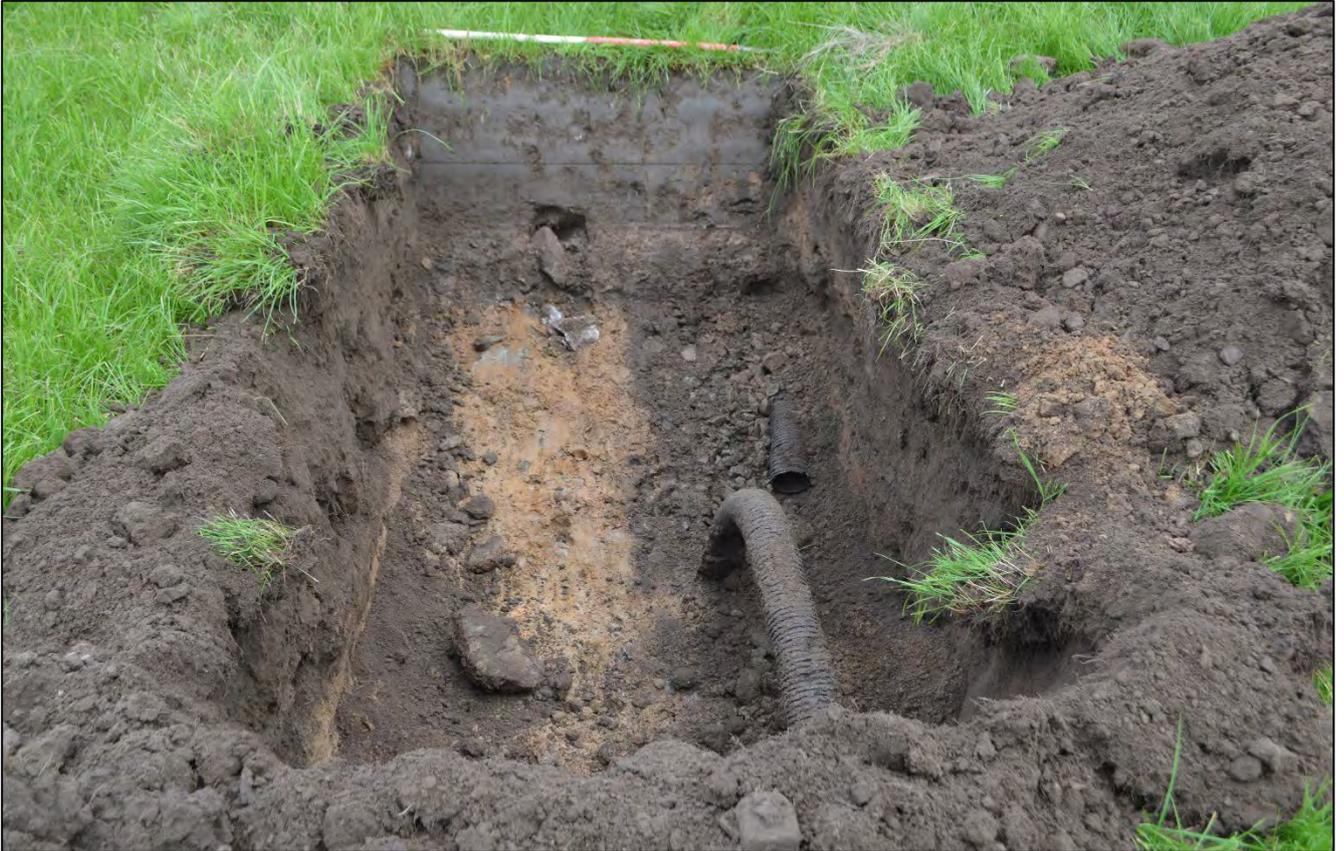
Plate 2: Example of field drain requiring new Test pit location

- 4.3 In the first instance of any archaeological feature being identified the procedure was to stop excavating and offset the proposed trench location so as to not interact with any archaeological remains. This also included modern field drains.

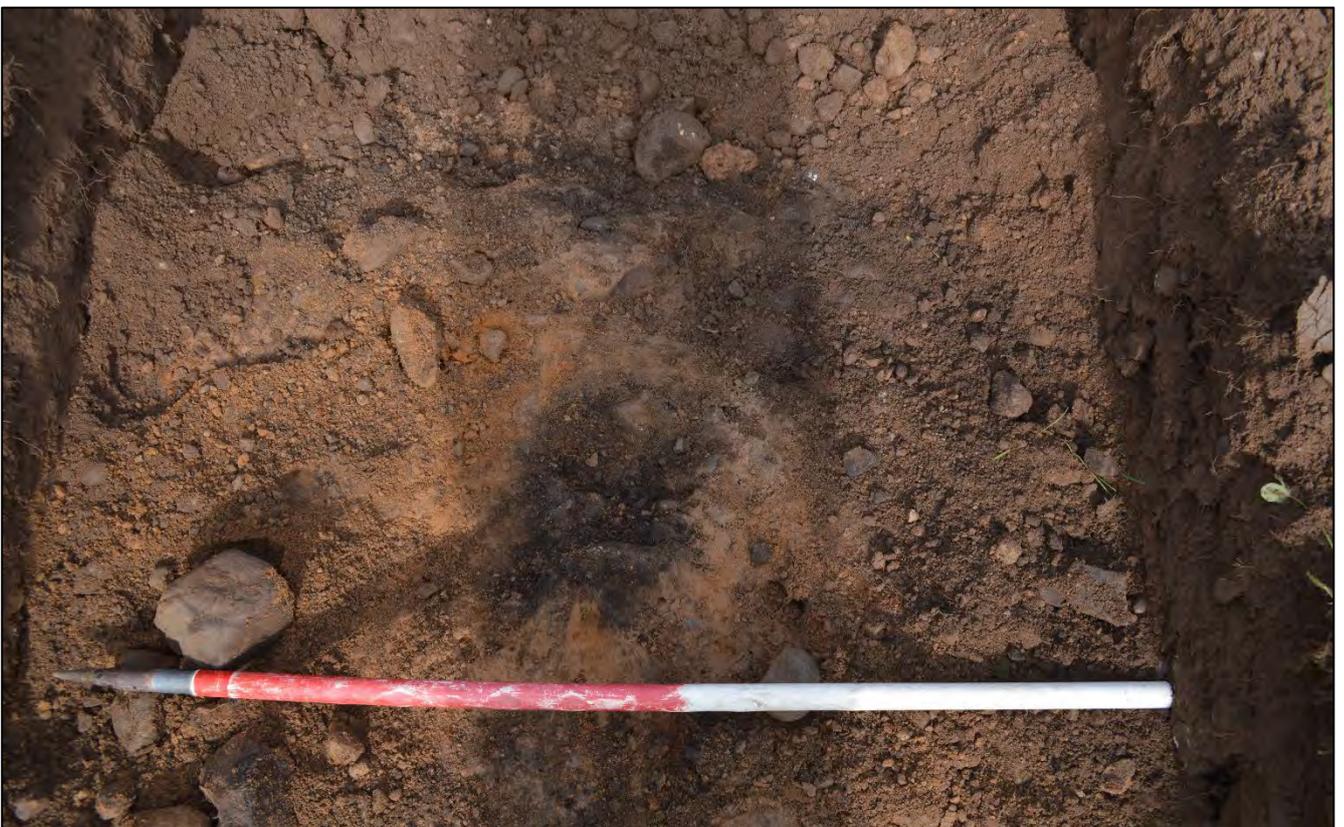
Plate 3: Postholes in Test pit 24

- 5.2 Test Pits 24, 28.1, 43, 47 and 59 contained archaeological features (**Figure 3**) (**Appendix 1**). TP24 contained two small pits or postholes and TP28.1 and TP 43 both contained a single posthole. These features were circular in plan and measured approximately 0.75m long by 0.75m wide (**Plates 3 & 4**). They were filled by greyish silty sand with possible ash material, small charcoal and burnt bone flecks. TP47 contained a single pit measuring 0.75m long by 0.65m wide at minimum, though the full shape and size could not be determined as the feature continued beyond the test pit edge. It was filled by friable greyish brown silty sand with frequent angular stones up to 0.15m across (**Plate 5**). A linear feature was identified at the northeastern end of TP59. It measured a minimum of 1.5m by 1.3m, though again the full extent of the feature lay beyond the edge of the test pit. It was filled by friable dark brownish grey sandy silt with occasional small to large angular and rounded stones. All features were recorded in situ and remained un-excavated as it was not necessary to do so as the test pit locations were moved in response.

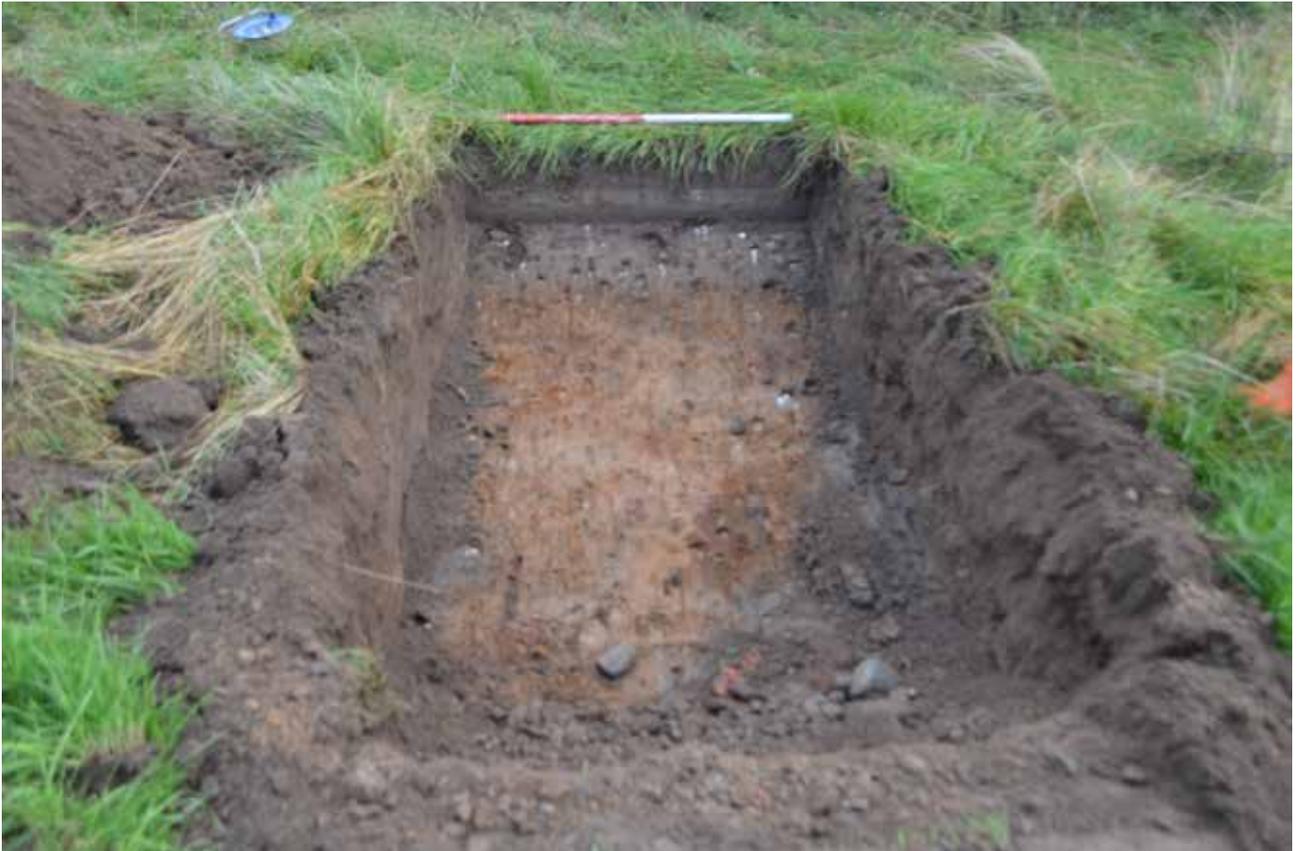
Plate 30 Post-excitation of TP22 showing ceramic field drain in southern corner.

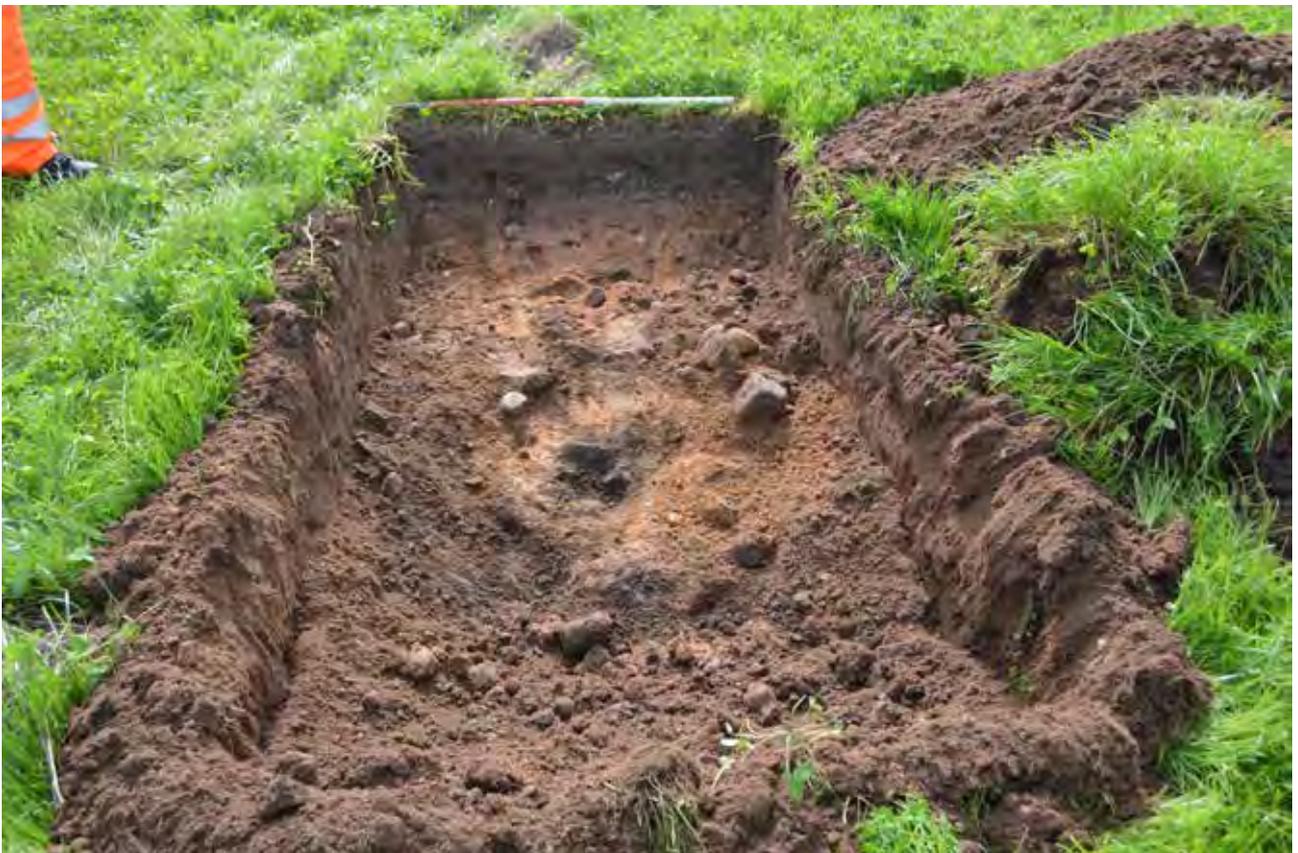
Plate 33 Post-excavation of TP24, showing possible postholes

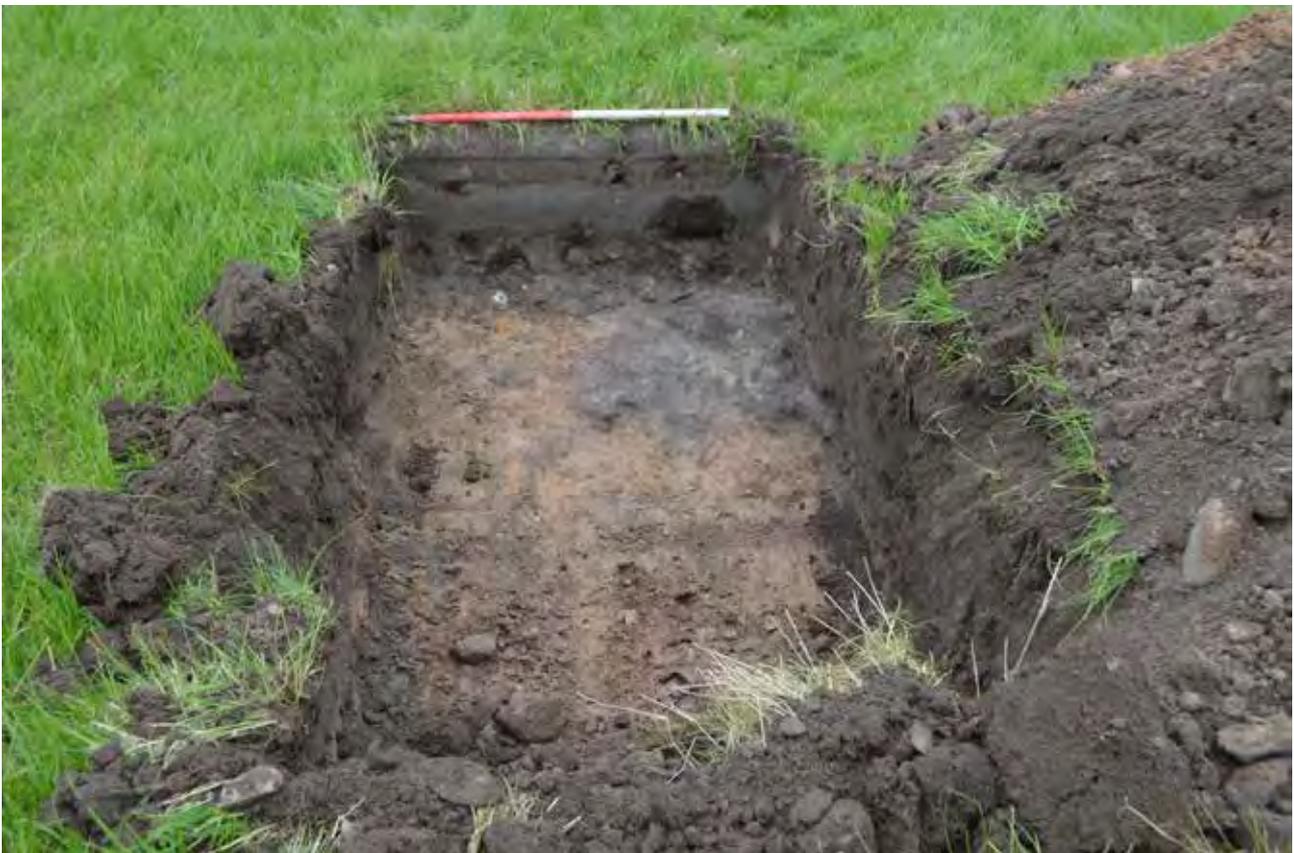
28.1	3	2.1	Grey-brown sandy silt topsoil over orange -brown sandy gravel natural Possible posthole (approximately 0.75x0.75m) located within east corner of TP28.1. Fill is greyish silty sand possible ash mixed in. Small charcoal flakes and tiny burnt bone flakes visible on surface. No excavation performed. No depth taken. Test pit backfilled over archaeology and moved to another location.	0.55	NE-SW

Plate 39 Post-excitation of TP28.1, showing possible posthole on east corner

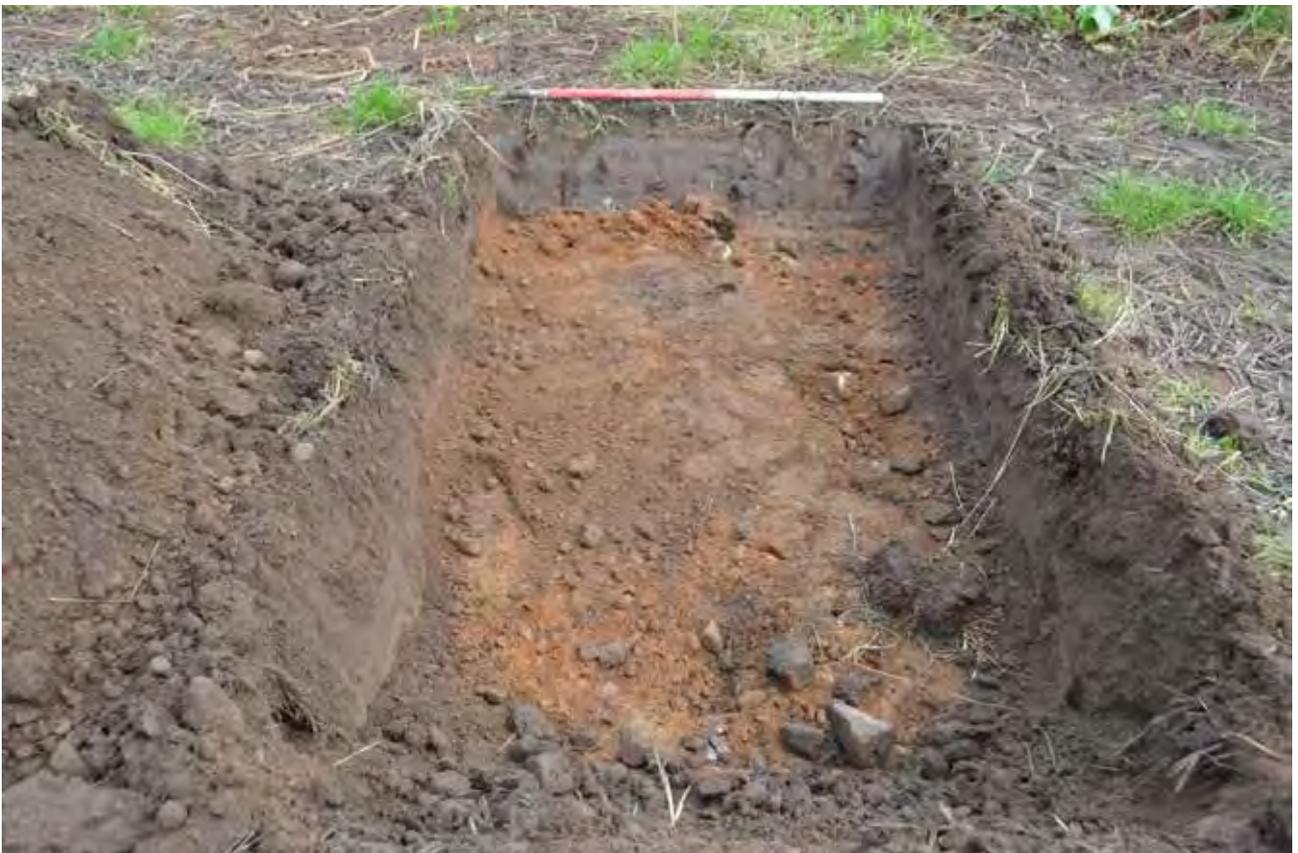
Plate 57 Post-excavation of TP43, showing possible posthole at the east end of the trial pit

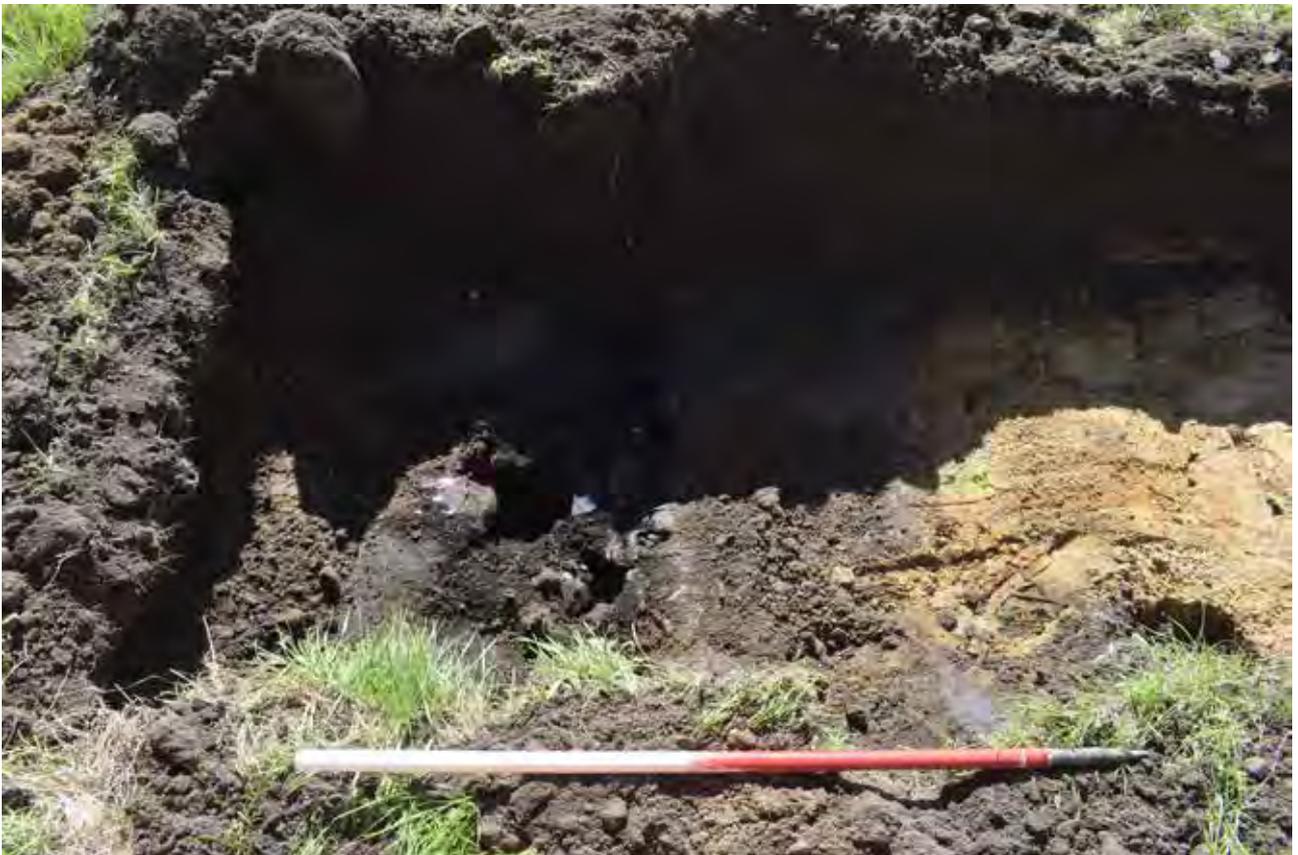
Plate 77 Possible linear feature 5902 in TP59

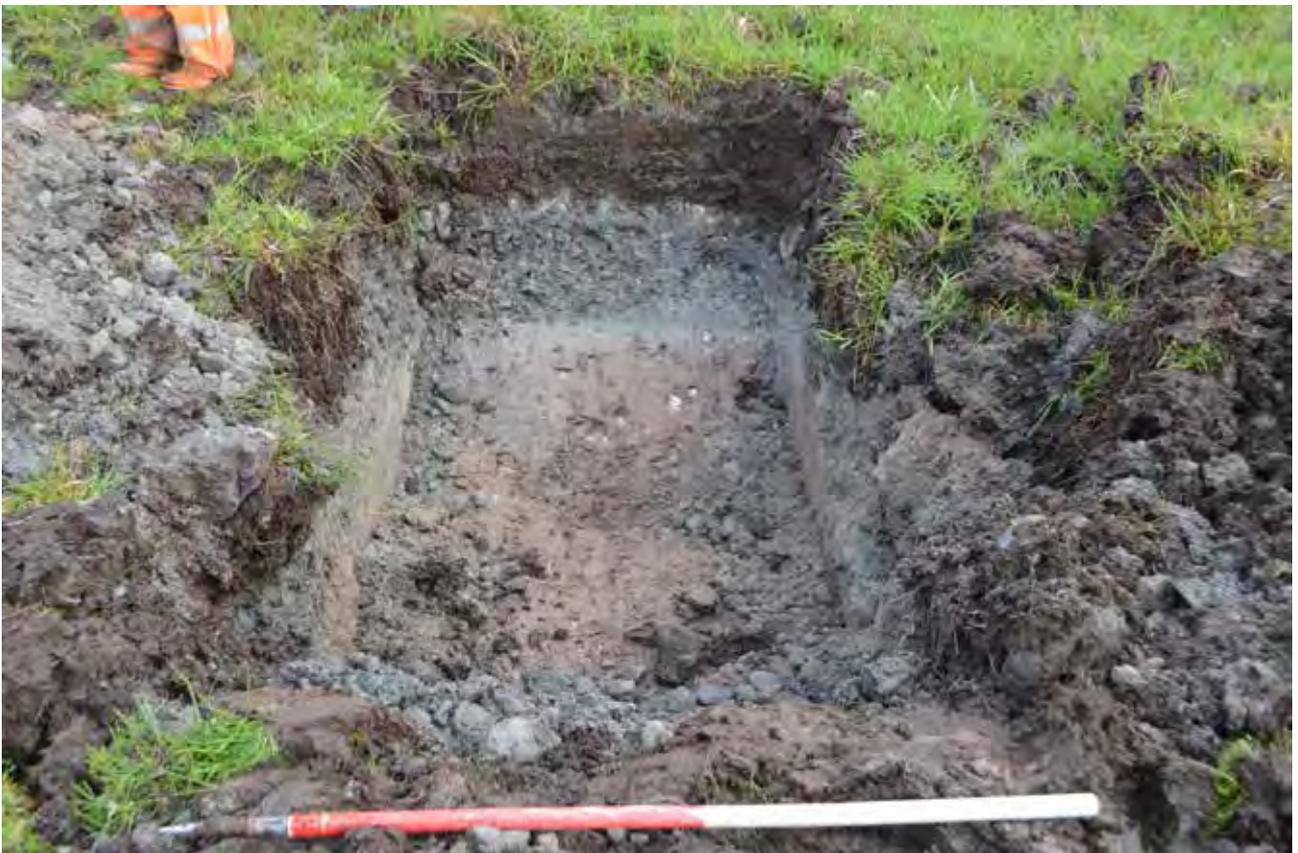
- 5.3 The edge of an old, backfilled mill pond was observed within TP70 with the appearance of a grey silt material rich in decayed organic matter. This material was overlain by a peaty topsoil with frequent boulders that look to have been part of a dam-like structure. The deposits relating to the mill pond were also observed in TP65 and 69.

Plate 85 Post-excavation of TP65 showing topsoil over clay layer

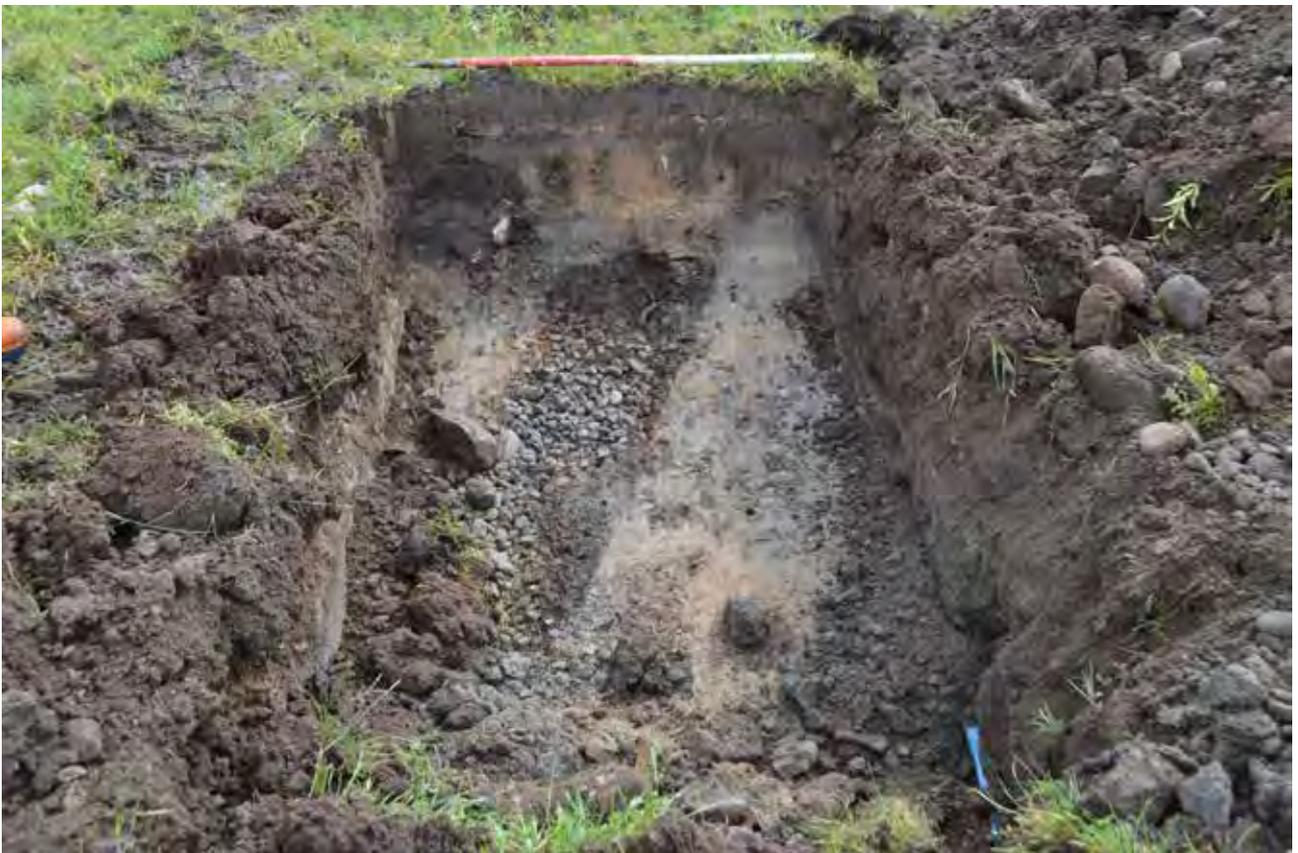
Plate 93 Post-excavation of TP72, including location of field drain and blue water service pipe
