**Spittal to Loch Buidhe to Beauly 400 kV
OHL Connection
Environmental Impact Assessment
Volume 5 | Technical Appendix**

**Appendix 10.1 | Schedule of
Watercourse Crossings**

VOLUME 5: APPENDIX 10.1 – SCHEDULE OF WATERCOURSE CROSSINGS

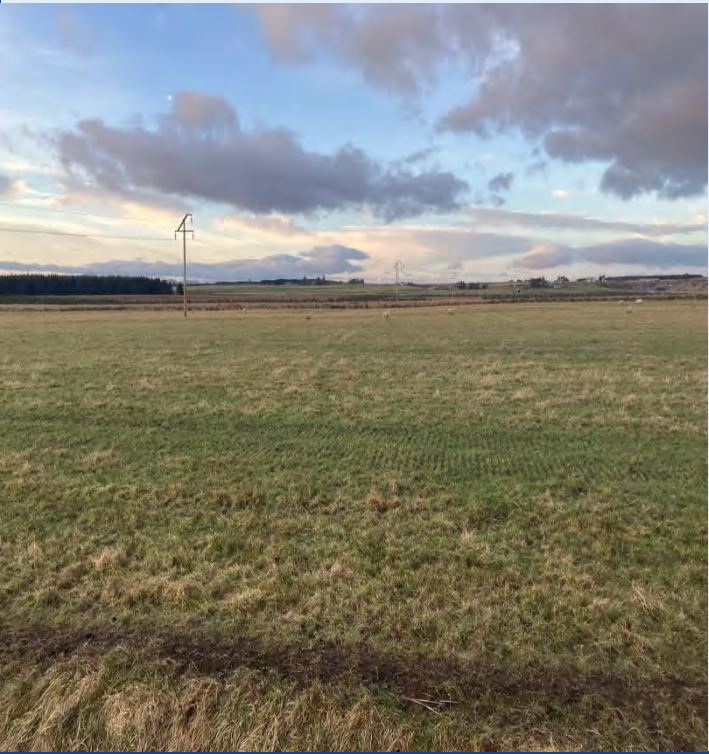
ID	Name	Easting	Northing	Width (m)	Sediment	Slope	Erosion	Crossing Type	Field Notes /Comments	Minor Watercourse (yes/no)	CAR Engineering Authorisation Required (yes/no)	Photo
Permanent Access Tracks - Northern Alignment												
1	Unnamed Field Drain	316526	956281	0.2	Earth	Gentle	Not observed	Proposed	Slow rate of flow. Average depth of 0.1 m. Bank side composed of grasses.	Yes	No	Not available
2	Unnamed field drain	318974	953965	Not observed	Not observed	Gentle	Not observed	Proposed	Pastureland. Dry with no visible signs of flowing water.	Yes	No

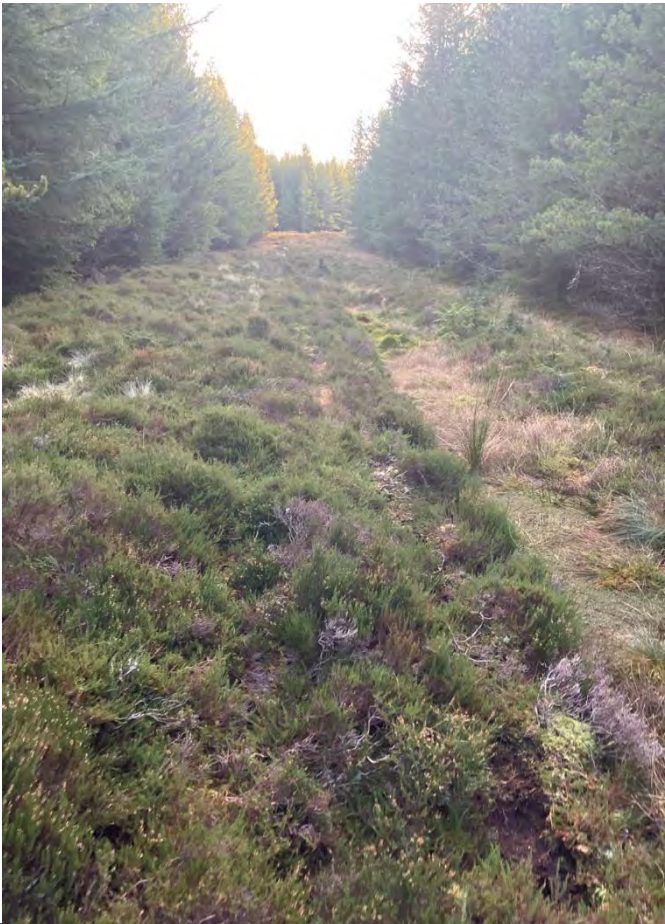
ID	Name	Easting	Northing	Width (m)	Sediment	Slope	Erosion	Crossing Type	Field Notes /Comments	Minor Watercourse (yes/no)	CAR Engineering Authorisation Required (yes/no)	Photo
3	Unnamed	319076	953660	Not observed	Not observed	Gentle	Not observed	Proposed	No visible sign of watercourse. Coniferous forestry. Dry.	Yes	No

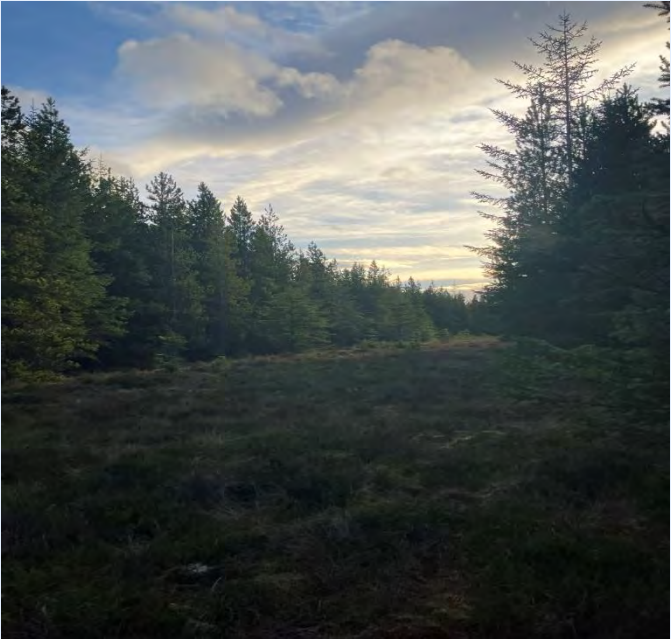
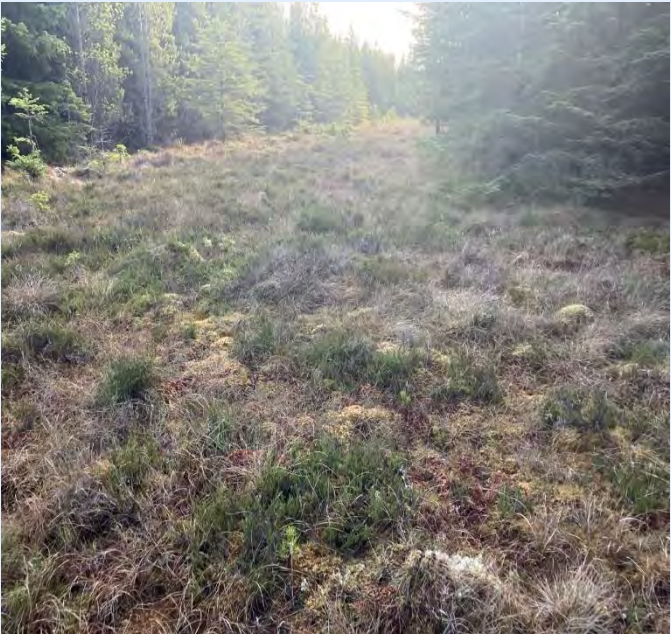
ID	Name	Easting	Northing	Width (m)	Sediment	Slope	Erosion	Crossing Type	Field Notes /Comments	Minor Watercourse (yes/no)	CAR Engineering Authorisation Required (yes/no)	Photo
4	Unnamed	319223	953111	Not observed	Not observed	Gentle	Not observed	Proposed	Not observed. Located in dense coniferous forestry.	Yes	No	<div>

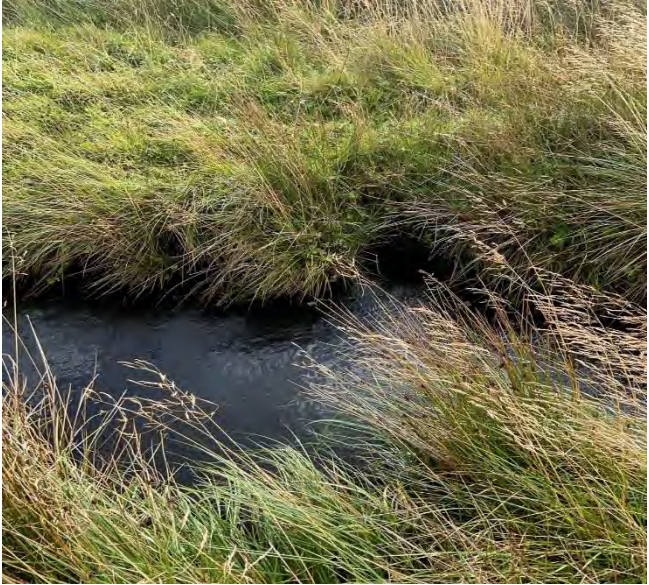
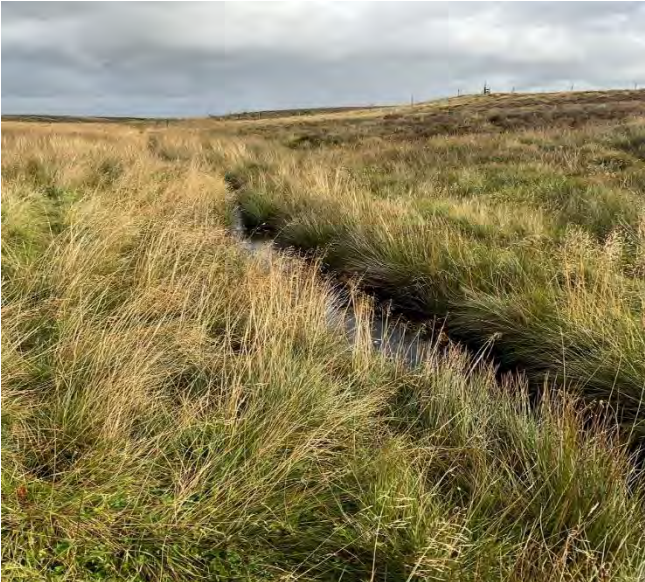
ID	Name	Easting	Northing	Width (m)	Sediment	Slope	Erosion	Crossing Type	Field Notes /Comments	Minor Watercourse (yes/no)	CAR Engineering Authorisation Required (yes/no)	Photo
5	Halsary Burn	319265	950201	1-1.5	Peat/silt	Gentle	Not observed	Proposed	Depth approximately 0.5 m. Moderate rate of flow. Banks composed of peat and are vegetated. Meandering channel.	No	Yes	<div>

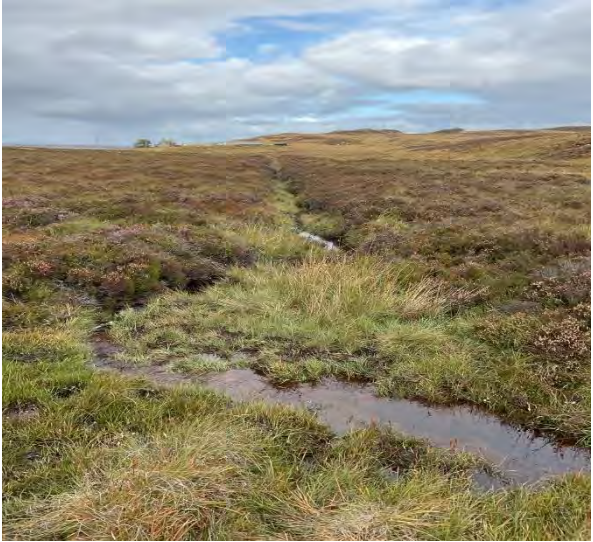
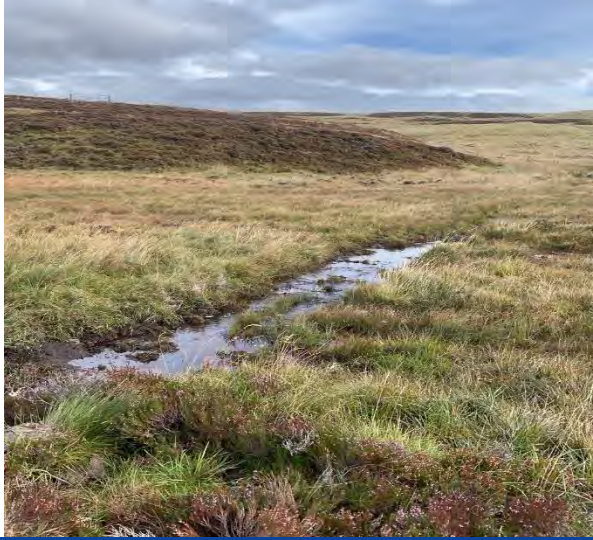
ID	Name	Easting	Northing	Width (m)	Sediment	Slope	Erosion	Crossing Type	Field Notes /Comments	Minor Watercourse (yes/no)	CAR Engineering Authorisation Required (yes/no)	Photo
9	Unnamed tributary of the Burn of Braehungie	318753	938941	0.5-1	Silt	Moderate	Not observed	Proposed	Moderate rate of flow. Bank height approximately 0.2-0.3 m. Sparse aquatic vegetation in channel. Stable environment.	No	Yes	<div>

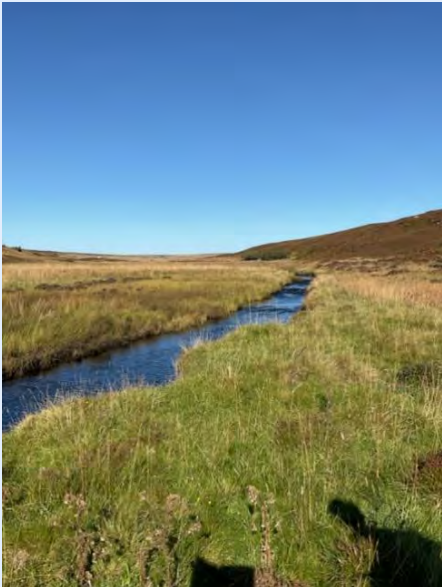
ID	Name	Easting	Northing	Width (m)	Sediment	Slope	Erosion	Crossing Type	Field Notes /Comments	Minor Watercourse (yes/no)	CAR Engineering Authorisation Required (yes/no)	Photo
10	Burn of Houstry	315417	932813	2.0-3.0	Silt	Gentle	Not observed	Proposed	Moderate flow. Shallow bank height. Depth up to 0.5 m.	No	Yes

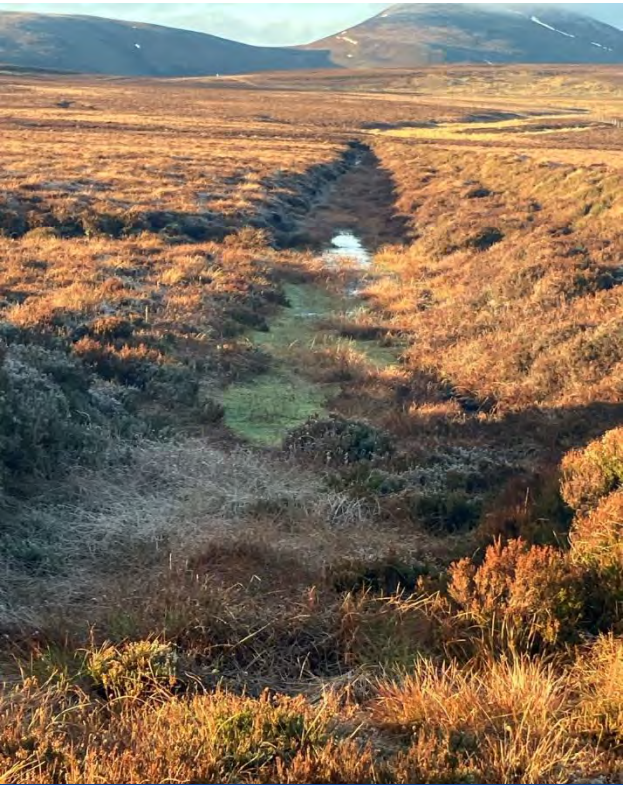
11	Unnamed drain	313196	929391	0.3	Peat	Gentle	Not observed	Proposed	Peat drain located in blanket bog. Very slow rate of flow. Depth approximately 0.1 m. Bank composed of heather, cotton grass and moss.	Yes	No

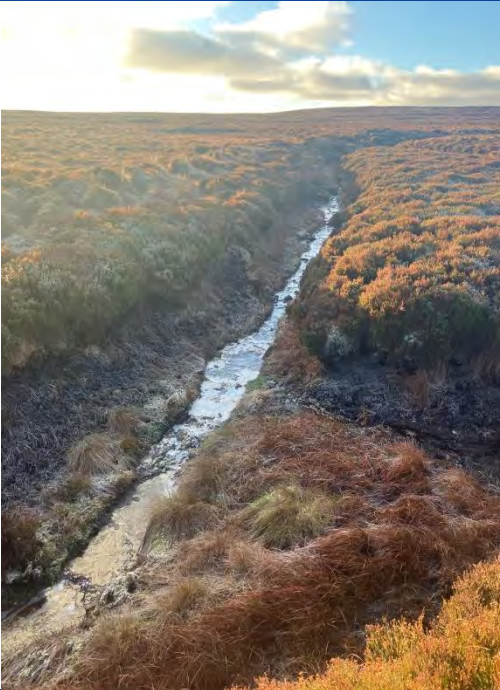
ID	Name	Easting	Northing	Width (m)	Sediment	Slope	Erosion	Crossing Type	Field Notes /Comments	Minor Watercourse (yes/no)	CAR Engineering Authorisation Required (yes/no)	Photo
12	Unnamed tributary of Allt Tarsuinn	313166	929262	0.5	Peat	Gentle	Not observed	Proposed	Depth approximately 0.2 m. Bank side composed of heather and moss.	Yes	No	Not available
13	Unnamed tributary of Allt Tarsuinn	313088	928953	0.3	Peat	Gentle	Not observed	Proposed	Depth approximately 0.1 m. Very slow rate of flow. Low volume of water flow that drains to the Allt Tarsuinn. Bank side composed of heather and moss.	Yes	No

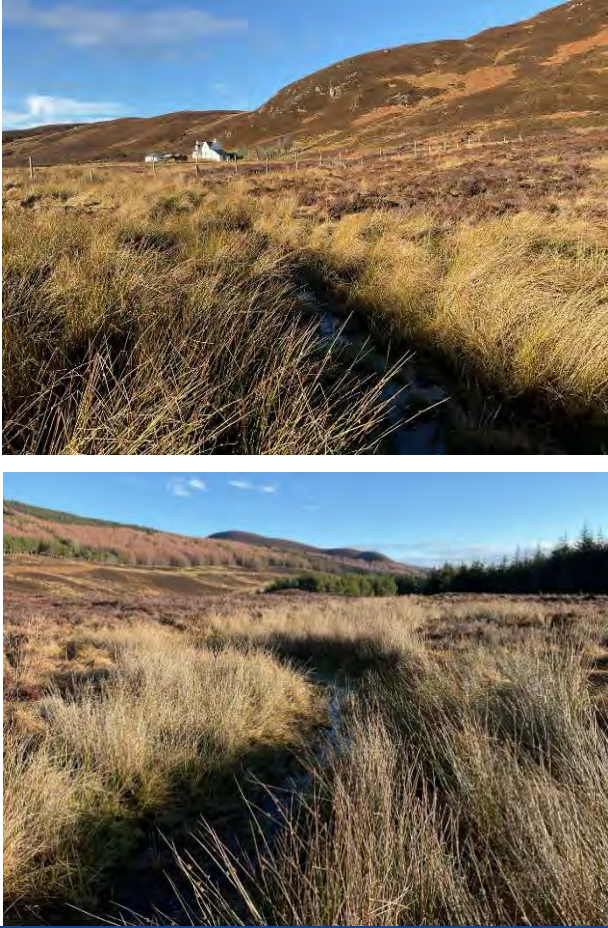
ID	Name	Easting	Northing	Width (m)	Sediment	Slope	Erosion	Crossing Type	Field Notes /Comments	Minor Watercourse (yes/no)	CAR Engineering Authorisation Required (yes/no)	Photo
27	Golspie Burn	278996	904828	0.5	Peat and rock	Gentle	No	Proposed	Fast rate of flow. Depth approximately 0.3 m. Bank side composed of grasses and rushes. Pictures taken upstream from point of watercourse crossing in a safe, accessible area.	No	Yes	<div>

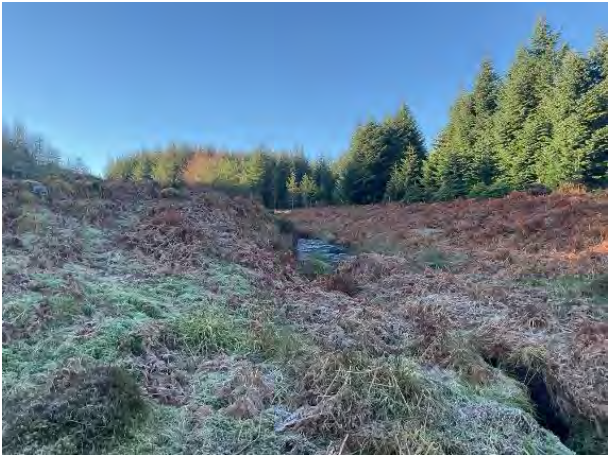
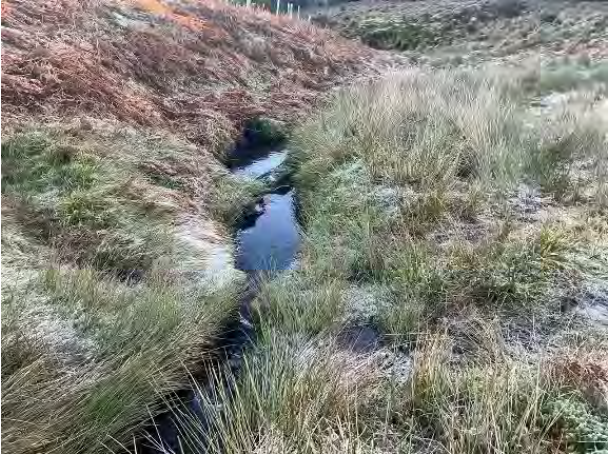
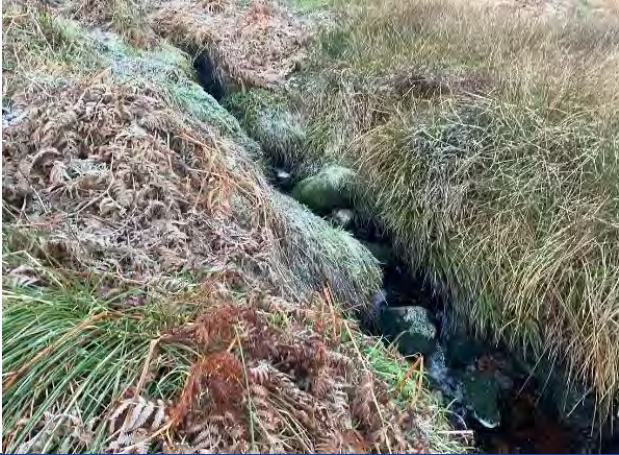
ID	Name	Easting	Northing	Width (m)	Sediment	Slope	Erosion	Crossing Type	Field Notes /Comments	Minor Watercourse (yes/no)	CAR Engineering Authorisation Required (yes/no)	Photo
29	Allt Cnoc na Gamhna	279049	903963	0.5 - 1	Rocks, gravels and boulders	Moderate	Yes – Undercutting banks	Proposed - located where existing track is	Steep undercutting banks 0.5 m. Slow flow apart from at waterfalls. 0.4 m deep. Mud and rock bank composition	No	Yes	<div>

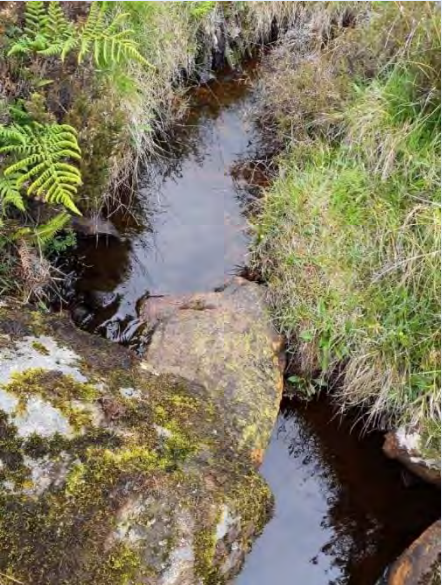
ID	Name	Easting	Northing	Width (m)	Sediment	Slope	Erosion	Crossing Type	Field Notes /Comments	Minor Watercourse (yes/no)	CAR Engineering Authorisation Required (yes/no)	Photo	
30	Allt bad a' Chrasgaidh	275105	901742	0.5	Rock	Gentle	Not observed	Proposed	Heavily vegetated, overhanging grassy bank. Large boulders within channel with sparse mosses. Located adjacent to 30x30 m pond. Average depth of 0.2 m.	No	Yes

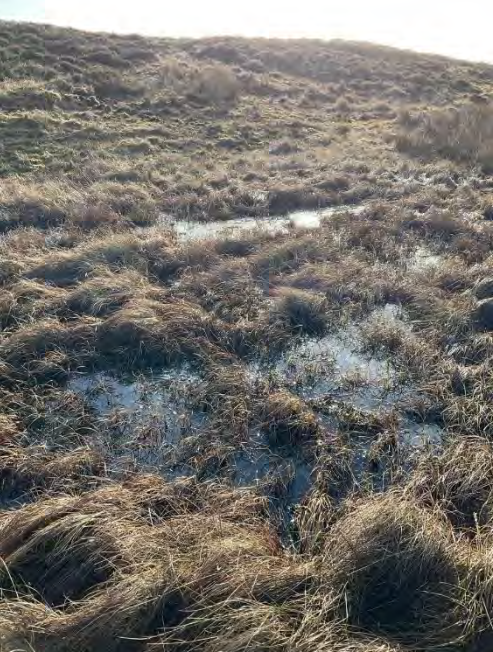
ID	Name	Easting	Northing	Width (m)	Sediment	Slope	Erosion	Crossing Type	Field Notes /Comments	Minor Watercourse (yes/no)	CAR Engineering Authorisation Required (yes/no)	Photo	
48	Unnamed	318174	942997	Not observed	Not observed	Moderate	No	Proposed	No defined channel. Boggy environment. Wetland/flushes .	Yes	No

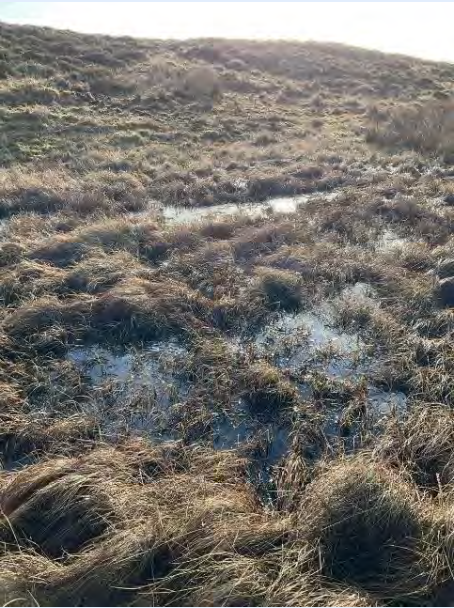
49	Unnamed	318184	942976	Not observed	Peat	Gentle	Moderate	Proposed	Wetland/flushes . No defined channel.	Yes	No

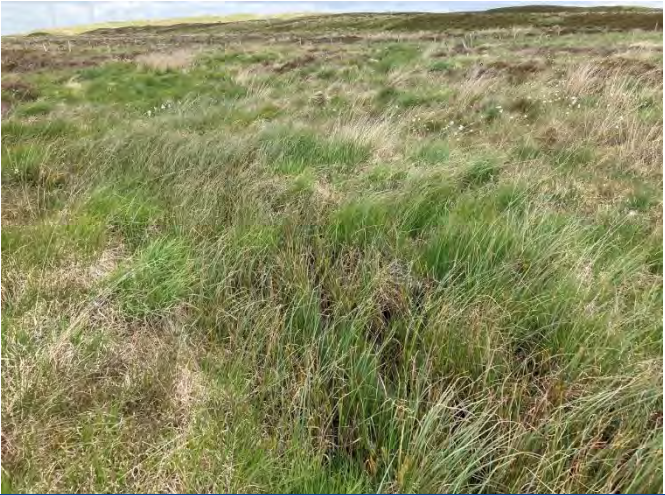
ID	Name	Easting	Northing	Width (m)	Sediment	Slope	Erosion	Crossing Type	Field Notes /Comments	Minor Watercourse (yes/no)	CAR Engineering Authorisation Required (yes/no)	Photo
50	Unnamed Field Drain	318218	942482	0.4	Peat	Gentle	No	Proposed	Very slow rate of flow. Bank side is low and densely vegetated.	Yes	No

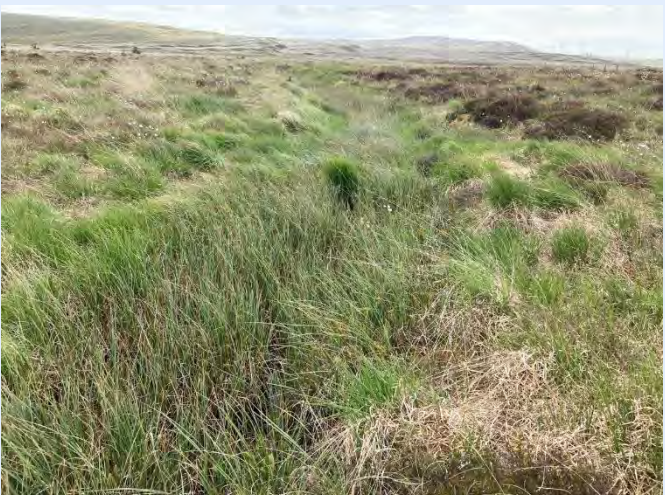
51	Unnamed Field Drain	318222	942463	0.4	Peat	Gentle	Not observed	Proposed	Very slow rate of flow. Bank side is low and densely vegetated.	Yes	No

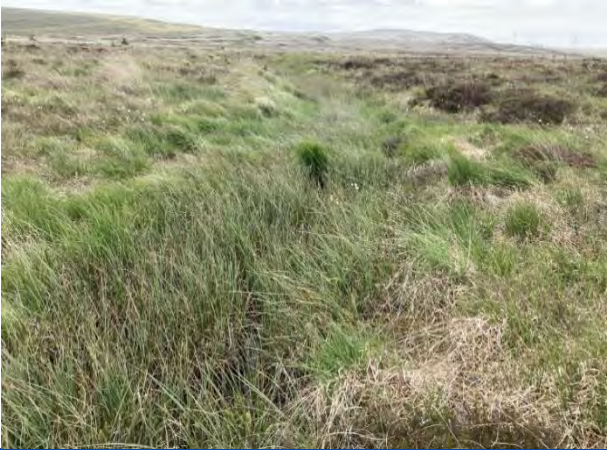
ID	Name	Easting	Northing	Width (m)	Sediment	Slope	Erosion	Crossing Type	Field Notes /Comments	Minor Watercourse (yes/no)	CAR Engineering Authorisation Required (yes/no)	Photo	
52	Unnamed tributary of the Burn of Aultachlevan	318242	942343	0.25-0.4	Peat	Gentle	Not observed	Proposed	Very slow rate of flow. Overhanging grassy banks. Heavily vegetated. Average depth from 0.1 m to 0.25 m.	yes	No

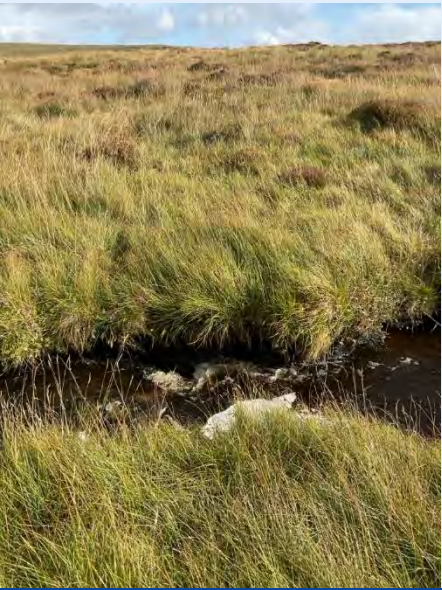
53	Burn of Aultachlevan	318254	942031	1.0-3.0	Gravels and large gravels	Gentle	Not observed	Proposed	Moderate flow with faster/flashy flow in narrow regions. Channel depth up to 0.5 m. Shallow bank with flat floodplain.	No	Yes

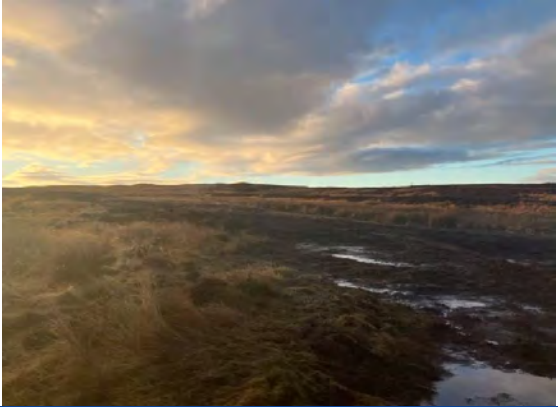
ID	Name	Easting	Northing	Width (m)	Sediment	Slope	Erosion	Crossing Type	Field Notes /Comments	Minor Watercourse (yes/no)	CAR Engineering Authorisation Required (yes/no)	Photo
54	Burn of Lochend	318516	940726	Not observed	Not observed	Gentle	Not observed	Proposed	Slow rate of flow.	No	Yes

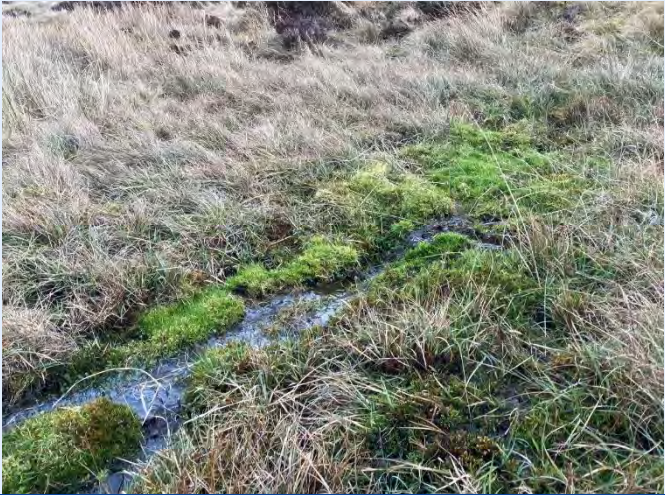
55	Unnamed	318714	938531	Not observed	Not observed	Gentle	No	Proposed	Overland flow. Landscape consisting of moss, rushes and grass.	Yes	No

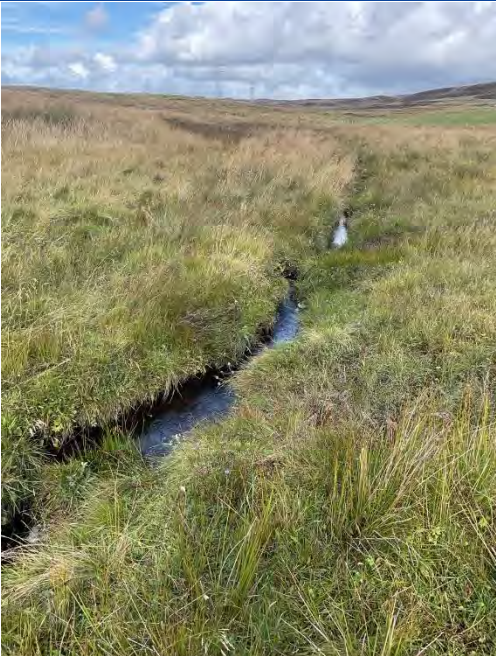
57	Unnamed Field Drain	318055	937410	Not observed	Not observed	Gentle	Not observed	Proposed	Not observed	Yes	No	Not available
58	Burn of Braehungie	318005	937281	0.6-1	Gravel	Gentle	No	Proposed	Moderate rate of flow. Channel depth approximately 0.5 m at max depth and shallower in regions along the watercourse. Bank height approximately 0.2 m.	No	Yes

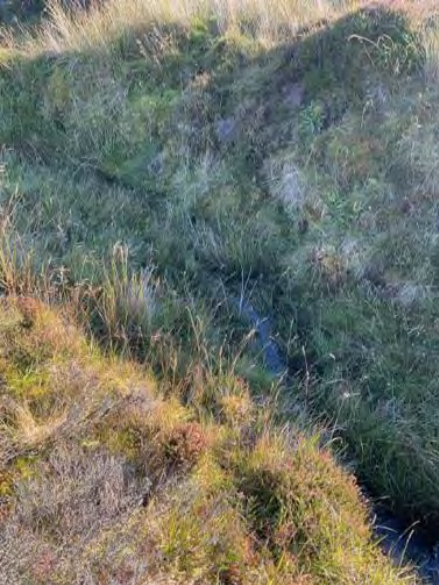
ID	Name	Easting	Northing	Width (m)	Sediment	Slope	Erosion	Crossing Type	Field Notes /Comments	Minor Watercourse (yes/no)	CAR Engineering Authorisation Required (yes/no)	Photo	
60	Unnamed Field Drain	318021	937178	Not observed	Not observed	Gentle	Not observed	Proposed	Not observed	Yes	No	Not available	
61	Unnamed tributary of the Burn of Latheronwheel	317396	936006	0.2-0.3	Mud/silt	Moderate	Not observed	Proposed	Moderate rate of flow. Overgrowing vegetation with very little flowing water. Liable to flooding. Ground highly saturated. Steep channel valley. Evidence of flooding.	No	Yes

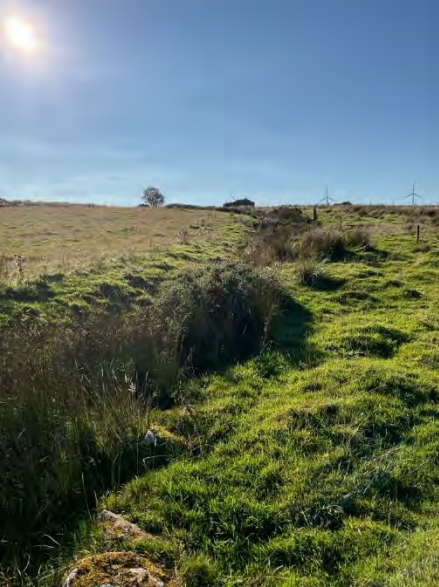
62	Unnamed tributary of the Burn of Latheronwheel	317259	935652	0.3-0.5	Mud/silt	Moderate	Not observed	Proposed	Densely vegetated with stream flowing underneath. Very slow rate of flow. Aquatic plants growing in the channel. Depth 0.1-0.2 m. Bankside dominated by rushes. Evidence of flooding.	No	Yes

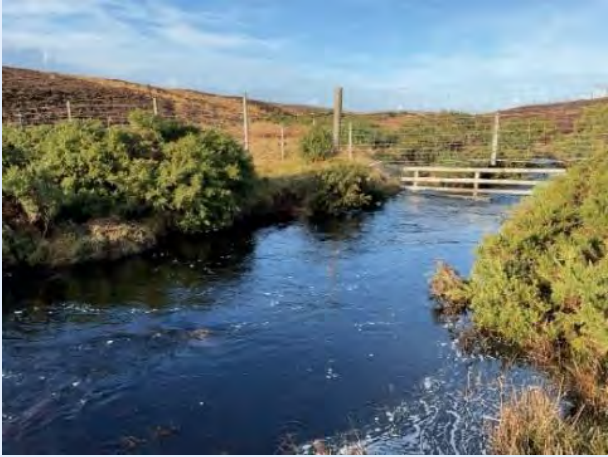
ID	Name	Easting	Northing	Width (m)	Sediment	Slope	Erosion	Crossing Type	Field Notes /Comments	Minor Watercourse (yes/no)	CAR Engineering Authorisation Required (yes/no)	Photo
63	Allt an Learanaich	314516	932033	2 - 3	Rocks and boulders	Gentle	Not observed	Proposed	Photo taken from closest spot due to fencing. Clearer photos taken downstream also included. Fast flowing channel. Unknown depth, unknown bank composition. Bankside composition is shrubs and grasses. Uniform channel.	No	Yes	<div>

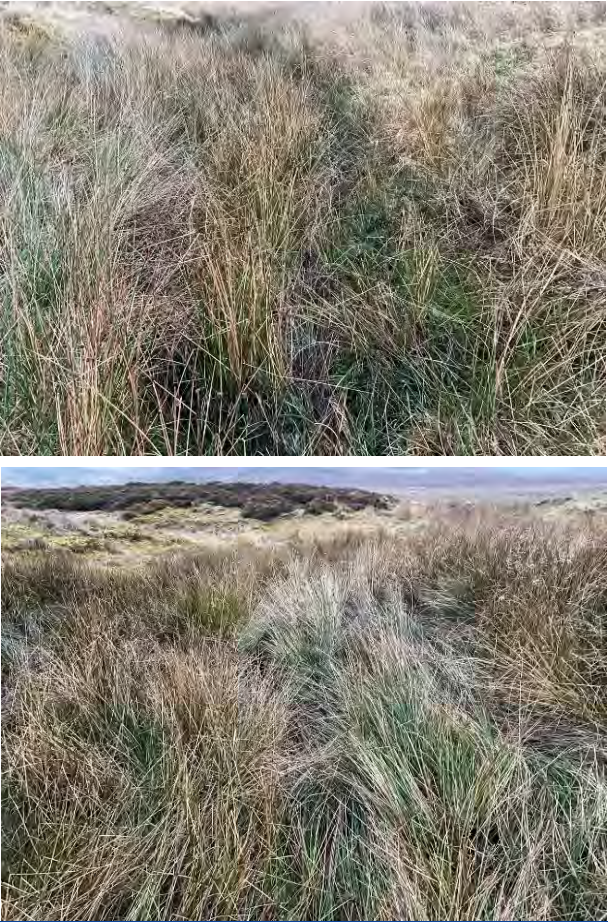
ID	Name	Easting	Northing	Width (m)	Sediment	Slope	Erosion	Crossing Type	Field Notes /Comments	Minor Watercourse (yes/no)	CAR Engineering Authorisation Required (yes/no)	Photo
74	Unnamed tributary of Ousdale Burn	305823	920259	0.5	Mud	Gentle	Not observed	Proposed	Heavily vegetated banks with rushes. Overhanging grassy banks that cover most of channel. Depth 0.2 m. Slow flow. Mud/silt bank composition.	No	Yes

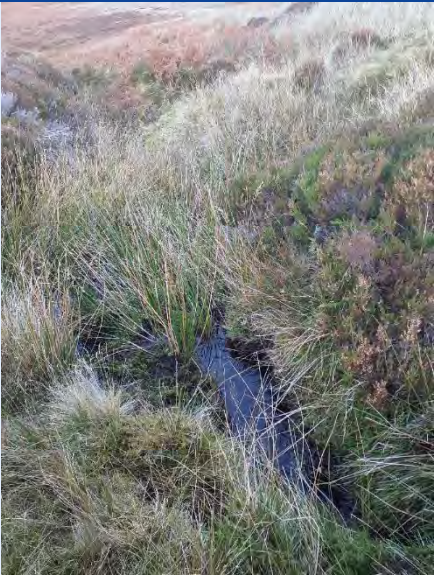
ID	Name	Easting	Northing	Width (m)	Sediment	Slope	Erosion	Crossing Type	Field Notes /Comments	Minor Watercourse (yes/no)	CAR Engineering Authorisation Required (yes/no)	Photo	
87	Unnamed tributary of the River Helmsdale	295579	916445	0.2	Sparse gravel, pebbles, cobbles and boulders.	Steep	Not observed	Proposed	Slow rate of flow. Exposed sections of peat. Depth up to 0.3 m.	No	Yes

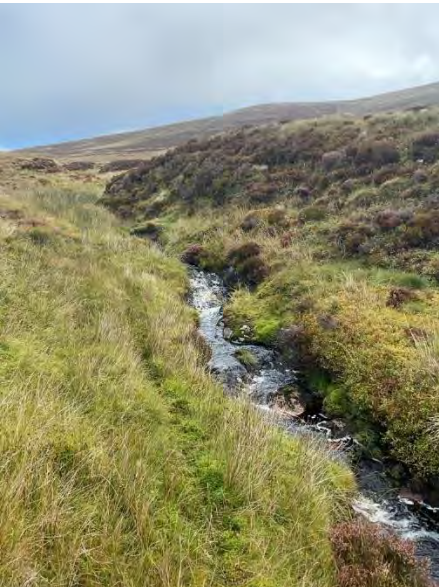
88	Gable Burn	294565	915515	1.0-2.0	Gravels with boulders	Moderate	Bank erosion	Proposed	Fast rate of flow. Depth highly variable up to 0.5 m. Gully in a steep valley. Aquatic plants sparse in channel.	No	Yes

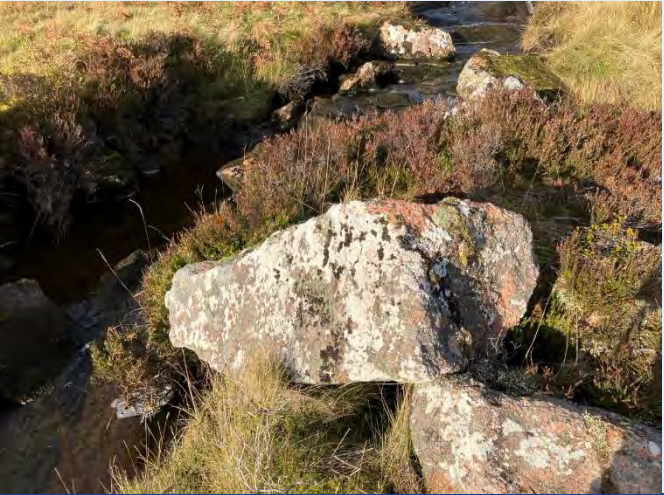
ID	Name	Easting	Northing	Width (m)	Sediment	Slope	Erosion	Crossing Type	Field Notes /Comments	Minor Watercourse (yes/no)	CAR Engineering Authorisation Required (yes/no)	Photo
89	Loth Burn	293898	915501	2	Rock	Gentle	Bank undercutting	Proposed	Moderate rate of flow. Shallow, rocky, heather banks. Average depth of 0.35 m. Narrow and meandering watercourse.	No	Yes

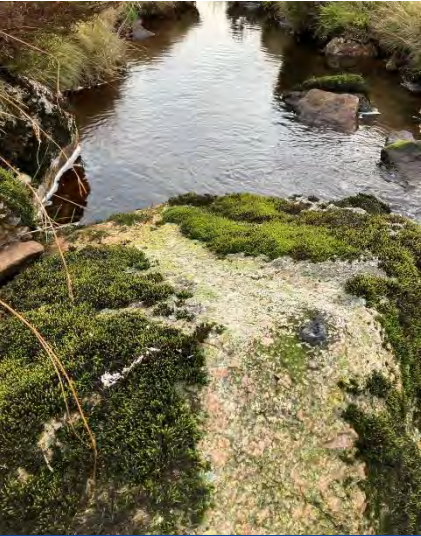
90	Gable Burn	294293	915206	2	Rock	Gentle	No	Proposed	Moderate rate of flow. Variable, rocky and vegetated bank with heather. Average water depth of 0.4 m.	No	Yes

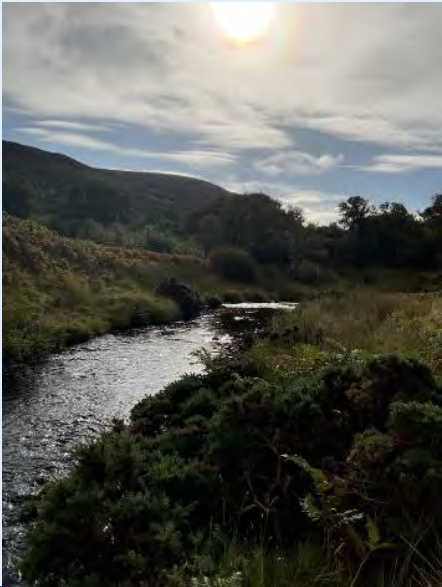
ID	Name	Easting	Northing	Width (m)	Sediment	Slope	Erosion	Crossing Type	Field Notes /Comments	Minor Watercourse (yes/no)	CAR Engineering Authorisation Required (yes/no)	Photo
91	Loth Burn	293500	913570	4	Rock and large boulders	Gentle	Not observed	Proposed	Fast rate of flow. Bank height approximately 0.4 m.	No	Yes

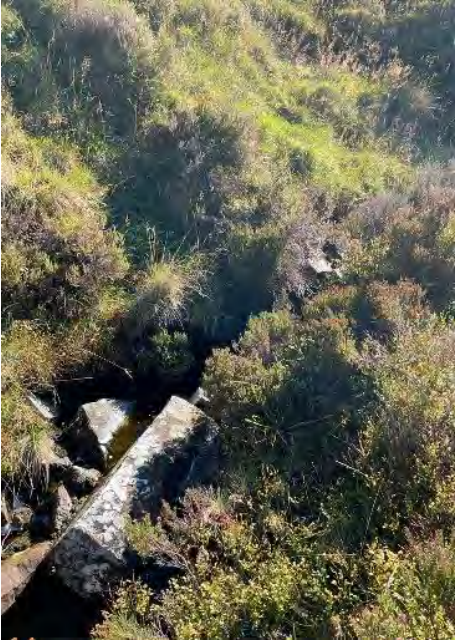
92	Allt a' Bhuic	291912	911855	0.5	Silt and rock	Moderate	Not observed	Proposed	Slow rate of flow. Average depth of 0.25 m. Banks composed of peat and rock.	No	Yes

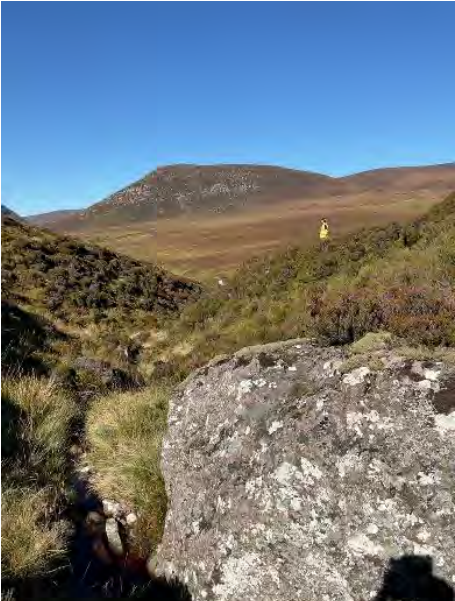
93	Unnamed	288408	908161	0.5-4	Mud/silt	Gentle	Not observed	Proposed	Saturated, boggy wetland with aquatic vegetation i.e. mosses.	No	Yes

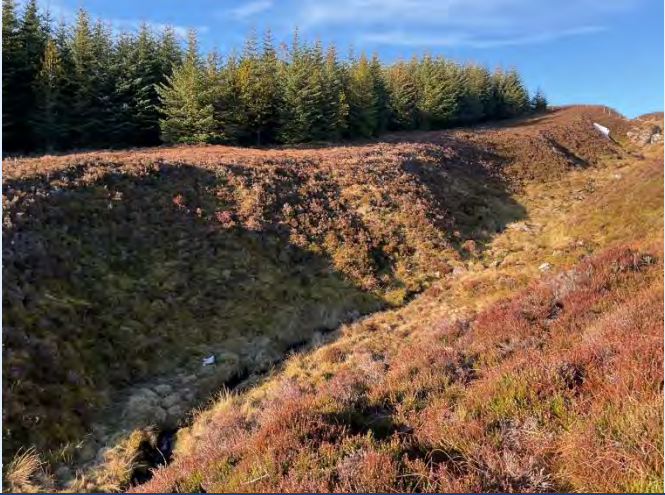
ID	Name	Easting	Northing	Width (m)	Sediment	Slope	Erosion	Crossing Type	Field Notes /Comments	Minor Watercourse (yes/no)	CAR Engineering Authorisation Required (yes/no)	Photo
95	Allt Horn	280149	905169	0.7	Rock	Moderate	Not observed	Proposed	Gully. Narrow, meandering channel with a steep valley. Bank height approximately 0.3 m. Depth approximately 0.2 m. Moderate rate of flow.	No	Yes

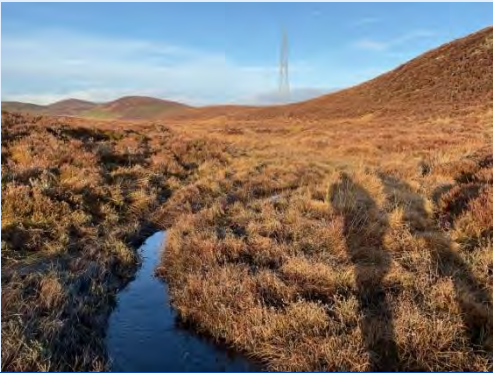
104	Allt na-h-Innse Aonair	272594	899154	2	Rocks and boulders	Gentle	Signs of undercutting banks	Proposed	Photo taken upstream of crossing due to terrain. Fast rate of flow. Large riparian debris in the channel. Bank composition mud and rocks. Bankside composition grasses and trees.	No	Yes

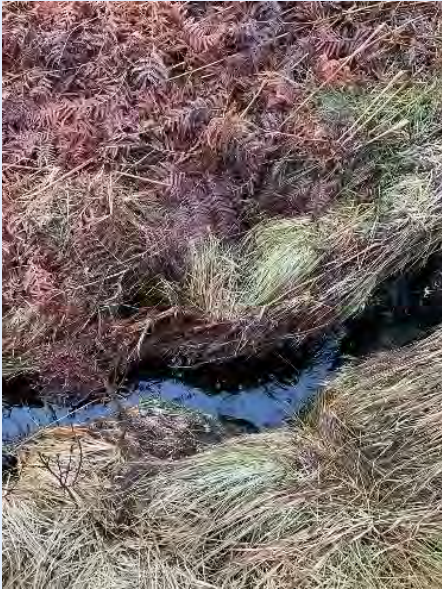
105	Unnamed tributary of Allt na-h Innse Aonair	272371	898947	0.3	Gravels, rocks and boulders	Moderate	Signs of undercutting banks	Proposed	Moderate flow. Depth 0.3 m. Bank height 0.3 m. Bankside composed of grasses and shrubs.	Yes	No

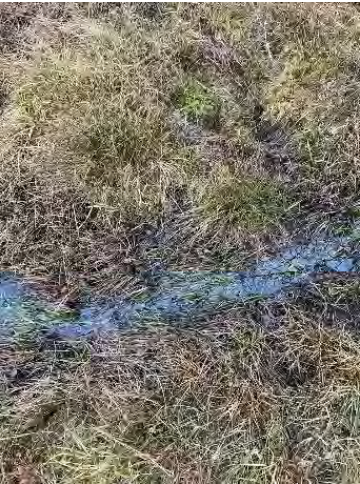
106	Unnamed tributary of Abhainn an t-Stratha Charnaig	272224	898554	No clear defined channel	Mud	Gentle	Not observed	Proposed	No clearly defined channel. Slow to zero flow. Plant debris in watercourse. Ground highly saturated.	No	Yes

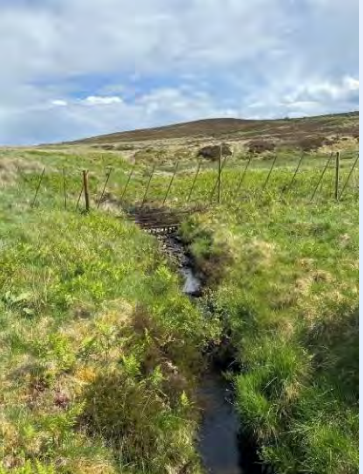
107	Allt Lochan Maolanaidh	271659	898176	0.4	Peat	Gentle	Not observed	Proposed	Fast rate of flow, average depth of 0.2 m. Photo taken downstream.	No	Yes

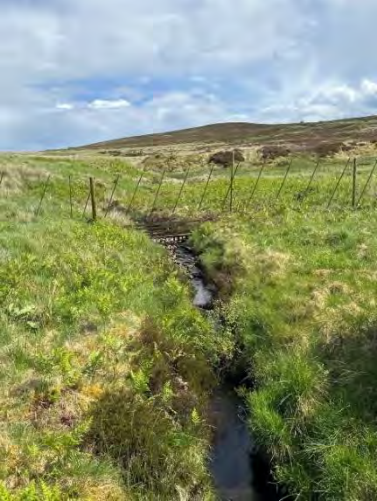
108	Garskelly Burn	271568	898147	1	Rocks	Gentle	Not observed	Proposed	Moderate flow. Grassy banks with ferns. Average depth of 0.4 m. Photo taken downstream.	No	Yes

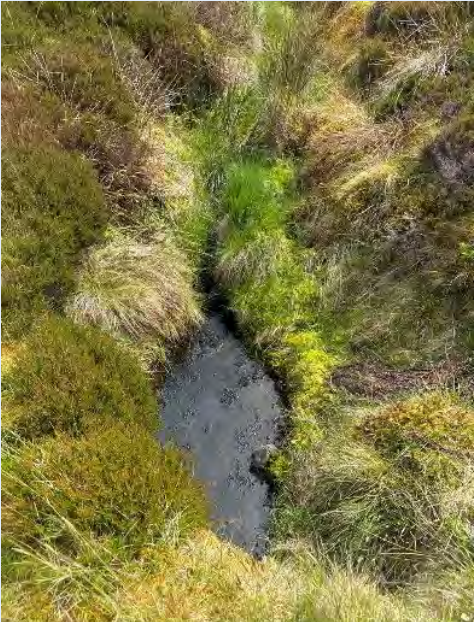
ID	Name	Easting	Northing	Width (m)	Sediment	Slope	Erosion	Crossing Type	Field Notes /Comments	Minor Watercourse (yes/no)	CAR Engineering Authorisation Required (yes/no)	Photo
109	Unnamed tributary of Abhainn an t-Stratha Charnaig	271326	898156	0.5	Mud	Gentle	Not observed	Proposed	Low flow/present watercourse. 1 m high valley. Vegetated channel.	No	Yes

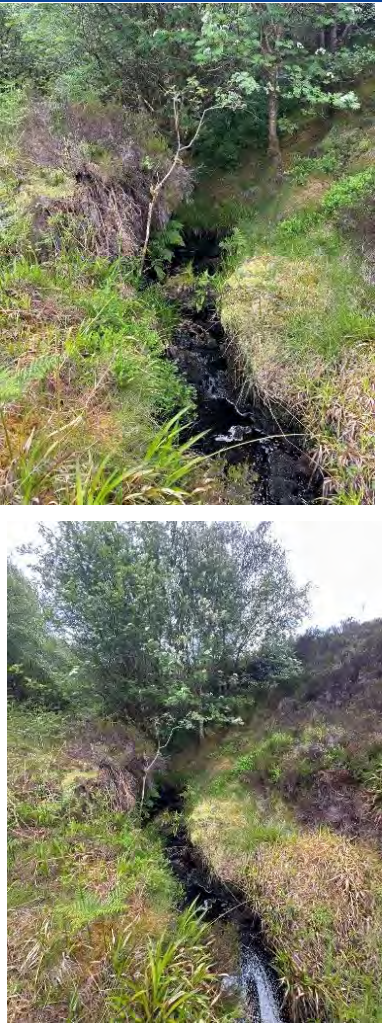
113	Alltan Riabhach	267398	898046	Not defined channel	Mud	Gentle	Not observed	Proposed	Photo taken downstream of point. No defined channel upstream of road. Defined channel after road.	No	yes

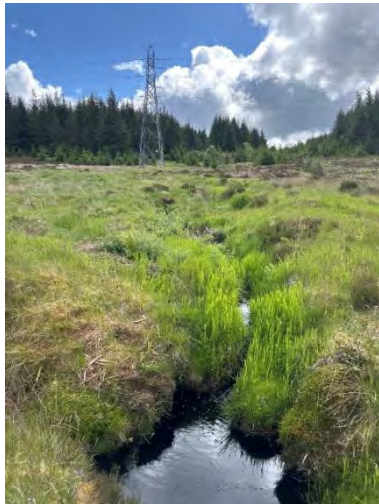
116	Alt Clach-bhuaile	266958	898000	0.3	Peat and rocks	Gentle	Not observed	Proposed	Slow to moderate rate of flow. Bank side composition consisting of grasses, rushes and sparse bracken. Average depth of 0.5 m.	No	Yes

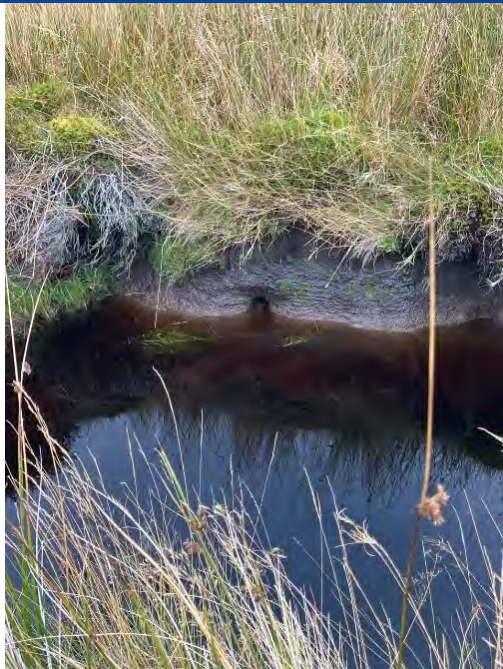
ID	Name	Easting	Northing	Width (m)	Sediment	Slope	Erosion	Crossing Type	Field Notes/ Comments	Minor Watercourse (yes/no)	CAR Engineering Authorisation Required (yes/no)	Photo	
121	Allt Srath nan Seasgach	255613	888135	1	Peat	Gentle	Not observed	Proposed	River. Slow rate of flow. Average water depth: 0.5 m. Exposed peat banks with grasses and rushes.	No	Yes

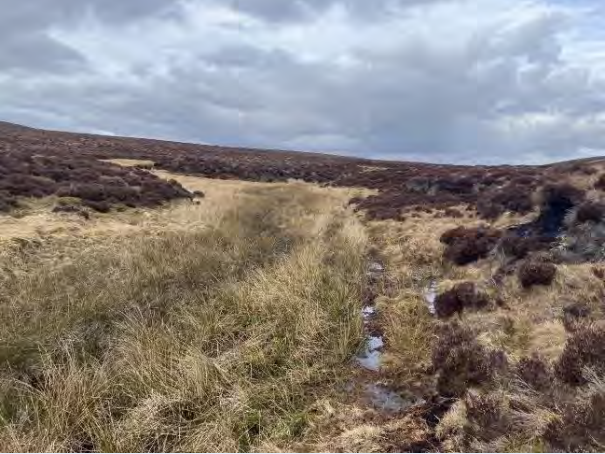
ID	Name	Easting	Northing	Width (m)	Sediment	Slope	Erosion	Crossing Type	Field Notes/ Comments	Minor Watercourse (yes/no)	CAR Engineering Authorisation Required (yes/no)	Photo	
126	Unnamed tributary of Allt a' Choire Dhuibh	256486	881181	0	Mud	Gentle	Not observed	Proposed	Overland flow perpendicular to the Alt a' Choire Dhuibh.	Yes	No

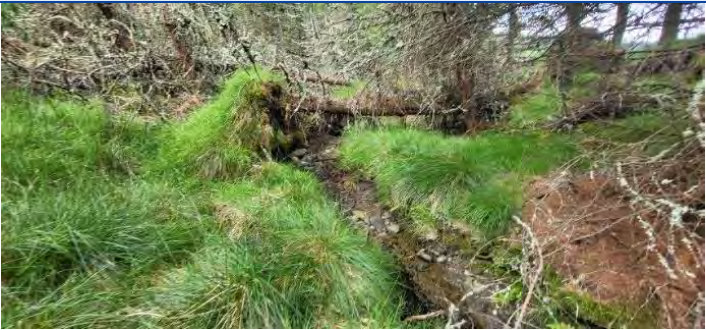
131	Unnamed	253570	864623	0.3	Mud and gravel	Moderate	Bank erosion	Proposed	Vegetation detritus present and large trees toppled onto channel. Ravine/steep banks in areas.	No	Yes

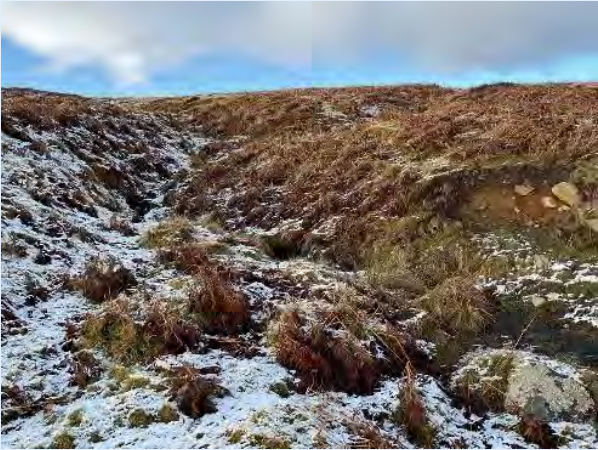
132	Unnamed tributary of River Sgitheach	253141	864370	0.2	Mud and rock	Moderate	Not observed	Proposed	Areas of overland flow with parts that are more channelised. Channel is 0.2 m deep. Slow flow. Bankside composition is grasses. Sheep bucket in water.	Yes	No

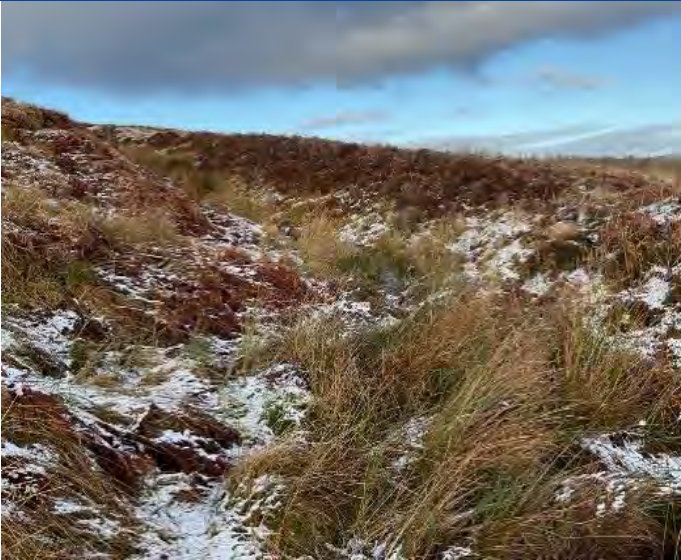
133	Unnamed tributary of River Sgitheach	253030	864291	Not clear channel	Mud	Moderate	Not observed	Proposed	No clear channel, wet underfoot. Some signs of flow but mostly no flow. Within 3 m gully. Grasses on side and covered by pools of water.	Yes	No

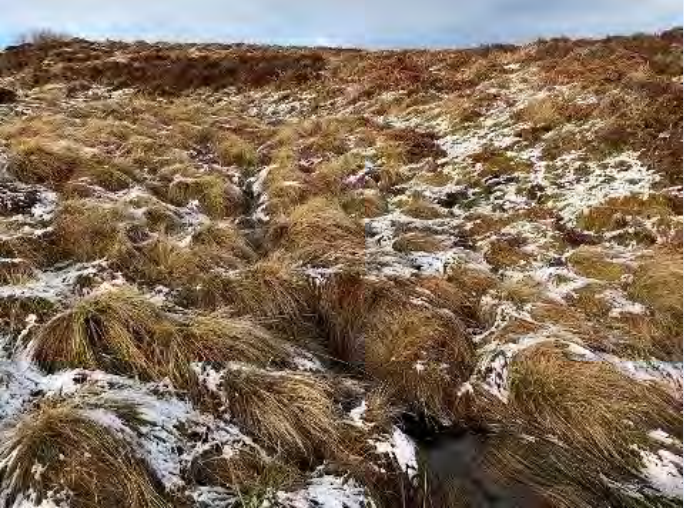
ID	Name	Easting	Northing	Width (m)	Sediment	Slope	Erosion	Crossing Type	Field Notes/ Comments	Minor Watercourse (yes/no)	CAR Engineering Authorisation Required (yes/no)	Photo	
134	Unnamed tributary of River Sgitheach	252904	864211	0.2	Mud	Moderate	Not observed	Proposed	Surface flow that goes sub surface for a short distance and then returns. Slow flow.	Yes	No

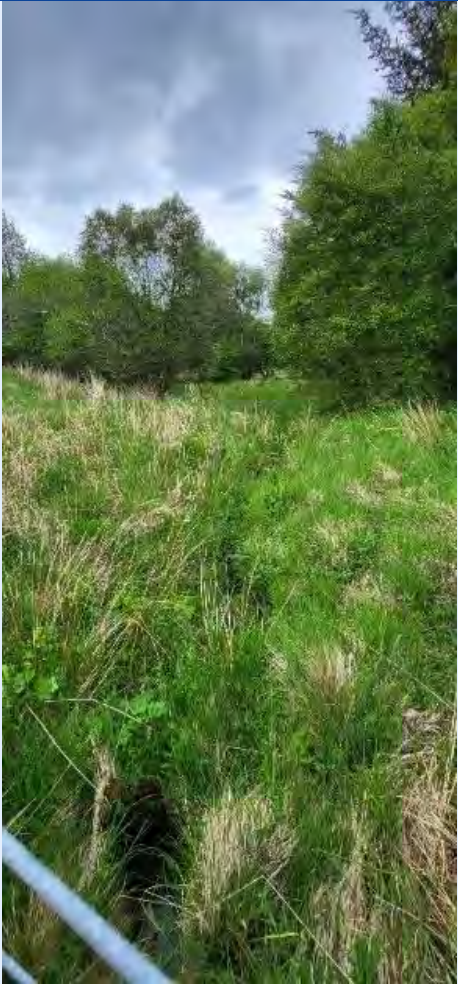
ID	Name	Easting	Northing	Width (m)	Sediment	Slope	Erosion	Crossing Type	Field Notes/ Comments	Minor Watercourse (yes/no)	CAR Engineering Authorisation Required (yes/no)	Photo		
136	Unnamed tributary of River Sgitheach	252816	864158	<0.1-0.5	Mud/silt	Gentle	Not observed	Proposed	Submerged channel by overhanging grassy banks.	No	Yes

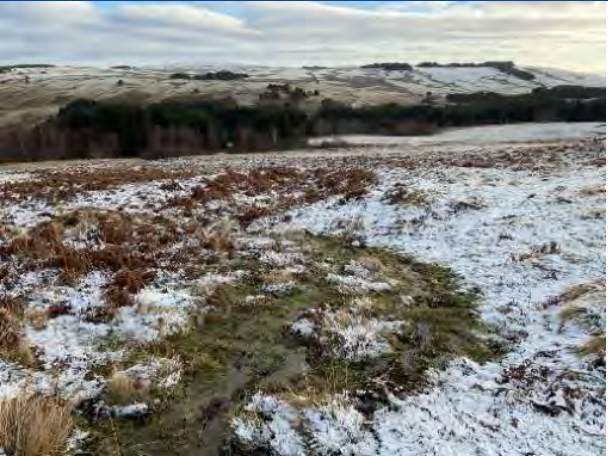
137	Unnamed tributary of River Sgitheach	252633	864048	Not clear channel	Mud	Gentle/ moderate	Not observed	Proposed	Overland flow. Gentle to moderate slope. Slow to no flow. No clearly defined channel. Pooling in some areas.	Yes	No

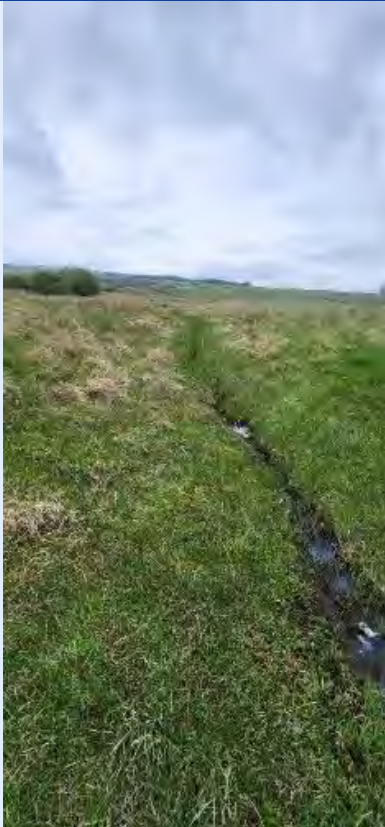
138	Unnamed Overland Flow Path	252571	864010	0.1-0.4	Mud with boulders	Gentle	Not observed	Proposed	Overland flow. Slightly submerged watercourse. Moderate flow rate with a low water level. Overhanging banks.	no	yes

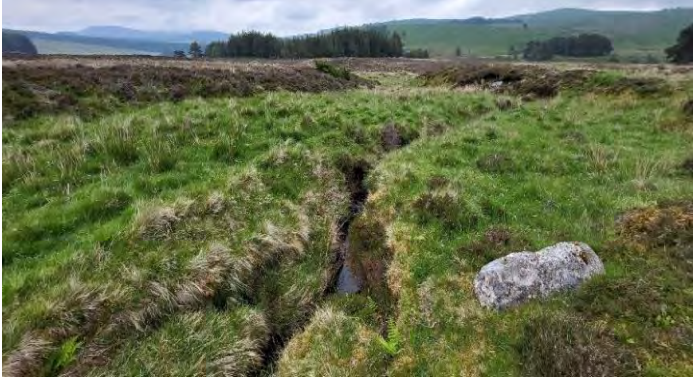
ID	Name	Easting	Northing	Width (m)	Sediment	Slope	Erosion	Crossing Type	Field Notes/ Comments	Minor Watercourse (yes/no)	CAR Engineering Authorisation Required (yes/no)	Photo	
143	Unnamed tributary of River Sgitheach	251856	863540	0.1-0.5	Gravel with large boulders	Gentle	Bank erosion	Proposed	Very slow, low-level flow, width and depth vary and undulate.	No	Yes

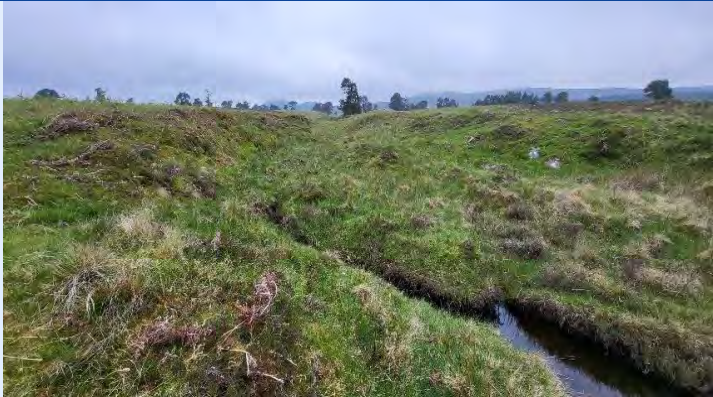
144	Allt na Criche	251472	863311	0.3-0.7	Gravel with small boulders	Gentle	Not observed	Proposed - perpendicular to existing track	Low flow, narrow channel that deepens towards river ford. Upstream banks slightly overhung.	No	Yes

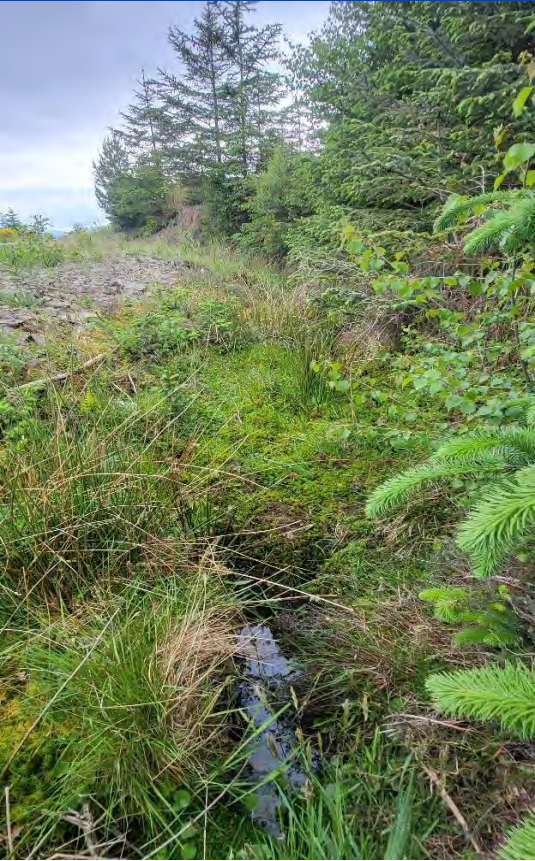
ID	Name	Easting	Northing	Width (m)	Sediment	Slope	Erosion	Crossing Type	Field Notes/ Comments	Minor Watercourse (yes/no)	CAR Engineering Authorisation Required (yes/no)	Photo	
155	Unnamed tributary of Peffery Burn	247429	860680	0.4	Mud/silt	Moderate	Not observed	Proposed	Slow rate of flow. Bank Side Composition: vegetated with brambles and debris. Average water depth: 0.15 m. Survey point taken upstream in the only safe, accessible area.	No	Yes
