**Spittal to Loch Buidhe to Beauly 400 kV
OHL Connection
Environmental Impact Assessment
Volume 5 | Technical Appendix**

**Appendix 10.1 | Schedule of
Watercourse Crossings**

VOLUME 5: APPENDIX 10.1 – SCHEDULE OF WATERCOURSE CROSSINGS

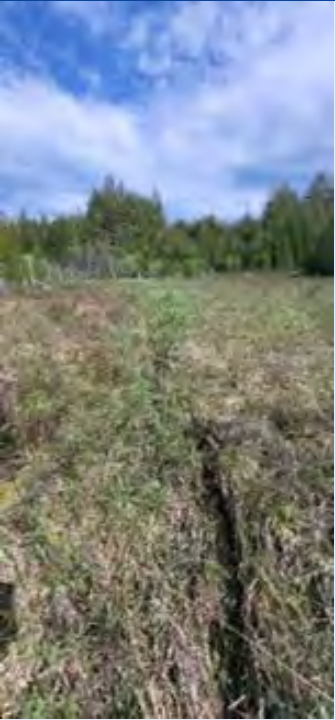
ID	Name	Easting	Northing	Width (m)	Sediment	Slope	Erosion	Crossing Type	Field Notes/ Comments	Minor Watercourse (yes/no)	CAR Engineering Authorisation Required (yes/no)	Photo		
158	Unnamed Overland Flow Path	246324	858572	0.1-0.3	Mud	Gentle	Not observed	Proposed	Overland flow path. Slow flow, shallow narrow channel - depth max 0.1 m. Grassy banks. Shallow marshy conditions.	Yes	No

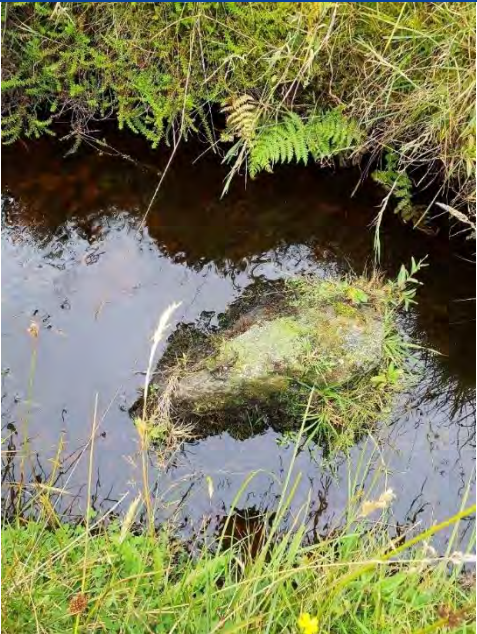
159	Allt Loch nam Bonnach	248229	848509	0.5	Rock	Gentle	Not observed	Proposed	River. Fast rate of flow. Average water depth: 0.2 m. Bankside: Heather, Rock and peat.	No	Yes

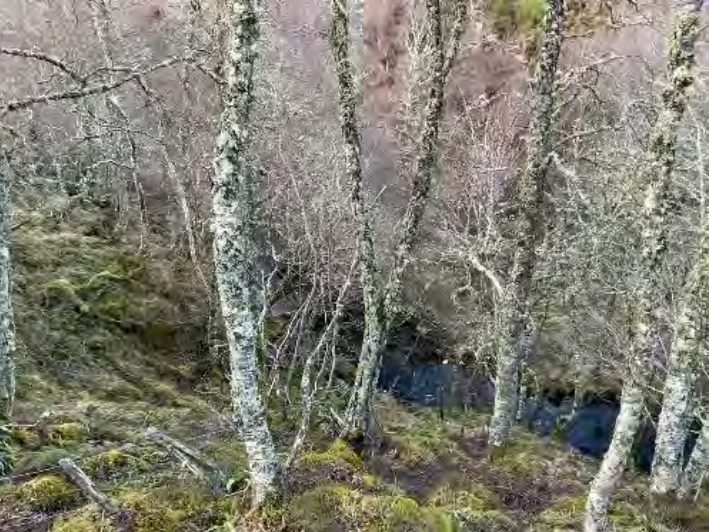
ID	Name	Easting	Northing	Width (m)	Sediment	Slope	Erosion	Crossing Type	Field Notes/ Comments	Minor Watercourse (yes/no)	CAR Engineering Authorisation Required (yes/no)	Photo	
164	Breakachy Burn	245223	845260	2	Gravel, pebbles and rocks and boulders	Moderate	Not observed	Proposed	Main River. Moderate rate of flow. Bank side composition: Grass, bog myrtle and moss. Small fish species visible.	No	Yes

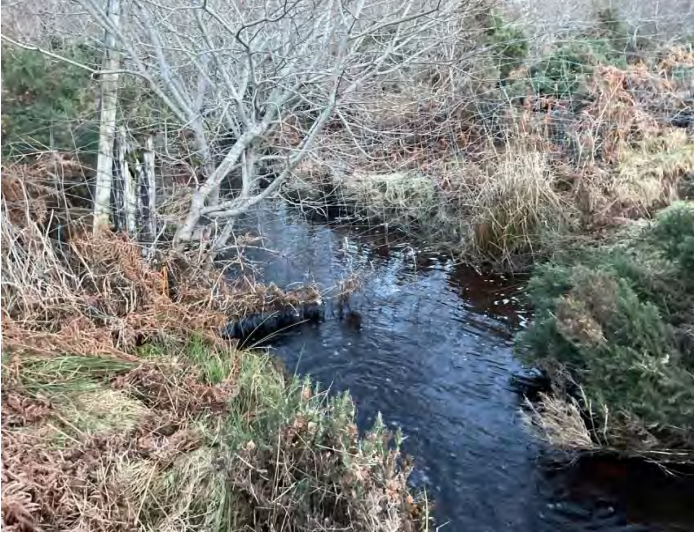
165	Allt na h-Athain	245323	843852	1.5	Gravels, rocks and boulders	Moderate	Bank erosion	Proposed	Fast rate of flow. Depth approximately 0.3 m. Rocky channel with steep sides. Bank side composed of rock, heather, gorse and bog myrtle.	No	Yes

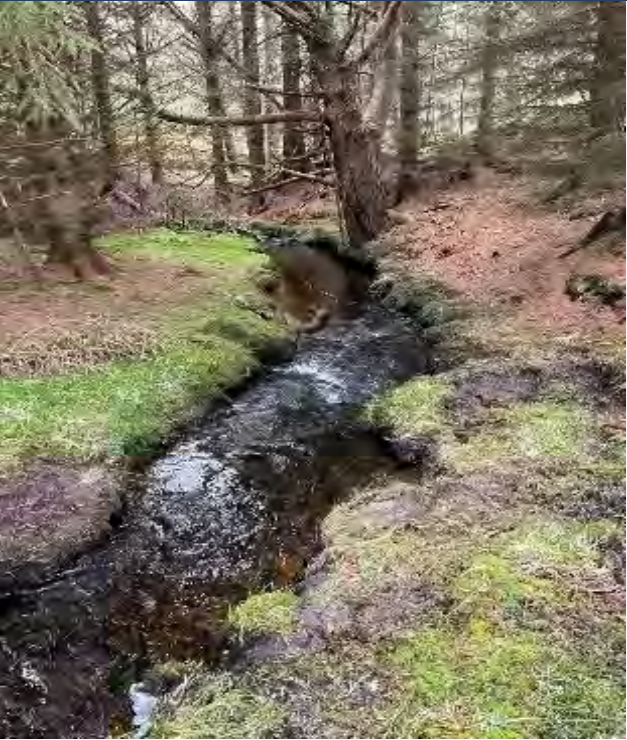
ID	Name	Easting	Northing	Width (m)	Sediment	Slope	Erosion	Crossing Type	Field Notes/ Comments	Minor Watercourse (yes/no)	CAR Engineering Authorisation Required (yes/no)	Photo	
173	Allt na Ghlinne	255965	869053	0.3-0.7	Rock and boulders	Gentle	Signs of erosion downstream of survey point.	Proposed	Moderate rate of flow. Bank composed of mud and rocks. Both sides of river fenced off.	No	Yes

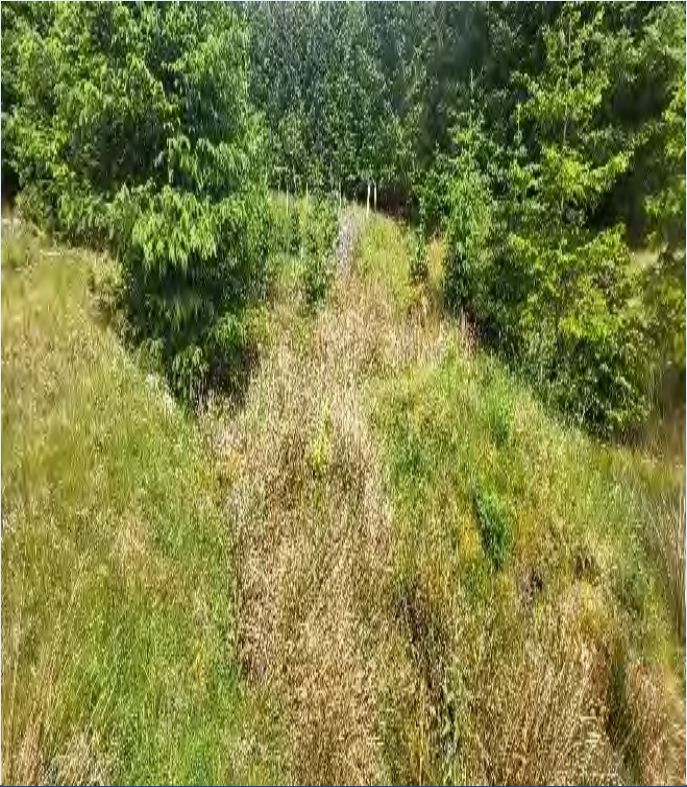
174	Unnamed tributary of the River Sgitheach	254447	865240	Not defined channel	Mud	Gentle	Not observed	Proposed	No water present 100 m upstream.	No	Yes
