# **Strathy Wood Wind Farm Grid Connection Additional Information Peatland Condition Assessment Report**

**June 2025**

## **Peatland Condition Assessment Report**

### **SSEN Transmission**

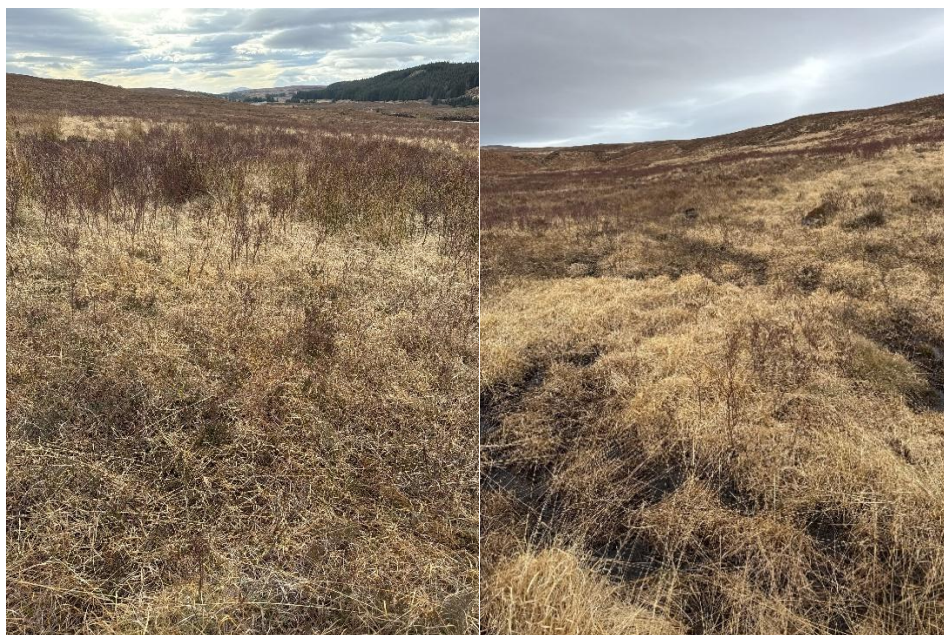
**Photo 2 – Dominant *Molinia caerulea* and *Myrica gale* at Towers 10 (left photo) and 6 (right photo)**

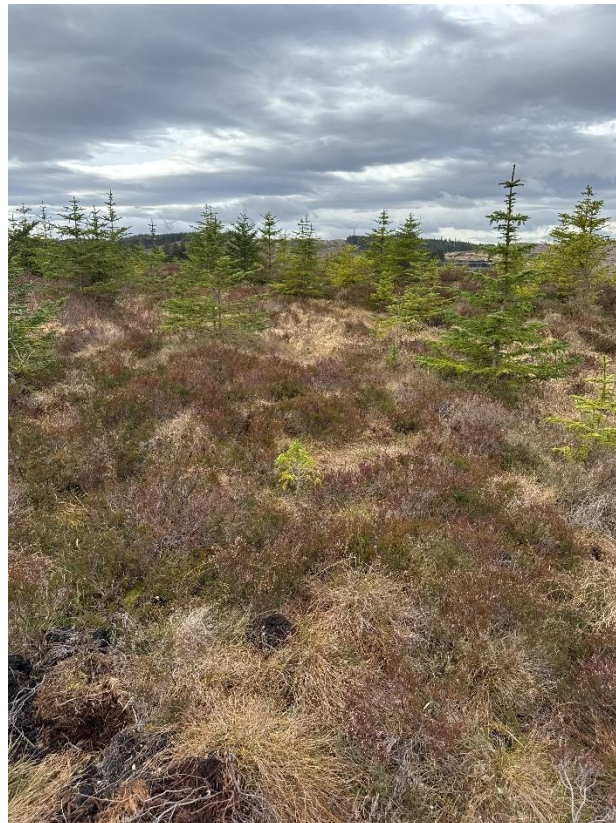
Forested areas comprise Sitka Spruce and Lodgepole Pine with limited under canopy cover. Within felled forestry and adjacent to the forestry areas of conifer regeneration, colonisation of open peat areas is observed. This is particularly notable close to Towers 2 to 4 and at Tower 18 (**Photo 3**).

**Photo 3 - Conifer Colonisation at Tower 18**
