Strathy South Wind Farm Grid Connection

Volume 4: Appendix V1-9.1: Peat Landslide Hazard and Risk Assessment

SSEN Transmission

SLR Consulting Limited

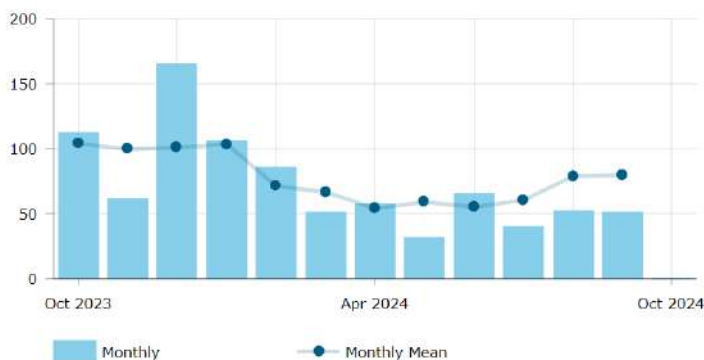
Figure 1: Monthly Rainfall totals in mm from Strathly Bridge Station

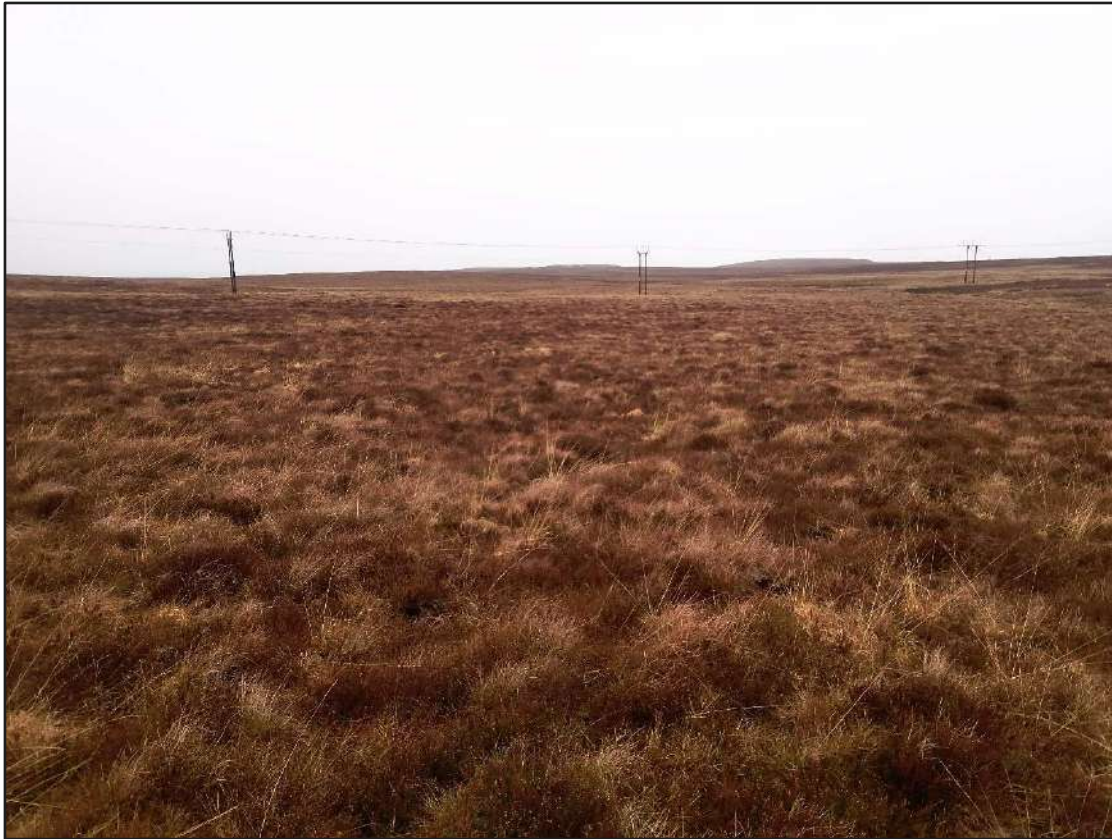
Photo 1: Area of deeper peat up to 2.5m recorded at Tower 35, looking north. National Grid Reference (NGR): NC 85433 62804

No areas of instability relating to peat deposits was observed across the Proposed Alignment.

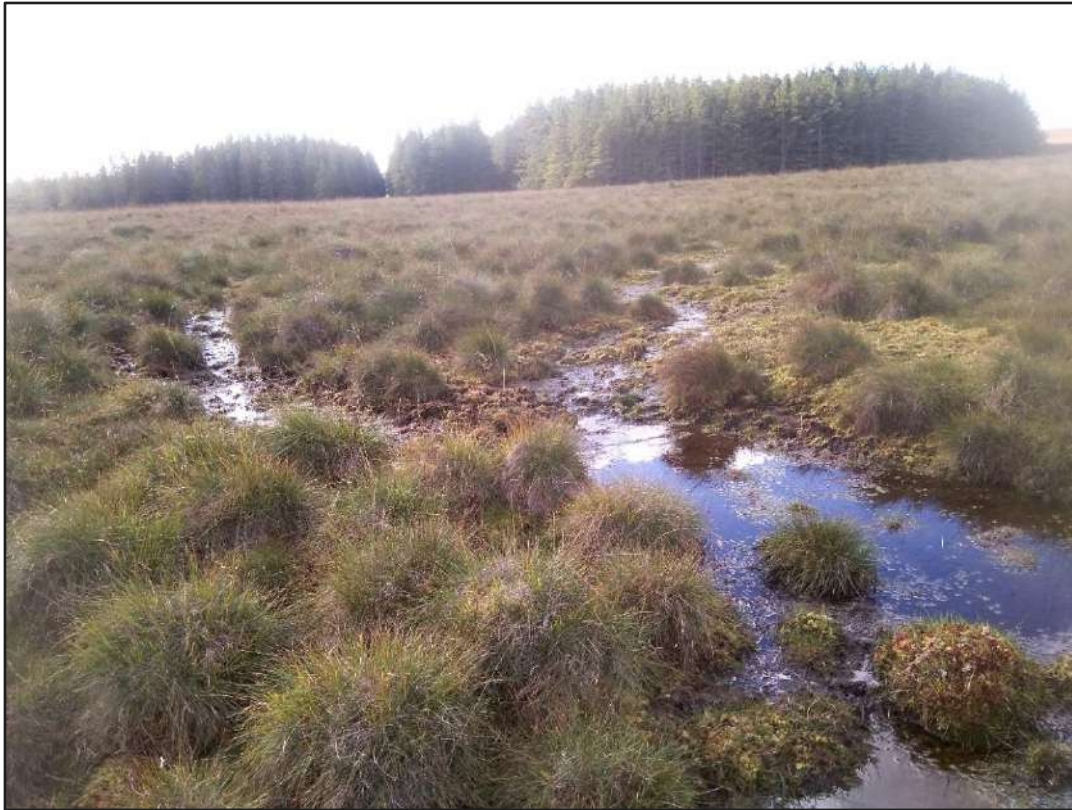
Photo 2: Area of bare peat and resulting dendritic drainage at Tower 49. NGR: NC 88139 61838.

From review of aerial photography, there are localised areas of bare peat across the Proposed Alignment, predominantly in the south-east areas near Tower 49 as shown by **Photo 2**. The erosion across this location was generally associated with the network of drainage in this area. No areas of instability relating to peat erosion was observed across the Proposed Alignment.

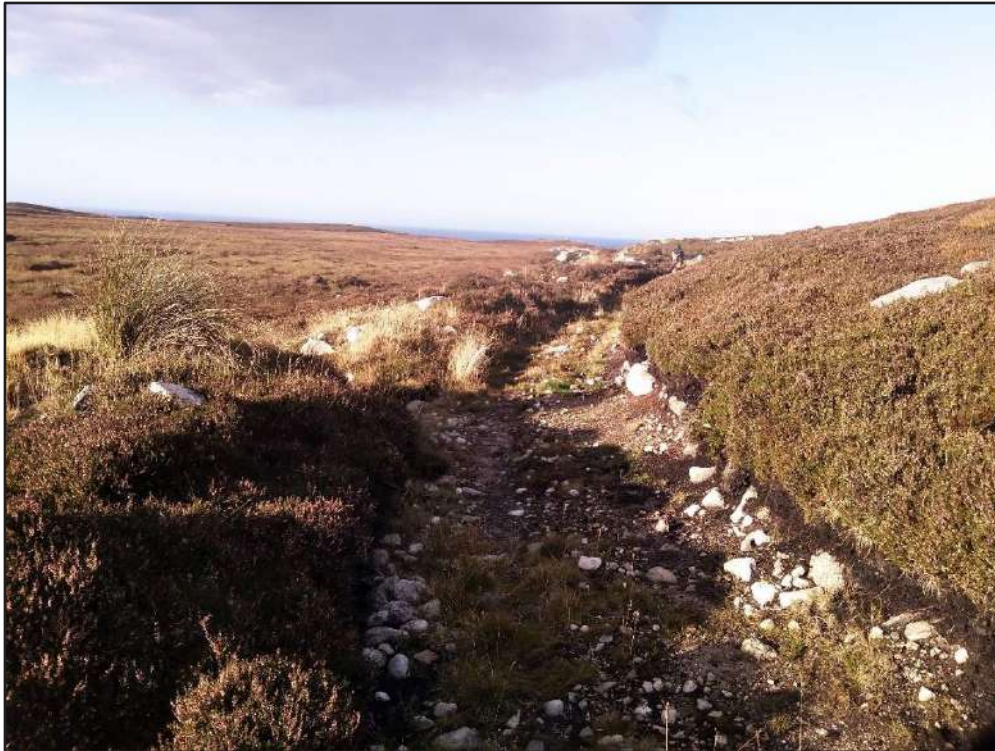
Photo 3: Artificial drainage ditch trending east to west at access track south of Cnoc a'Choire Mhor. NGR: NC 87732 63486.

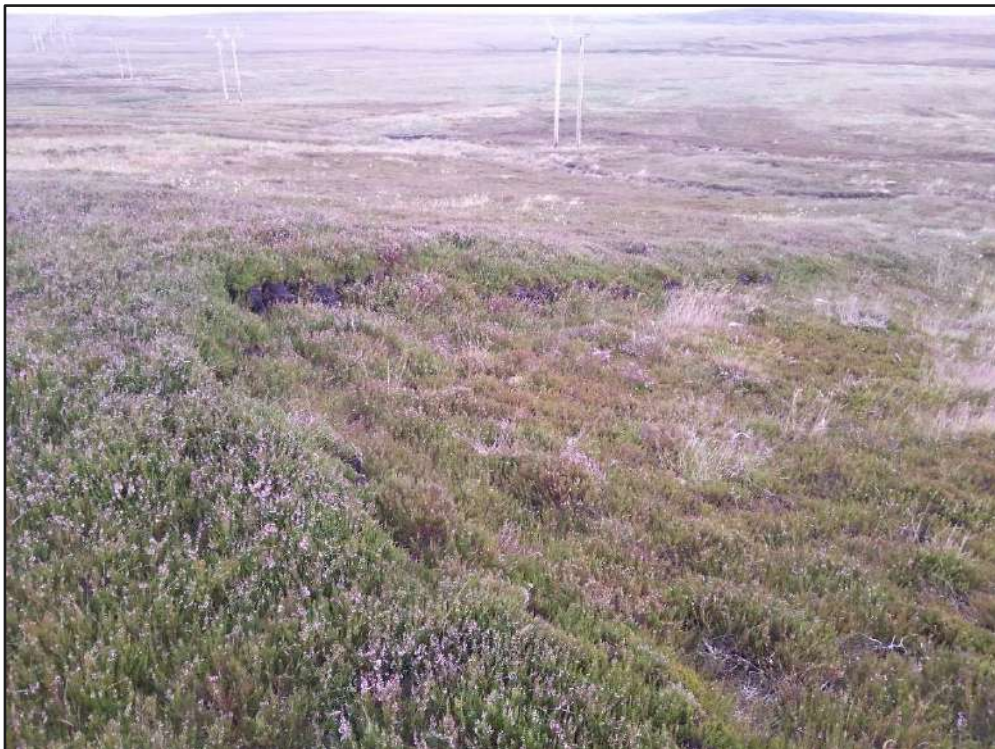
Photo 4: Peat cuttings near Towers 36 and 37, looking north. NGR: NC 86075 63030.

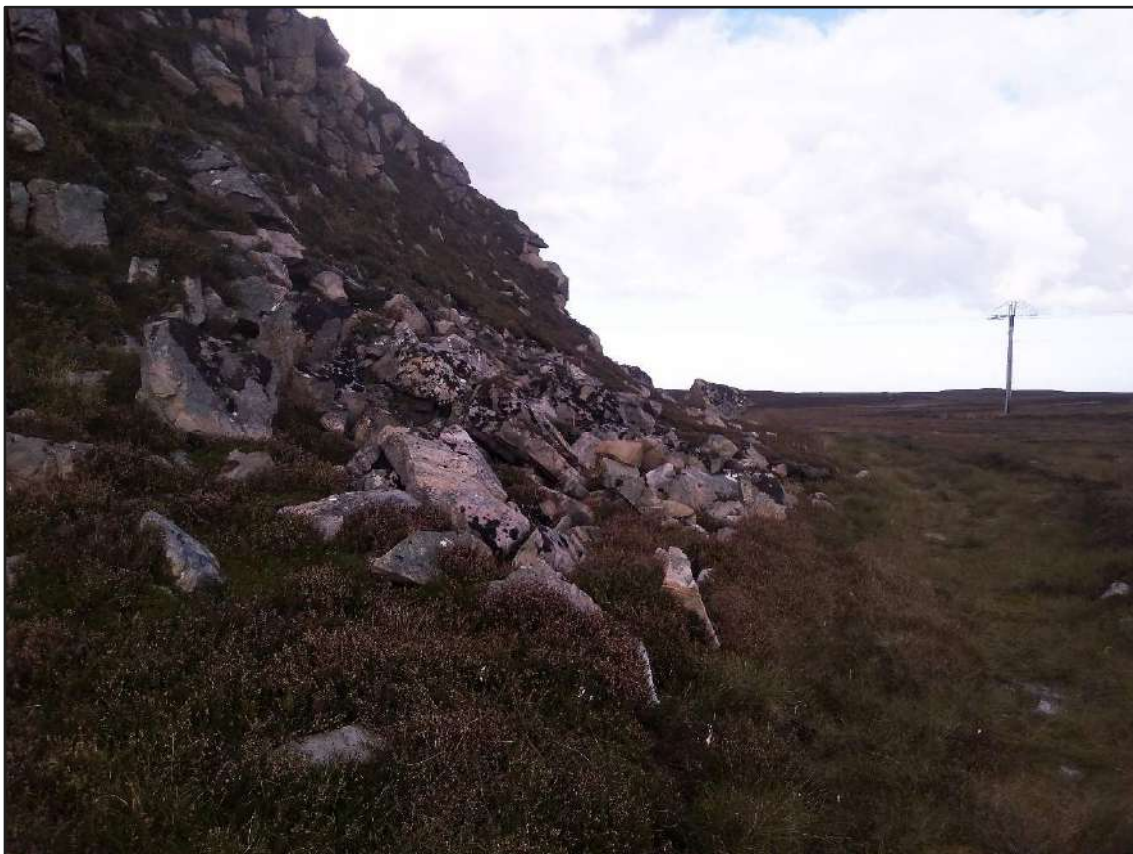
Photo 5: Bedrock outcrop of Psammite near Tower 41 at Creagan Reamhar, looking north-west. NGR: NC 87003 63168.

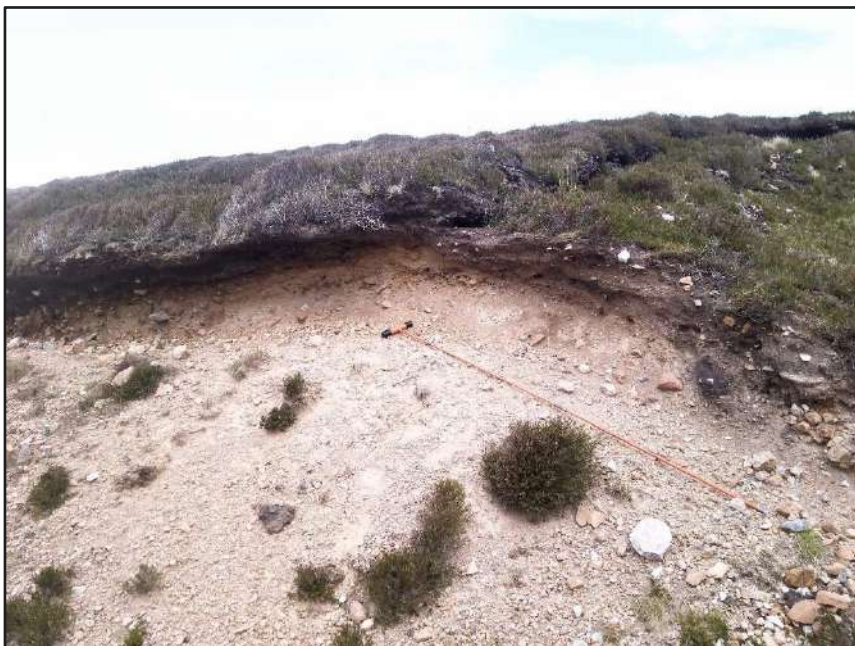
Photo 6: Road cutting displaying granular substrate at existing access track (to be upgraded) near Cnoc Eadar Dha Allt looking east. NGR: NC 86658 64682.

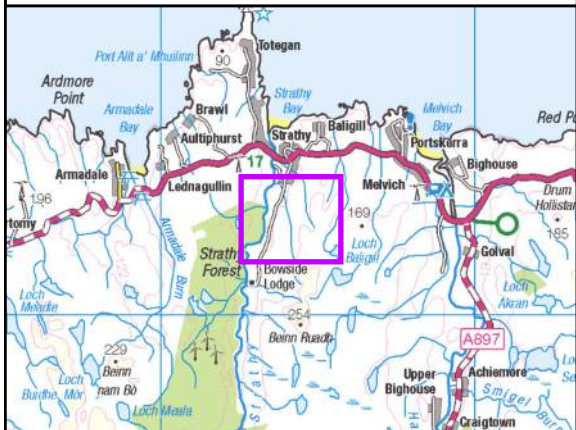
Superficial Geology

- Alluvium - Clay, Silt, Sand And Gravel
- Glaciofluvial Deposits - Gravel, Sand And Silt
- Hummocky (moundy) Glacial Deposits - Sand, Gravel And Boulders
- Peat - Peat
- Bedrock at or Near Surface

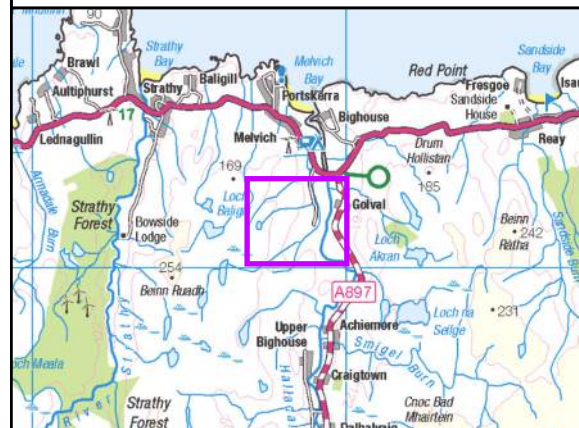
- Legend**
- Proposed Steel Lattice Tower
 - Proposed OHL Alignment
 - Limit of Deviation (OHL)
 - Existing Access Track (to be upgraded)
 - Proposed Permanent Access Track
 - Proposed Temporary Access Track
 - Limit of Deviation (Access Tracks)
 - Existing Wood Pole (H pole) (to be dismantled)
 - Existing 132kV OHL (to be dismantled)
 - Existing Wood Pole (H pole) (to be retained)
 - Existing 132kV OHL (to be retained)
- Superficial Geology**
- Alluvial Fan Deposits - Sand, Gravel And Boulders
 - Alluvium - Clay, Silt, Sand And Gravel
 - Glaciofluvial Deposits - Gravel, Sand And Silt
 - Glaciofluvial Ice Contact Deposits - Gravel, Sand, Silt And Clay
 - Glaciofluvial Sheet Deposits - Gravel, Sand And Silt
 - Hummocky (moundy) Glacial Deposits - Sand, Gravel And Boulders
 - Peat - Peat
 - River Terrace Deposits - Gravel, Sand And Silt
 - Bedrock at or Near Surface
