Strathy South Wind Farm Grid Connection

Volume 4: Appendix V1-9.4: Detailed Peatland Condition Assessment

SSEN Transmission

SLR Consulting Limited

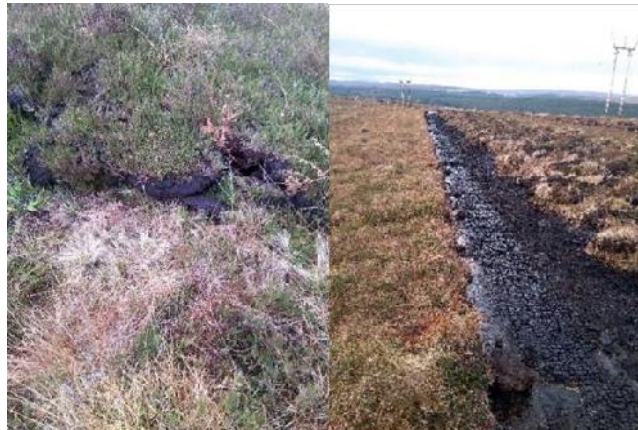
Plate 3 - Hydrophobic and Charred Peat at edge of Peat Banks near Tower 30

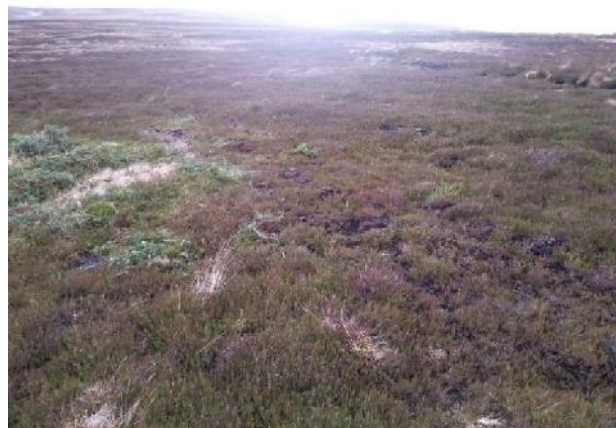
Plate 4 - Colonisation of charred peat by *Calluna vulgaris* at base of peat cutting near Tower 47

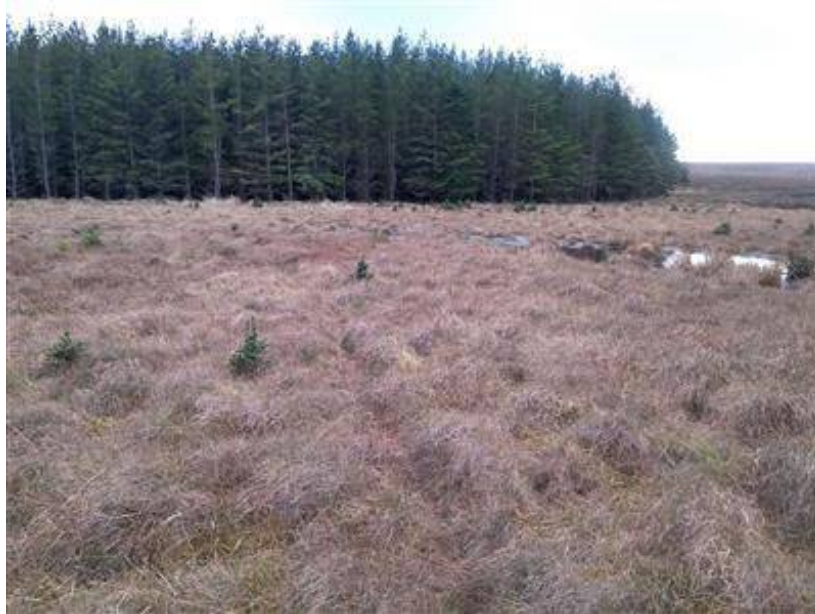
this drying effect will promote further colonisation of open areas of peatland unless action is taken to increase water tables.

Plate 6 - Plantation Forestry adjacent to Tower 49 including minor conifer colonisation of open peatland

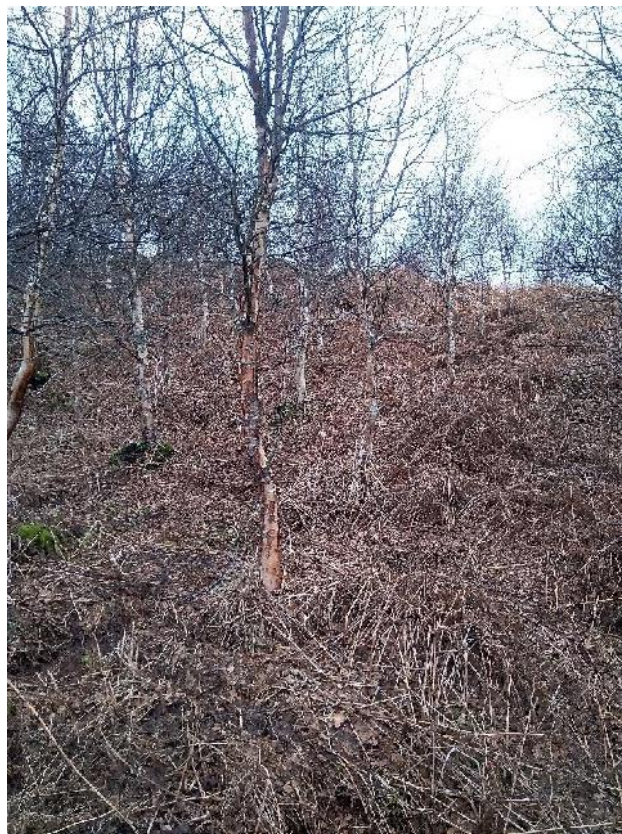
Native forestry (**Plate 7** and **Annex B: Figure V1-9.4.2 - Erosion and Landuse Features**) can be found close to Towers 51, 54, 58, 59, with only the woodland at Tower 54 being located on peat. Planting in this area has generally used mounding where trees are raised above the water table with an adjacent open borrow pit forming a pool leading to discontinuous drainage. Further drainage is applied in the form of narrow hill drainage although not at the density observed within commercial forestry.

Overall native and plantation forestry is likely to have a negative impact on peatland condition where present on peat due to the presence of drainage and vascular plants reducing water tables and the potential for conifer encroachment onto currently open areas of peatland.

Plate 7 - Native Forestry using mounding and pit techniques on organic rich soils causing drainage near Tower 51

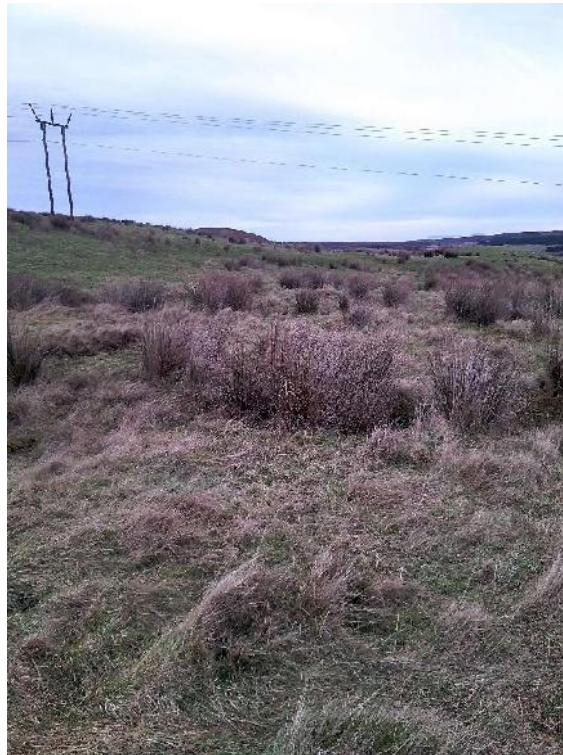
Grazing evidence by sheep is present across the Proposed Alignment primarily as evidence of footprints, scats and actual sightings. Where present evidence of scrabbling and puddling is frequent especially where feeders are placed. In areas with higher sheep densities, *Molinia* tussocks and grazed heather predominate replacing peatland and heath species. Whilst it is likely that sheep numbers have reduced over time across the Proposed Alignment, livestock continue have to have a negative impact on peatland condition

Plate 9 - Improved Pasture in western part of Proposed Alignment adjacent to T50
