Strathy South Wind Farm Grid Connection

Volume 4: Appendix V5-7.1: Peat Landslide Hazard and Risk Assessment – Alternative Alignment

SLR Consulting Limited

5 February 2025

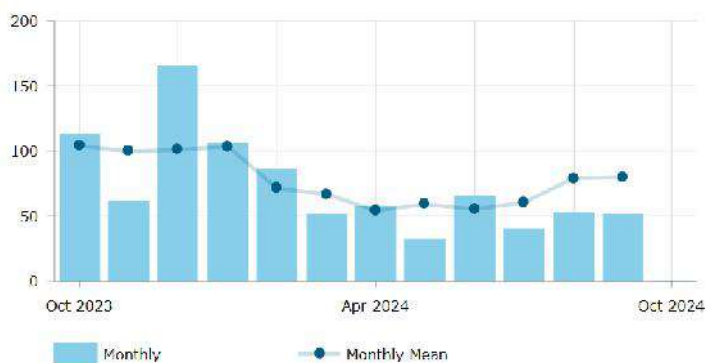
Figure 1: Monthly Rainfall totals in mm from Strathly Bridge Station

Periods of intense heavy rainfall are often seen as triggers for instability events. Rainfall data from the closest SEPA weather station¹⁸ at Strathly Bridge (station number 234319), located approximately 860 m to the north of the Alternative Alignment, shows the monthly rainfall in the region from October 2023 until October 2024. The highest monthly rainfall was 165.6 mm in December 2023.

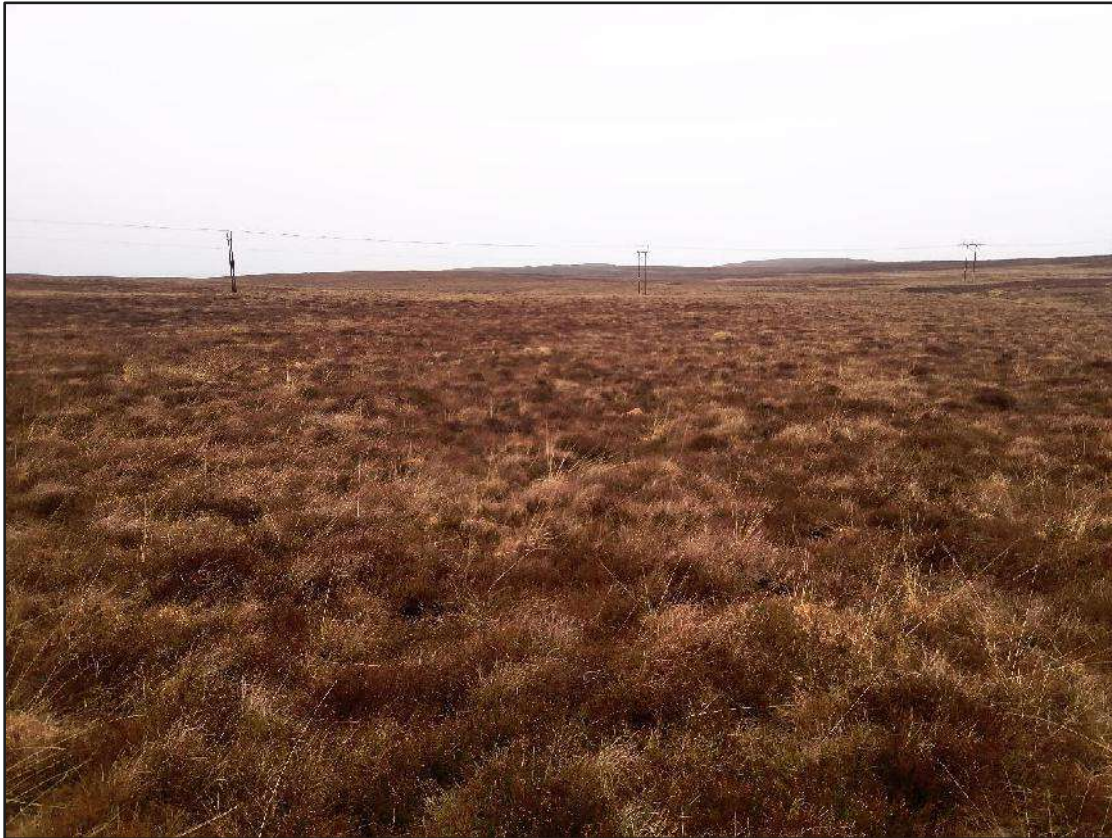
Photo 1: Area of deeper peat up to 2.5m, looking north. National Grid Reference (NGR): NC 85433 62804

Within the central areas of the Alternative Alignment, deep peat of up to 2 m was recorded within the area of Towers A1 to A9, with most peat depths ranging from 1 to 1.5 m. Typical peat deposits observed in the central area of the OHL alignment are shown by **Photo 1**. Towards the eastern extends of the Alternative Alignment peat depths of over 2 m were recorded at Towers A20 and A24 as these towers are within flatter expanses. Towers 47, 48 and 49 are also positioned within flatter expanses and peat depths up to 3 m were mapped.

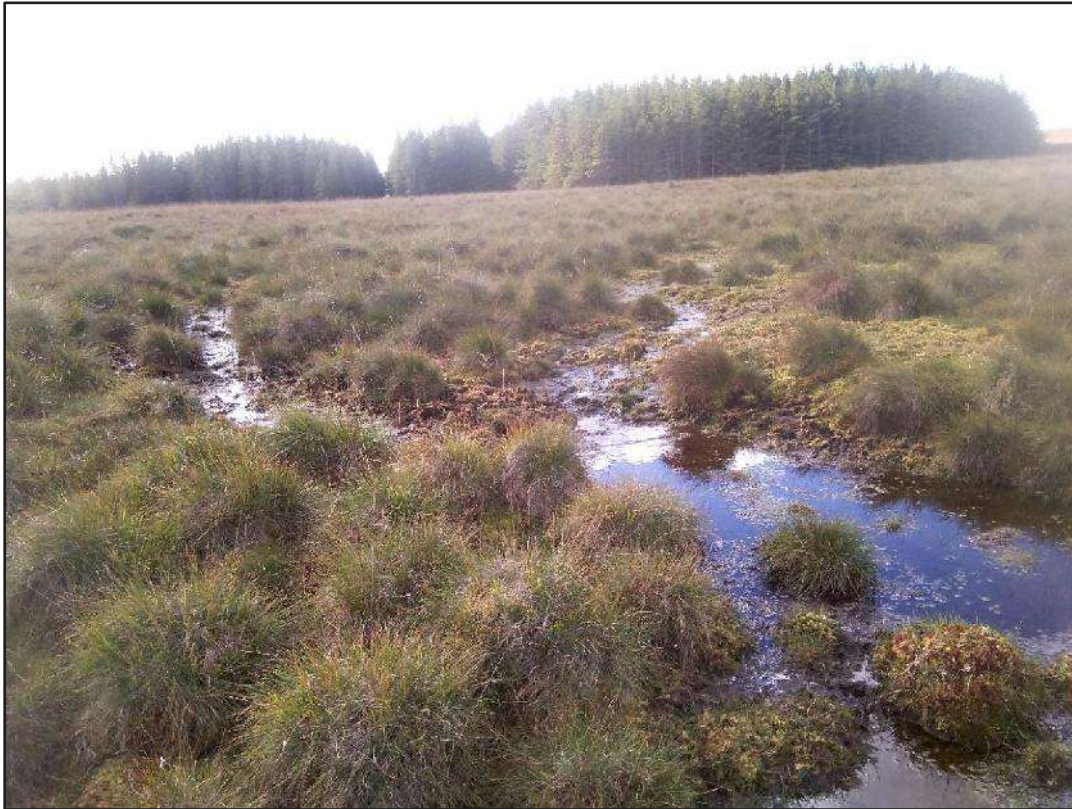
Photo 2: Area of bare peat and resulting dendritic drainage at Tower 49. NGR: NC 88139 61838.

From review of aerial photography, there are localised areas of bare peat across the Alternative Alignment, predominantly in the south-east near Tower 49 as shown by **Photo 2**. The erosion across this location was generally associated with the network of drainage in this area.

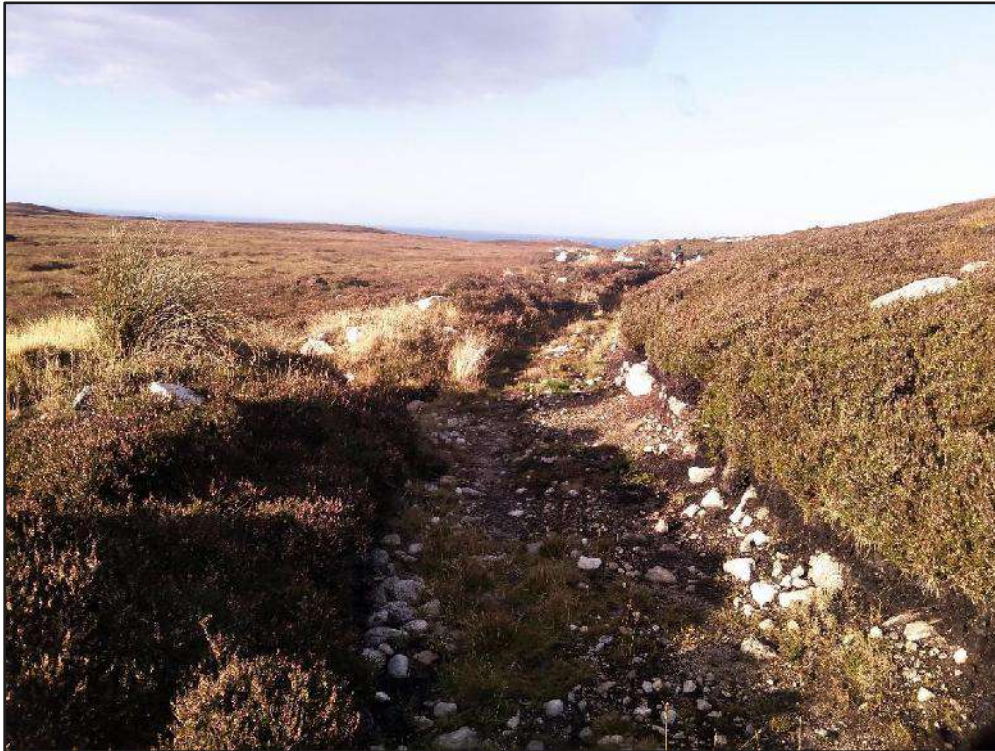
Photo 3: Artificial drainage ditch trending east to west at access track south of Cnoc a'Choire Mhor. NGR: NC 87732 63486.

Artificial drainage and peat cuttings were frequently observed on review of aerial photography and during site visits.

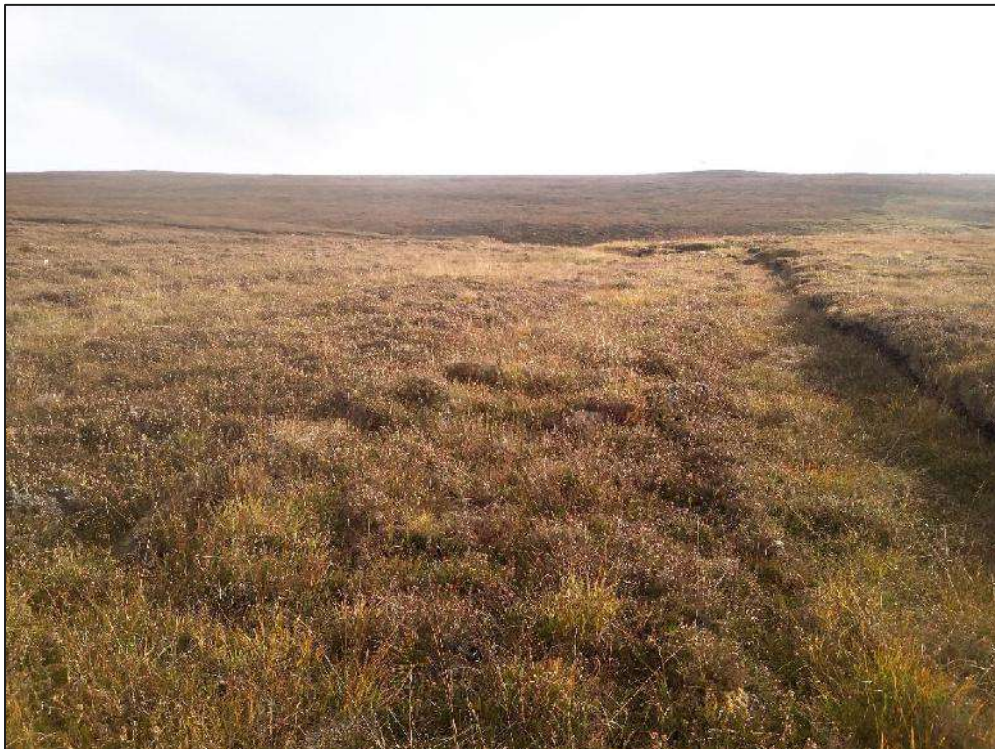
Photo 4: Peat cuttings near Tower A7, looking north. NGR: NC 85426 63928.

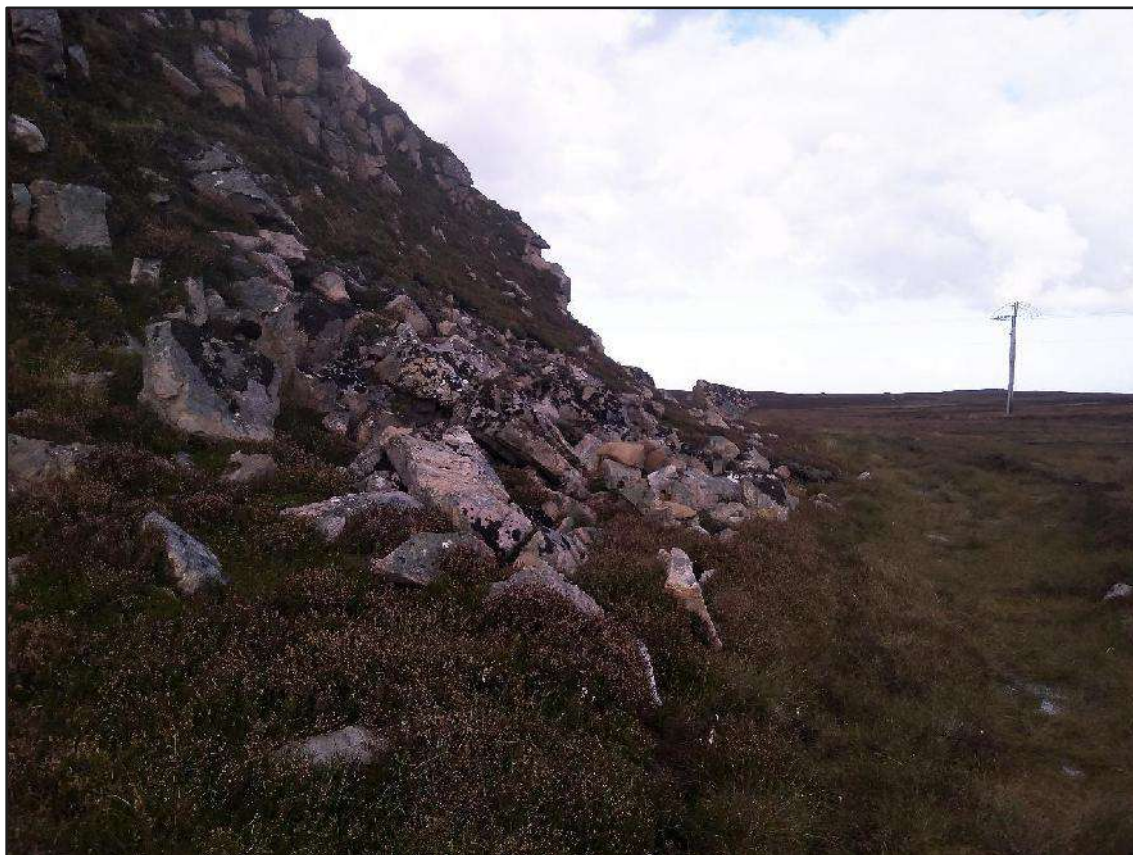
**Photo 5: Bedrock outcrop of Psammite at Creagan Reamhar, looking north-west.
NGR: NC 87003 63168.**

The OS mapping and aerial photography exhibits bedrock exposures across the Alternative Alignment. This was confirmed by site visits where exposed bedrock was frequently recorded, especially in the western extents of the Alternative Alignment across the steeper slopes near Bowside Lodge and in the eastern extents near Tower 62 adjacent to the Halladale River. Bedrock outcrops were also observed at Creagan Reamhar, within the central area of the Alternative Alignment (see **Photo 5**).

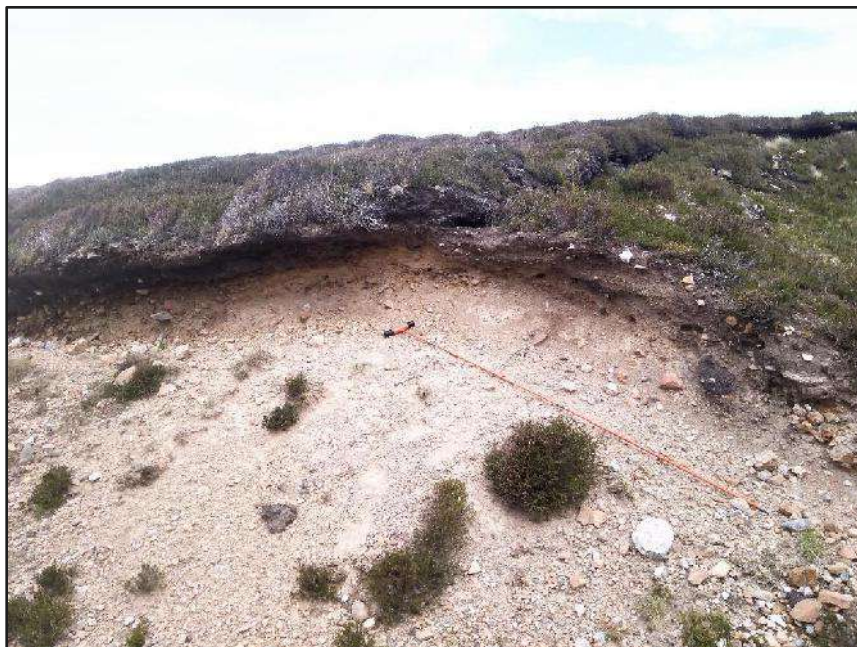
Photo 6: Road cutting displaying granular substrate at existing access track (to be upgraded) near Cnoc Eadar Dha Allt looking east. NGR: NC 86658 64682.

Based on a review of the BGS mapping and site surveys, the granular material is anticipated to be of glacial till origin and of weathered bedrock (see **Photo 6**). No rock samples were recovered from probe locations however, based on the limited rock exposures and BGS mapping, the bedrock is interpreted to be metamorphic, igneous and sedimentary in nature.
