SKYE REINFORCEMENT PROJECT

Appendix V2-6.2: Schedule of Permanent Watercourse Crossings

Prepared for: Scottish & Southern Electricity
Networks Transmission (SSEN Transmission)

SLR Ref: 428.04707.00020
Version No: Final
September 2022

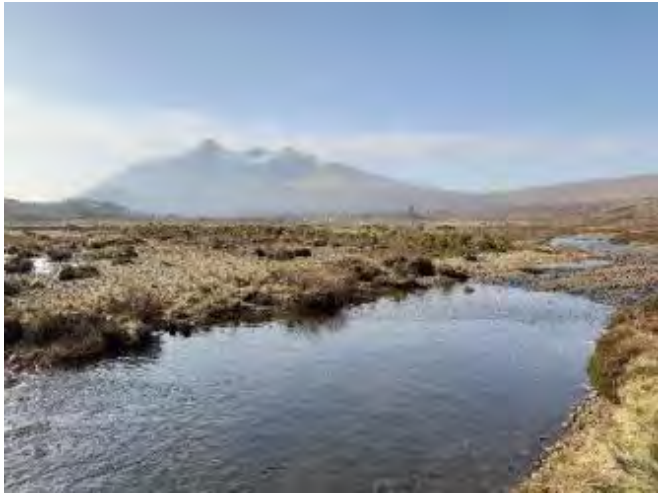
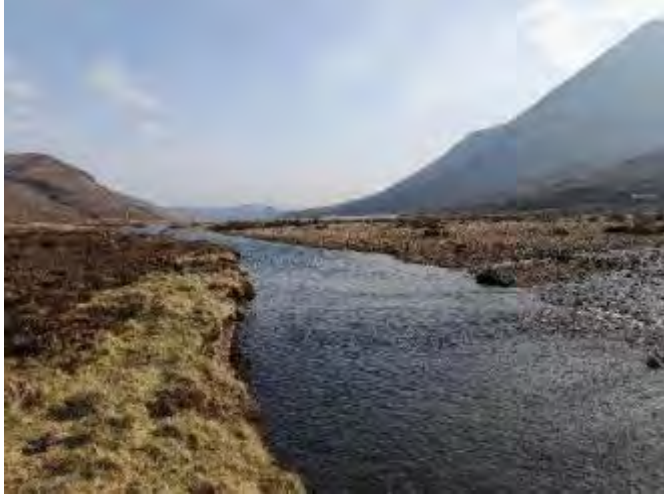
Section 0	
There are no proposed HDD crossings in Section 0.	
Section 1	
There are no proposed HDD crossings in Section 1.	
Section 2	
Watercourse Crossing ID	WX2.1
Watercourse Crossing Details	<p>Watercourse Crossing: WX2.1 NGR: NG 48907 30474 Watercourse Width: 10-30m Watercourse Depth: 2m Notes: large, braided river with depth varying between 0.3m where braided and 2-3m in the active channel.</p>
Photograph Looking Upstream

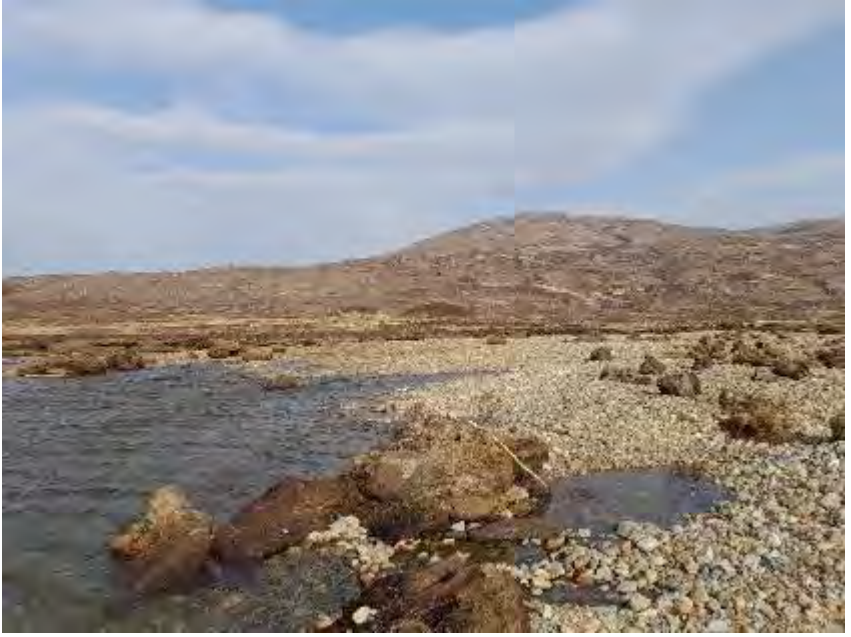
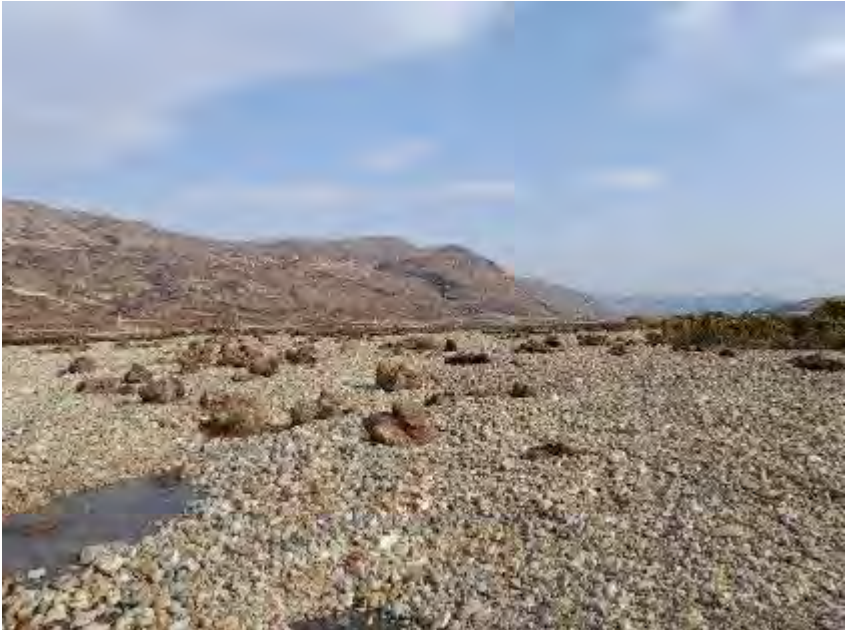
Watercourse Crossing ID	WX2.2
Watercourse Crossing Details	<p>Watercourse Crossing: WX2.2 NGR: NG 48995 30418 Watercourse Width: 30m Watercourse Depth: N/A Notes: watercourse depth unknown due to significant gravel and cobble deposits through the channel, flows are generally fast but on the date of the survey.</p>
Photograph Looking Upstream

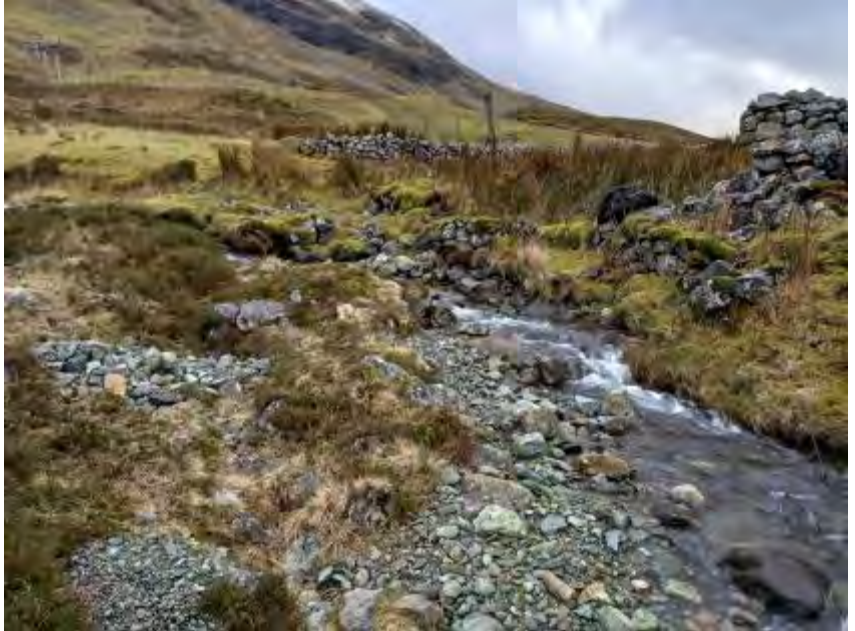
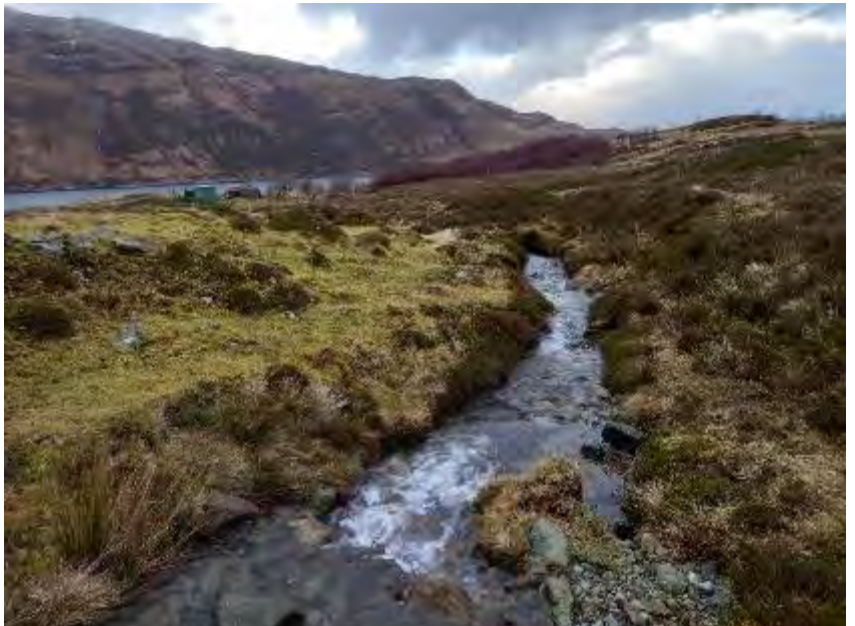
Watercourse Crossing ID	WX2.3
Watercourse Crossing Details	Watercourse Crossing: WX2.3 NGR: NG 51351 31435 Watercourse Width: 1-2m Watercourse Depth: 0.5m Notes: deep fast flow in superficial deposits with boulders in channel.
Photograph Looking Upstream

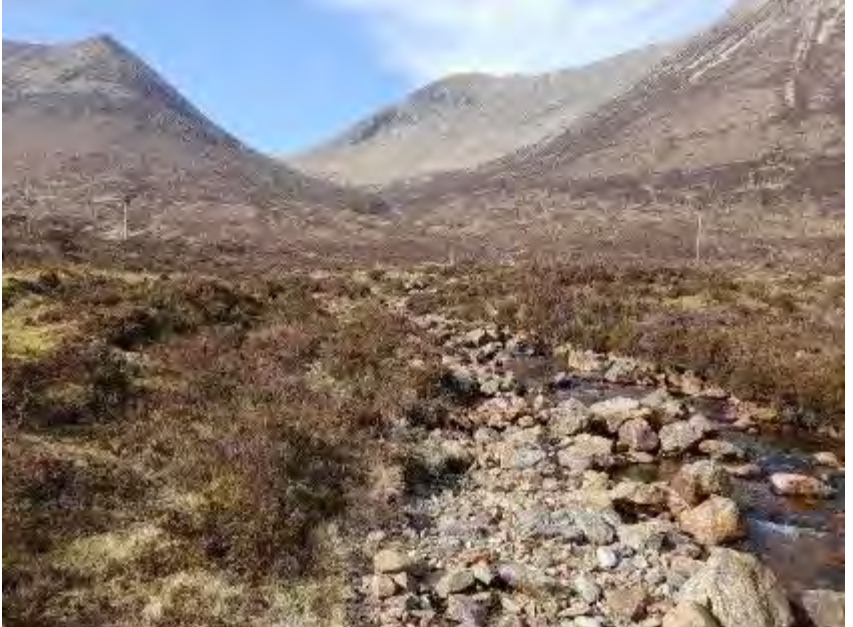
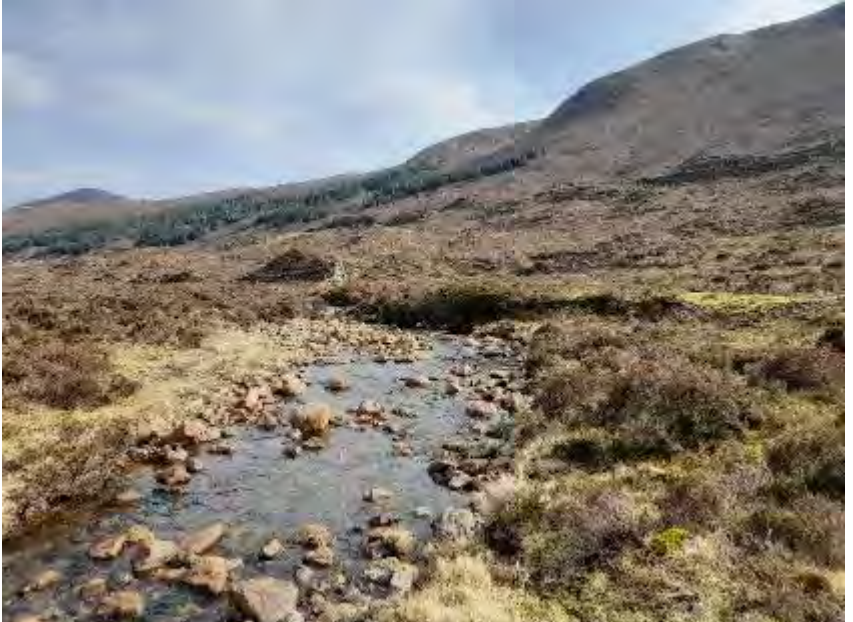
Watercourse Crossing ID	WX2.4
Watercourse Crossing Details	<p>Watercourse Crossing: WX2.4 NGR: NG 53385 29725 Watercourse Width: 2.5m Watercourse Depth: 1m Notes: incised in bedrock with boulders. There is evidence of a wider active channel to a width of around 5m.</p>
Photograph Looking Upstream

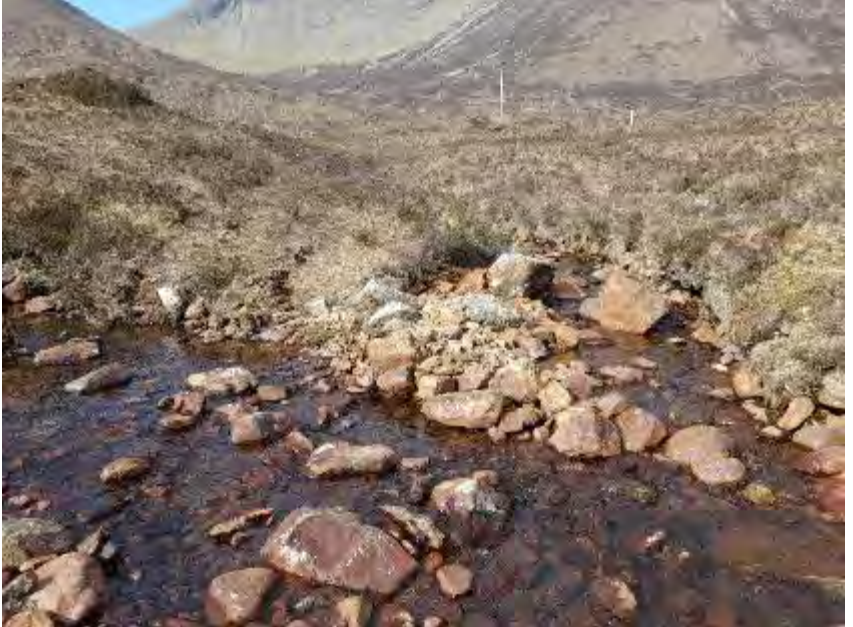
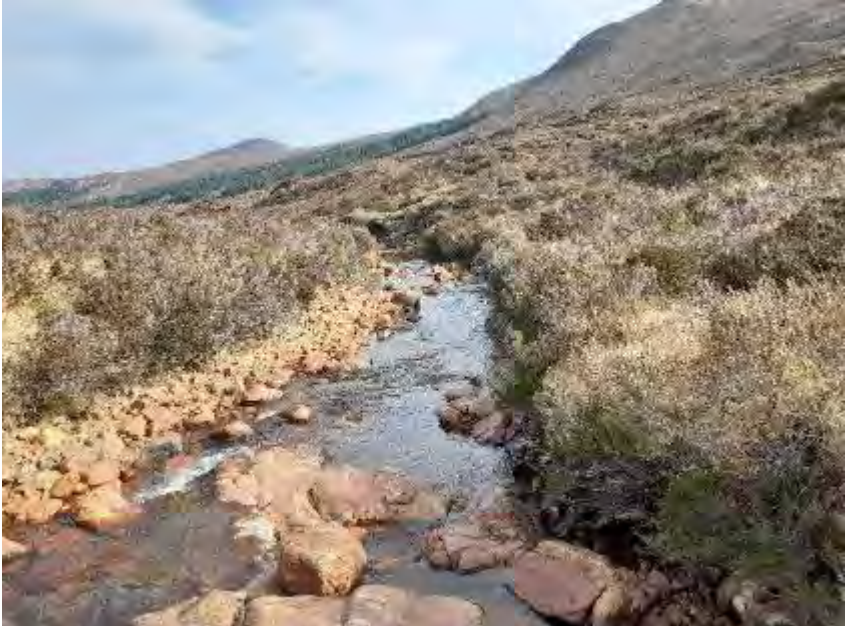
Watercourse Crossing ID	WX2.5
Watercourse Crossing Details	<p>Watercourse Crossing: WX2.5 NGR: NG 53308 29566 Watercourse Width: 3m Watercourse Depth: 1m</p> <p>Notes: watercourse crossing immediately downstream of a confluence, channel is incised into the bedrock with boulders present.</p>
Photograph Looking Upstream

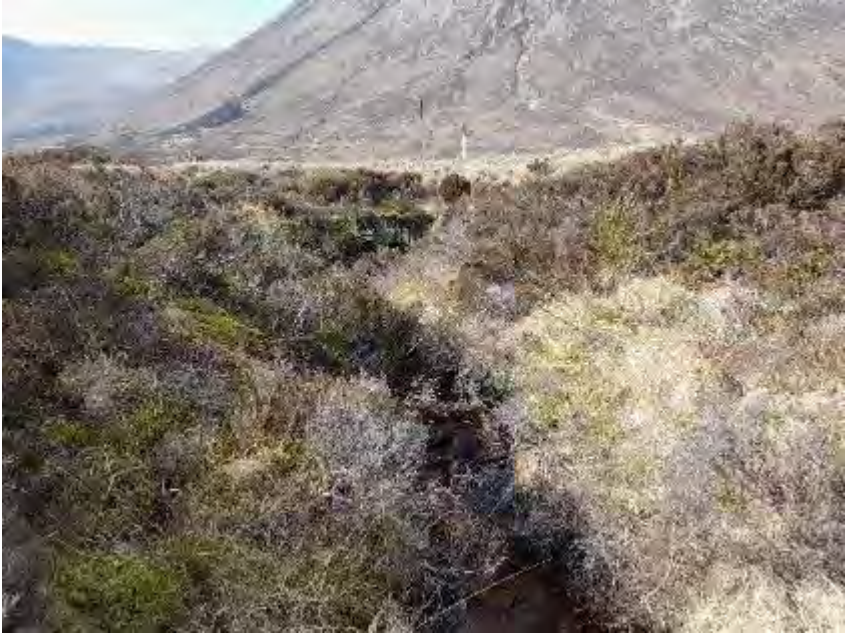
Watercourse Crossing ID	WX2.7
Watercourse Crossing Details	<p>Watercourse Crossing: WX2.7 NGR: NG 53304 28440 Watercourse Width: 0.4m Watercourse Depth: 0.7m Notes: active channel is incised into bedrock with and within a larger channel which is up to 2m high and wide, the channel is culverted beneath the A87 via a 0.4m diameter culvert.</p>
Photograph Looking Upstream

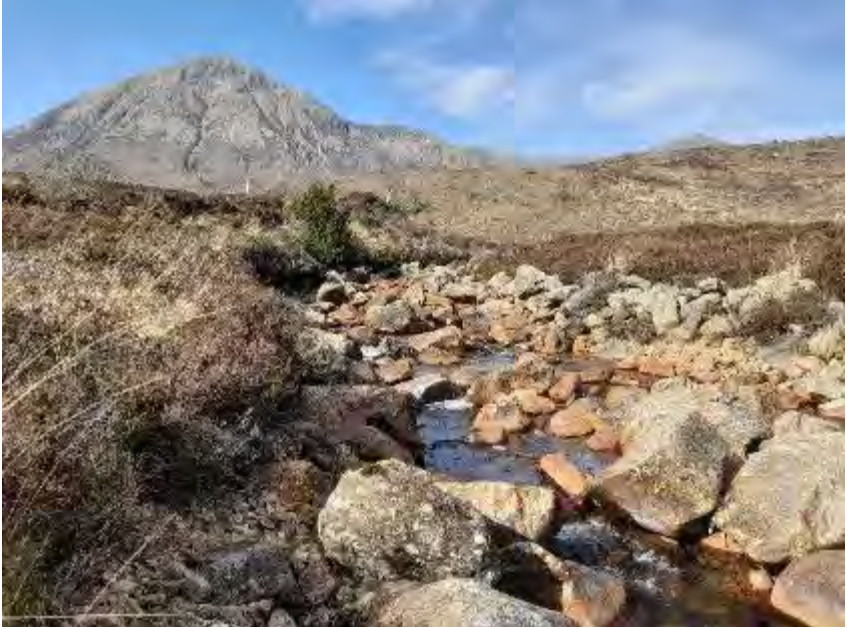
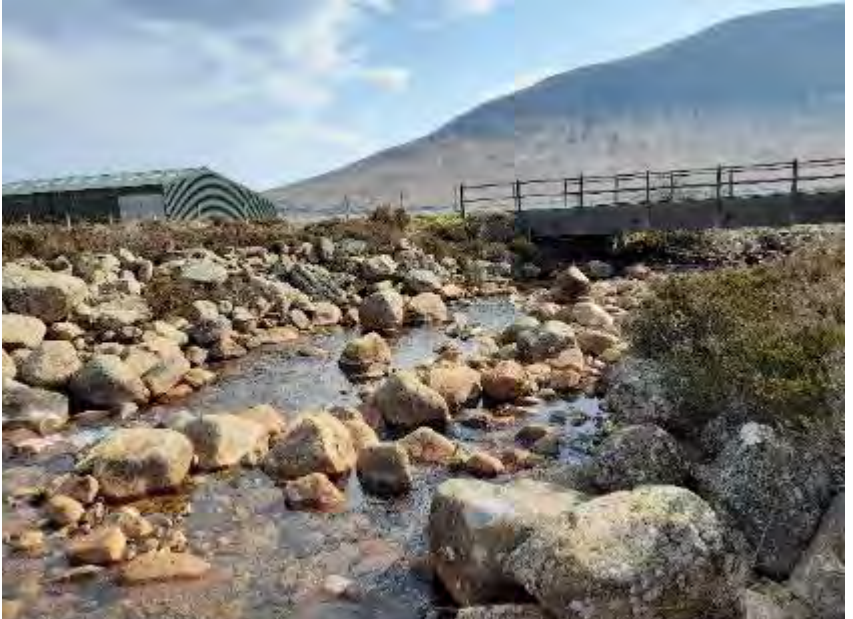
Watercourse Crossing ID	WX2.8
Watercourse Crossing Details	<p>Watercourse Crossing: WX2.8 NGR: NG 53925 27822 Watercourse Width: 3-4m Watercourse Depth: 1m Notes: river crossing with channel banks reinforced by boulders and an open span bridge downstream of the proposed HDD.</p>
Photograph Looking Upstream

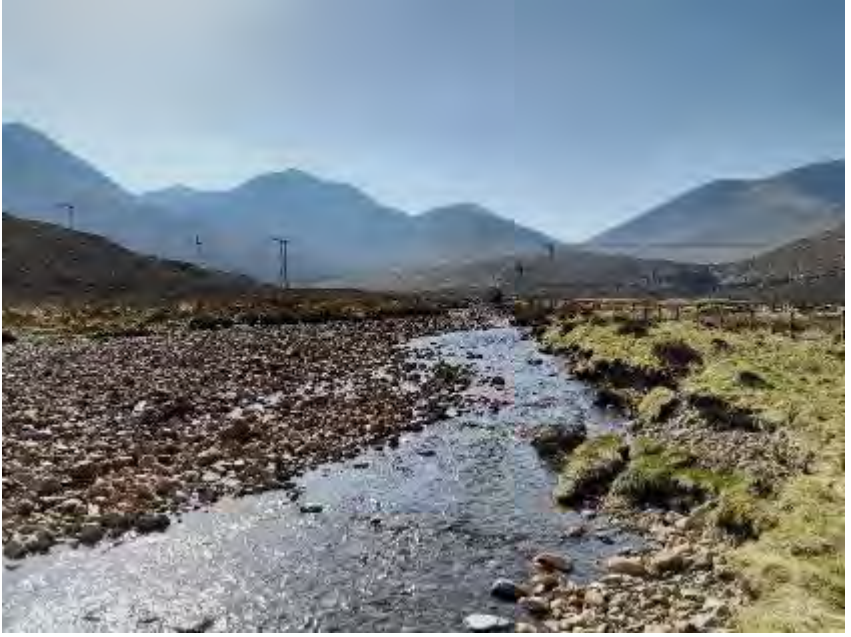
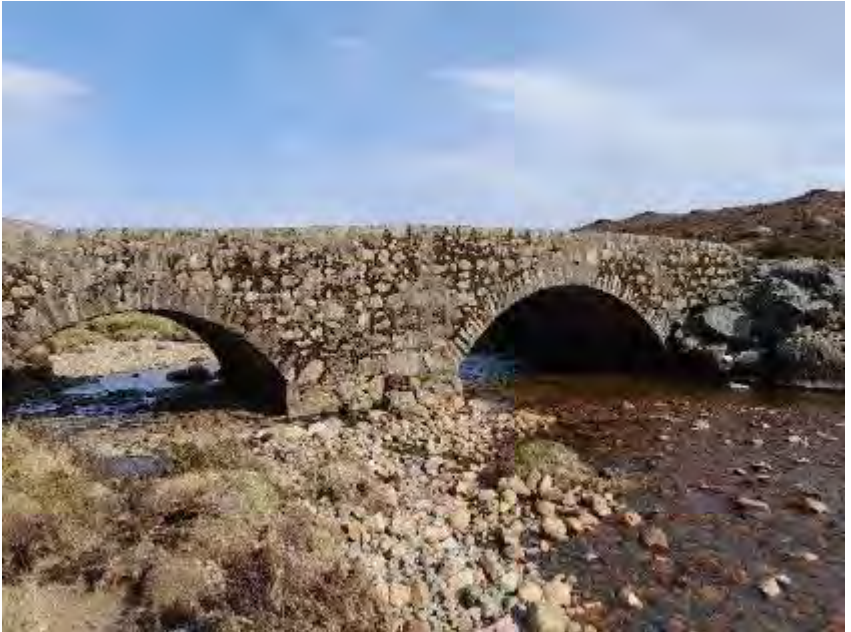
Watercourse Crossing ID	WX2.9
Watercourse Crossing Details	<p>Watercourse Crossing: WX2.9 NGR: NG 53915 27050 Watercourse Width: 10-15m Watercourse Depth: 1m Notes: the active channel during the survey was only around 3m wide. A double arched bridge is located immediately downstream with 4m with and 2m height.</p>
Photograph Looking Upstream

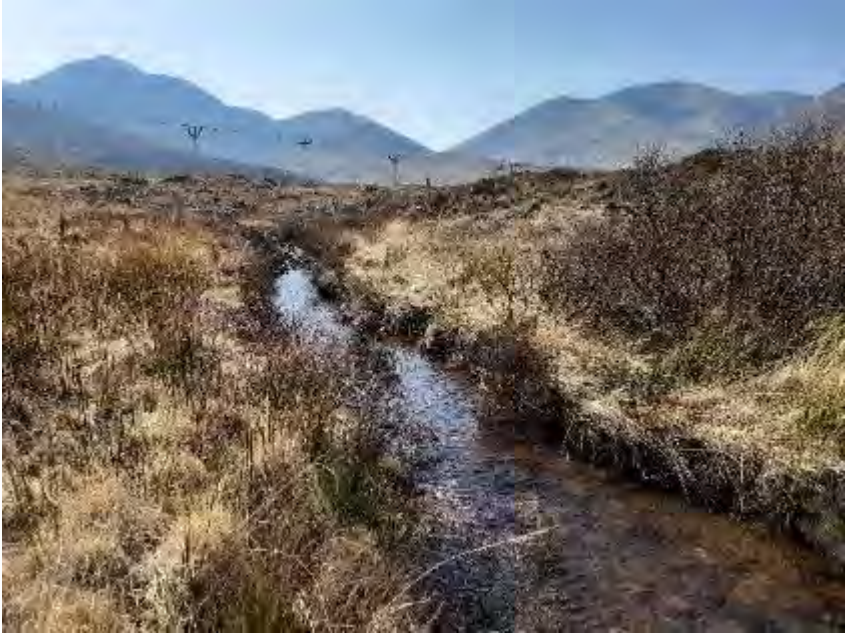
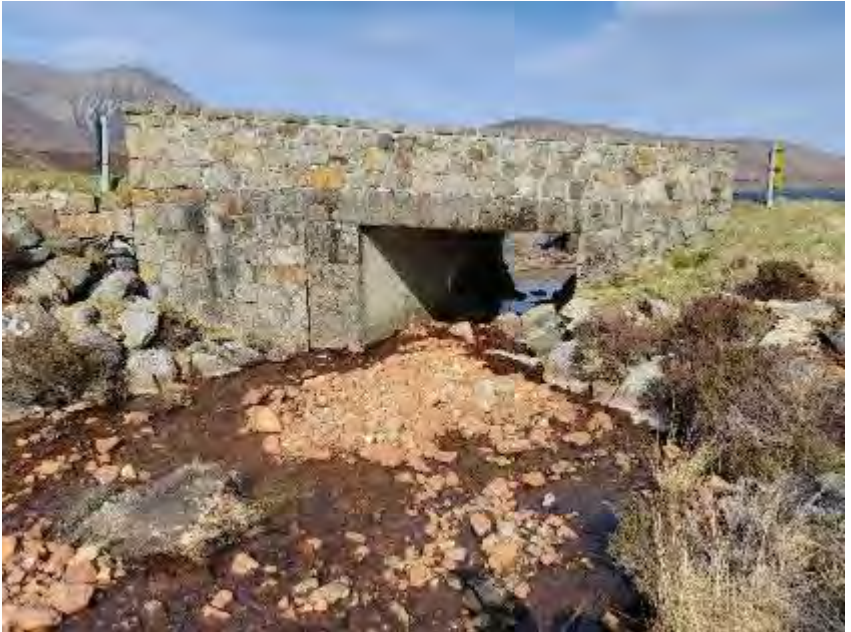
Watercourse Crossing ID	WX2.10
Watercourse Crossing Details	<p>Watercourse Crossing: WX2.10 NGR: NG 54302 26816 Watercourse Width: 1-2m Watercourse Depth: 0.5-1m Notes: immediately upstream of a large square open span culvert beneath the A87, the channel is incised into superficial deposits and boulders are present along the banks at the A87 culvert.</p>
Photograph Looking Upstream

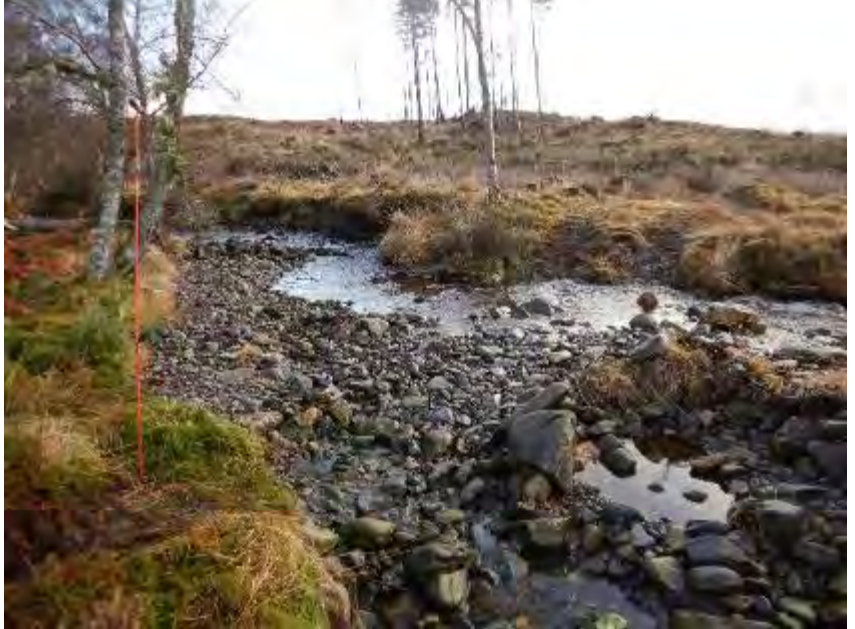
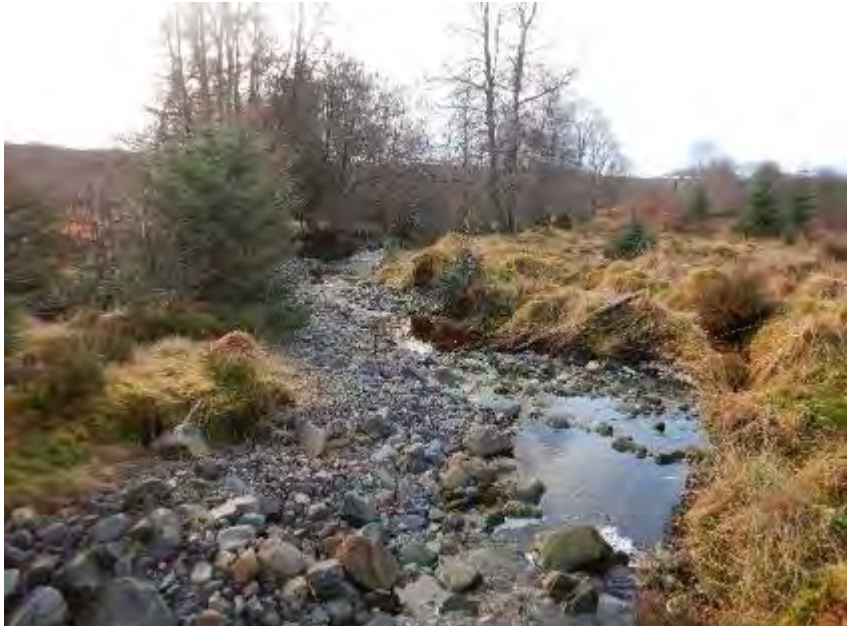
Watercourse Crossing ID	WX6.2
Watercourse Crossing Details	<p>Watercourse Crossing: WX6.2 NGR: NH 31929 05761 Watercourse Width: 3-5m Watercourse Depth: 0.6m Notes: Narrow incised valley into bedrock adjacent to forestry, boulders deposited in the channel bed.</p>
Photograph Looking Upstream

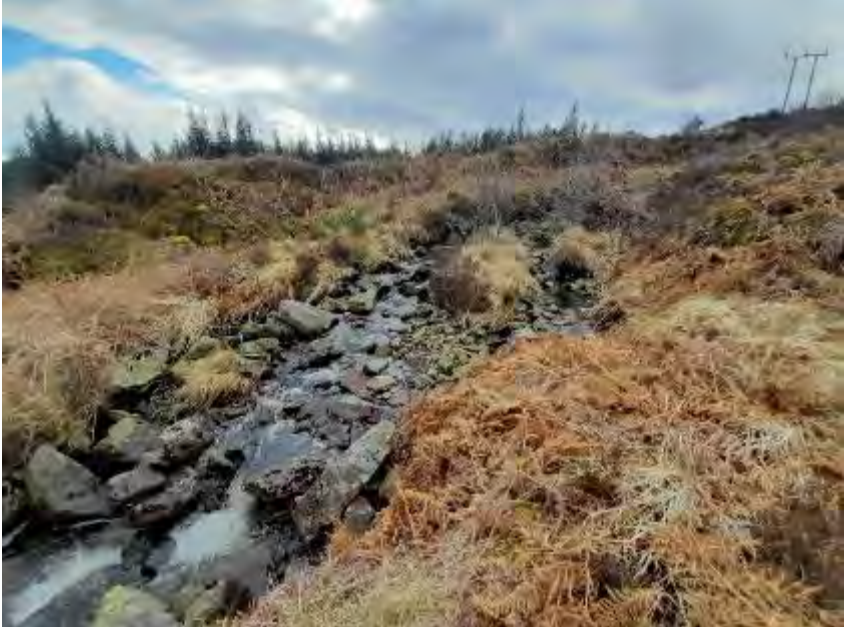
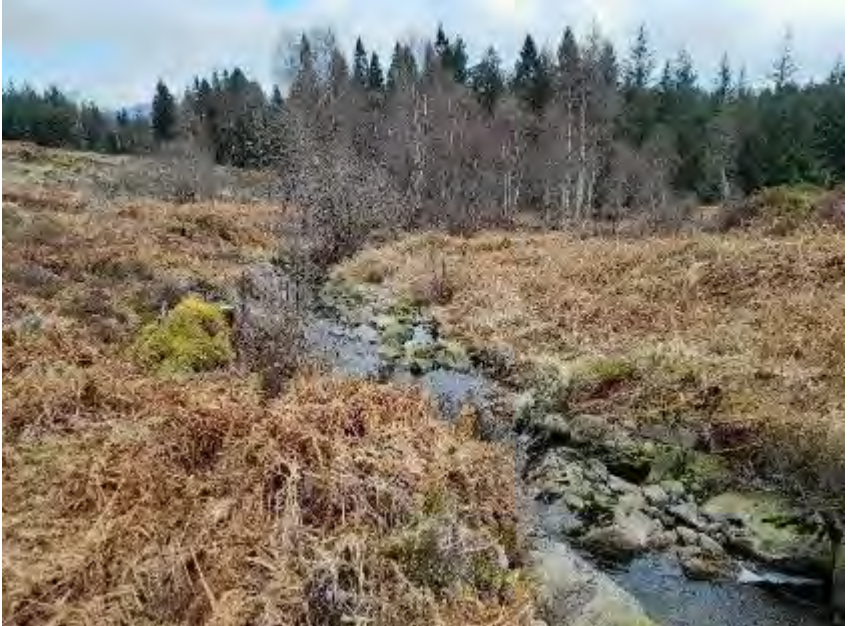
Watercourse Crossing ID	WX6.3
Watercourse Crossing Details	Watercourse Crossing: WX6.3 NGR: NH 33784 07805 Watercourse Width: 1-2m Watercourse Depth: 0.2-0.4m Notes: Bedrock channel with cobbles and boulders. Evidence of flooding.
Photograph Looking Upstream

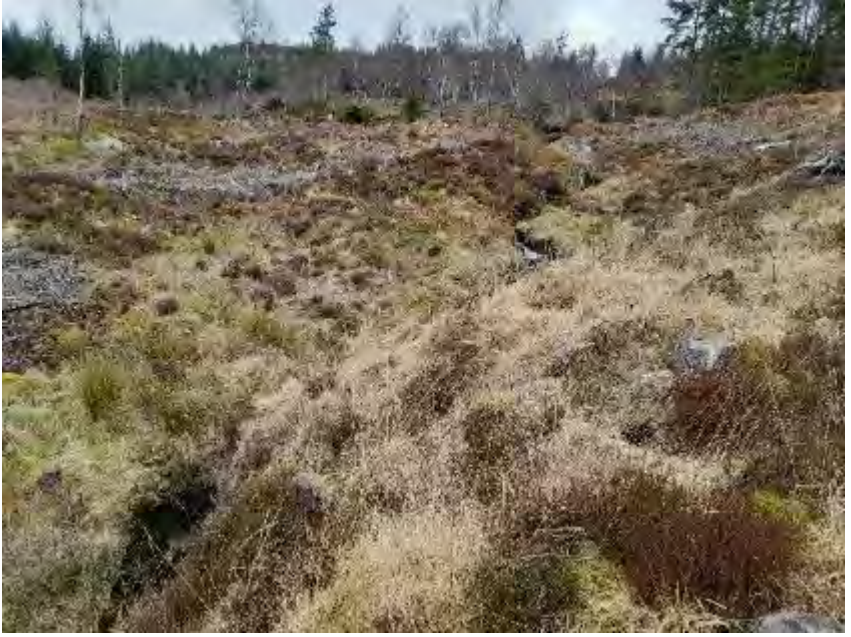
Watercourse Crossing ID	WX6.4
Watercourse Crossing Details	<p>Watercourse Crossing: WX6.4 NGR: NH 34204 08002 Watercourse Width: 0.4m Watercourse Depth: 0.3-0.5m Notes: Bedrock channel with some cobbles and boulders. Some evidence of flooding. Watercourse flows down quite a significant gradient.</p>
Photograph Looking Upstream

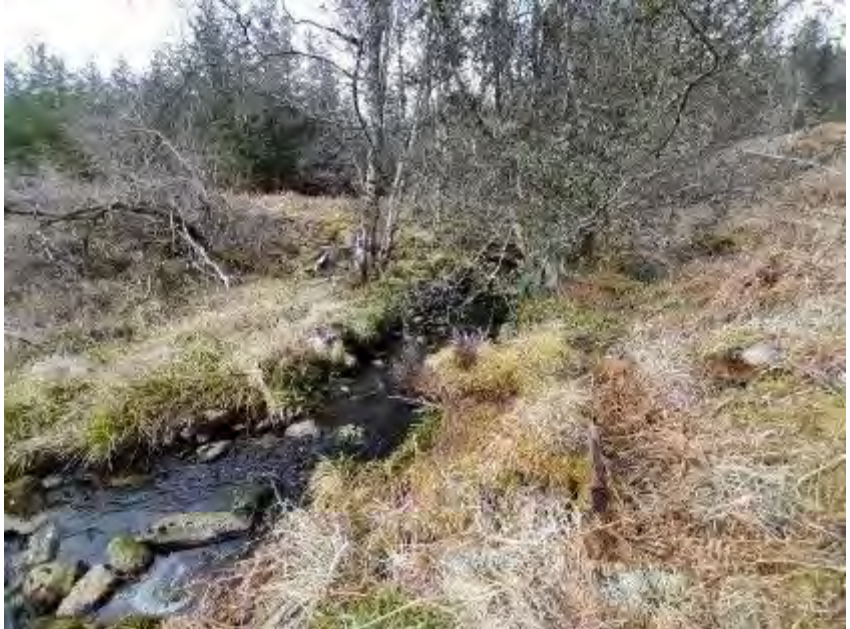
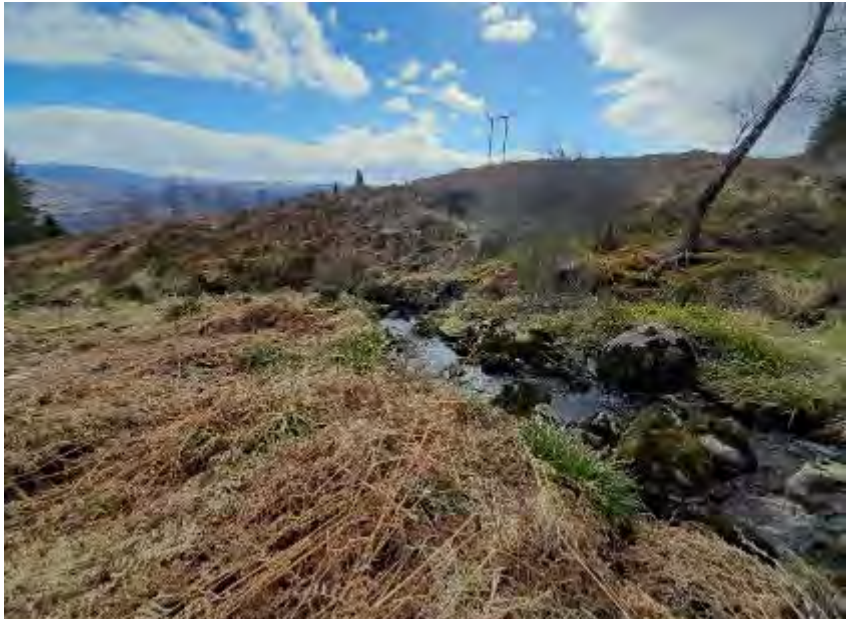
Watercourse Crossing ID	WX6.5
Watercourse Crossing Details	<p>Watercourse Crossing: WX6.5 NGR: NH 34816 08553 Watercourse Width: 0.5-0.8m Watercourse Depth: 0.4-0.5m Notes: Bedrock channel with some cobbles and boulders. Some evidence of flooding.</p>
Photograph Looking Upstream

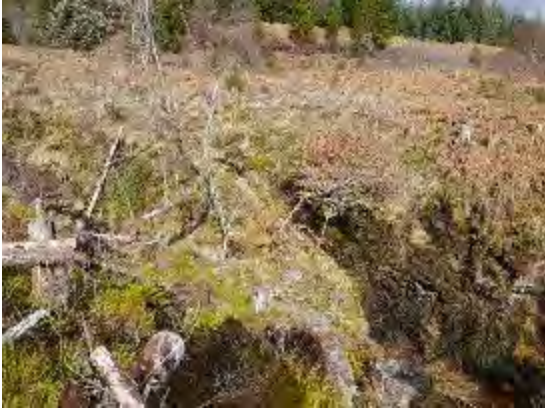
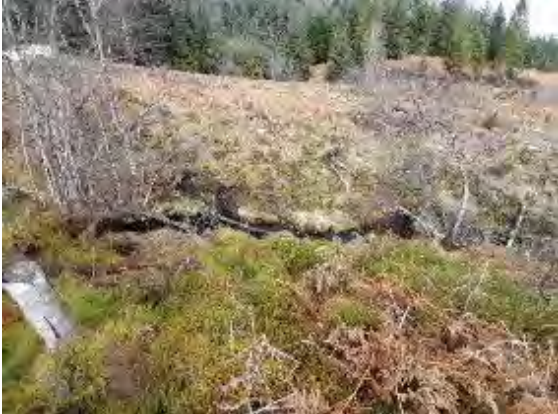
Watercourse Crossing ID	WX6.6
Watercourse Crossing Details	<p>Watercourse Crossing: WX6.6 NGR: NH 35034 08678 Watercourse Width: 0.4m (c. 20m upstream) Watercourse Depth: 0.3-0.5m (c. 20m upstream) Notes: Watercourse crossing proposed location is a stream in a vertical and c. 15m deep valley. At this location the width and depth of the stream cannot be seen. Suggest moving the watercourse crossing c. 20m upstream where there is no valley. At this location it is a bedrock channel with some cobbles and boulders.</p>
Photograph Looking Upstream

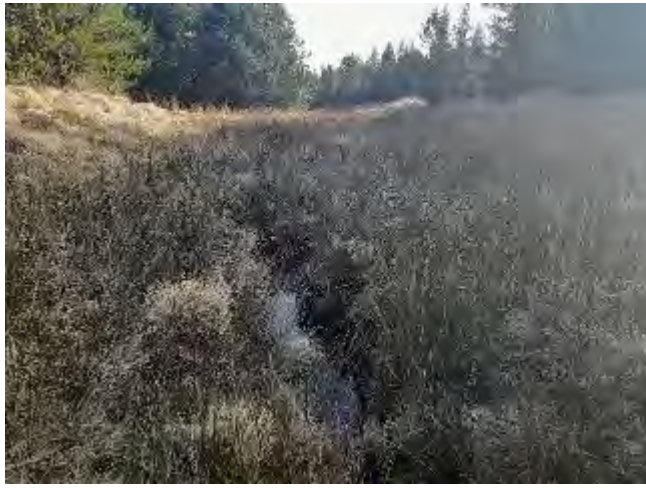
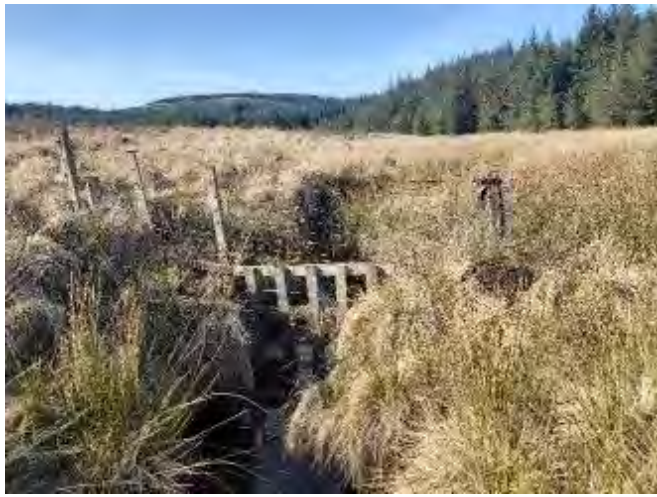
Section 0	
There are no new permanent tracks in Section 0.	
Section 1	
Watercourse Crossing ID	WX1.1
Watercourse Crossing Details	<p>Watercourse Crossing: WX1.1 NGR: NG 41264 43008 Watercourse Width: 1.5m Watercourse Depth: 1m Notes: channel incised in peat with low flow</p>
Photograph Looking Upstream

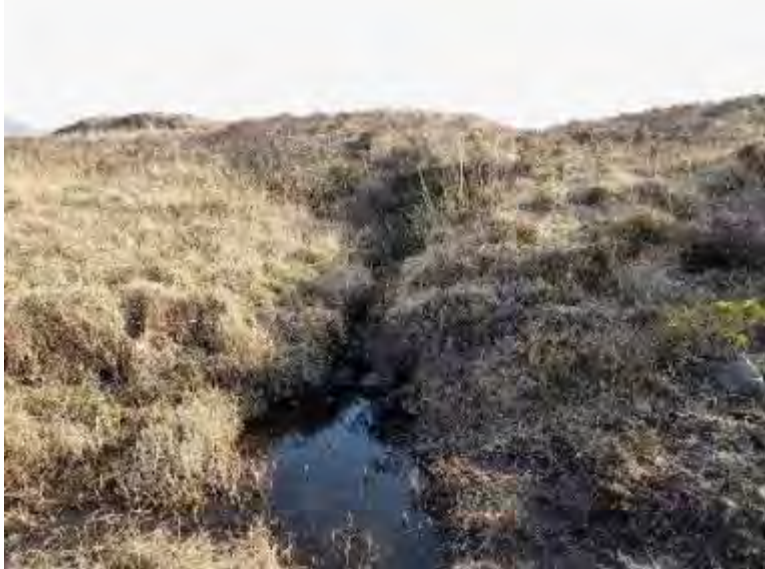
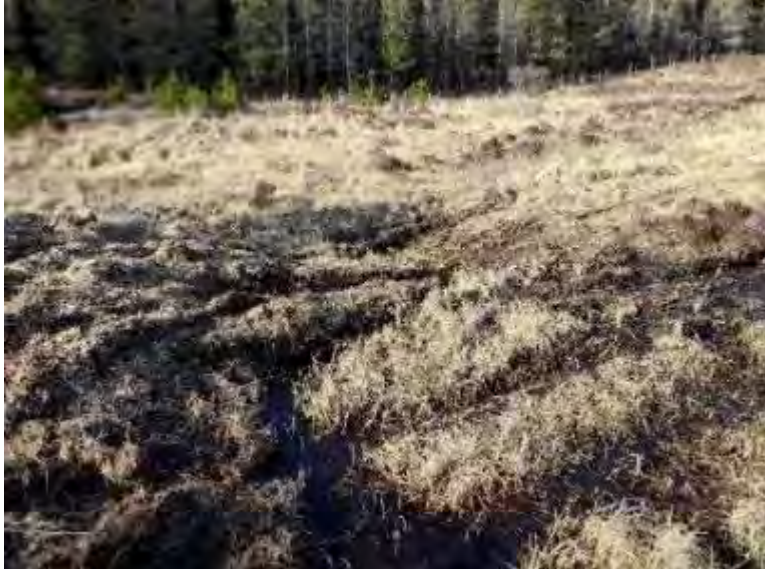
Watercourse Crossing ID	WX1.4
Watercourse Crossing Details	<p>Watercourse Crossing: WX1.4 NGR: NG 47855 31908 Watercourse Width: 0.4m Watercourse Depth: 0.5m Notes: within deposits of peat and been subject to previous vehicle tracks / movement</p>
Photograph Looking Upstream

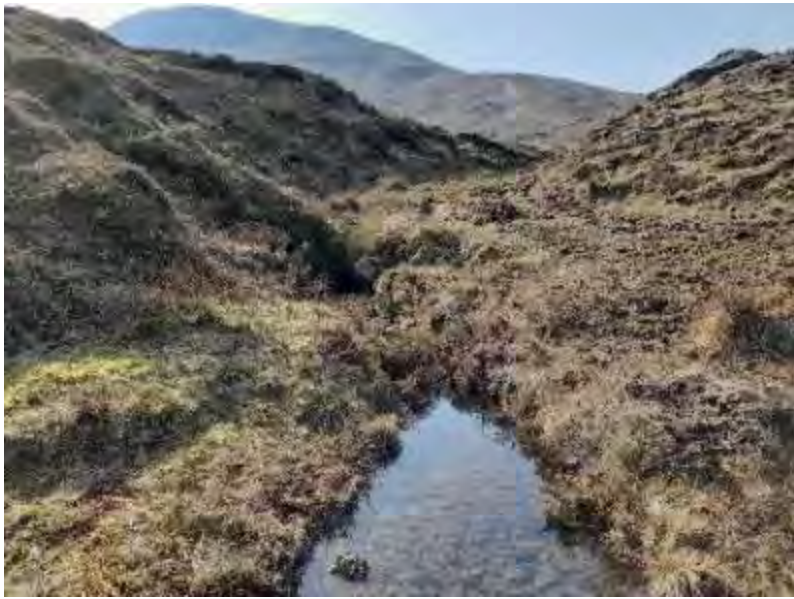
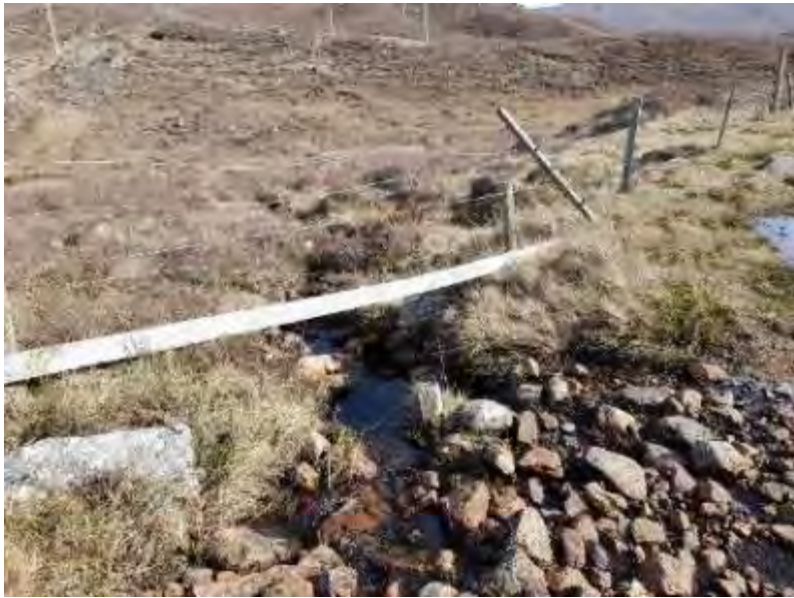
Section 2	
Watercourse Crossing ID	WX2.12
Watercourse Crossing Details	Watercourse Crossing: WX2.12 NGR: NG 56463 27475 Watercourse Width: 0.4m Watercourse Depth: 0.3m Notes: none
Photograph Looking Upstream

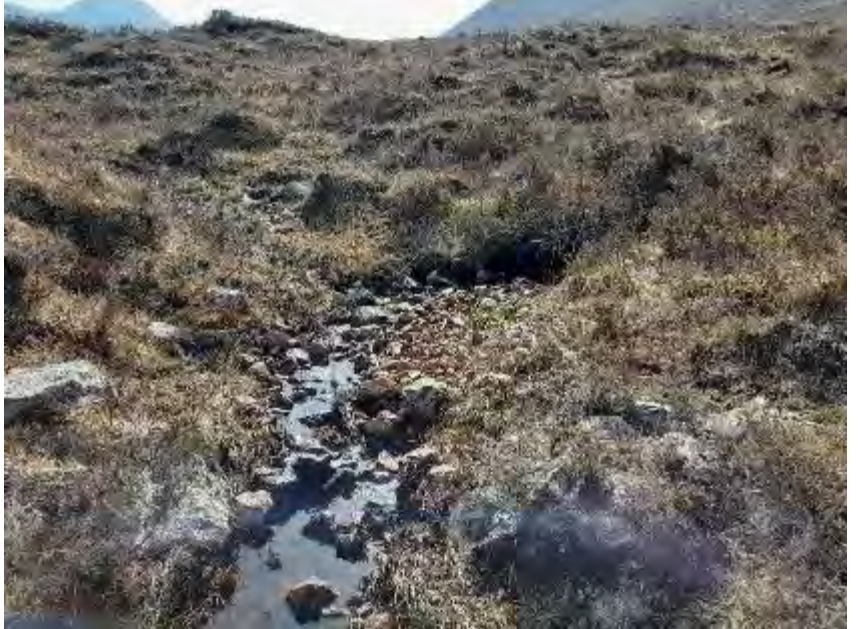
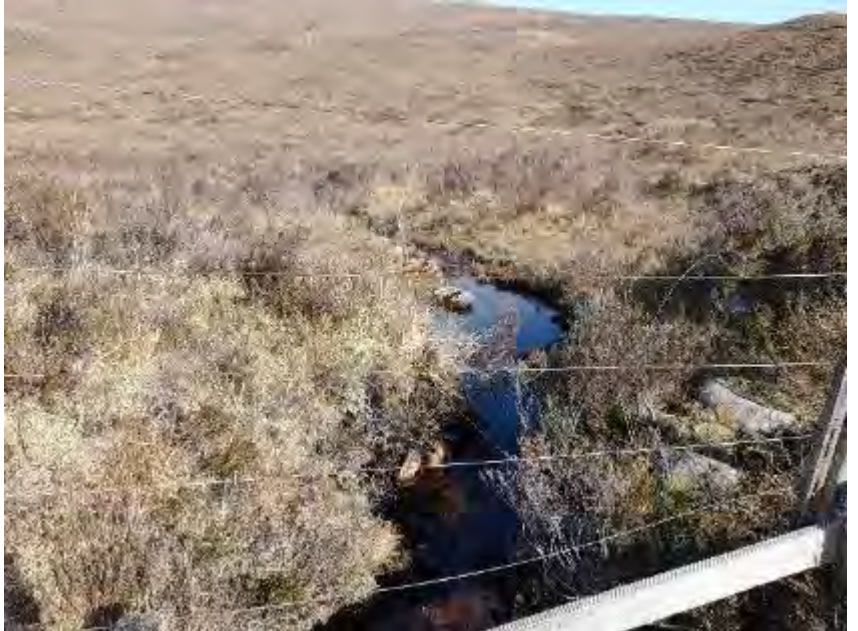
Watercourse Crossing ID	WX2.13
Watercourse Crossing Details	<p>Watercourse Crossing: WX2.13 NGR: NG 56550 27278 Watercourse Width: 0.5m Watercourse Depth: 0.1m Notes: channel incised into superficial geology with boulders present in the channel</p>
Photograph Looking Upstream

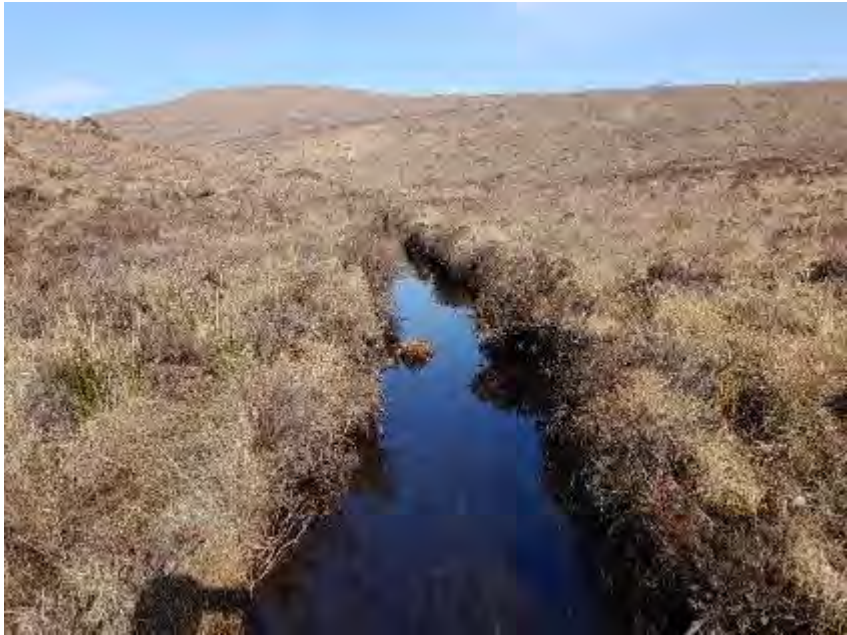
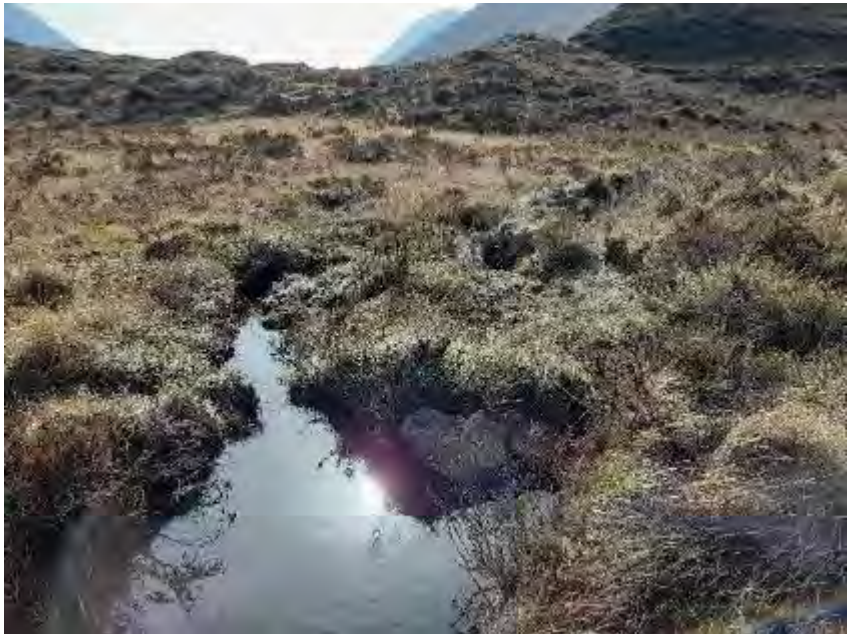
Watercourse Crossing ID	WX2.15
Watercourse Crossing Details	<p>Watercourse Crossing: WX2.15 NGR: NG 56730 27127 Watercourse Width: 0.8m Watercourse Depth: 0.5m Notes: watercourse breaks into two smaller channels for a short stretch immediately downstream of crossing, channel is incised into peat with cobbles deposited in channel.</p>
Photograph Looking Upstream

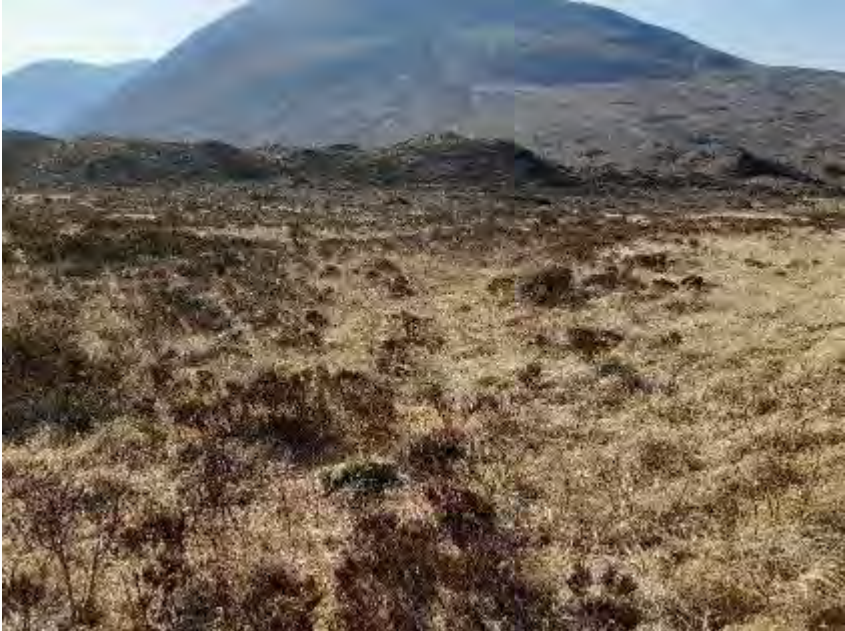
Watercourse Crossing ID	WX2.17
Watercourse Crossing Details	Watercourse Crossing: WX2.17 NGR: NG 56952 27077 Watercourse Width: N/A Watercourse Depth: N/A Notes: no defined channel found and more likely only conveys flows / surface water runoff during periods of high rainfall.
Photograph Looking Upstream

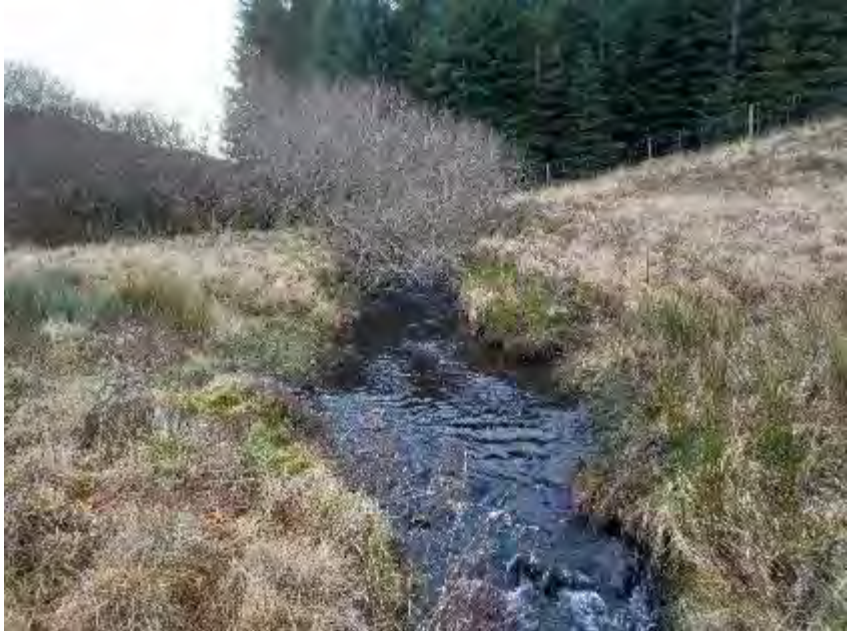
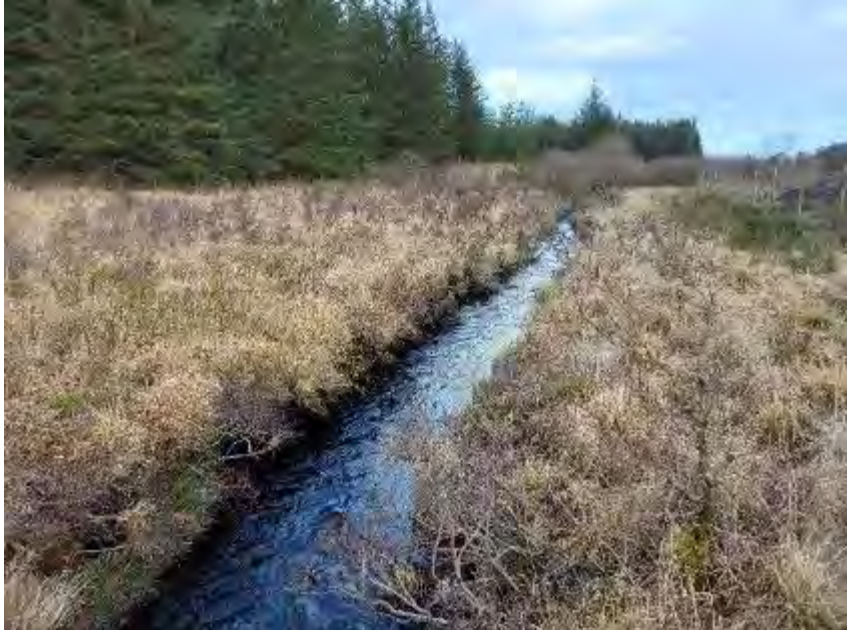
Watercourse Crossing ID	WX3.2
Watercourse Crossing Details	Watercourse Crossing: WX3.2 NGR: NG 63523 23076 Watercourse Width: 2.5m Watercourse Depth: 1m Notes: channel relatively uniform and incised into peat.
Photograph Looking Upstream

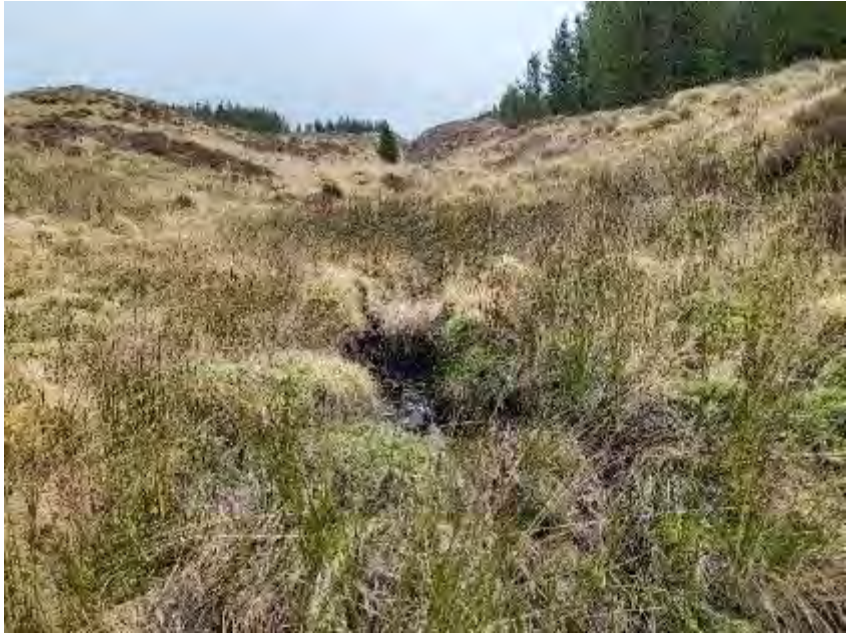
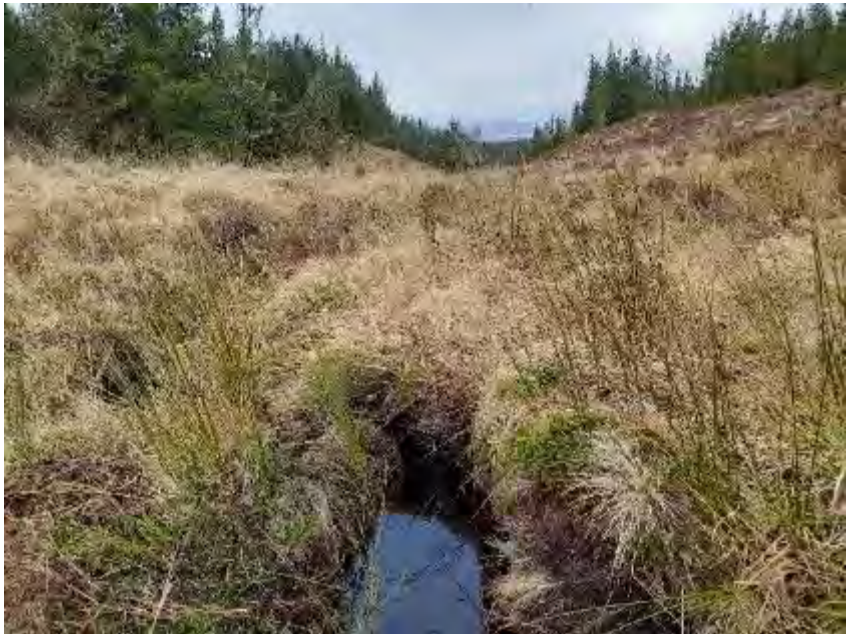
Watercourse Crossing ID	WX3.4
Watercourse Crossing Details	Watercourse Crossing: WX3.4 NGR: NG 71866 23624 Status: New Watercourse Width: 0.3m Watercourse Depth: 0.4m Notes: channel incised into peat
Photograph Looking Upstream
