SKYE REINFORCEMENT PROJECT

Appendix V2-6.2: Schedule of Permanent Watercourse Crossings

Prepared for: Scottish & Southern Electricity
Networks Transmission (SSEN Transmission)

SLR Ref: 428.04707.00020
Version No: Final
September 2022

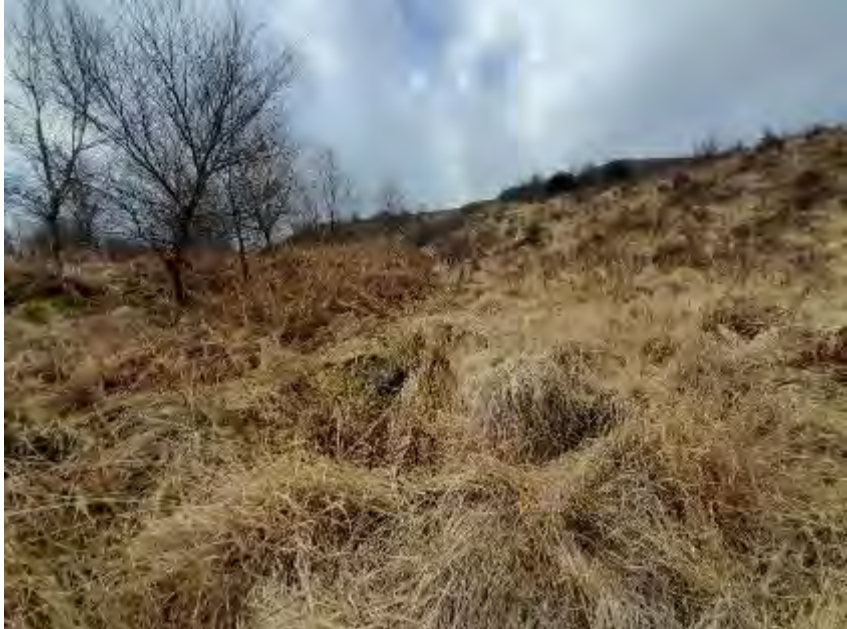
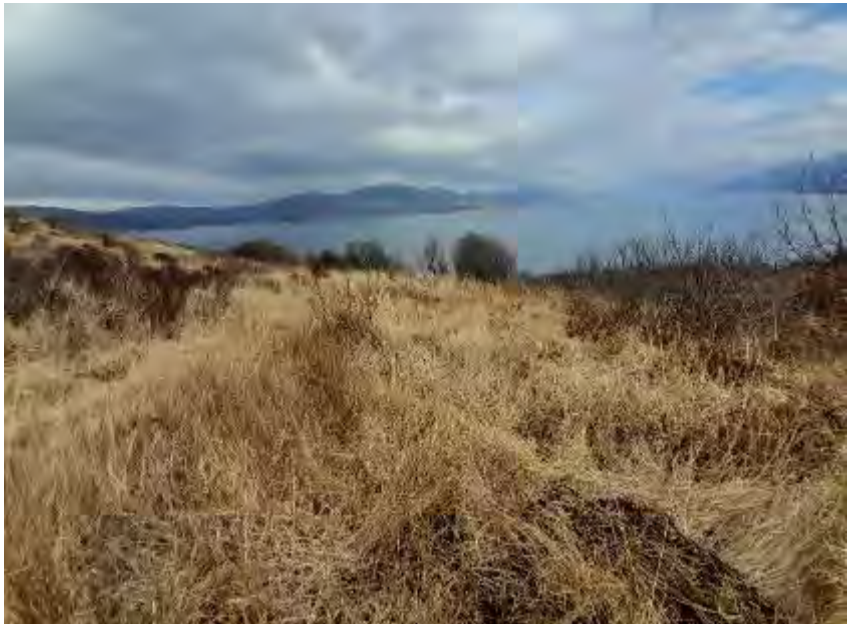
Watercourse Crossing ID	WX3.7
Watercourse Crossing Details	Watercourse Crossing: WX3.7 NGR: NG 79398 24607 Watercourse Width: 0.1m Watercourse Depth: 0.1m Notes: no defined channel
Photograph Looking Upstream

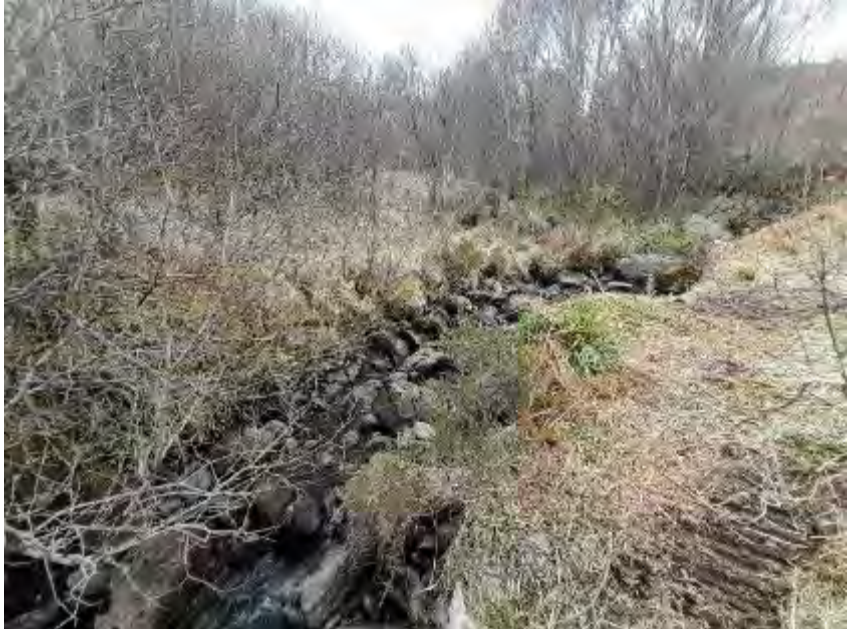
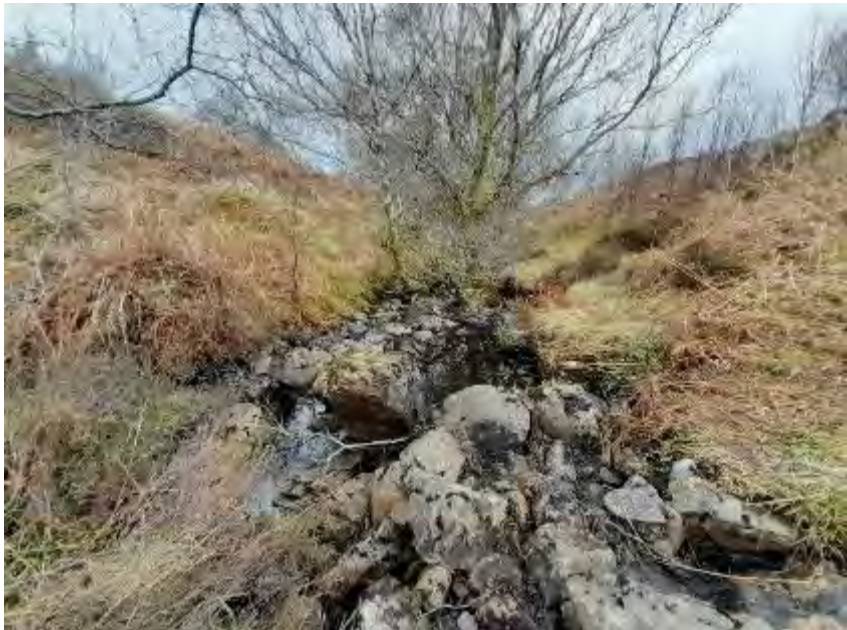
Watercourse Crossing ID	WX3.8
Watercourse Crossing Details	Watercourse Crossing: WX3.8 NGR: NG 79475 24500 Watercourse Width: 1m Watercourse Depth: 0.2m Notes: channel incised into bedrock with boulders present
Photograph Looking Upstream

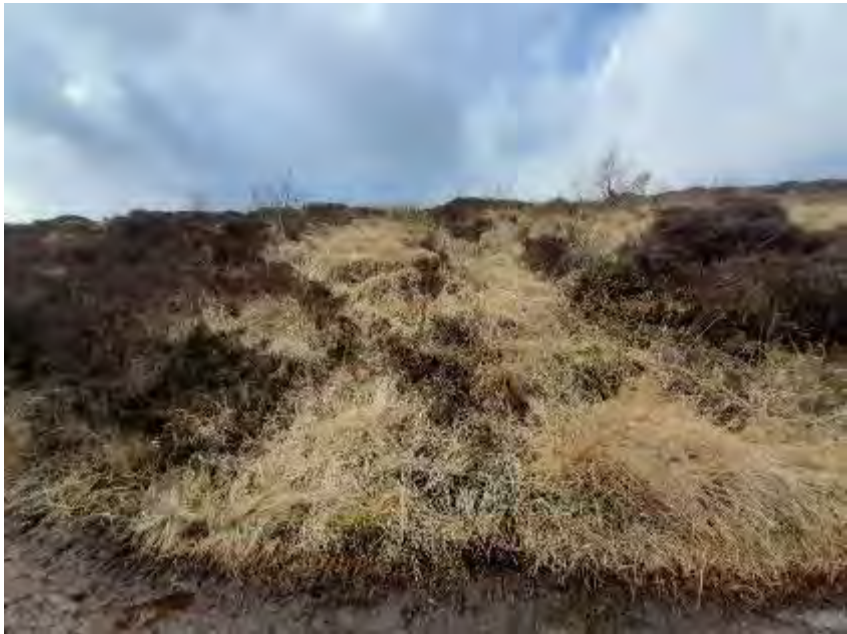
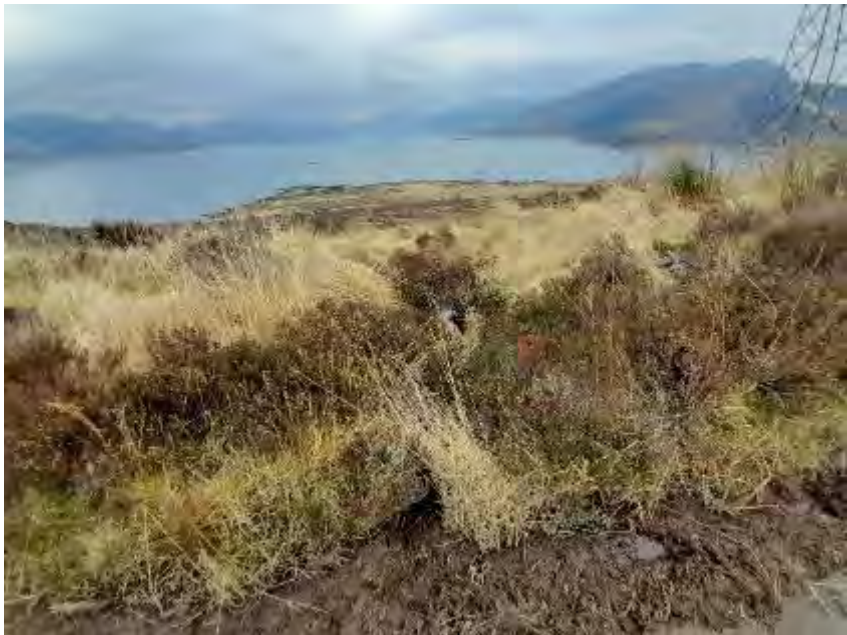
Watercourse Crossing ID	WX3.9
Watercourse Crossing Details	Watercourse Crossing: WX3.9 NGR: NG 79374 24128 Watercourse Width: 0.1m Watercourse Depth: 0.2-0.4m Notes: very low flow / stagnant water with no defined channel upstream but evidence of recent surface water flow
Photograph Looking Upstream

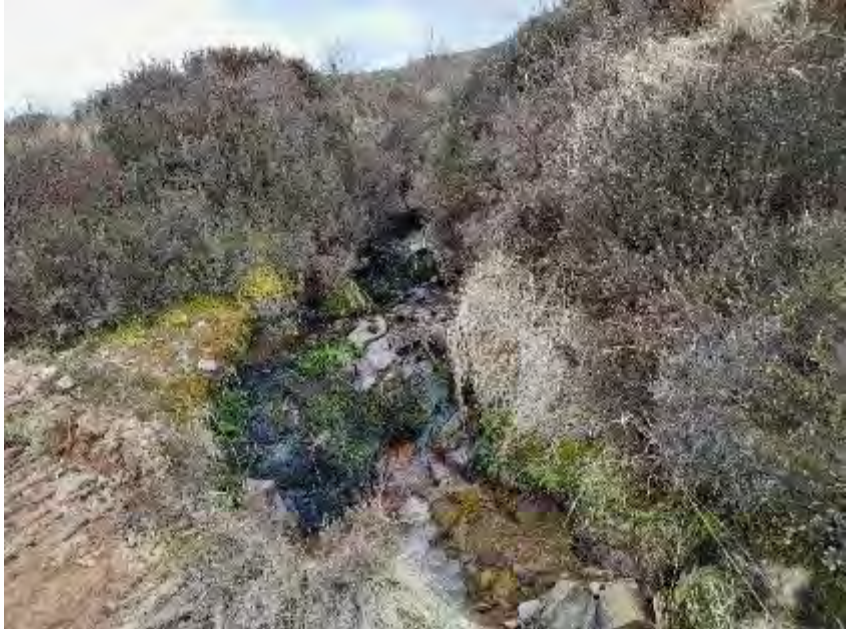
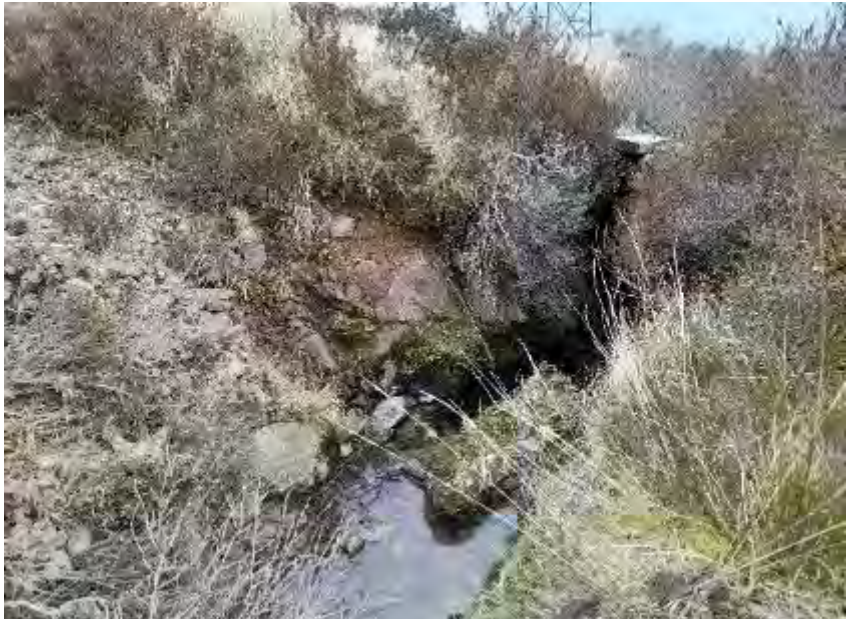
Watercourse Crossing ID	WX3.10
Watercourse Crossing Details	<p>Watercourse Crossing: WX3.10 NGR: NG 79370 24094 Watercourse Width: 0.4m Watercourse Depth: 0.2-1m Notes: channel much deeper (1m) downstream but only 0.2m upstream, and where a channel is present this is on bedrock</p>
Photograph Looking Upstream

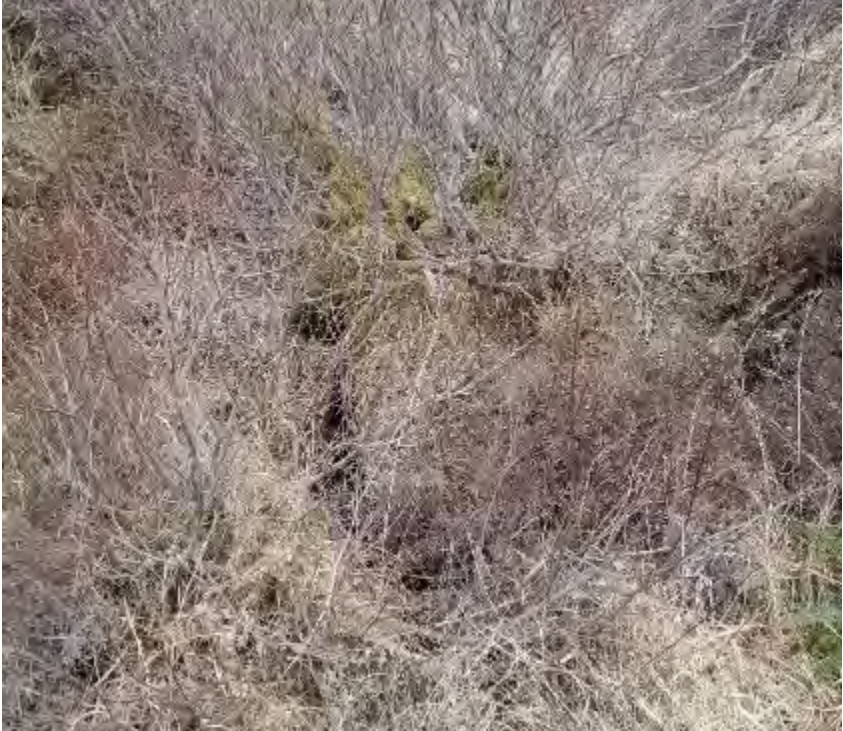
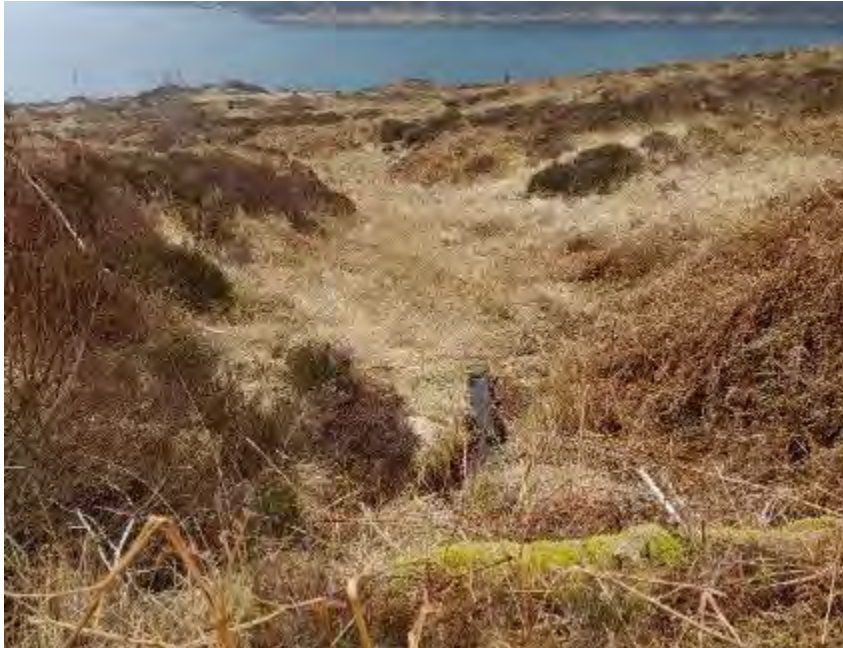
Watercourse Crossing ID	WX3.12
Watercourse Crossing Details	<p>Watercourse Crossing: WX3.12 NGR: NG 79463 23838 Watercourse Width: 0.1m Watercourse Depth: 0.2m Notes: channel upstream and downstream both heavily reeded/vegetated.</p>
Photograph Looking Upstream

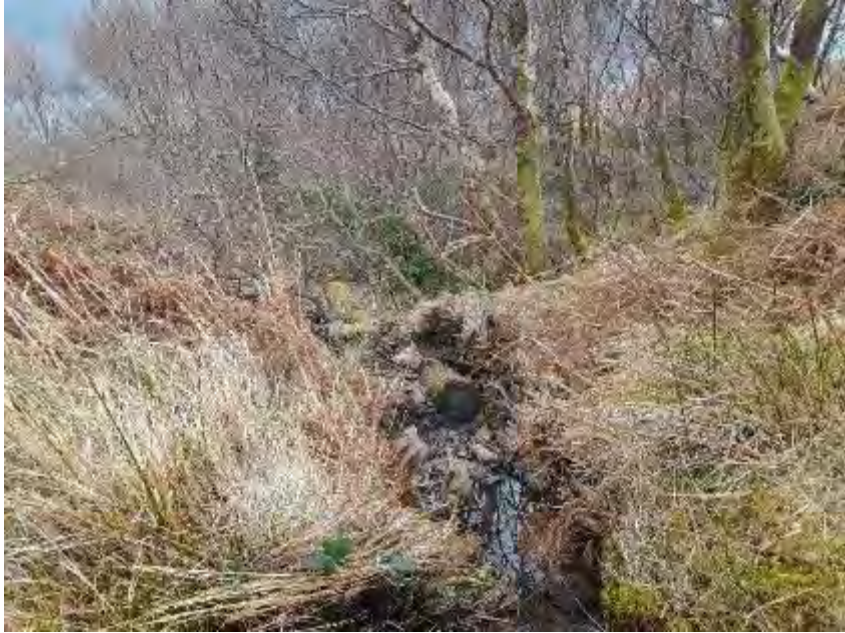
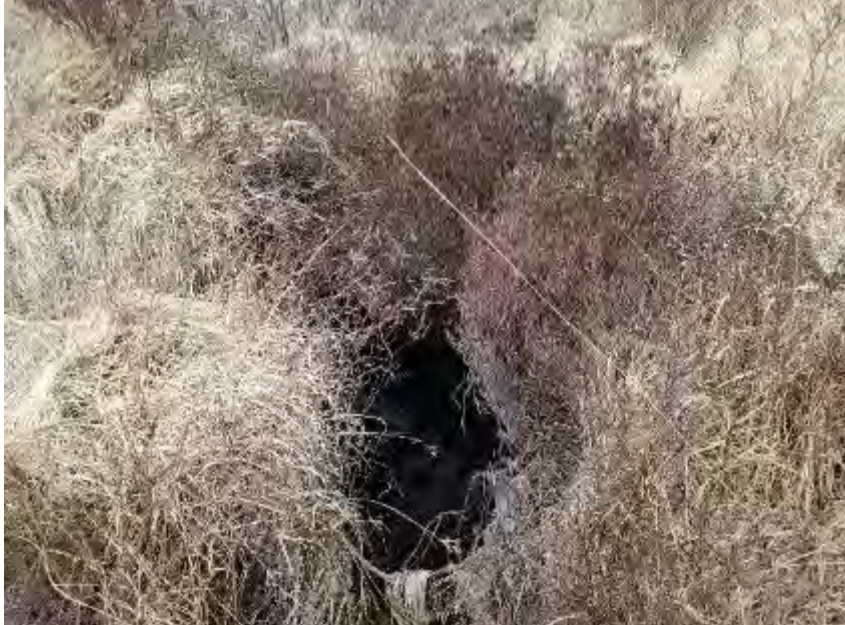
Watercourse Crossing ID	WX3.13
Watercourse Crossing Details	Watercourse Crossing: WX3.13 NGR: NG 79320 23413 Watercourse Width: 0.3m Watercourse Depth: 0.2m Notes: none
Photograph Looking Upstream

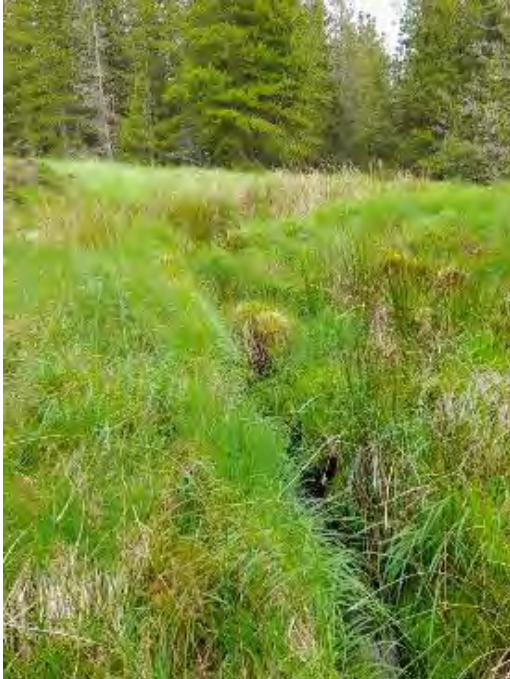
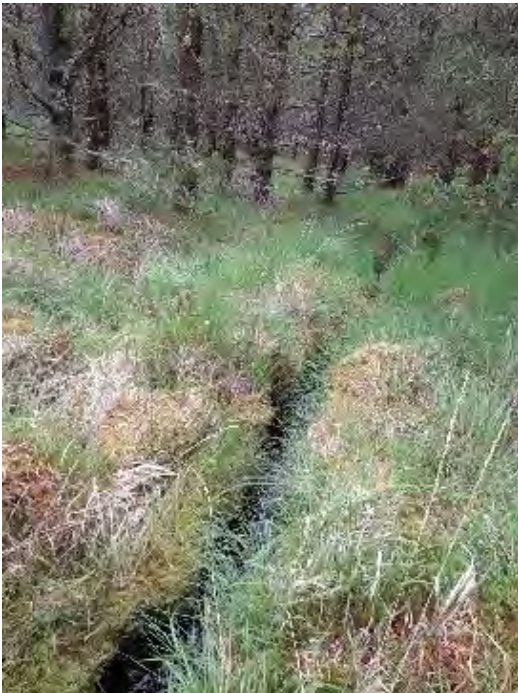
Watercourse Crossing ID	WX3.28
Watercourse Crossing Details	<p>Watercourse Crossing: WX3.28 NGR: NG 71461 23359 Watercourse Width: 0.5 m Watercourse Depth: 0.8 m Notes: Small watercourse incised in peat.</p>
Photograph Looking Upstream

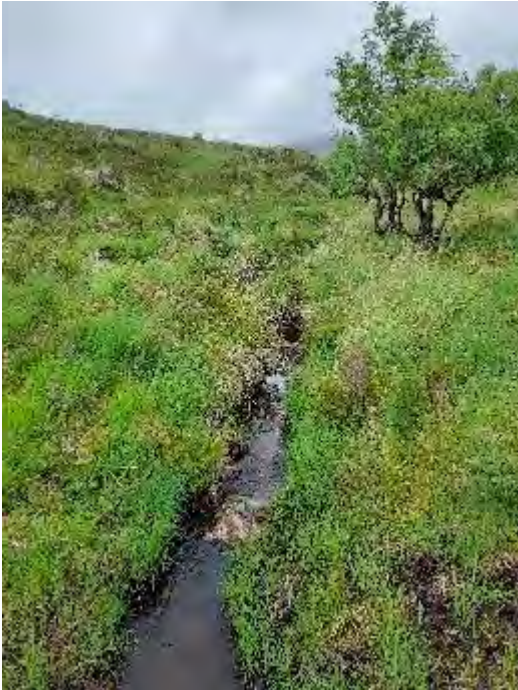
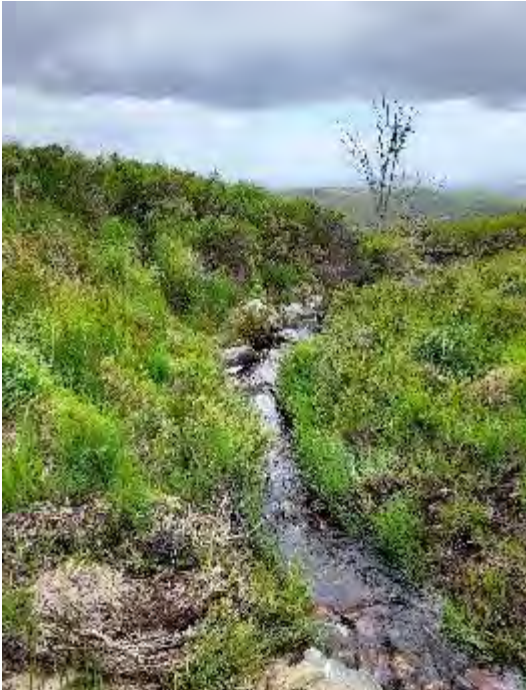
Watercourse Crossing ID	WX3.29
Watercourse Crossing Details	<p>Watercourse Crossing: WX3.29 NGR: NG 73490 24349 Watercourse Width: 0.5 m Watercourse Depth: 0.2 m Notes: Small watercourse incised in bedrock / shallow soils.</p>
Photograph Looking Upstream

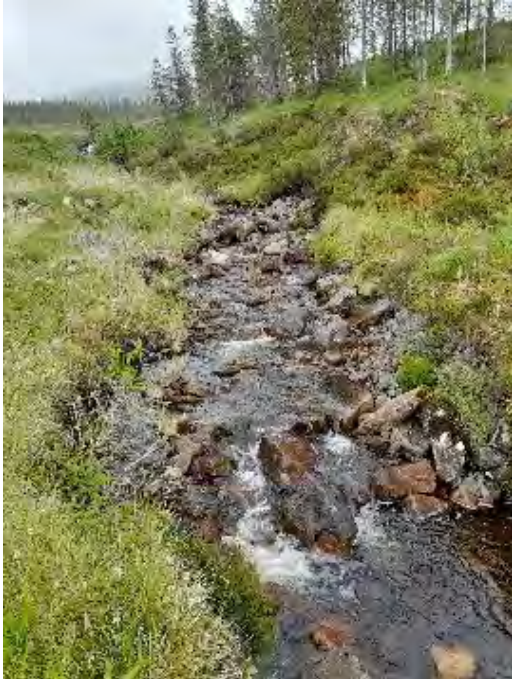
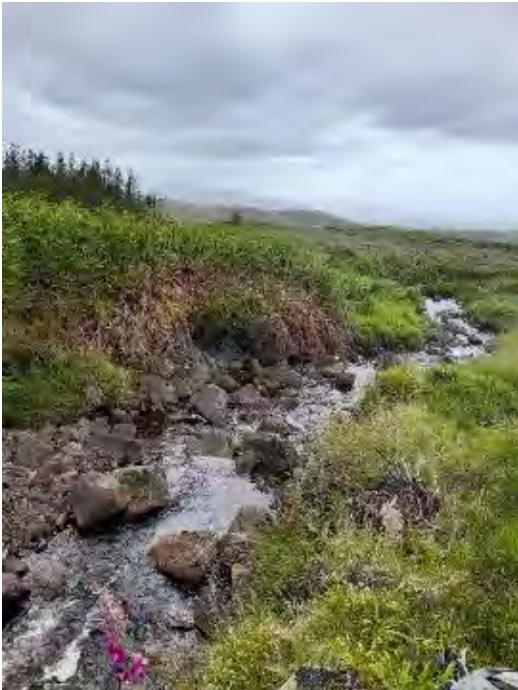
Watercourse Crossing ID	WX3.30
Watercourse Crossing Details	<p>Watercourse Crossing: WX3.30 NGR: NG 73699 24267 Watercourse Width: 1.5 m Watercourse Depth: 1.8 m Notes: Watercourse on bedrock with large boulders in channel.</p>
Photograph Looking Upstream

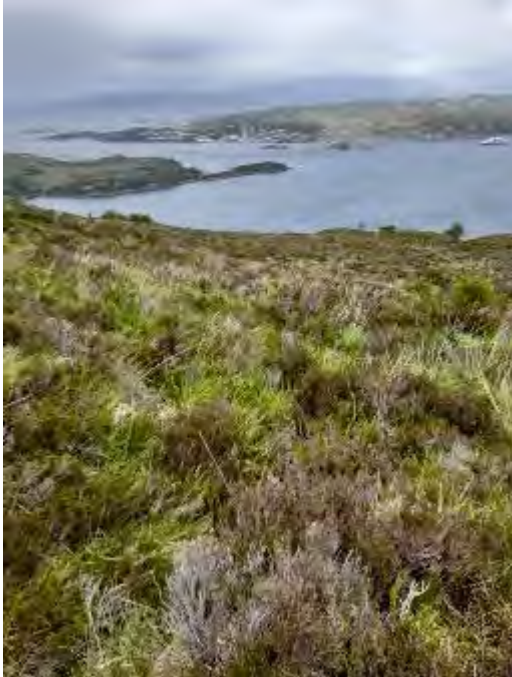
Watercourse Crossing ID	WX3.31	
Watercourse Crossing Details	<p>Watercourse Crossing: WX3.31 NGR: NG 76283 24538 Watercourse Width: 0.3 m Watercourse Depth: 1 m Notes: Channel incised in peat with bedrock noted at the bed of the watercourse.</p>	
Photograph Looking Upstream

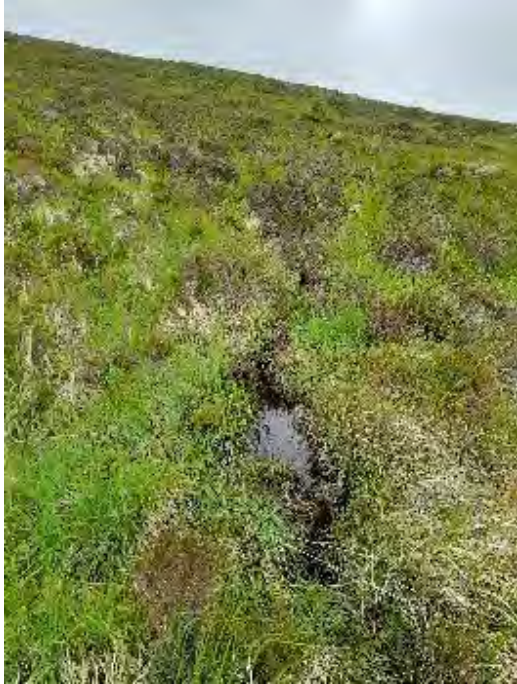
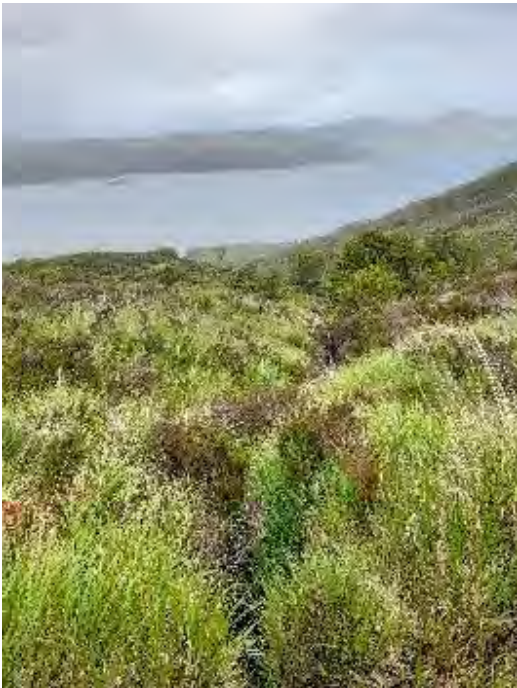
Watercourse Crossing ID	WX3.32
Watercourse Crossing Details	Watercourse Crossing: WX3.32 NGR: NG 76317 24509 Watercourse Width: 0.2 m Watercourse Depth: 0.2 m Notes: Small channel.
Photograph Looking Upstream

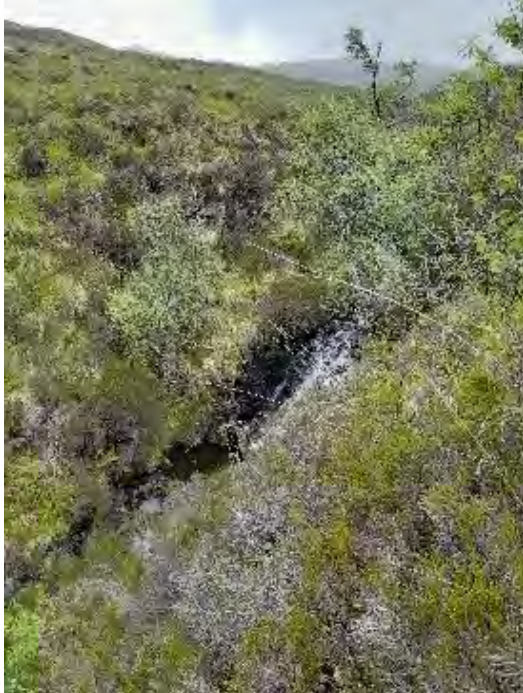
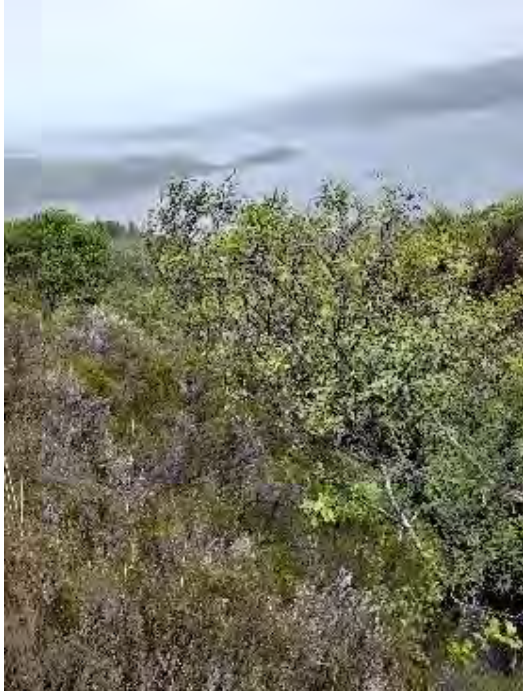
Watercourse Crossing ID	WX3.33
Watercourse Crossing Details	Watercourse Crossing: WX3.33 NGR: NG 76444 24483 Watercourse Width: 5 m Watercourse Depth: 0.8 m Notes: Deep watercourse incised in bedrock
Photograph Looking Upstream

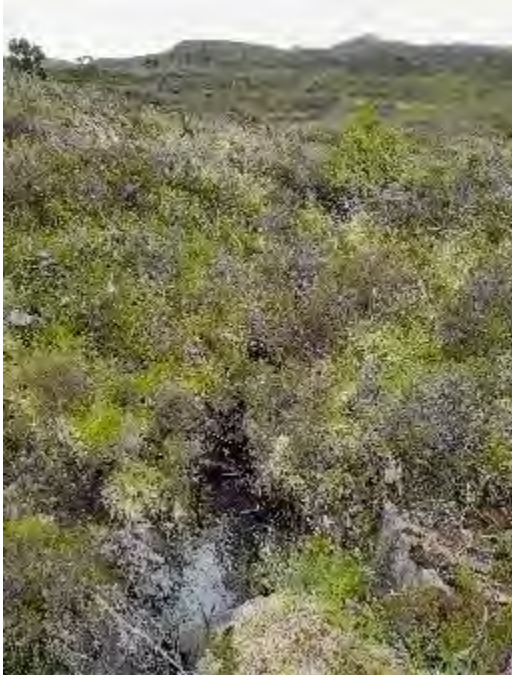
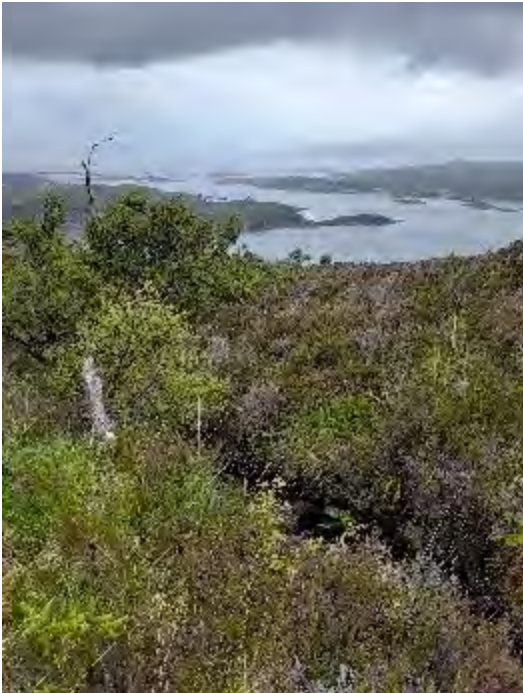
Watercourse Crossing ID	WX3.34
Watercourse Crossing Details	<p>Watercourse Crossing: WX3.34 NGR: NG 76566 24527 Watercourse Width: 0.3 m Watercourse Depth: 0.4 m Notes: Small watercourse incised in bedrock.</p>
Photograph Looking Upstream

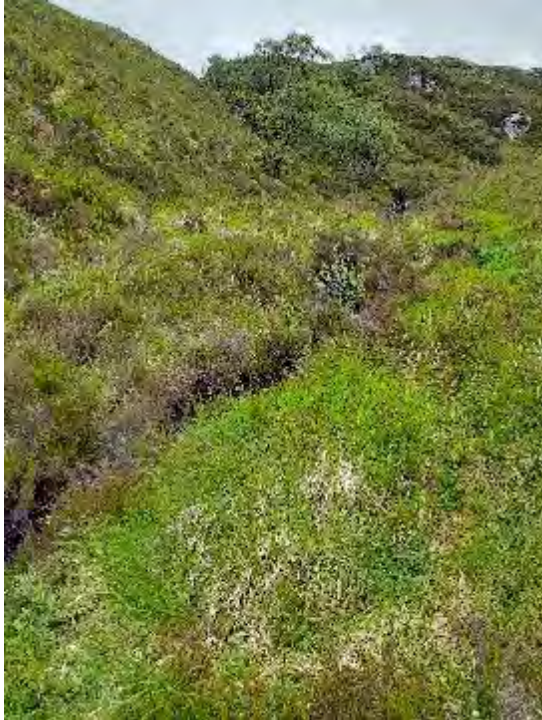
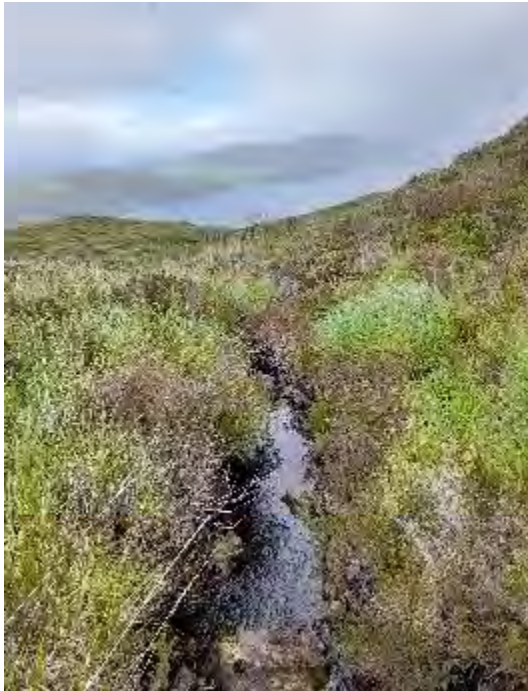
Watercourse Crossing ID	WX3.35
Watercourse Crossing Details	<p>Watercourse Crossing: WX3.35 NGR: NG 77137 24540 Watercourse Width: 0.5 m Watercourse Depth: 0.6 m Notes: Small watercourse on bedrock.</p>
Photograph Looking Upstream

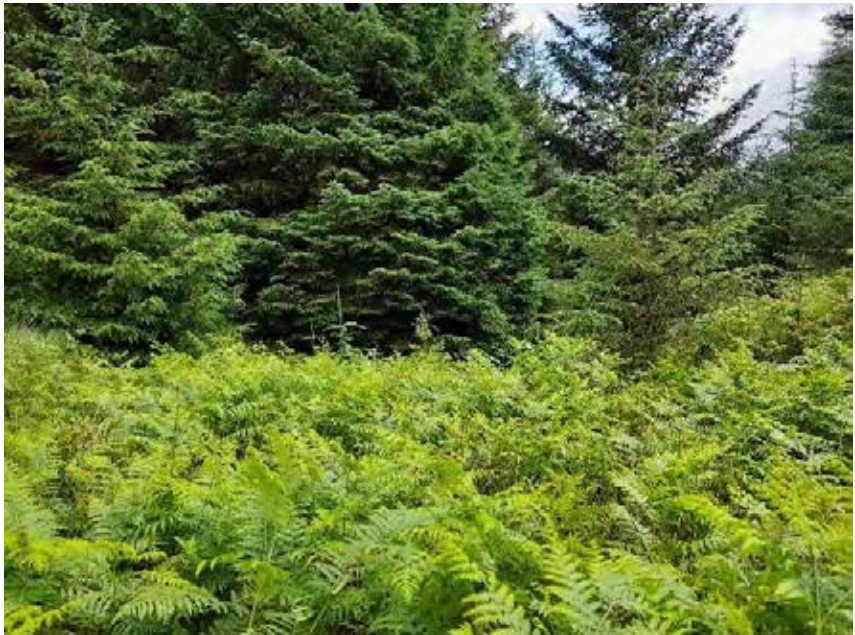
Watercourse Crossing ID	WX4.17
Watercourse Crossing Details	<p>Watercourse Crossing: WX4.17 NGR: NG 81269 22164 Watercourse Width: N/A Watercourse Depth: N/A Notes: No active channel noted at crossing location. The wider channel area extended to approximately 5m wide, with waterlogged soils and bracken. Watercourse becomes more defined downstream of crossing location.</p>
Photograph Looking Upstream

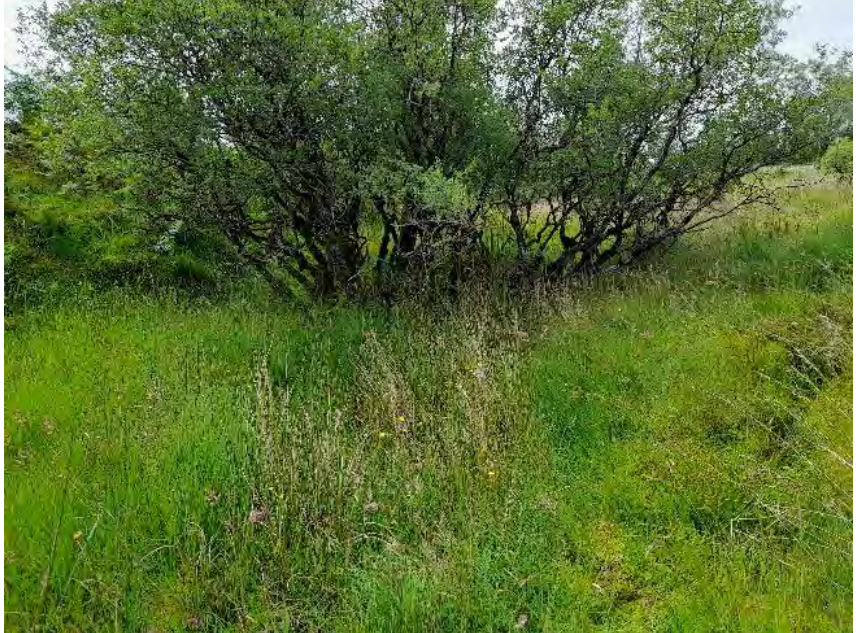
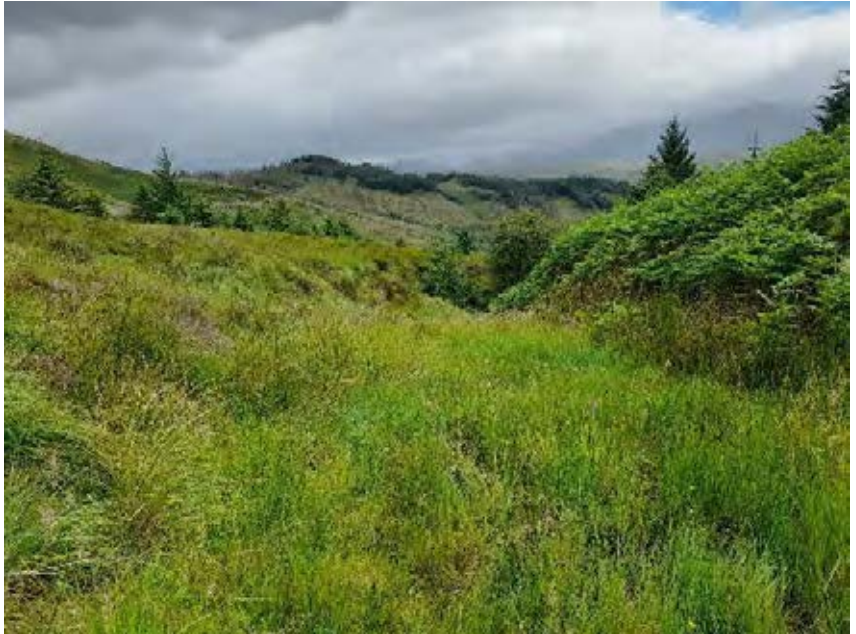
Watercourse Crossing ID	WX4.18
Watercourse Crossing Details	<p>Watercourse Crossing: WX4.18 NGR: NG 81324 22169 Watercourse Width: 0.2 m Watercourse Depth: 0.1 m Notes: Watercourse located in a wider reeded channel approximately 3 m wide and 3 m high.</p>
Photograph Looking Upstream

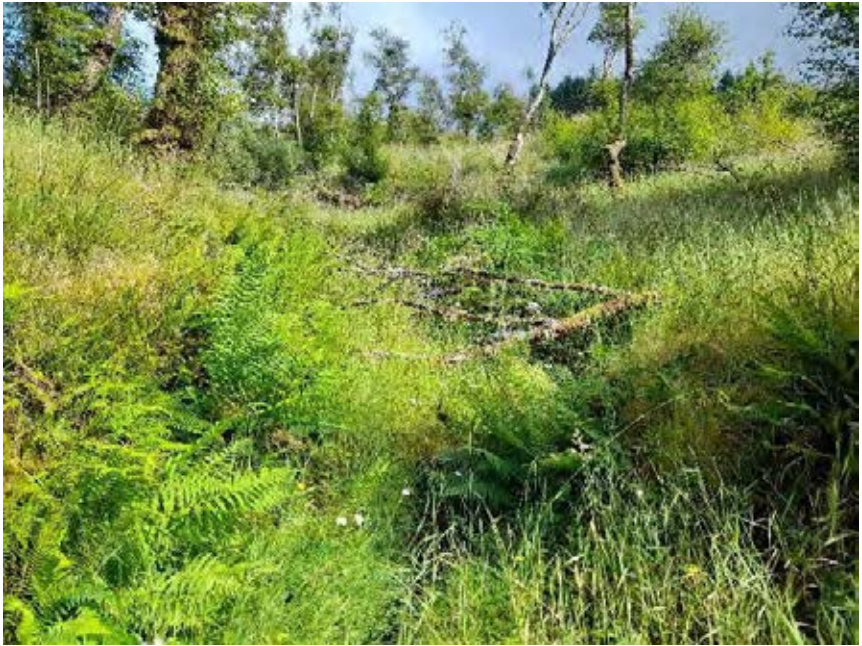
Watercourse Crossing ID	WX4.19
Watercourse Crossing Details	<p>Watercourse Crossing: WX4.19 NGR: NG 81740 21417 Watercourse Width: 0.3 m Watercourse Depth: 0.4 m Notes: Steep watercourse incised in superficial deposits and heavily vegetated channel. Watercourse surveyed approximately 150 m downstream of crossing point as crossing point was inaccessible.</p>
Photograph Looking Upstream

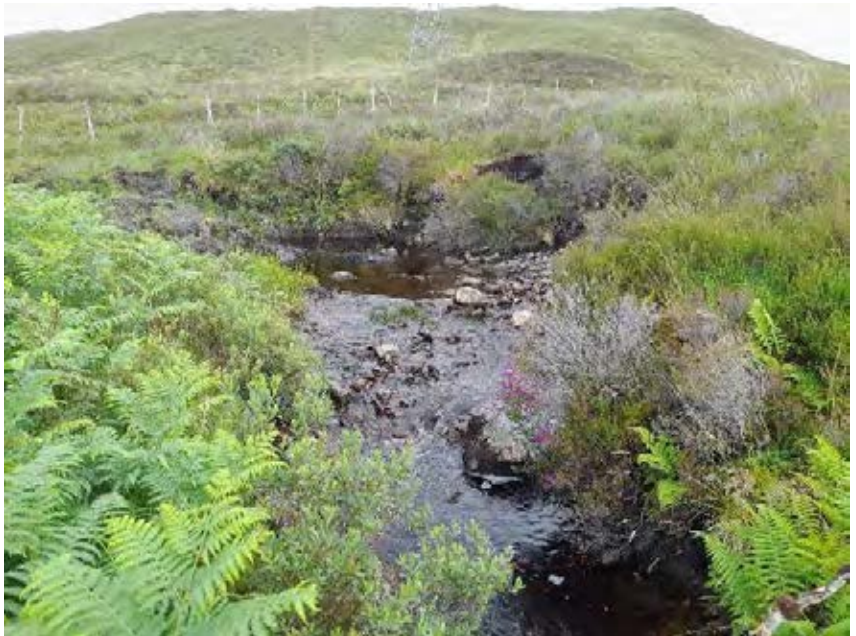
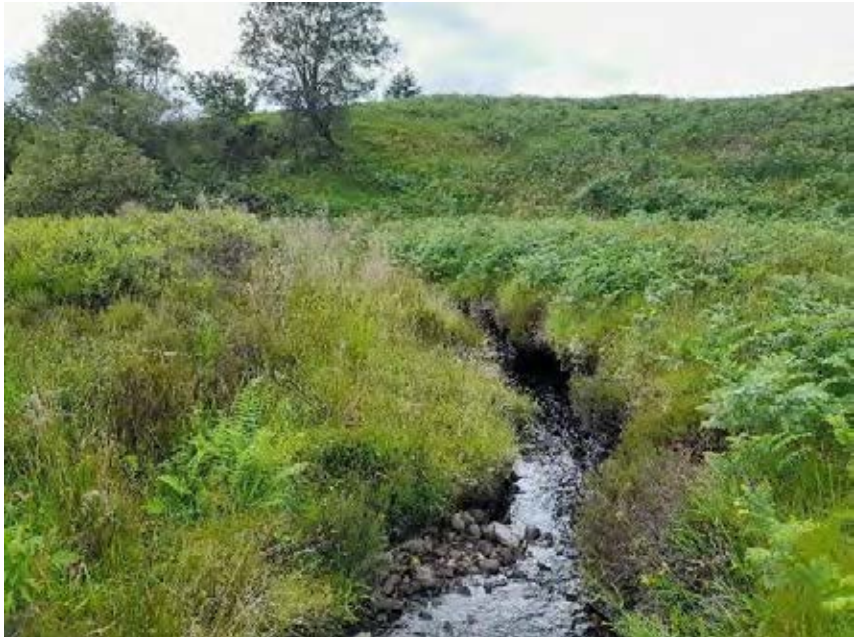
Watercourse Crossing ID	WX4.21
Watercourse Crossing Details	<p>Watercourse Crossing: WX4.21 NGR: NG 82642 20961 Watercourse Width: 1 m Watercourse Depth: 0.5 m Notes: Incised in peat and superficial deposits.</p>
Photograph Looking Upstream

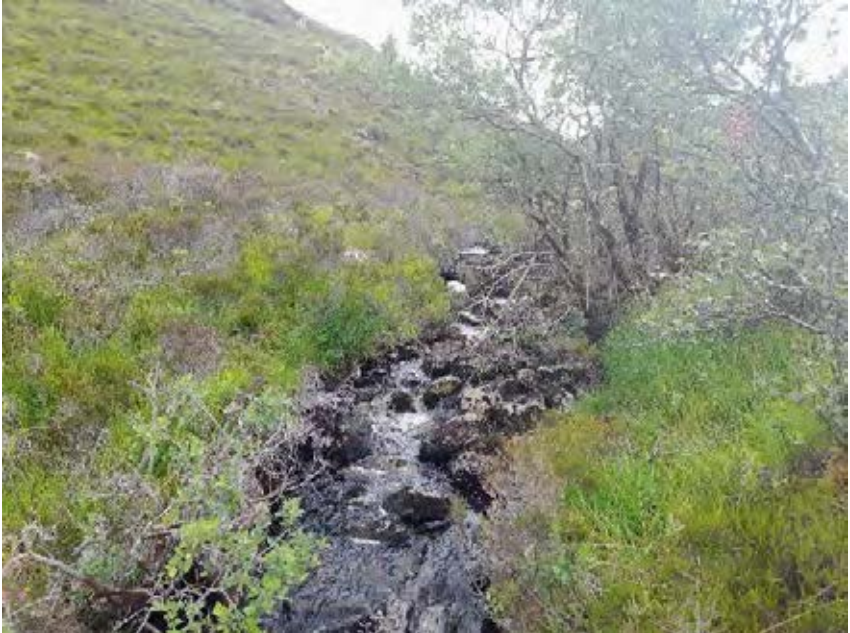
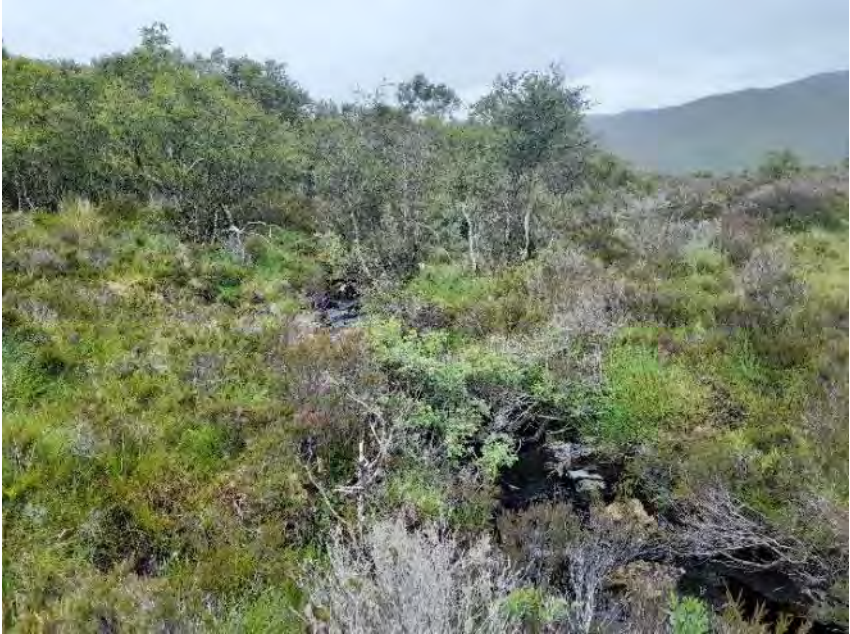
Watercourse Crossing ID	WX4.23
Watercourse Crossing Details	Watercourse Crossing: WX4.23 NGR: NG 84303 19017 Watercourse Width: 1.5 m Watercourse Depth: 0.5 m Notes: On bedrock and boulders in channel.
Photograph Looking Upstream

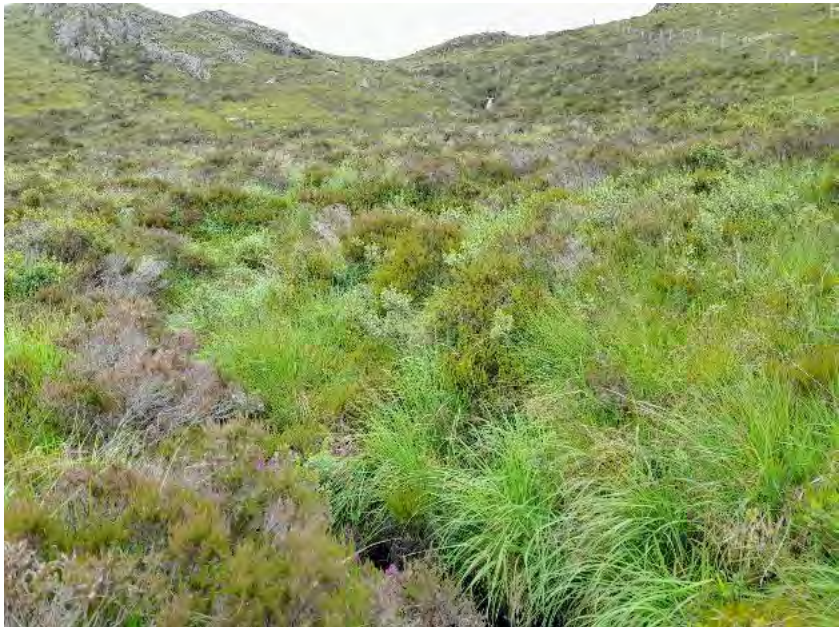
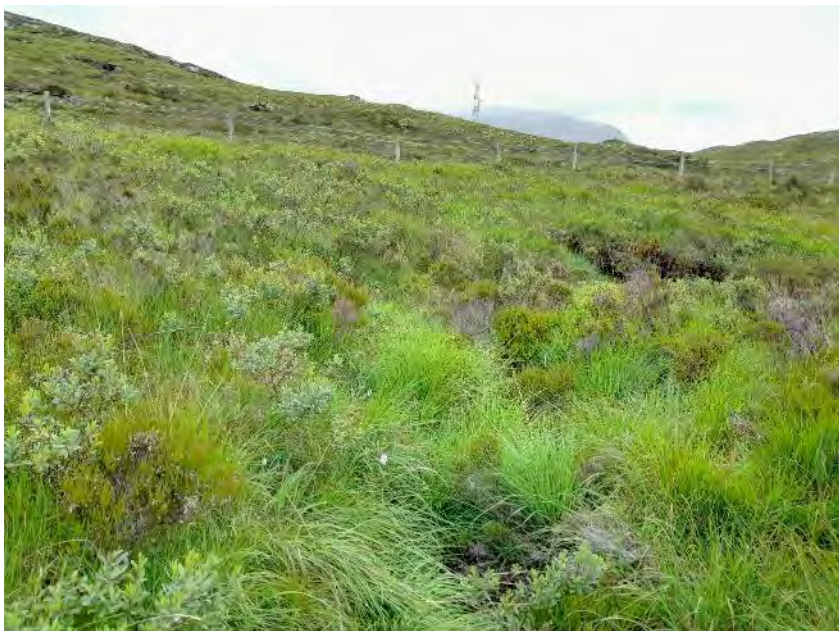
Watercourse Crossing ID	WX4.24
Watercourse Crossing Details	Watercourse Crossing: WX4.24 NGR: NG 84519 17963 Watercourse Width: 1 m Watercourse Depth: 0.9 m Notes: Small meandering watercourse incised in peat.
Photograph Looking Upstream

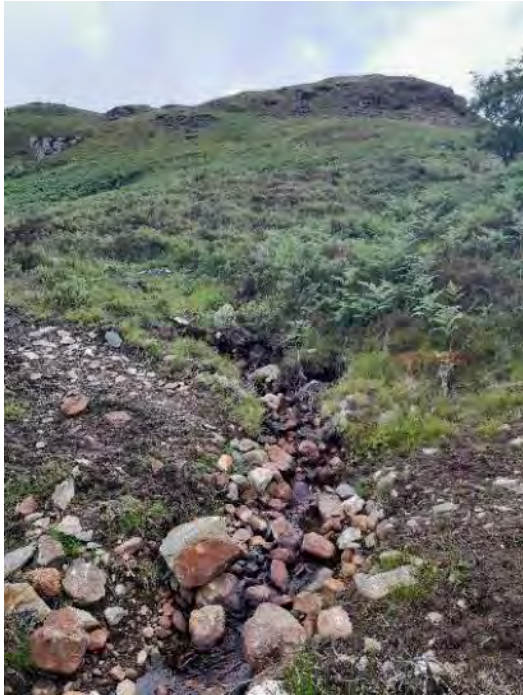
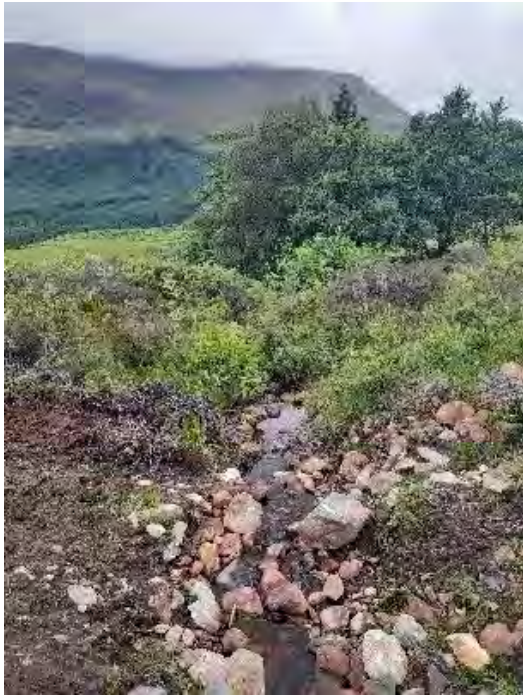
Watercourse Crossing ID	WX4.25
Watercourse Crossing Details	Watercourse Crossing: WX4.25 NGR: NG 85114 17126 Watercourse Width: 0.5 m Watercourse Depth: 0.2 m Notes: Small watercourse incised in superficial deposits.
Photograph Looking Upstream

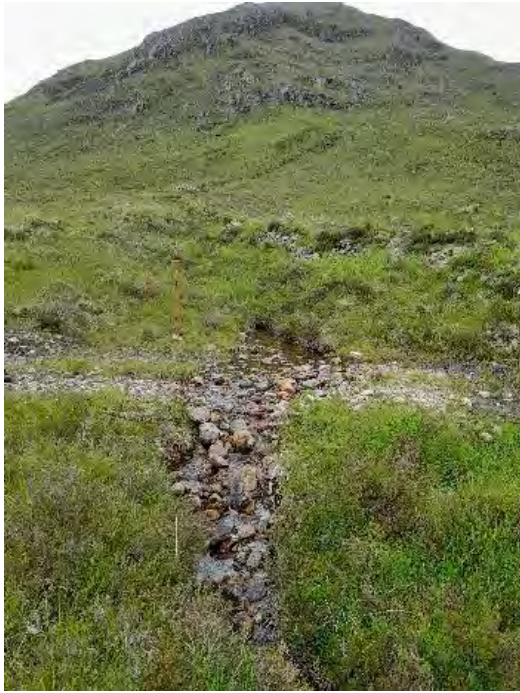
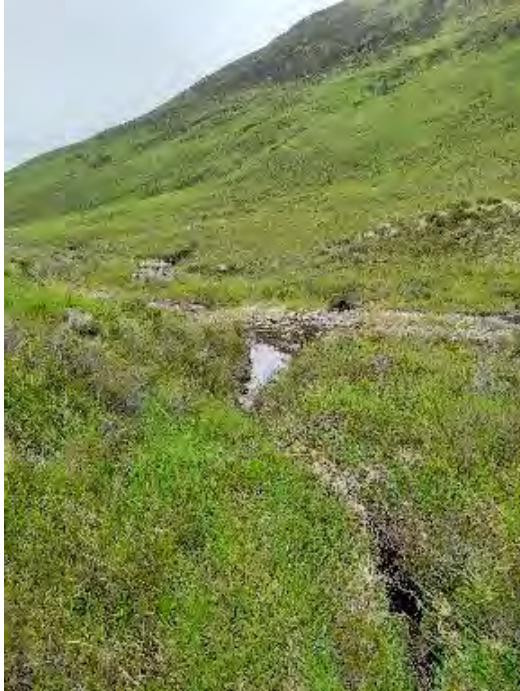
Watercourse Crossing ID	WX4.26
Watercourse Crossing Details	Watercourse Crossing: WX4.26 NGR: NG 87537 14158 Watercourse Width: 1 m Watercourse Depth: 0.2 m Notes: Small steep watercourse.
Photograph Looking Upstream

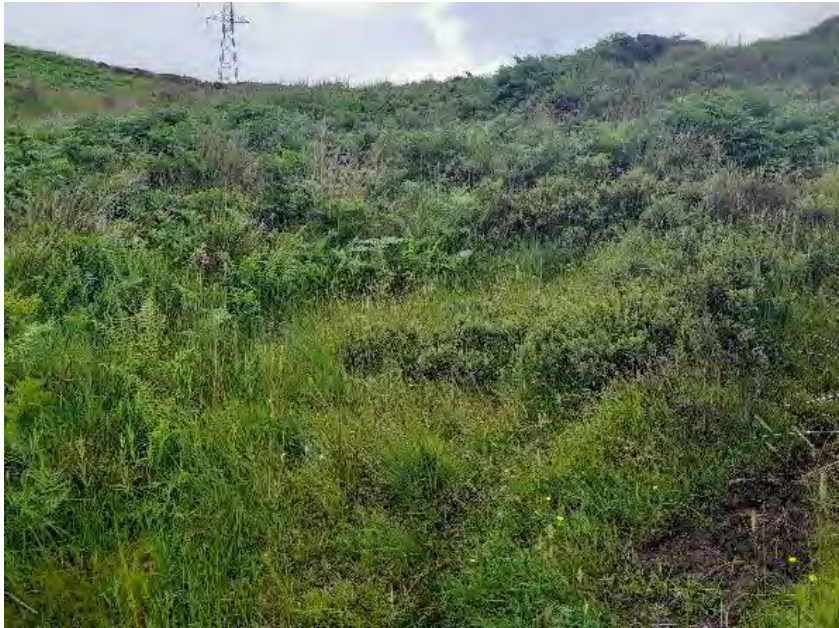
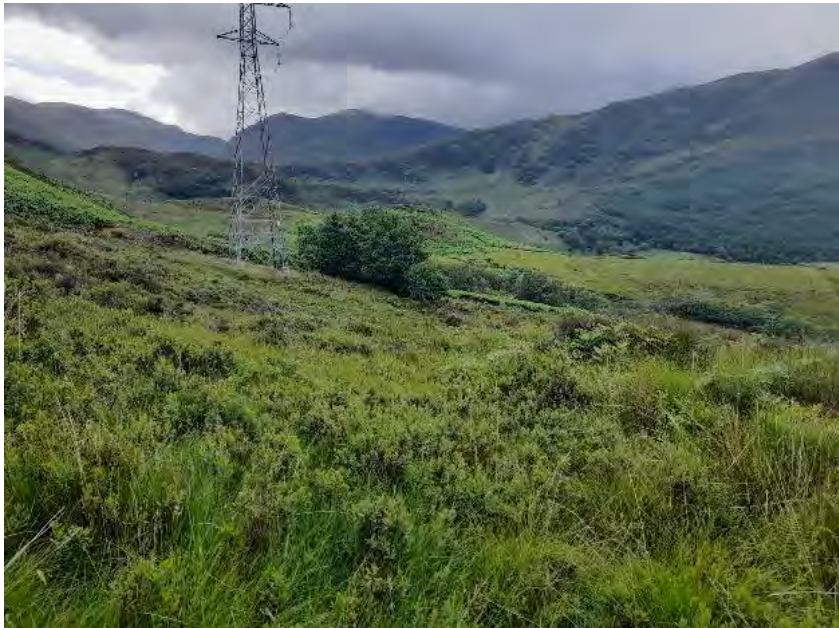
Watercourse Crossing ID	WX4.27
Watercourse Crossing Details	<p>Watercourse Crossing: WX4.27 NGR: NG 85071 17184 Watercourse Width: 0.1 m Watercourse Depth: 0.1 m Notes: Small surface water incised in peat, near the start of the watercourse. Watercourse located within a larger channel 1.5 m wide and 0.5 m deep.</p>
Photograph Looking Upstream

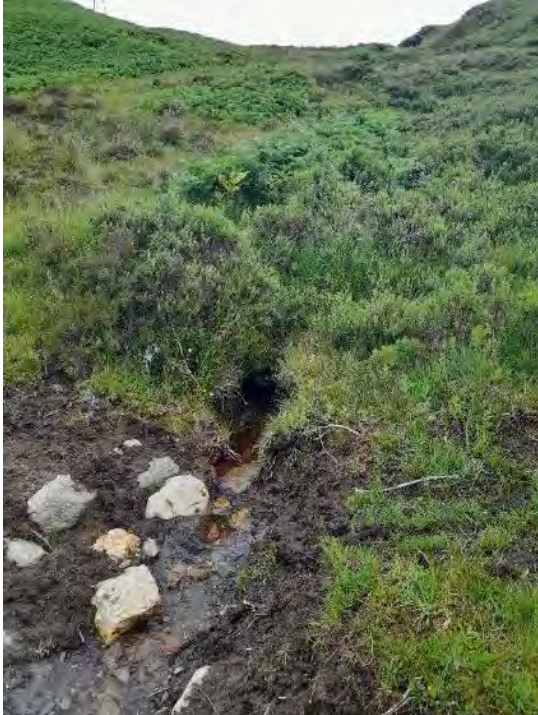
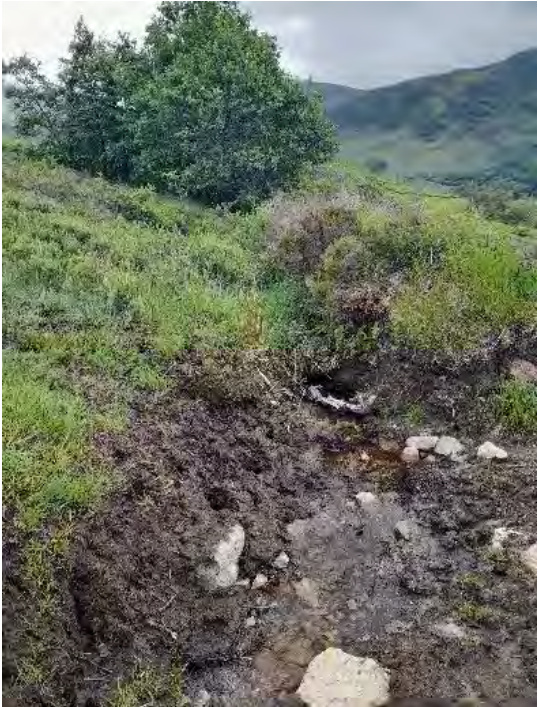
Watercourse Crossing ID	WX4.28
Watercourse Crossing Details	Watercourse Crossing: WX4.28 NGR: NG 85081 17145 Watercourse Width: 0.2 m Watercourse Depth: 0.4 m to 0.9 m Notes: Small watercourse incised in peat.
Photograph Looking Upstream
