SKYE REINFORCEMENT PROJECT

Appendix V2-6.2: Schedule of Permanent Watercourse Crossings

Prepared for: Scottish & Southern Electricity
Networks Transmission (SSEN Transmission)

SLR Ref: 428.04707.00020
Version No: Final
September 2022

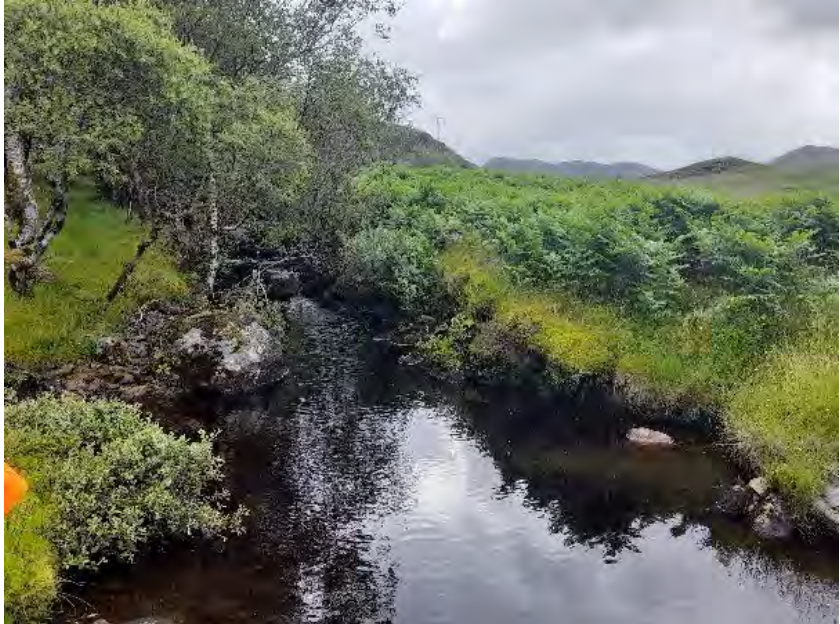
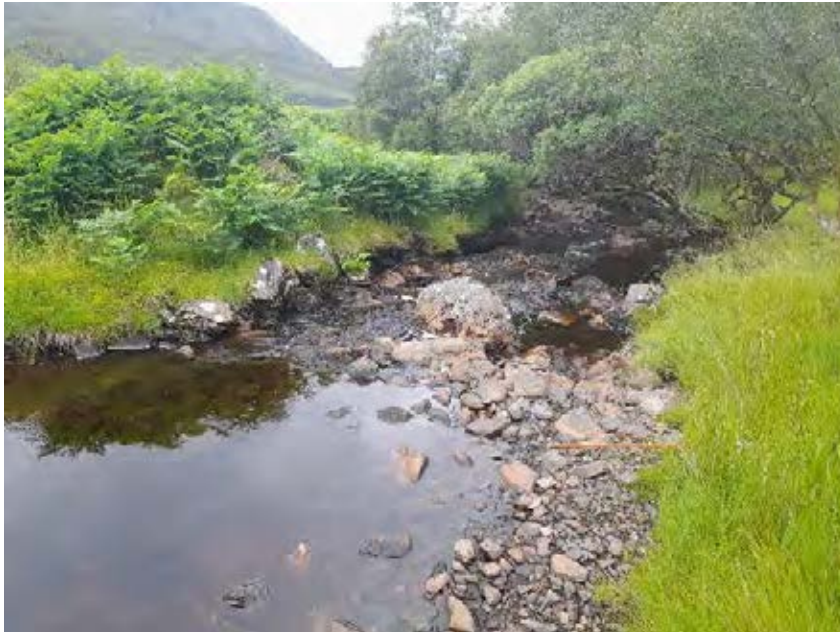
Watercourse Crossing ID	WX4.29
Watercourse Crossing Details	Watercourse Crossing: WX4.29 NGR: NG 85208 16953 Watercourse Width: 3 m Watercourse Depth: 0.1 m to 0.4 m Notes: Large watercourse with boulders and ripples in channel.
Photograph Looking Upstream

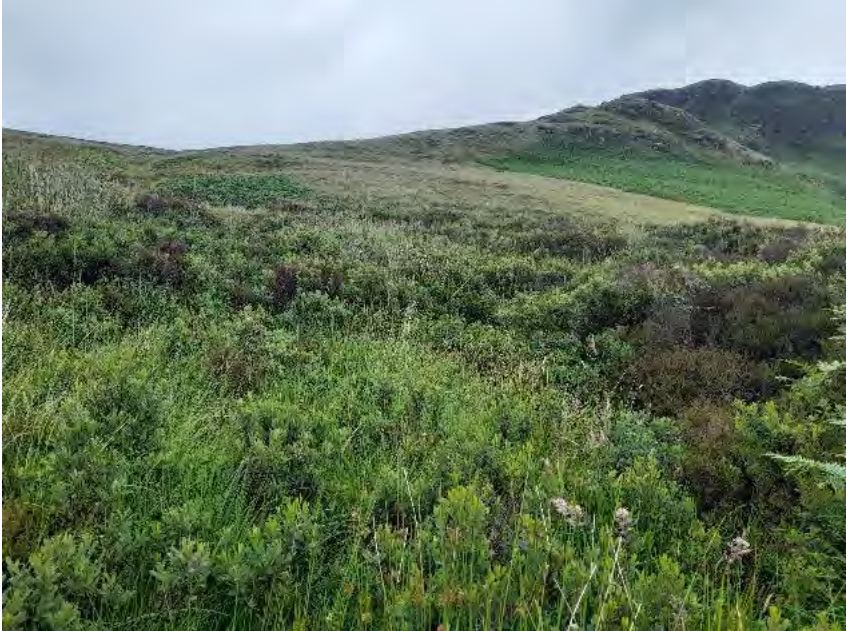
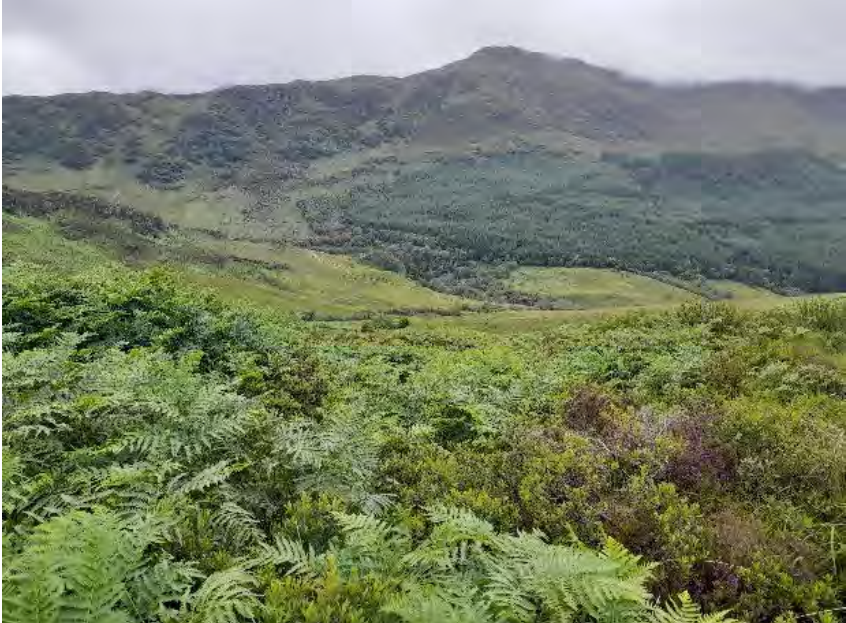
Watercourse Crossing ID	WX4.30
Watercourse Crossing Details	Watercourse Crossing: WX4.30 NGR: NG 85590 16643 Watercourse Width: 1 m Watercourse Depth: 0.6 m Notes: Small meandering watercourse which is heavily vegetated.
Photograph Looking Upstream

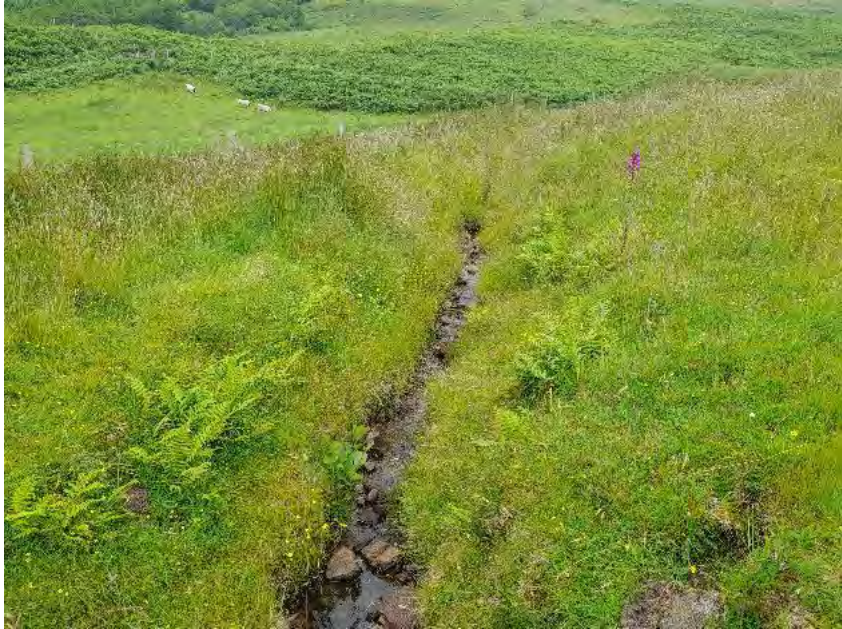
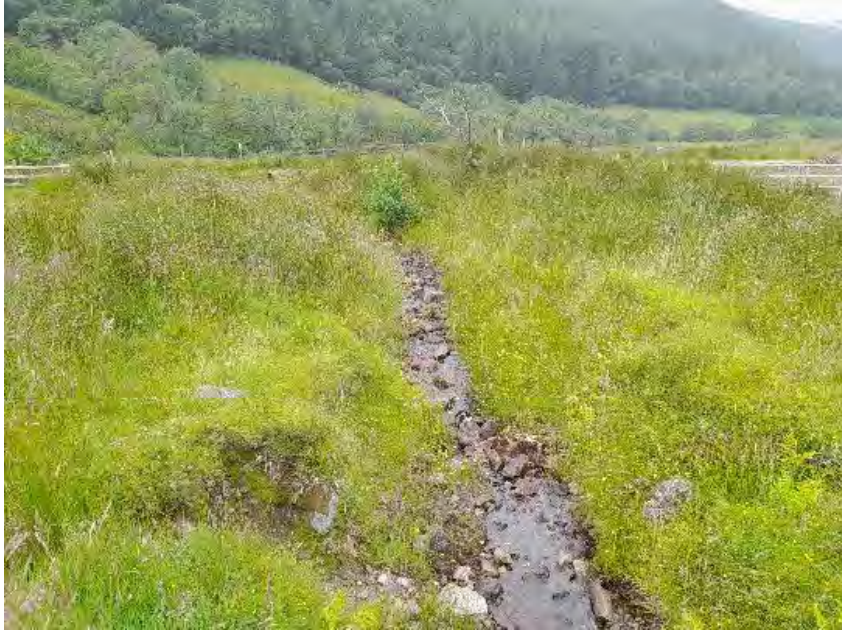
Watercourse Crossing ID	WX4.34
Watercourse Crossing Details	Watercourse Crossing: WX4.34 NGR: NG 84967 16372 Watercourse Width: 0.3 m Watercourse Depth: 0.2 m Notes: Small watercourse with steady flow.
Photograph Looking Upstream

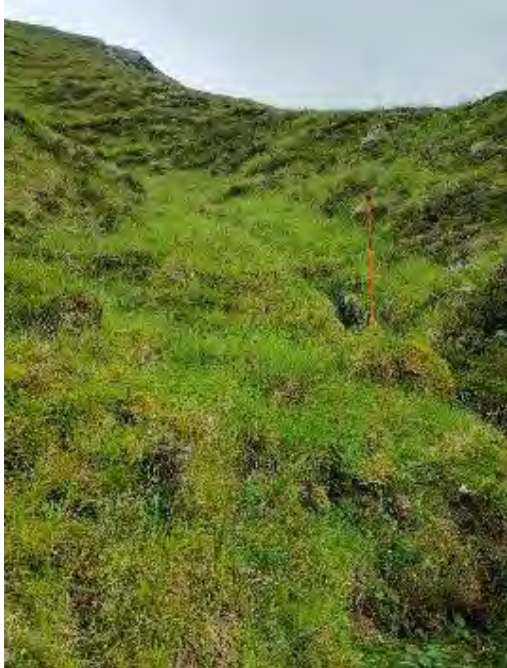
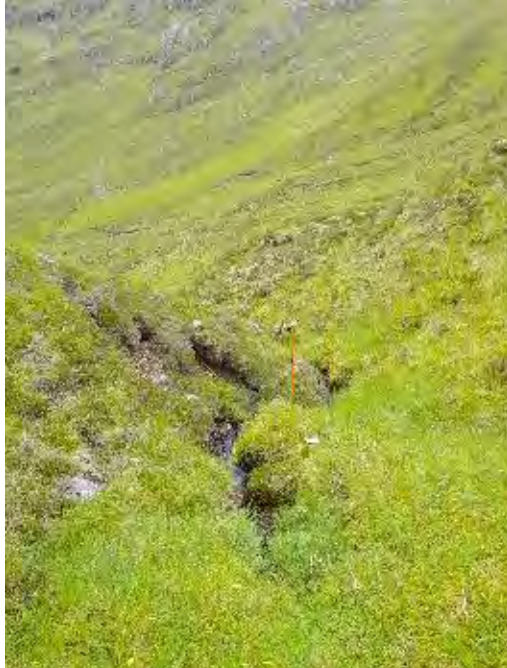
Watercourse Crossing ID	WX4.46
Watercourse Crossing Details	<p>Watercourse Crossing: WX4.46 NGR: NG 87908 12635 Watercourse Width: 1.5 m Watercourse Depth: 4 m Notes: Steep watercourse in wider channel, approximately 6 m wide, which is incised in bedrock.</p>
Photograph Looking Upstream

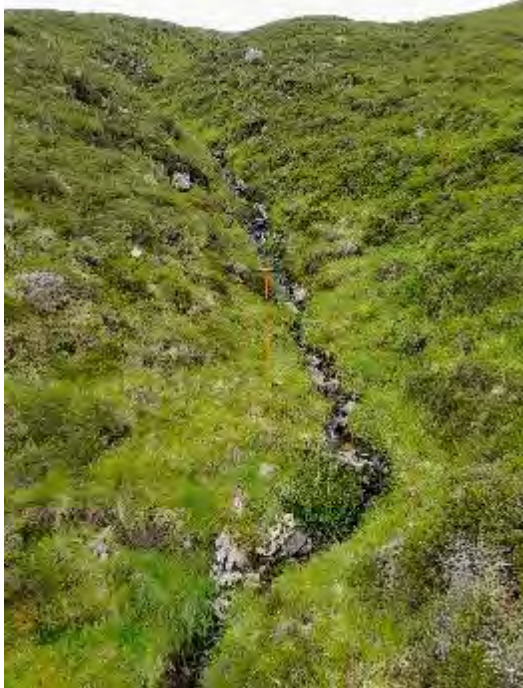
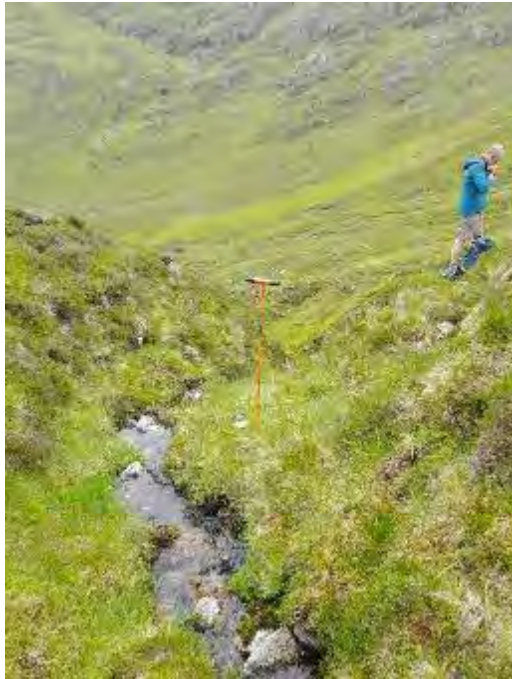
Watercourse Crossing ID	WX4.47
Watercourse Crossing Details	<p>Watercourse Crossing: WX4.47 NGR: NG 87911 12600 Watercourse Width: 1.5 m Watercourse Depth: 2.5 m Notes: Small steep watercourse in a slightly wider channel, approximately 4 m wide, which is incised in bedrock.</p>
Photograph Looking Upstream

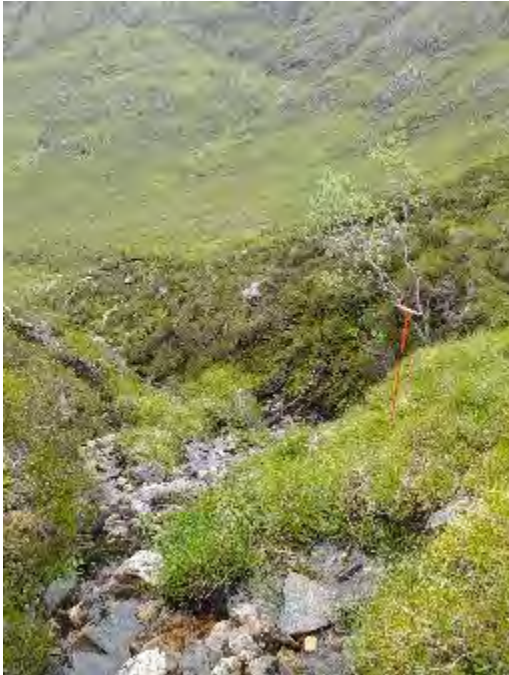
Photograph Looking Downstream

Watercourse Crossing ID	WX4.48
Watercourse Crossing Details	<p>Watercourse Crossing: WX4.48 NGR: NG 87914 12564 Watercourse Width: 1 m Watercourse Depth: 3 m Notes: Steep watercourse in a defined channel with boulders in channel. Recommended to move slightly downstream where slopes are less steep.</p>
Photograph Looking Upstream

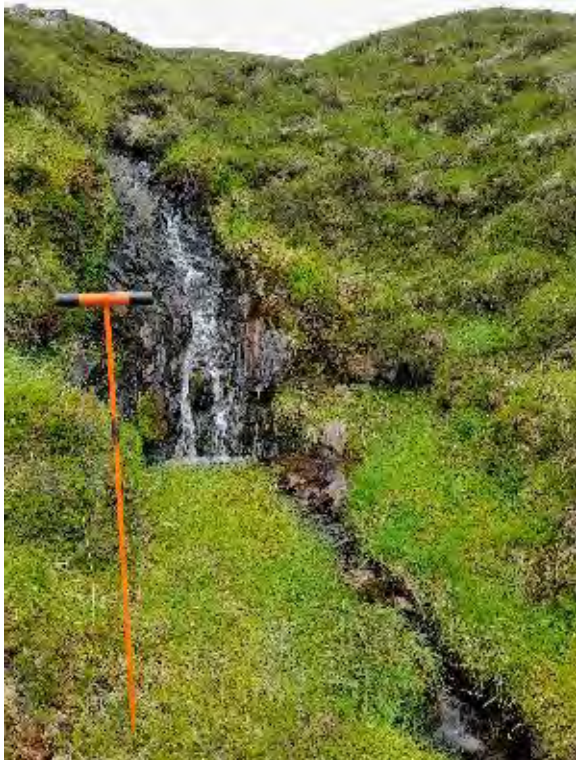
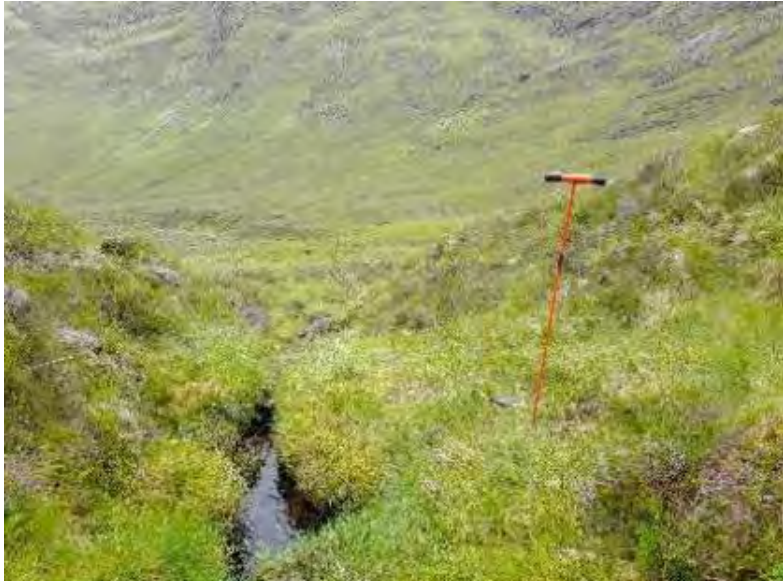
Watercourse Crossing ID	WX4.49
Watercourse Crossing Details	<p>Watercourse Crossing: WX4.49 NGR: NG 87934 12472 Watercourse Width: 0.2 m Watercourse Depth: 0.5 m Notes: Watercourse incised in bedrock in a wider channel approximately 5.5 m wide and 3.5 m deep. Watercourse invert immediately upstream of crossing, approximately 2 m higher.</p>
Photograph Looking Upstream

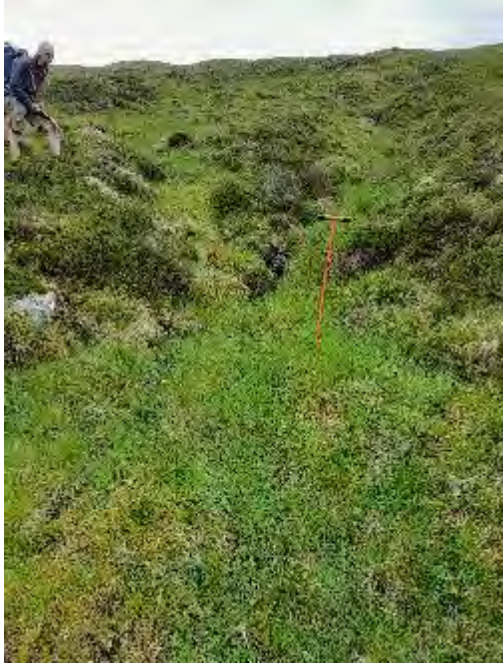
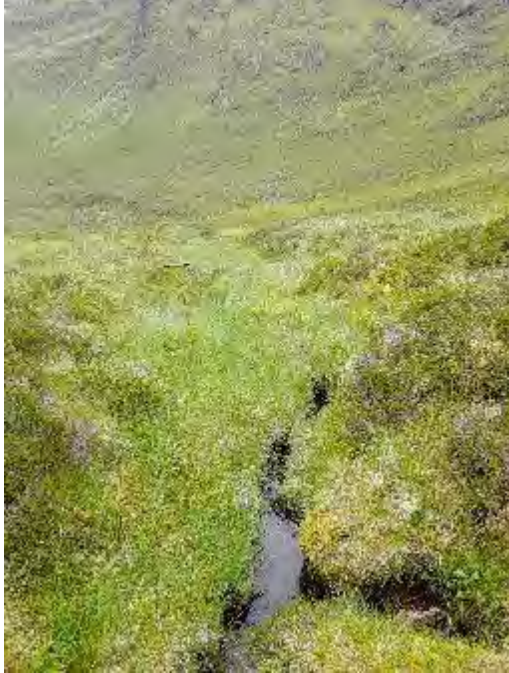
Watercourse Crossing ID	WX4.50
Watercourse Crossing Details	<p>Watercourse Crossing: WX4.50 NGR: NG 87949 12432 Watercourse Width: 0.4 m Watercourse Depth: 0.4 m Notes: Watercourse located in a wider channel approximately 3.5 m wide and 1.5 m high. Watercourse is incised in bedrock.</p>
Photograph Looking Upstream

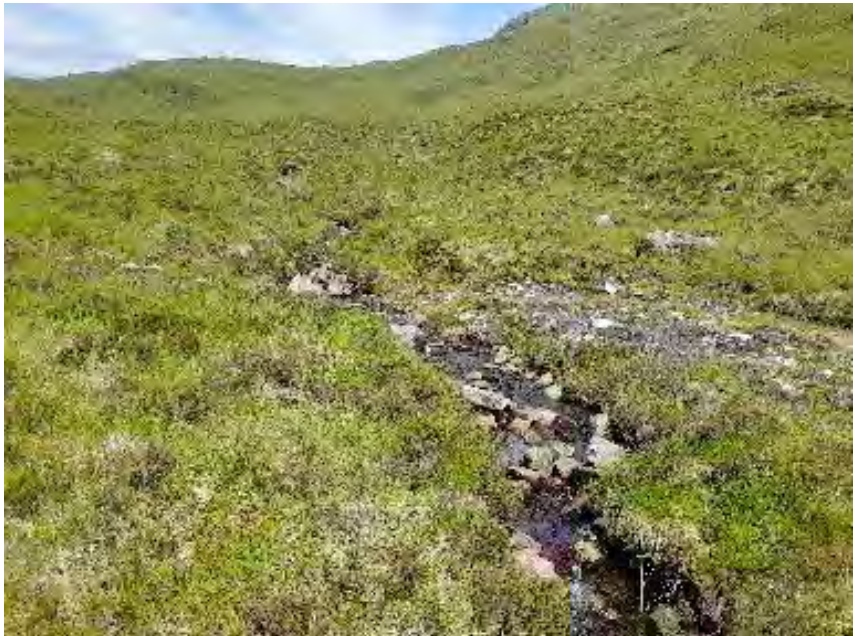
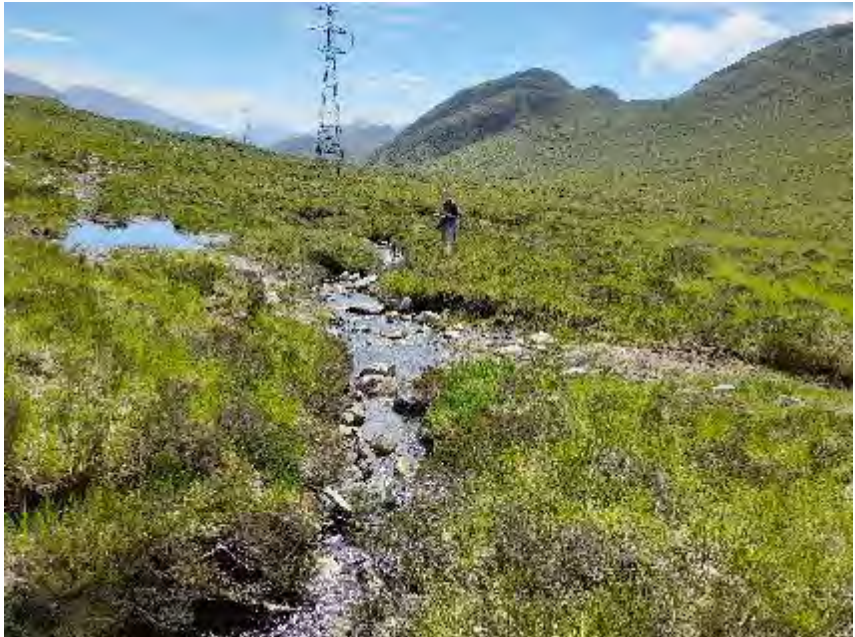
Watercourse Crossing ID	WX4.53
Watercourse Crossing Details	Watercourse Crossing: WX4.53 NGR: NG 88887 11745 Watercourse Width: 0.8 m Watercourse Depth: 0.5 m Notes: On bedrock with numerous boulders in channel.
Photograph Looking Upstream

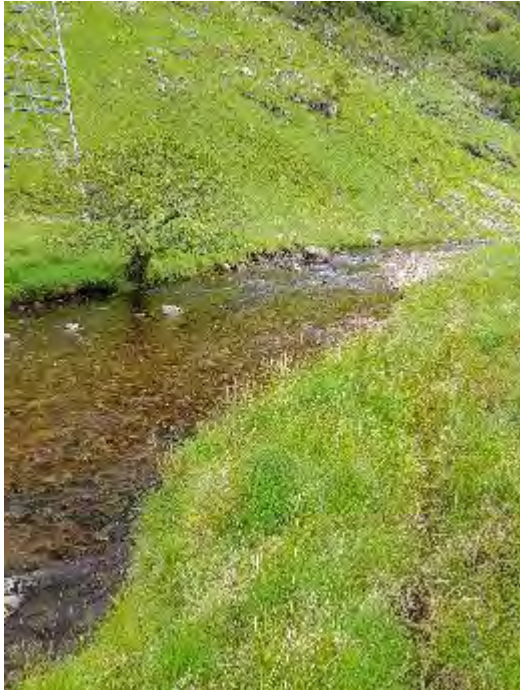
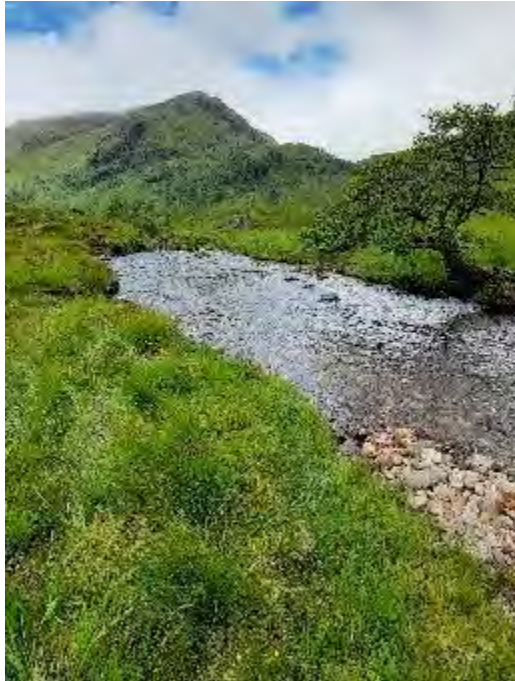
Watercourse Crossing ID	WX4.57
Watercourse Crossing Details	<p>Watercourse Crossing: WX4.57 NGR: NG 91013 10090 Watercourse Width: 10 m Watercourse Depth: 1.5 m Notes: Large meandering watercourse on bedrock.</p>
Photograph Looking Upstream

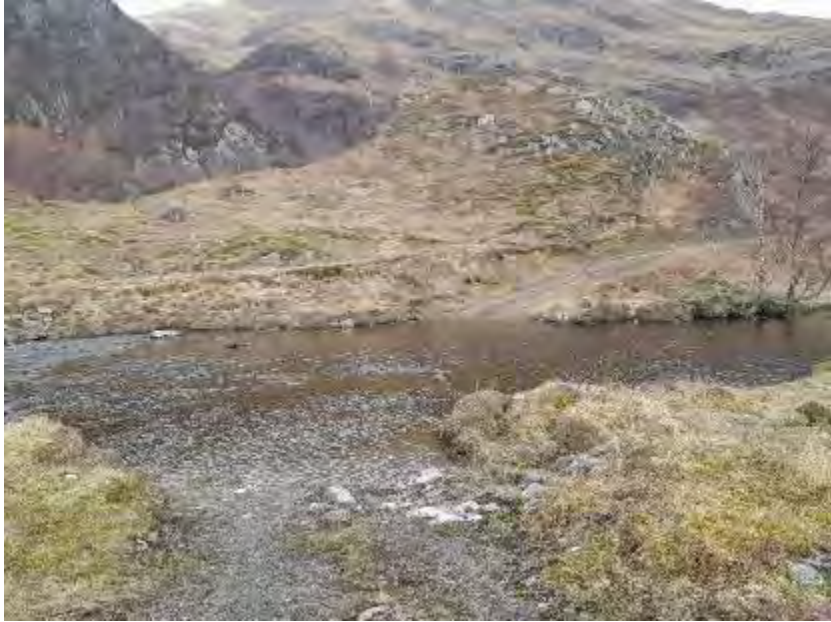
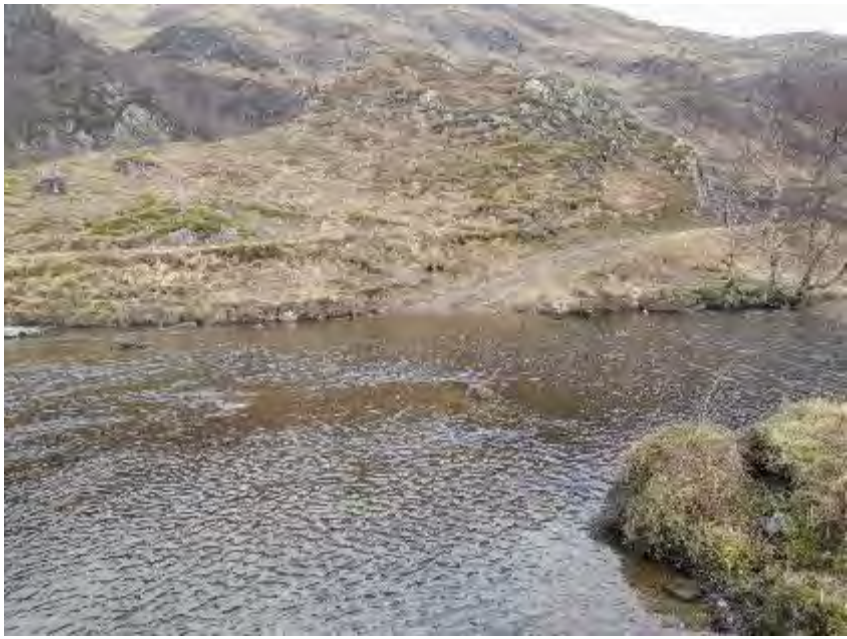
Watercourse Crossing ID			WX4.82
Watercourse Crossing Details			<p>Watercourse Crossing: WX4.82 NGR: NG 95919 05593 Watercourse Width: 30 m Watercourse Depth: 1 m Notes: Large existing ford.</p>
Photograph Watercourse	Looking	Across

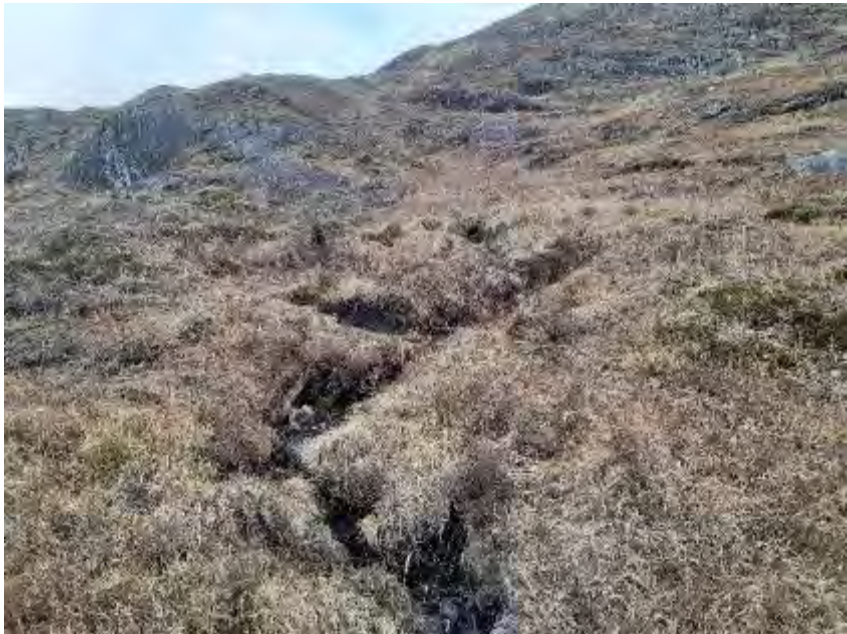
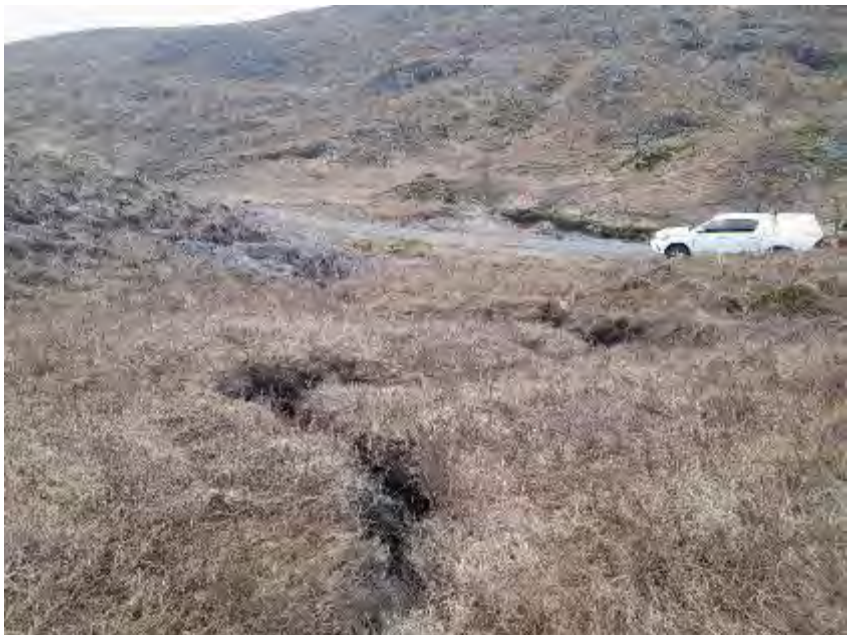
Watercourse Crossing ID	WX4.84
Watercourse Crossing Details	Watercourse Crossing: WX4.84 NGR: NG 97741 03796 Watercourse Width: 0.1m Watercourse Depth: 0.4m Notes: Incised into peat.
Photograph Looking Upstream

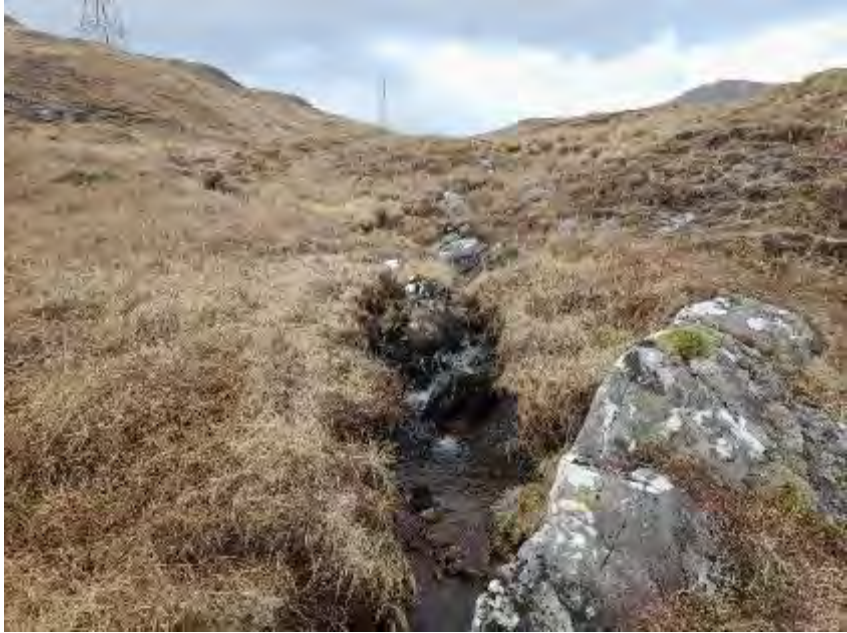
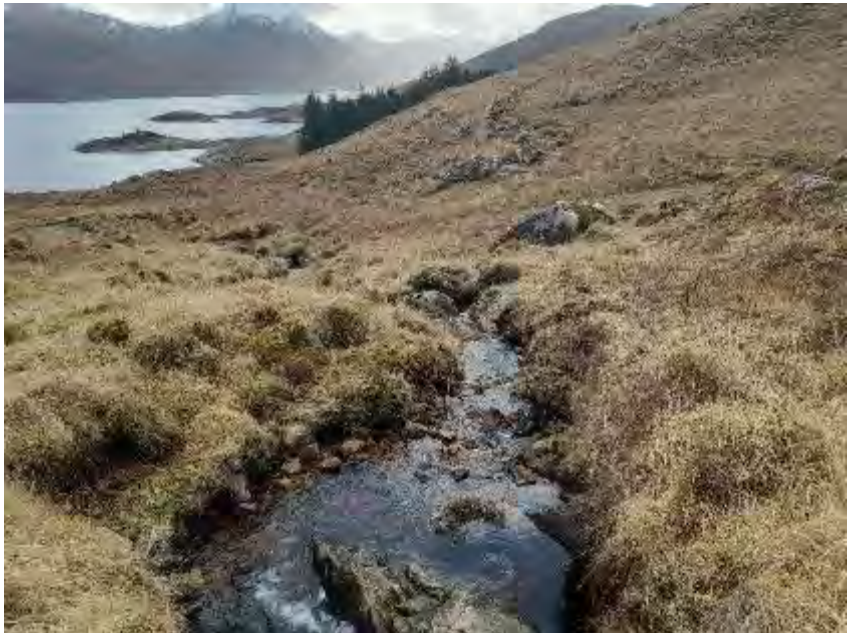
Watercourse Crossing ID	WX4.87
Watercourse Crossing Details	Watercourse Crossing: WX4.87 NGR: NH 00690 03524 Watercourse Width: 0.5-1.5m Watercourse Depth: 0.5m Notes: steep channel incised into bedrock
Photograph Looking Upstream

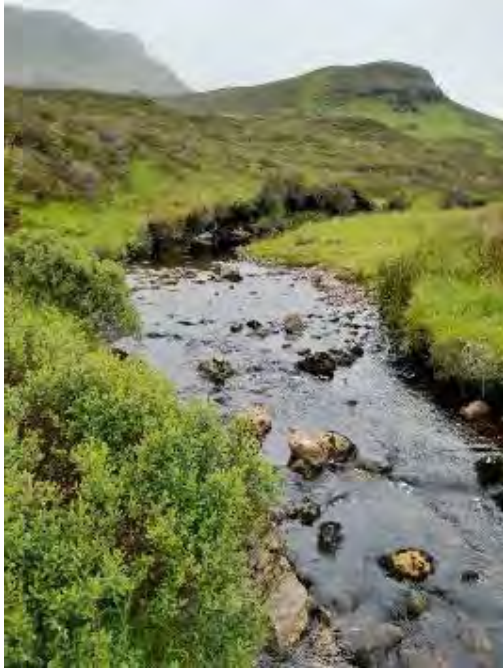
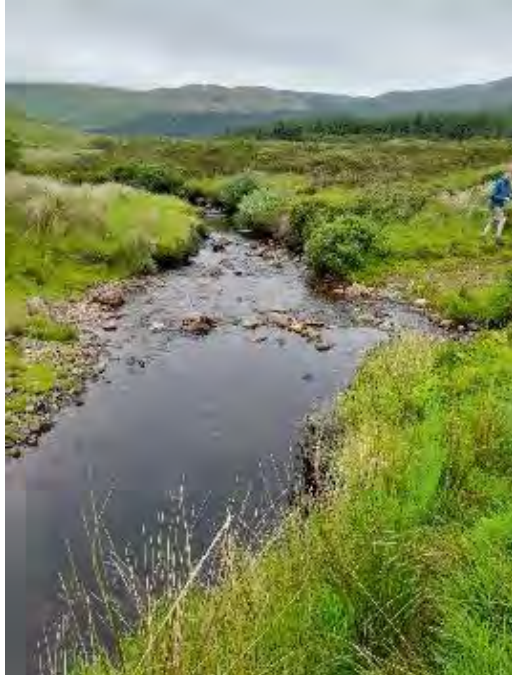
Watercourse Crossing ID	WX4.89
Watercourse Crossing Details	Watercourse Crossing: WX4.89 NGR: NG 88667 17205 Watercourse Width: 3.5 m Watercourse Depth: 0.8 m Notes: Large meandering watercourse incised on bedrock.
Photograph Looking Upstream

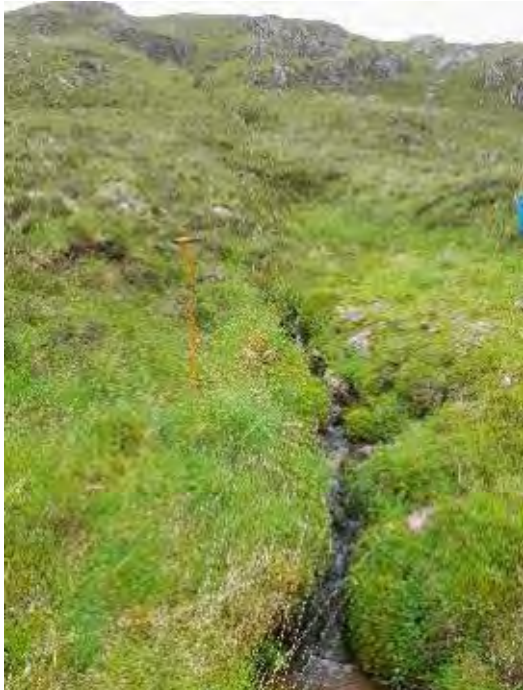
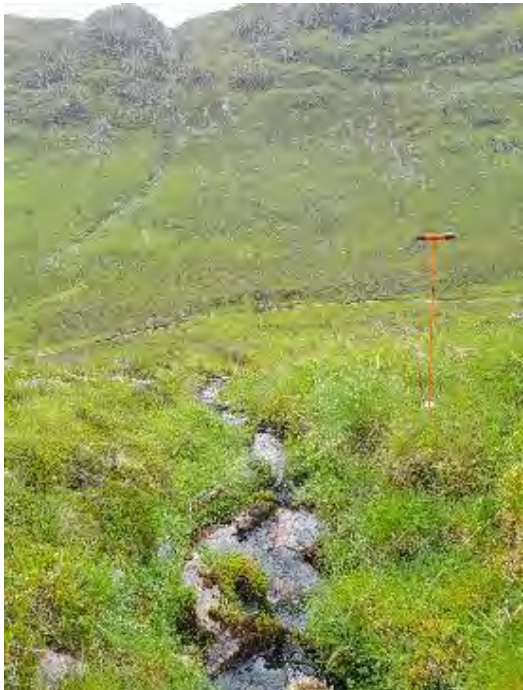
Watercourse Crossing ID	WX4.90
Watercourse Crossing Details	<p>Watercourse Crossing: WX4.90 NGR: NG 87805 13528 Watercourse Width: 0.4 m Watercourse Depth: 0.6 m Notes: Watercourse incised into bedrock.</p>
Photograph Looking Upstream

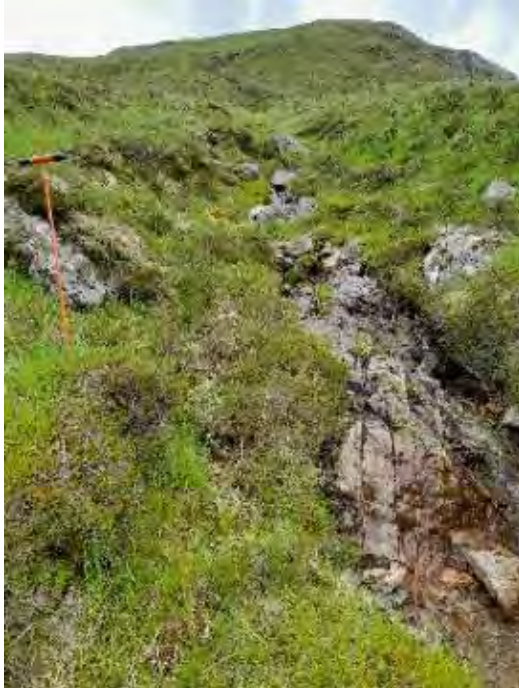
Watercourse Crossing ID	WX4.91
Watercourse Crossing Details	<p>Watercourse Crossing: WX4.91 NGR: NG 87861 13208 Watercourse Width: 1.5 m Watercourse Depth: 2 m Notes: Steep watercourse incised in bedrock.</p>
Photograph Looking Upstream

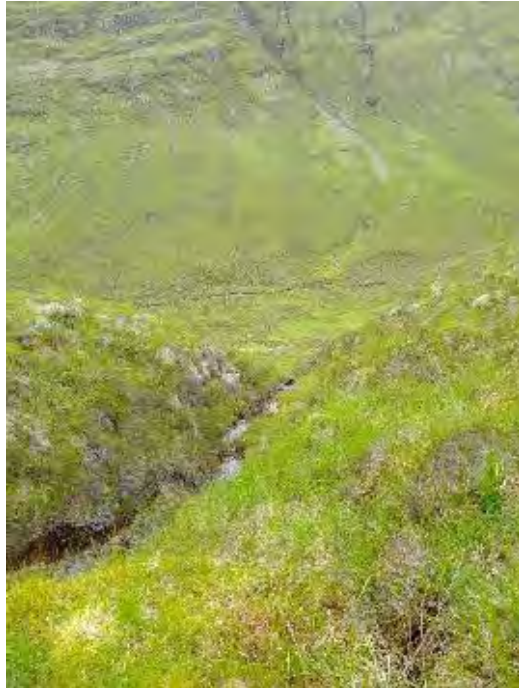
Watercourse Crossing ID	WX4.92
Watercourse Crossing Details	<p>Watercourse Crossing: WX4.92 NGR: NG 87871 13121 Watercourse Width: 0.4 m Watercourse Depth: 0.2 m Notes: Watercourse located within a wider channel approximately 4 m high and 3 m wide.</p>
Photograph Looking Upstream

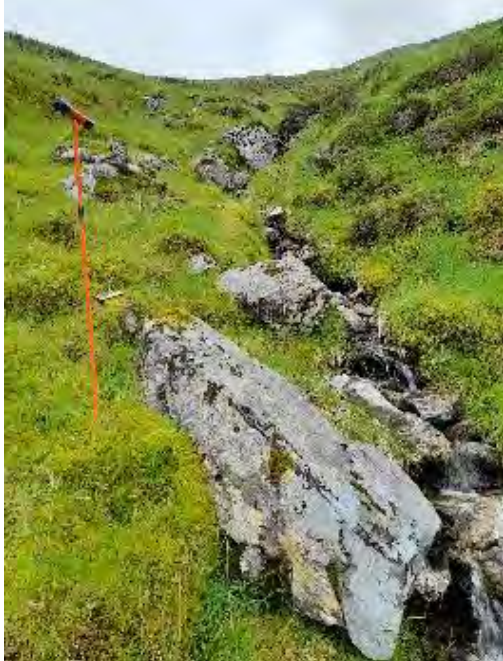
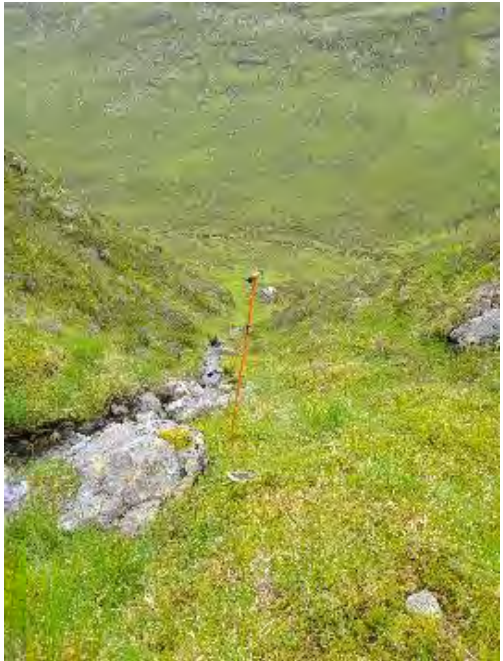
Watercourse Crossing ID	WX4.93
Watercourse Crossing Details	<p>Watercourse Crossing: WX4.93 NGR: NG 87888 13074 Watercourse Width: 1 m Watercourse Depth: 0.3 m Notes: Watercourse in a wider channel approximately 5 m high and 10 m wide, incised into bedrock.</p>
Photograph Looking Upstream

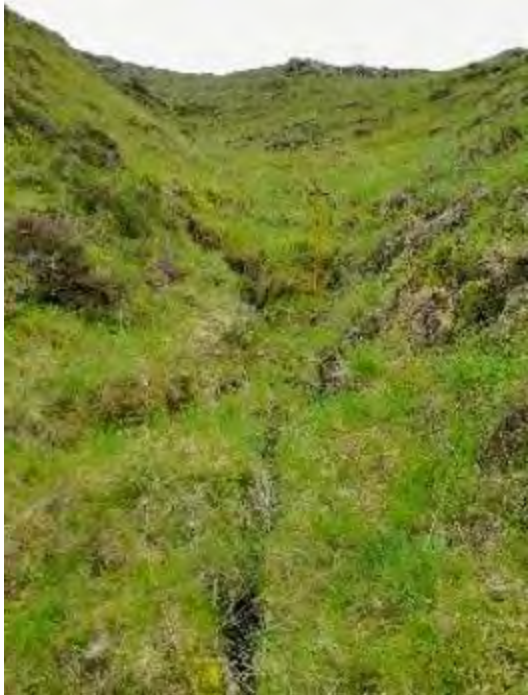
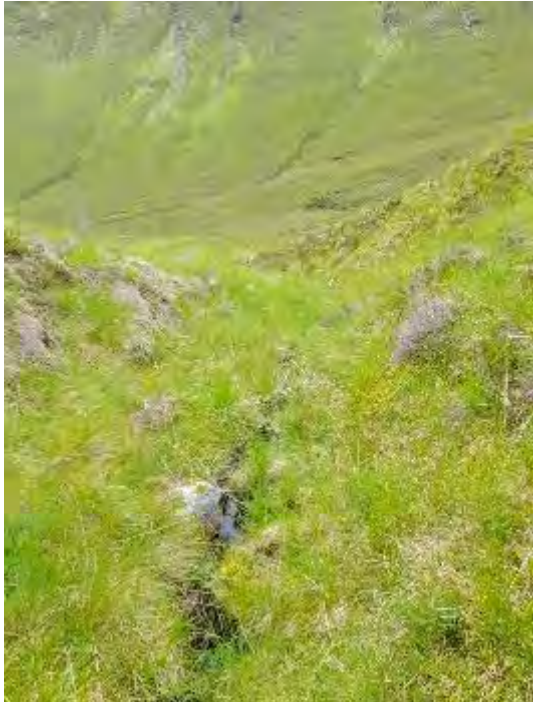
Watercourse Crossing ID	WX4.95
Watercourse Crossing Details	<p>Watercourse Crossing: WX4.95 NGR: NG 87908 12911 Watercourse Width: 1 m Watercourse Depth: 4 m Notes: Incised watercourse within larger channel profile.</p>
Photograph Looking Upstream

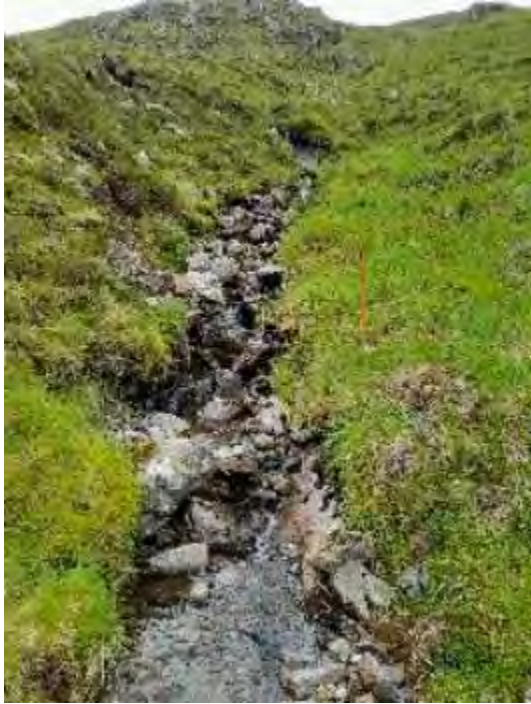
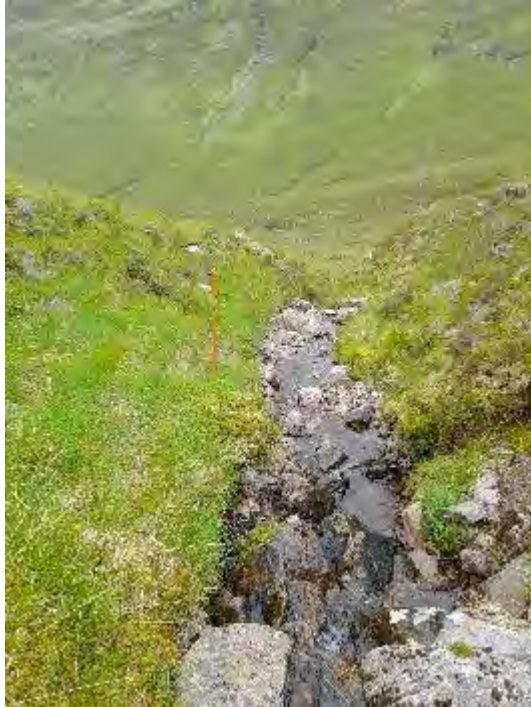
Watercourse Crossing ID	WX4.96
Watercourse Crossing Details	<p>Watercourse Crossing: WX4.96 NGR: NG 87903 12808 Watercourse Width: 1.5 m Watercourse Depth: 4 m Notes: Steep watercourse incised into bedrock.</p>
Photograph Looking Upstream

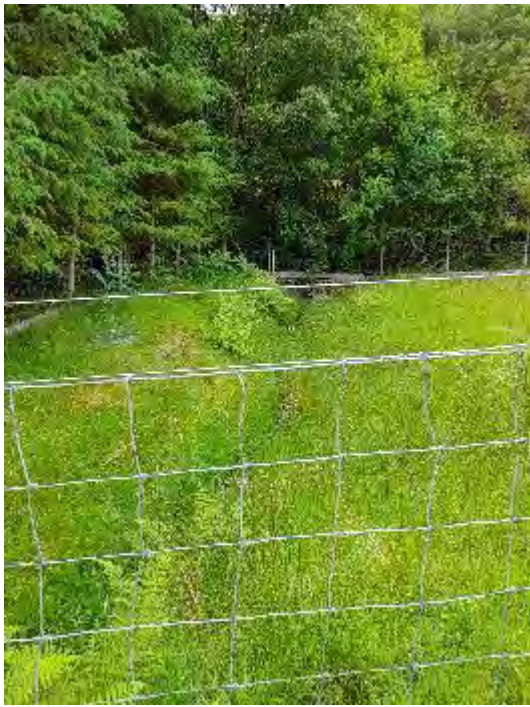
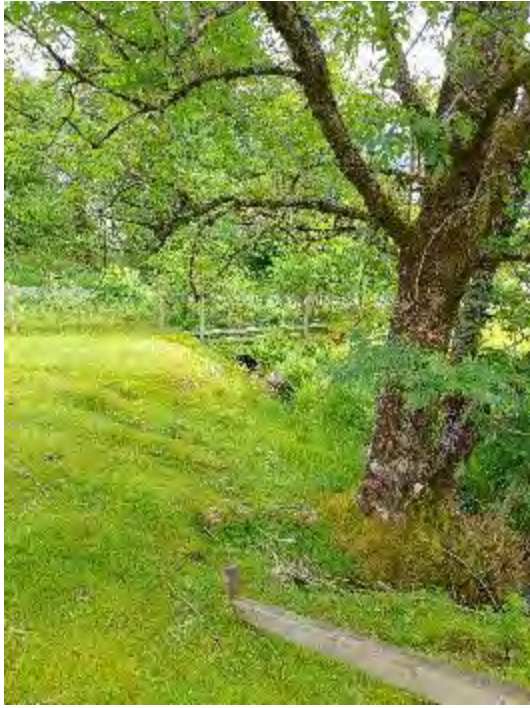
Section 5	
Watercourse Crossing ID	WX5.1
Watercourse Crossing Details	Watercourse Crossing: WX5.1 NGR: NH 20900 02481 Watercourse Width: 0.3 m Watercourse Depth: 0.5 m Notes: Small watercourse.
Photograph Looking Upstream

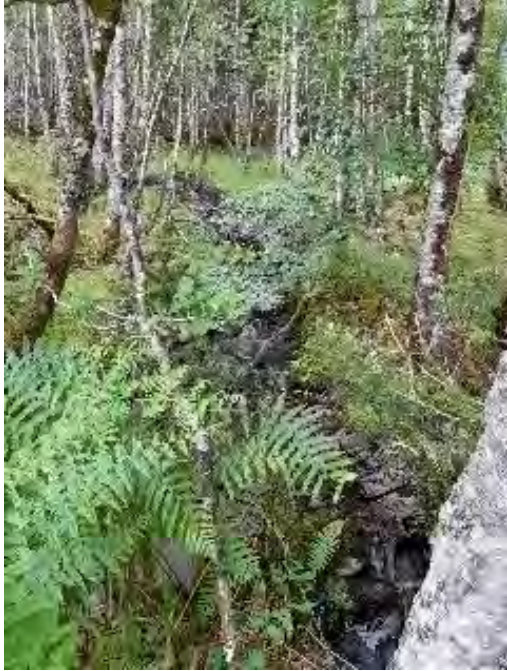
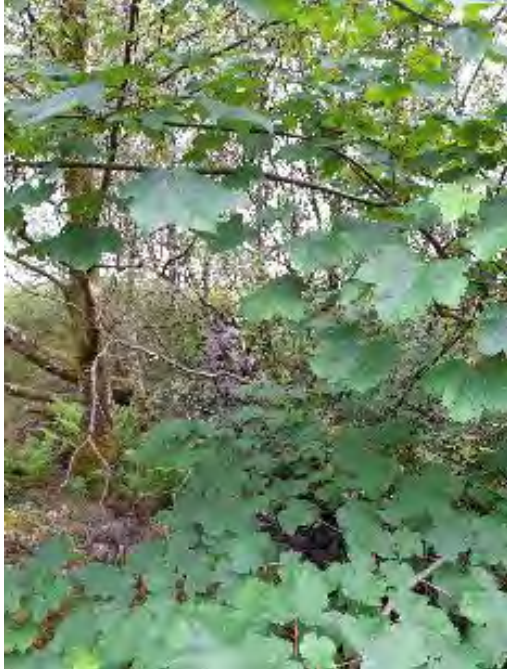
Watercourse Crossing ID	WX5.2
Watercourse Crossing Details	Watercourse Crossing: WX5.2 NGR: NH 21778 02414 Watercourse Width: 0.8 m Watercourse Depth: 0.3 m Notes: Watercourse incised on bedrock.
Photograph Looking Upstream

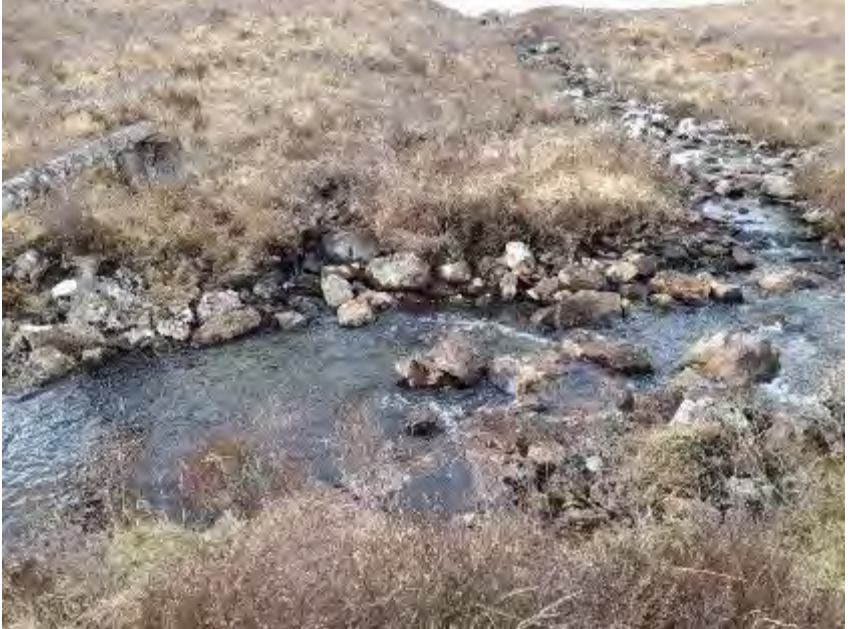
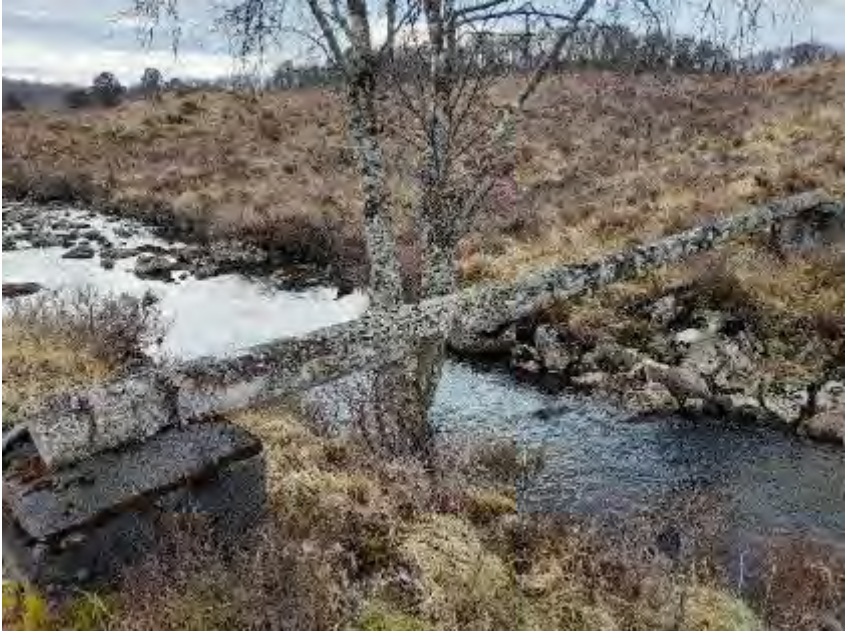
Watercourse Crossing ID	WX5.4
Watercourse Crossing Details	<p>Watercourse Crossing: WX5.4 NGR: NH 29056 02464 Watercourse Width: 2.5-3m Watercourse Depth: 0.5m Notes: Crossing located immediately downstream of a confluence, some evidence of flooding and boulders deposited in stream.</p>
Photograph Looking Upstream

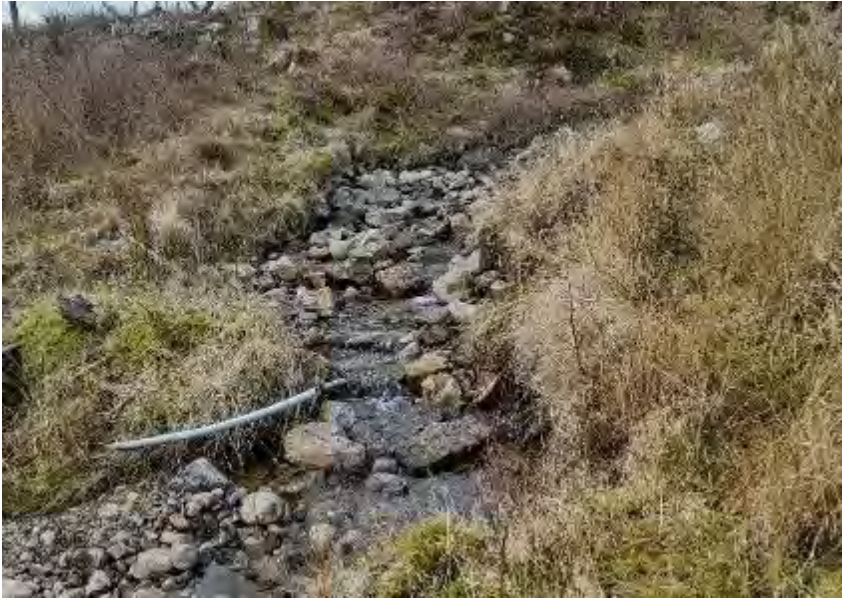
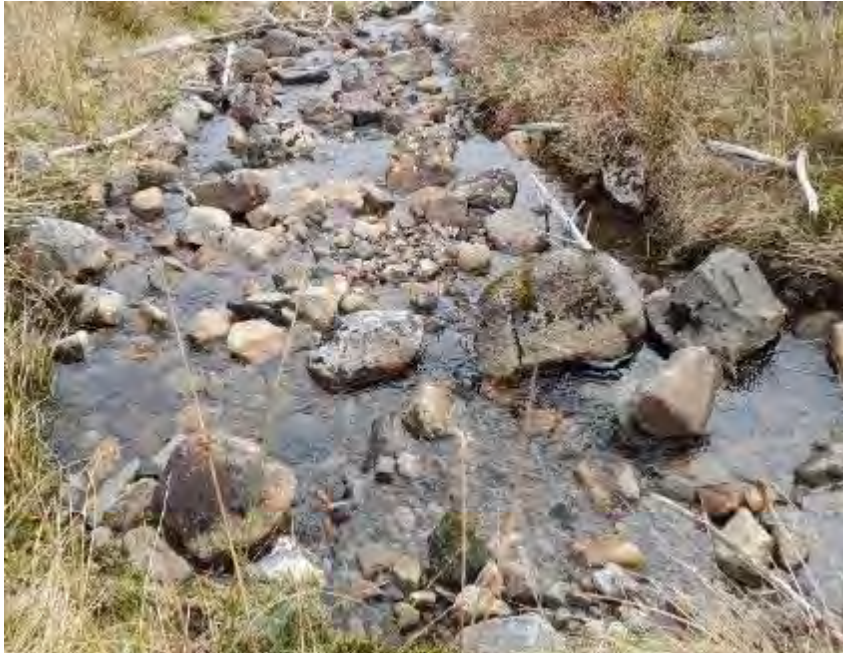
Watercourse Crossing ID	WX5.6
Watercourse Crossing Details	Watercourse Crossing: WX5.6 NGR: NH 23639 02869 Watercourse Width: 1-3m Watercourse Depth: 0.3-0.5m Notes: none
Photograph Looking Upstream

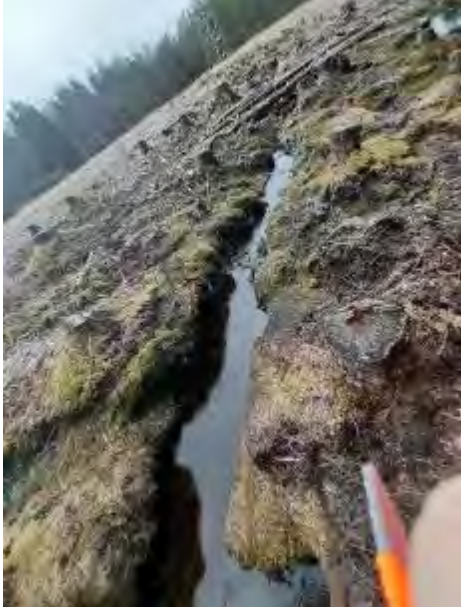
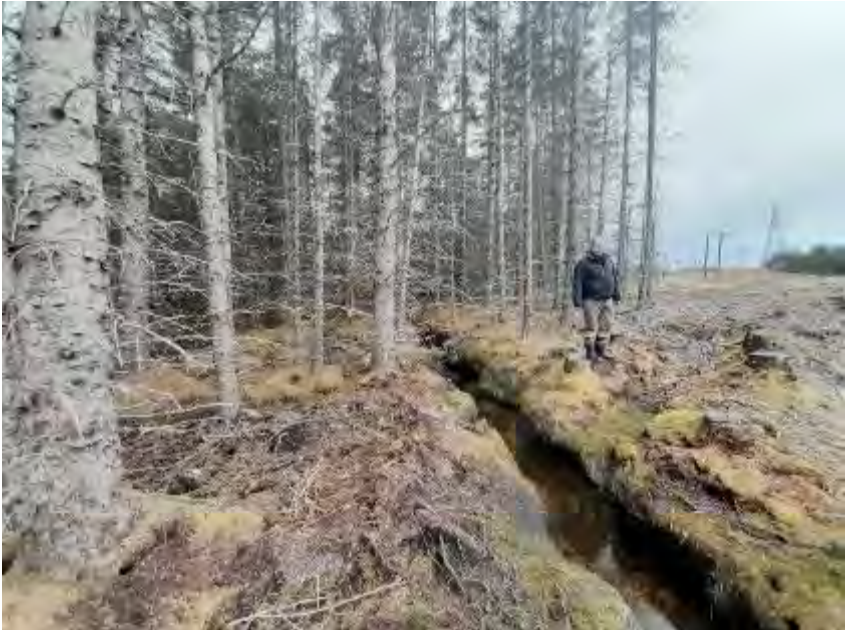
Watercourse Crossing ID	WX5.8
Watercourse Crossing Details	<p>Watercourse Crossing: WX5.8 NGR: NH 15844 01567 Watercourse Width: 0.5m Watercourse Depth: 0.5m Notes: very incised channel in a larger bog and forested area, cobbles and boulders deposited in channel</p>
Photograph Looking Upstream

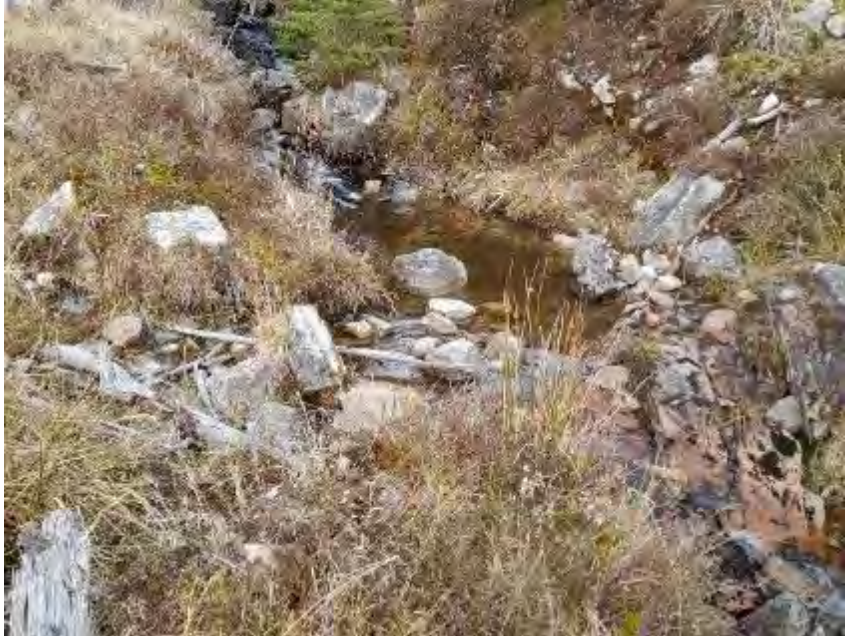
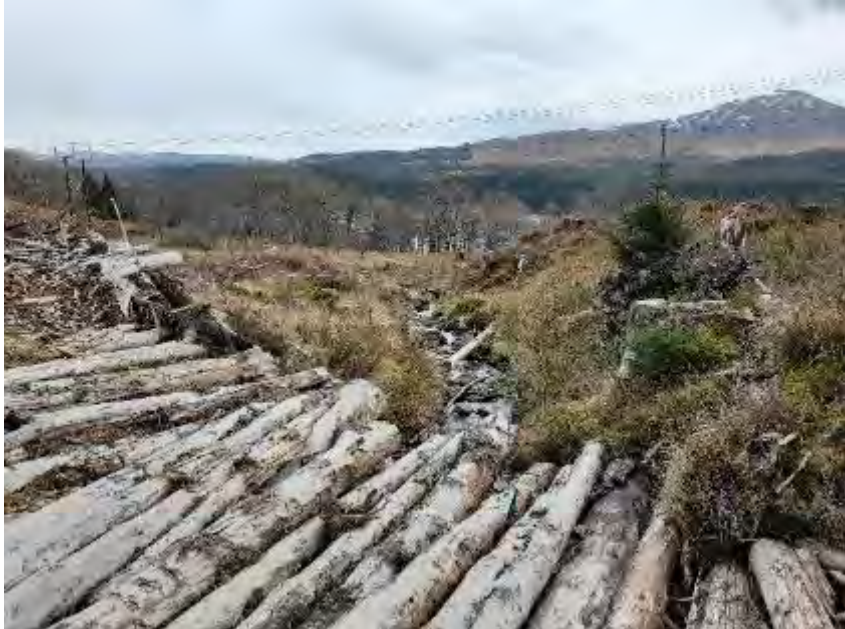
Watercourse Crossing ID	WX5.11
Watercourse Crossing Details	Watercourse Crossing: WX5.11 NGR: NH 23606 02907 Watercourse Width: 0.8-1.5m Watercourse Depth: 0.4m Notes: channel banks up to 2m high incised into bedrock with pebbles and boulders deposited, existing makeshift log crossing restricting flow.
Photograph Looking Upstream
