SKYE REINFORCEMENT PROJECT

Appendix V2-6.2: Schedule of Permanent Watercourse Crossings

Prepared for: Scottish & Southern Electricity
Networks Transmission (SSEN Transmission)

SLR Ref: 428.04707.00020
Version No: Final
September 2022

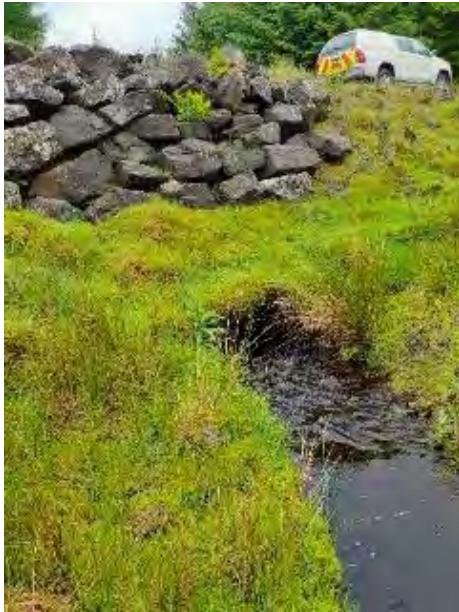
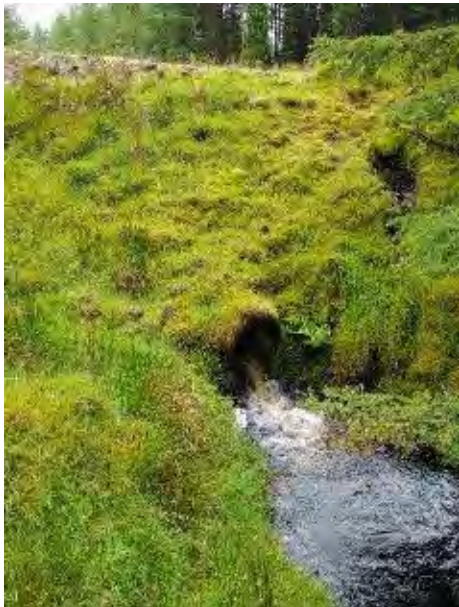
Watercourse Crossing ID	WX1.5	
Watercourse Crossing Details	<p>Watercourse Crossing: WX1.5 NGR: NG 43050 37024 Status: Existing Culvert Diameter: 0.6 m Culvert Construction Type: concrete circular Watercourse Width: 1 m Watercourse Depth: N/A Notes: culvert partially covered in vegetation, but strong flow through the culvert</p>	
Photograph Looking at Culvert Entrance from Upstream

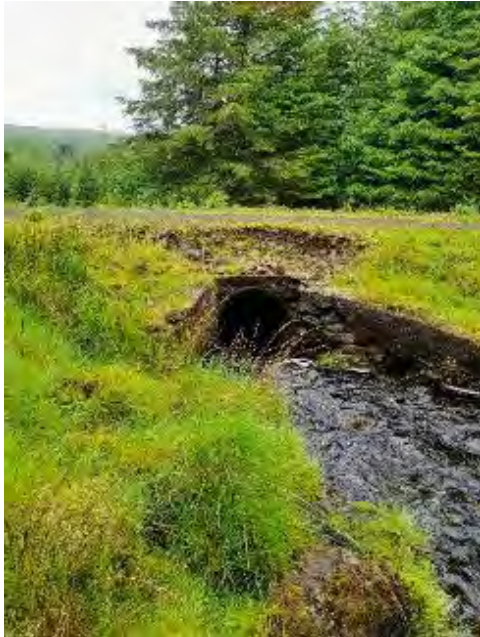
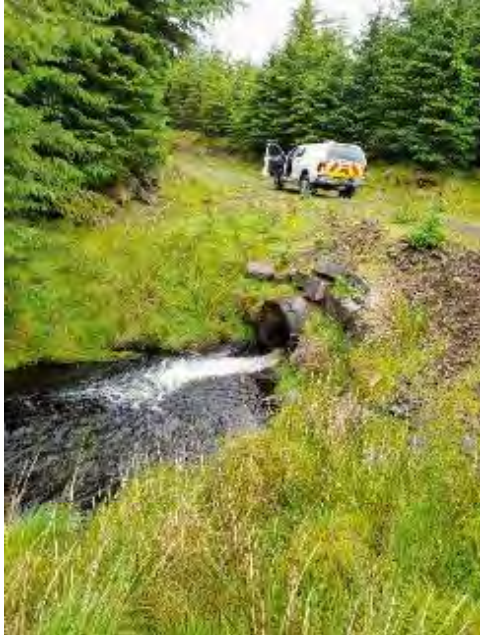
Watercourse Crossing ID	WX1.6	
<p>Watercourse Crossing Details</p>	<p>Watercourse Crossing: WX1.6 NGR: NG 42911 36174 Status: Existing Culvert Diameter: 1 m Culvert Construction Type: concrete circular Watercourse Width: 2.5 m Watercourse Depth: N/A Notes: Culvert reinforced with headwall.</p>	
<p>Photograph Looking at Culvert Entrance from Upstream</p>

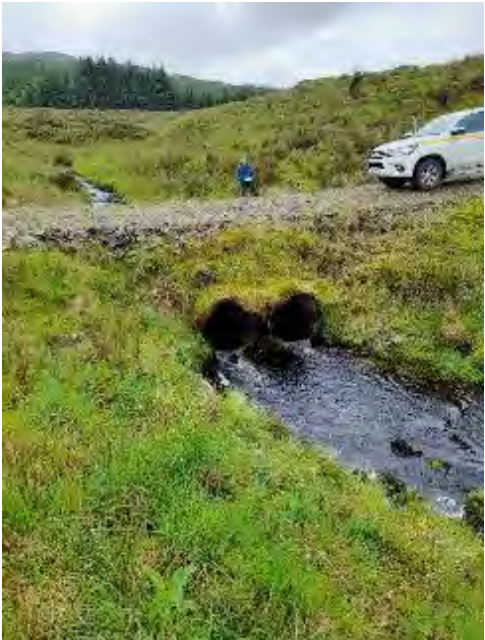
Watercourse Crossing ID	WX1.10
Watercourse Crossing Details	<p>Watercourse Crossing: WX1.10 NGR: NG 42097 36428 Status: Existing Culvert Diameter: 1 m x2 Culvert Construction Type: two concrete circular Watercourse Width: 2.5 m Watercourse Depth: N/A Notes: Culverts in good condition.</p>
Photograph Looking at Culvert Entrance from Upstream

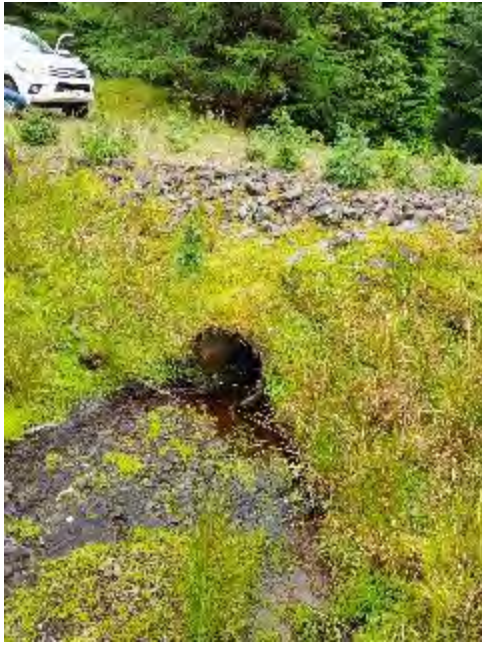
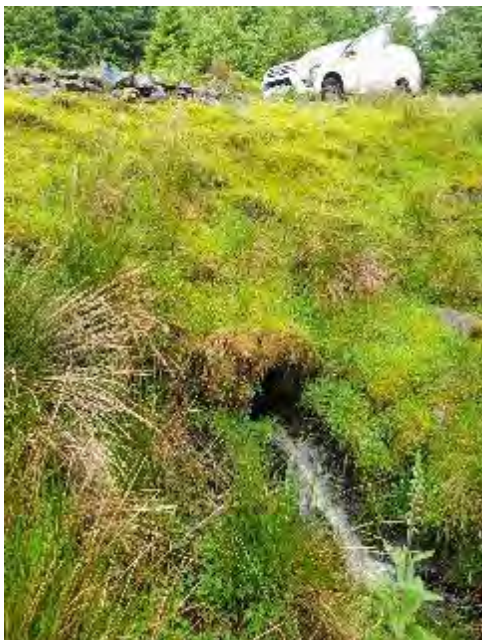
Watercourse Crossing ID	WX1.11	
Watercourse Crossing Details	<p>Watercourse Crossing: WX1.11 NGR: NG 41974 36571 Status: Existing Culvert Diameter: 0.6 m Culvert Construction Type: concrete circular Watercourse Width: 0.5 to 1 m Watercourse Depth: N/A Notes: Partially covered in vegetation, but no obstruction to flow.</p>	
Photograph Looking at Culvert Entrance from Upstream

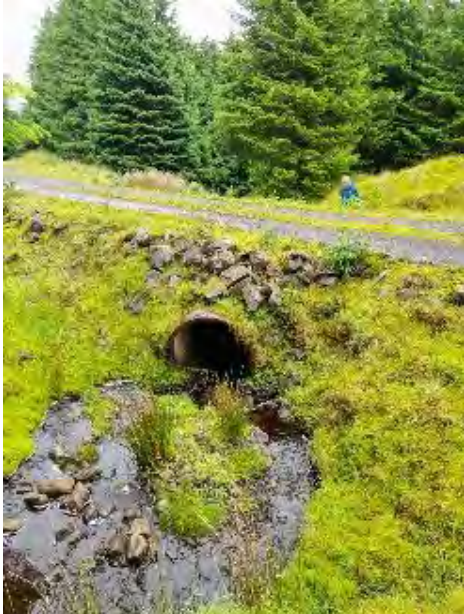
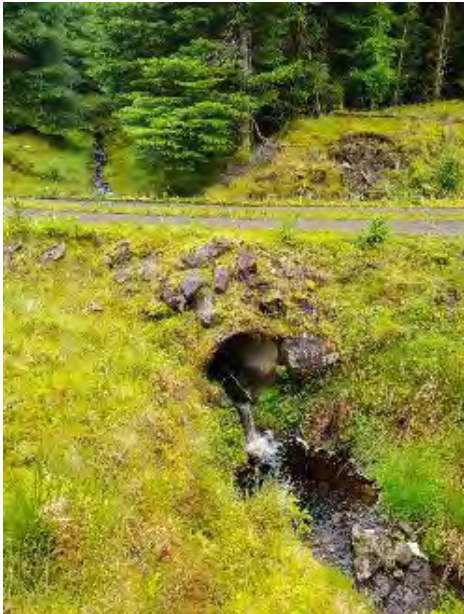
Watercourse Crossing ID	WX1.12
Watercourse Crossing Details	<p>Watercourse Crossing: WX1.12 NGR: NG 41862 36585 Status: Existing Culvert Diameter: 1 m Culvert Construction Type: concrete circular Watercourse Width: 1 to 2 m Watercourse Depth: N/A Notes: Culvert in good condition, cobbles and reeds noted within the channel</p>
<p>Photograph Looking at Culvert Entrance from Upstream</p>

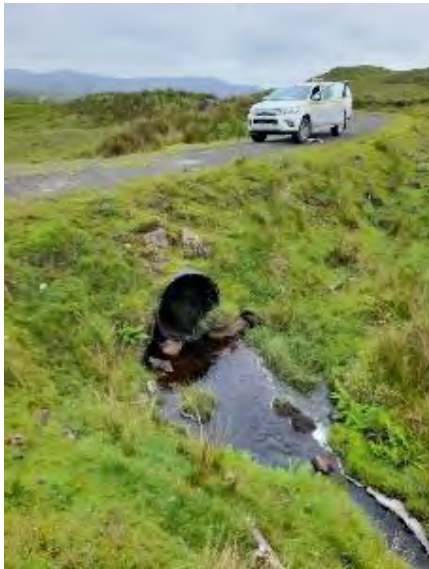
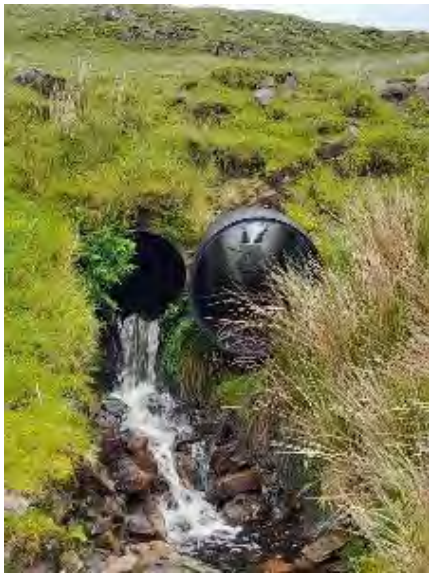
Watercourse Crossing ID	WX1.14
Watercourse Crossing Details	<p>Watercourse Crossing: WX1.14 NGR: NG 40817 35634 Status: Existing Culvert Diameter: 0.6 m and 1 m Culvert Construction Type: concrete circular with adjacent slightly larger twinwall plastic culvert Watercourse Width: 1 m upstream and 2 – 3m downstream Watercourse Depth: N/A Notes: all flow is concentrated within the concrete culvert which is partially blocked upstream. Very little flow was noted in the plastic culvert.</p>
Photograph Looking at Culvert Entrance from Upstream

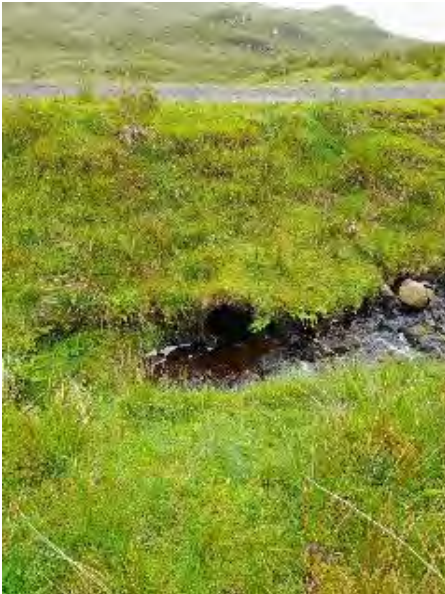
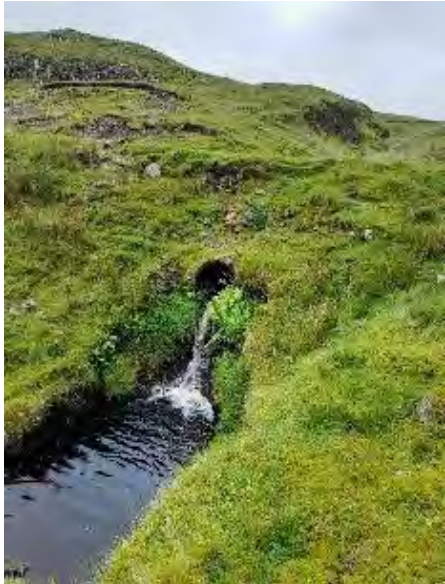
Watercourse Crossing ID	WX1.15	
Watercourse Crossing Details	<p>Watercourse Crossing: WX1.15 NGR: NG 40719 35581 Status: Existing Culvert Diameter: 0.6 m Culvert Construction Type: concrete circular Watercourse Width: 1 m Watercourse Depth: N/A Notes: Culvert in good condition.</p>	
Photograph Looking at Culvert Entrance from Upstream

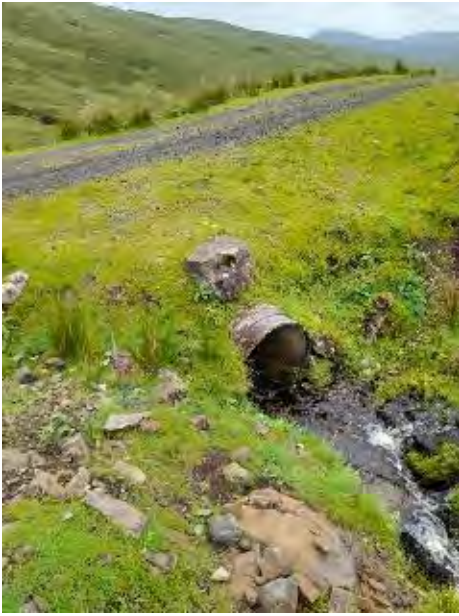
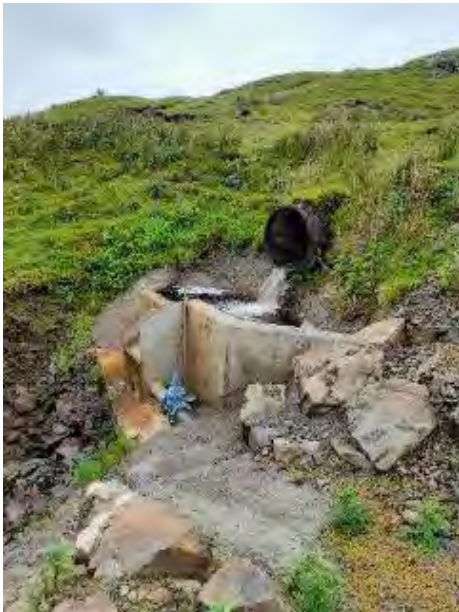
Watercourse Crossing ID	WX1.16
Watercourse Crossing Details	<p>Watercourse Crossing: WX1.16 NGR: NG 40316 35489 Status: Existing Culvert Diameter: 0.6 m Culvert Construction Type: concrete circular Watercourse Width: 1 m Watercourse Depth: N/A Notes: Culvert in good condition. Water is collected immediately downstream of crossing for an offtake (for a small scale hydro scheme).</p>
Photograph Looking at Culvert Entrance from Upstream

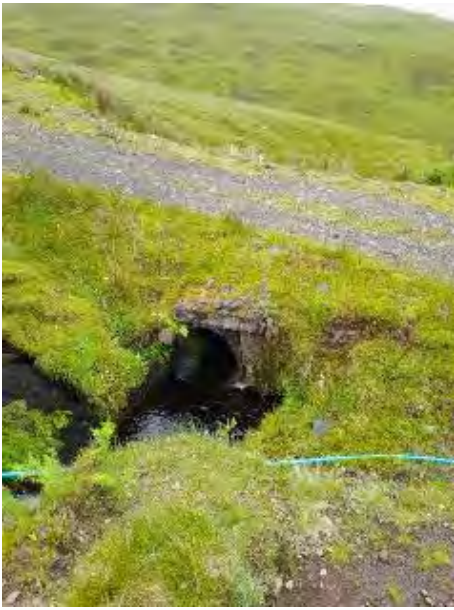
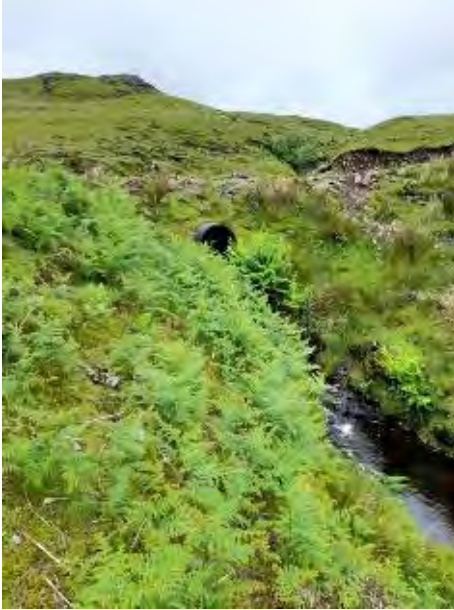
Watercourse Crossing ID	WX1.17	
Watercourse Crossing Details	<p>Watercourse Crossing: WX1.17 NGR: NG 39441 35044 Status: Existing Culvert Diameter: 1 m Culvert Construction Type: twinwall plastic circular Watercourse Width: 1.5 m Watercourse Depth: N/A Notes: upstream side reinforced with stone cover.</p>	
Photograph Looking at Culvert Entrance from Upstream

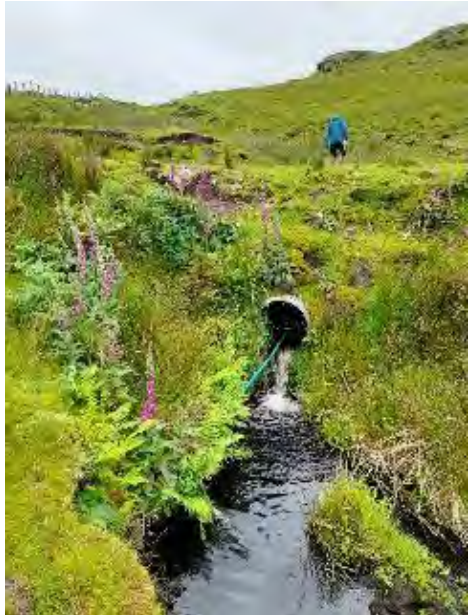
Watercourse Crossing ID	WX1.18	
Watercourse Crossing Details	<p>Watercourse Crossing: WX1.18 NGR: NG 39405 35022 Status: Existing Culvert Diameter: 0.7 m Culvert Construction Type: twinwall plastic circular Watercourse Width: 1 to 1.5 m Watercourse Depth: N/A Notes: Culvert in good condition.</p>	
Photograph Looking at Culvert Entrance from Upstream

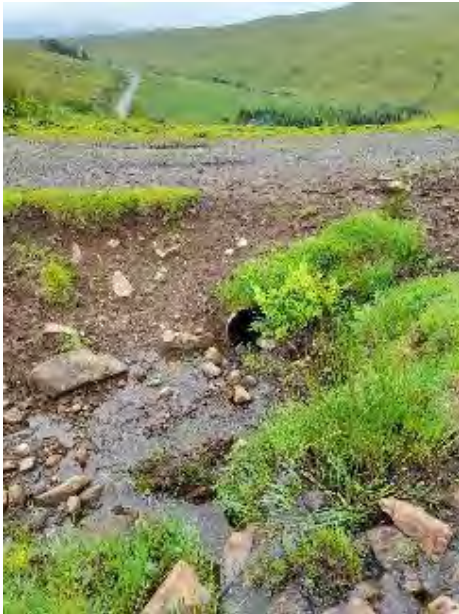
Watercourse Crossing ID	WX1.19	
Watercourse Crossing Details	<p>Watercourse Crossing: WX1.19 NGR: NG 39209 34960 Status: Existing Culvert Diameter: 0.5 m Culvert Construction Type: corrugated metal Watercourse Width: 0.5 m Watercourse Depth: N/A Notes: Upstream entrance partially blocked</p>	
Photograph Looking at Culvert Entrance from Upstream

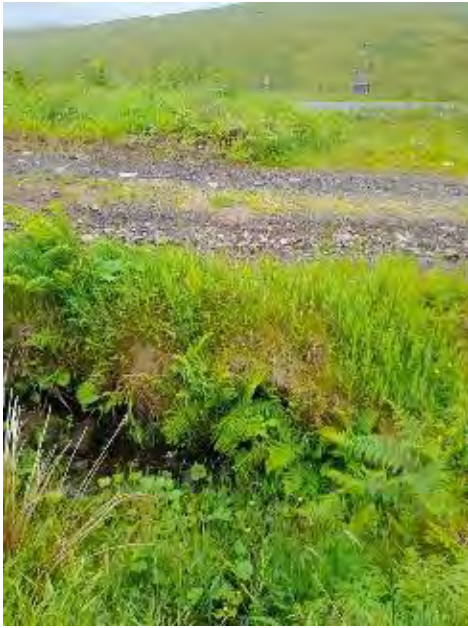
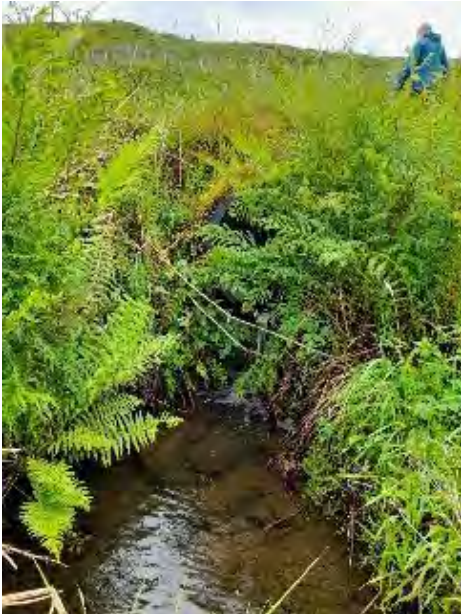
Watercourse Crossing ID	WX1.20	
Watercourse Crossing Details	<p>Watercourse Crossing: WX1.20 NGR: NG 39022 34957 Status: Existing Culvert Diameter: 0.6 m Culvert Construction Type: plastic circular Watercourse Width: 1 m Watercourse Depth: N/A Notes: Culvert partially obstructed by vegetation</p>	
Photograph Looking at Culvert Entrance from Upstream

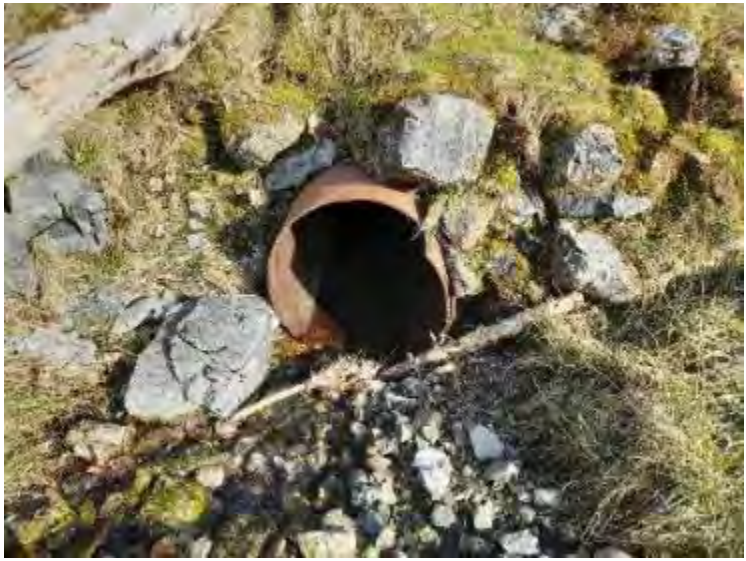
Photograph Looking at Culvert Exit Downstream

Section 2	
Watercourse Crossing ID	WX2.6
Watercourse Crossing Details	<p>Watercourse Crossing: WX2.6 NGR: NG 62443 24578 Status: Existing Culvert Diameter: 0.5m Culvert Construction Type: corrugated iron pipe Watercourse Width: 1-2m Watercourse Depth: 1m Notes: existing iron culvert has rusted. Evidence of flooding at culvert entrance</p>
Photograph Looking at Culvert Entrance from Upstream

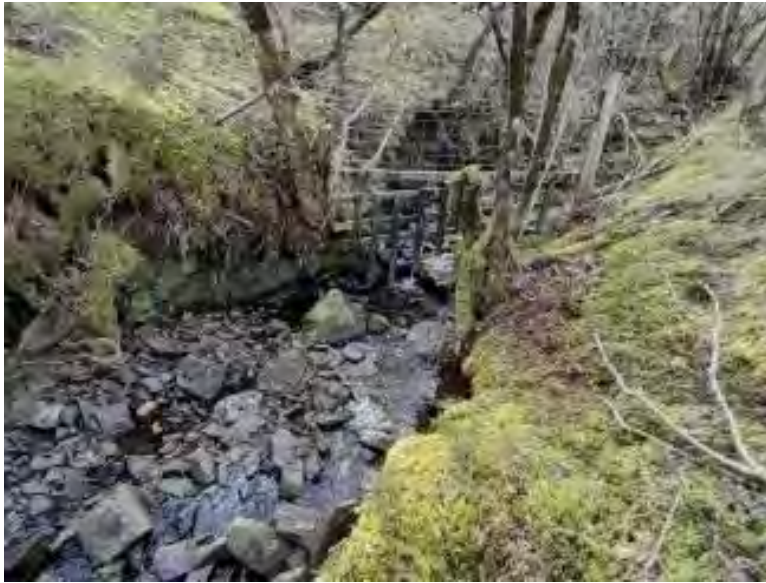
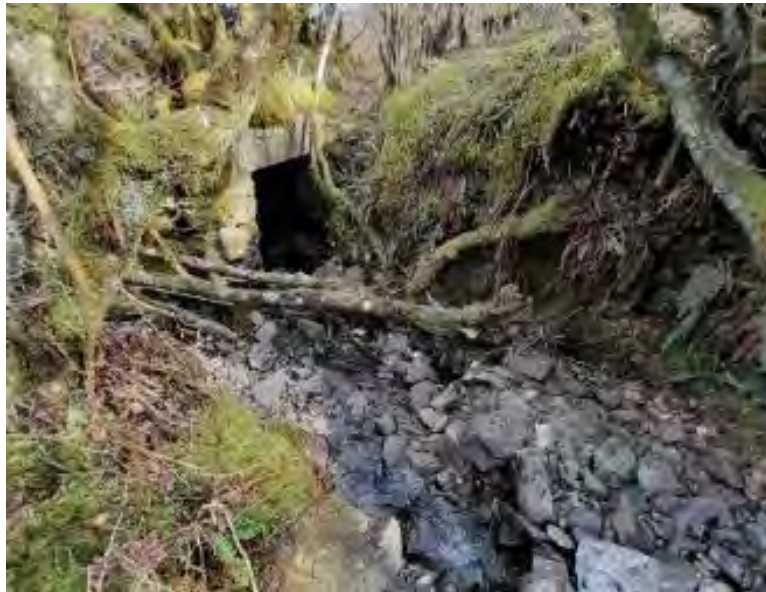
Watercourse Crossing ID	WX2.11
Watercourse Crossing Details	<p>Watercourse Crossing: WX2.11 NGR: NG 60192 26627 Status: Existing Culvert Diameter: 1m Culvert Construction Type: square concrete open bottomed culvert Watercourse Width: 1-2m Watercourse Depth: 0.3m Notes: cobbles and boulders present in channel and no evidence of flooding at the culvert.</p>
Photograph Looking at Culvert Entrance from Upstream

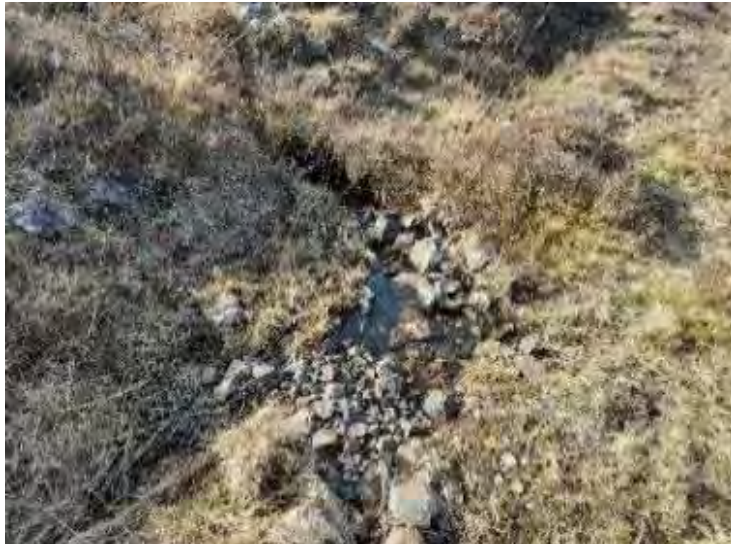
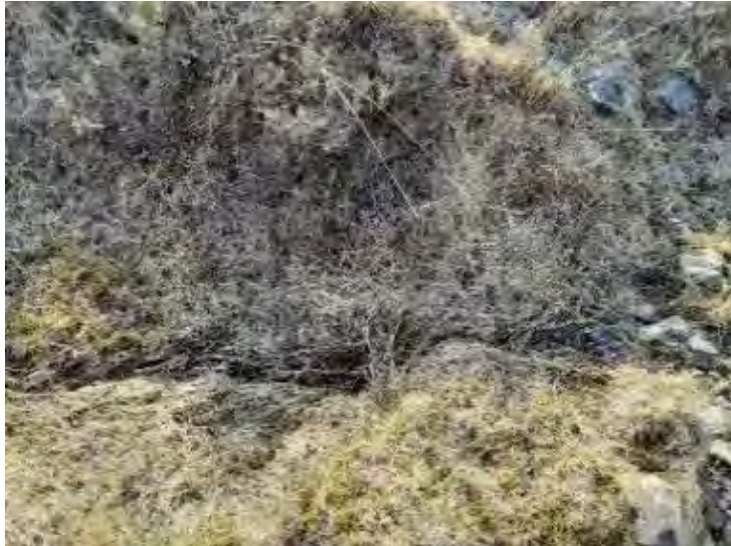
Watercourse Crossing ID	WX2.19
Watercourse Crossing Details	<p>Watercourse Crossing: WX2.19 NGR: NG 59155 26686 Status: Existing Culvert Diameter: N/A Culvert Construction Type: N/A Watercourse Width: 0.2m Watercourse Depth: 0.1m Notes: upstream, the culvert is covered by vegetation and flow has diverted parallel to the road resulting in water overtopping onto the road, part of the culvert cover has collapsed with rocks inhibiting flow progression.</p>
Photograph Looking at Culvert Entrance from Upstream

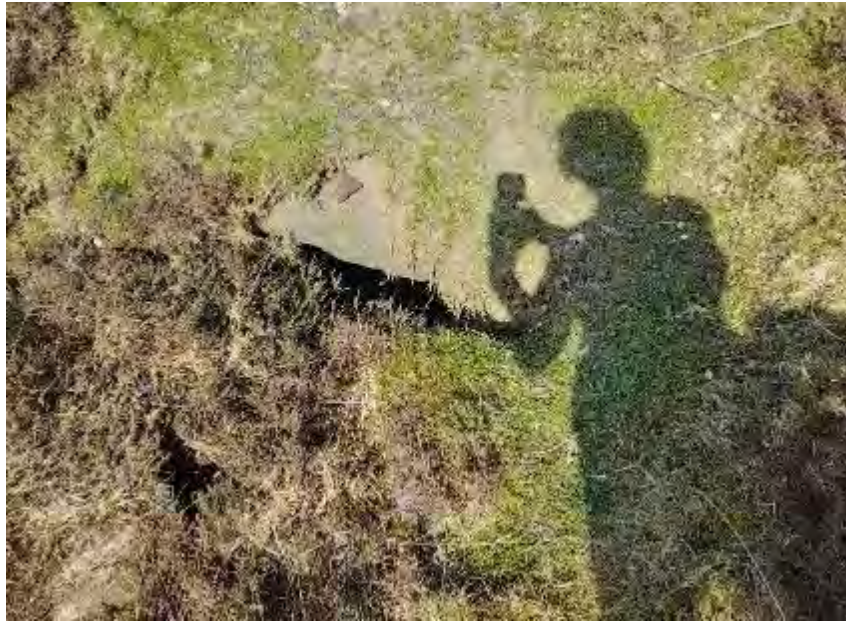
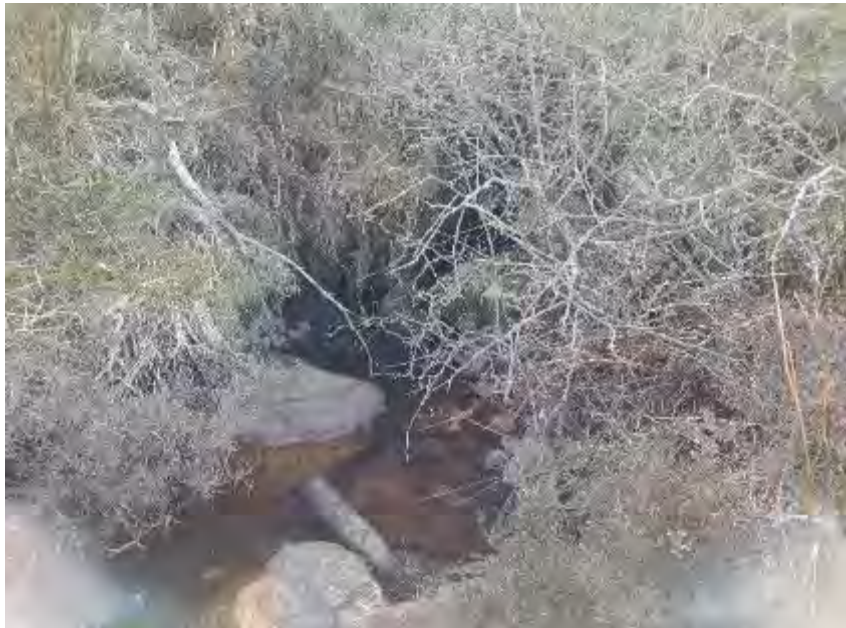
Watercourse Crossing ID	WX2.20
Watercourse Crossing Details	<p>Watercourse Crossing: WX2.20 NGR: NG 59281 26546 Status: Existing Culvert Diameter: 0.5m Culvert Construction Type: concrete and stone Watercourse Width: 0.5m Watercourse Depth: 0.2m Notes: evidence of flooding adjacent to the culvert entrance.</p>
Photograph Looking at Culvert Entrance from Upstream

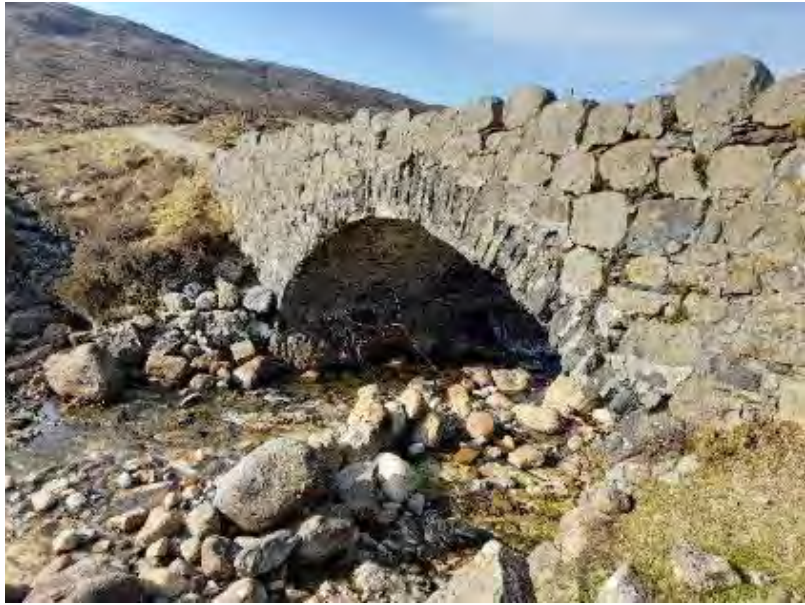
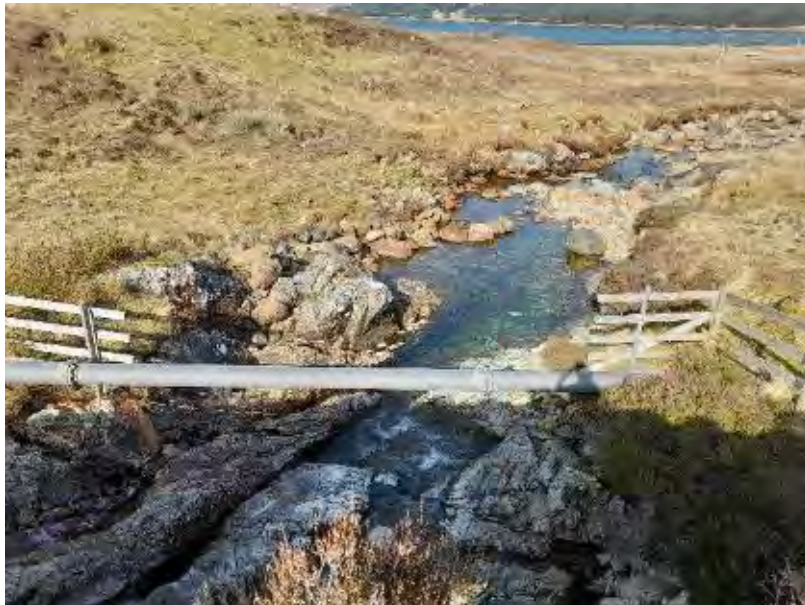
Watercourse Crossing ID	WX2.21
Watercourse Crossing Details	<p>Watercourse Crossing: WX2.21 NGR: NG 59375 26514 Status: Existing Culvert Diameter: 3m Culvert Construction Type: stone arched bridge Watercourse Width: 3m Watercourse Depth: 2m Notes: channel is incised into bedrock with boulders present. A waterfall is also located just upstream of the crossing.</p>
Photograph Looking at Culvert Entrance from Upstream

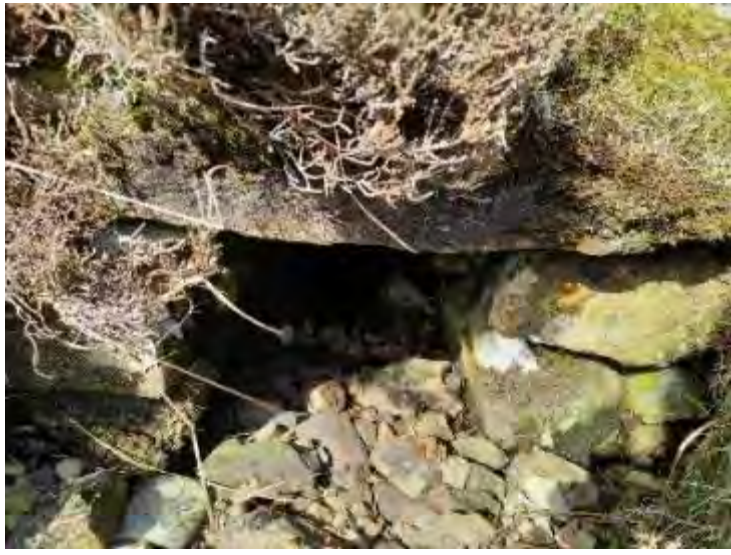
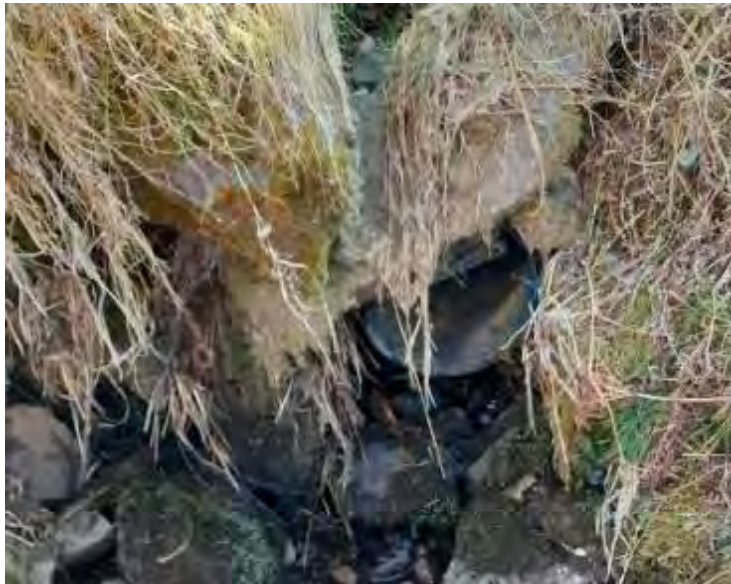
Watercourse Crossing ID	WX2.22
<p>Watercourse Crossing Details</p>	<p>Watercourse Crossing: WX2.22 NGR: NG 59536 26583 Status: Existing Culvert Diameter: 0.3m Culvert Construction Type: plastic pipe, stone and concrete Watercourse Width: 0.5m Watercourse Depth: 0.3 Notes: channel is incised into bedrock with cobbles and boulders throughout the reach. Some flow present upstream however culvert on the date of the survey was dry. Culvert has a hole on the top. Pipe coming out of the culvert at the downstream end is crushed by rocks the collapse of the ground.</p>
<p>Photograph Looking at Culvert Entrance from Upstream</p>

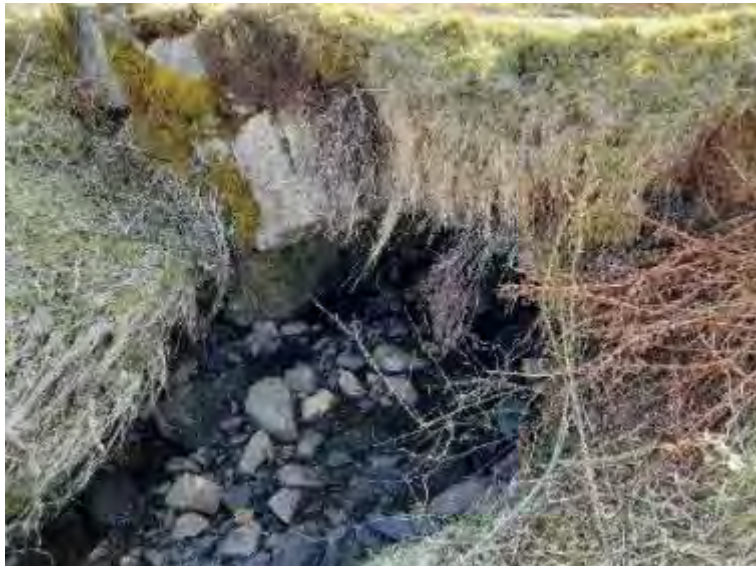
Photograph Looking at Culvert Exit Downstream.

Watercourse Crossing ID	WX2.24
Watercourse Crossing Details	<p>Watercourse Crossing: WX2.24 NGR: NG 59723 26604 Status: Existing Culvert Diameter: 0.4m height, 0.6m wide Culvert Construction Type: stone arch in good condition Watercourse Width: 1.5-2m Watercourse Depth: 1m Notes: channel incised into bedrock with boulders deposited at the reach. Evidence of flooding around the culvert entrance.</p>
Photograph Looking at Culvert Entrance from Upstream

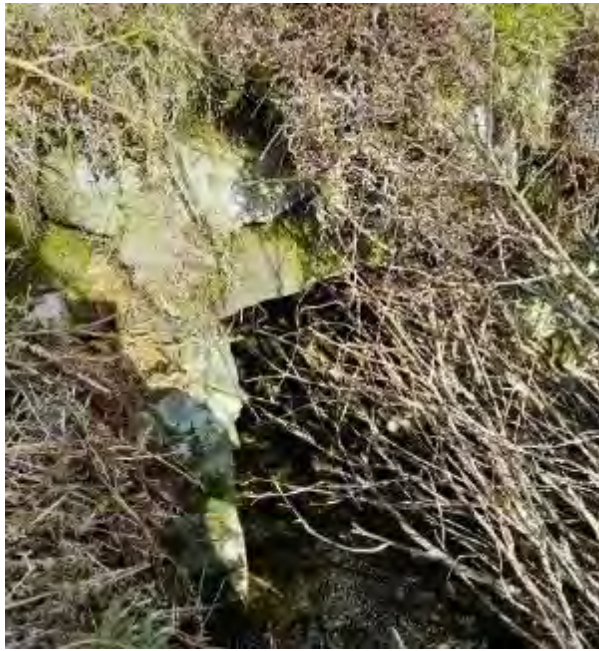
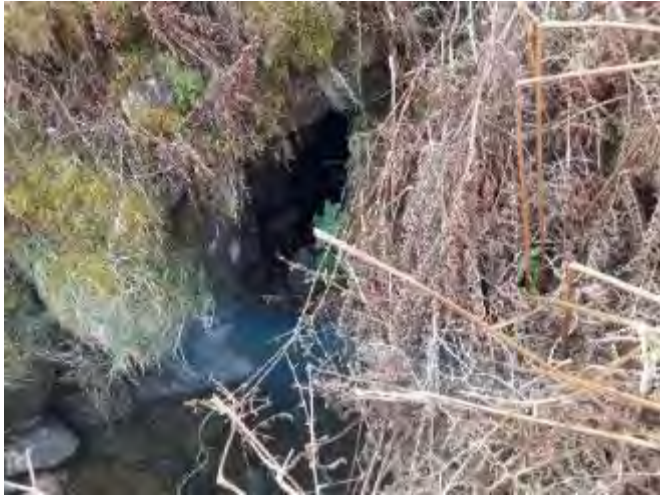
Watercourse Crossing ID	WX2.25
Watercourse Crossing Details	<p>Watercourse Crossing: WX2.25 NGR: NG 59971 26638 Status: Existing Culvert Diameter: 0.5m Culvert Construction Type: open bottom concrete culvert Watercourse Width: 0.4m Watercourse Depth: 0.5m Notes: cobbles and boulders present throughout the reach with evidence of flooding.</p>
Photograph Looking at Culvert Entrance from Upstream

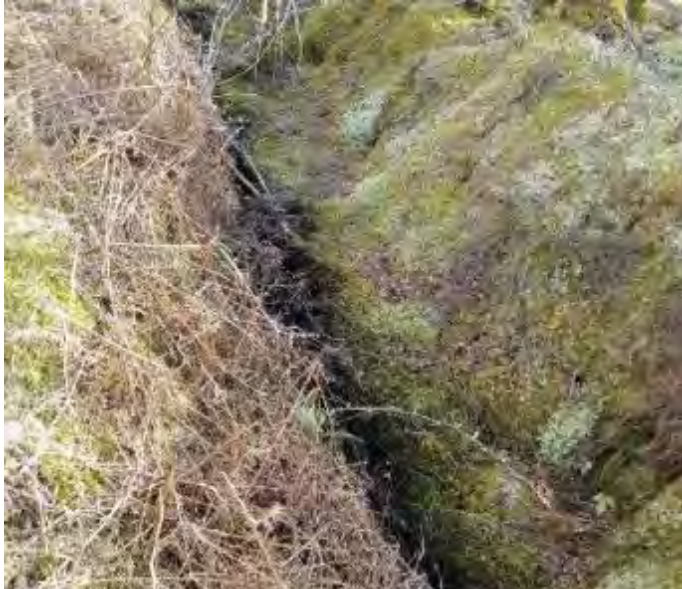
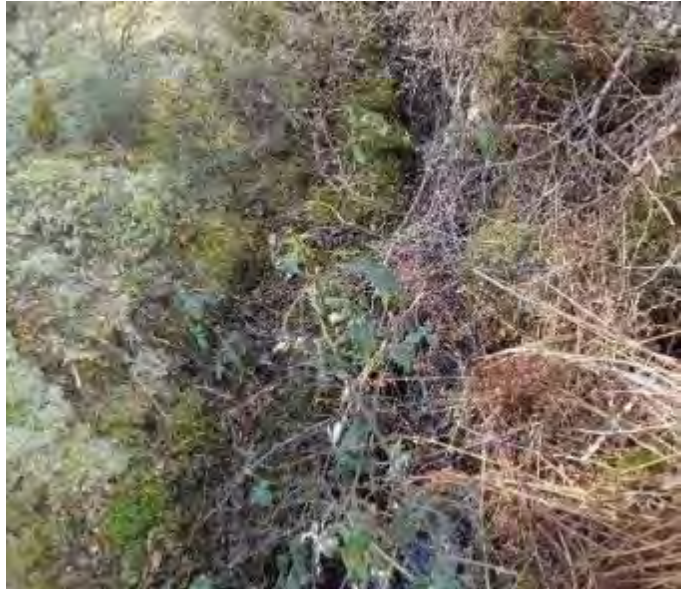
Watercourse Crossing ID	WX2.26
Watercourse Crossing Details	<p>Watercourse Crossing: WX2.26 NGR: NG 60160 26628 Culvert Diameter: N/A Culvert Construction Type: N/A Watercourse Width: N/A Watercourse Depth: N/A Notes: drainage diverted along track to WX2.24</p>
Photograph Looking Upstream

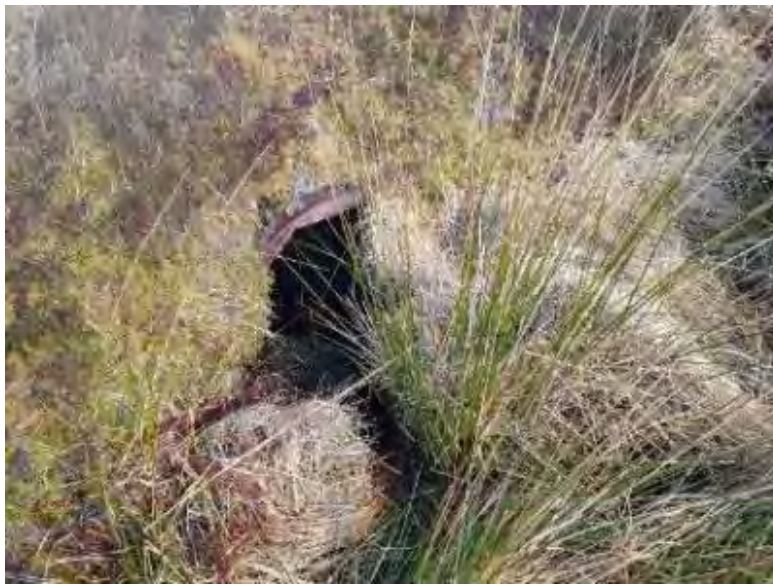
Section 3	
Watercourse Crossing ID	WX3.5
Watercourse Crossing Details	<p>Watercourse Crossing: WX3.5 NGR: NG 72493 24122 Status: Existing Culvert Diameter: 0.4m Culvert Construction Type: circular corrugated metal Watercourse Width: 0.3m Watercourse Depth: 1m Notes: watercourse crossing is at a confluence of a few smaller 0.1m deep channels upstream. Low flow on date of survey.</p>
Photograph Looking at Culvert Entrance from Upstream

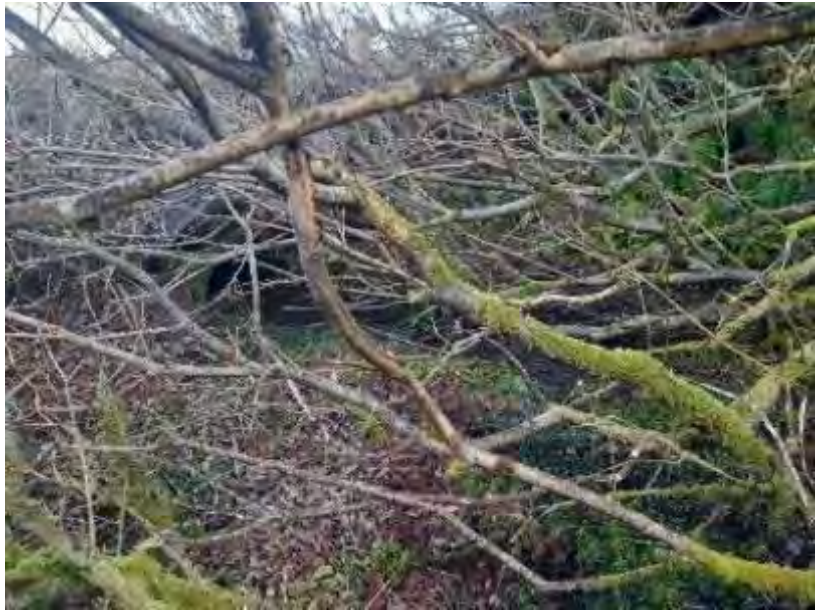
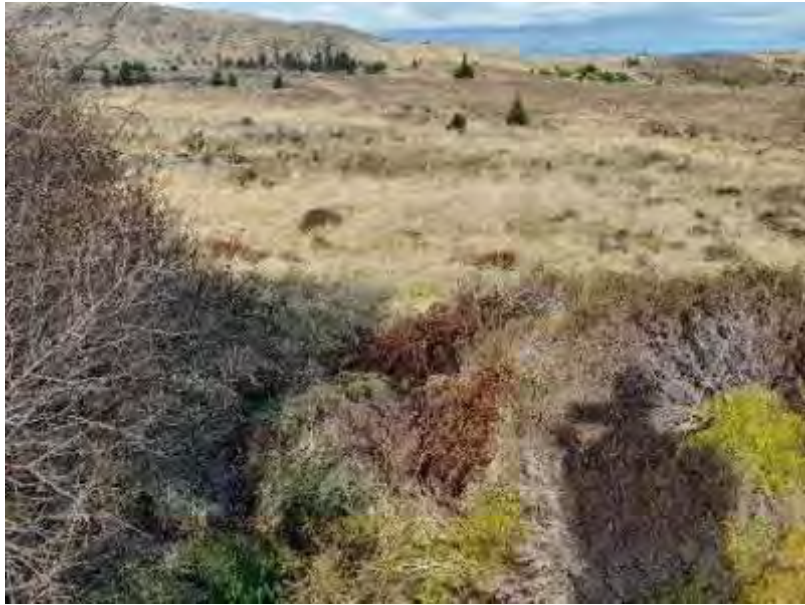
Watercourse Crossing ID	WX3.6
Watercourse Crossing Details	<p>Watercourse Crossing: WX3.6 NGR: NG 72826 24314 Status: Existing Culvert Diameter: 0.3m Culvert Construction Type: concrete Watercourse Width: 0.1m Watercourse Depth: 0.3m Notes: dry silted channel on date of survey which contains fallen trees upstream</p>
Photograph Looking at Culvert Entrance from Upstream

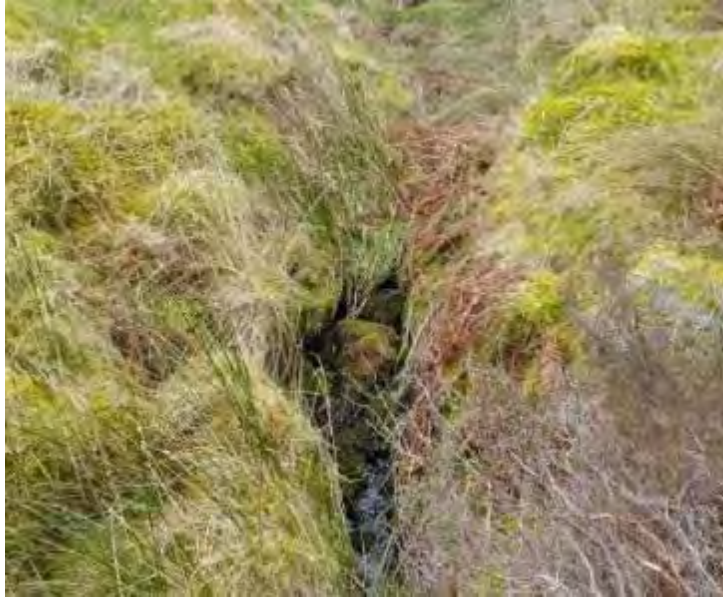
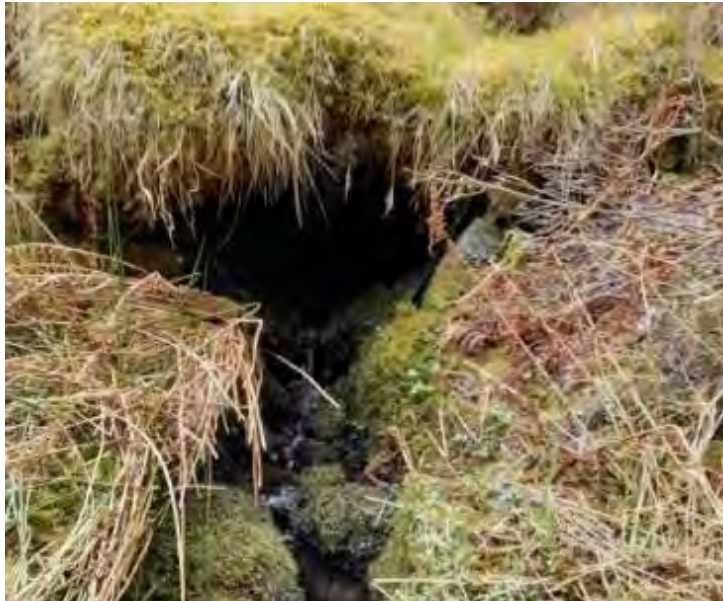
Watercourse Crossing ID	WX3.15
Watercourse Crossing Details	<p>Watercourse Crossing: WX3.15 NGR: NG 79156 23144 Status: Existing Culvert Diameter: 0.4m Culvert Construction Type: circular plastic culvert Watercourse Width: 0.2m Watercourse Depth: 0.2m Notes: channel is incised into peat, culvert which is slightly deformed downstream</p>
Photograph Looking at Culvert Entrance from Upstream

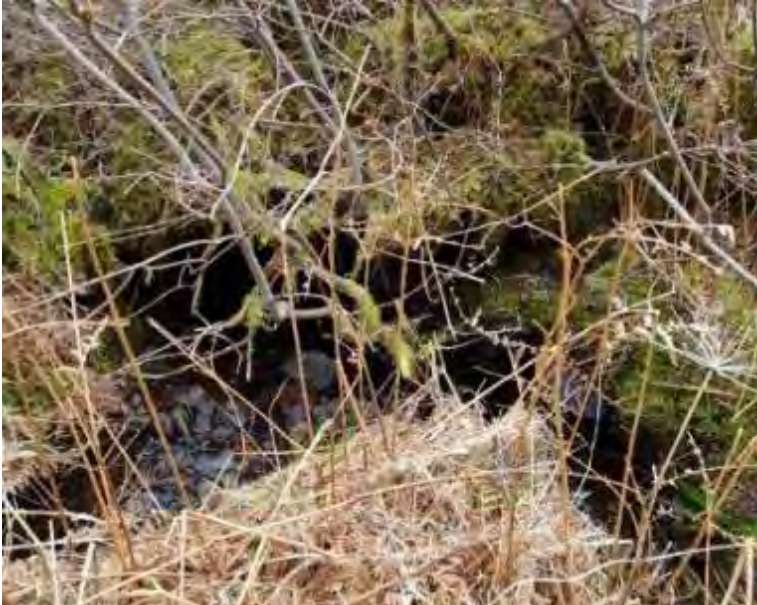
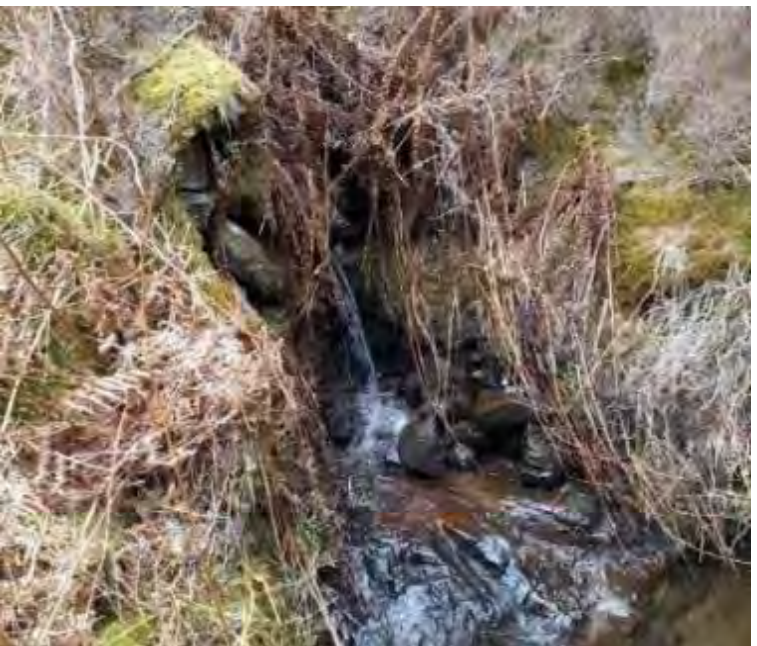
Watercourse Crossing ID	WX3.16
Watercourse Crossing Details	<p>Watercourse Crossing: WX3.16 NGR: NG 79031 22919 Status: Existing Culvert Diameter: 0.4m Culvert Construction Type: circular corrugated metal culvert Watercourse Width: 0.1m Watercourse Depth: 0.2m Notes: two small 0.1m x 0.2m channels join at the crossing, incised into peat</p>
Photograph Looking at Culvert Entrance from Upstream

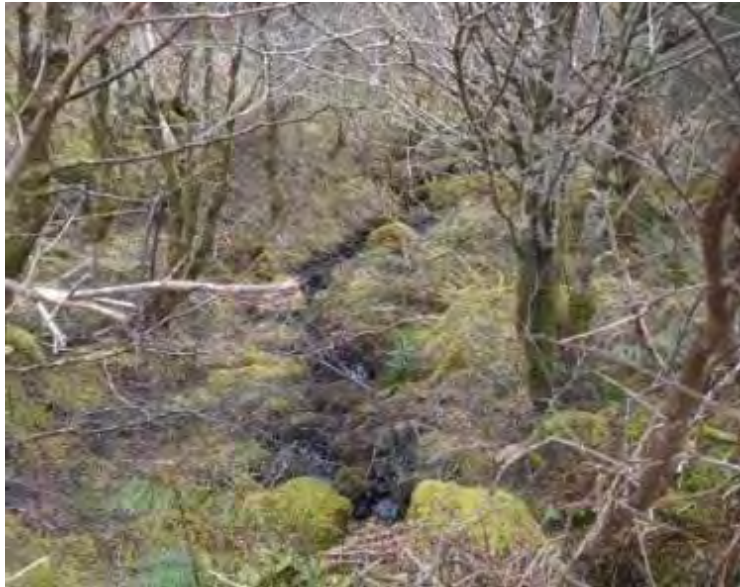
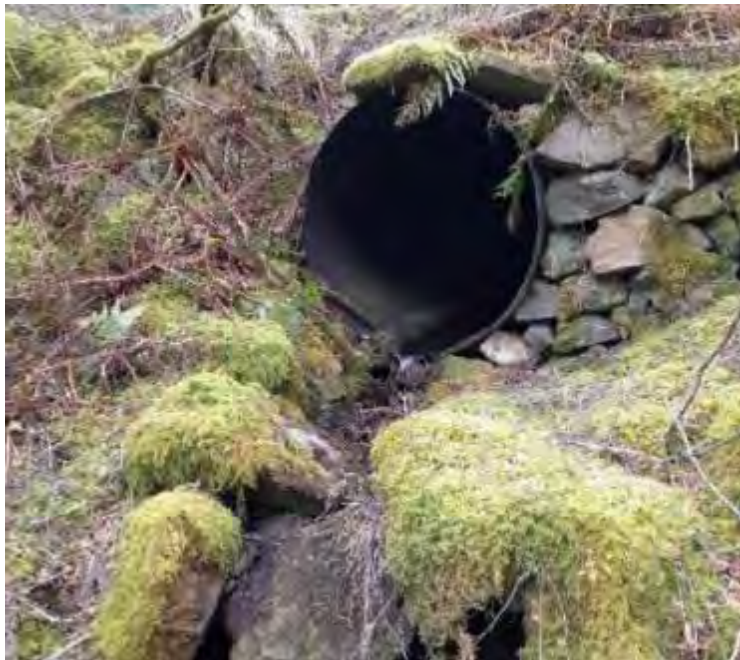
Watercourse Crossing ID	WX3.17
Watercourse Crossing Details	<p>Watercourse Crossing: WX3.17 NGR: NG 78874 22689 Status: Existing Culvert Diameter: 1m Culvert Construction Type: circular corrugated metal culvert Watercourse Width: 0.3m Watercourse Depth: 0.1m Notes: two small channels join upstream of the culvert.</p>
Photograph Looking Upstream from Upstream

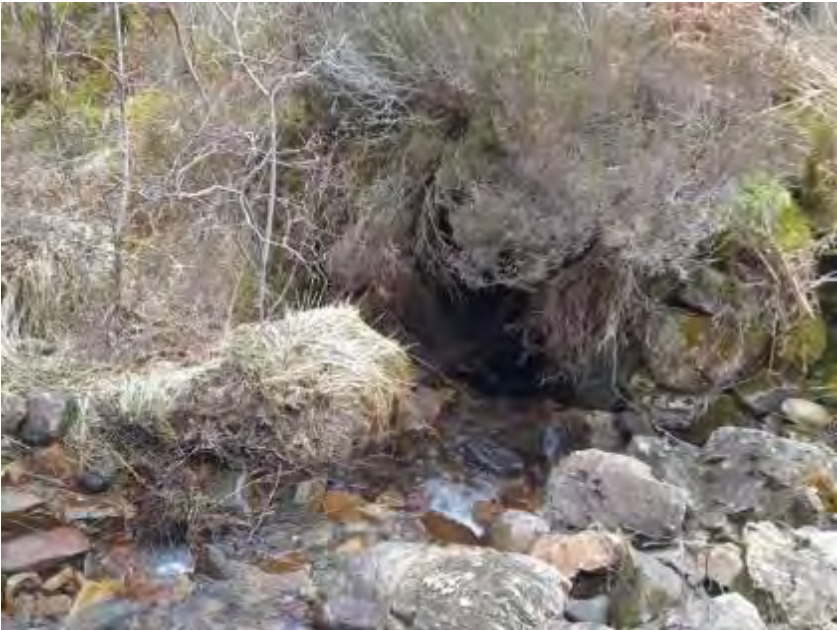
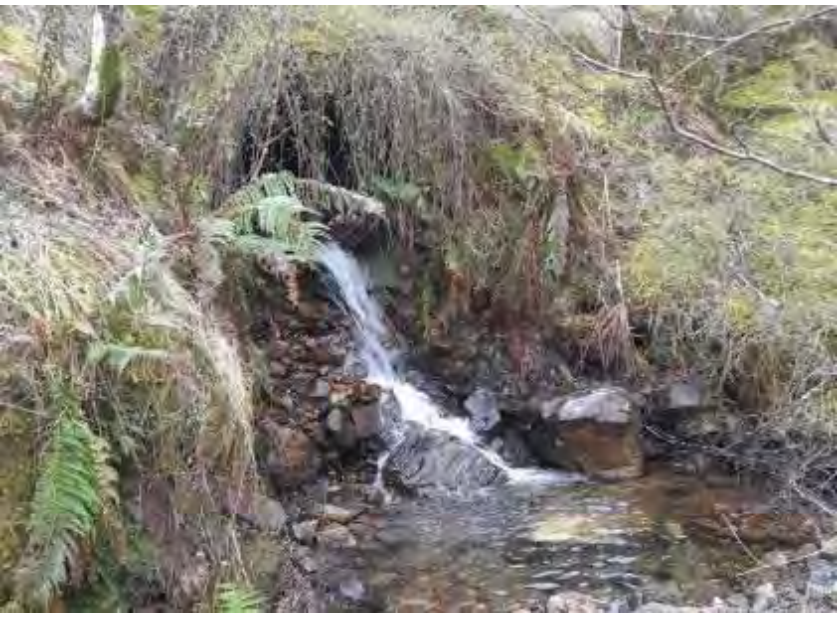
Watercourse Crossing ID	WX3.18
Watercourse Crossing Details	<p>Watercourse Crossing: WX3.18 NGR: NG 78860 22636 Status: Existing Culvert Diameter: 1m Culvert Construction Type: circular corrugated metal Watercourse Width: 2-3m Watercourse Depth: 0.3m Notes: upstream catchment is steep with waterfall</p>
Photograph Looking at Culvert Entrance from Upstream

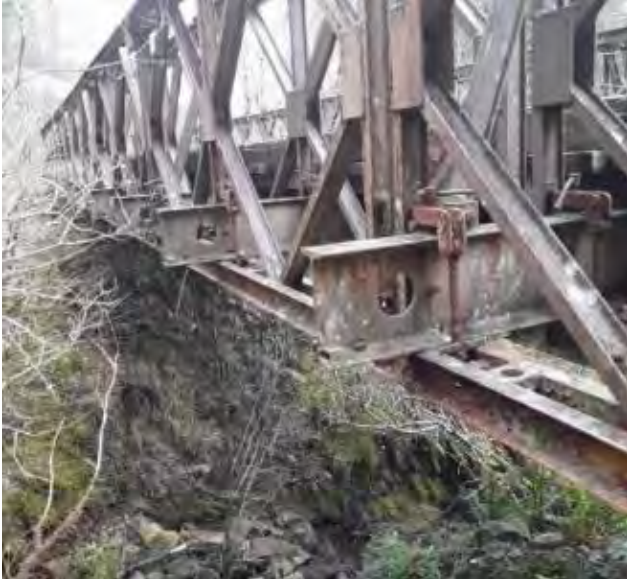
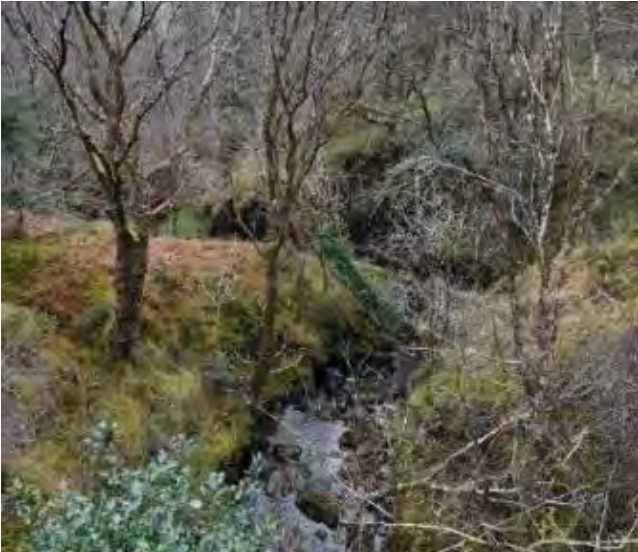
Watercourse Crossing ID	WX3.19
Watercourse Crossing Details	<p>Watercourse Crossing: WX3.19 NGR: NG 78665 22360 Status: Existing Bridge Width: 20m Culvert Construction Type: open span bridge with steel frame and wooden slats Watercourse Width: 5m Watercourse Depth: 10-15m Notes: fast flowing channel with various knick points incising into bedrock.</p>
Photograph Looking at Bridge from Upstream
