SKYE REINFORCEMENT PROJECT

Appendix V2-6.2: Schedule of Permanent Watercourse Crossings

Prepared for: Scottish & Southern Electricity
Networks Transmission (SSEN Transmission)

SLR Ref: 428.04707.00020
Version No: Final
September 2022

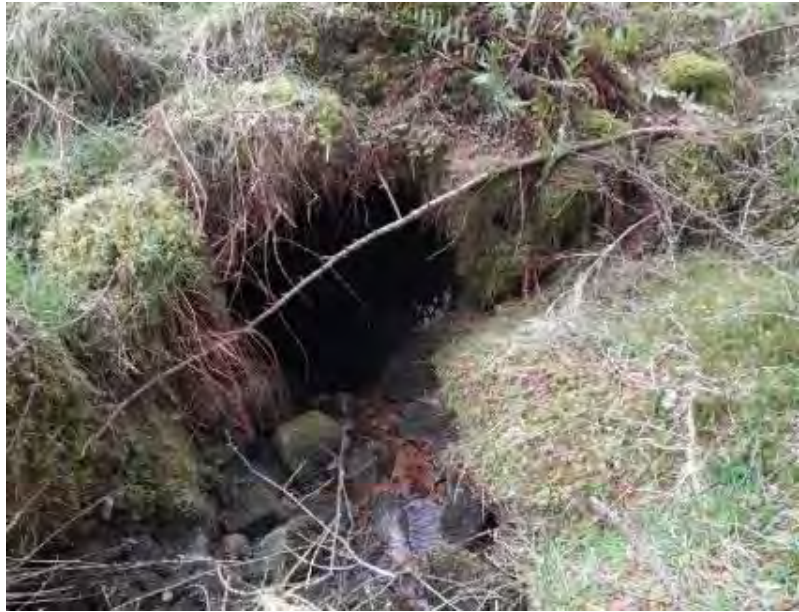
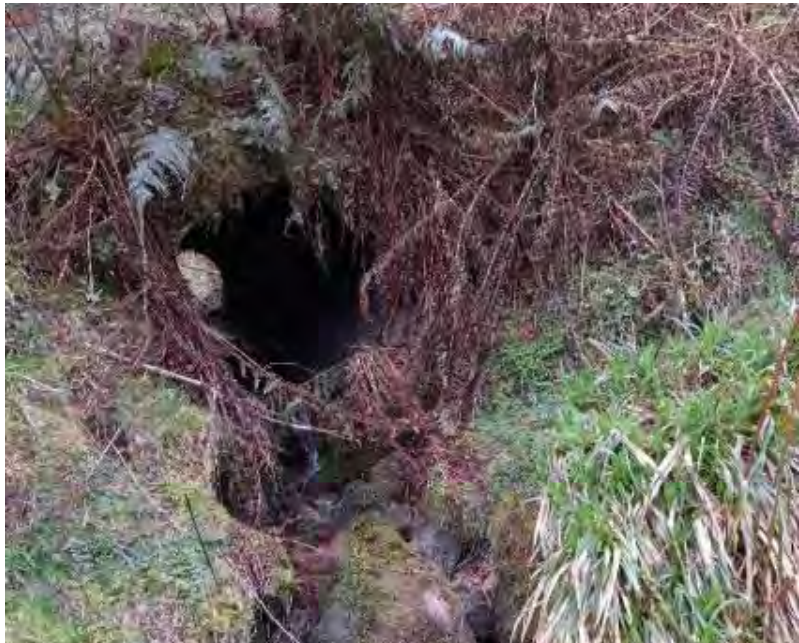
Watercourse Crossing ID	WX3.20
Watercourse Crossing Details	<p>Watercourse Crossing: WX3.20 NGR: NG 78649 22218 Status: Existing Culvert Diameter: 0.4m Culvert Construction Type: circular corrugated metal culvert Watercourse Width: 0.4m Watercourse Depth: 0.2m Notes: none</p>
Photograph Looking at Culvert Entrance from Upstream

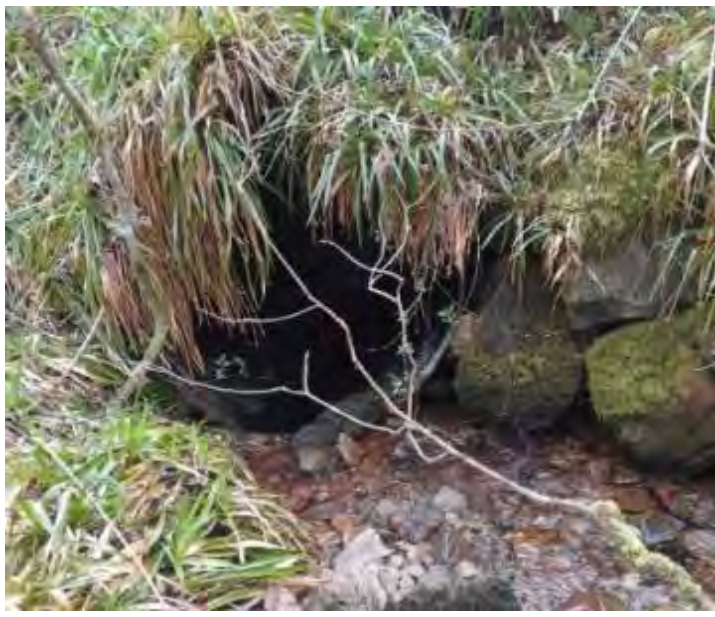
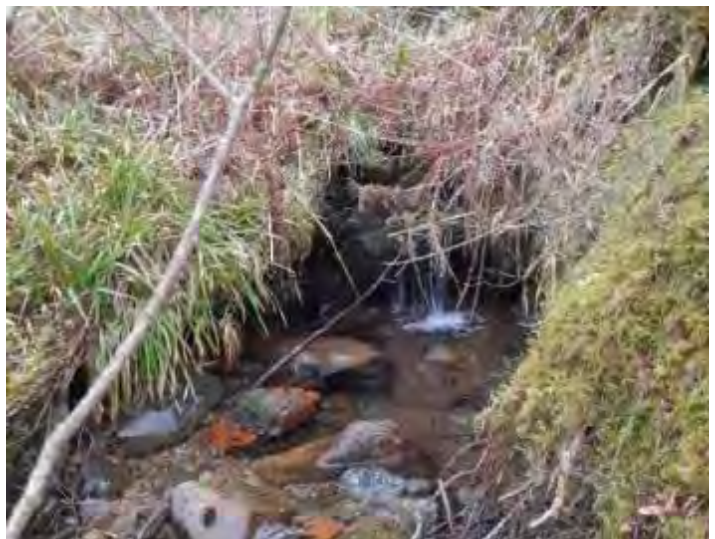
Watercourse Crossing ID	WX3.21
Watercourse Crossing Details	<p>Watercourse Crossing: WX3.21 NGR: NG 78657 22171 Status: Existing Culvert Diameter: 1m Culvert Construction Type: circular corrugated metal culvert Watercourse Width: 1-3m Watercourse Depth: 0.3m Notes: upstream channel is around 1m wide but downstream the cross section is less uniform extending to 1 - 3m width. Active watercourse in a 2m high channel.</p>
Photograph Looking at Culvert Entrance from Upstream

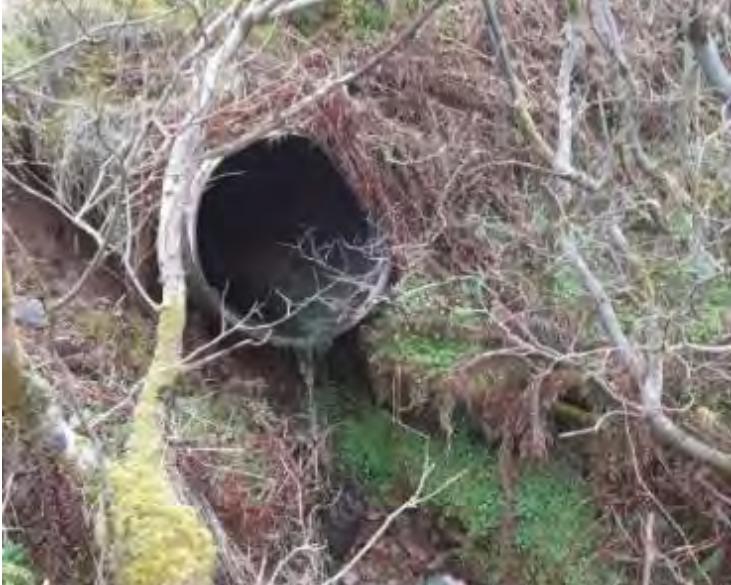
Photograph Looking at Culvert Exit from Downstream.

Watercourse Crossing ID	WX3.24
Watercourse Crossing Details	<p>Watercourse Crossing: WX3.24 NGR: NG 78681 21851 Status: Existing Culvert Diameter: 0.3m Culvert Construction Type: circular corrugated metal Watercourse Width: 0.2-0.4m Watercourse Depth: 0.1m Notes: active channel sits within a large channel which is 1.5m deep. Downstream outfall culvert has slightly corroded with moss present along the base.</p>
Photograph Looking at Culvert Entrance from Upstream

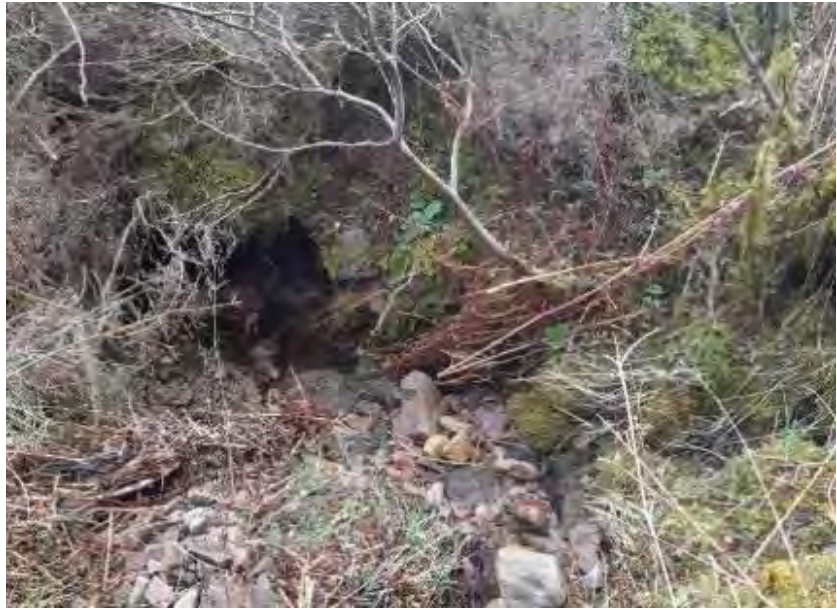
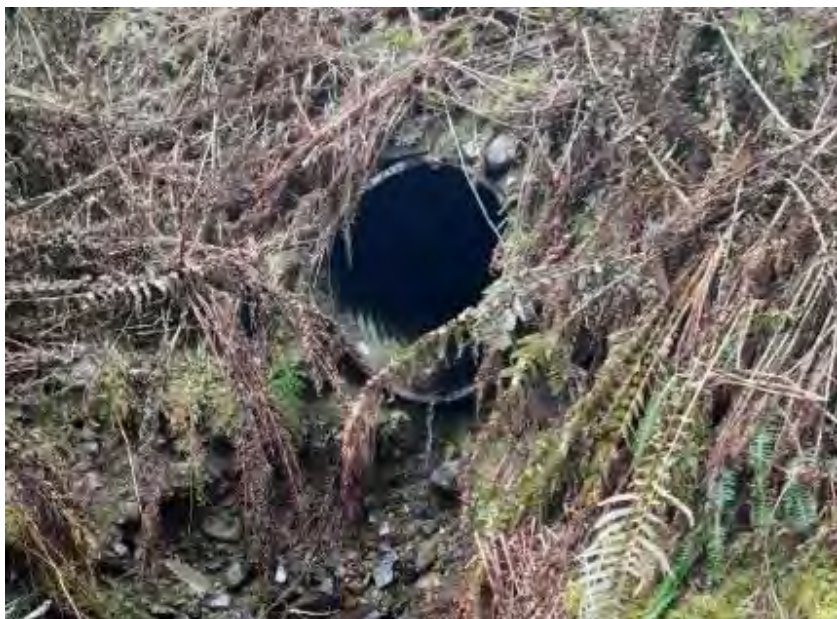
Watercourse Crossing ID	WX3.25
Watercourse Crossing Details	<p>Watercourse Crossing: WX3.25 NGR: NG 78665 21765 Status: Existing Culvert Diameter: 0.8m Culvert Construction Type: circular corrugated metal culvert Watercourse Width: 0.3-1.5m Watercourse Depth: 0.1-0.3m Notes: channel significantly narrower upstream (0.3m) and much wider downstream (1.5m), dry on the date of the survey.</p>
Photograph Looking at Culvert Entrance from Upstream

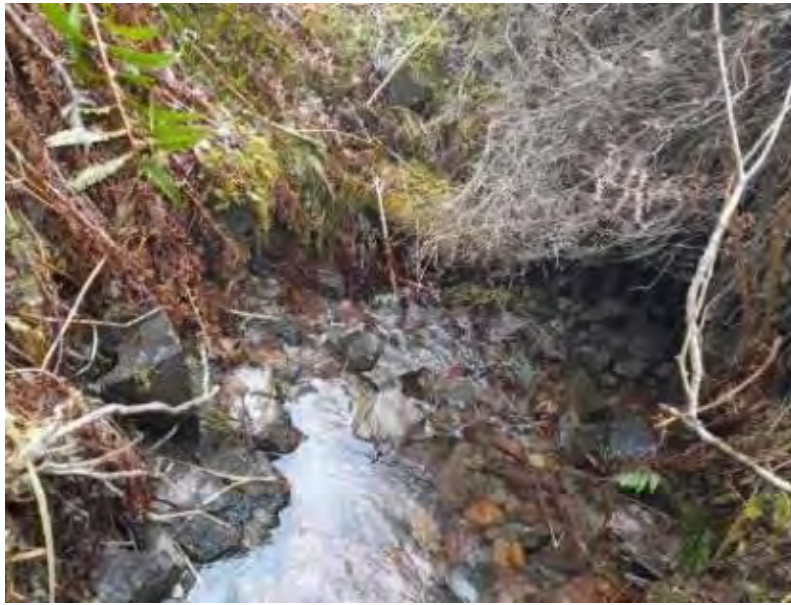
Watercourse Crossing ID	WX3.26
Watercourse Crossing Details	<p>Watercourse Crossing: WX3.26 NGR: NG 78677 21465 Status: Existing Culvert Diameter: 0.8m Culvert Construction Type: circular corrugated metal culvert Watercourse Width: 0.4m Watercourse Depth: 0.3-1m Notes: channel deeper downstream of the culvert which is partially misshapen at the outfall.</p>
Photograph Looking at Culvert Entrance from Upstream

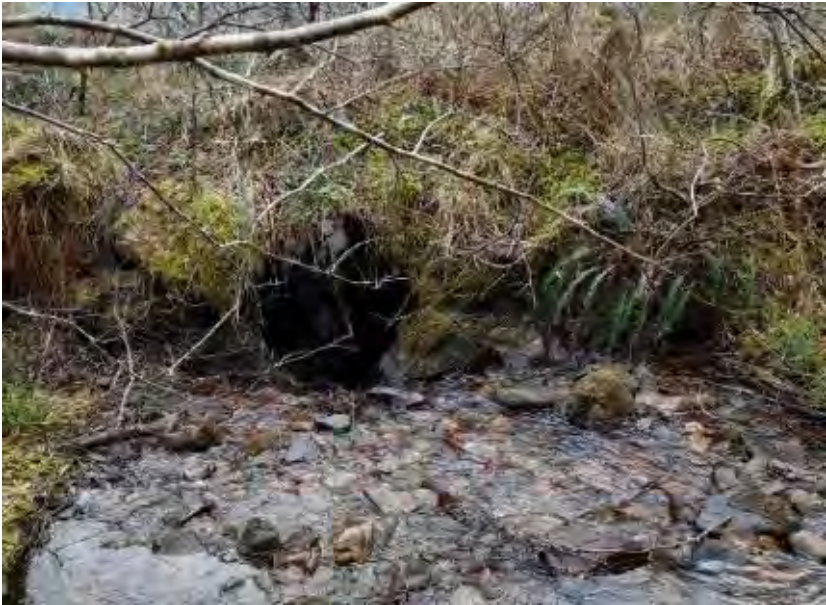
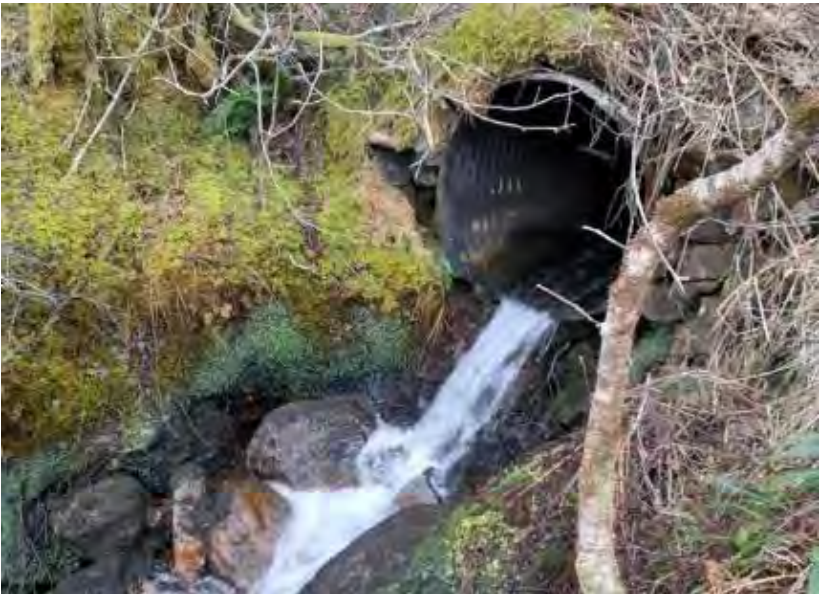
Watercourse Crossing ID	WX3.27
Watercourse Crossing Details	<p>Watercourse Crossing: WX3.27 NGR: NG 78778 22514 Status: Existing Culvert Diameter: 0.6m Culvert Construction Type: circular corrugated metal culvert Watercourse Width: 0.5-1.5m Watercourse Depth: 0.4m Notes: channel becomes more incised into bedrock downstream to form a channel depth of 3m</p>
Photograph Looking at Culvert Entrance from Upstream

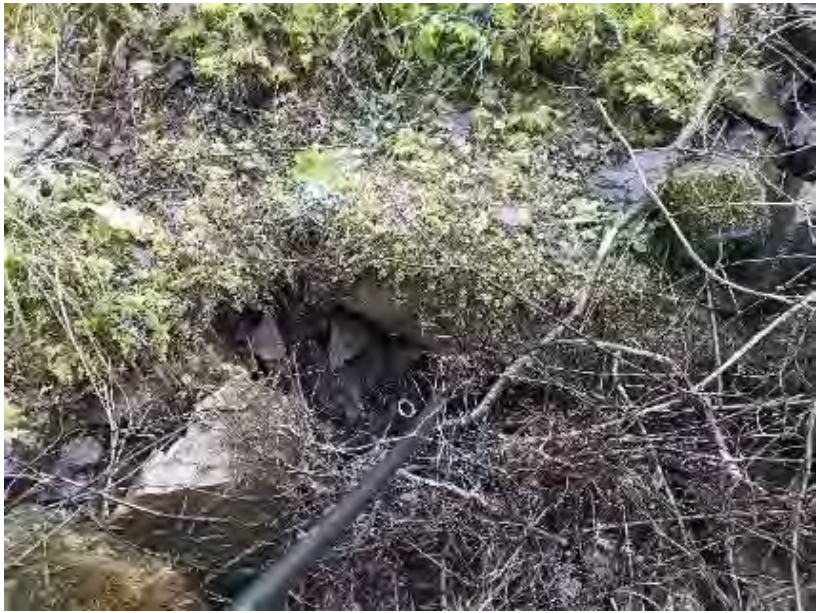
Photograph Looking at Culvert Exit from Downstream

Section 4	
Watercourse Crossing ID	WX4.1
Watercourse Crossing Details	<p>Watercourse Crossing: WX4.1 NGR: NG 79540 21392 Status: Existing Culvert Diameter: 0.3m Culvert Construction Type: open arch culvert Watercourse Width: 0.5 Watercourse Depth: 0.1m Notes: culvert is rusted, dented and partially blocked with debris.</p>
Photograph Looking at Culvert Entrance Upstream

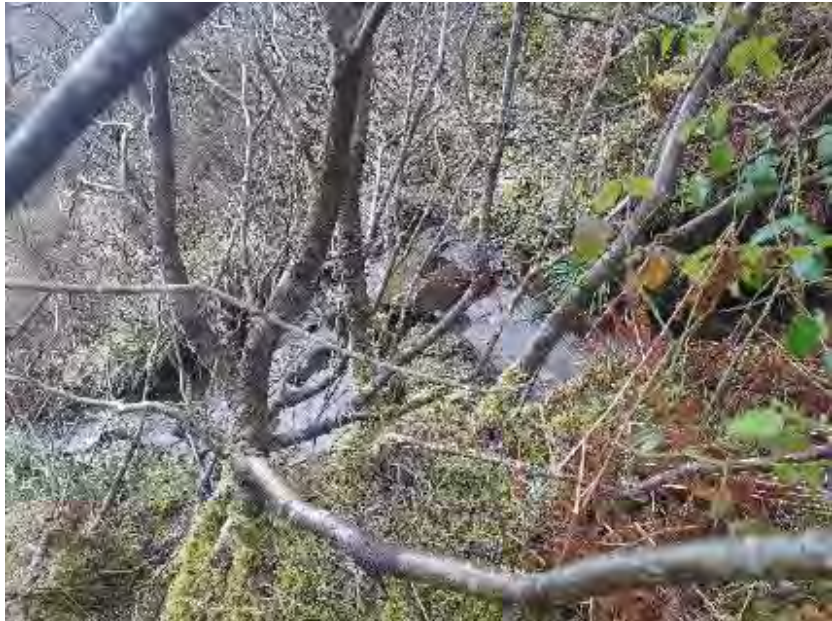
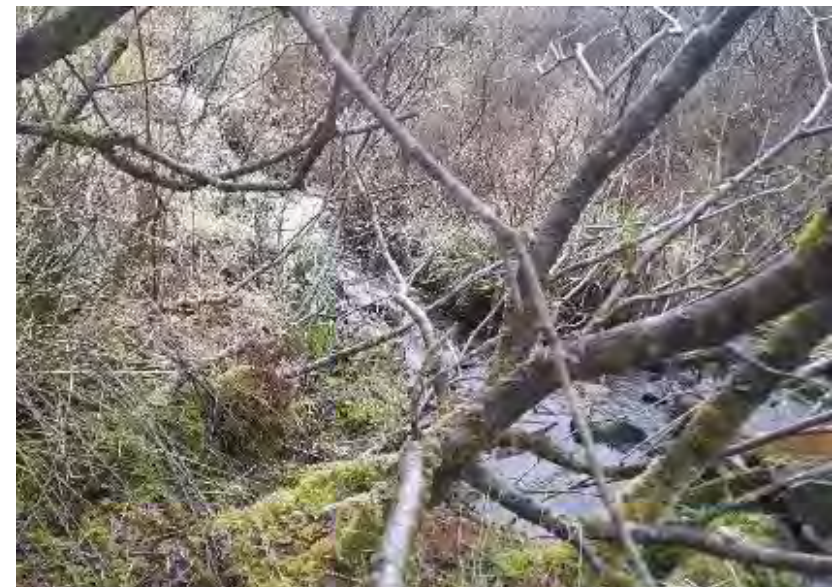
Watercourse Crossing ID	WX4.2
Watercourse Crossing Details	<p>Watercourse Crossing: WX4.2 NGR: NG 79597 21909 Status: Existing Culvert Diameter: 0.5m Culvert Construction Type: circular corrugated metal culvert Watercourse Width: 0.4m Watercourse Depth: 0.5m Notes: none</p>
Photograph Looking at Culvert Upstream

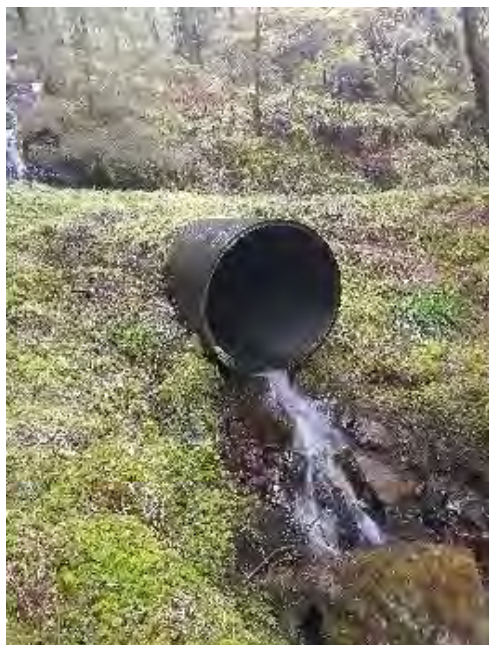
Watercourse Crossing ID	WX4.4
Watercourse Crossing Details	<p>Watercourse Crossing: WX4.4 NGR: NG 79787 22217 Status: Existing Culvert Diameter: 1.5m Culvert Construction Type: circular plastic culvert Watercourse Width: 0.5-1.5m Watercourse Depth: 0.1m Notes: channel is deeper and wider downstream with boulders and cobbles noted, existing culvert appears in good condition</p>
Photograph Looking at Culvert Entrance from Upstream

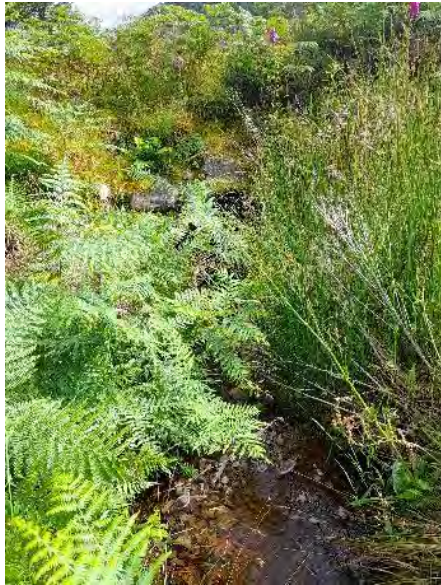
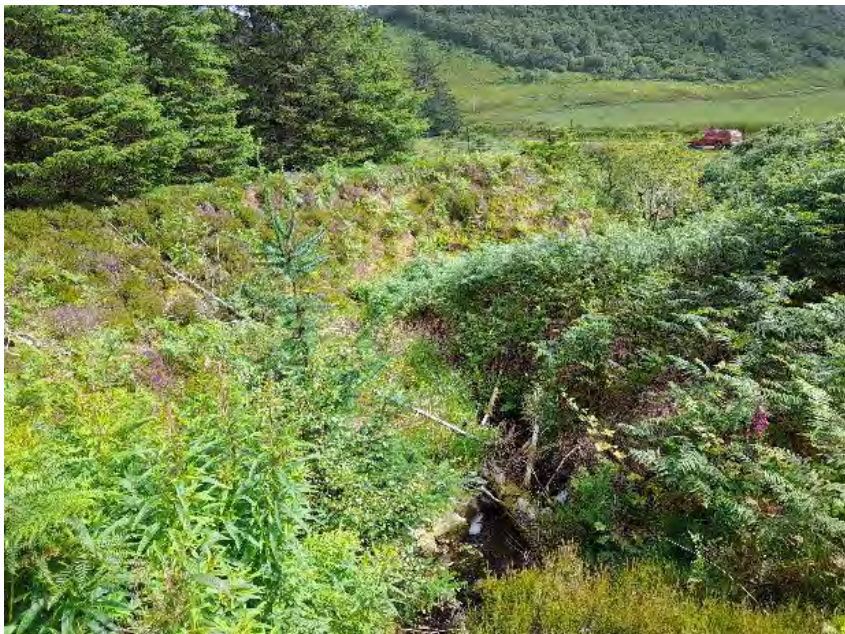
Watercourse Crossing ID	WX4.6
Watercourse Crossing Details	<p>Watercourse Crossing: WX4.6 NGR: NG 81031 21563 Status: Existing Culvert Diameter: 1 m Culvert Construction Type: plastic circular Watercourse Width: 1 m Watercourse Depth: 0.3 m Notes: Small watercourse incised on bedrock</p>
Photograph Looking at Culvert Entrance from Upstream

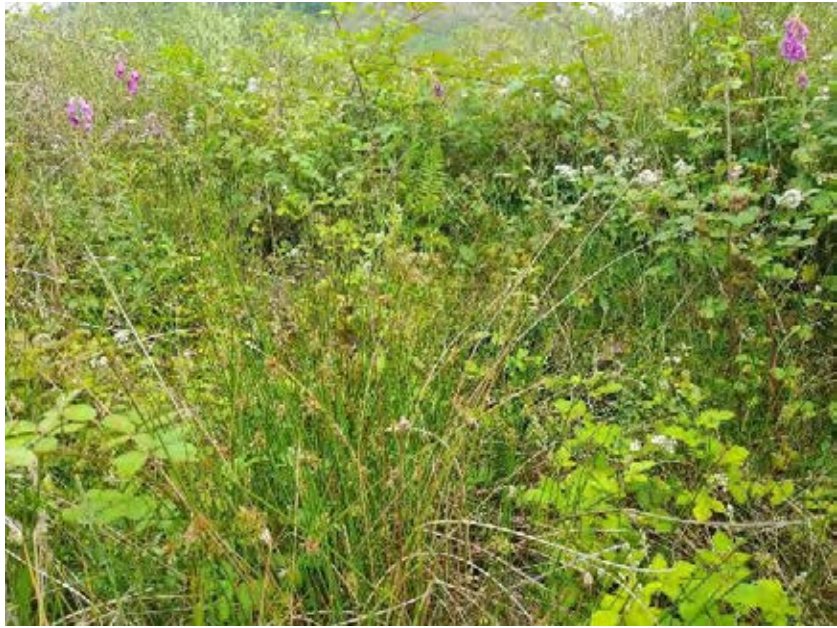
Watercourse Crossing ID	WX4.7
Watercourse Crossing Details	<p>Watercourse Crossing: WX4.7 NGR: NG 81107 21590 Status: Existing Culvert Diameter: 0.4 m Culvert Construction Type: plastic circular Watercourse Width: 0.2 m Watercourse Depth: 0.1 m Notes: Watercourse obstructed with dense vegetation</p>
Photograph Looking at Culvert Entrance from Upstream

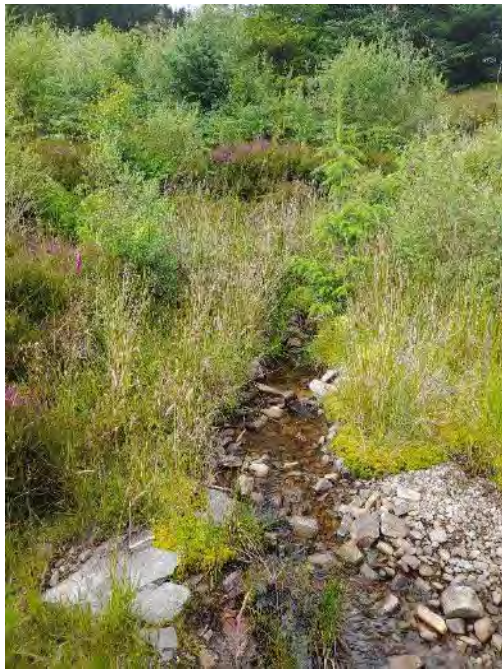
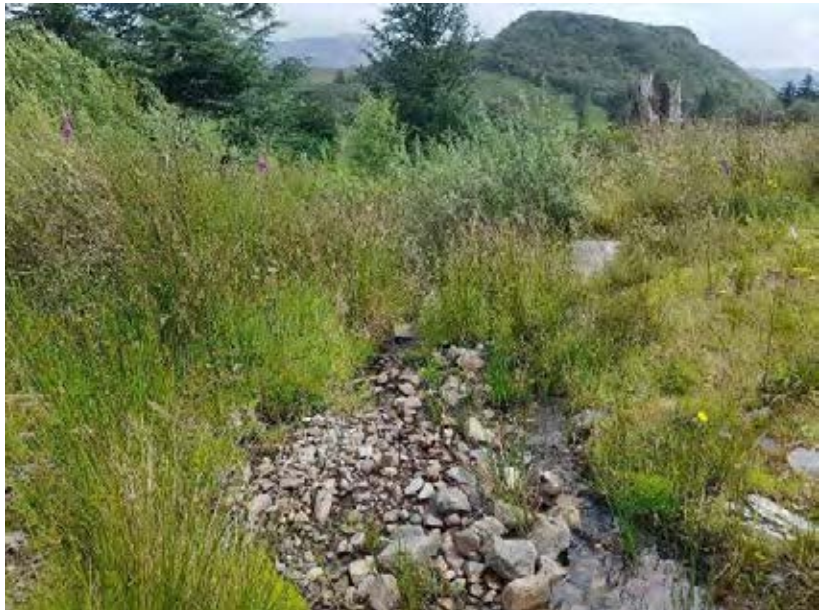
Watercourse Crossing ID	WX4.8
Watercourse Crossing Details	<p>Watercourse Crossing: WX4.8 NGR: NG 81212 21659 Status: Existing Culvert Diameter: N/A Culvert Construction Type: N/A Watercourse Width: 0.3 m Watercourse Depth: 0.1 m Notes: Small watercourse which flows over track with no formal infrastructure</p>
Photograph Looking Upstream

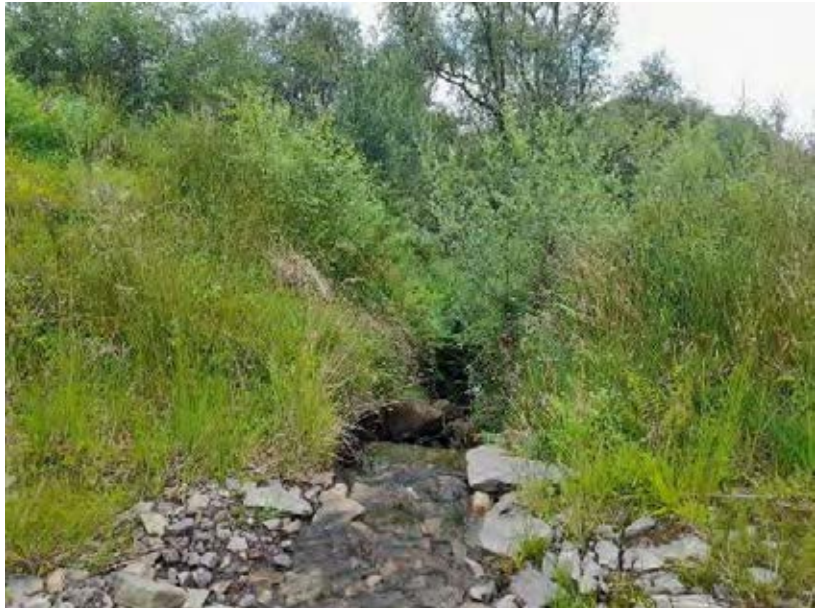
Photograph Downstream.

Watercourse Crossing ID	WX4.9
Watercourse Crossing Details	<p>Watercourse Crossing: WX4.9 NGR: NG 81262 21683 Status: Existing Culvert Diameter: N/A Culvert Construction Type: N/A Watercourse Width: 1 m Watercourse Depth: 0.2 m Notes: No formal infrastructure noted.</p>
Photograph Upstream

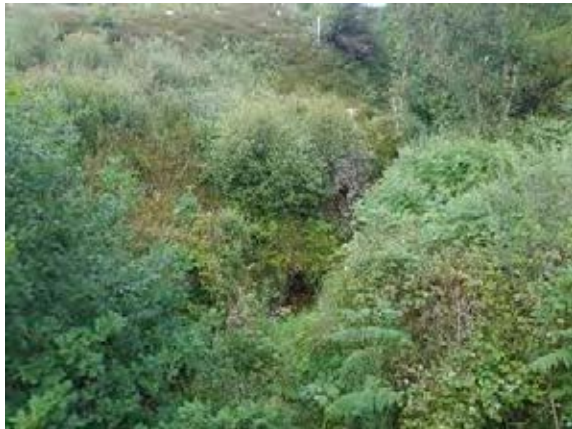
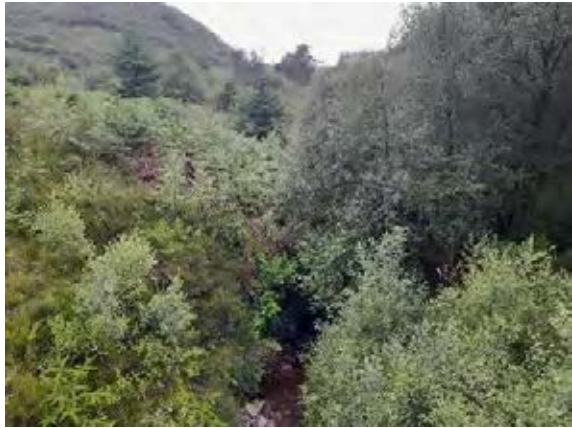
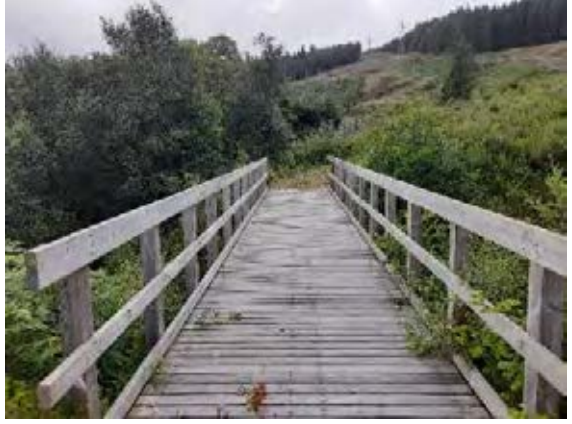
Watercourse Crossing ID	WX4.10
Watercourse Crossing Details	<p>Watercourse Crossing: WX4.10 NGR: NG 81337 21659 Status: Existing Culvert Diameter: N/A Culvert Construction Type: timber single span bridge Watercourse Width: 2.5 m Watercourse Depth: 5 m Notes: Single span bridge reinforced with steel. Bridge is approximately 15m long and 1.5m wide.</p>
Photograph Looking Upstream

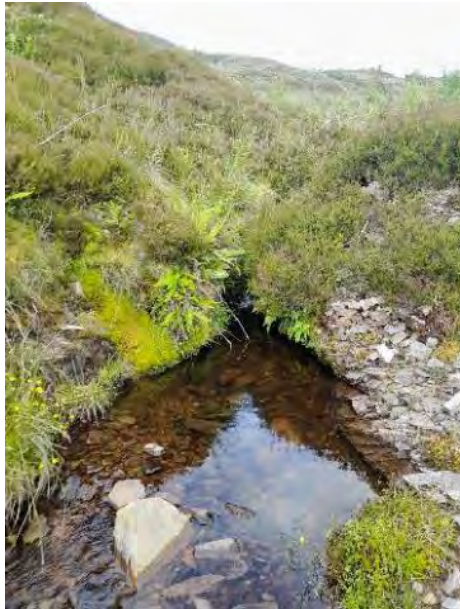
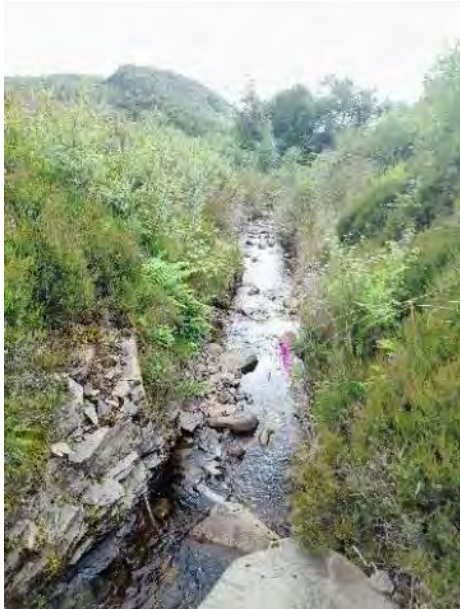
Watercourse Crossing ID	WX4.11
Watercourse Crossing Details	<p>Watercourse Crossing: WX4.11 NGR: NG 81416 21624 Status: Existing Culvert Diameter: N/A Culvert Construction Type: N/A Watercourse Width: 1.5 m Watercourse Depth: 0.2 m Notes: No formal infrastructure noted. Watercourse incised in bedrock, which becomes more incised upstream and downstream of crossing point.</p>
Photograph Looking Upstream

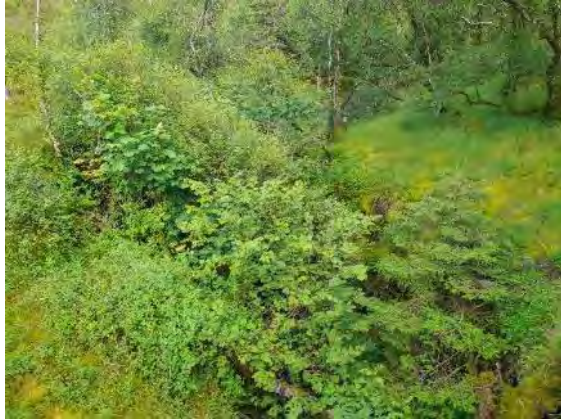
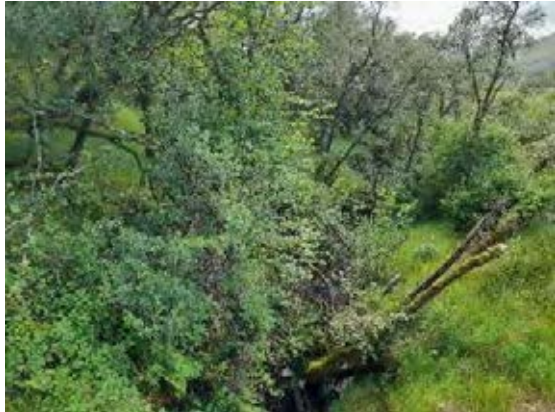
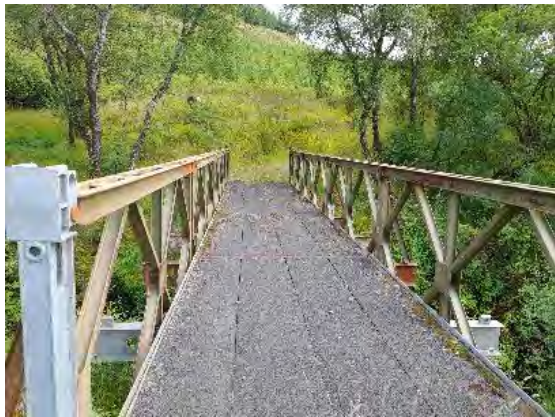
Watercourse Crossing ID	WX4.12
Watercourse Crossing Details	<p>Watercourse Crossing: WX4.12 NGR: NG 81504 21567 Status: Existing Culvert Diameter: N/A Culvert Construction Type: iron single span bridge Watercourse Width: 3 m Watercourse Depth: 10 m Notes: Single span bridge which is approximately 15 m long and 1.5 m wide.</p>
Photograph Looking Upstream

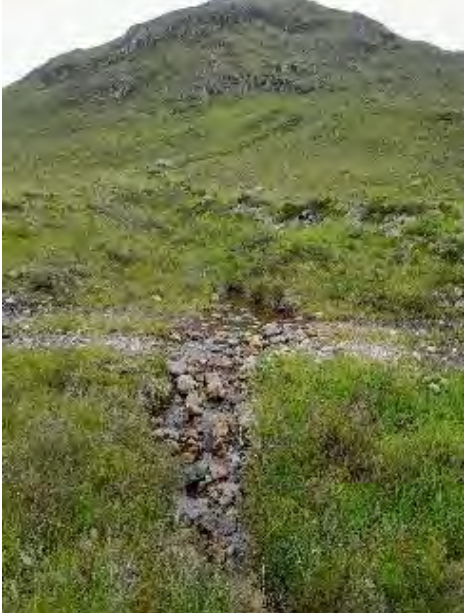
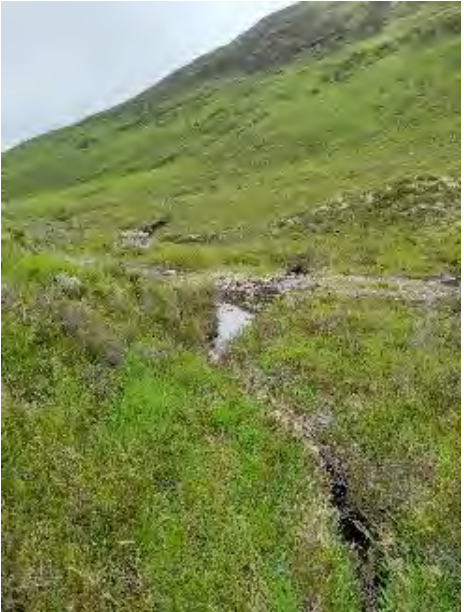
Watercourse Crossing ID	WX4.26	
Watercourse Crossing Details	<p>Watercourse Crossing: WX4.26 NGR: NG 87537 14158 Status: Existing Culvert Diameter: N/A Culvert Construction Type: N/A Watercourse Width: 1.5 m Watercourse Depth: 0.2 m Notes: Water flows over existing track, no formal infrastructure noted. Watercourse with steady flow incised into bedrock.</p>	
Photograph Looking Upstream

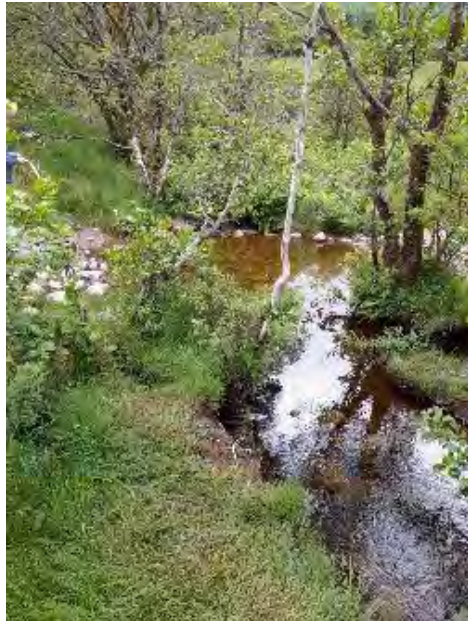
Watercourse Crossing ID	WX4.32
Watercourse Crossing Details	<p>Watercourse Crossing: WX4.32 NGR: NG 85158 16174 Status: Existing Culvert Diameter: N/A Culvert Construction Type: N/A Watercourse Width: 4 m Watercourse Depth: 0.2 m Notes: Wide ford crossing, no formal infrastructure noted</p>
Photograph Looking Upstream

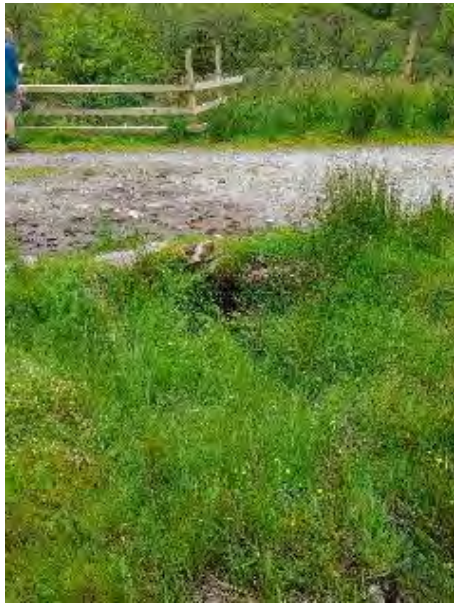
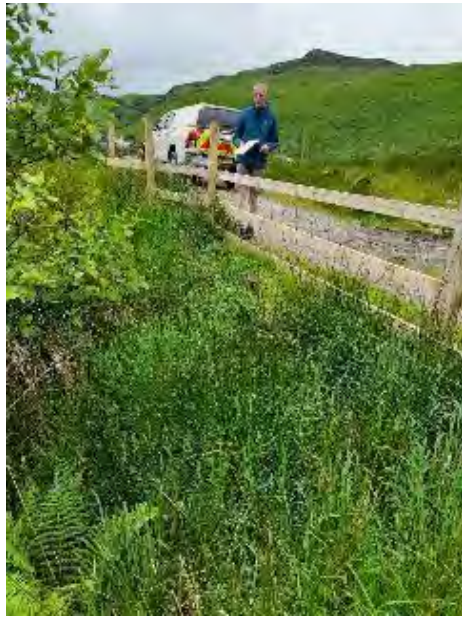
Watercourse Crossing ID	WX4.33	
<p>Watercourse Crossing Details</p>	<p>Watercourse Crossing: WX4.33 NGR: NG 84955 16346 Status: Existing Culvert Diameter: 0.8 m Culvert Construction Type: corrugate metal Watercourse Width: 0.5 m Watercourse Depth: N/A Notes: Watercourse and crossing heavily vegetated.</p>	
<p>Photograph Looking at Culvert Entrance from Upstream</p>

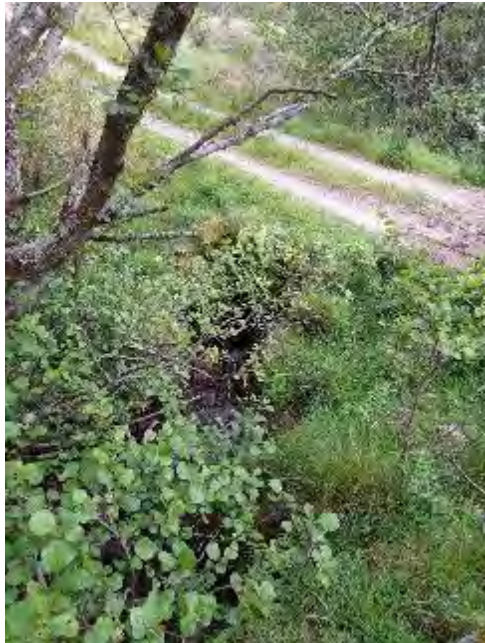
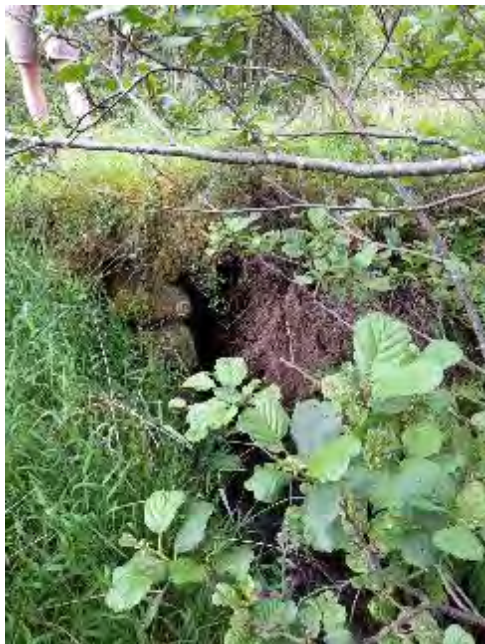
Watercourse Crossing ID	WX4.35	
Watercourse Crossing Details	<p>Watercourse Crossing: WX4.35 NGR: NG 86270 15935 Status: Existing Culvert Diameter: 0.4 m Culvert Construction Type: stone open span Watercourse Width: 1 m Watercourse Depth: N/A Notes: Heavily vegetated near culvert and along watercourse banks.</p>	
<p>Photograph Looking at Culvert Entrance from Upstream</p>

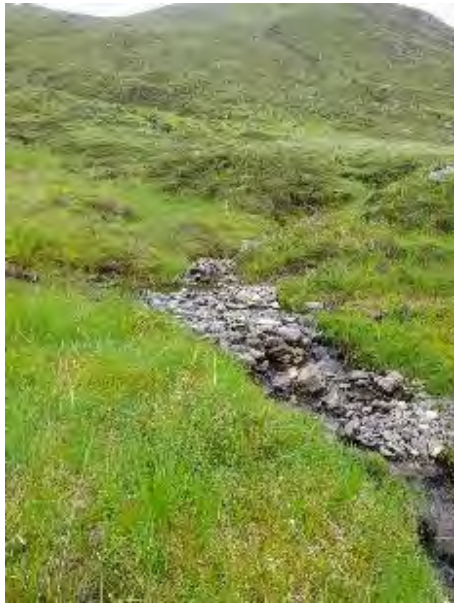
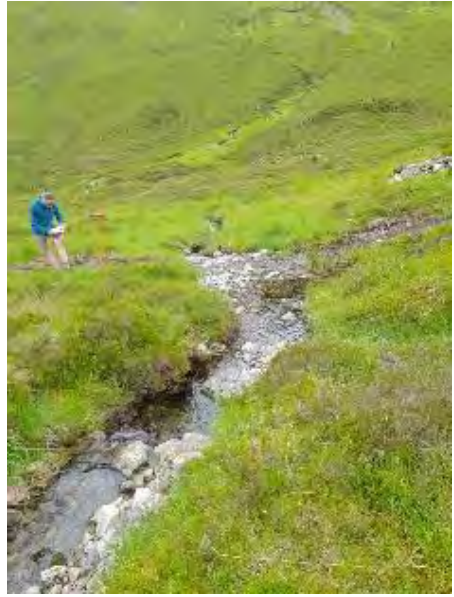
Watercourse Crossing ID	WX4.42
Watercourse Crossing Details	<p>Watercourse Crossing: WX4.42 NGR: NG 88032 13179 Status: Existing Culvert Diameter: N/A Culvert Construction Type: N/A Watercourse Width: 2 m Watercourse Depth: 0.4 m Notes: Water flows over existing track, no formal infrastructure noted. Steep watercourse and boulders within the channel.</p>
Photograph Looking Upstream

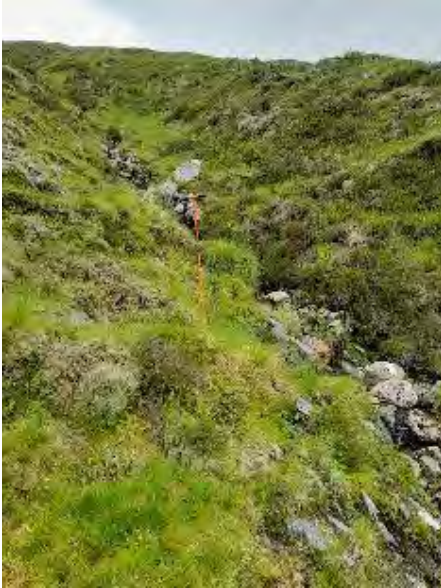
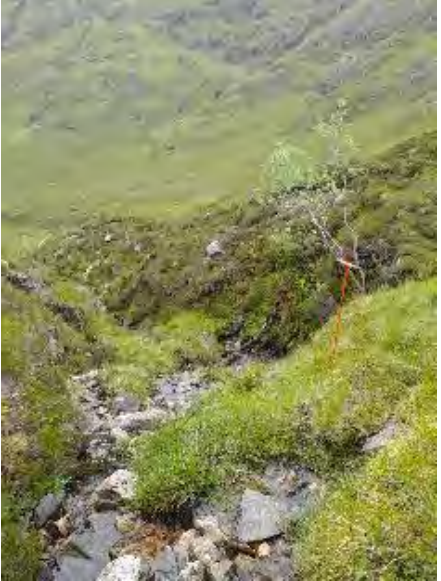
Watercourse Crossing ID	WX4.45	
Watercourse Crossing Details	<p>Watercourse Crossing: WX4.45 NGR: NG 88113 12727 Status: Existing Culvert Diameter: N/A Culvert Construction Type: N/A Watercourse Width: 1 to 4 m Watercourse Depth: 3 m Notes: Water flows across existing track, no formal infrastructure noted. Photographs taken approximately 200 m upstream on the same watercourse.</p>	
Photograph Looking at Culvert Entrance from Upstream

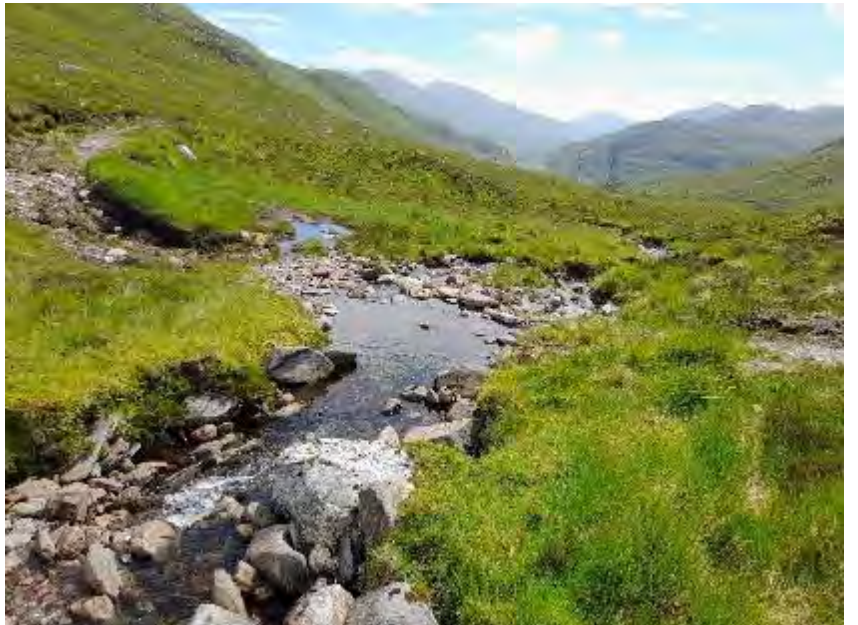
Watercourse Crossing ID	WX4.54
Watercourse Crossing Details	<p>Watercourse Crossing: WX4.54 NGR: NG 89301 11475 Status: Existing Culvert Diameter: N/A Culvert Construction Type: N/A Watercourse Width: 1.7 m Watercourse Depth: 0.8 m Notes: Small ford crossing on bedrock. No formal infrastructure noted.</p>
Photograph Looking Upstream

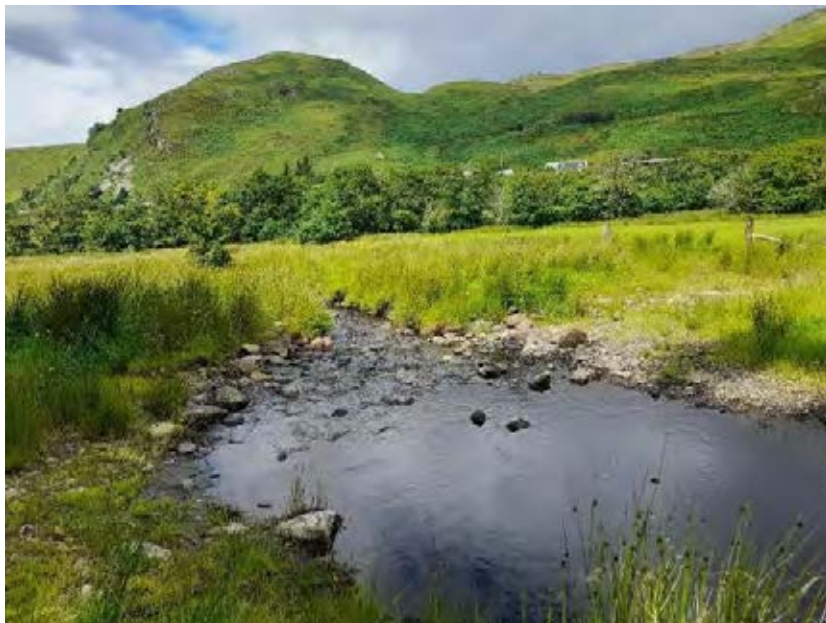
Photograph Looking Downstream

Watercourse Crossing ID	WX4.58
Watercourse Crossing Details	<p>Watercourse Crossing: WX4.58 NGR: NG 84260 19808 Status: Existing Culvert Diameter: N/A Culvert Construction Type: N/A Watercourse Width: 3 m Watercourse Depth: 0.3 m Notes: Ford crossing with no formal infrastructure. Channel noted narrower and slightly deeper both upstream and downstream of crossing location</p>
Photograph Looking Upstream

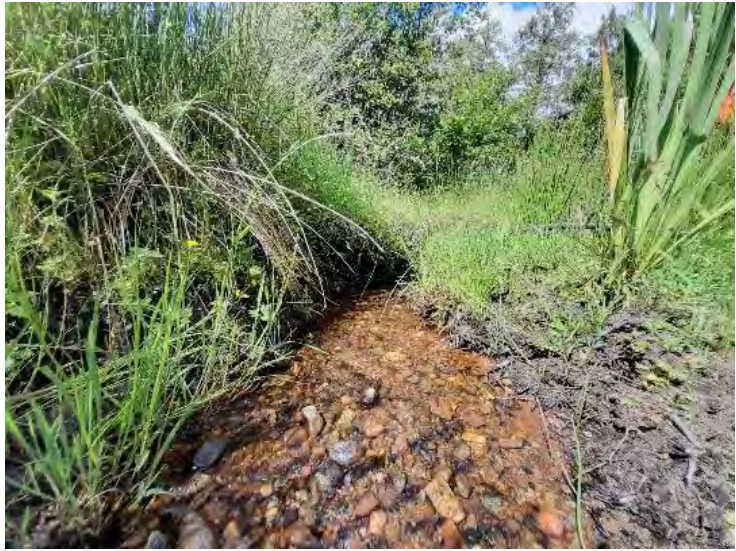
Watercourse Crossing ID	WX4.59
Watercourse Crossing Details	<p>Watercourse Crossing: WX4.59 NGR: NG 84161 19695 Status: Existing Culvert Diameter: 0.2 m Culvert Construction Type: plastic circular Watercourse Width: 0.3 m Watercourse Depth: 0.3 m Notes: Small watercourse with reeds and long grasses</p>
Photograph Looking at Culvert Entrance from Upstream

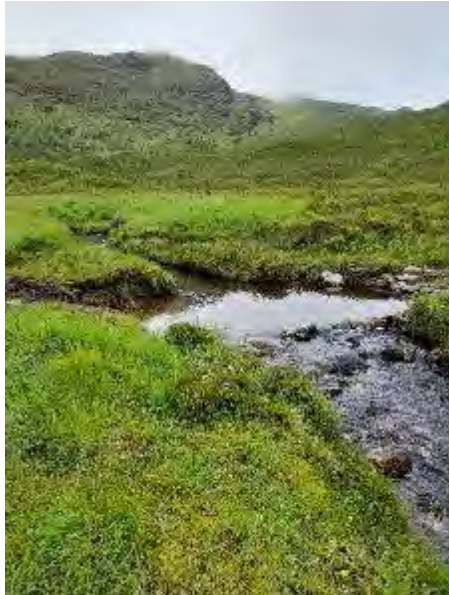
Watercourse Crossing ID	WX4.61
Watercourse Crossing Details	<p>Watercourse Crossing: WX4.61 NGR: NG 92411 09085 Status: Existing Culvert Diameter: N/A Culvert Construction Type: N/A Watercourse Width: 5 m Watercourse Depth: 1 m Notes: Ford crossing no formal infrastructure noted. Watercourse incised in peat.</p>
Photograph Looking Upstream

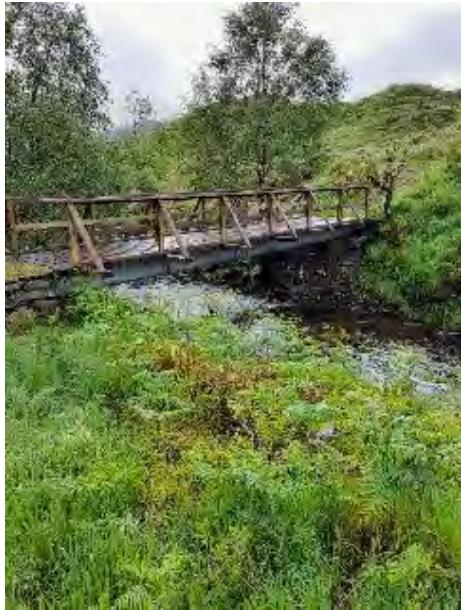
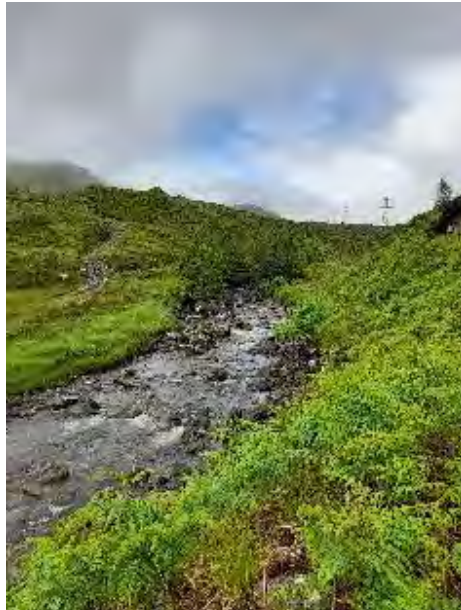
Watercourse Crossing ID	WX4.62	
Watercourse Crossing Details	<p>Watercourse Crossing: WX4.62 NGR: NG 93306 08689 Status: Existing Culvert Diameter: N/A Culvert Construction Type: timber single span bridge Watercourse Width: 7 m Watercourse Depth: 3 m Notes: Single span bridge reinforced with metal joists. Large meandering river with small ripples in the channel.</p>	
Photograph Looking at Bridge Entrance from Upstream

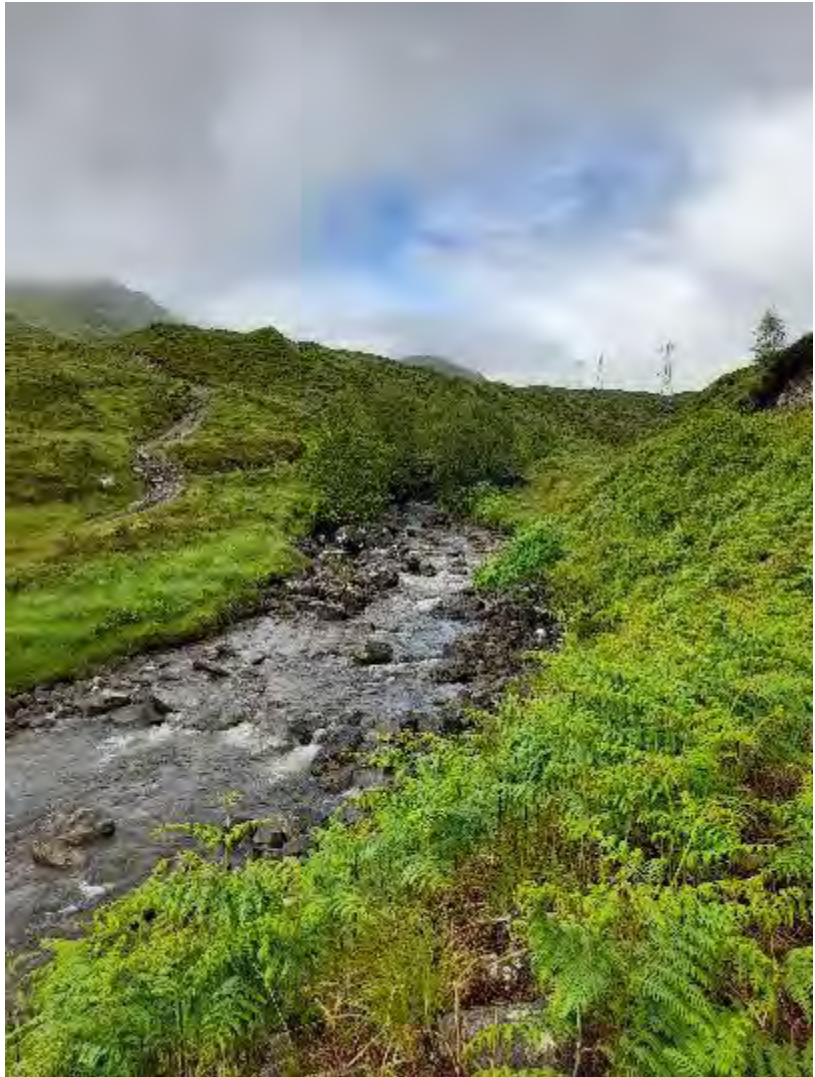
Watercourse Crossing ID	WX4.63
Watercourse Crossing Details	<p>Watercourse Crossing: WX4.63 NGR: NG 93358 08653 Status: Existing Culvert Diameter: N/A Culvert Construction Type: N/A Watercourse Width: 7 m Watercourse Depth: 1.5 m Notes: Large ford crossing downstream of large meandering river with little ripples and boulders (same as WX4.62).</p>
Photograph Looking Upstream

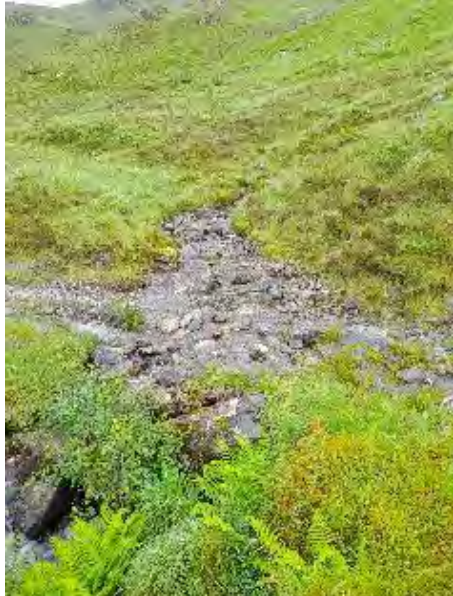
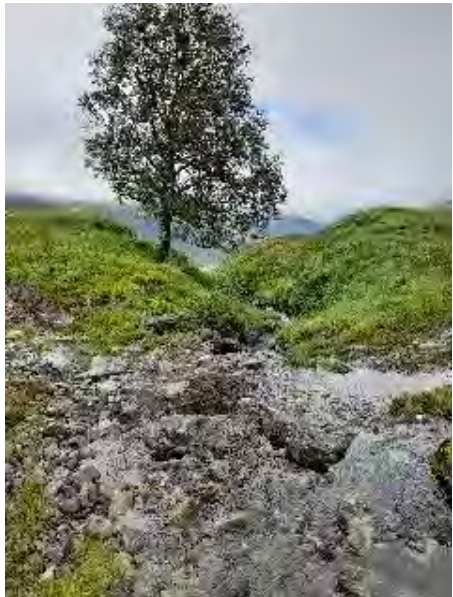
Watercourse Crossing ID	WX4.64
Watercourse Crossing Details	<p>Watercourse Crossing: WX4.64 NGR: NG 93799 08249 Status: Existing Culvert Diameter: N/A Culvert Construction Type: N/A Watercourse Width: 4.5 m Watercourse Depth: 0.5 m Notes: Survey taken approximately 100 m upstream of crossing. Watercourse becomes more incised downstream.</p>
Photograph Looking Upstream

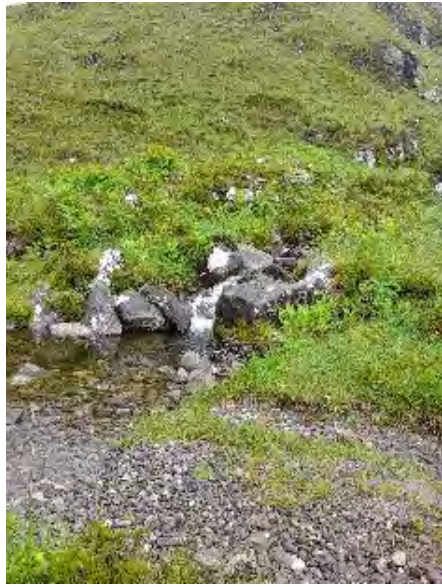
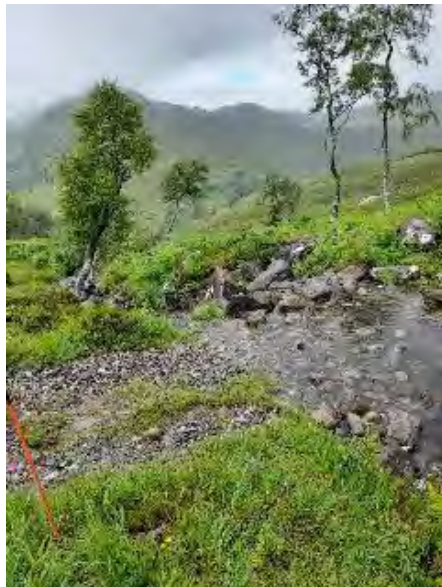
Watercourse Crossing ID	WX4.65	
Watercourse Crossing Details	<p>Watercourse Crossing: WX4.65 NGR: NG 93927 08201 Status: Existing Culvert Diameter: N/A Culvert Construction Type: N/A Watercourse Width: 3.5 m Watercourse Depth: 0.5 m Notes: Small incised watercourse. Water flows over track with on formal infrastructure.</p>	
Photograph Looking Upstream

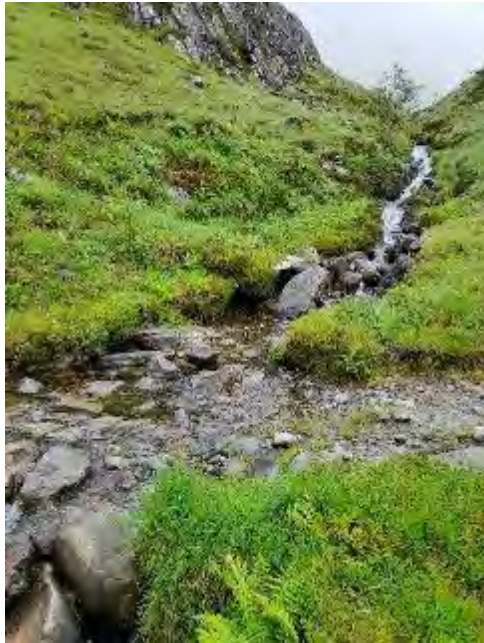
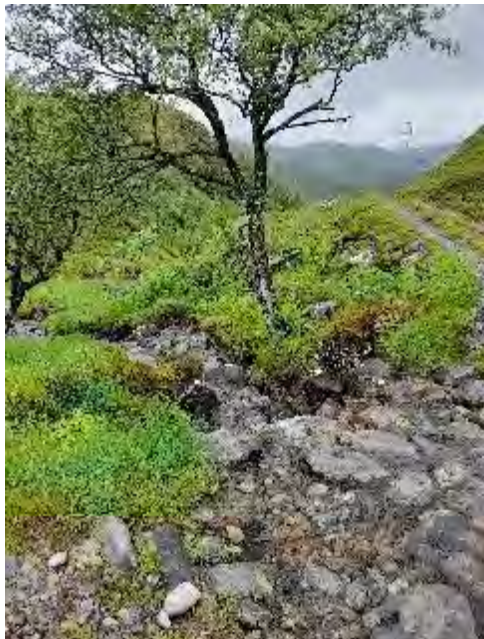
Watercourse Crossing ID	WX4.66	
Watercourse Crossing Details	<p>Watercourse Crossing: WX4.66 NGR: NG 94203 07971 Status: Existing Culvert Diameter: N/A Culvert Construction Type: N/A Watercourse Width: 4 m Watercourse Depth: 0.6 m Notes: Small incised watercourse in bedrock. No formal infrastructure.</p>	
Photograph Looking Upstream
