SKYE REINFORCEMENT PROJECT

Appendix V2-6.2: Schedule of Permanent Watercourse Crossings

Prepared for: Scottish & Southern Electricity
Networks Transmission (SSEN Transmission)

SLR Ref: 428.04707.00020
Version No: Final
September 2022

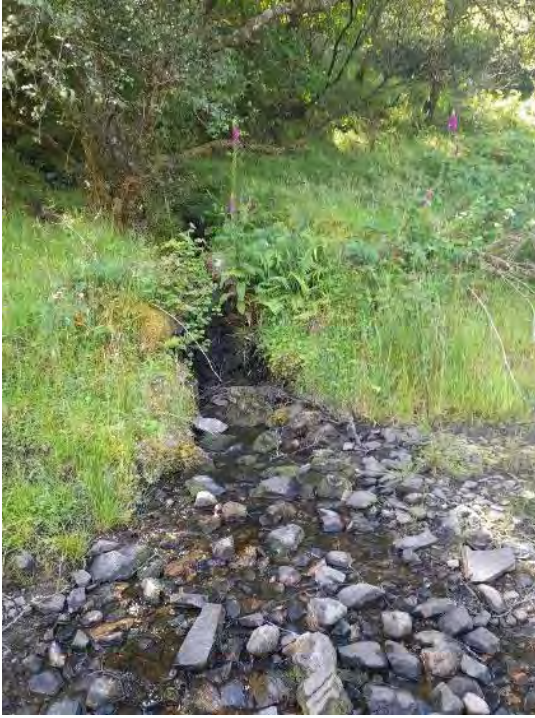
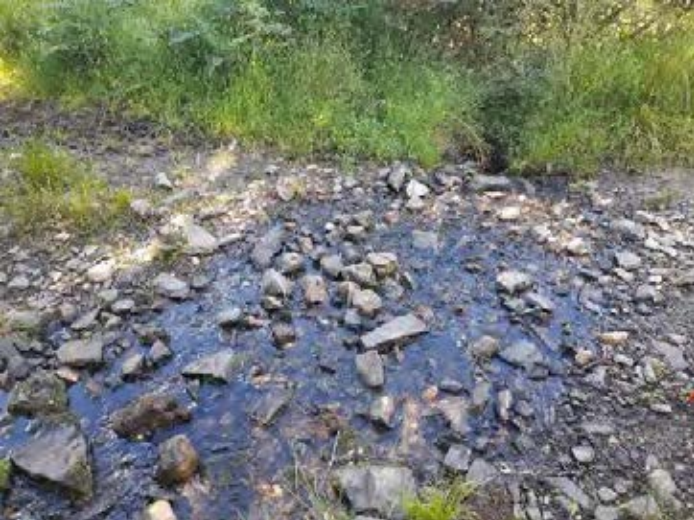
Watercourse Crossing ID	WX4.67
Watercourse Crossing Details	<p>Watercourse Crossing: WX4.67 NGR: NG 84032 19632 Status: Existing Culvert Diameter: N/A Culvert Construction Type: N/A Watercourse Width: 0.4 m Watercourse Depth: 1 m Notes: Small ford crossing with no formal infrastructure. Steep incised watercourse which becomes wider and shallower at crossing location.</p>
Photograph Looking Upstream

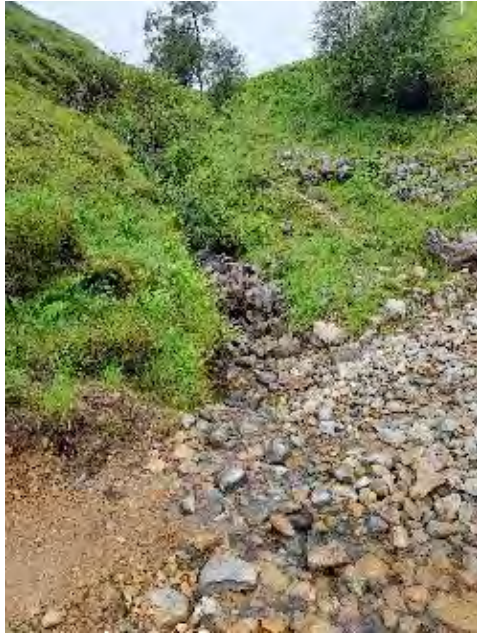
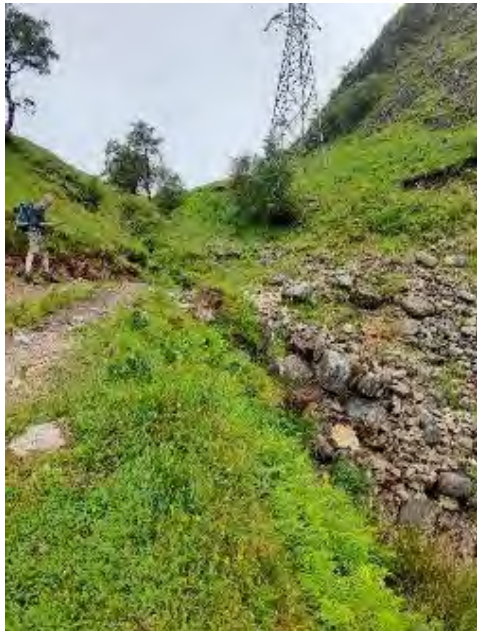
Watercourse Crossing ID	WX4.68	
Watercourse Crossing Details	<p>Watercourse Crossing: WX4.68 NGR: NG 94576 07643 Status: Existing Culvert Diameter: N/A Culvert Construction Type: N/A Watercourse Width: 1.5 m Watercourse Depth: 0.5 m Notes: Small very steep watercourse incised in bedrock. Water flows over track with no formal infrastructure</p>	
Photograph Looking Upstream

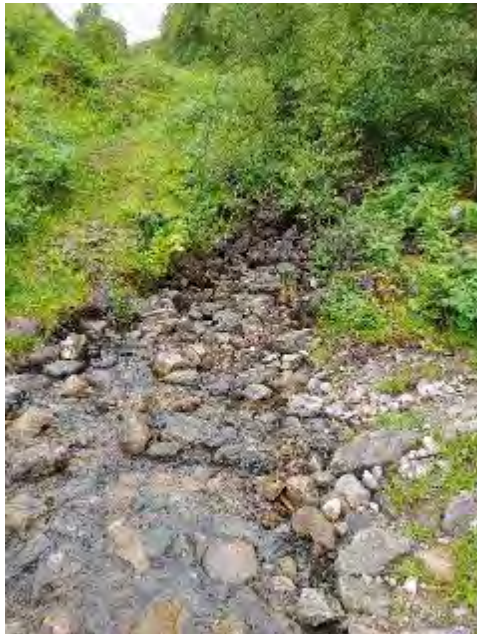
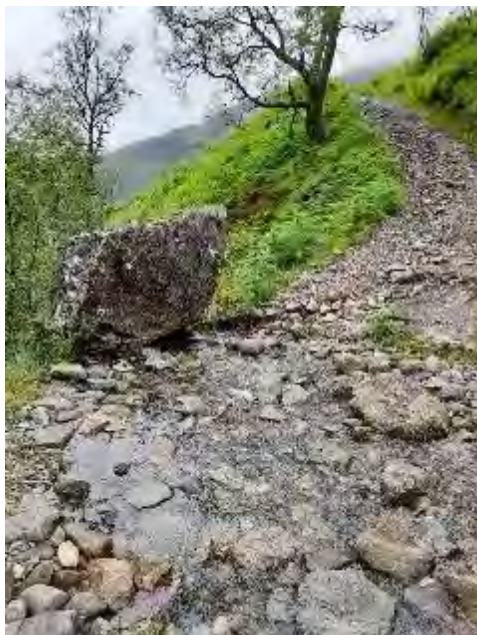
Watercourse Crossing ID	WX4.69	
Watercourse Crossing Details	<p>Watercourse Crossing: WX4.69 NGR: NG 94729 07543 Status: Existing Culvert Diameter: N/A Culvert Construction Type: N/A Watercourse Width: 3.5 m Watercourse Depth: 0.5 m Notes: Water flows over track with no formal infrastructure.</p>	
Photograph Looking Upstream

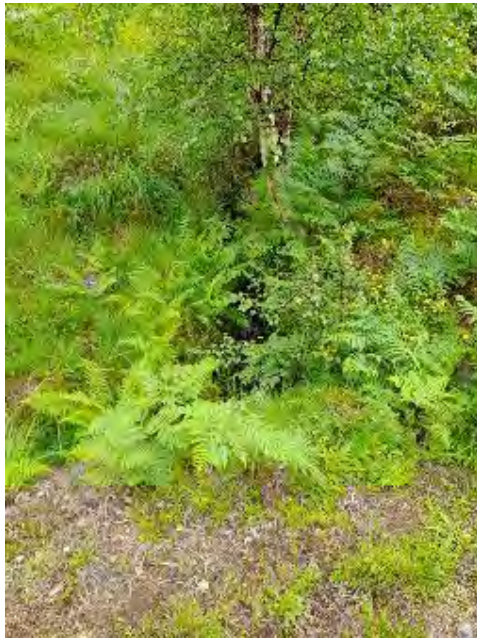
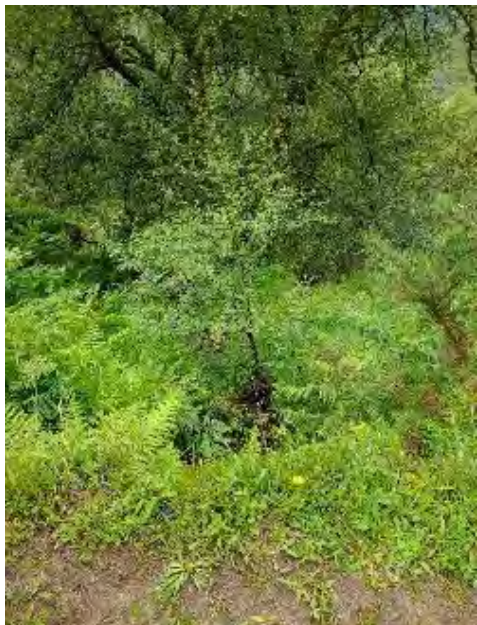
Watercourse Crossing ID	WX4.70	
Watercourse Crossing Details	<p>Watercourse Crossing: WX4.70 NGR: NG 94839 07478 Status: Existing Culvert Diameter: N/A Culvert Construction Type: stone slabs over watercourse Watercourse Width: 0.5 m Watercourse Depth: 0.5 m Notes: Small stream incised in bedrock which is heavily vegetated</p>	
Photograph Looking Upstream

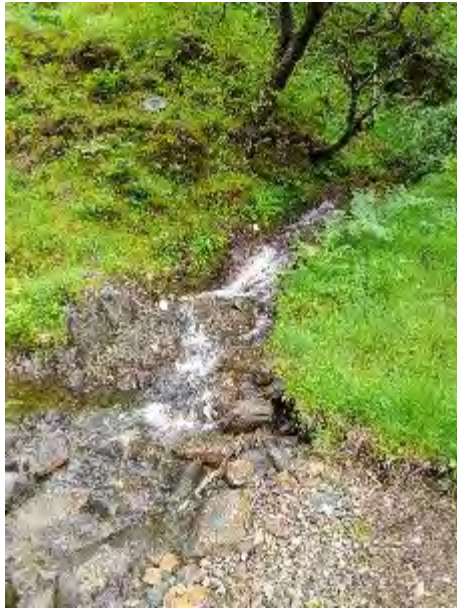
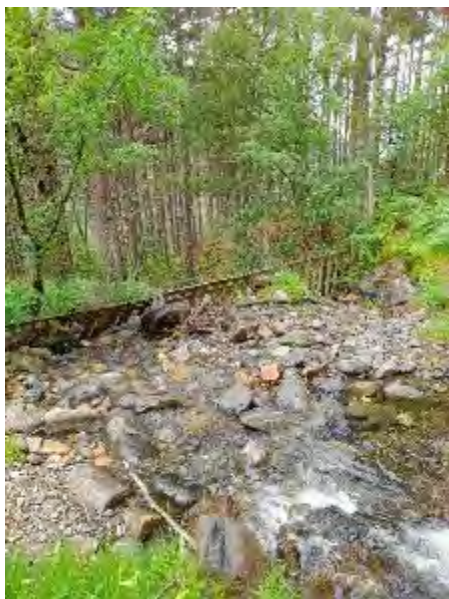
Watercourse Crossing ID	WX4.71	
Watercourse Crossing Details	<p>Watercourse Crossing: WX4.71 NGR: NG 94897 07411 Status: Existing Culvert Diameter: N/A Culvert Construction Type: N/A Watercourse Width: 3.5 m Watercourse Depth: 1 m Notes: Ford crossing. Watercourse incised in bedrock with steady flow. Fence noted across watercourse immediately downstream of crossing.</p>	
Photograph Looking Upstream

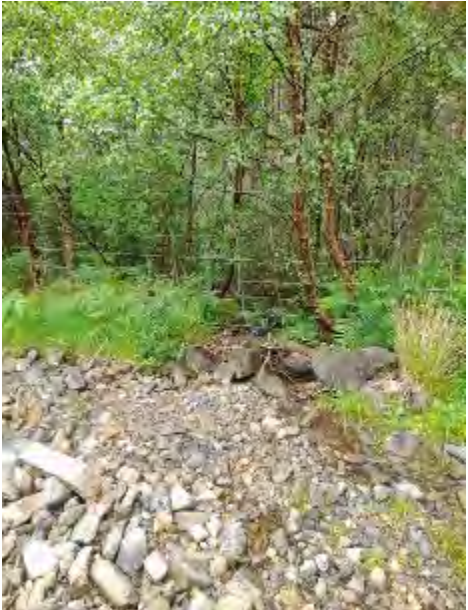
Photograph Looking Downstream

Watercourse Crossing ID	WX4.72	
Watercourse Crossing Details	<p>Watercourse Crossing: WX4.72 NGR: NG 95051 07319 Status: Existing Culvert Diameter: N/A Culvert Construction Type: N/A Watercourse Width: 2.5 m Watercourse Depth: 0.2 m Notes: Water flows over track with no formal infrastructure noted. Most of water is diverted down the track.</p>	
Photograph Looking Upstream

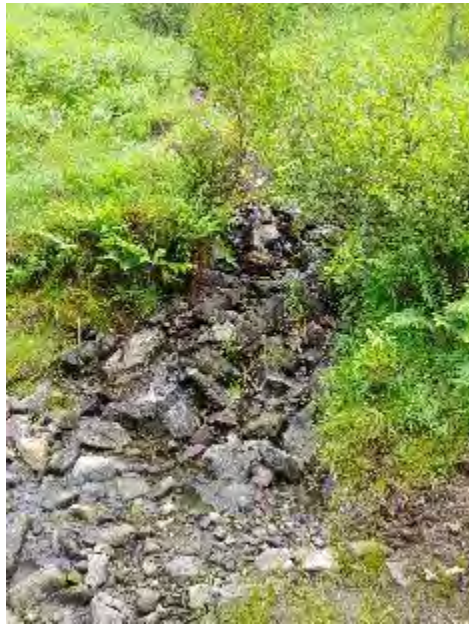
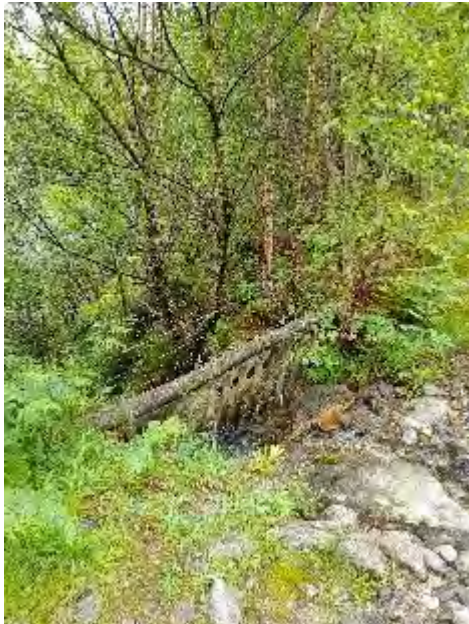
Watercourse Crossing ID	WX4.73
Watercourse Crossing Details	<p>Watercourse Crossing: WX4.73 NGR: NG 95093 07305 Status: Existing Culvert Diameter: N/A Culvert Construction Type: N/A Watercourse Width: 2 m Watercourse Depth: 0.5 m Notes: Small watercourse incised in bedrock with small fence immediately downstream of track crossing.</p>
Photograph Looking Upstream

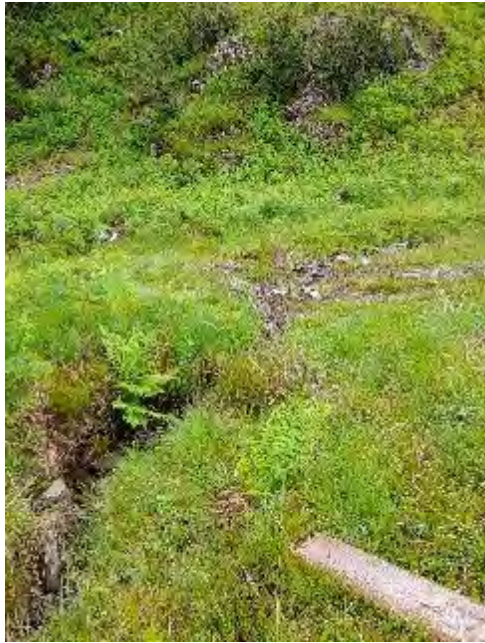
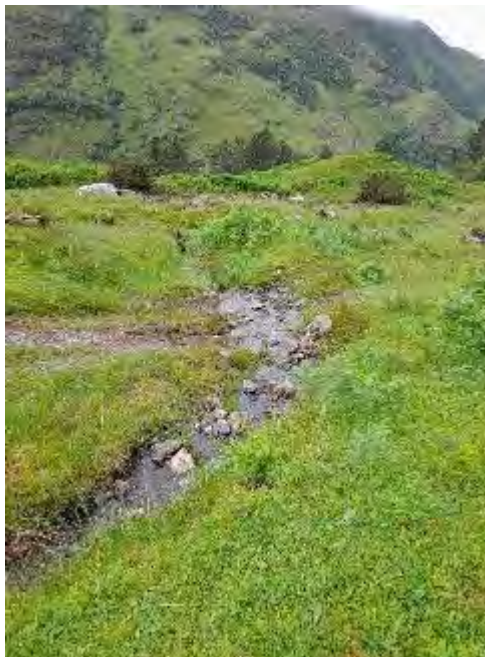
Watercourse Crossing ID	WX4.74
Watercourse Crossing Details	<p>Watercourse Crossing: WX4.74 NGR: NG 95382 07043 Status: Existing Culvert Diameter: N/A Culvert Construction Type: N/A Watercourse Width: 1.5 m Watercourse Depth: 0.3 m Notes: Water flows over track with no formal infrastructure.</p>
Photograph Looking Upstream

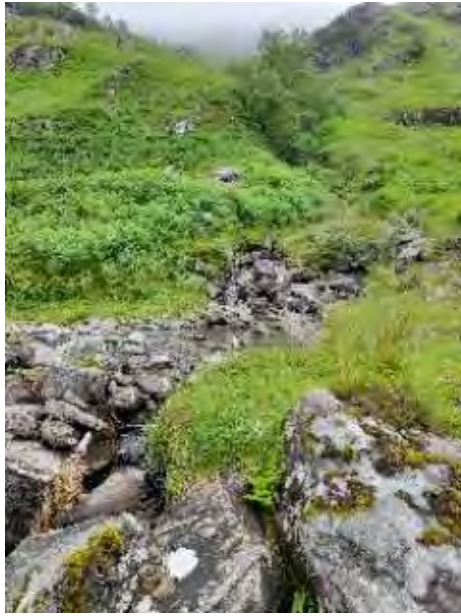
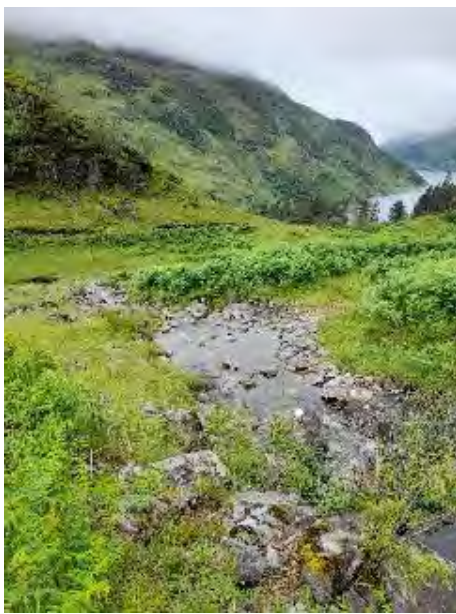
Watercourse Crossing ID	WX4.75	
Watercourse Crossing Details	<p>Watercourse Crossing: WX4.75 NGR: NG 95452 07002 Status: Existing Culvert Diameter: N/A Culvert Construction Type: N/A Watercourse Width: 3 m Watercourse Depth: 0.3 m Notes: Water flows over track as a small ford with no formal infrastructure.</p>	
Photograph Looking Upstream

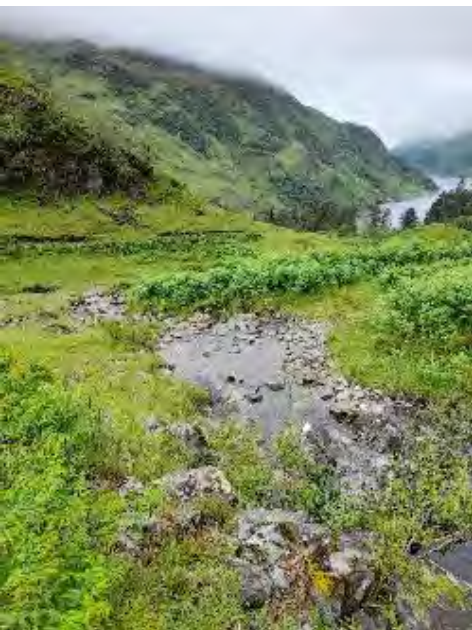
Photograph Looking Downstream

Watercourse Crossing ID	WX4.76	
Watercourse Crossing Details	<p>Watercourse Crossing: WX4.76 NGR: NG 95459 06997 Status: Existing Culvert Diameter: N/A Culvert Construction Type: N/A Watercourse Width: 3 m Watercourse Depth: 0.3 m Notes: Same as WX4.75 as no additional watercourse is not noted.</p>	
Photograph Looking Upstream

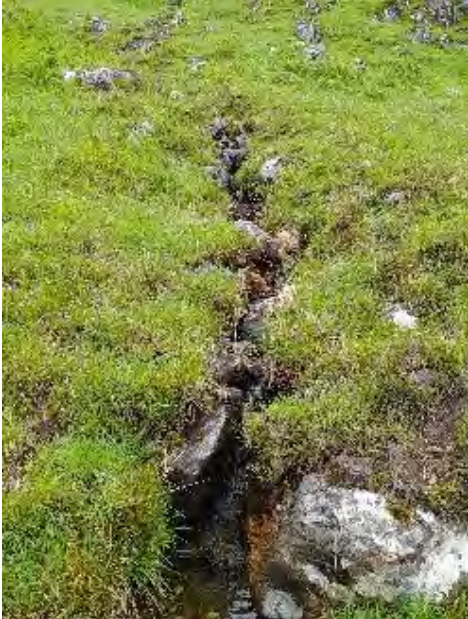
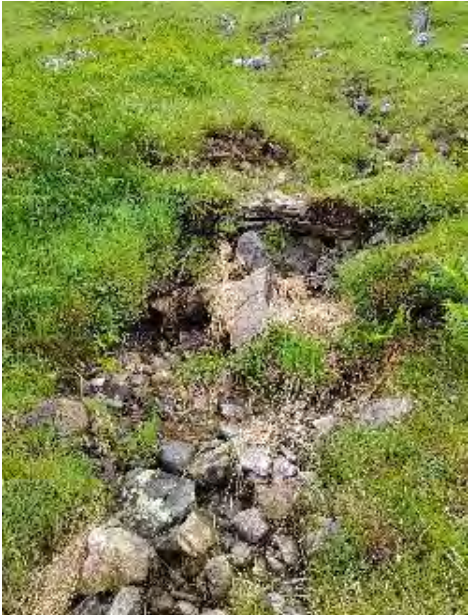
Watercourse Crossing ID	WX4.77	
Watercourse Crossing Details	<p>Watercourse Crossing: WX4.77 NGR: NG 95616 06871 Status: Existing Culvert Diameter: N/A Culvert Construction Type: stone slabs over watercourse Watercourse Width: 0.5 m Watercourse Depth: 0.5 m Notes: Incised watercourse in bedrock. Crossing is partially blocked on downstream end with large boulders.</p>	
Photograph Looking Upstream

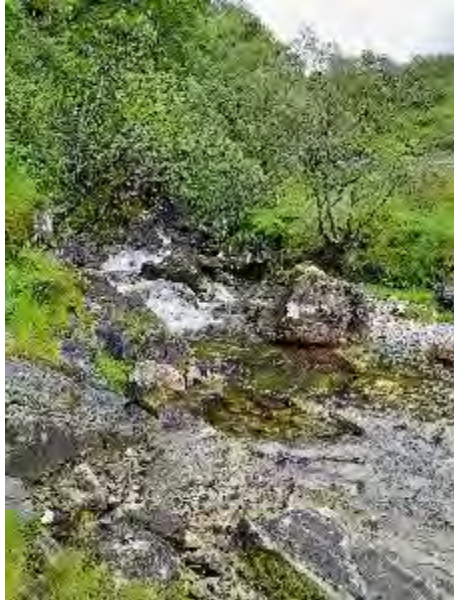
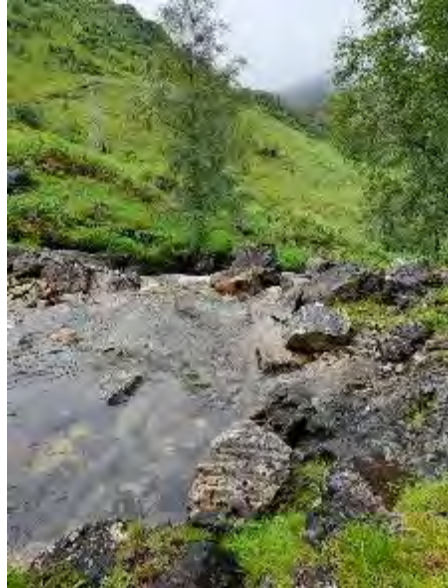
Watercourse Crossing ID	WX4.78	
Watercourse Crossing Details	<p>Watercourse Crossing: WX4.78 NGR: NG 95956 06751 Status: Existing Culvert Diameter: N/A Culvert Construction Type: N/A Watercourse Width: 8 m Watercourse Depth: 1 m Notes: Large ford over existing track. Watercourse incised into bedrock with large boulders in channel and small waterfall immediately downstream of the crossing.</p>	
Photograph Looking Upstream

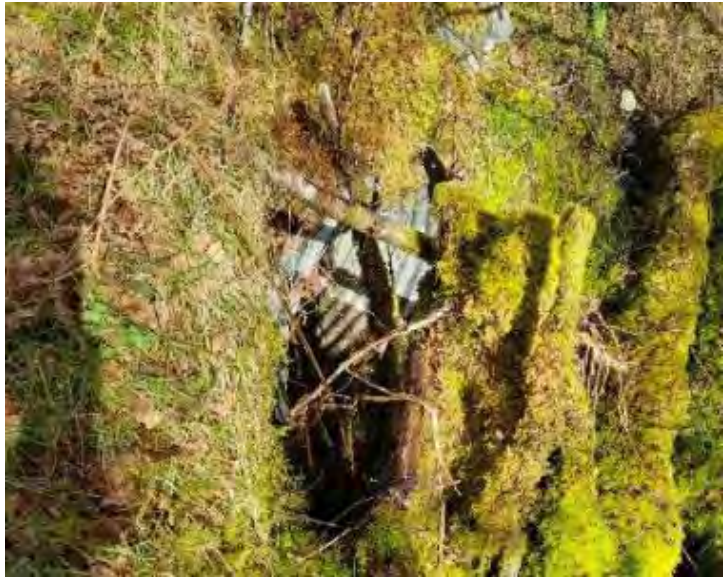
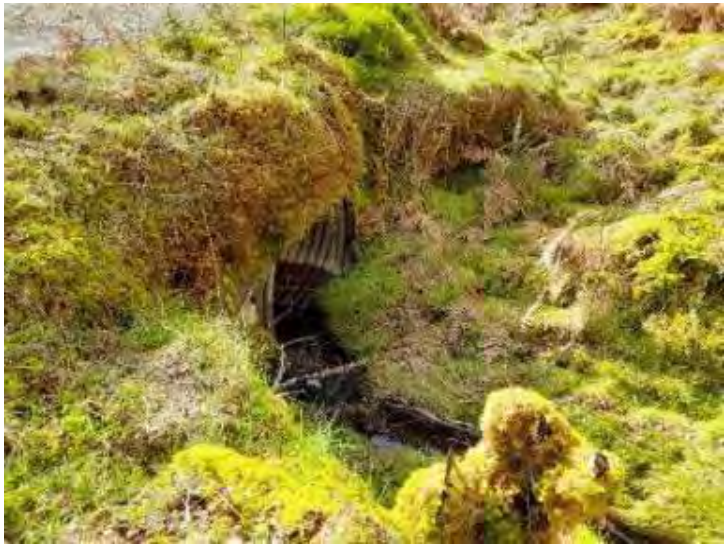
Section 5	
Watercourse Crossing ID	WX5.3
Watercourse Crossing Details	<p>Watercourse Crossing: WX5.3 NGR: NH 27567 02750 Status: Existing Culvert Diameter: 0.8m Culvert Construction Type: circular corrugated iron culvert Watercourse Width: 0.2m Watercourse Depth: 0.2m Notes: very small channel, culvert slightly damaged but not blocked, raised at the outfall forming a hydraulic drop, pebbles and cobbles deposited in channel.</p>
Photograph Looking at Culvert Entrance from Upstream

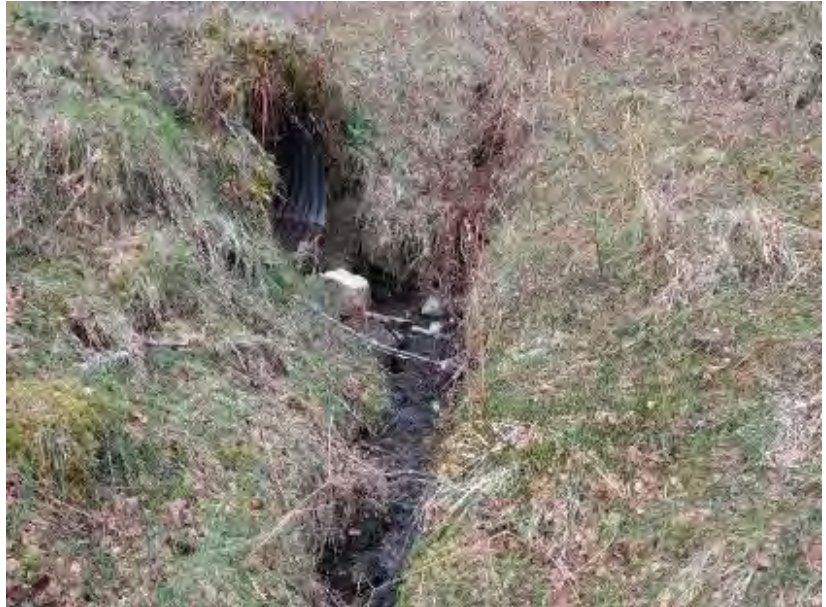
Watercourse Crossing ID	WX5.5
Watercourse Crossing Details	<p>Watercourse Crossing: WX5.5 NGR: NH 28420 02034 Status: Existing Culvert Diameter: 1m Culvert Construction Type: corrugated metal culvert Watercourse Width: 0.3m Watercourse Depth: 0.3m Notes: culvert showing corrosion, existing track is located directly on top with little cover between the road level and culvert soffit, no evidence of flooding, pebbles and cobbles deposited in channel</p>
Photograph Looking at Upstream of Culvert

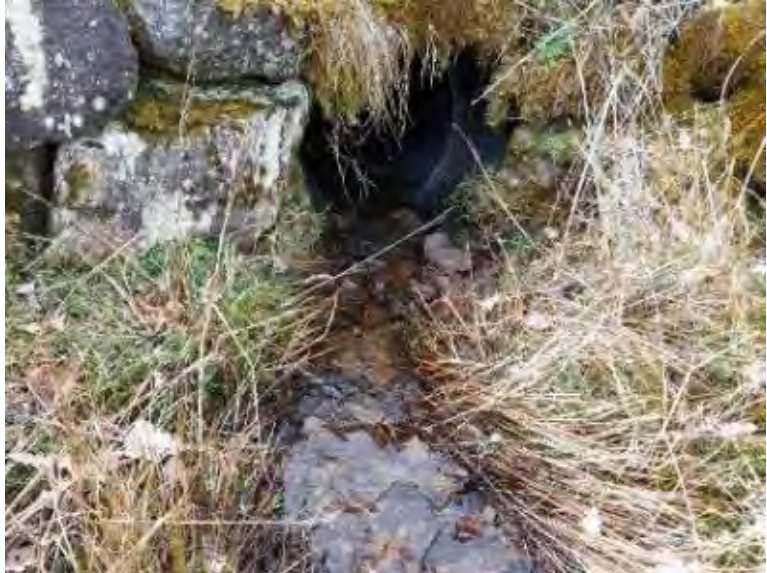
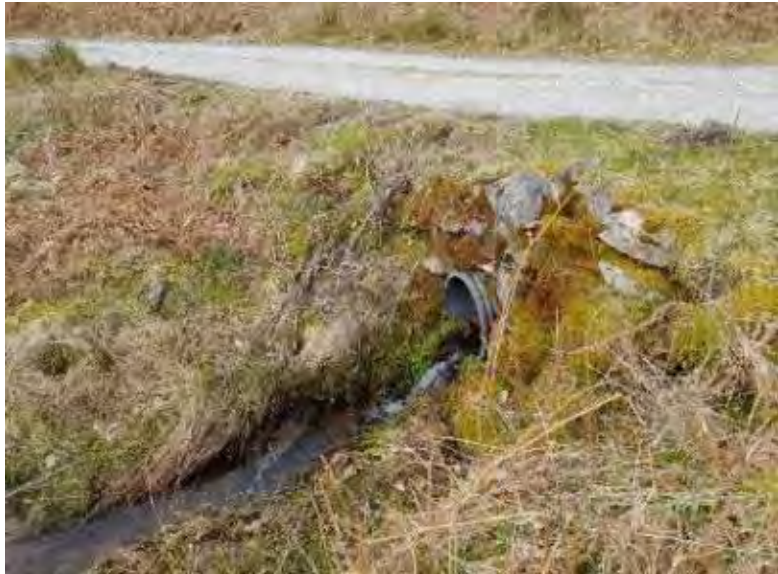
Watercourse Crossing ID	WX5.7
Watercourse Crossing Details	<p>Watercourse Crossing: WX5.7 NGR: NH 25014 03005 Status: Existing Culvert Diameter: 0.5m Culvert Construction Type: circular plastic culvert Watercourse Width: 0.3m Watercourse Depth: 1.8m Notes: bed substrate comprised of sand, pebbles and cobbles, some evidence of flooding and a small hydraulic drop on downstream end of culvert (outfall).</p>
Photograph Looking at Culvert Entrance from Upstream

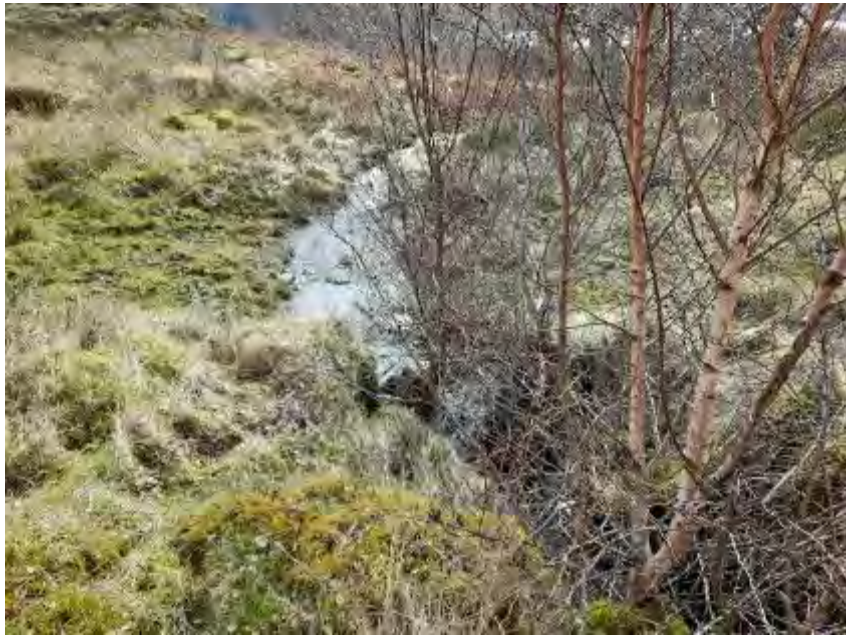
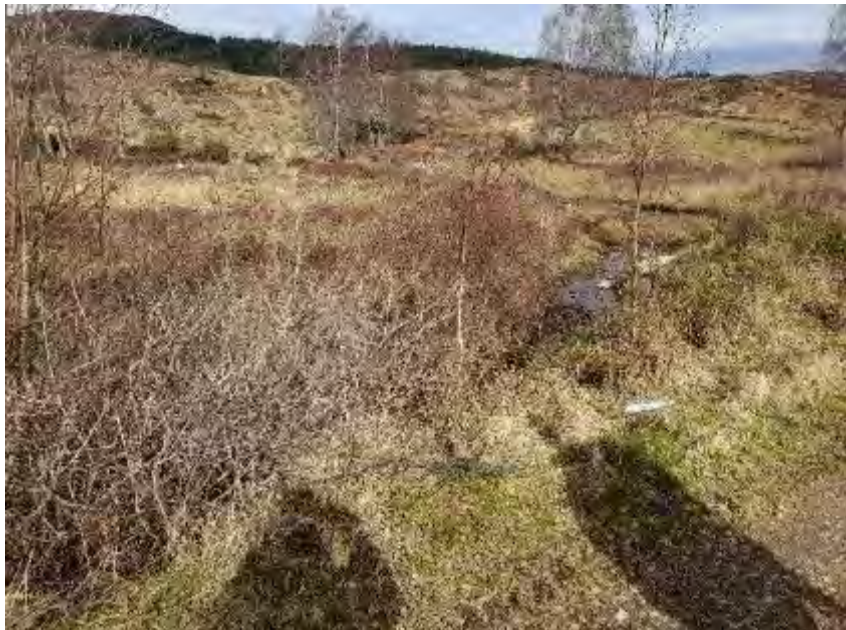
Watercourse Crossing ID	WX5.9
Watercourse Crossing Details	<p>Watercourse Crossing: WX5.9 NGR: NH 27071 02880 Status: Existing Culvert Diameter: N/A Culvert Construction Type: wooden bridge Watercourse Width: 1.2m Watercourse Depth: 0.2-0.5m Notes: no evidence of flooding, wooden bridge crossing supported by bricks on the channel bank, some small boulders deposited in channel.</p>
Photograph Looking Upstream

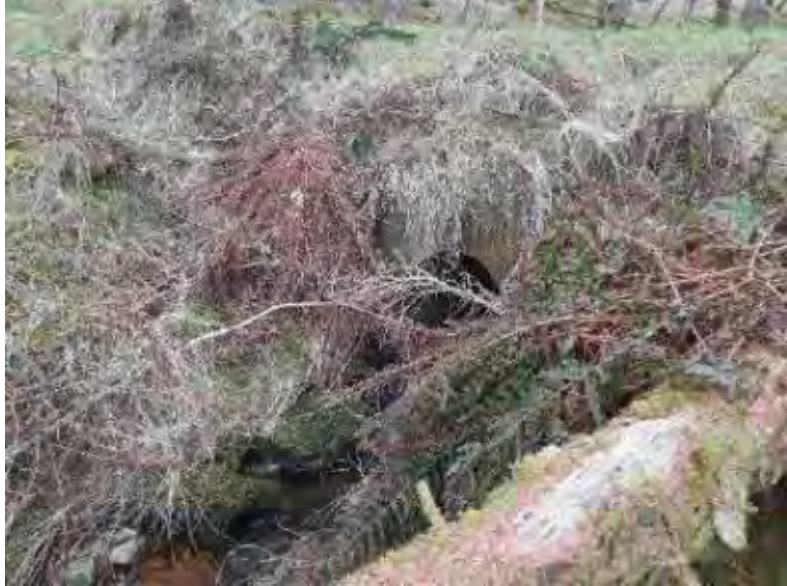
Photograph Looking at Culvert Exit from Downstream.

Watercourse Crossing ID	WX5.10
Watercourse Crossing Details	<p>Watercourse Crossing: WX5.10 NGR: NH 19927 02456 Status: Existing Culvert Diameter: 0.6m Culvert Construction Type: circular concrete culvert Watercourse Width: 0.5m Watercourse Depth: 0.2-1m Notes: channel incised into bedrock with boulders deposited in the reach, existing culvert appears in good condition, evidence of flooding adjacent to the channel.</p>
Photograph Looking at Culvert Entrance from Upstream
