**Fanellan Hub 400 kV Substation and  
Converter Station  
Environmental Impact Assessment Report  
Volume 4 | Technical Appendices**

**Appendix 9.2 – Protected Species Baseline  
February 2025**

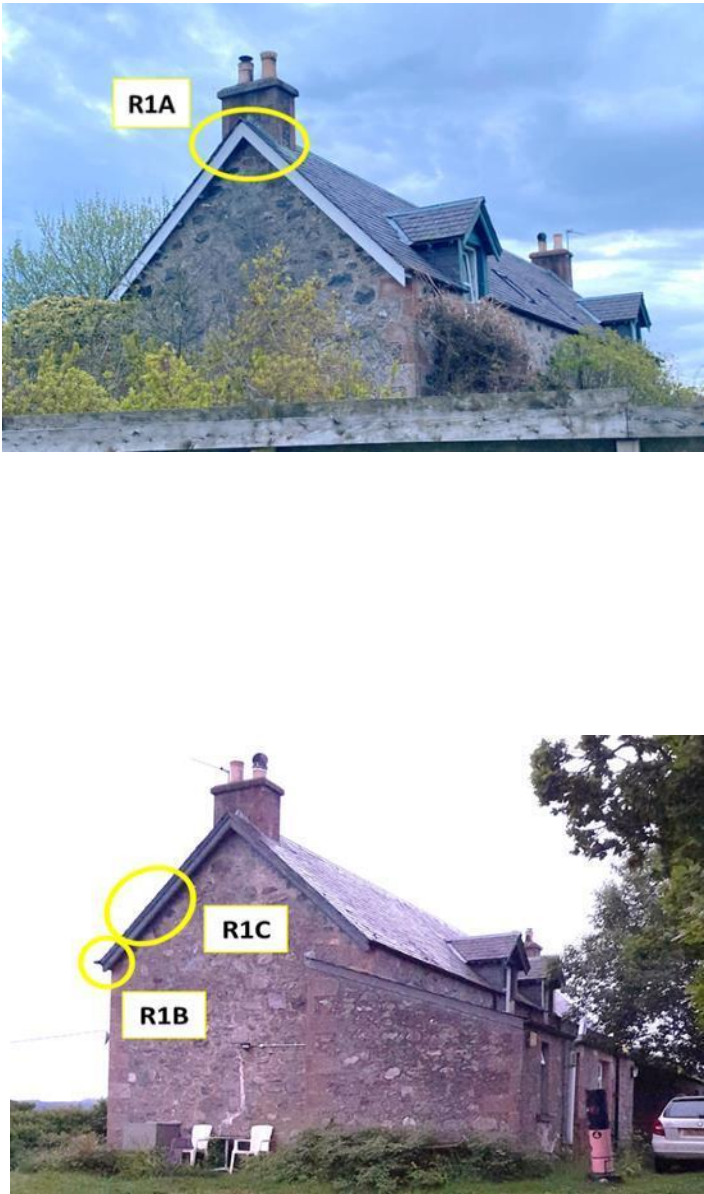
Reference	Type	Dates Observed	Roost reference and Type	Species & Maximum Observed Quantity	Roost Details
R1	Structure	30/04/2024 (R1A) 28/05/2024 (R1B & R1C)	R1A: Day Roost R1B: Day Roost R1C: Maternity Roost	R1A: 1x soprano pipistrelle. R1B: 1x common pipistrelle. R1C: 32x common pipistrelle; and 5x soprano pipistrelle.	R1A: Near chimney on the western aspect. R1B: Southeast corner of roof.

Reference	Type	Dates Observed	Roost reference and Type	Species & Maximum Observed Quantity	Roost Details
					<p>R1C: Southeastern gable end.</p>

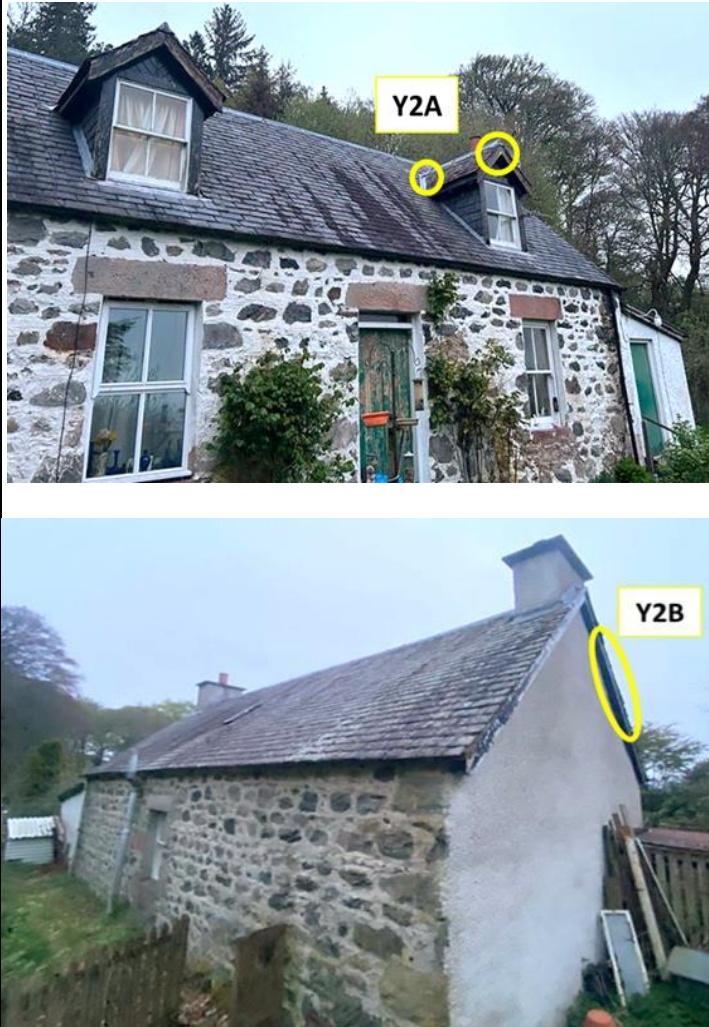
Reference	Type	Dates Observed	Roost reference and Type	Species & Maximum Observed Quantity	Roost Details
Y2	Structure	01/05/2024 (Y2A & Y2B) 28/05/2024 (Y2B)	Y2A: Maternity Roost Y2B: Day Roost	Y2A: 19x soprano pipistrelle. Y2B: 5x soprano pipistrelle.	<p>Y2A: Eastern aspect, most northerly dormer. Y2B: Southern gable end.</p>

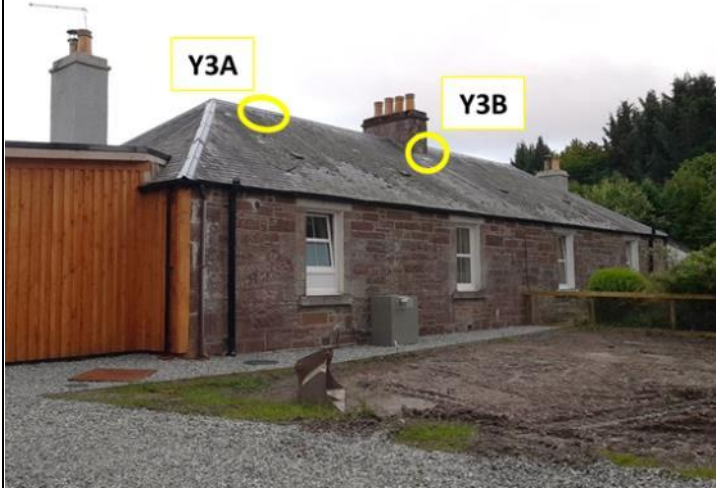
Reference	Type	Dates Observed	Roost reference and Type	Species & Maximum Observed Quantity	Roost Details
Y3	Structure	30/05/2024 (Y3A & Y3B) 26/06/2024 (Y3B)	Y3A: Day Roost Y3B: Day Roost	Y3A: 1x soprano pipistrelle. Y3B: 1x soprano pipistrelle.	<p>Y3A: Northeast apex of roof. Y3B: Northwest edge of chimney.</p>

3.2.21 Two roosts were observed in **Structure Y3**:
