## Overhead Line Tie-in; Cambushinnie 400kV OHL Tie-In

Geo-environmental Desk Study

Project number: 60721943 60721943-R-002

23 May 2025

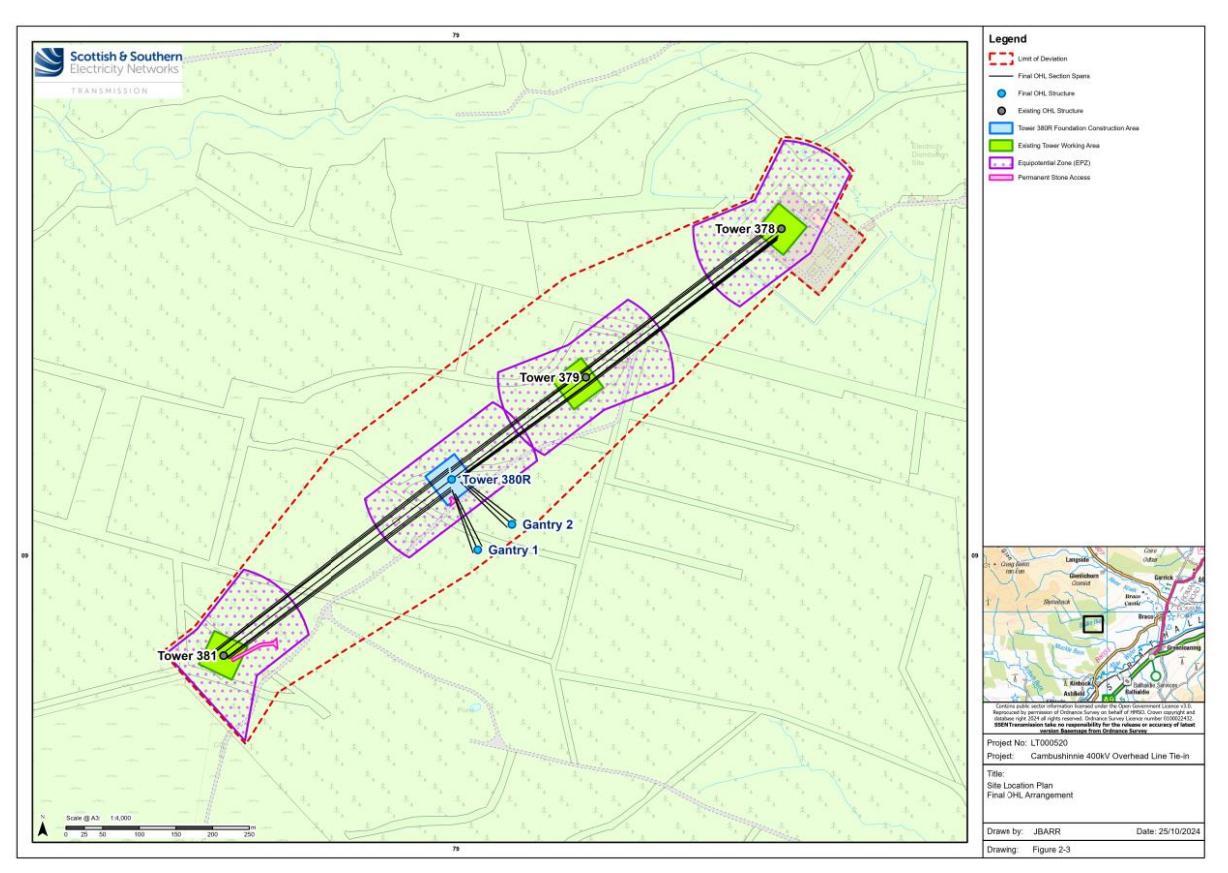
#### Figure 1. Final OHL Arrangement Plan

- Implementation of two temporary towers 380T and 379T to allow for short term OHL diversions during the construction of the new terminal tower 380R;
- One new permanent terminal tower 380R;
- Dismantling of redundant tower T380; and
- Temporary access routes to permanent and temporary towers except at T378.

The Site location plan and Final OHL Arrangement plan are included for the Proposed Development in **Appendix A**, with an extract of the Final OHL Arrangement provided in **Figure 1**, below.

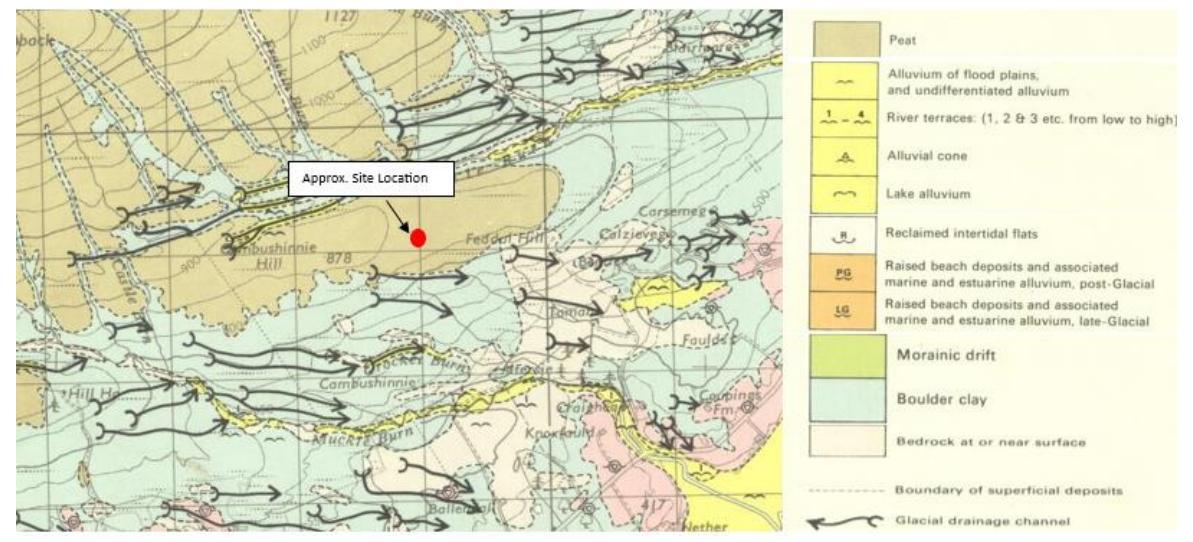
#### Figure 3 Drift Geology

The southwest of the Site is indicated by BGS mapping to be underlain by natural superficial deposits of Peat, and a small area of Till. The immediate surrounding area of the Site comprises Alluvium (of Clay, Silt, Sand and Gravel) to the northwest and northeast, and Glacial Till (Till Devensian-Diamicton) to the north, east, south and west of the Site. This is also confirmed by the Groundsure Report (**Appendix C**).

The paper map in **Figure 3** below shows '*Peat*' across the Site. This is in general agreement with the Groundsure Report and BGS Geoindex.

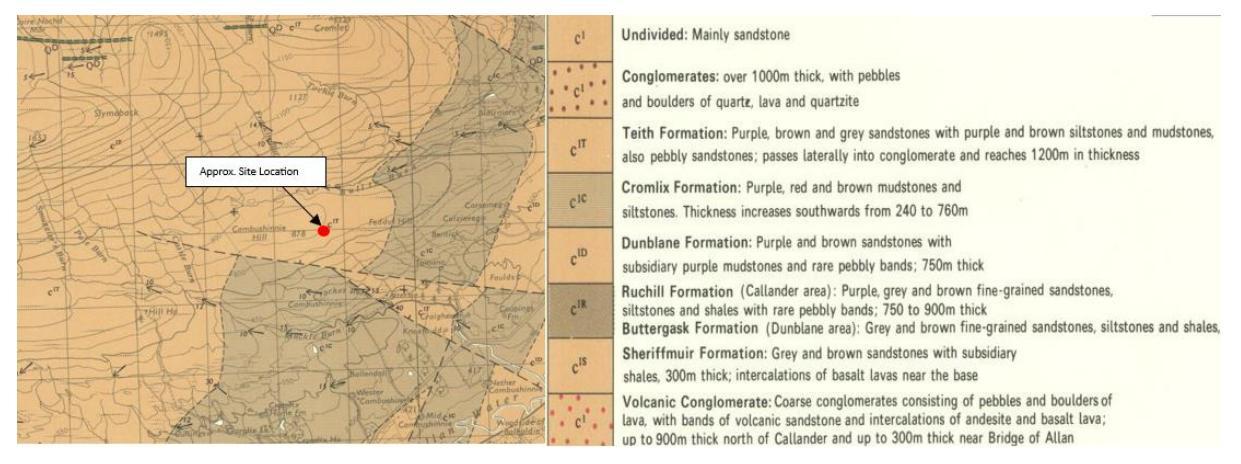
#### Figure 4 Solid Geology

The bedrock is disrupted by faults within 1 km of the Site. The faults are inferred and present at approximately 270 m southwest and 980 m south of the Site.
