Bingally 400 kV Overhead Line Tie-In

Geotechnical and Geo-environmental Desk Study

Project number: 60701792
60701792-R-002
April 2025

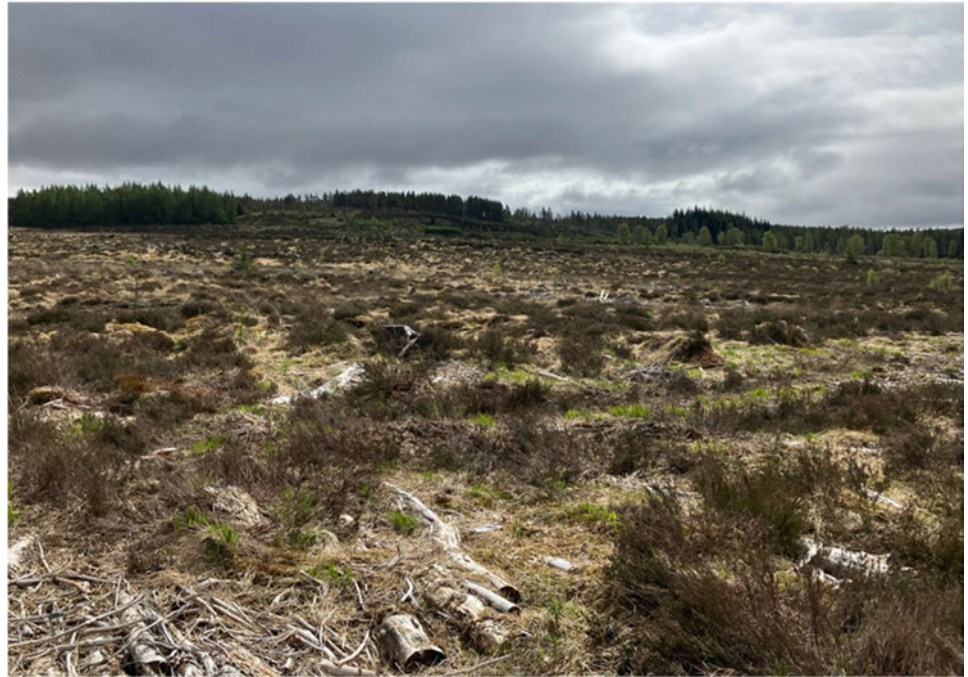
New substation
development area
(proposed Bingally
substation only)

(facing east)

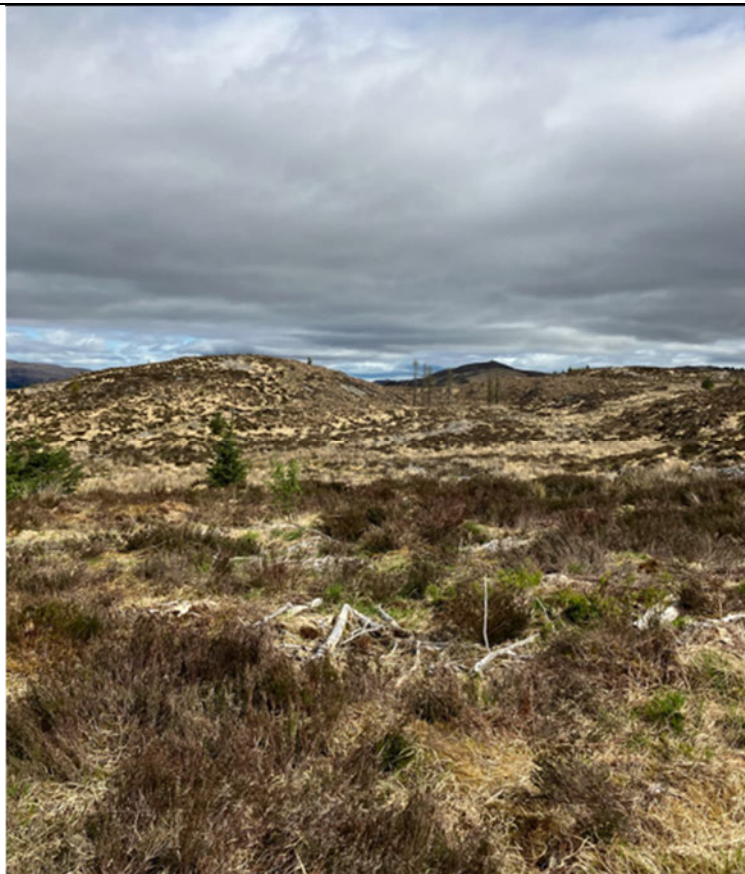
Photo No.
2

New substation
development area
(proposed Bingally
substation only)

(facing north-east)

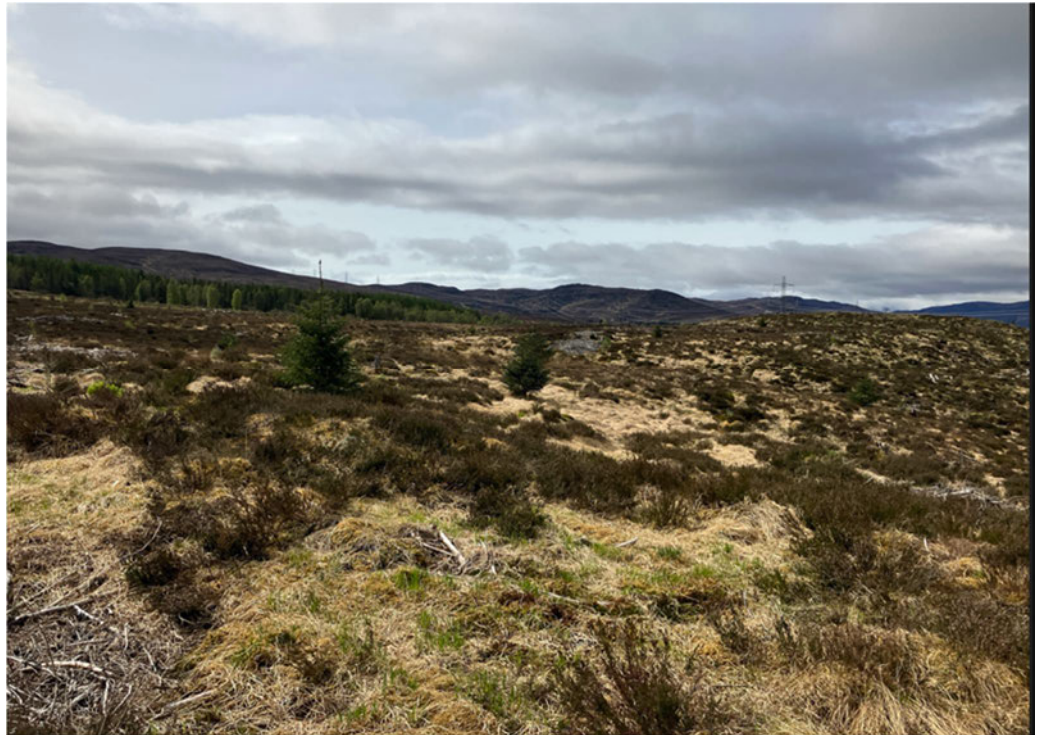
**Client Name: SSEN
Transmission****Bingally Overhead Line****Project No.
60701792****Photo No.**
3**Date:**
10/05/2024New substation
development area
(proposed Bingally
substation only)

(facing south)

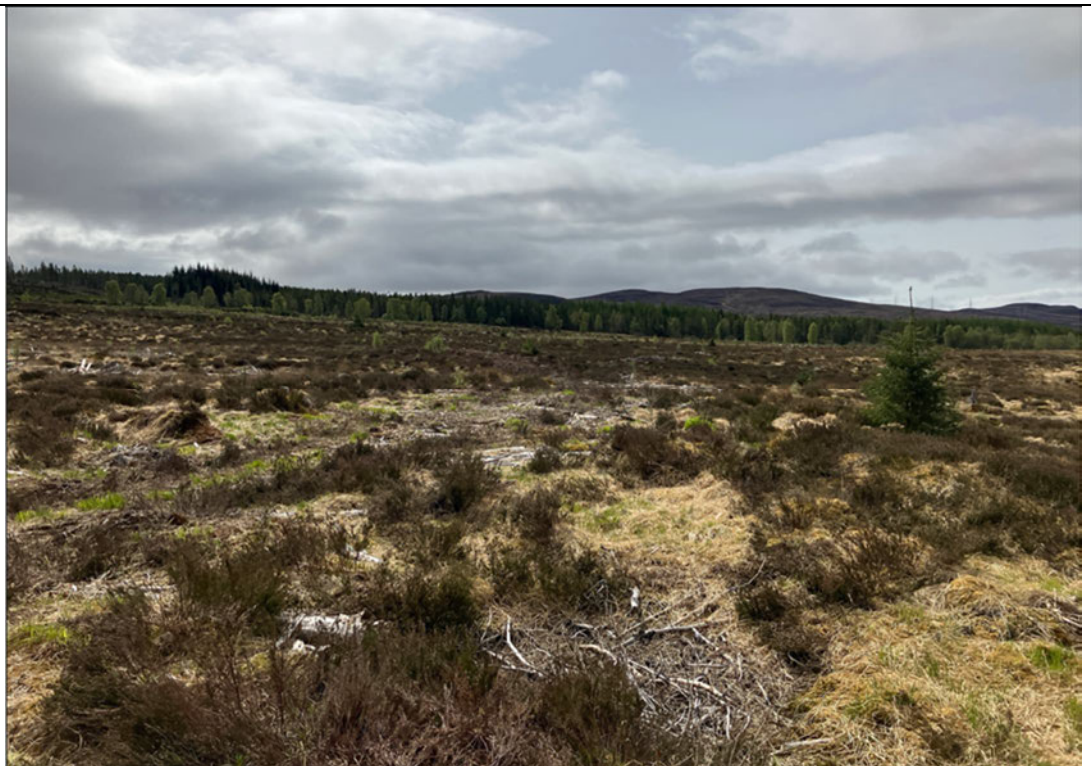
**Photo No.**
4**Date:**
10/05/2024New substation
development area
(proposed Bingally
substation only)

(facing south-east)

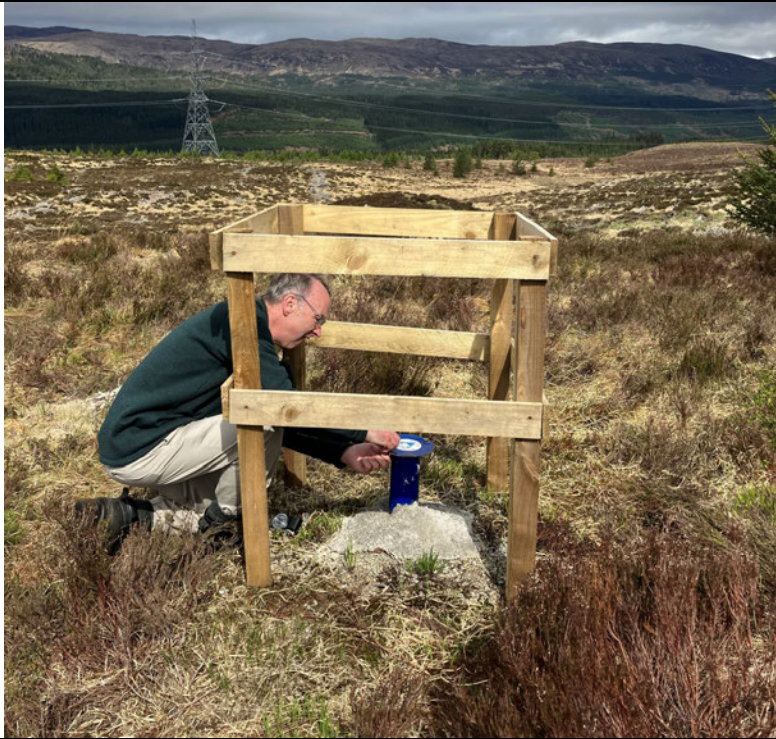
Evidence of recent ground investigation works including ground disturbance and monitoring well apparatus were noted during the walkover within the proposed Bingally substation site.

Monitoring well on the new substation development area (proposed Bingally substation only)

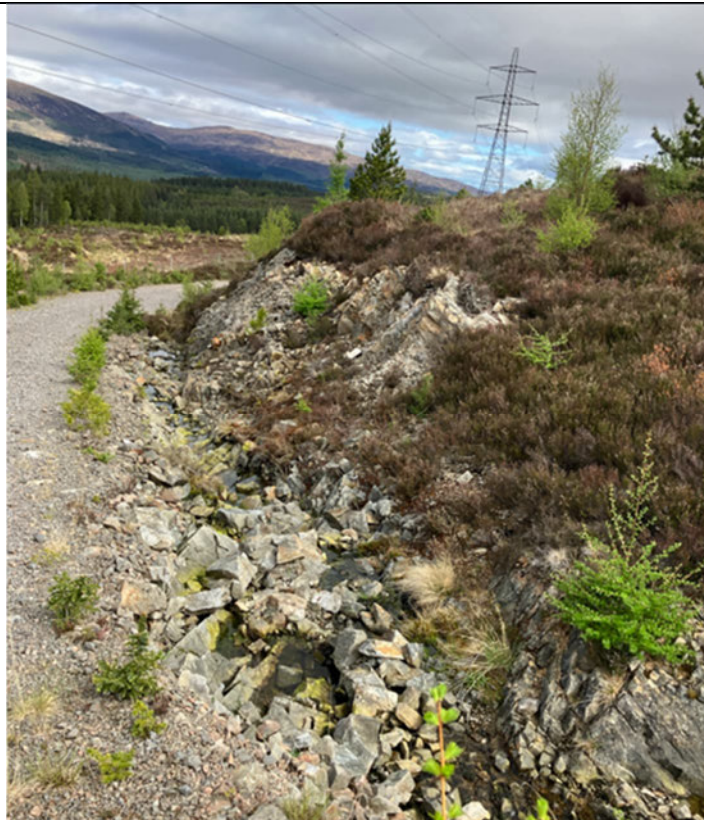
Photo No.
6

Off-site gravelly access track with drainage running channel alongside the track, to the north-west of the Proposed Development.

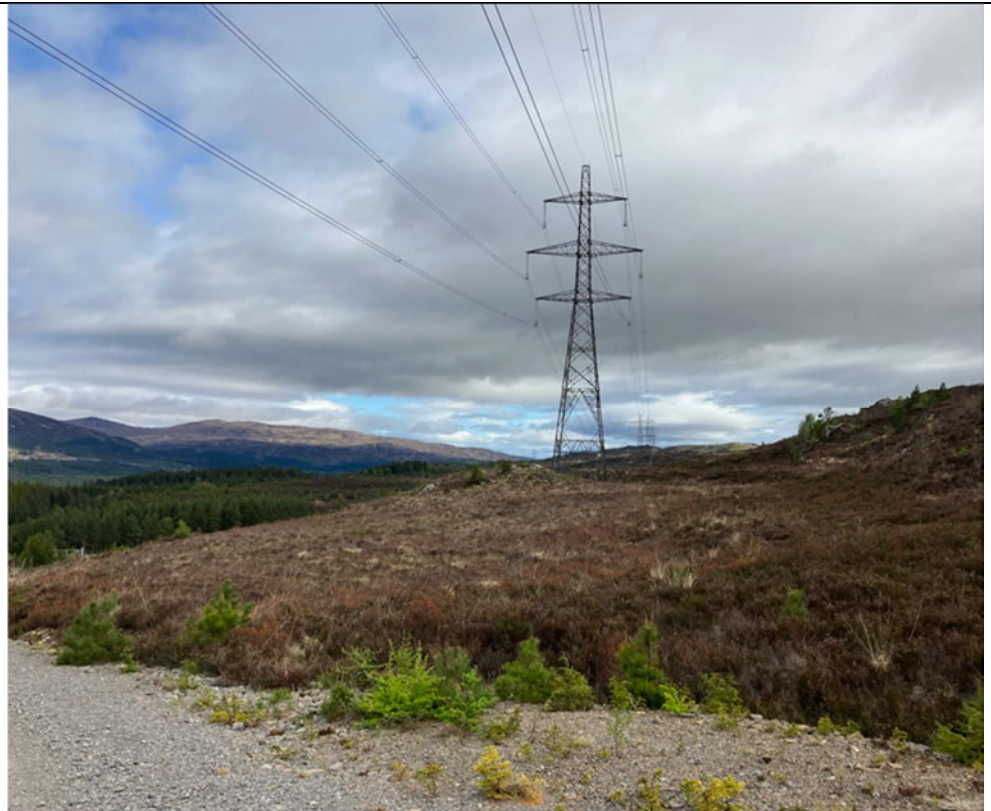
Existing pylon associated
with Beaulieu Denny
transmission.

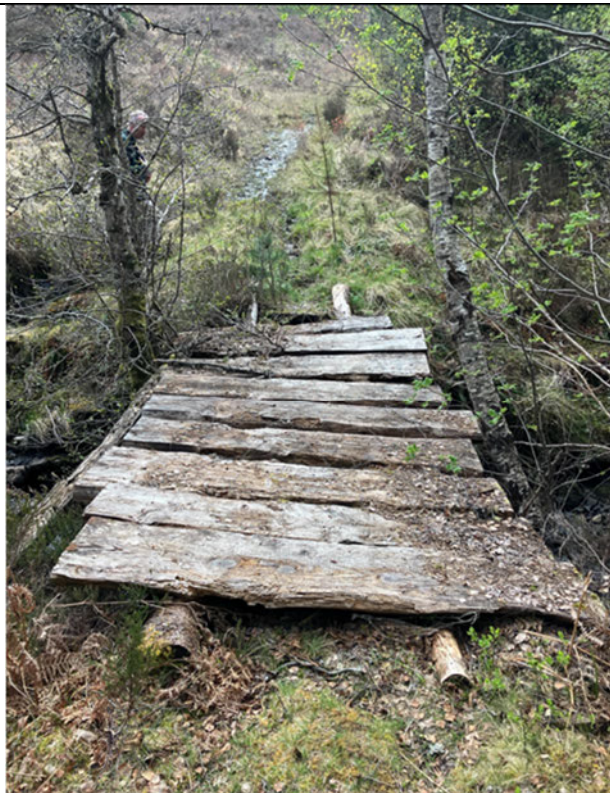
Offsite old foot bridge
across burn to the north-
west of the new substation
development area
(proposed Bingally
substation only)
